**JEFFERSON MEMORIAL
NATIONAL MALL & MEMORIAL PARKS
WASHINGTON, DC**

CONTRACT # 1443C2000040800
REPAIR AND CONTROL SETTLEMENT AT JEFFERSON
MEMORIAL SEAWALL, NORTH PLAZA, AND TRANSITION
AREAS
PMIS NO. 128232

SUPPLEMENTAL DOCUMENTS

NATIONAL PARK SERVICE
DENVER SERVICE CENTER
April 2, 2009

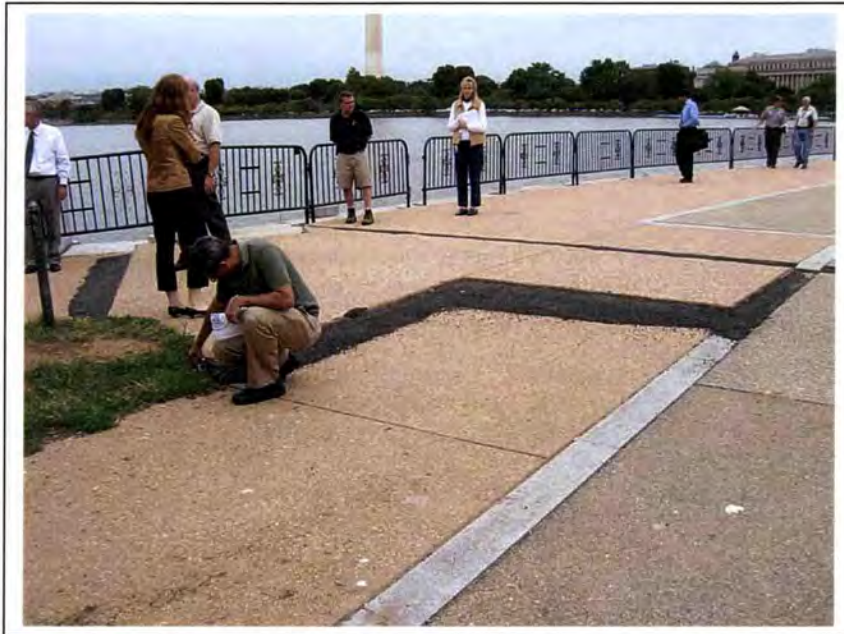
Presently, there is differential settlement between the Circular Roadway on grade and the North Plaza structure on piles. This differential settlement is pronounced on the west side, and has necessitated frequent asphalt patching to mitigate tripping hazards. Park maintenance personnel have indicated that these locations require additional patching at the rate of approximately 0.5 inches every three months, and this frequent patching is only a recent necessity (2006-2008). Figures 4 and 5 show the asphalt patches on the western side of the North Plaza.

Figure 4. Asphalt Patches on North Plaza and Circular Roadway Interface (9-12-06)

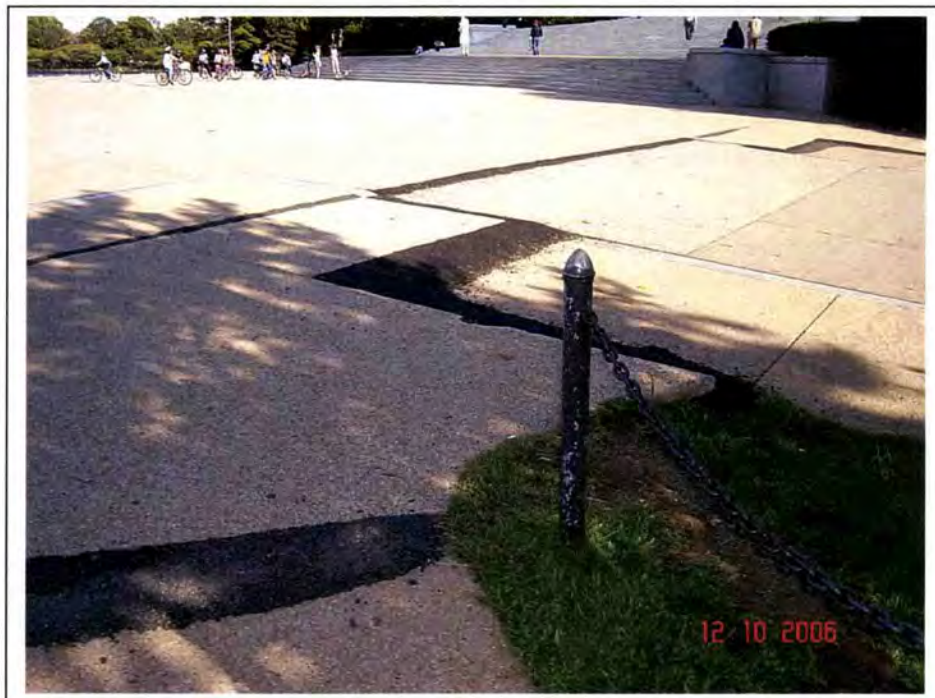
Figure 5. Asphalt Patches on North Plaza and Circular Roadway Interface (10-12-06). Note "bulge" in grassy area suggesting the presence of a grade beam on piles.

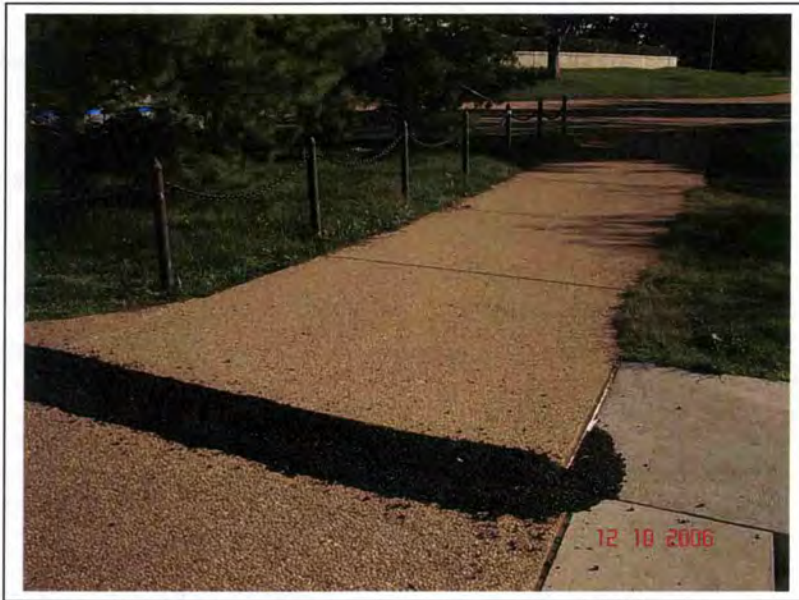
A slab-on-grade sidewalk intersects the stairs perpendicularly from the south. At this interface, there are differential elevations resulting in a tripping hazard, which has been mitigated through asphalt patching. Figure 6 shows a photograph of the vicinity.

Figure 6. Asphalt Patch at Northwest Stairs (10-12-06)

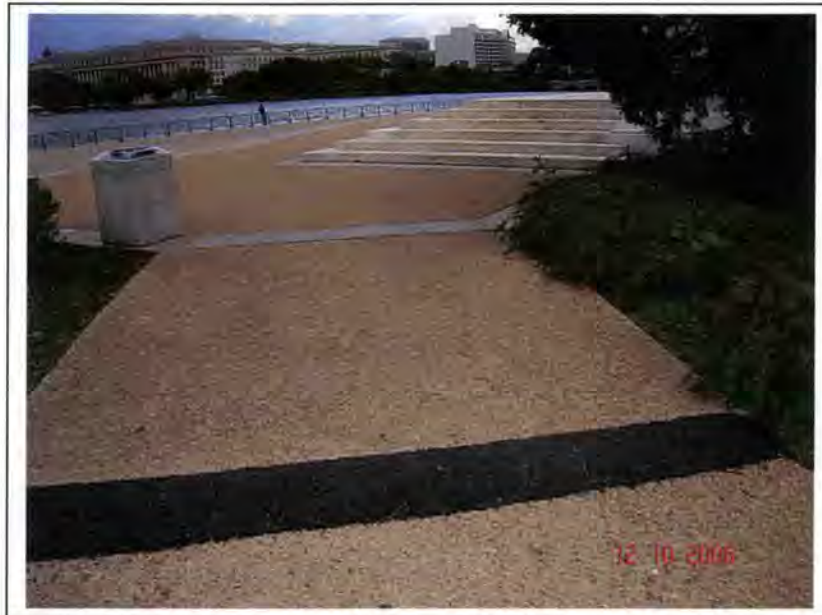
Settlement is also occurring on the exposed aggregate concrete sidewalk that leads to the exhibit area on the west side of the Terrace Walk. As shown in Figure 8, there is an asphalt patch in this area to mitigate tripping hazards. The foundation plans for the Jefferson Memorial indicate that the structure is pile-supported from the center of the Memorial to the extent of the Terrace Wall. (Refer to Figure 1, Jefferson Memorial Foundation Types.) Therefore, the West Terrace Walk can be presumed to be pile-supported.

Figure 8. West Terrace Walkway Looking Toward Main Stairs
(10-12-06)

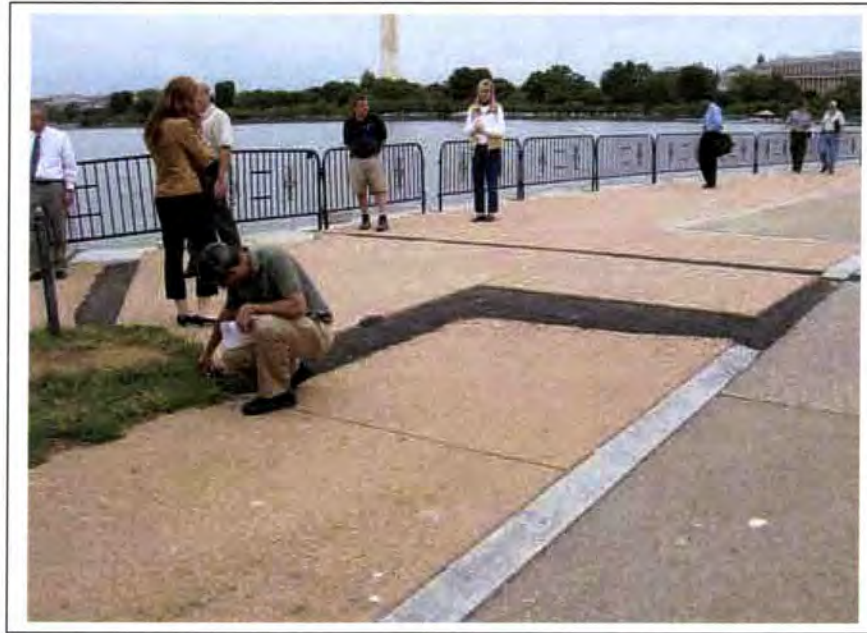
Presently, there is differential settlement between the Circular Roadway on grade and the North Plaza structure on piles. This differential settlement is pronounced on the west side, and has necessitated frequent asphalt patching to mitigate tripping hazards. Park maintenance personnel have indicated that these locations require additional patching at the rate of approximately 0.5 inches every three months, and this frequent patching is only a recent necessity (2006-2008). Figures 3 and 4 show the asphalt patches on the western side of the North Plaza. Sheet 3 in Appendix A shows the Previous and Current Settlement Studies.

Figure 3. Asphalt Patches on North Plaza and Circular Roadway Interface (9-12-06)

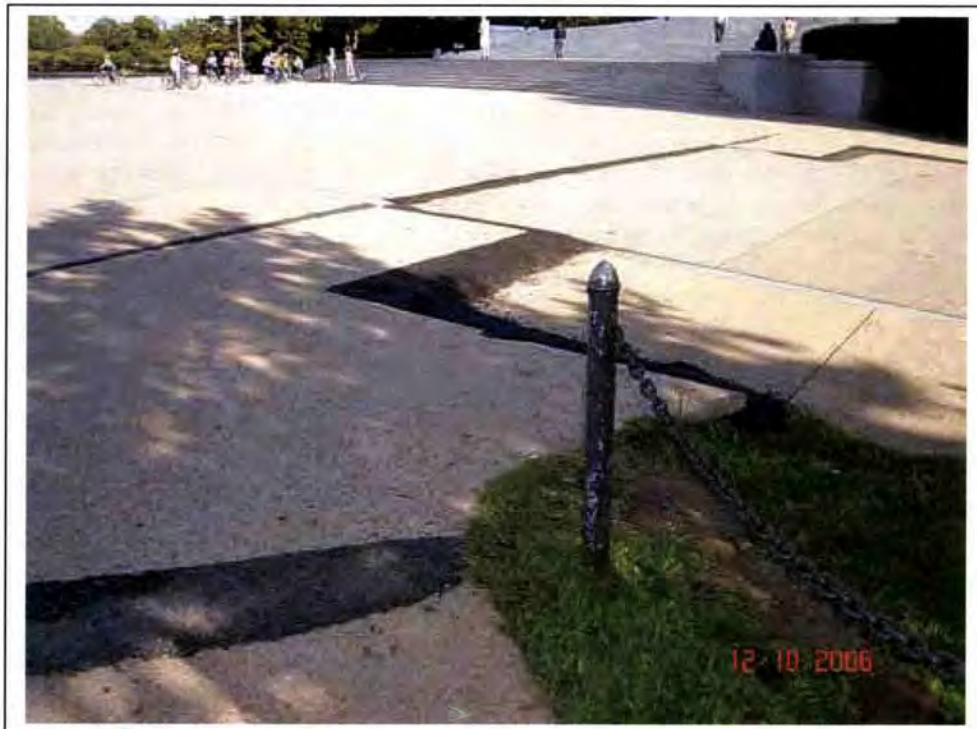
Figure 4. Asphalt Patches on North Plaza and Circular Roadway Interface (10-12-06). Note "bulge" in grassy area suggesting the presence of a grade beam on piles.

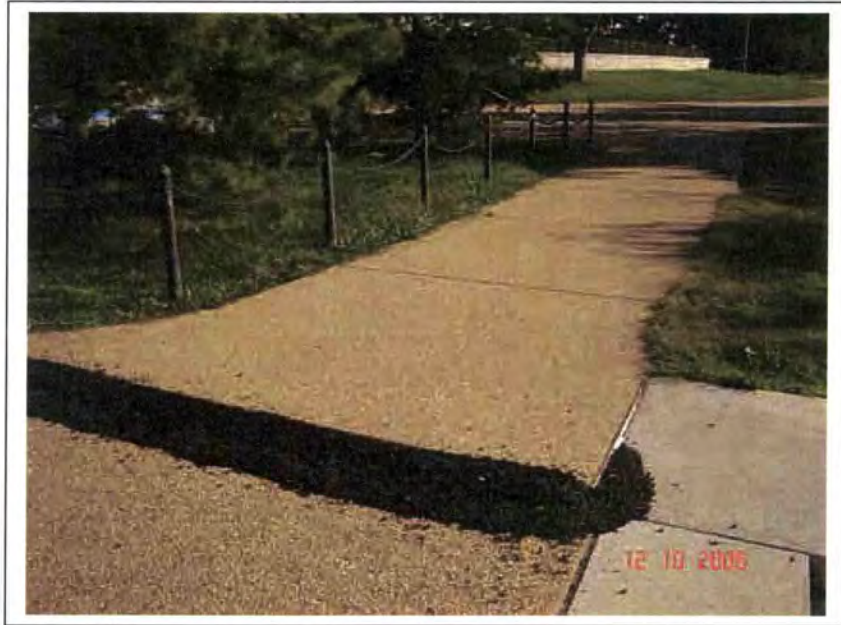
Figure 5. Asphalt Patch at Northwest Stairs (10-12-06)

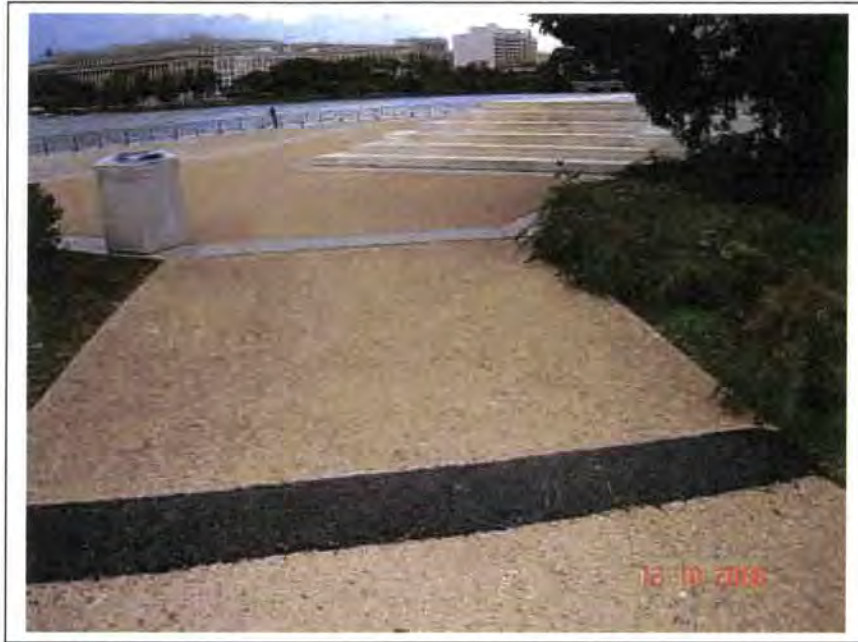
Settlement is also occurring on the exposed aggregate concrete sidewalk that leads to the exhibit area on the west side of the Terrace Walk. As shown in Figure 7, there is an asphalt patch in this area to mitigate tripping hazards. The foundation plans for the Jefferson Memorial indicate that the structure is pile-supported from the center of the Memorial to the extent of the Terrace Wall. Therefore, the West Terrace Walk can be presumed to be pile-supported.

Figure 7. West Terrace Walkway Looking Toward Main Stairs
(10-12-06)

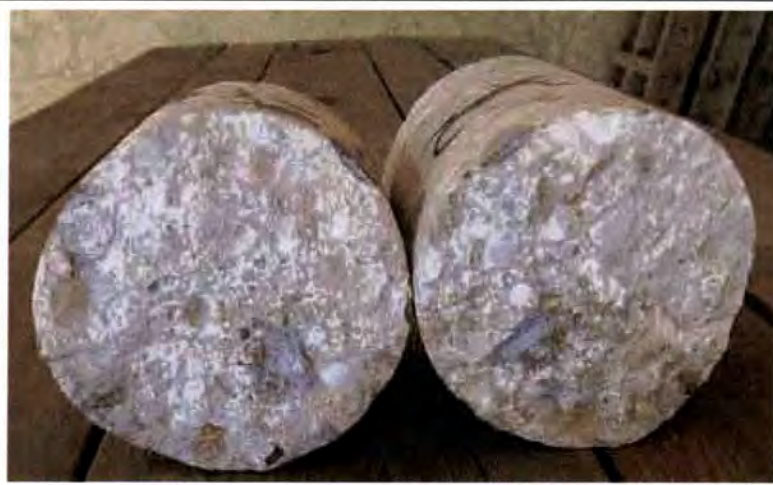
Photo 13: Core 3, Segments 1 and 2 - Cross section of break showing evidence of efflorescence (white staining).

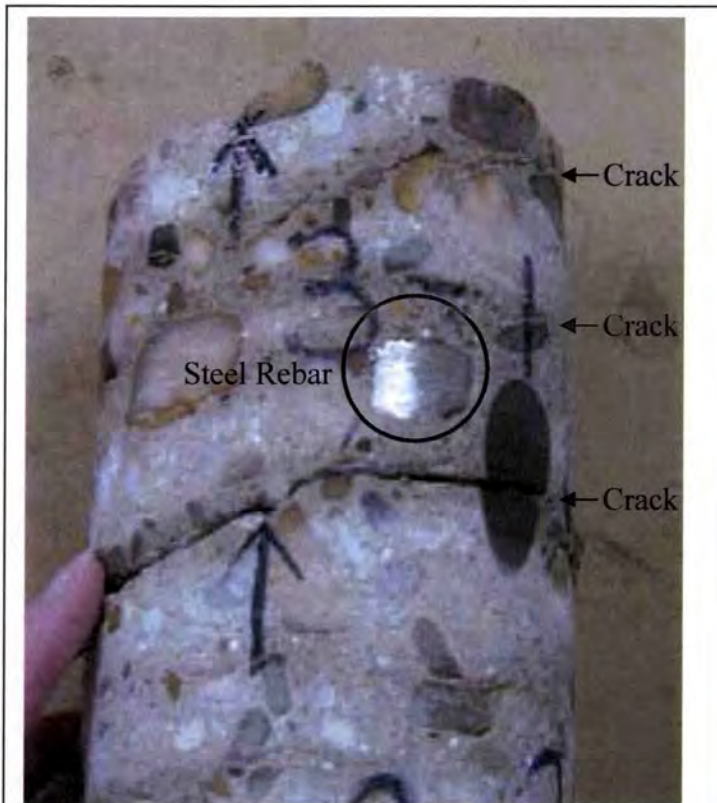
Photo 16: Core 3, Segments 1 and 2 - Cracking shows that concrete was likely placed in lifts. Steel rebar is also shown here.

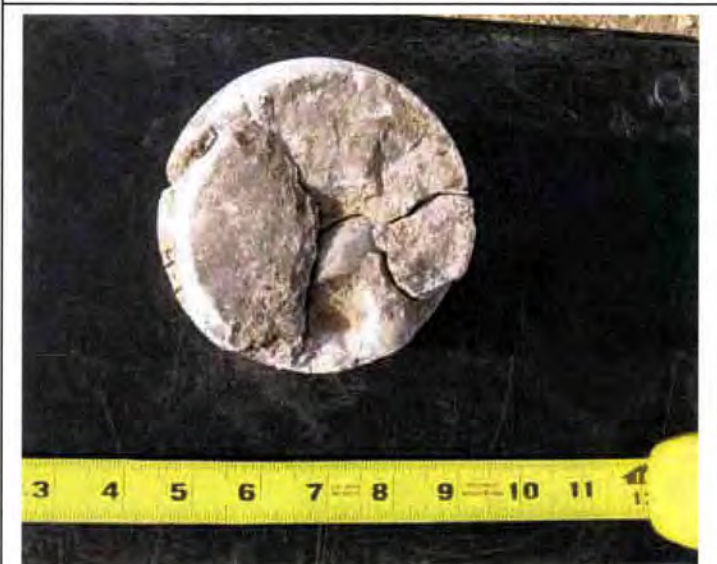
Photo 17: Core 4, Segment 1 - Top of core shows significant cracking.

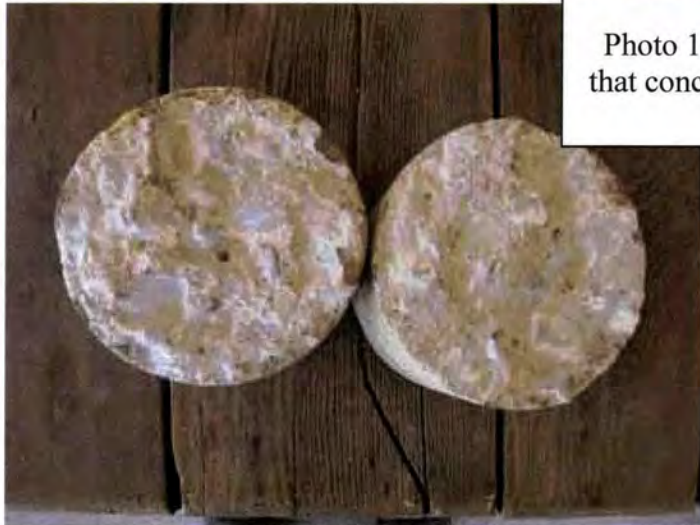
Photo 20: Core 4, Segments 1 and 2 - Cross section shows signs of wearing.

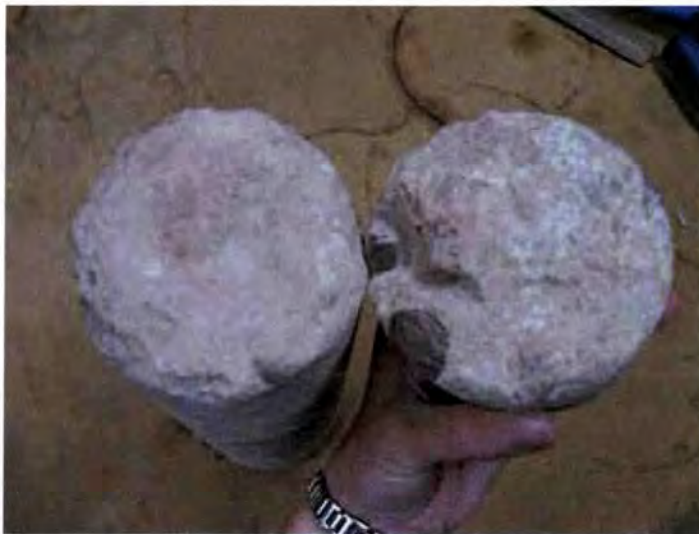
Photo 21: Core 4, Segments 4 and 5 - Cross section of break shows evidence of wearing.

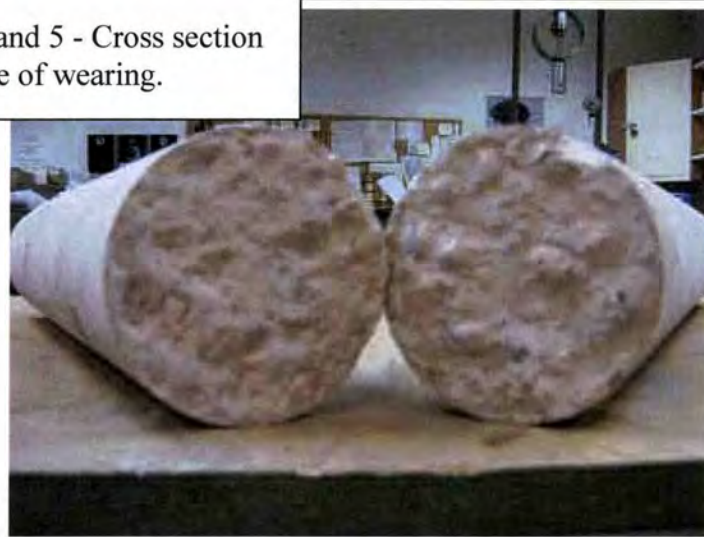
Photo 22: Core 4, Segments 6 and 7 - Cross section of break shows evidence of wearing.

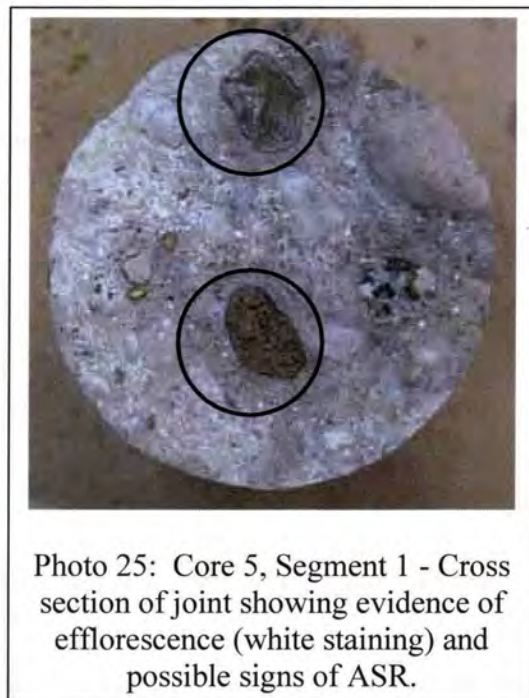
Photo 25: Core 5, Segment 1 - Cross section of joint showing evidence of efflorescence (white staining) and possible signs of ASR.
