**JEFFERSON MEMORIAL
NATIONAL MALL & MEMORIAL PARKS
WASHINGTON, DC**

CONTRACT # 1443C2000040800
REPAIR AND CONTROL SETTLEMENT AT JEFFERSON
MEMORIAL SEAWALL, NORTH PLAZA, AND TRANSITION
AREAS
PMIS NO. 128232

FINAL PREDESIGN DOCUMENTS

NATIONAL PARK SERVICE
DENVER SERVICE CENTER
March 6, 2008

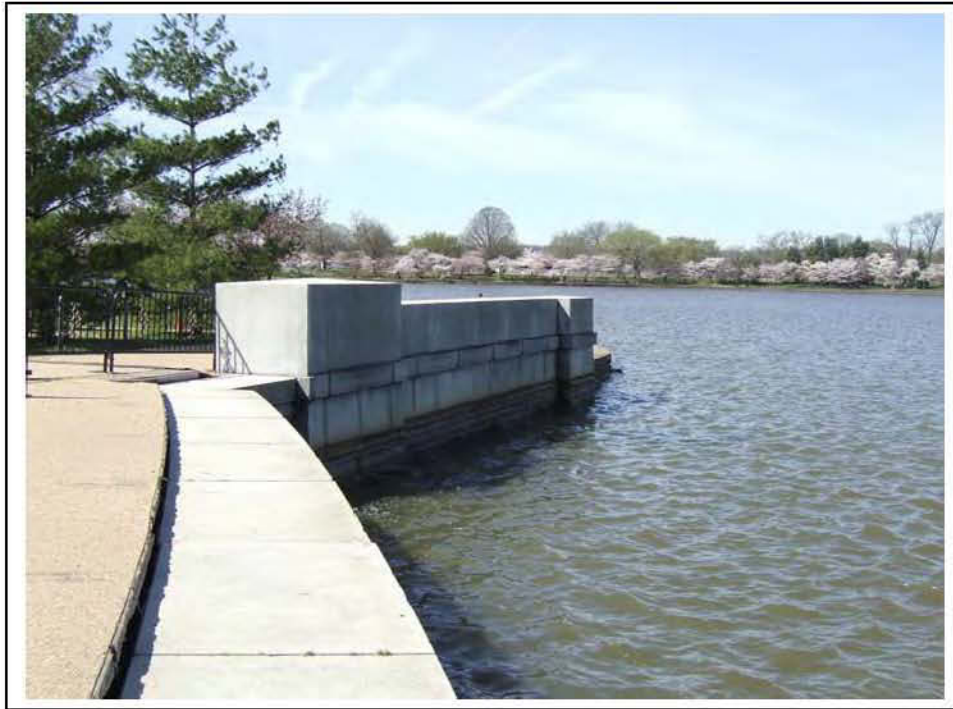
Figure 2. View Standing on the Ashlar Seawall Looking West (3-29-07)

The wall is comprised of 10 wall segments separated by joints. At the joints between wall segments, the capstones of the Ashlar Seawall are displaced with respect to each other, indicating relative movement and/or rotation between the seawall segments. Figures 2 and 3 are photos of the Ashlar Seawall and North Plaza interface.

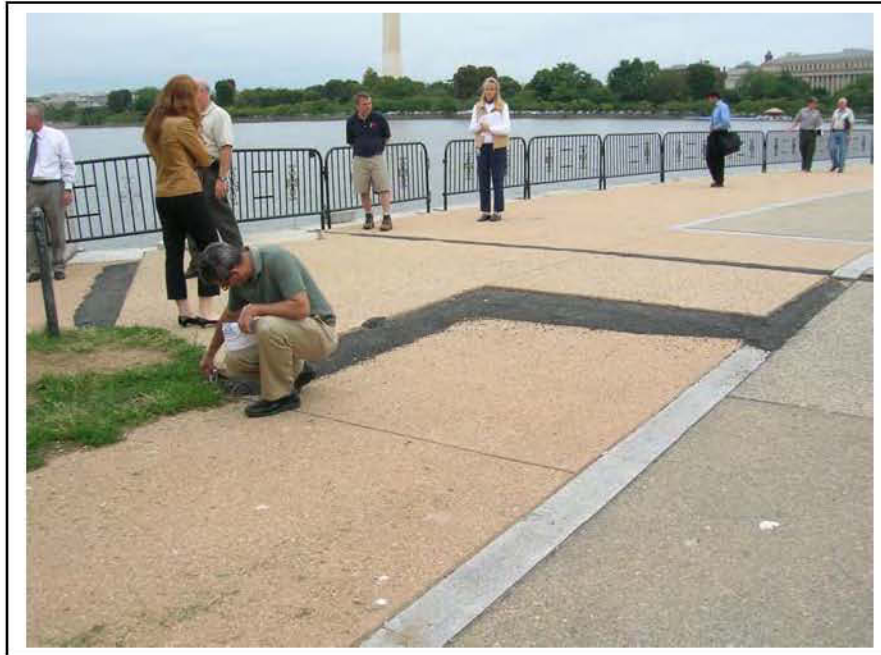
Presently, there is differential settlement between the Circular Roadway on grade and the North Plaza structure on piles. This differential settlement is pronounced on the west side, and has necessitated frequent asphalt patching to mitigate tripping hazards. Park maintenance personnel have indicated that these locations require additional patching at the rate of approximately 0.5 inches every three months, and this frequent patching is only a recent necessity (2006-2008). Figures 4 and 5 show the asphalt patches on the western side of the North Plaza.

Figure 4. Asphalt Patches on North Plaza and Circular Roadway Interface (9-12-06)

At the North Plaza, there is noticeable relative movement at the interface between the structural slab-on-piles and the adjacent Circular Road slab-on-grade. The elevation difference, resulting from settlement of the slab-on-grade, is a tripping hazard and requires frequent asphalt patching. Our proposed remediation method consists of cutting at the edge of the structural slab, removing 10 feet of the Circular Roadway slab at both ends of the North Plaza, and replacing with a 10-foot wide structural transition slab. Micropiles would be installed at five feet on center adjacent to the eastern and western-most grade beams on the North Plaza, and would be capped with a grade beam. This beam would support the one edge of a new structural slab. A new footing would support the other edge of the slabs, and at either end a flexible joint would be used to allow the slab to undergo anticipated settlements without causing tripping hazards.

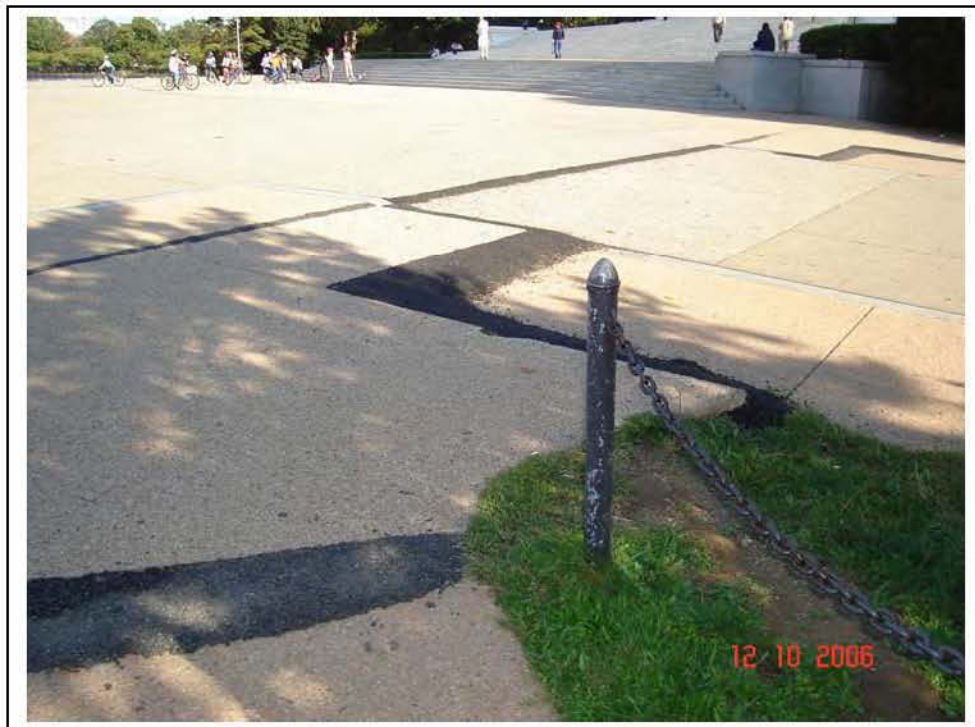
Figure 5. Asphalt Patches on North Plaza and Circular Roadway Interface (10-12-06). Note "bulge" in grassy area suggesting the presence of a grade beam on piles.

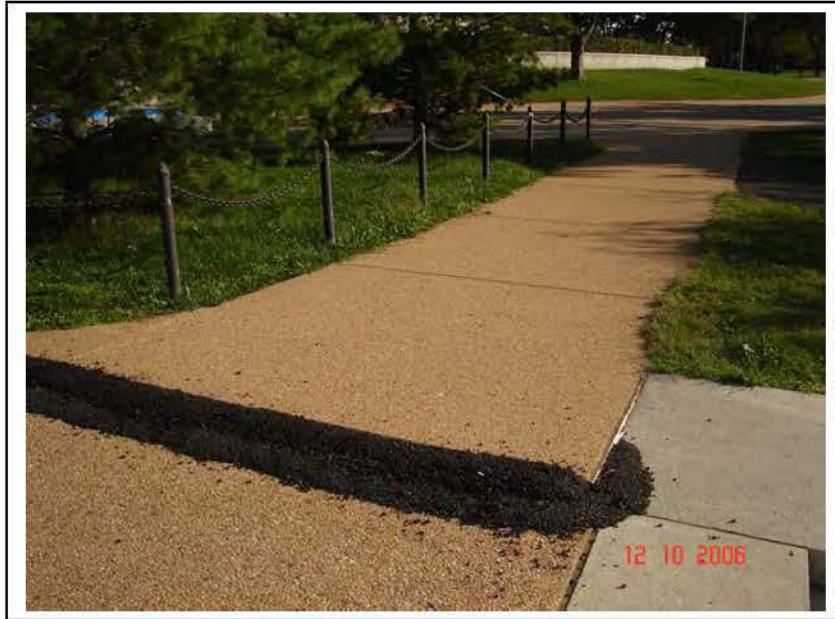
A slab-on-grade sidewalk intersects the stairs perpendicularly from the south. At this interface, there are differential elevations resulting in a tripping hazard, which has been mitigated through asphalt patching. Figure 6 shows a photograph of the vicinity.

Figure 6. Asphalt Patch at Northwest Stairs (10-12-06)

The Northwest Stairs that approach the North Plaza along the Ashlar Seawall are supported on their north side by the seawall, and on their south side by H piles and a grade beam. To the south of the stairs, a slab-on-grade sidewalk intersects perpendicularly. At this interface between the sidewalks on piles and on grade, there are differential elevations resulting in a tripping hazard and the need for an asphalt patch. Our proposed remediation method consists of removing 10 feet of the sidewalk slab, and creating a joint at the base of the existing grade beam. A new structural slab would be constructed and supported on the existing beam to the north, and a new footing at the south edge. The interface would be sealed with a flexible joint to allow the sidewalk to undergo anticipated settlements.

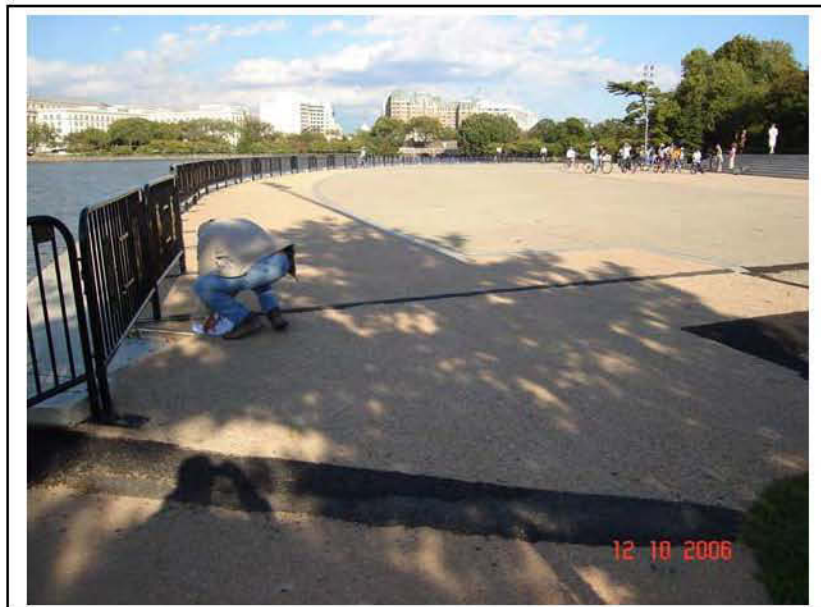
The walkway joins the North Plaza through a roughly triangular-shaped segment of exposed aggregate concrete. The foundation for this triangular wedge is unknown. The HNTB report from 2008 indicates the existence of a significant void underneath this area. It is possible that this triangular wedge is supported on piles or that it is partially bearing on the walkway grade beam and on the North Plaza foundation. The triangular wedge is experiencing settlement, but at a lesser rate than the slab-on-grade Circular Roadway. Figure 7 shows the triangular wedge bounded by asphalt patches.

Figure 7. Standing on West Approach Walk and Looking at Triangular Wedge (10-12-06)

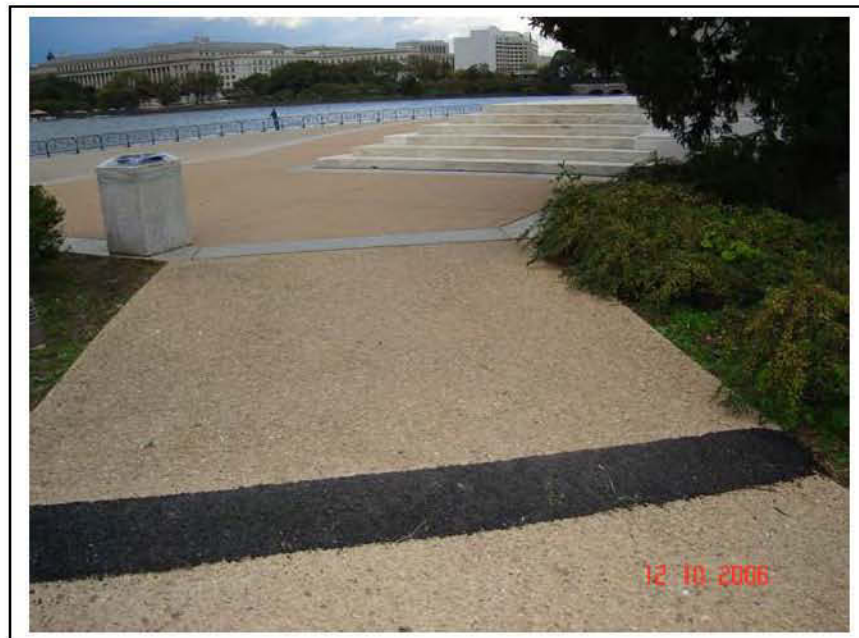
Settlement is also occurring on the exposed aggregate concrete sidewalk that leads to the exhibit area on the west side of the Terrace Walk. As shown in Figure 8, there is an asphalt patch in this area to mitigate tripping hazards. The foundation plans for the Jefferson Memorial indicate that the structure is pile-supported from the center of the Memorial to the extent of the Terrace Wall. (Refer to Figure 1, Jefferson Memorial Foundation Types.) Therefore, the West Terrace Walk can be presumed to be pile-supported.

Figure 8. West Terrace Walkway Looking Toward Main Stairs
(10-12-06)

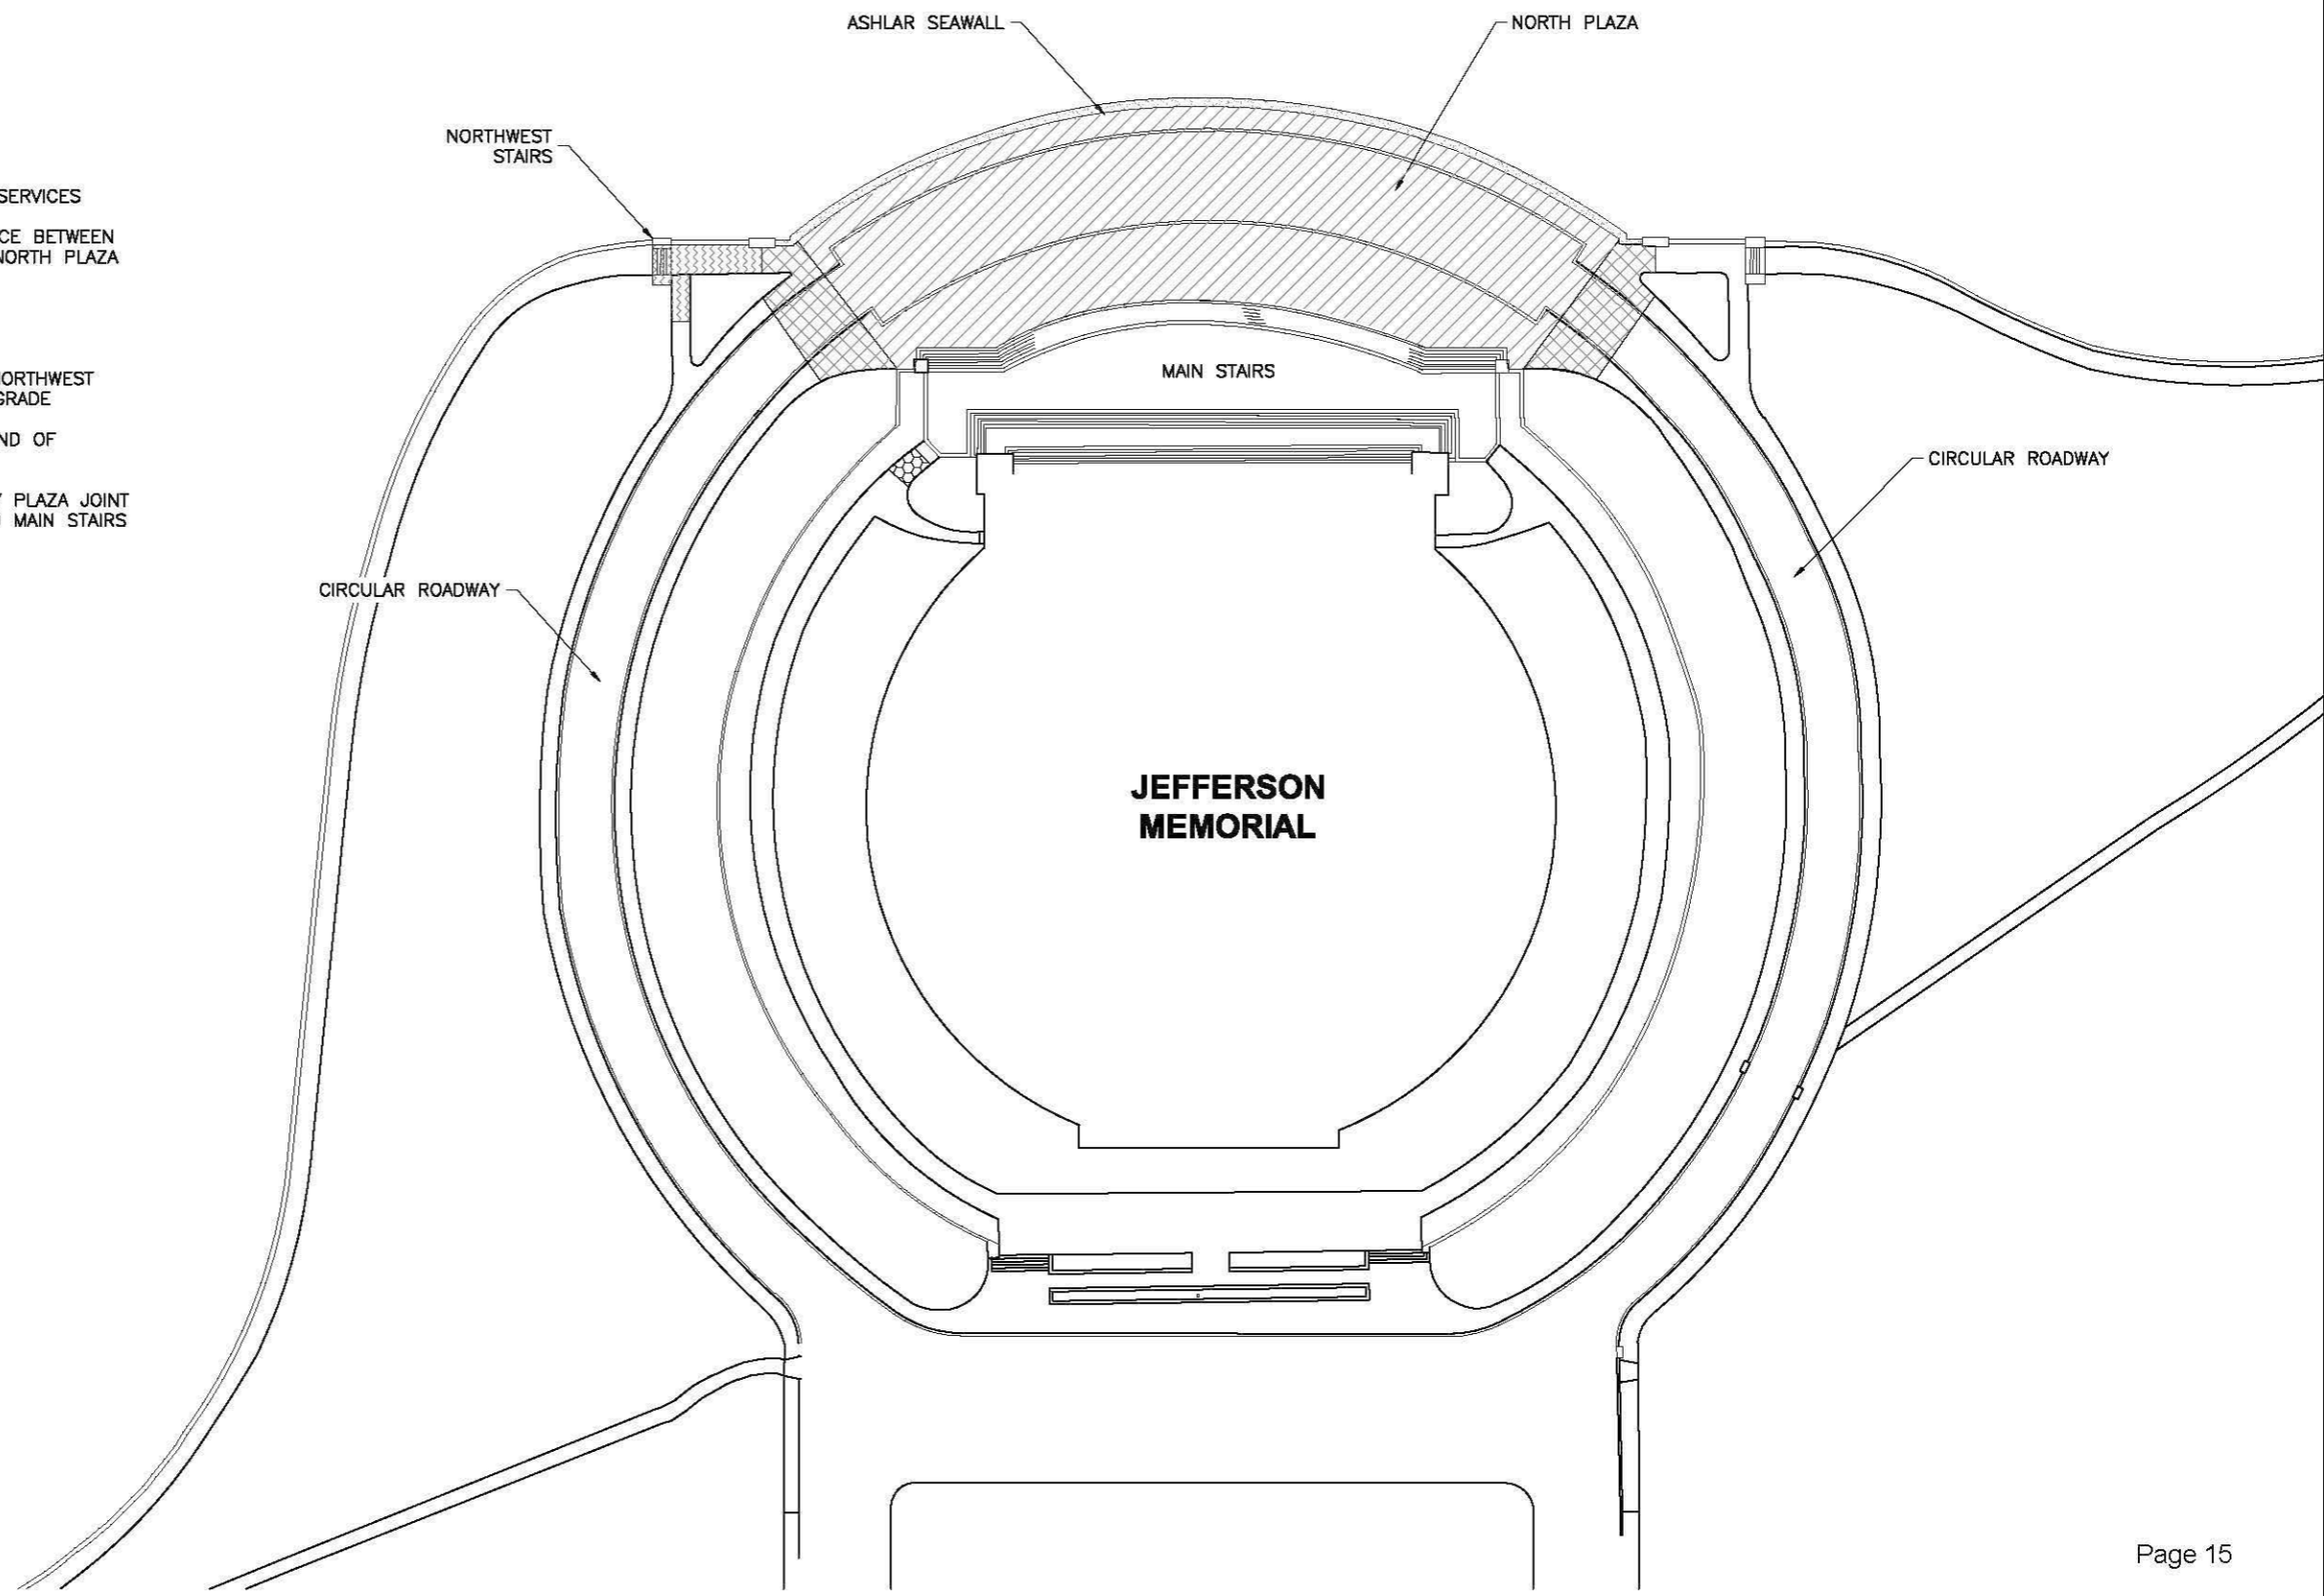
FIGURE 9

LATERAL MOVEMENT AS EVIDENCED BY PLAZA JOINT OPENING BETWEEN NORTH PLAZA AND MAIN STAIRS
