## Appendix A

# EXAMPLES OF PERIMETER PANEL FLOOR TRUSS CONNECTORS

The floor trusses were attached to the perimeter panels at the interior intersection of the columns and spandrels by different types of connectors. The following appendix displays photographic examples, taken by National Institute of Standards and Technology (NIST), of these types of connectors as observed on the recovered panels.

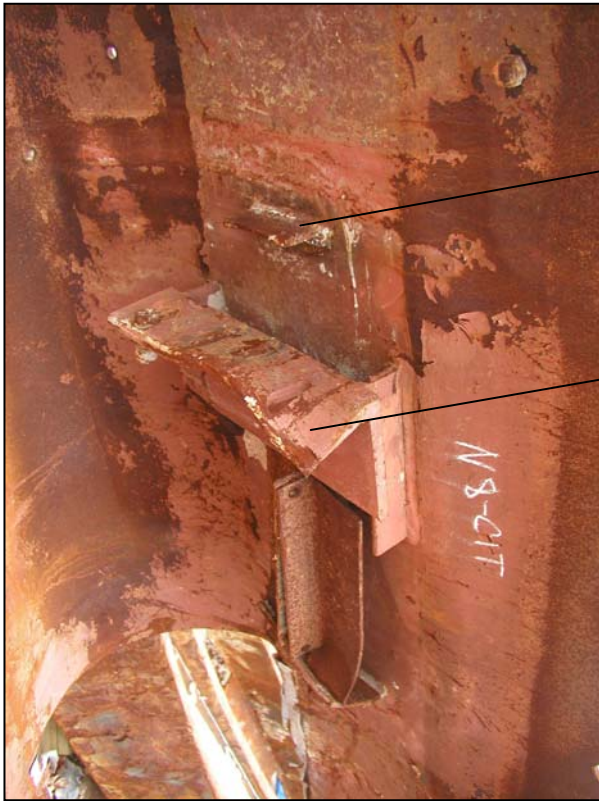
**Connection N8-CIT**

Portion of welded gusset plate with backing bar

Seat with 2 intact bolt holes for truss attachment

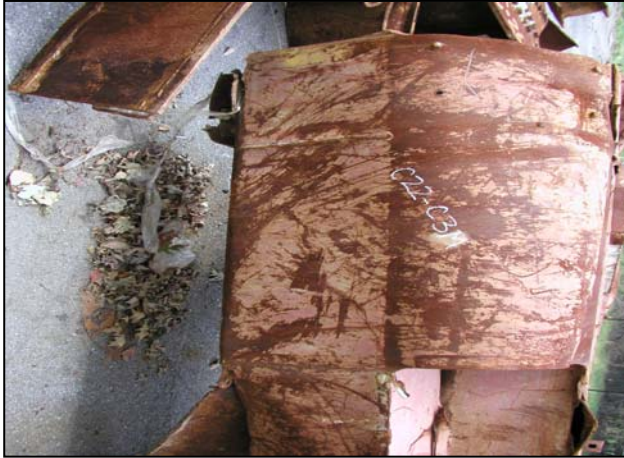
Seat 1: Both holes intact, one has bolt remaining, seat was bent

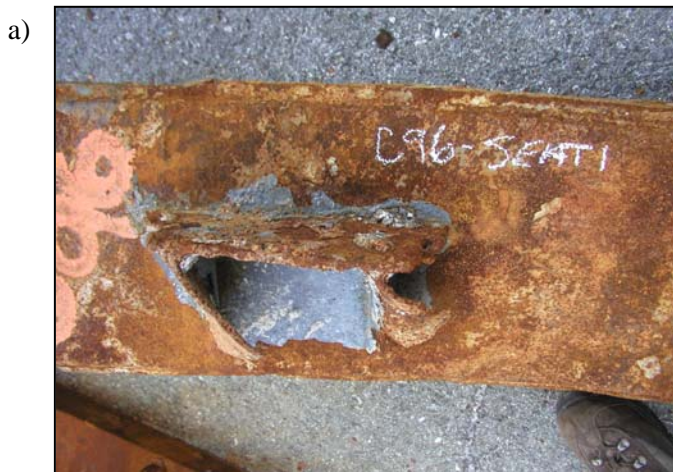
Seat 1: Both holes ripped out, seat appears corroded

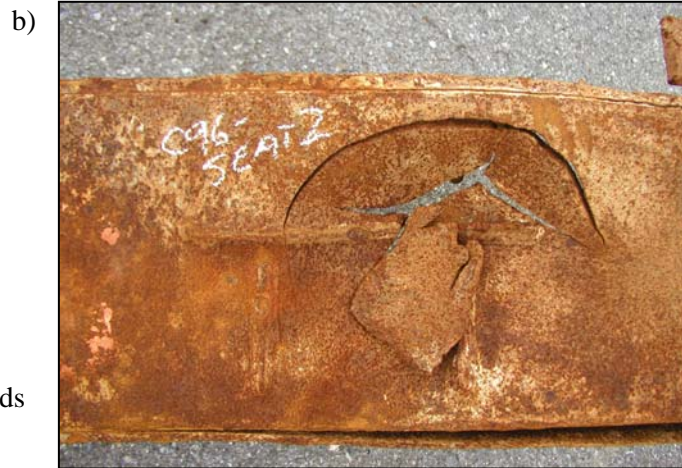
Seat 2: Seat ripped off at welds

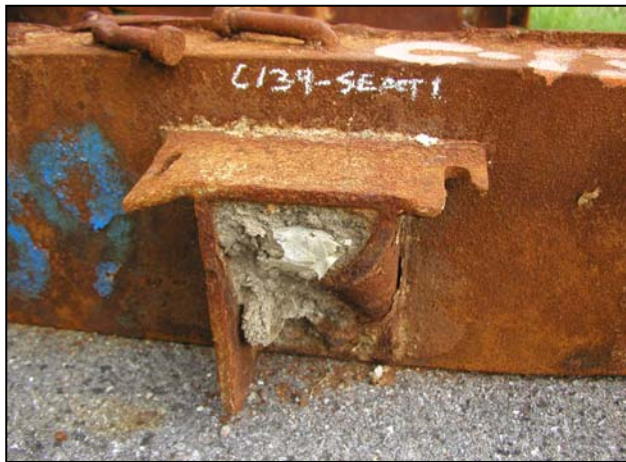
One seat with one hole intact, other ripped out, seat was damaged

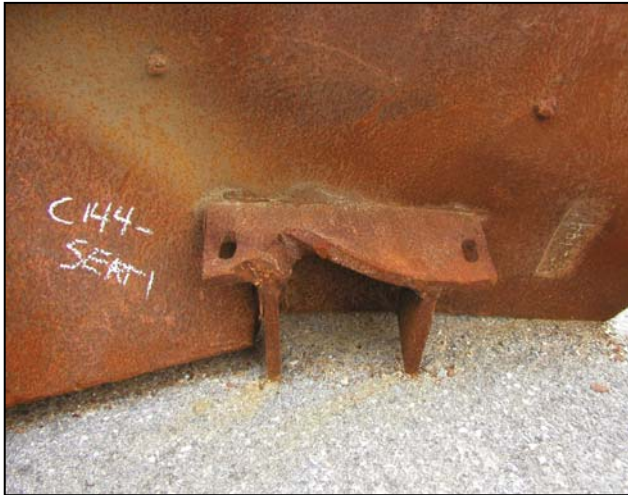
One seat with both holes intact, seat was damaged

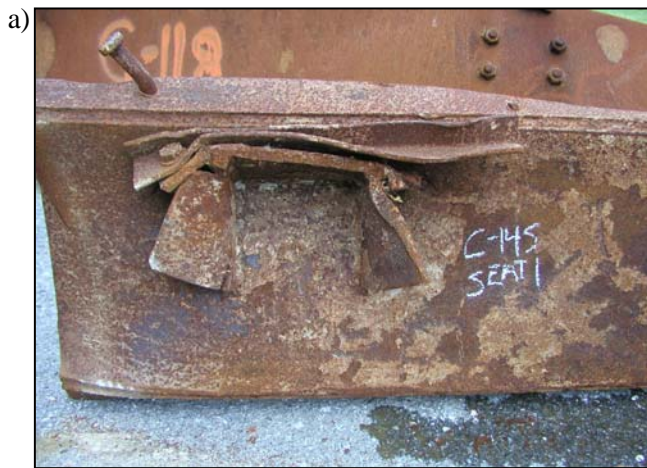
Seat 1: One hole intact with bolt and angle attached, other ripped, seat was damaged

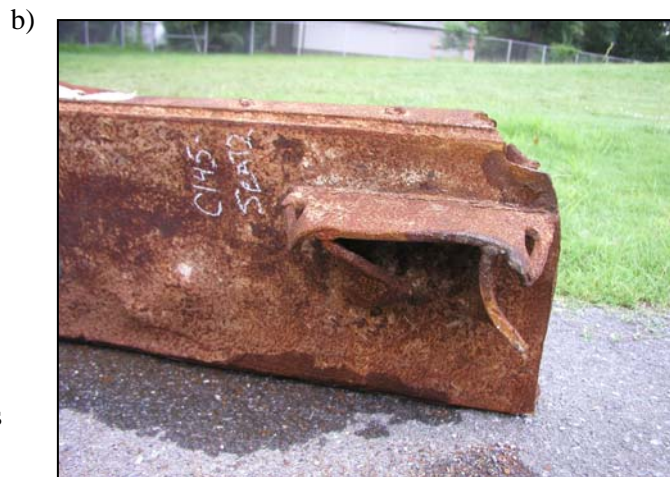
Seat 2: Both holes intact, seat was bent

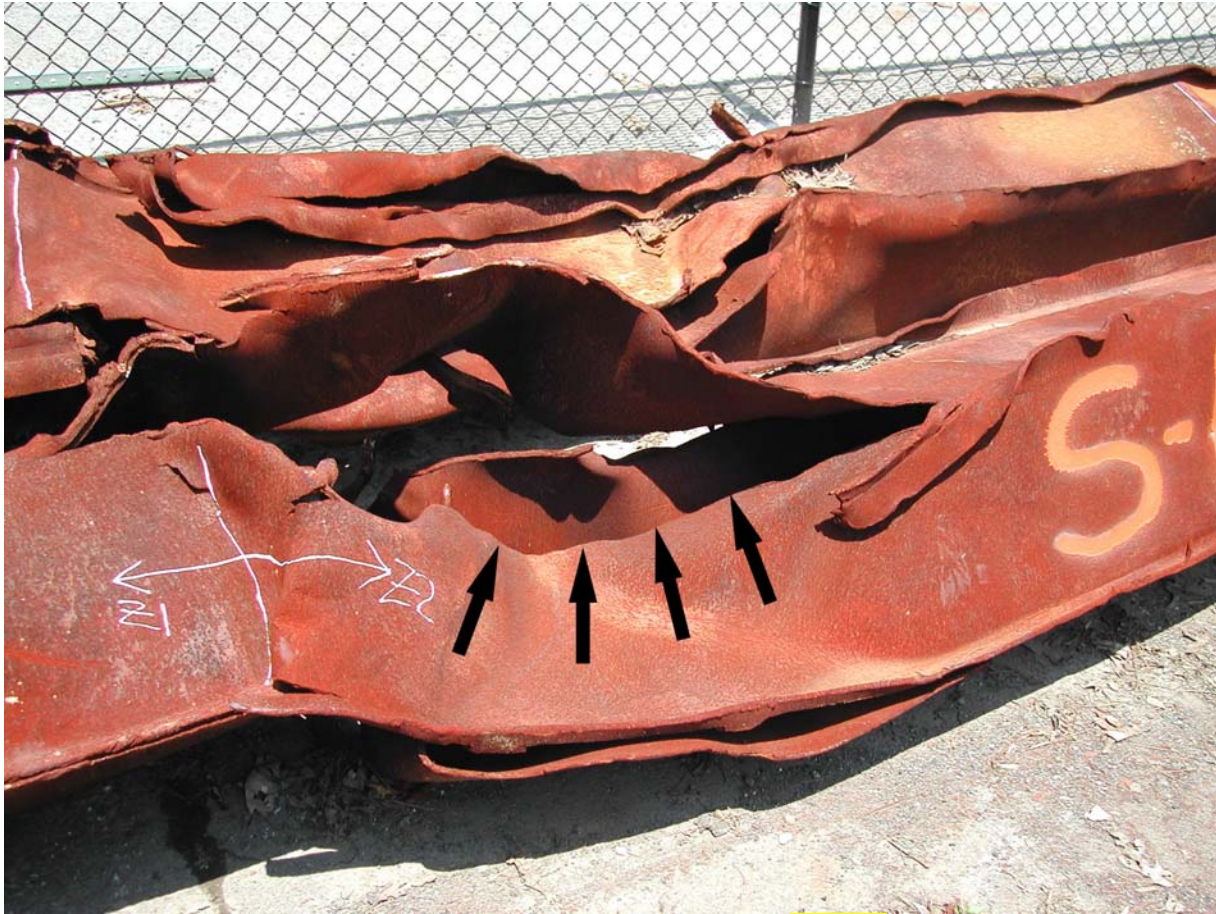
Figure 9. Ruptures of fillet welds through parent material HAZ on *possible* fire-affected region of Piece S-10

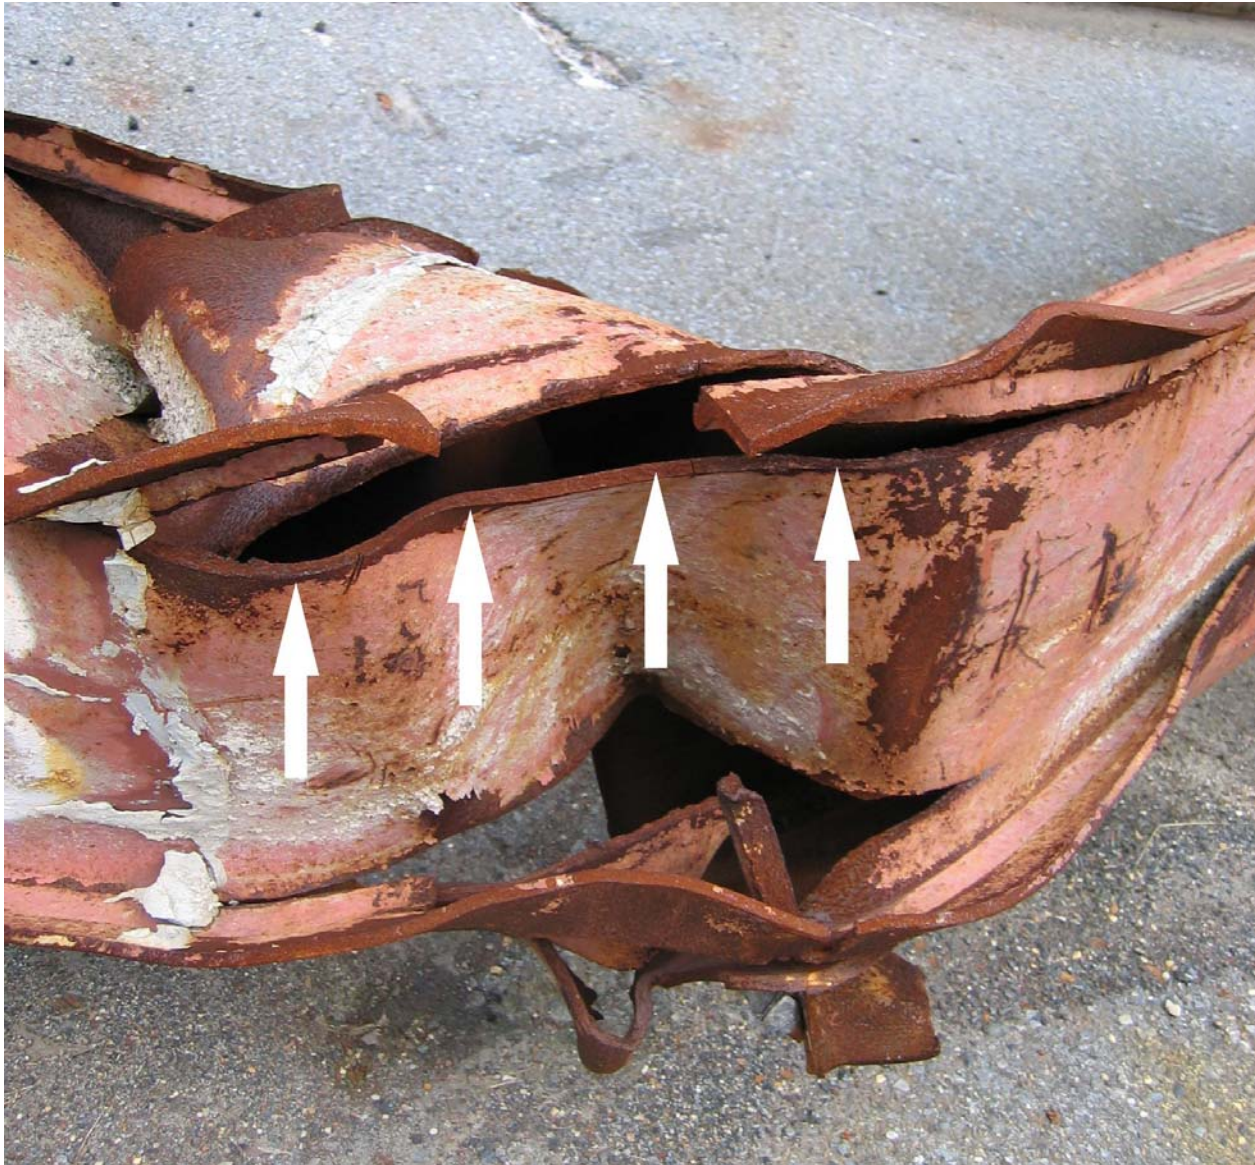
*Figure 10. Ruptures of fillet welds through parent material HAZ (at arrows) on probable mechanically pinched zone on Piece C-40 (ruptures through parent material away from welds are also observable in the photo)*

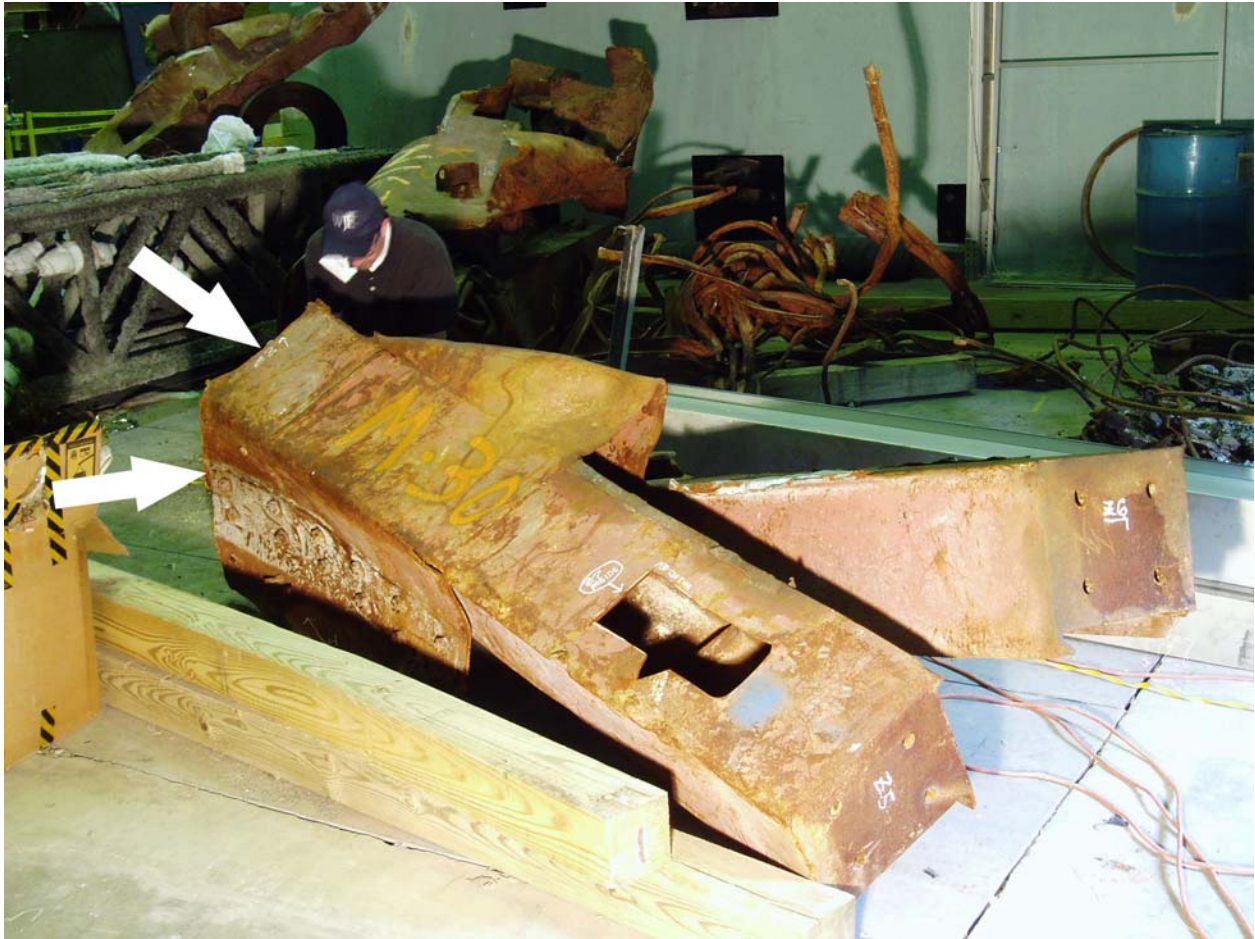
*Figure 13. Severed column (at arrows) as observed on Piece M-30.*

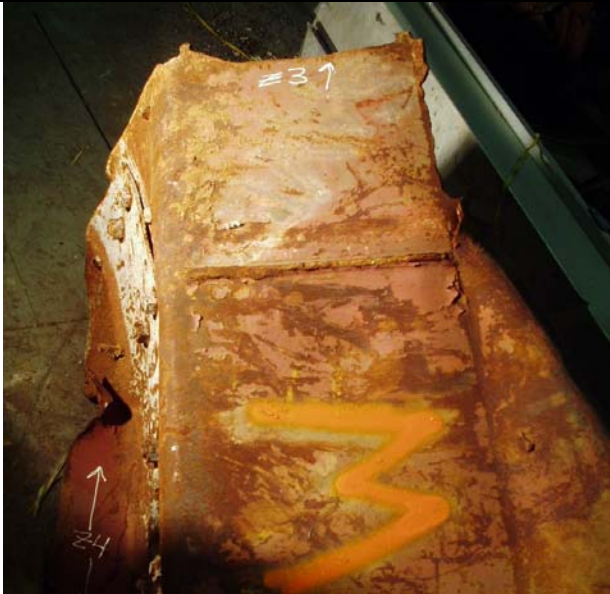
<p data-bbox="207 1478 776 1566">Figure F-A-6e: Close view of Column 132, showing sever at the top edge of the 95th floor spandrel. View here is of the inside face of the column and spandrel.</p>	<p data-bbox="824 888 1422 1136">Column 132 was also severed at approximately the 95th floor line, shown Figures A-23 and A-24. The severed edge is marked Z3 in Figure A-23. As with Column 133, the fracture of this column occurred generally at the location of an internal column diaphragm stiffener. It is almost certain that these fractures were caused by the impact of the aircraft and therefore occurred at a high rate of loading.</p>

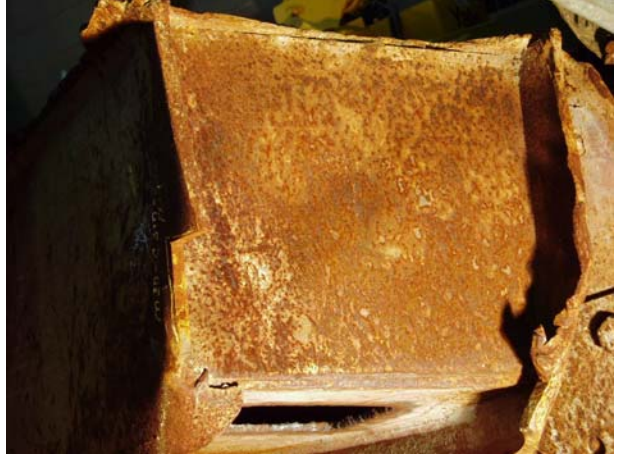
<p data-bbox="207 680 782 768">Figure F-A-6f: Close view of severed Column 132, viewed as if looking down from above. Inside face of column is at top of photo.</p>		<p data-bbox="824 772 1432 1260">The 95th floor spandrel splice at the left of Column 132 was recovered with this piece. The recovered connection materials include bolts and connection plate. A fragment of the spandrel plate that extended from the splice to Column 131 was also recovered with this piece. The opposite edge of this additional piece, marked Z4 in Figure A-25, has a fracture surface that is inclined at 45 degrees. It is not certain that this fracture was caused by impact of the aircraft, because photographic evidence (FEMA 403, Figure 2-15) suggests that this segment of the 95th floor spandrel, although bent inward, may still be intact. Column 131 and the associated spandrel panel at the 95th floor were recovered as part of Piece M-27. There is a chance that the fracture surface that would mate to the fractured edge marked Z4 may exist on piece M-27.</p>

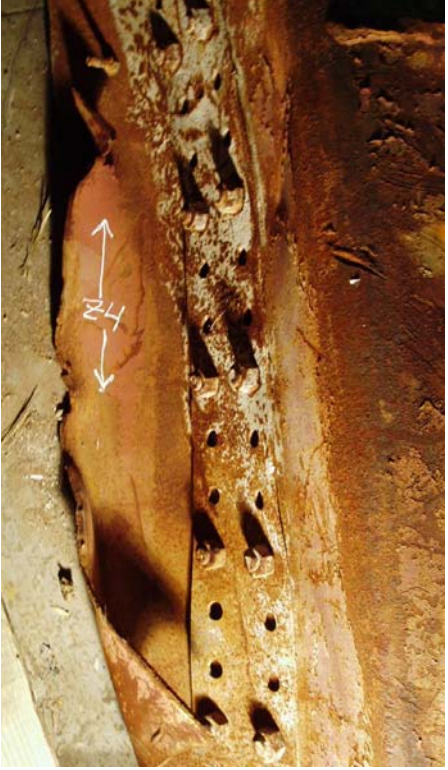
<p data-bbox="214 1537 776 1652">Figure F-A-6g: View of severed 95th floor spandrel plate to left of Column 132, showing spandrel connection bolts and connection plate. Column 131 would have been at left, and Column 132 is at right</p>

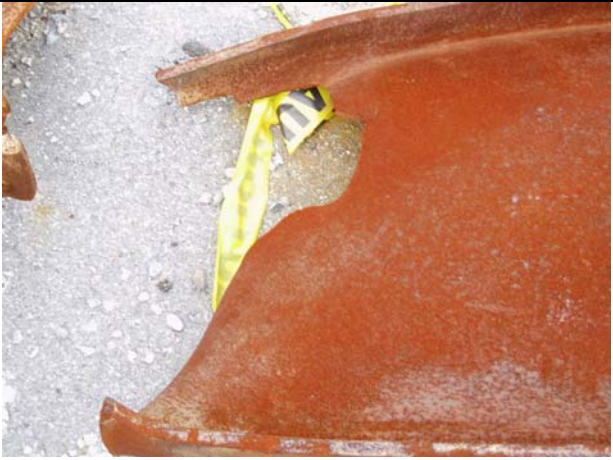
<p>Figure F-C-1b: Piece C-31. Fracture at end of beam stub that remains in-plane</p>
