**Federal Building and Fire Safety Investigation of the  
World Trade Center Disaster**

**Damage and Failure Modes of  
Structural Steel Components**

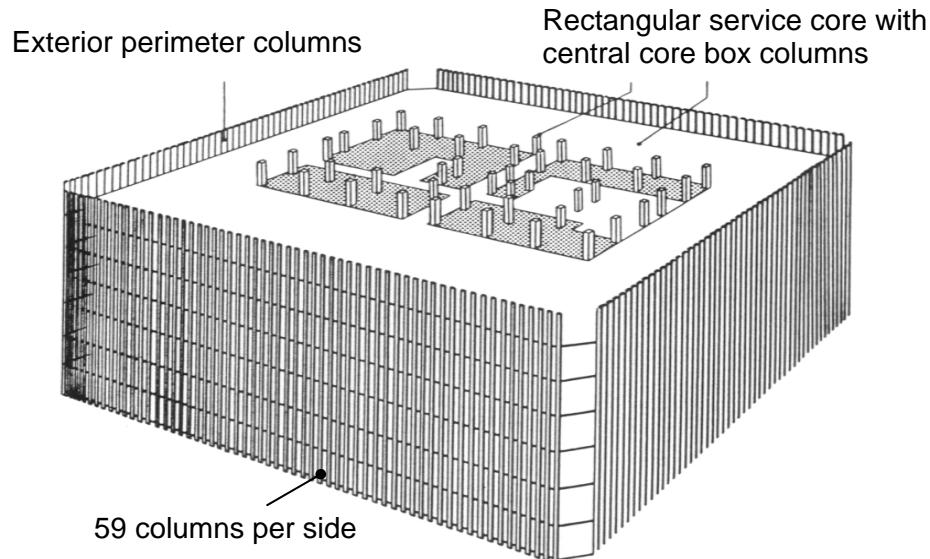
**Figure 1–1.** Tubular construction for WTC 1 and WTC 2 consisting of a rectangular service core and exterior perimeter columns.

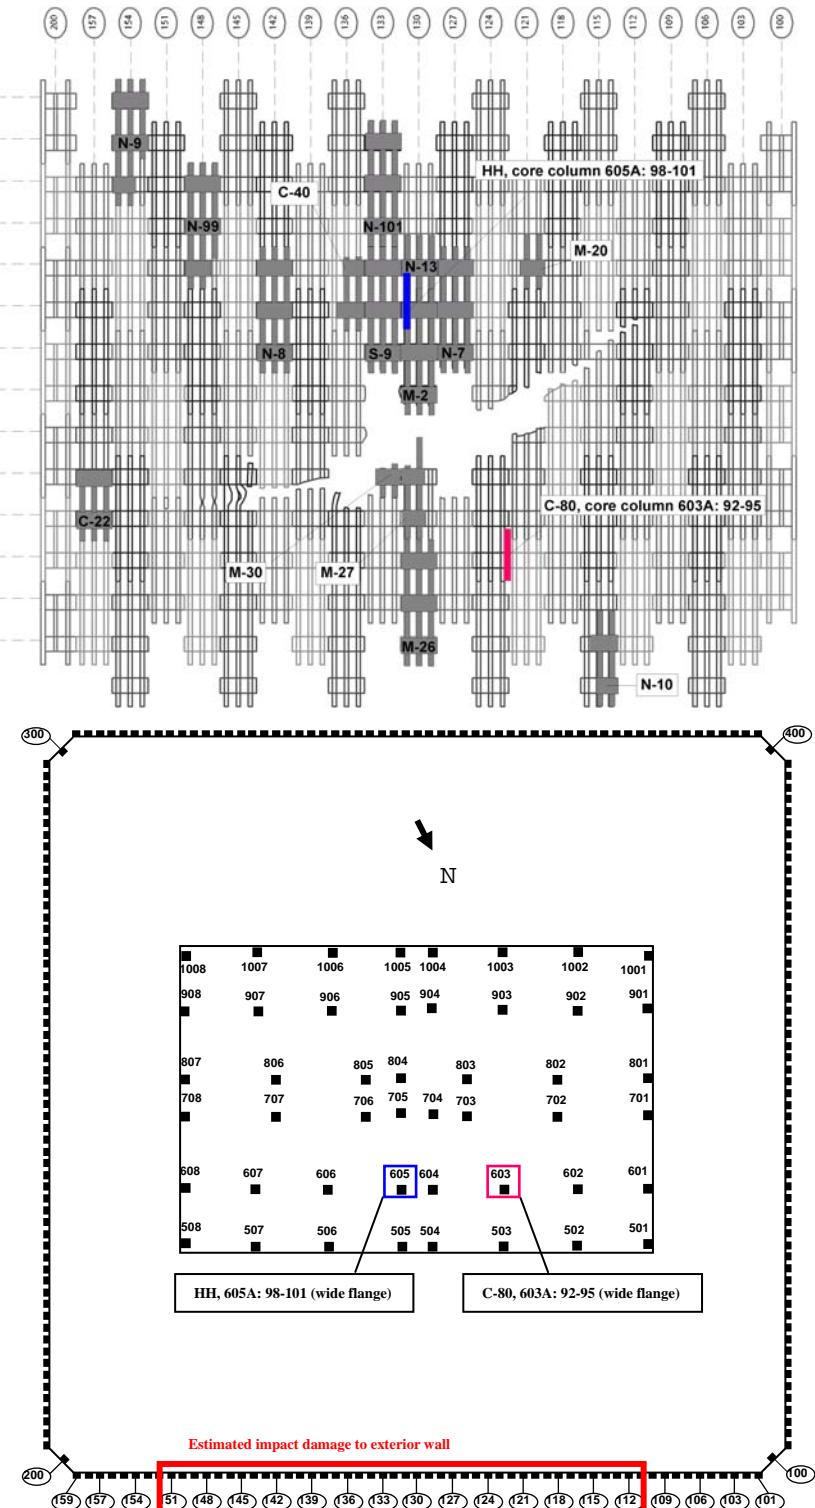
**Figure 1–7. Impact damage location and recovered structural elements from WTC 1. Visual evidence of pre-collapse fires was observed on floors highlighted in red.**

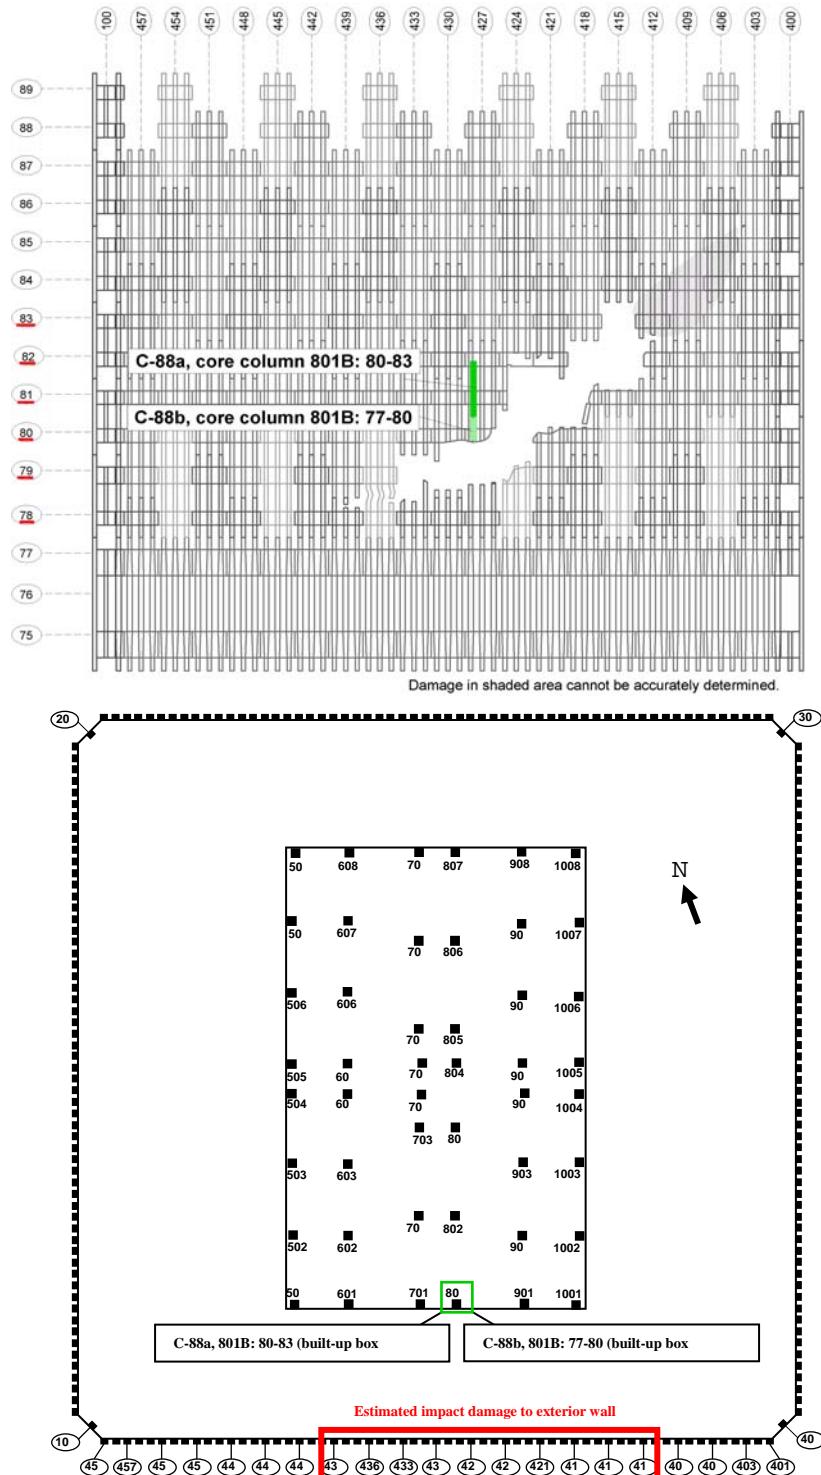
**Figure 1–8. Impact damage location and recovered structural elements from WTC 2. Visual evidence of pre-collapse fires was observed on floors highlighted in red.**

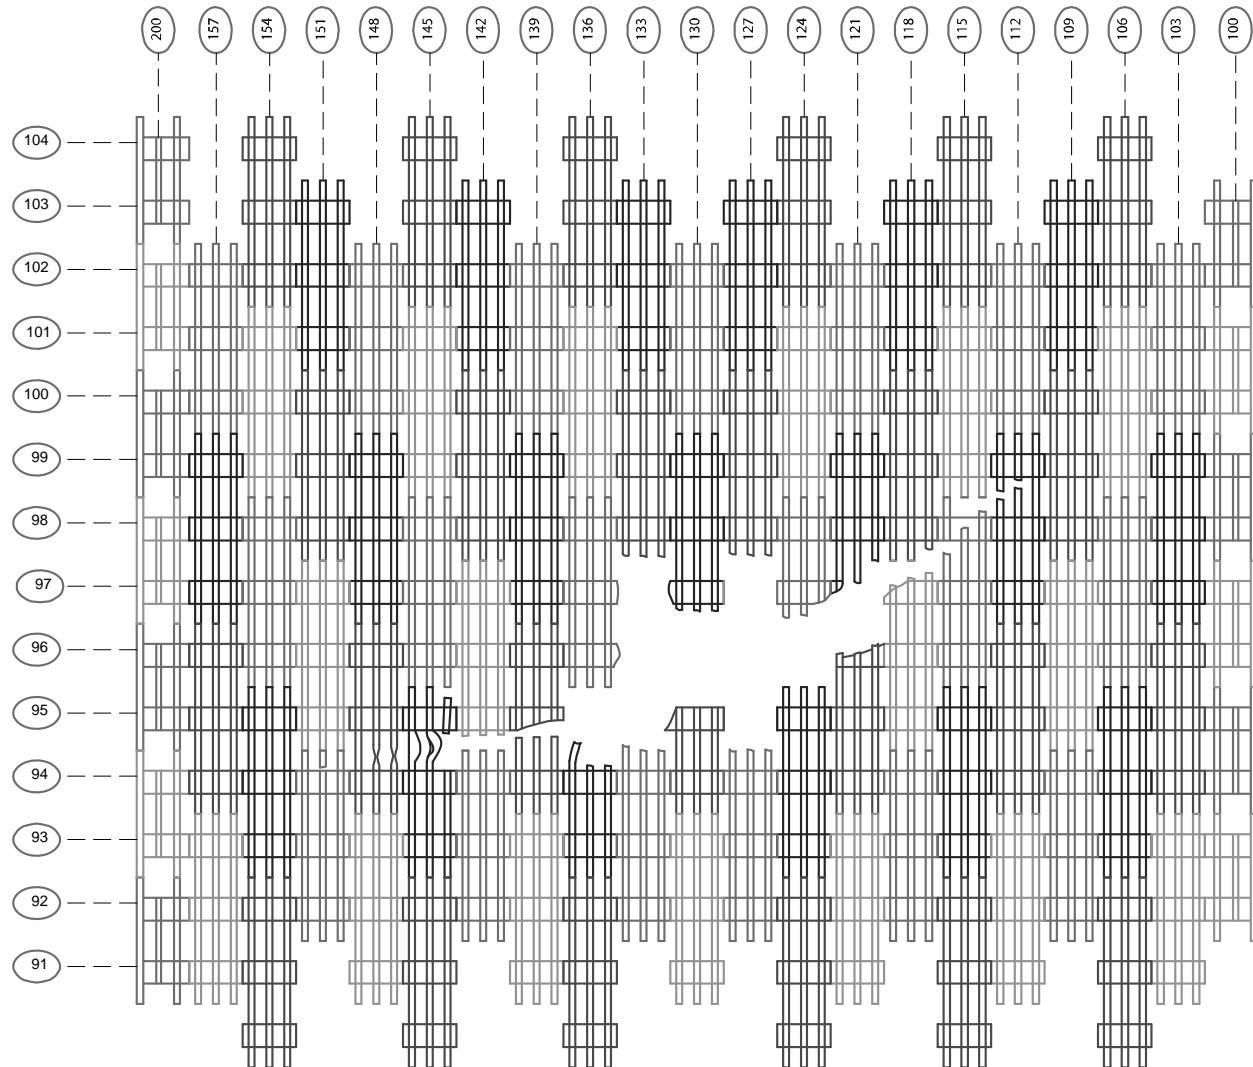
**Figure 2–1. Estimated amount of damage to the north face of WTC 1, as determined by NIST.**

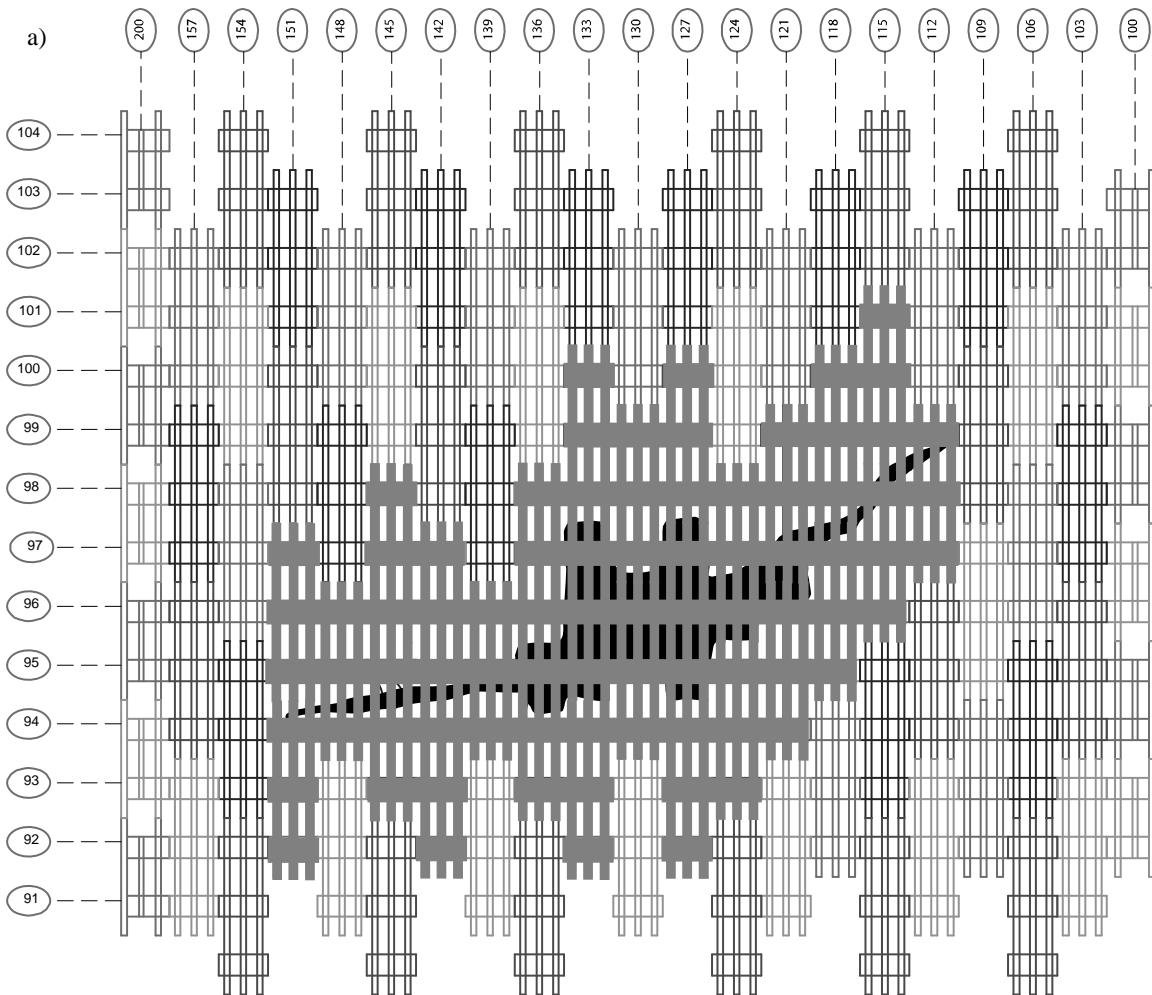
**Figure 2–2a. Pictorial display showing the panels damaged on the north face of WTC 1 around the airplane impact region.**

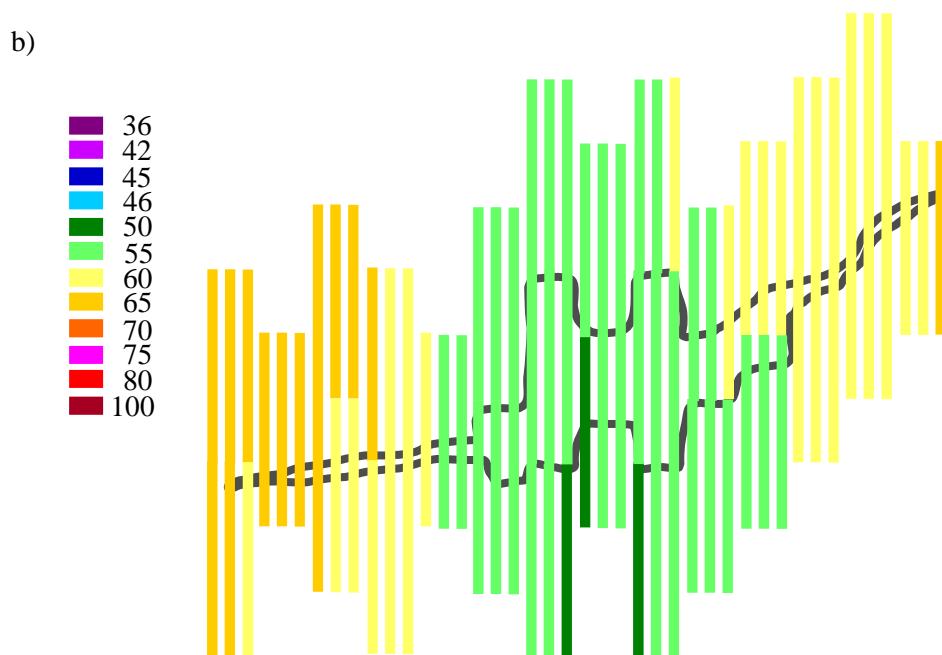
**Figure 2–2b.** The specified minimum yield strength of the exterior columns for WTC 1 shown in (a).

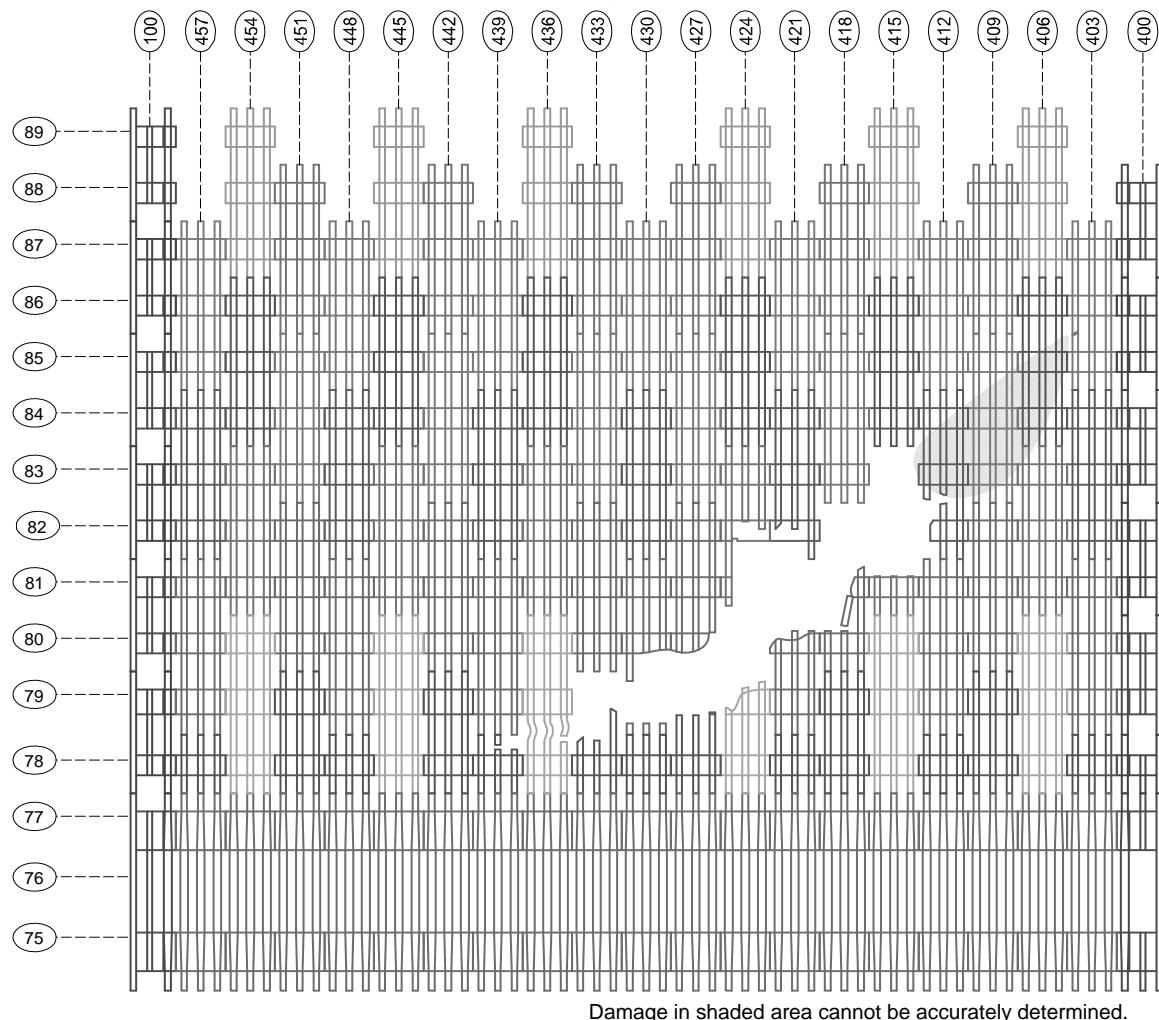
**Figure 2–4. Estimated amount of damage to the south face of WTC 2, as determined by NIST.**

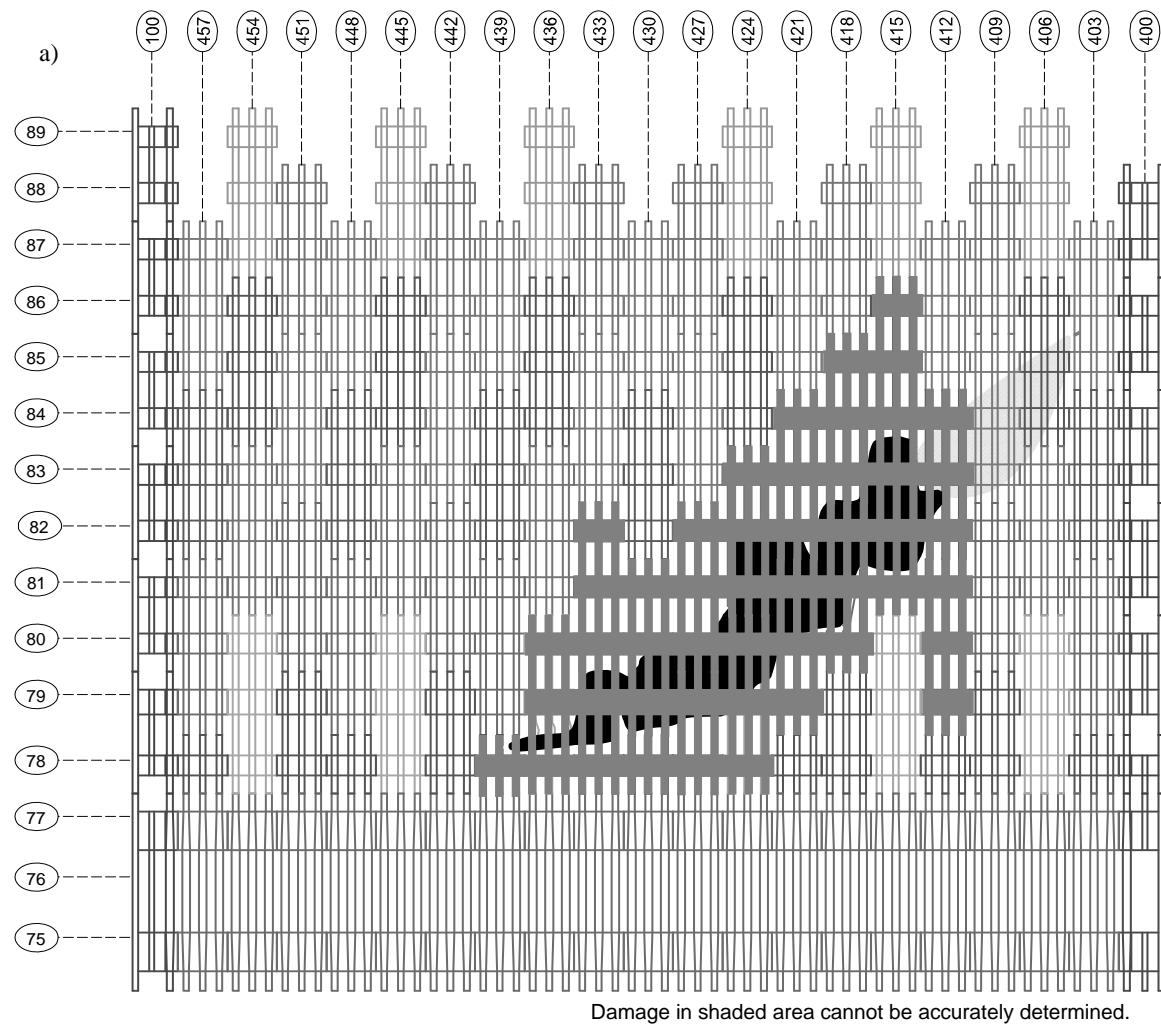
**Figure 2–5a. Pictorial display showing the panels possibly damaged on the south face of WTC 2 around the airplane impact region.**

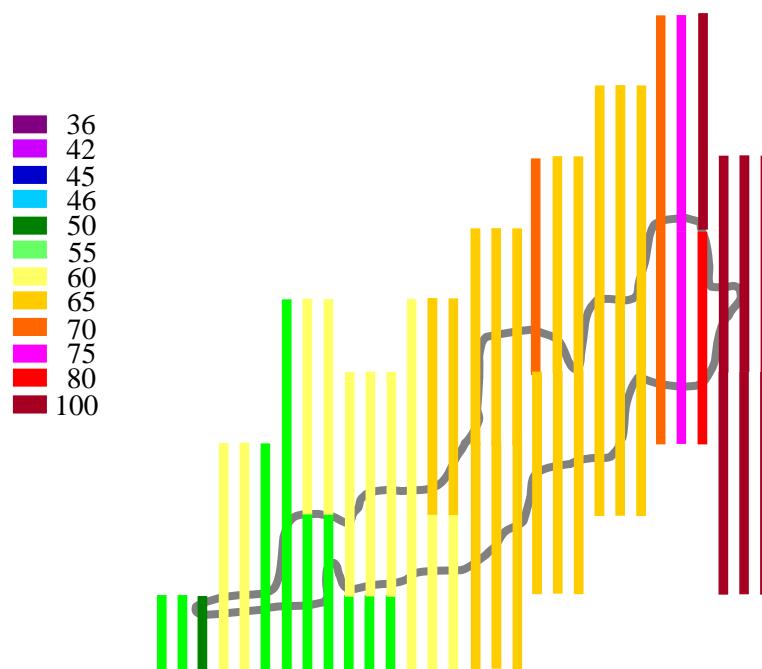
**Figure 2–5b.** The specified minimum yield strength of the exterior columns for WTC 2 shown in (a).

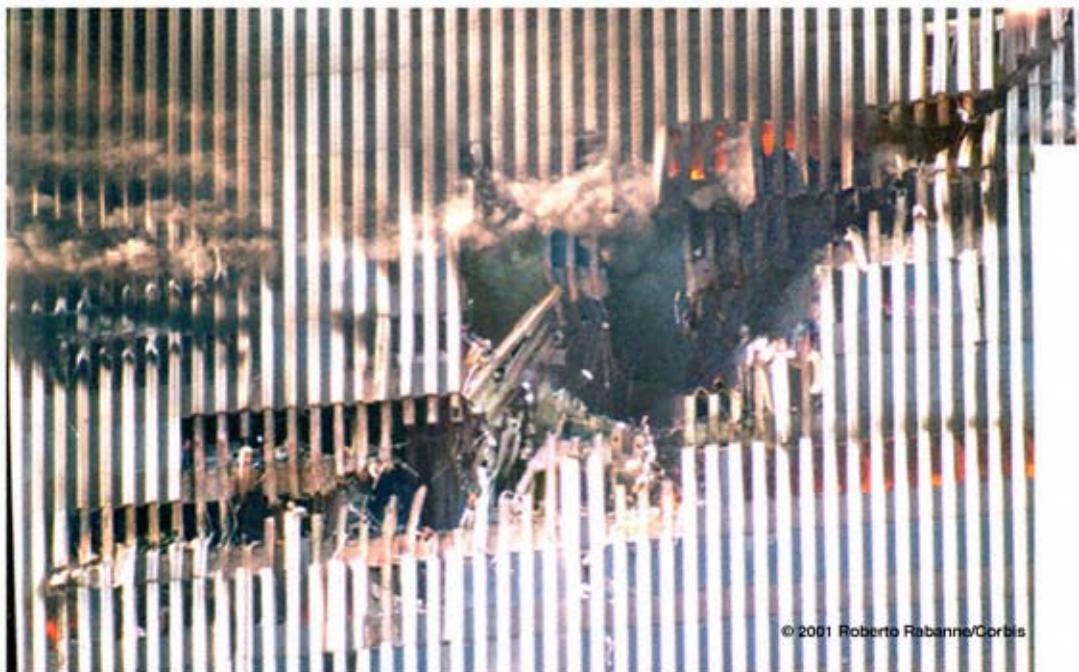
**Figure 2–8.** Image from Fig. 2–7 with addition of a small piece of image “7\_1.jpg” (original photograph copyright Roberto Rabanne 2001), then computer image enhanced for maximum visibility of damage to exterior wall panels.

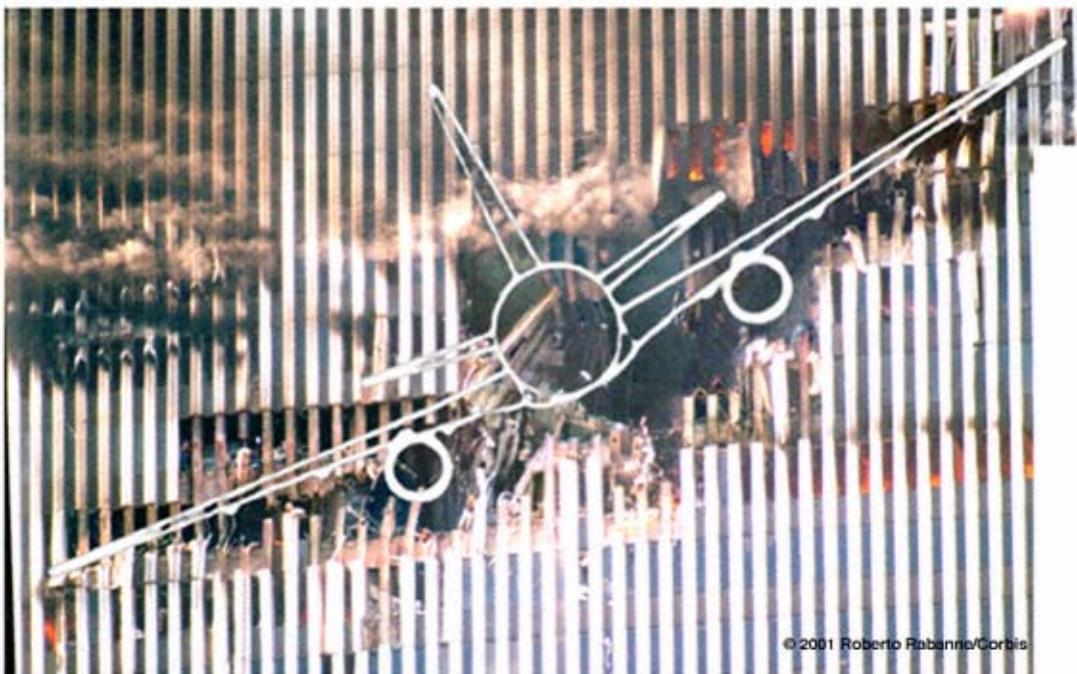
**Figure 2–9.** Image from Fig. 2–8 with overlay of the outline of a Boeing 767 as it appears at rest.

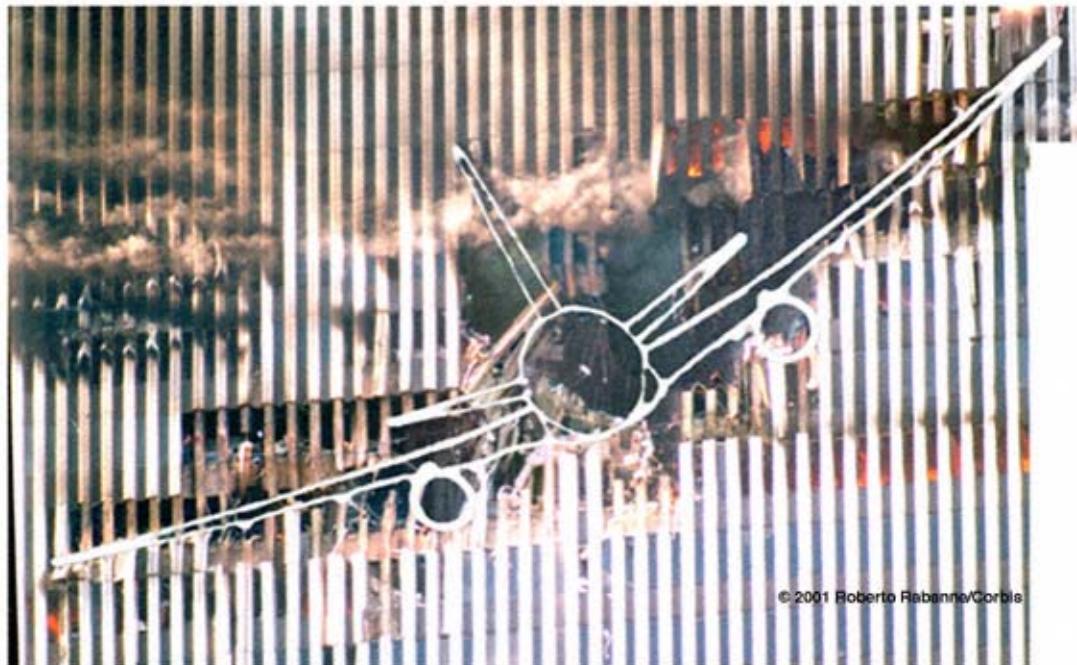
**Figure 2–10.** Image from Fig. 2–8 with overlay of the outline of a Boeing 767 that has been manually distorted in the computer to get a best approximate fit with damage to WTC 1.

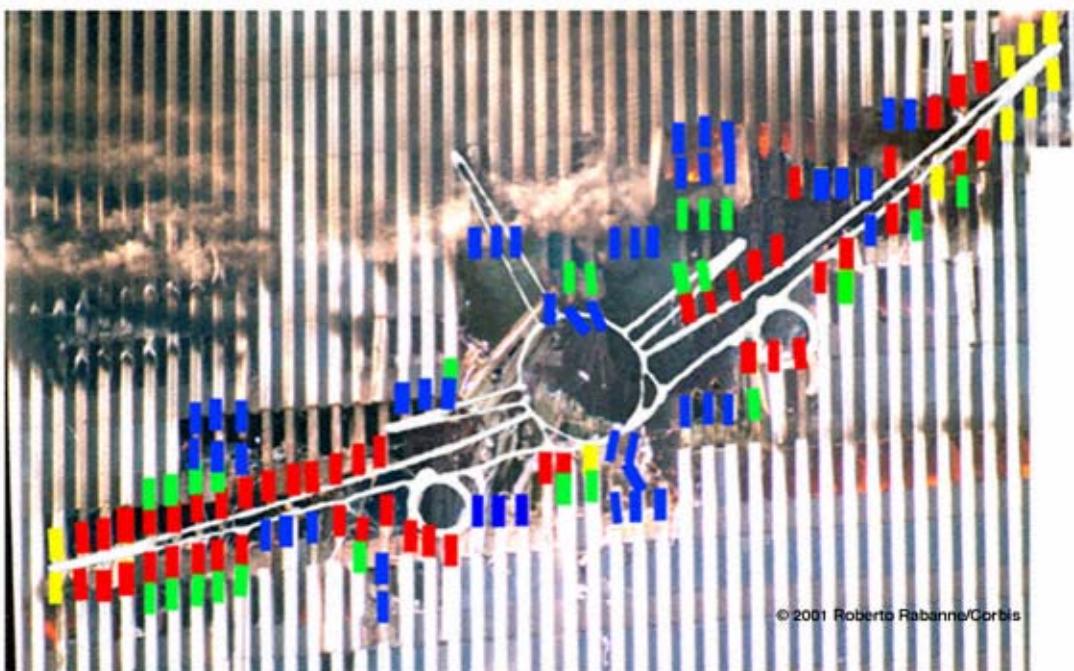
**Figure 2–11.** Image from Fig. 2–10 with indications of location and type of localized damage. Red designates cut metal components; blue, broken vertical column connection bolts; green, locations of failure of longitudinal welds in the box columns; and yellow shows regions that could not be identified from any photographic evidence.

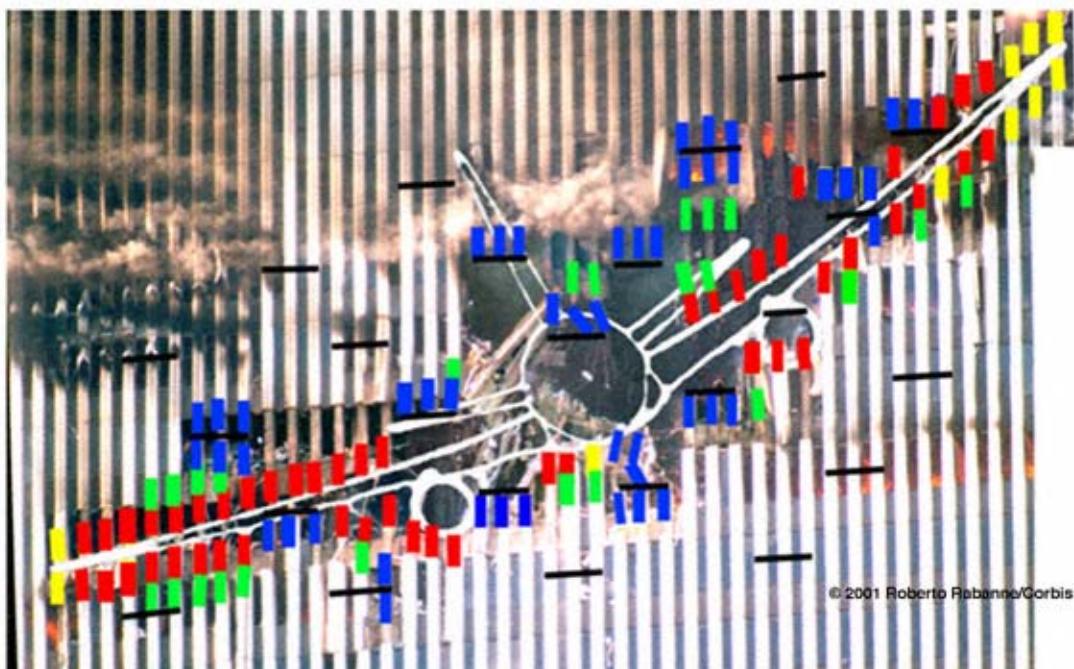
**Figure 2–12.** Image from Fig. 2–11 with black lines showing the location of bolted vertical column connections between panels.

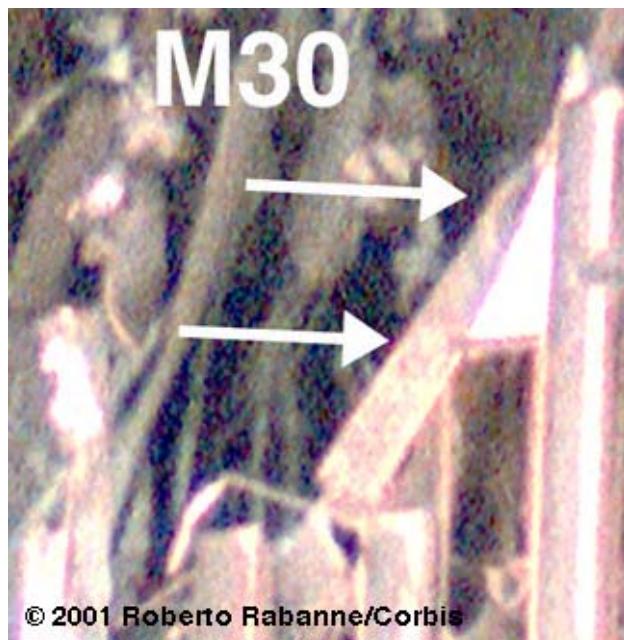
Figure 2–14. Close-up of pre-collapse condition of panel M-30 (A133: 94-97).

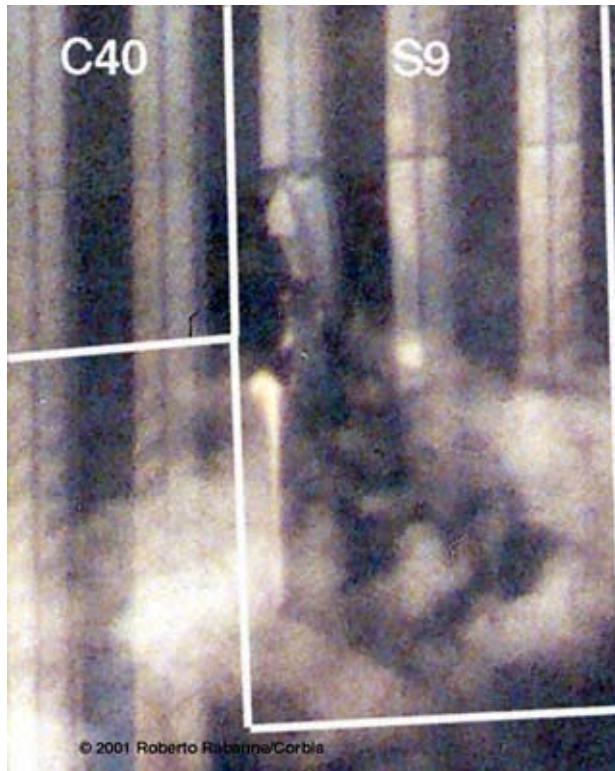
**Figure 2–15.** Close-up of pre-collapse condition of panel S-9 (A133: 97-100).

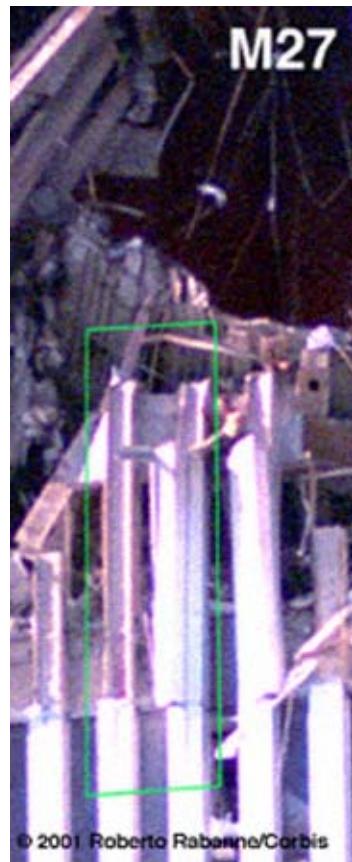
**Figure 2–16.** Close-up of pre-collapse condition of panel M-27 (A130: 93-96).

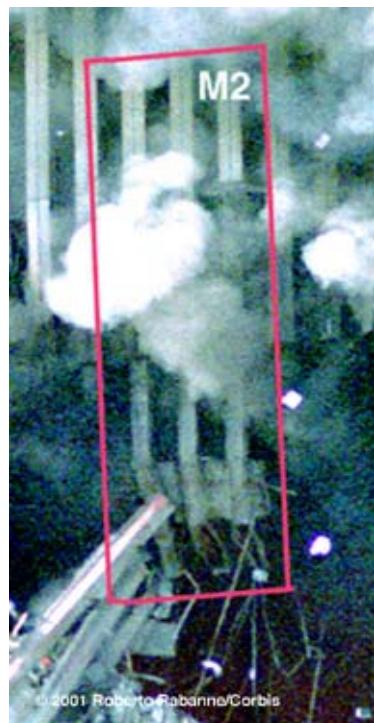
Figure 2–17. Close-up of pre-collapse condition of panel M-2 (A130: 96-99).

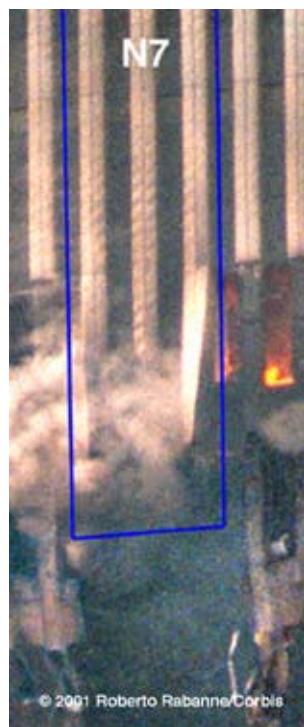
Figure 2–18. Close-up of pre-collapse condition of panel N-7 (A127: 97-100).

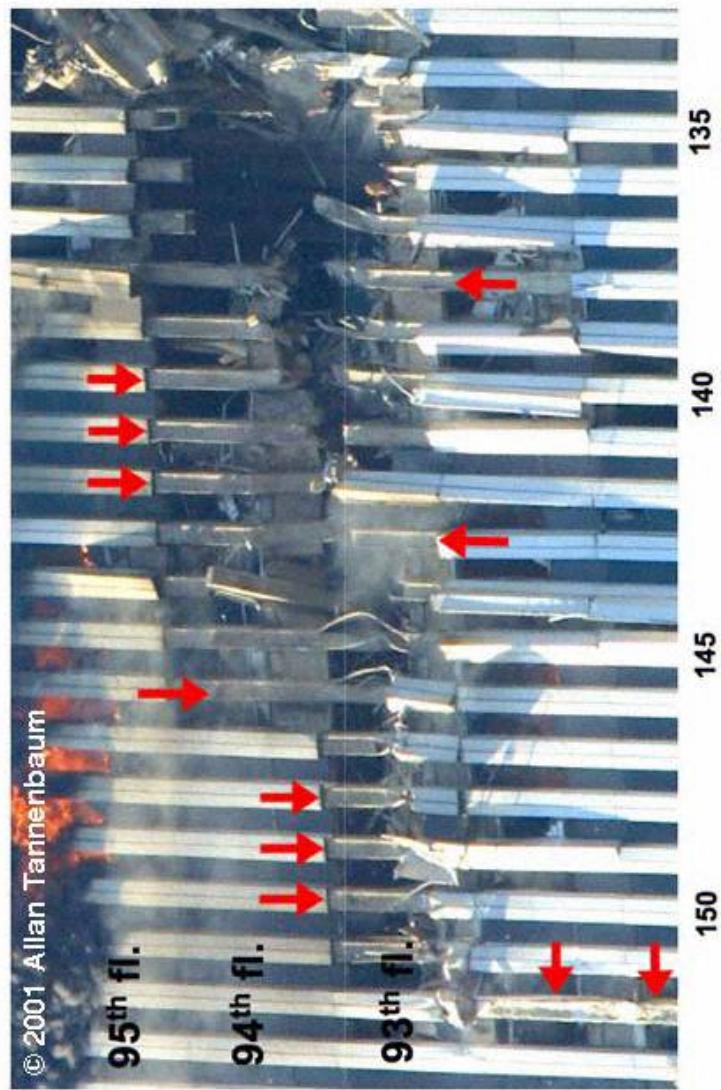
Figure 2-22. Port side of impact hole in north face of WTC 1 showing missing sprayed fire-resistive material. The red arrows indicate a few of the many instances of missing sprayed fire-resistive material around the impact hole. The region roughly approximated as the area where the aluminum panels were dislodge has been digitally enhanced for clarity.

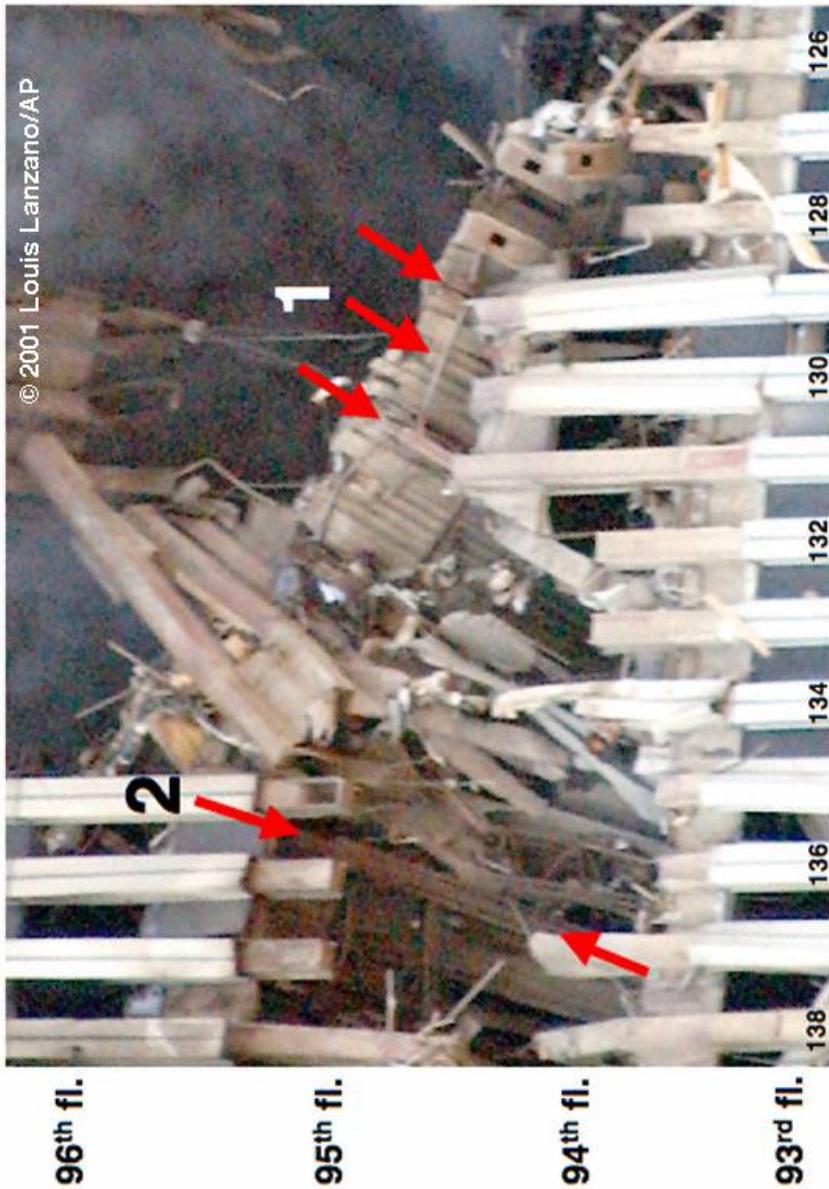
Figure 2–23. Image showing missing sprayed fire-resistant material on floor trusses that fell into impact hole on north face of WTC 1. The arrows labeled “1” are three trusses where you can see the lower or upper chords, and can distinguish the line that separates the two angle iron components. The arrows labeled “2” lie at either end of a lower chord of a truss that fell farther inside the building, and is made up of 4 angle irons (a double truss). The red paint color being visible and the fact that the line between the angle iron can be seen indicated that the sprayed fire-resistant material was displaced.

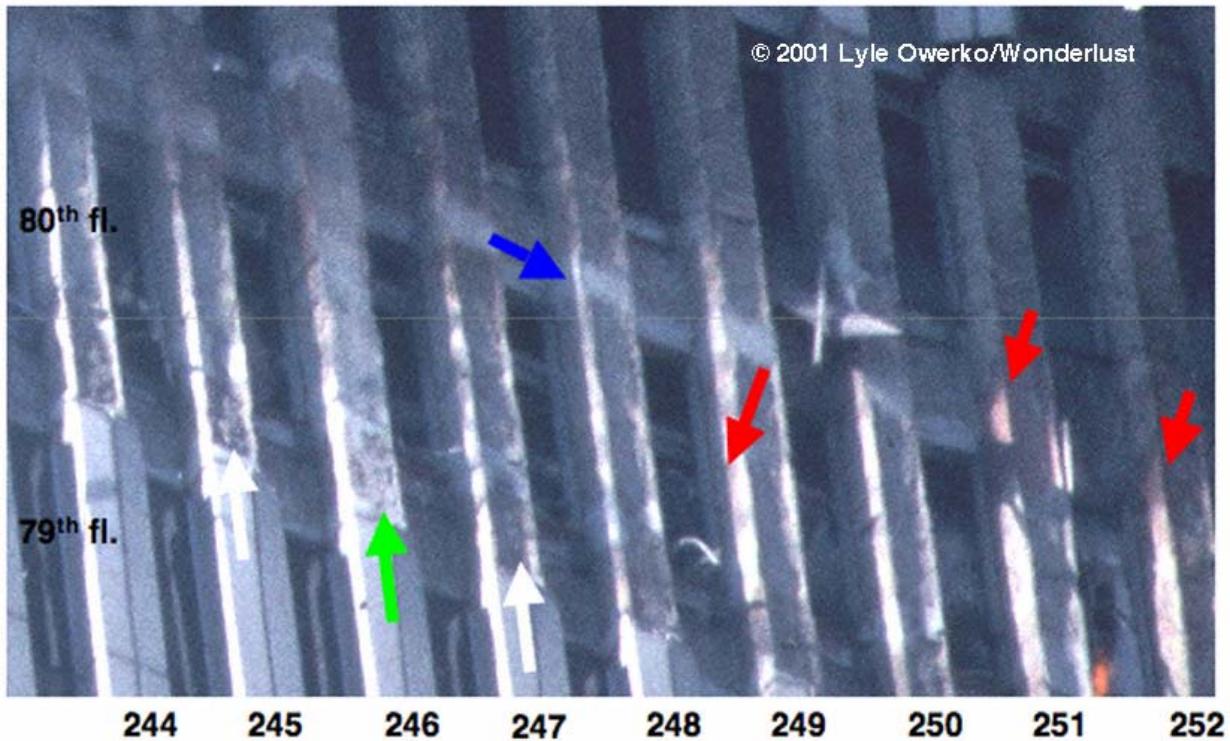
Figure 2–24. Image of inward bowing of south face (at right, with dark lines overdrawn) of WTC 1. This image was taken at 10:23 a.m. from a NYPD helicopter.

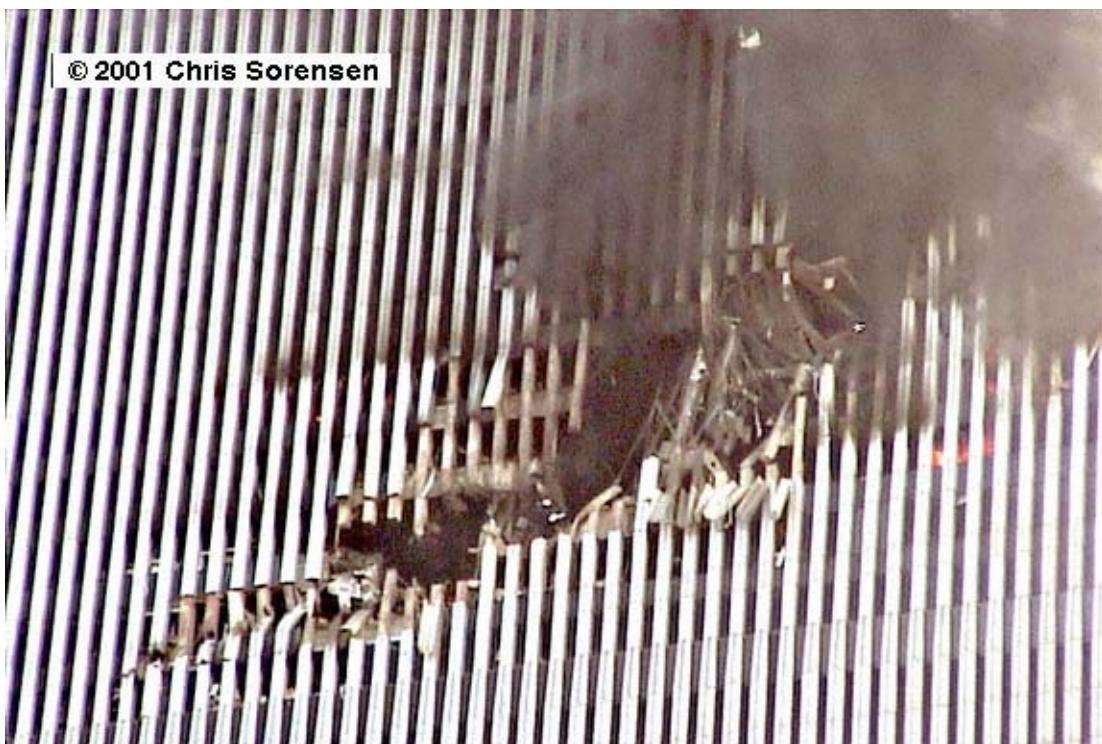
**Figure 2–28.** Image from Fig. 2–27 computer image enhanced for maximum visibility of damage to exterior wall panels.

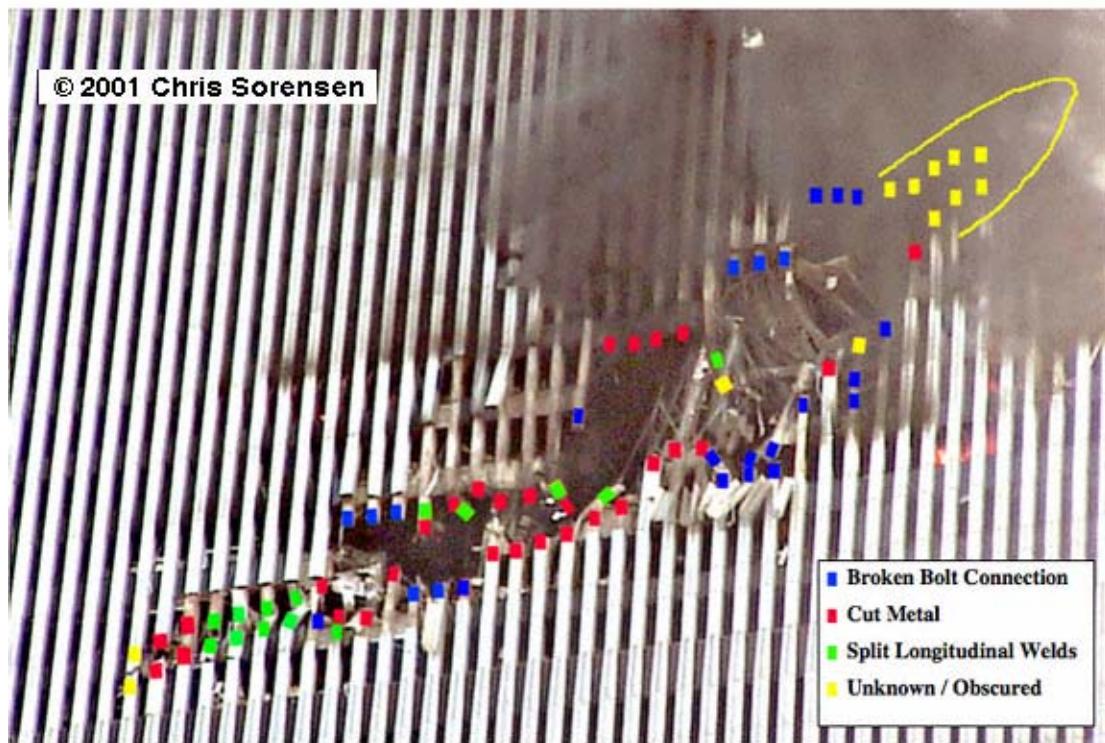
**Figure 2–29.** Image from Fig. 2–28 with indications of location and type of localized damage. Red designates cut metal components, blue indicates broken vertical column connection bolts, green indicates locations of failure of longitudinal welds in the box columns, and yellow shows regions that could not be identified from any photographic evidence.

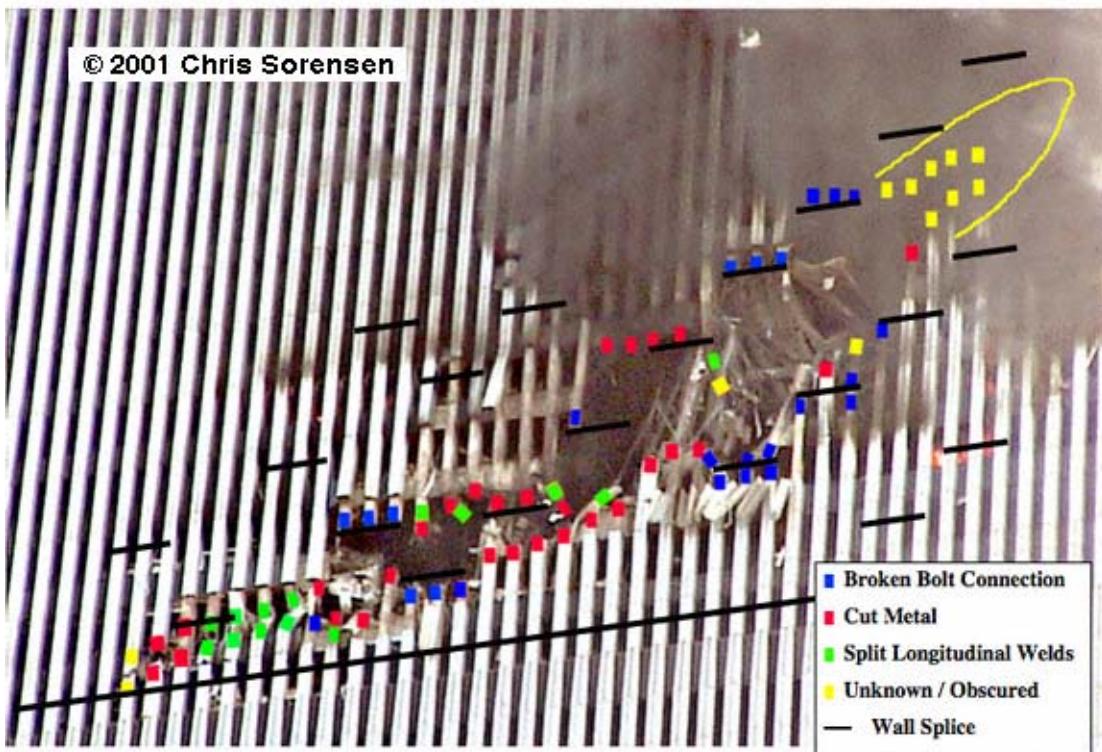
Figure 2–30. Image from Fig. 2–29 with black lines showing the location of bolted vertical column connections between panels.

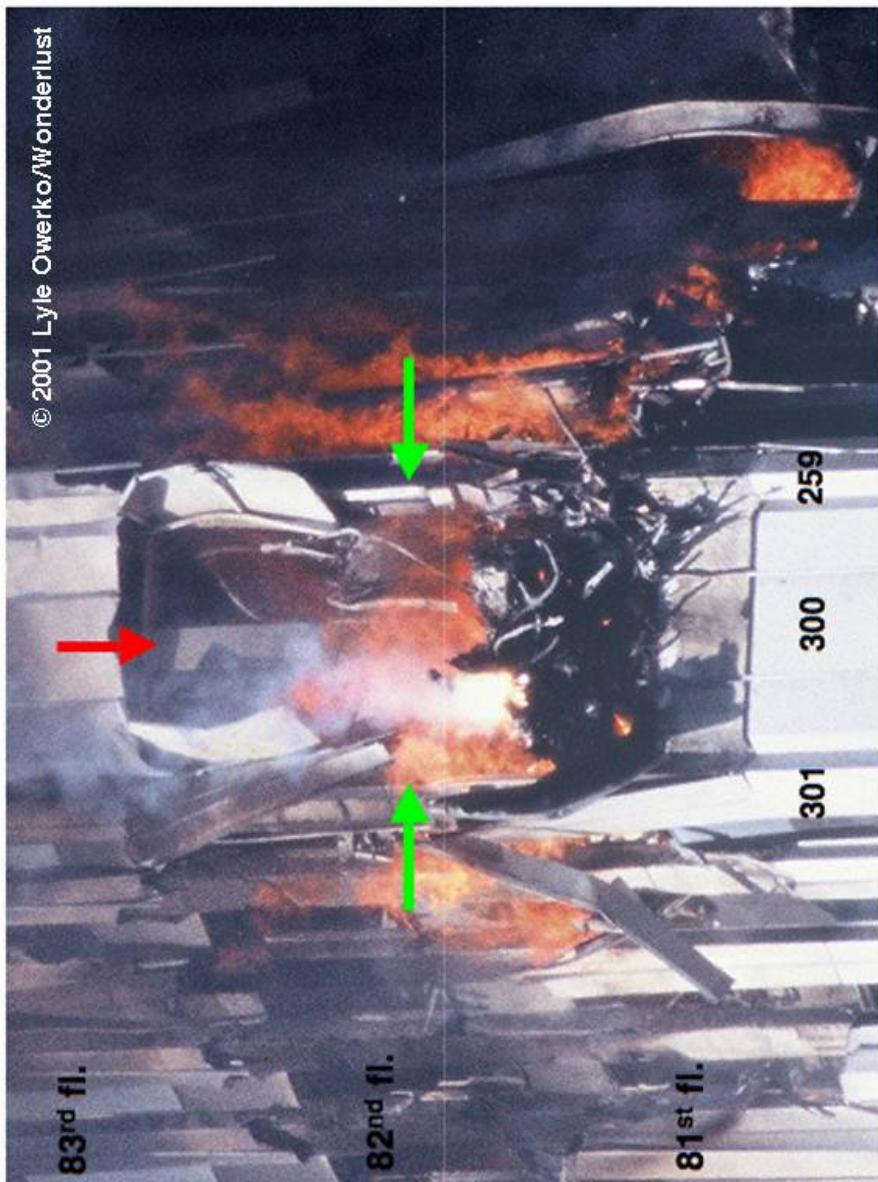
Figure 2–31. Image showing damage to NE corner of WTC 2 at 81st floor. The red arrow indicates an intact column 300 at the 82nd floor. Other photographs confirm that the spandrel connecting column 300 to columns 259 and 301 is also intact (location indicated by green arrows).

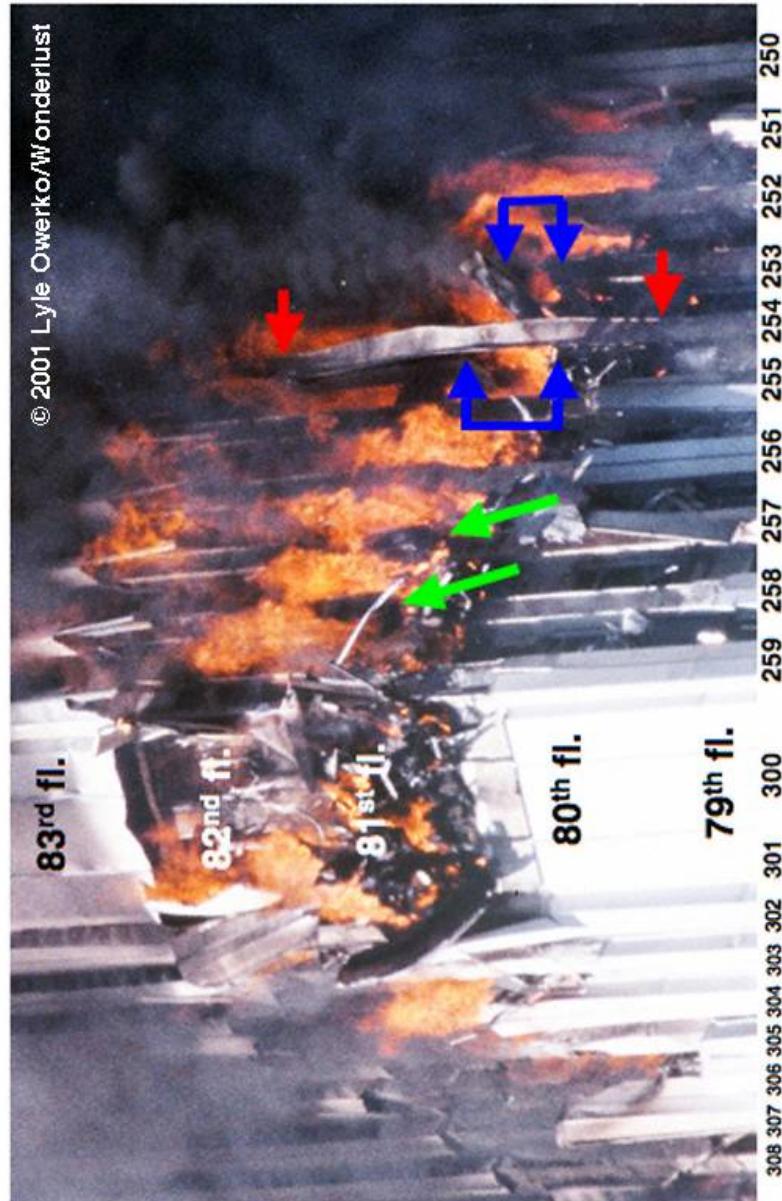
Figure 2–32. Image showing damage to columns on N face of WTC 2 near NE corner due to internal impact by debris. Broken vertical column bolted connections (green arrows) are visible, along with an intact outer web on column 254 (red arrows) and missing column sections (blue arrows).
