**Federal Building and Fire Safety Investigation of the  
World Trade Center Disaster**

**Damage and Failure Modes of  
Structural Steel Components**

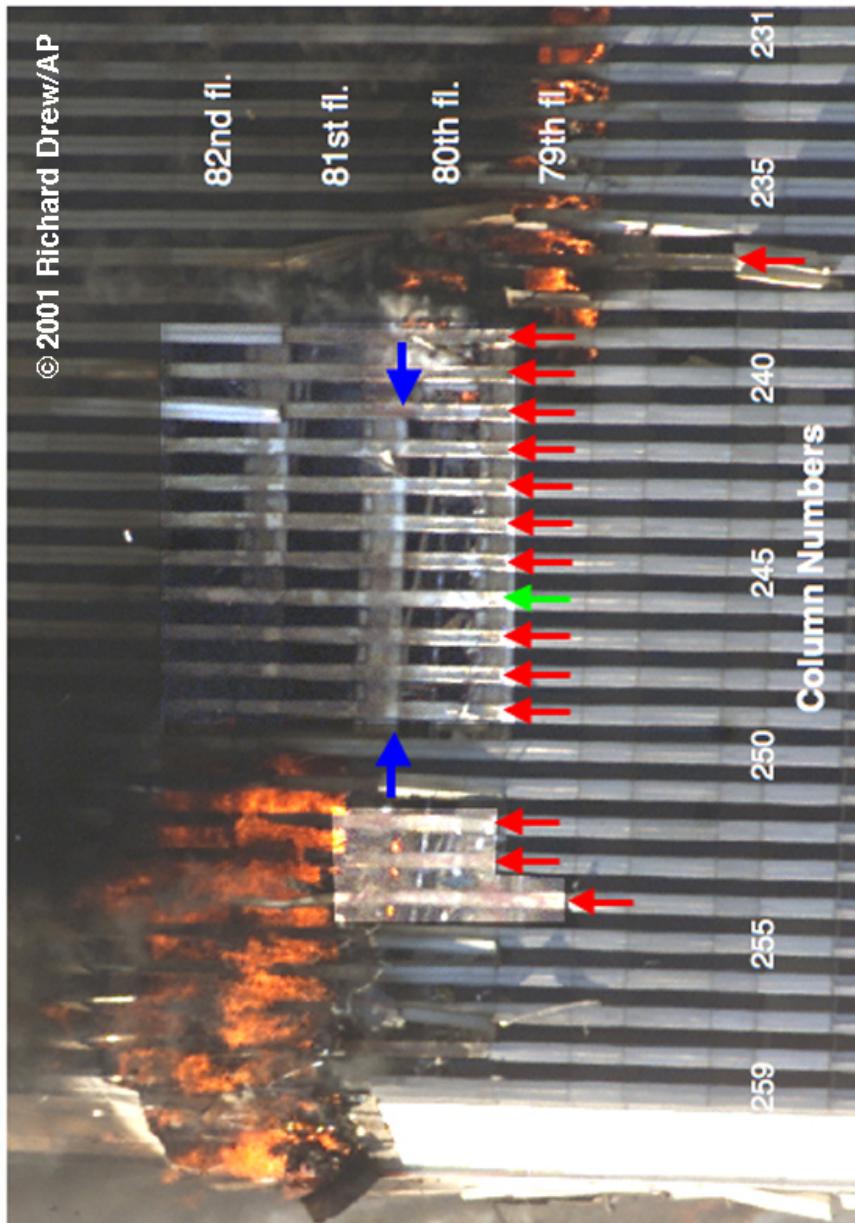
Figure 2–33. Image showing missing façade and sprayed fire-resistant material on N face of WTC 2. Two regions have had contrast and gamma adjusted to enhance visibility of the features. Red arrows indicate columns with missing or damaged sprayed fire-resistant material. Missing or damaged sprayed fire-resistant material determinations were made from this and several other photos taken at different times and angles. Blue arrows indicate white features where some sort of coating has preserved the sprayed fire-resistant material in place.

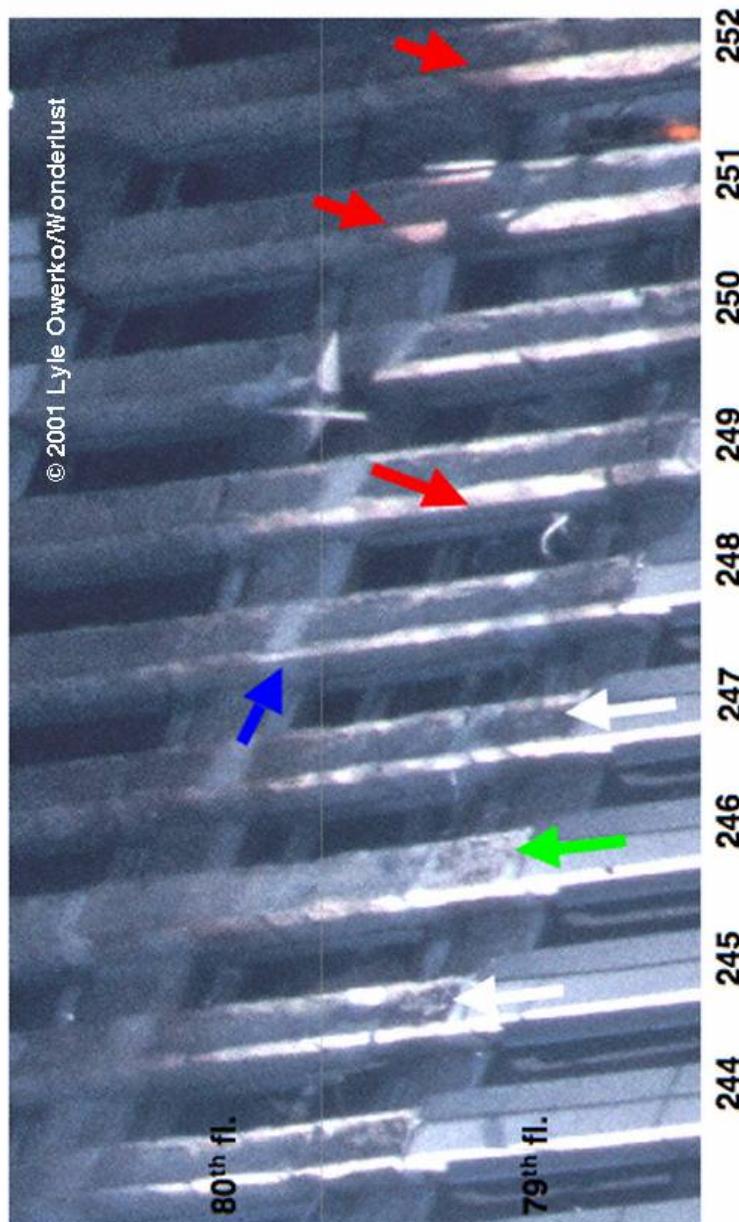
Figure 2–34. Image of missing sprayed fire-resistant material on flanges of exterior columns of N face of WTC 2. sprayed fire-resistant material has come off, revealing red Tnemec paint of the column (red arrows). This image also shows how the outer web regions have been partially or completely denuded of sprayed fire-resistant material. Damage is evidenced by shading by sunlight - compare green (undamaged sprayed fire-resistant material) and white (damaged sprayed fire-resistant material) arrows. Blue arrow indicates same type of white coated area of sprayed fire-resistant material as previous figure that adhered when material above and below was dislodged.

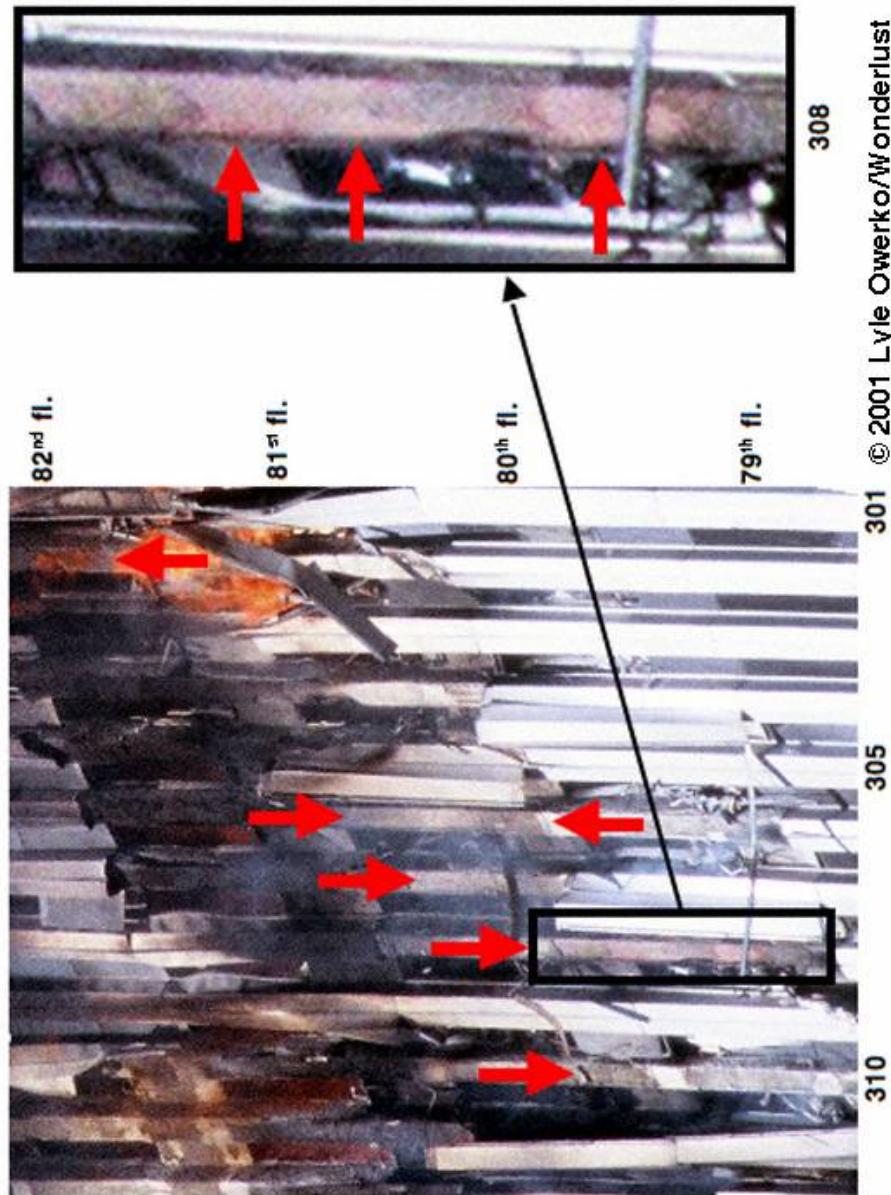
Figure 2–35. Image showing damage to sprayed fire-resistant material on east face of WTC 2 due to internal impact. Red arrows highlight areas where sprayed fire-resistant material has been damaged. The blowup to the right shows a column were the red Tremec paint of the column is visible.

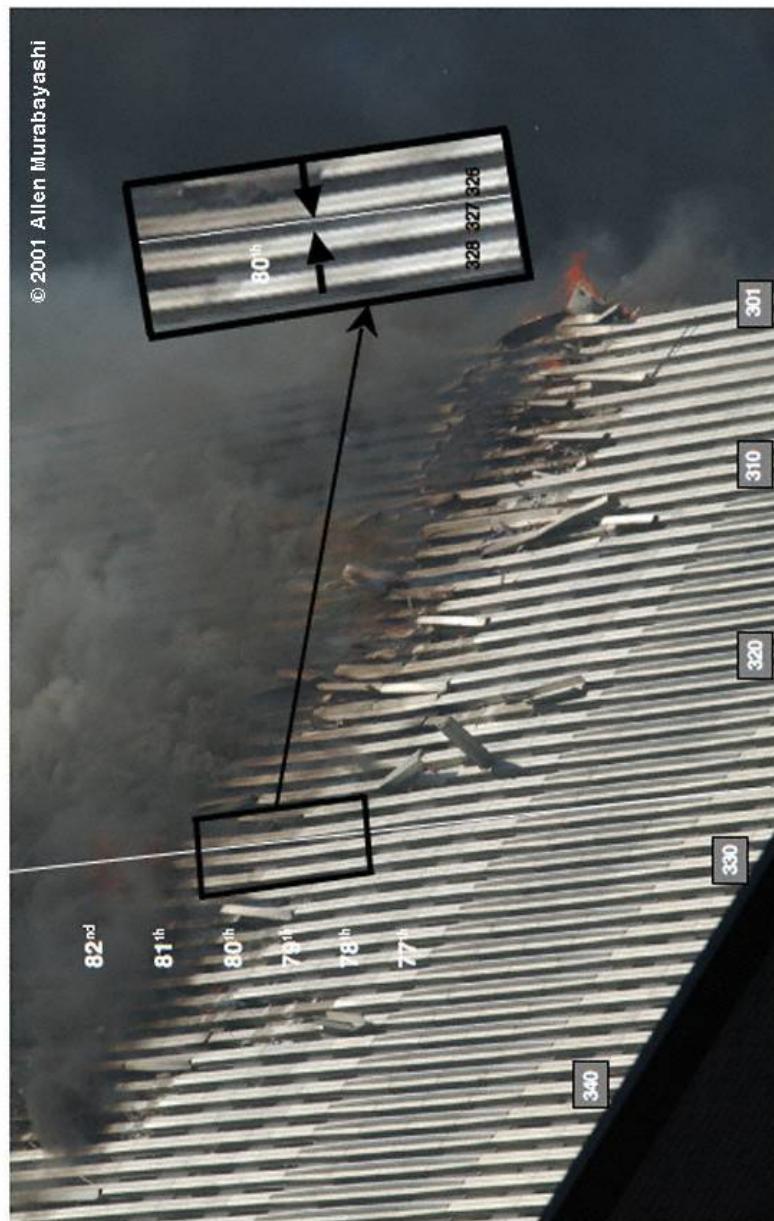
Figure 2-36. East face of WTC 2 at time 9:21:29, showing a small degree of inward deflection of the outer wall.

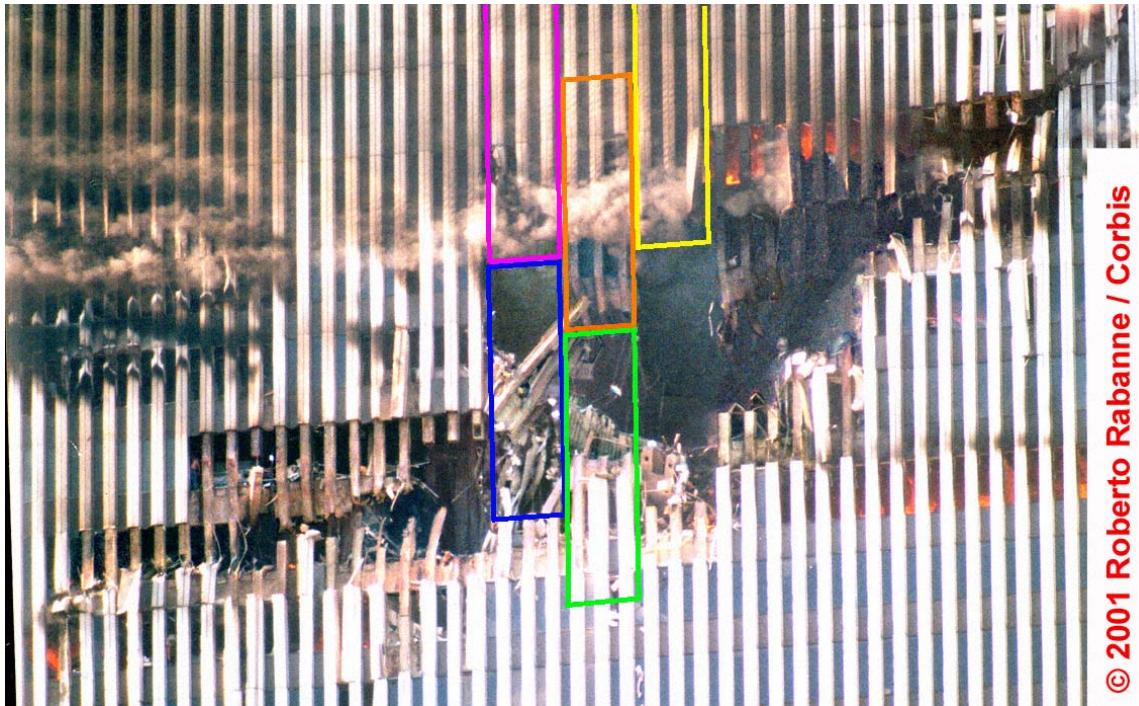
© 2001 Roberto Rabanne / Corbis

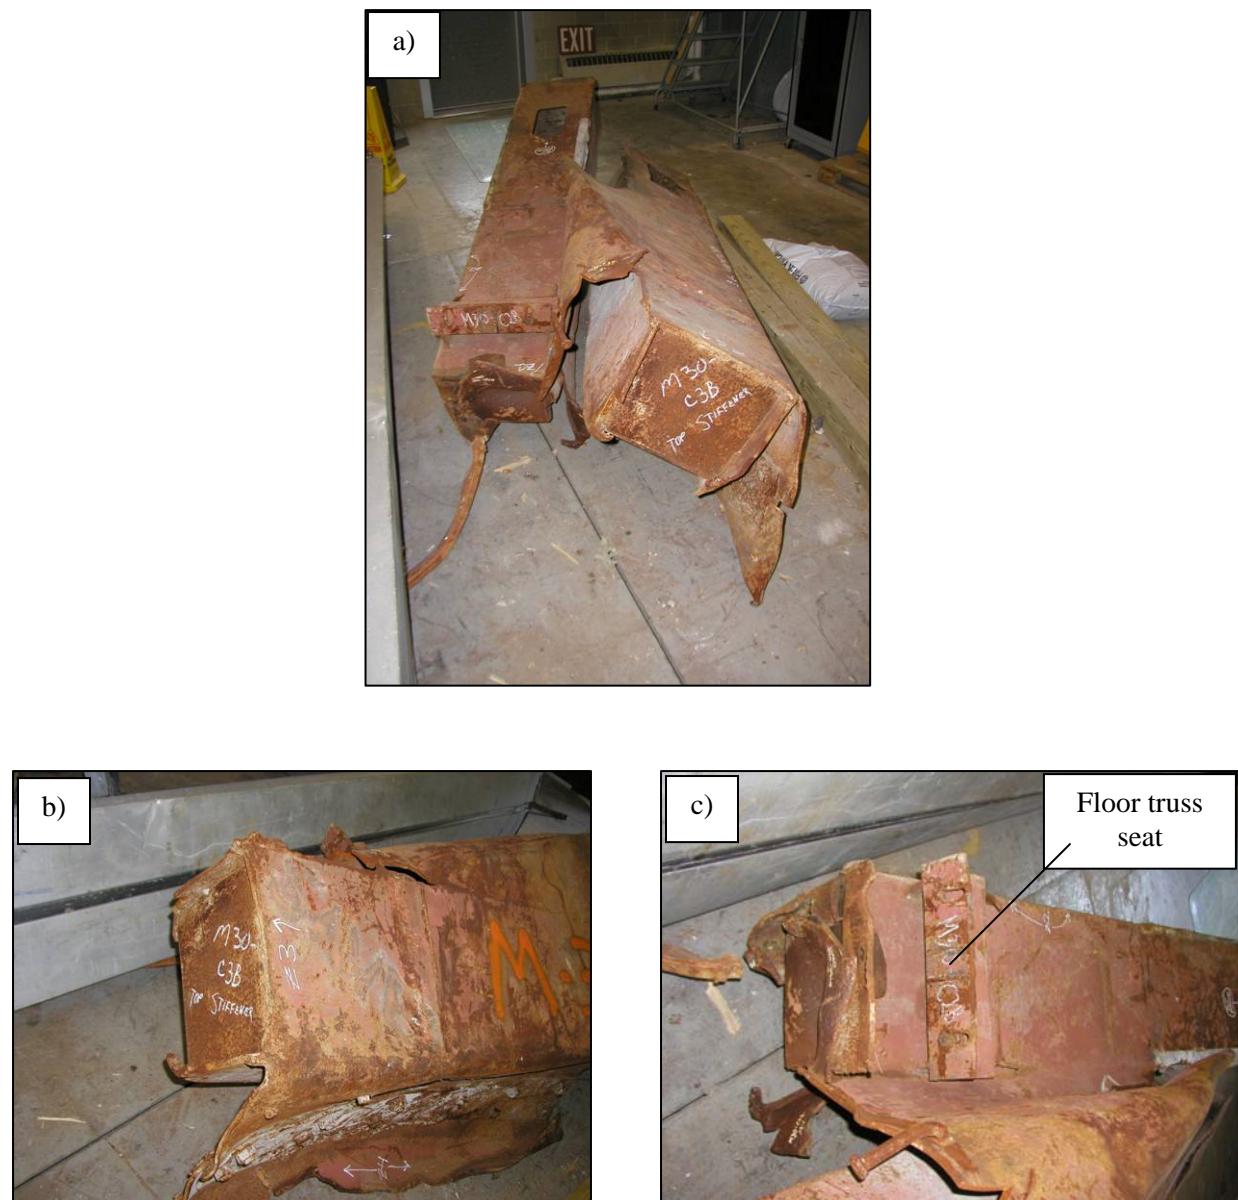
**Figure 3–1. Image showing impact damage to the north face of WTC 1. The as-built location of the five recovered panels from the impact zone were highlighted: S-9 (pink), M-30 (blue), M-2 (orange), M-27 (green), and N-7 (yellow).**

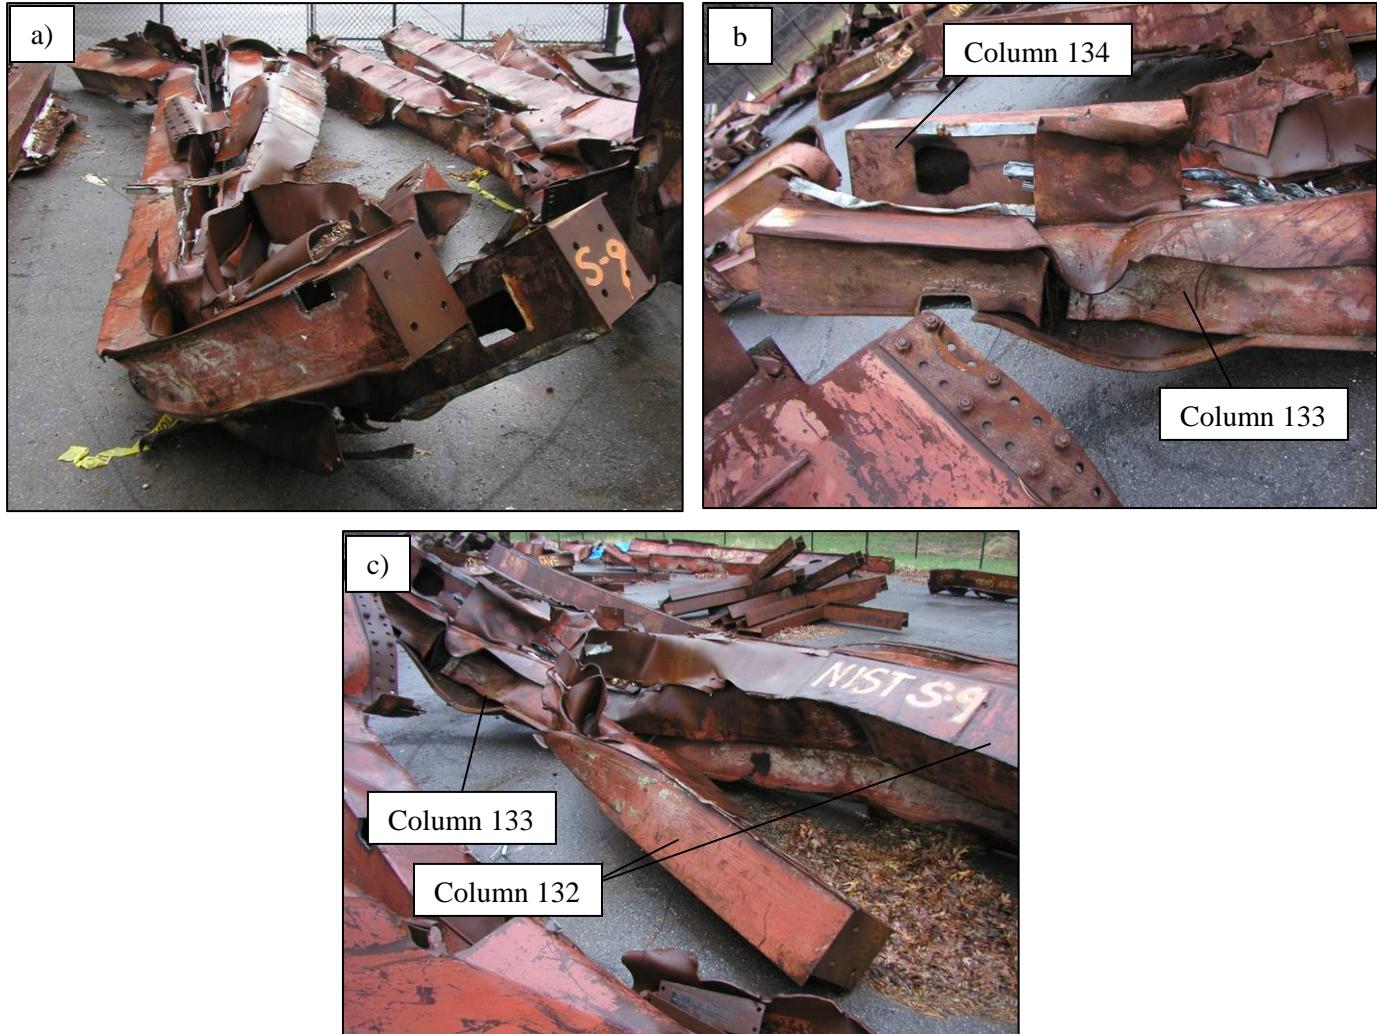
**Figure 3-2. a) Overall image of panel M-30 (A133: 94-97), b) severing of column 132 at the stiffener plate associated with the top of the spandrel, and c) severing of column 133 at a slightly lower elevation associated with the 95th floor level concrete slab.**

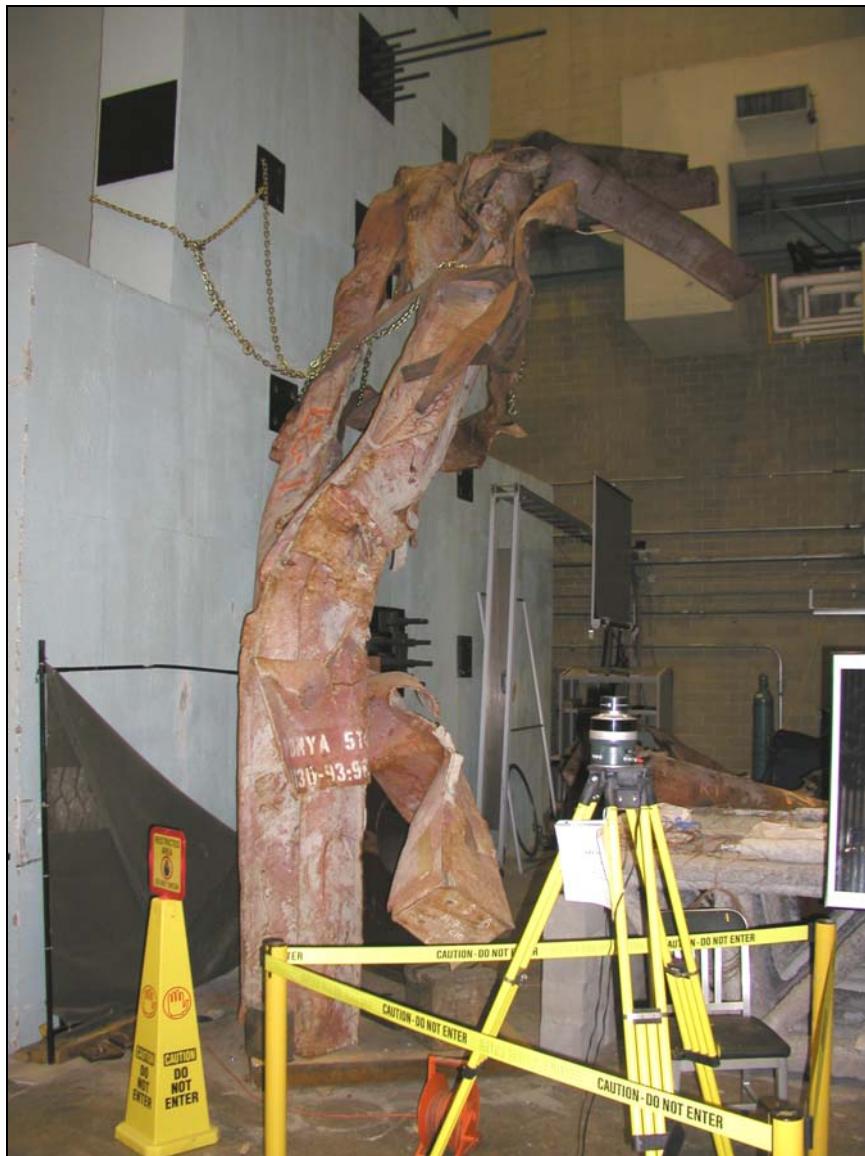
**Figure 3–3. a) Overall image of panel S-9 (A133: 97-100) and b) lower portion of panel showing possible damage from airplane impact, bottoms of columns 133 and 134 shown, and c) column 132 that sustained a fair amount of damage.**

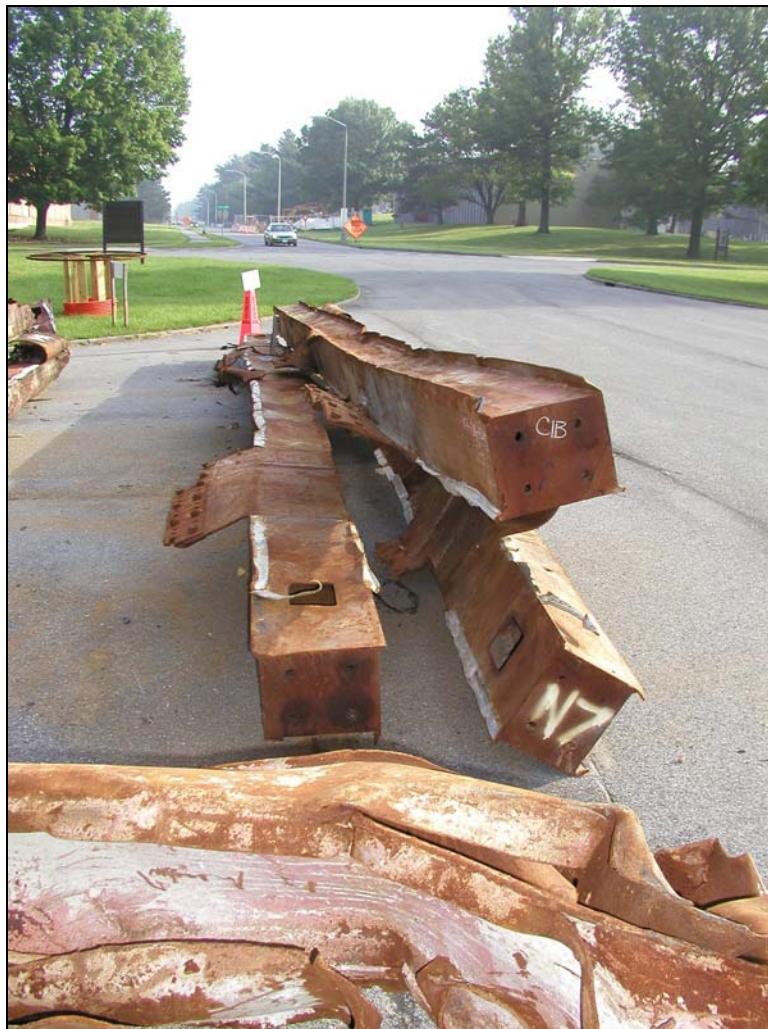
**Figure 3–5. Panel M-2 (A130: 94-97).** This panel was from the north face of WTC 1. The lower portion of the panel was struck by the fuselage of the airplane. General shape of panel is due to airplane impact and bending about the 97th floor slab. a) Overall view, bottom of panel is on the left-hand side of the picture and the outside of the panel is facing down, b) major bend in panel located at the 97th floor level, and c) splayed bottoms of columns 129 and 130.

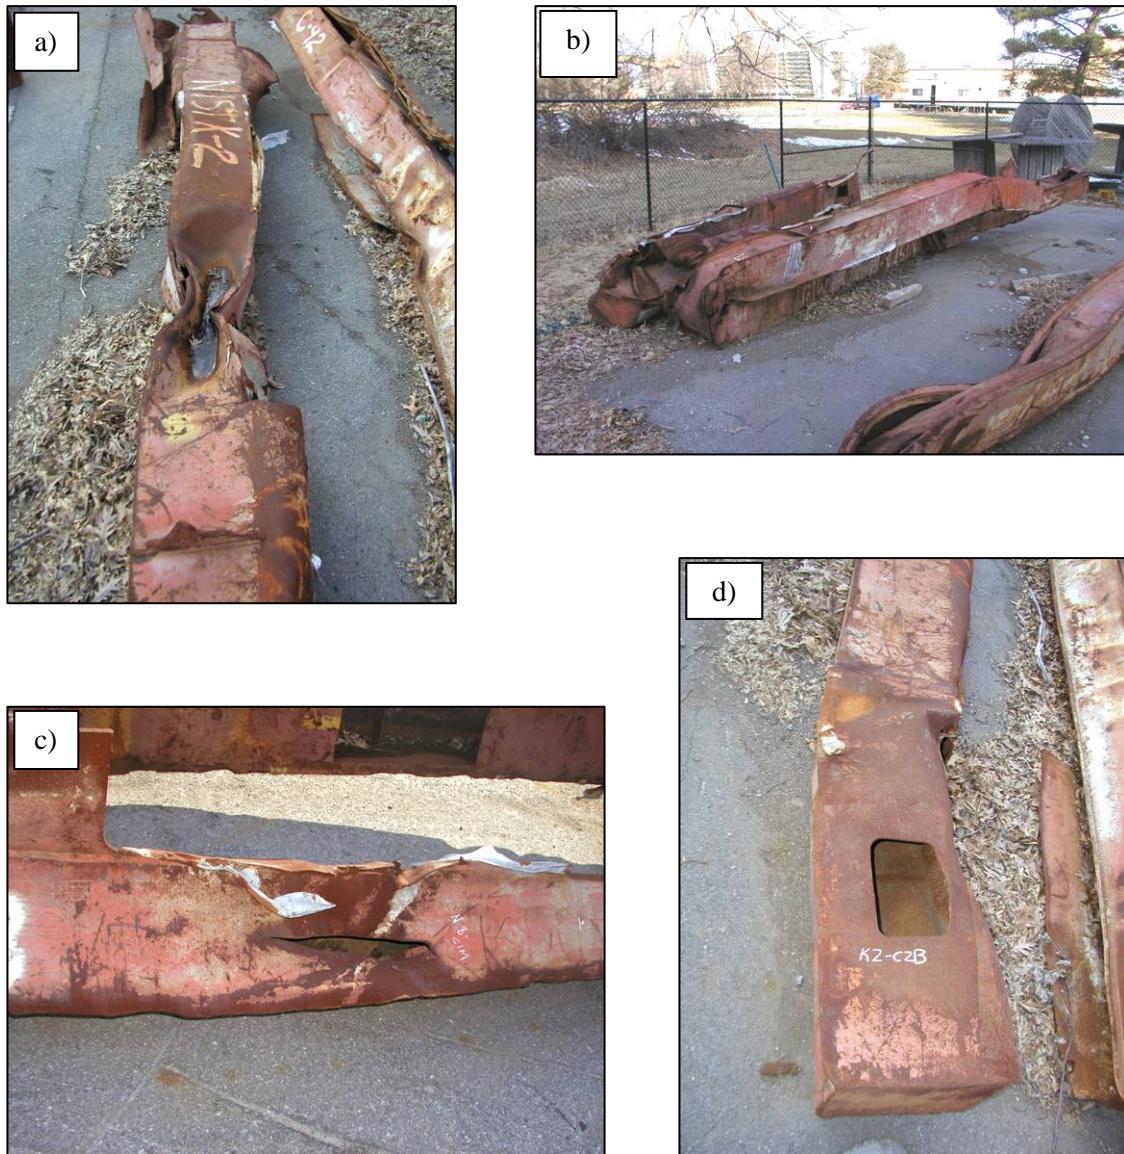
**Figure 3–6. Overall image of sample N-7 (A127: 97-100). Panel was in relatively good shape besides being folded inward about an axis parallel to the length of the columns with the outer web of the columns facing outward. This was believed to have happened during the collapse or recovery efforts. The three columns were relatively intact with limited damage.**

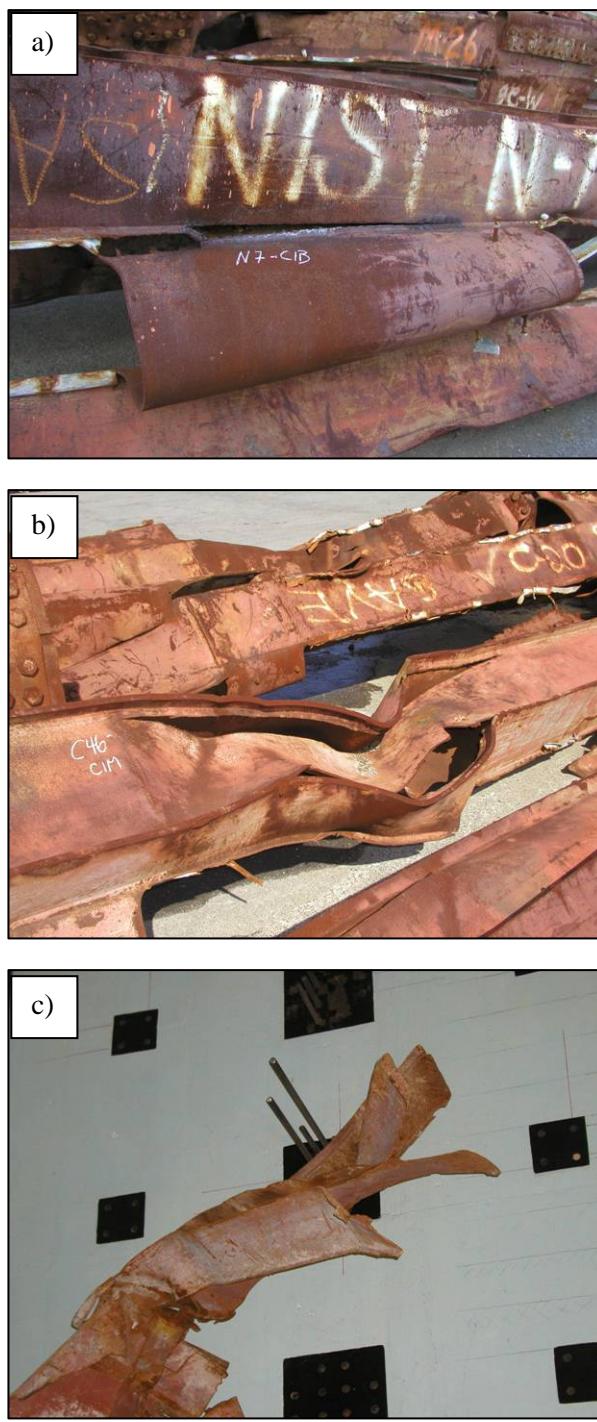
**Figure 3–7. Photographic examples of Type 1 damage feature for exterior panel columns, gross physical distortion of flanges and webs. a) Type 1a, crushed columns from K-2 (A236: 92-95), b) Type 1a, crushed column from N-12 (A206: 92-95), c) Type 1b, punctured column from N-8 (A142: 97-100), and d) Type 1c, buckling of column from K-2.**

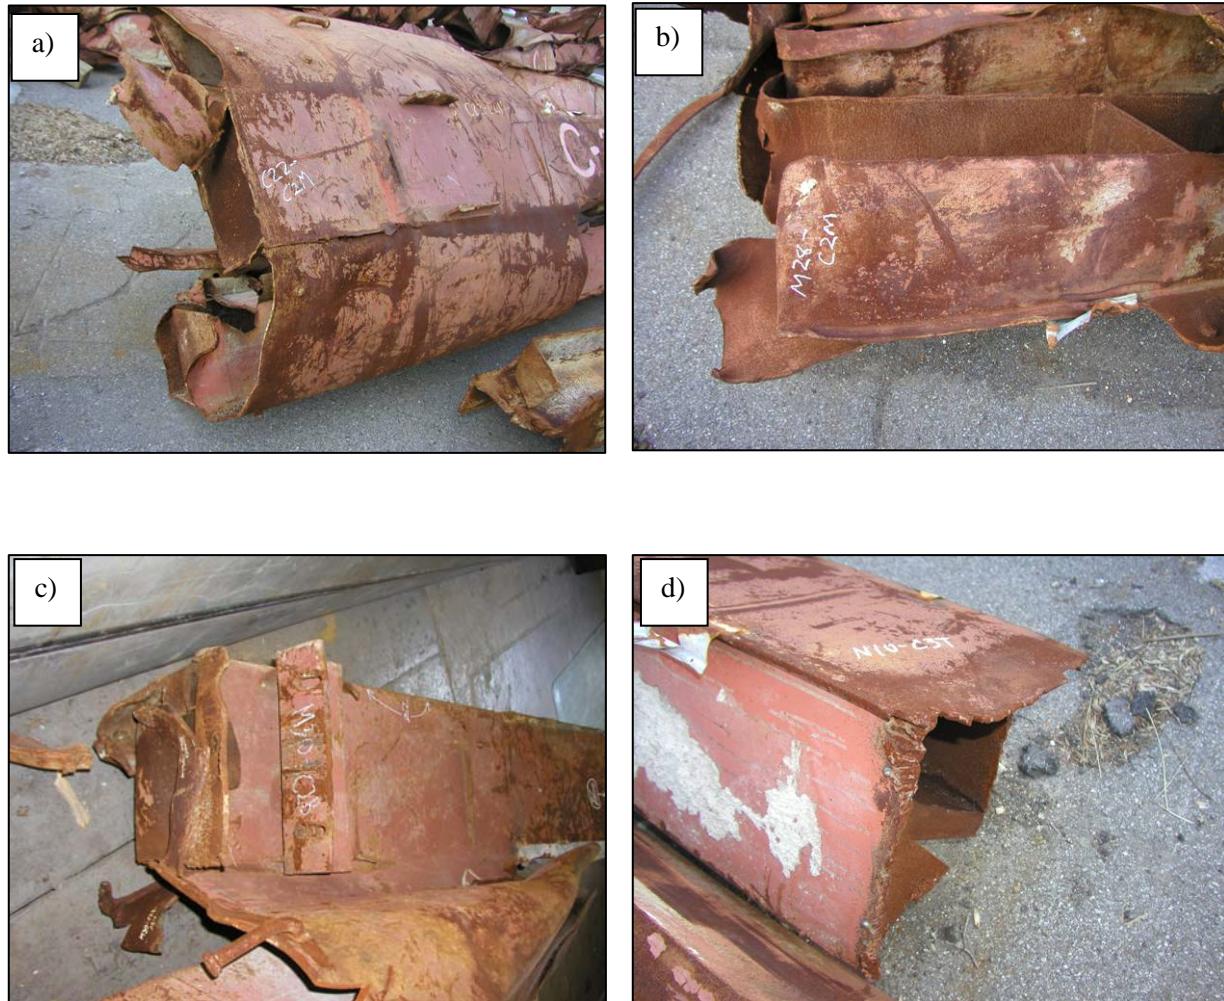
**Figure 3–8. Photographic examples of Type 2 damage feature for exterior panel columns, fracture in base plate near fillet welds. a) Type 2a, localized fracture from N-7 (A127: 97-100), b) Type 2b, extensive fracture from C-46 (B157: 68-71), and c) Type 2c, extensive fracture resulting in “splaying” of column from M-27 (A130: 93-96).**

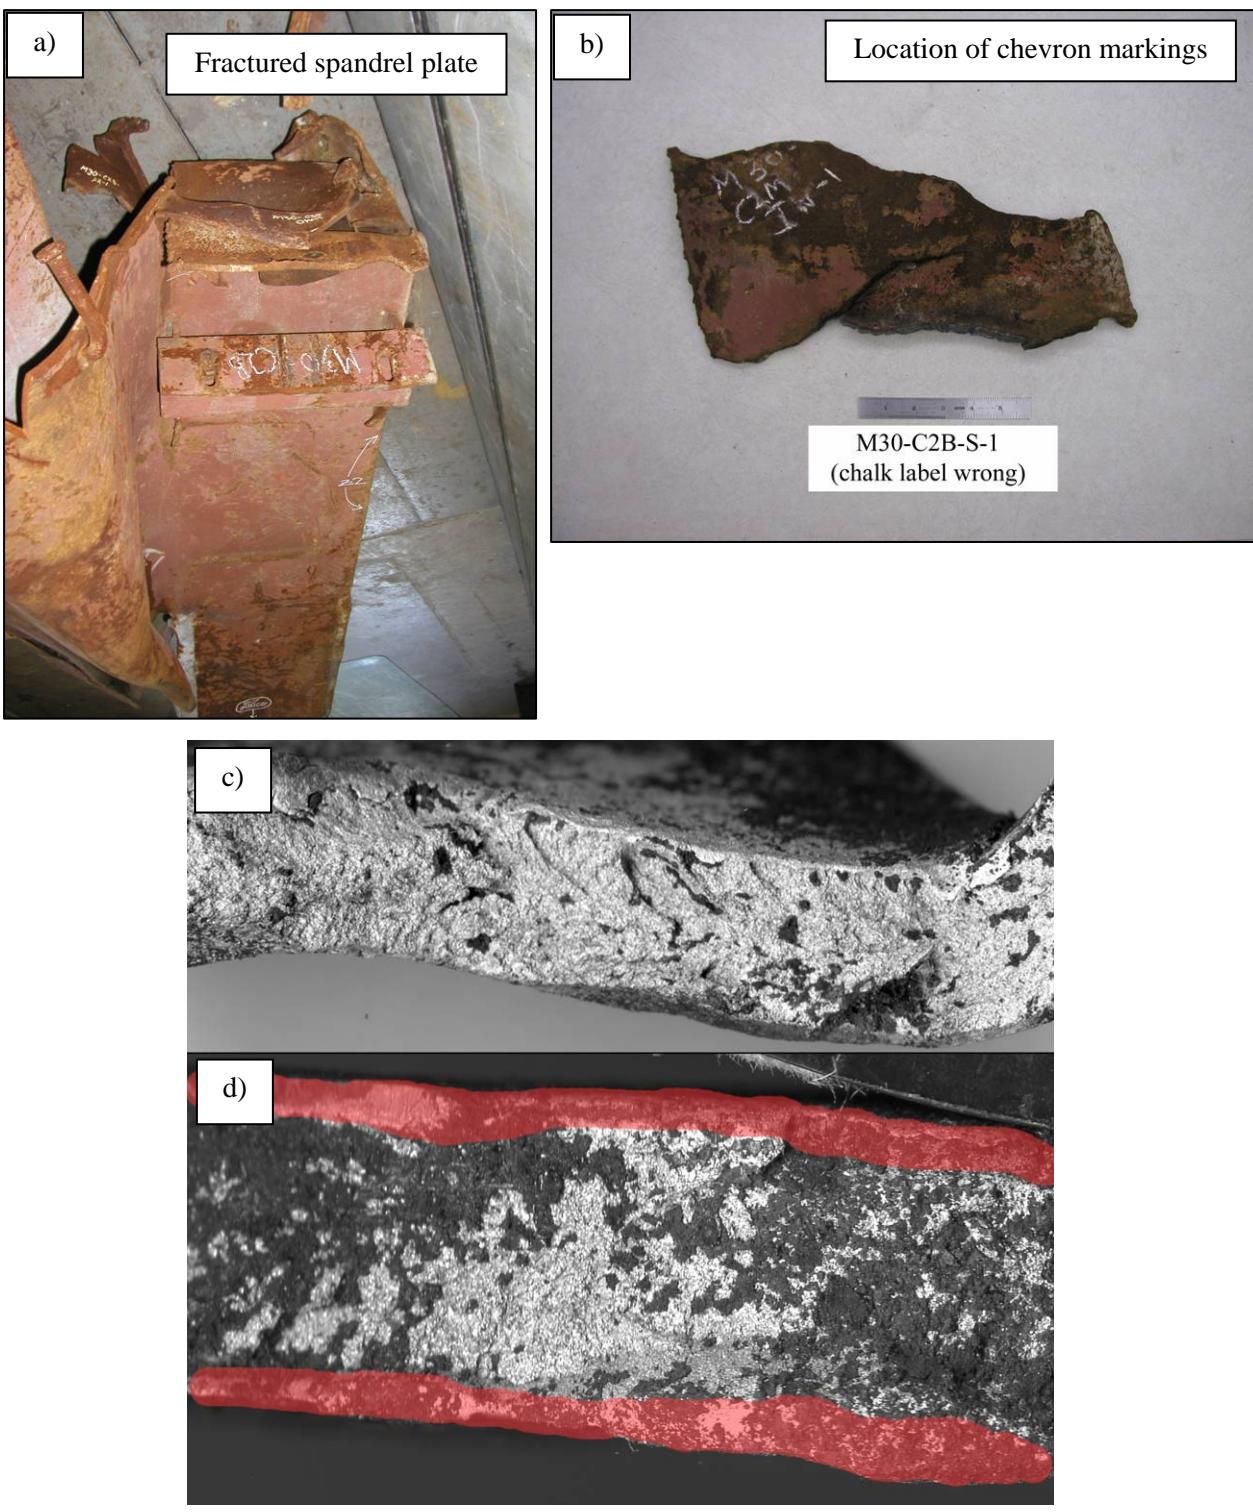
**Figure 3–9. Photographic examples of Type 3 damage feature for exterior panel columns, severing of columns. a) Type 3a, sever associated with stiffener or diaphragm plate from C-22 (A157: 93-96), b) Type 3b, sever occurred away from stiffener or diaphragm plate from M-28 (B345: 98-101), c) Type 3c, sever occurred at concrete slab of floor from M-30 (A133: 94-97), and d) end was flame cut during recovery from N-10 (A115: 89-92).**

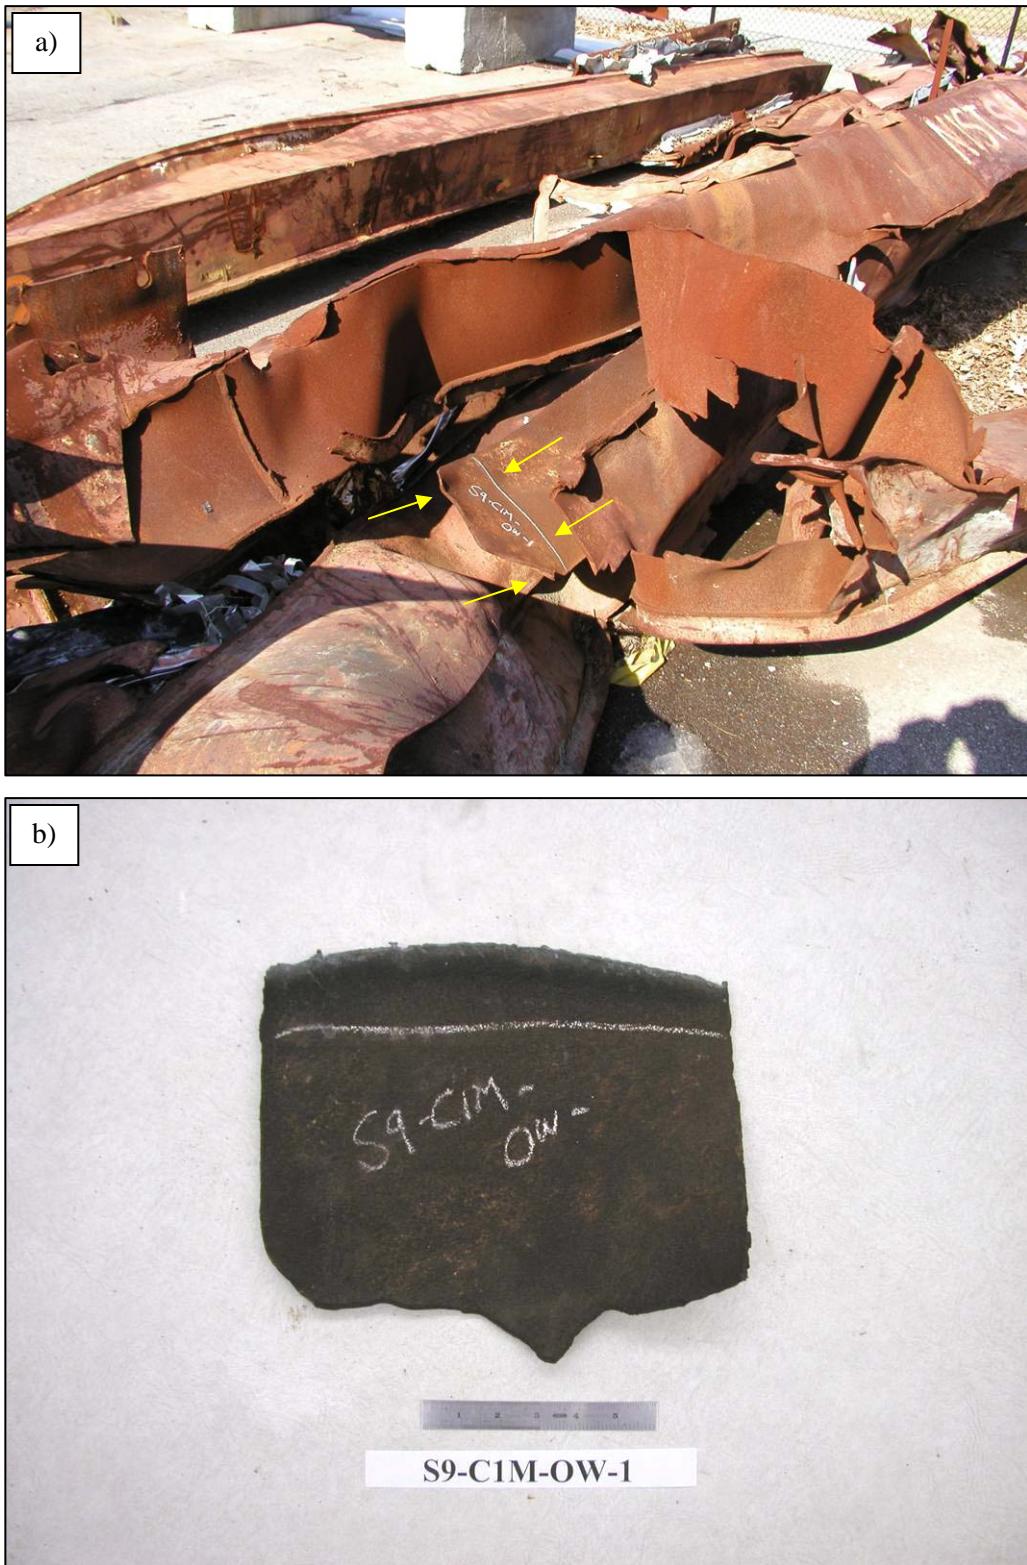
**Figure 3–10. Fracture surface of sample M-30 (A133: 94-97), spandrel plate of column 133. Fracture was due to airplane impact of WTC 1.** a) Location of sample removed, b) laboratory image showing sample removed, c) fracture shows chevrons running along the length of the crack path, and d) red highlighted area showing the location of small shear lips.

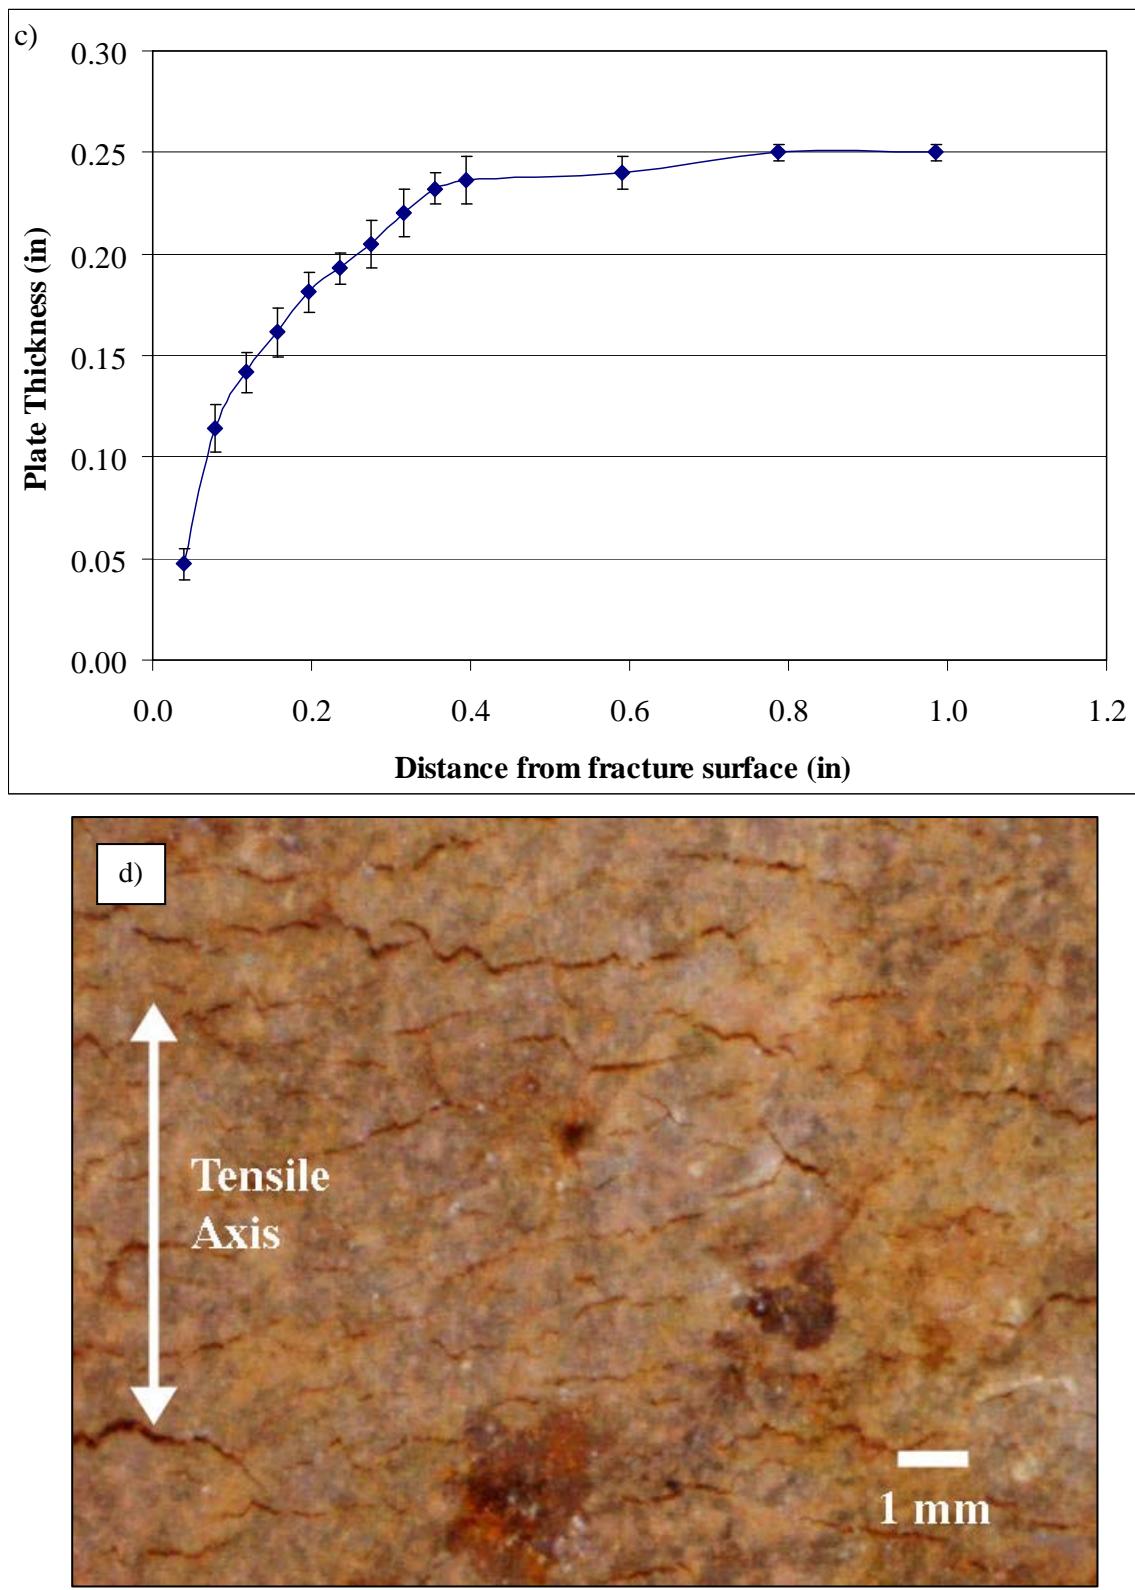
**Figure 3-11. Analysis of fractured plate from sample S-9 (A133: 97-100), outer web of column 132. This panel from WTC 1 was struck by the vertical tail assembly. a) Location of sample removed, b) laboratory image showing sample removed.**

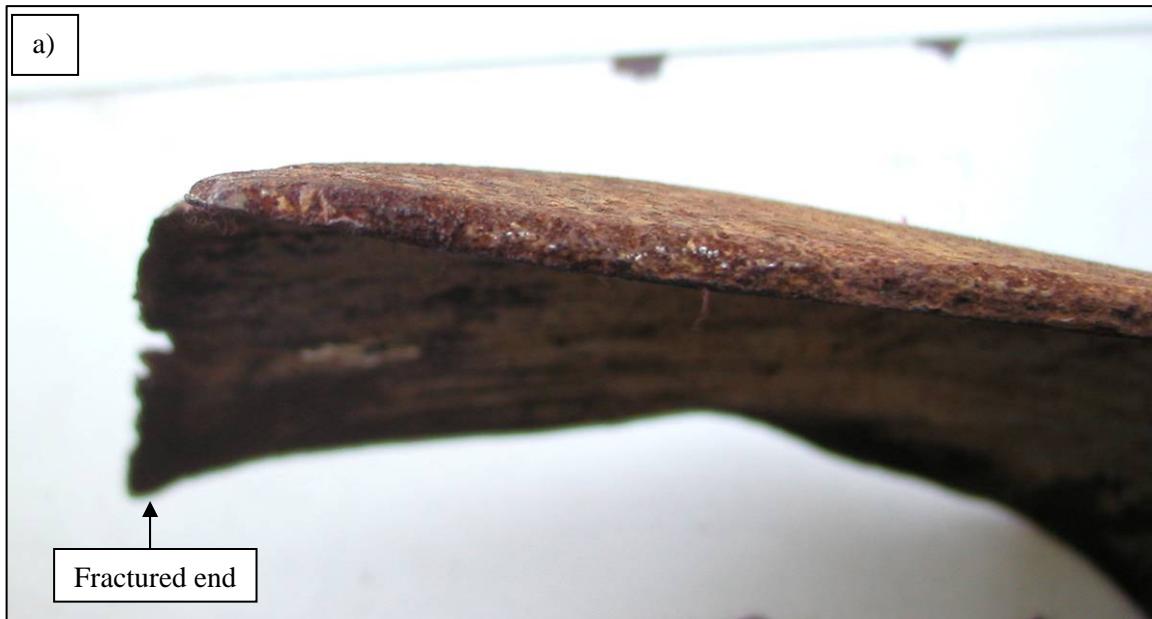
**Figure 3-11. Analysis of fractured plate from sample S-9 (A133: 97-100), outer web of column 132. c) graph indicating plate thinning near fracture surface, d) image showing paint cracking as a result of tensile loading of the plate.**

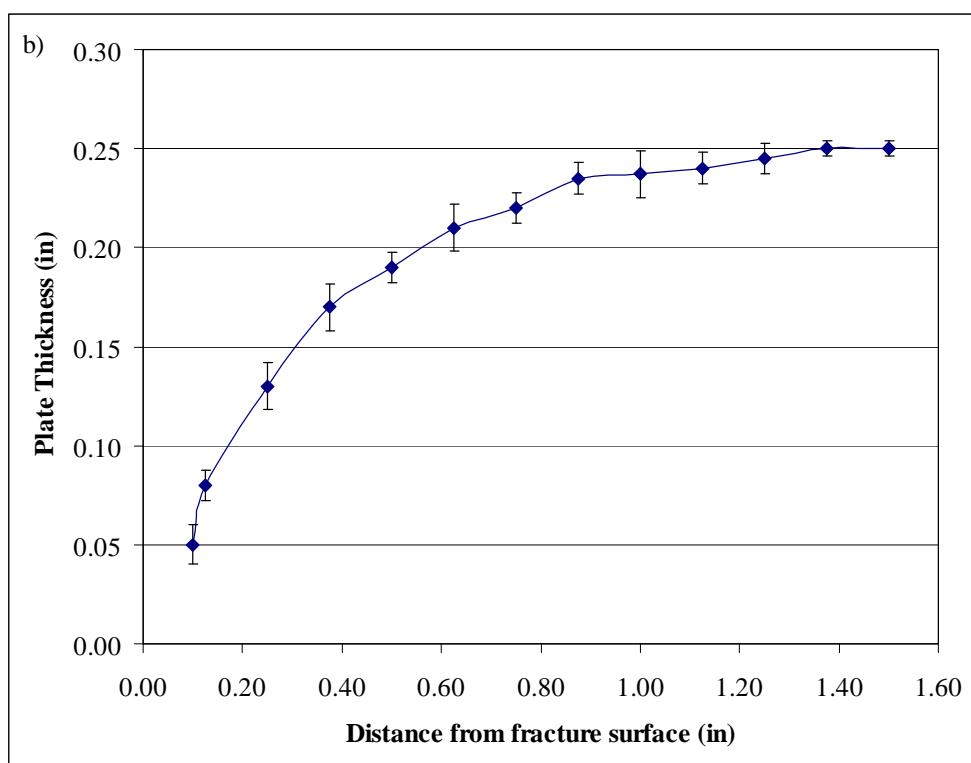
**Figure 3–12.** Thinning of outer web from column 130 of panel M-2 (A130: 96-99). Tensile failure of the plate was a result of airplane impact into WTC 1. a) photograph showing thinning, b) graph indicating plate thinning near fracture surface.

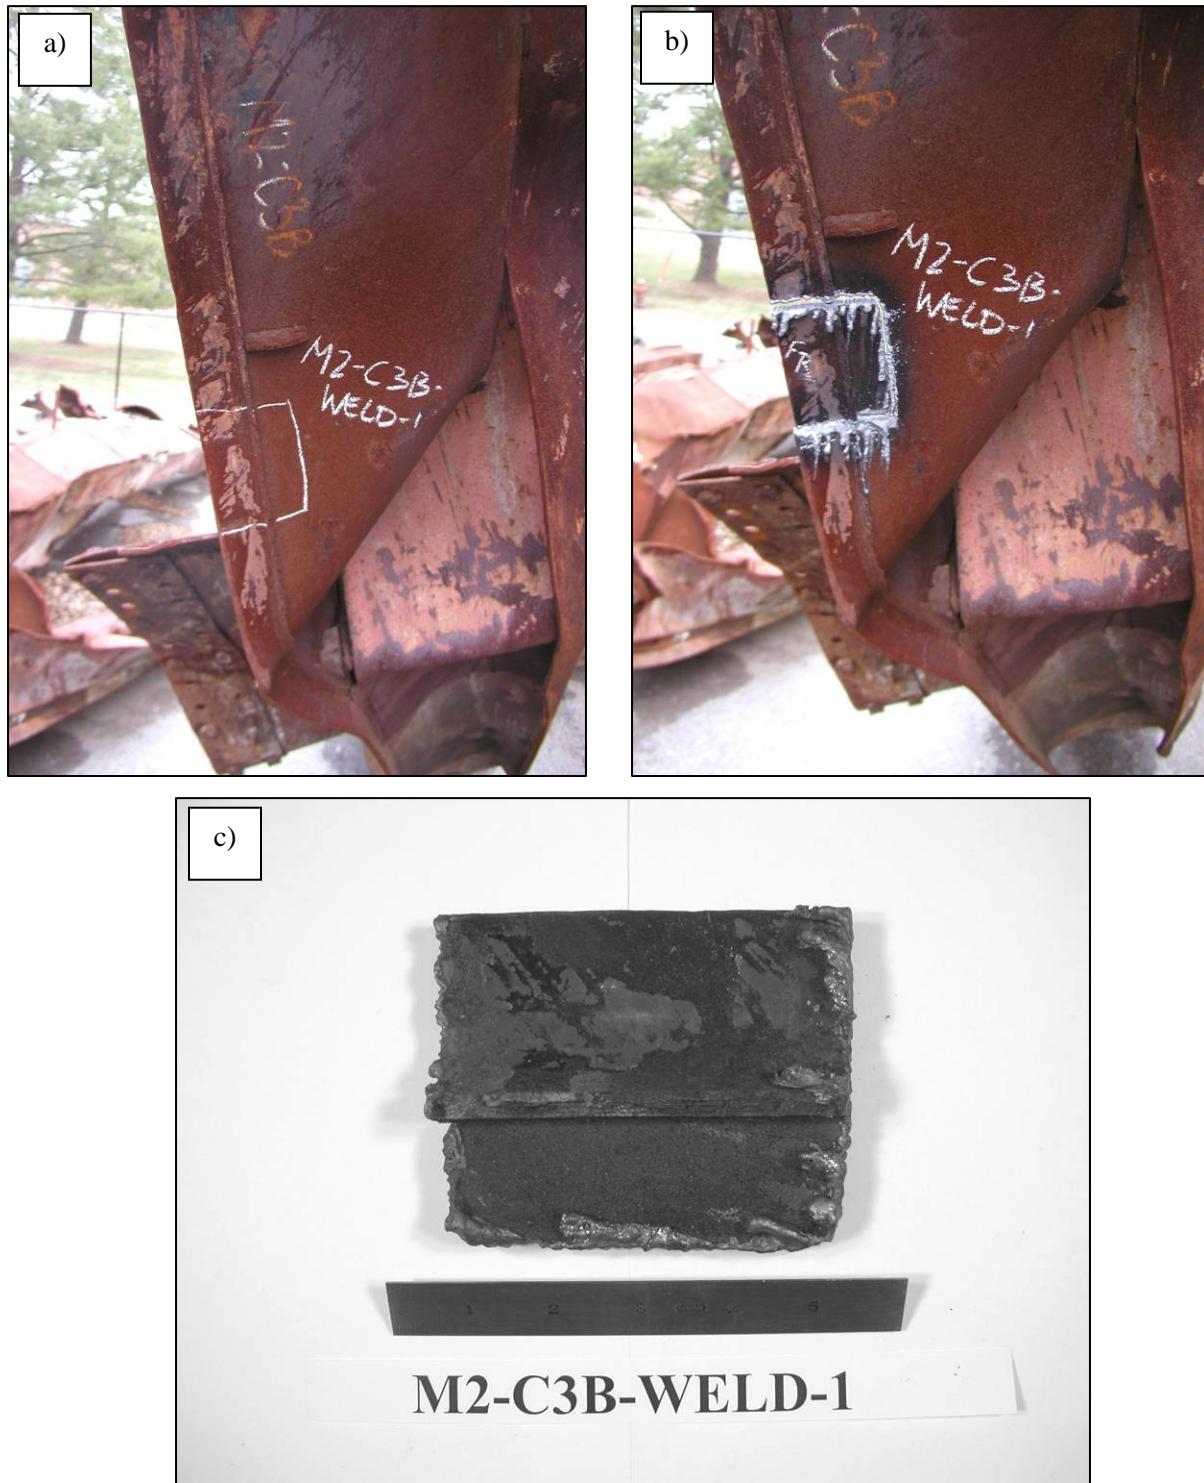
**Figure 3–13. Damage images from sample M-2 (A130: 96-99). Panel from WTC 1 was struck by fuselage of airplane and bent about the 97th floor. a) Large buckles observed on the flange plates of column 130, b) cracking of the flange plates on column 130, c) cracking of spandrel at 97th floor level, and d) no cracking near the welds in this area on column 130.**
