**Federal Building and Fire Safety Investigation of the  
World Trade Center Disaster**

**Damage and Failure Modes of  
Structural Steel Components**

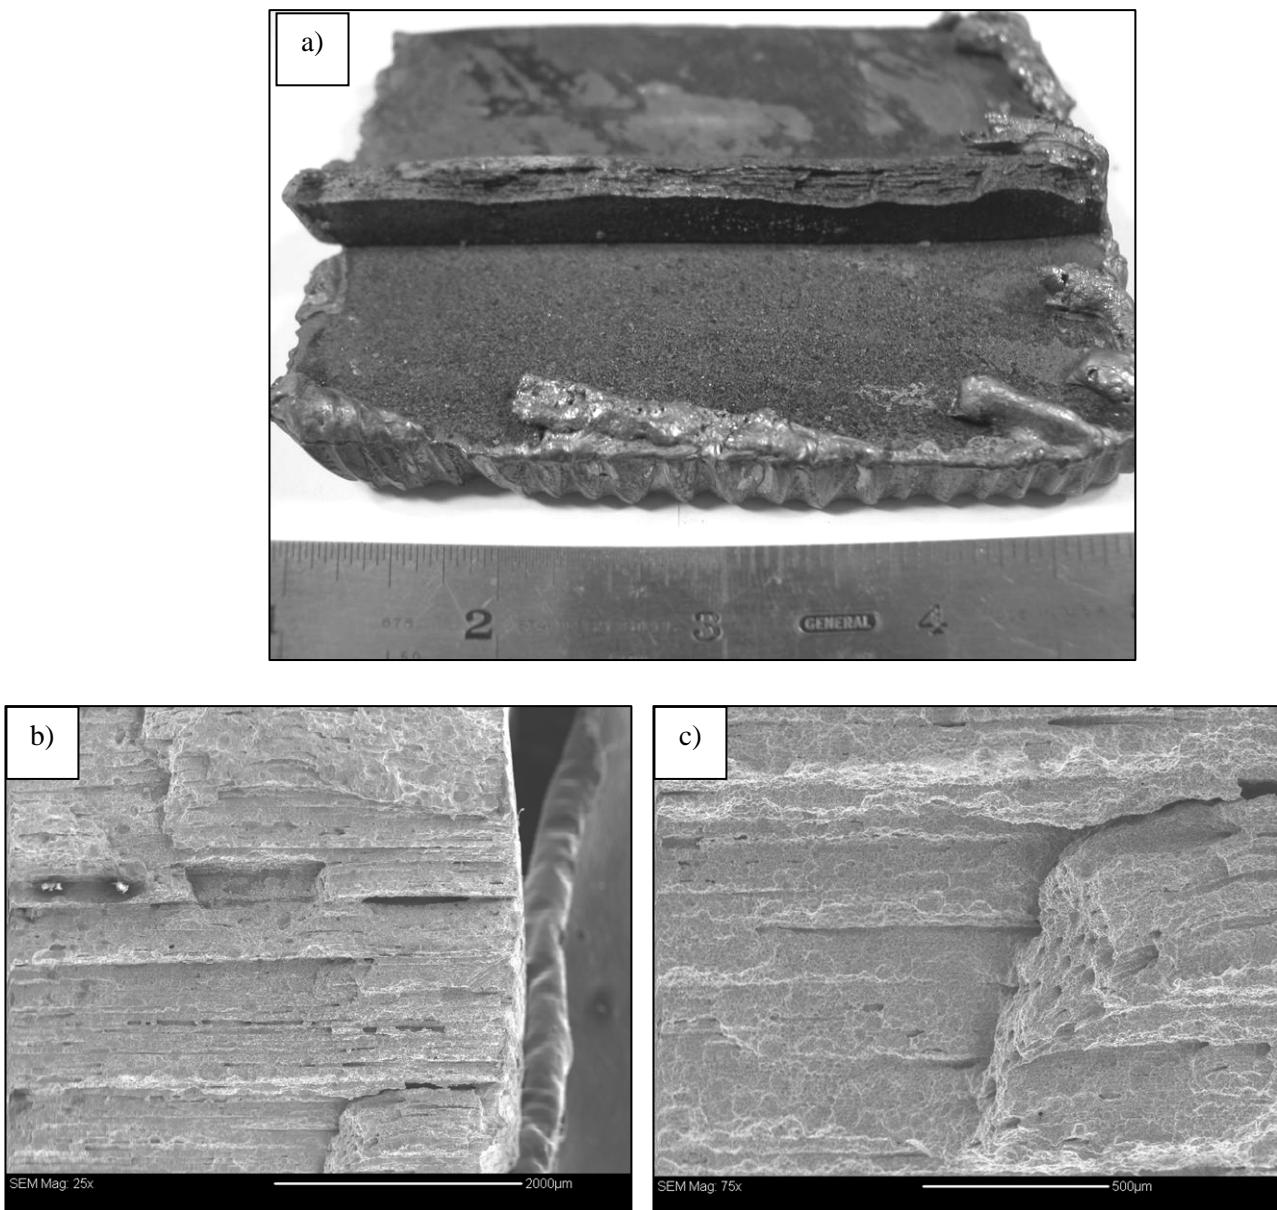
**Figure 3–14.** Example of fracture near weld of a perimeter column as a result of airplane impact, sample M2-C3B-Weld-1 (A130: 96-99, column 129), images taken a) prior to sample removal, b) after flame cutting, and c) in the laboratory.

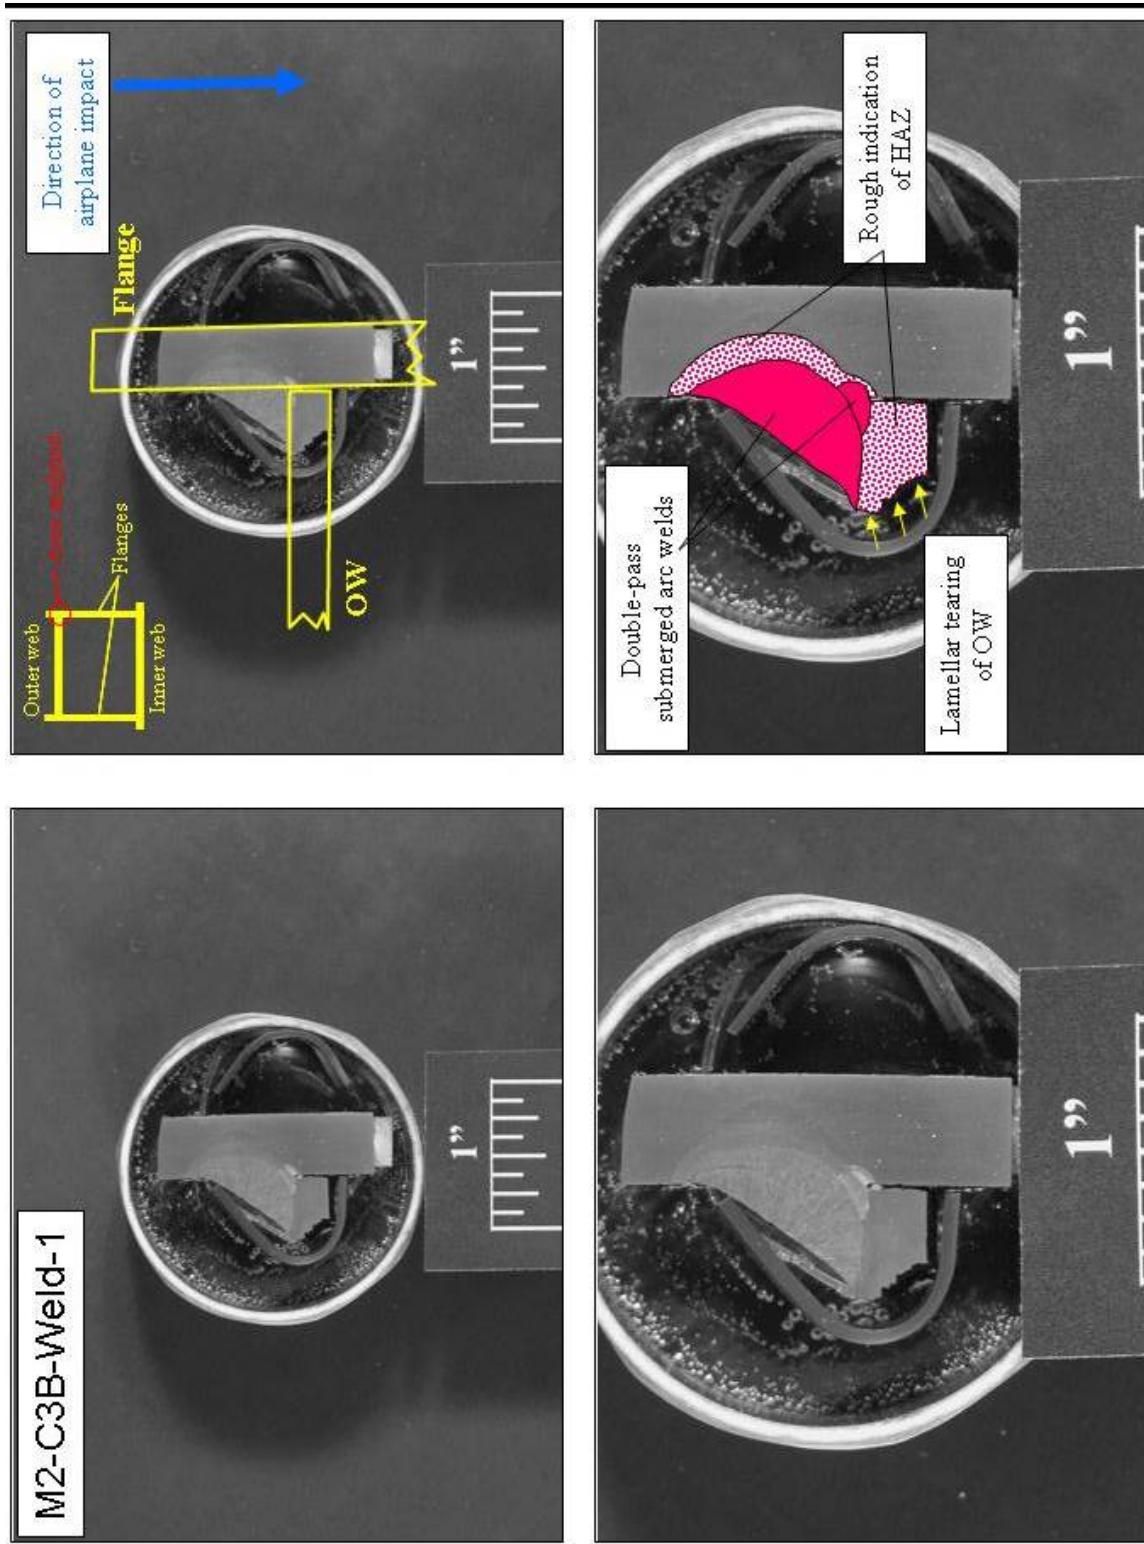
**Figure 3-15. Fracture surface for sample M2-C3B-Weld-1 (A130: 96-99, column 129) shown in Fig. 3-14. Fracture features of outer web have “lamellar tearing” type fracture characteristics. a) Light micrograph, b) and c) scanning electron micrographs.**

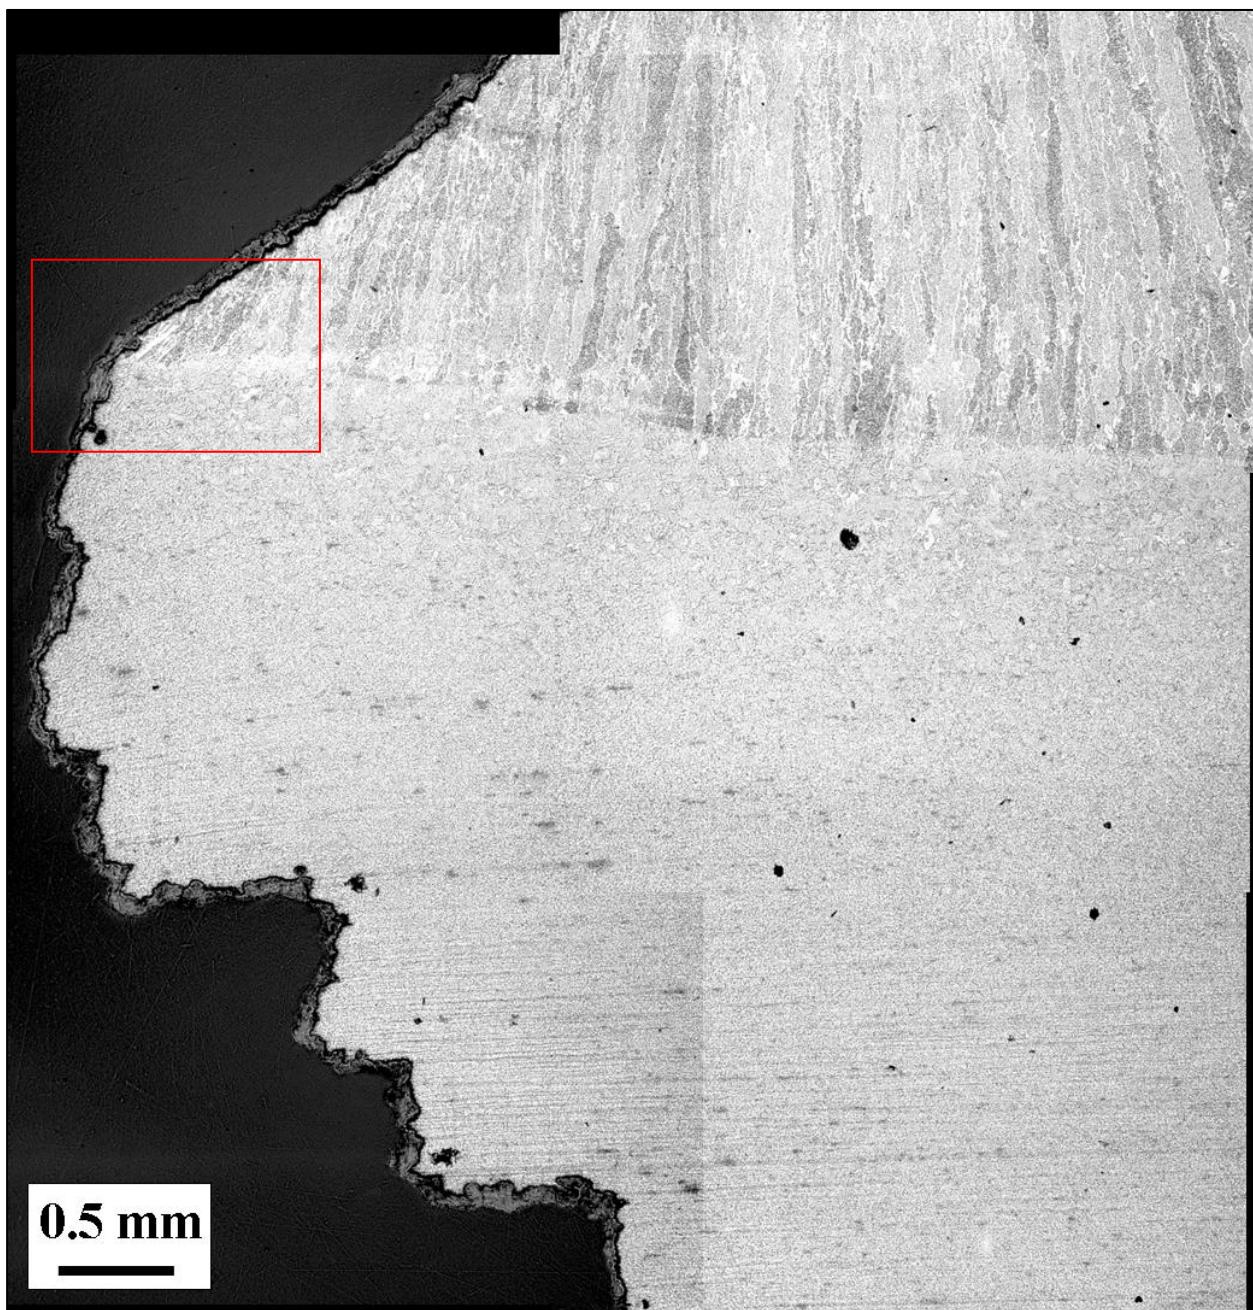
**Figure 3-16. Polished and etched cross-section of fracture near weld between outer web and flange as seen in Fig. 3-14. Sample was from panel M-2 (A130: 96-99, column 129) that was directly hit by the plane. Fracture occurred in web plate; weld was intact. Two percent nital and 4 percent picral etch.**

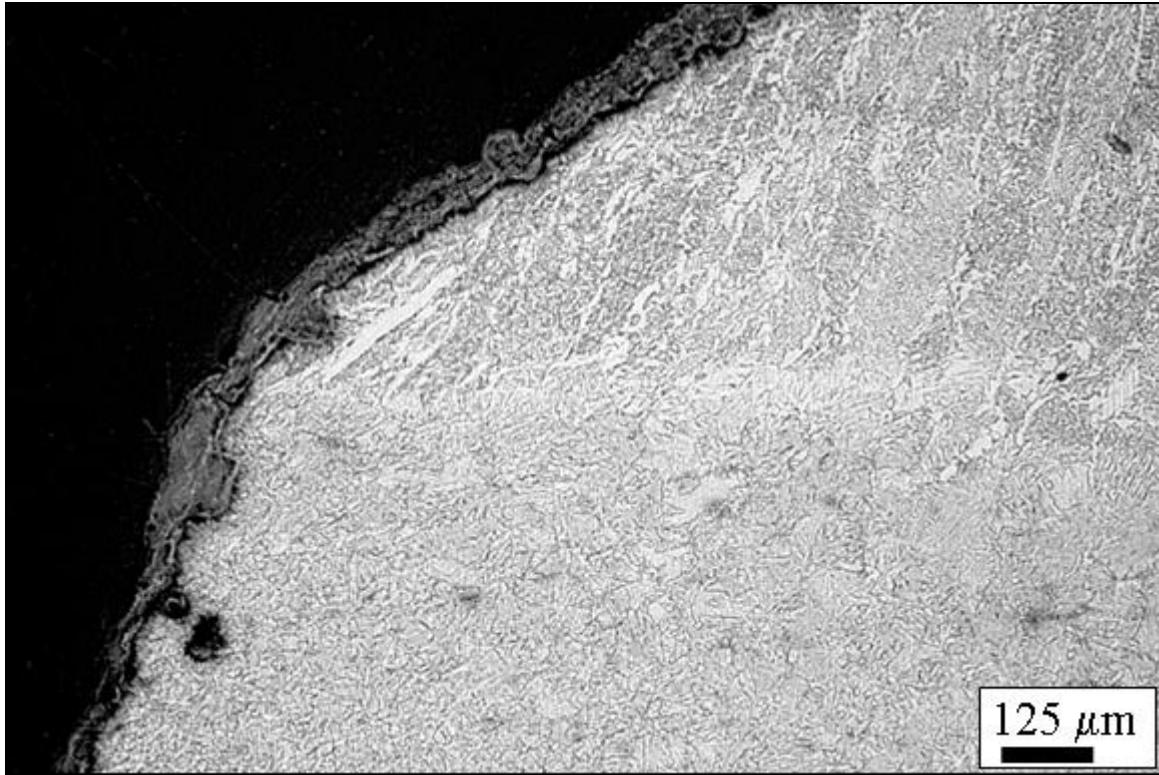
**Figure 3-17. Light optical micrograph a) showing fracture of the outer web plate as a result of airplane impact (seen in Fig. 3-14). Fracture initiated at the toe of the weld and traveled through the HAZ of the plate. Two percent nital and 4 percent picral etch. (panel M-2, A130: 96-99, column 129)**

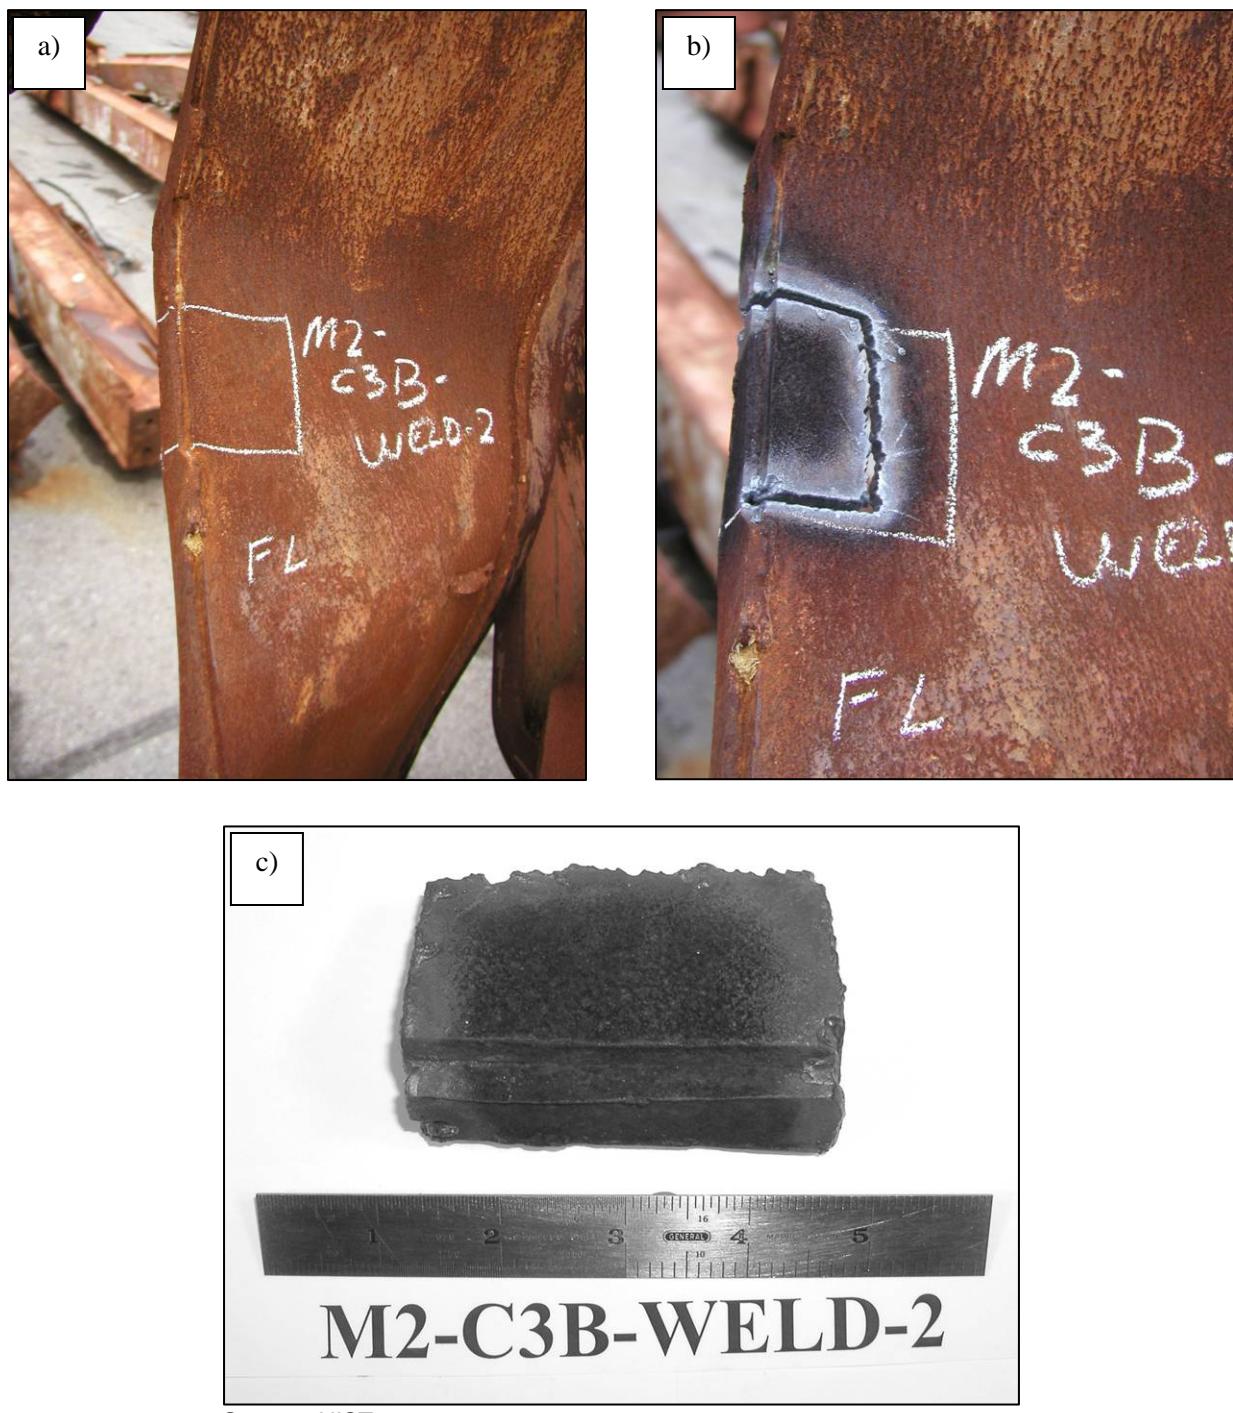
**Figure 3–17. Light optical micrograph b) at higher magnification (red box in [a]) showing initiation of fracture at the toe of the weld and traveling through the HAZ of the plate. Two percent nital and 4 percent picral etch. (A130: 96-99, column 129)**

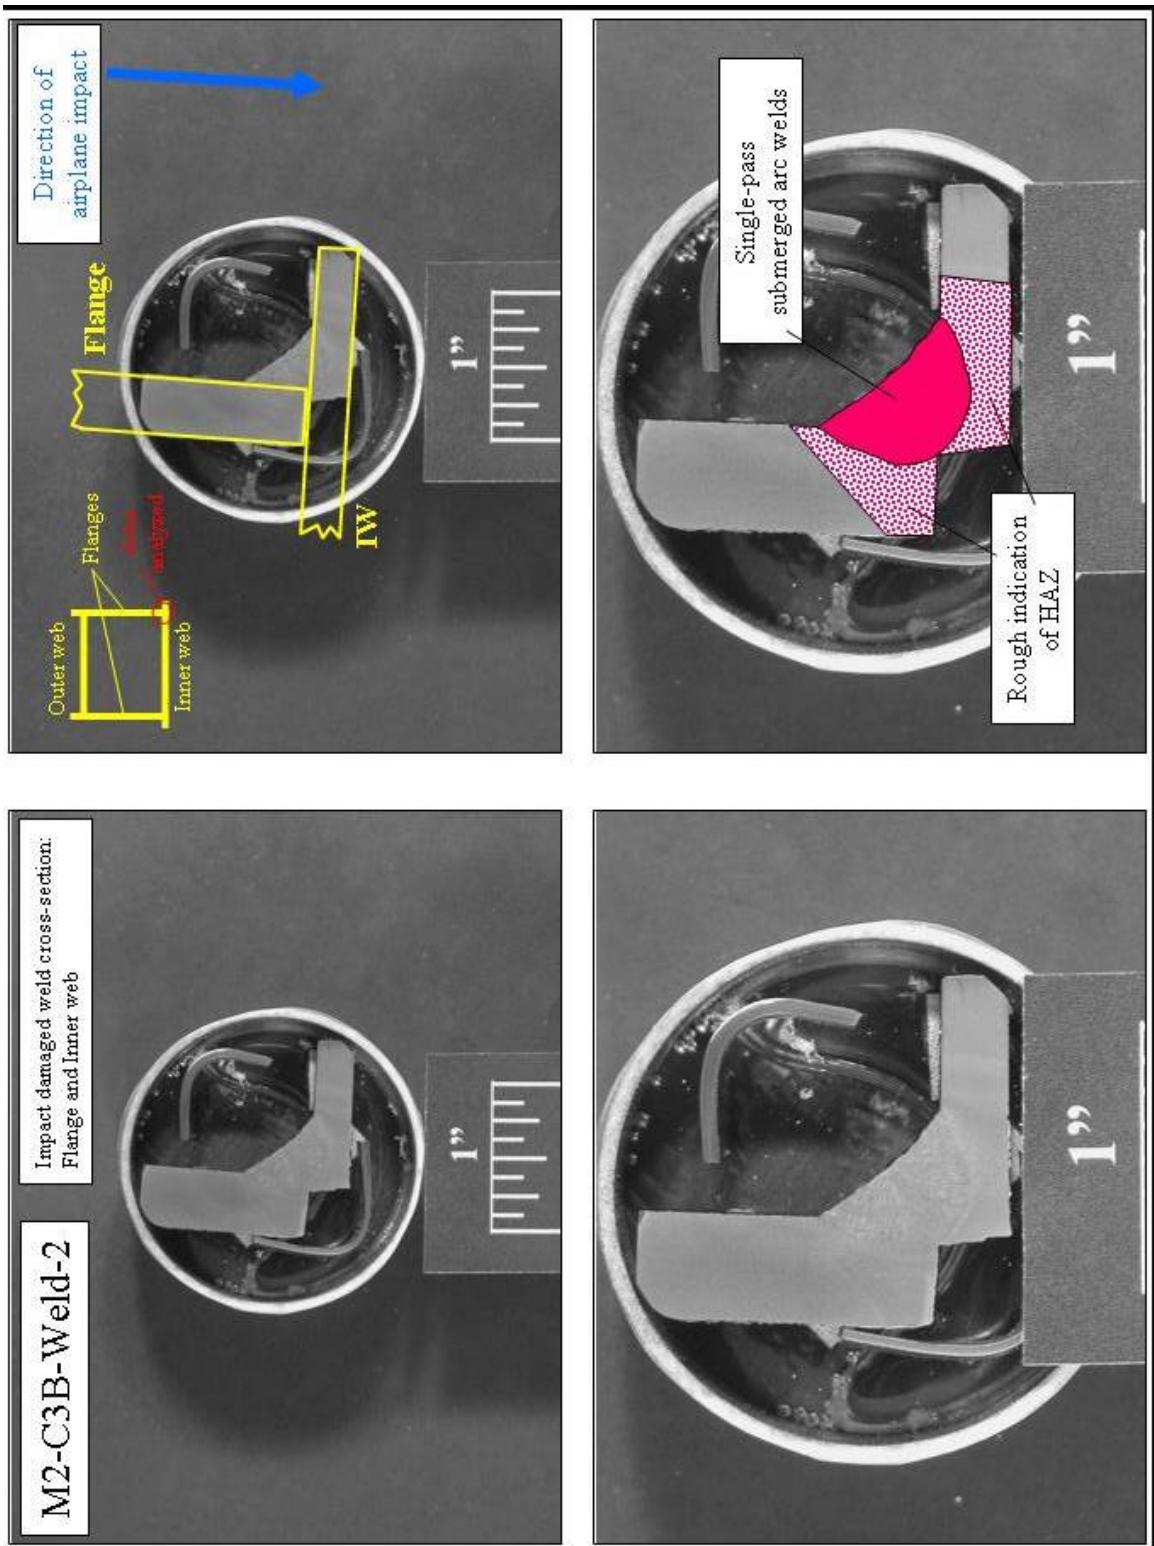
**Figure 3-18. Example of fracture near weld of a perimeter column, sample M2-C3B-Weld-2 (A130: 96-99, column 129), images taken a) prior to sample removal, b) after flame cutting, and c) in the laboratory. Fracture was a result of airplane impact.**

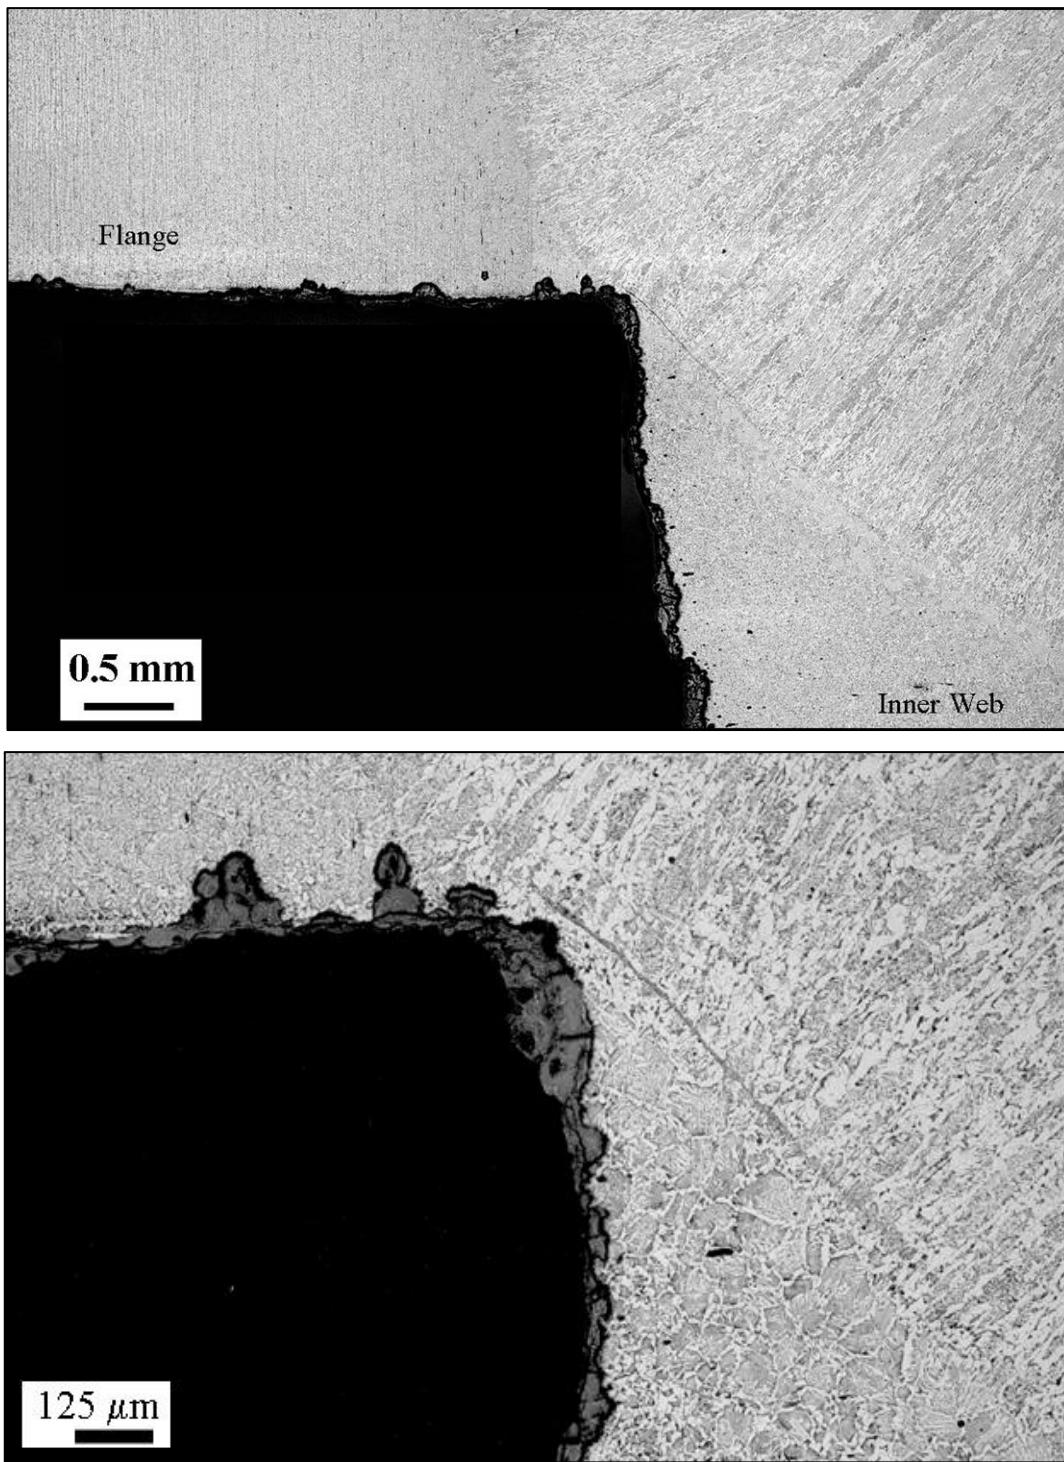
Figure 3-19. Polished and etched cross-section of fracture near weld between inner web and flange as seen in Fig. 3-18. Sample was from panel M-2 (A130: 96-99, column 129) that was directly hit by the plane. Fracture occurred in inner web plate; weld was intact. Two percent nital and 4 percent picral etch.

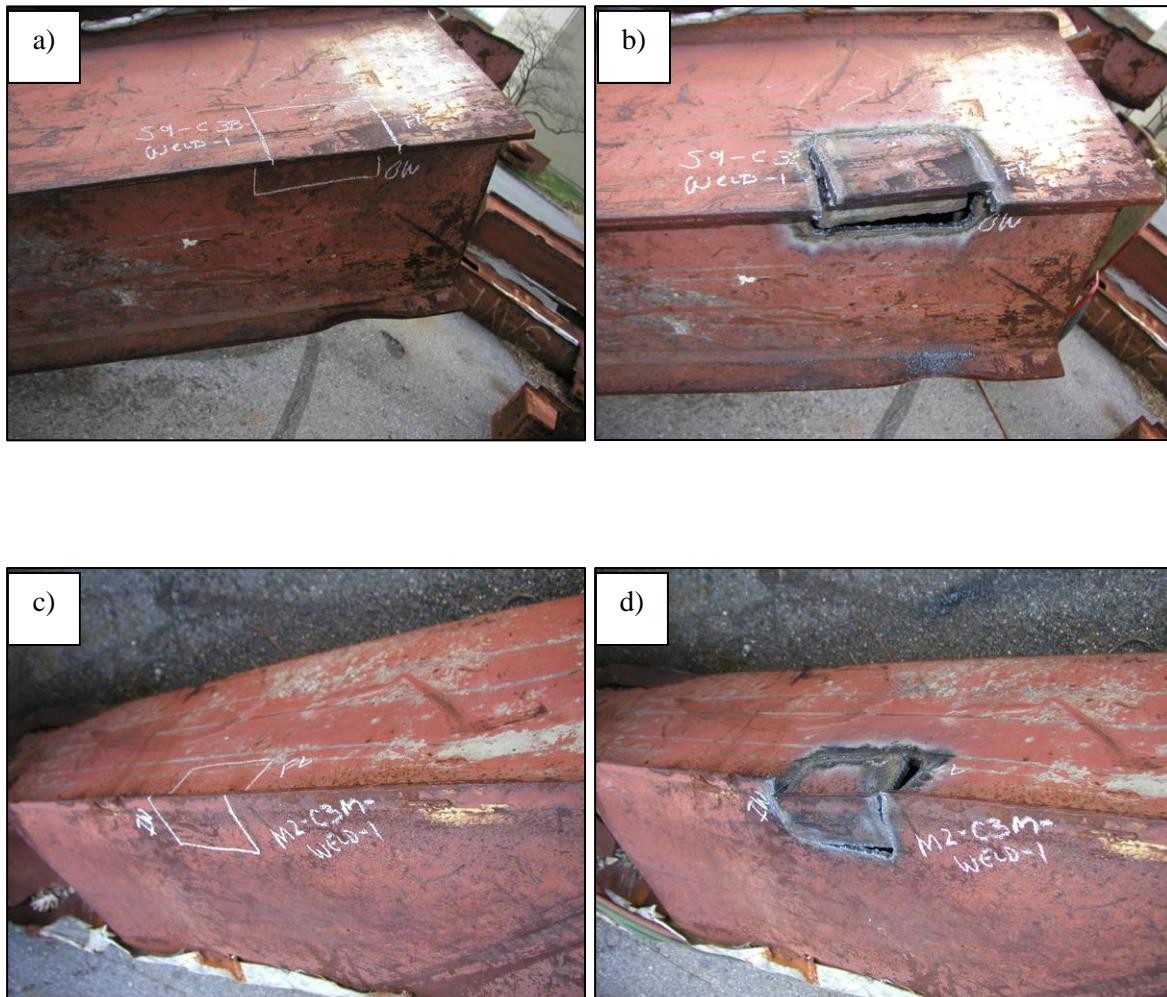
**Figure 3–20.** Light optical micrograph showing fracture of the inner web (from Fig. 3–18) initiating near the fusion line in the HAZ of the plate. Two percent nital and 4 percent picral etch. (A130: 96-99, column 129).

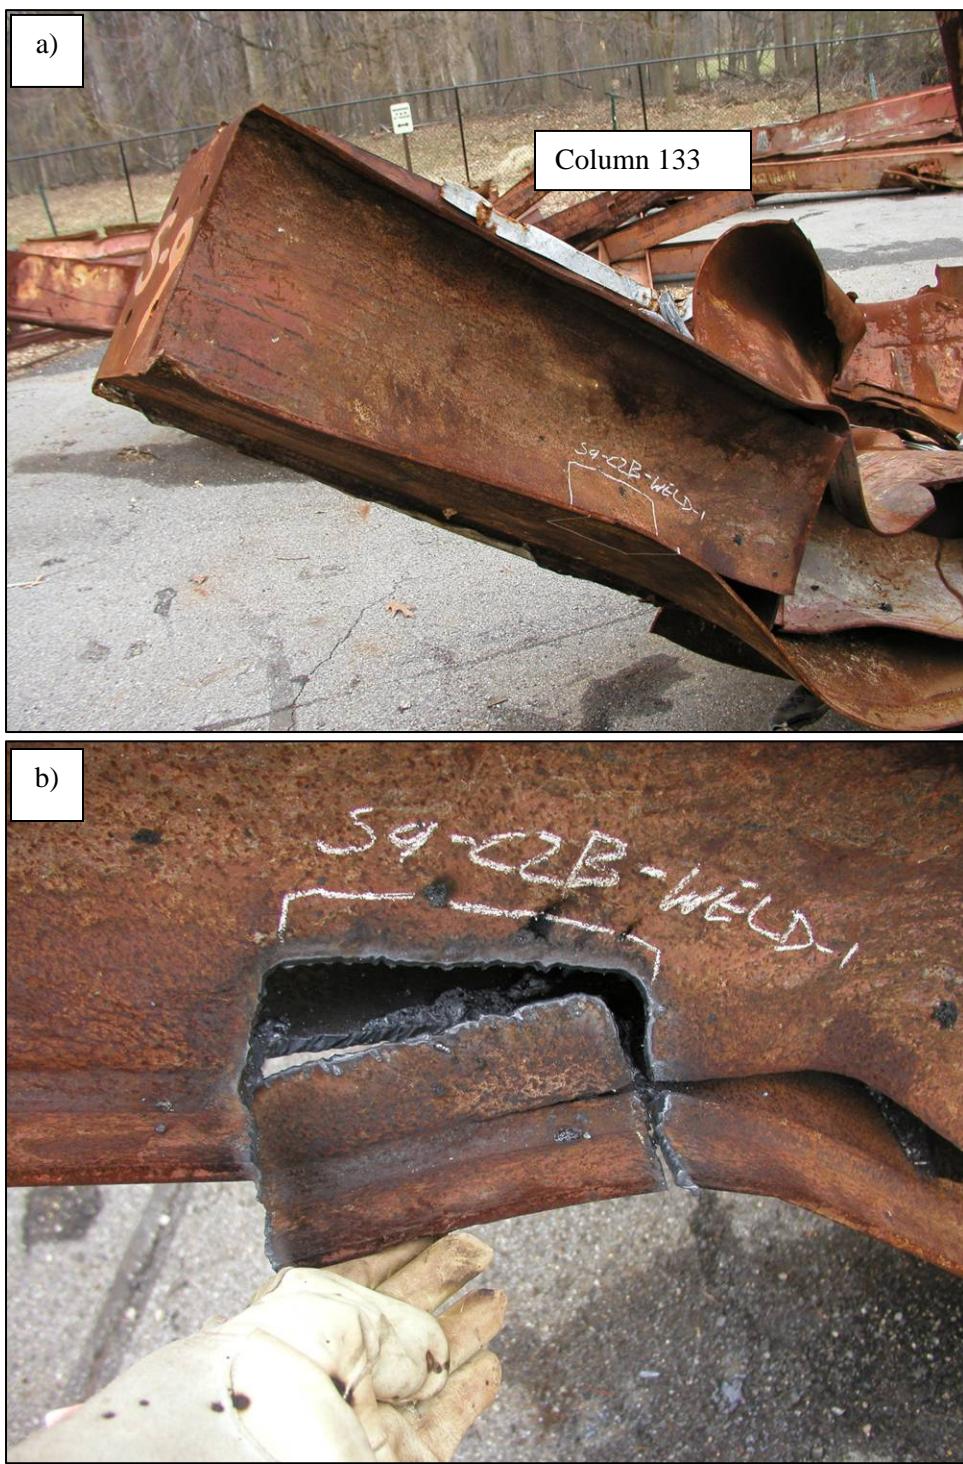
Figure 3-23. Polished and etched cross-section of intact weld between inner web and flange (same as shown in Fig. 3-21c and 3-21d). The sample was removed from an undamaged portion of column of panel M-2 (A130: 96-99, column 129) that was directly hit by the plane. Note the geometry of the HAZ in the inner web base plate. Two percent nital and 4 percent picral etch.

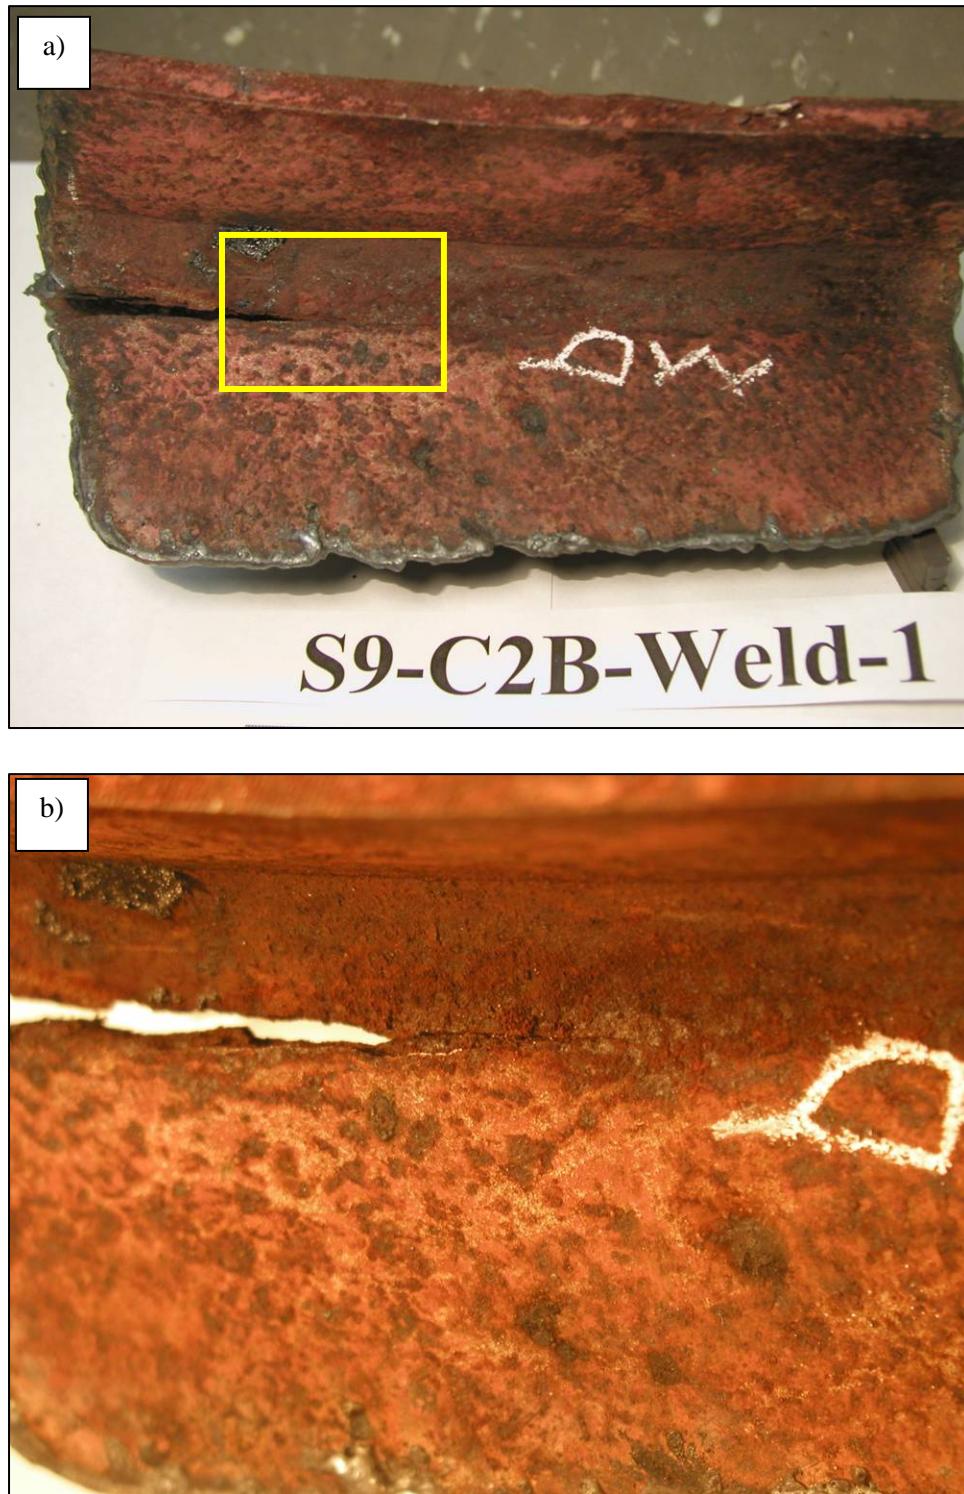
**Figure 3-24. Weld fracture sample S9-C2B-Weld-1 (A133: 97-100, column 133), images taken a) prior to sample removal and b) after flame cutting. Panel S-9 was struck by the vertical tail assembly of the airplane.**

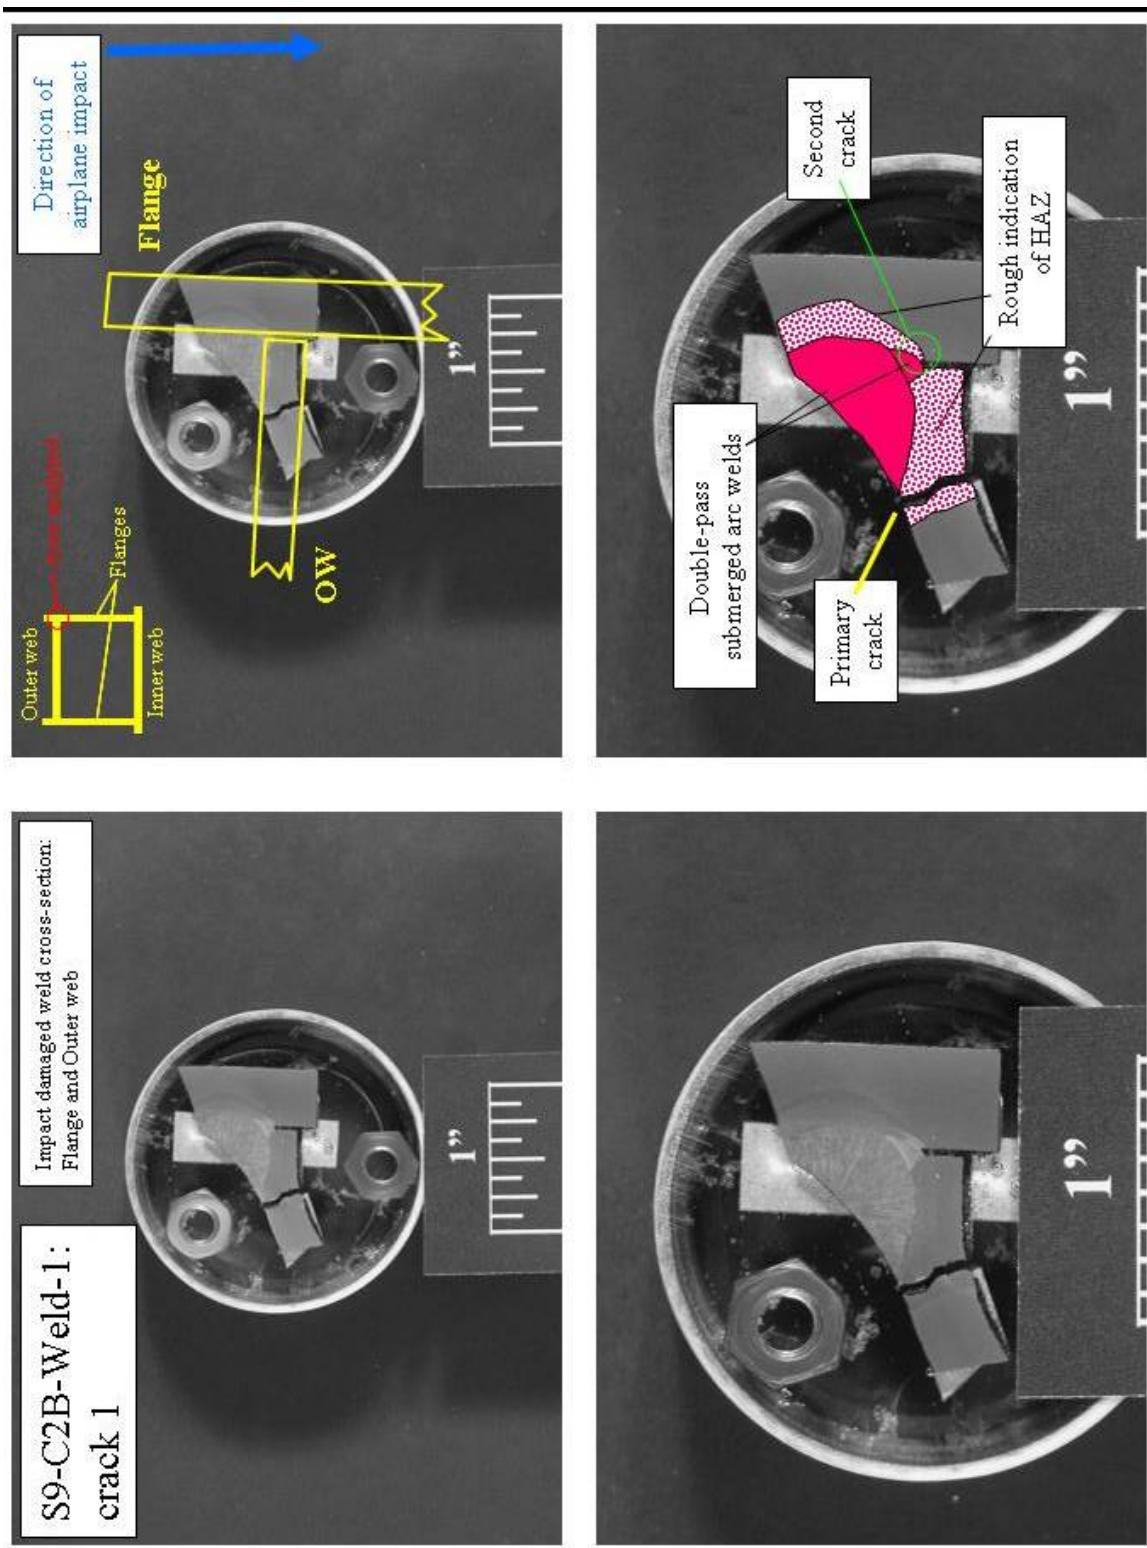
**Figure 3–25. Fracture near a weld on a perimeter panel, sample S9-C2B-Weld-1 (A133: 97-100, column 133), laboratory images a) overall and b) close-up of crack and crack front propagating through the outer web. Fracture may be a result of airplane impact (vertical tail assembly) with removal shown in Fig. 3–24.**

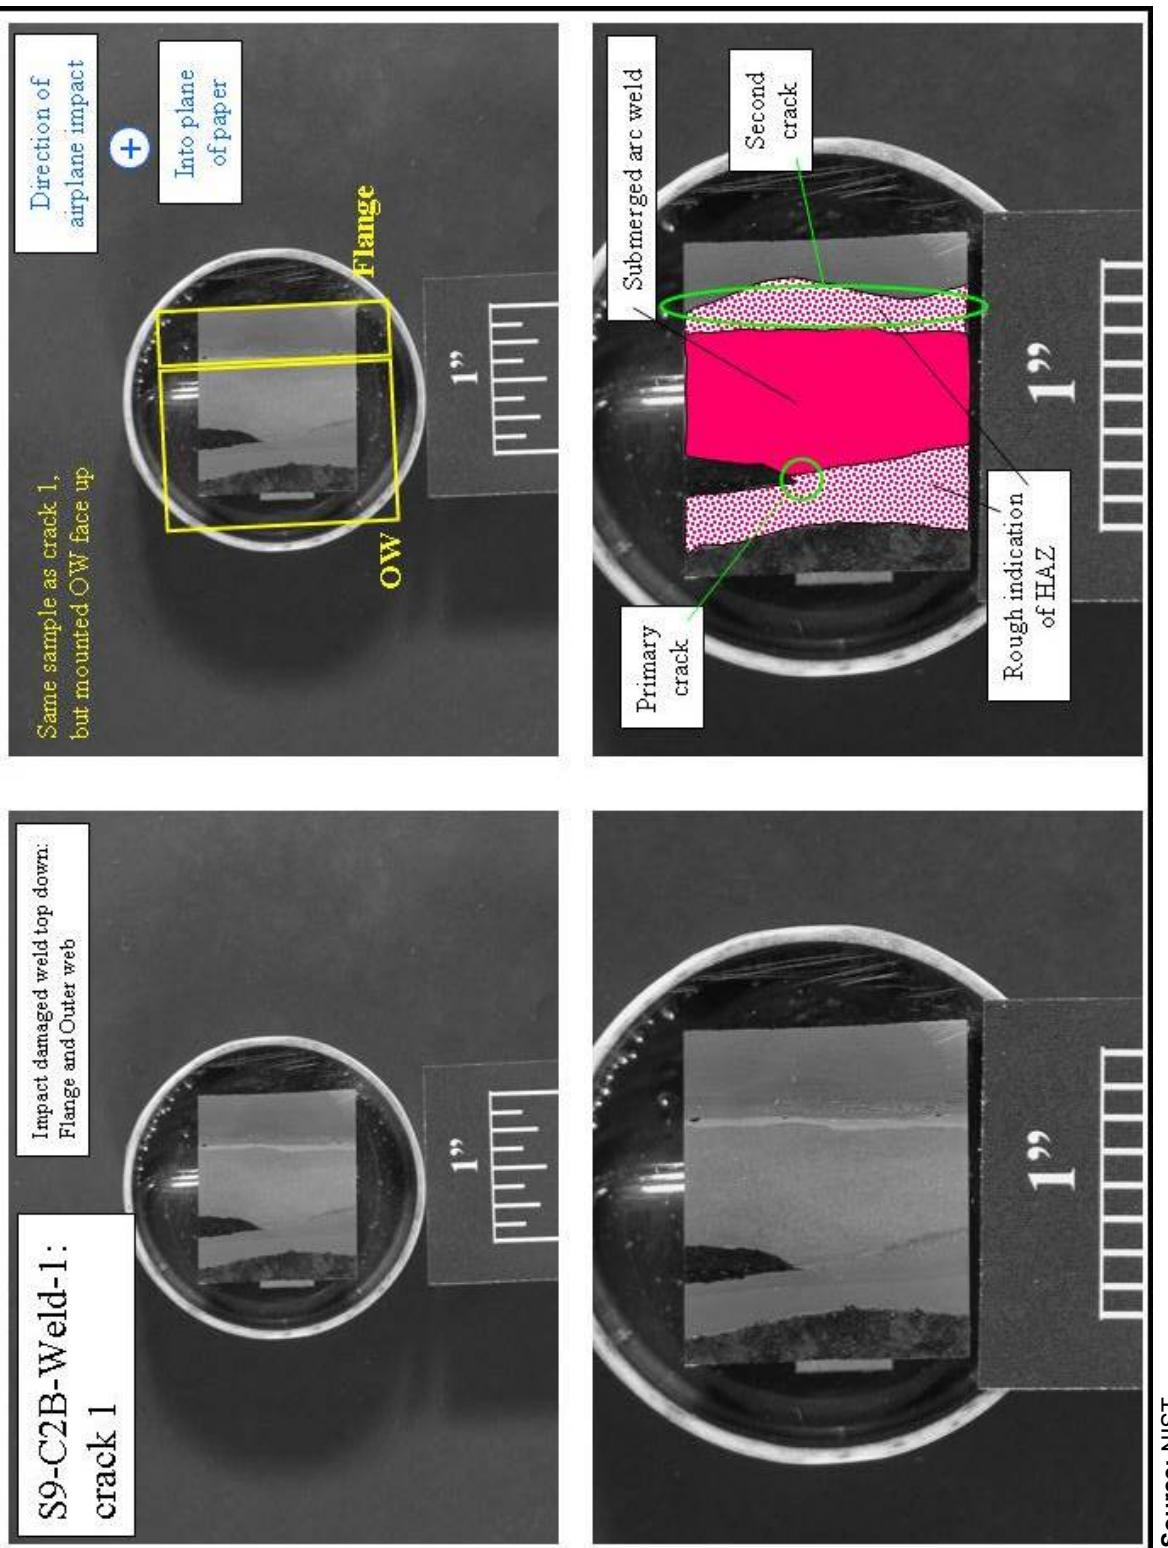
**Figure 3-26. Polished and etched cross-section of fracture near weld between outer web and flange (as seen in Fig. 3-24). Sample was from panel S-9 that was directly hit by the vertical tail assembly of the plane. Yellow arrow indicates viewing direction of “planar” sample seen in Fig. 3-27. Two percent nitric acid and 4 percent picral etch. (A133: 97-100, column 133)**

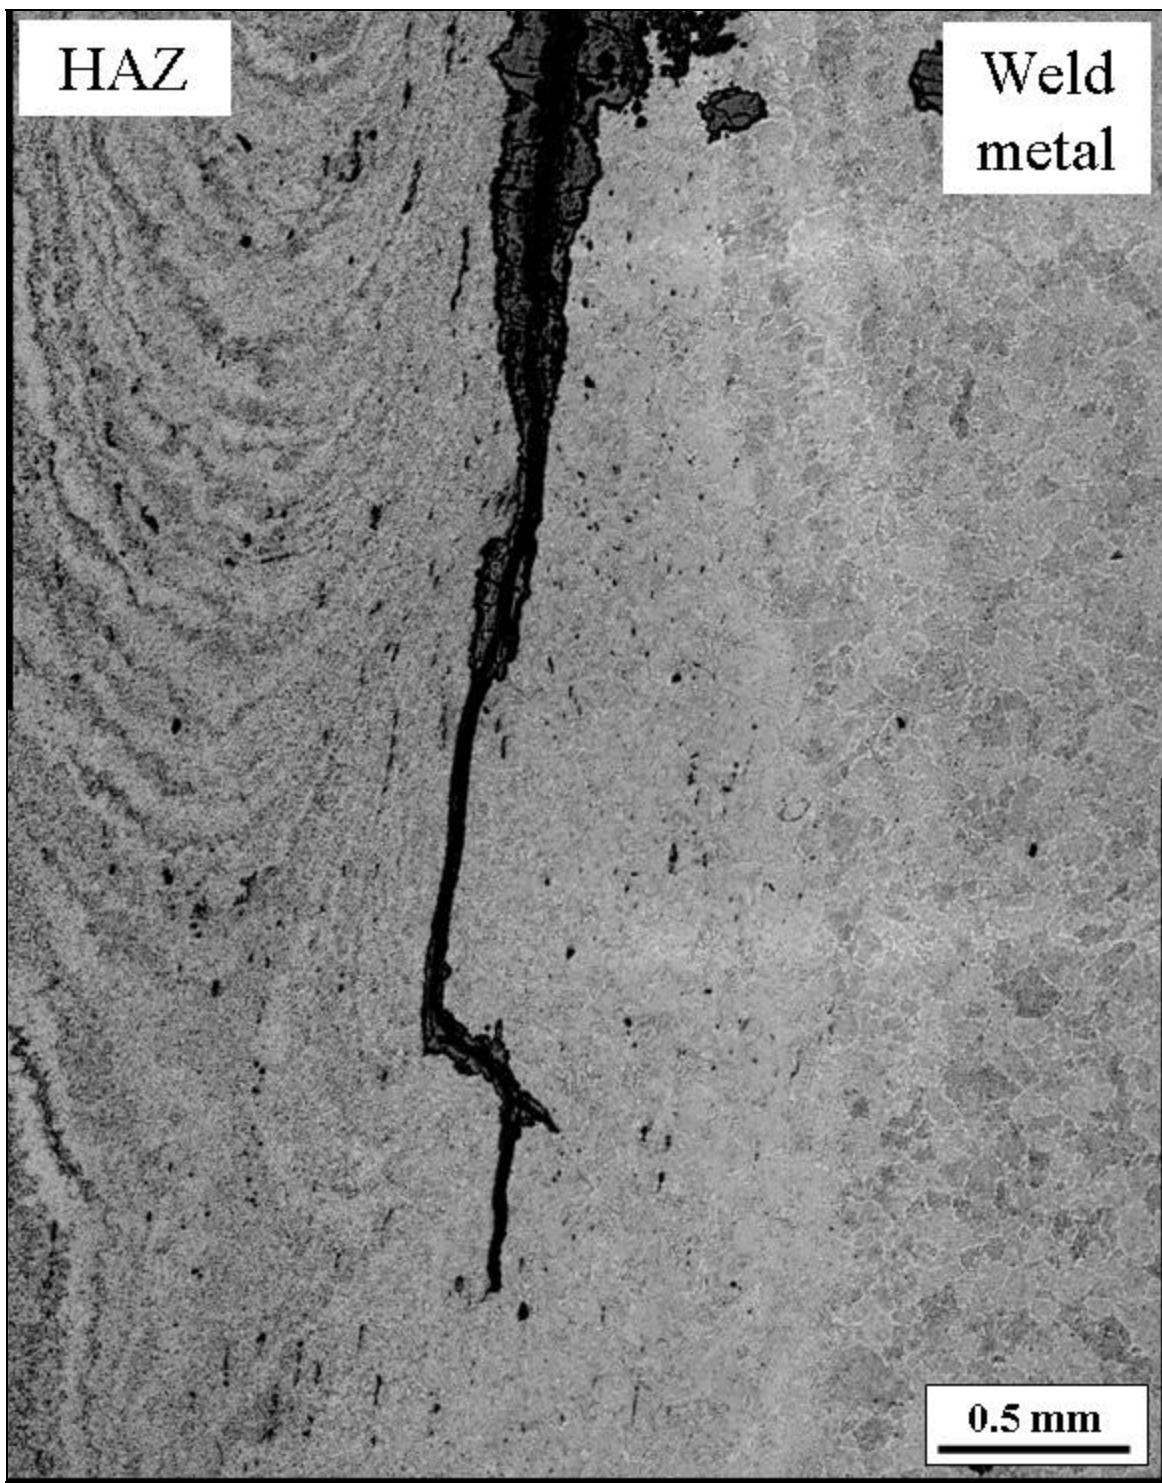
**Figure 3-27. Polished and etched “planar” view of fracture near weld between outer web and flange (as seen in Fig. 3-24). The rolling plane of the outer web is parallel to the plane of the paper. Sample was from panel S-9 that was directly hit by the vertical tail assembly of the plane. Two percent nital and 4 percent picral etch. (A133: 97-100, column 133)**

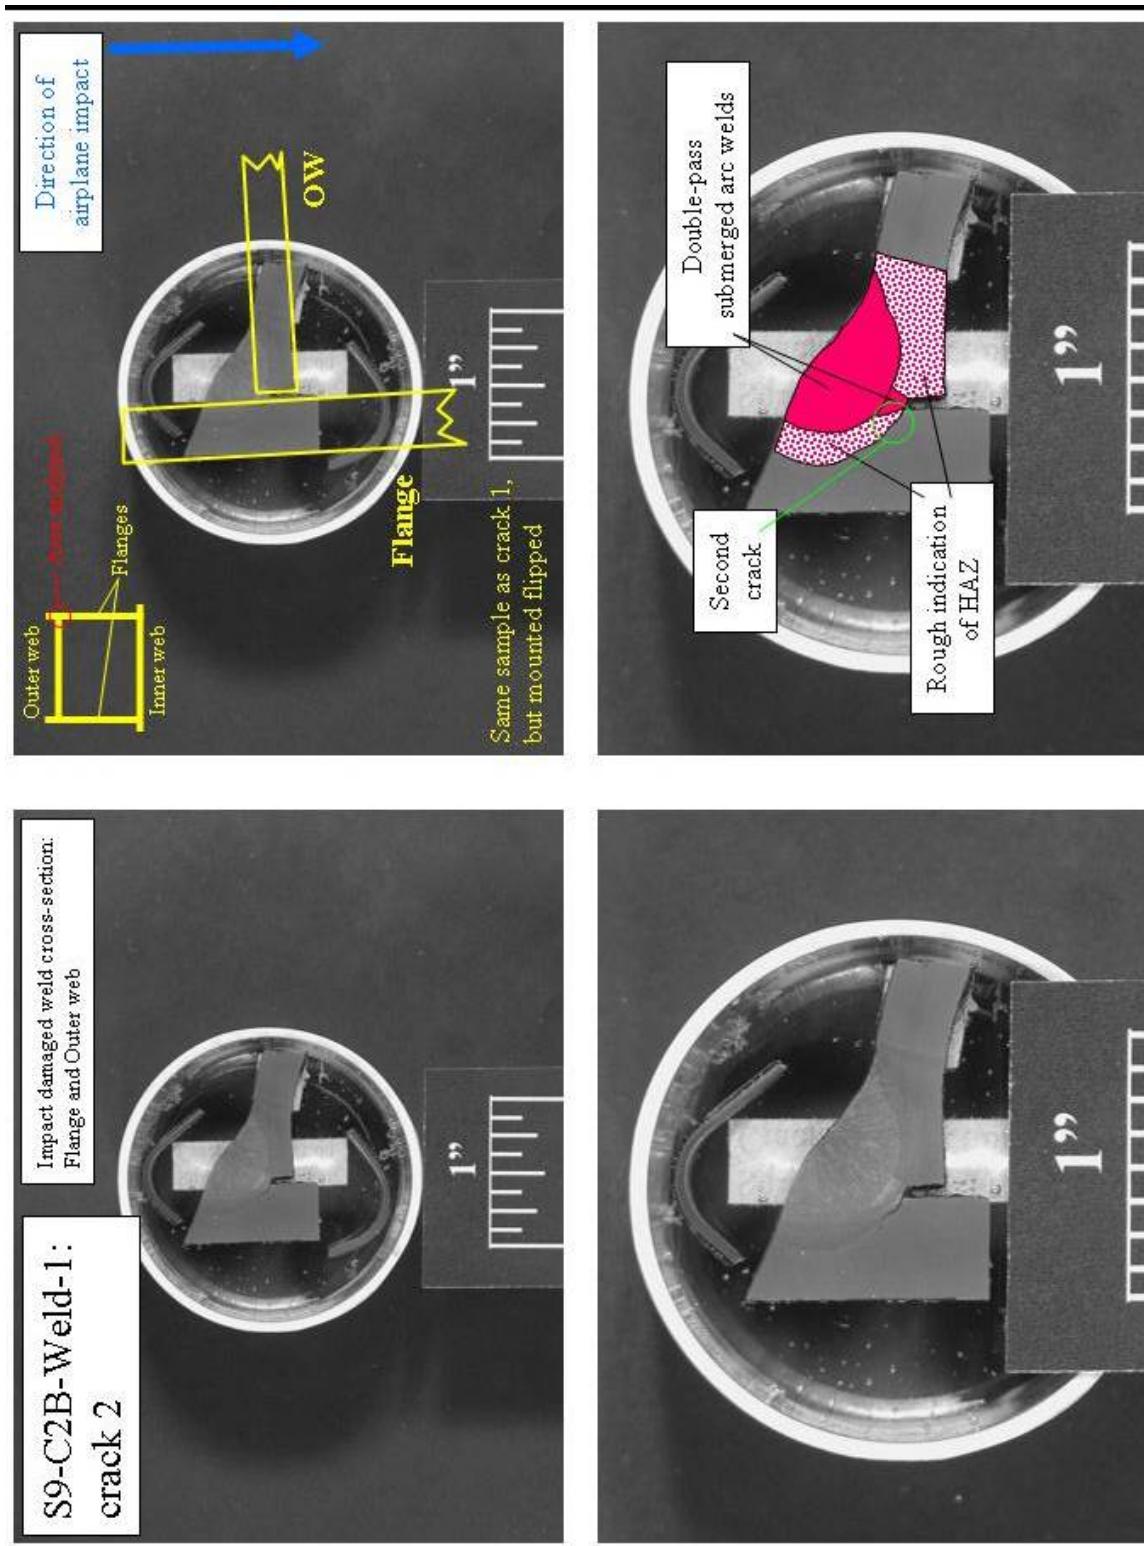
**Figure 3–28. Light optical micrograph showing fracture of the outer web (from Fig. 3–27) occurring solely in the HAZ of the plate along the fusion line of the weld. Fracture may have been a result of airplane impact. Two percent nital and 4 percent picral etch. (panel S-9, A133: 97-100, column 133)**
