**Federal Building and Fire Safety Investigation of the  
World Trade Center Disaster**

**Damage and Failure Modes of  
Structural Steel Components**

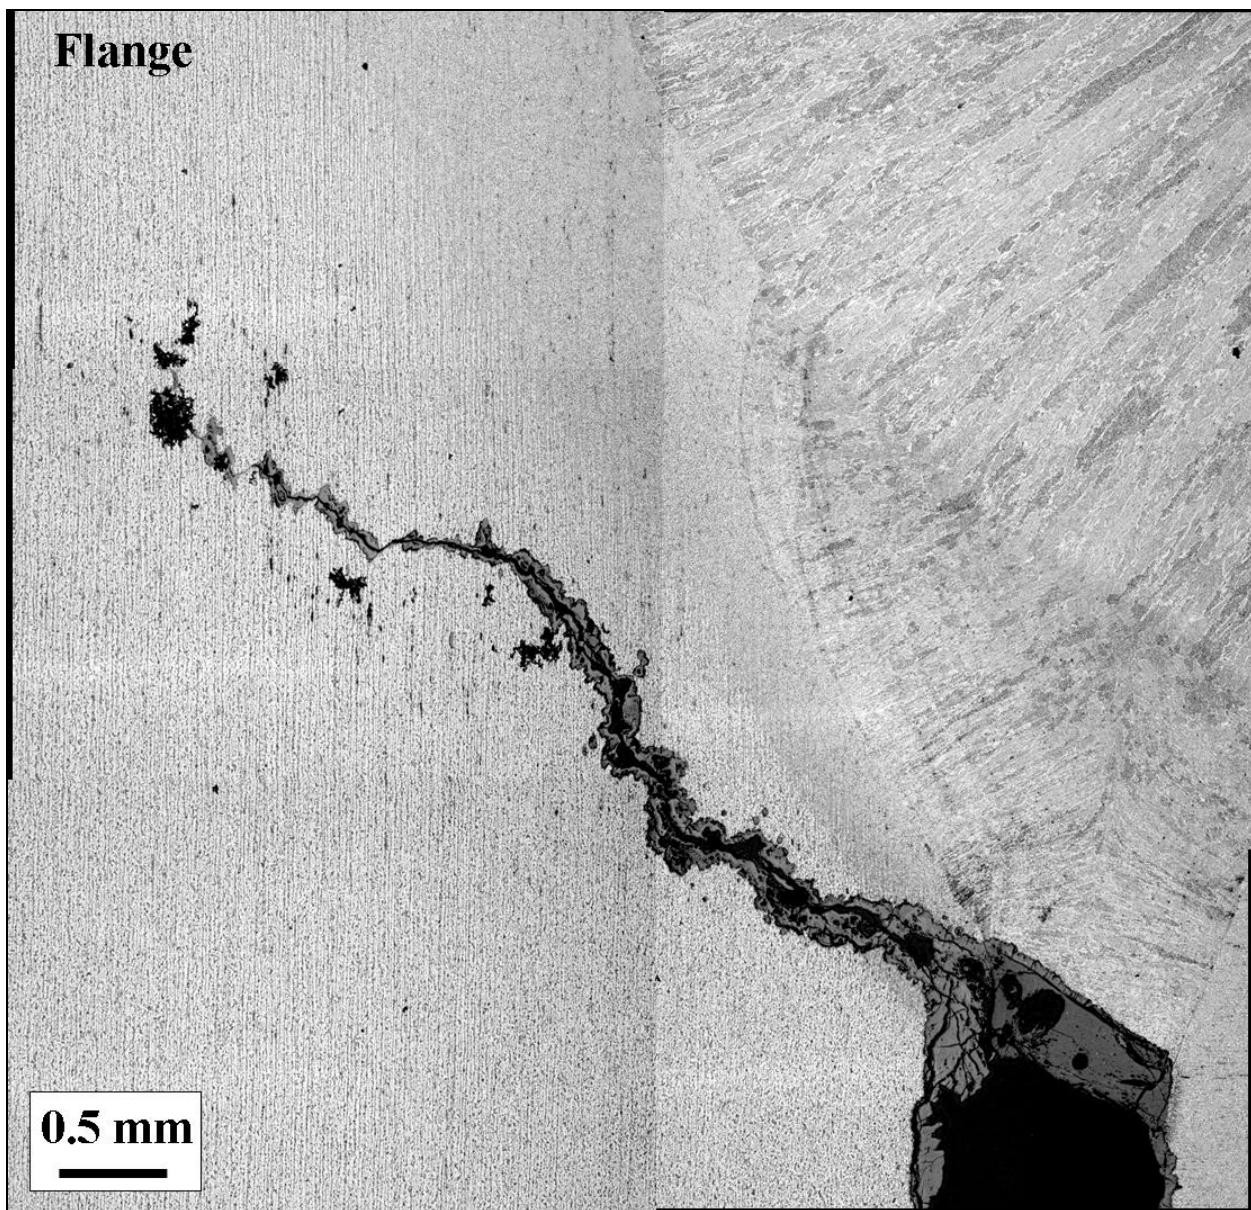
**Figure 3-29. Polished and etched cross-section of fracture near weld between outer web and flange. Sample was the same as Fig. 3-25, but from well ahead of the original crack tip and mounted 180 degrees reversed so that viewed from the opposite direction as Fig. 3-26. Note that the crack started in the HAZ of the weld, but traveled into the flange plate. Two percent nital and 4 percent picral etch. (A133: 97-100, column 133)**

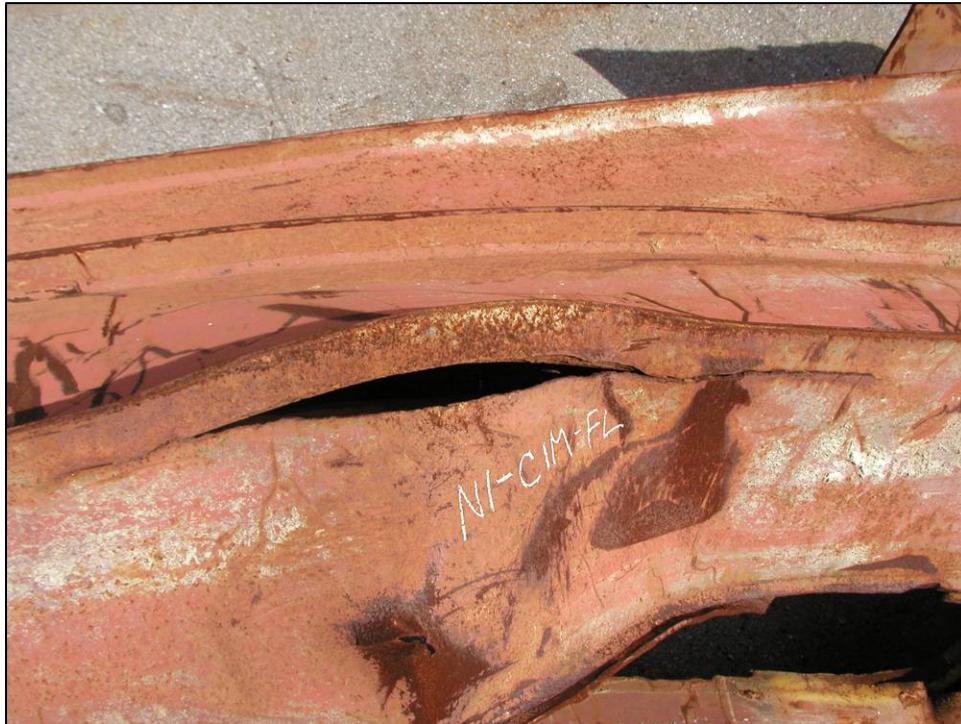
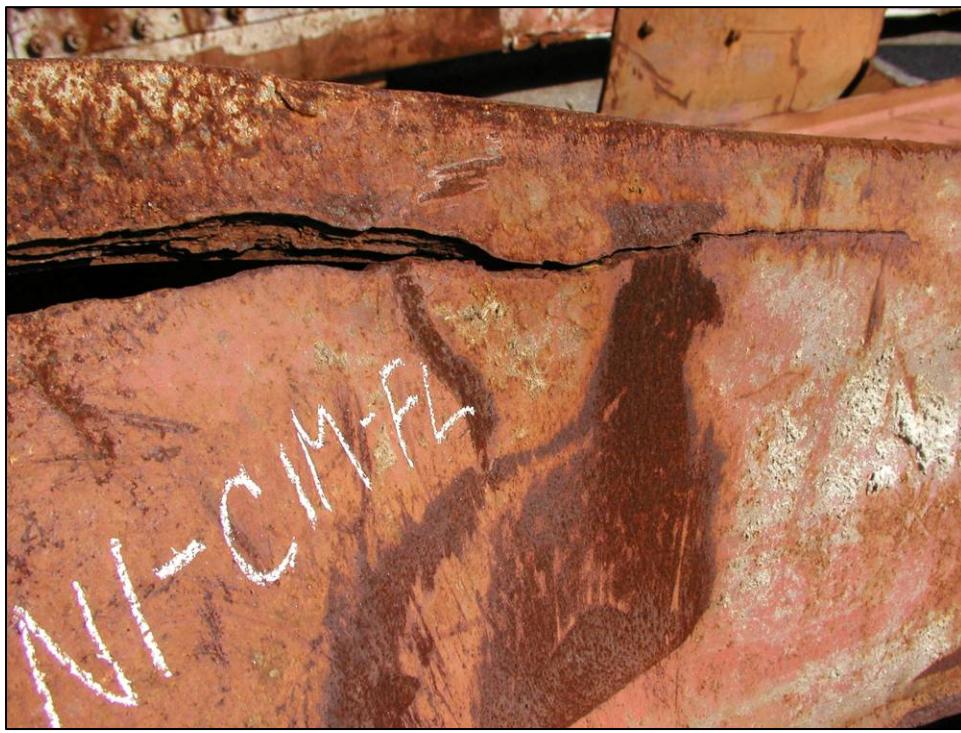
**Figure 3–30.** Light optical micrograph showing fracture of the flange plate (as seen in Fig. 3–29) initiating in the HAZ of the first submerged arc weld and then propagating into the unaffected base material. Two percent nital and 4 percent picral etch. (A133: 97-100, column 133)

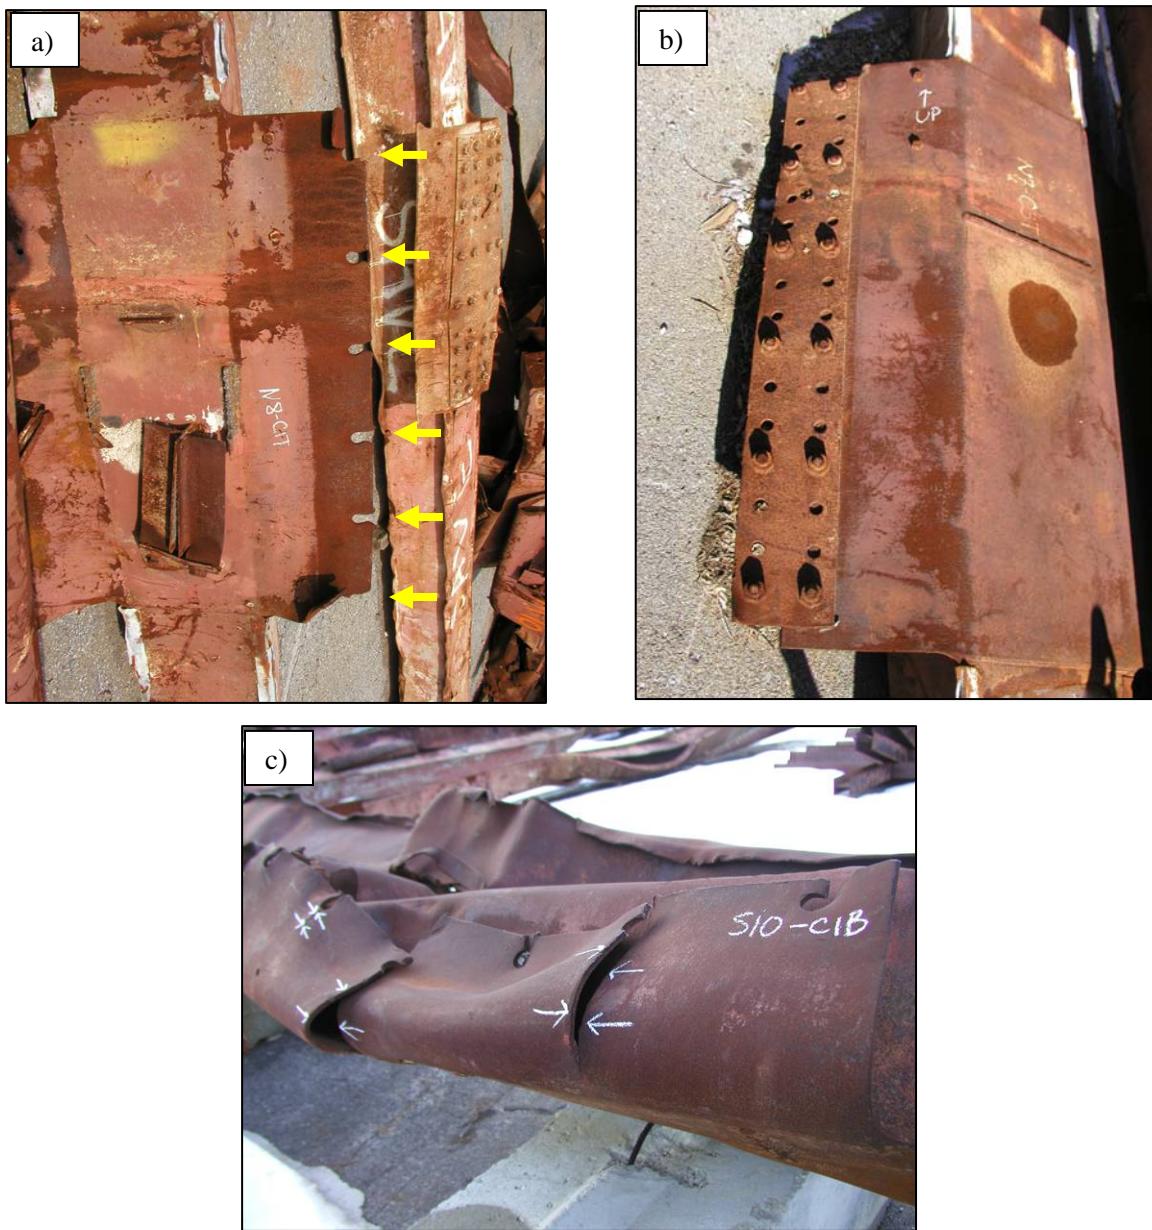
**Figure 3–31. Most-likely scenario for fracture associated with weld if second crack of sample S9-C2B-Weld-1 had continued to propagate through the flange plate. Sample shown is from N-1 (A218: 82-85). Damage most likely occurred during the collapse of WTC 1.**

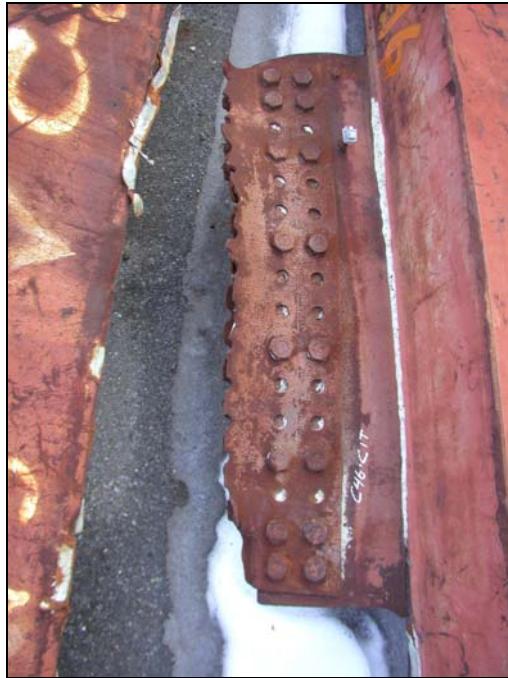
**Figure 3-32. Photographic examples of Type 1 failure mode for spandrel connections.**  
 a) Type 1a, the observed spandrel connection possessed the tear outs (arrows) from N-8 (A142: 97-100), b) Type 1b, the splice plate and all bolts of the observed spandrel connection remained, thus, tear out occurred in the neighboring spandrel plate to which it was attached from N-7 (A127: 97-100), and c) Type 1c, the observed spandrel connection possessed the tear out, with the additional fracture of the spandrel plate in a horizontal manner from S-10 (A224: 92-95). All orientations are from the inside of the buildings looking out. Damage of this type may be due to any one of the extreme loading events.

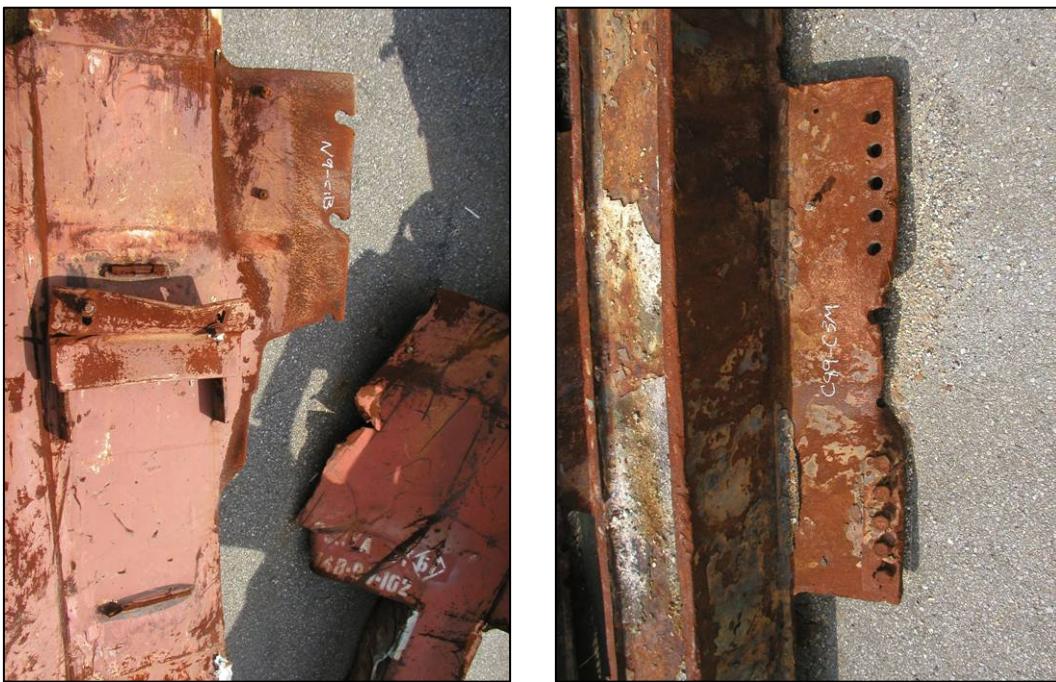
**Figure 3–33. Photographic example of Type 2 failure mode for spandrel connections, bolt tear out in splice plate from C-46 (B157: 68-71). Orientation was from the outside of the building looking in. Damage of this type may be due to any one of the extreme loading events.**

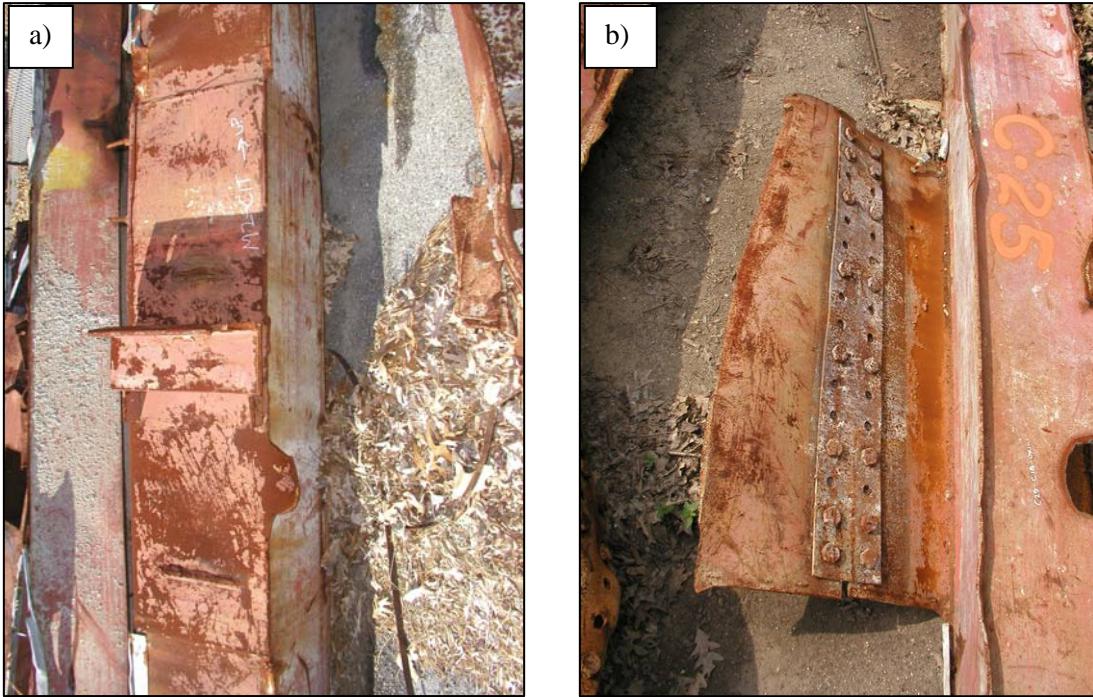
**Figure 3–34. Photographic examples of Type 3 failure mode for spandrel connections, mixed mode. Left image orientation was from the inside of the buildings looking out from N-9 (A154: 101-104), right image orientation was from the outside of the building looking in from C-89 (B215: 12-15). Damage of this type may be due to any one of the extreme loading events.**

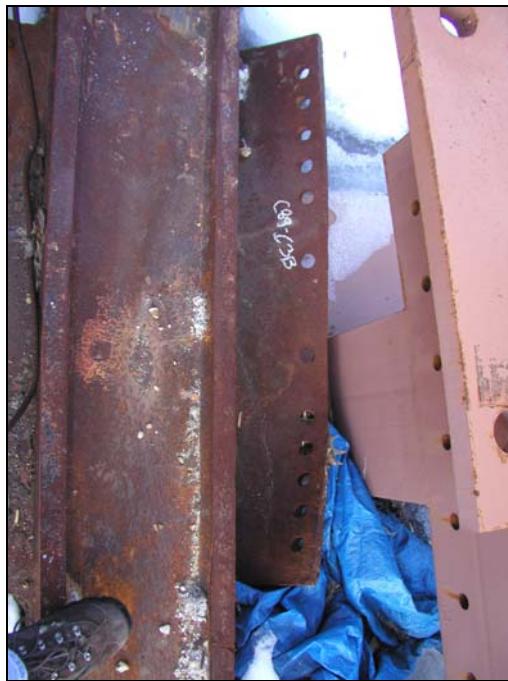
**Figure 3–35. Photographic examples of Type 4 failure mode for spandrel connections. a) Type 4a, vertical fracture of observed spandrel plate (observed from inside the building looking out) from M-2 (A130: 96-99) and b) Type 4b, vertical fracture of the neighboring spandrel plate resulting in the observed spandrel connection retaining both the splice plate and portion of spandrel from neighboring panel (observed from outside the building looking in) from C-25 (A206: 89-92). Damage of this type may be due to any one of the extreme loading events.**

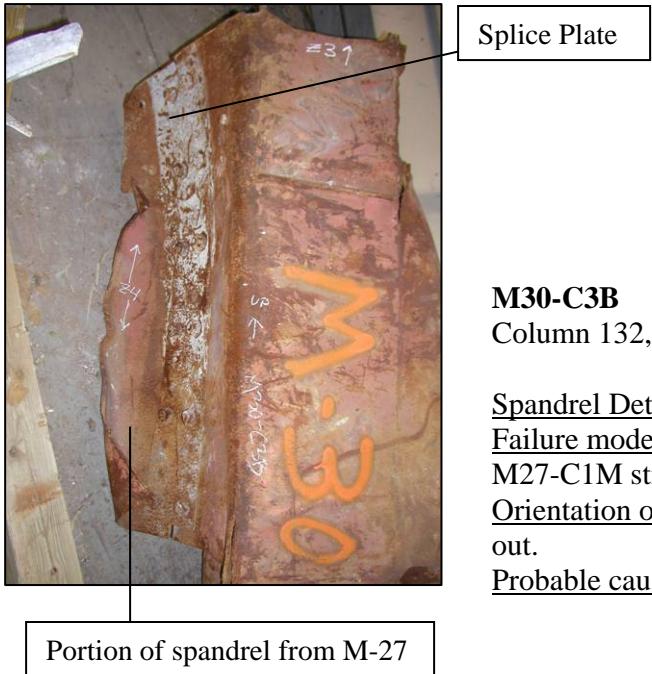
**Figure 3–36. Photographic example of Type 5 failure mode for spandrel connections, bolt failure resulting in intact holes in spandrel or splice plate (observed from outside the building looking in) from C-89 (B215: 12-15). Damage of this type may be due to any one of the extreme loading events.**

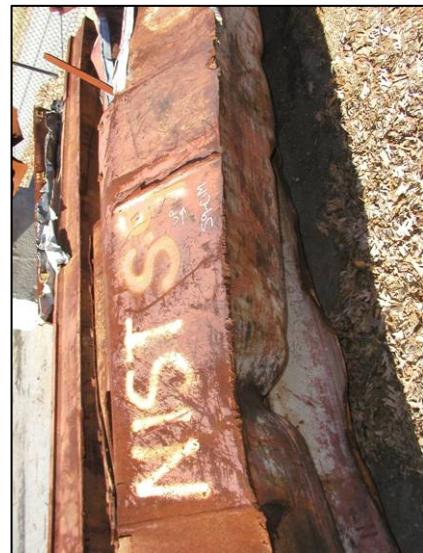
Probable cause of damage: Collapse

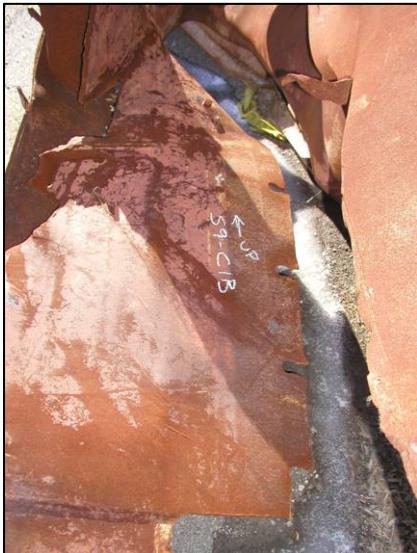
Probable cause of damage: Collapse

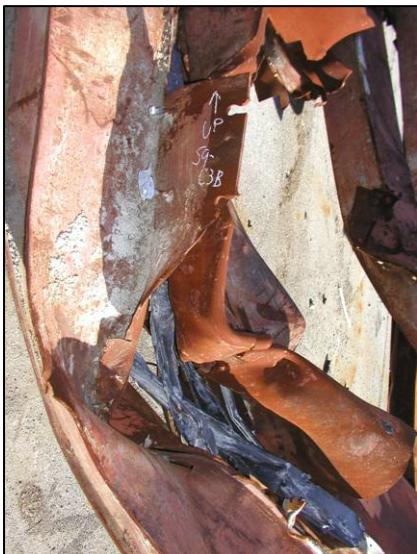
Probable cause of damage: Collapse

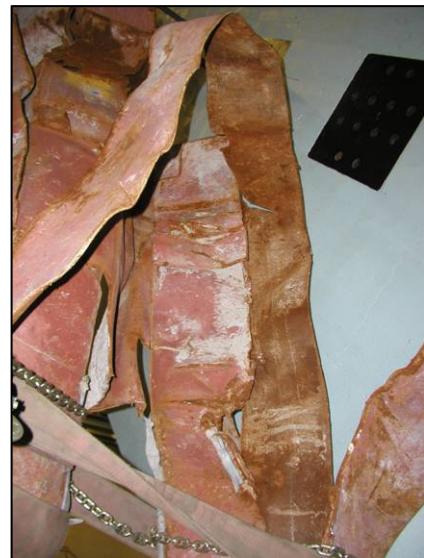
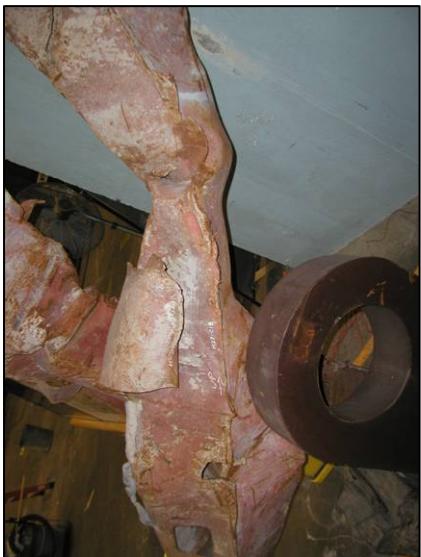
**M27-C1B**  
Column 131, 94th floor

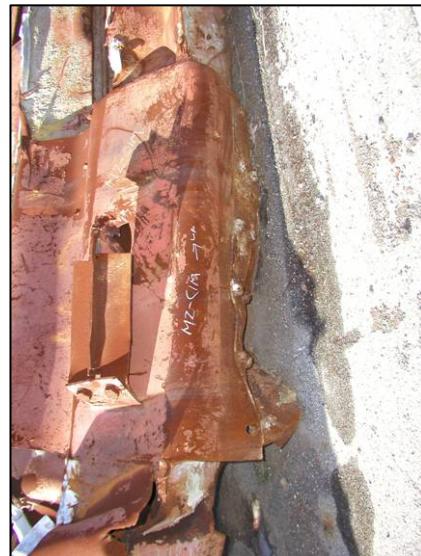
**M2-C1M**  
Column 131, 98th floor

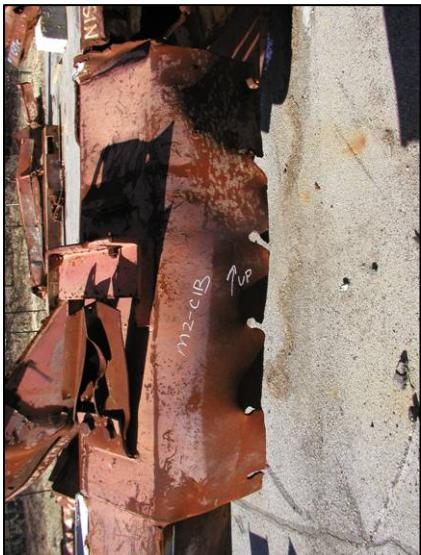
**M2-C1B**  
Column 131, 97th floor

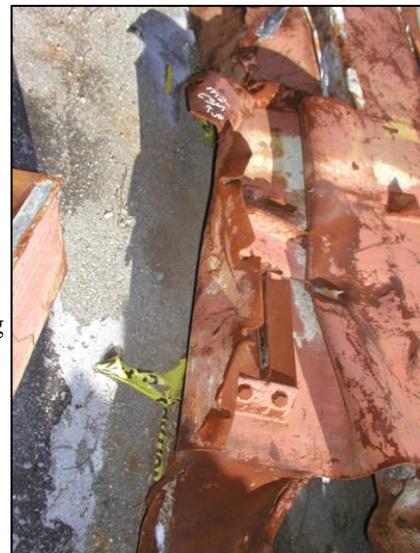
Probable cause of damage: Collapse

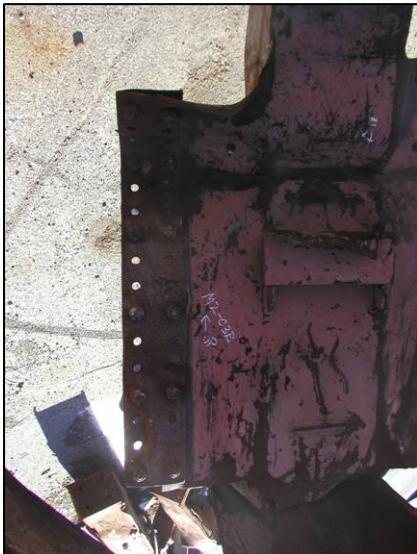
Probable cause of damage: Impact or collapse

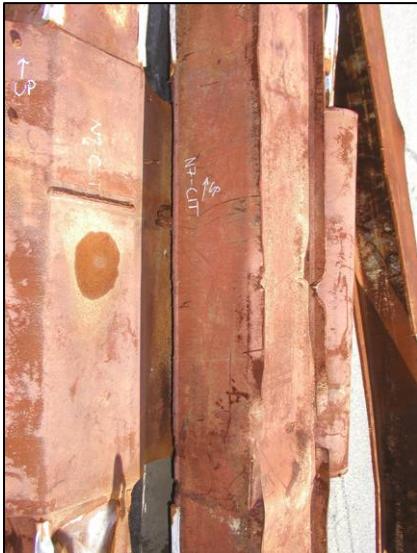
**N7-C1T**  
Column 128, 100th floor

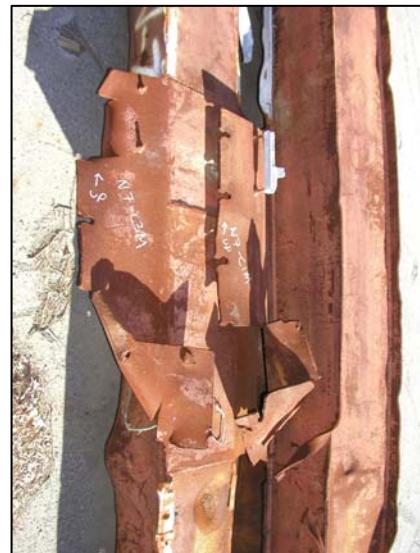
**N7-C1M**  
Column 128, 99th floor

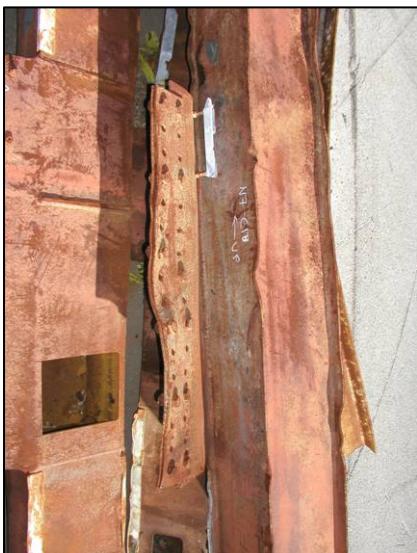
**N7-C1B**  
Column 128, 98th floor

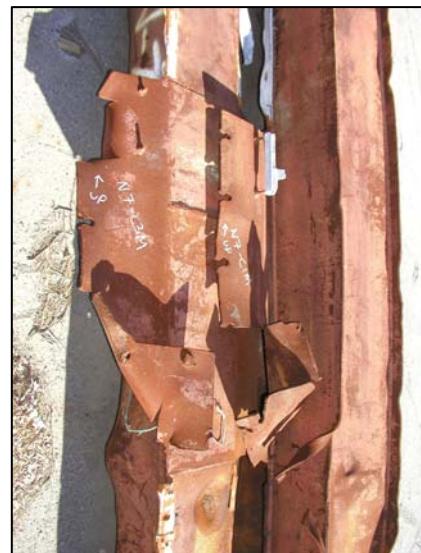
Probable cause of damage: Collapse

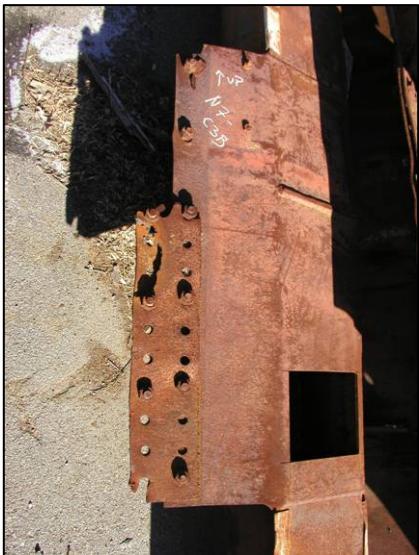
Probable cause of damage: Collapse

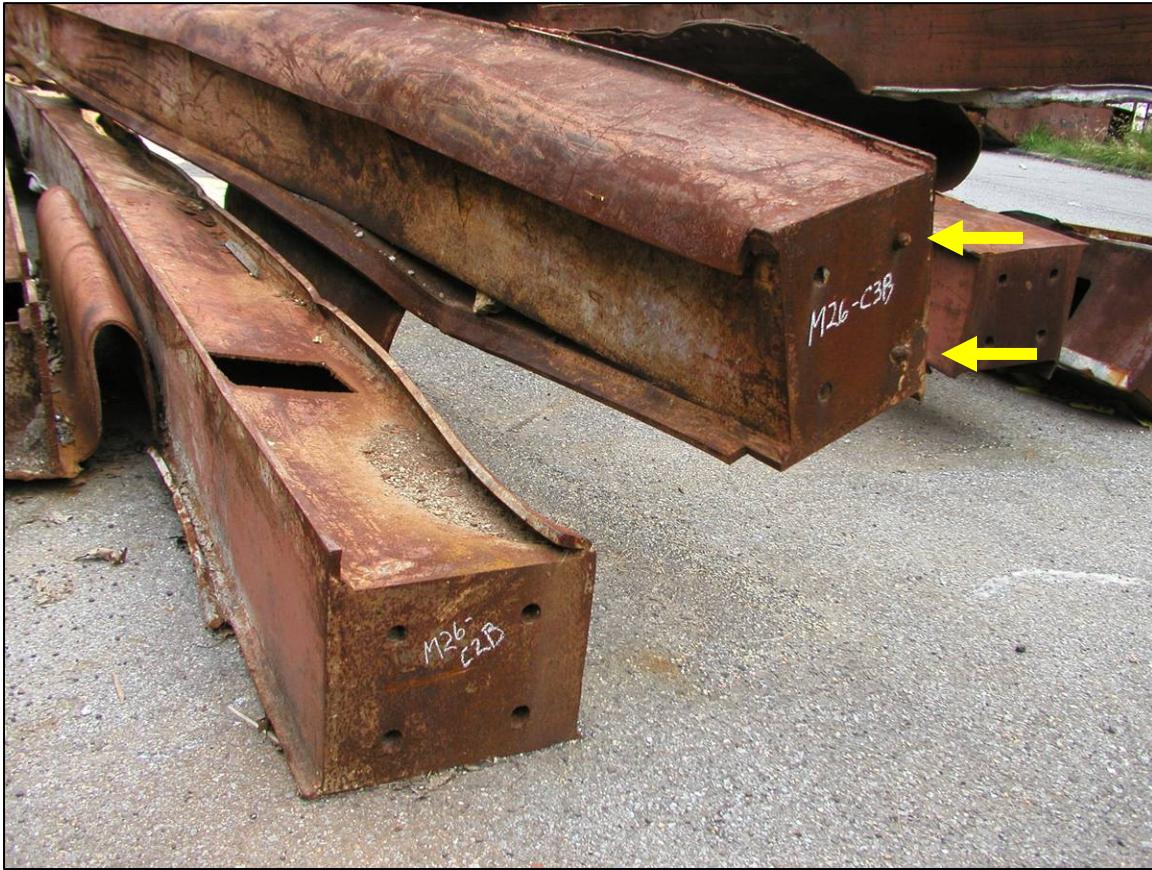
**Figure 3-41. Photographs of recovered spandrel connections from sample N-7 (A127: 97-100) (cont.).**

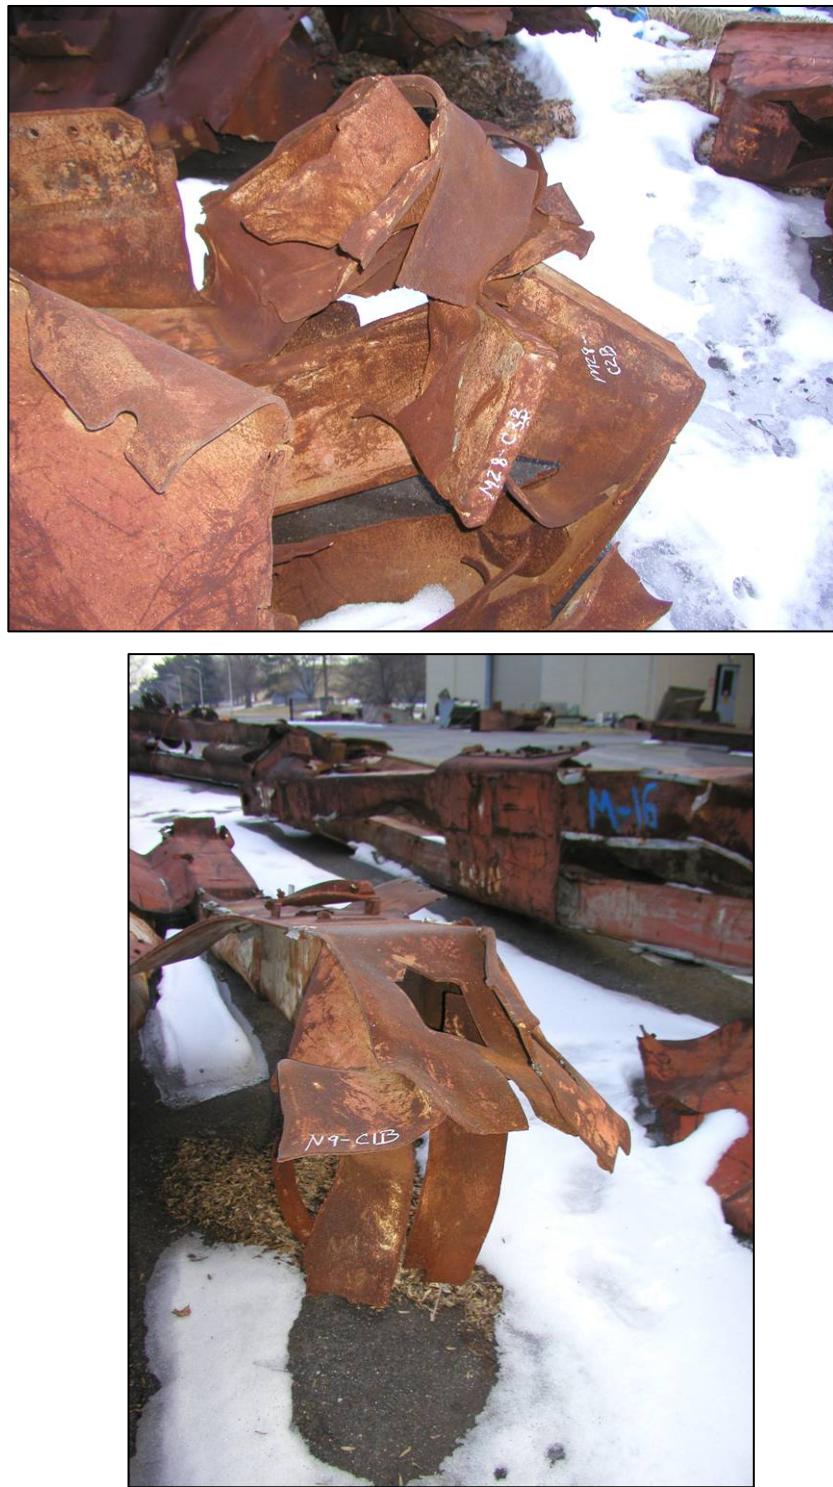
**Figure 3–42. Photographic example of Type 1 failure mode for end plate connections, bolt failure. Column on right (M26-C3B) has two failed bolts remaining (arrows). Sample shown is M-26 (A130: 90-93). Damage of this type may be due to any one of the extreme loading events.**

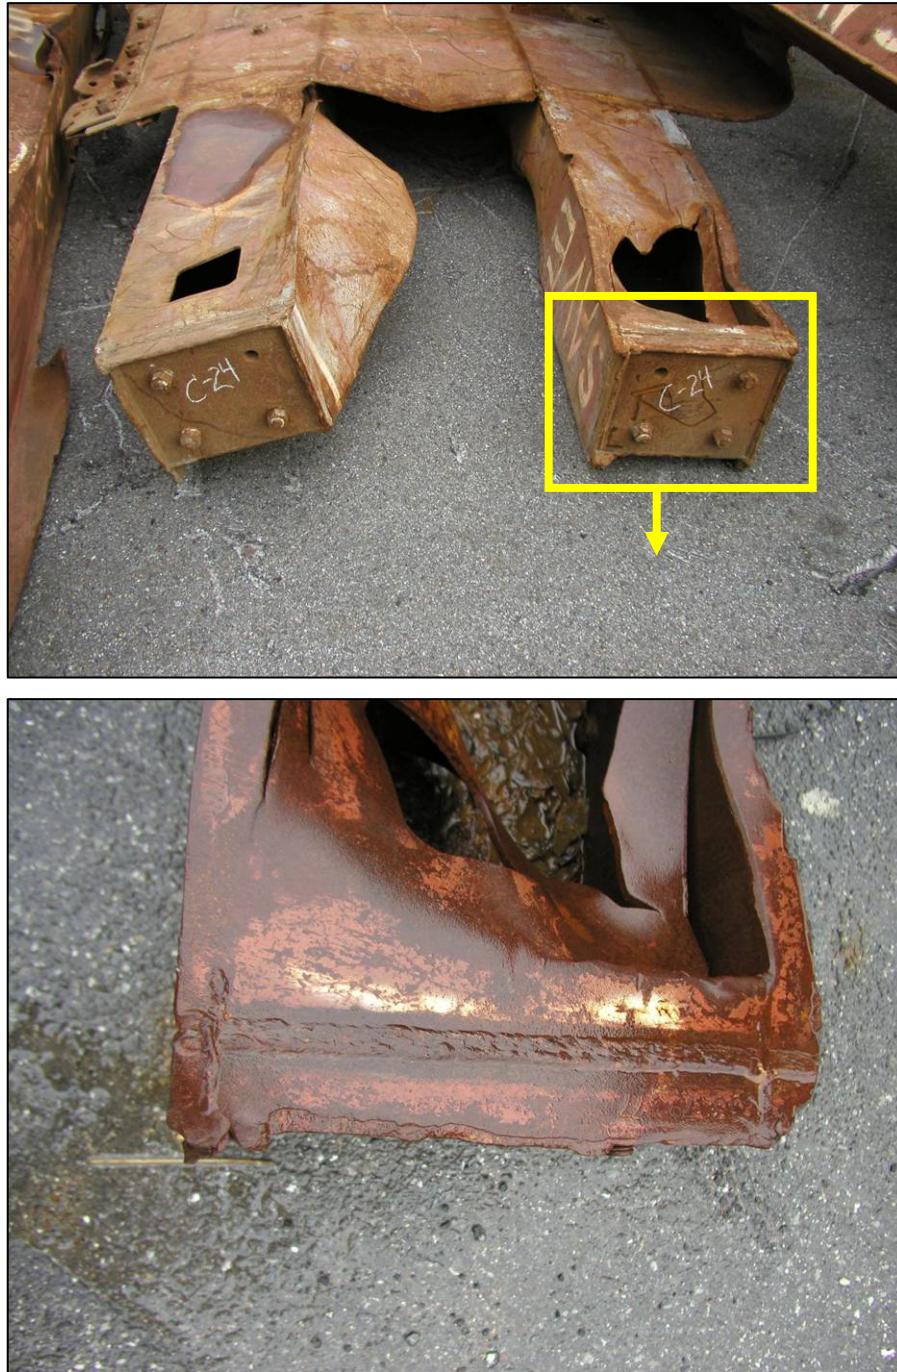
**Figure 3–43. Photographic example of Type 2 failure mode for end plate connections.**  
**a) Type 2a, partial failure with end plate still remaining (arrows) from M-28 (B345: 98-101) and b) Type 2b, full failure with end plate missing from N-9 (A154: 101-104). Damage of this type may be due to any one of the extreme loading events.**

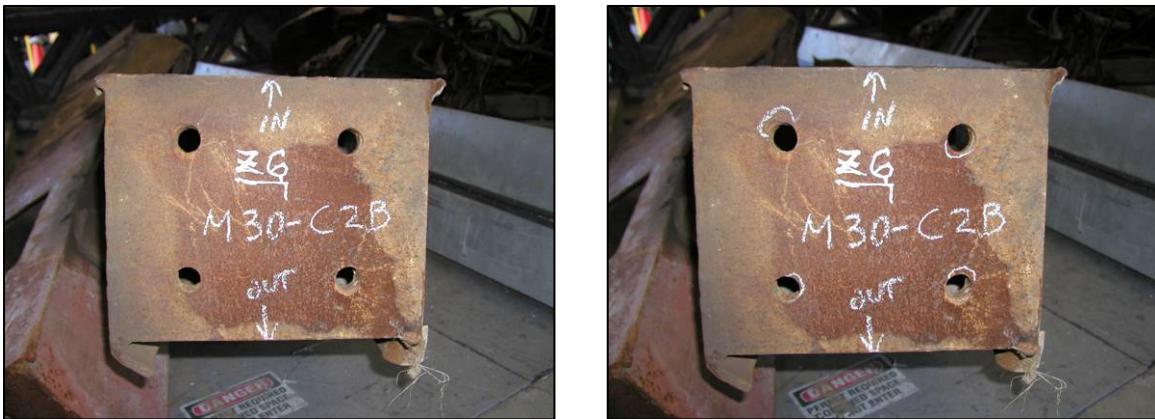
M30-C2B  
WTC1  
Col 133  
Fl 94

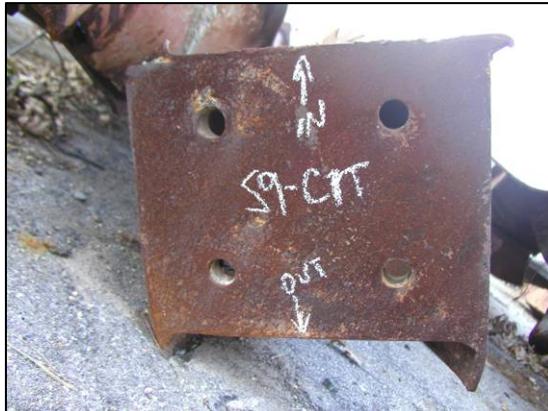
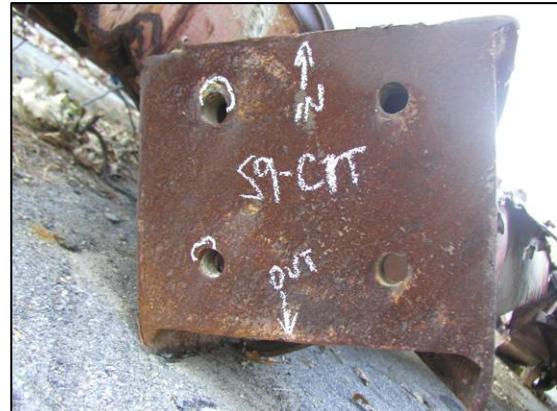
S9-C1T  
WTC1  
Col 134  
Fl 100

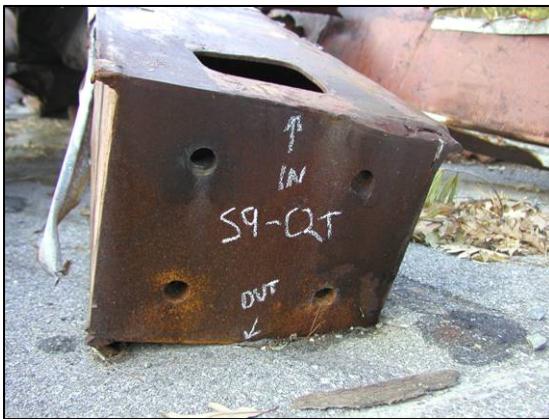
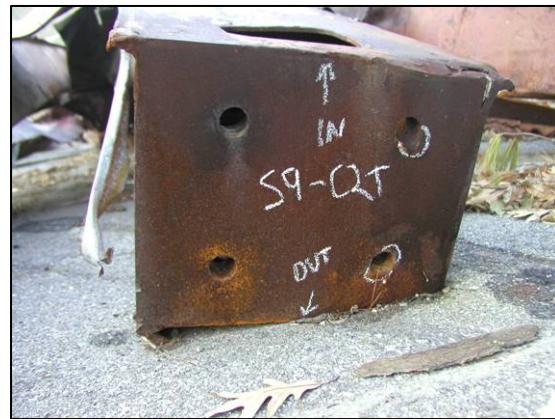
S9-C2T  
WTC1  
Col 133  
Fl 100

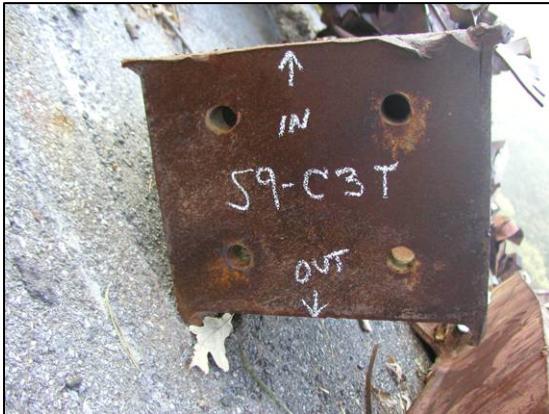
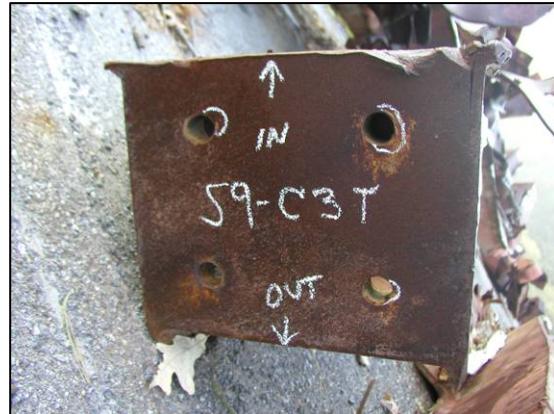
S9-C3T  
WTC1  
Col 132  
Fl 100

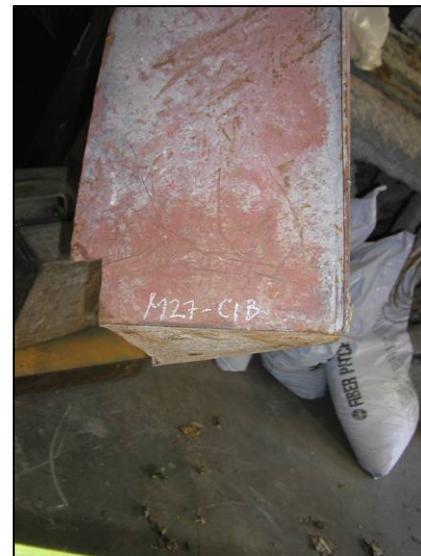
**Endplate is bent, no weld failures observed**

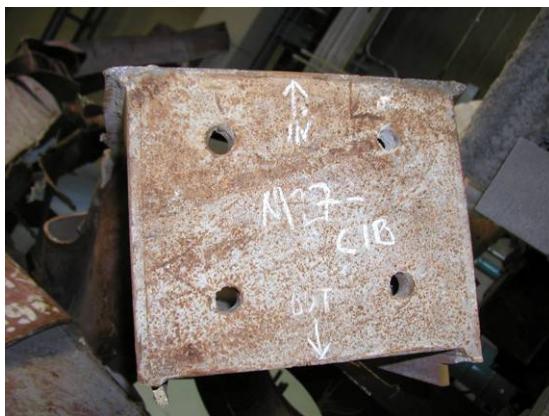
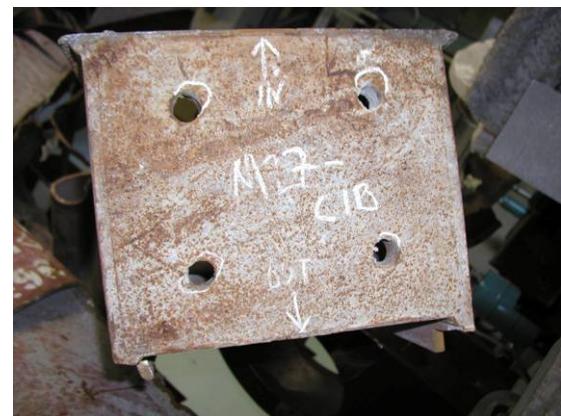
**M27-C1B  
WTC1  
Col 131  
Fl 93**

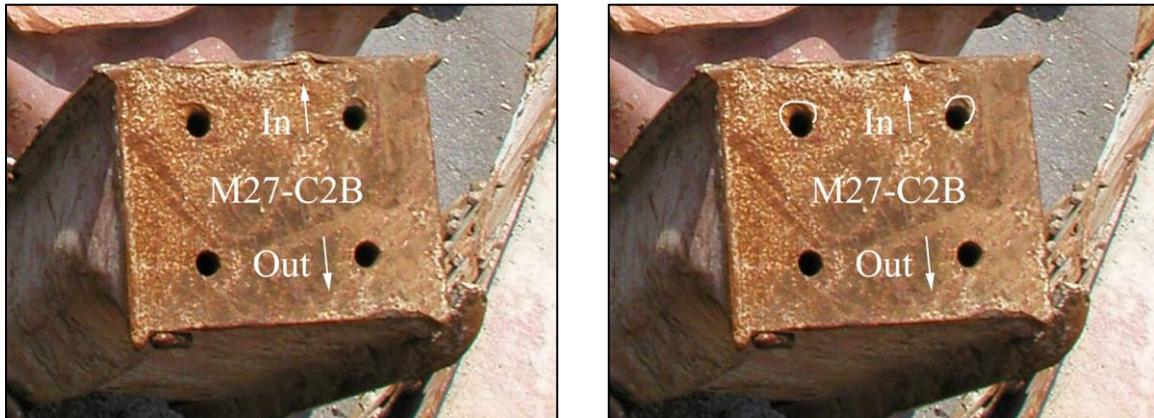
**M27-C2B  
WTC1  
Col 130  
Fl 93**

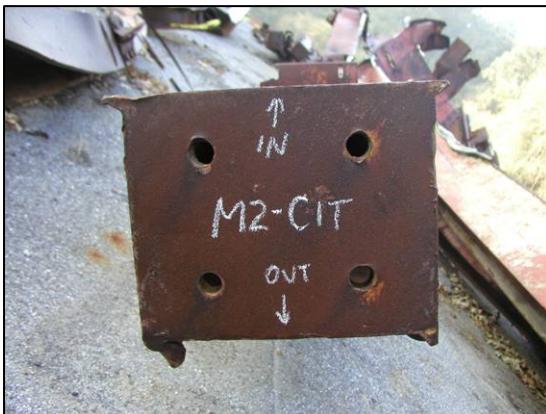
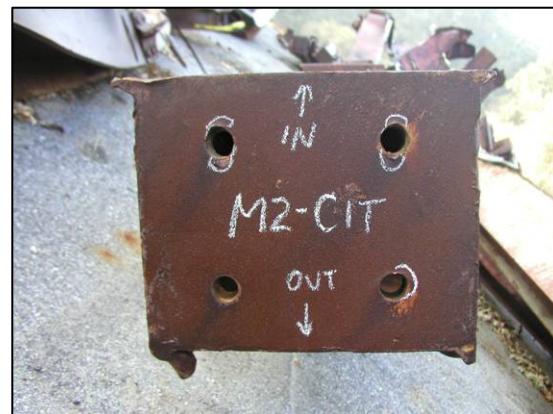
M2-C1T  
WTC1  
Col 131  
Fl 99

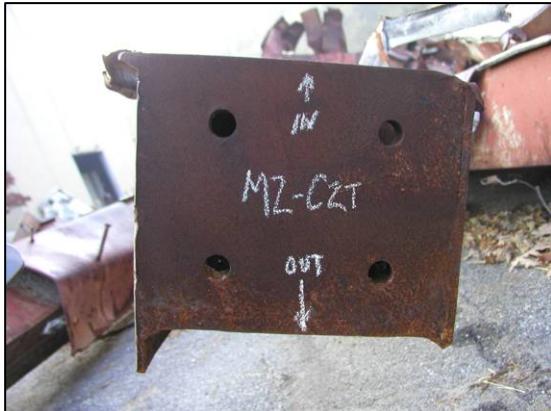
No change in bolt  
hole shape

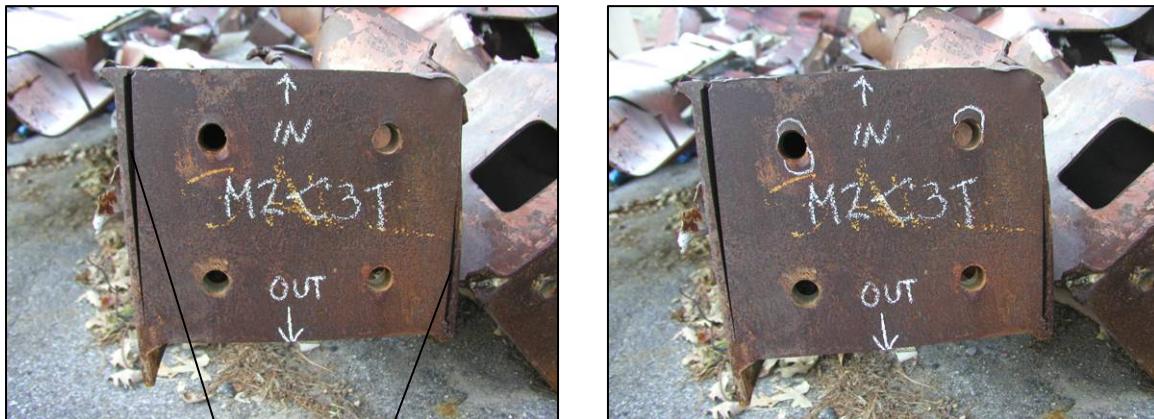
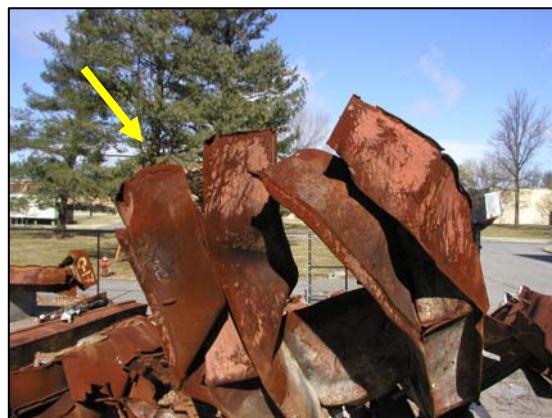
M2-C3B  
WTC1  
Col 129  
Fl 96

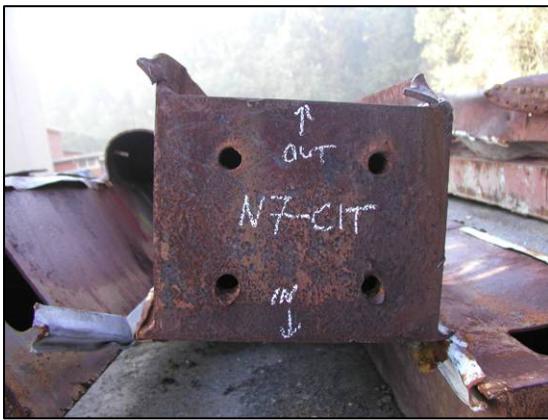
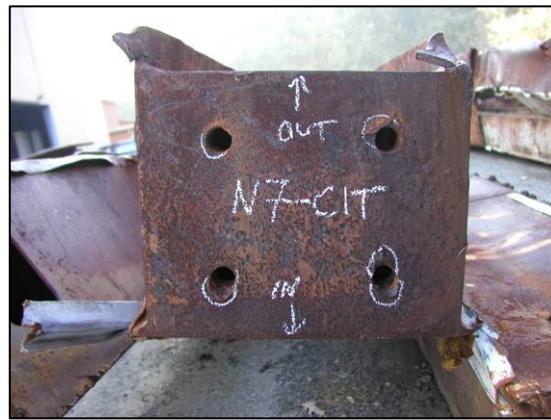
**N7-C1T**  
**WTC1**  
**Col 128**  
**Fl 100**

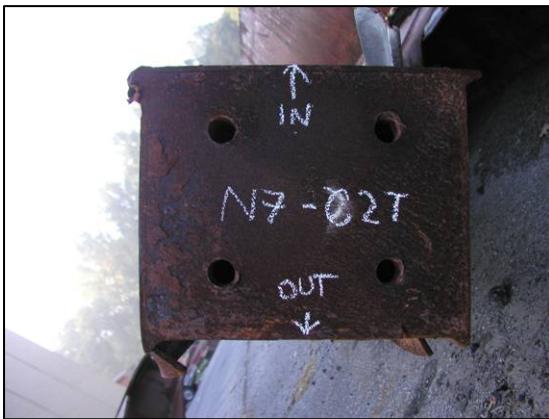
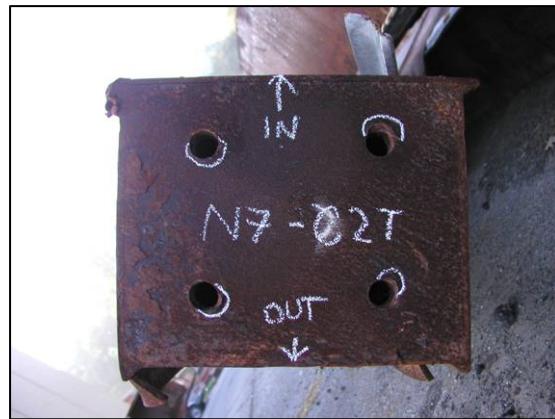
N7-C2T  
WTC1  
Col 127  
Fl 100

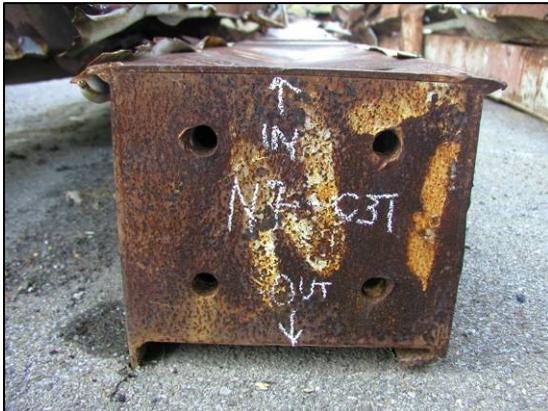
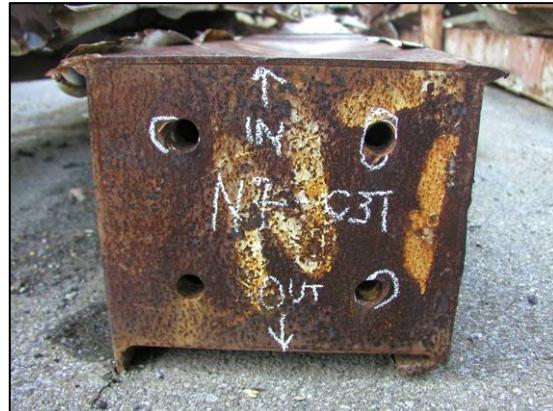
N7-C3T  
WTC1  
Col 126  
Fl 100

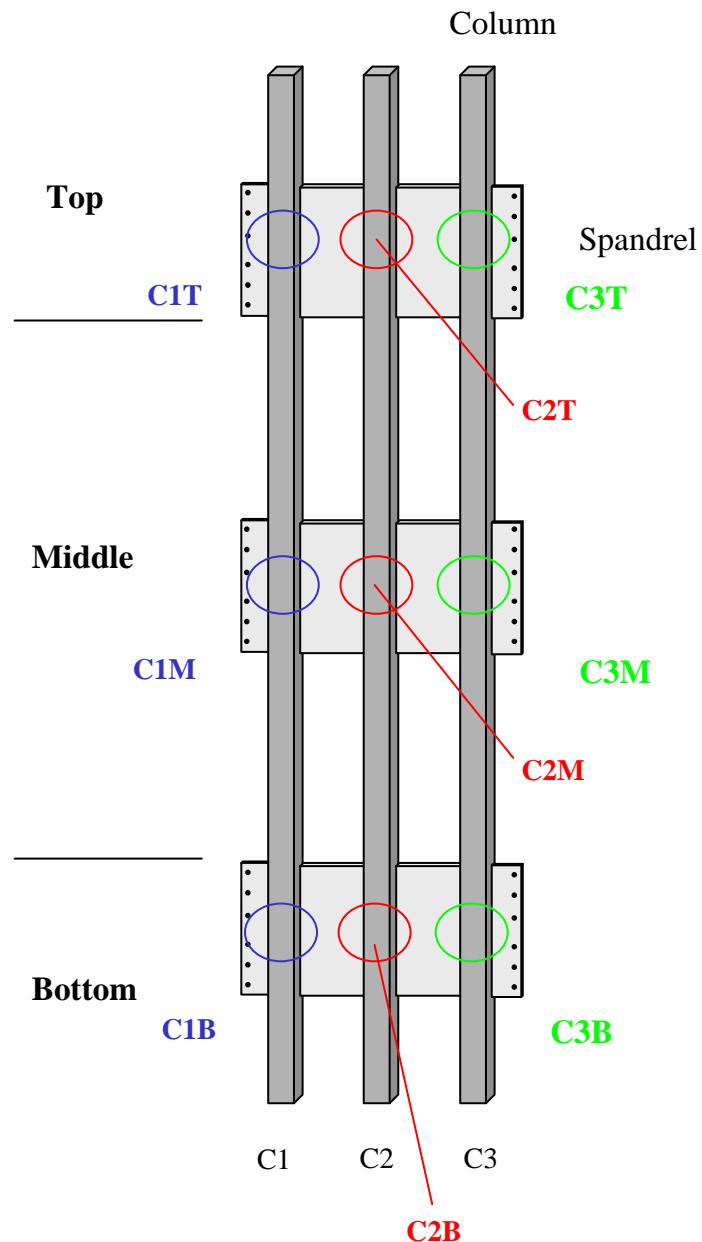
**Figure 3–50. Labeling system used by NIST to identify the specific intersections of columns and spandrels of the exterior wall panels.**

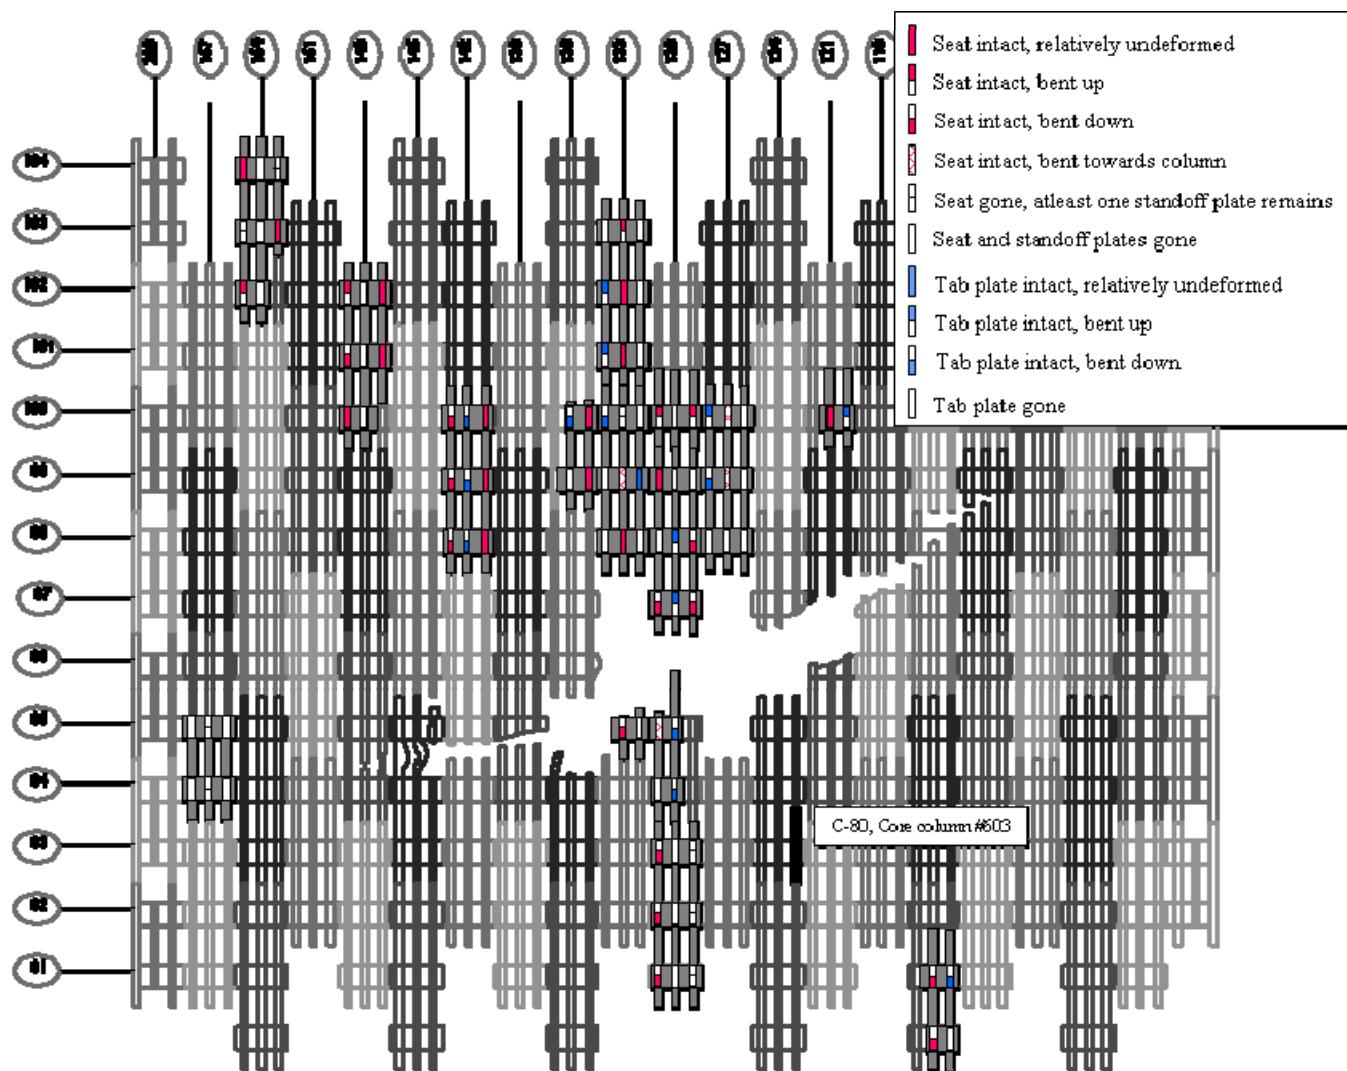
**Figure 3–51a. WTC 1, damage diagram overlaid with recovered samples and damage of connectors.**
