**Federal Building and Fire Safety Investigation of the  
World Trade Center Disaster**

**Damage and Failure Modes of  
Structural Steel Components**

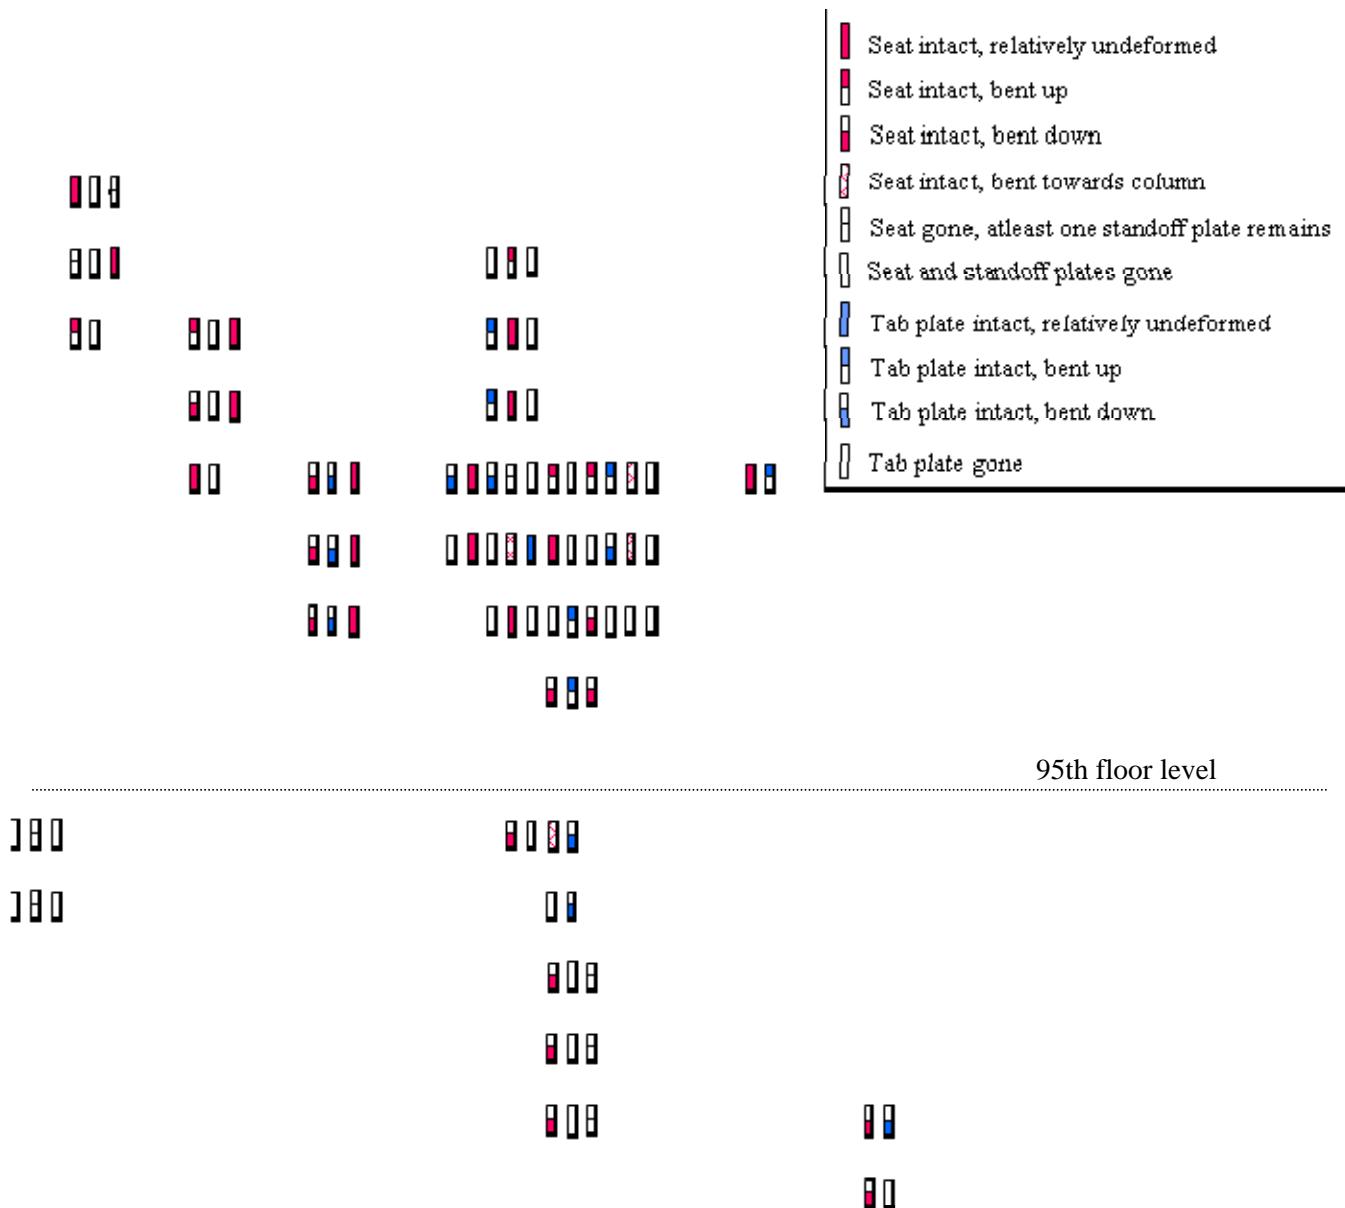
**Figure 3–51b. WTC 1, damage of connectors. At or below the 95th floor, all connectors are either bent down or missing.**

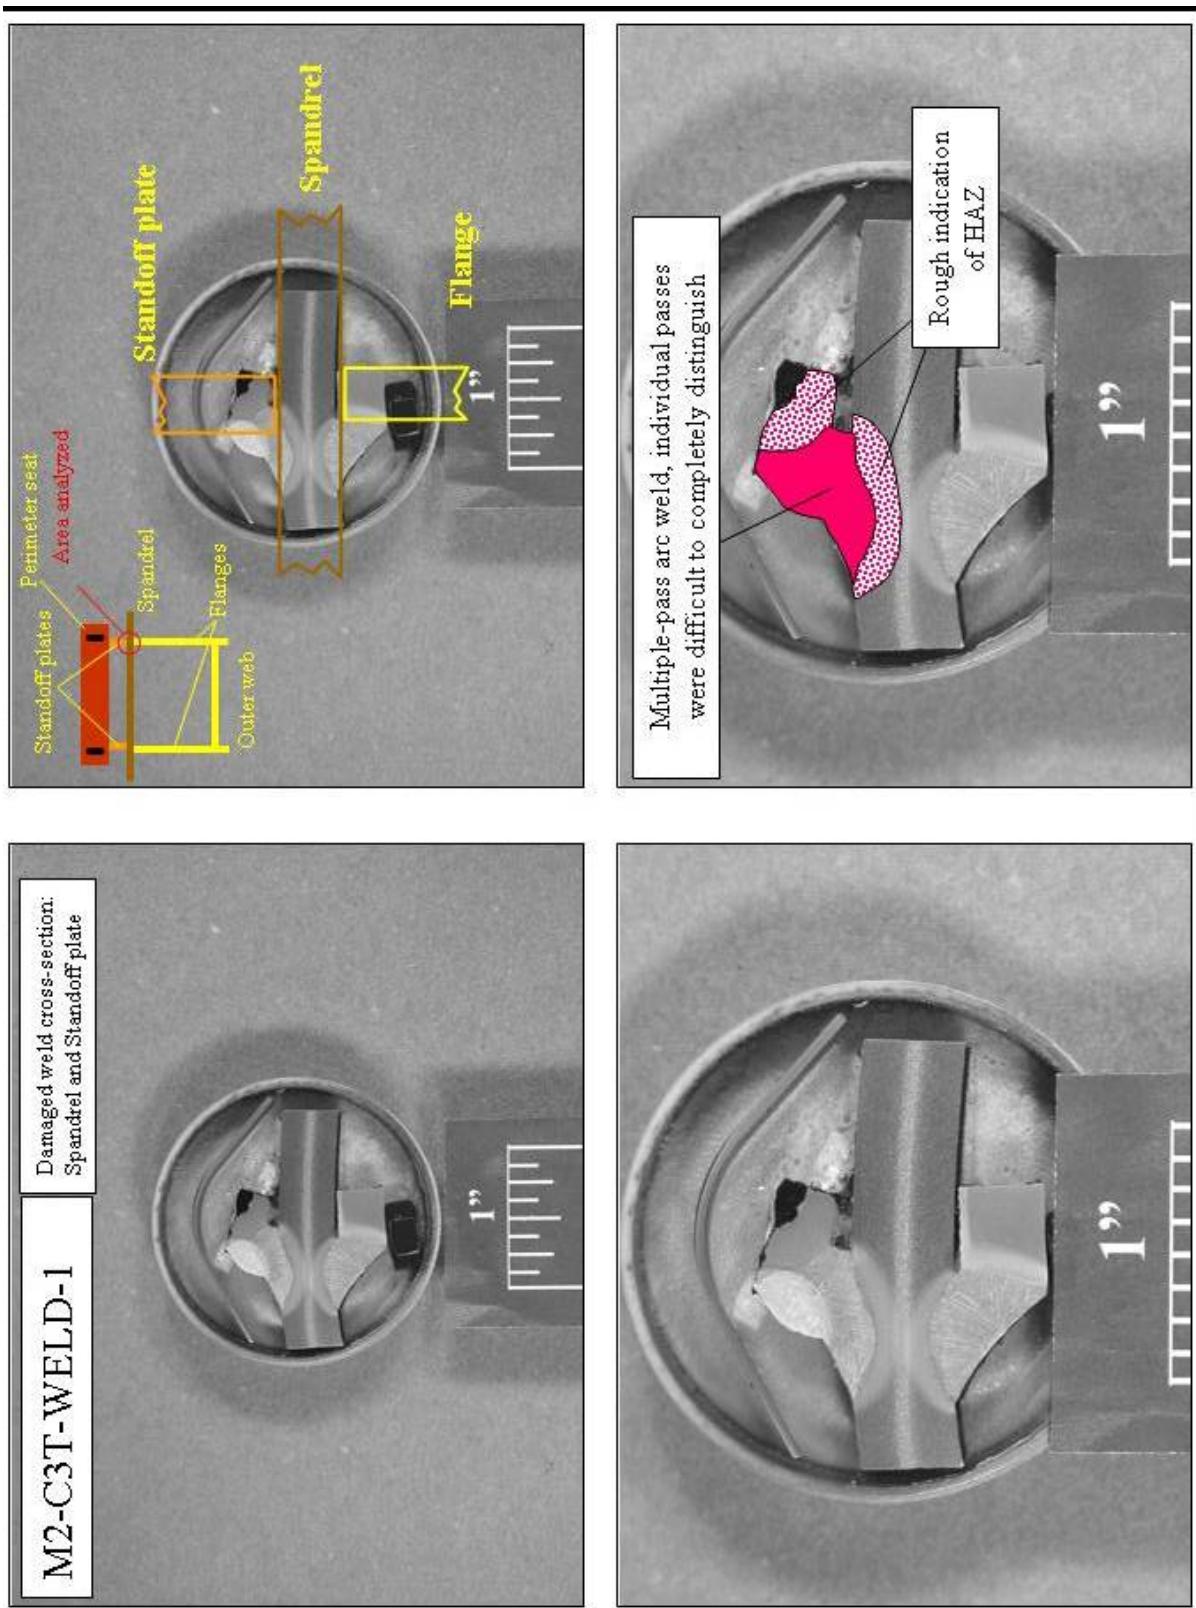
**Source:** NIST  
**Figure 3-53b.** Etched cross-section of fracture near weld between spandrel plate (36 ksi) and standoff plate (42 ksi). Sample was from panel M-2 (A130: 96-99, column 129, 99th floor). Two percent nital and 4 percent picral etch (cont.).

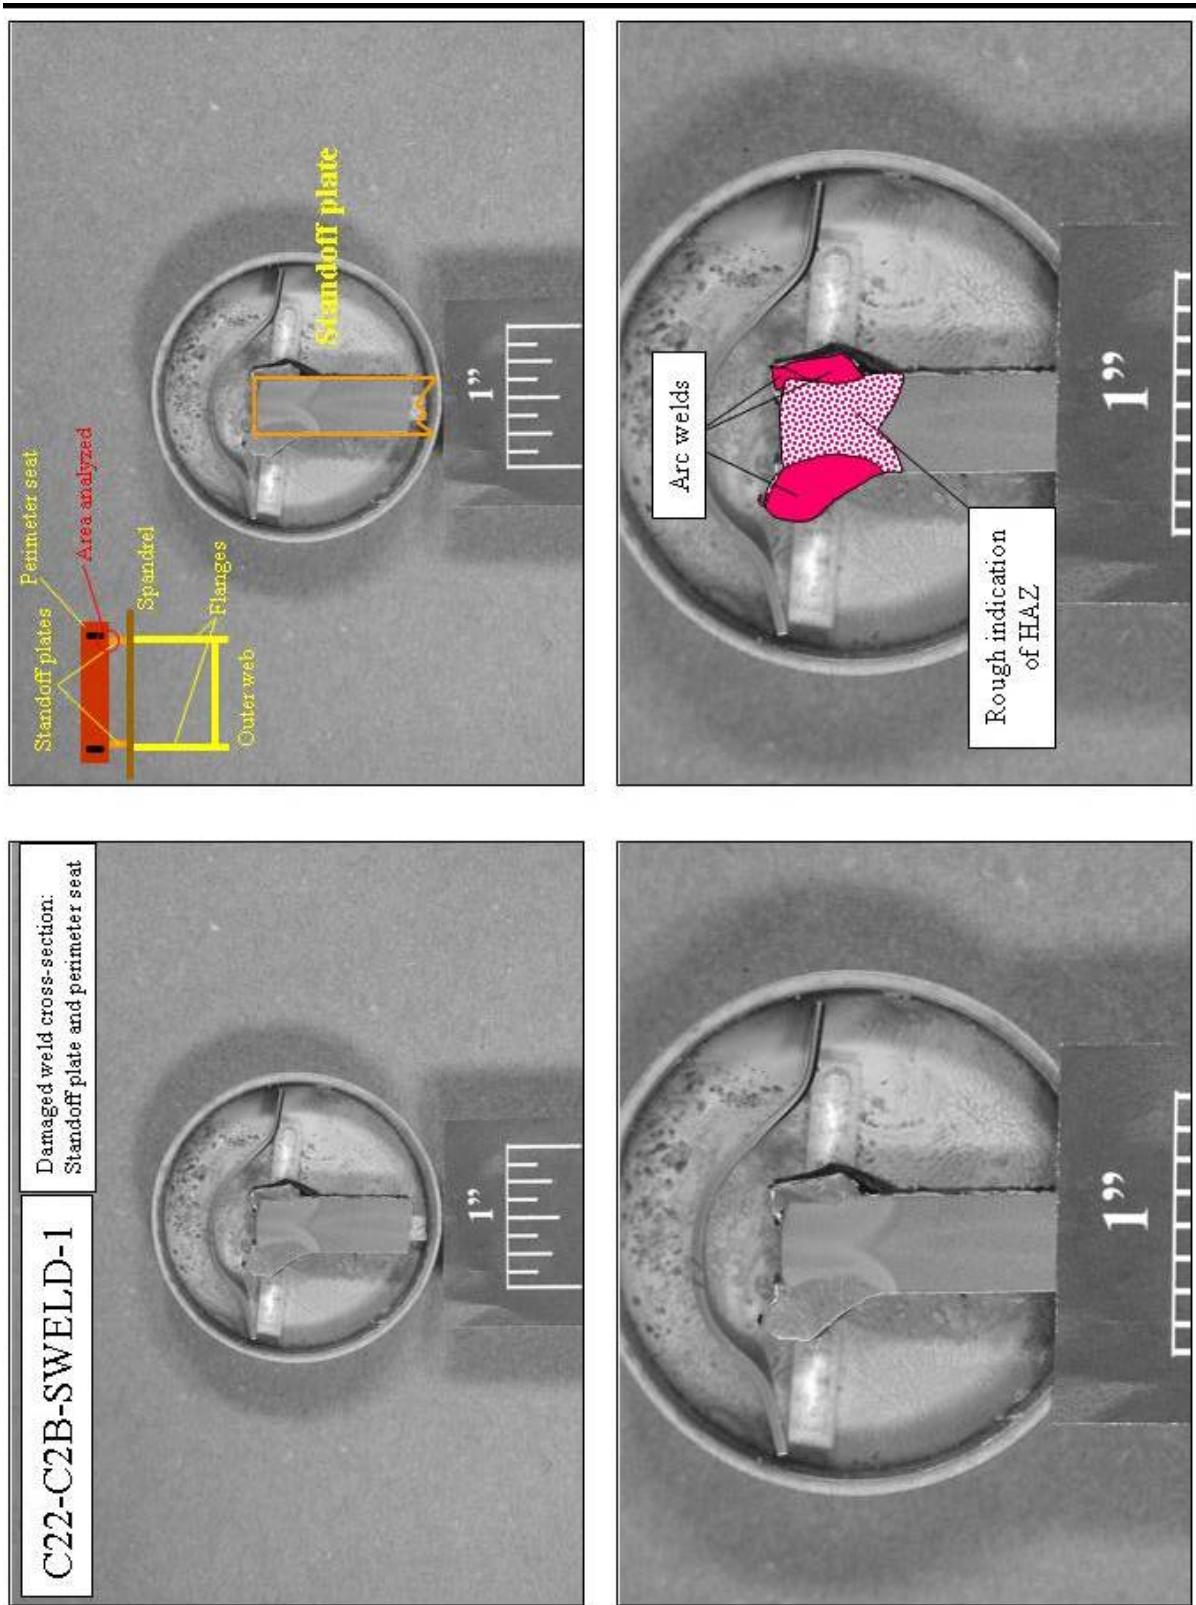
Figure 3-54b. Etched cross-section of fracture near weld between standoff plate and truss seat. Sample was from panel C-22 (A157: 93-96, column 156, 94th floor). Two percent nital and 4 percent picral etch.

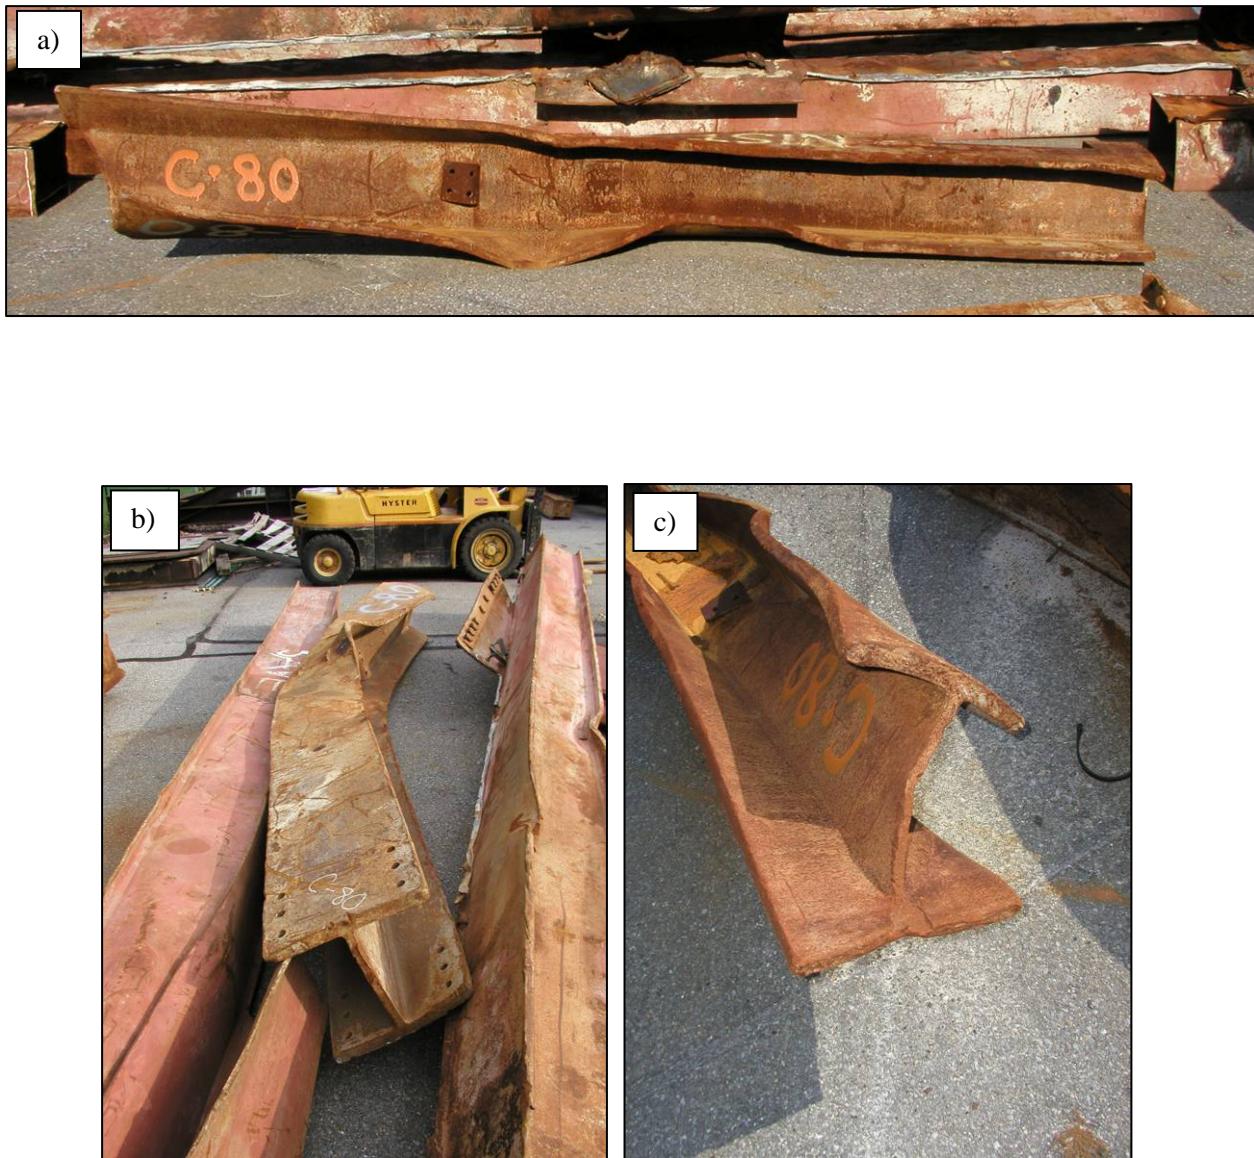
NIST has documented approximately 1 percent of all core columns intersecting floors with damage from the impact or fire floors. Thus, the preceding forensic analysis does not, and cannot, give a full and accurate picture of the type and amount of impact damage sustained by the vast majority of core columns.

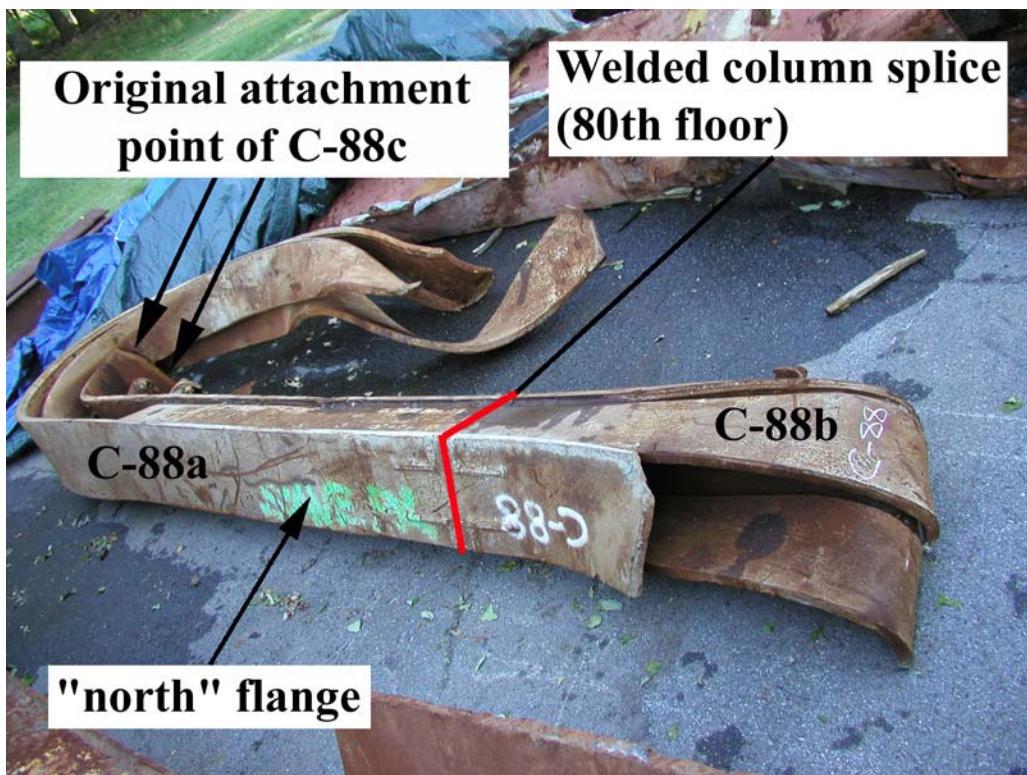
**Figure 4–1. Core column C-80 (603A: 92-95) located in the impact zone for WTC 1. Damage believed to be due to collapse. a) Overall view of recovered column, b) view of connection in the 92nd floor region, failure as a result of bolt fracture, and c) torn end of column near the 94th floor region.**

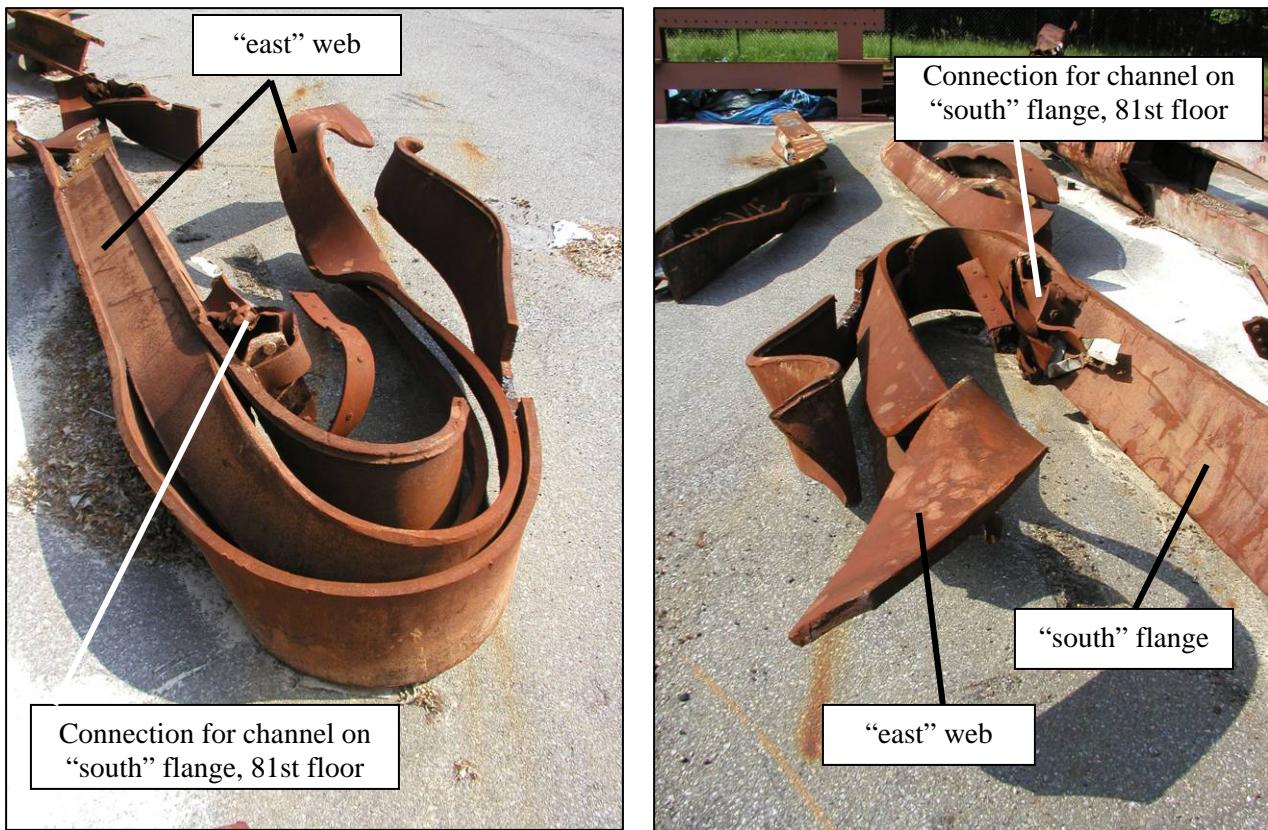
Figure 4–2. Overall view of recovered core columns C-88a (801B: 80-83) and C-88b (801B: 77-80) that were located in the impact zone of WTC 2. The north flange of C-88b may have sustained impact damage. Note that the welded column splice was still intact though the airplane may have struck a portion of this column.

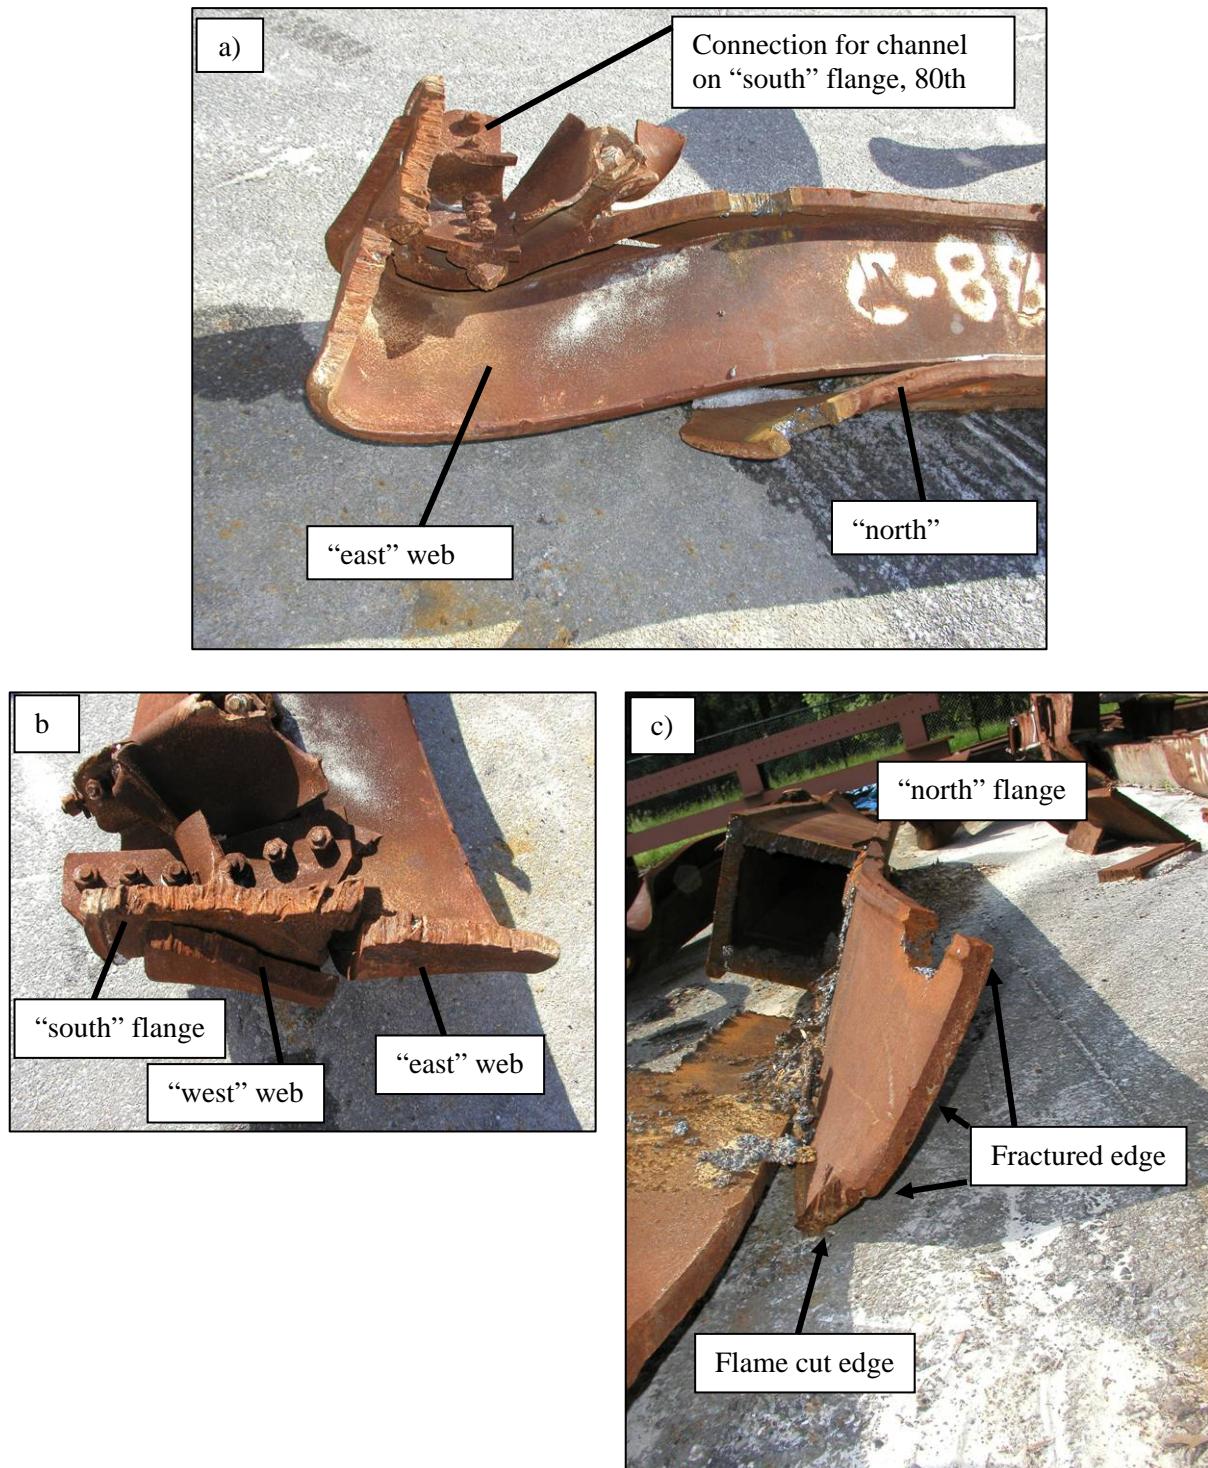
**Figure 4–3. Damage associated with core column C-88a (801B: 80-83) from the impact zone of WTC 2.**

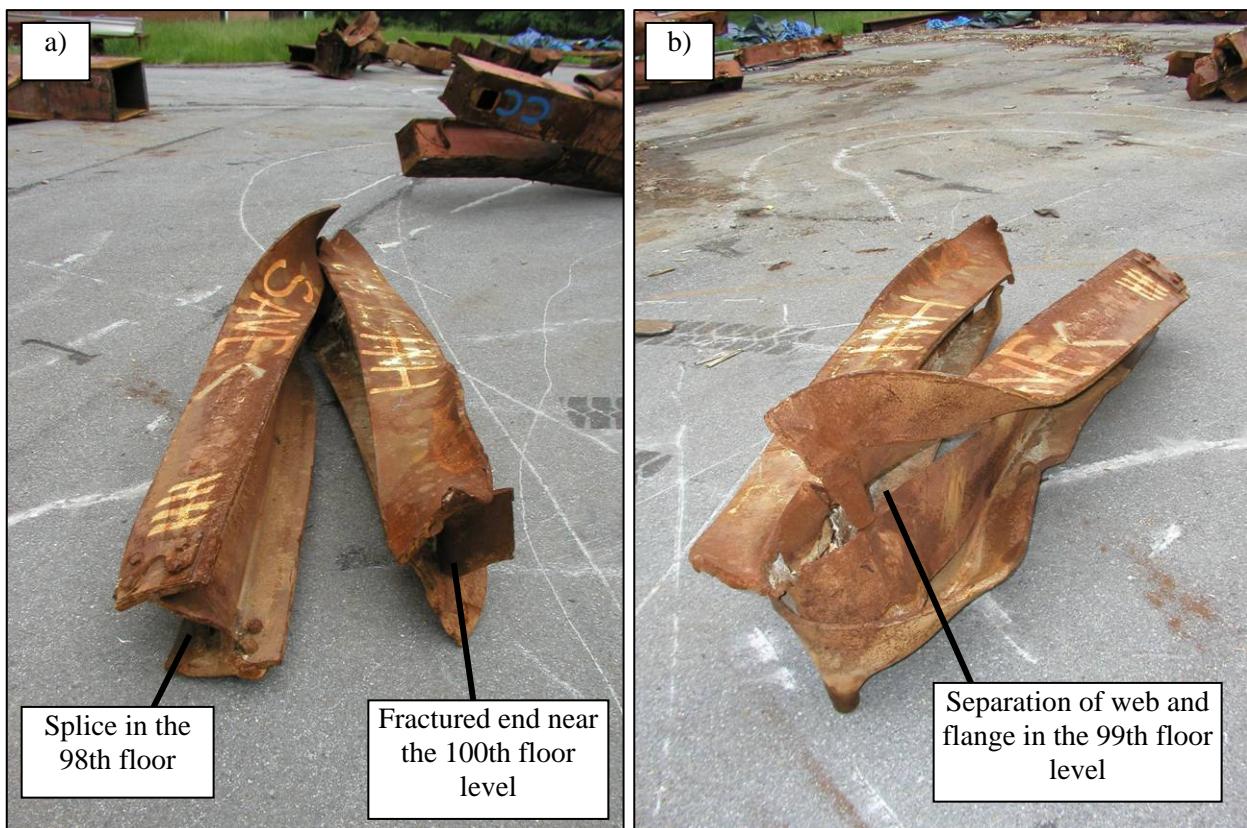
**Figure 4–4. Damage associated with core column C-88b (801B: 77-80) from the impact zone of WTC 2.** a) Overall view of fractured end, b) bottoms of “south” flange and both webs bent toward the east just below the 80th floor level, ends were flame cut prior to arrival at NIST, and c) “north” flange bent toward the north, majority of plate was fractured with some flame cutting (prior to arrival at NIST).

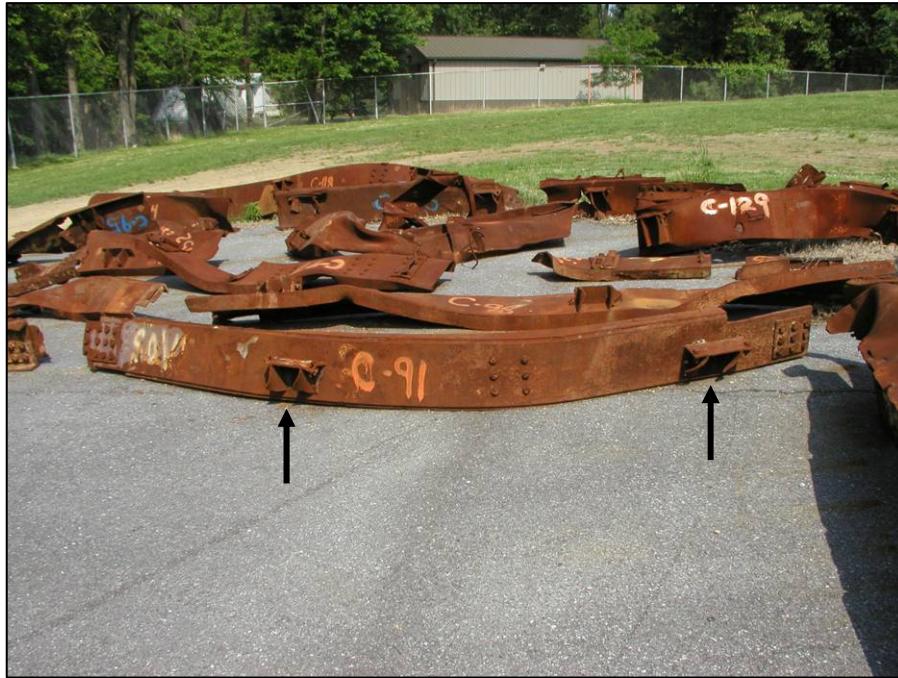
**Figure 4-5. Core column HH (605A: 98-101) from the fire floors of WTC 1. a) Failure at both ends and b) separation between flange and web in the 99th floor region.**

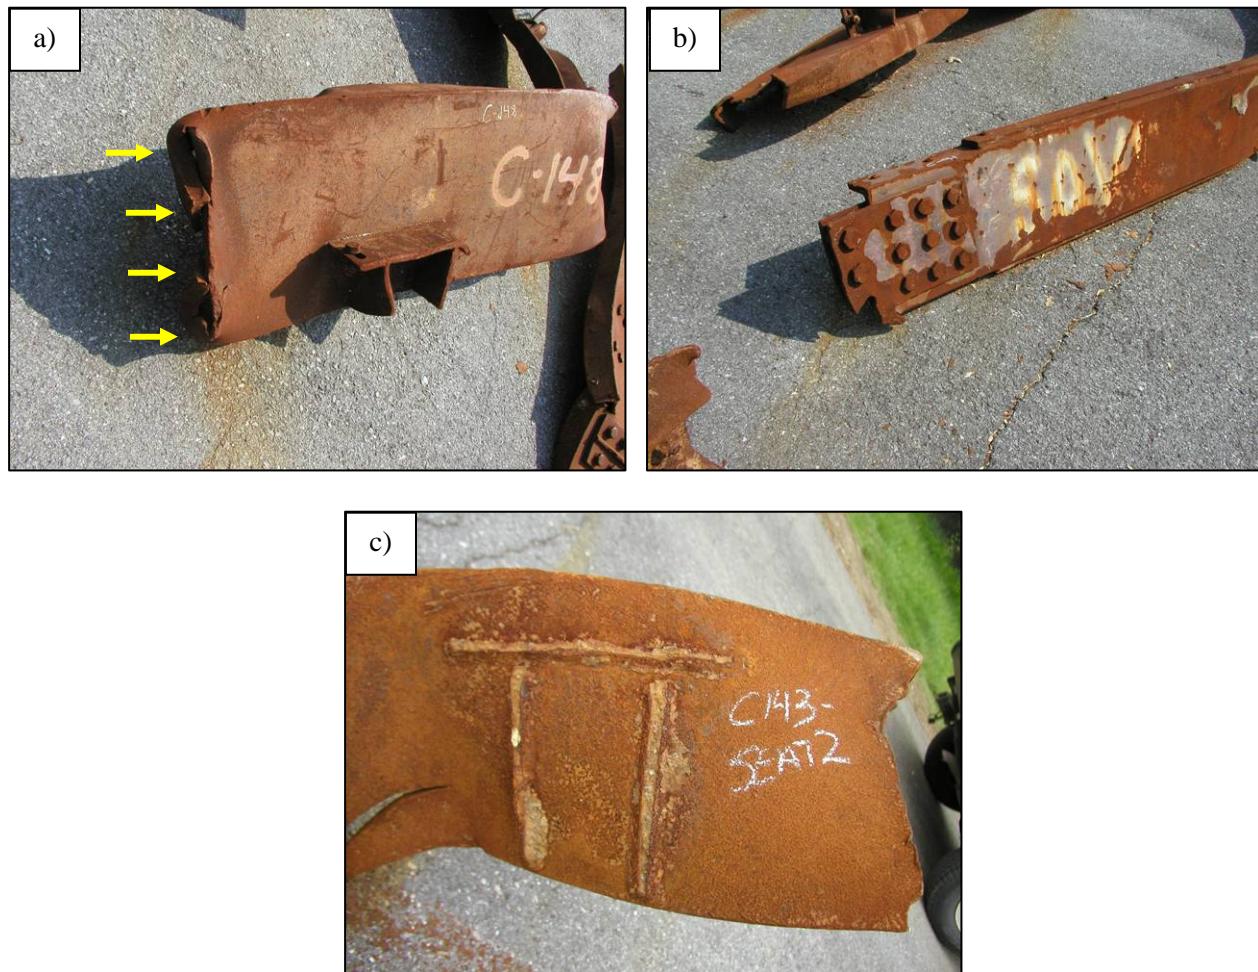
**Figure 4–8. Channel with ambiguous code stamped on it.  
The stampings read: “35 21 – 35 27 55”.**

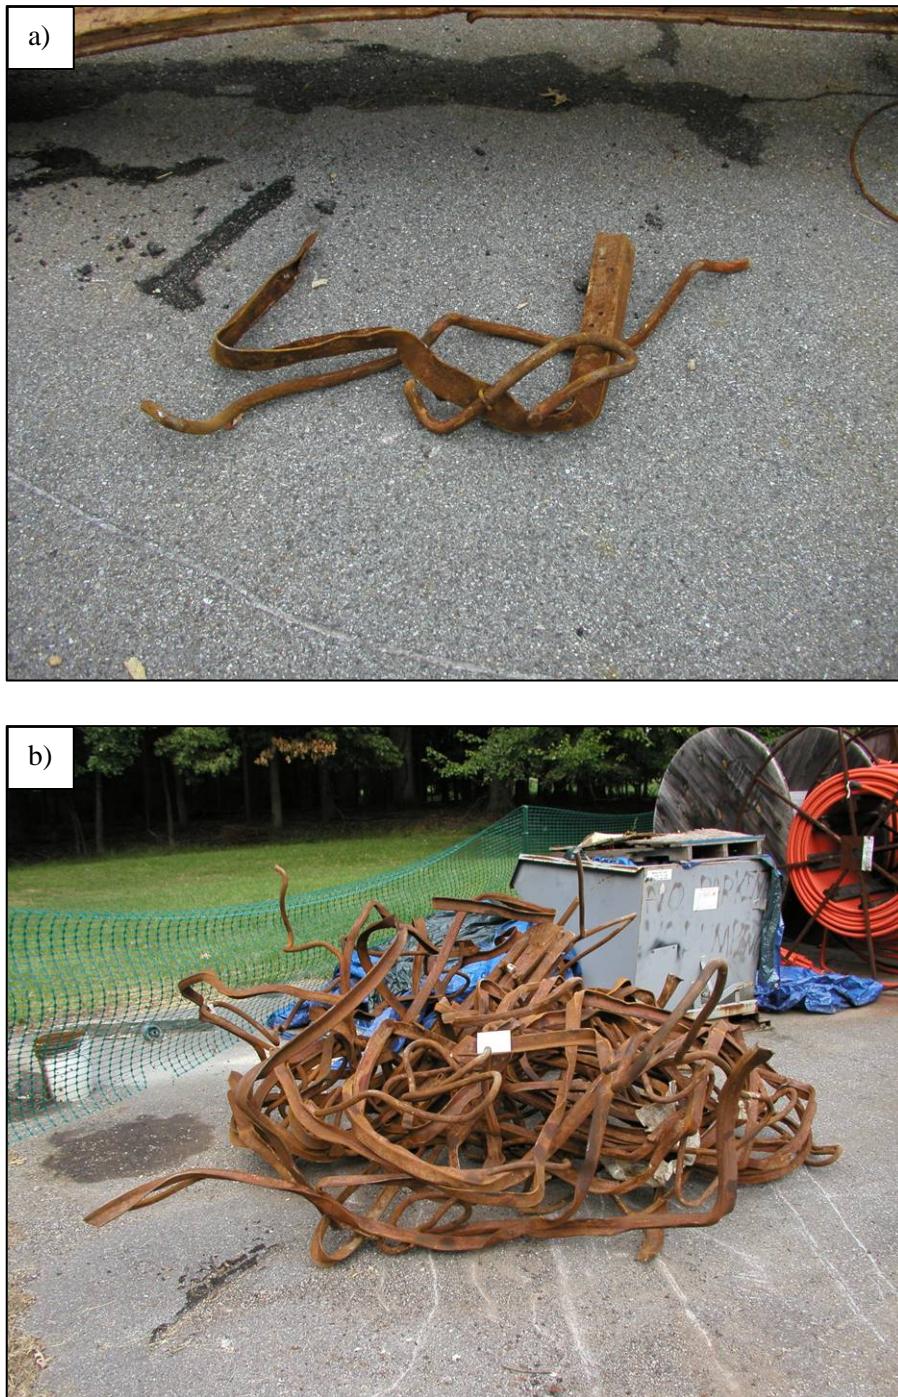
- Failure of the connection between the floor truss and seats was typically a result of bolt failure.
- Failure of a large majority of the compression resistance welds was observed.

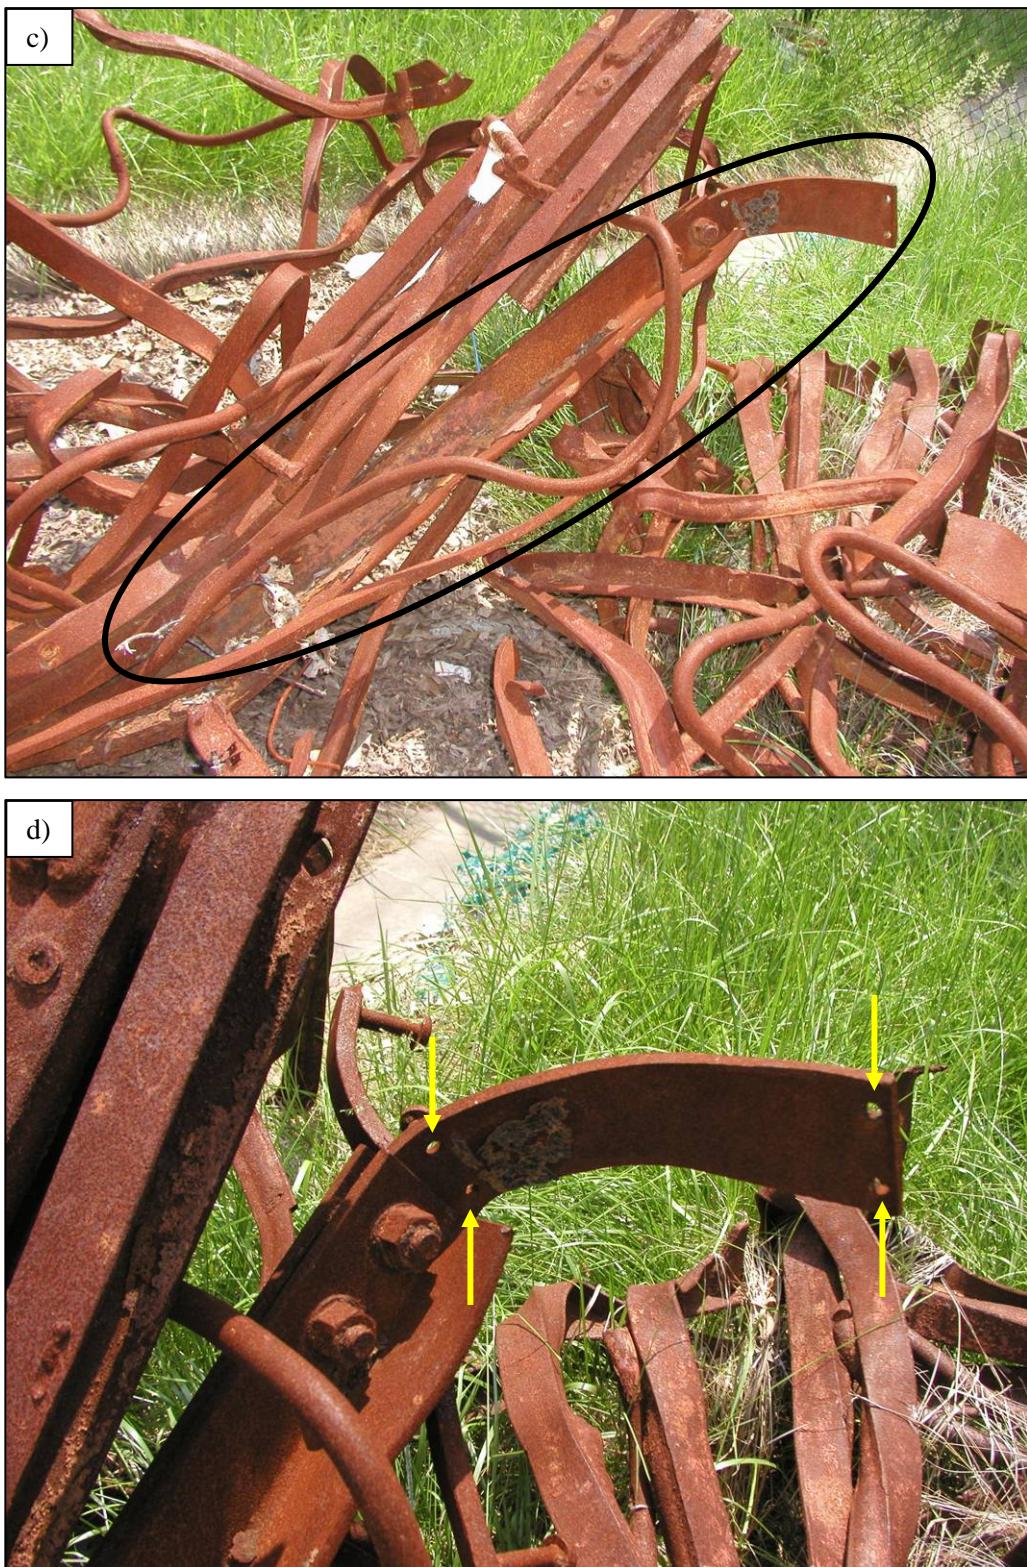
**Figure 5–2. Recovered floor truss connectors from sample C-137f. a) Upper support and b) remnants of gusset plate (as indicated) welded to top chord of truss during construction.**

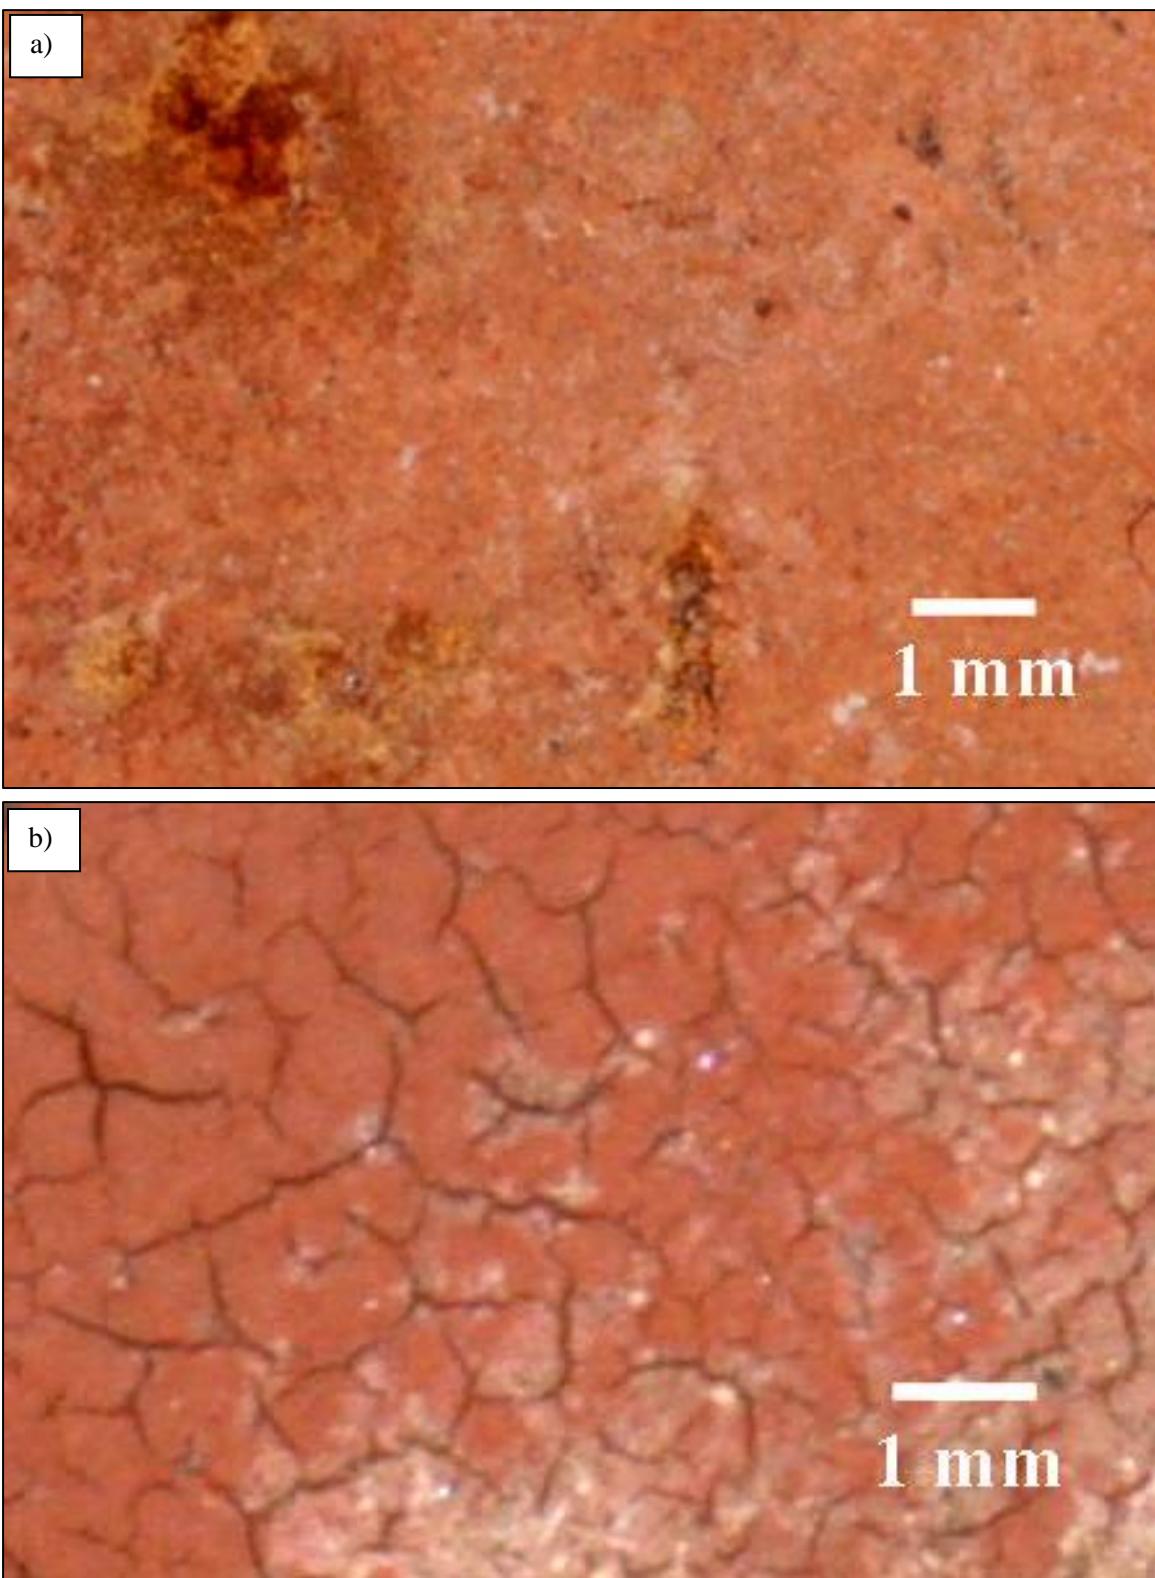
NIST has documented approximately 3 percent of all perimeter columns and 1 percent of all core columns intersecting floors with pre-collapse fires. Thus, the preceding forensic analysis does not, and cannot, give a picture of temperatures seen by the vast majority of perimeter and core columns.

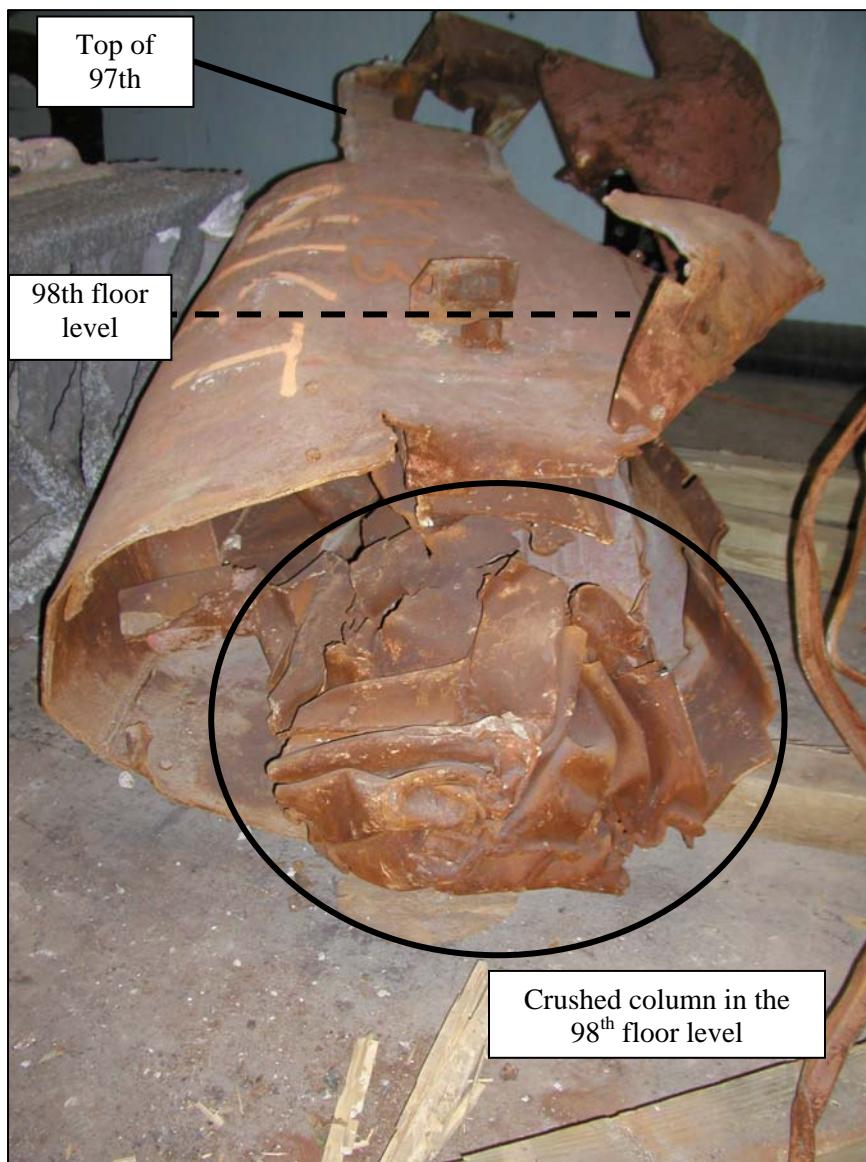
**Figure 6–1. Photographic images of the primer paint. a) paint in its original condition and b) mud cracking of paint after exposure at 250 °C for 1 h.**

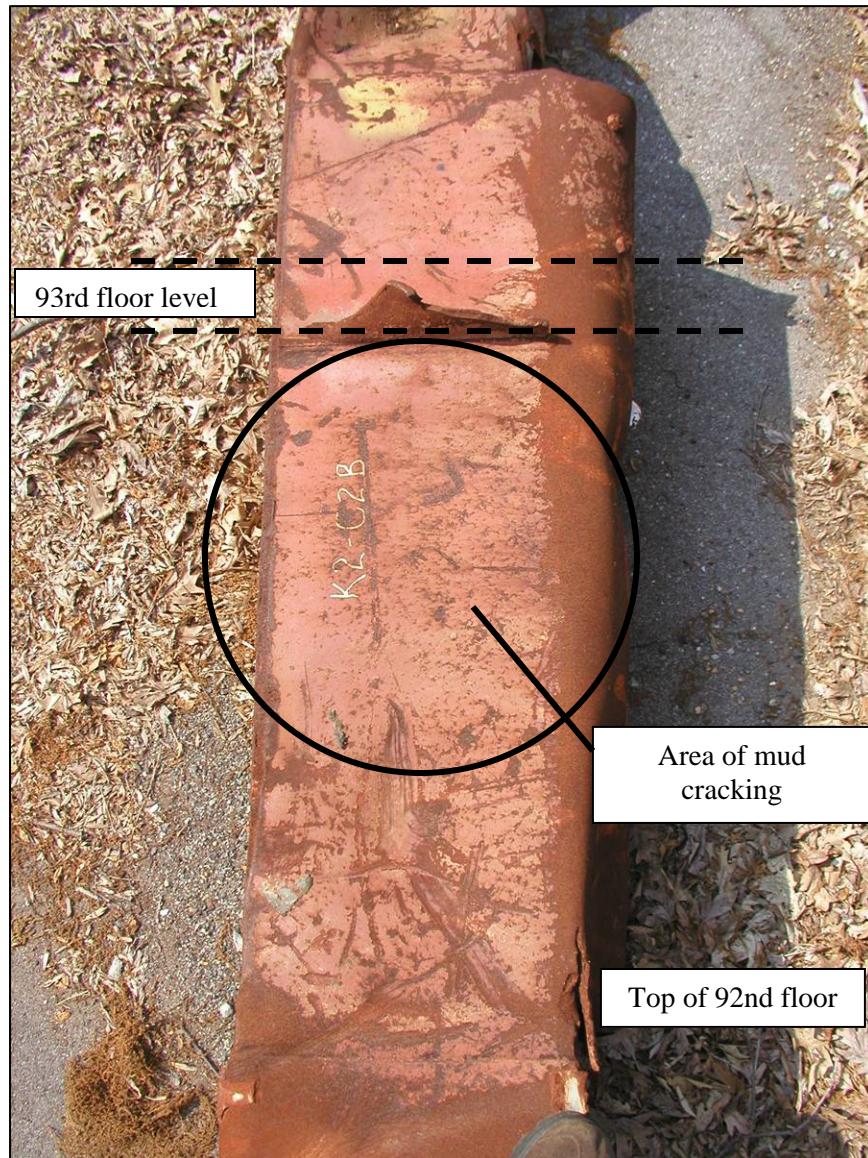
**Figure 6–2. Crushed portion of column 210 in the area of the 98th floor of WTC 1 (panel K-1, A209: 97-100). Mud cracking of the paint was observed in crushed portion of this column. The cracking of the paint was a result of either temperature exposure over 250 °C, mechanical deformation, or environmental degradation.**

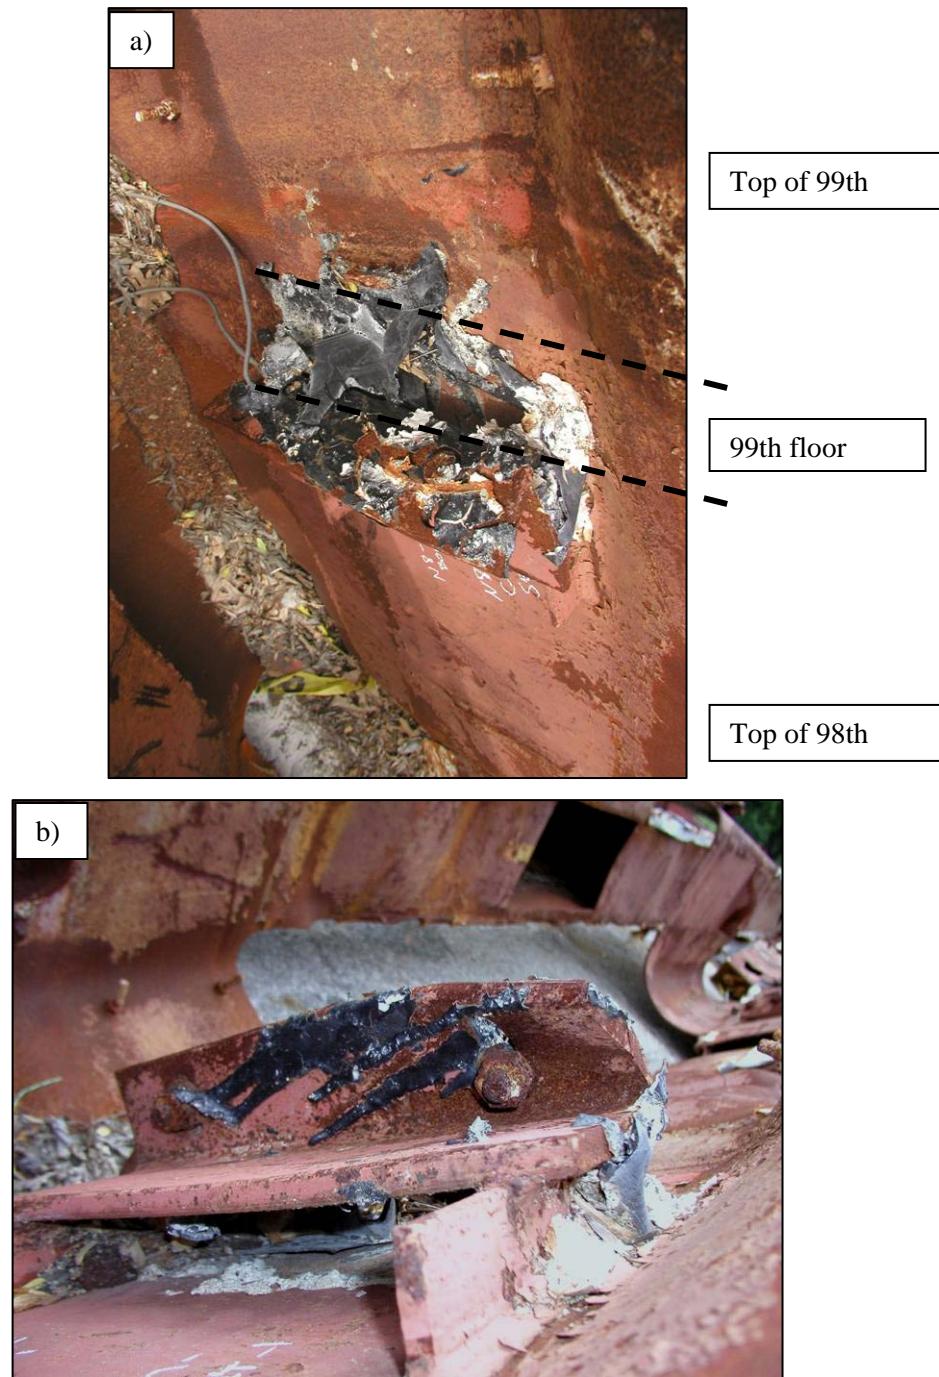
**Figure 6–3. Spandrel at the 93rd floor of column 236 of WTC 1 from panel K-2 (A236: 92-95). Mud cracking of the paint occurred below the 93rd floor line. No evidence of mud cracking was observed above the floor line.**

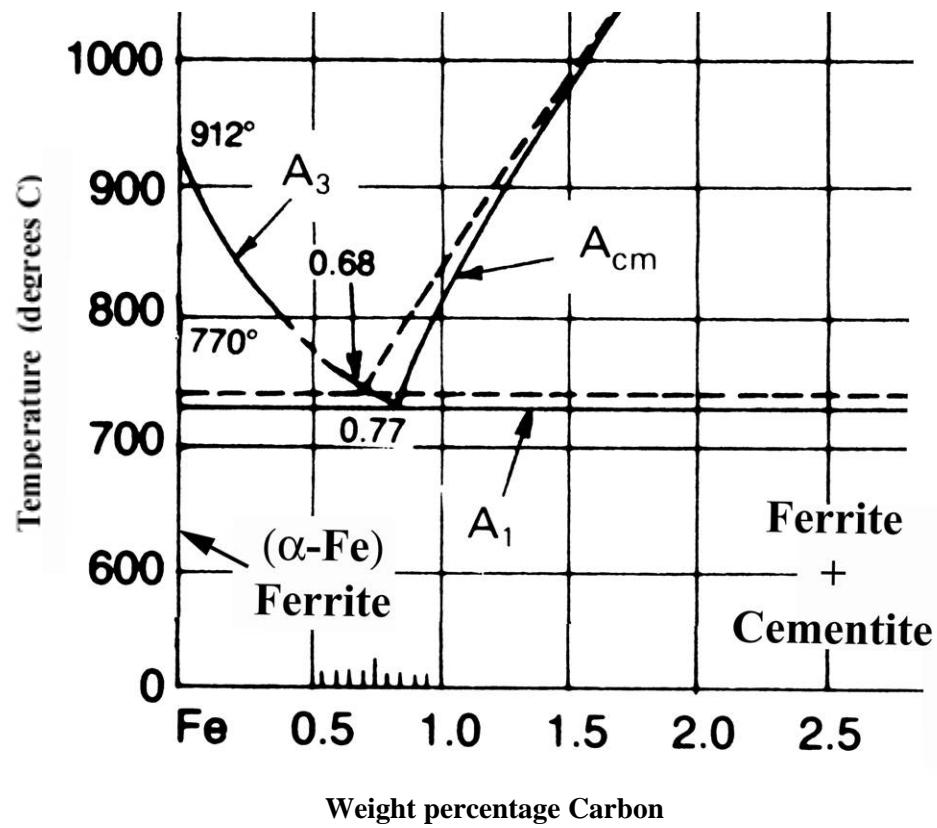
Figure 6–5. Portion of the iron-carbon (Fe-C) phase diagram.
