**Federal Building and Fire Safety Investigation of the  
World Trade Center Disaster**

**Damage and Failure Modes of  
Structural Steel Components**

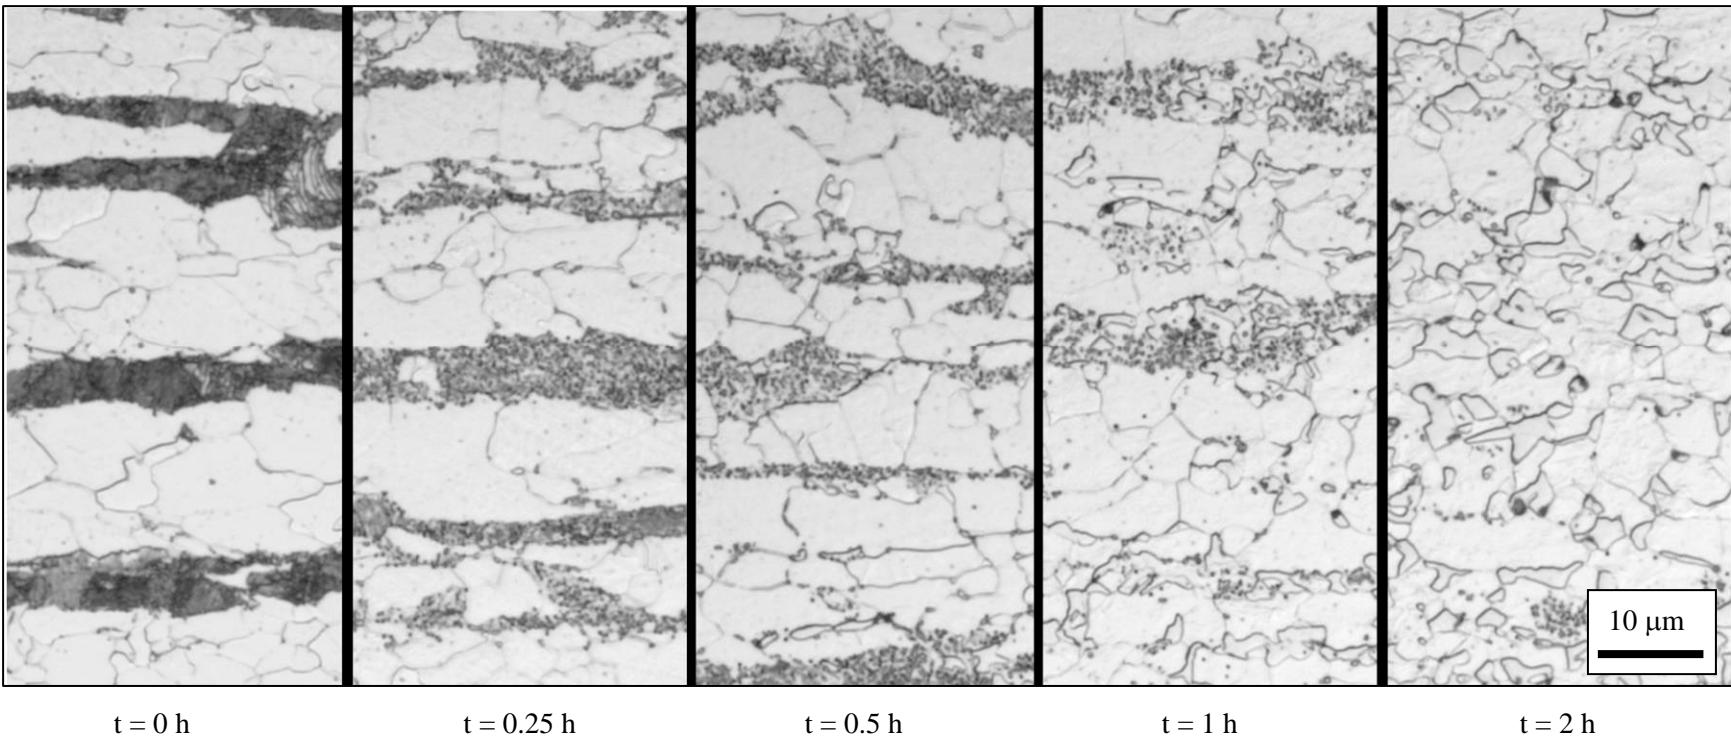
Figure 6–5. Portion of the iron-carbon (Fe-C) phase diagram.

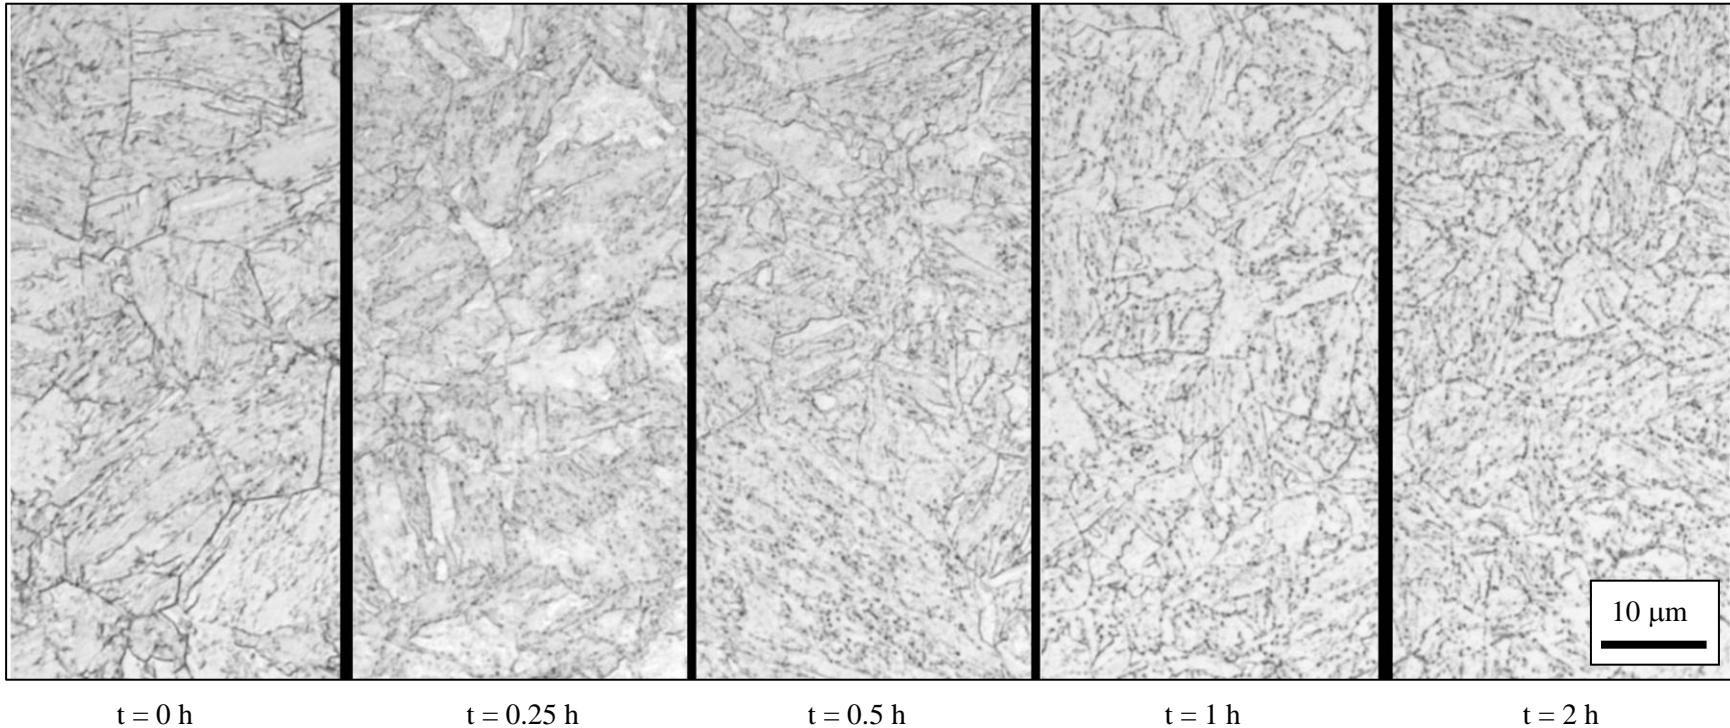
**Figure 6–6. Change in microstructure of a 60 ksi flange plate that was heat treated in a laboratory furnace at 625 °C for various times. Pearlite was observed to spheroidize. Sample shown was from panel N-7 (WTC 1, column 126, 97th floor). Two percent nital and 4 percent picral etch.**

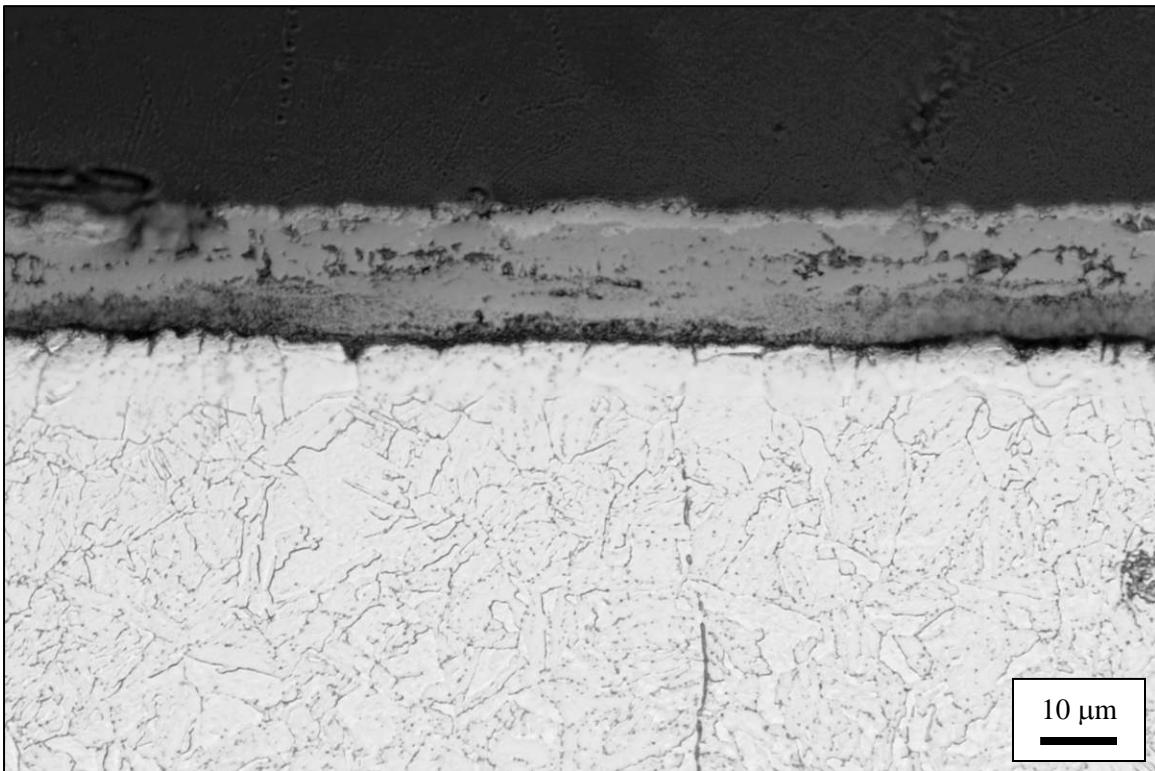
**Figure 6–7. Change in microstructure of a 100 ksi flange plate that was heat treated in a laboratory furnace at 625 °C for various times (t). Sharpness of lath boundaries was observed to decrease while the carbide precipitates became more discernable. Sample was from panel C-10 (WTC 1, column 451, 88th floor). Two percent nital and 4 percent picral etch.**

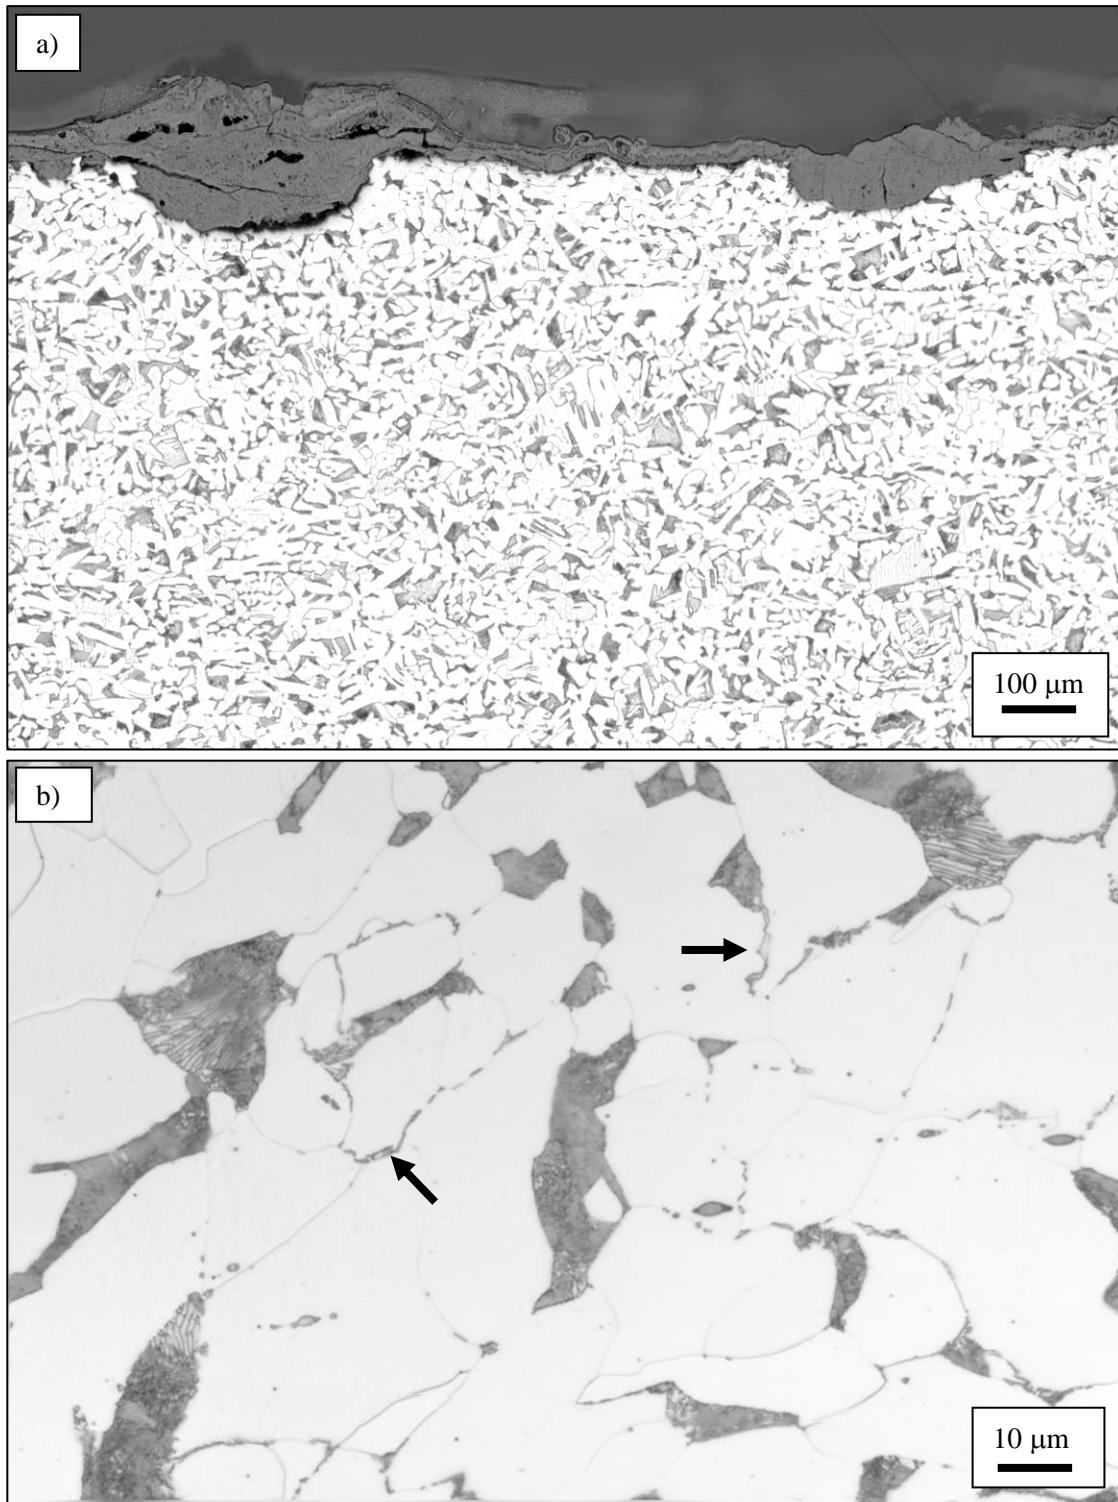
**Figure 6–8.** Iron oxide scale that developed on a 100 ksi quenched-and-tempered flange plate after isothermal exposure at 625 °C for 2 h. Sample was from panel C-10 (WTC 1, column 451, 88th floor). Two percent nital and 4 percent picral etch.

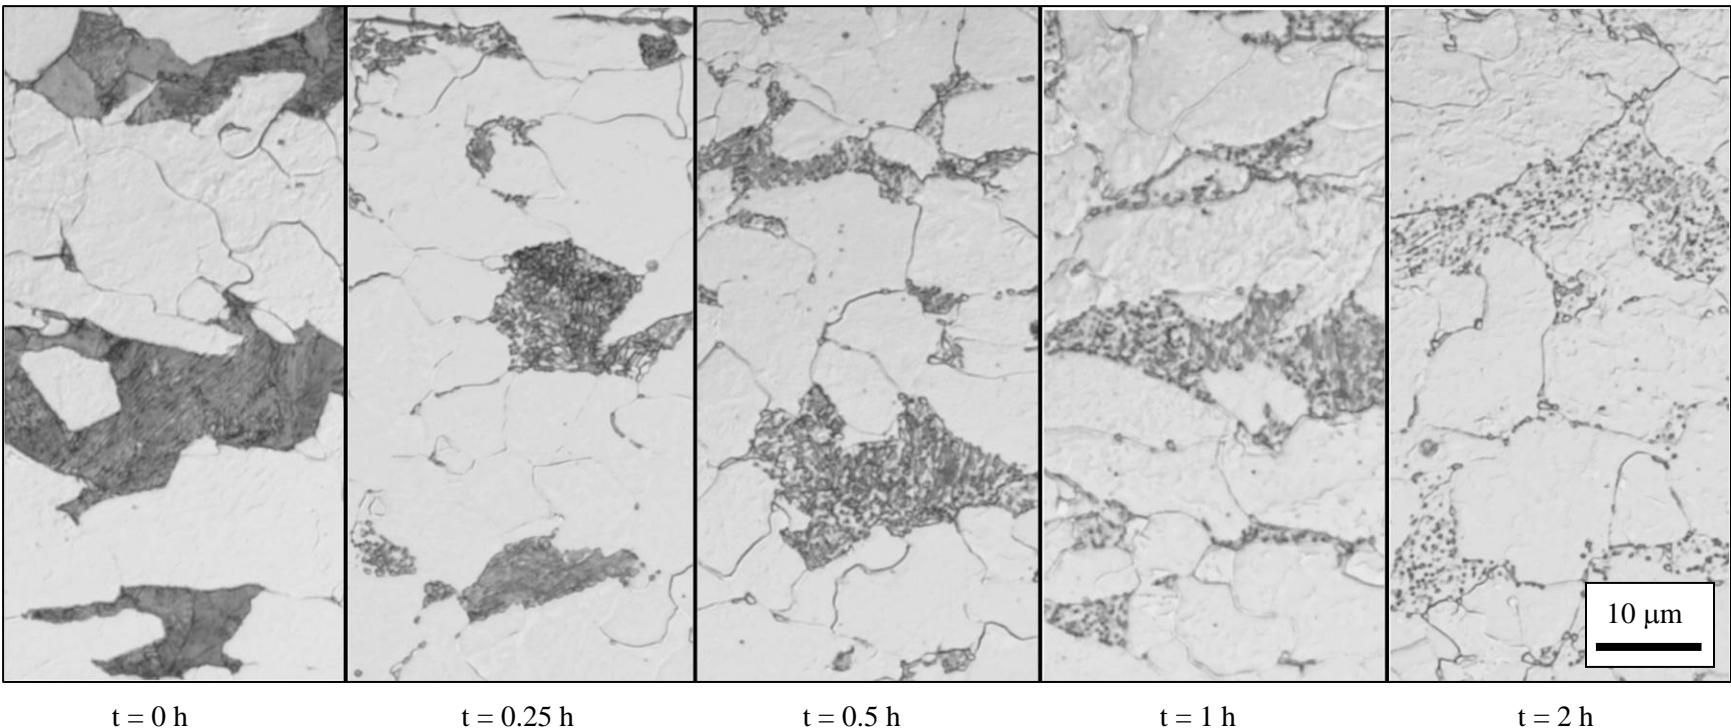
**Figure 6–9. Light optical micrographs showing the microstructures from “fire exposed” spandrels. a) Ferrite-pearlite structure and developed oxide scale, b) lamellae were observable in pearlite, carbides (indicated by arrows) decorating ferrite grain boundaries. Both images taken from the 99th floor spandrel of WTC 1, panel M-2 (A130: 96-99). Two percent nital and 4 percent picral etch.**

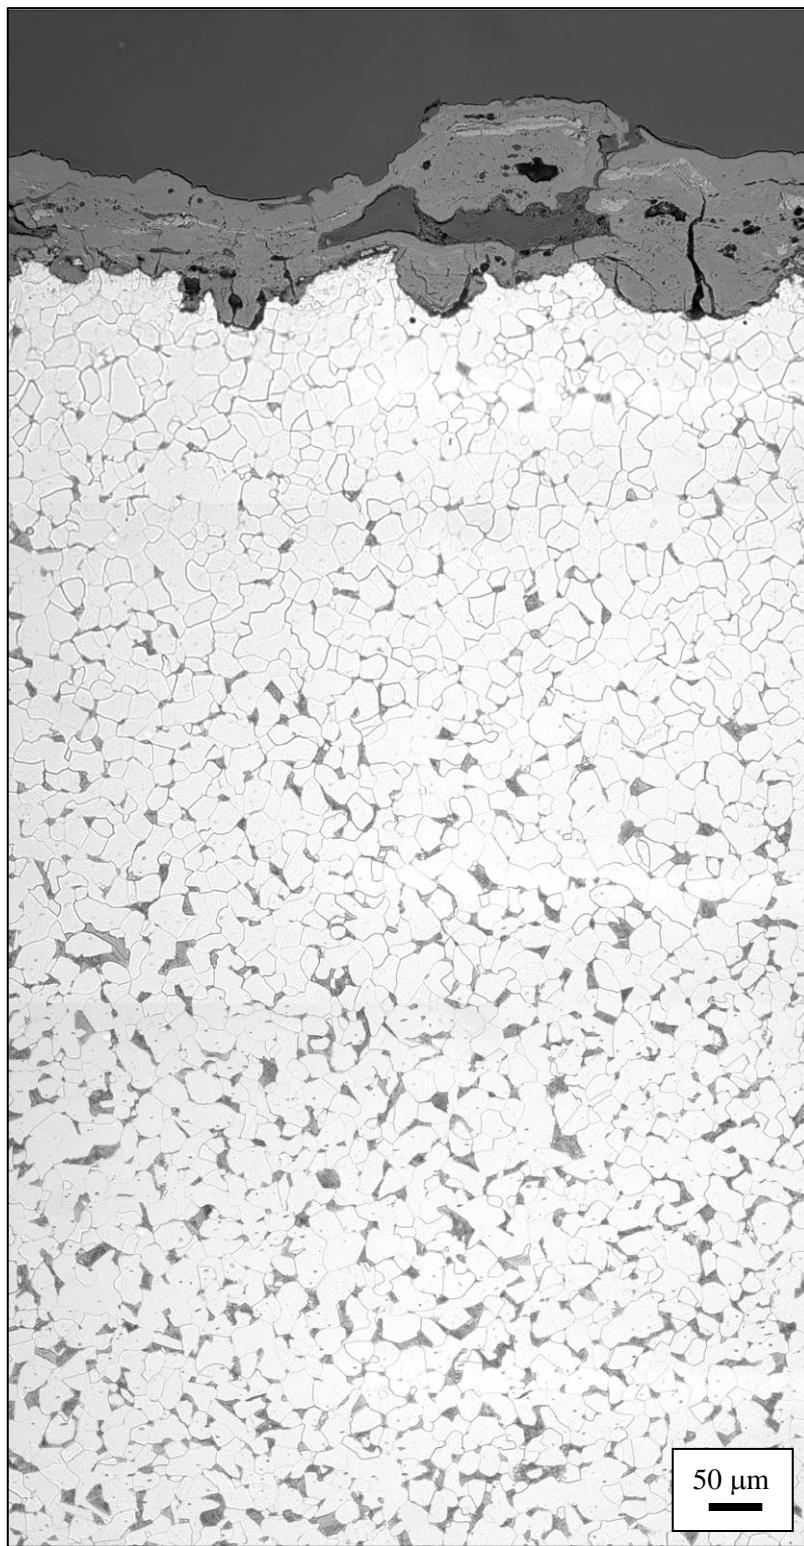
**Figure 6–10. Change in microstructure of a 42 ksi spandrel plate that was heat treated in a laboratory furnace at  $625\text{ }^{\circ}\text{C}$  for various times. Pearlite was observed to spheroidize. Sample shown was from panel N-9 (WTC 1, 102nd floor spandrel, near column 154). Two percent nital and 4 percent picral etch.**

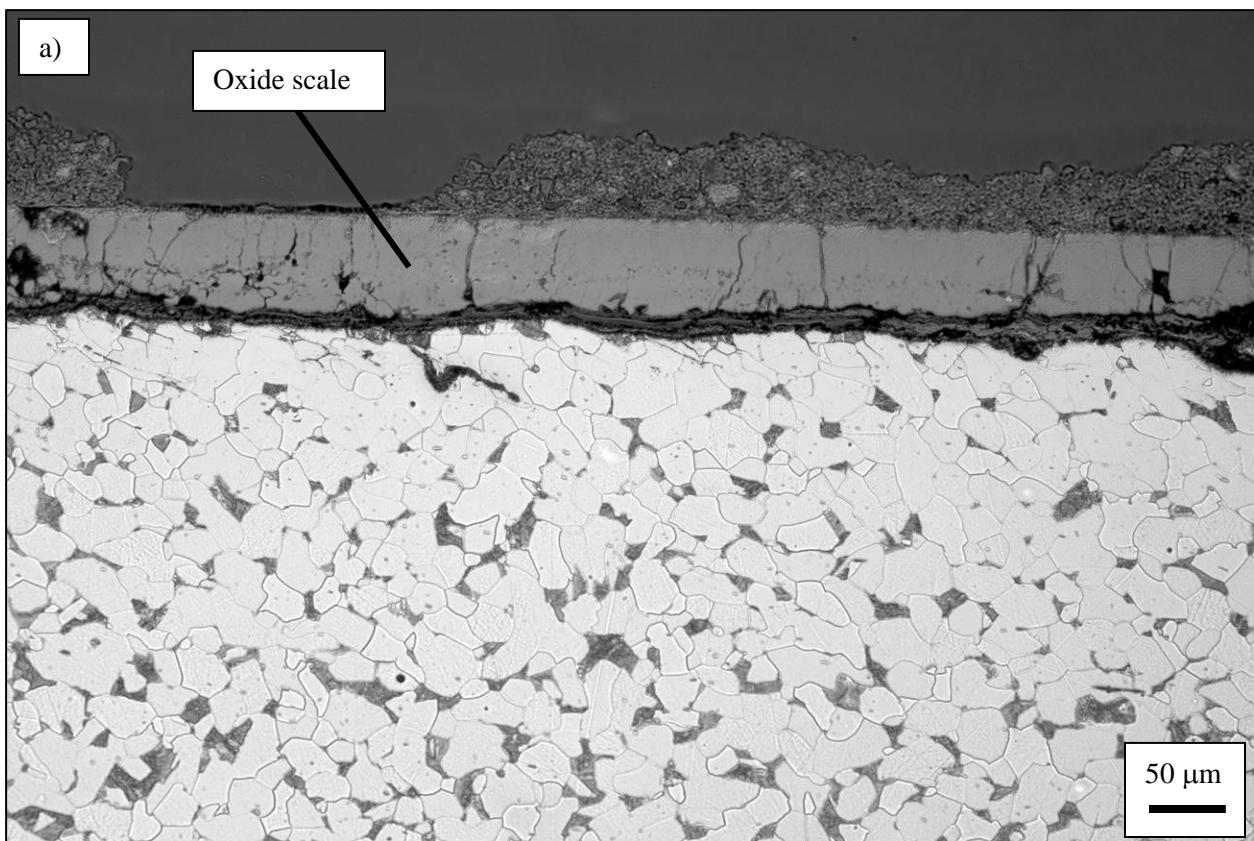
**Figure 6–11.** Light optical micrograph showing the partially decarburized zone found near the surface of a perimeter floor truss seat from directly above the airplane impact on the 99th floor of WTC 1, panel M-2 (A130: 96-99). Two percent nital and 4 percent picral etch.

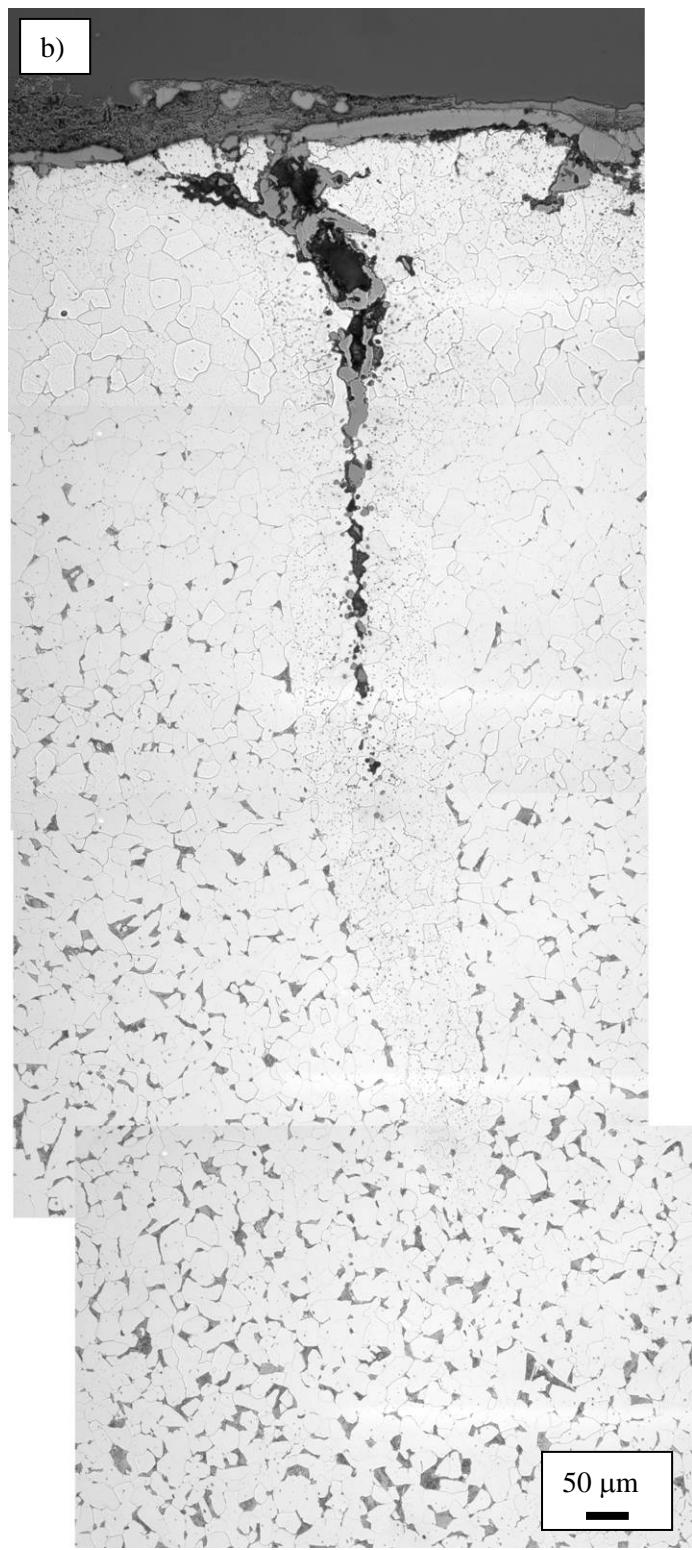
**Figure 6–12. Light optical micrographs of the microstructure of a perimeter floor truss seat from the 99th floor of WTC 1, panel N-8 (A142: 97-100). a) Ferrite-pearlite microstructure and developed oxide scale. Two percent nital and 4 percent picral etch.**

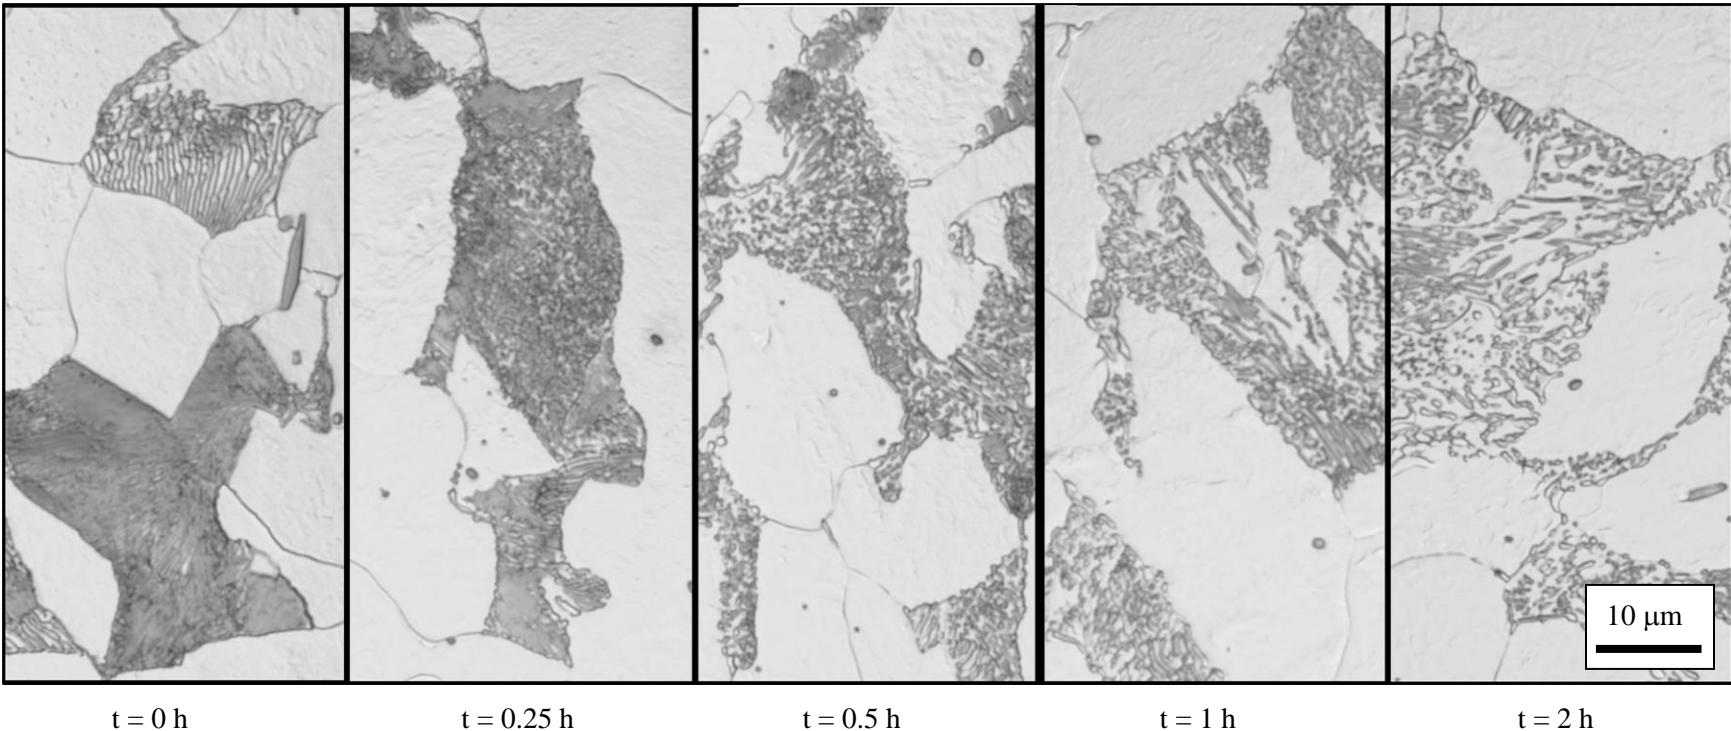
**Figure 6–12. Light optical micrographs of the microstructure of a perimeter floor truss seat from the 99th floor of WTC 1, panel N-8 (A142: 97-100). b) penetration of the iron oxide phase with internal oxidation and decarburization fronts possibly due to elevated temperature exposure. Two percent nital and 4 percent picral etch (cont.).**

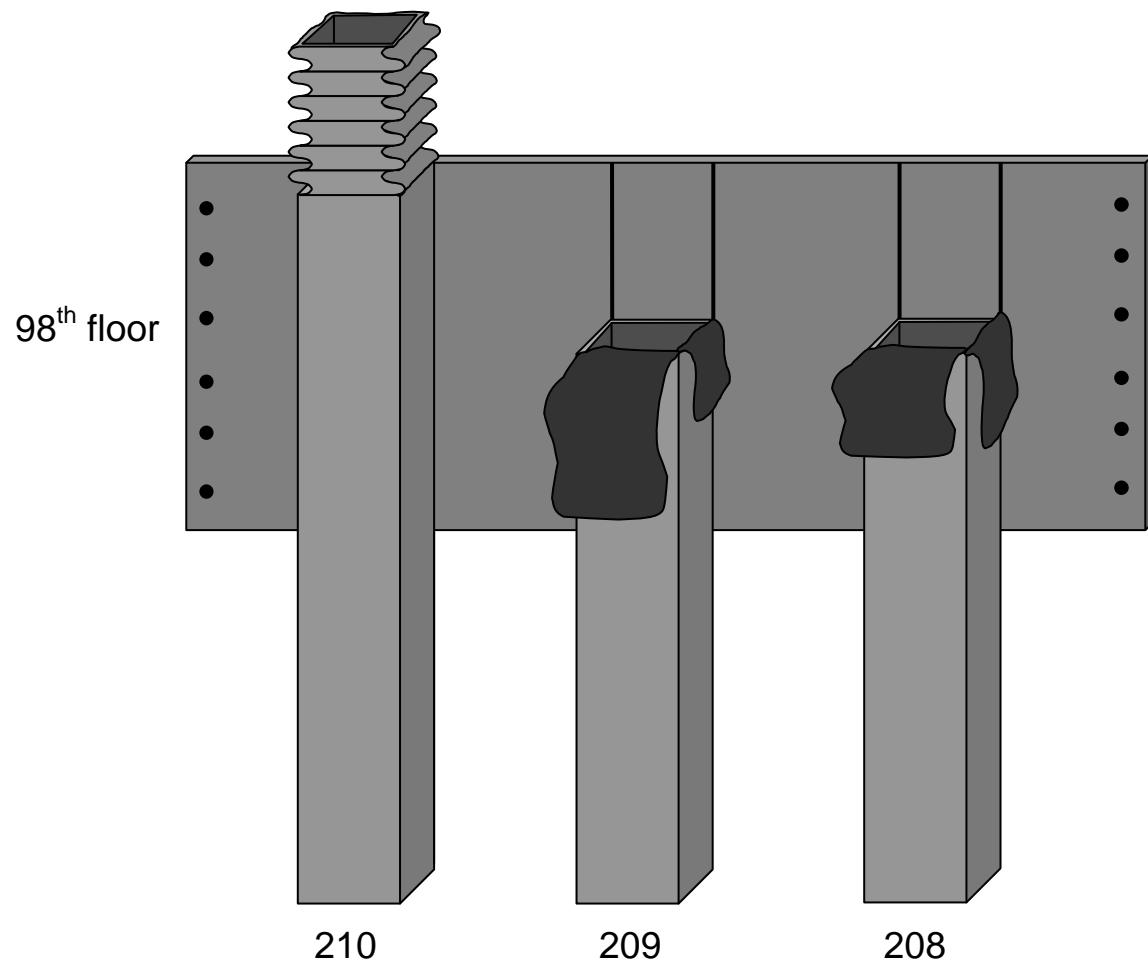
**Figure 6–14. Panel K-1 from the east face of WTC 1 (A209: 97-100). a) Schematic showing the damage to the panel when viewed from outside the building looking inward.**

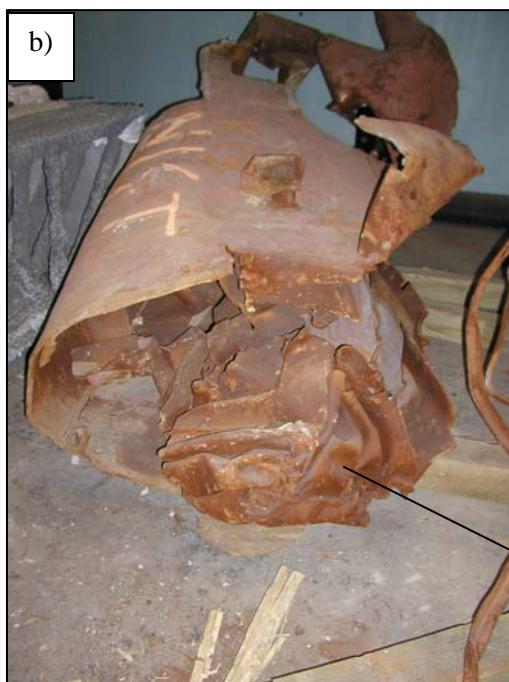
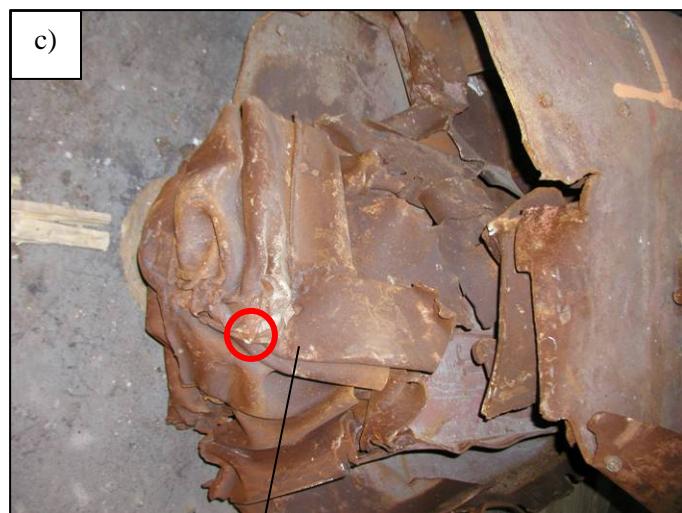
Column 210 in the 98th floor level

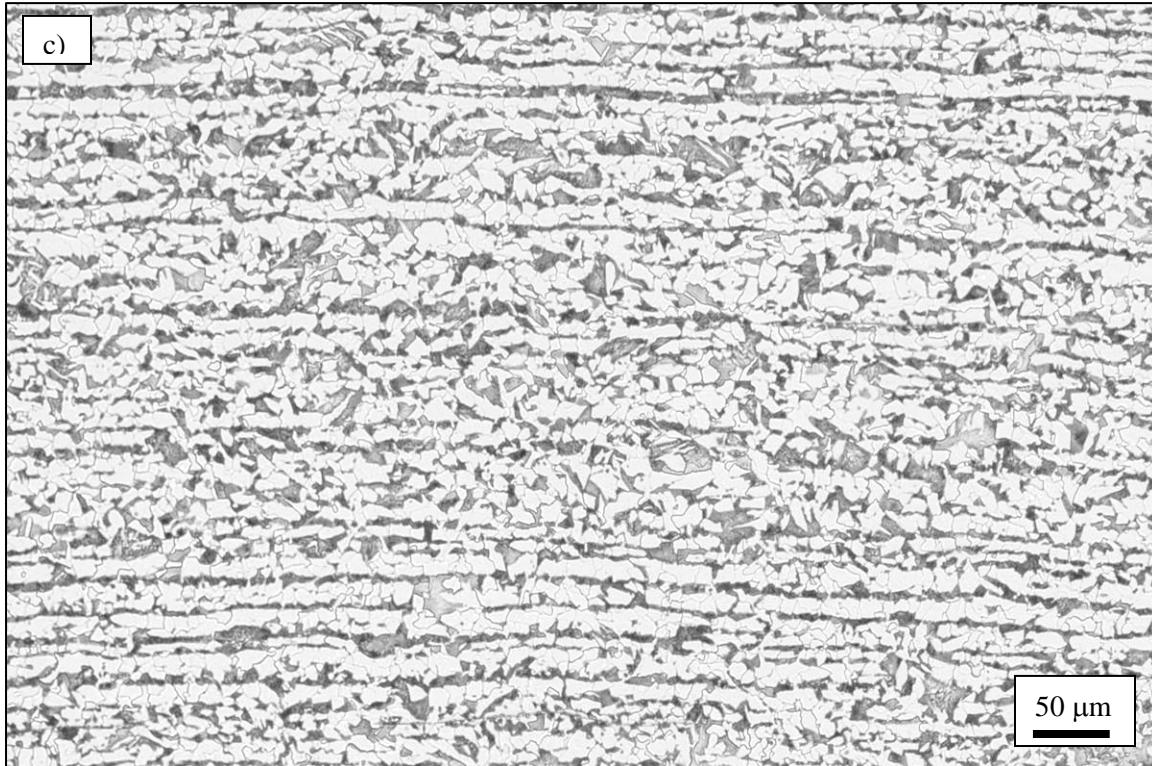
**Figure 6–16.** Images from a flange of column 210 of panel K-1 (A209: 97-100) from the crumpled area above the 98th floor spandrel. a) Location of micrographs taken on the bent sample, b) light optical micrograph of the outer surface of the sample showing elongated grains. Two percent nital and 4 percent picral etch.

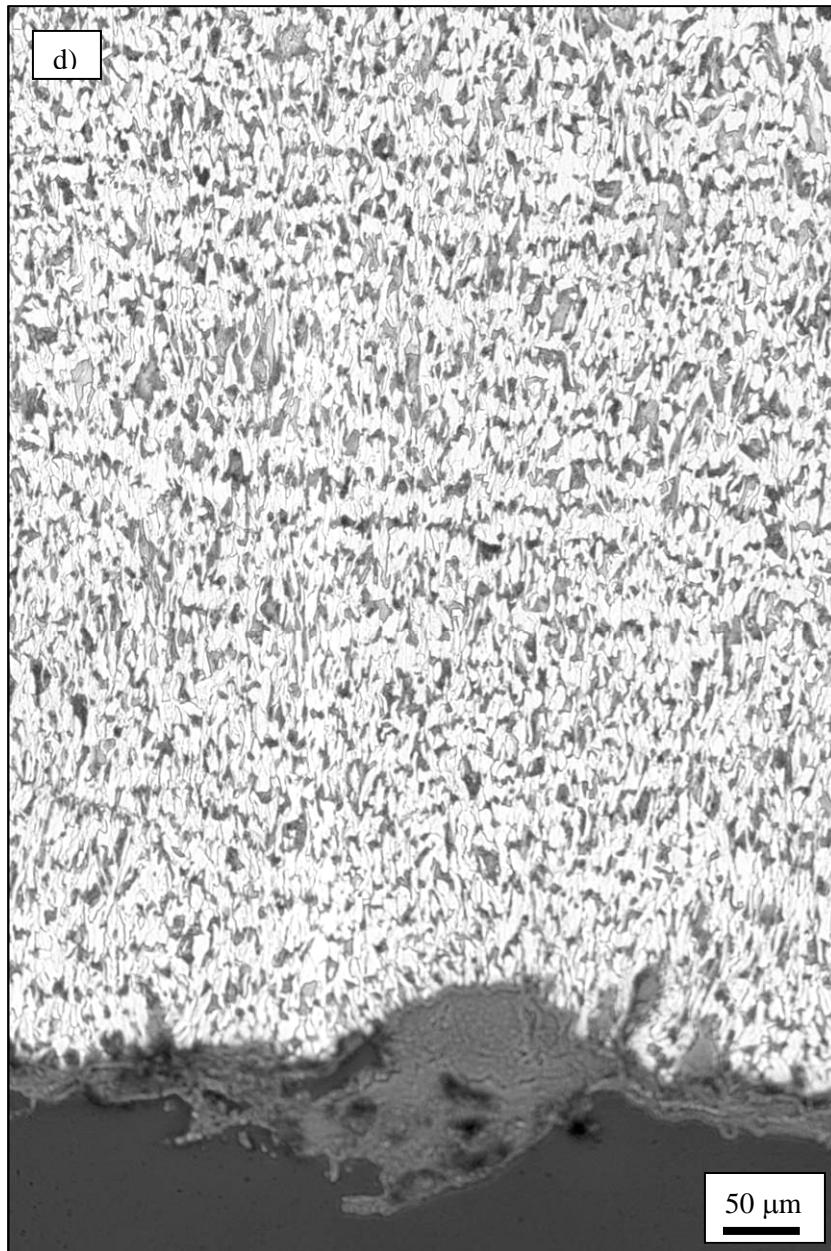
**Figure 6–16.** Light optical micrographs showing the microstructure from flange of column 210 of panel K-1 (A209: 97-100) from the crumpled area above the 98th floor spandrel. c) centerline of plate showing relatively undeformed grains of blocky ferrite and pearlite colonies. Two percent nital and 4 percent picral etch.

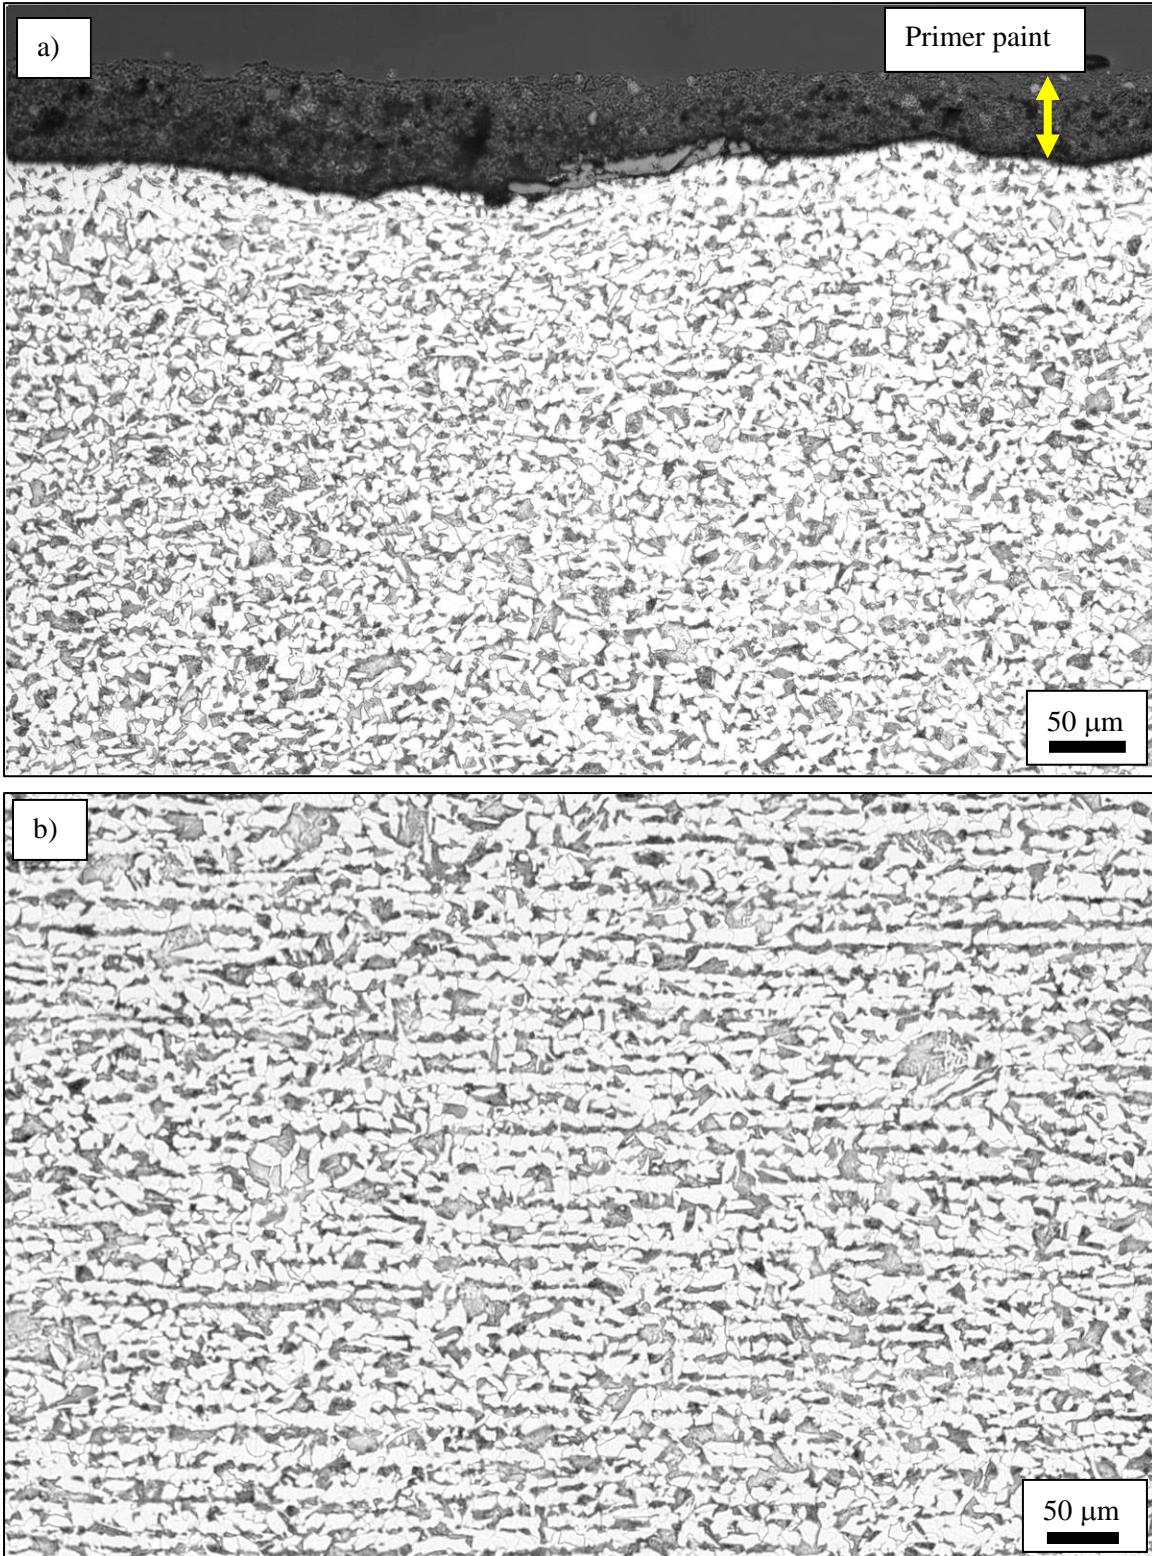
**Figure 6–16.** Light optical micrographs showing the microstructure from flange of column 210 of panel K-1 (A209: 97-100) from the crumpled area above the 98th floor spandrel. d) inner surface of plate showing compressed constituents of ferrite and pearlite. Two percent nital and 4 percent picral etch.

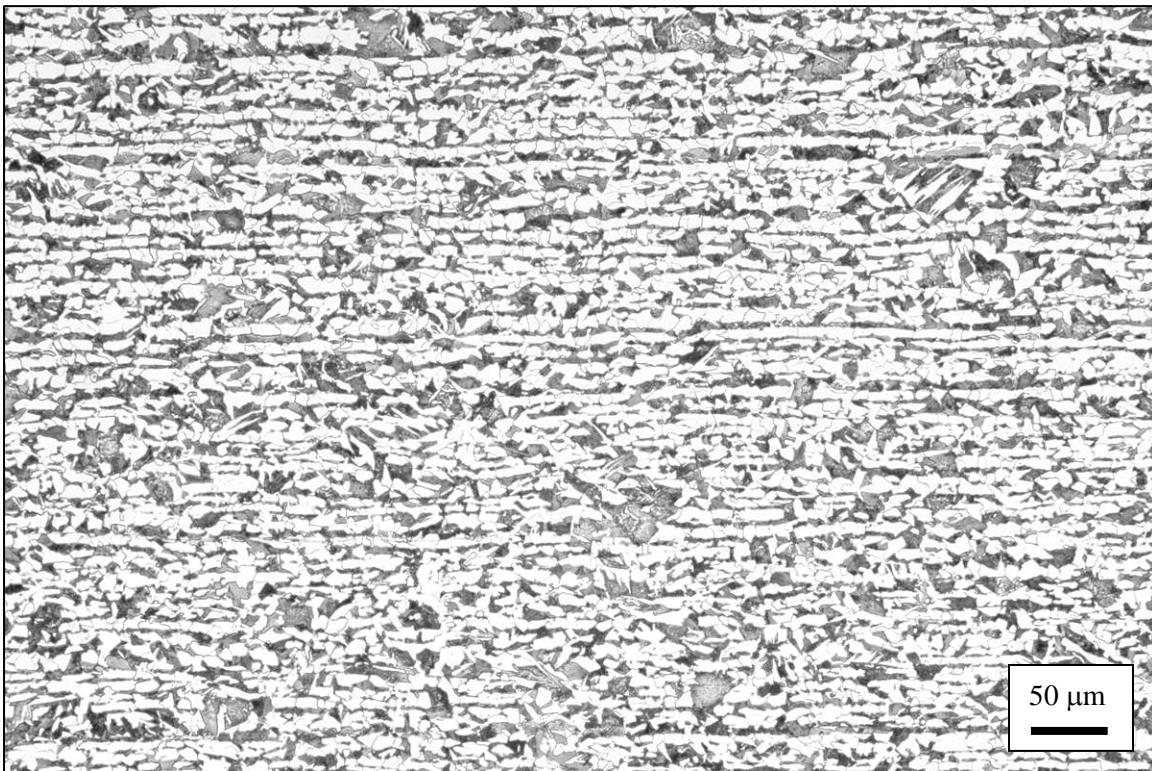
**Figure 6-17.** Light optical micrographs showing microstructure from flange of column 210 of panel K-1 (A209: 97-100) from the flange below the 98th floor spandrel. a) outer surface of sample and b) center line of plate. Two percent nital and 4 percent picral etch.

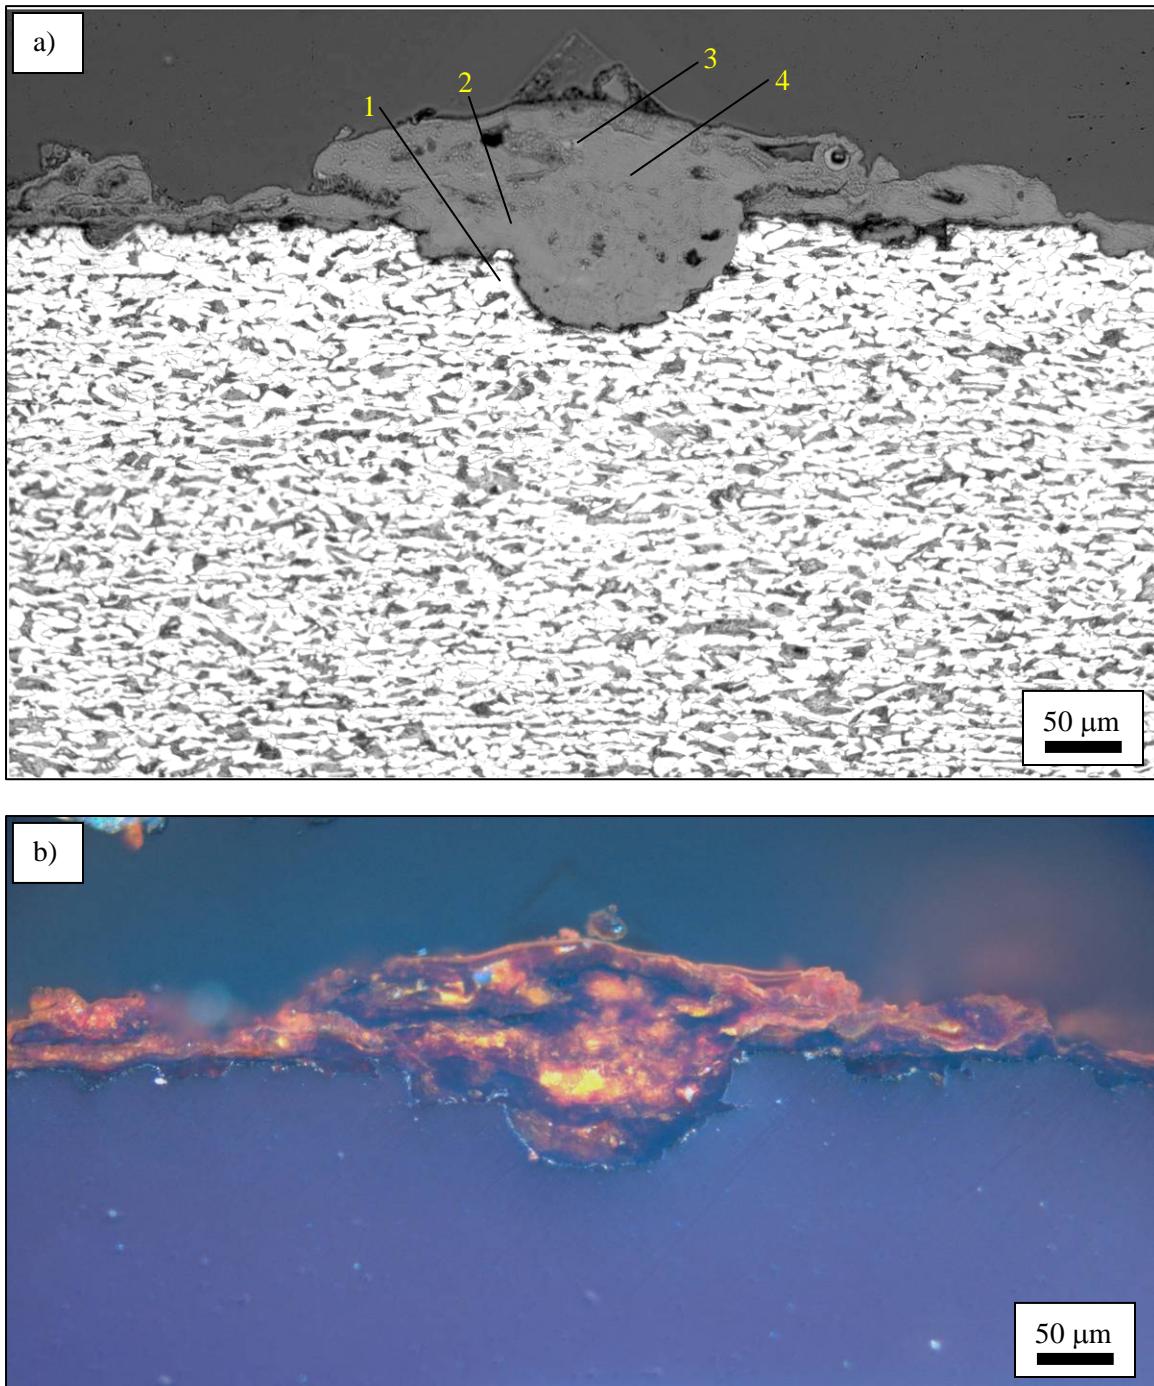
**Figure 6–18.** Light optical micrograph showing a characteristic microstructure taken at the centerline of a 60 ksi outer web plate. Sample is from panel C-40 (A136: 98-101), column 136 in the 99th floor region of WTC 1. Two percent nital and 4 percent picral etch.

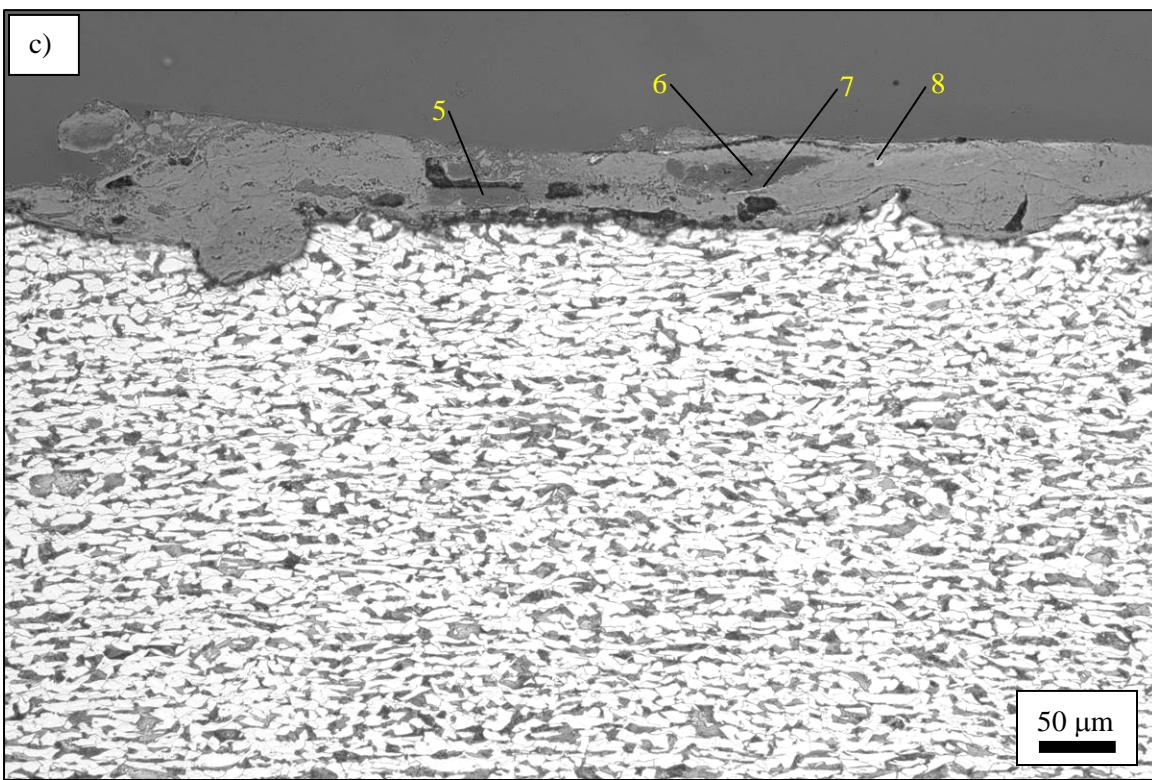
**Figure 6-19. Light optical micrographs showing microstructure from flange of column 210 of panel K-1 (A209: 97-100) from the crumpled area above the 98th floor spandrel.**  
**a)** Characteristic scale formation, 2 percent nital and 4 percent picral etch. **b)** same area, as polished, using polarized light.

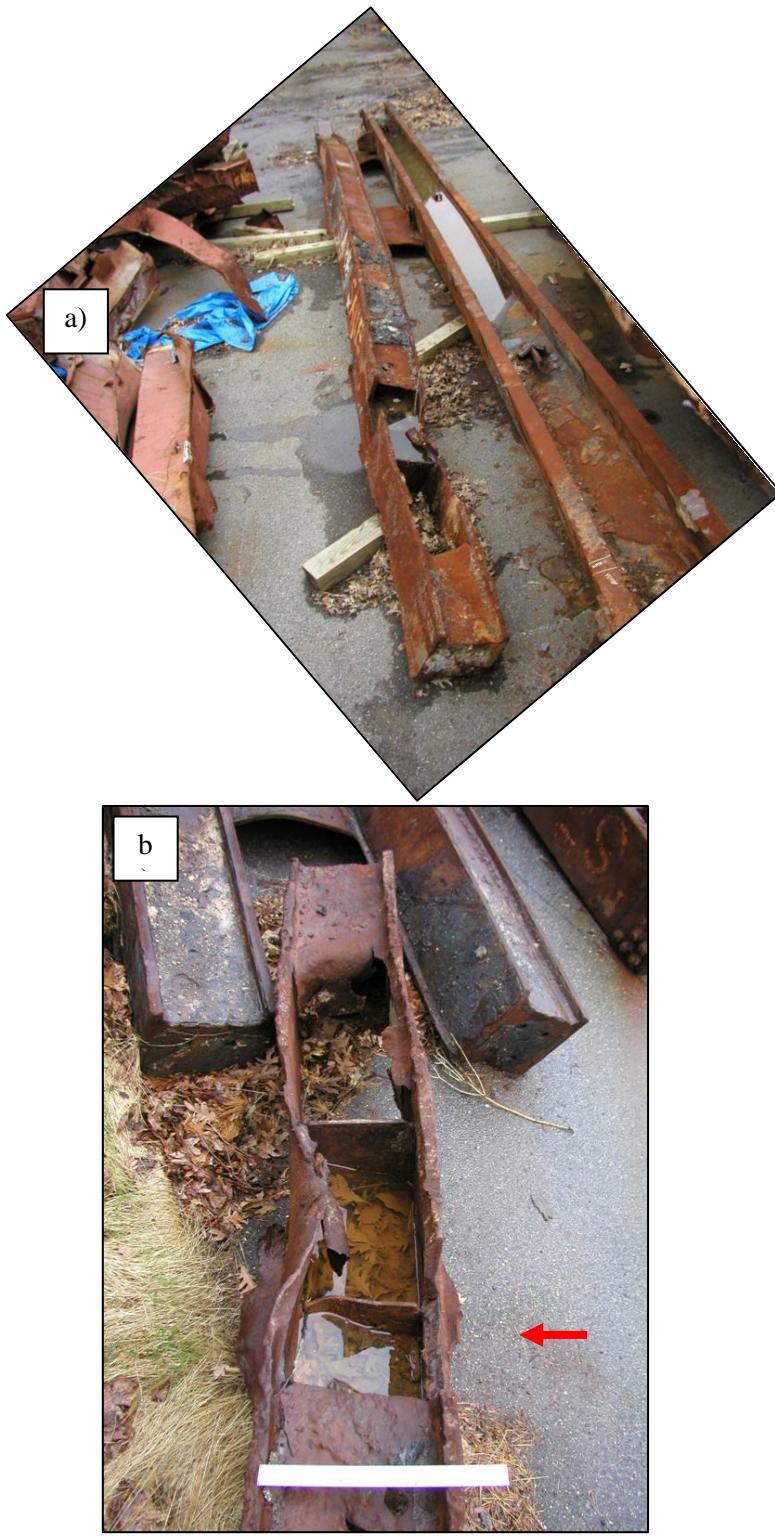
**Figure 6–19.** Light optical micrographs showing microstructure from flange of column 210 of panel K-1 (A209: 97-100) from the crumpled area above the 98th floor spandrel. c) Characteristic scale formation. Two percent nital and 4 percent picral etch.
