**Federal Building and Fire Safety Investigation of the  
World Trade Center Disaster**

**Damage and Failure Modes of  
Structural Steel Components**

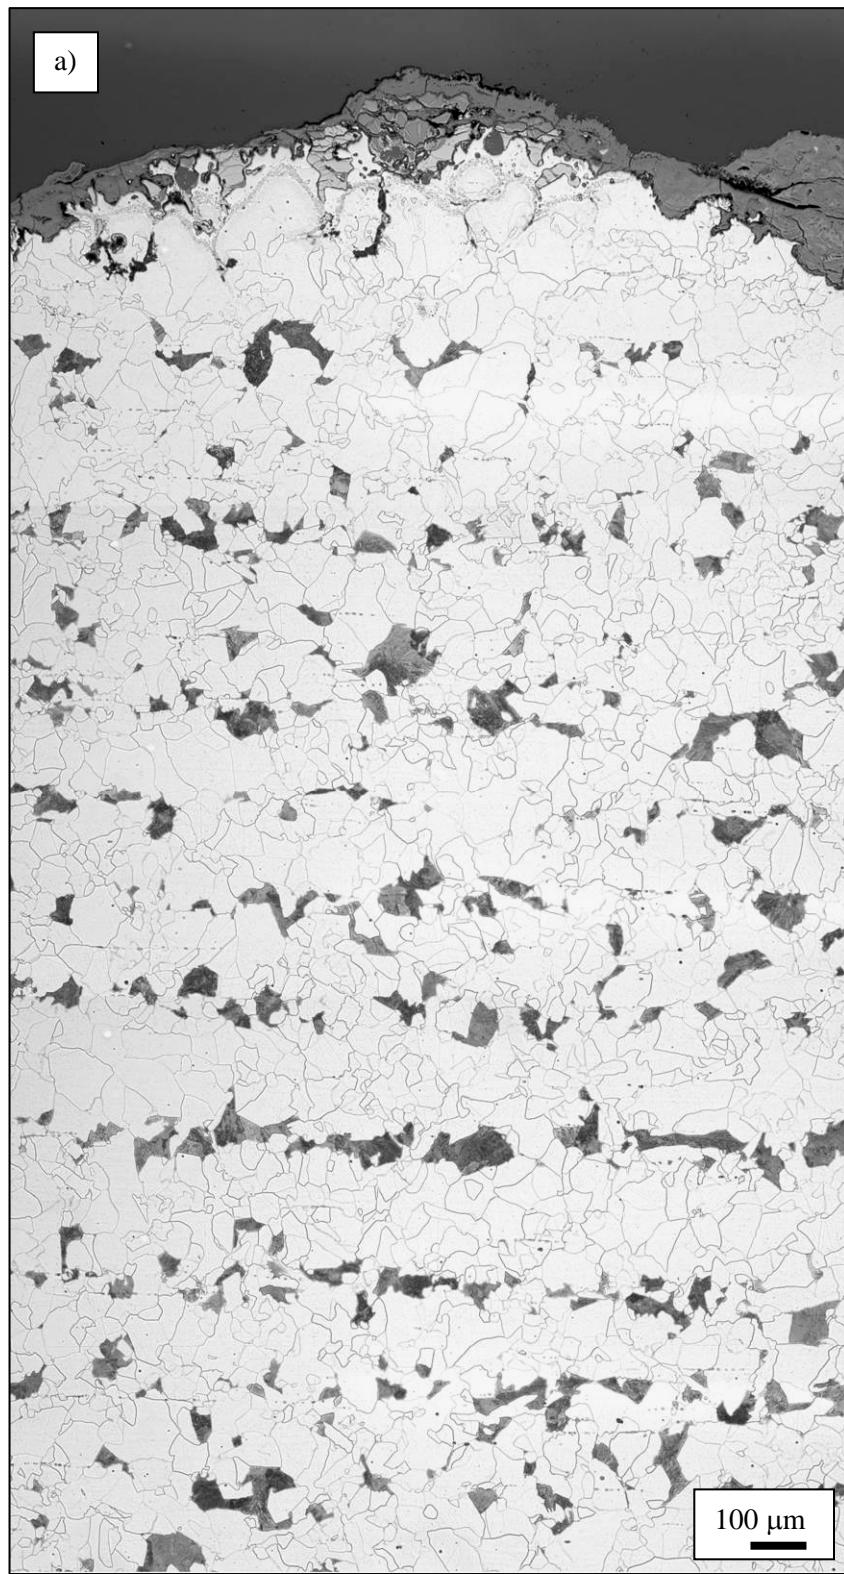
**Figure 6–20. a) Overall image of panel K-16 and b) images showing the deterioration of the column due to erosion/corrosion mechanisms. Red arrow indicates direction of photograph seen in Fig. 6–23.**

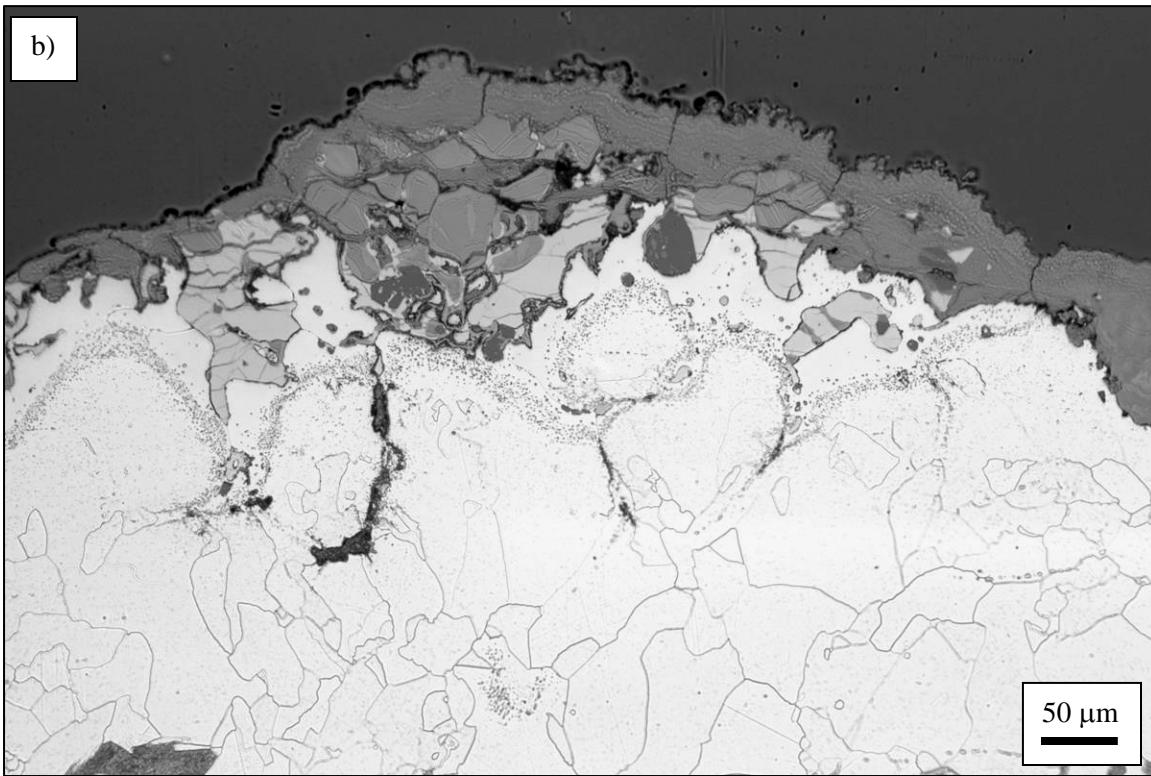
**Figure 6–21. a) Light optical micrograph showing banded structure of the 50 ksi column labeled K-16 near where the extreme corrosion process occurred. As-built location was not known. Two percent nital and 4 percent picral etch.**

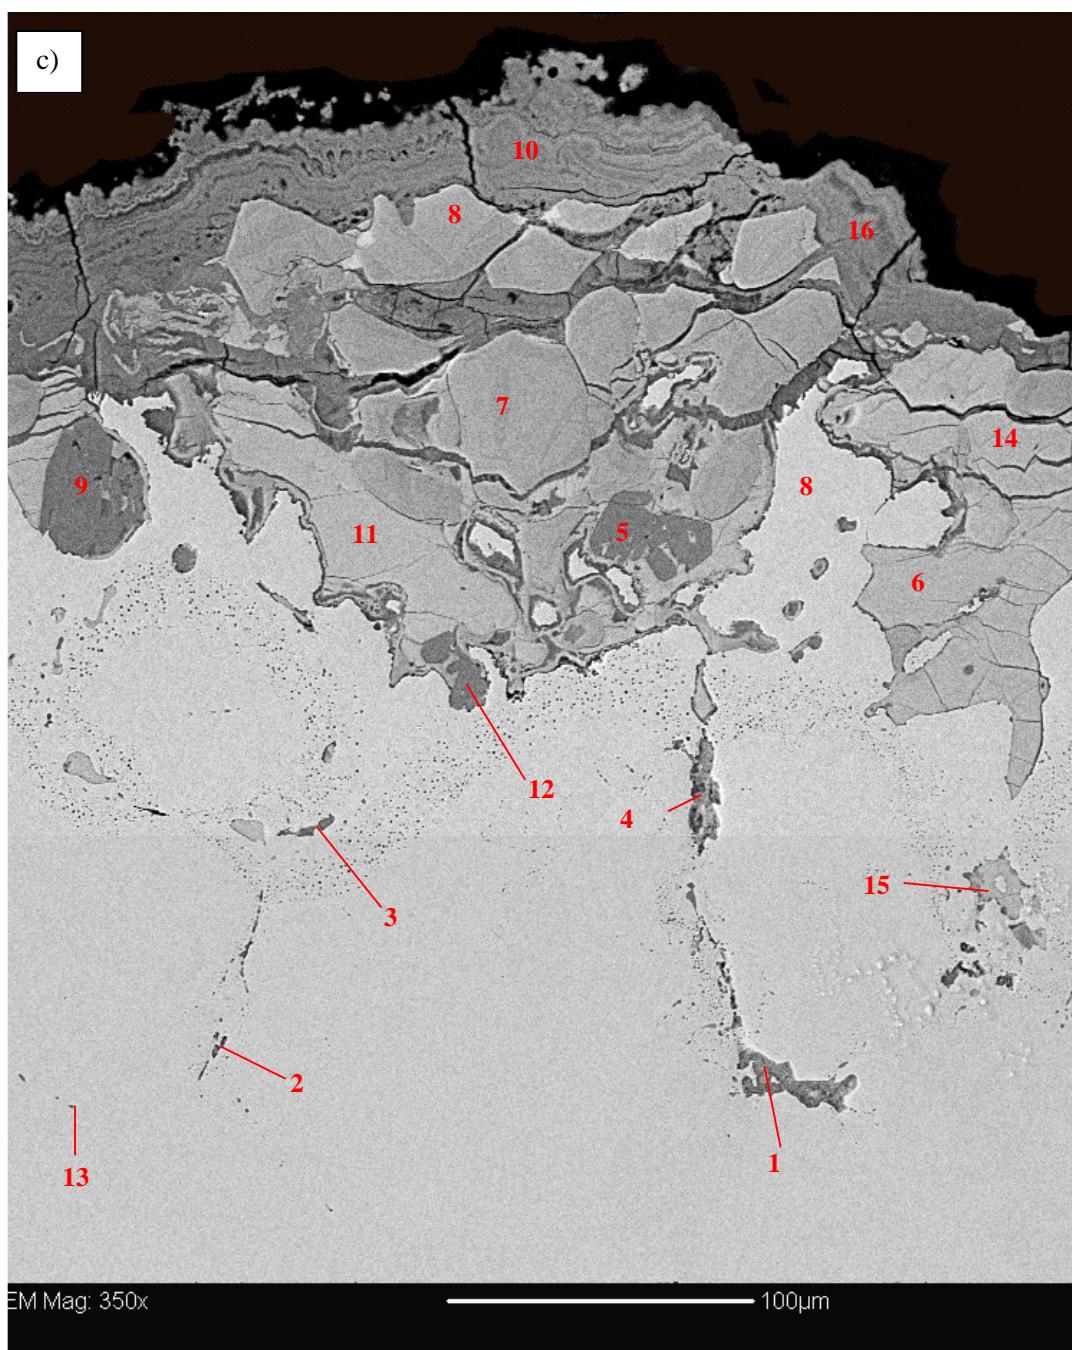
**Figure 6–21. b)** Light optical micrograph showing the microstructure near the metal-scale interface of the 50 ksi column labeled K-16 near where the corrosion process occurred. As-built location was not known. Two percent nital and 4 percent picral etch (cont.).

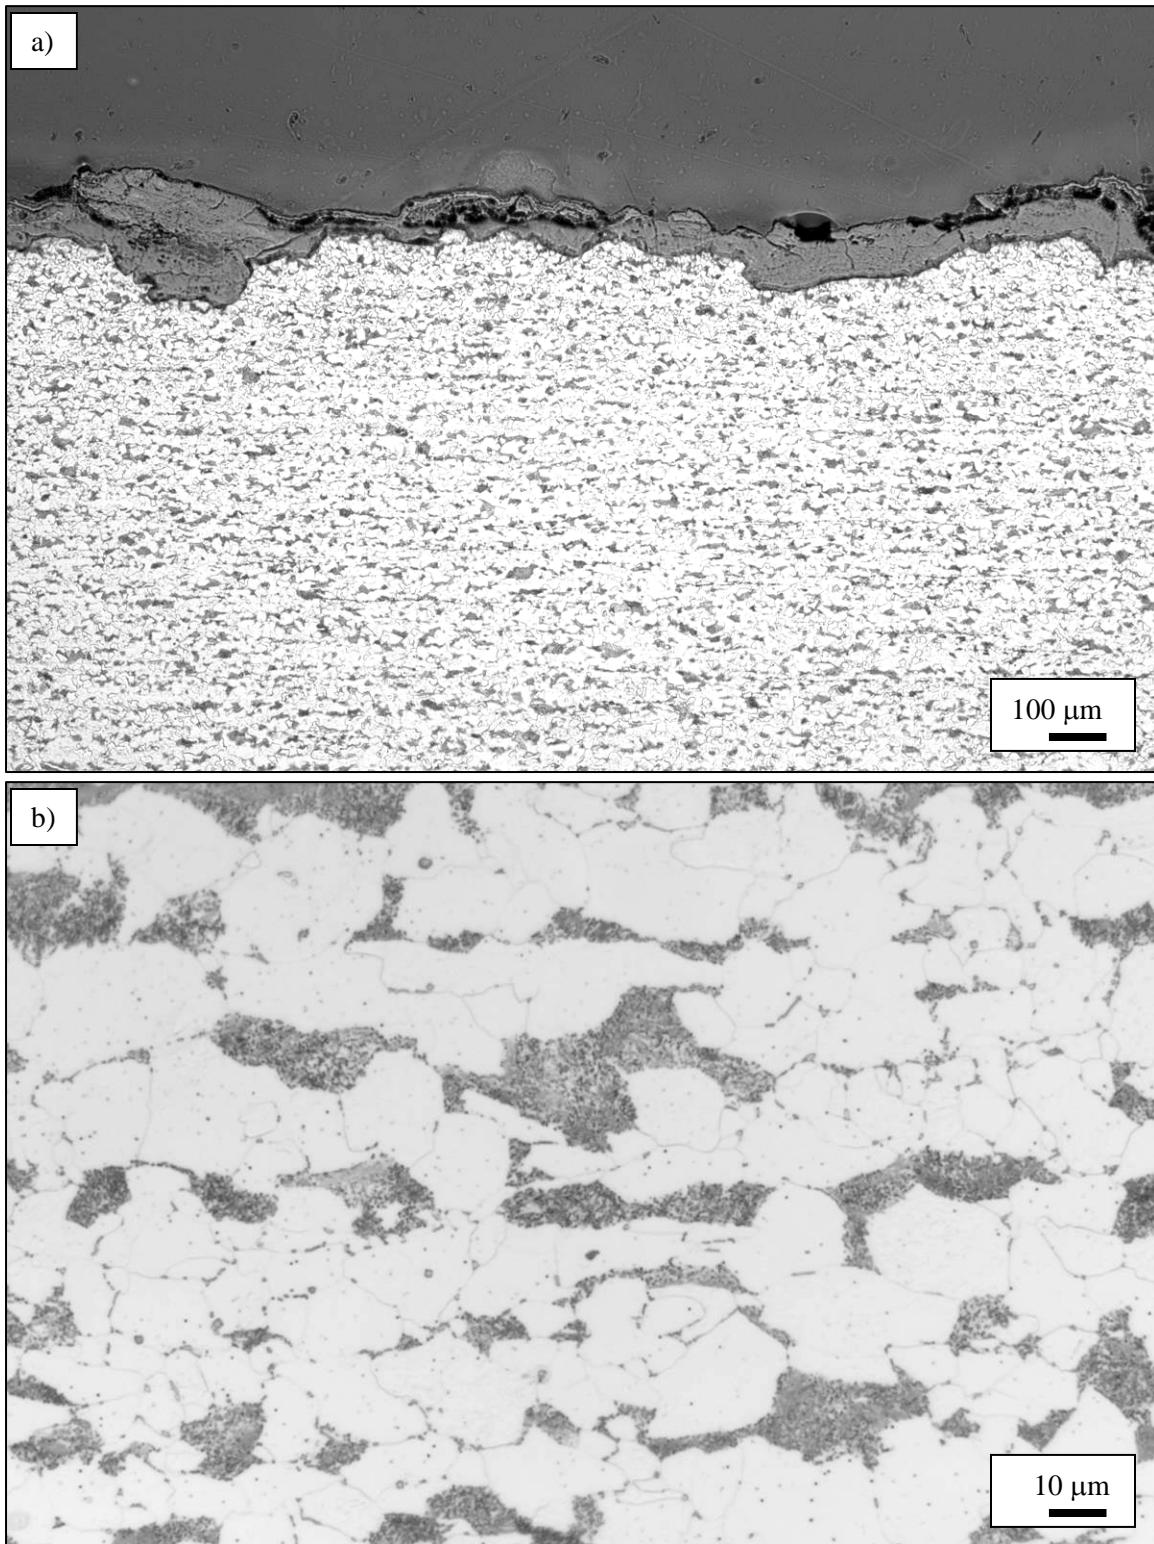
**Figure 6–21. c) Secondary electron micrograph showing corrosion scale formation on panel K-16. As-built location was not known. Sample in the as-polished condition (cont.).**

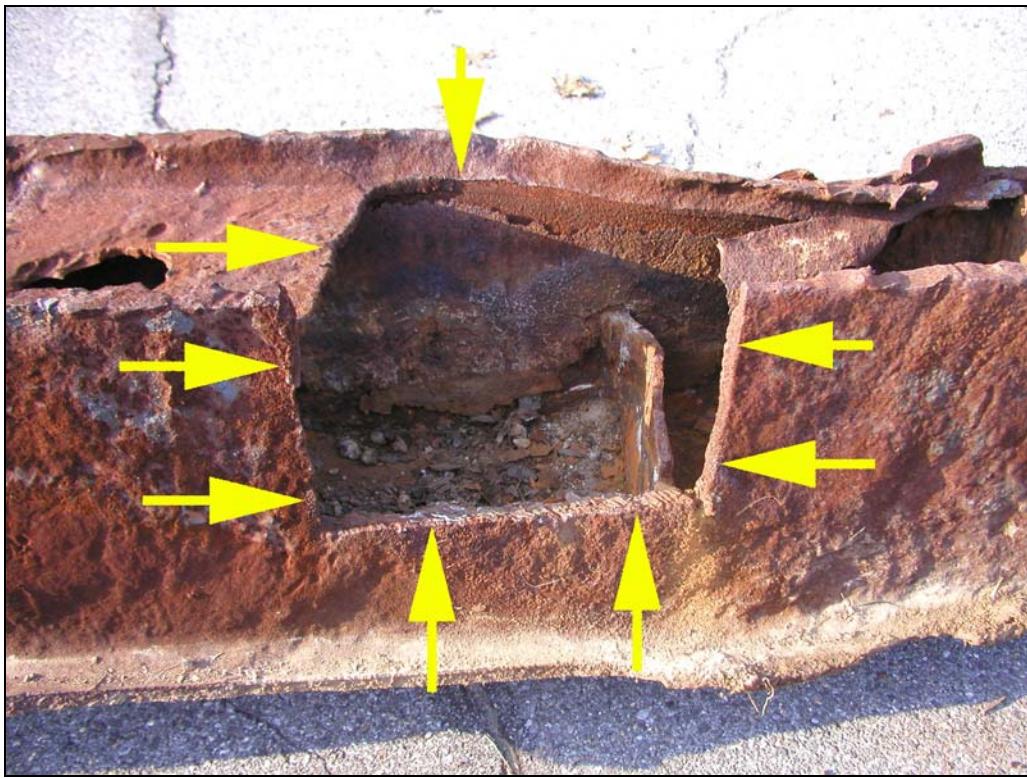
**Figure 6–22. Light optical micrographs showing structure of the 50 ksi column labeled K-16 near the base of the column where the corrosion process did not occur. As-built location was not known. a) low magnification and b) pearlite has begun to spheroidize. Two percent nital and 4 percent picral etch.**

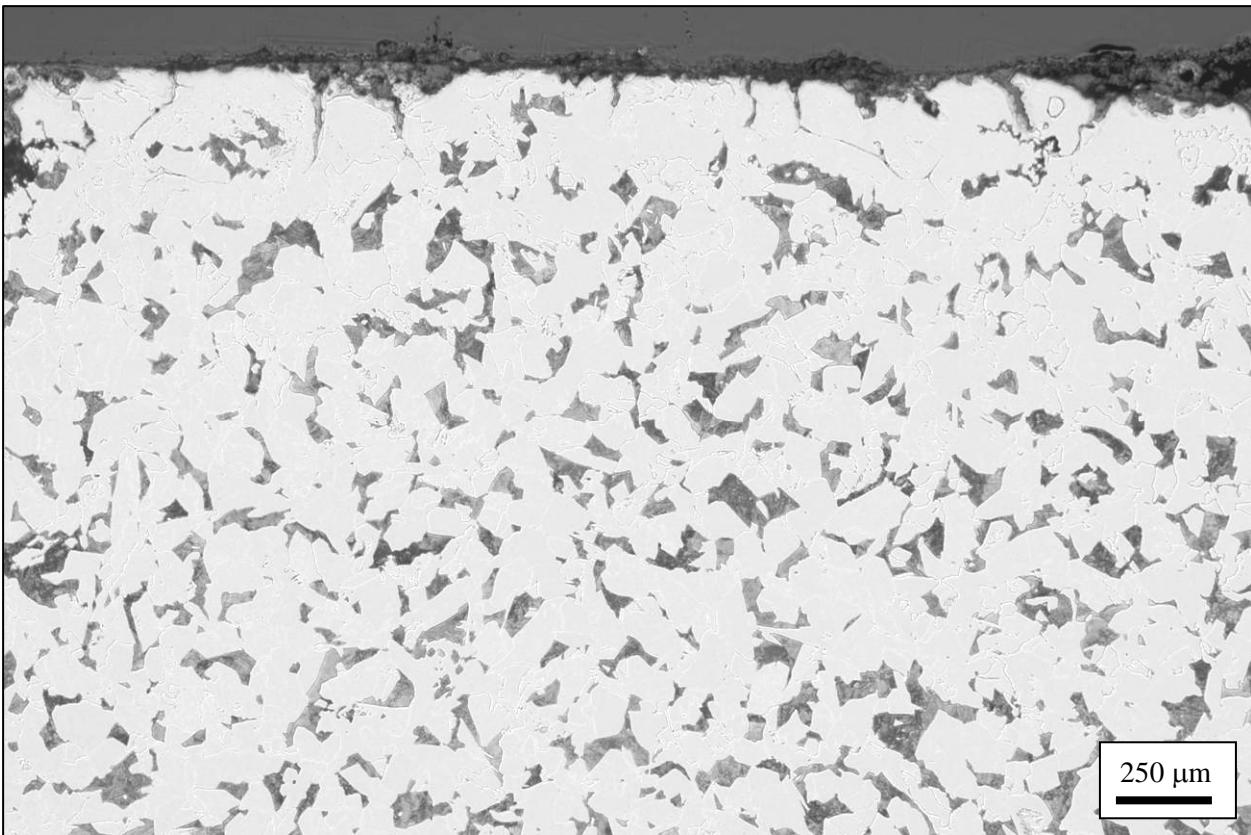
**Figure 6–26. Light optical micrographs showing the structure of a typical A 242 truss rod (sample T1-LR-1). a) Overall structure at 50x, b) Widmanstatten ferrite indicated with arrows. Two percent nital and 4 percent picral etch.**

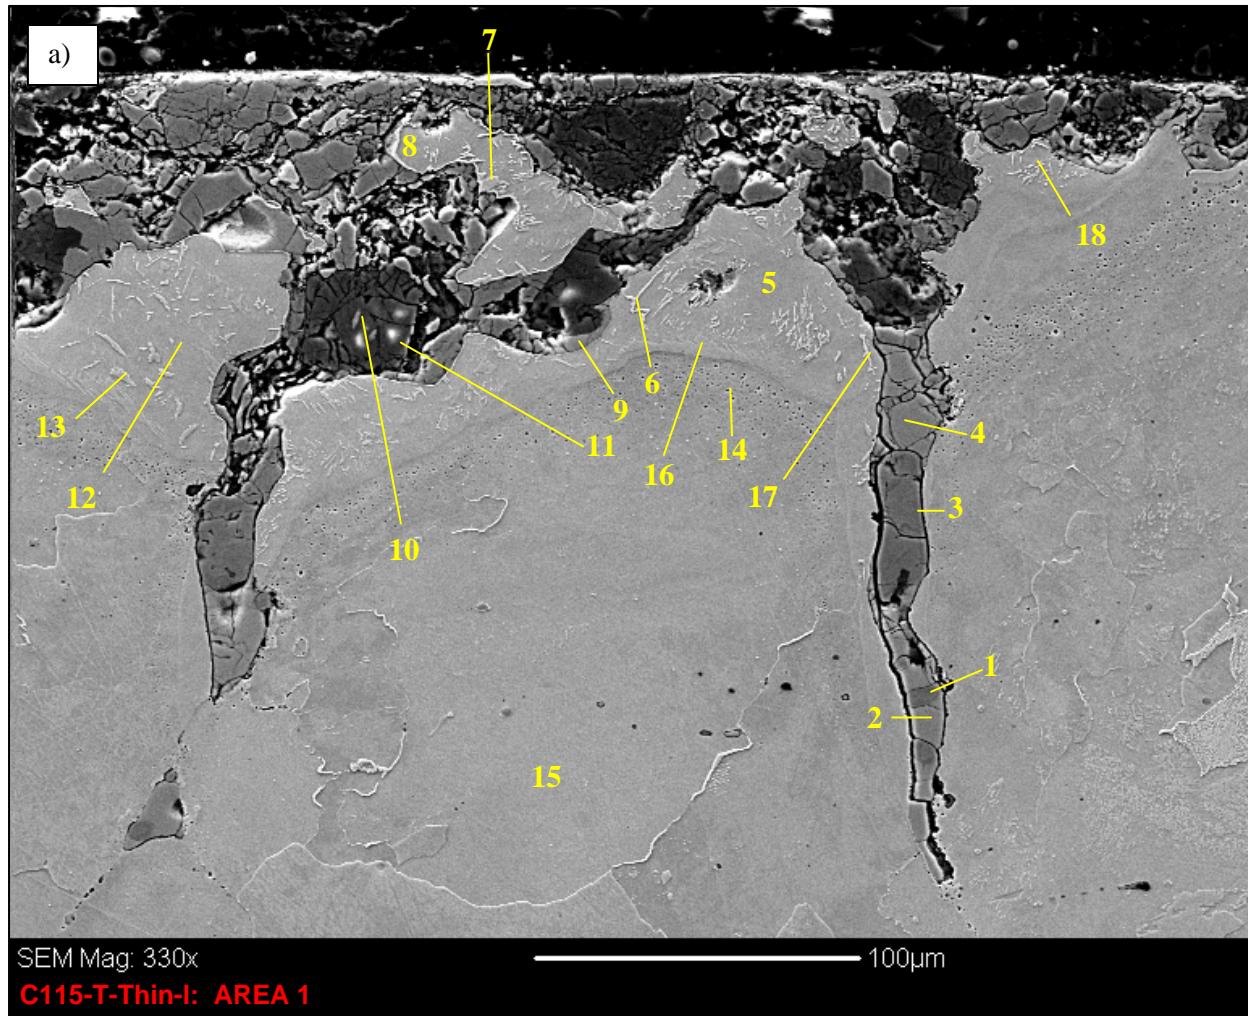
**Figure 6–28. Secondary electron image showing the corrosion scale found on sample C-115. a) The location of EDS analysis (results shown in Table 6–3) were indicated. Two percent nital and 4 percent picral etch.**

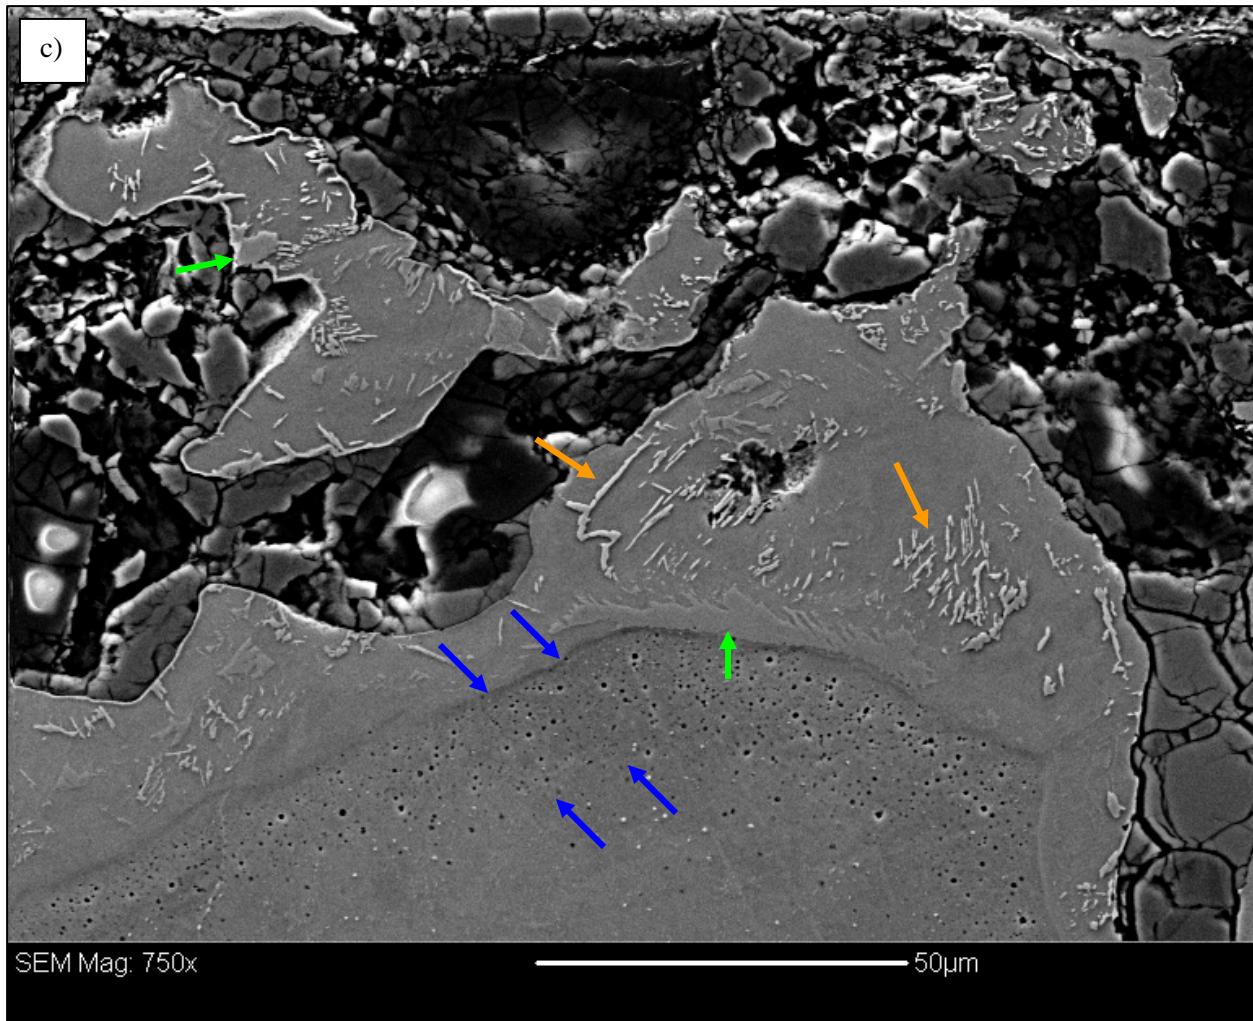
**Figure 6–28. Secondary electron image showing the corrosion scale found on sample C-115. b) yellow arrows indicating the Fe-Ni layer between the penetrating corrosion product and internal oxidation zone. Two percent nital and 4 percent picral etch (cont.).**
