**NIST NCSTAR 1-5A**

**Federal Building and Fire Safety Investigation of the  
World Trade Center Disaster**

# **Visual Evidence, Damage Estimates, and Timeline Analysis**

September 2005

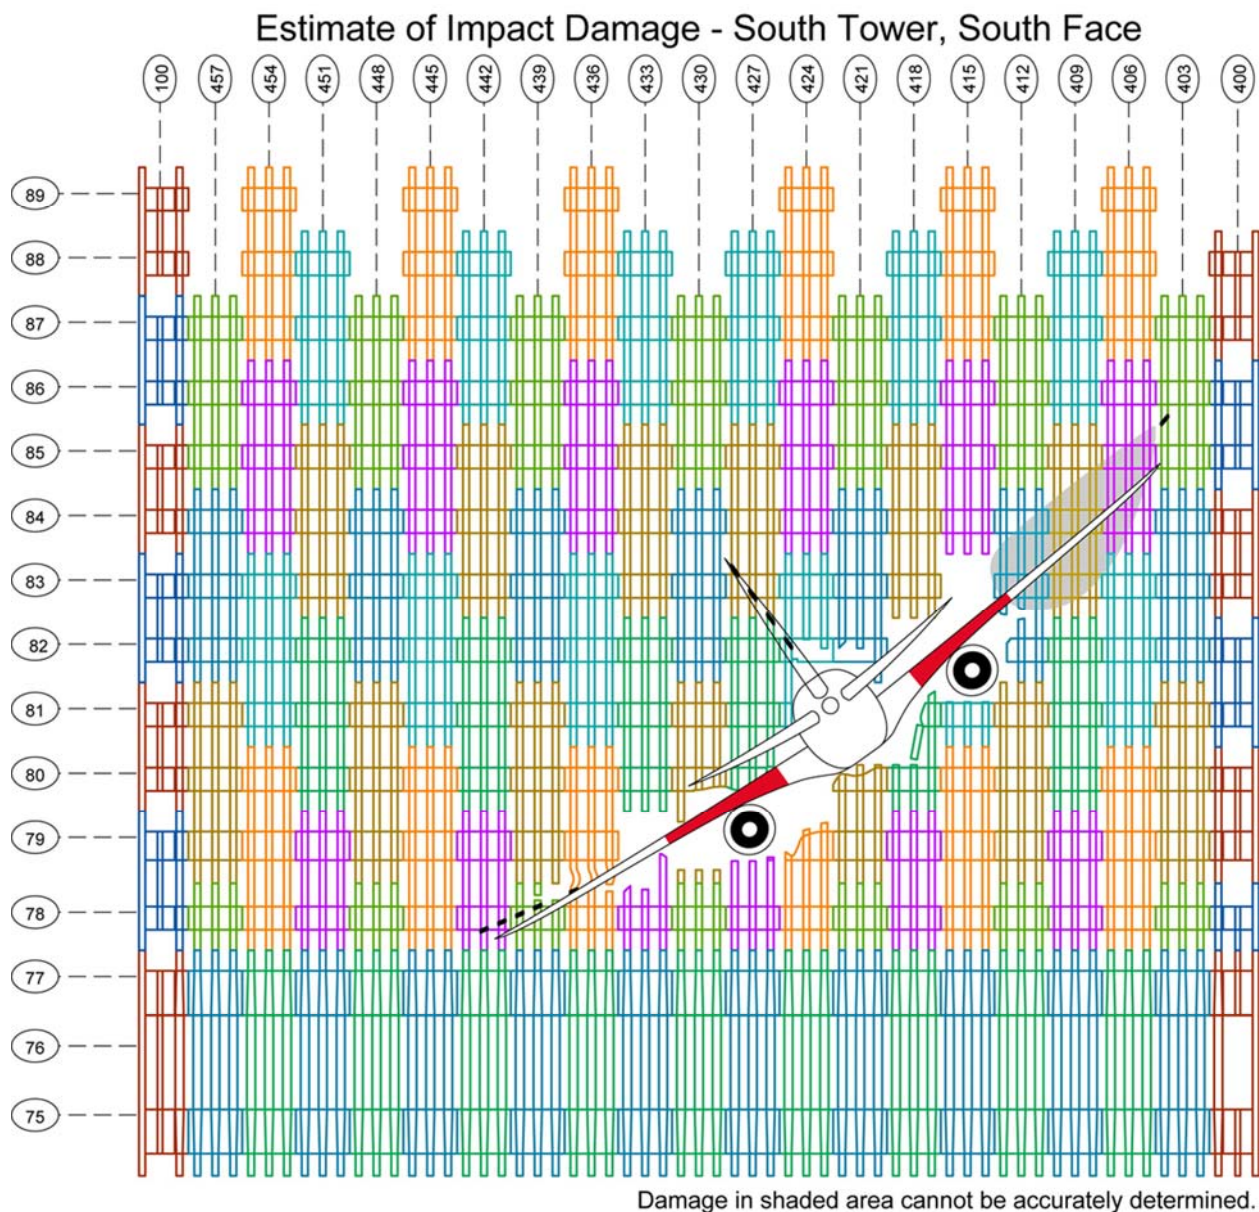
**Figure E-3. A scaled outline of a Boeing 767-200ER is superimposed on the damage diagram for the south face of WTC 2. The position of the aircraft has been adjusted to best match the damage pattern and marks showing where the wing tips and vertical stabilizer struck. The red areas correspond to the approximate locations of fuel on the aircraft based on an analysis reported elsewhere (NCSTAR 1-2B).**

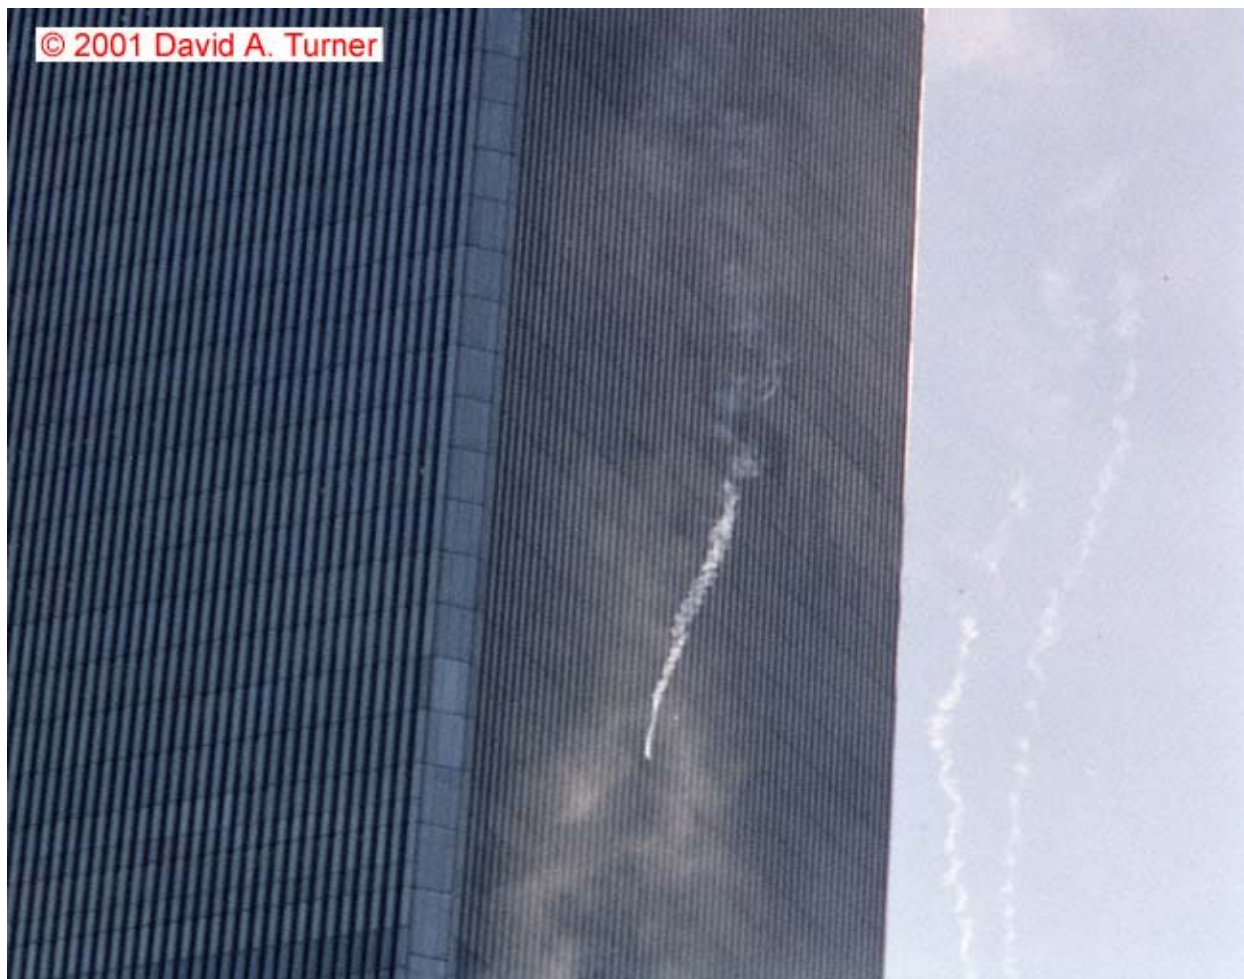
**Figure 5-7. This cropped and enhanced photograph shows the west and south faces of WTC 1. An intense streamer is falling near the south face of the tower, and two additional streamers have already fallen through the image to the south. The exact time of this photograph is unknown.**

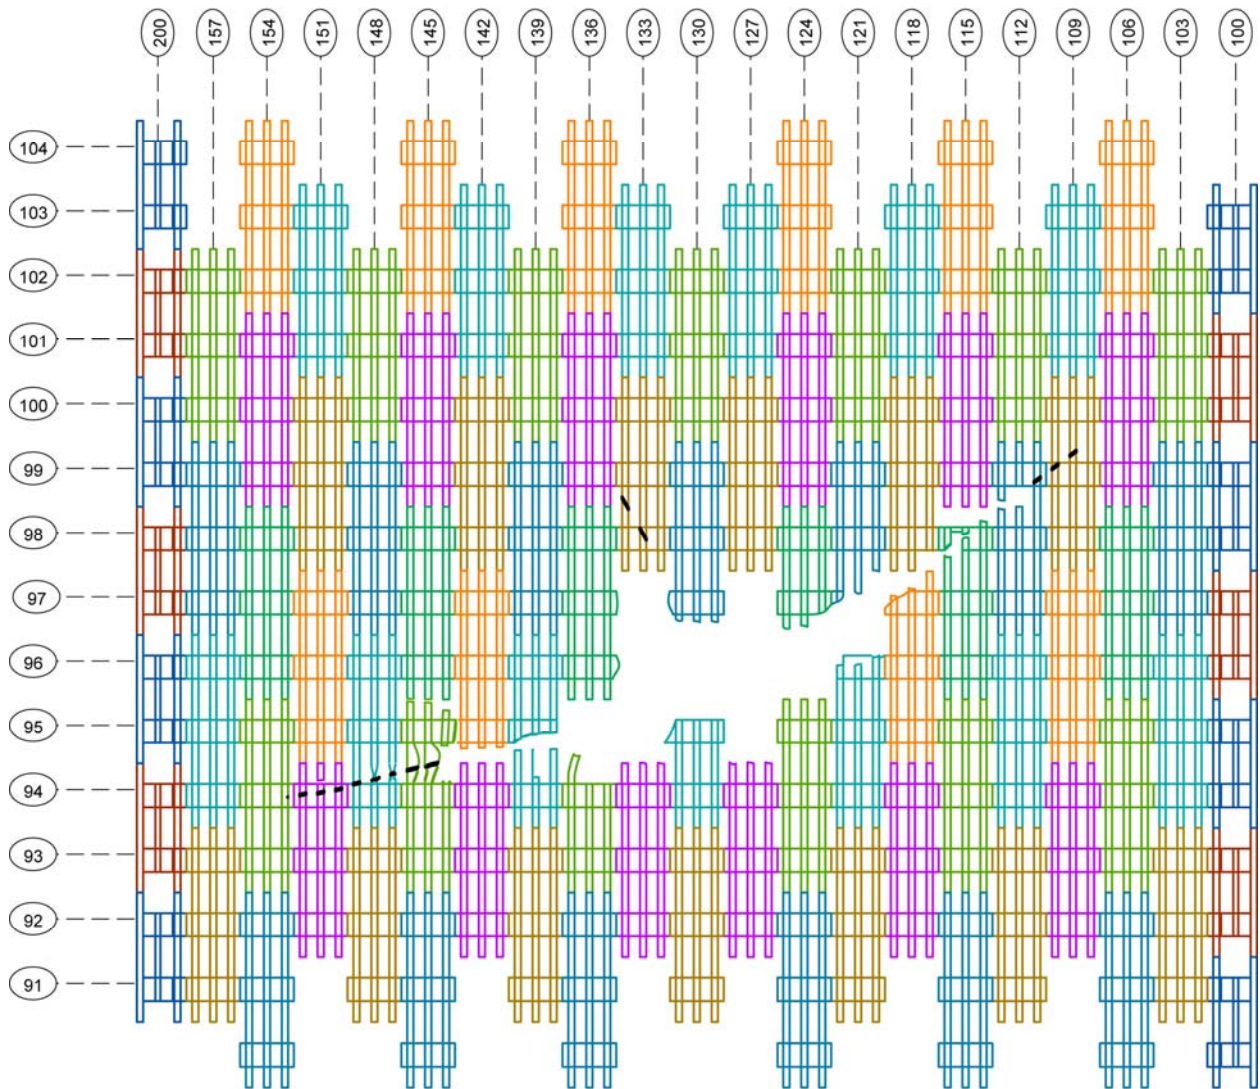
**Figure 6-6. A drawing shows the aircraft impact damage to the steel façade of WTC 1. The dark dotted lines indicate locations where the wings and vertical stabilizer of the aircraft marked the aluminum cladding on columns.**

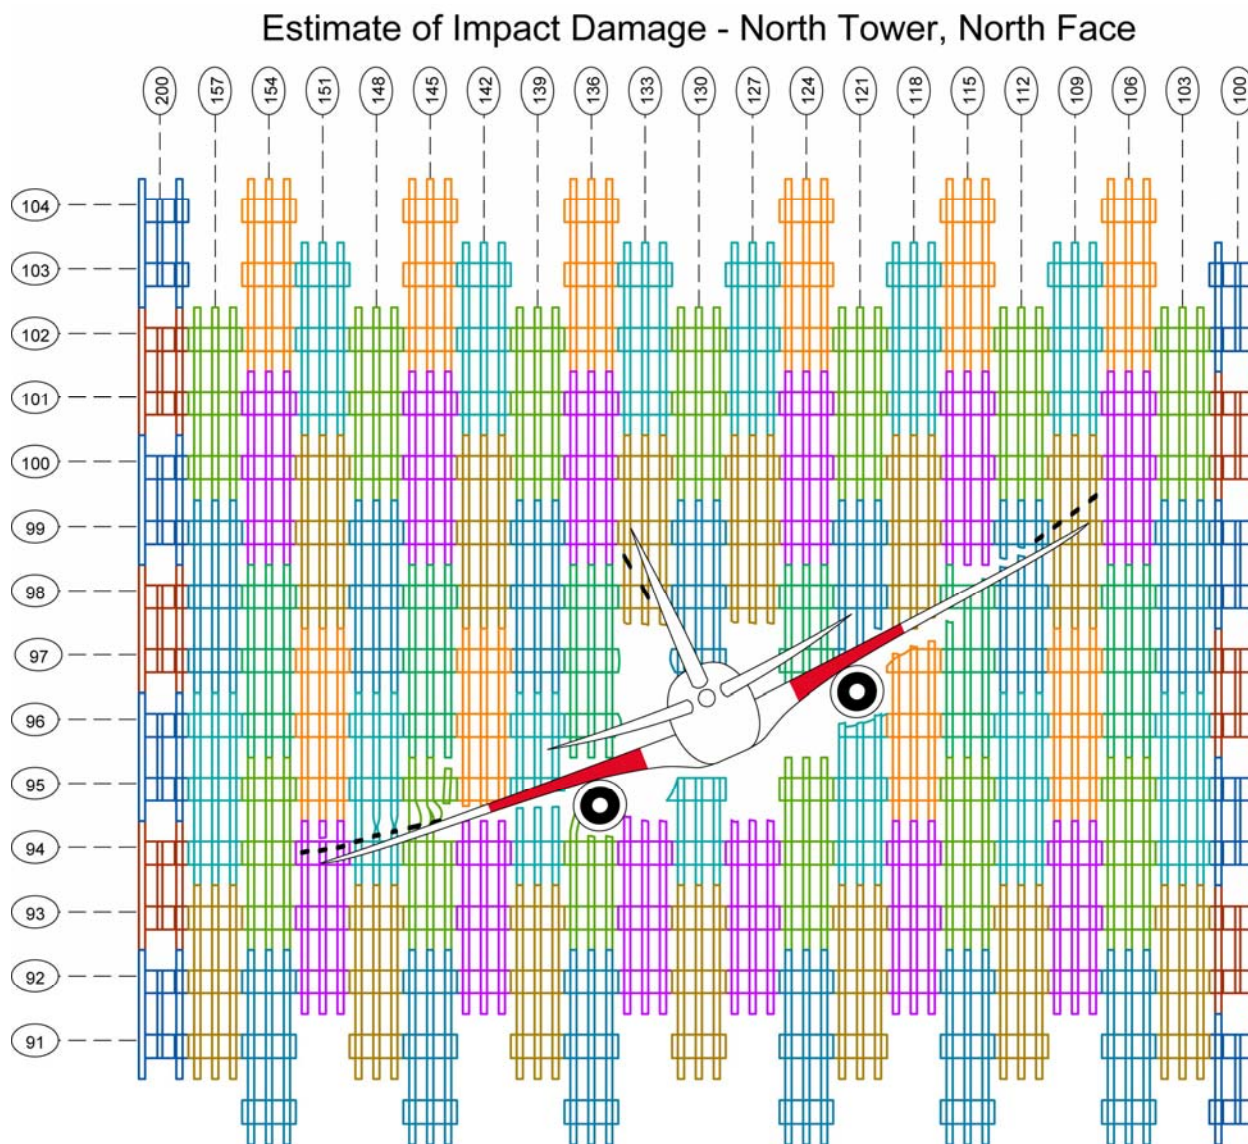
**Figure 6-7. A scaled outline of a Boeing 767-200ER is superimposed on the damage diagram shown in Figure 6-6. The position of the aircraft has been adjusted to give the best match with the damage pattern and marks showing where the wing tips and vertical stabilizer struck. The red areas correspond to the approximate locations of fuel on the aircraft based on an analysis reported elsewhere (NIST NCSTAR 1-2B).**

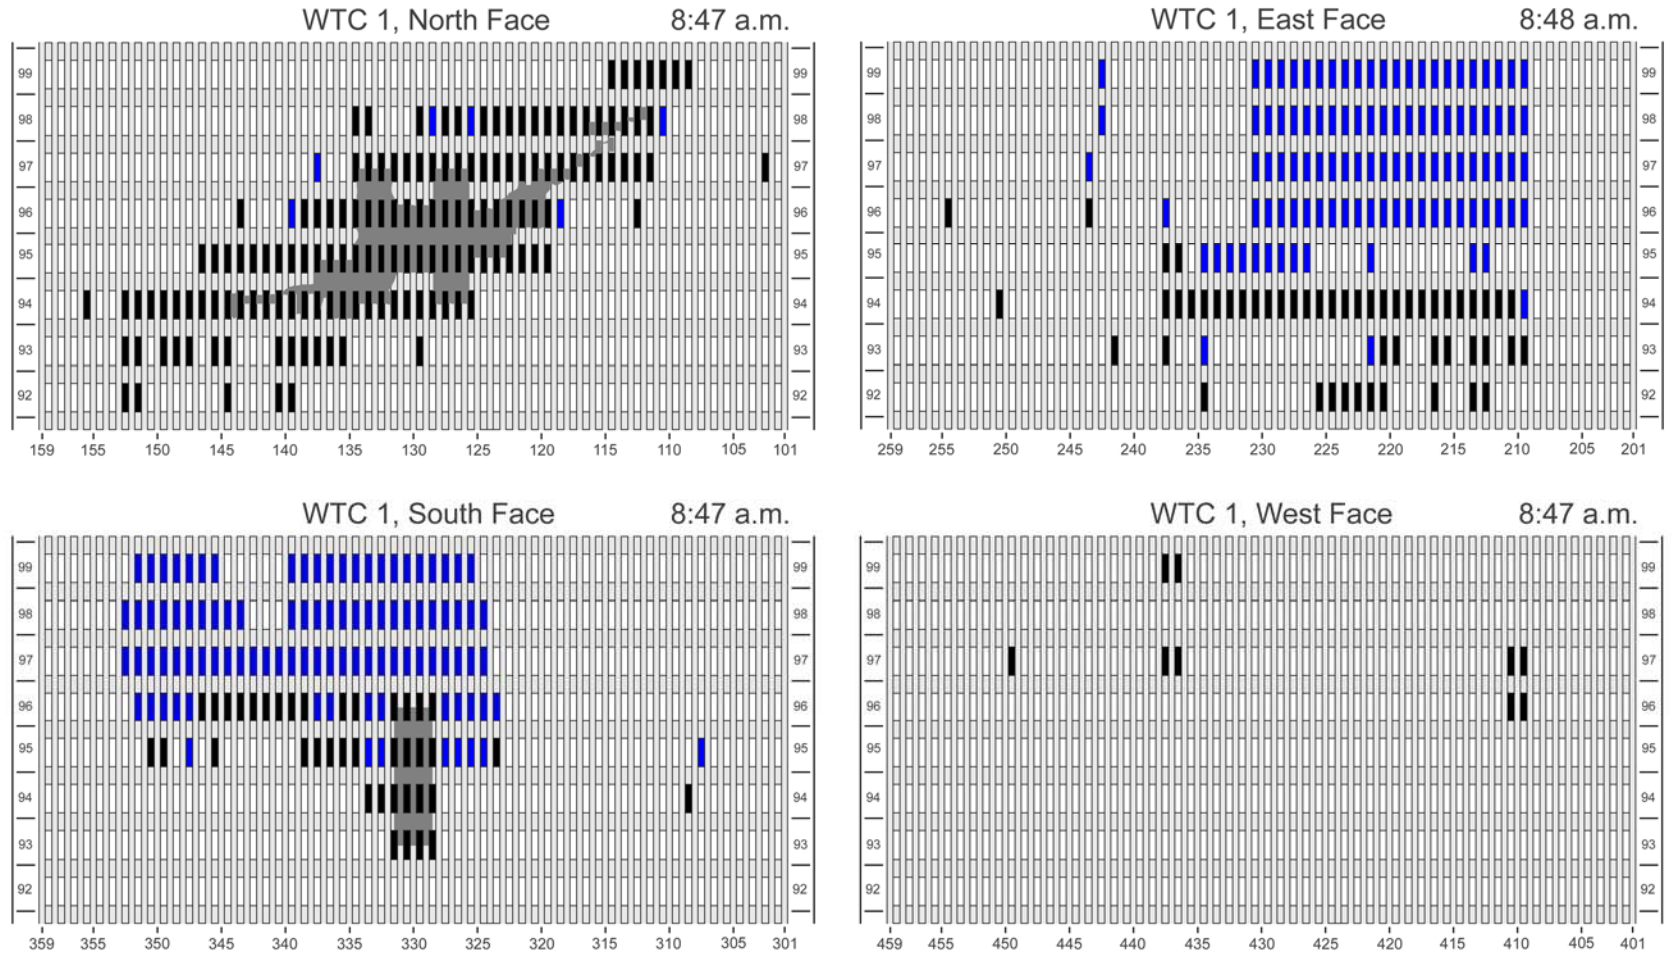
**Figure 6-9. The condition of windows is shown for the four faces of WTC 1 around 8:47 a.m. shortly after it was struck by American Airlines Flight 11. The colors represent  - window broken open,  - glass in place, and  - not visible.**

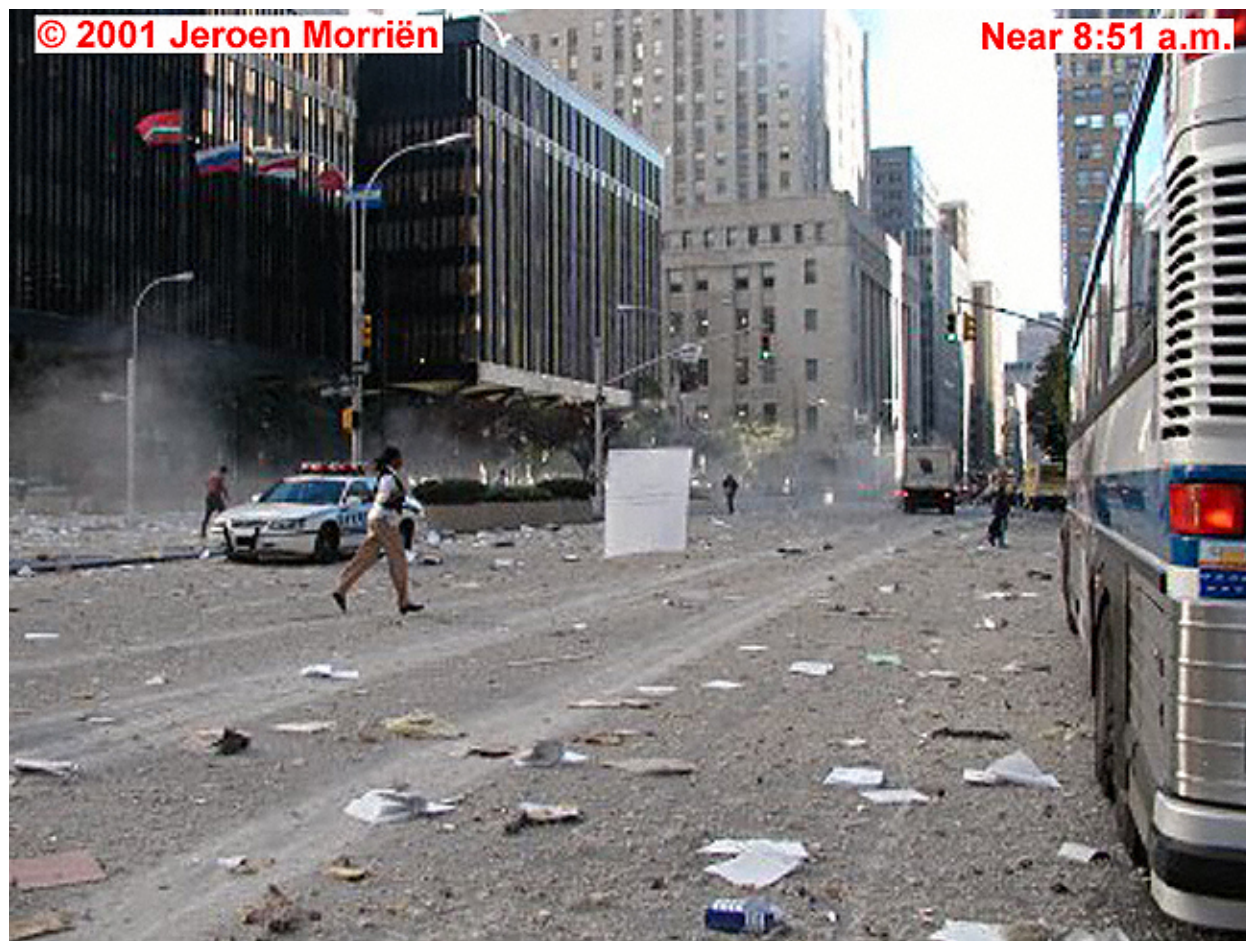
**Figure 6-14. A photograph recorded around 8:51 a.m. shows debris present on Church Street, which ran along the east side of the WTC complex. WTC 5 is located on the left-hand side.**

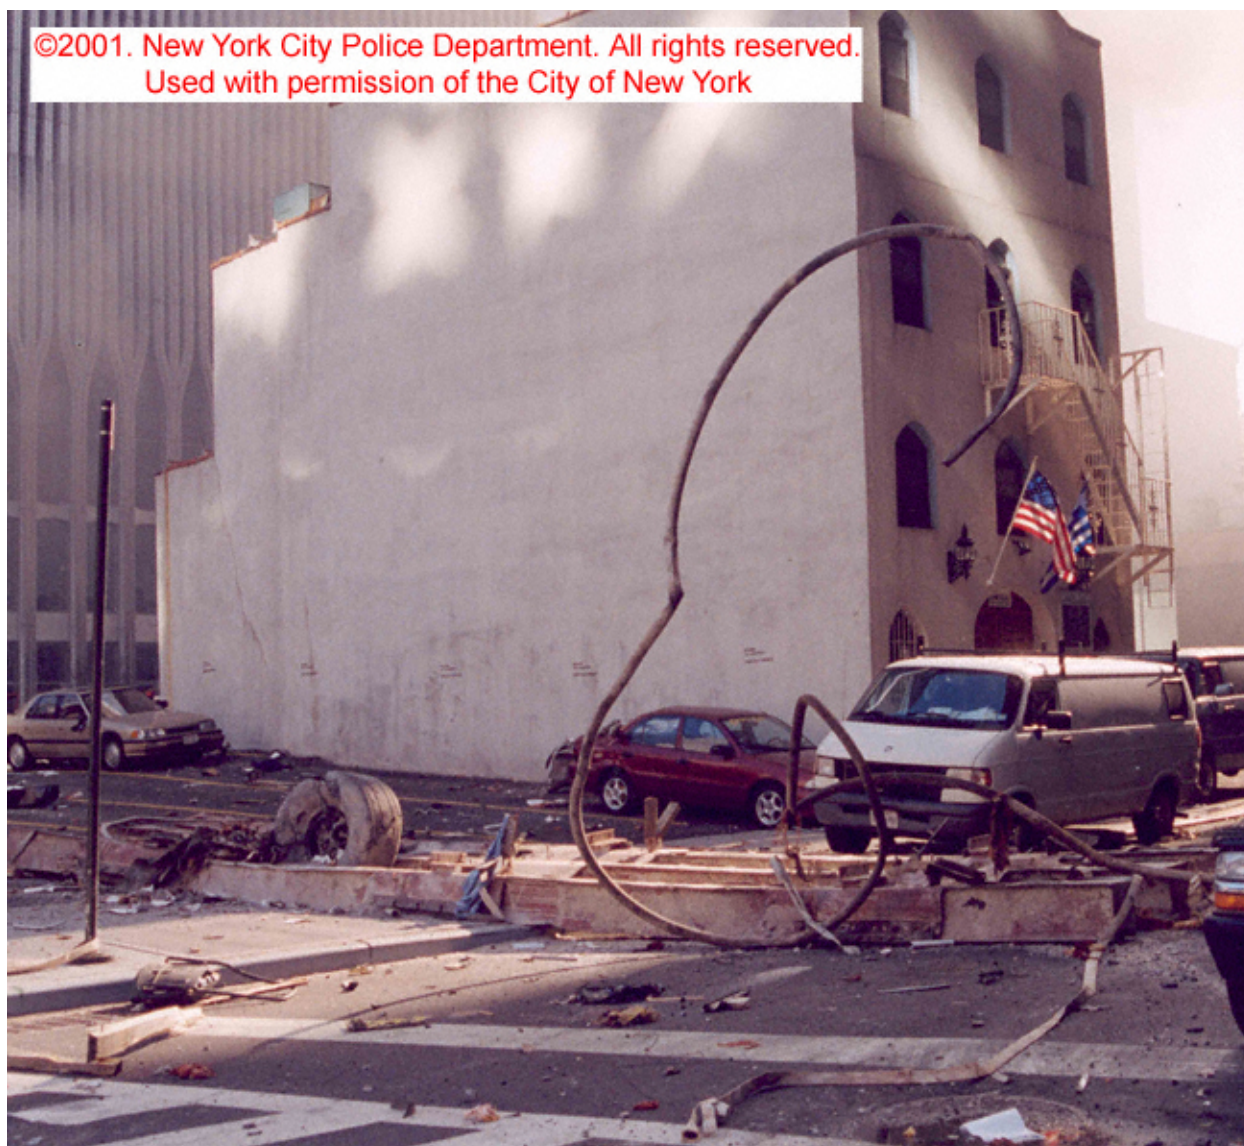
**Figure 6-16. Photograph showing a full steel panel section lying in Cedar Street near its intersection with West Street. An aircraft wheel is embedded in one of the windows. The building behind the panel is Saint Nicholas Greek Orthodox Church and the lower section of WTC 2 can be seen across Liberty Street.**

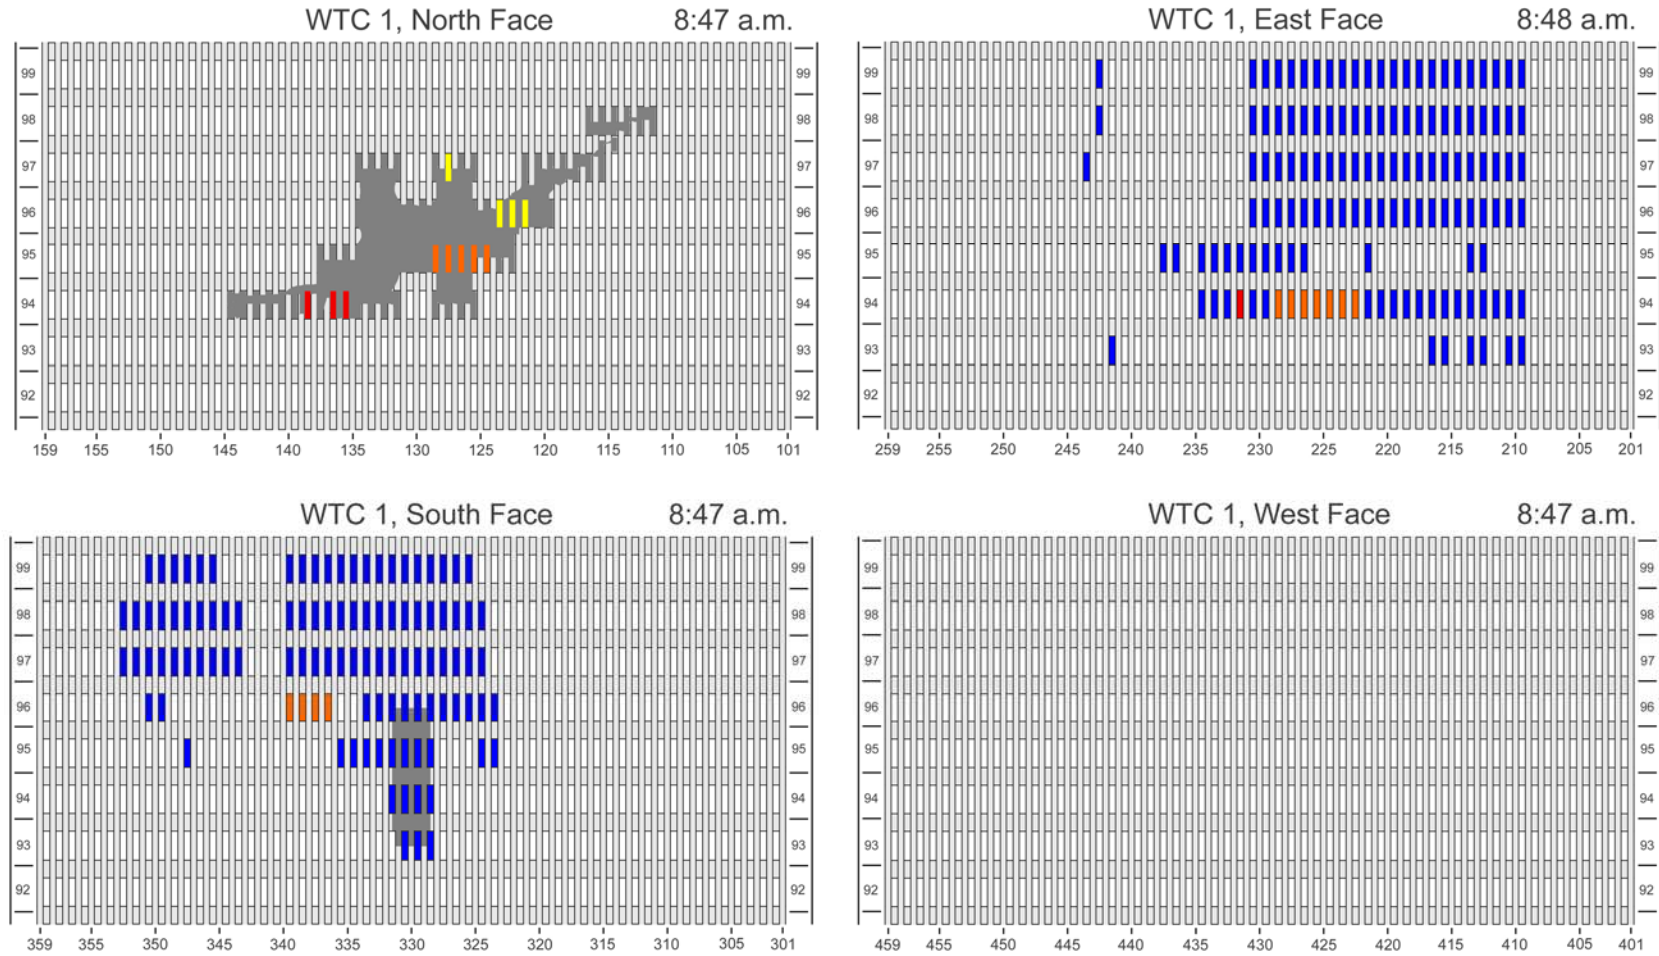
**Figure 6-19. Maps of observed fires on the four faces of WTC 1 are shown for the period shortly after the rapid burn off of fuel released during the aircraft impact. The colors represent**  **- no fire observed,**  **- spot fire,**  **- fire inside,**  **- external flaming, and**  **- not visible.**

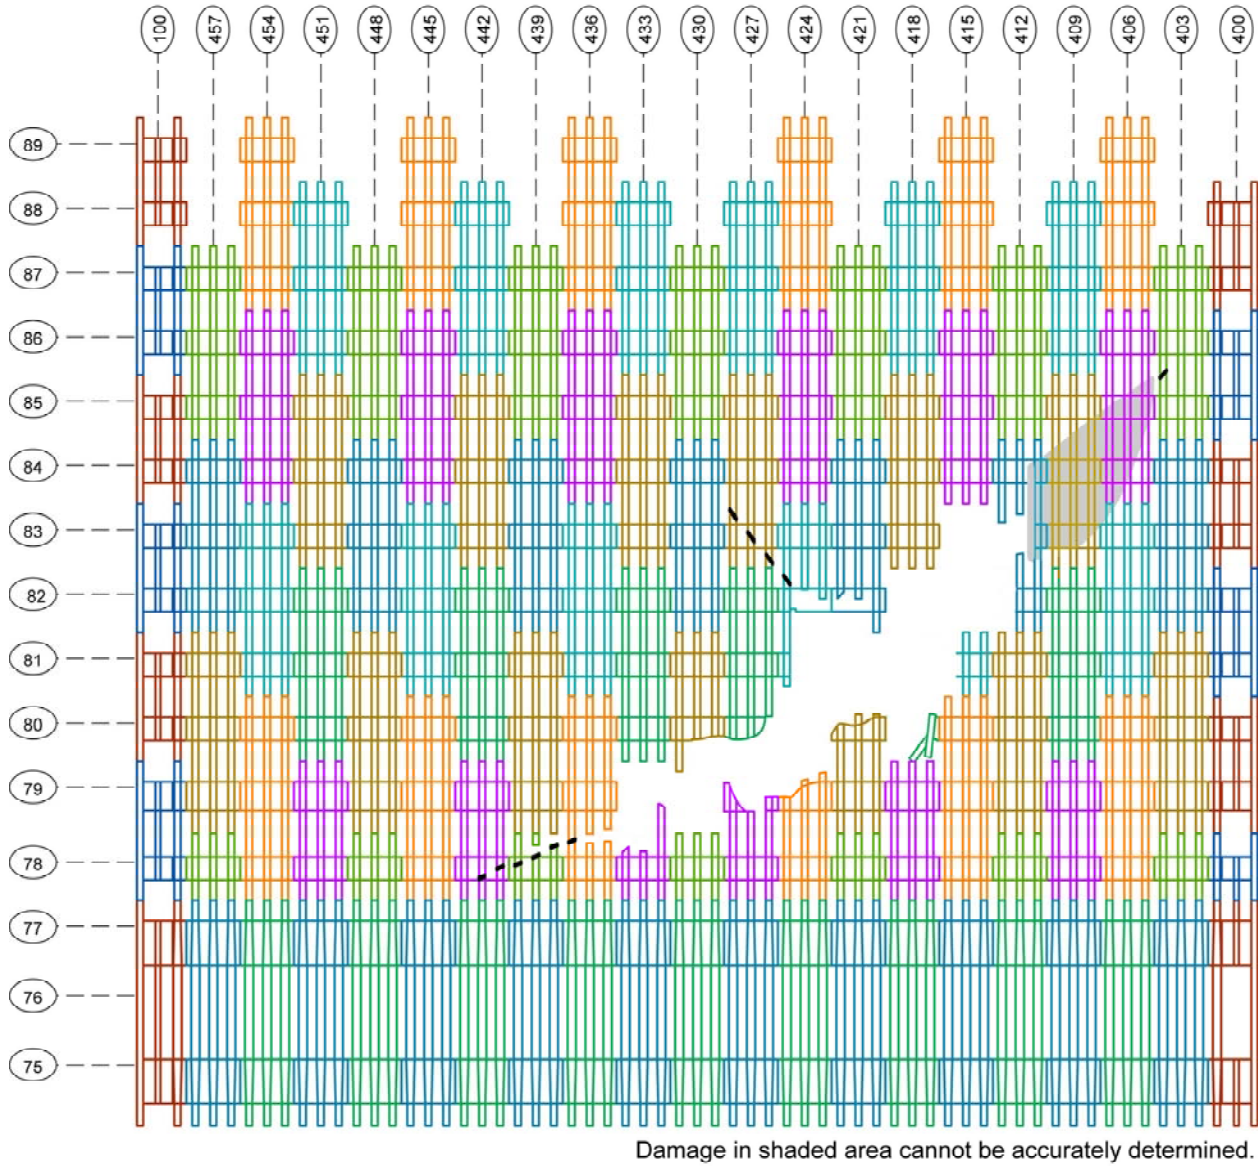
**Figure 7-25. A diagram of the south-face steel façade of WTC 2 shows the damage inflicted by the aircraft impact. The dark dotted lines indicate locations where the wings and tail of the aircraft marked the aluminum cladding on columns. The area shaded in gray was hidden by smoke and could not be observed.**

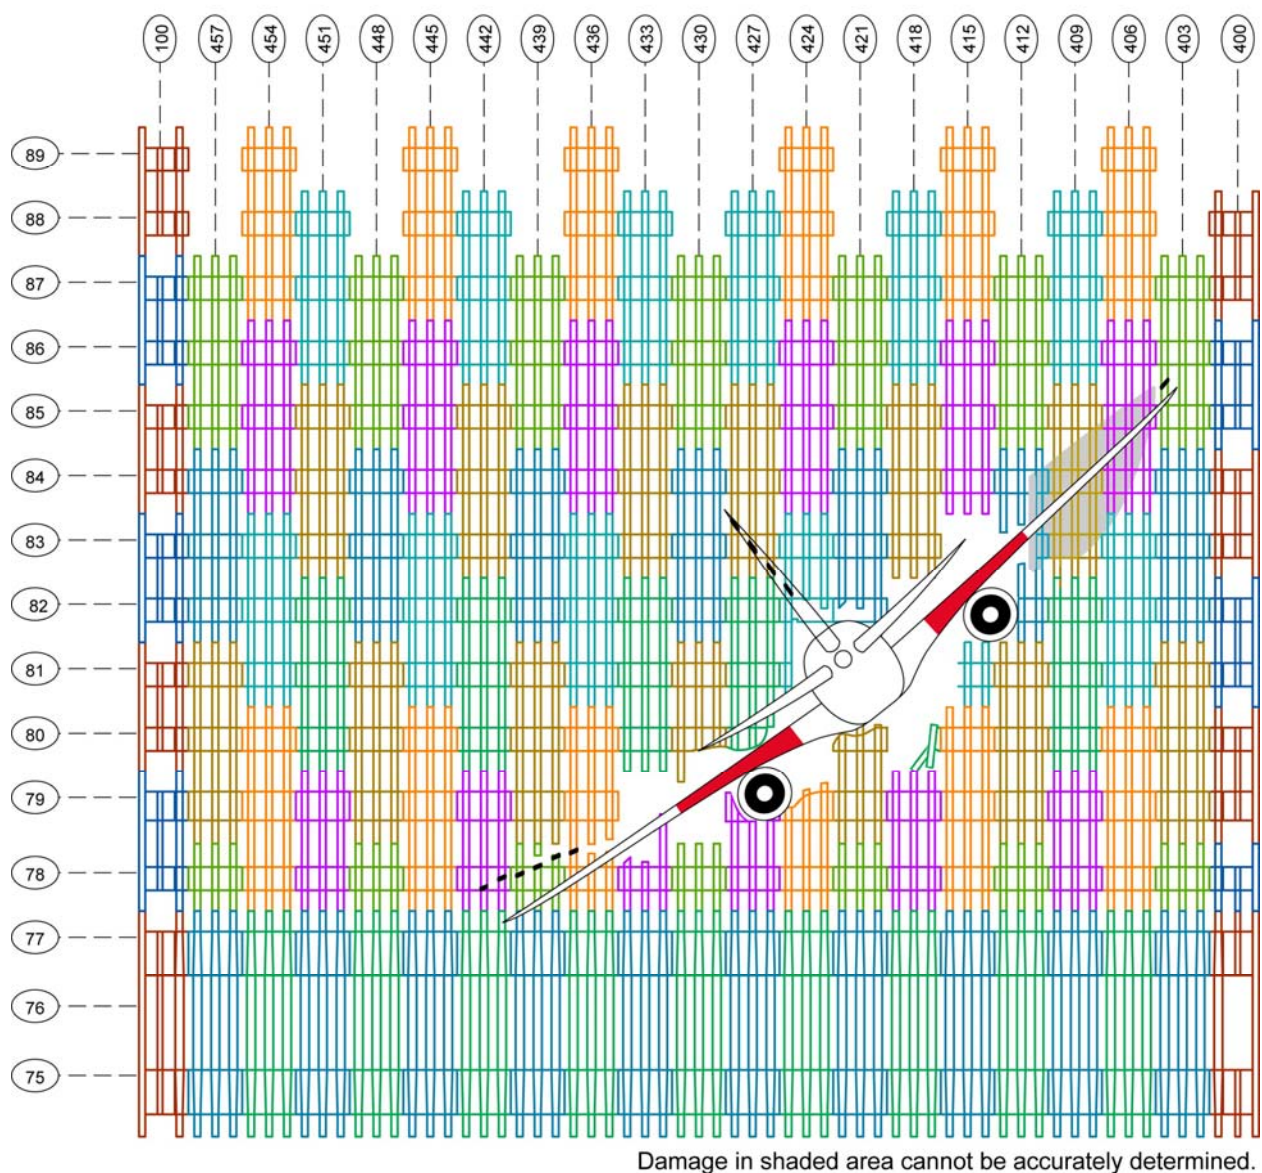
**Figure 7-26.** A scaled outline of a Boeing 767-200ER is superimposed on the damage diagram shown in Figure 7–25. The position of the aircraft has been adjusted to give the best match with the damage pattern and marks showing where the wing tips and vertical stabilizer struck. The match is not expected to be perfect since the drawing shows the aircraft as it appears when on the ground. The red areas correspond to the approximate locations of fuel on the aircraft based on an analysis reported elsewhere (NCSTAR 1-2B).

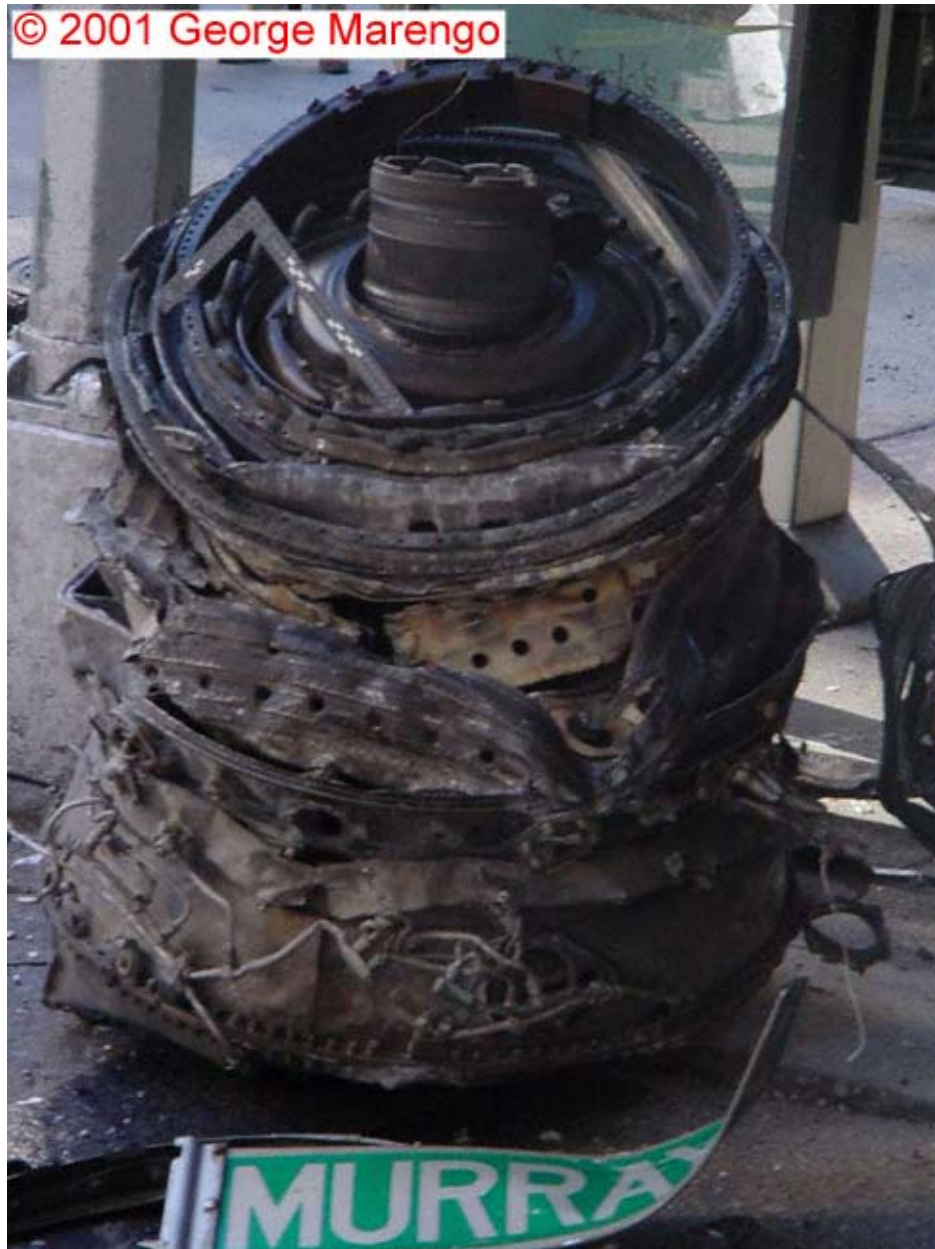
**Figure 7-34. This photograph shows what appears to be part of an aircraft engine lying near the northeast corner of the intersection of Church and Murray Streets. The photograph was taken prior to the collapse of WTC 2.**

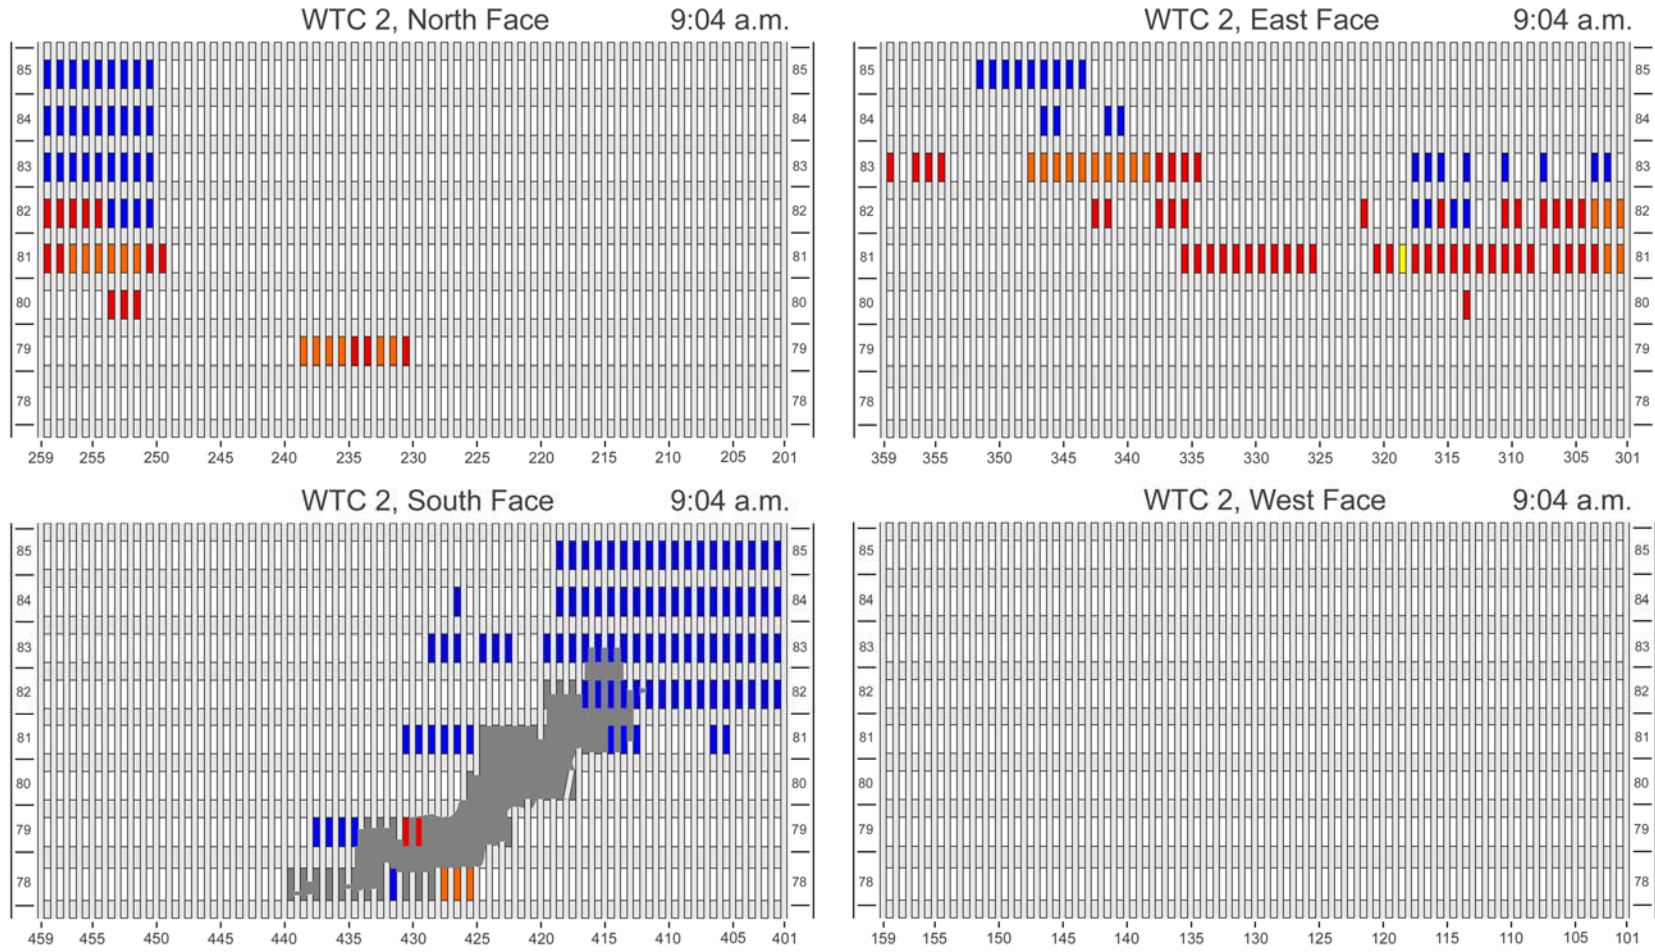
**Figure 7-39. Maps of observed fires on the four faces of WTC 2 are shown for the period shortly after the rapid burn off of aviation fuel released during the aircraft impact. The colors represent  - no fire observed,  - spot fire,  - fire inside,  - external flaming, and  - not visible.**
