NIST NCSTAR 1-5D

**Federal Building and Fire Safety Investigation of the
World Trade Center Disaster**

Reaction of Ceiling Tile Systems to Shocks

September 2005

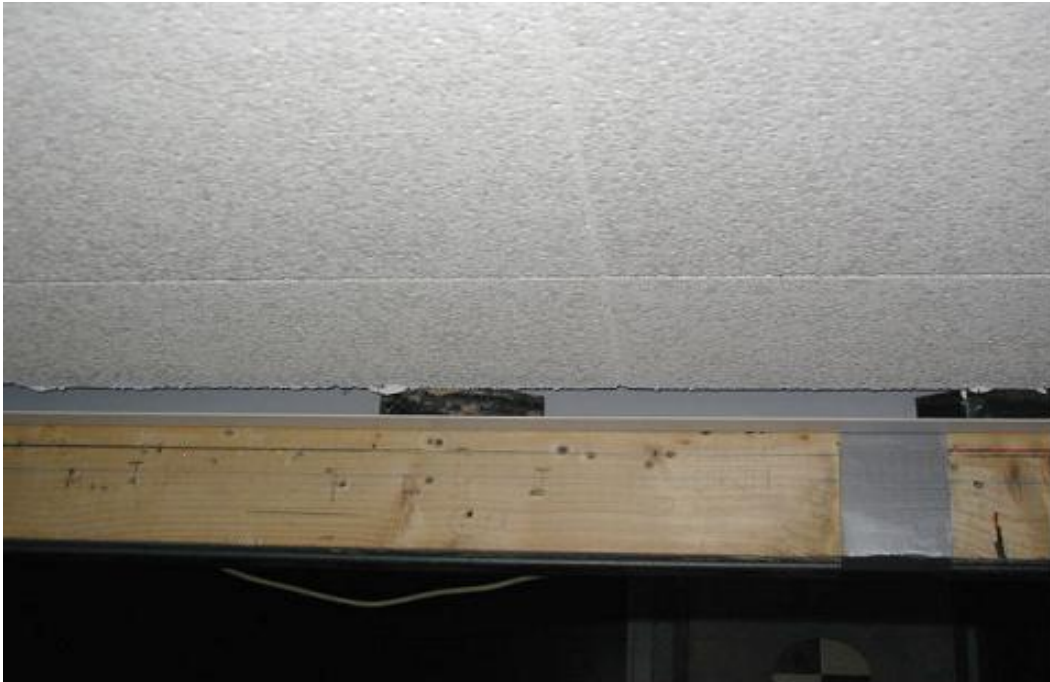
Figure 3-1. Displacement of perimeter tiles over perimeter spring clips following Test 20 for ceiling system CS1.

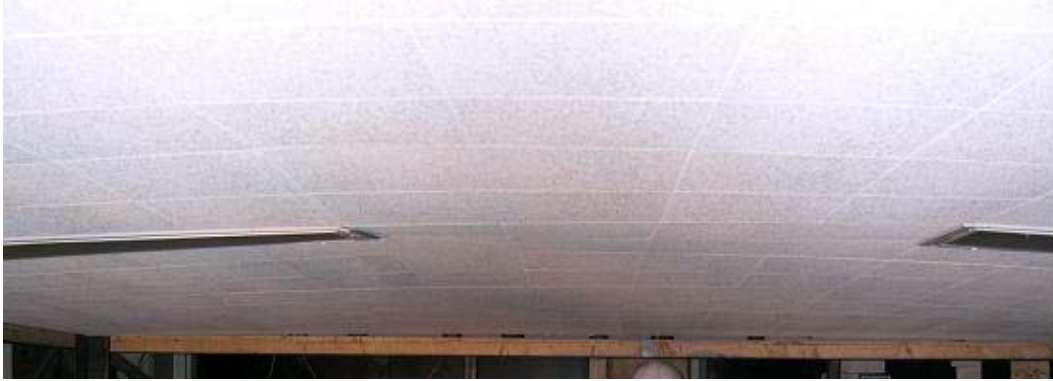
Figure 3–3. Bottom view of damage to ceiling system CS1 following Test 20.

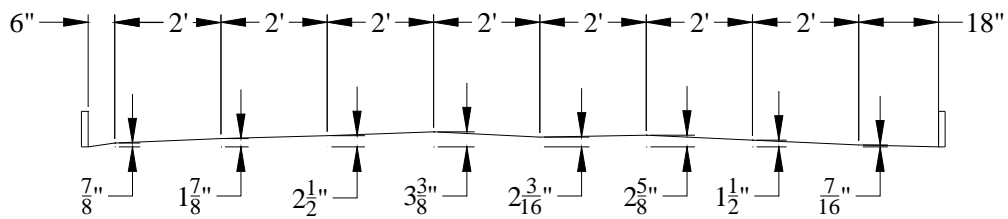
Figure 3–4. Permanent vertical displacements of Z-bars in the east-west direction following Test 20 for ceiling system CS1.

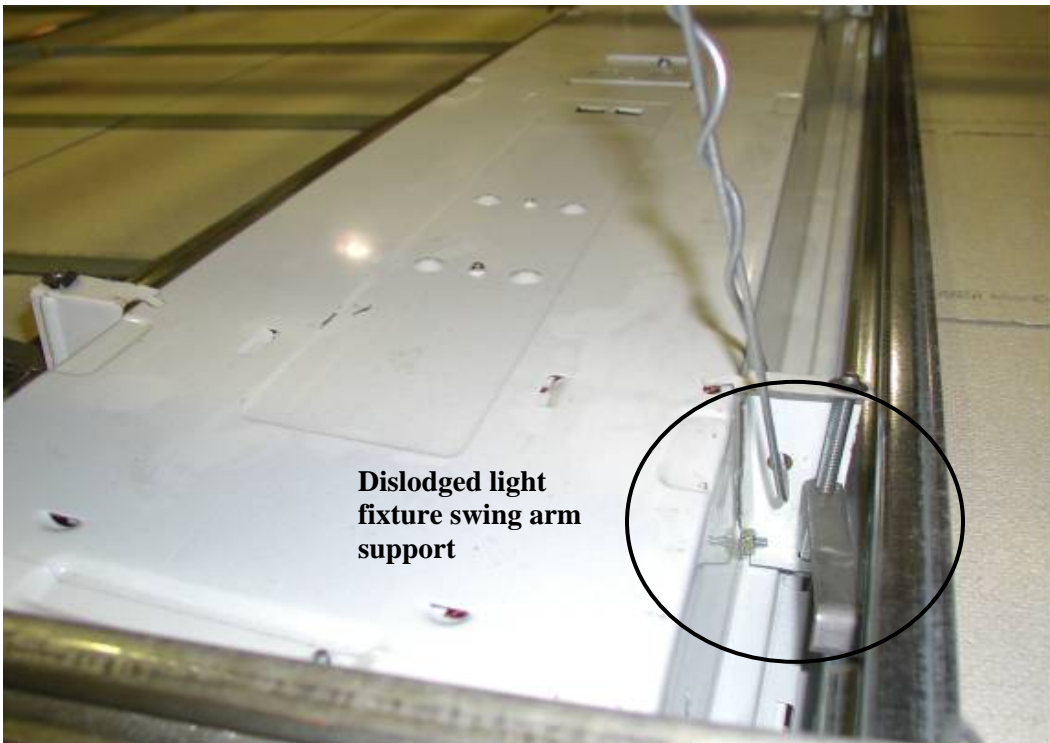
Figure 3–5. Light fixture swing arm support dislodged following Test 21 for ceiling system CS1.

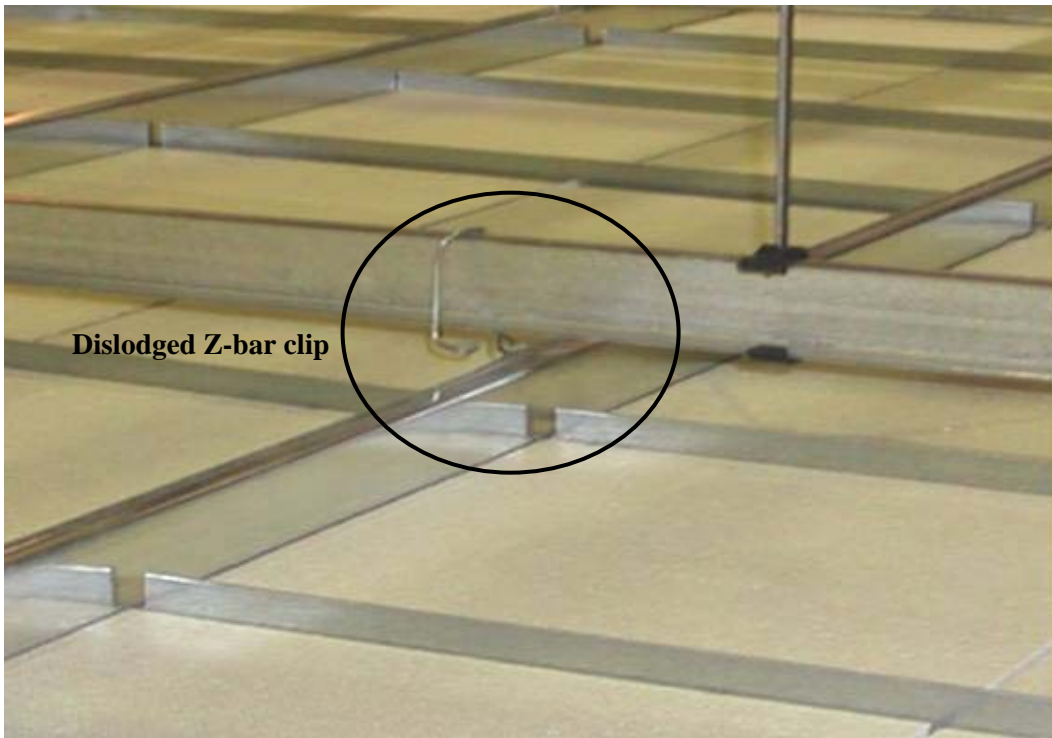
Figure 3–6. Dislodged Z-bar clip in ceiling system CS1 following Test 21.

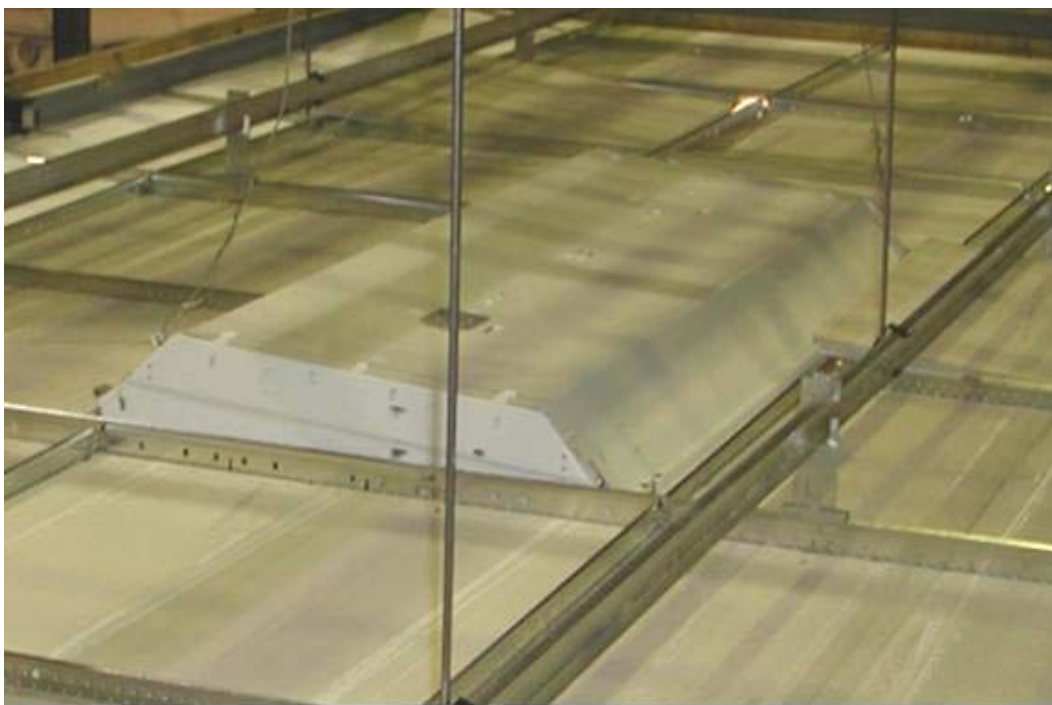
Figure 3–7. Dislodged southern light fixture corner in ceiling system CS2 following Test 14.

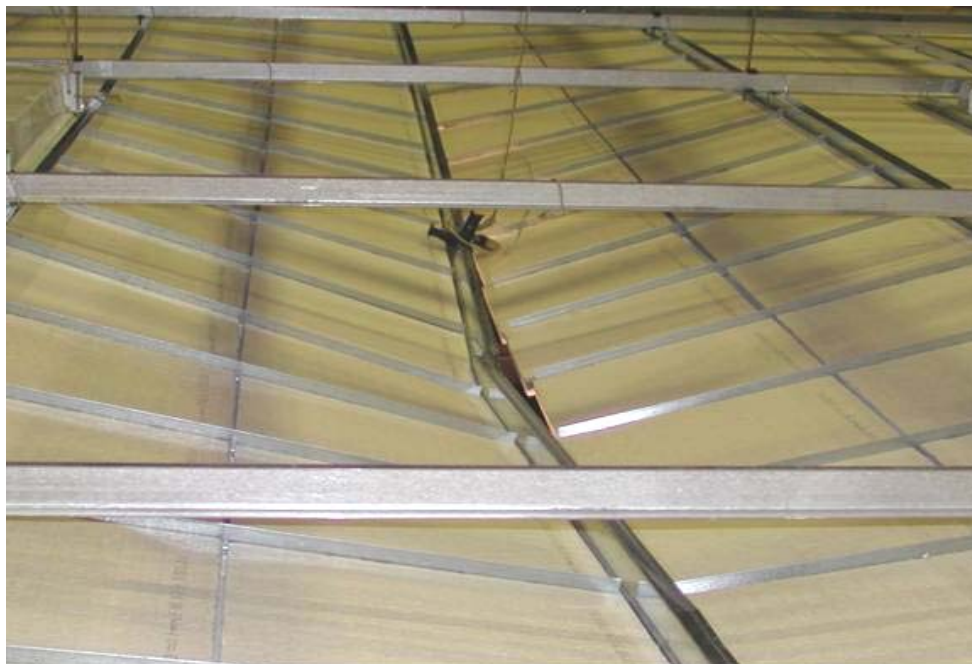
Figure 3–10. Damage to the center of ceiling system CS3 following Test 23.

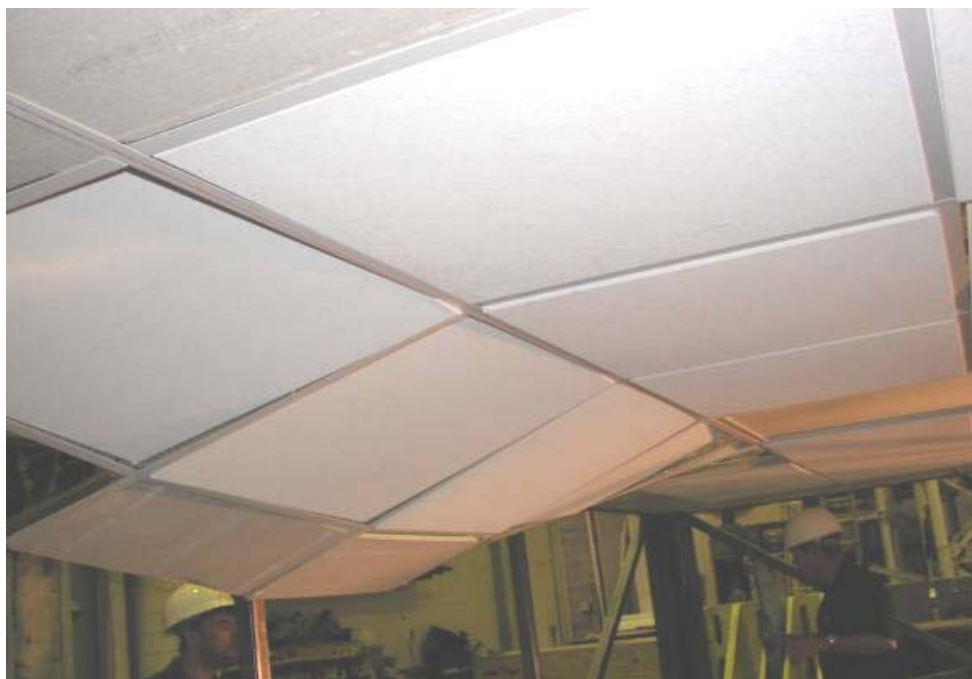
Figure 3–11. Damage to the northern perimeter of ceiling system CS4 following Test 23.

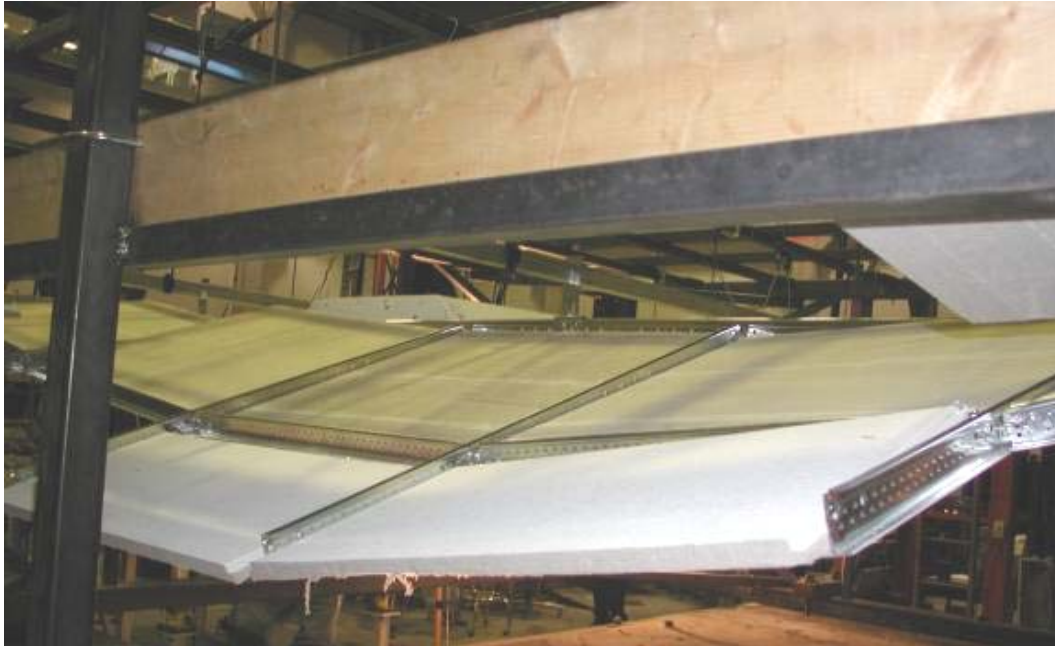
Figure 3–12. Damage to the northern perimeter of ceiling system CS4 following Test 23.

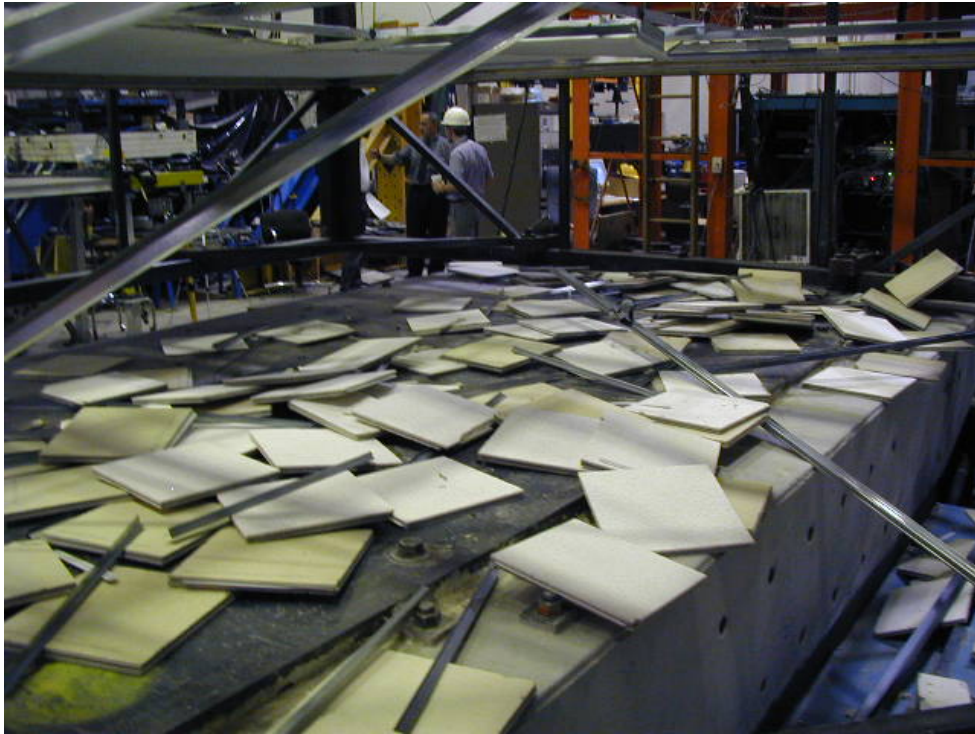
Figure 3–13. Collapse of ceiling system CS3 after 2.5g earthquake excitation.

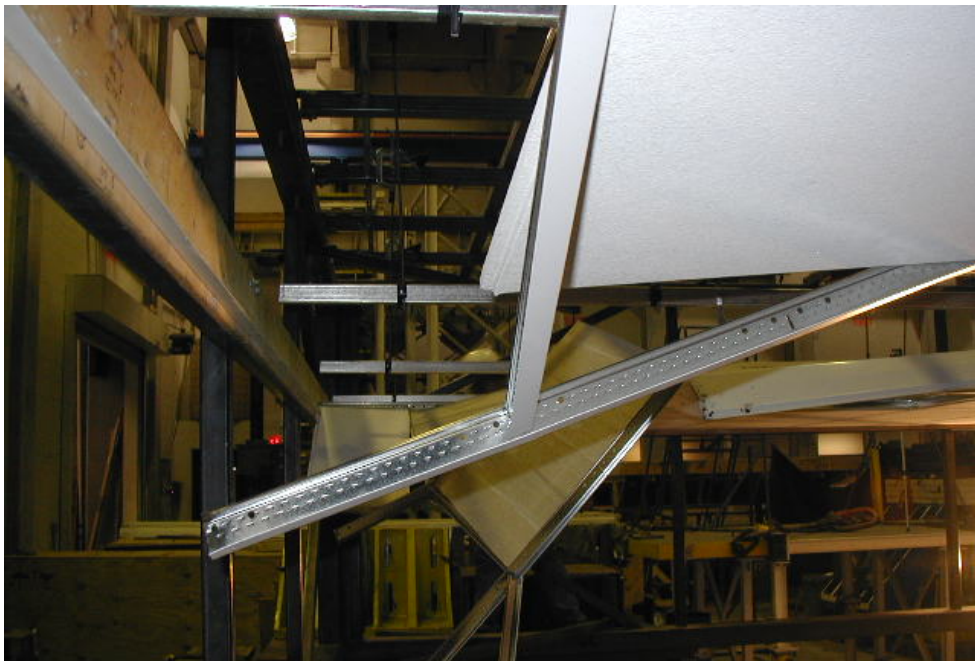
Figure 3–14. Damage to north perimeter of ceiling system CS4 after 1.75g earthquake excitation.
