Frontier Analysis, Ltd.

TECHNICAL SERVICE RESPONSE NO.: UT011

Subject: Analysis of Residue That Resulted After an Unknown Basketball-Size Object Impacted a Car

Date: April 6, 2001

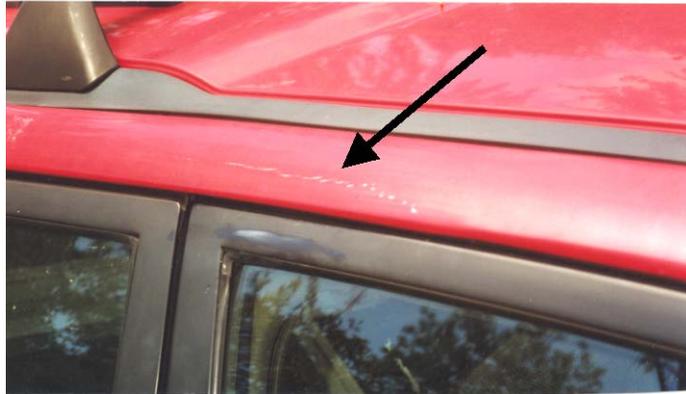
Residue on the Car

- 1.) Metal oxide, silicate mineral (a kaolinite type), a celluloidal material and indications of a trace amount of natural ester are found in the cream/gray colored residue on the car. There is a very high probability the metal oxide originates from the object. (It does not appear to be a common type used in paint formulations.) The celluloidal material could also be from the object. Though it should be noted that a modified celluloidal material (specifically cellulose acetate butyrate - CAB) is commonly used as a filler in paint. This material is not chemically modified; it appears to be of natural plant origin. This speculation is fortified by the indicated presence of a natural ester. The silicate source remains unclear. However, some types are known to be used as additives in paint. (Without knowing the specifications of the paint used in a 1992 Ford Escort) we cannot be sure of its origin. However, this analyst feels the silicate is related to the object. Components of the finish/paint are also detected, i.e. an acrylate/styrene/urethane polymer coat (probably the clear coat) and an epoxy layer which probably contains the red pigment. Additionally detected in trace amounts are materials thought to contaminate the sample, e.g. skin fragment and a styrene/isoprene polymer.

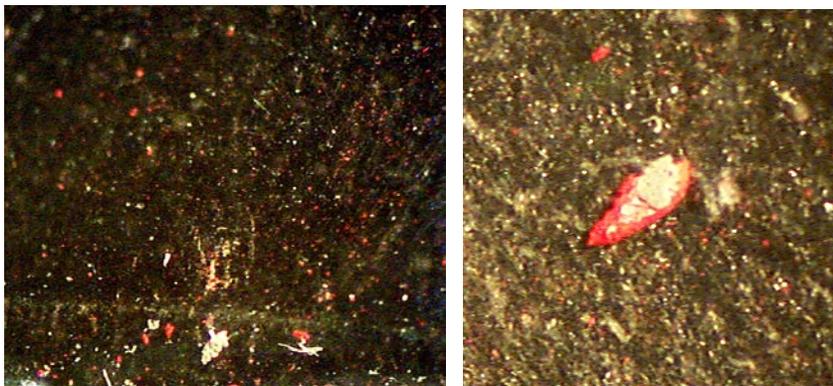
Microscope pictures of the particulates follow. The red particulates are paint from the car. The cream colored material is residue resulting from impact with the unknown object. The particulates were less than one mm in size, i.e. in the micron ranges.

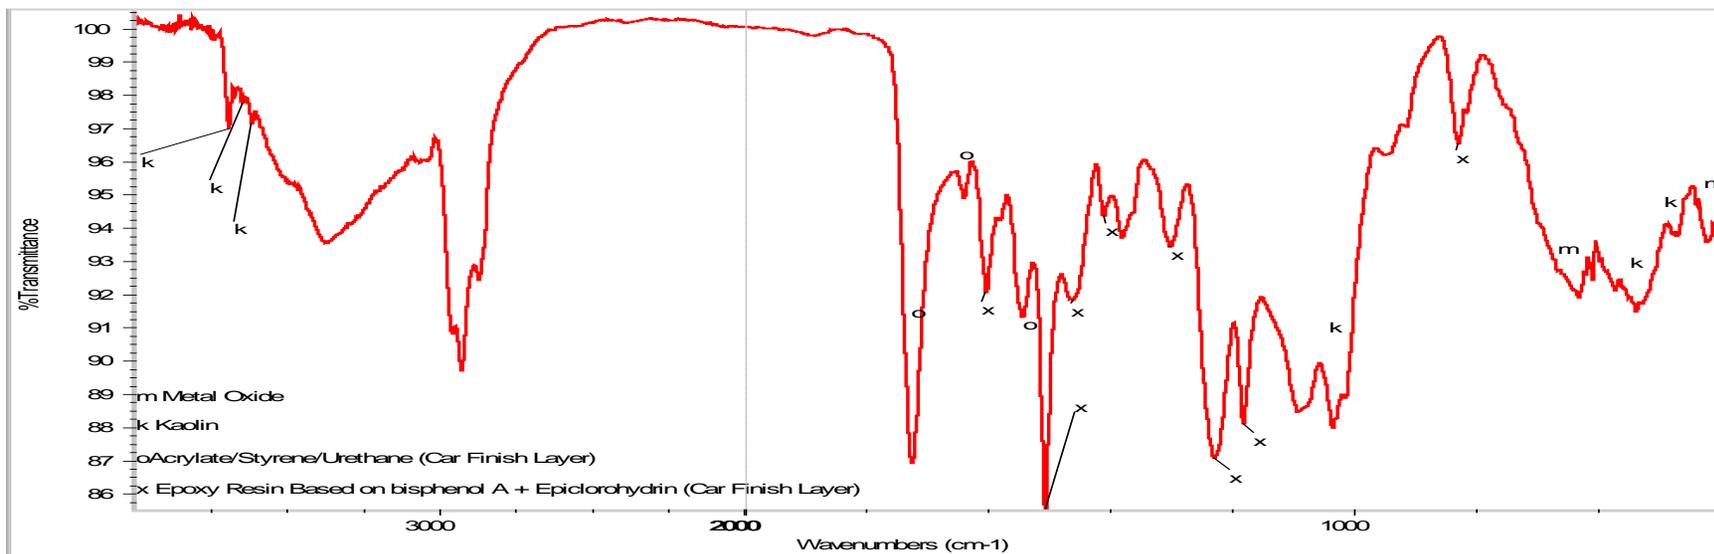
Figure 1. Infrared spectrum of cream/gray colored impact residue.

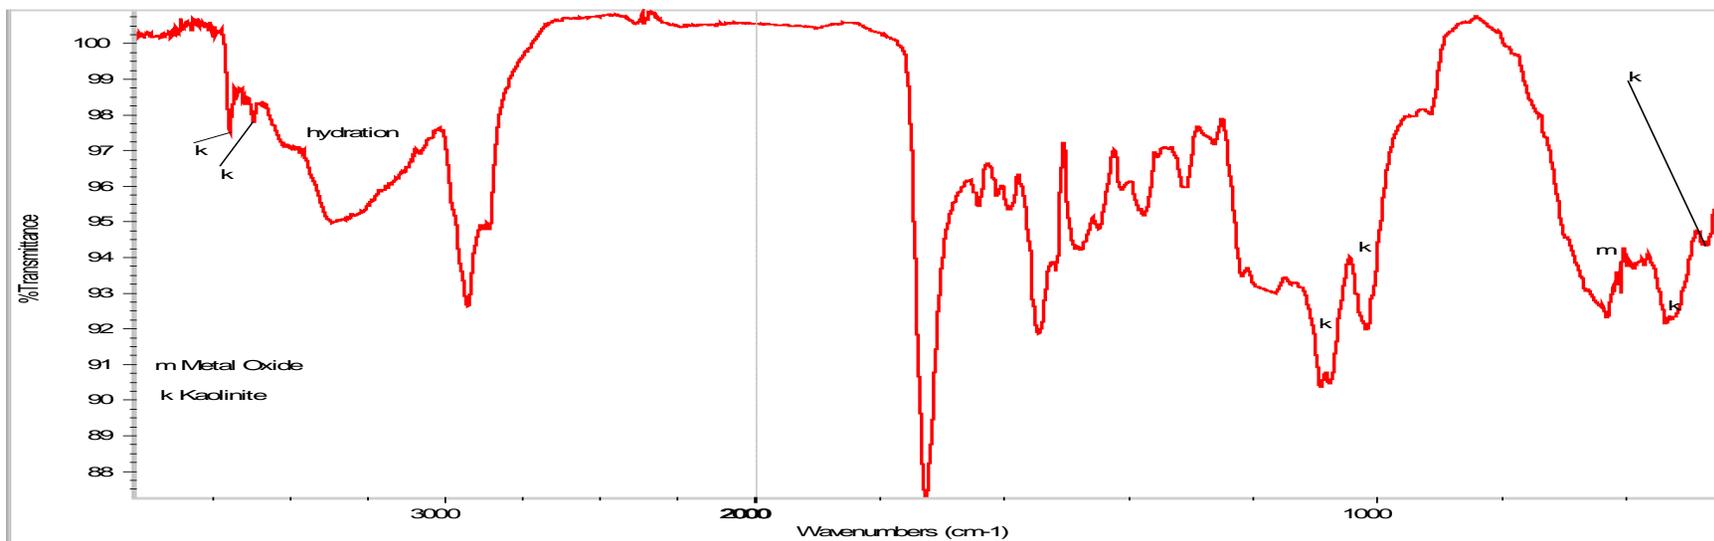
Figure 2. Infrared spectrum with paint interference removed.

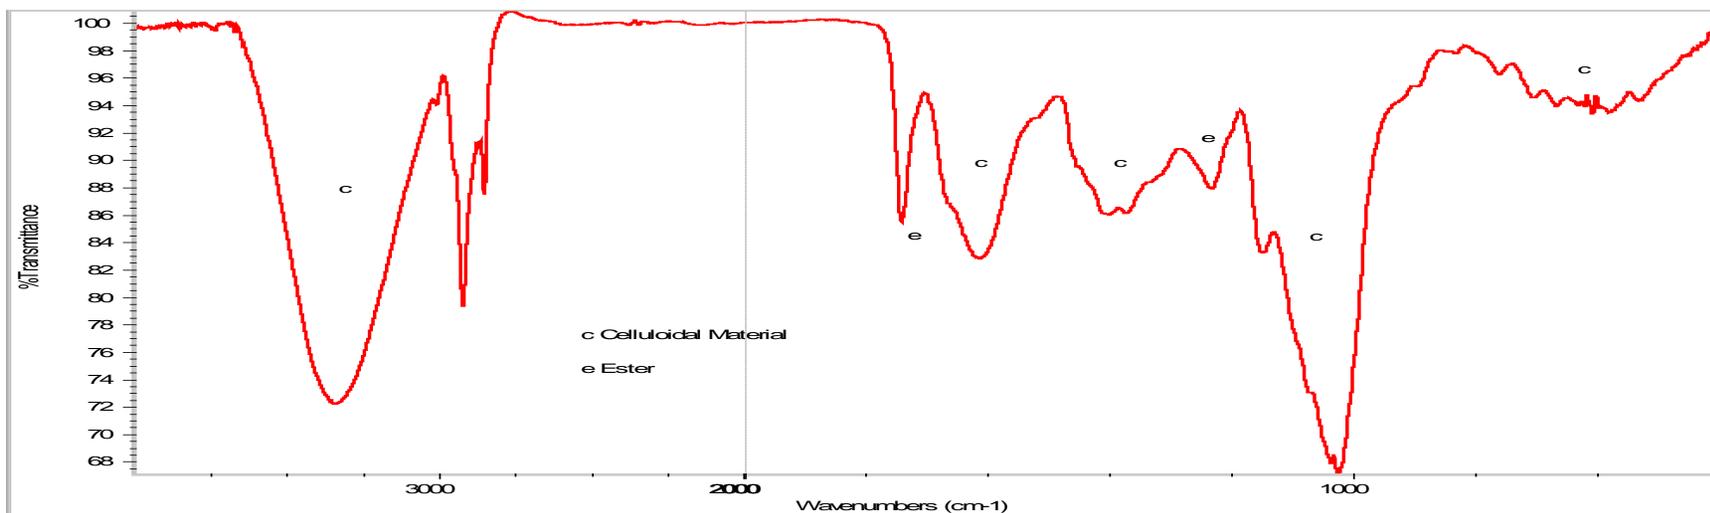
Figure 4. Infrared spectrum of gray particles from the impact residue.

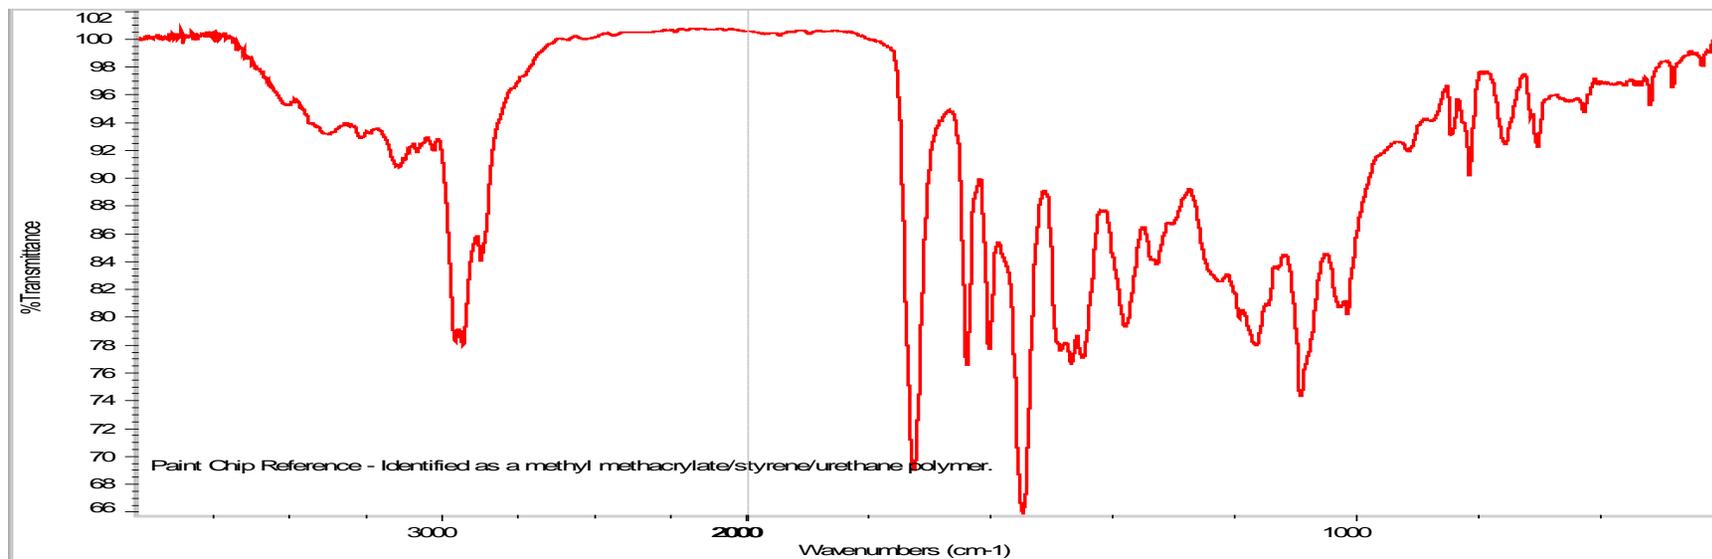
Figure 5. Infrared spectrum of a red paint chip from the car.
