Frontier Analysis, Ltd.

TECHNICAL SERVICE RESPONSE NO.: UT011

Subject: Analysis of Residue That Resulted After an Unknown Basketball-Size Object Impacted a Car

Date: April 6, 2001

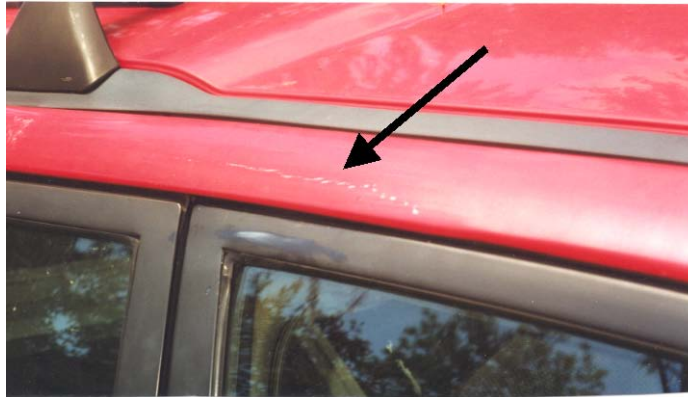
Residue on the Car

1.) Metal oxide, silicate mineral (a kaolinite type), a celluloidal material and indications of a trace amount of natural ester are found in the cream/gray colored residue on the car. There is a very high probability the metal oxide originates from the object. (It does not appear to be a common type used in paint formulations.) The celluloidal material could also be from the object. Though it should be noted that a modified celluloidal material (specifically cellulose acetate butyrate - CAB) is commonly used as a filler in paint. This material is not chemically modified; it appears to be of natural plant origin. This speculation is fortified by the indicated presence of a natural ester. The silicate source remains unclear. However, some types are known to be used as additives in paint. (Without knowing the specifications of the paint used in a 1992 Ford Escort) we cannot be sure of its origin. However, this analyst feels the silicate is related to the object. Components of the finish/paint are also detected, i.e. an acrylate/styrene/urethane polymer coat (probably the clear coat) and an epoxy layer which probably contains the red pigment. Additionally detected in trace amounts are materials thought to contaminate the sample, e.g. skin fragment and a styrene/isoprene polymer.

3.) A dull thud on impact, and the fact that the car was not dented, suggests the object was of low mass. A bolide/meteorite would be expected to leave a sizable dent (Note: the area impact at this date (two years later) is clear of the residue and also shows no damage to the paint.)¹

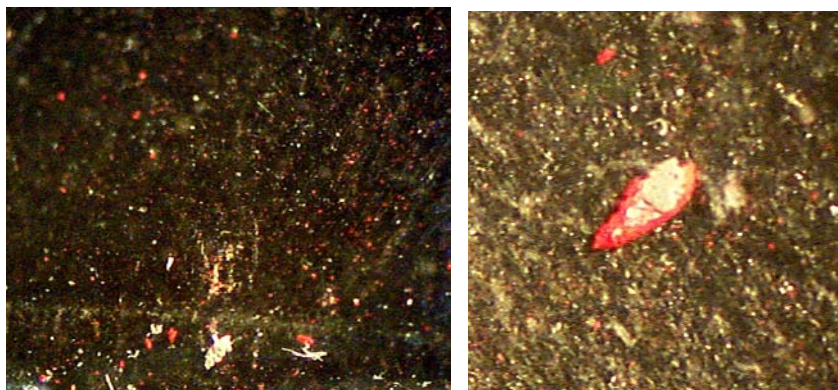
Microscope pictures of the particulates follow. The red particulates are paint from the car. The cream colored material is residue resulting from impact with the unknown object. The particulates were less than one mm in size, i.e. in the micron ranges.

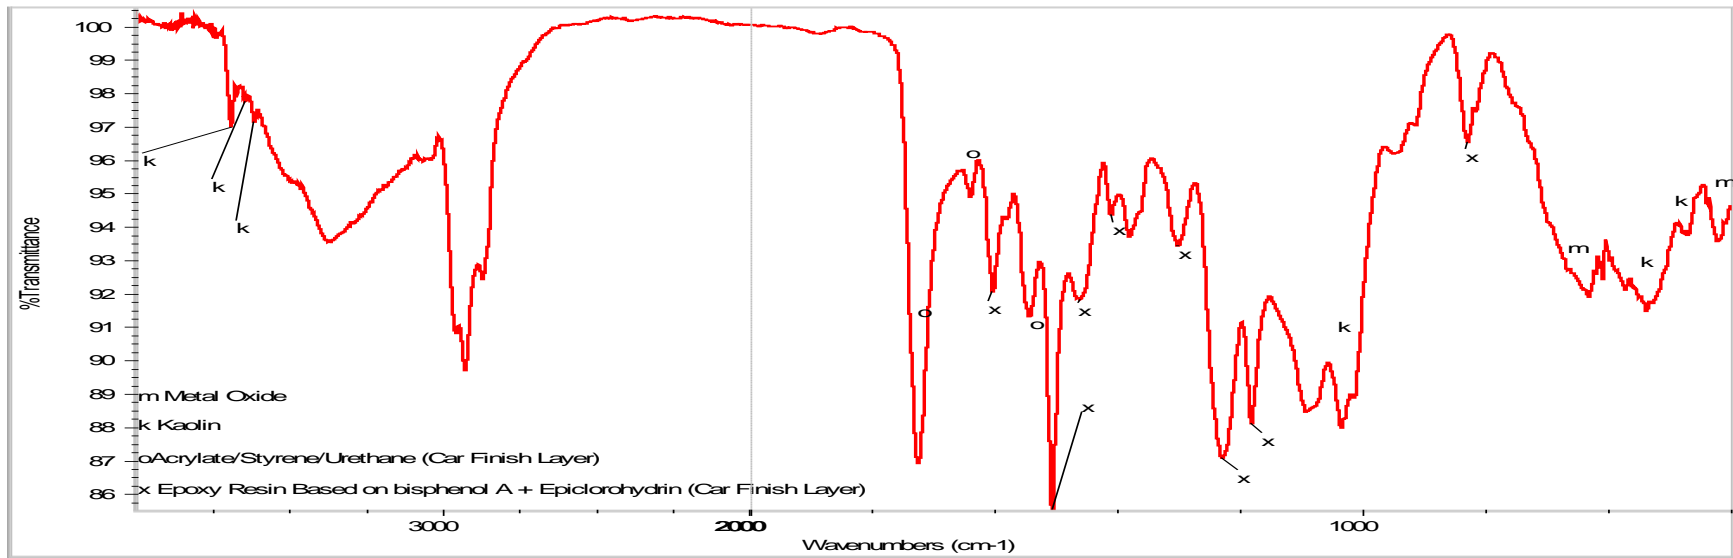
Figure 1. Infrared spectrum of cream/gray colored impact residue.

| Spectrum | Identification | Spectrum Figures |
|---|---|---|
| Cream - Gray Colored Material | The spectra show indications of a mixture of silicate mineral (kaolinite, an aluminum silicate) and a metal oxide. One or both the inorganics (silicate and metal oxide) appear to be hydrated. These materials are in the presence of the car finish layers, i.e. epoxy resin based on bisphenol A and residual methyl methacrylate/styrene/urethane. Computer massaging of the data to remove paint interference enhances the mineral absorption for one spectrum (Fig. 2) which is also shown. (Five spectra contain evidence of this material.) A kaolinite reference (Fig. 3) is also included for comparison. | 1, 2, 3 |

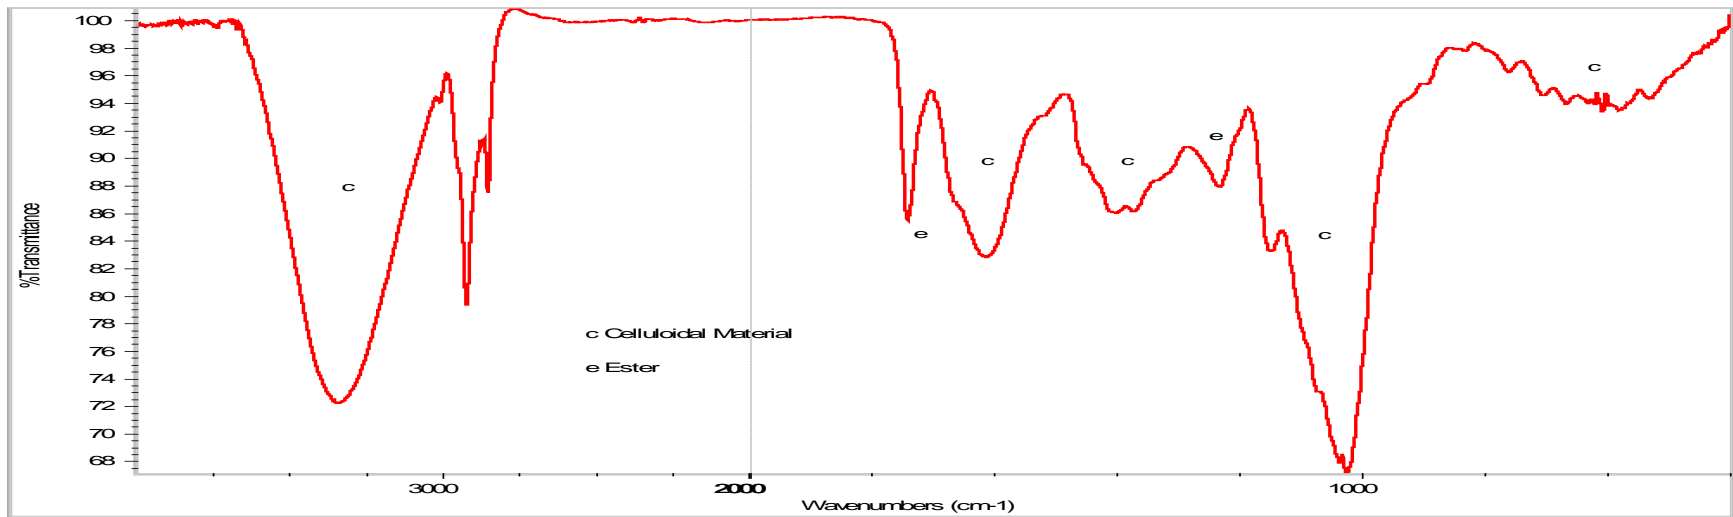
Figure 4. Infrared spectrum of gray particles from the impact residue.

| Spectrum | Identification | Spectrum Figures |
|---|---|---|
| Gray Particles | These spectra identify cellulosidal material and long chain ester material speculated to be natural ester. (Three different spectra showed these materials.) | 4 |

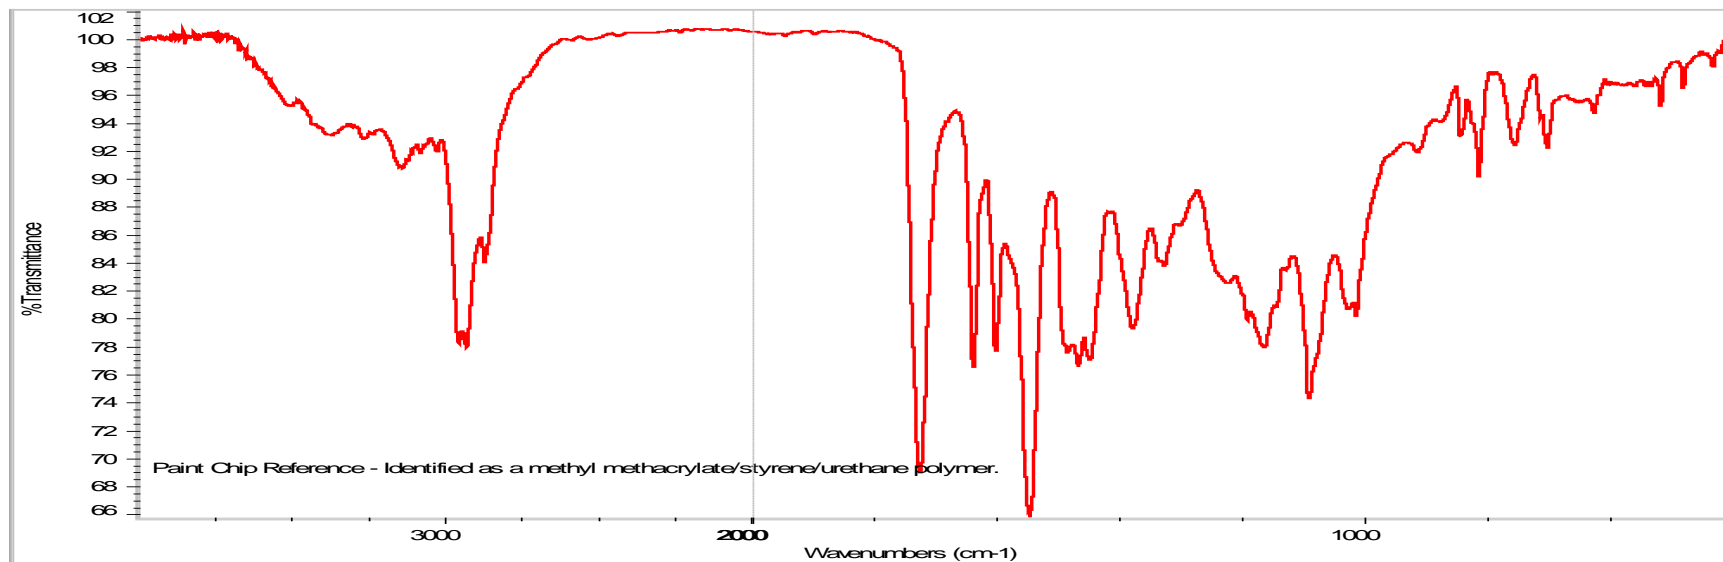
Figure 5. Infrared spectrum of a red paint chip from the car.

| Spectrum | Identification | Spectrum Figures |
|---|---|---|
| Red Chip | These spectra are obviously of paint and were taken for reference. It shows a methyl methacrylate/styrene/urethane enamel type coating. It is speculated to belong to the outer clear coat finish layer of the car. (Two spectra were obtained of this material.) | 5 |
