Frontier Analysis, Ltd

TECHNICAL SERVICE RESPONSE NO.: UT060

Subject: Addendum to Technical Service Response No.: UT050: Analysis of a Metal Chunk Purportedly from a UFO (1995)

Date: January 22, 2009

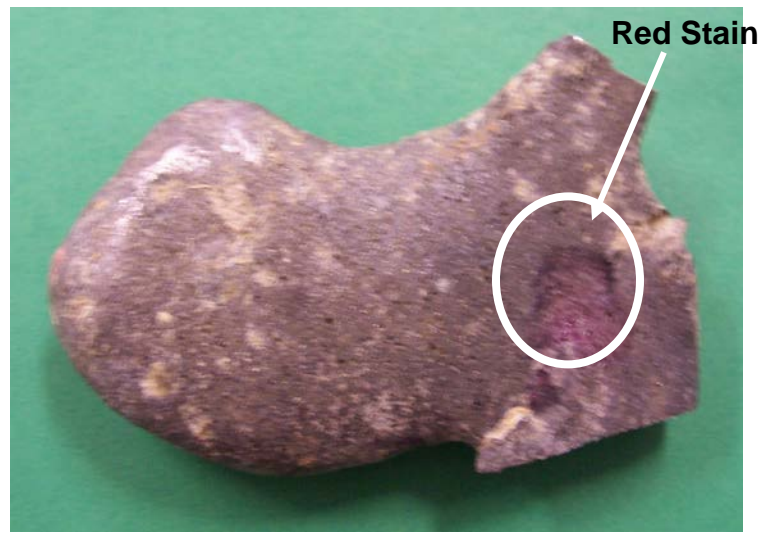
On October 4, 2008, a second section of the metal piece was delivered to this laboratory by Nick Reiter. This piece had a red-appearing stain on the surface. The objective is to analyze the stain using infrared spectroscopy.

A photograph of the metal piece with the red stain follows.

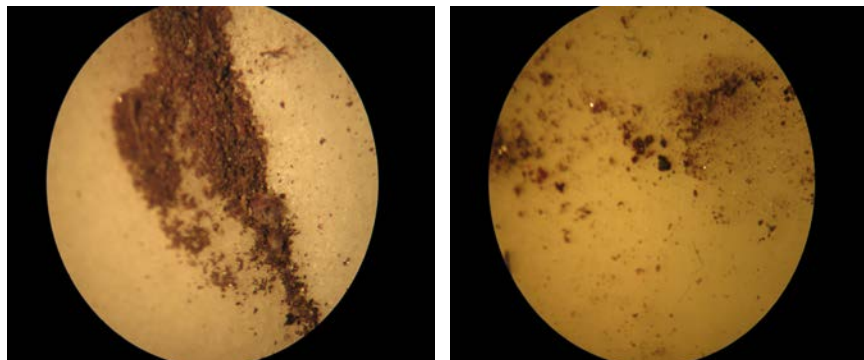
Microscope photographs of material scraped from the red stain show a granular reddish material. Two photographs follow.

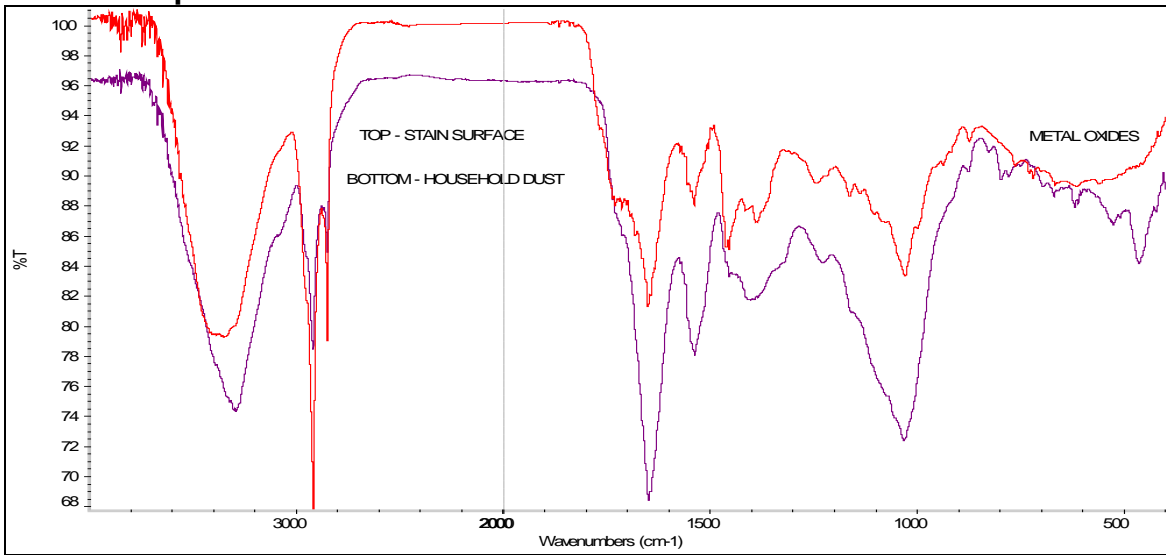
Infrared Spectra of Stain Surface Material and Household Dust Reference

The first infrared spectrum of the stain surface shows mostly contamination from handling and dust. Also, there is evidence of metal oxides. The spectrum is typical of dust that typically contains protein amide (skin cells) and silicate (dirt). The spectrum compares to a reference of household dust. Following are spectra of the surface stain and a reference of dust for comparison.

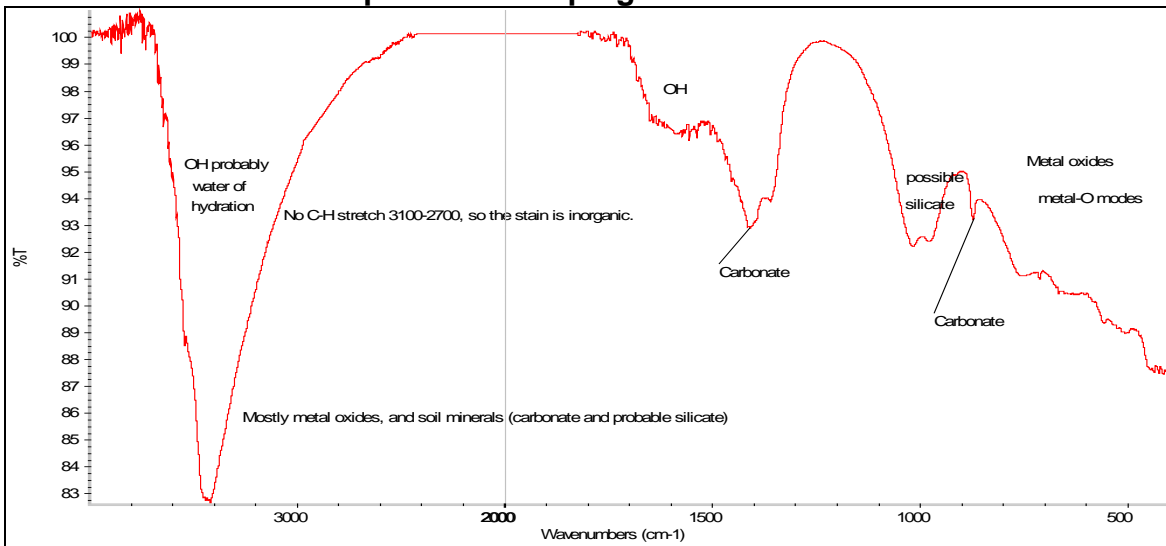
Infrared Spectrum Scrapings from the Red Stain

- Infrared spectroscopy indicates the stain area contains one or more metal oxides of which aluminum oxide predominates. There are also soil mineral-type components such as calcium carbonate (calcite and/or dolomite) and silicate. Water of hydration is apparent. There is no organic material. The stain surface is contaminated with dust-like components such as protein, skin cells and silicate (dirt). Some contamination is probably due to handling.

- It is unknown what causes the reddish color. There are no iron oxides or organic dyes. It is speculated that it may be due to trace/undetectable amounts of another materials, perhaps a chromium derivative. Many trace materials are capable of producing significant color.

Infrared analysis of the material under the surface contamination shows it to be more representative of the stain material. The spectra display one or more metal oxides, of which aluminum oxide probably predominates. (Based on the EDS results (below) iron oxide is not present, and therefore, not responsible for the red color.) There are also soil mineral-type components such as calcium carbonate (calcite and/or dolomite) and silicate. Water of hydration is apparent. No organic materials are detected, i.e. there are no organic C-H stretching modes between $3100-2700\text{ cm}^{-1}$. The following is the best representative spectrum of the red material with pertinent peaks labeled.

- XRD analysis is recommended on the stain for further characterization.⁸

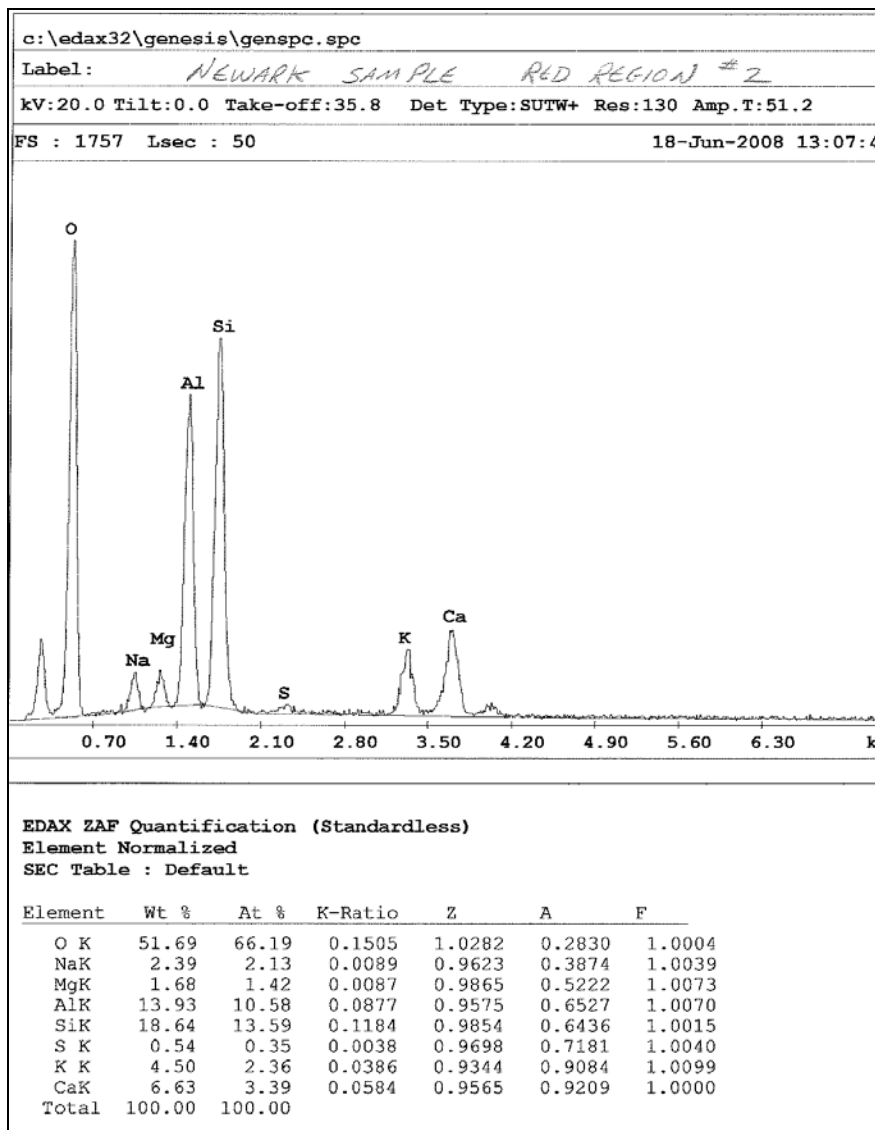
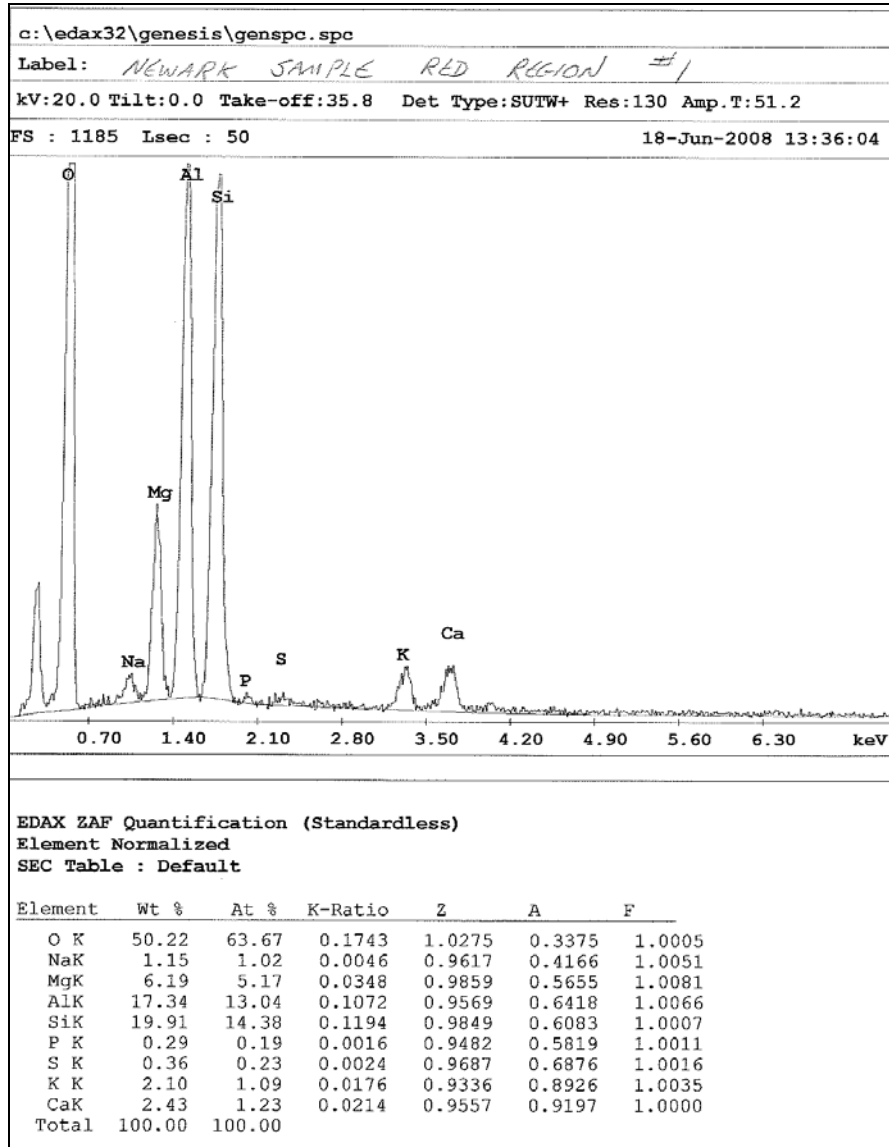
EDS analysis provided by The Avalon Foundation would support the infrared analysis. The spectra show major elements of Al, Si, O and minors of Ca, K, S, Mg, Na. Nick Reiter offered the following.⁹

“...(The spectra seem) to be to be a grab bag of metal oxides - possibly a region where trace metallic elements in the overall alloy segregated at the surface like slag or dross. I'm wondering if the red hue and pink fluorescence might actually imply ruby, due to some very slight amount of Cr. If so, that would be equally curious, as it would imply at some point a temperature way beyond just enough to melt an Al-Si alloy (650 - 700C). Artificial ruby needs to have Cr diffusion at something like 1400C I think. I could experiment with that actually.” Following are the spectra.
