Frontier Analysis, Ltd

TECHNICAL SERVICE RESPONSE NO.: UT084

Subject: Analysis of a Fragment near the Roswell Crash Site (Event Date: Approximately 2-3 July 1947)

Date: July 7, 2014

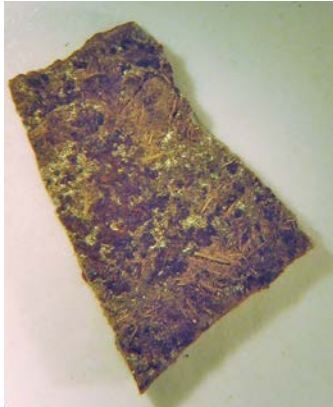
Black Side
'As Received'

Microscopic examination of the fragment 'as received' shows environmental debris. Vegetation particulates as well as dirt/soil are observed. This identification was confirmed by infrared analysis below. The area, cleaned of 'dirt', reveals a light gray material that has a melted-appearing surface, indicating heat exposure. It is not known

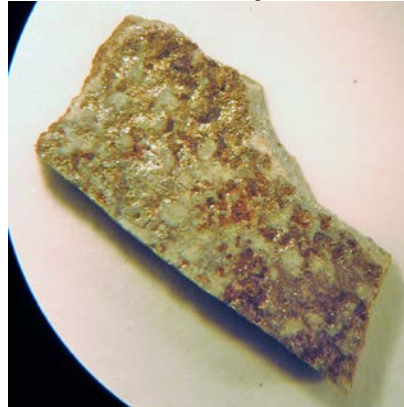
Black Side
Surface Cleaned

whether or not this occurred as part of a manufacturing process. There is a reddish substance in the crevices of the gray substance. The fragment is very brittle and broke on cleaning, which is why it has a different shape. The magnification is also more than the 'as received' photograph. The microscope photographs follow.

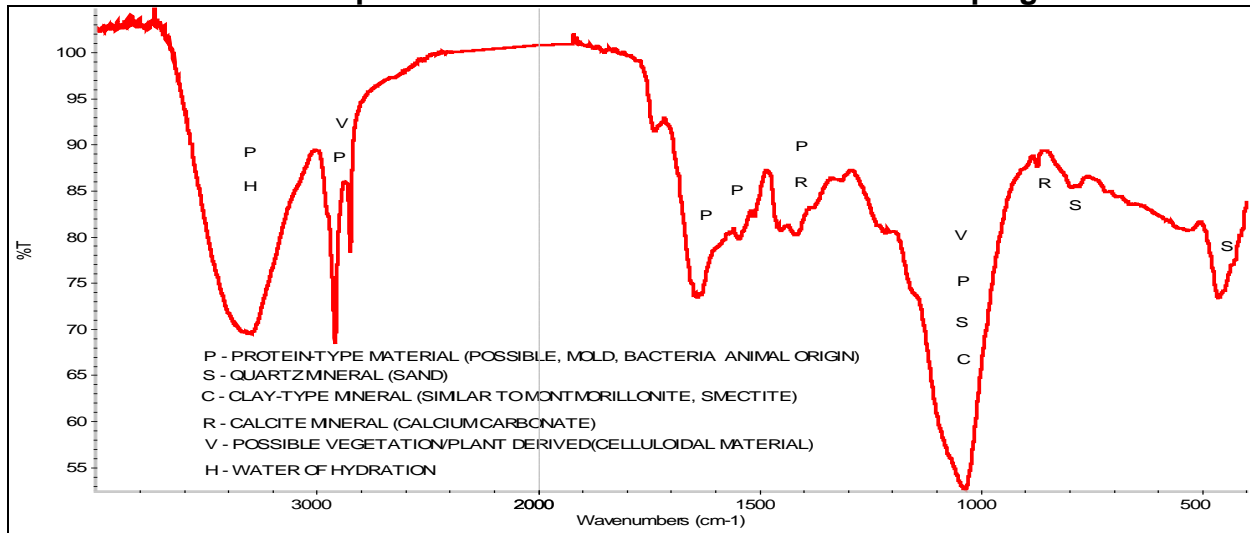
Infrared Spectrum of the 'Black' Side Surface Scrapings

Infrared analysis of scrapings from the surface of the fragment reveals typical environmental debris such as dirt/soil, protein derived material, and possibly some vegetation. Specifically detected are inorganic minerals such as clay (montmorillonite/smectite-like), sand (quartz) and calcite (calcium carbonate). The origin of the protein-type material is most likely mold, bacteria and/or animal. The spectrum follows, labeled with the peak identifications.

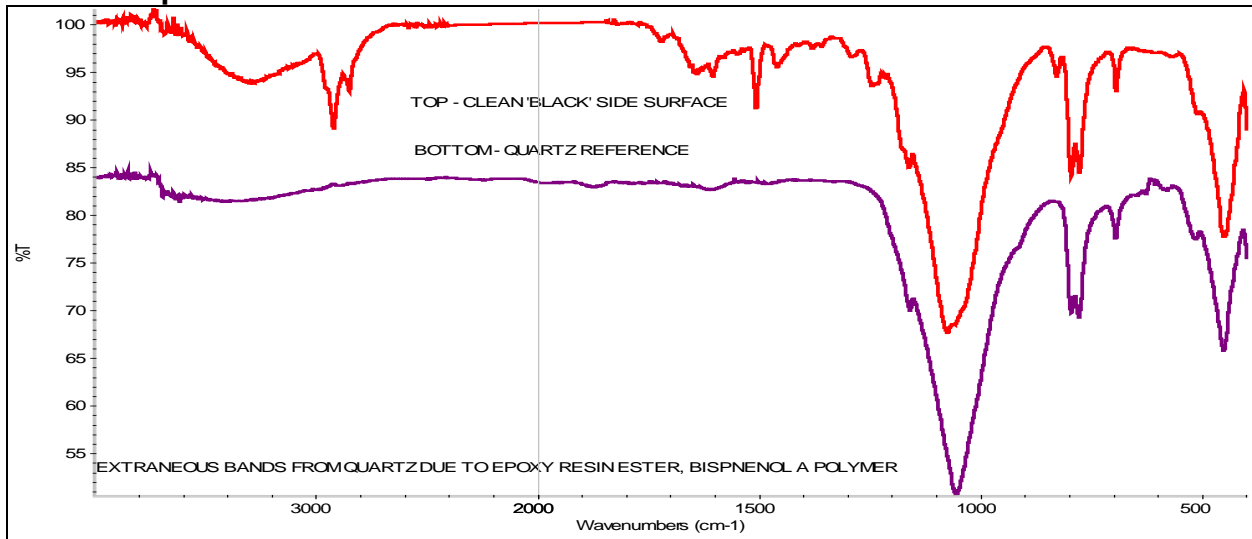
Infrared Spectra of the 'Black' Side after Debris Removal and Reference of Quartz

An infrared spectrum of the gray surface of the 'black' side, after much of the debris was removed, reveals an epoxy resin ester based on bisphenol-A with a quartz filler.

Additionally a small amount of protein-type material is detected. A speculation is that possibly mold/bacteria had established itself on the fragment. A difference spectrum was generated between a surface spectrum and a quartz reference to partially remove interfering quartz absorption. This procedure enhanced and revealed more bands of the resin which helped to facilitate its identification. The bands in a reference spectrum of epoxy resin ester, bisphenol-A match those in the difference spectrum, confirming its identification. Following are spectra of the gray surface material, along with a quartz reference, and the difference spectrum plus a reference spectrum of the epoxy resin ester, bisphenol-A.

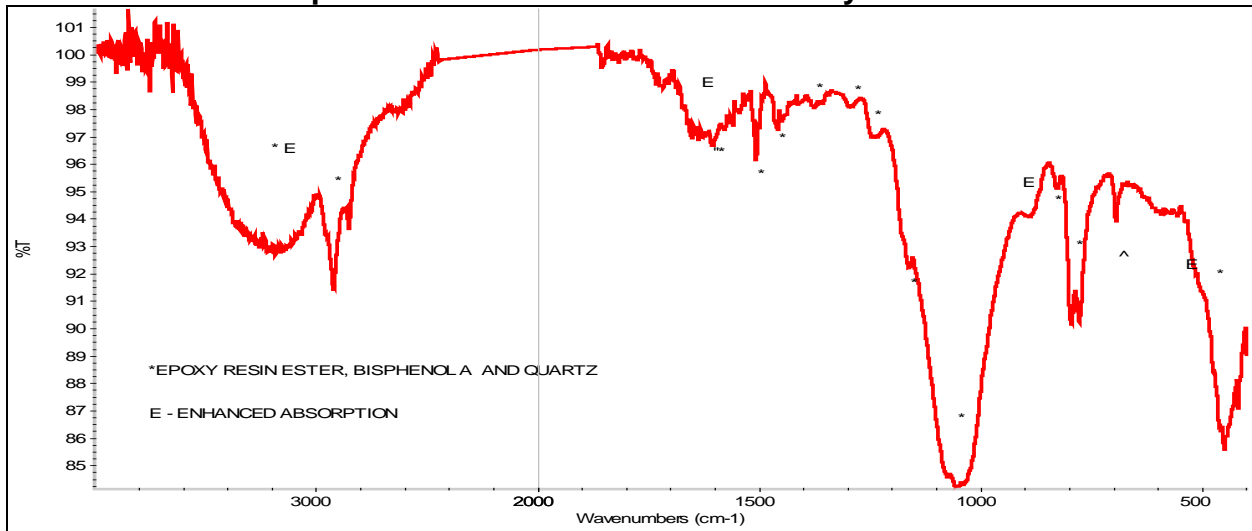
Infrared Spectrum of Reddish Material in Gray Resin Crevices

An infrared spectrum of a reddish material that remained in crevices of the gray resin after much of the debris was removed expectedly shows absorption due to the resin, but

an additional band is also observed at 884 cm^{-1} . A difference spectrum generated between that of the red material versus the clean gray material enhanced absorption and revealed additional bands that were identified as belonging to olivine (chrysolite). It is unknown whether olivine is part of the fragment formulation or more environmental debris. Following are spectra of the red material, the difference spectrum, and olivine reference for comparison.

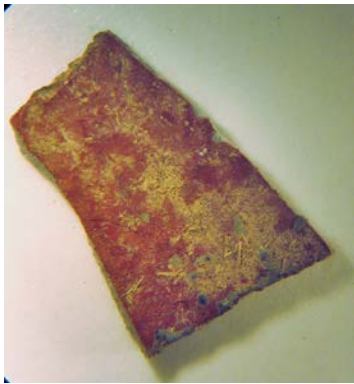
Red Side "As Received"

Examination of the 'as received' red side of the sample under the microscope expectedly shows environmental debris (dirt/plant fragments) like the black side. Removal of the debris clearly displays the remnants of a red coating. Some paint was removed to observe the material under the paint. It is gray with bubbles, indicating heat exposure. Following are the photographs.

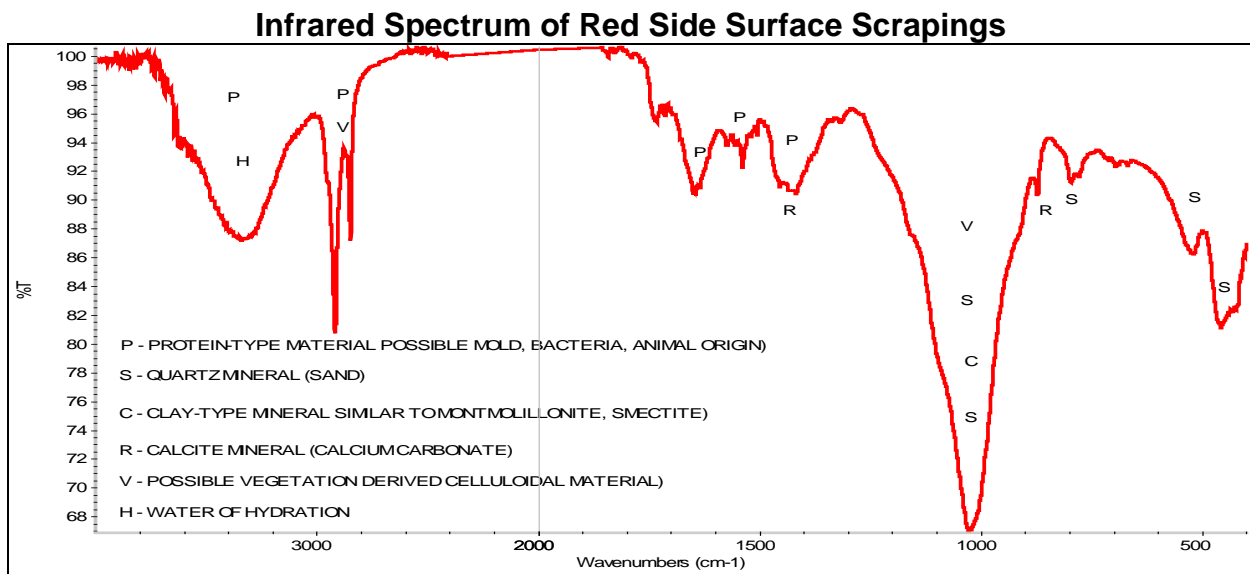
Infrared analysis of scrapings from the 'uncleaned' surface of the fragment shows the same environmental debris as noted in on the 'black' side, though band ratio variances suggest a difference in a quantitative mixture. Specifically detected are clay, sand, calcite, a protein-type substance and possible plant derived material. Following is the spectrum.

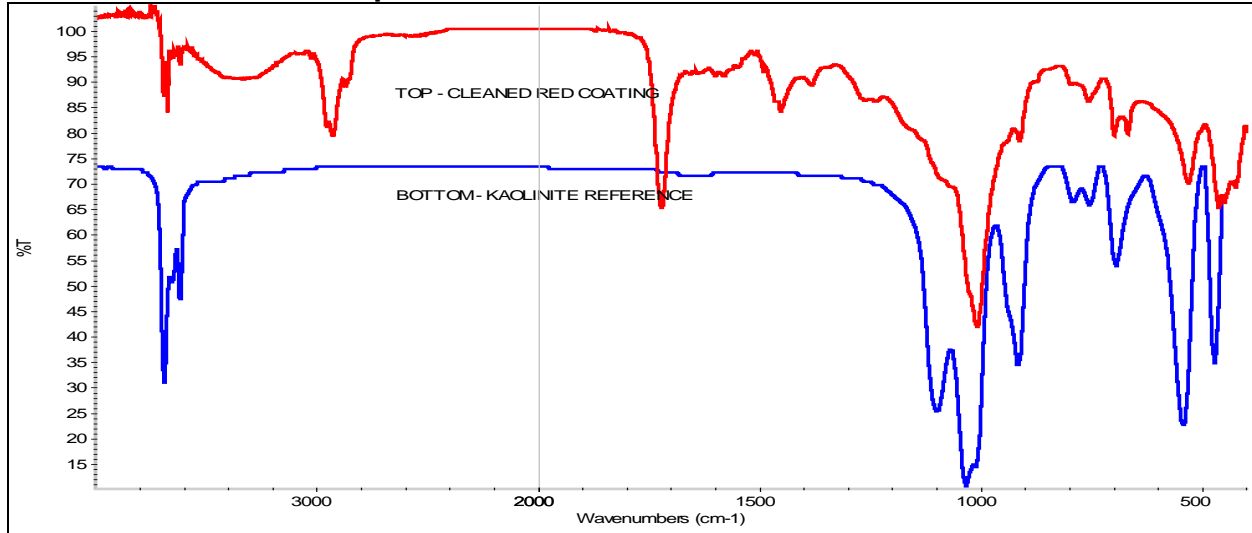
Infrared Spectra of Red Paint and Kaolinite Reference

Infrared analysis of the red paint after cleaning clearly reveals it is composed of a poly(acrylate styrene) copolymer and a kaolinite-type mineral filler. The kaolinite masks

much of the polymer absorption. Therefore, a difference spectrum was generated to diminish this effect and enhance and reveal new bands from the polymer. The difference spectrum clearly displays bands matching a reference of poly(acrylate styrene), confirming its identity. Following are spectra of the red paint with a kaolinite reference and the difference spectrum with a poly(acrylate styrene) reference.

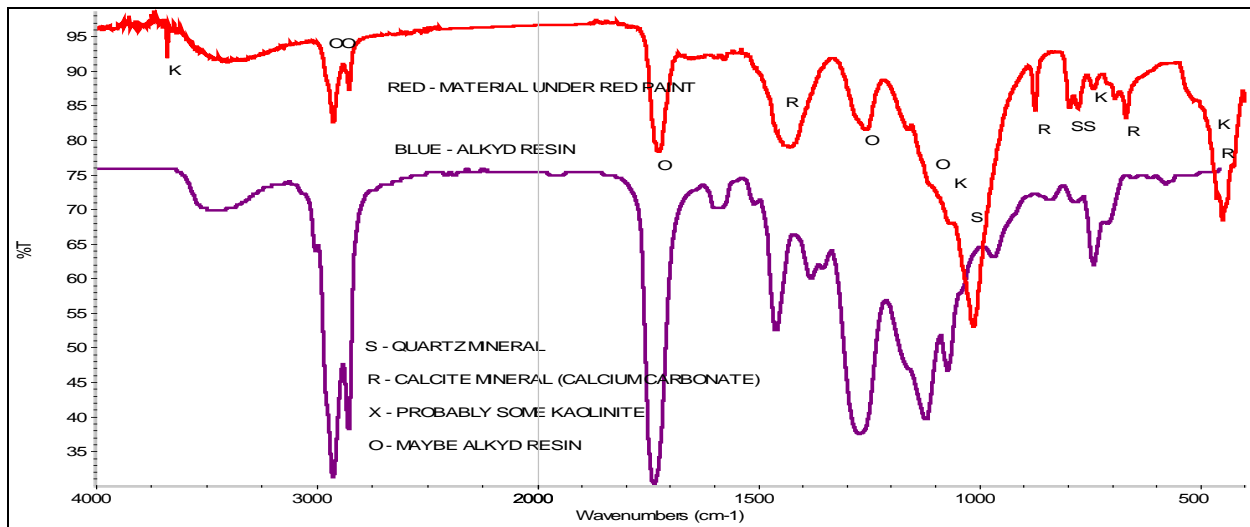
Infrared Spectrum of the Material underneath the Red Paint and Alkyd Resin Reference

The paint was scraped from the surface, not only to see the appearance underneath (see above), but also to determine if and what was in between the paint and resin layer. An infrared spectrum taken of the gray area after paint removal suggest it is a combination of some resin components detected on the black side and some paint components. Detected are quartz mineral and probably kaolinite. Additionally, there is calcium carbonate which is not believed to be part of the 'dirt', because it is in between

the paint and resin. Also, there may be an alkyd resin which could be a paint component. This may indicate the surface was covered with another coating before application of the red paint. Following are spectra of the material underneath the red paint and a reference of alkyd resin for comparison.

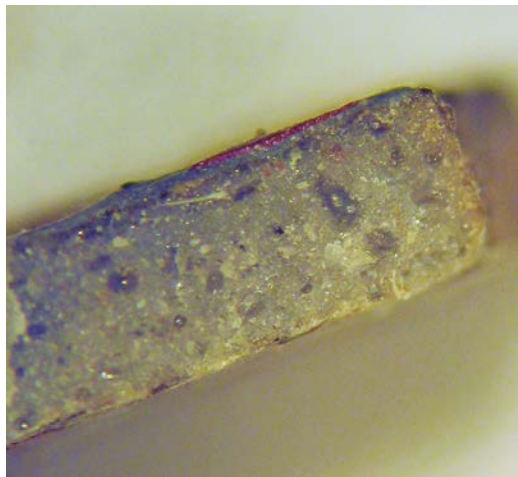
Fragment Edge

A microscope photograph of the edge of the fragment displays a thin red edge from the paint, and the main resin/quartz portion. Bubbles are observed again, clearly showing the fragment has been subjected to heat. The photograph follows.

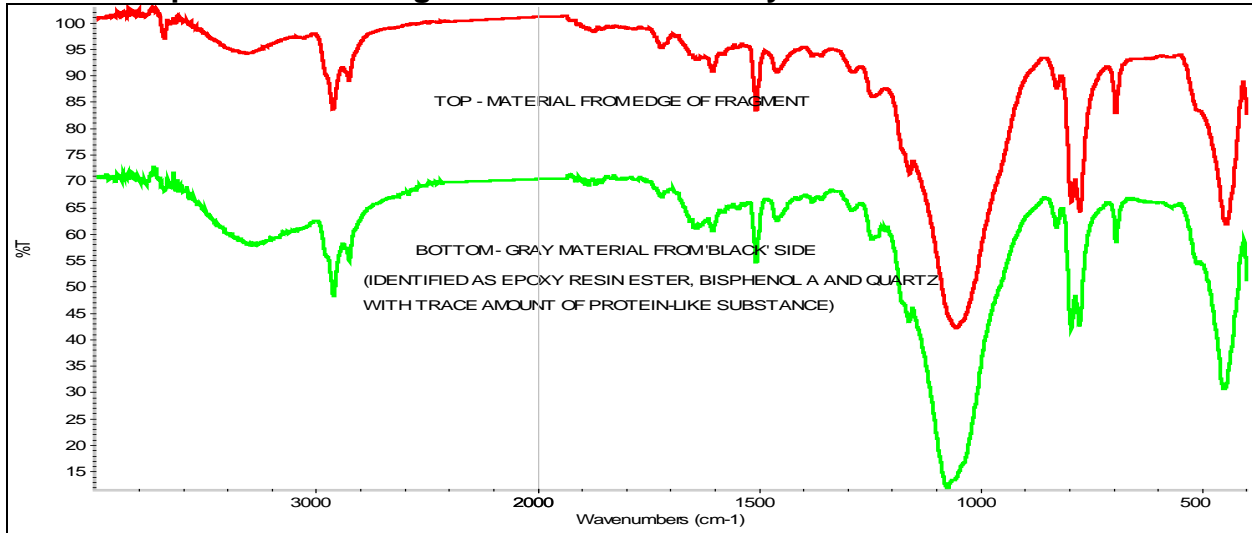
Infrared Spectra of the Edge Material and the Gray Material from the 'Black' Side

The infrared spectrum of the edge of the fragment matches that of the gray material from the cleaned 'black' side. Therefore the same interpretation applies. (See page 4)

In summation, the material is composed of an epoxy resin ester based on bisphenol-A with a quartz filler. A small amount of protein-type material is detected. Following are spectra of the edge material and the cleaned gray material from the 'black' side for comparison.
