**AIRCRAFT
ACCIDENT INVESTIGATION BOARD
REPORT**

**US ARMY UH-60
BLACK HAWK HELICOPTERS
87-26000 AND 88-26060**

TECHNICAL OR ENGINEERING EVALUATIONS

AMSEL-RD-NV-SE-EWD (SFAE-AV-AEC/25 Apr 1994) (70-1r) 1st End
Mr. R. Paolella and Ms. P. Lum/x44697 and x43211
SUBJECT: Failure Analysis on Crash Damaged Electronic Equipment

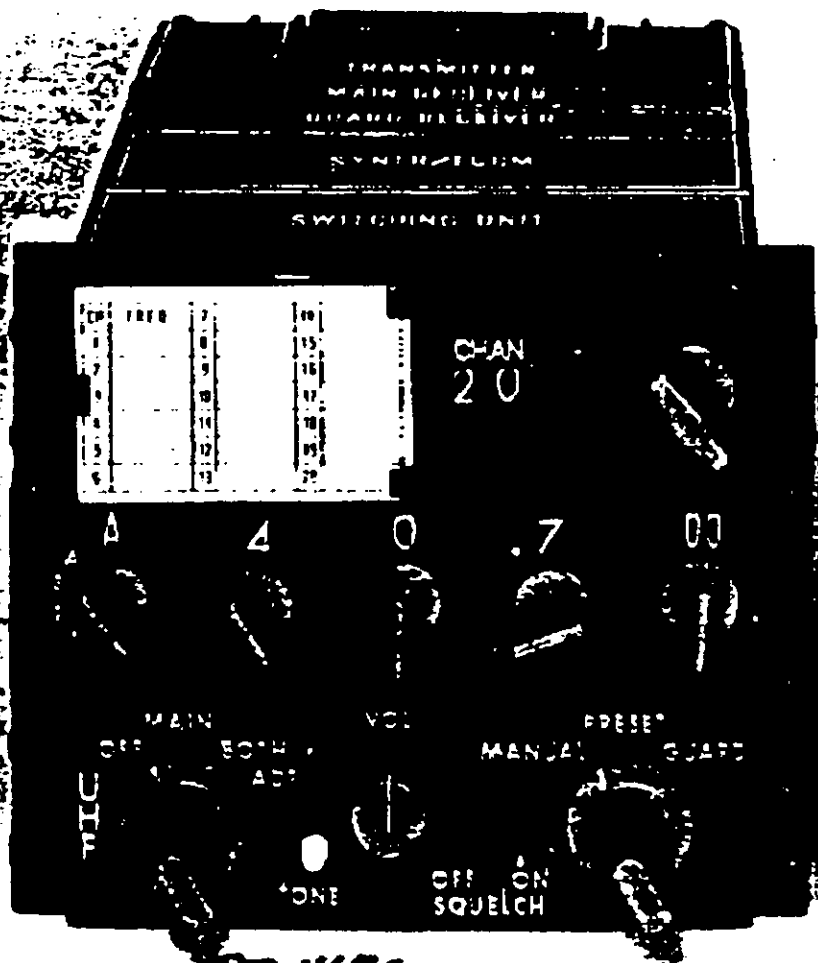
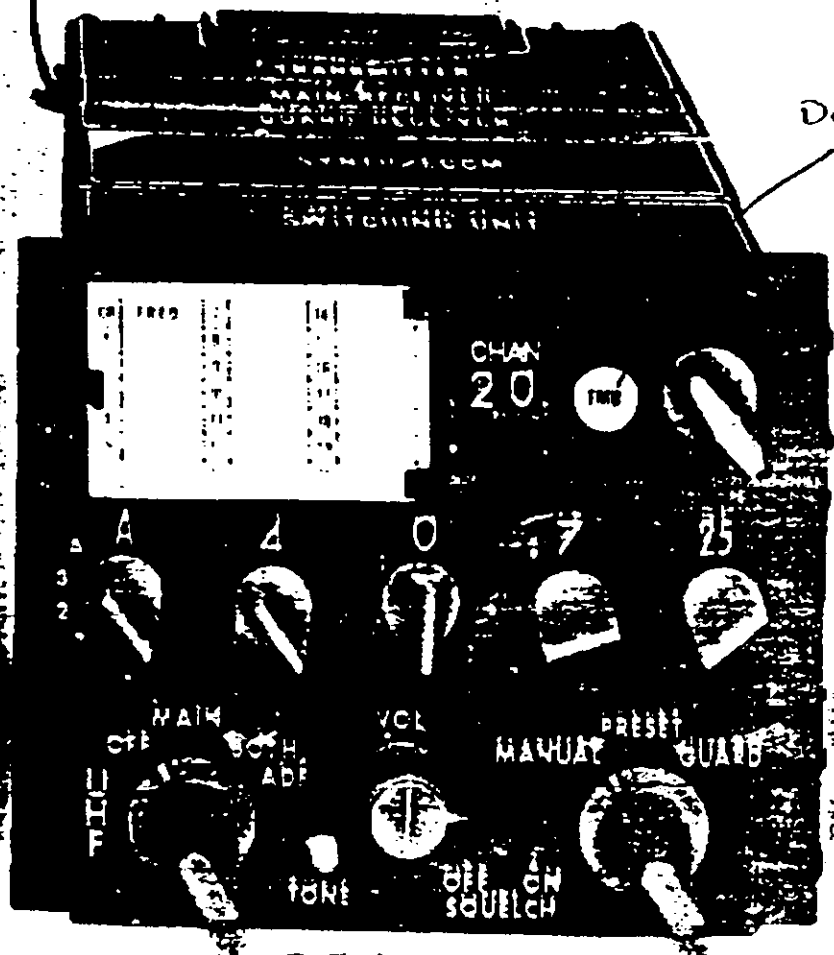
ARC-164 Comparison *White Triangle*

a. The RT-1167 faceplate is of different construction than the RT-1168 faceplate. The RT-1167 faceplate has grommets and a different channel selector switch which enables it to be rain-proof. The RT-1167 actually gets a rain test in the factory. The RT-1168 gets humidity testing only, no rain.

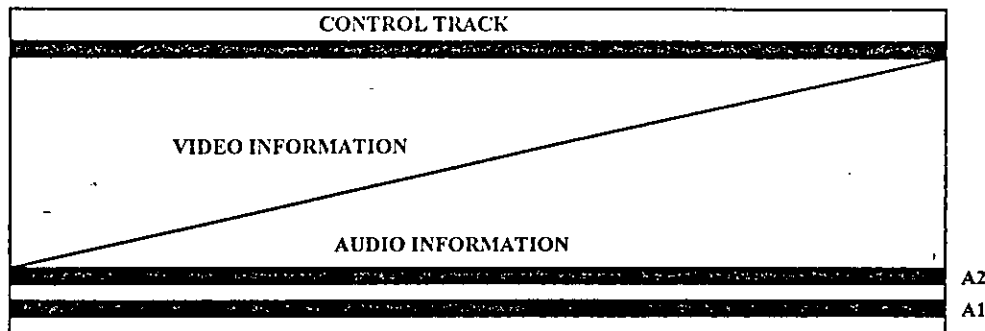
Figure 1. Video Tape Recording Characteristics and Track Information

5. 1800 - 1930: Mount magnet inside VCR prior to audio head, just after video head.
 - a. Magnet position is crucial to the success of this test.
 - b. Stereo recording creates two audio tracks. Both tracks are located at the bottom of the tape (see Figure 1.) as it passes across the audio head.
 - c. For standard stereo recordings (this recording is verified as standard), the affects of re-recording are as follows:
 - i. Both audio tracks are initially passed across the "main" erase head.
 - This essentially performs a "gross" erasure of all information on the tape (video and audio)
 - ii. Track 1 (labeled A2) is then passed through a second erase head for the purpose of recording. If this track is not passed across a separate erase head, no recording takes place.
 - iii. Track 2 (labeled A1) does not pass across a second erase head.
