**AIRCRAFT
ACCIDENT INVESTIGATION BOARD
REPORT**

**US ARMY UH-60
BLACK HAWK HELICOPTERS
87-26000 AND 88-26060**

TECHNICAL REPORT F-15 MAINTENANCE

Aircraft Evaluated: F-15C, Tail Number 79-0025

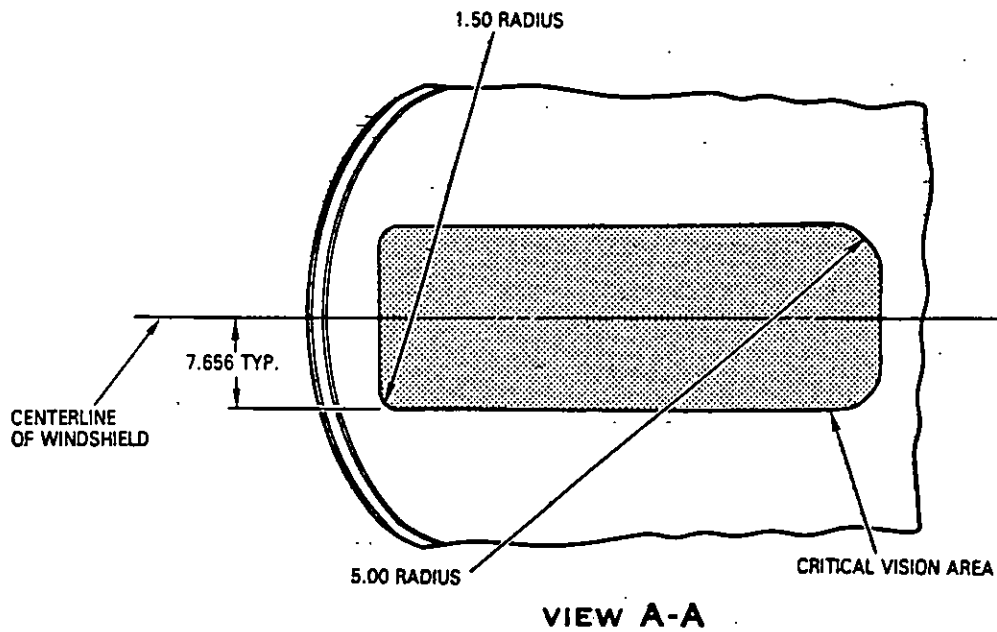
On my evaluation of A/C 9025 I found a scratch approximately 4 inches long at the 11 o'clock position on the windshield, near the windshield arch (Atch 3). Through visual inspection I found no distortion, and therefore there is no visual distortions. I then inspected the canopy, I found a few scratches that look like they may have come from a pilots helmet, but determined that they would be out of the pilots view area, and there was not any distortion.

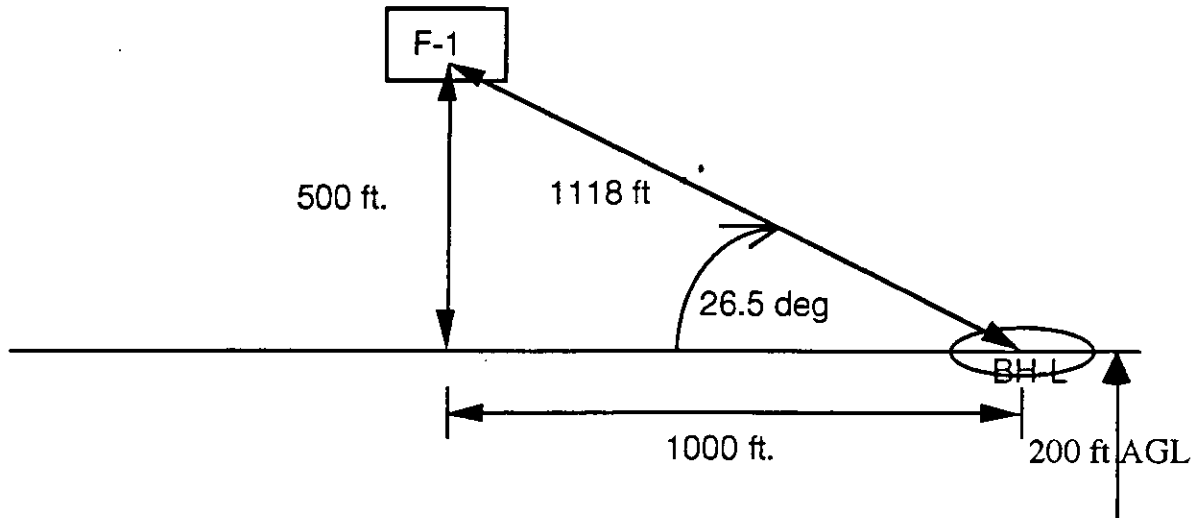
Figure 1. F-1 is at a slant range of 1118 feet from BH-L and the look down angle is 26.5 degrees.

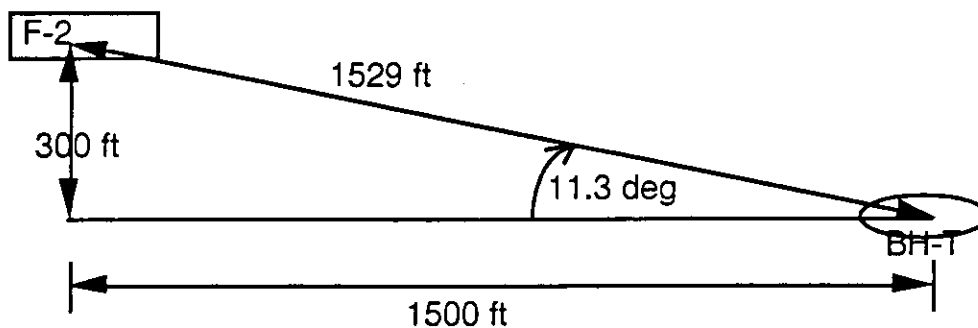
Figure 2. F-2 is at a slant range of 1529 feet from BH-T, and the look down angle is 11.3 degrees.

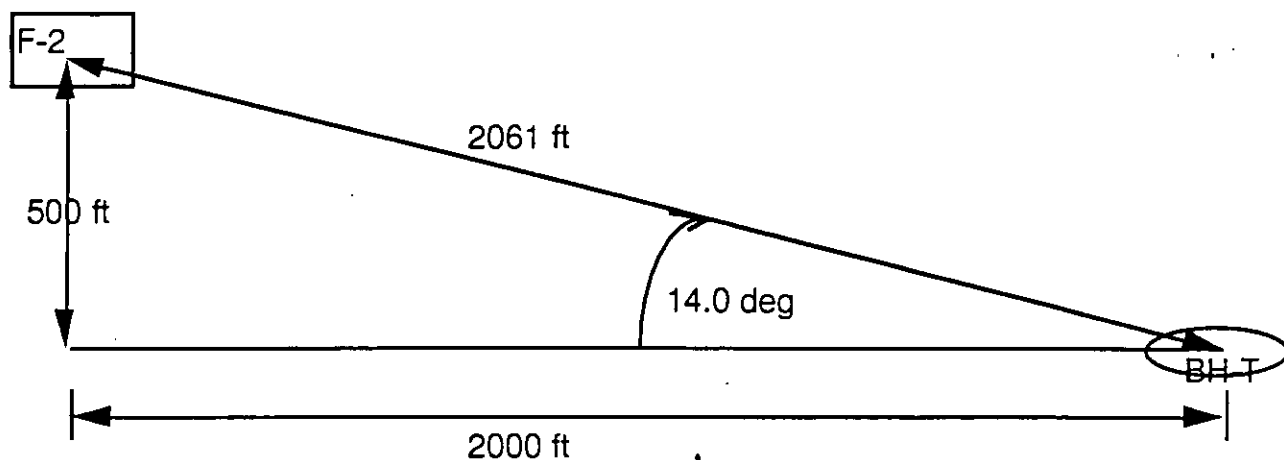
Figure 3. F-2 is at a slant range of 2061 feet from BH-T, and the look down angle is 14.0 degrees.

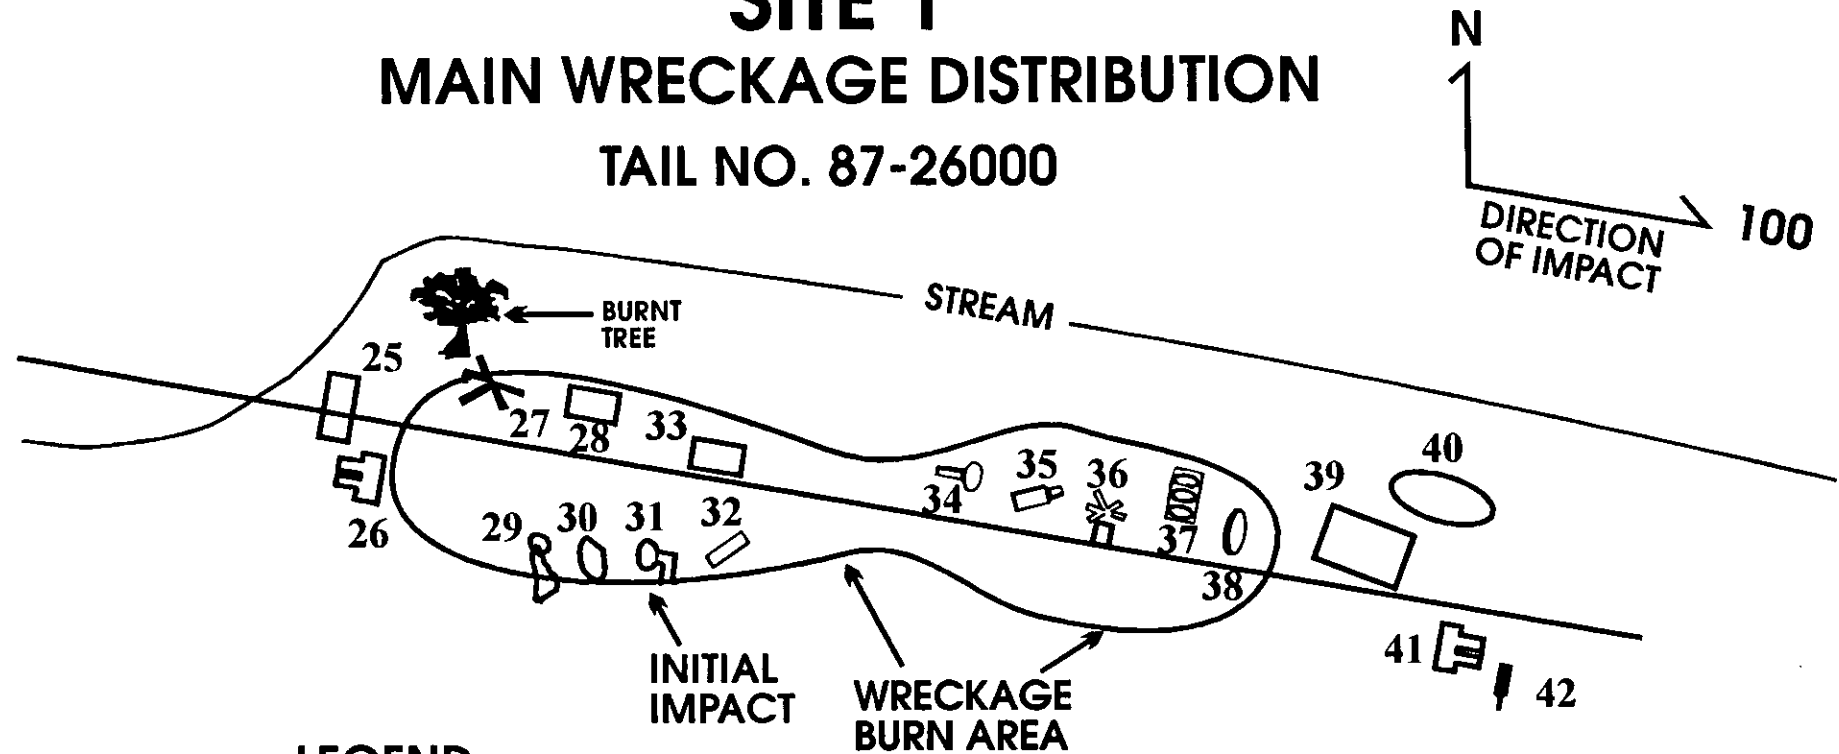
MAIN WRECKAGE DISTRIBUTION

ITEM	DESCRIPTION	DIST (FT)	DIR (MAG)
25	RIGHT STABILATOR PART	96	290
26	LEFT ESSS PART	98	280
27	TAIL ROTOR PYLON	56	275
28	TAIL BOOM PART	53	278
29	LEFT WHEEL STRUT	51	255
30	SEARCH LITE	50	258
31	PEDAL, TAIL ROTOR CONTROL	50	258
32	MAIN ROTOR BLADE PART	40	300
33	TAIL BOOM PART	43	278
34	OIL COOLER FAN	15	300
35	LEFT ENGINE	5	300
36	MAIN TRANSMISSION	0	0
37	HYDRAULIC ASSIST MODULE	10	110
38	SLEEPING BAG	13	112
39	CARGO FLOOR PIECE	30	115
40	RIGHT ESSS FUEL TANK	47	108
41	RIGHT ESSS PYLON	75	120
42	RIGHT ENGINE	88	120

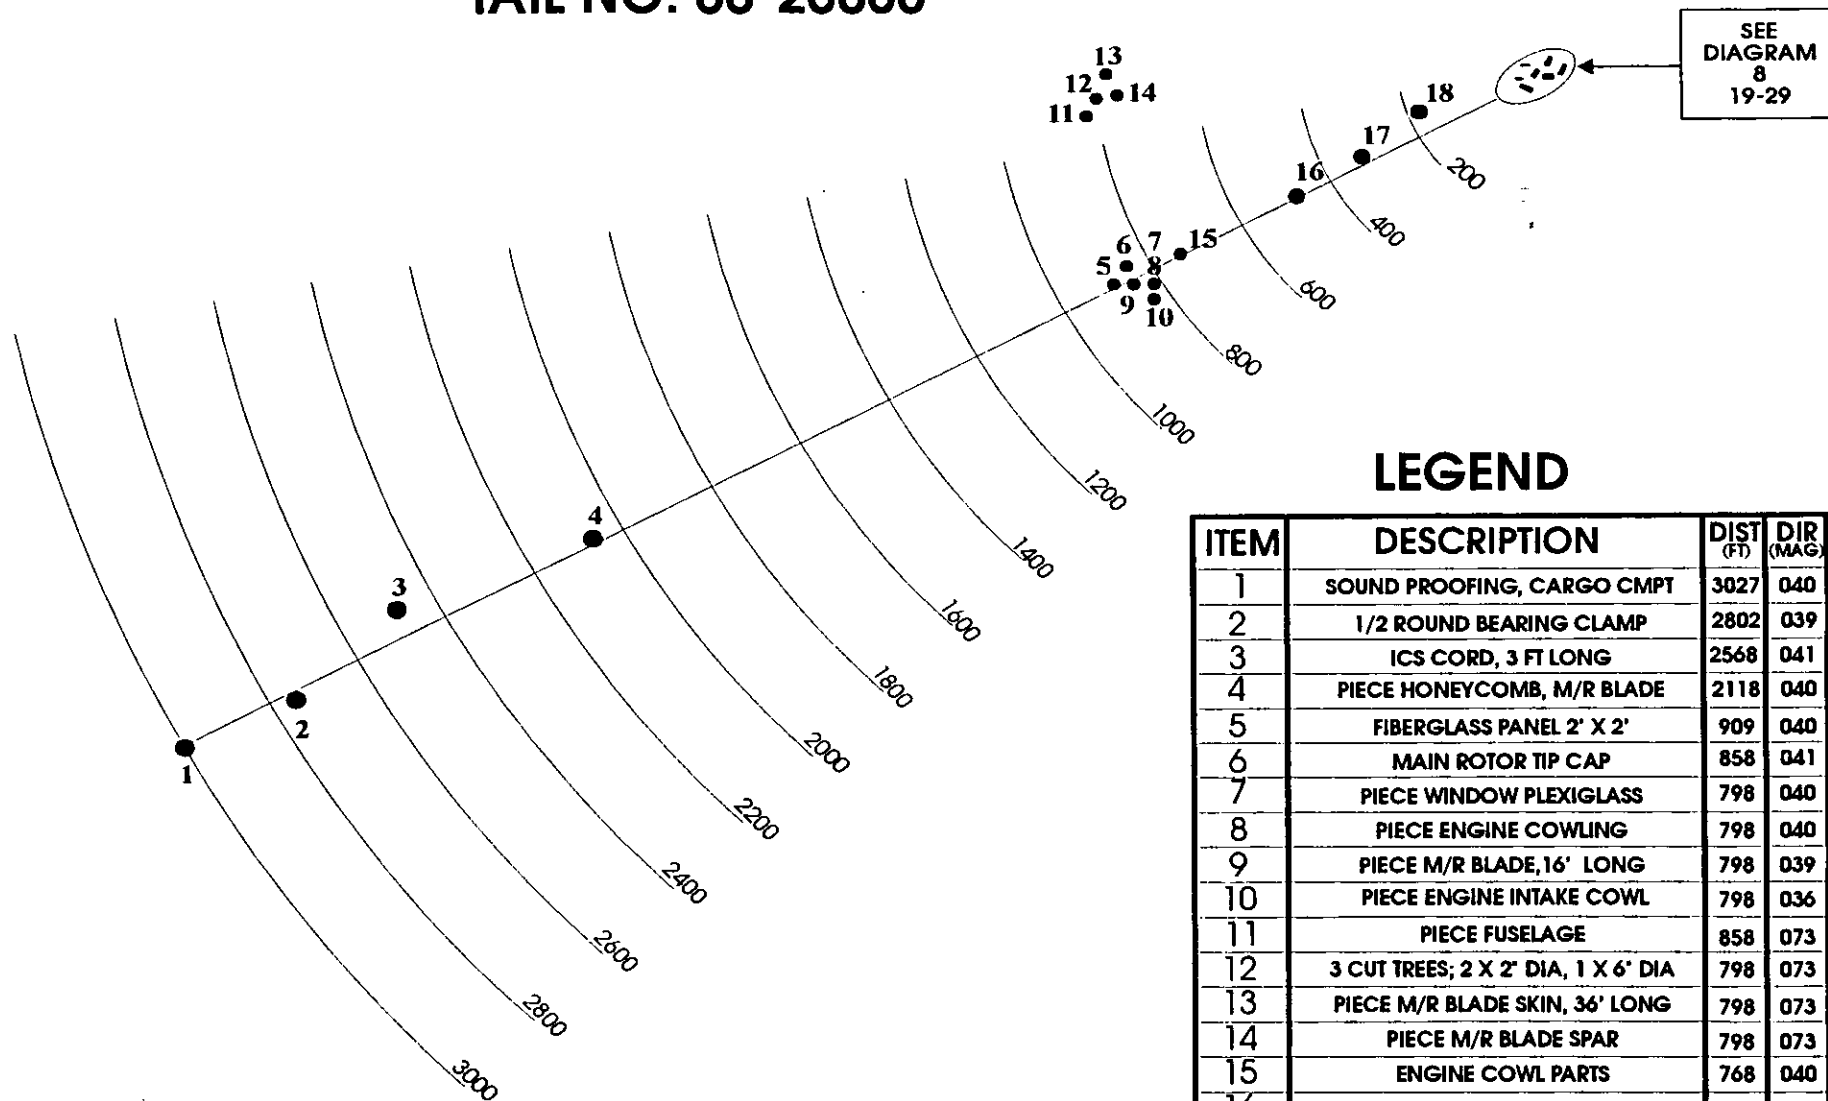
FLIGHT PATH WRECKAGE DISTRIBUTION SITE 2 TAIL NO. 88-26060

ITEM	DESCRIPTION	DIST (FT)	DIR (MAG)
19	APU DECK	130	480
20	PIECE TAIL BOOM, RIGHT	77	195
21	MIXING UNIT	48	215
22	MAIN FUSELAGE	41	230
23	TAIL ROTOR	41	210
24	LEFT ENGINE	35	235
25	ESSS TANK	32	250
26	MAIN TRANSMISSION	0	0
27	APU ENGINE	35	200
28	GROUND SCAR RIGHT ENGINE	55	100
29	RIGHT ENGINE	71	125
