**AIRCRAFT  
ACCIDENT INVESTIGATION BOARD  
REPORT**

**US ARMY UH-60  
BLACK HAWK HELICOPTERS  
87-26000 AND 88-26060**

**VOLUME 7**

## **TECHNICAL REPORT F-15 MAINTENANCE**

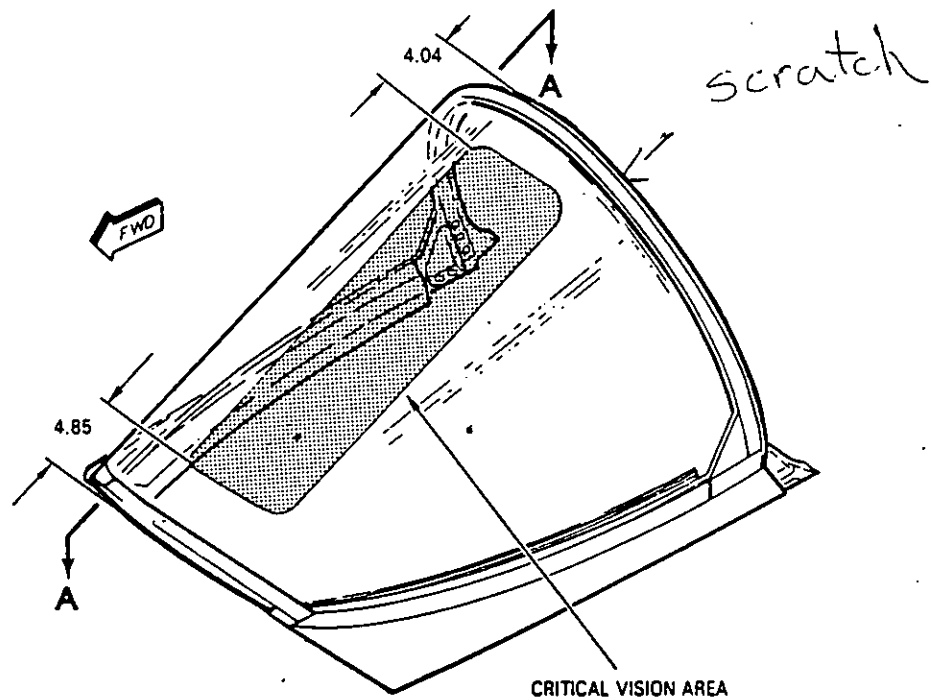
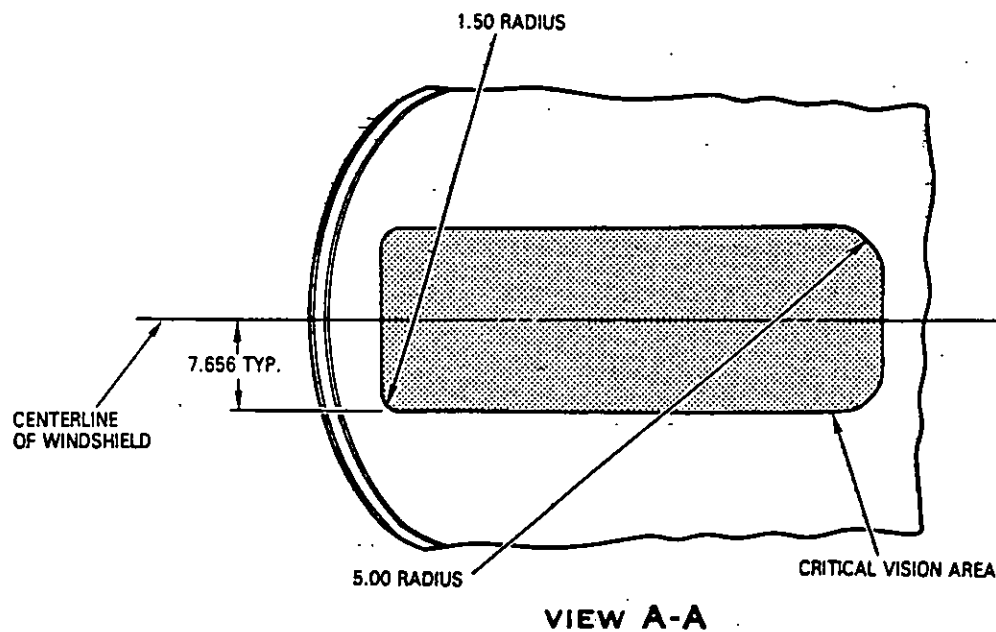
On my evaluation of A/C 9025 I found a scratch approximately 4 inches long at the 11 o'clock position on the windshield, near the windshield arch (Atch 3). Through visual inspection I found no distortion, and therefore there is no visual distortions. I then inspected the canopy, I found a few scratches that look like they may have come from a pilots helmet, but determined that they would be out of the pilots view area, and there was not any distortion.

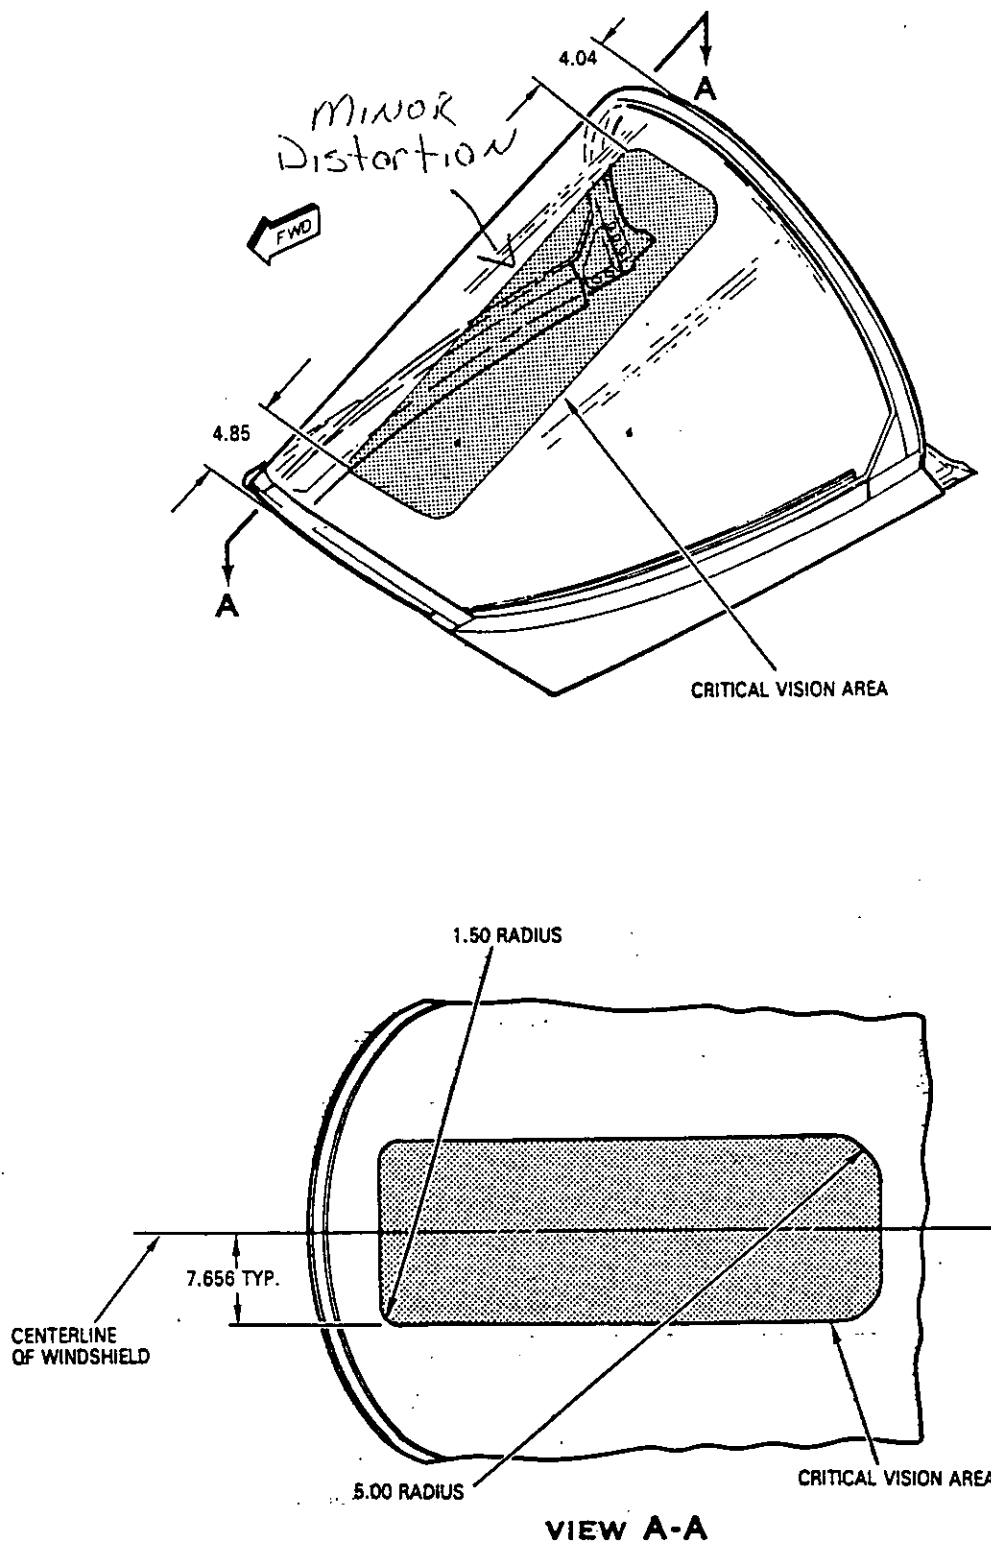
A/C 4025..

I then inspected A/C 4025. Upon inspection I found a small distortion in the windshield at about 12:10 position. This was about half way down the windshield in the critical view area (Atch 4). I was not sure if it was a distortion or not so I examined the canopy and found the same thing I found on A/C 9025, and that was a few scratches but no distortions. I then went back and looked at the windshield again to make sure the distortion was still there and it was still there. Upon further inspection I determined that it was a small area not an area where a pilot would be able to focus in on for a long period of time.

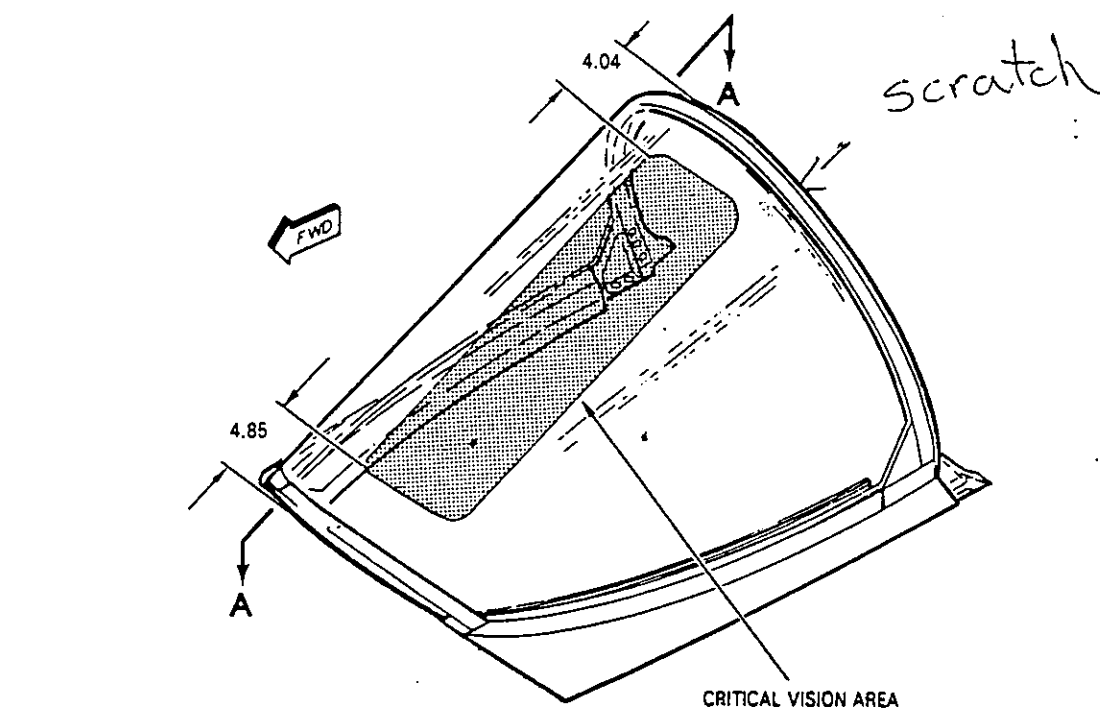
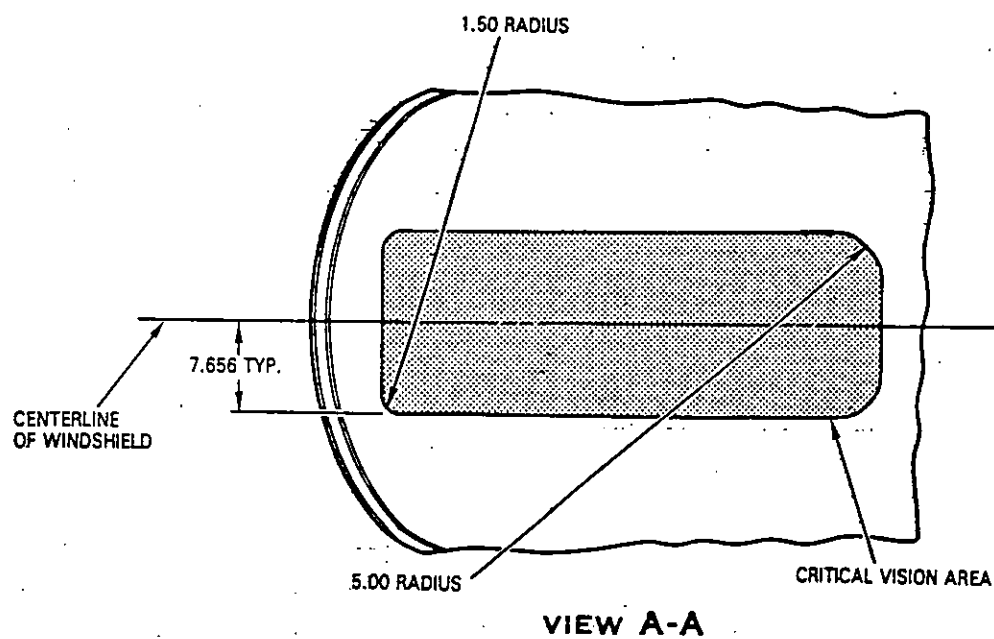
On my evaluation of A/C 9025 I found a scratch approximately 4 inches long at the 11 o'clock position on the windshield, near the windshield arch (Atch 3). Through visual inspection I found no distortion, and therefore there is no visual distortions. I then inspected the canopy, I found a few scratches that look like they may have come from a pilots helmet, but determined that they would be out of the pilots view area, and there was not any distortion.

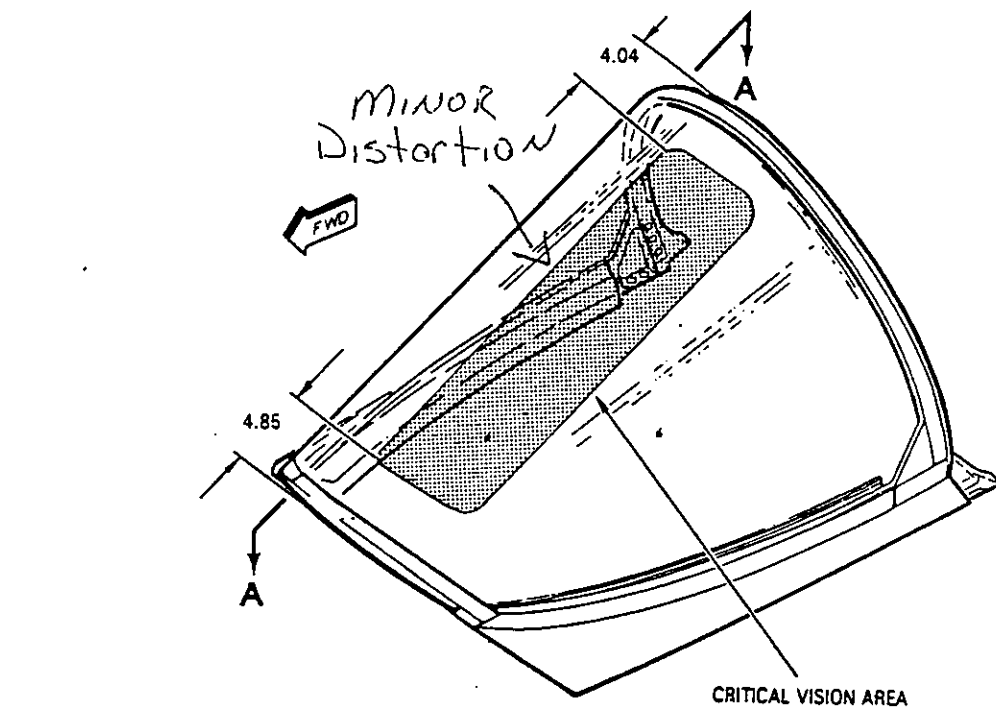
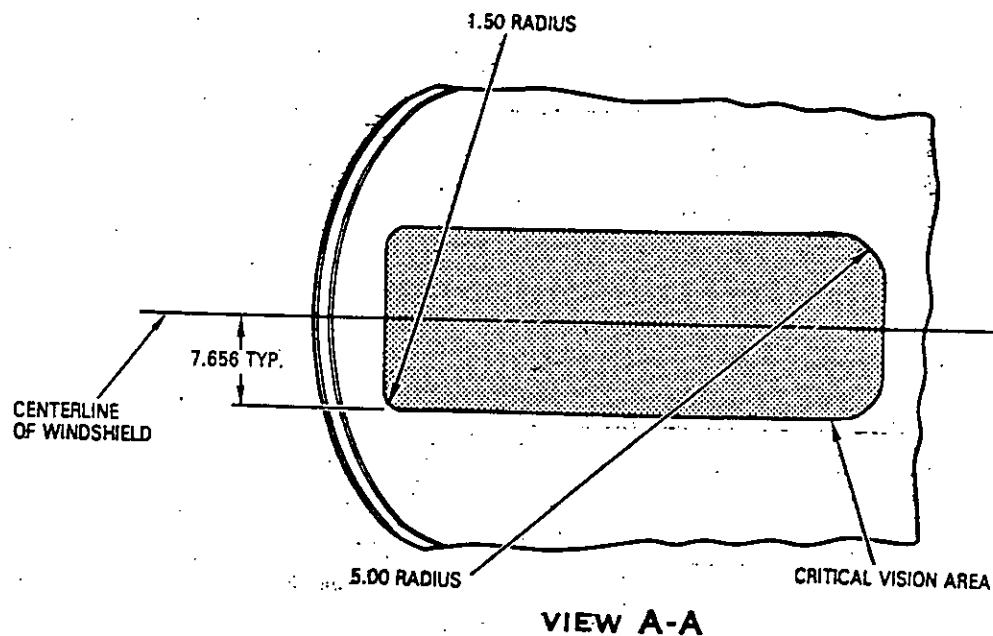
A/C 4025

I then inspected A/C 4025. Upon inspection I found a small distortion in the windshield at about 12:10 position. This was about half way down the windshield in the critical view area (Atch 4). I was not sure if it was a distortion or not so I examined the canopy and found the same thing I found on A/C 9025, and that was a few scratches but no distortions. I then went back and looked at the windshield again to make sure the distortion was still there and it was still there. Upon further inspection I determined that it was a small area not an area where a pilot would be able to focus in on for a long period of time.
