# AIRMUNITIONS LETTER

OCAMA AIRMUNITIONS LETTER  
NO. 136-11-56C

SUBJECT: Advance Explosive Ordnance Disposal Technical Information

## SUMMARY OF NUCLEAR WEAPONS INCIDENTS (AF FORM 1058) AND RELATED PROBLEMS JUNE 1960

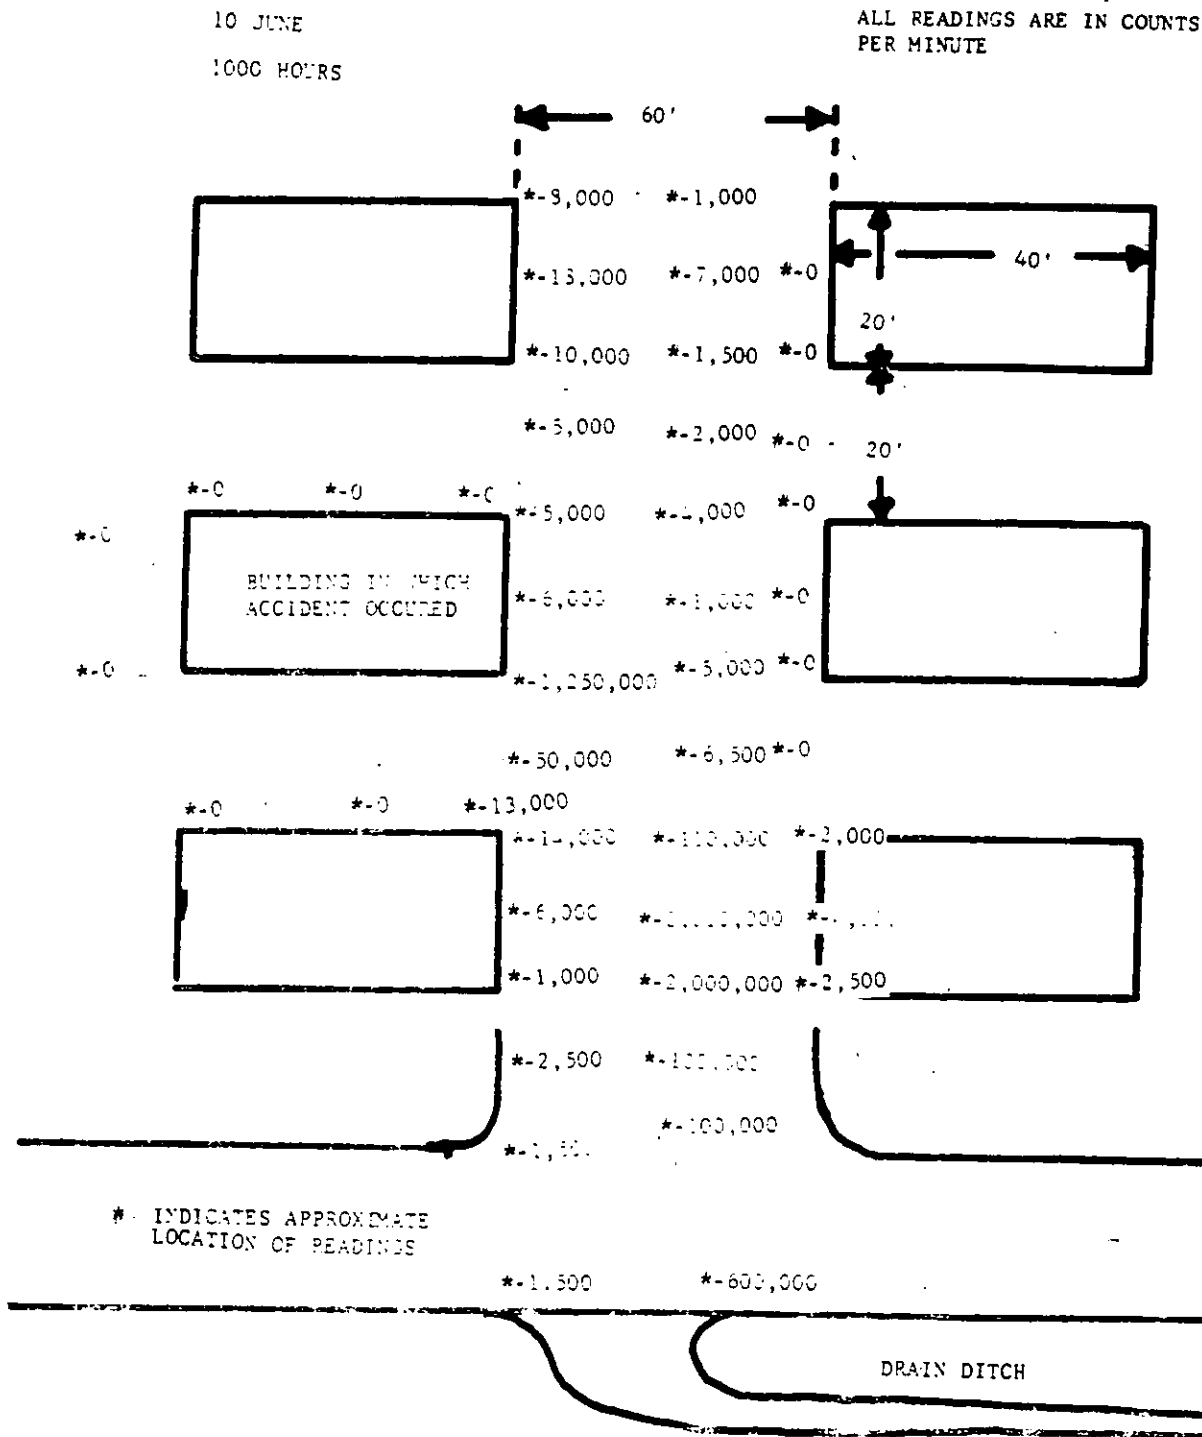
approximately 66 square miles and reported that no contamination were found. Another survey was made inside the shelter it had dried. A reading of over 2,000,000 CPM was taken near the warhead residue. Other areas within the shelter had 100 CPM to 50,000 CPM. The entire inside of the shelter and all readings indicating contamination were limited immediately around and slightly forward of the warhead area was roped off and kept wet the rest of the day June. Personnel entering the area were kept to a minimum. An accident investigation team trying to determine the cause of explosion and fire. (Reference Figure 1.)

FIGURE 1. Monitoring Survey Results, 8 June 1960.
