AIRMUNITIONS LETTER

COAMA AIRMUNITIONS LETTER
NO 136-11-56G

SUBJECT: Advance Explosive Ordnance Disposal Technical Information

(U) SUMMARY OF NUCLEAR WEAPONS INCIDENTS (AF FORM 1055) AND
RELATED PROBLEMS - JANUARY 1961

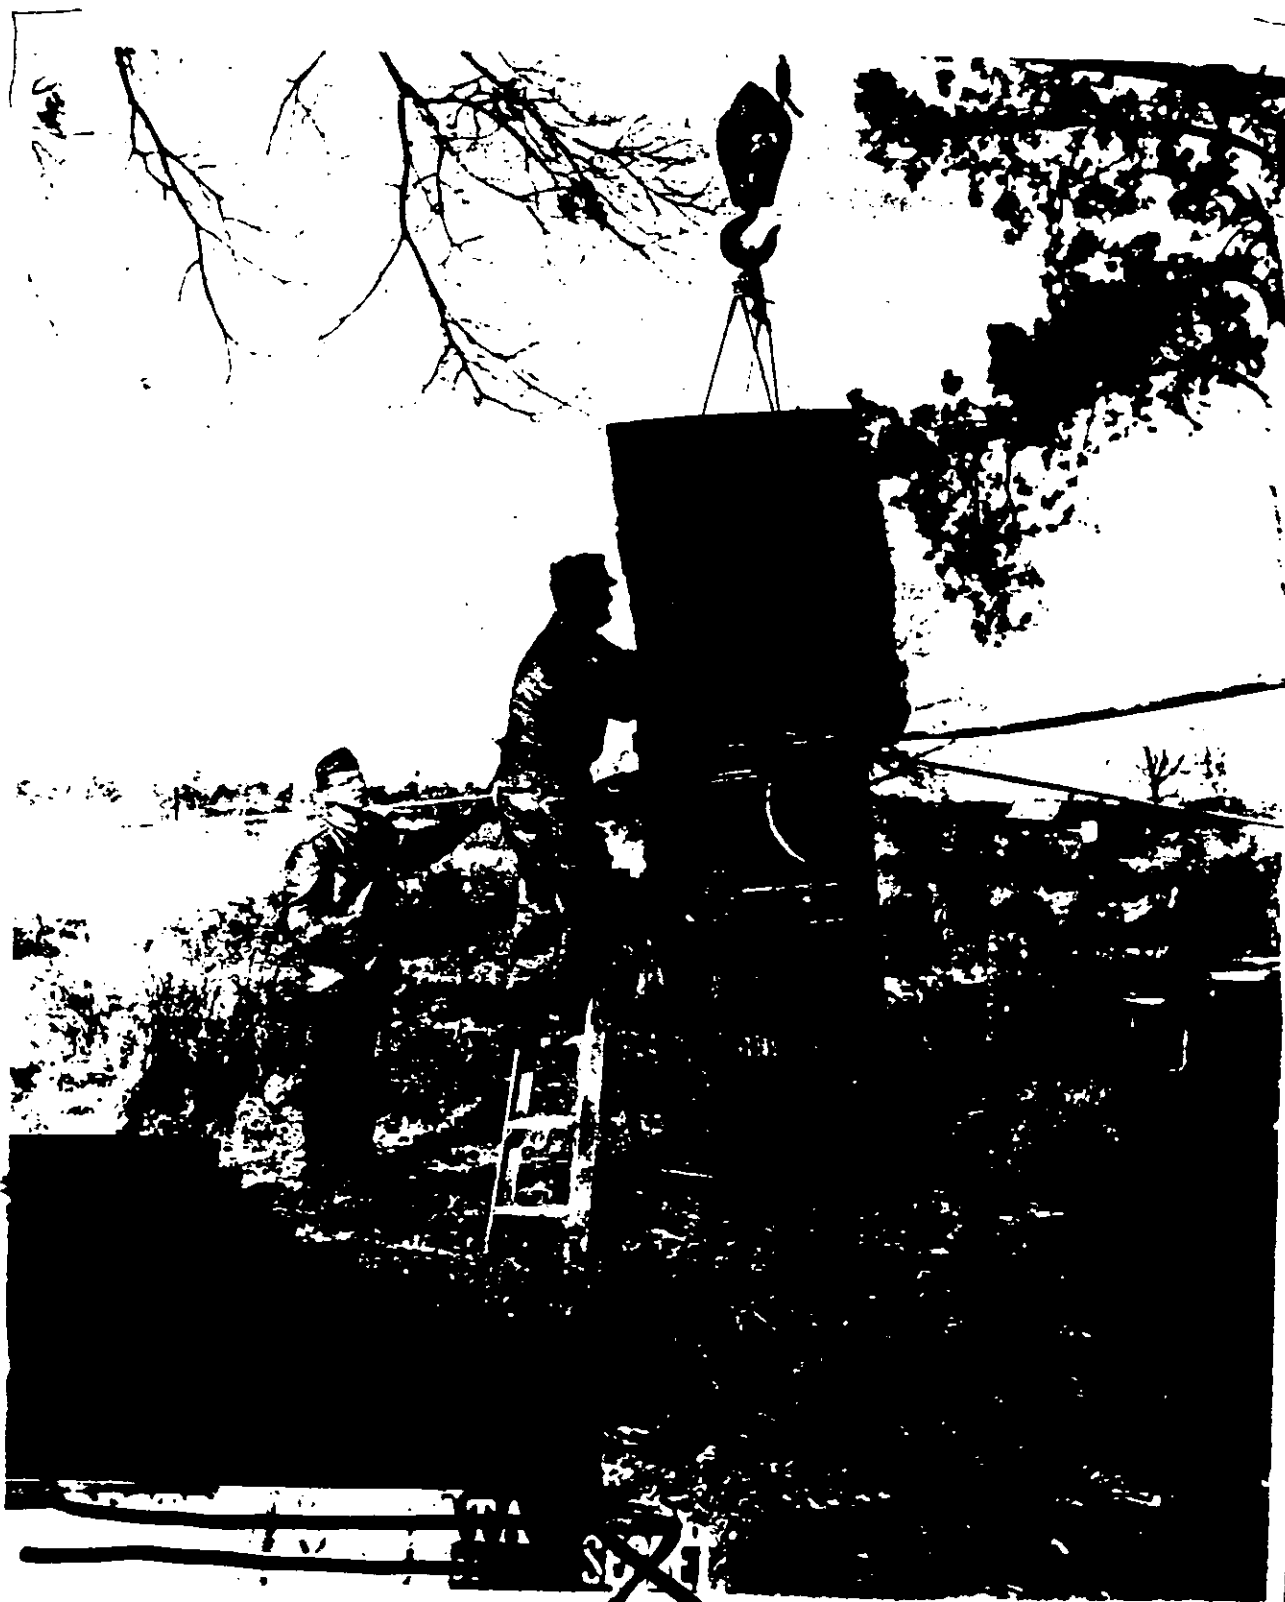
FIGURE 5. Primary Removal.
