Sweeney, Christopher J (ISI), 07:39 AM 2/3/2003, Thoughts and Prayers

Howard M. Adelman, 01:13 PM 2/3/2003, Response to questions about Columbia

Date: Wed, 12 Feb 2003 13:48:15 -0500
To: r.h.daugherty@larc.nasa.gov
From: "Katherine A. Barnstorff" <k.a.barnstorff@larc.nasa.gov>
Subject: Associated Press article

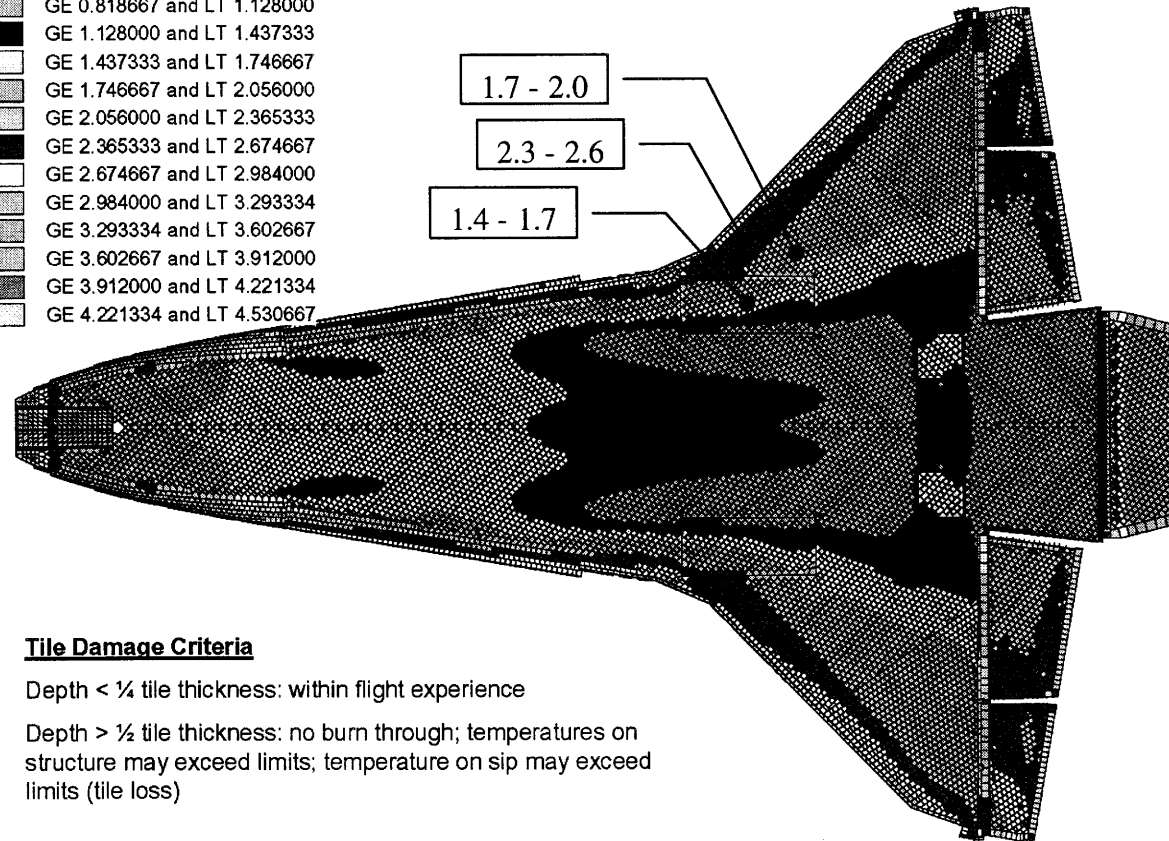
Tile Damage Criteria

Depth < 1/4 tile thickness: within flight experience

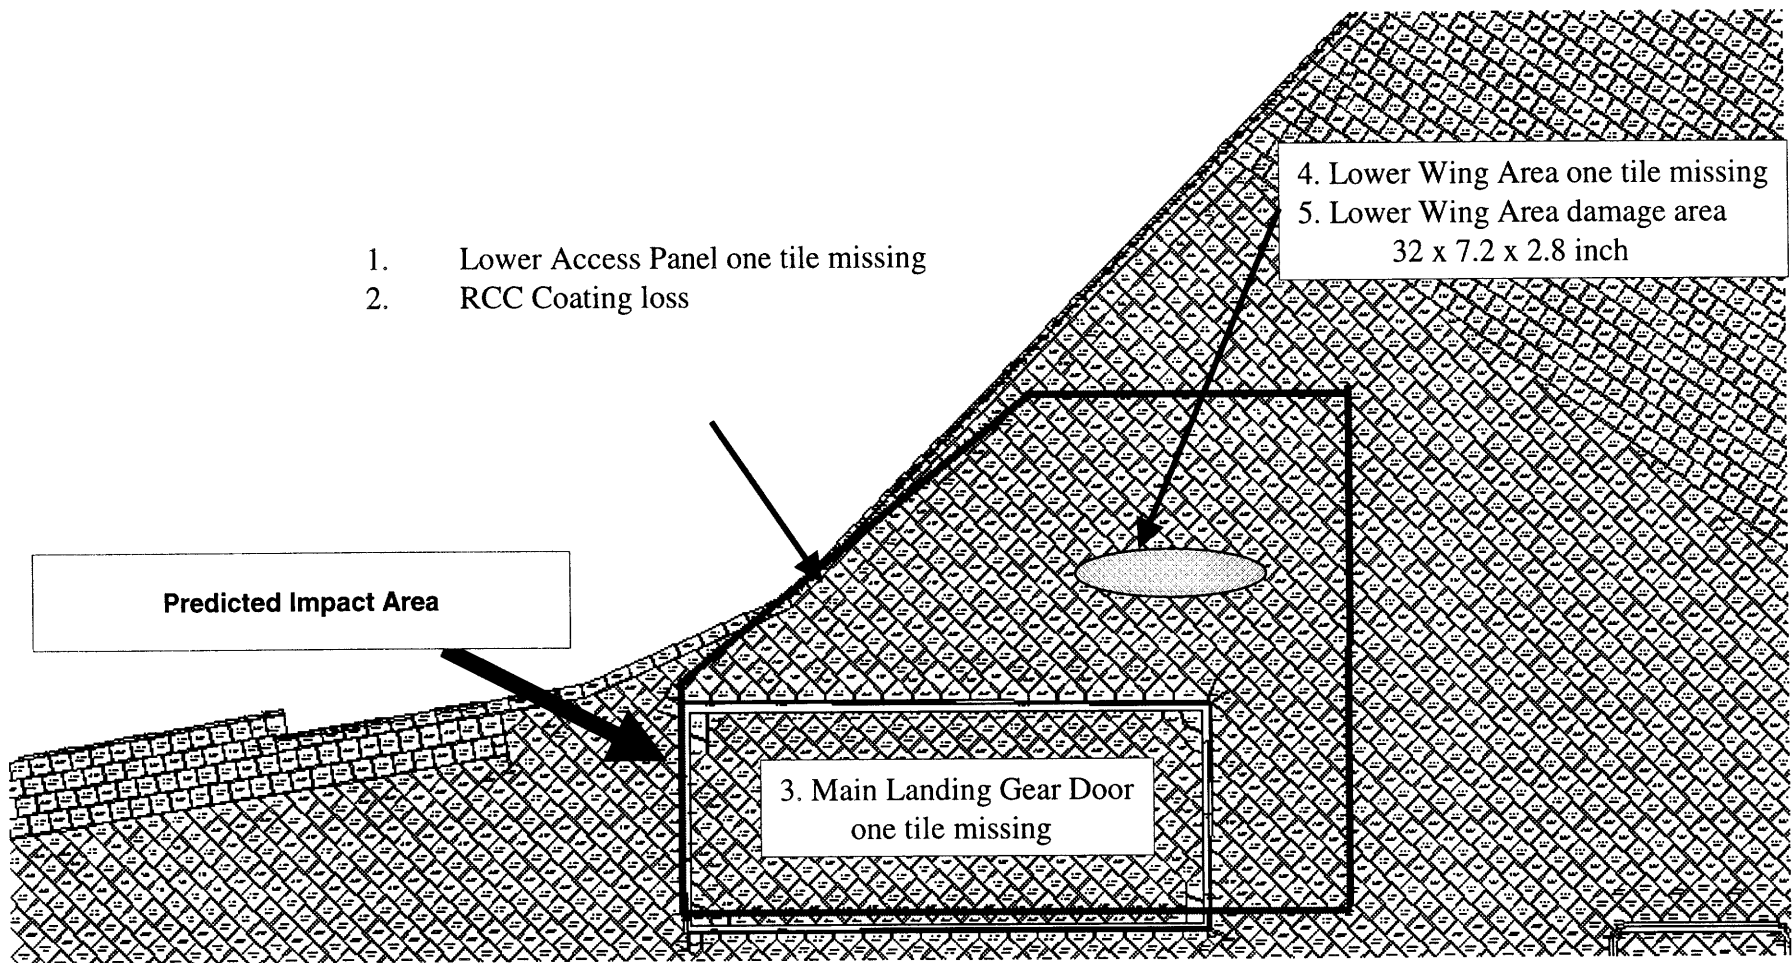
Impacted Lower Surface Location Thermal Predictions

Case	Location	Assumptions	Results
1	Access Panel (one tile missing)	Loss to last layer of TMM Densified layer ~ .2 inches	Temperature of Al Tube Carrier 790 °F No issue
2	RCC Panel 9 Lower Flange OML (Coating Missing)	Coating loss and Carbon substrate exposed	Substrate thickness: 0.193 inches Loss .09 inches No issue
3	Main Landing Gear Door (one tile missing)	Loss to last 2 layers of TMM Densified layer ~ .4 inches	Temperature of Structure 540 °F No issue
4	Lower Wing Area (one tile missing)	Loss to last 2 layers of TMM Densified layer ~ .4 inches	Temperature below 350 °F design req. No issue
5	Lower Wing Area (32 x 7.2 x 2.8 inch) Damage	Loss to last layers of TMM Densified layer ~ .2 inches	
6	Main Landing Gear Door (several tiles Lost)	Loss to last layers of TMM Densified layer ~ .2 inches

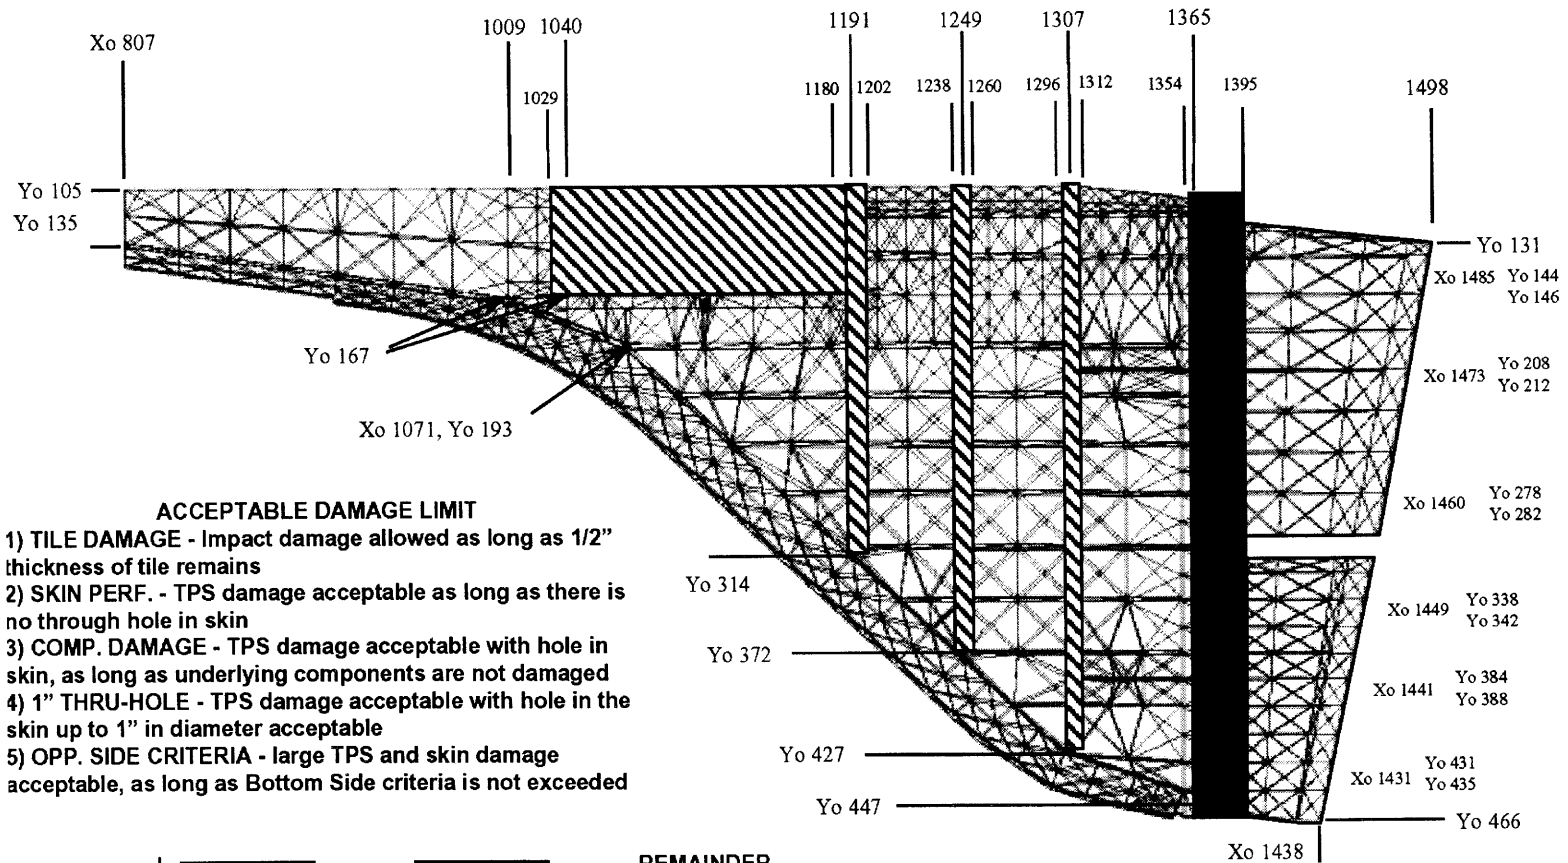
ACCEPTABLE DAMAGE LIMIT

- 1) **TILE DAMAGE** - Impact damage allowed as long as 1/2" thickness of tile remains
- 2) **SKIN PERF.** - TPS damage acceptable as long as there is no through hole in skin
- 3) **COMP. DAMAGE** - TPS damage acceptable with hole in skin, as long as underlying components are not damaged
- 4) **1" THRU-HOLE** - TPS damage acceptable with hole in the skin up to 1" in diameter acceptable
- 5) **OPP. SIDE CRITERIA** - large TPS and skin damage acceptable, as long as Bottom Side criteria is not exceeded

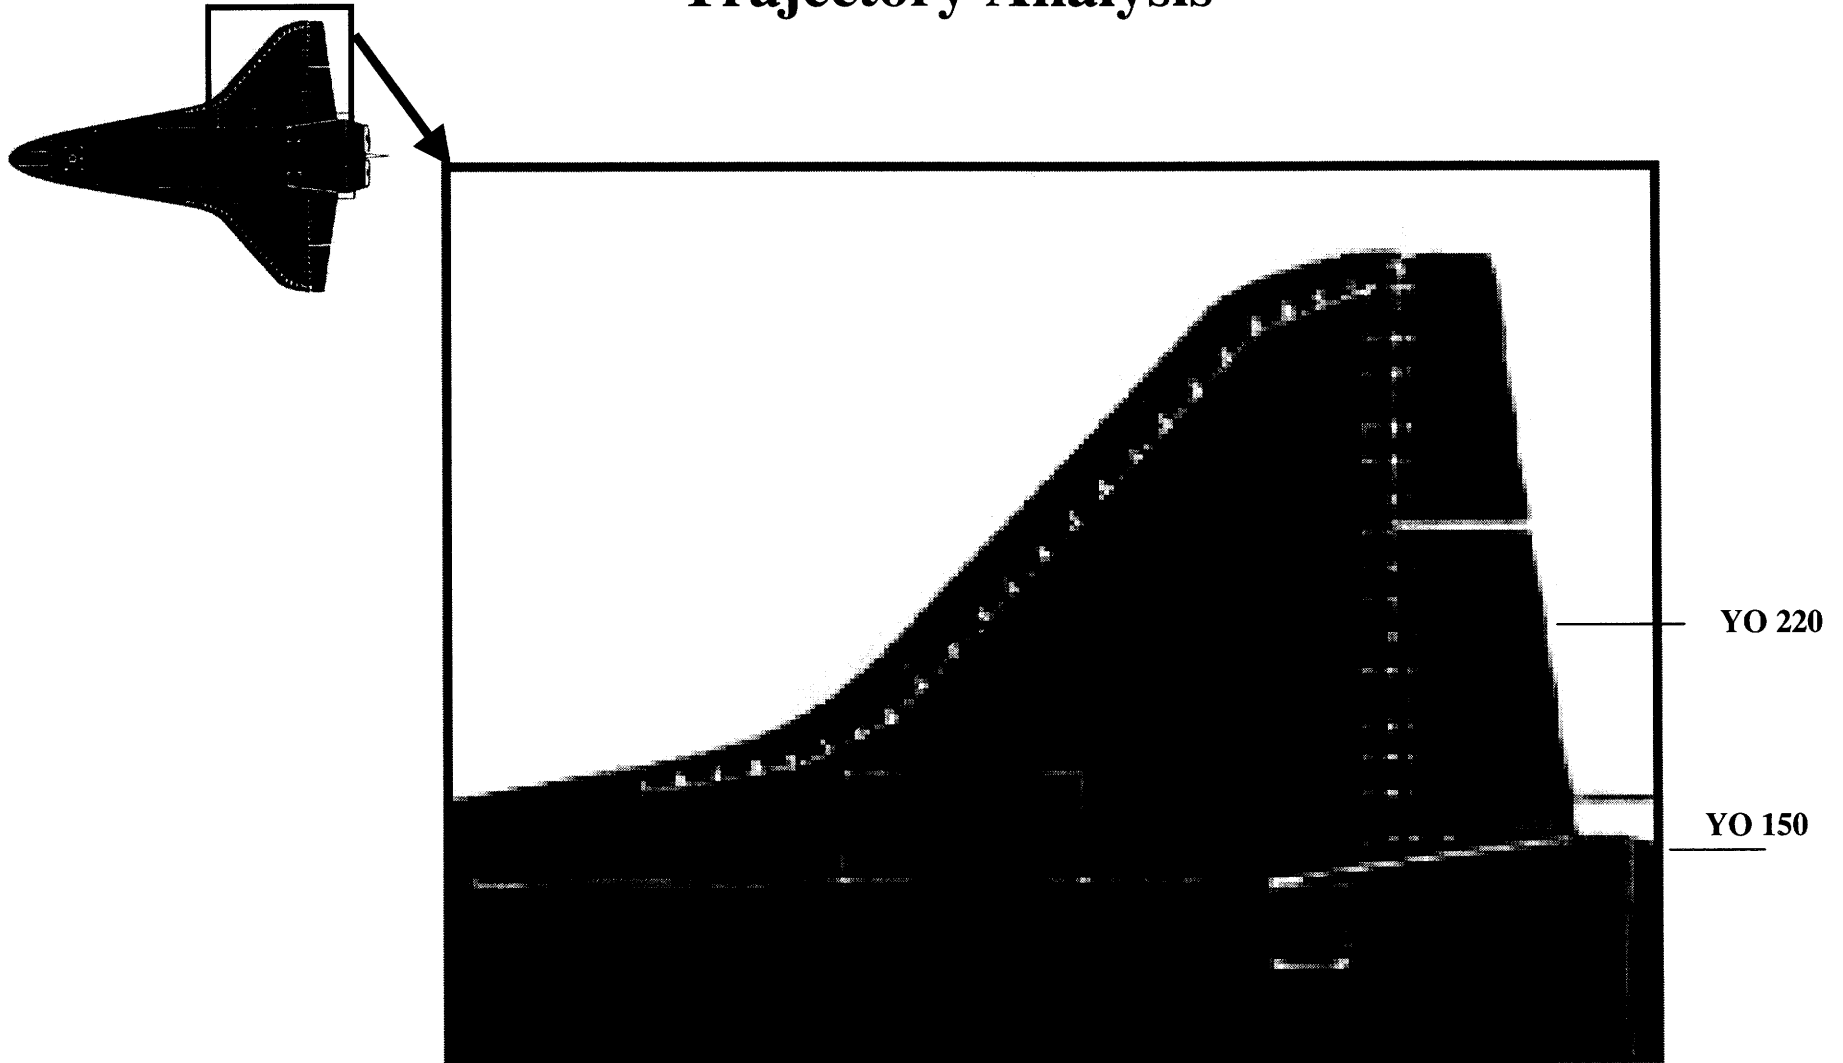
STS-107 Debris Impacting Orbiter Wing

(Debris Size = 20'' x 10'' x 6'', Density = 2.4 lb/ft³)

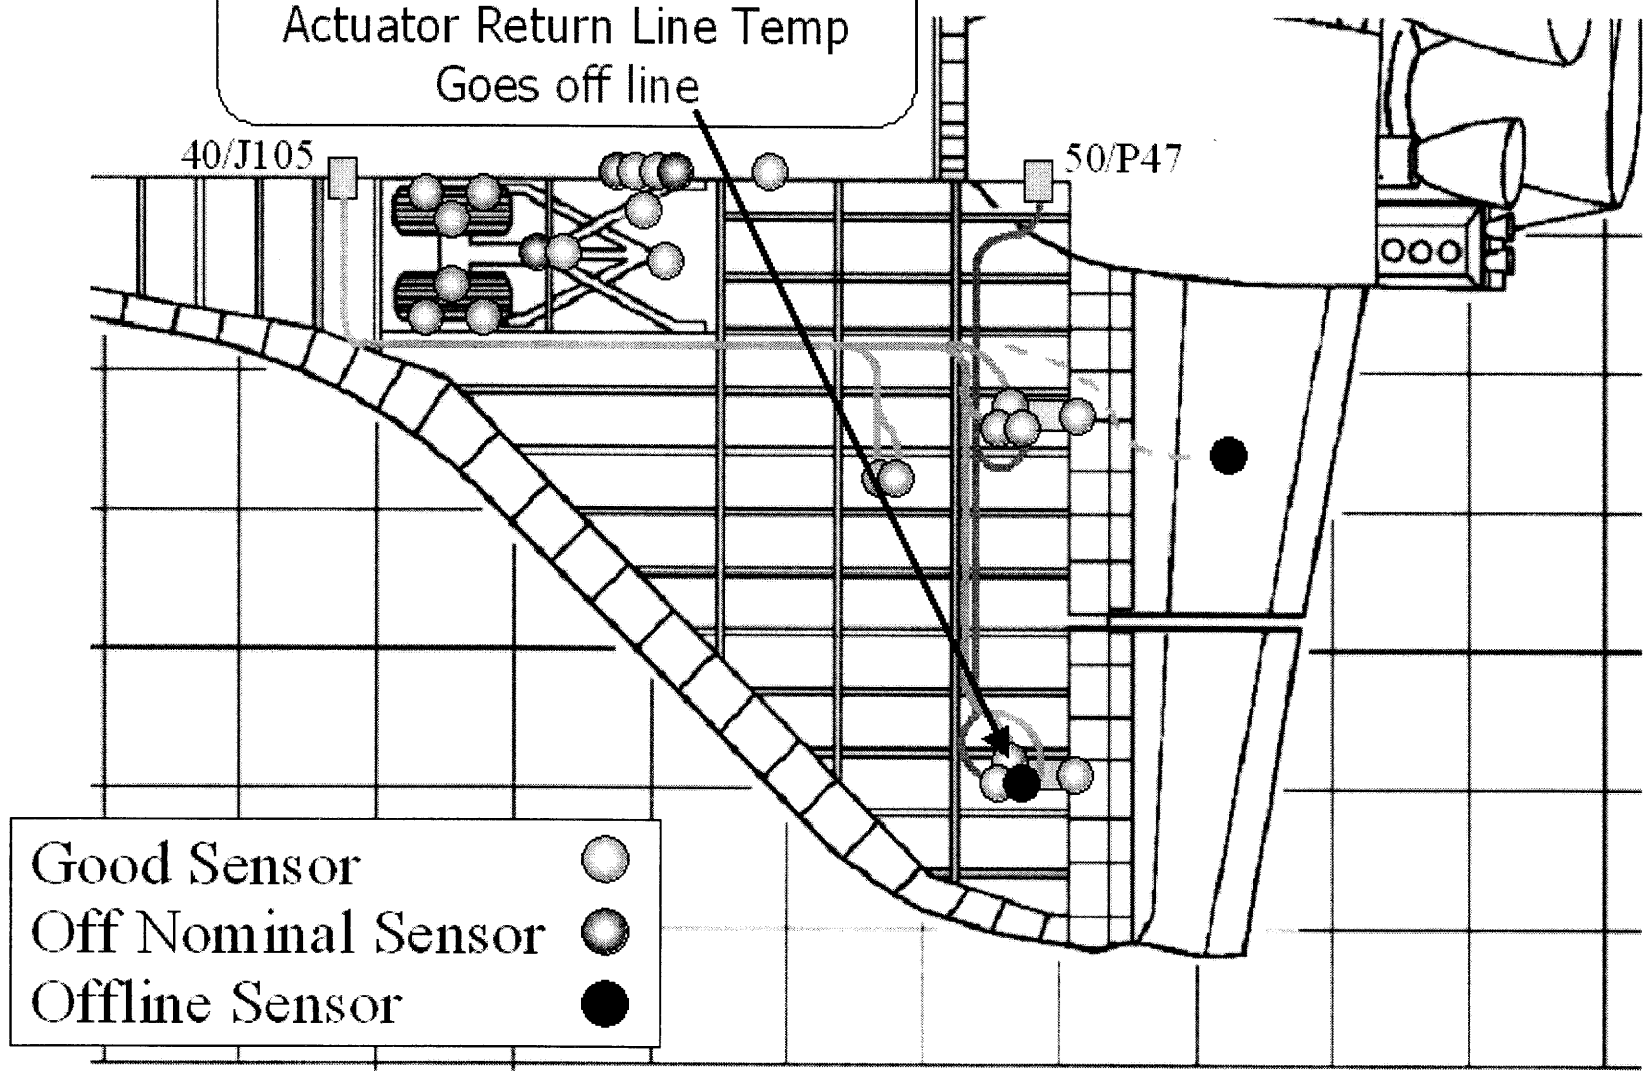
V58T0394
Hyd Sys 3 Left Outboard Elevon
Actuator Return Line Temp
Goes off line

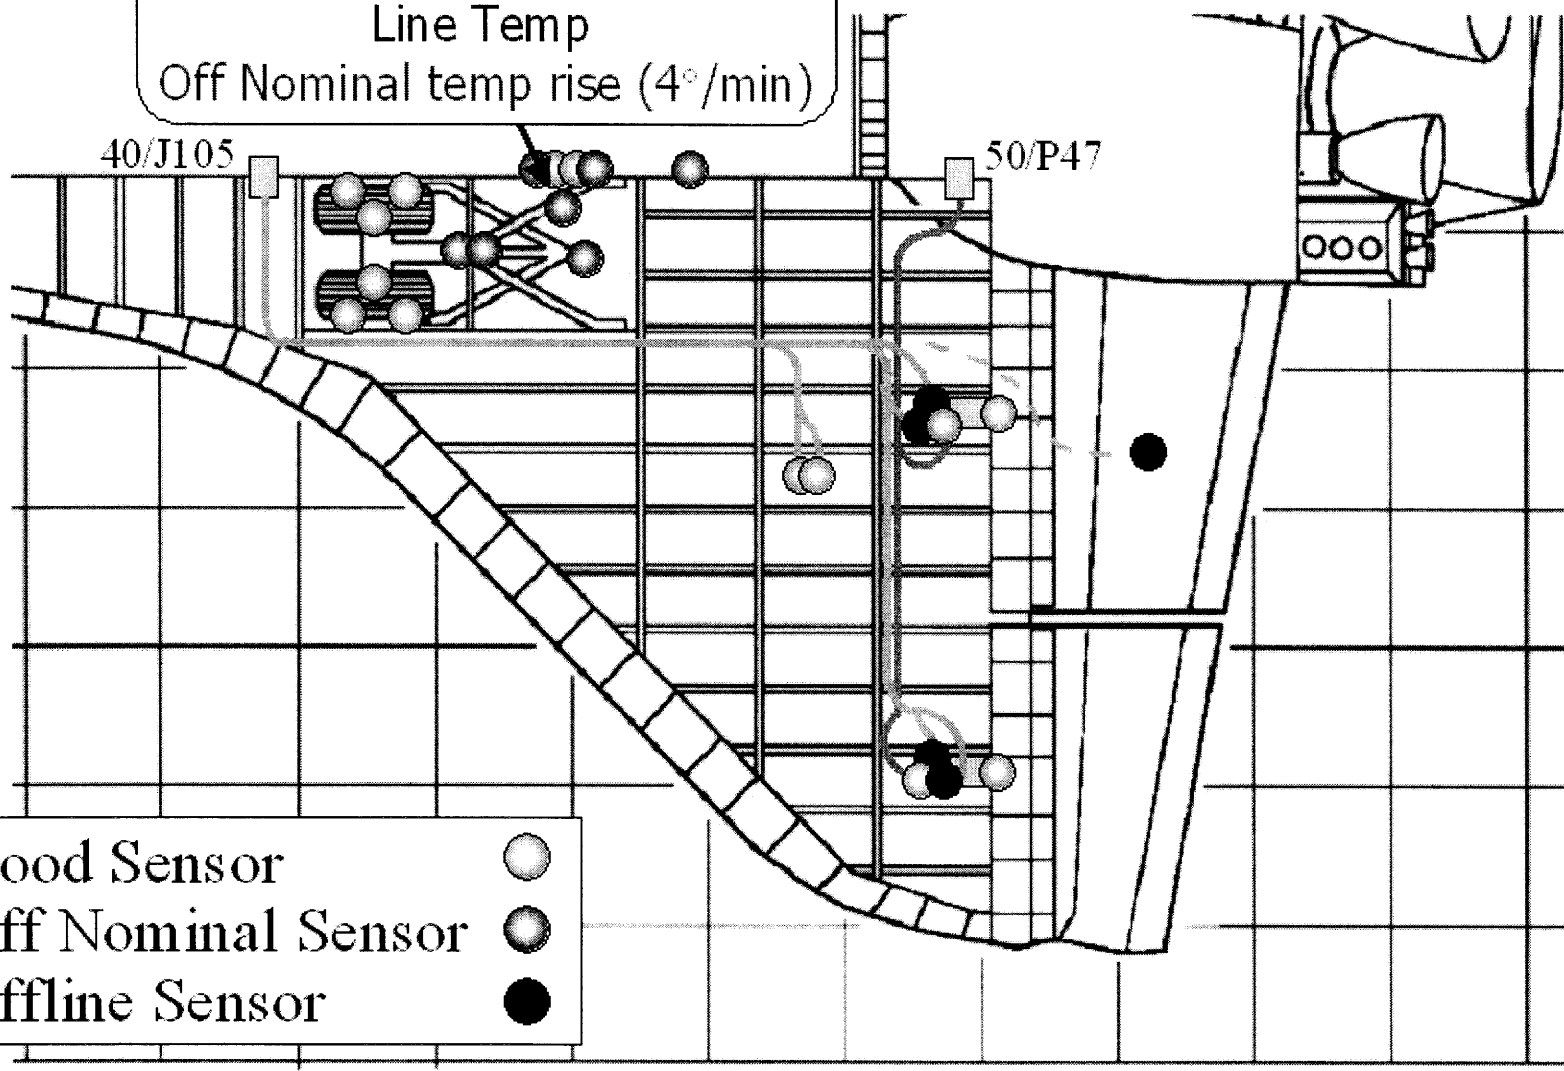
V58T0125
LMG Uplock Actuator Unlock
Line Temp
Off Nominal temp rise (4°/min)

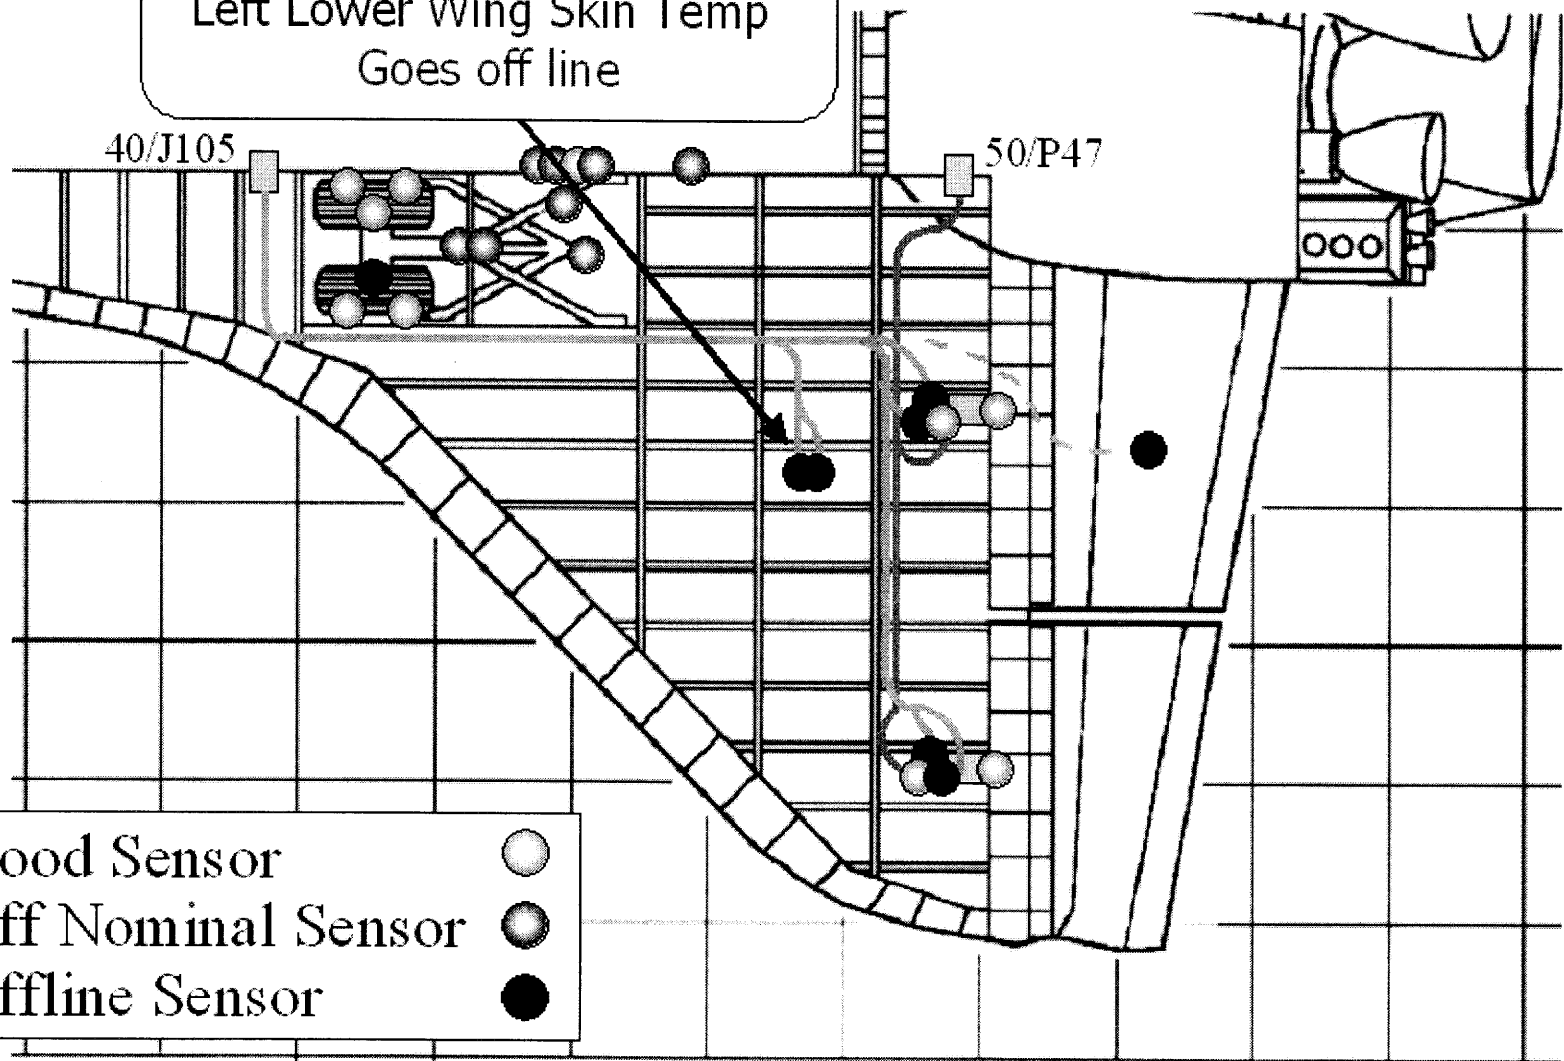
V09T1024 ; V09T1002
Left Upper Wing Skin Temp
Left Lower Wing Skin Temp
Goes off line

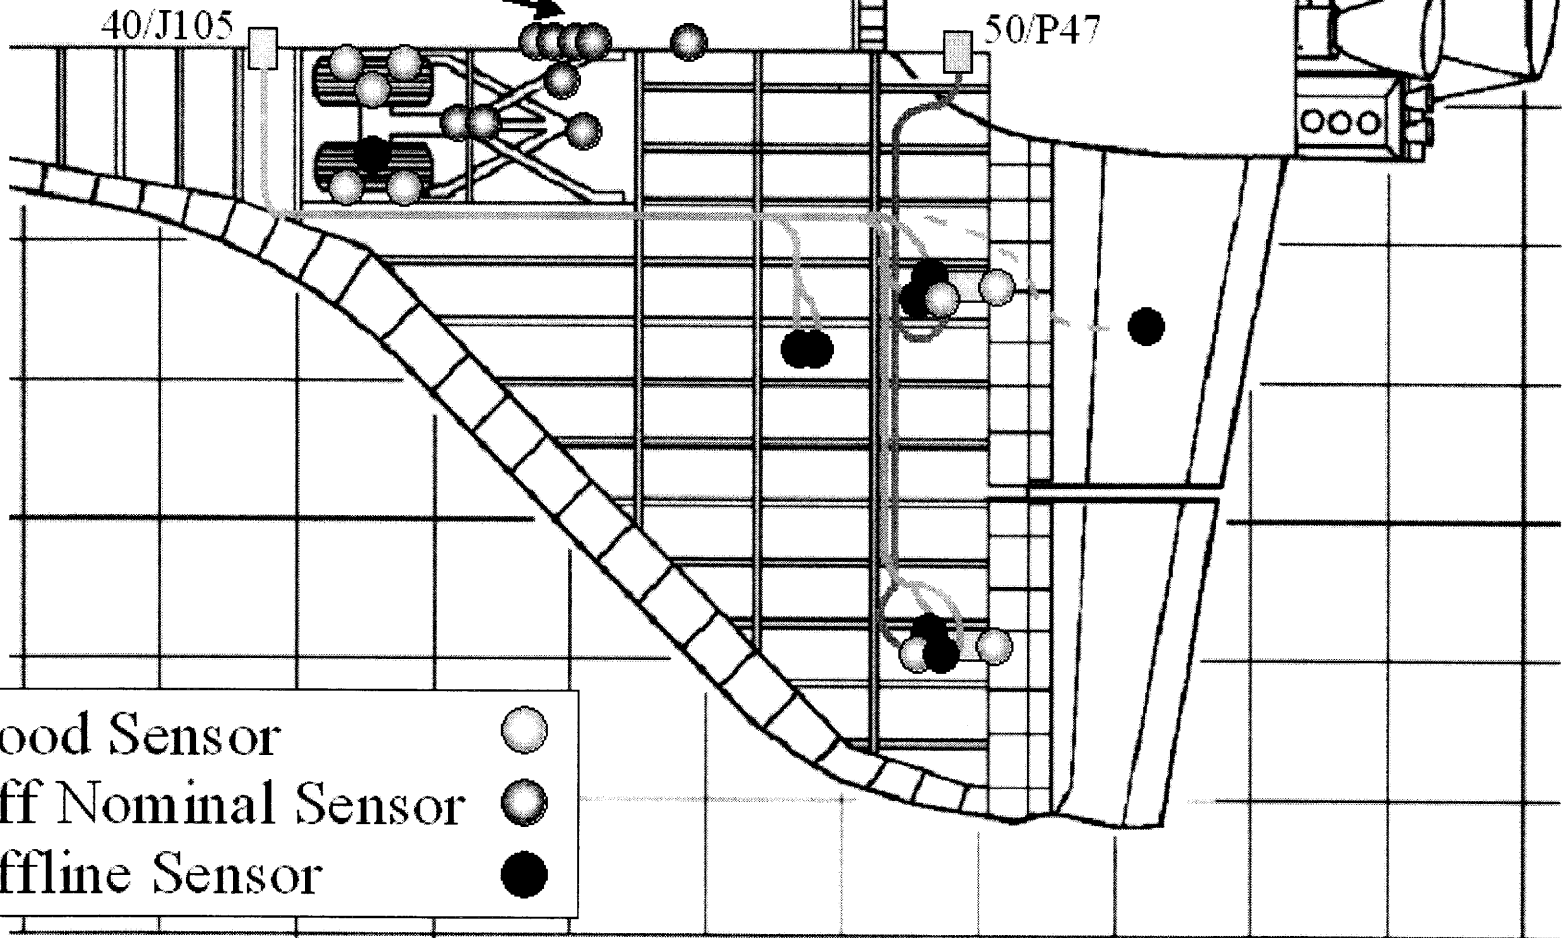
V58T0841
System 2 LH Aft Brake
Switch Valve Return Temp
Off Nominal temp rise (14°/min)

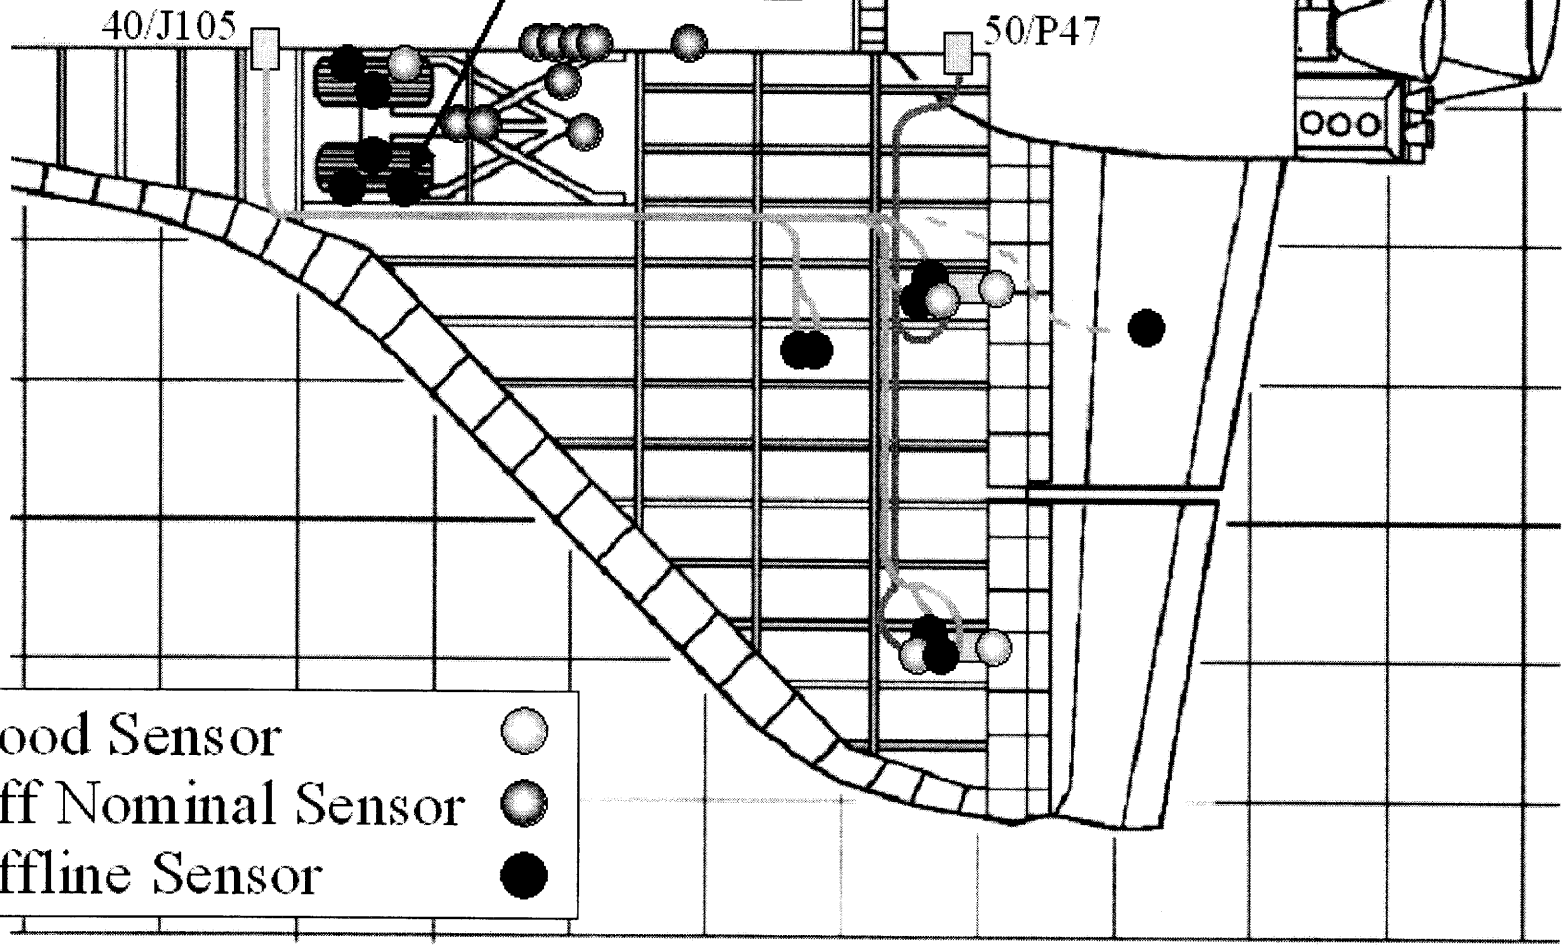
V51P0572A
Main Landing Gear Left Hand
Outboard Tire Press 2
Goes off line
