REPORT ON THE ANALYSES OF RECOVERED 1201-3 FILM SAMPLES

(KODAK High Definition Aerial Film 1414 (ESTAR Ultra-Thin Base).

1201-3

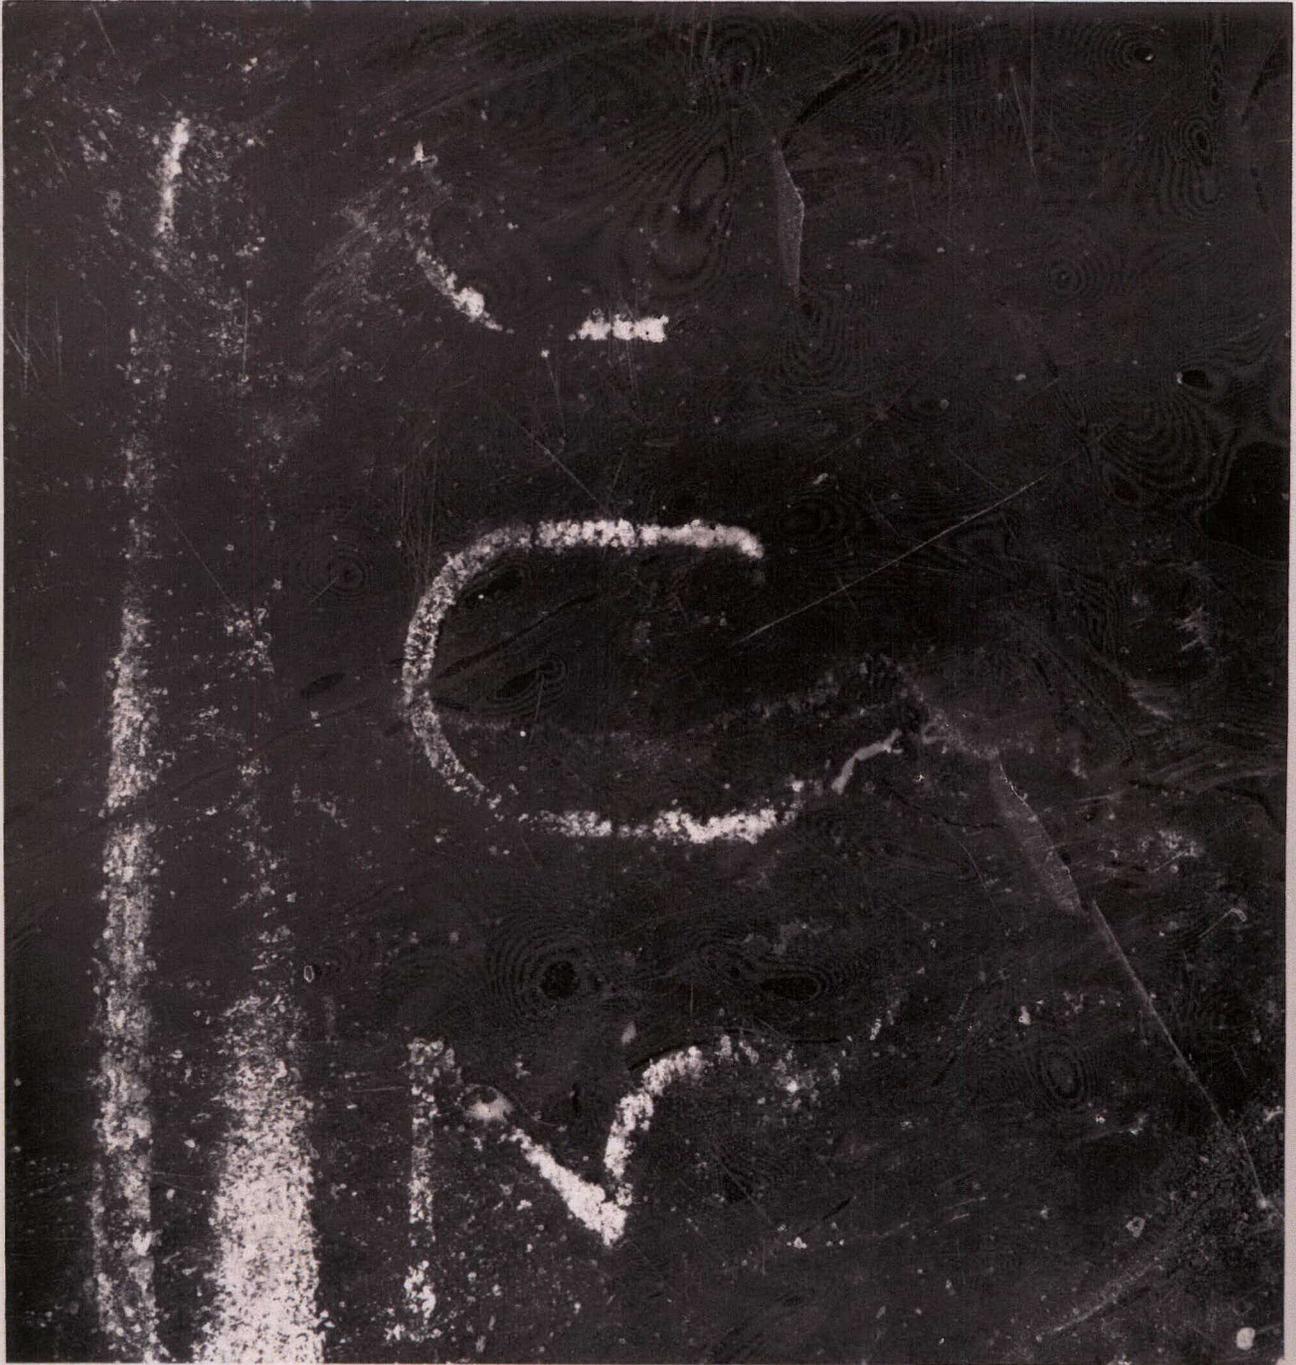
Figure No.2

20 X

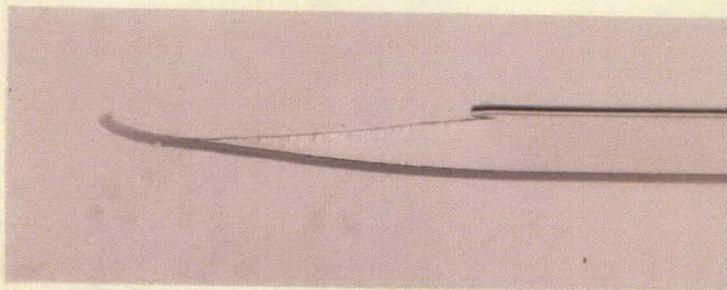
1414 Raw Stock

Figure 3 depicts four typical edges. The first edge is produced by very rapid snapping of the film (a "fracture"). The "wedge" profile is typical of this type film break and is caused by tensile shearing. The second edge profile illustrates the fracture and separation occurring on the recovered film. Three physical samples all showed this characteristic cross-section. Third edge was produced by nicking a salvaged film sample with scissors and applying tearing forces by hand. This edge shows relaxation of the film base and recovery shrinkage resulting in a slightly thicker but short edge profile. The fourth picture is the edge profile typical of film slitting.

Cross-section (200X)  
Produced by "whip  
snap" shattering.

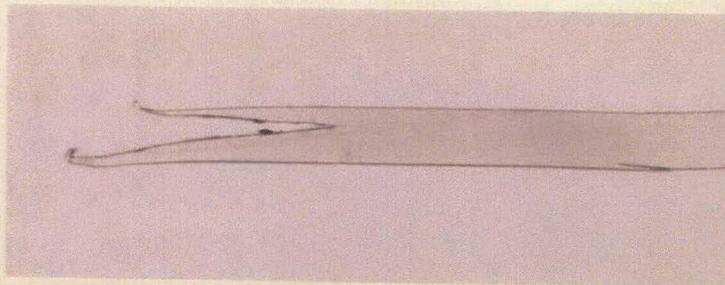
Recovered 1414

By comparing the edge profiles, the "recovered film" most closely matches that caused by sudden tensile shear failure.

Cross-section (200X)  
Film edge caused in  
overall recovery  
operation.

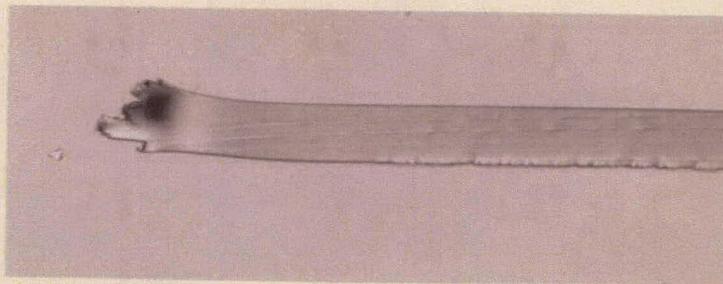
Recovered 1414

Cross-section (200X)  
Film edge caused by  
hand tearing.

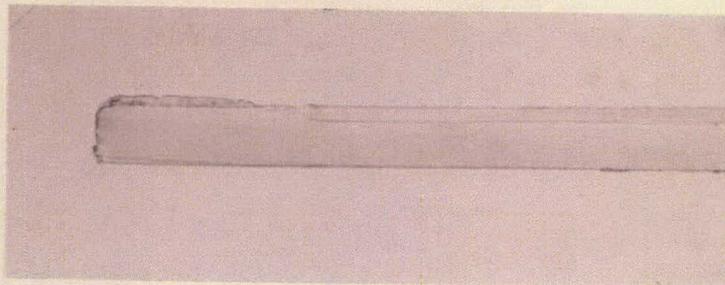
Recovered 1414

Cross-section (200X)  
Film edge normal to  
manufacturing.
