**Federal Building and Fire Safety Investigation of the
World Trade Center Disaster**

**Structural Fire Response and
Probable Collapse Sequence of
World Trade Center Building 7**

VOLUME 1

November 2008

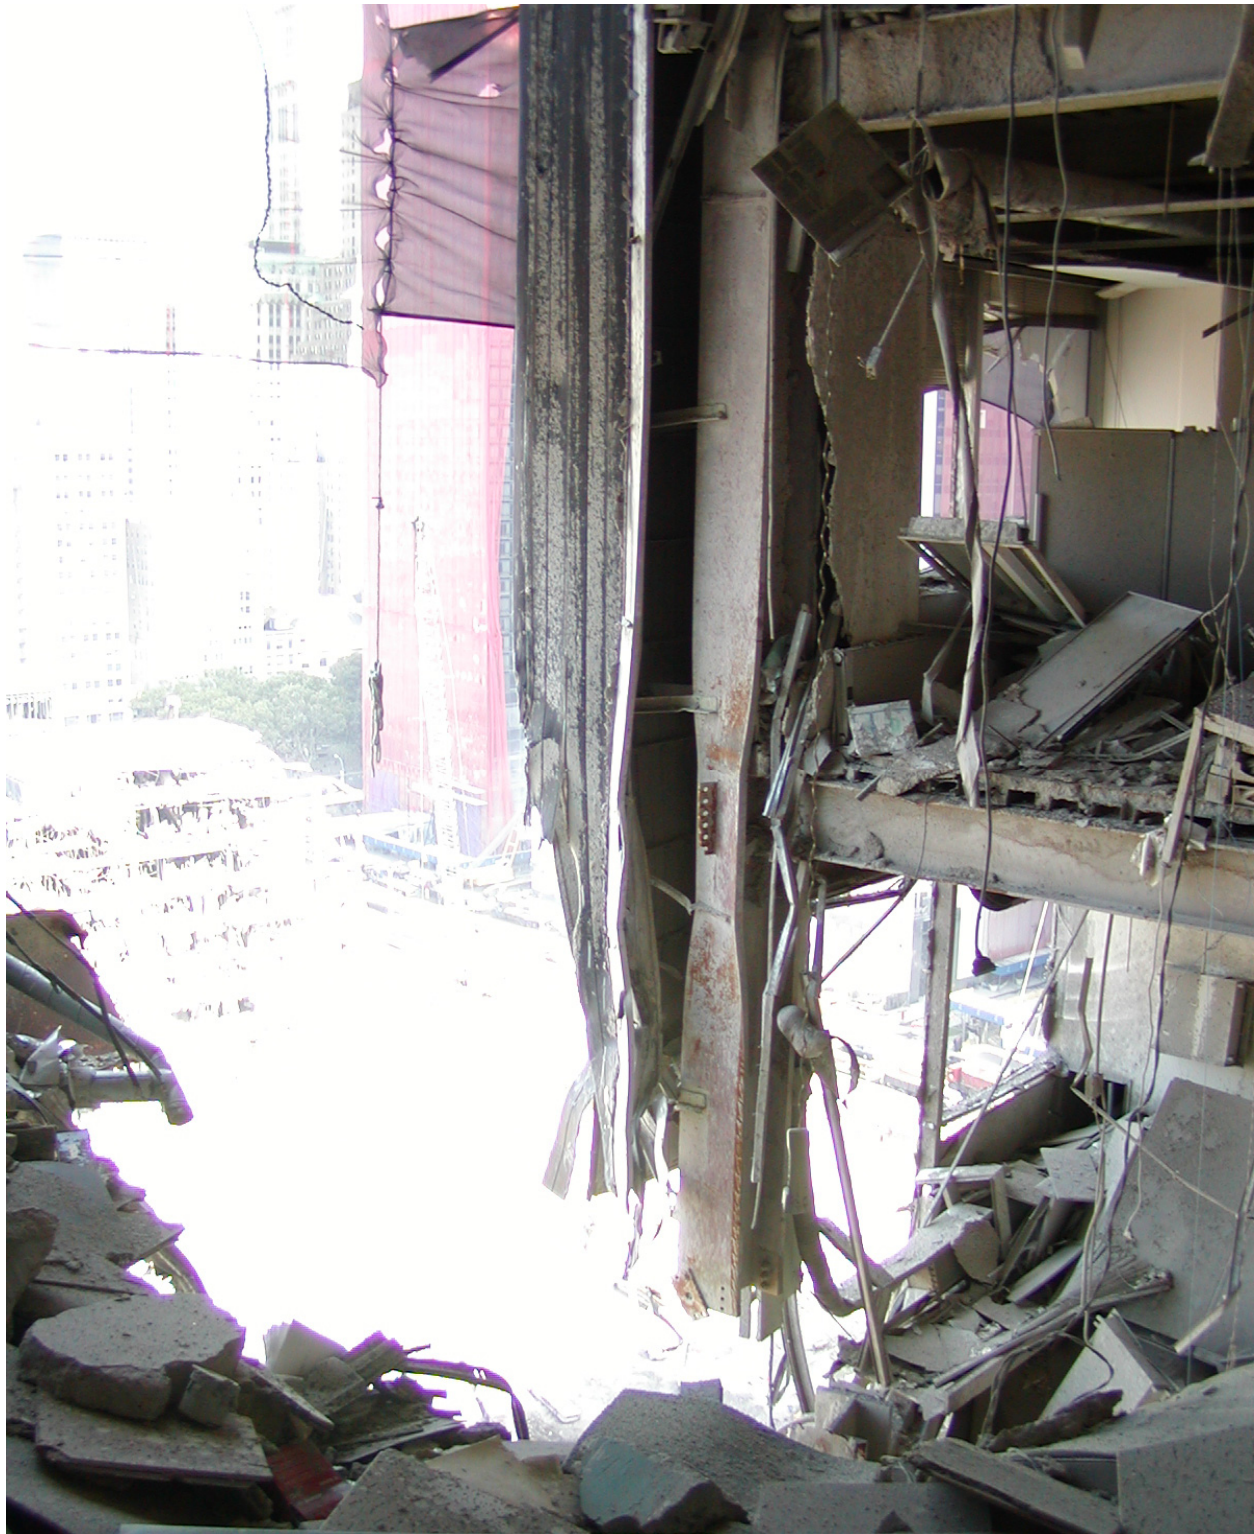
Figure 2–32 shows the extent of the damage that was documented by the FEMA WTC Building Performance Study (McAllister 2002). Immediately after the damage was incurred, the ceilings and column enclosures were still in place, so possible SFRM damage in other parts of the building could not be observed.

Figure 2–31. Interior view of damage to the north face of 130 Liberty Street by debris falling from WTC 2.

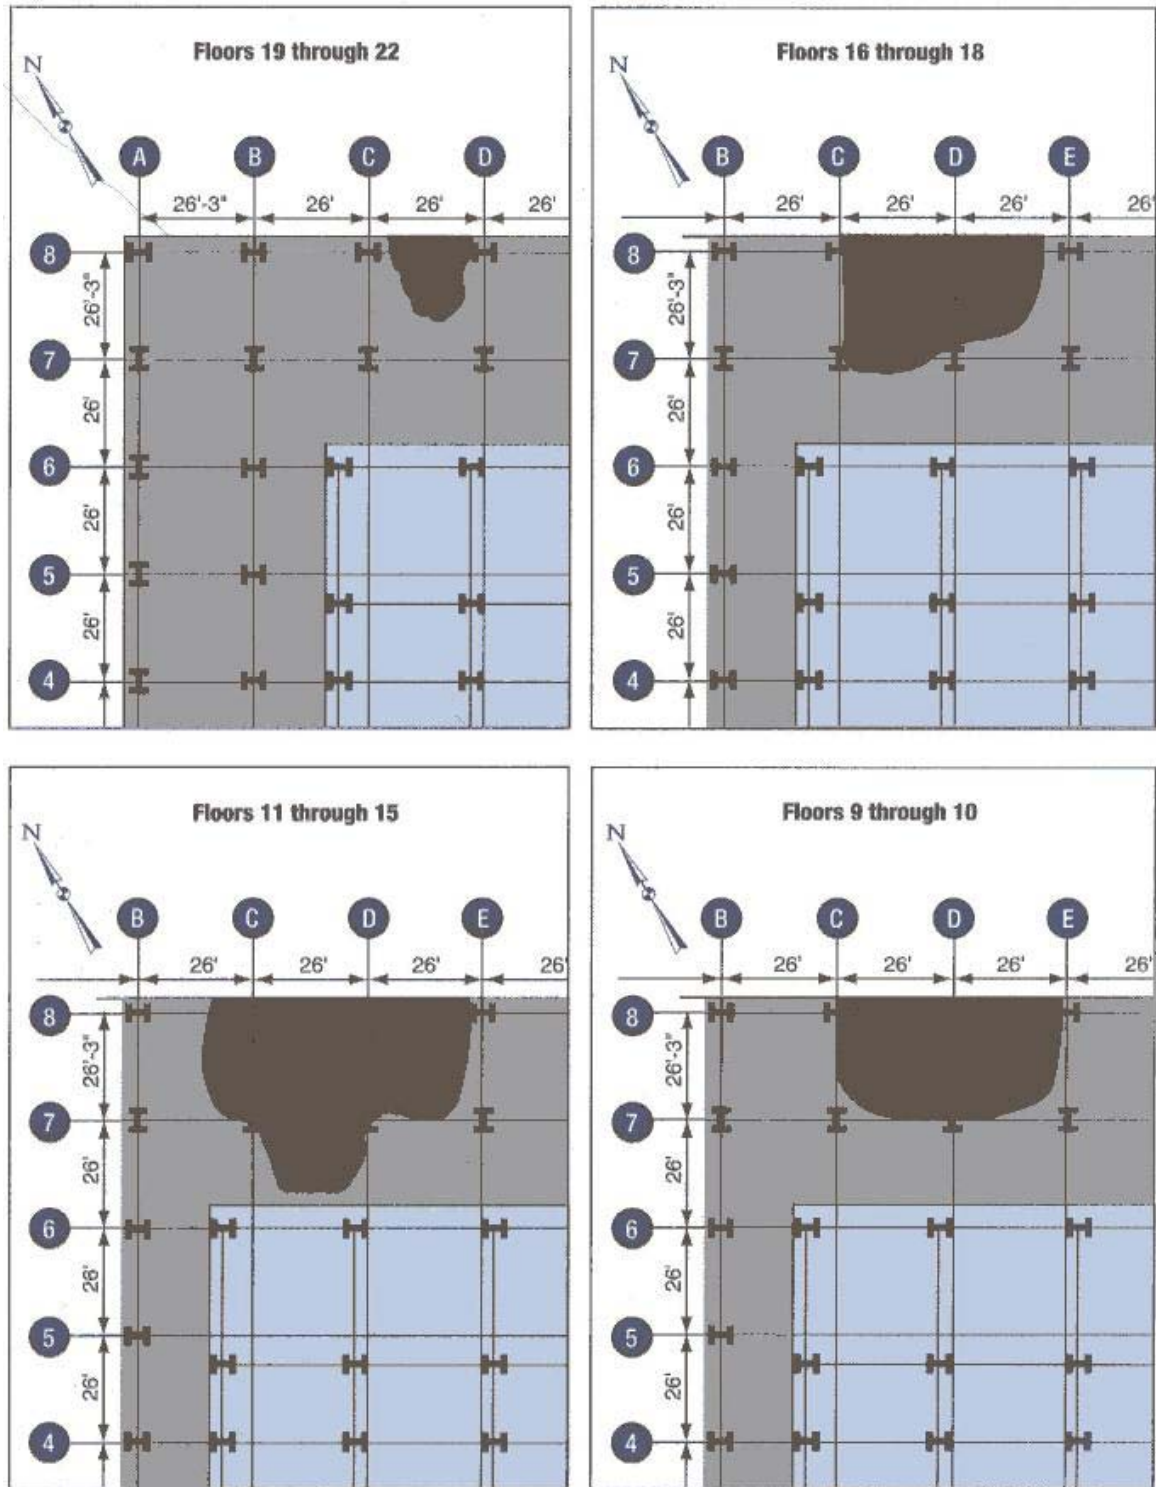
Figure 6-5 Approximate zones of damage – 19th through 22nd floors, 16th through 18th floors, 11th through 15th floors, and 9th through 10th floors.

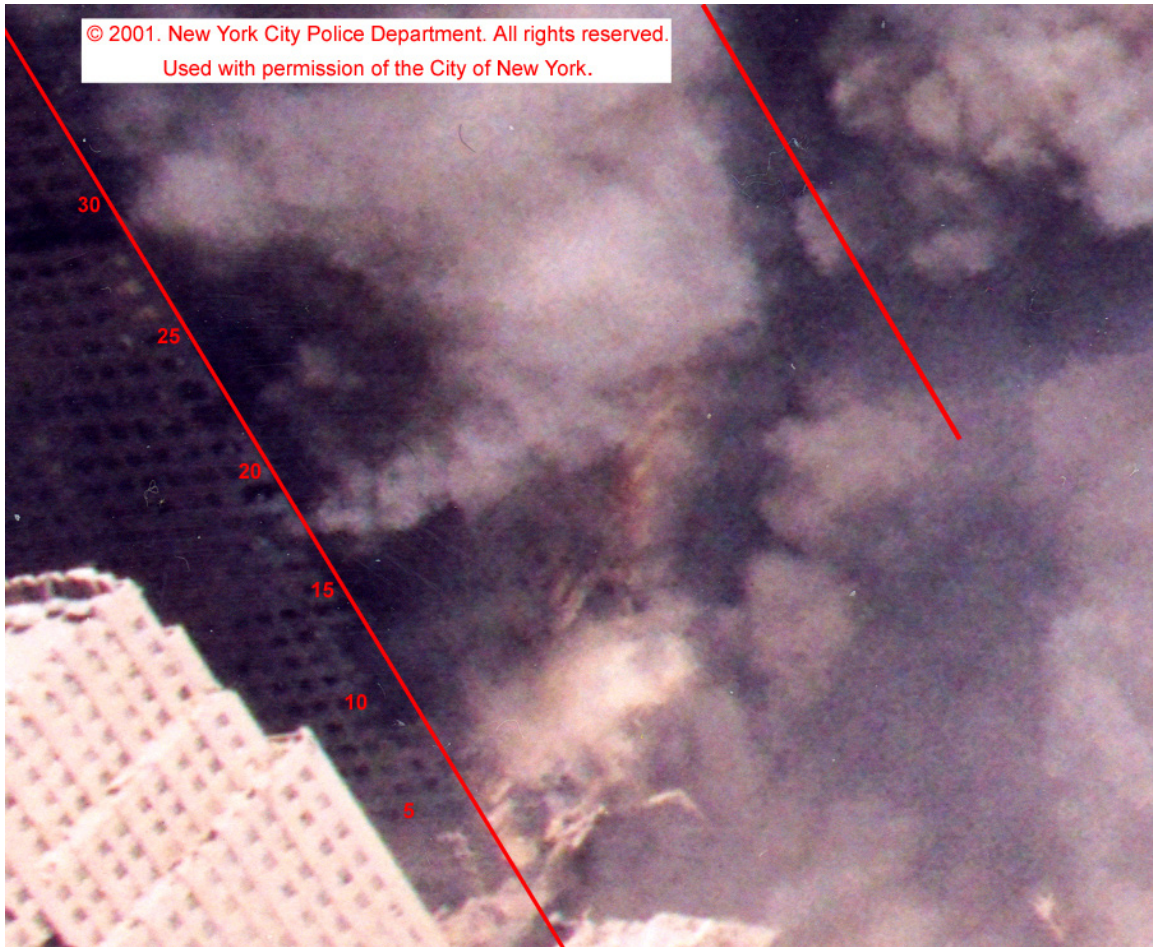
Figure 5-61 is an enlargement of the lower portion of WTC 7 from Figure 5-60. Floor numbers have been added along the southern edge of the west face. Details are difficult to discern due to the distance of the photograph, but it is possible to see parts of the south face that were damaged during the collapse of WTC 1. A dark area extending up to the 14th or 15th floor can be seen near the center of the face. This location suggests that this is the damage identified earlier near Column 22, based on Figure 5-52 to Figure 5-55. This damage appears to extend downward to about the 9th floor. As observed earlier, intact spandrels are visible to the right of this opening.

Figure 5-61. Enlarged portion of Figure 5-60 showing the south face of WTC 7.

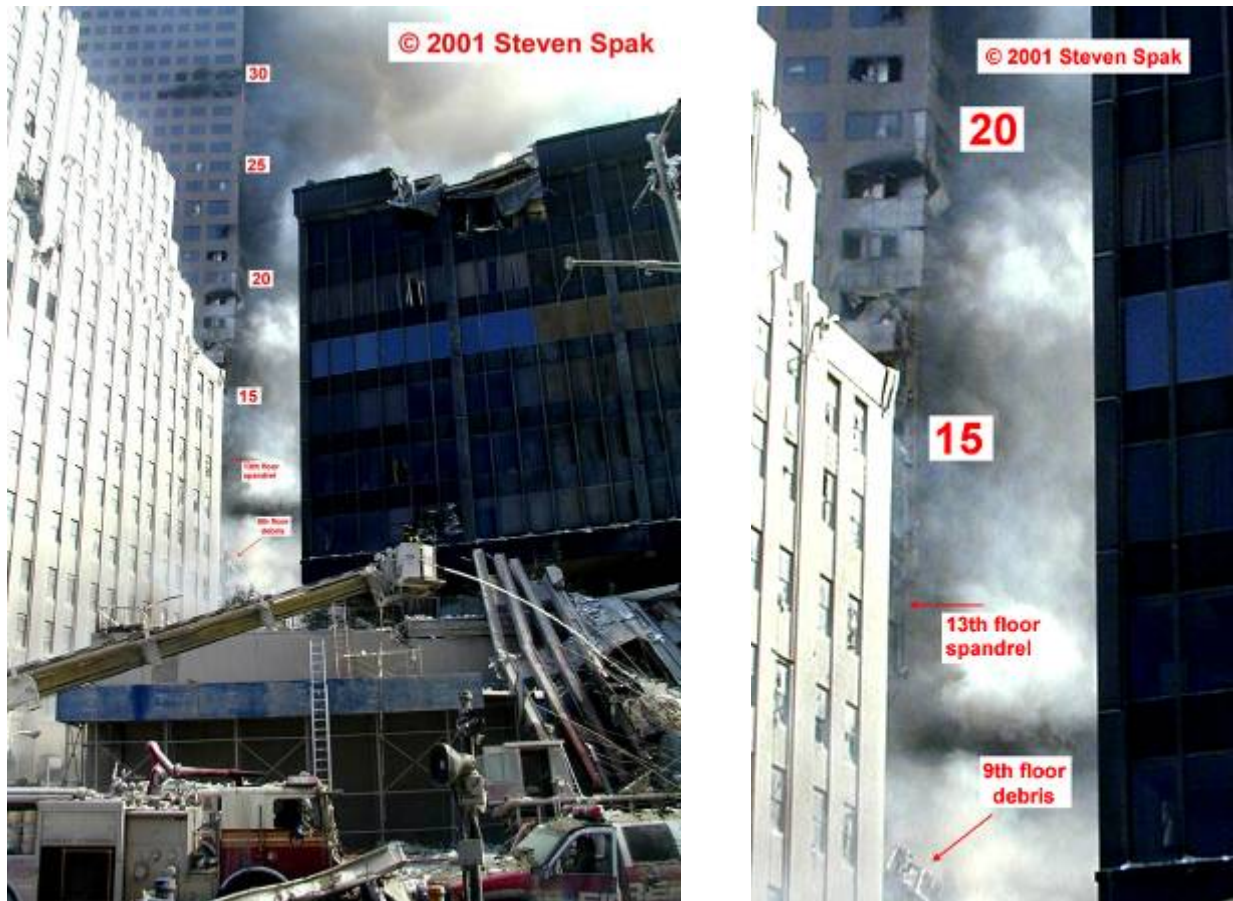
The image shows considerable damage to the southwest corner, starting at the 17th floor and extending downward to at least the 8th floor. Below the 17th floor, the corner of the building appears to be missing. At a minimum, the granite cladding and its supports have been removed. Figure 5–66 shows a photograph taken at 12:48 p.m. from West Street showing the same area of WTC 7 and an enlargement of the southwest corner. In this image, it is clear that the corner granite has been removed, and it appears that the corner Column 15 (Figure 5–20 and Figure 5–26) has been exposed, but is still in place down to the 12th floor. This column was located just behind the southwest corner. The dull color of the steel indicates that its insulation had been stripped away.

Figure 5–66. Photographs showing the southwest corner of WTC 7, shot from West Street at 12:47:40 p.m.

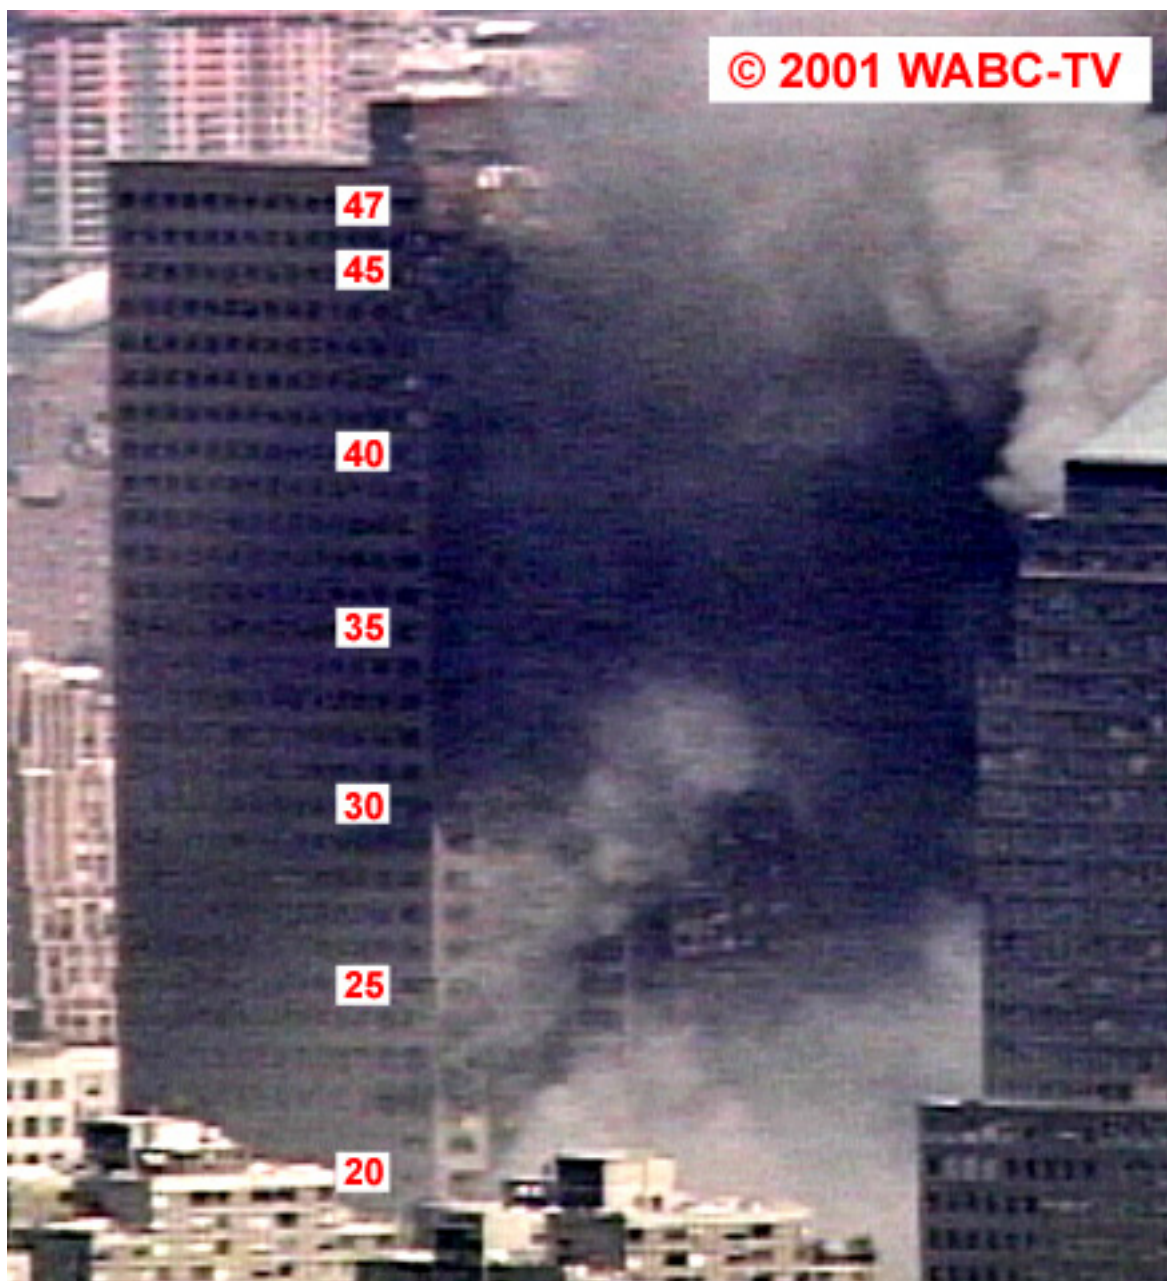
Figure 5–82. Cropped view of the south face of WTC 7 taken from a video shot from a helicopter hovering to the southwest of the WTC site around 1:00 p.m.
The intensity levels have been adjusted.

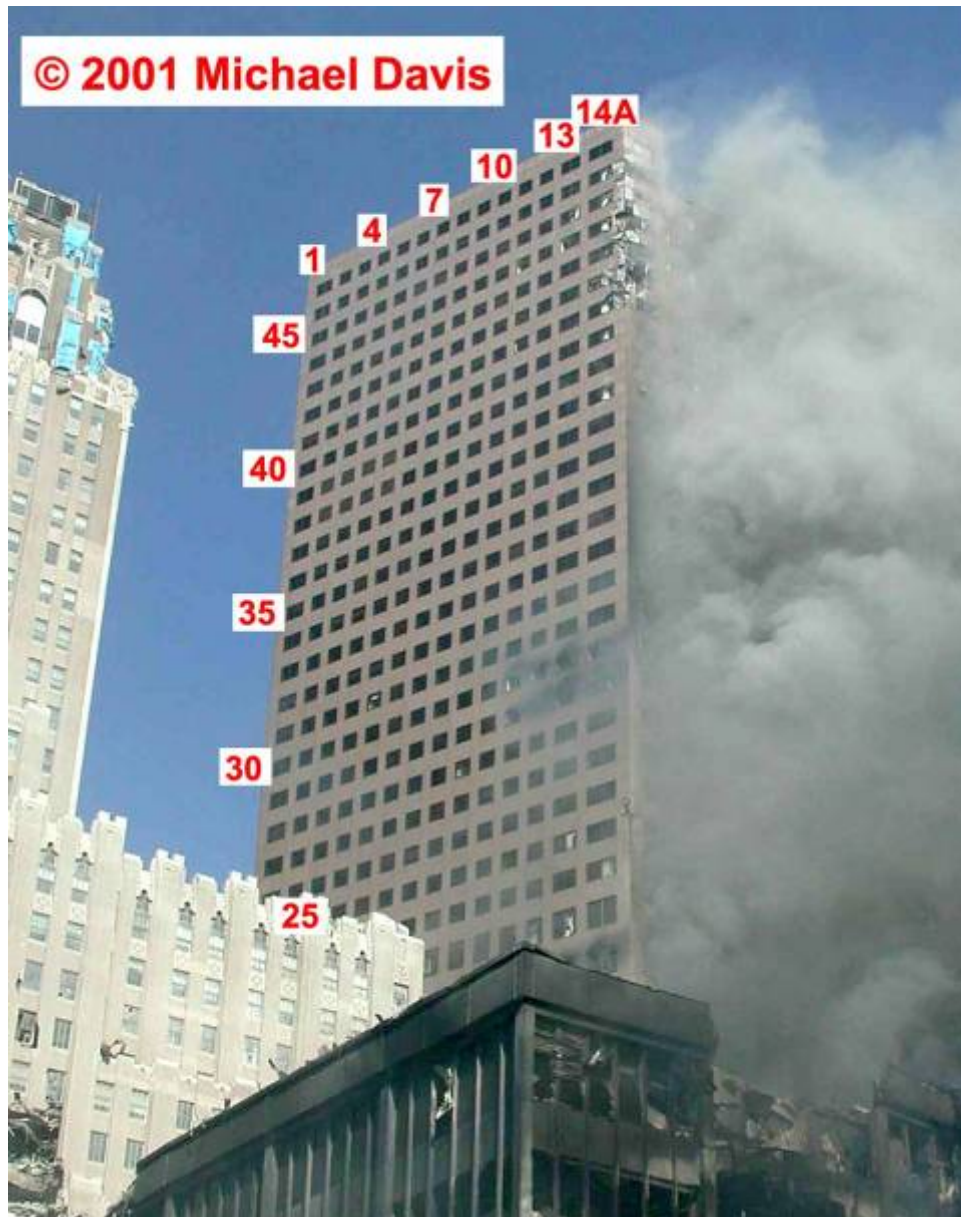
Another photograph showing the upper part of the west face of WTC 7 is reproduced in Figure 5-85. Generally, the damage visible on the 34th to 47th floors is consistent with that seen in Figure 5-84. One exception is window 11 on the 41st floor. A small portion of the glass appears to be broken out in Figure 5-85, which is not evident in Figure 5-84. Most of the granite appears to be intact between the 23rd and 33rd floors, with only minor damage evident at the southwest corner at the base of the 26th floor and on the 25th floor. Glass is missing from windows 13A, 13B, 14A, and 15 on the 29th and 30th floors. As discussed below, fires were observed in these areas, which may have opened up these windows prior to the time when Figure 5-85 was taken. Elsewhere on these floors, glass is missing from isolated windows 31-5, 28-9, 27-14, 25-13B, 24-14A, 23-12, and 23-13B.

Figure 5–85. Cropped photograph showing the west face of WTC 7, taken shortly after 3:00 p.m. from West Street.

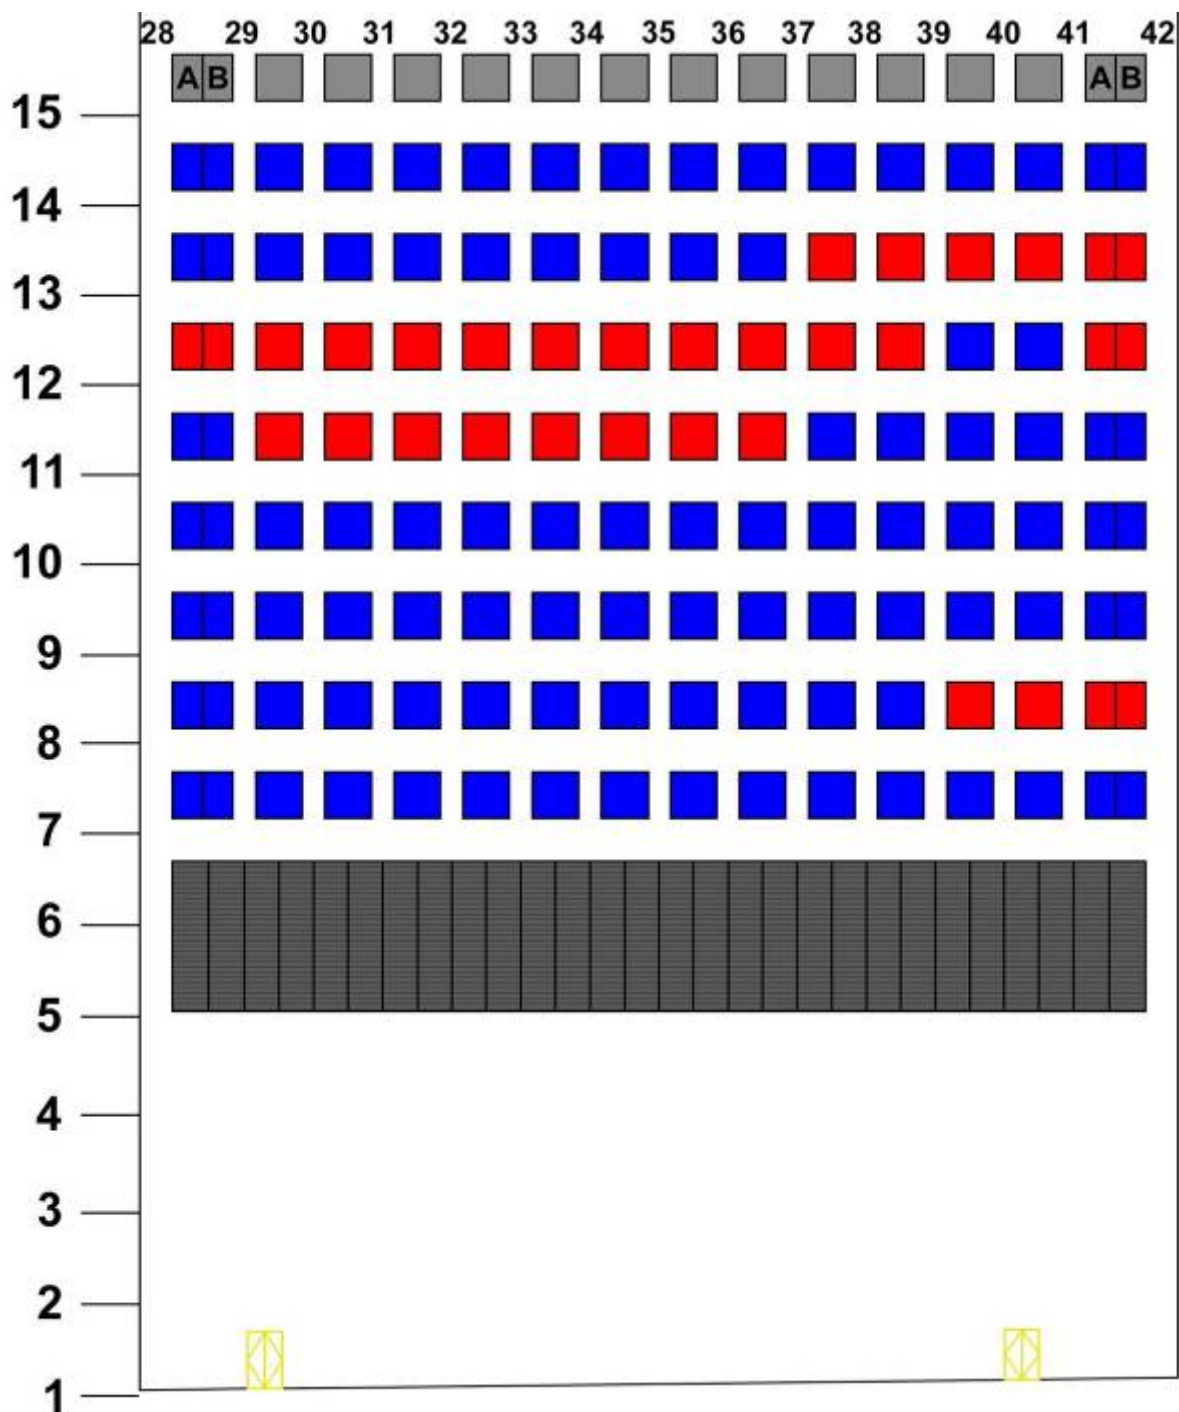
Figure 5–181. Façade map of the east face of WTC 7 showing locations where windows were broken and/or fire was observed during the period when fire first appeared on the face around 2:00 p.m. and the building collapsed at 5:20:52 p.m.

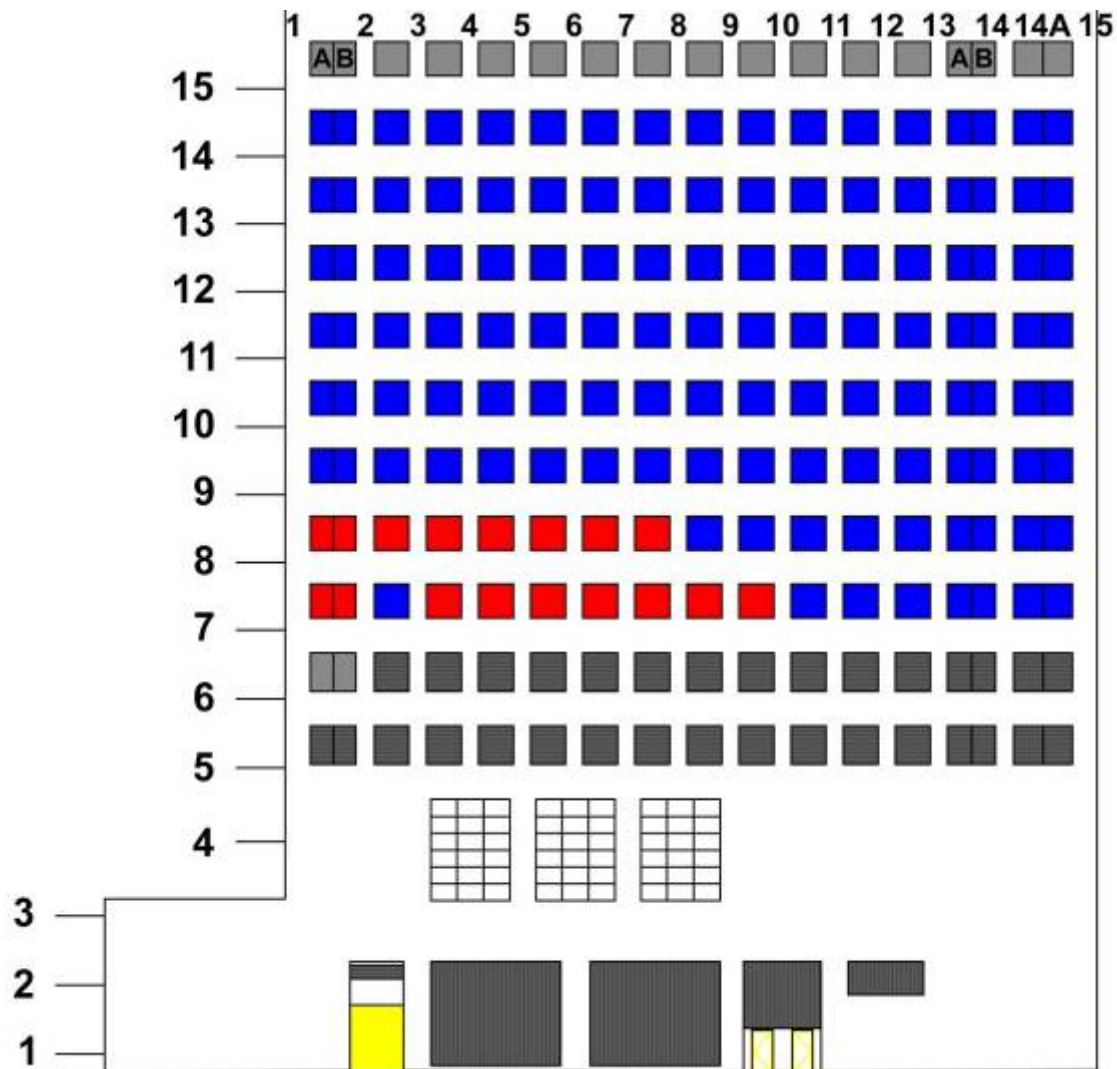
Figure 5-182. Façade map of the west face of WTC 7 showing locations where windows were broken and/or fire was observed during the period when fire first appeared on the face before 2:00 p.m. and the building collapsed at 5:20:52 p.m.

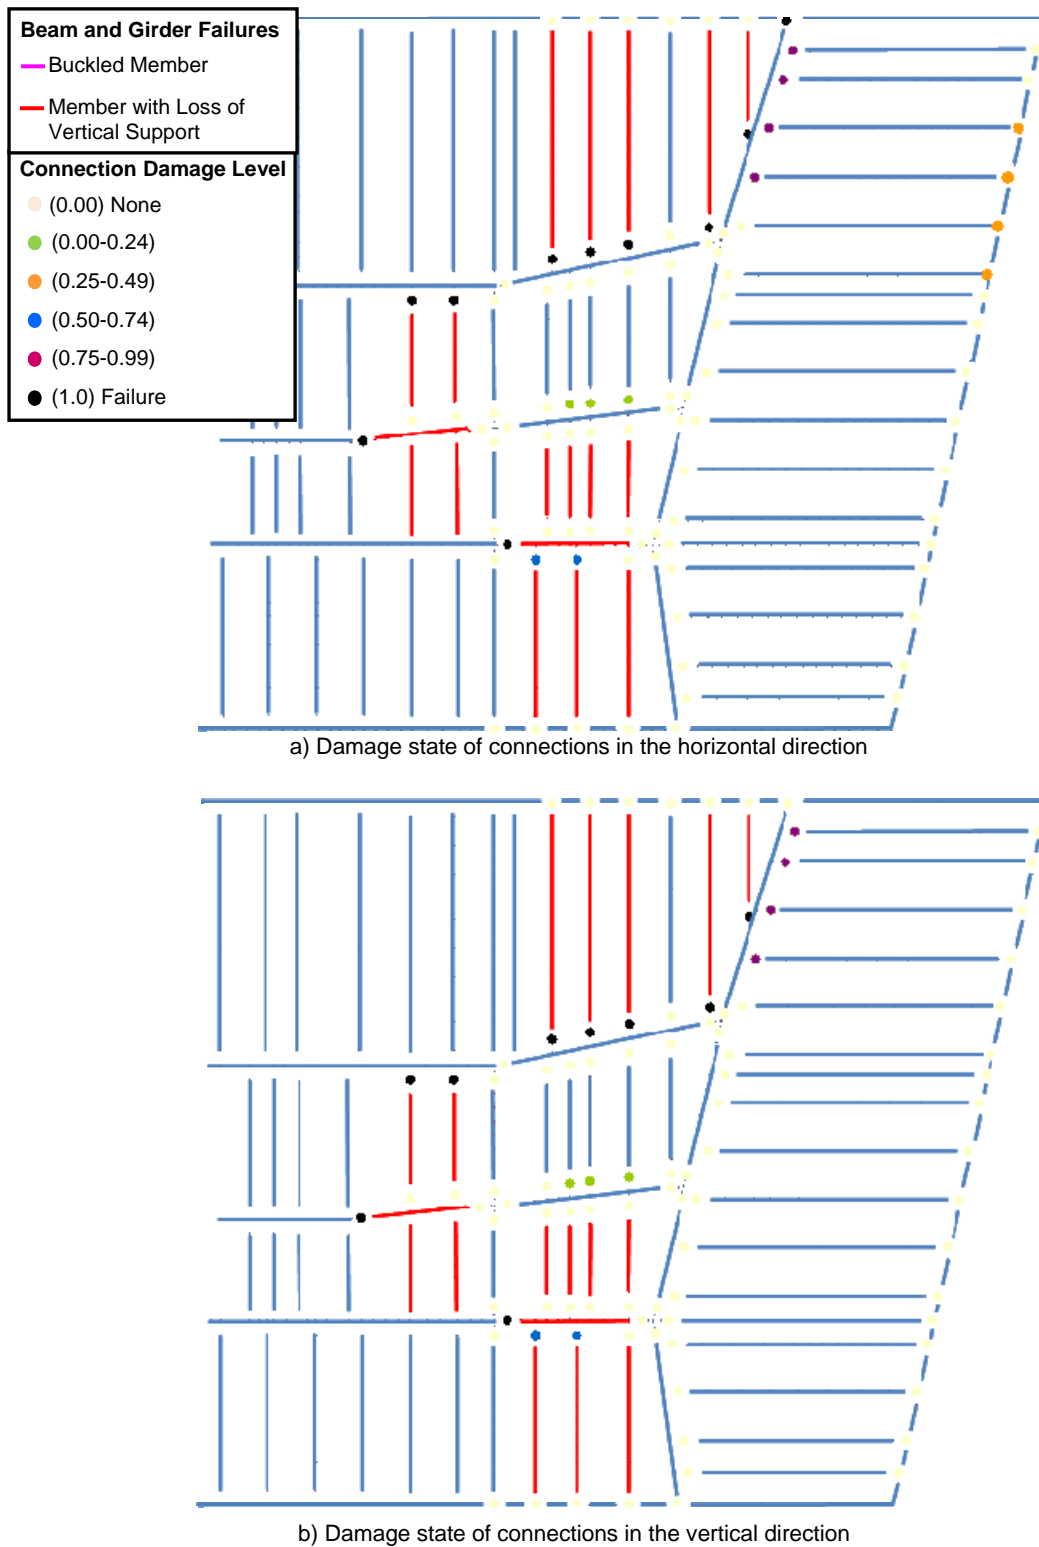
Figure 11–22. Damage state of connections, beams, and girders in Floor 8 at 3.5 h for Case B temperatures.

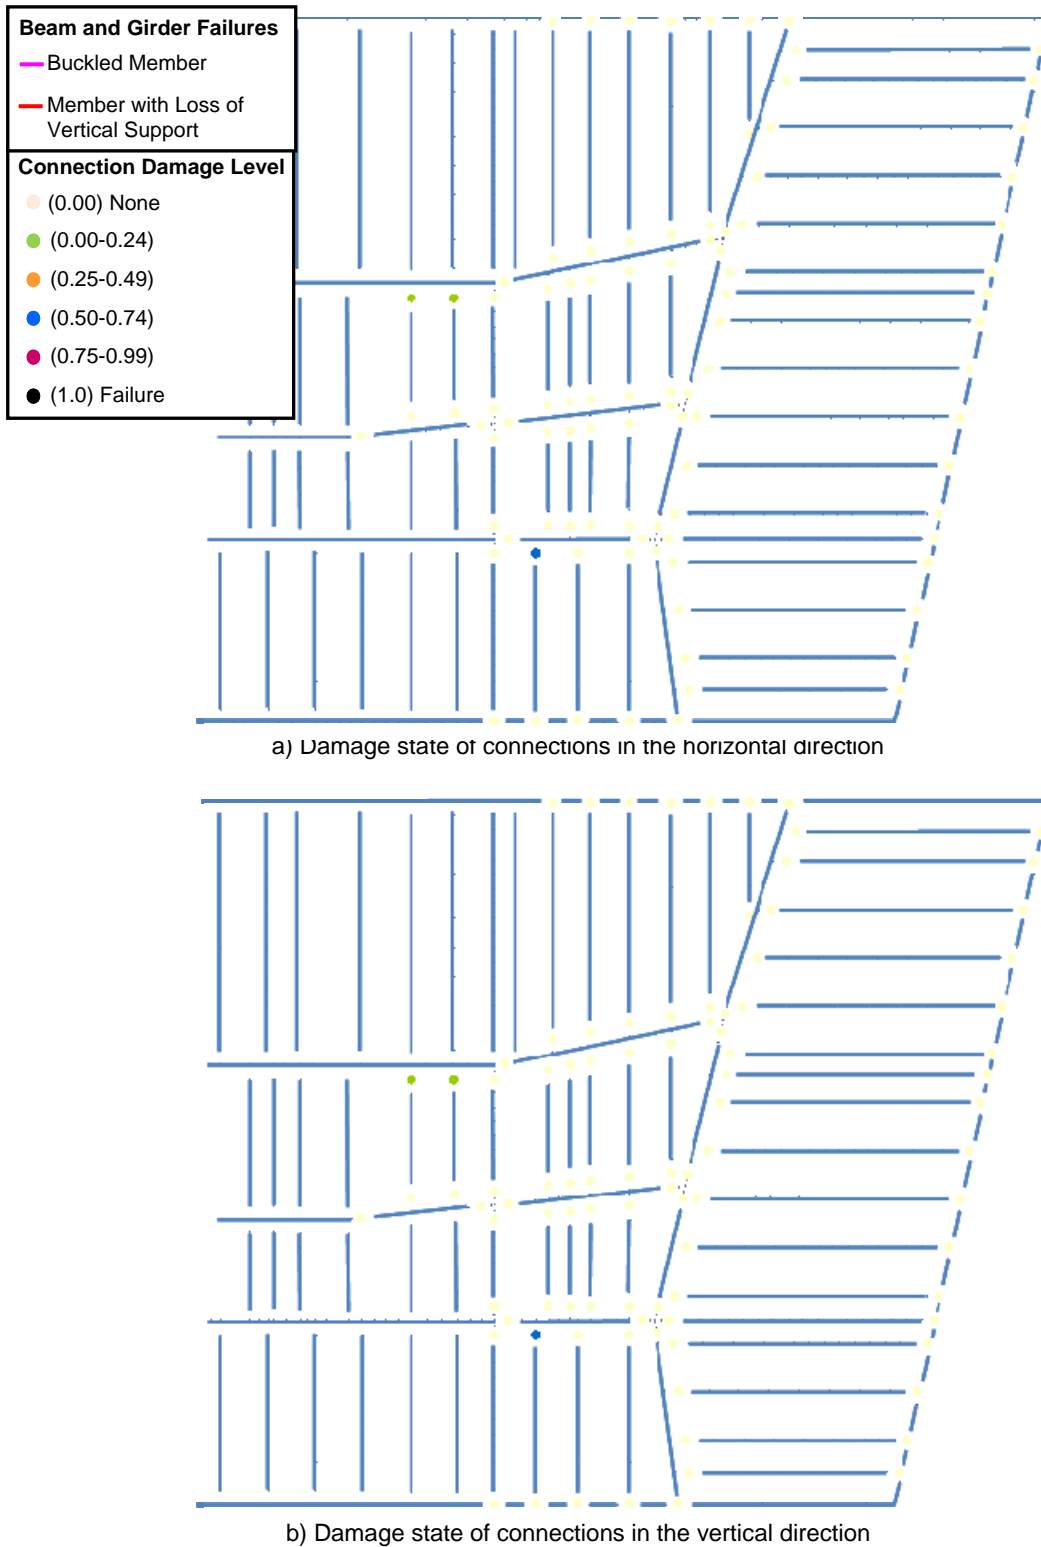
Figure 11–23. Damage state of connections, beams, and girders in Floor 9 at 3.5 h for Case B temperatures.

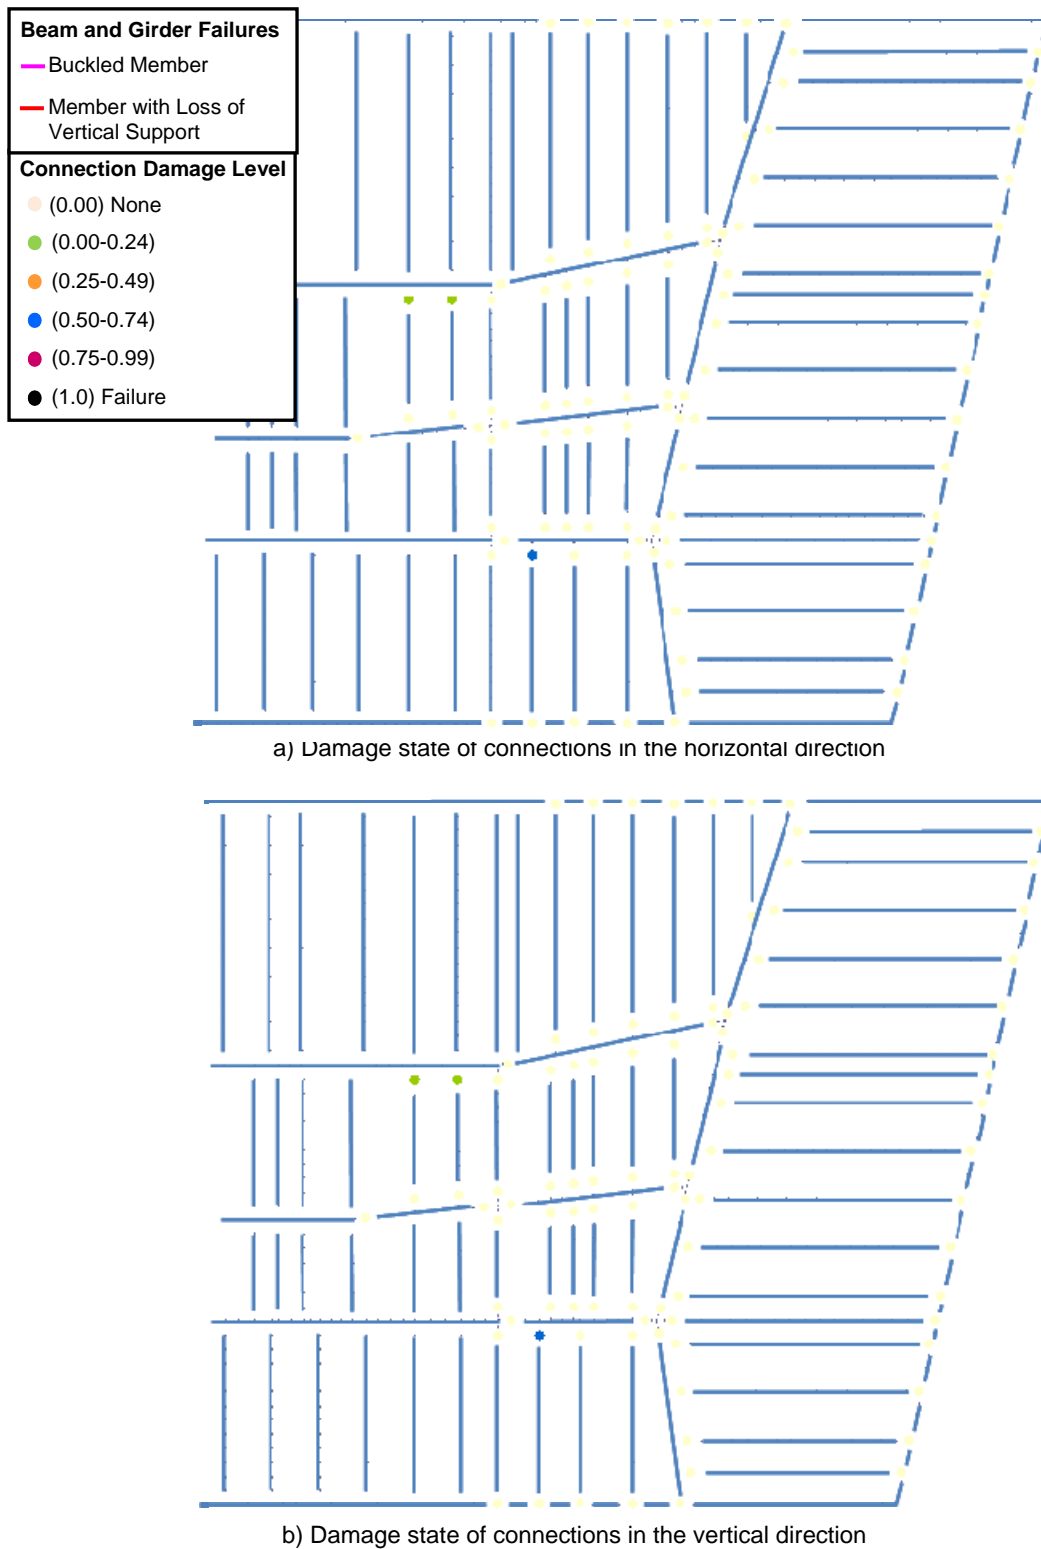
Figure 11–24. Damage state of connections, beams, and girders in Floor 10 at 3.5 h for Case B. temperatures.

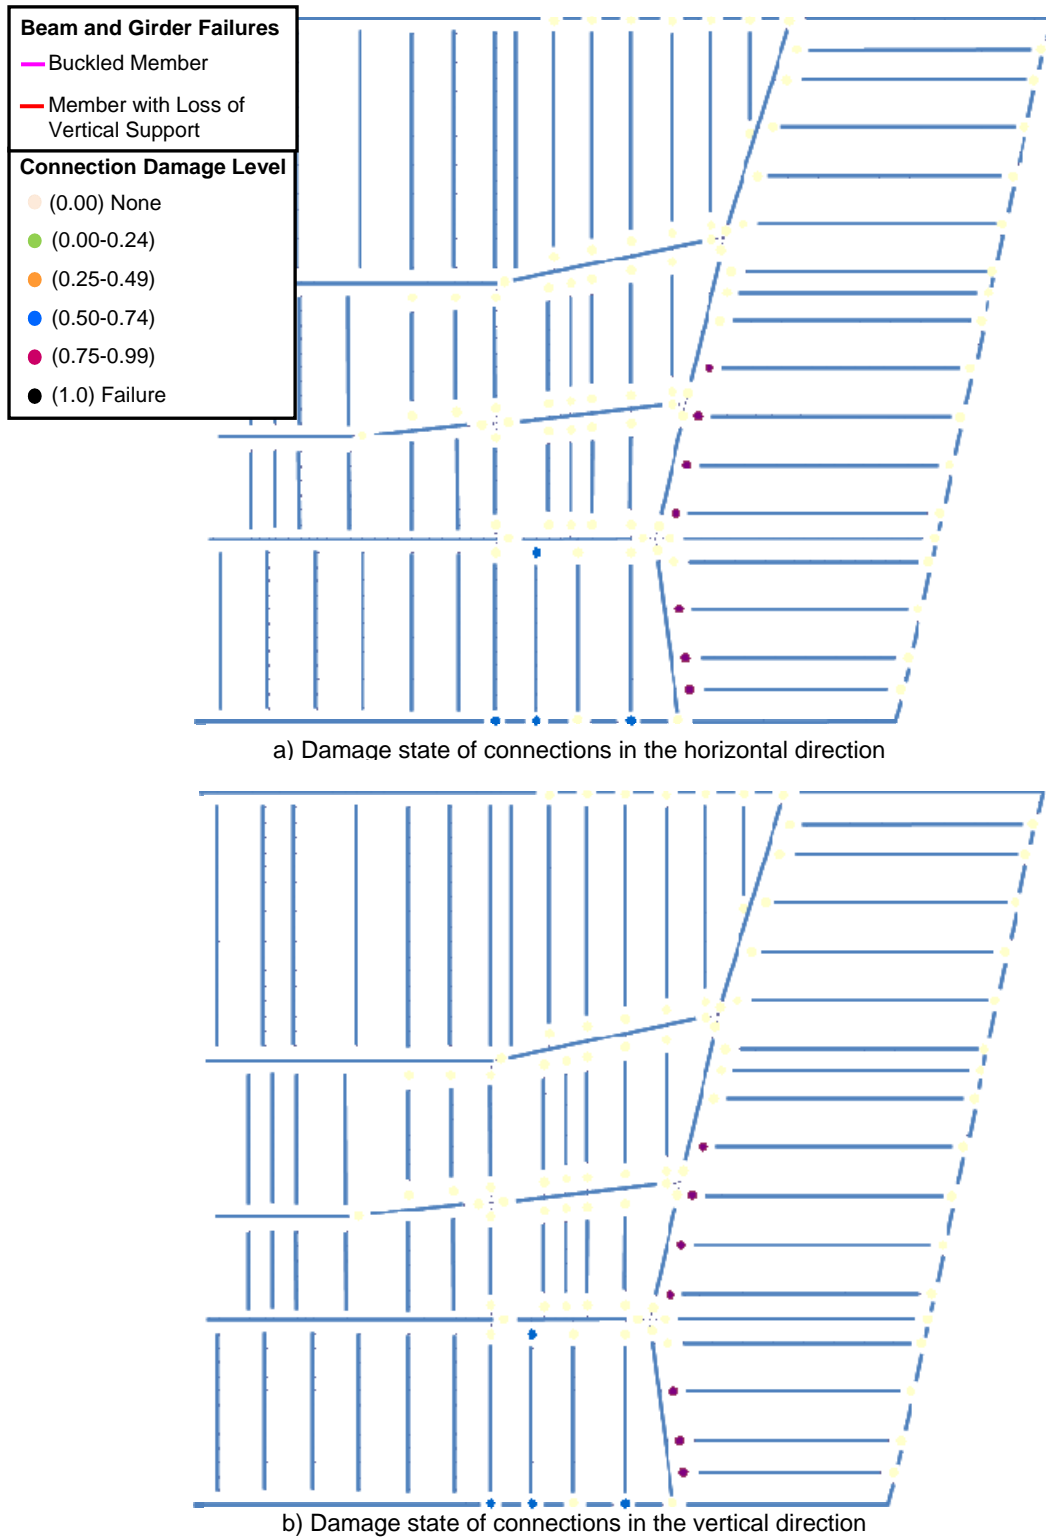
Figure 11–25. Damage state of connections, beams, and girders in Floor 11 at 3.5 h for Case B temperatures.

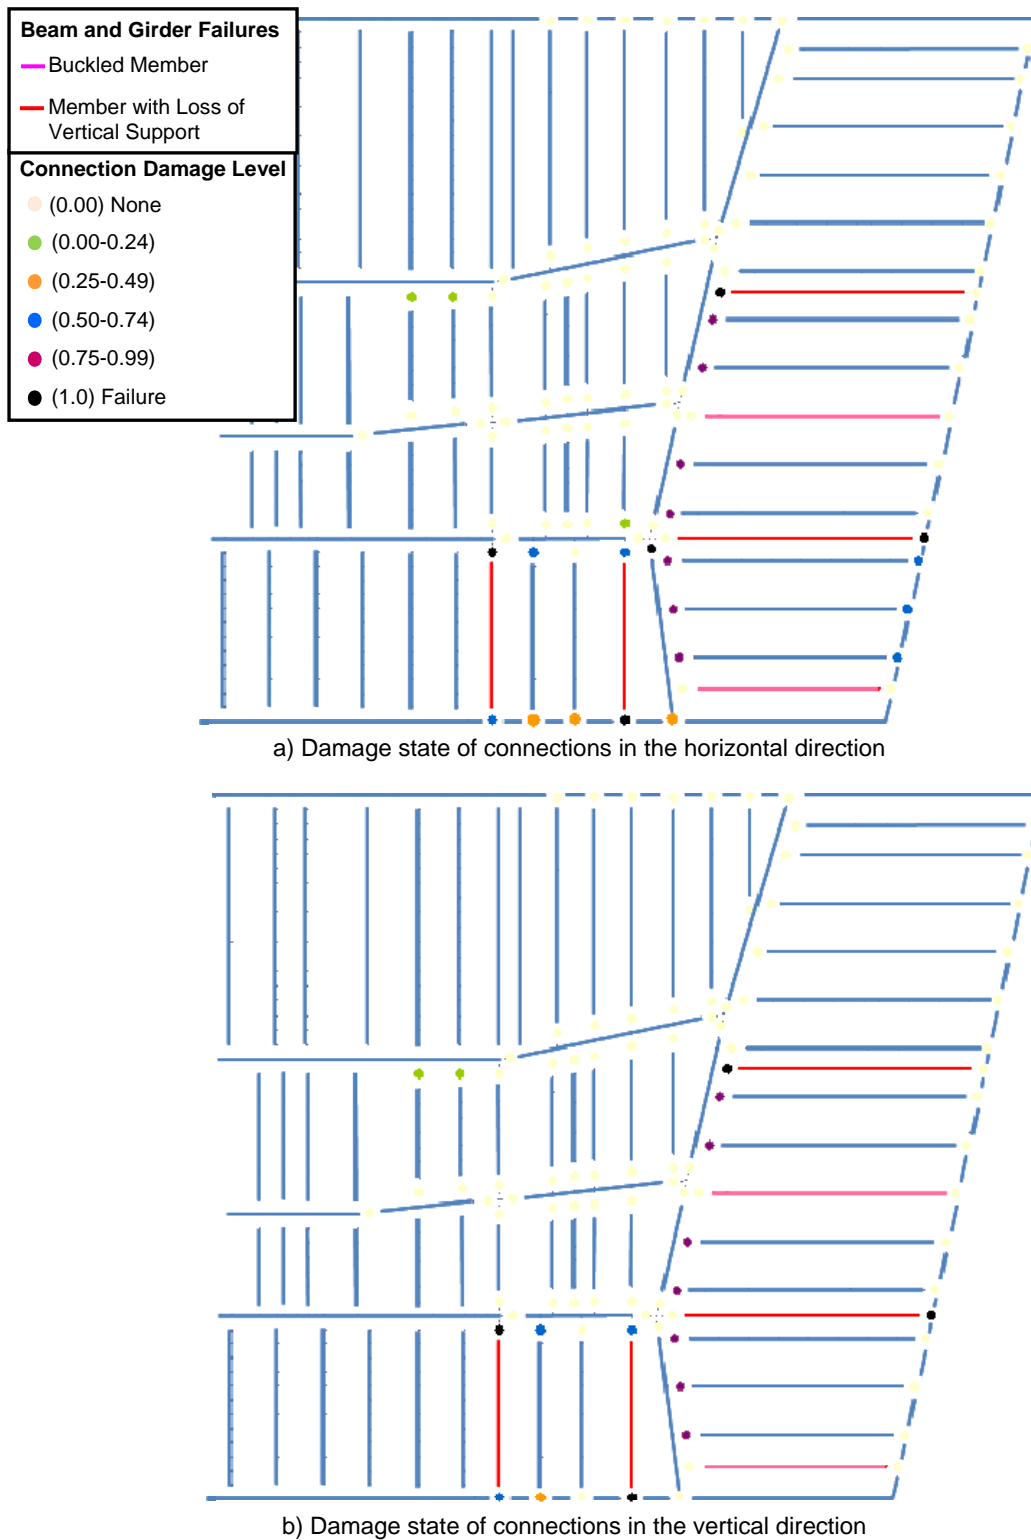
Figure 11–26. Damage state of connections, beams, and girders in Floor 12 at 3.5 h for Case B temperatures.

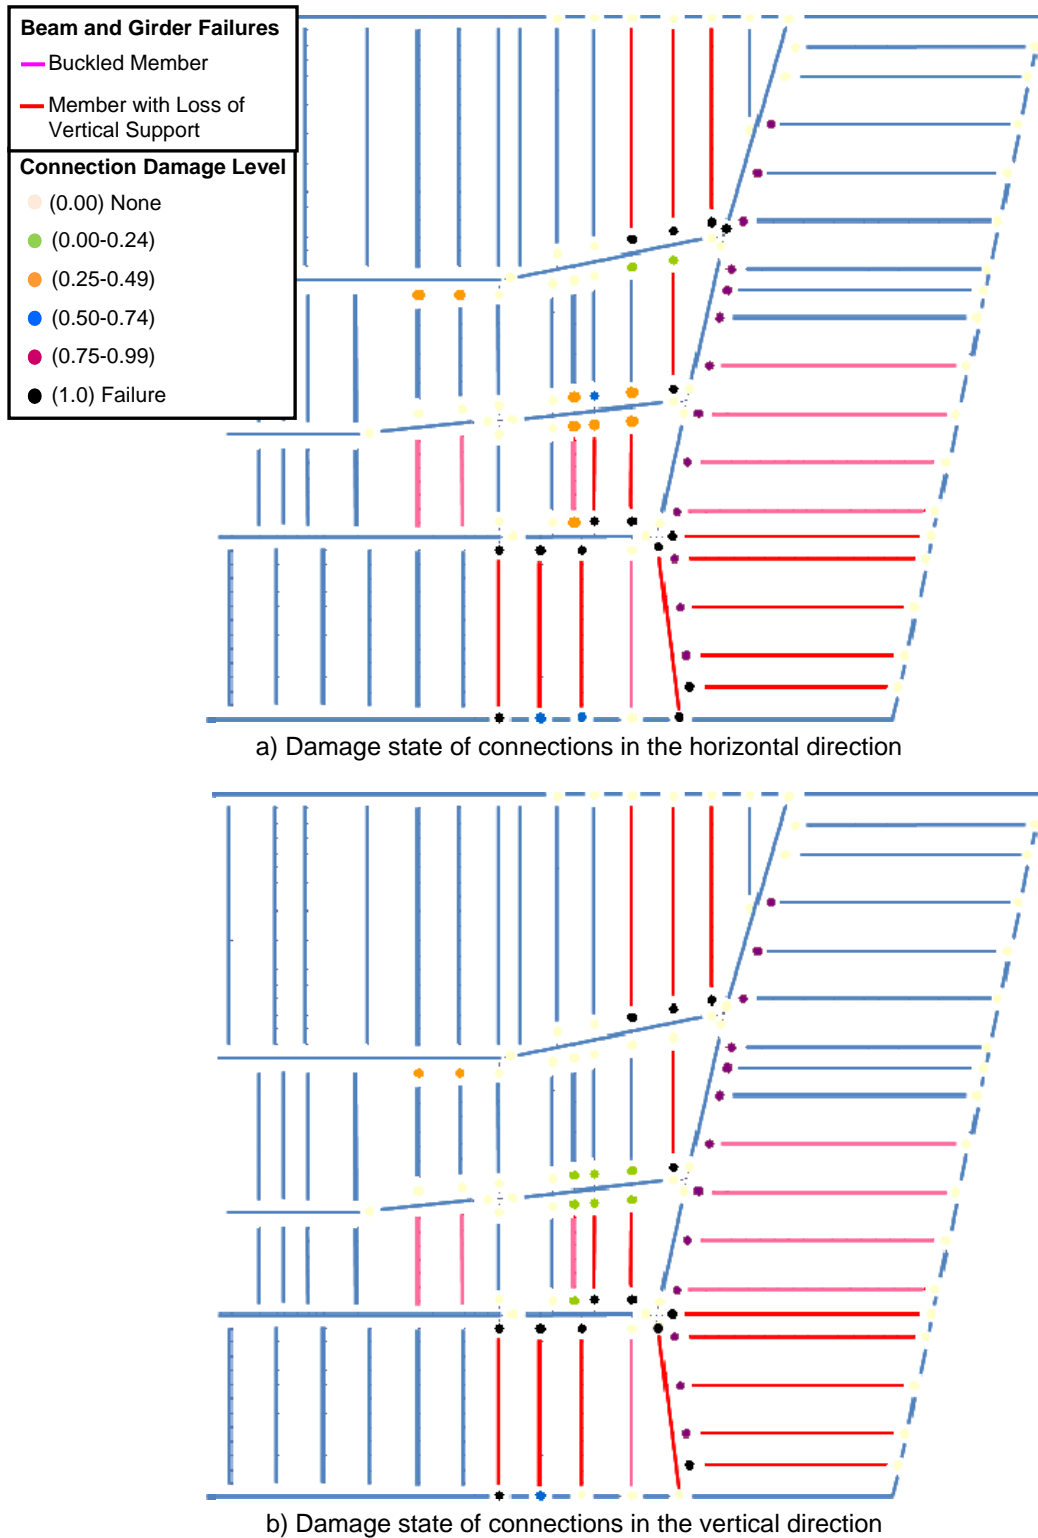
Figure 11–27. Damage state of connections, beams, and girders in Floor 13 at 3.5 h for Case B temperatures.
