**Federal Building and Fire Safety Investigation of the
World Trade Center Disaster**

**Structural Fire Response and
Probable Collapse Sequence of
World Trade Center Building 7**

VOLUME 1

November 2008

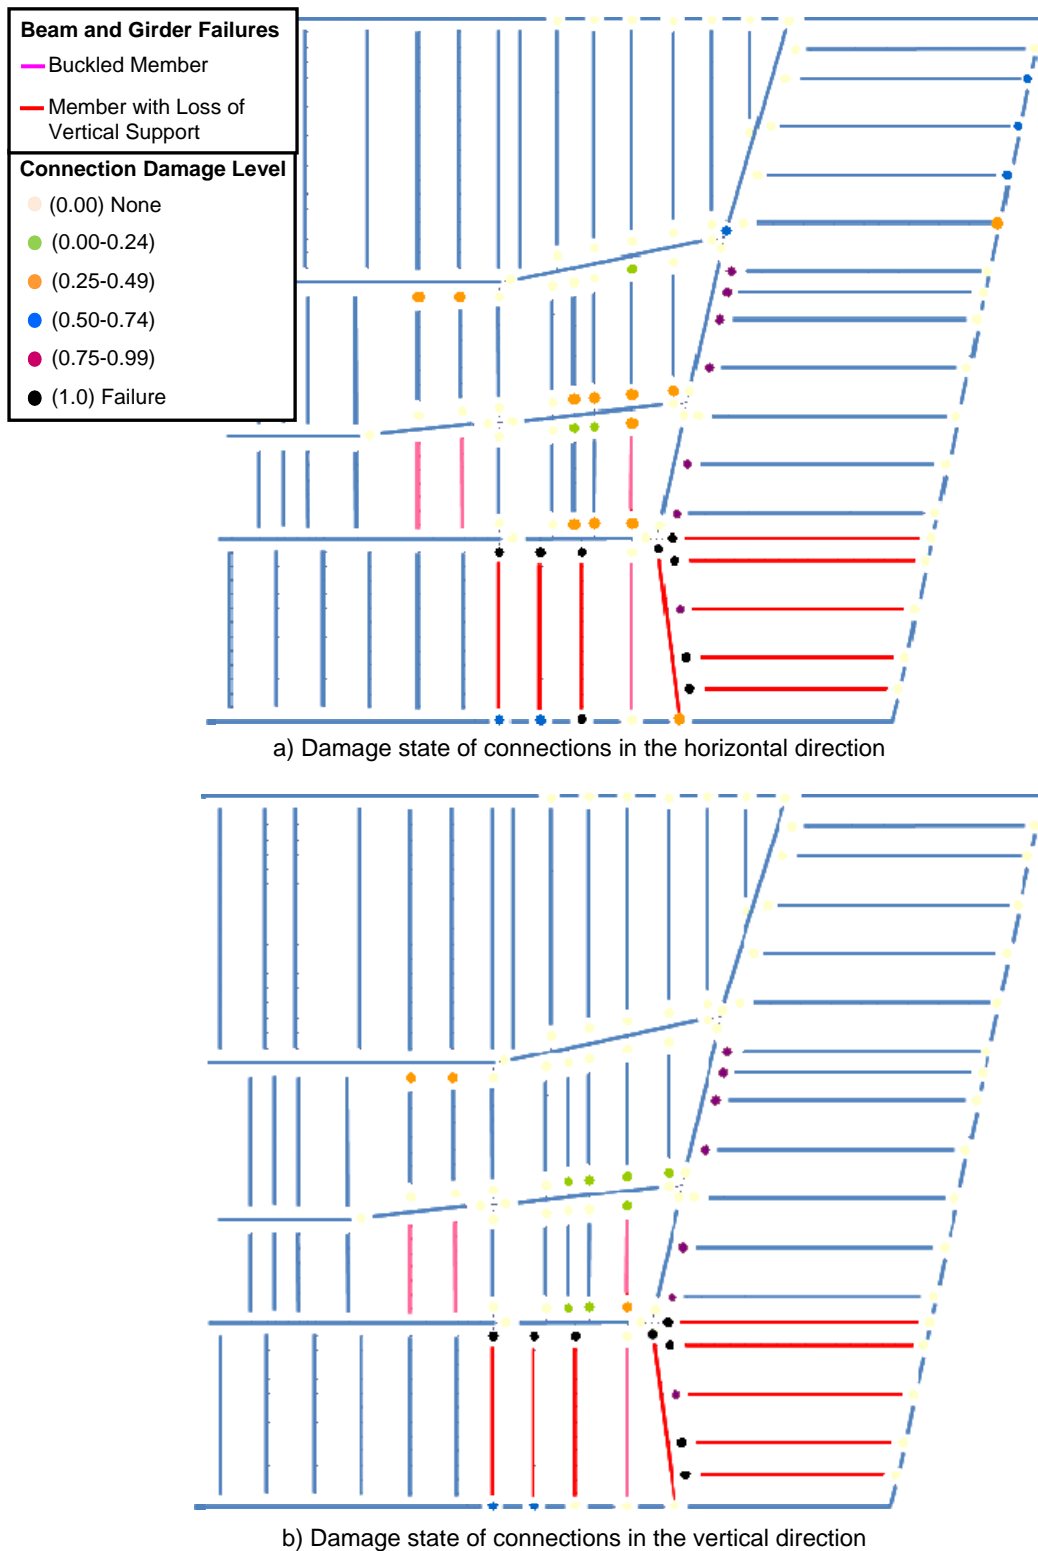
Figure 11–28. Damage state of connections, beams, and girders in Floor 14 at 3.5 h for Case B temperatures.

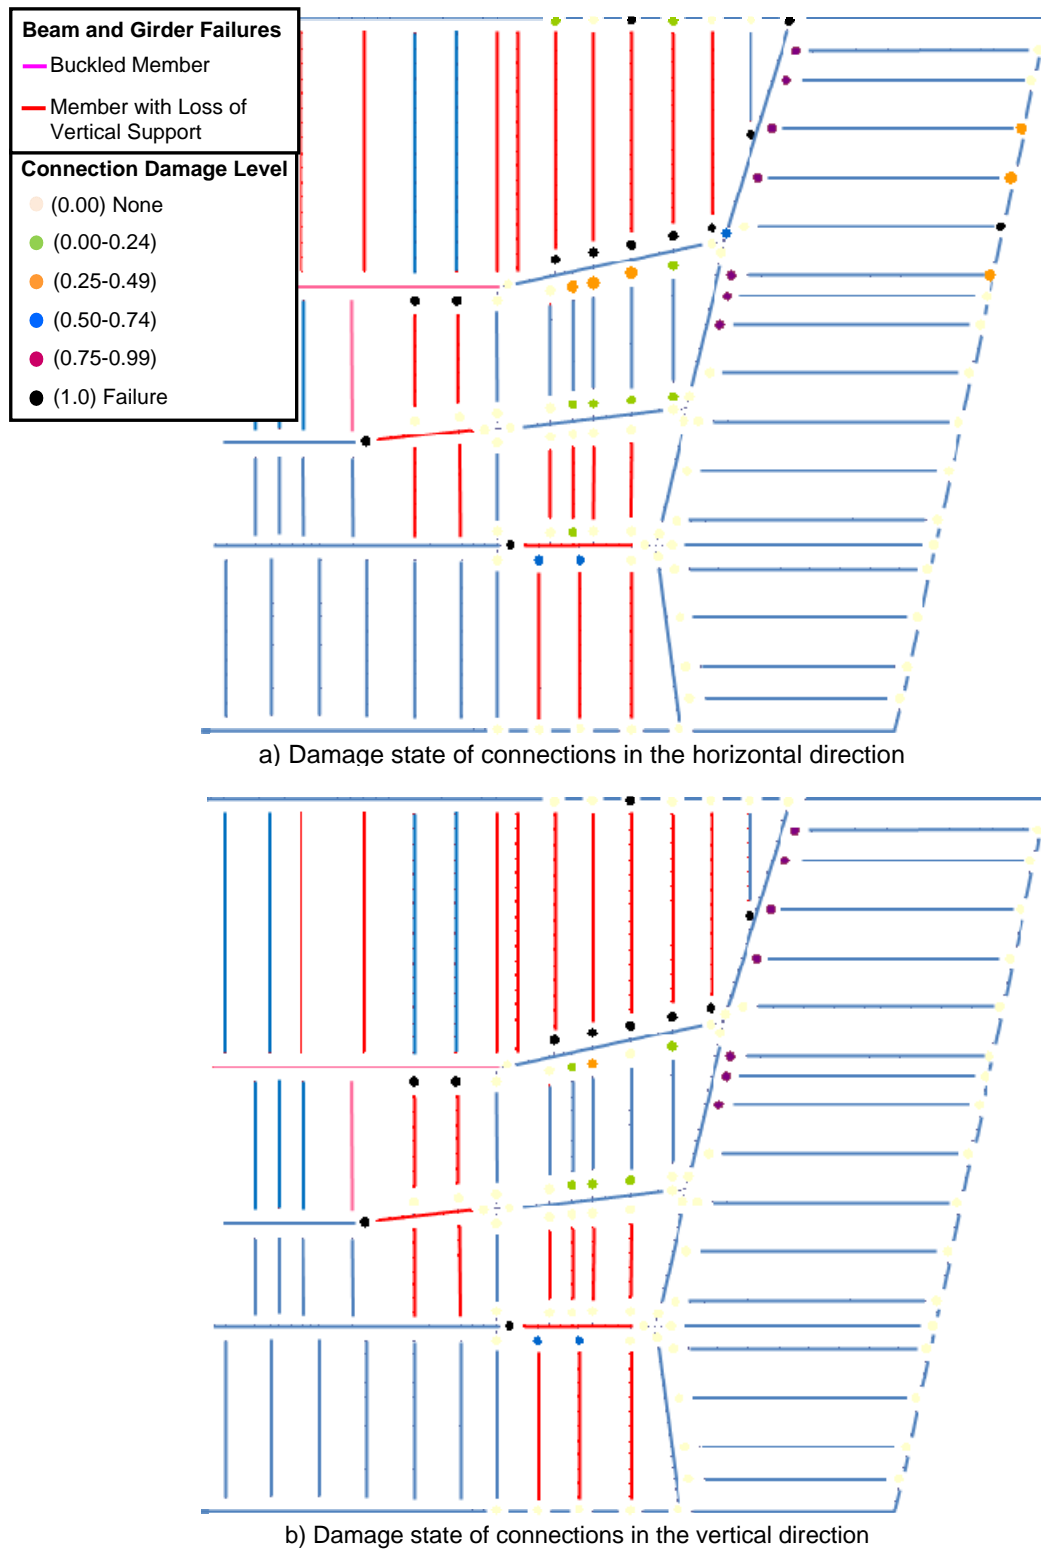
Figure 11–30. Damage state of connections, beams, and girders in Floor 8 at 4.0 h for Case B temperatures.

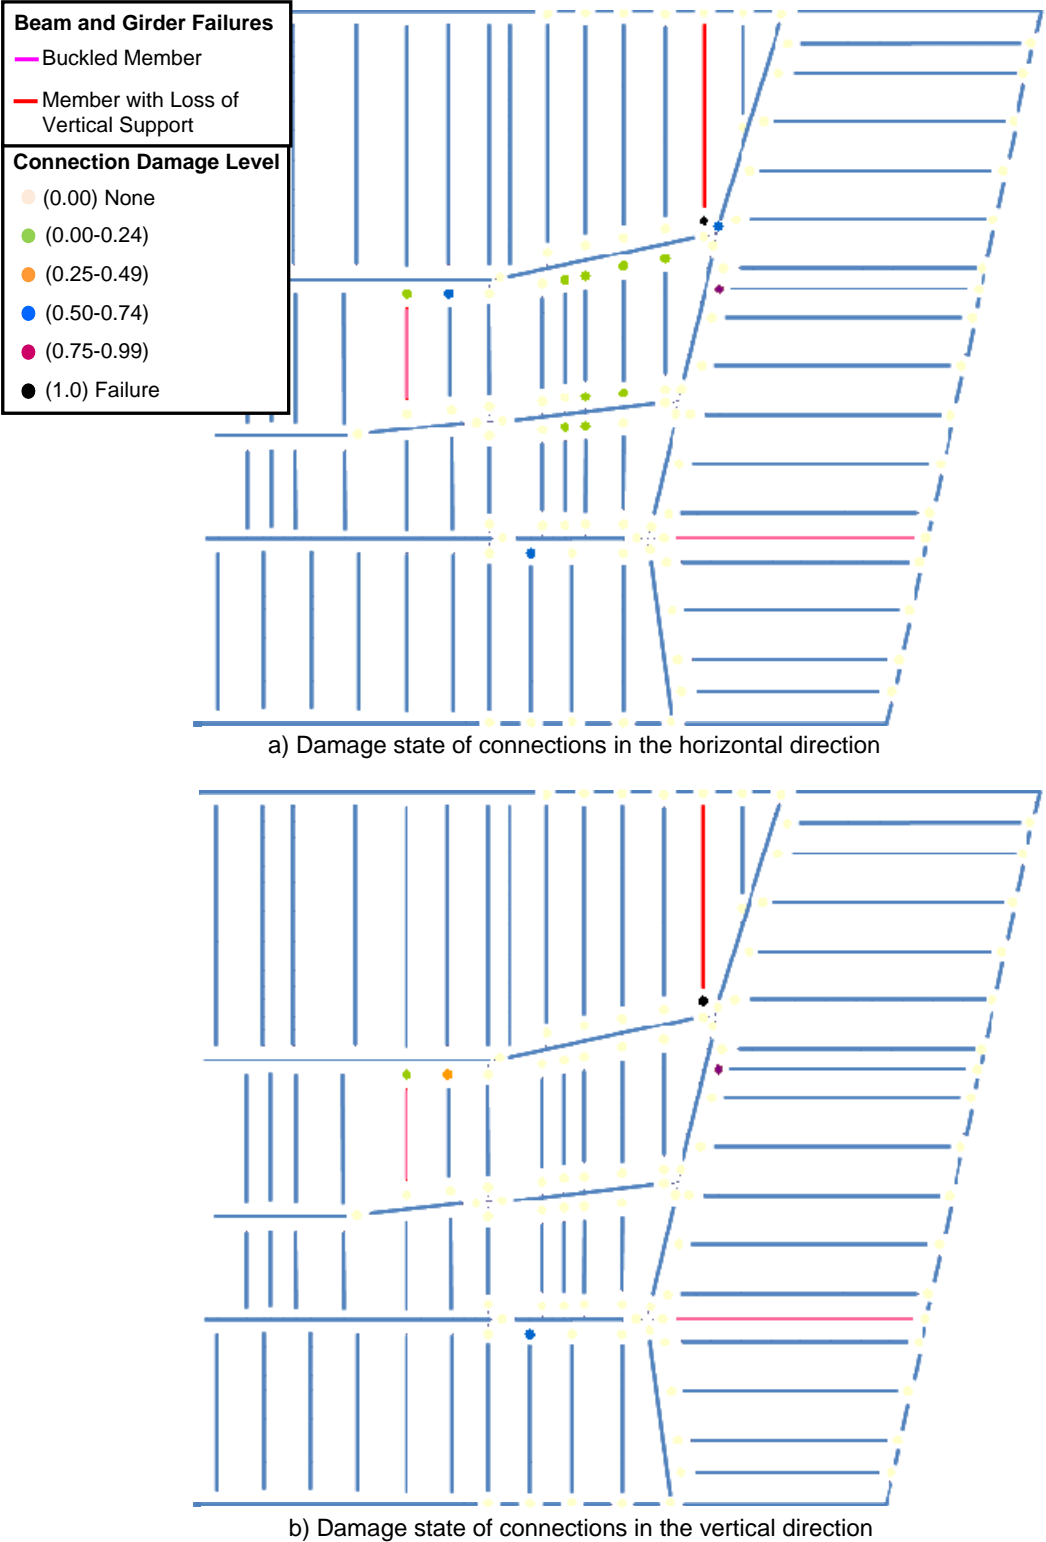
Figure 11–31. Damage state of connections, beams, and girders in Floor 9 at 4.0 h for Case B temperatures.

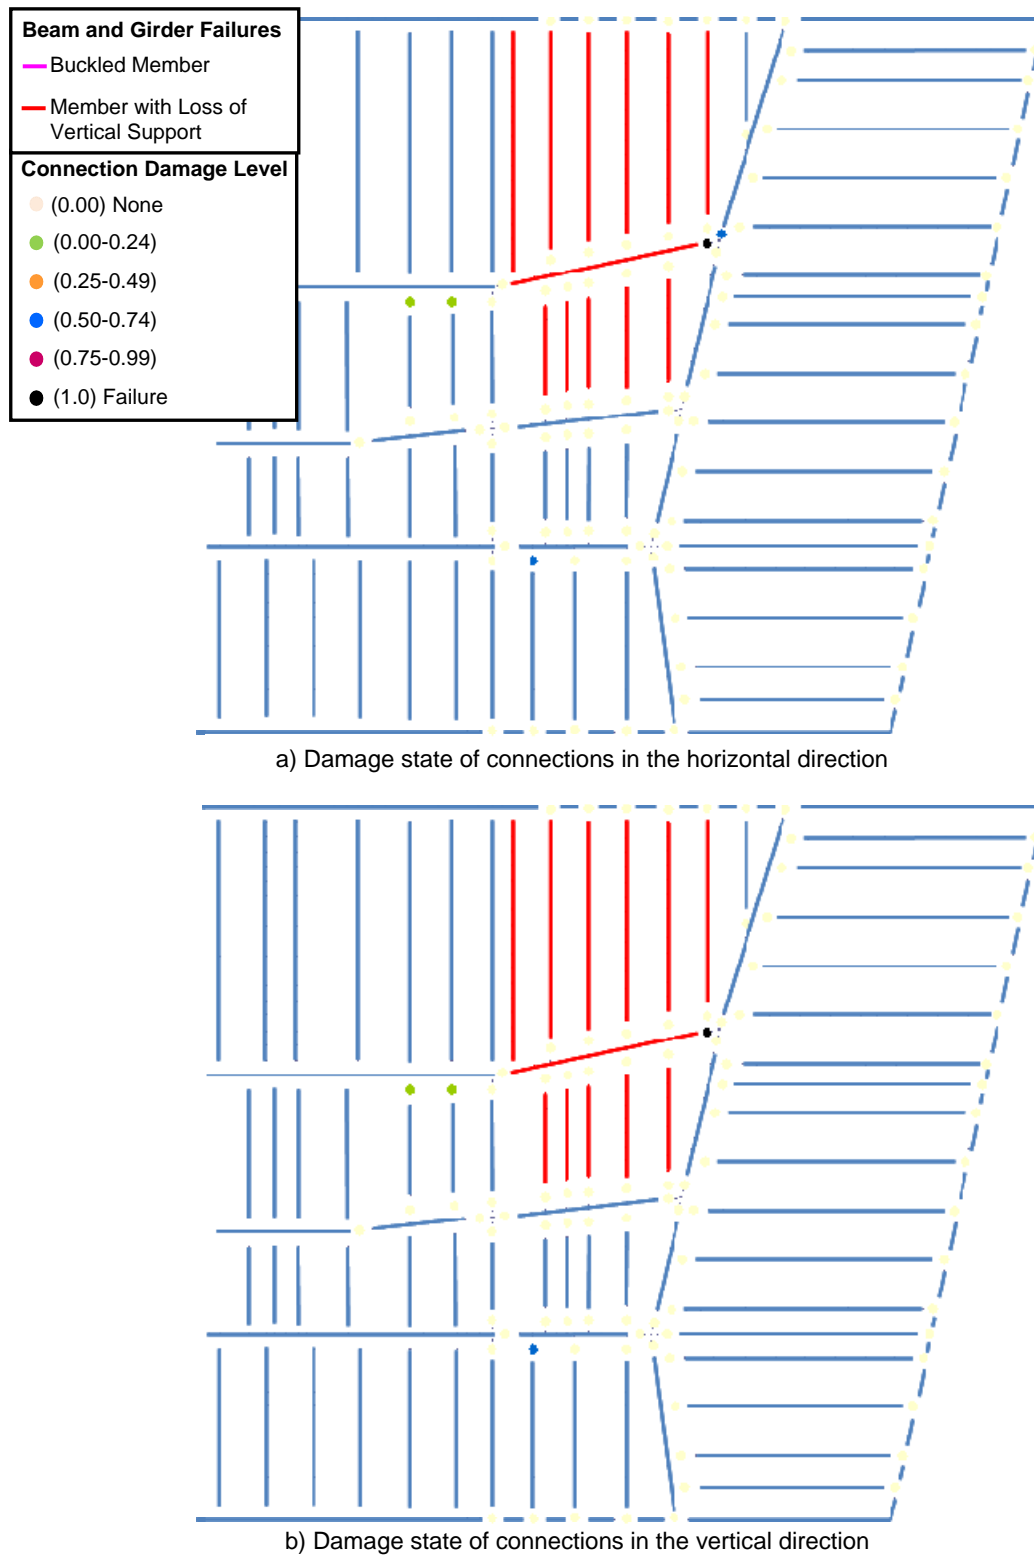
Figure 11-32. Damage state of connections, beams, and girders in Floor 10 at 4.0 h for Case B temperatures.

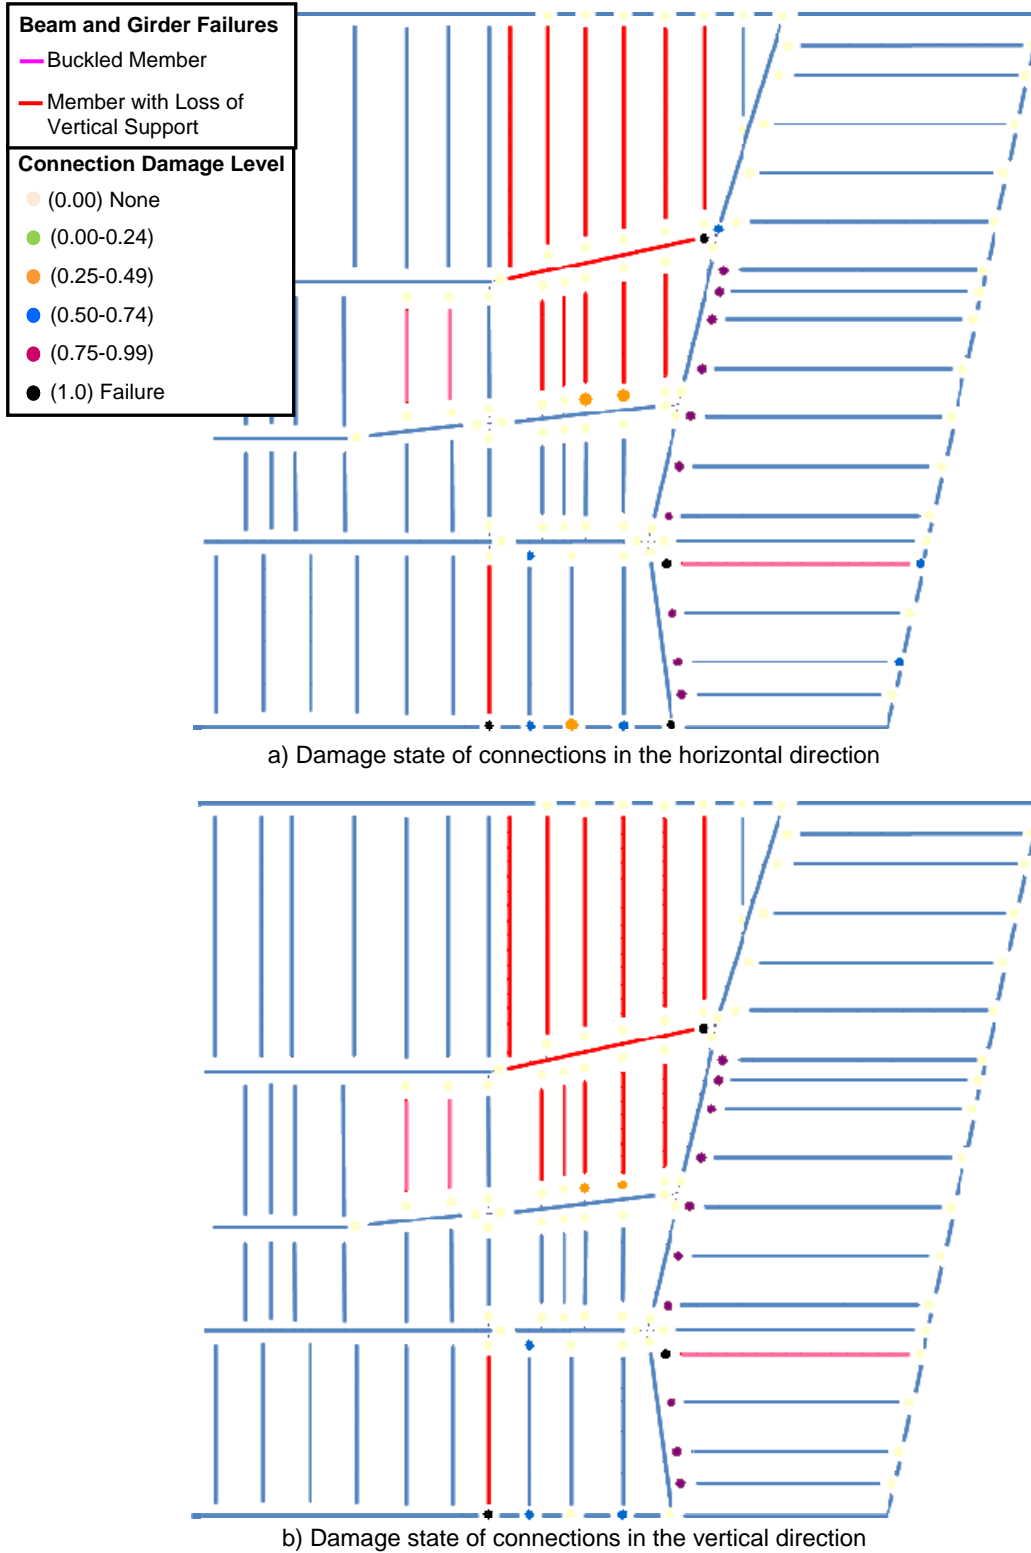
Figure 11–33. Damage state of connections, beams, and girders in Floor 11 at 4.0 h for Case B temperatures.

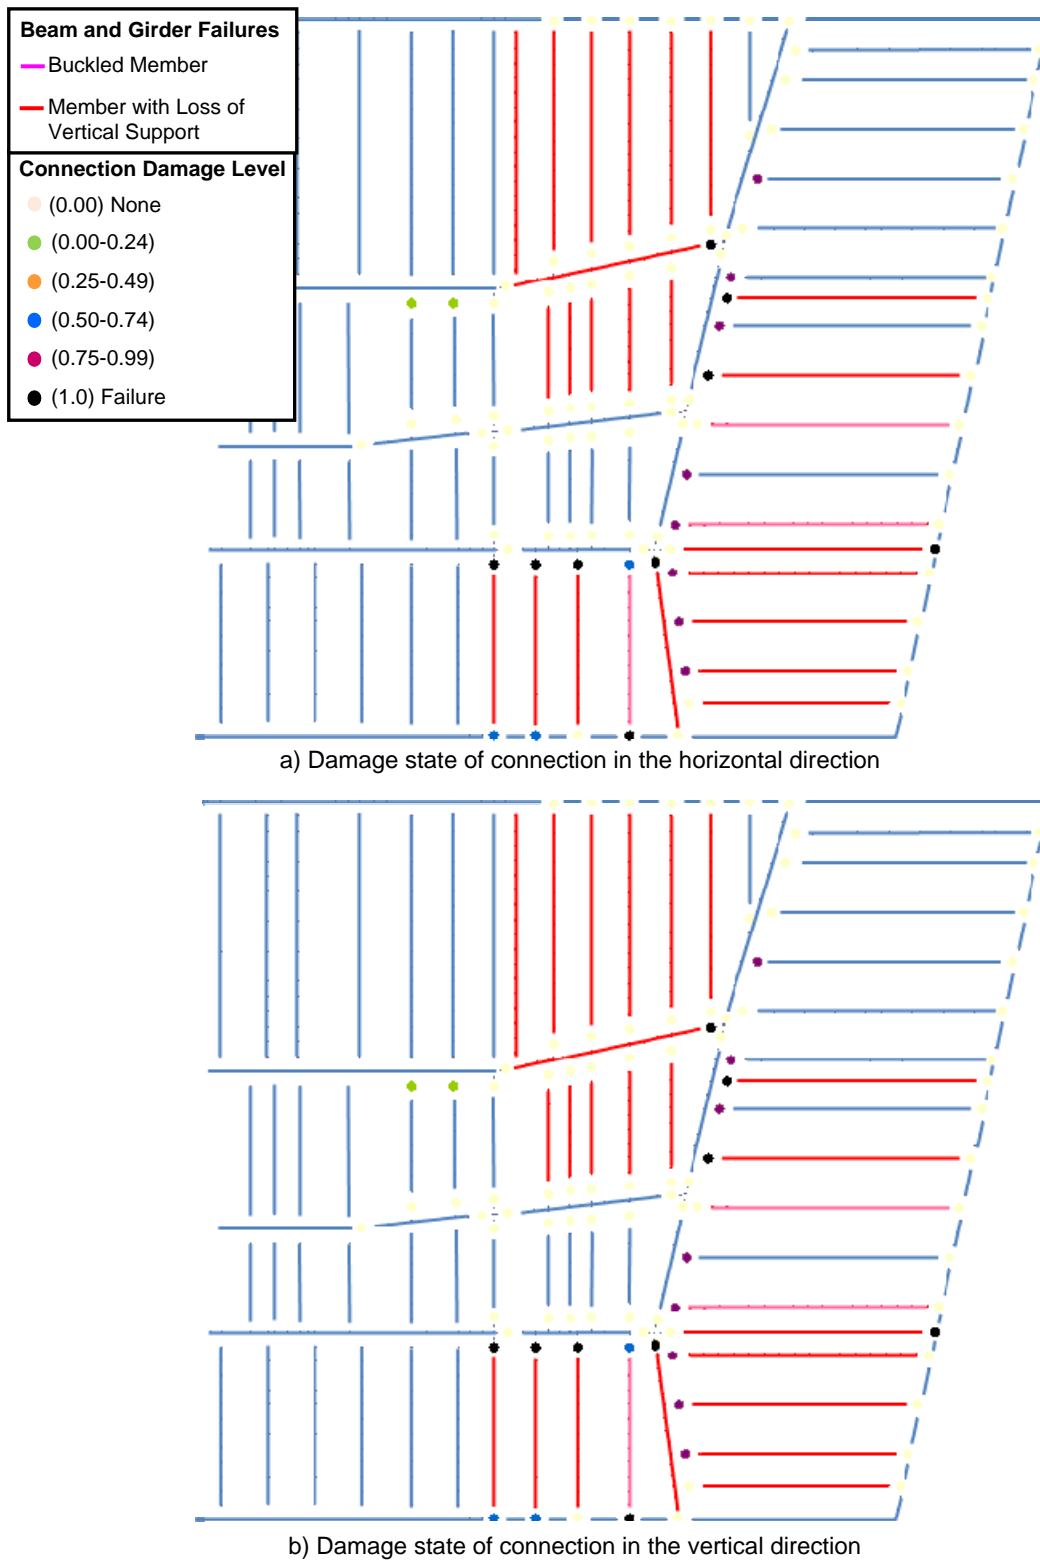
Figure 11-34. Damage state of connections, beams, and girders in Floor 12 at 4.0 h for Case B temperatures.

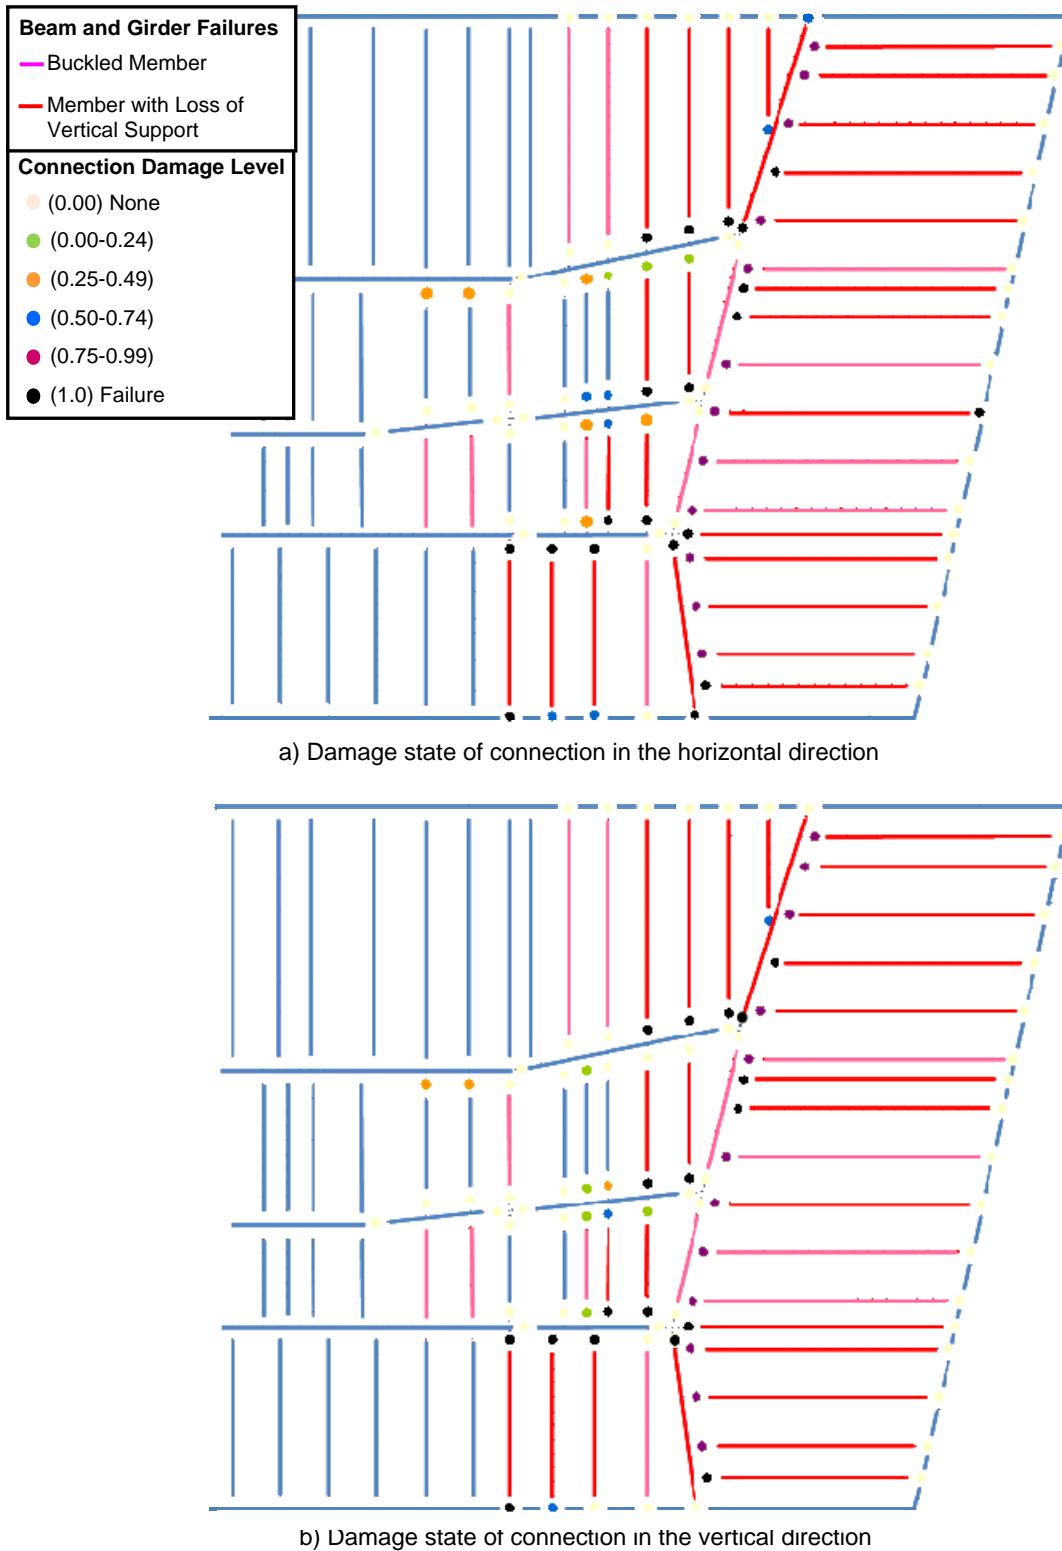
Figure 11-35. Damage state of connections, beams, and girders in Floor 13 at 4.0 h for Case B temperatures.

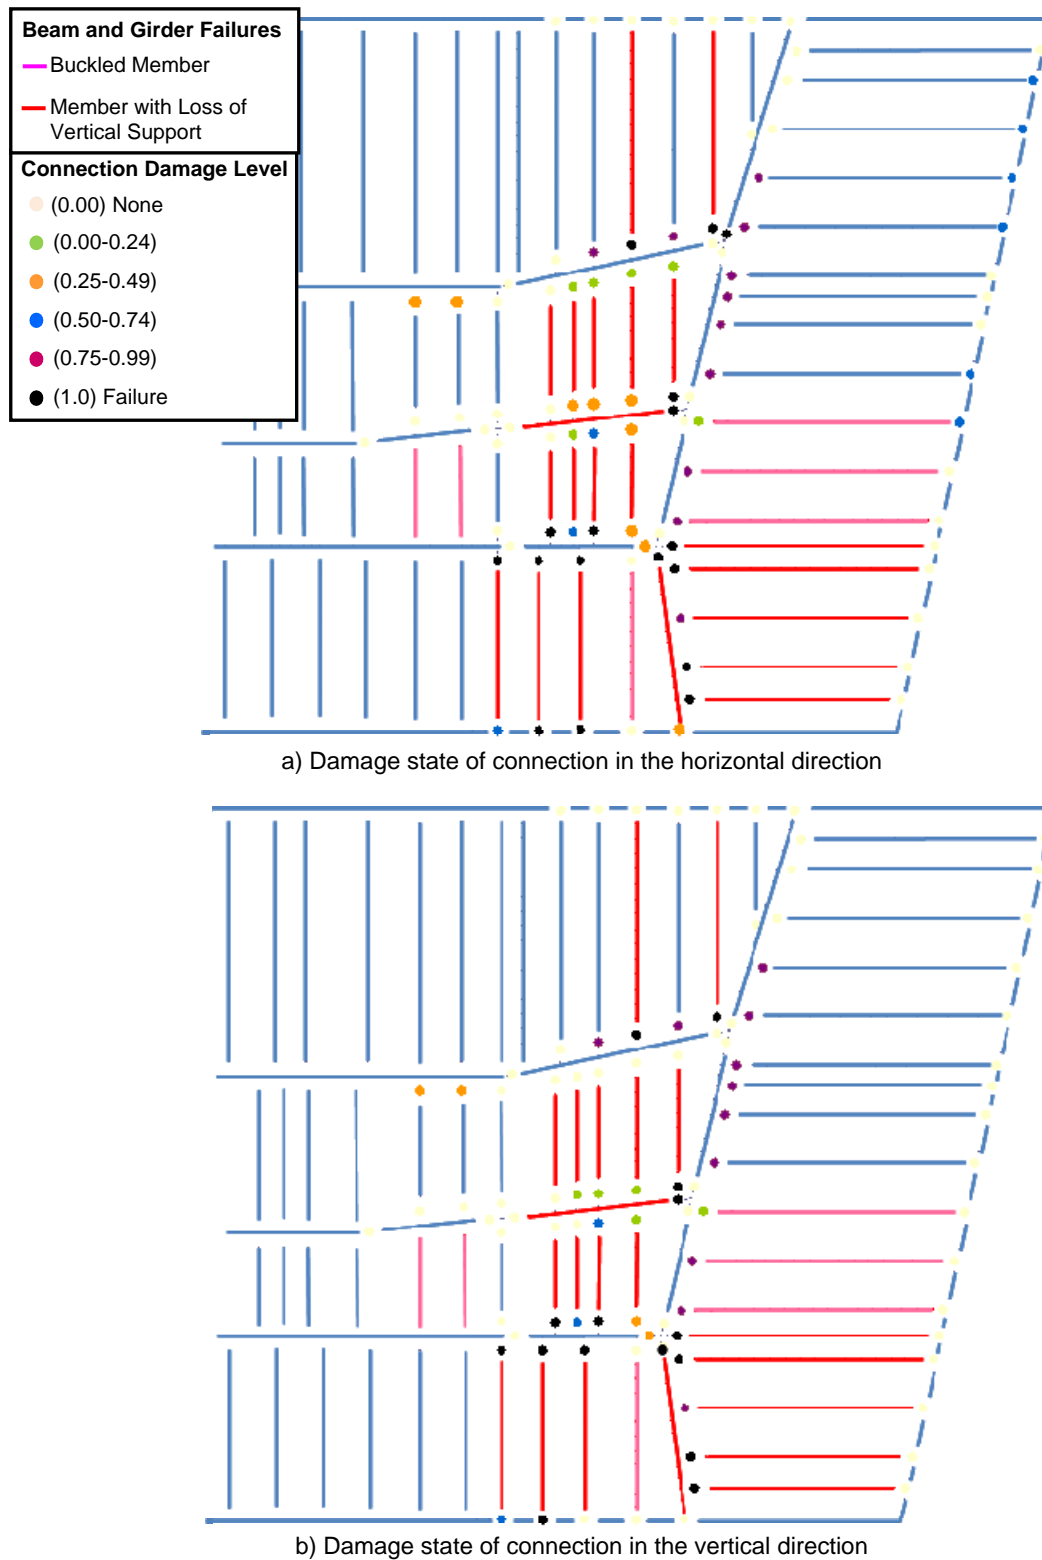
Figure 11-36. Damage state of connections, beams, and girders in Floor 14 at 4.0 h for Case B temperatures.

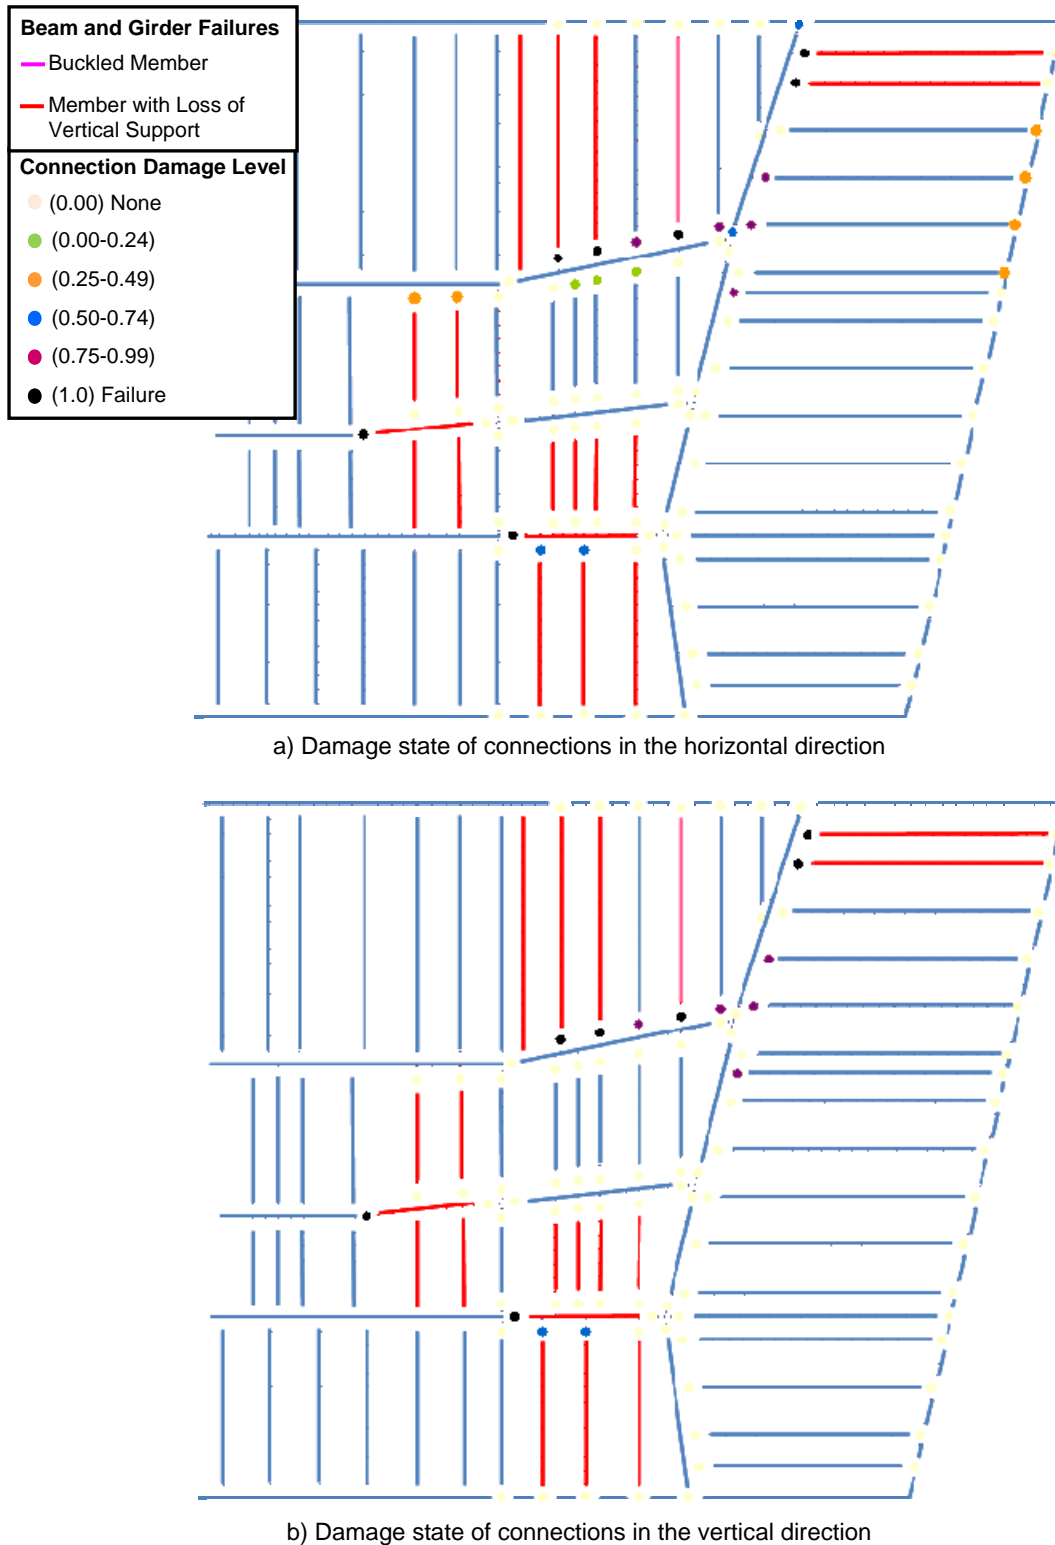
Figure 11-38. Damage state of connections, beams, and girders in Floor 8 at 4.0 h for Case C temperatures.

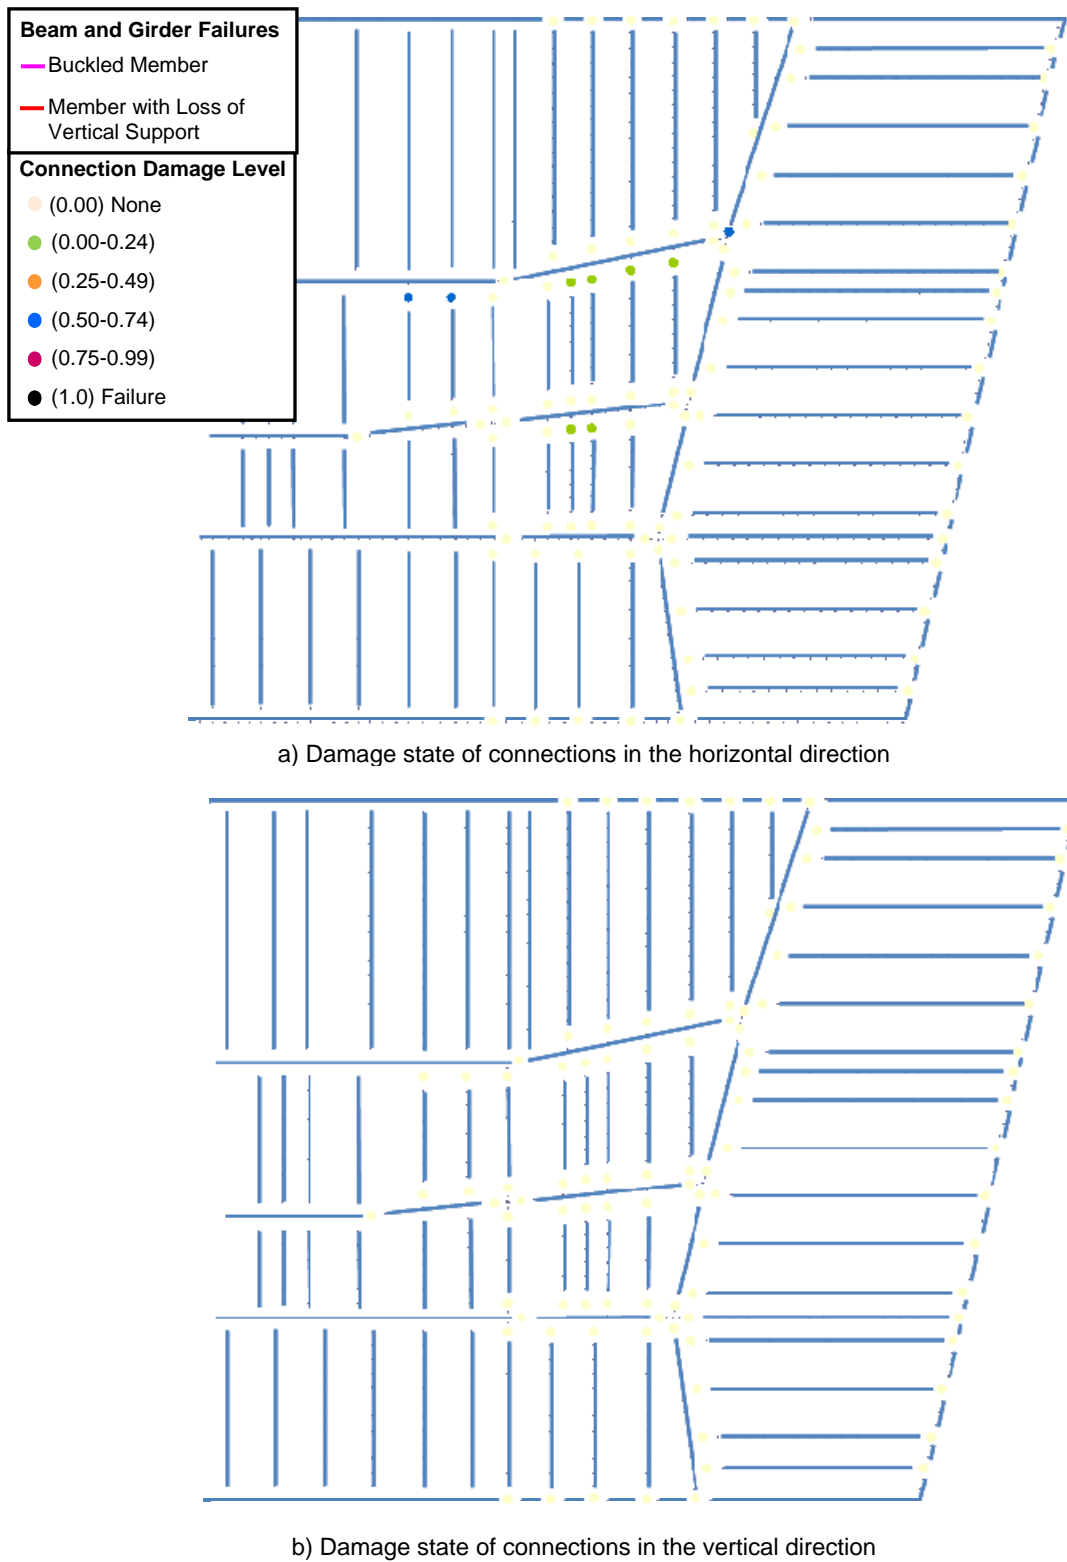
Figure 11–39. Damage state of connections, beams, and girders in Floor 9 at 4.0 h for Case C temperatures.

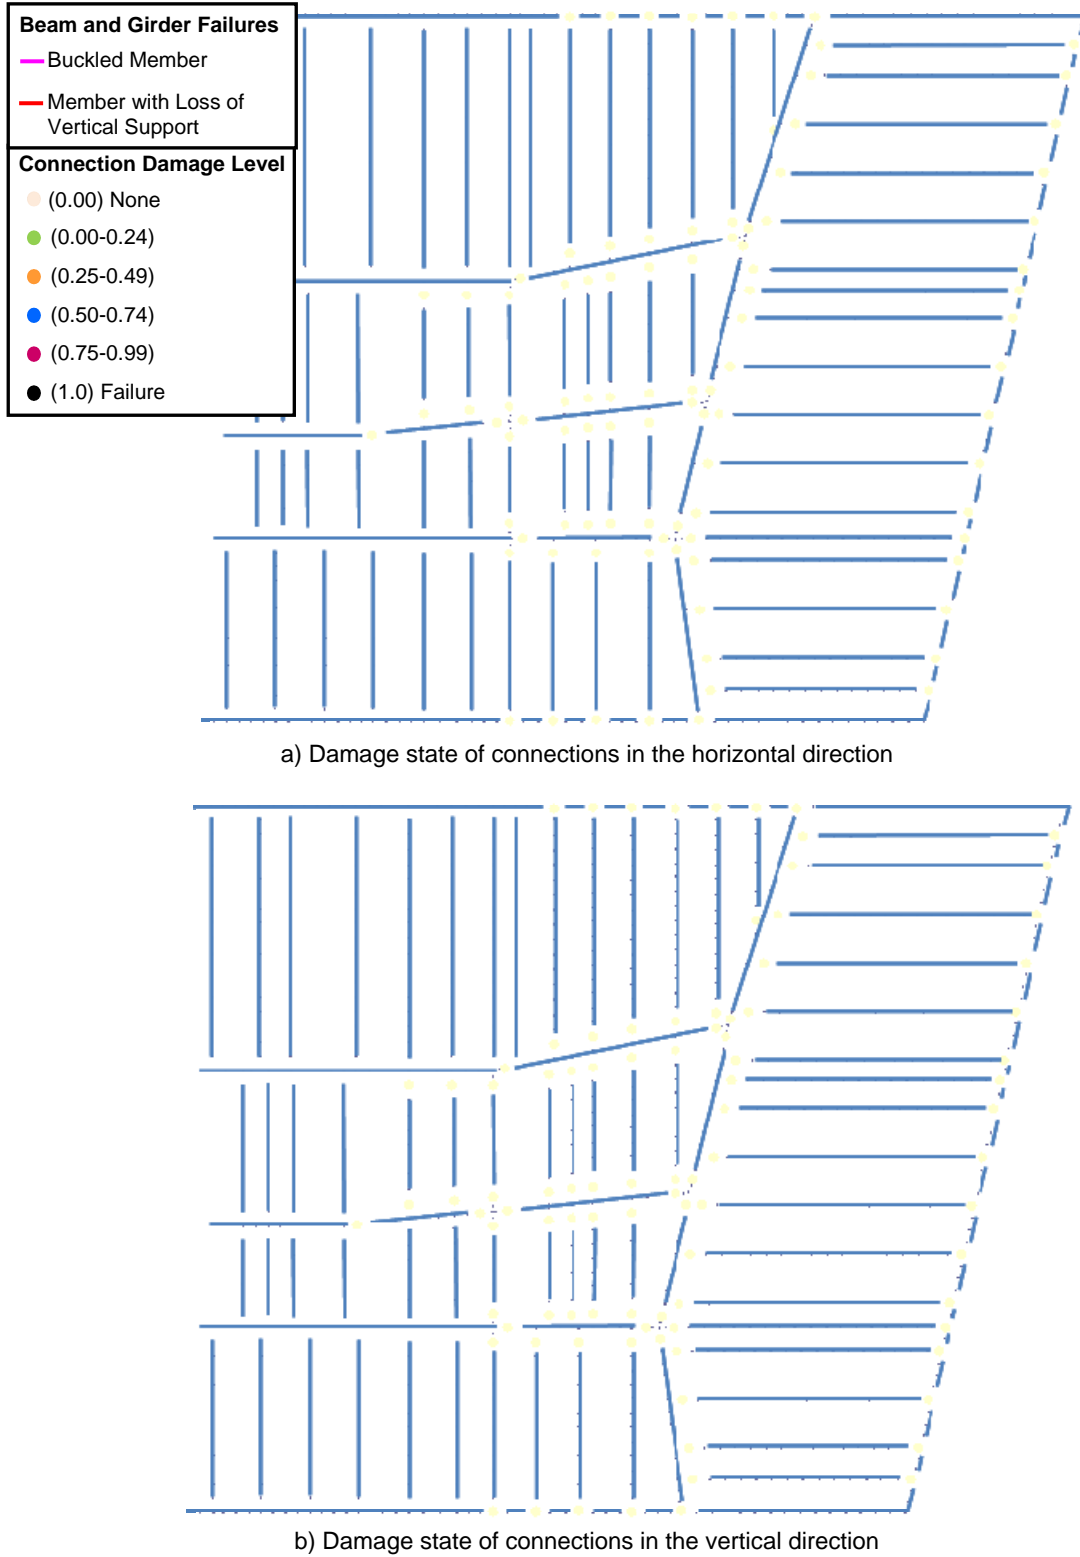
Figure 11–40. Damage state of connections, beams, and girders in Floor 10 at 4.0 h for Case C temperatures.

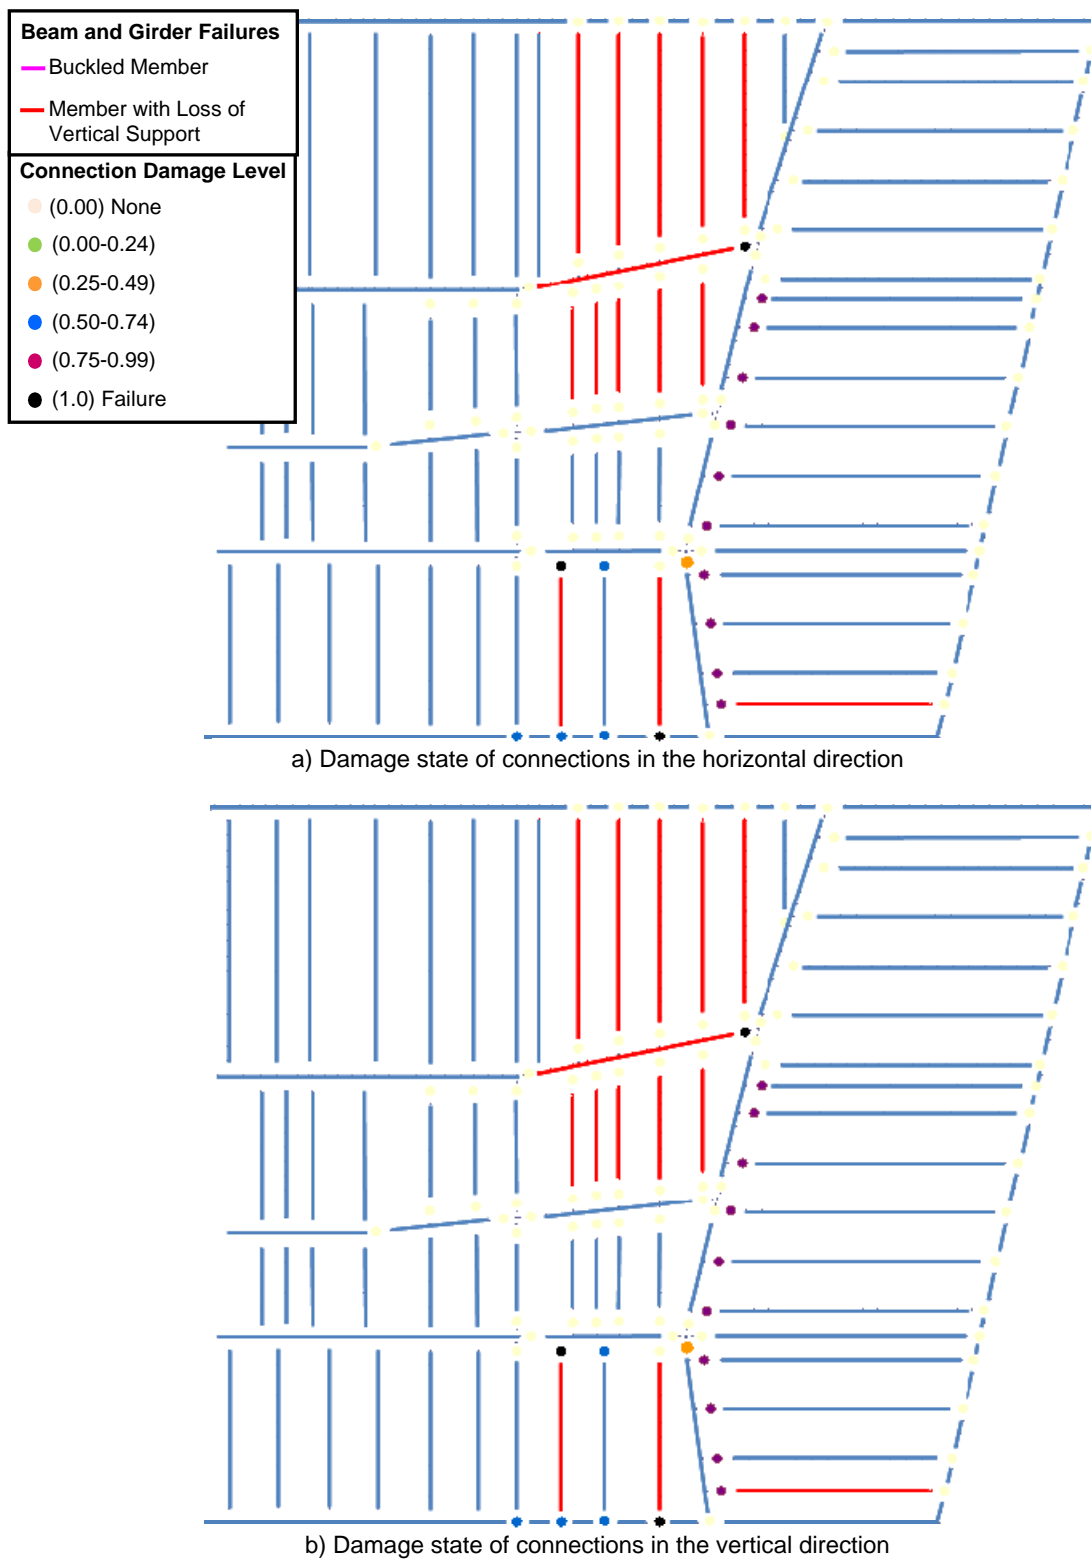
Figure 11–41. Damage state of connections, beams, and girders in Floor 11 at 4.0 h for Case C temperatures.

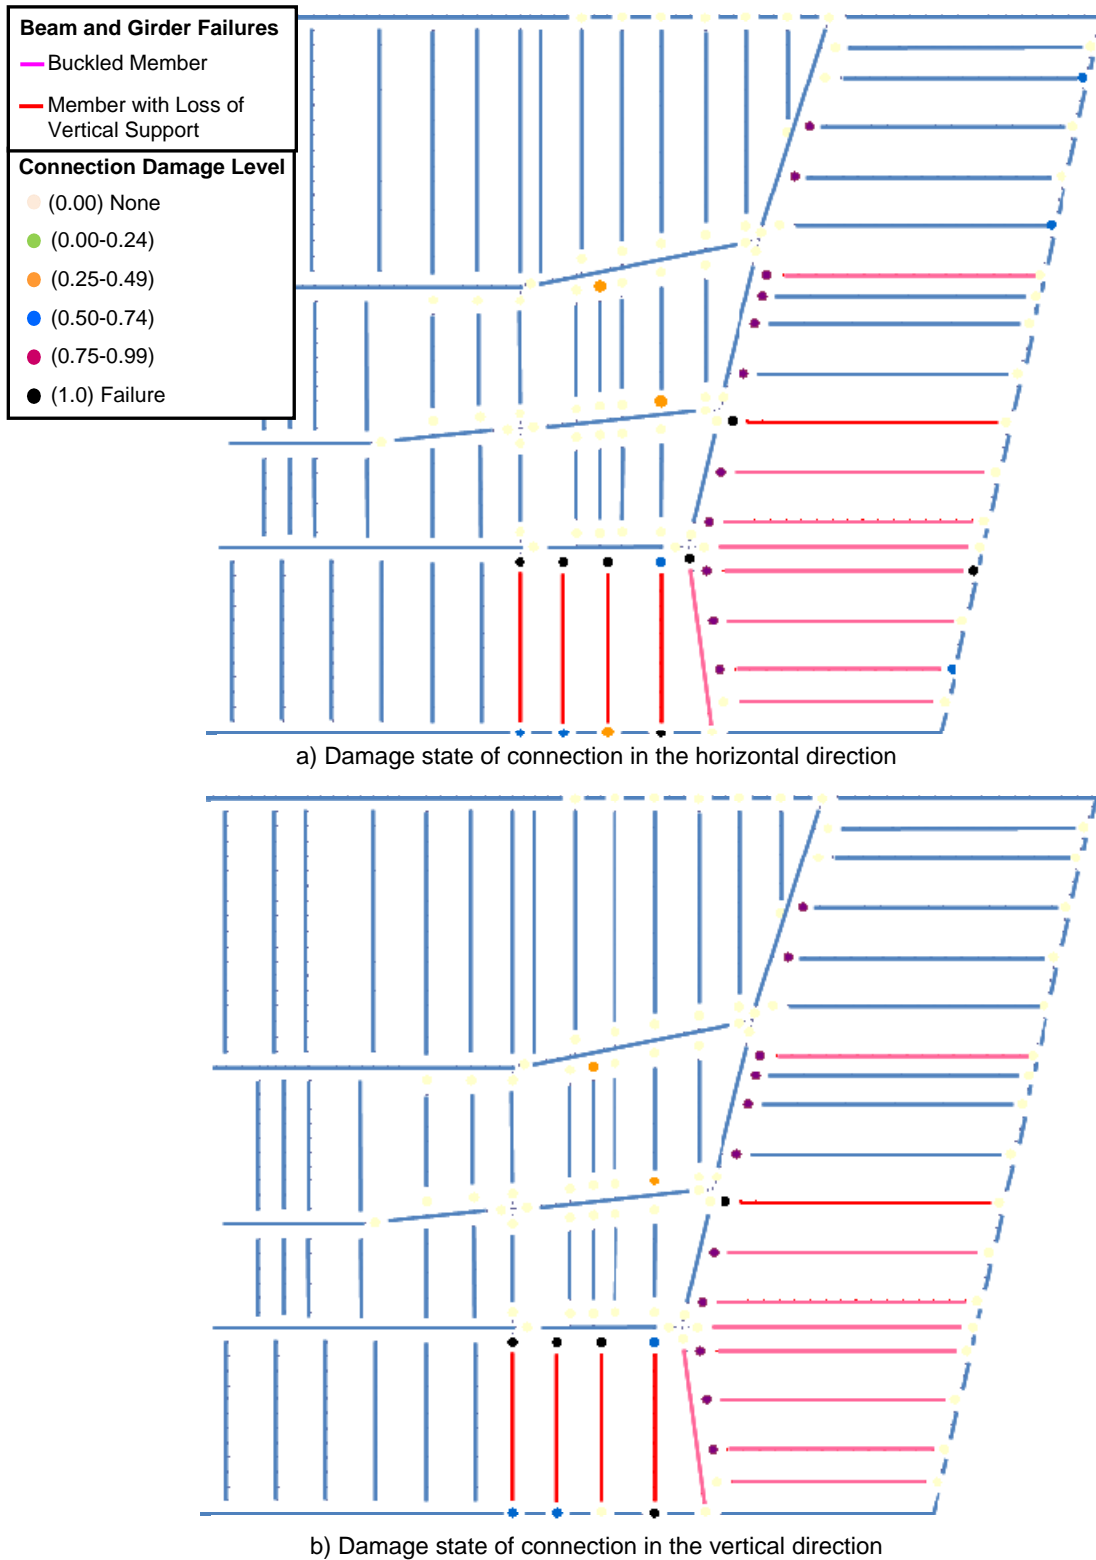
Figure 11-42. Damage state of connections, beams, and girders in Floor 12 at 4.0 h for Case C temperatures.
