**Federal Building and Fire Safety Investigation of the
World Trade Center Disaster**

**Structural Fire Response and
Probable Collapse Sequence of
World Trade Center Building 7**

VOLUME 1

November 2008

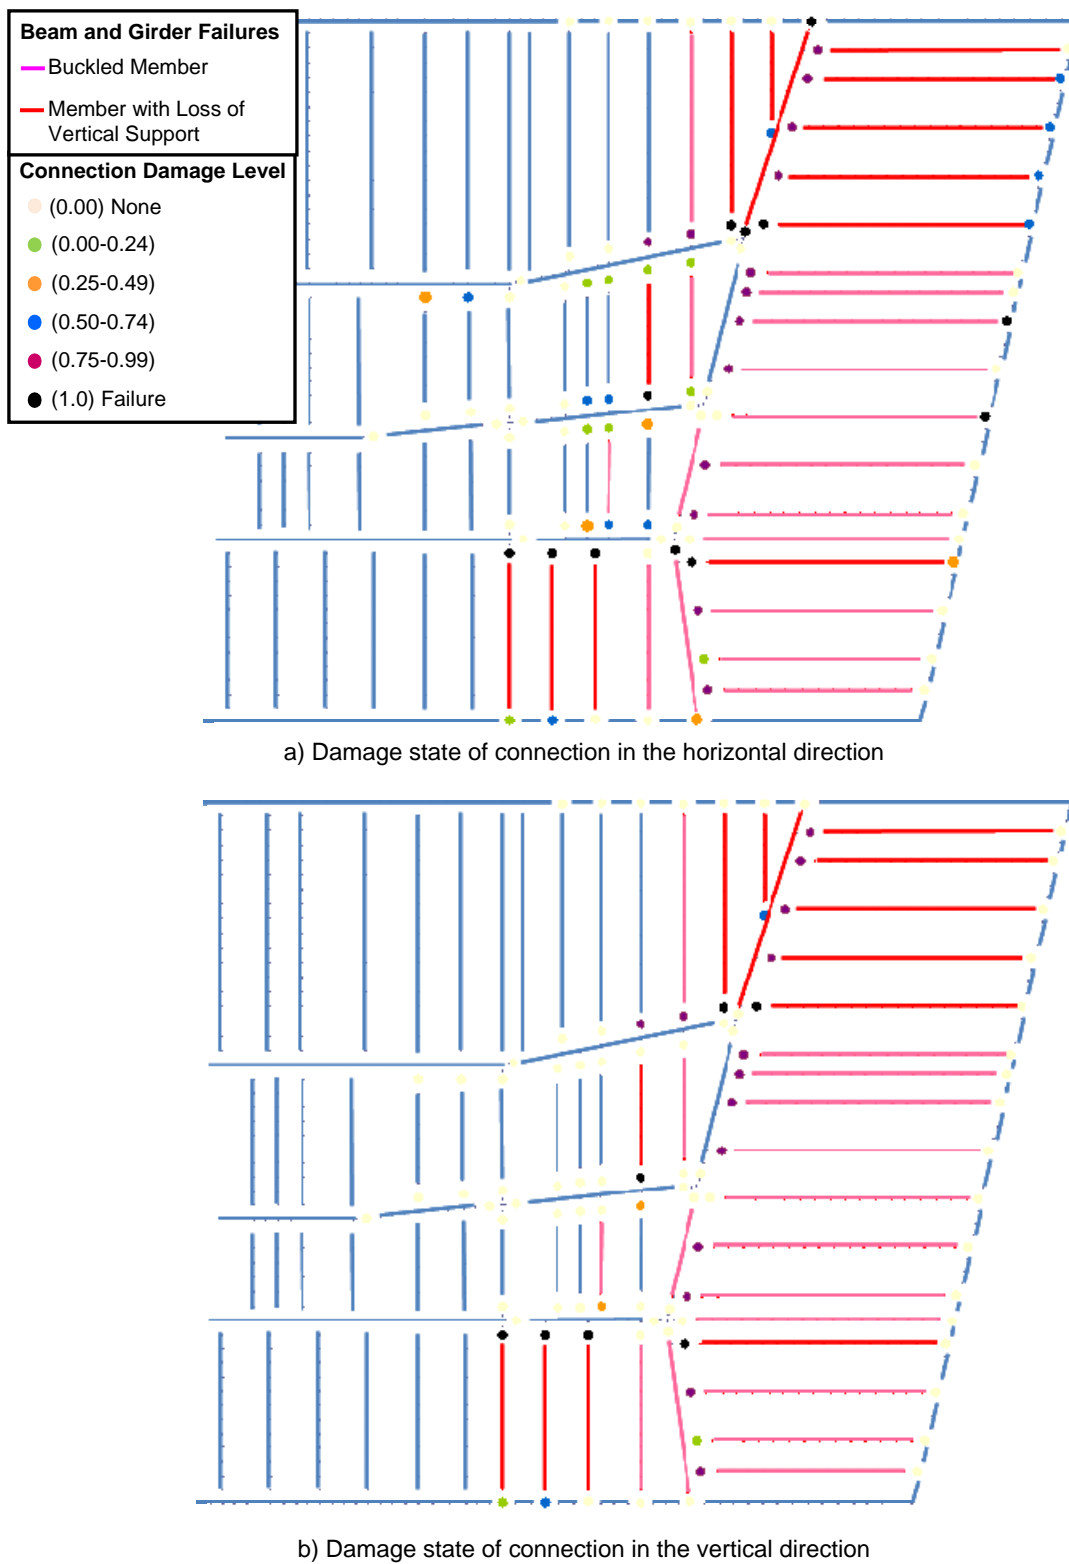
Figure 11–43. Damage state of connections, beams, and girders in Floor 13 at 4.0 h for Case C temperatures.
