NIST NCSTAR 1-3

**Federal Building and Fire Safety Investigation of the
World Trade Center Disaster**

Mechanical and Metallurgical Analysis of Structural Steel

September 2005

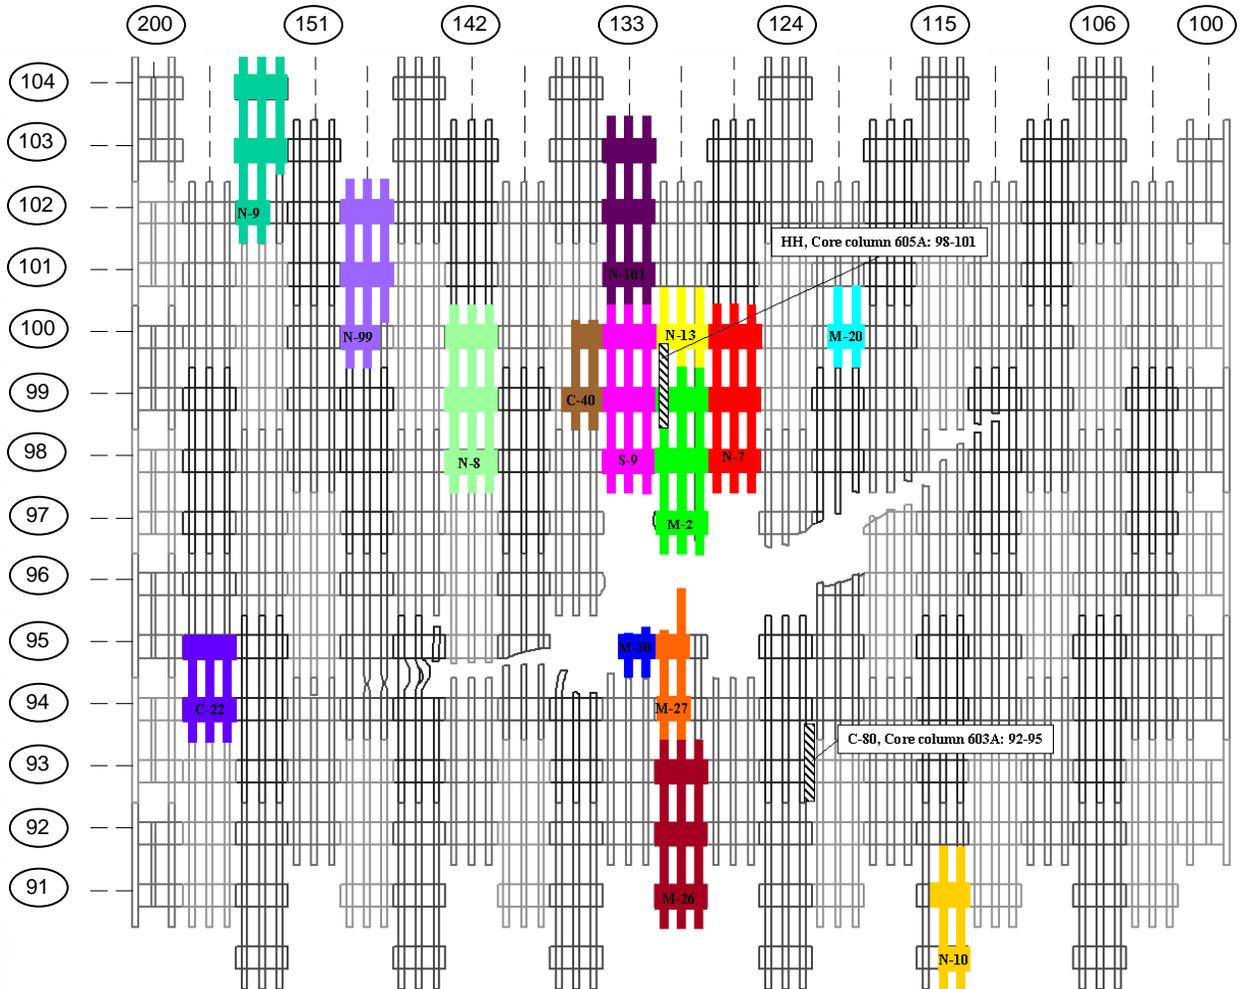
Figure 5–5a. Interpreted column damage, from photographic evidence, to north face of WTC 1, with overlay of recovered steel identified by NIST. Colored regions represent recovered portions. Both core columns (#603 and #605) are in the second row from the north face of WTC 1.

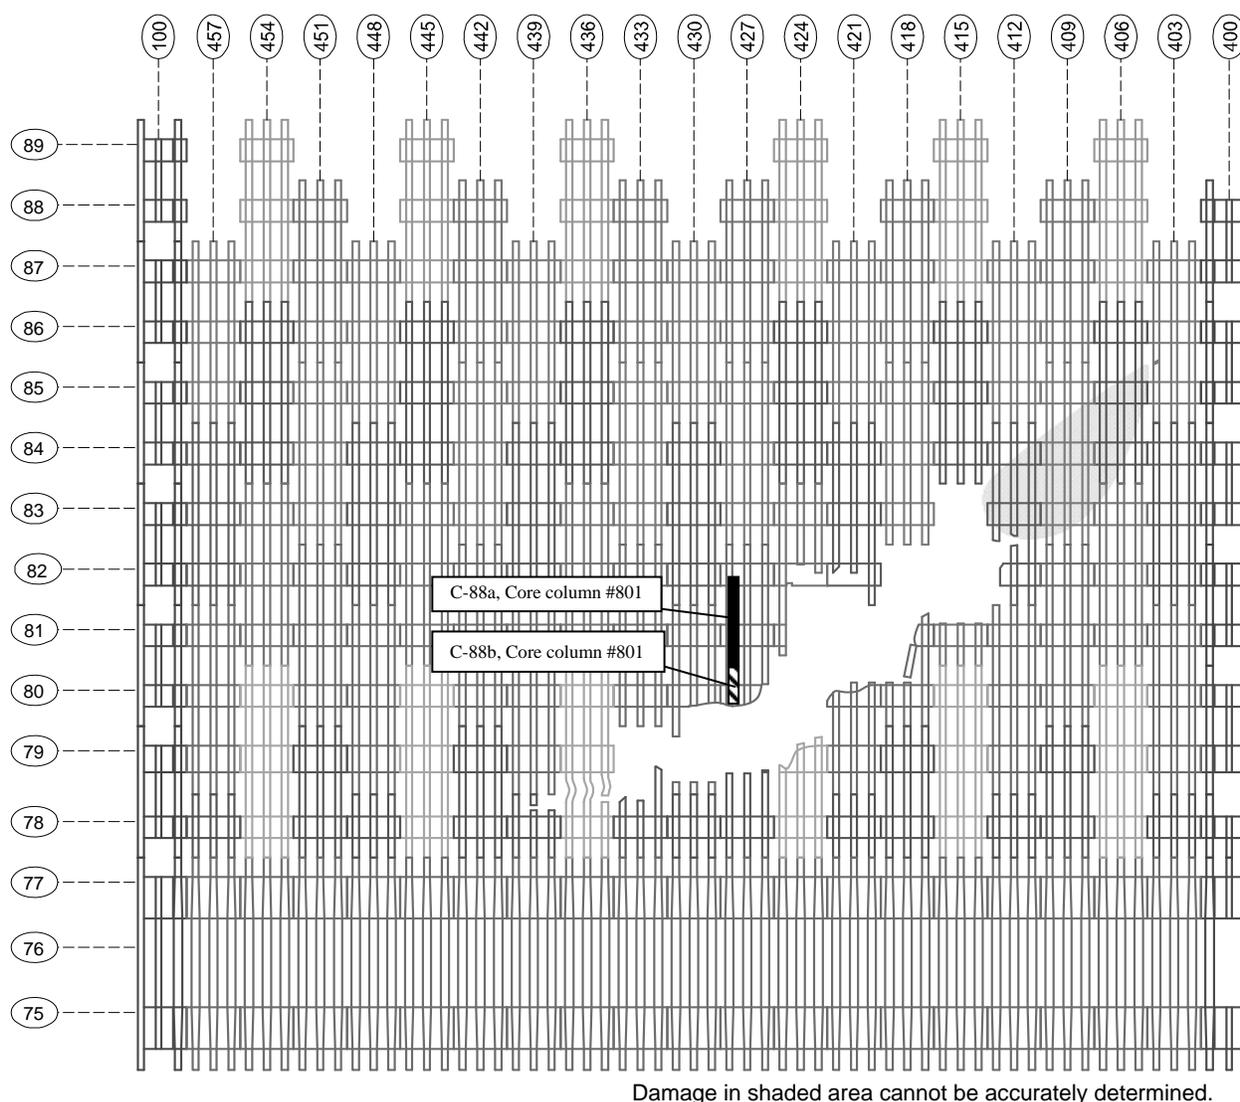
Figure 5–5b. Interpreted column damage, from photographic evidence, to south face of WTC 2, with overlay of recovered steel identified by NIST. Samples shown represent recovered portions. Core column line 801 is in the row closest to the south face of WTC 2.

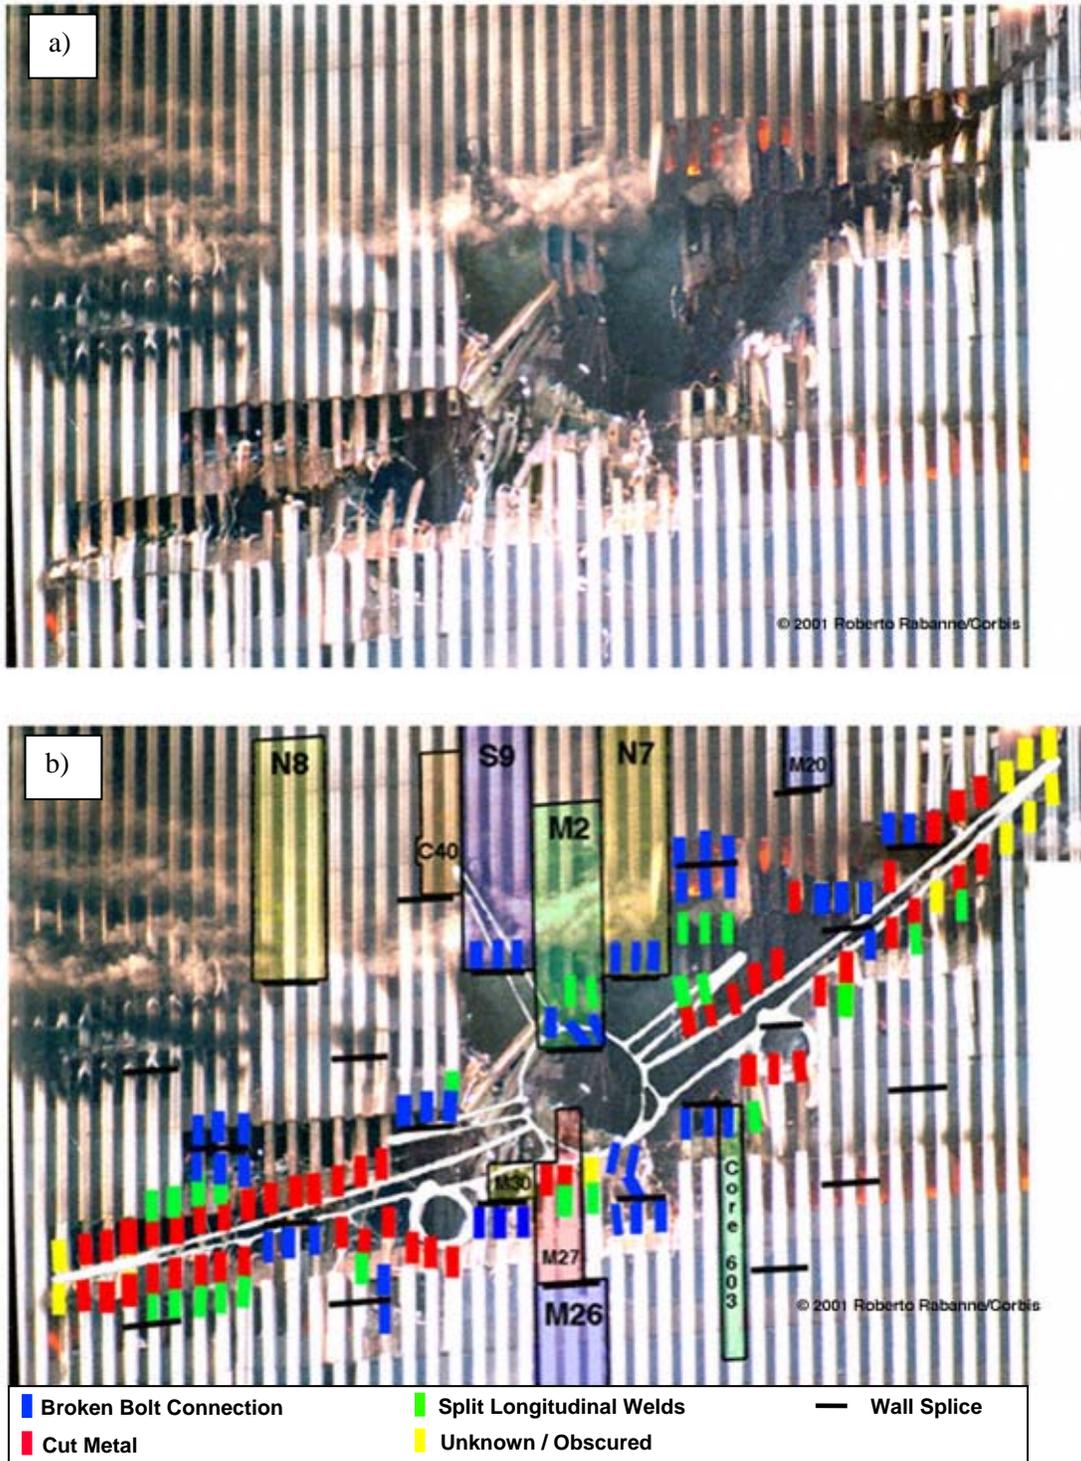
Figure 6-1. (top) Enhanced image showing the impact hole in the north face of WTC 1, and (bottom) overlay of an outline of a Boeing 767 that has been distorted to get a best approximate fit with damage to WTC 1. The location and type of localized damage has been indicated.

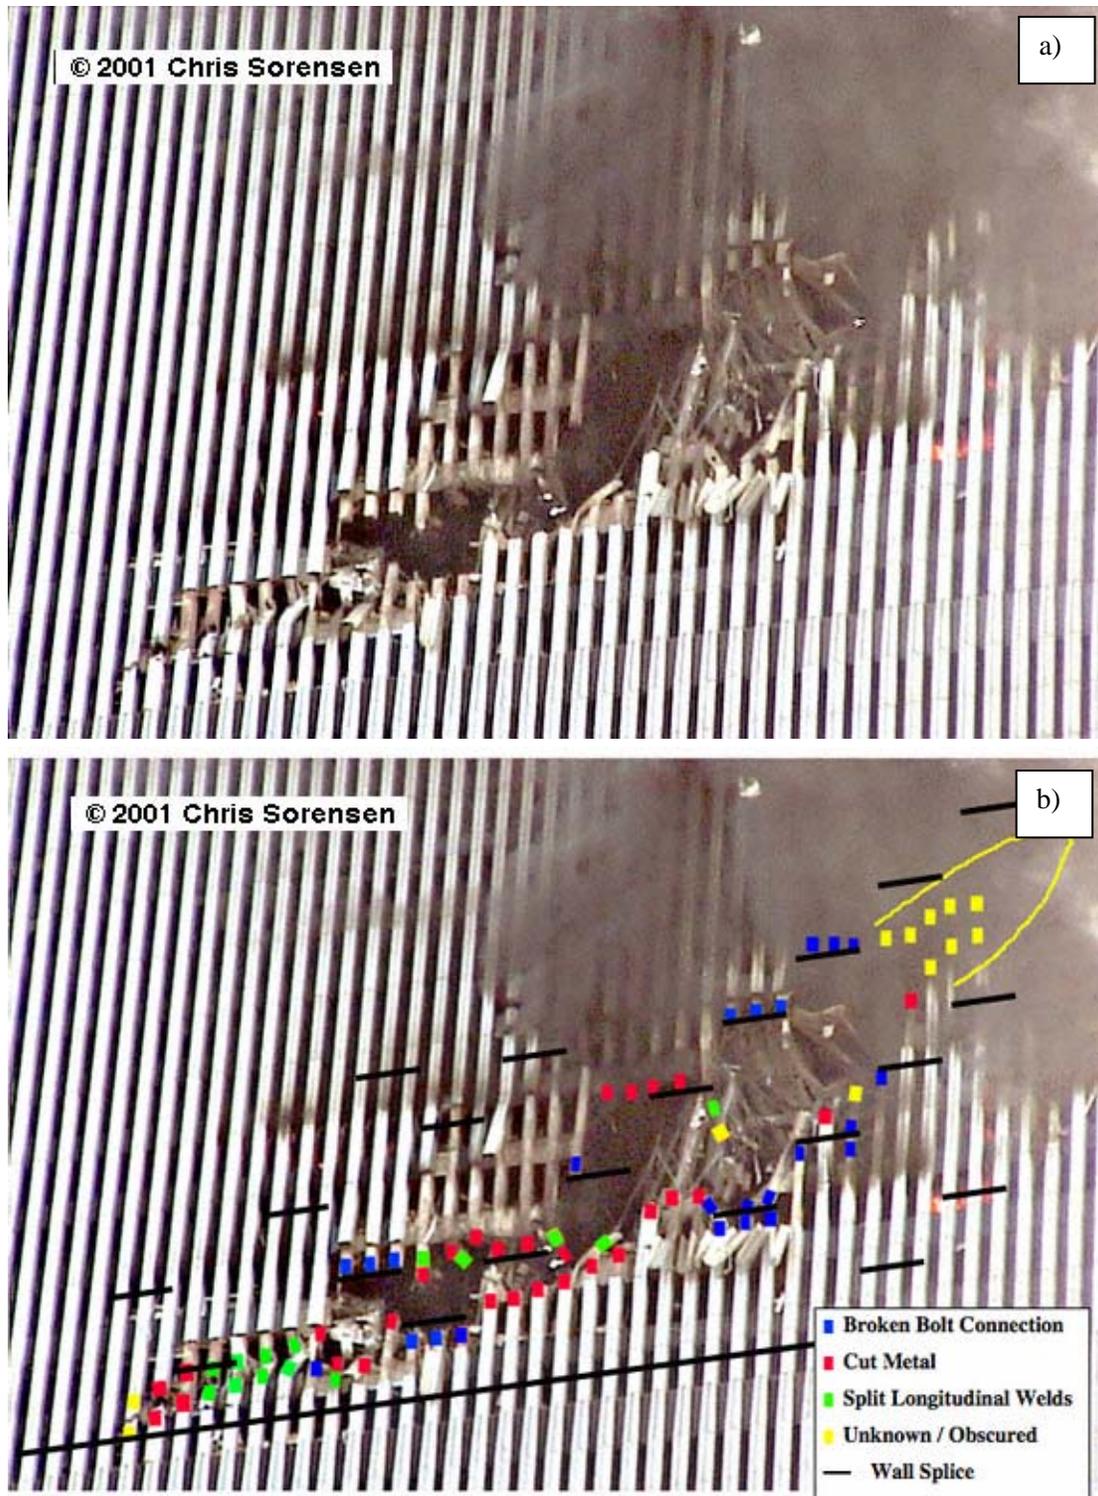
Figure 6-2. (top) Enhanced image showing the impact hole in the south face of WTC 2 and (bottom) overlay of the location and type of localized damage.

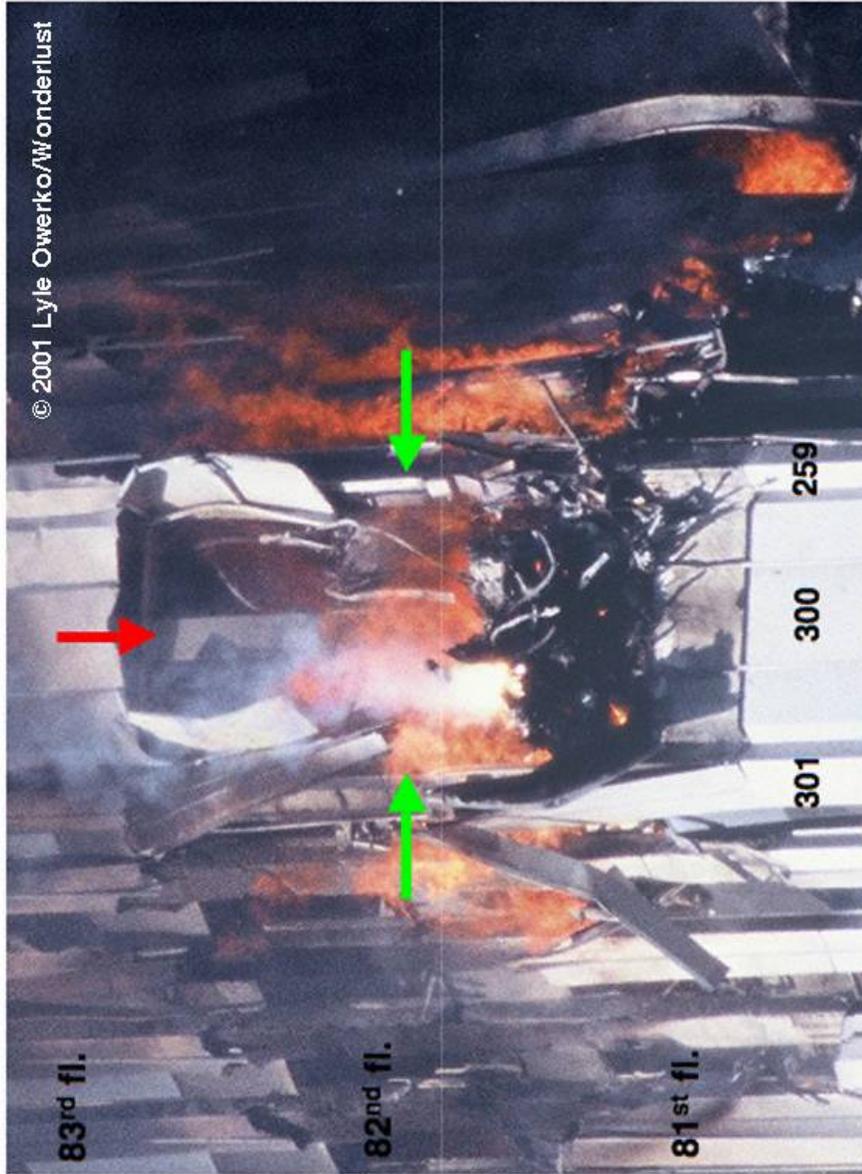
Figure 6-3. Damage to northeast corner of WTC 2 at 81st floor. The red arrow indicates an intact column 300 at the 82nd floor. Other photographs confirm that the spandrel connecting column 300 to columns 259 and 301 is also intact (location indicated by green arrows).

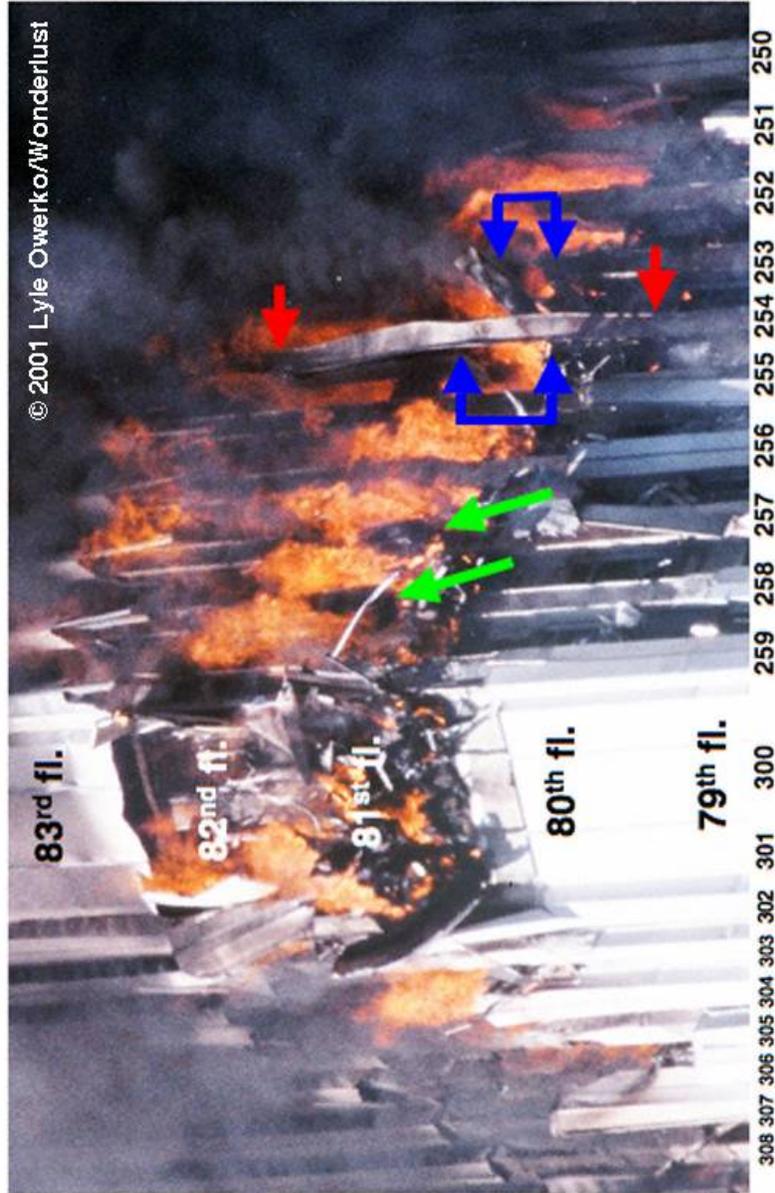
Figure 6-4. Damage to columns on north face of WTC 2 near northeast corner due to internal impact by debris. Broken vertical column bolted connections (green arrows) are visible, along with an intact outer web on column 254 (red arrows) and missing column sections (blue arrows).

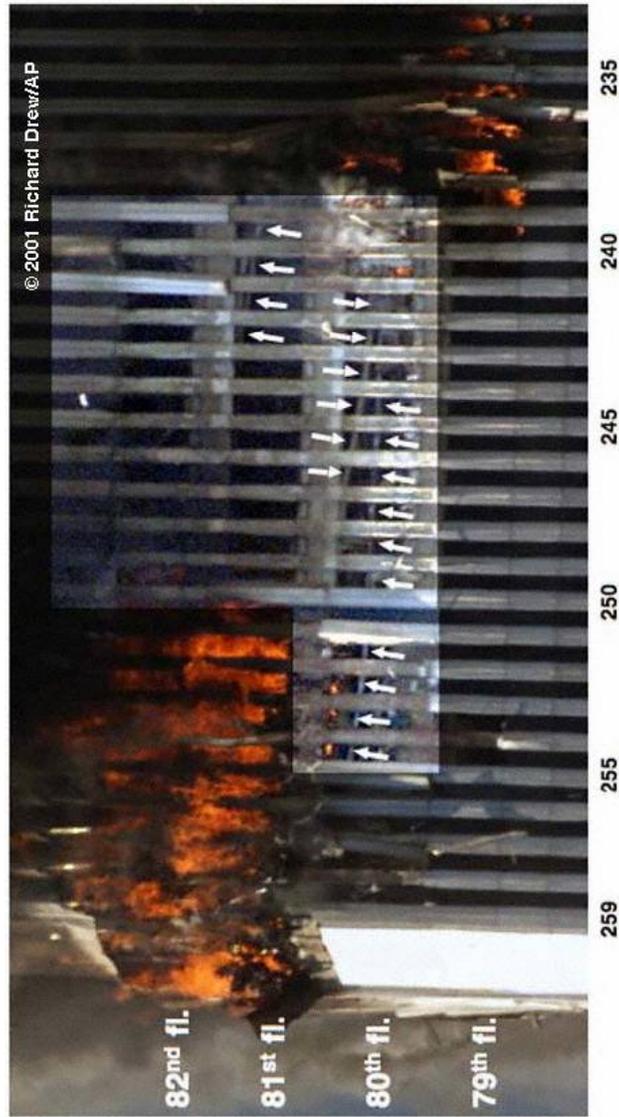
Figure 6-5. Dropped floors on north face of WTC 2.

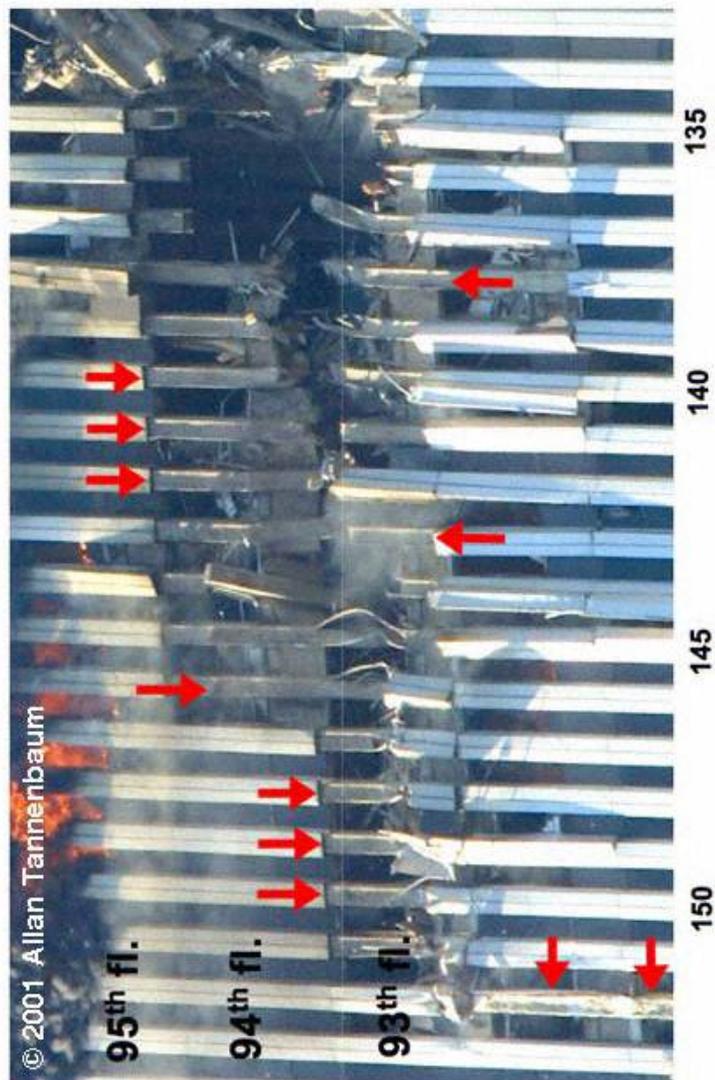
Figure 6-8. Port side of impact hole in north face of WTC 1 showing missing fireproofing. The red arrows indicate a few of the many instances of missing fireproofing around the impact hole. The region roughly approximated as the area where the aluminum panels were dislodge has been digitally enhanced for clarity.

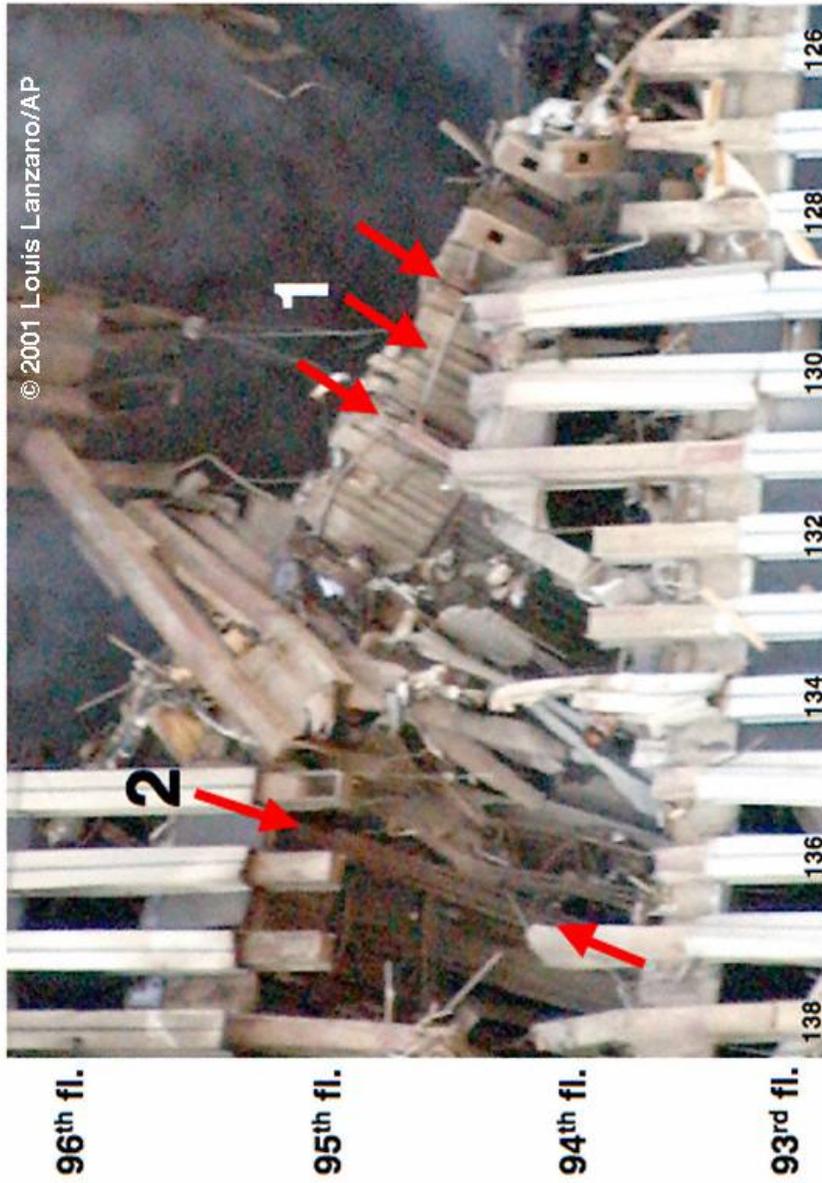
Figure 6-9. Missing fireproofing on floor trusses that fell into impact hole on north face of WTC 1. The arrows labeled “1” are three trusses where the lower or upper chords can be seen, and can distinguish the line that separates the two angle iron components. The arrows labeled “2” lie at either end of a lower chord of a truss that fell farther inside the building, and is made up of four angle irons (a double truss). The red paint color being visible and the fact that the line between the angle iron can be seen indicated that the fireproofing was displaced.

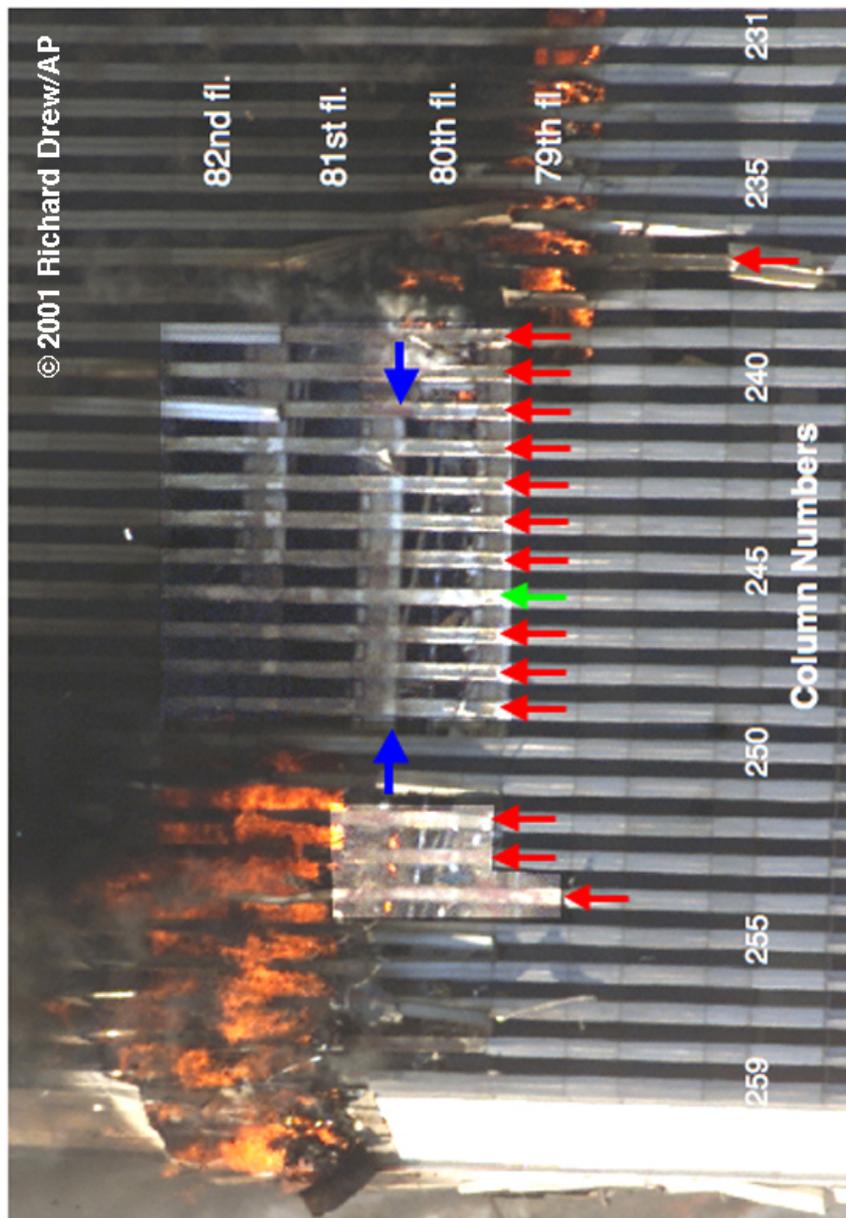
Figure 6–10. Missing façade and fireproofing on north face of WTC 2. Two regions have had contrast and gamma adjusted to enhance visibility of the features. Red arrows indicate columns with missing or damaged fireproofing. Missing or damaged fireproofing determinations were made from this and several other photos taken at different times and angles. Blue arrows indicate white features where some sort of coating has preserved the fireproofing in place.

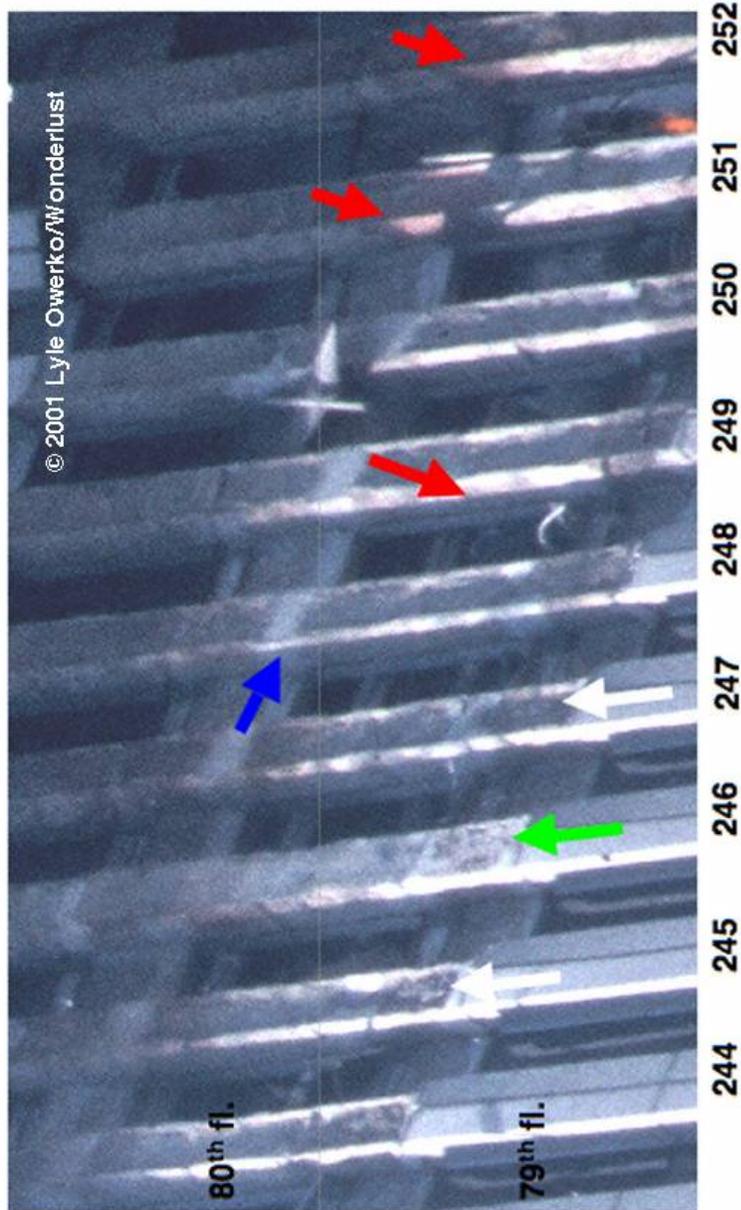
Figure 6-11. Missing fireproofing on flanges of exterior columns of north face of WTC 2. Fireproofing has come off, revealing red Tnemec paint of the column (red arrows). This image also shows how the outer web regions have been partially or completely denuded of fireproofing. Damage is evidenced by shading by sunlight - compare green (undamaged fireproofing) and white (damaged fireproofing) arrows. Blue arrow indicates same type of white coated area of fireproofing as previous figure that adhered when material above and below was dislodged.

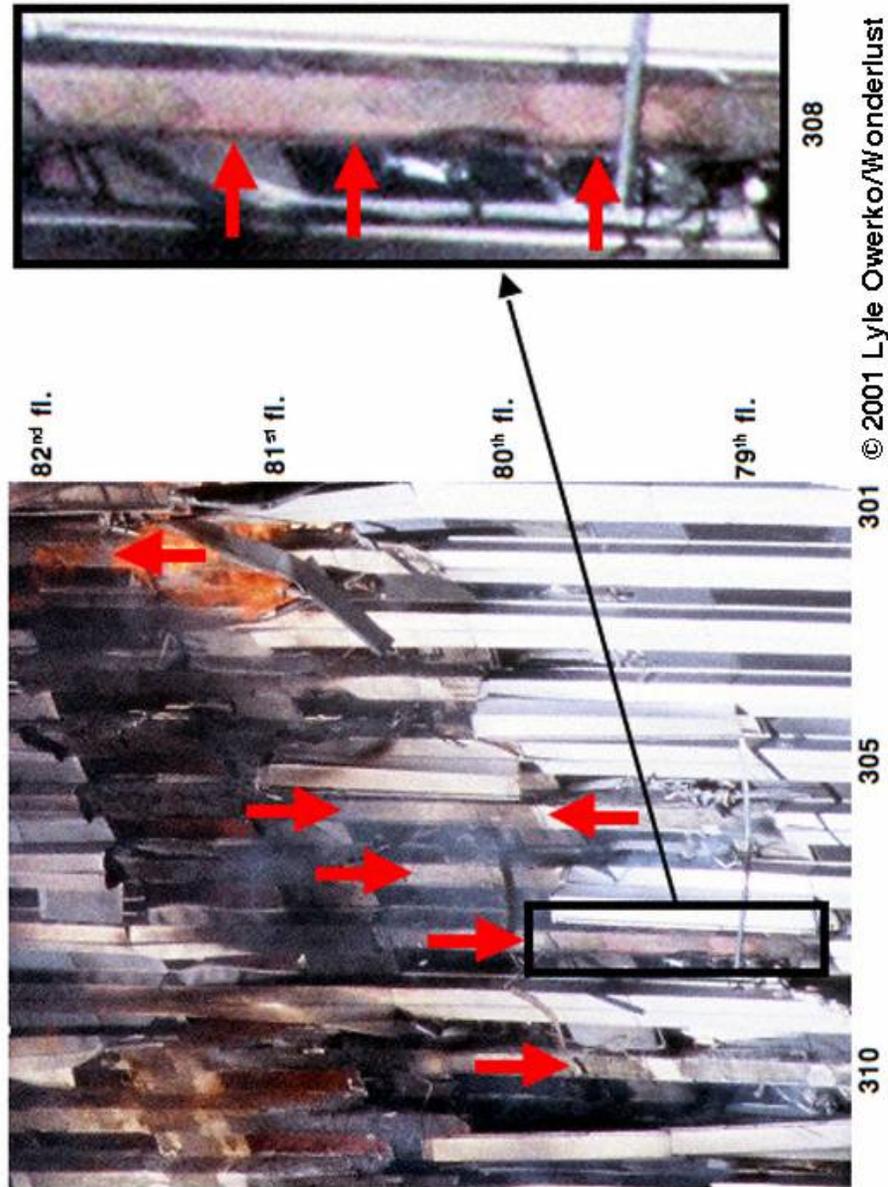
Figure 6-12. Damage to fireproofing on east face of WTC 2 due to internal impact. Red arrows highlight areas where fireproofing has been damaged. The blowup to the right shows a column where the red Tnemec paint of the column is visible.

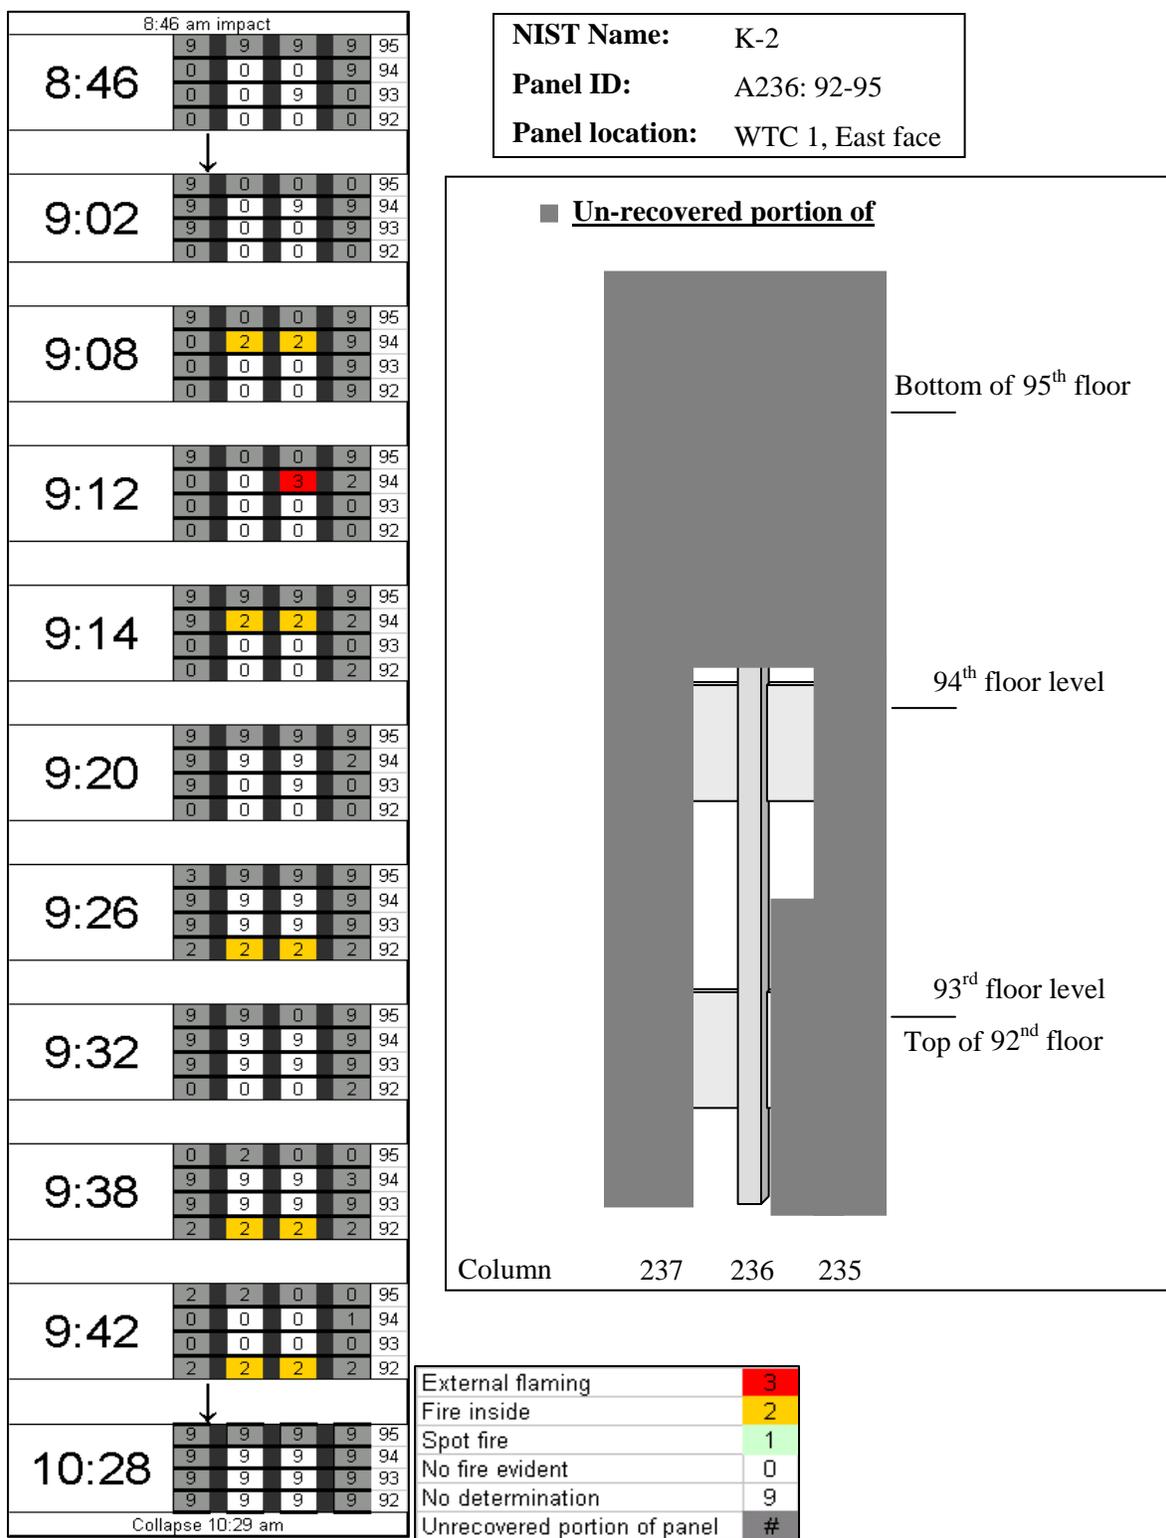
Figure 6–13 displays a time-fire exposure map for panel K-2 (WTC 1, center column line 236, floors 92 to 95). On the right-hand side is a schematic showing the recovered portion of the panel, drawn as if viewed from outside of the building, with the floors and column lines labeled. The “grayed-out” sections of the panel were not recovered, resulting in portions of only six different windows available for inspection. On the left-hand side of the figure, the time line analysis for exposure to fire can be observed for that given panel, along with the color-coded, numerical key. The location of each window for a given

Figure 6–13. Time-fire exposure map for panel K-2 (A236: 92-95). Fire can be observed on the 92nd and 94th floors of the panel.

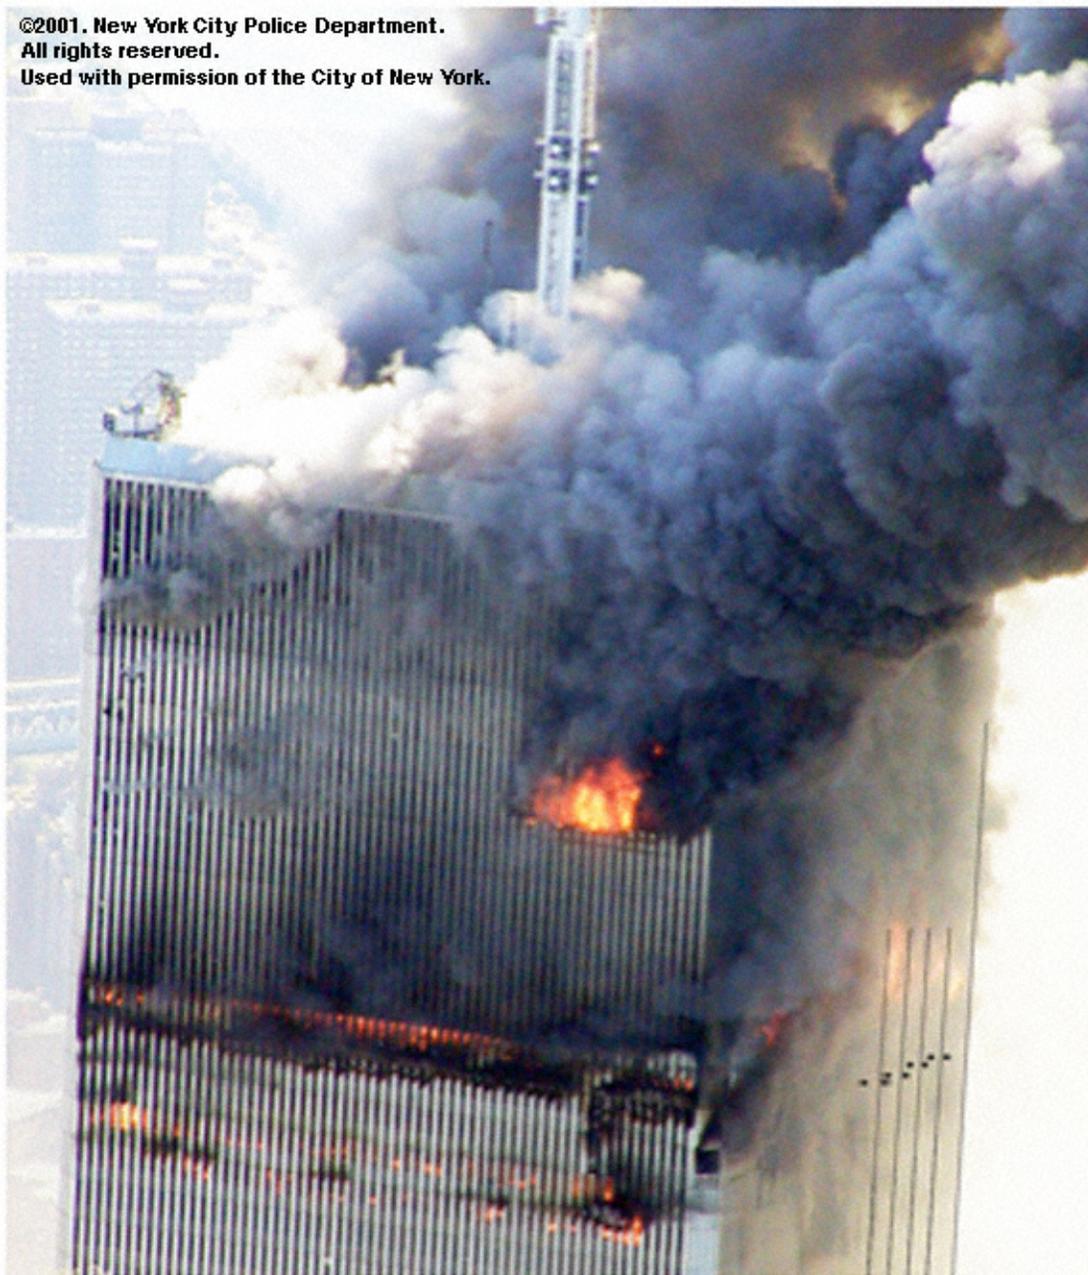
Figure 6–14. Inward bowing of south face (at right, with dark lines overdrawn) of WTC 1. Taken at 10:23 a.m. from an NYPD helicopter.

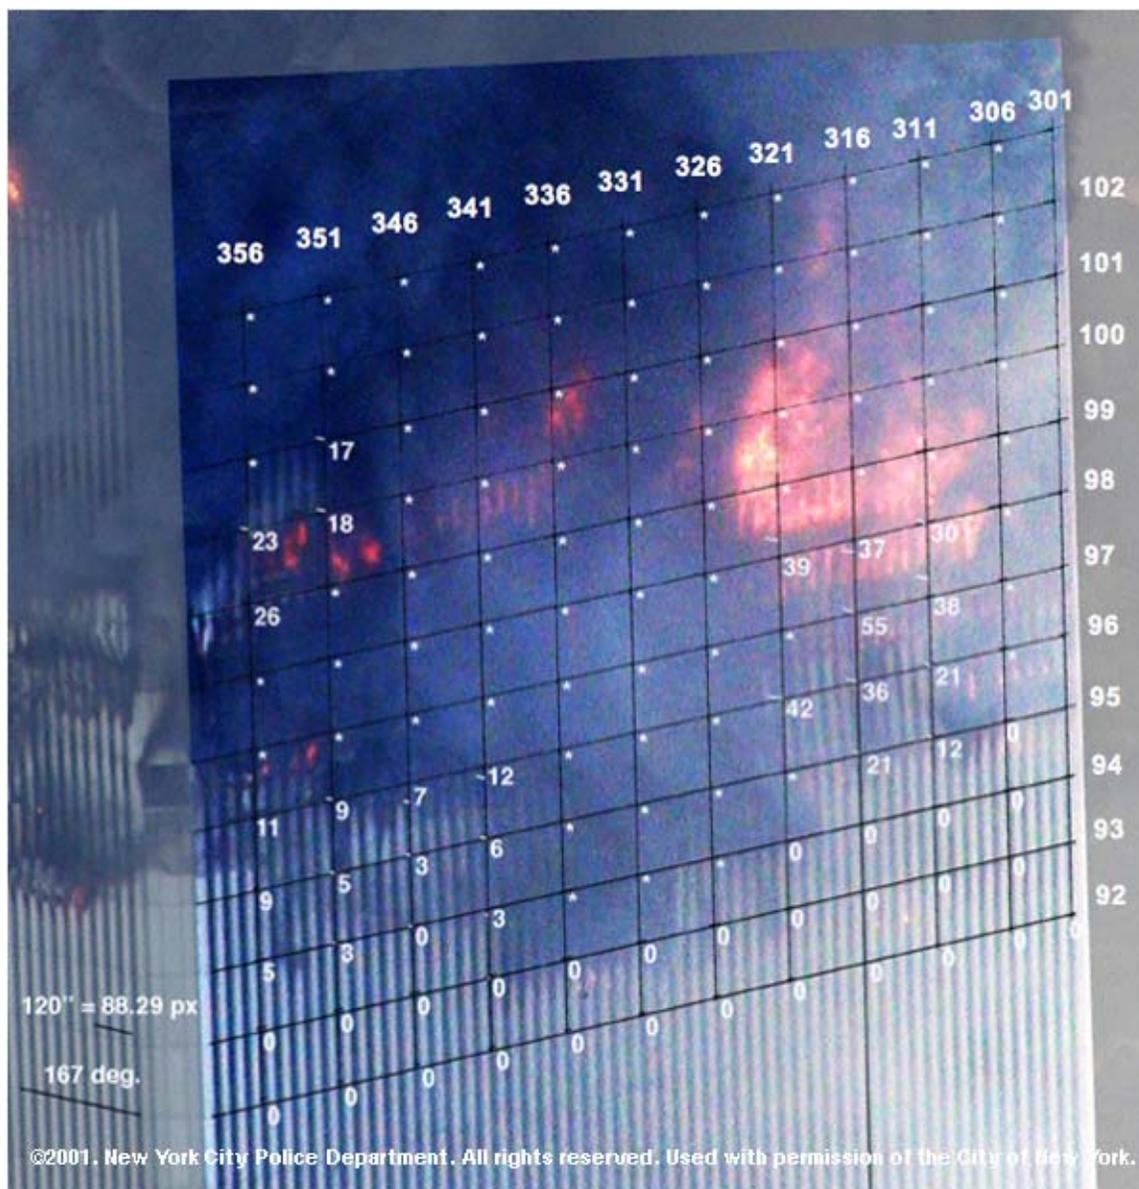
Figure 6–15. Pull in of south face of WTC 1 at 10:23 a.m. showing considerable displacements of outer columns into the building. Faint white vertical features are the aluminum façade of the exterior. Maximum visible inward displacement of the columns is 55 in. +/- 6 in. Poor resolution leads to large uncertainties in measurements; a large fraction of the south face of the building is obscured by smoke.

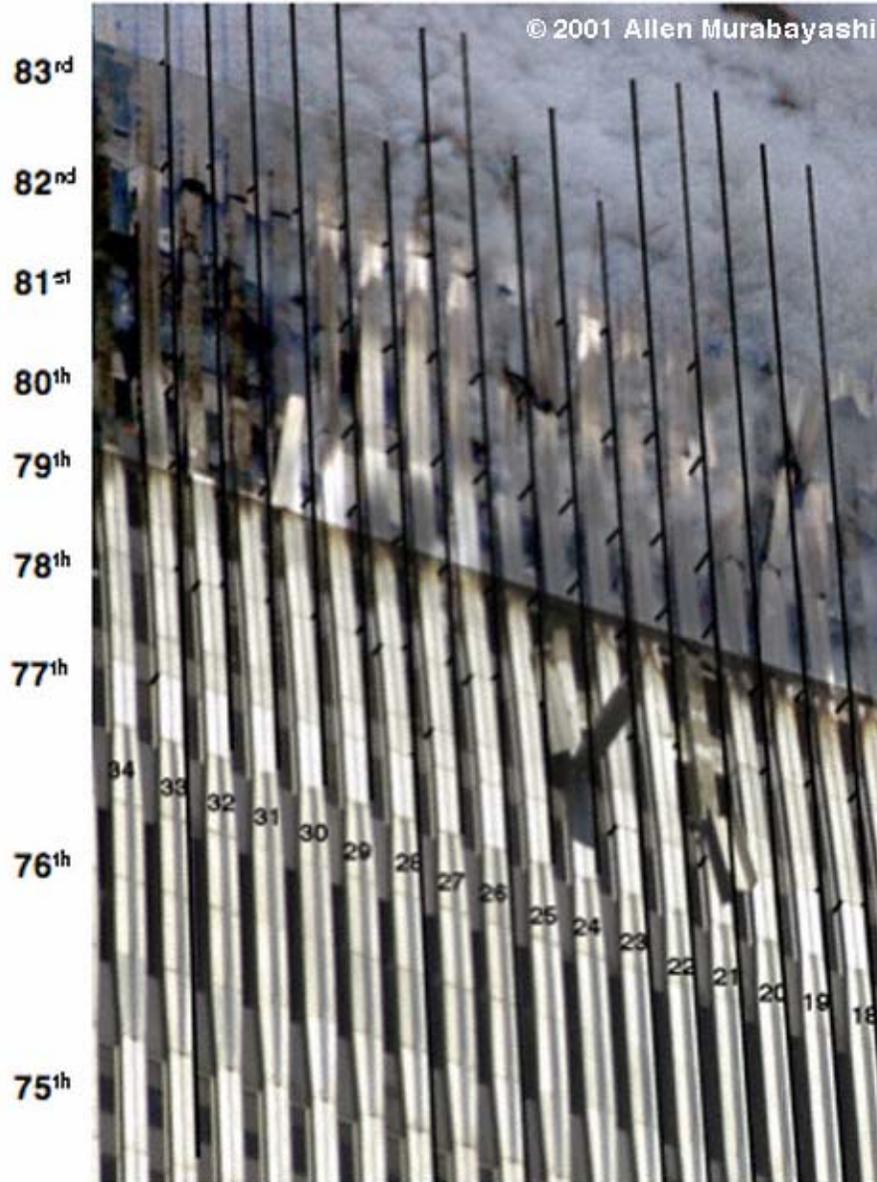
Figure 6–16. East face of WTC 2 at 9:53:04 a.m. showing a larger amount of pull in. The vertical black lines were drawn to establish the original line of the exterior wall columns, and the shorter line segments are drawn at the same angle as the nearest observable joint in the exterior aluminum panels to establish the inward bowing distance. For actual column numbers, add a “3” to the front of the two-digit designations in the image.

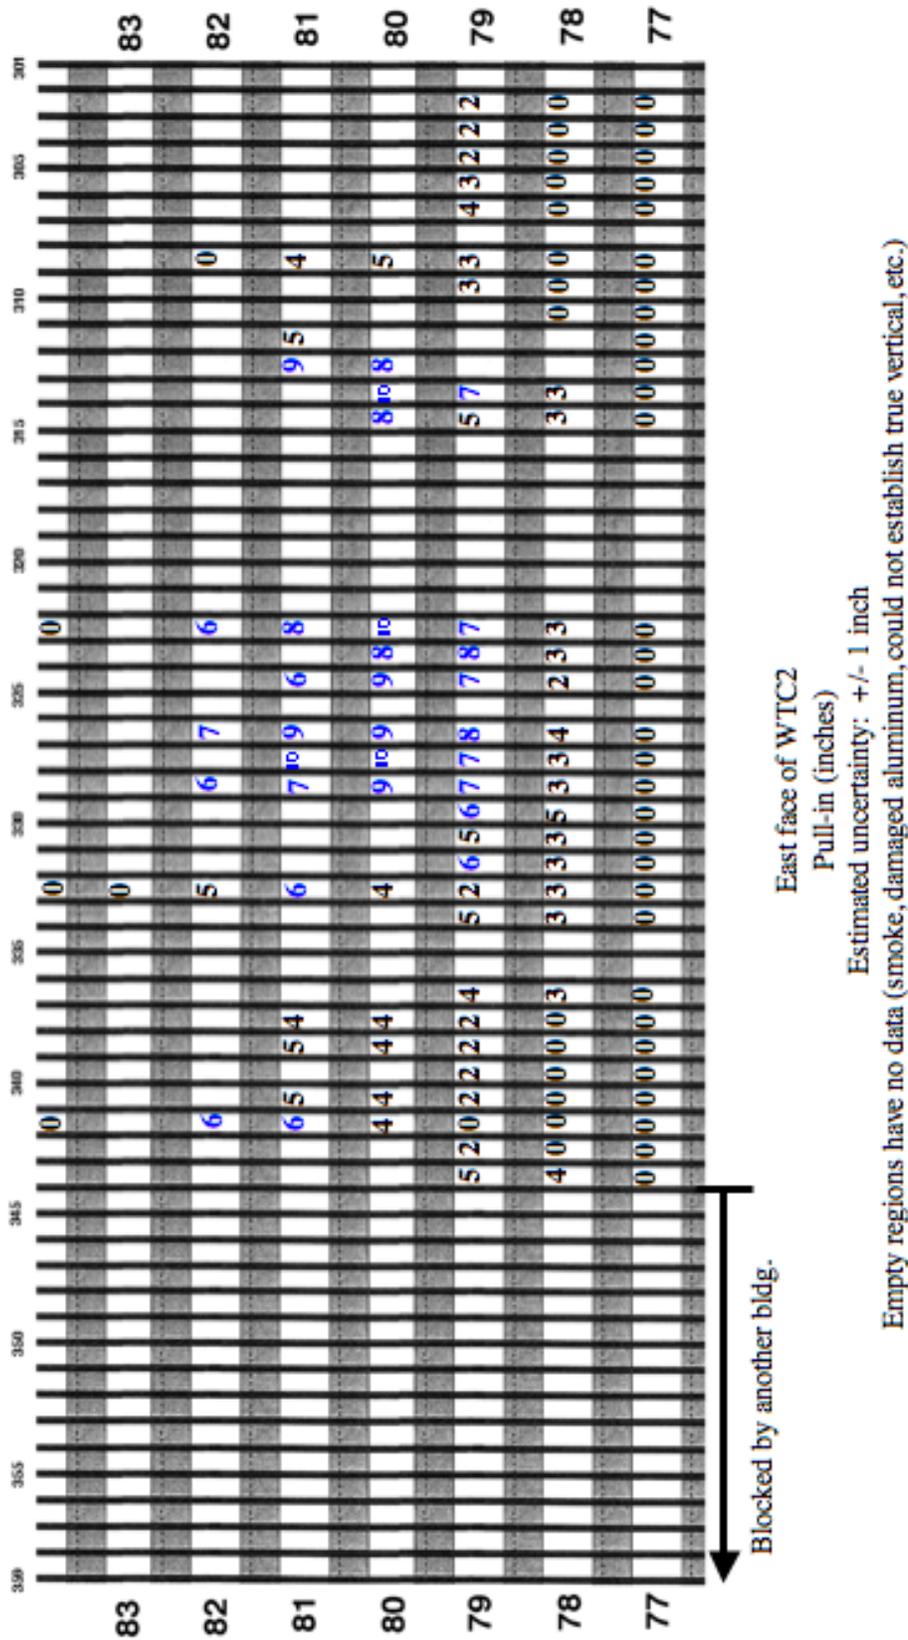
Figure 6-17. Map of inward displacements of the east outer face of WTC 2 inward at 9:21:29 a.m. Each measurement refers to the upper left corner of the window within which the number resides. Measurements were in inches. The colors refer to groups of 5 in. displacements (0-5: black, 6-10: blue) for easier visualization.
