NIST NCSTAR 1-3

**Federal Building and Fire Safety Investigation of the
World Trade Center Disaster**

Mechanical and Metallurgical Analysis of Structural Steel

September 2005

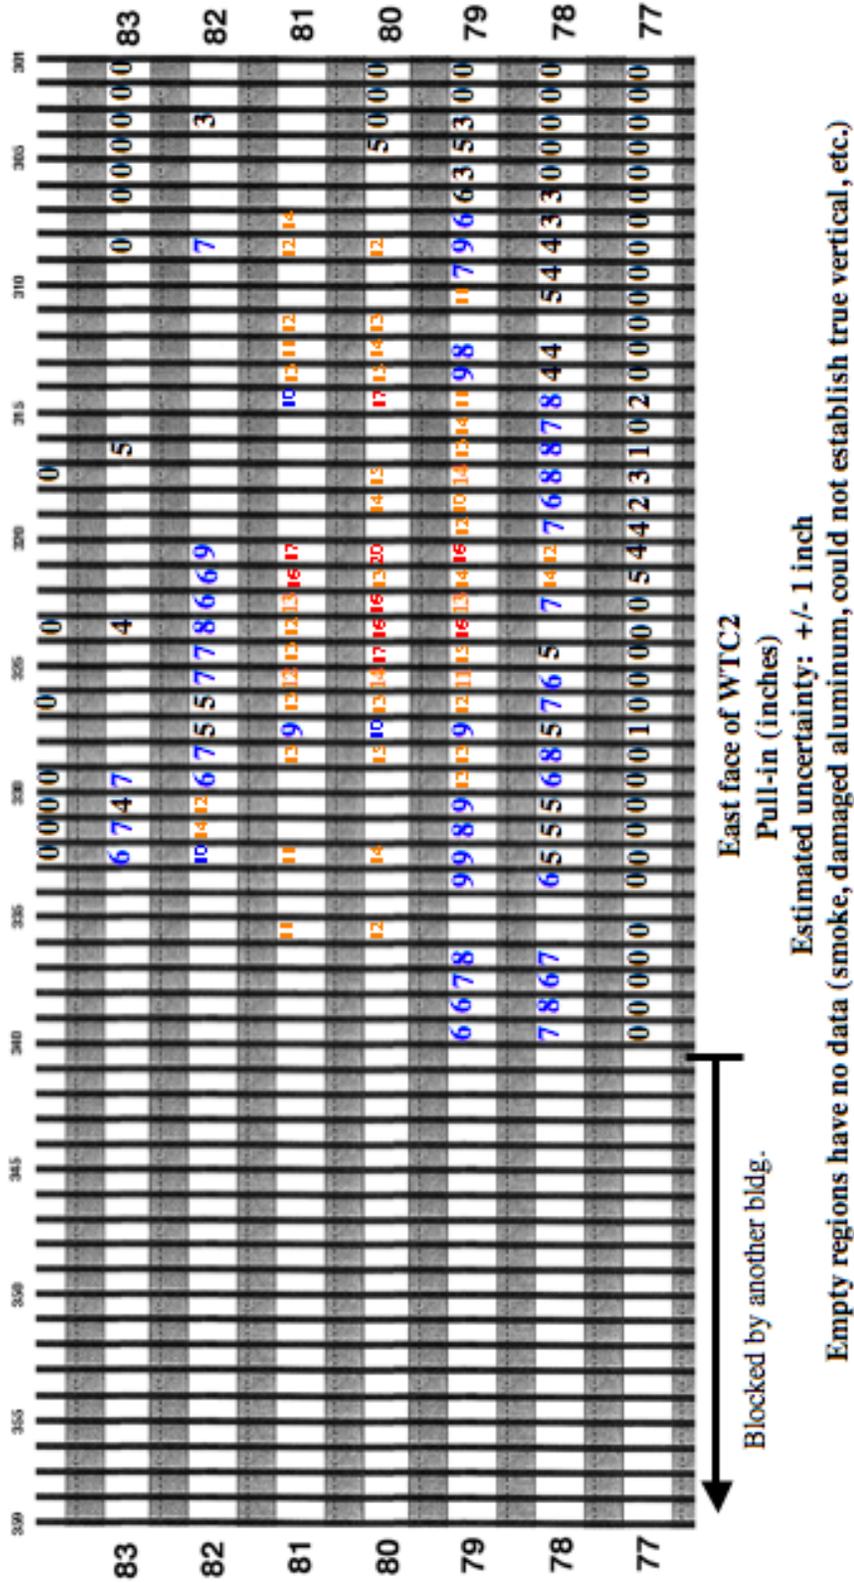
Figure 6-18. Map of pull in displacements of the east outer face of WTC 2 inward shortly before collapse. Each measurement refers to the upper left corner of the window within which the number resides. Measurements were in inches. The colors refer to groups of 5 in. displacements (0-5: black, 6-10: blue, 11-15: orange, 16-20: red) for easier visualization. This data was combined from two images taken by the same photographer at nearly the same location 10 s apart, and it is assumed that the inward deflection did not change appreciably during this time.

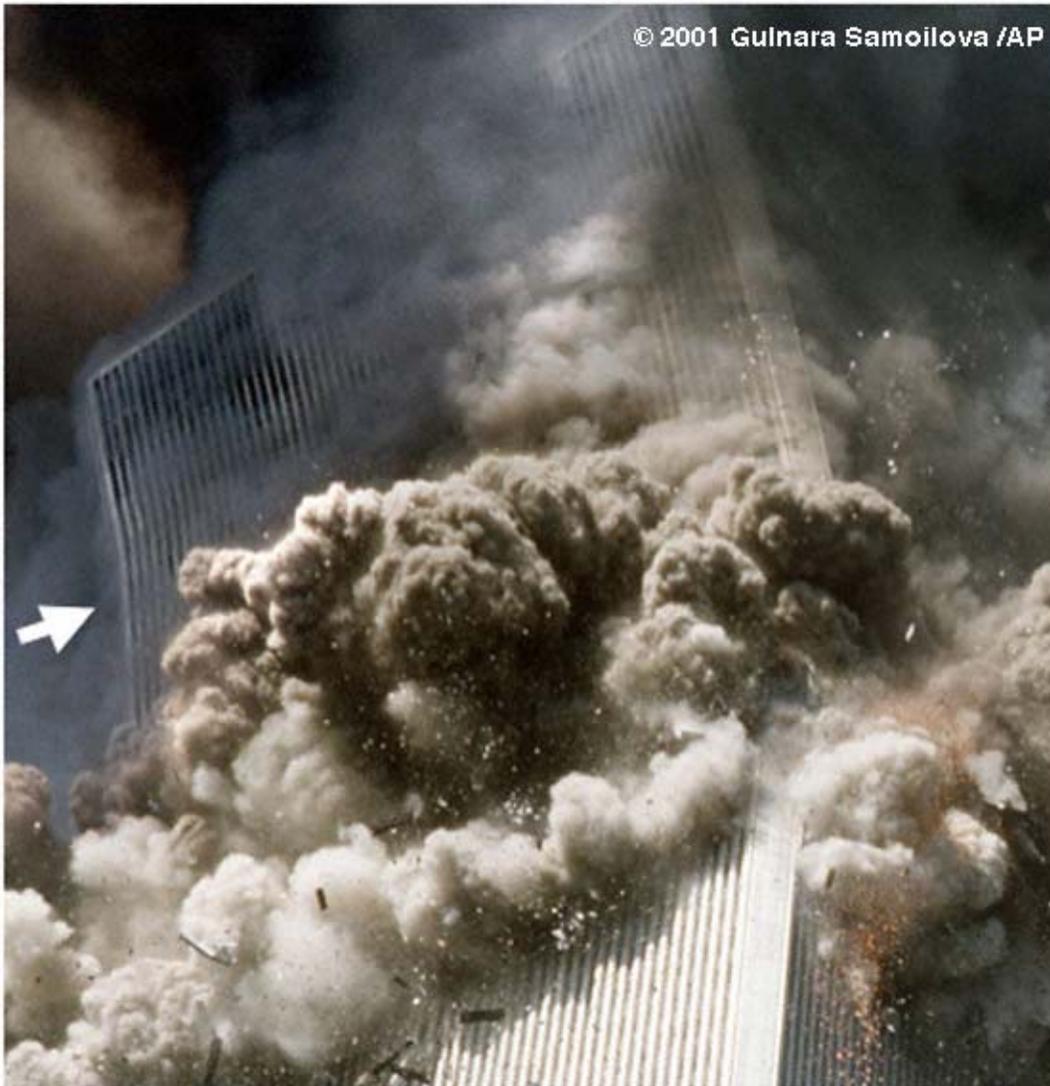
Figure 6–19. Initial seconds of collapse of WTC 2 viewed from the east-northeast, and kink in the southeast edge of the building near the 106th floor (arrow).

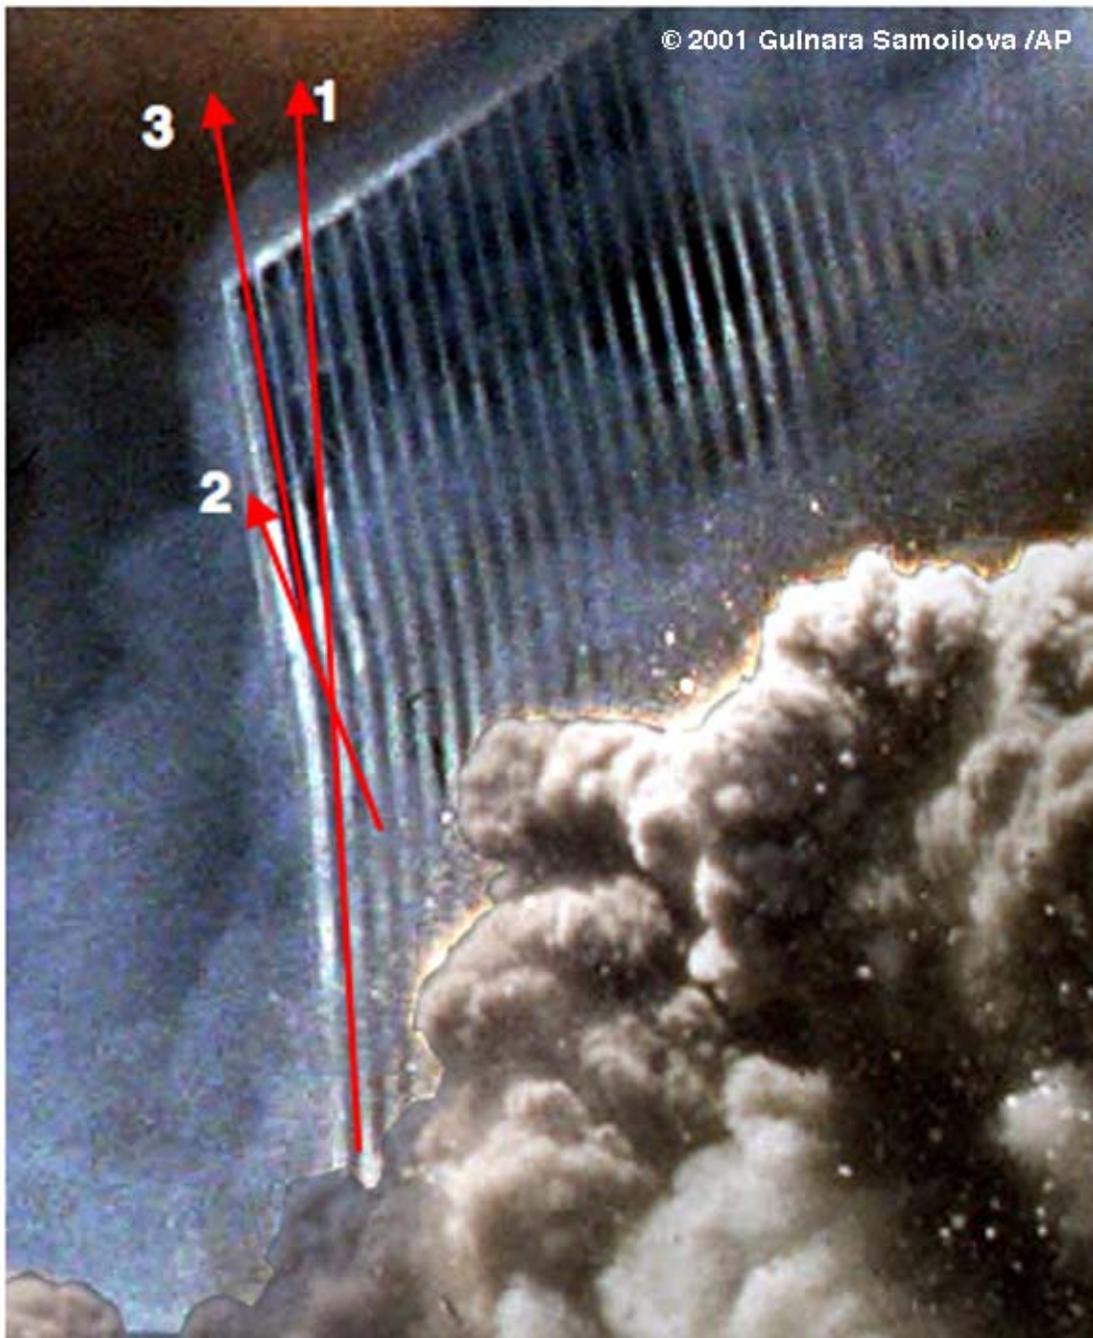
Figure 6–20. A close-up of the kink area in the previous figure (southeast corner, WTC 2), with overlaid lines to highlight the details of the kink geometry. The edge of the building (1) bends an angle to another direction (2), then bends back somewhat toward the original direction (3).

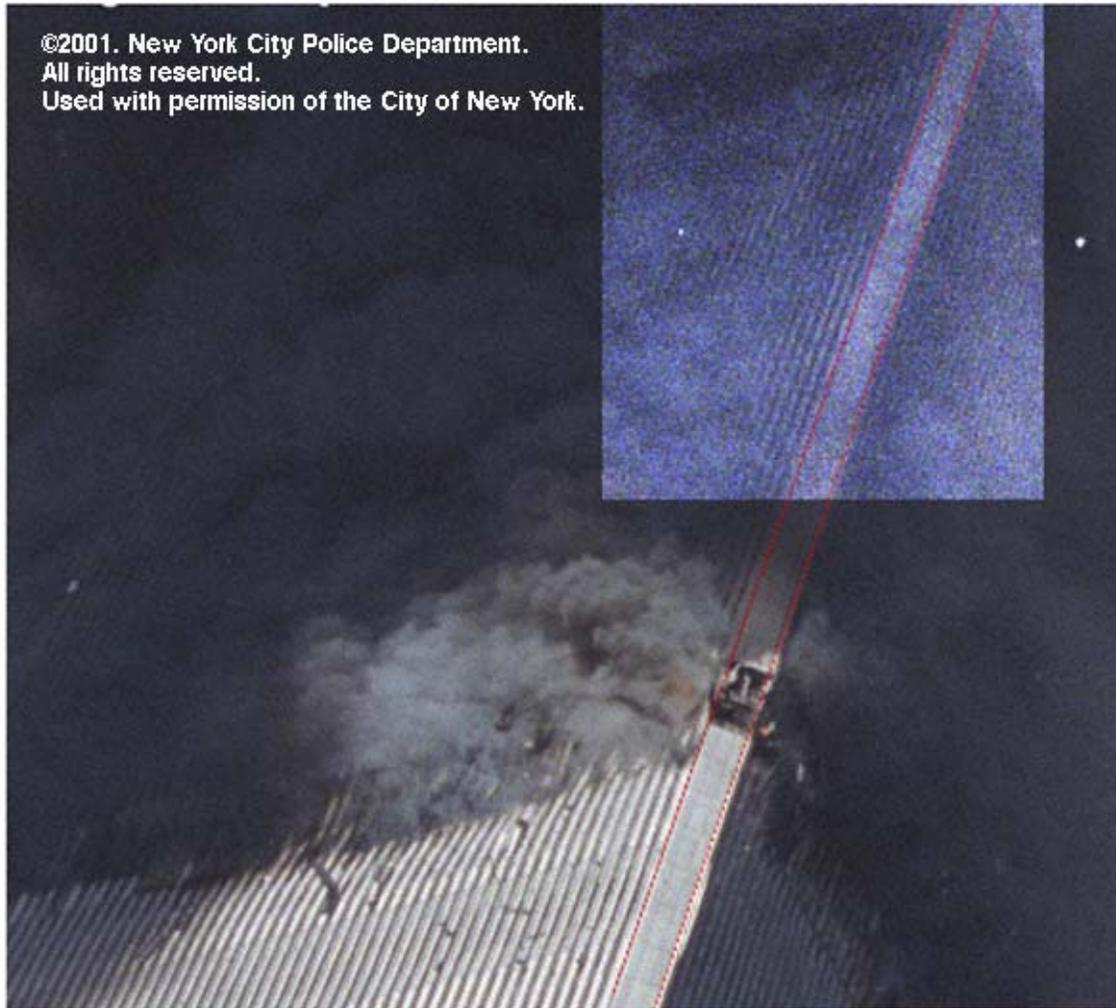
Figure 6–21. Northeast corner of WTC 2, several seconds before collapse. The corner shows no distortion of the type in the previous figure, implying that the distortion accompanied the collapse and did not precede it. The region in the upper right is enhanced for visibility.

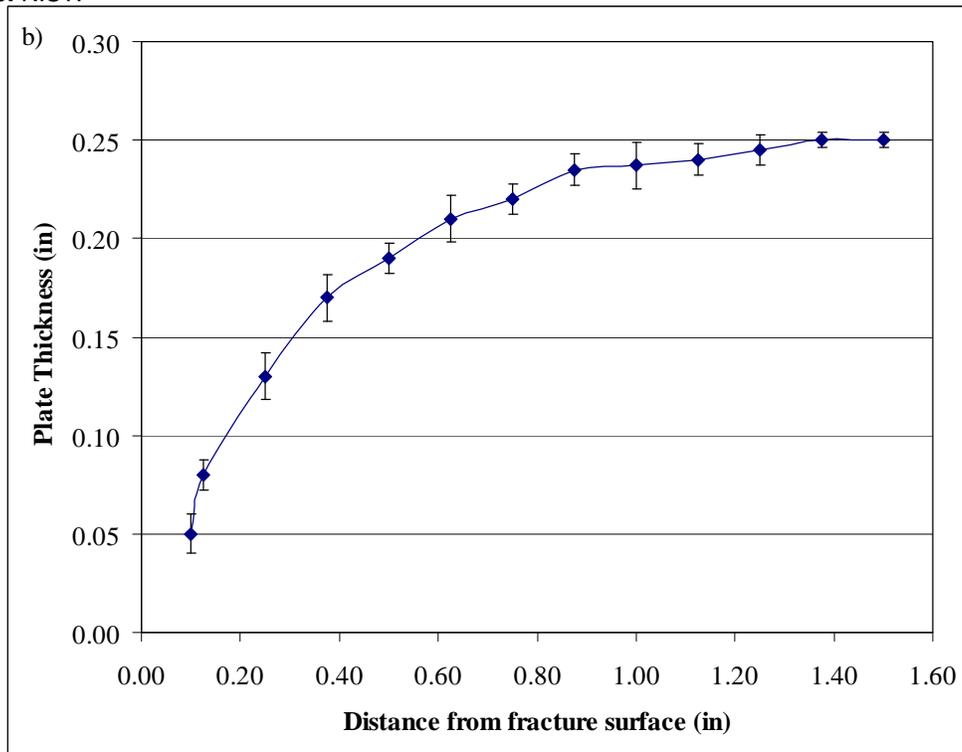
**Figure 6–23. Thinning of outer web from column 130 of panel M-2 (A130: 96-99).
a) Photograph showing thinning, b) graph indicating plate thinning near fracture surface.**

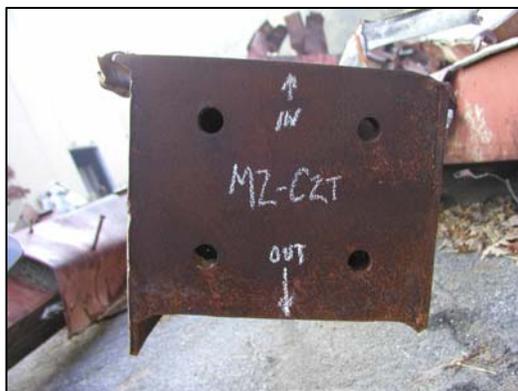
No change in bolt hole shape

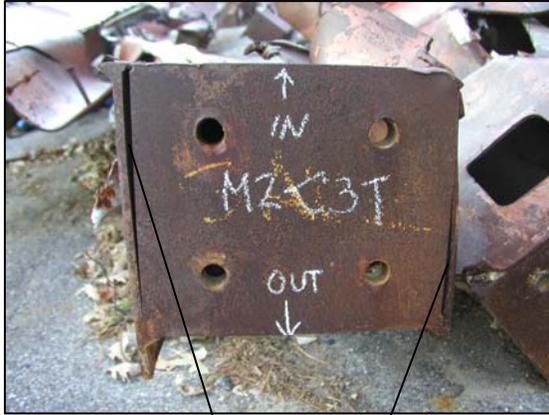
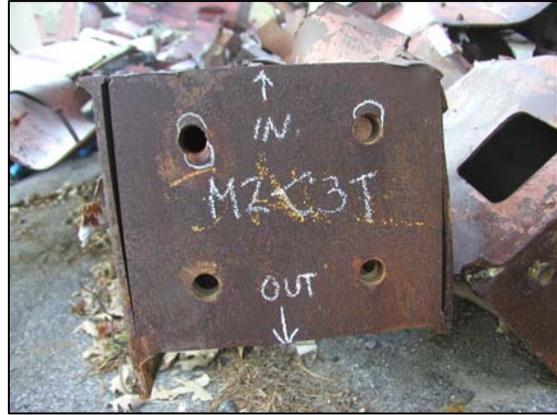
Separation between flange plates and butt plate

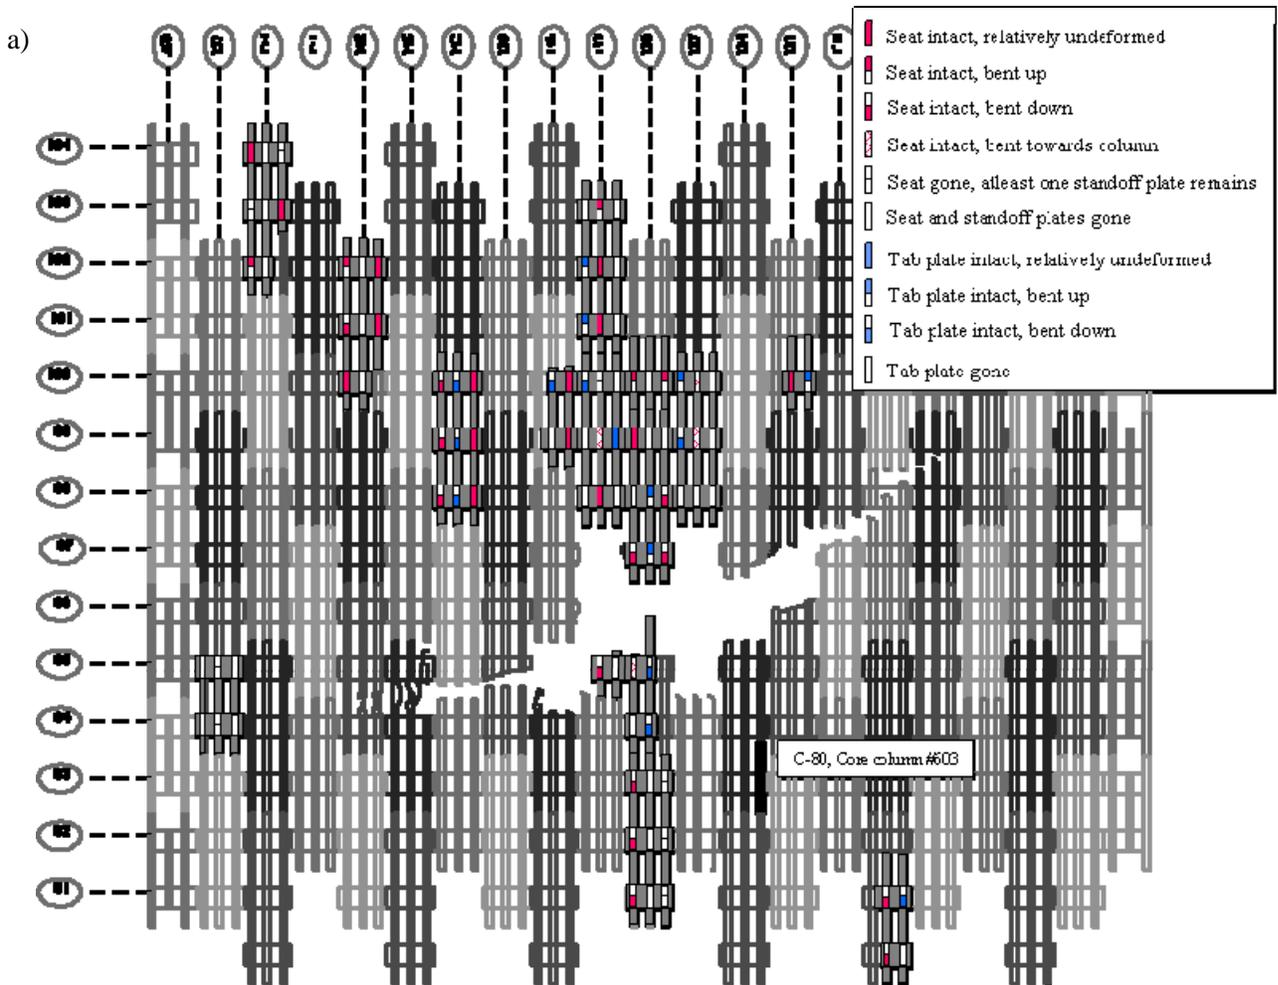
Figure 6–28a. Damage diagram overlaid with recovered samples and damage of connectors.

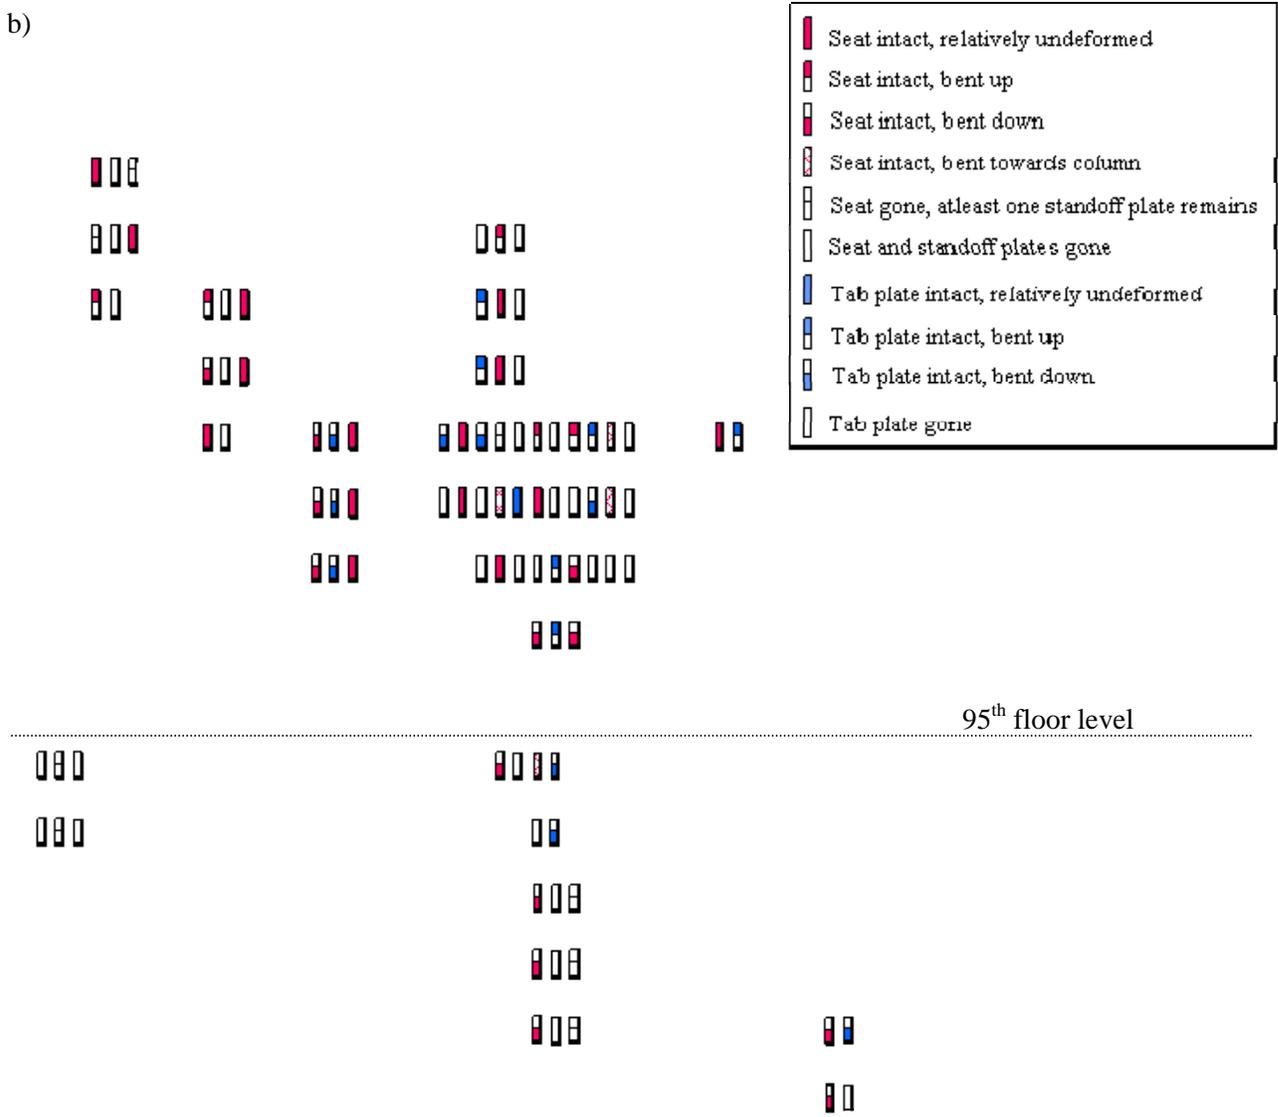
Figure 6–28b. Damage of connectors. At or below the 95th floor, all connectors are either bent down or missing.

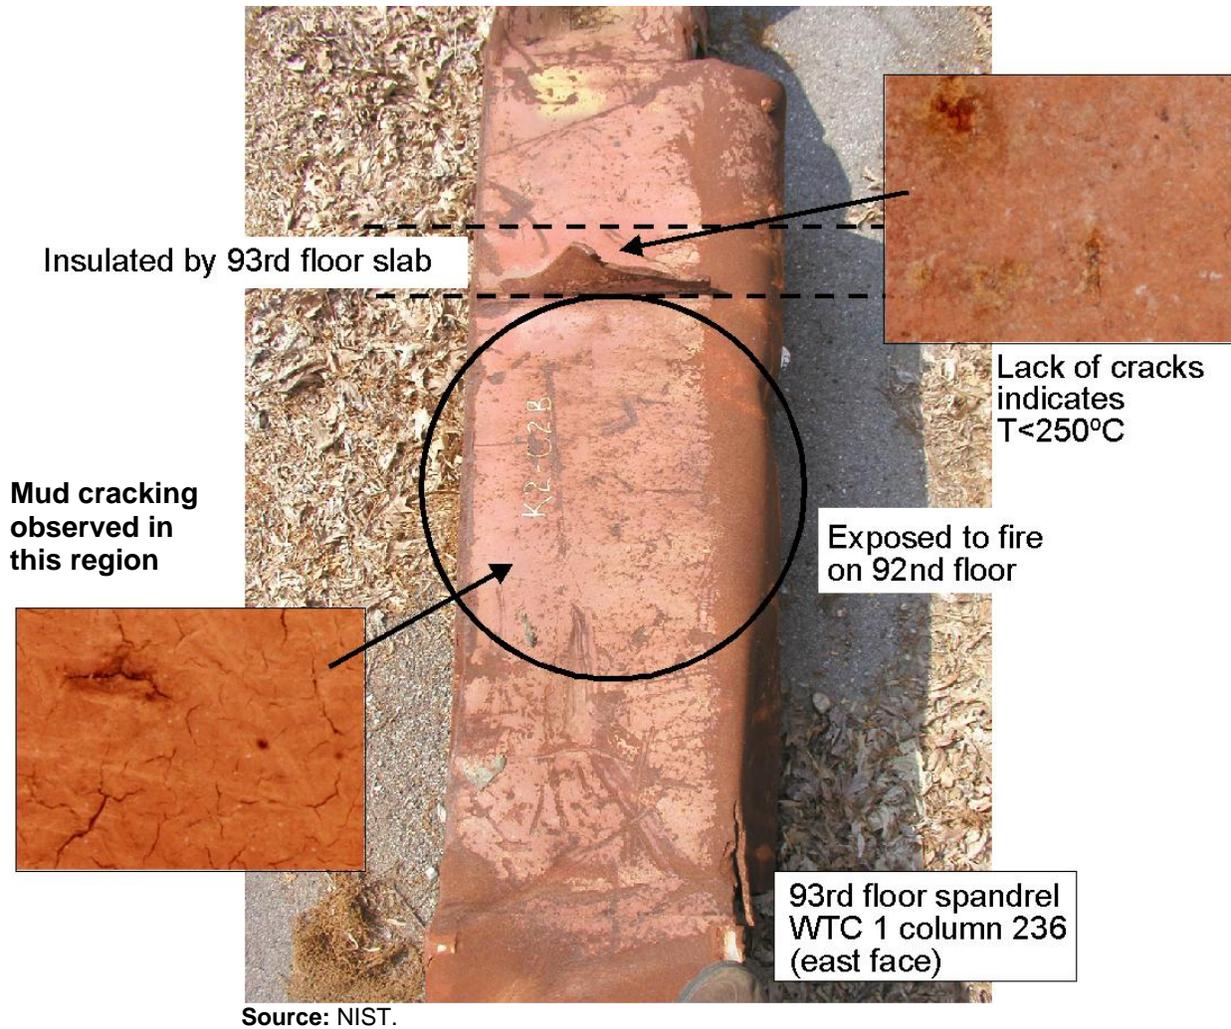
Figure 6–37. Spandrel at the 93rd floor of column 236 from sample K-2 (A236: 92-95). Paint mud cracking was found below the 93rd floor line, no evidence of paint mud cracking was found above floor line.
