NIST NCSTAR 1-5

**Federal Building and Fire Safety Investigation of the
World Trade Center Disaster**

**Reconstruction of the Fires in the
World Trade Center Towers**

September 2005

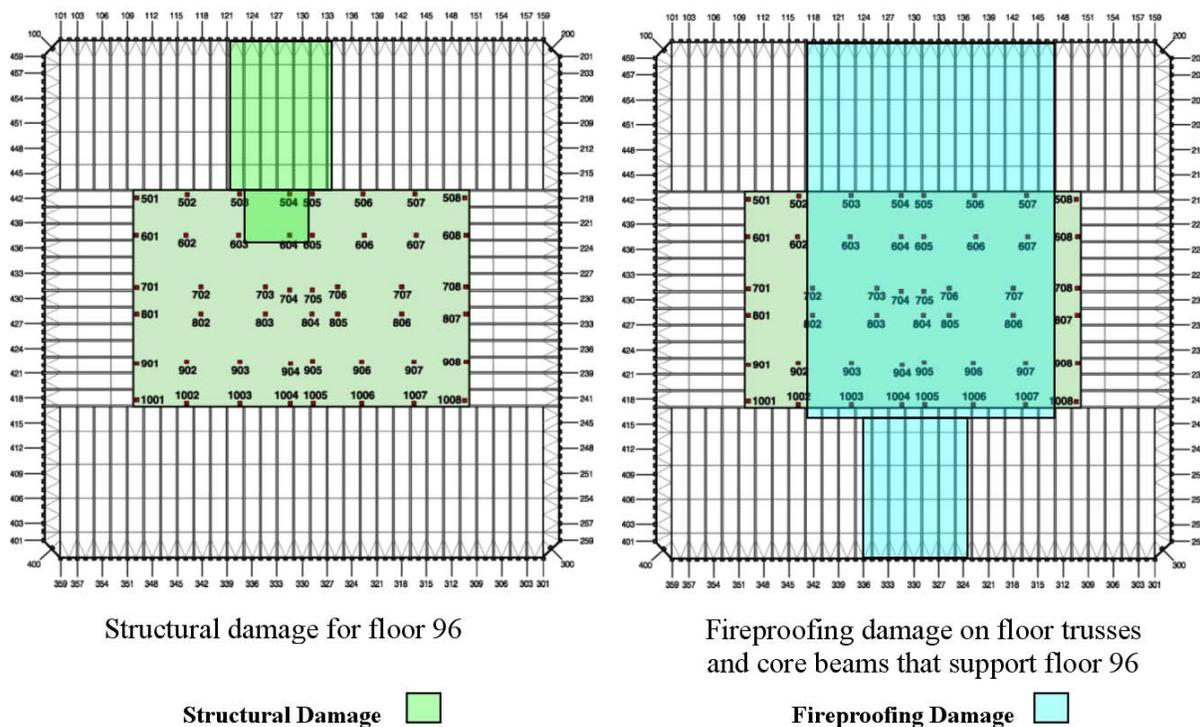
Figure E-3. Structural and insulation damage to floor 96 of WTC 1, Case B.

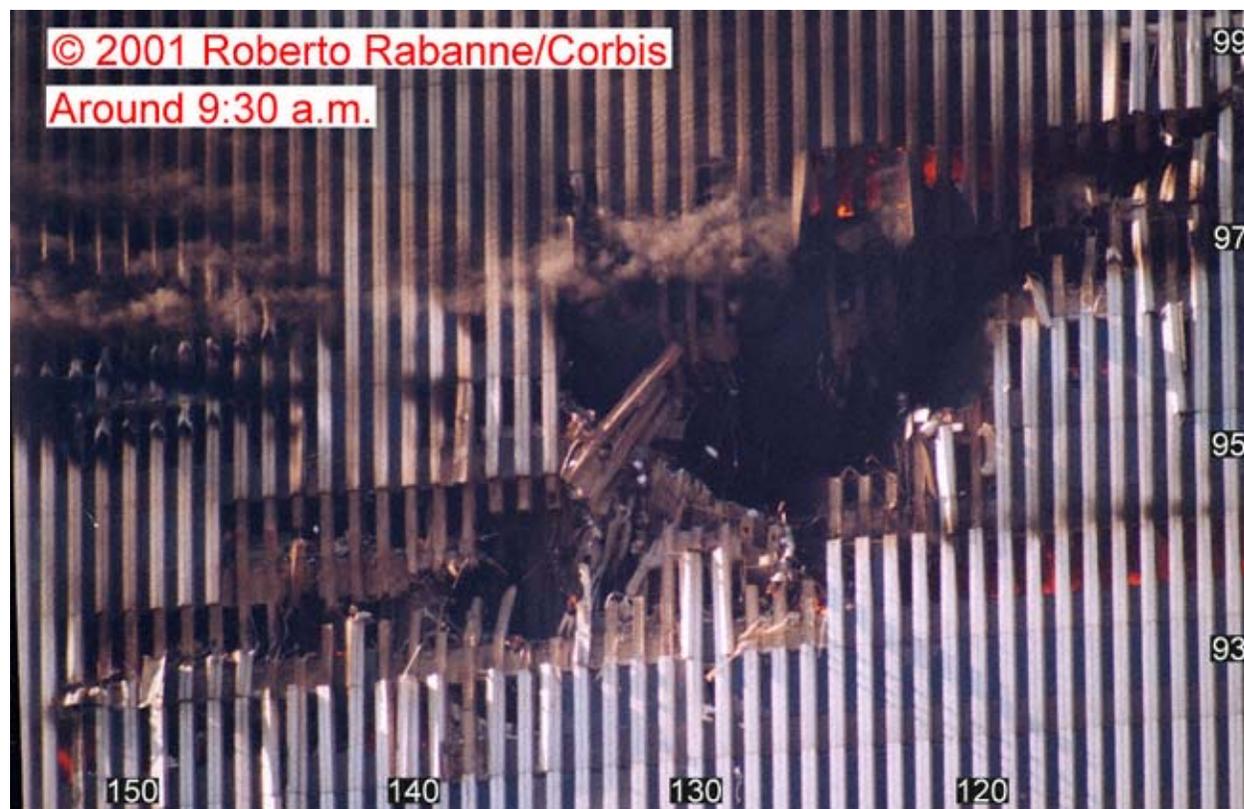
Figure 2–2. Photograph of the north face of WTC 1 around 9:30 a.m. showing the area damaged by the aircraft strike.

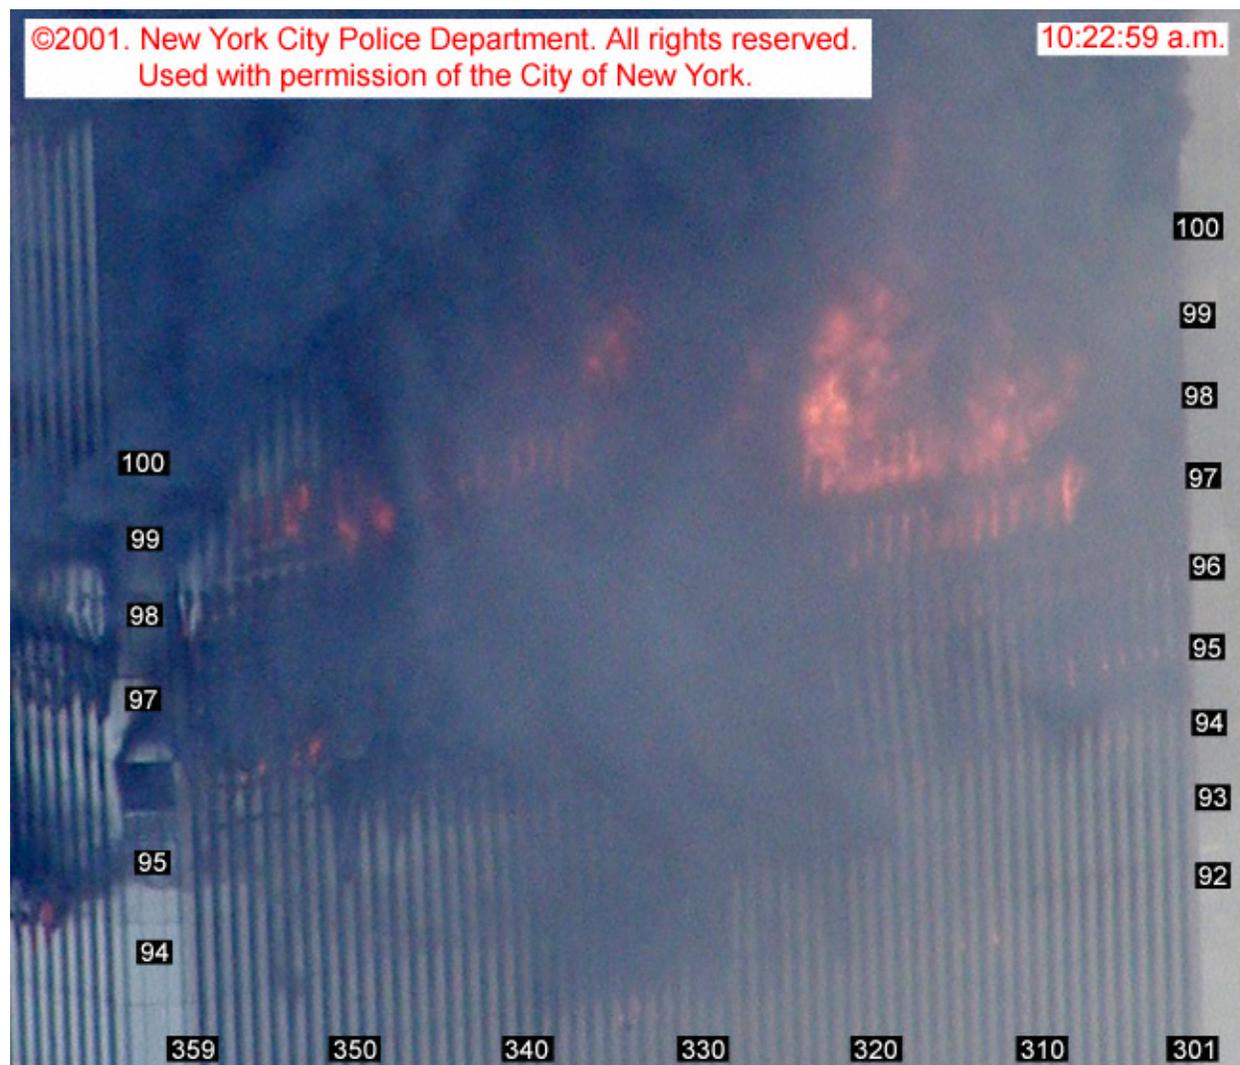
Figure 2–3. View of the south face of WTC 1, cropped from a photograph shot from a helicopter at 10:22:59 a.m. It has been enhanced by adjusting the intensity levels, and column and floor numbers have been added.

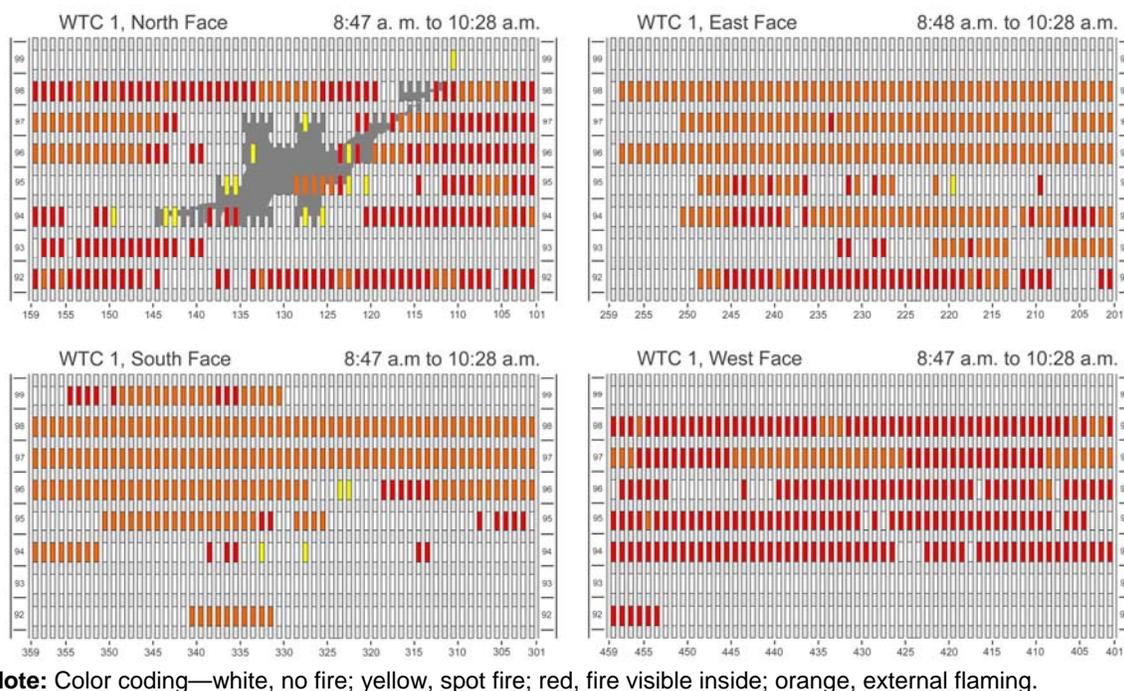
Fire growth and spread in WTC 1 was extensive during the 102 min between the aircraft impact and collapse of the tower. Figure 2–4 shows the results for the four faces of integrating the fire observations over the entire event. Extensive fires were observed from the 92nd to 99th floors. (Note that fires were also present on higher floors, including the intense fire on the south side of the west face of the 104th floor.) Fire seems to have spread over almost all of the 96th to 98th floors, while unburned areas were still present on lower floors. The largest unburned areas seem to have been on the 93rd and 95th floors.

Figure 2–4. Maps of integrated fire observations between 8:47 a.m. and 10:28 a.m. for the four faces of WTC 1.

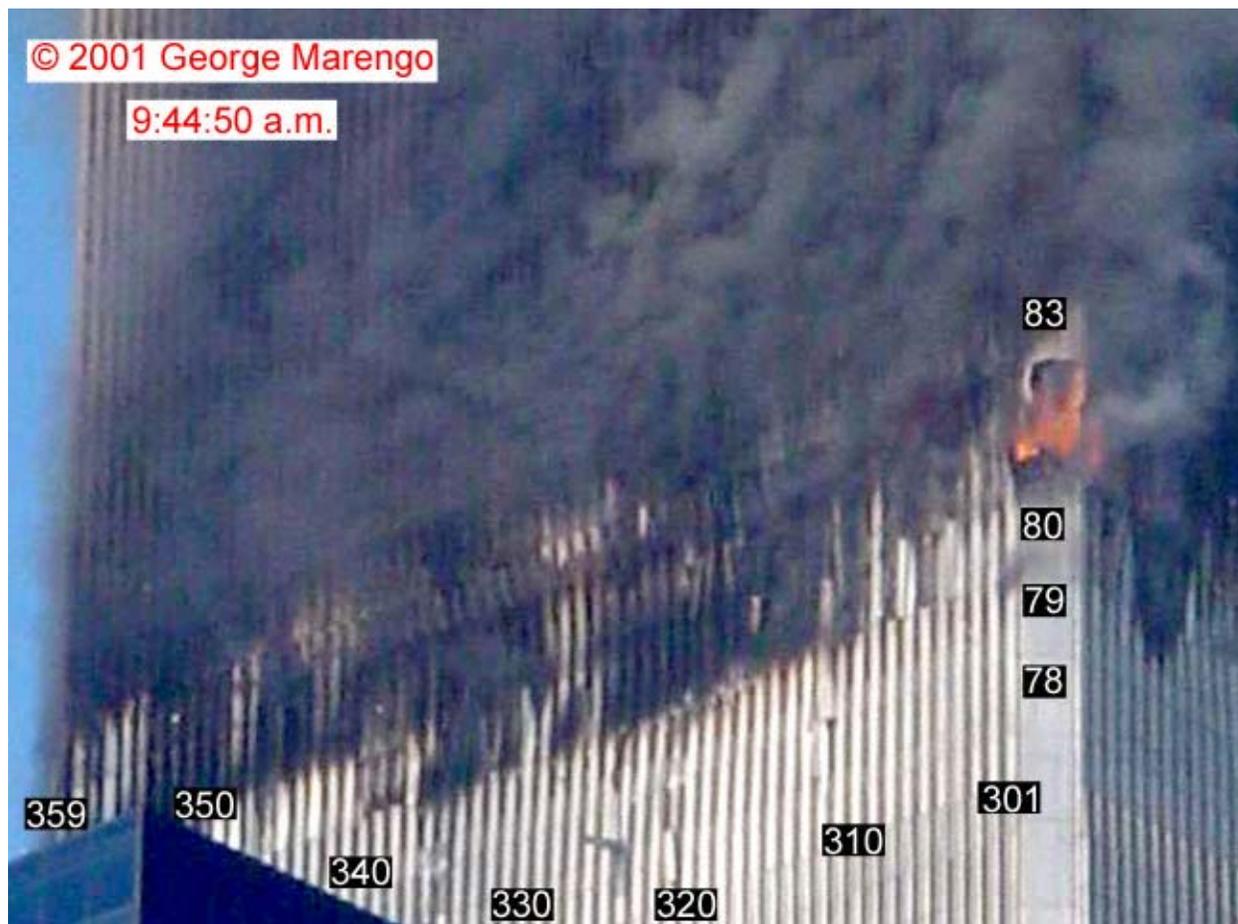
Figure 2–10. Photograph was shot from the northeast, showing east face of WTC 2 at 9:44:50 a.m. The original intensity levels have been adjusted, and column and floor numbers have been added.

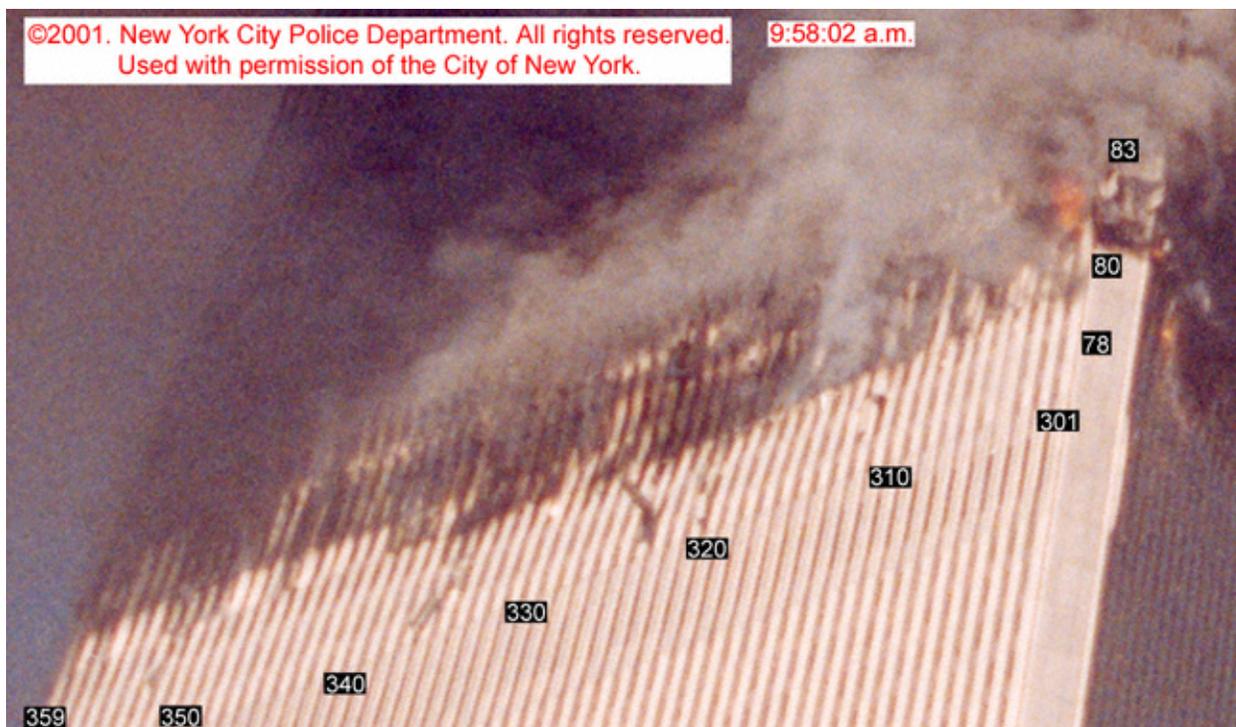
Figure 2–11. Cropped photograph of the east face of WTC 2 at 9:58:02 a.m. The intensity levels have been adjusted, and column and floor numbers have been added.

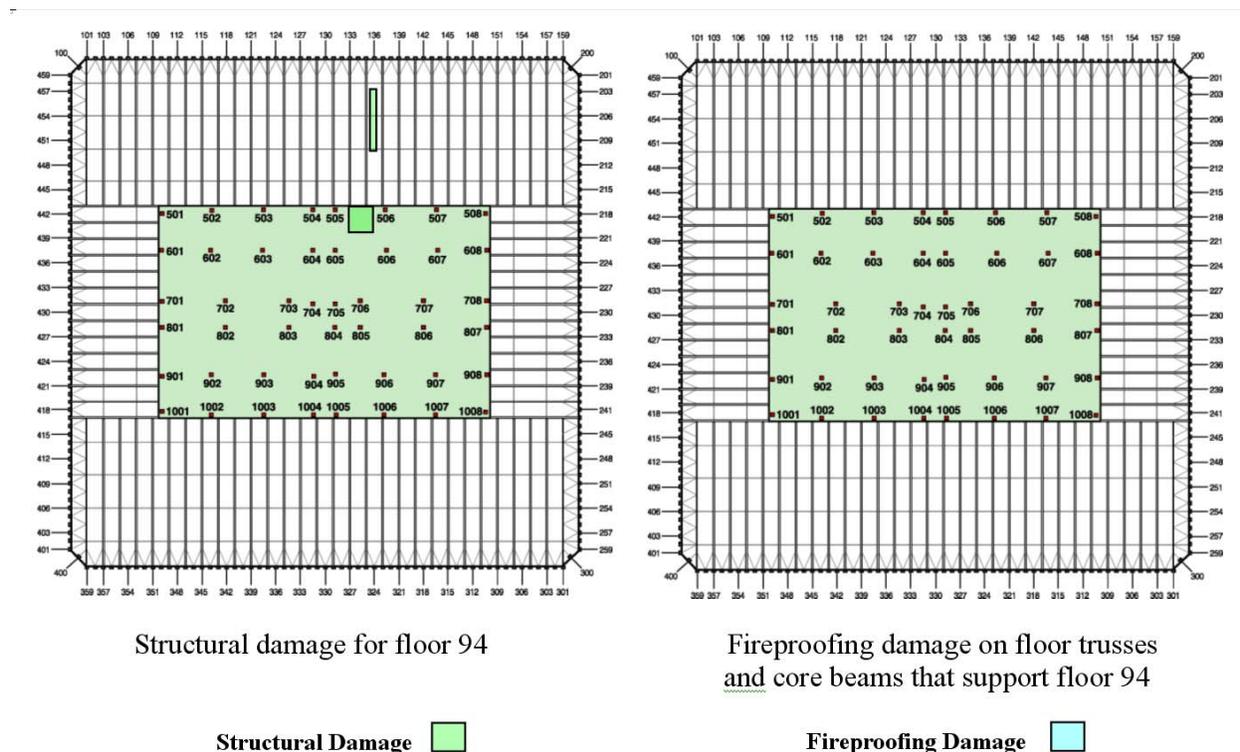
Figure 6–45. Structural and insulation damage to floor 94 of WTC 1, Case A.

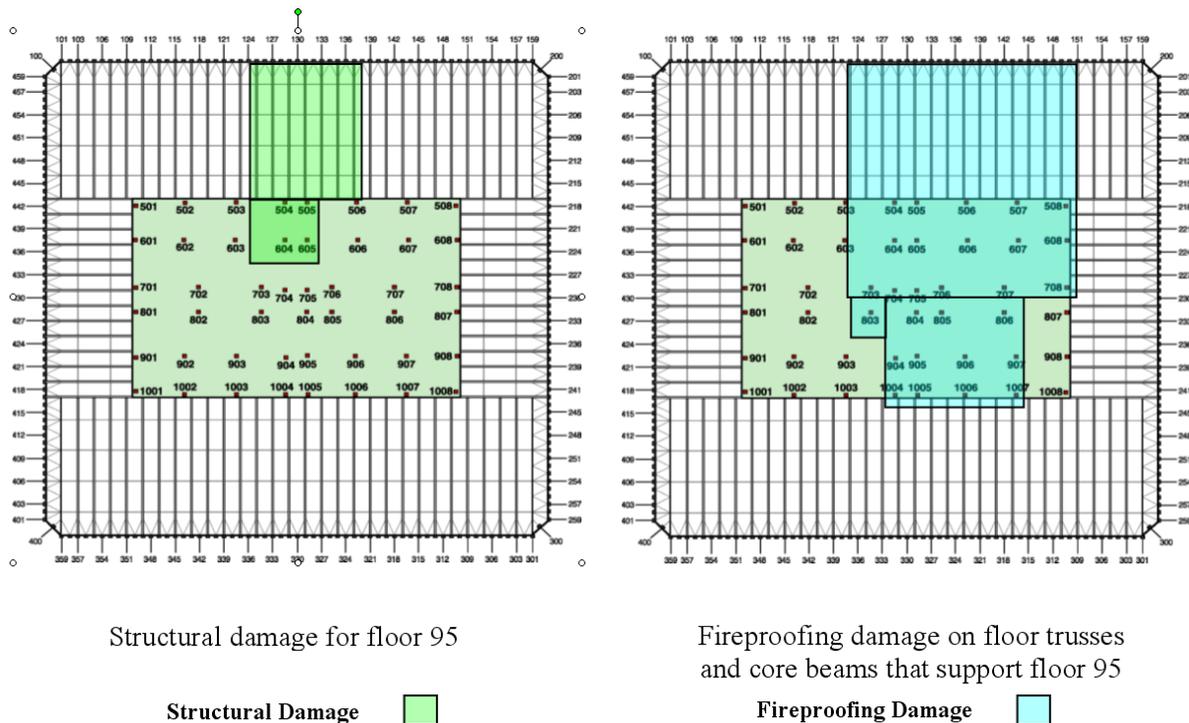
Figure 6–46. Structural and insulation damage to floor 95 of WTC 1, Case A.

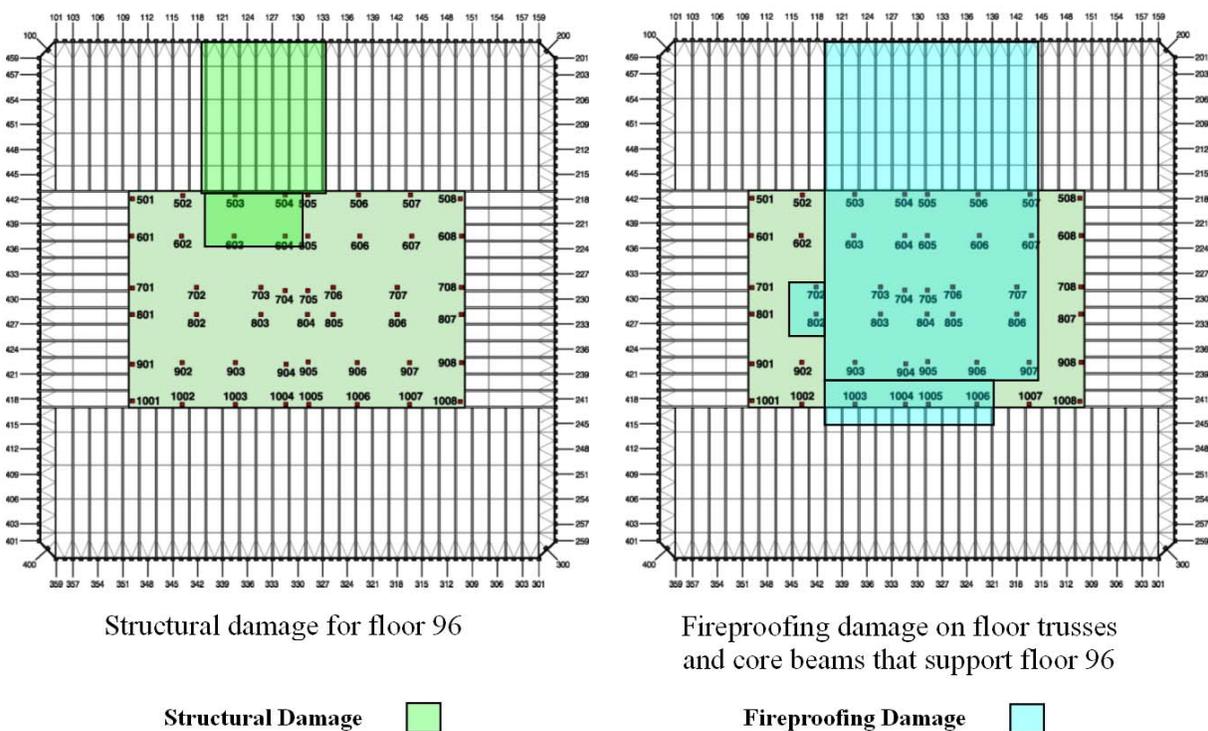
Figure 6–47. Structural and insulation damage to floor 96 of WTC 1, Case A.

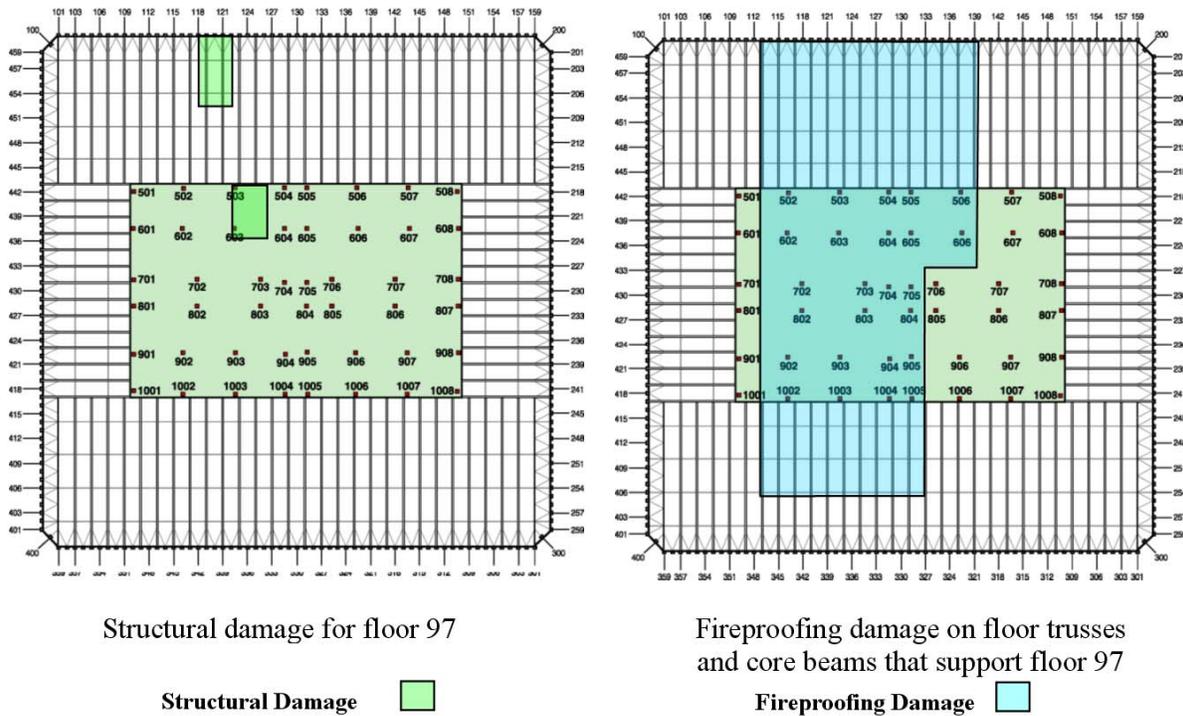
Figure 6–48. Structural and insulation damage to floor 97 of WTC 1, Case A.

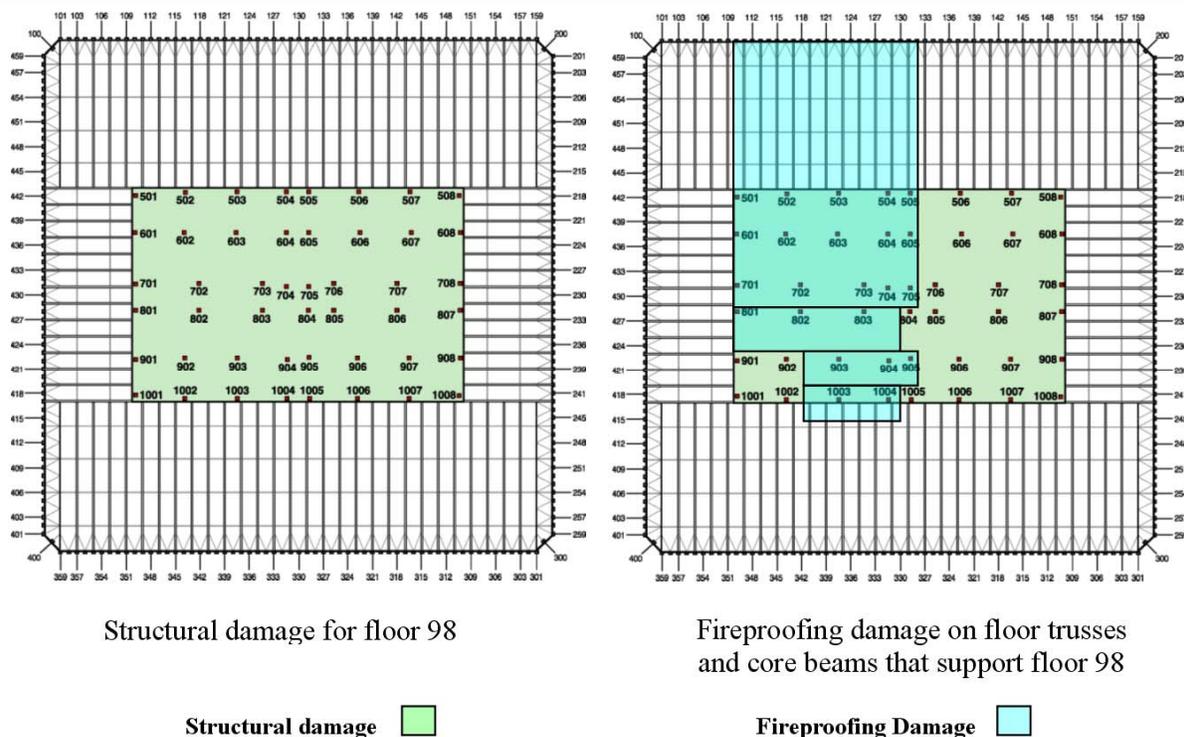
Figure 6–49. Structural and insulation damage to floor 98 of WTC 1, Case A.

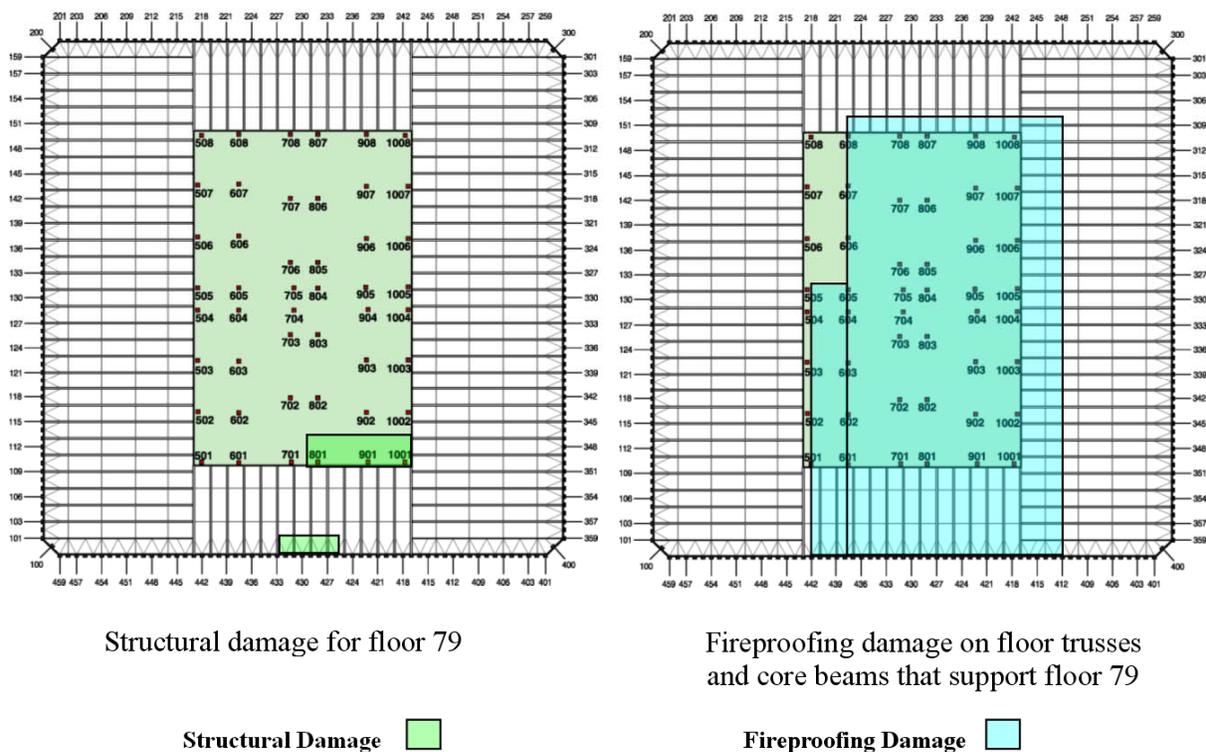
Figure 6–60. Structural and insulation damage on floor 79 of WTC 2, Case C.

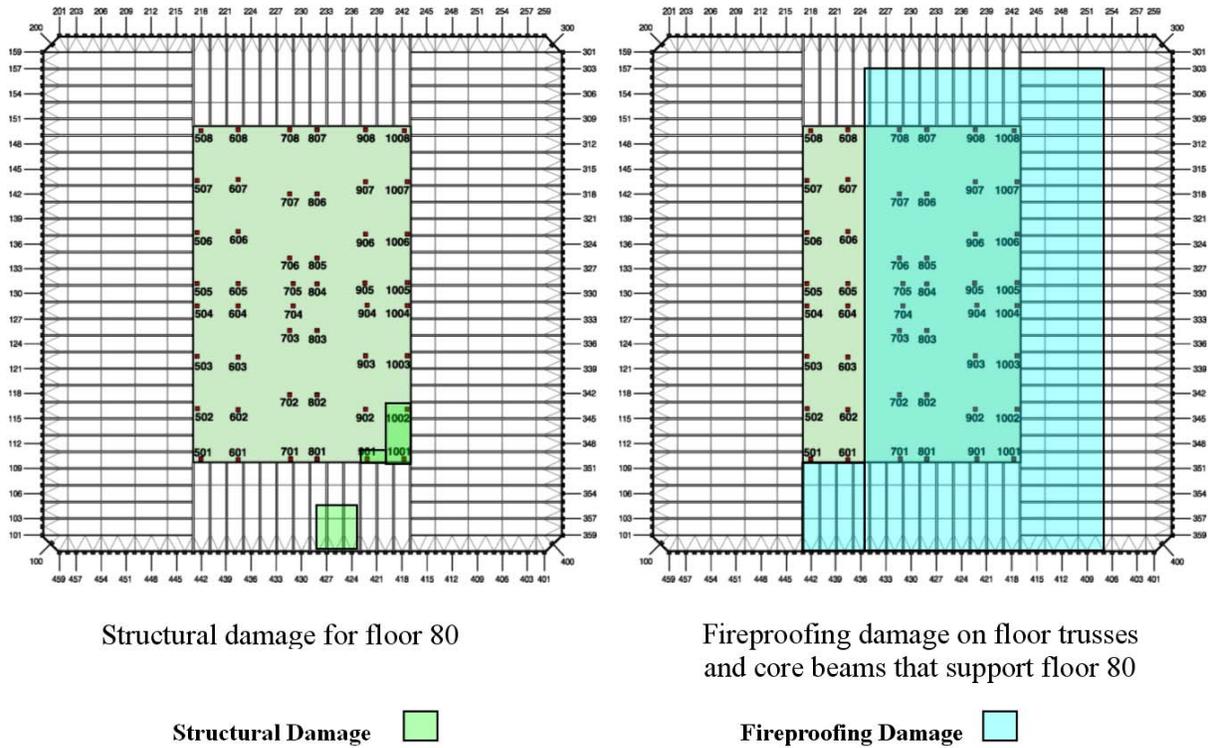
Figure 6–61. Structural and insulation damage on floor 80 of WTC 2, Case C.

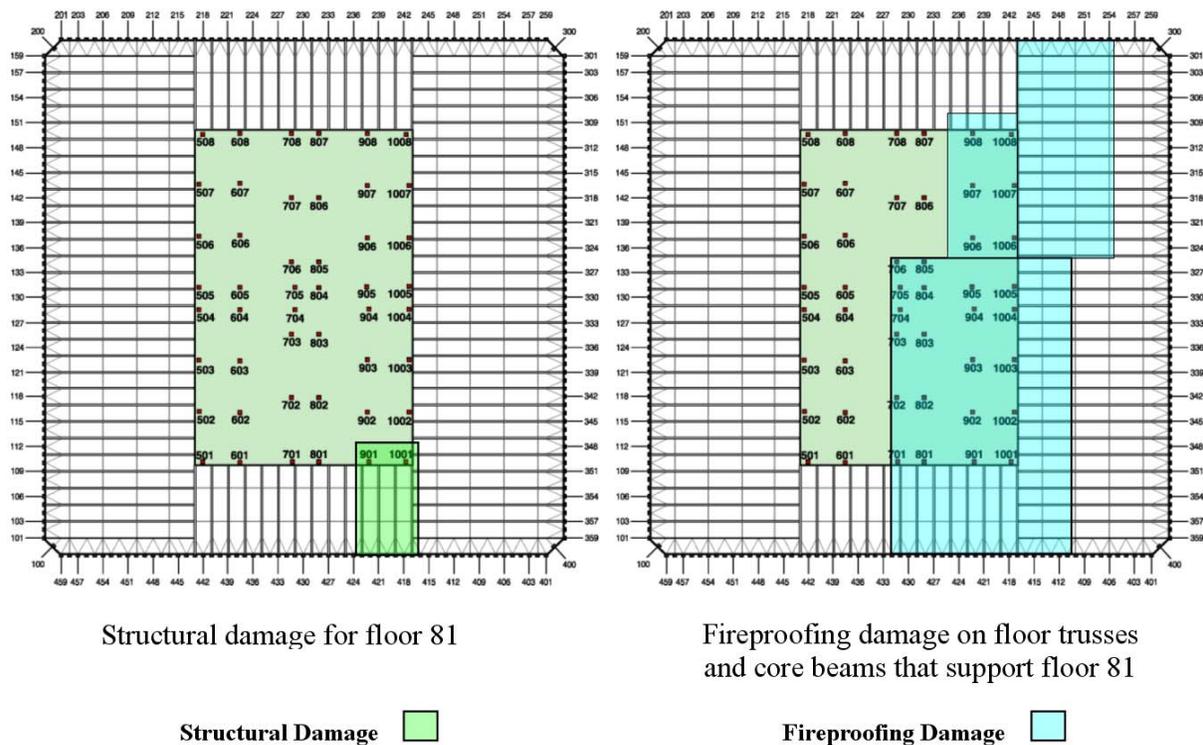
Figure 6–62. Structural and insulation damage on floor 81 of WTC 2, Case C.

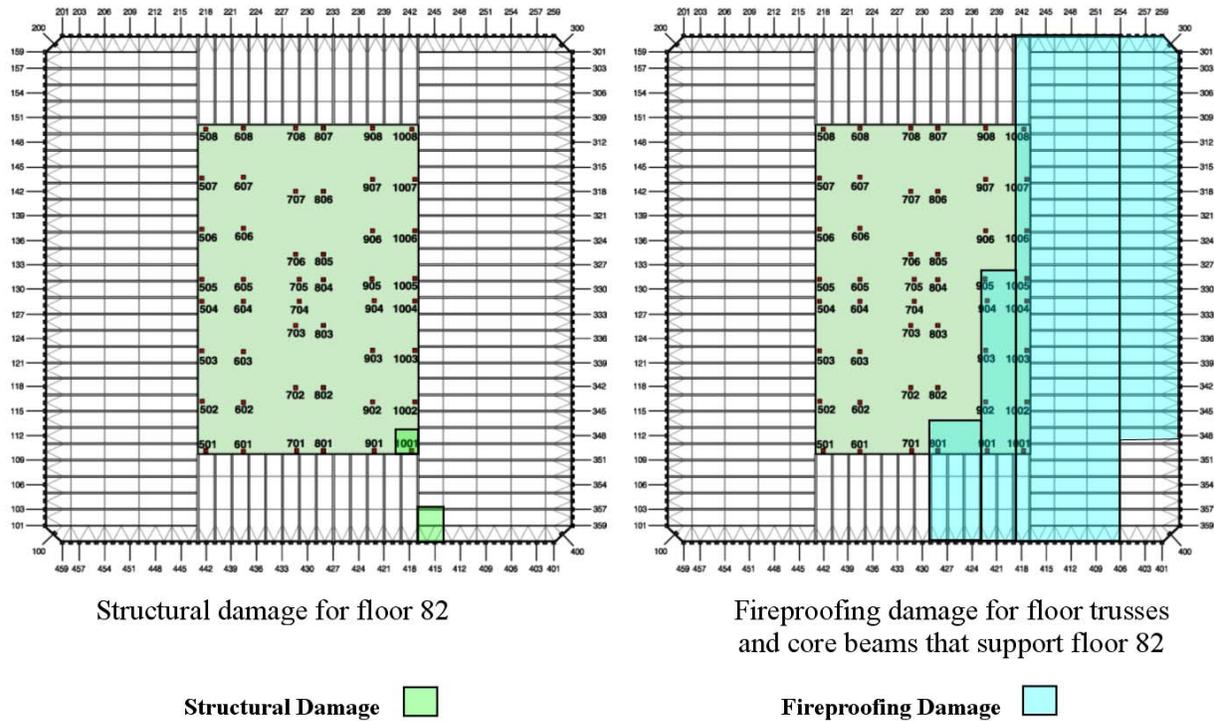
Figure 6–63. Structural and insulation damage on floor 82 of WTC 2, Case C.
