Individual Lift Device.

BELL AEROSYSTEMS CO BUFFALO NY

15 OCT 1967

INDIVIDUAL LIFT DEVICE PHASE II

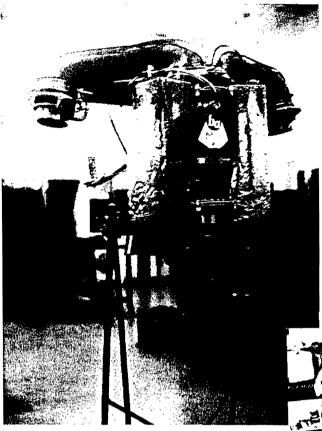
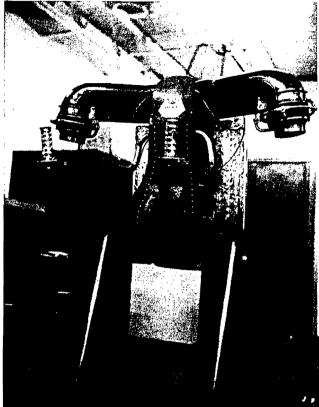
Assembled Individual Lift Device at Williams Research

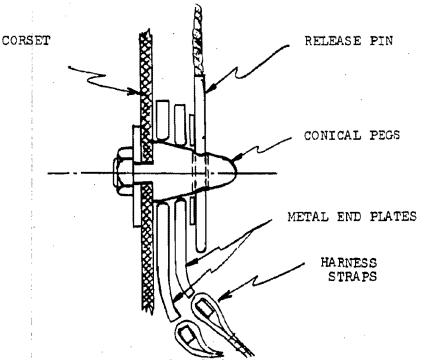
Preparation for installation of the emergency recovery system, defined and designed to recover the operator only, necessitated changes in the Jet Belt suspension system to provide separation between the operator and the Jet Belt. These changes pertain primarily to the attachment points of operator suspension harness on the Jet Belt i.e. groin, abdominal, and shoulder straps. The previous harness attachment bolts were replaced by chrome-plated, conically shaped, steel pegs with a hole near the apex for the attachment and release pins. (see Sketch "A")

The fixed mounting ends of the various straps were provided with metal plates which have holes drilled to fit loosely over the conical pegs. Placing the appropriate attachment plates over the proper conical pegs and inserting the release pins through the holes near the apex of the pegs as shown in the sketch results in a suspension
