**NIST NCSTAR 1-3B**

**Federal Building and Fire Safety Investigation of the  
World Trade Center Disaster**

# **Steel Inventory and Identification**

Stephen W. Banovic

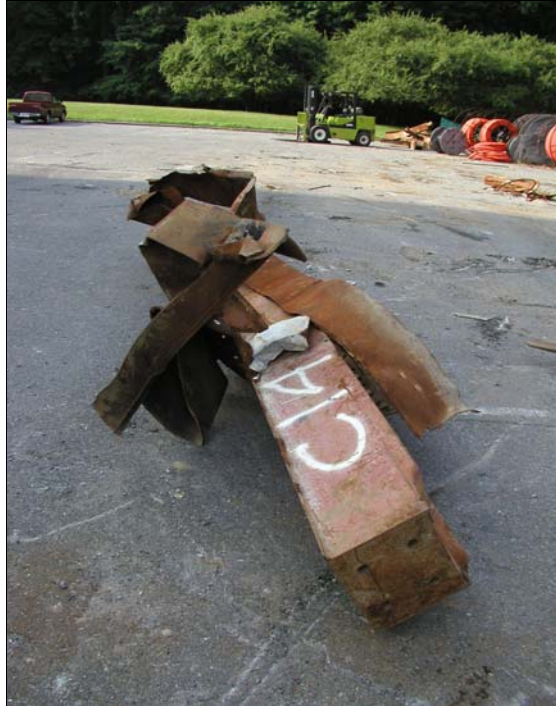
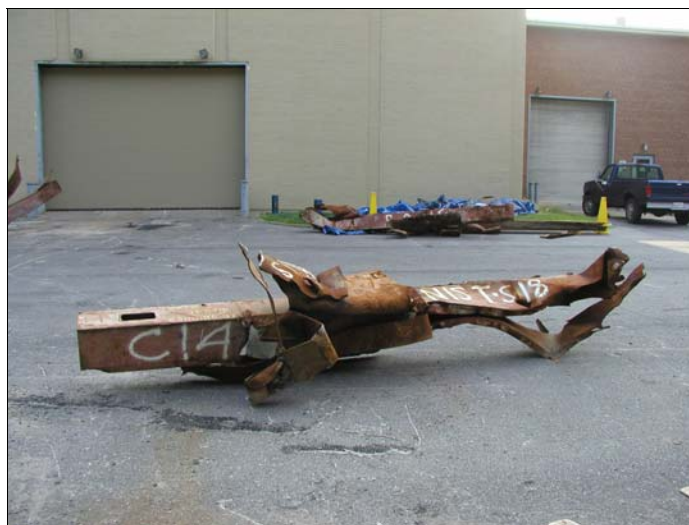
**Figure 3–1. Characteristic “overall” view of the samples taken for each piece received. Sample shown here is C-14.**

As samples were delivered, overall images of the pieces were taken for record-keeping purposes. An example is shown in Fig. 3–1. Samples are identified by their original alphanumeric identification codes assigned by Structural Engineers Association of New York to be consistent with the Federal Emergency Management Agency report. However, there were cases in which two different codes were found on one piece. In these instances, if the pieces were already undergoing documentation procedures, the first code noted was used. Samples that arrived lacking a code were labeled as part of the U series. Additionally, samples brought from Hanger 17 at John F. Kennedy International Airport maintained their “B”-series labels provided in the Voorsanger report.<sup>2</sup>

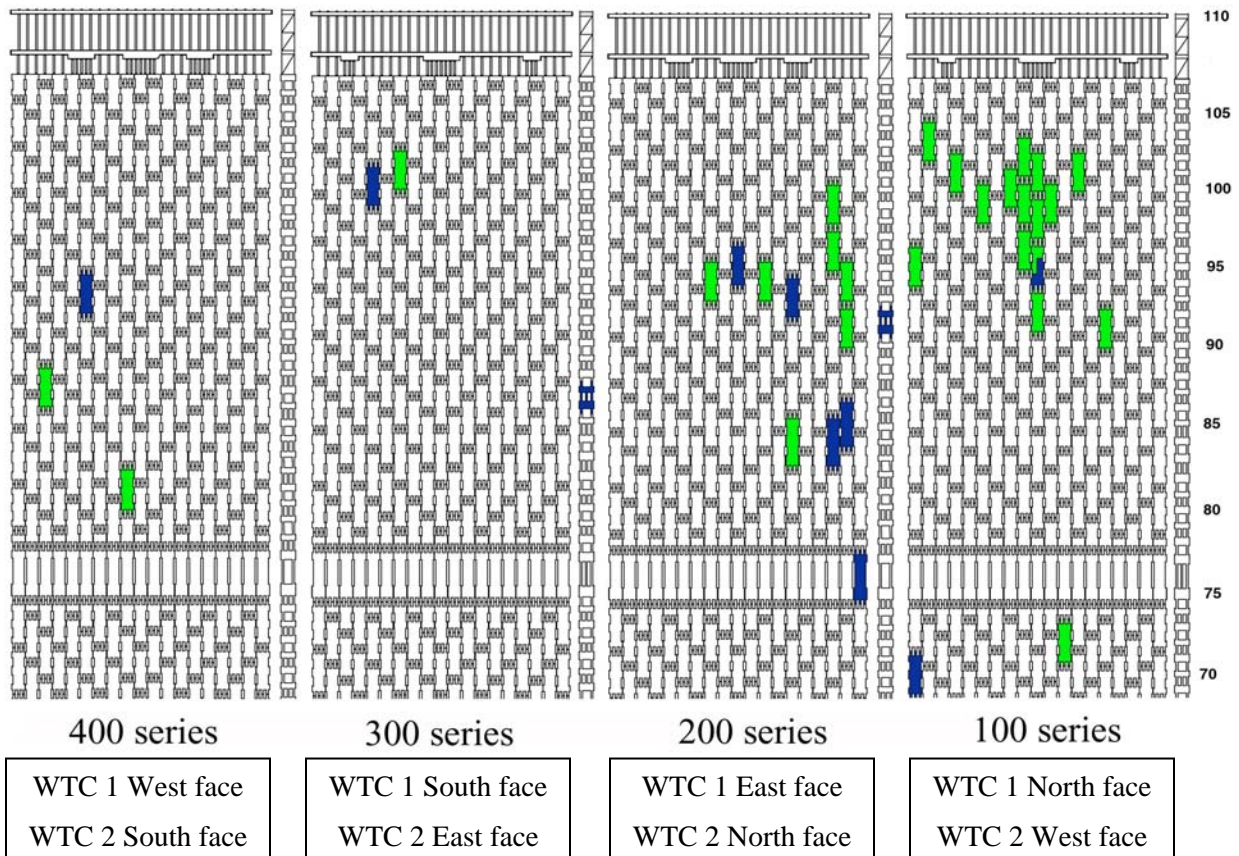
**Note:** WTC 1 panels are shown in green and WTC 2 panels are in blue.

**Figure 3–2. Location of the exterior panels recovered from the top third of WTC 1 and WTC 2.**

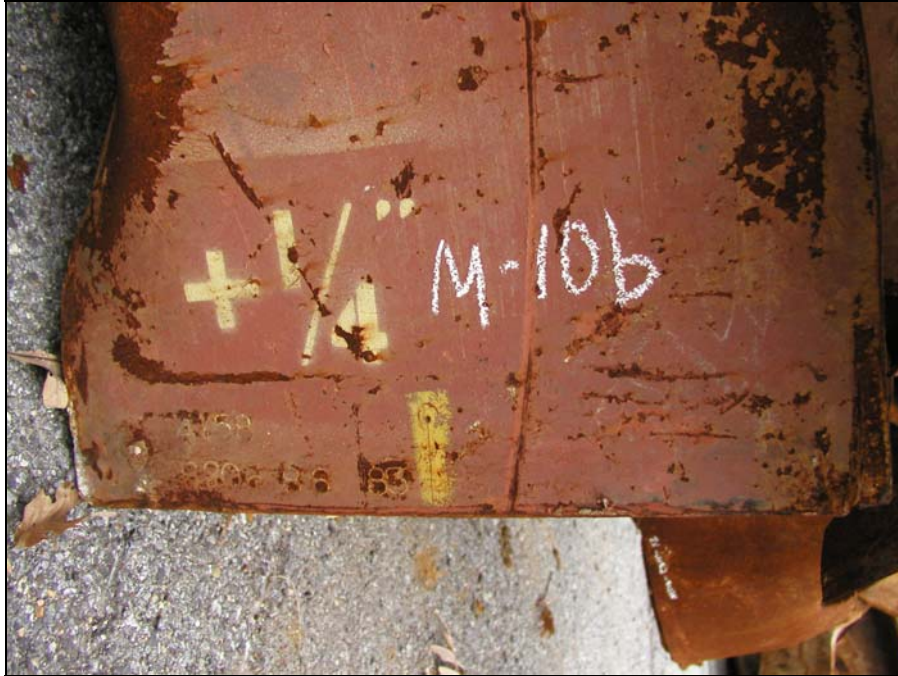
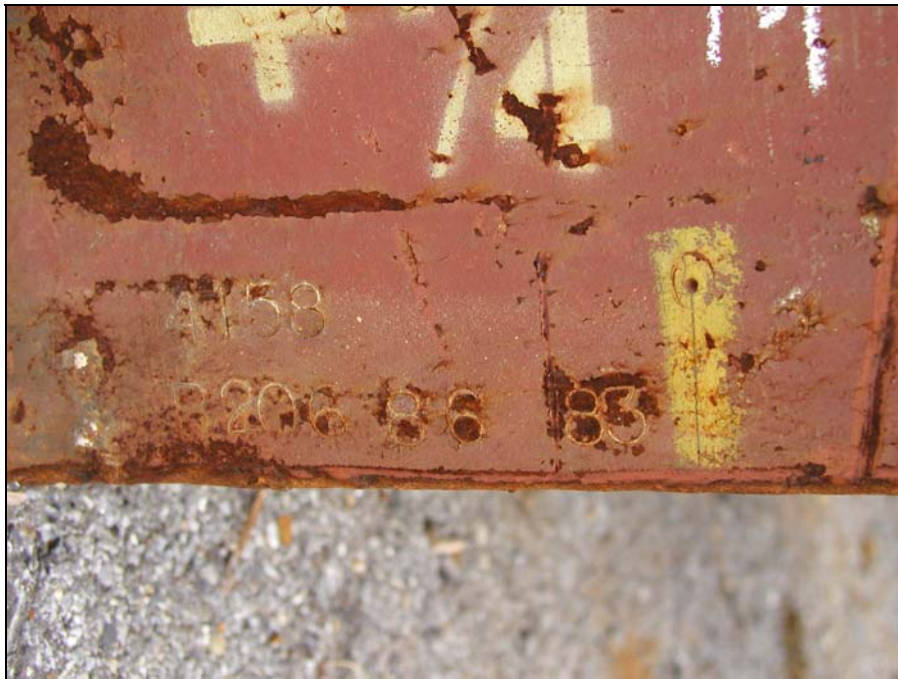
**Figure 3–3. Example of stampings on the interior base of the middle column for each panel.**

The positive identification of the structural elements was made possible by deciphering the stampings and/or stencils found on them. During the fabrication process, the exterior panel sections were stamped at the bottom of the center column on the inside face. These stampings indicated the building, center column line number, and floors spanned by the columns. The core columns had stampings placed at the lower end of the component near the connector. The building was typically represented as "A" for WTC 1 and "B" for WTC 2. An example of a stamping found on an exterior column is shown in Fig. 3-3, where the stamping indicates that the piece was from WTC 2, with center column line number 206, spanning floors 83 through 86. Core column material was found to have similar markings (Fig. 3-4). Other stampings have also been found on the flanges of the perimeter columns that indicated the column type (Fig. 3-5 and Table 3-5) as well as the specified minimum yield strength of the column. All of these stampings typically reside within 1 m from the bottom of the column.

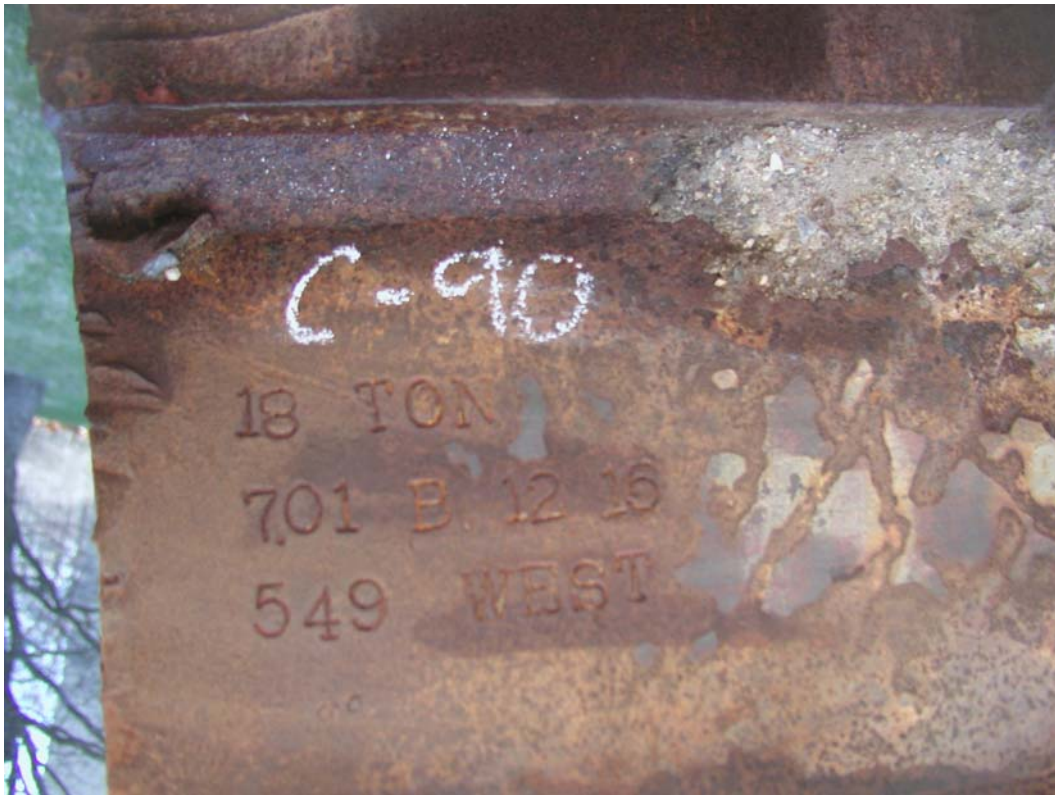
**Figure 3–4. Example of stampings placed on one end of a core column.**

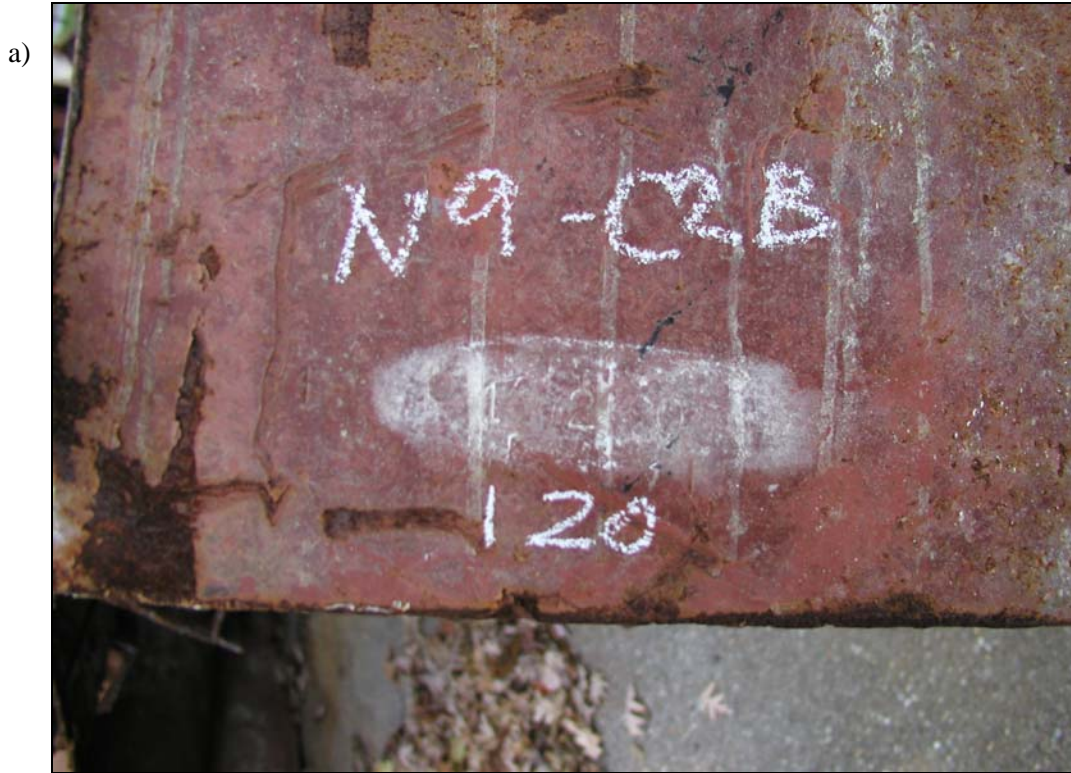
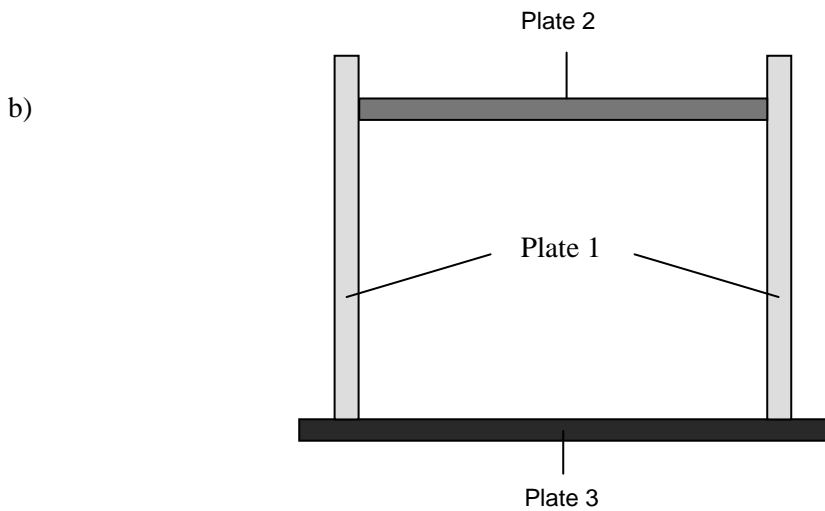
**Figure 3–5. (a) Example of stamping placed on flange indicating the column type (120), and (b) schematic indicating the various plates corresponding to Table 3–5.**

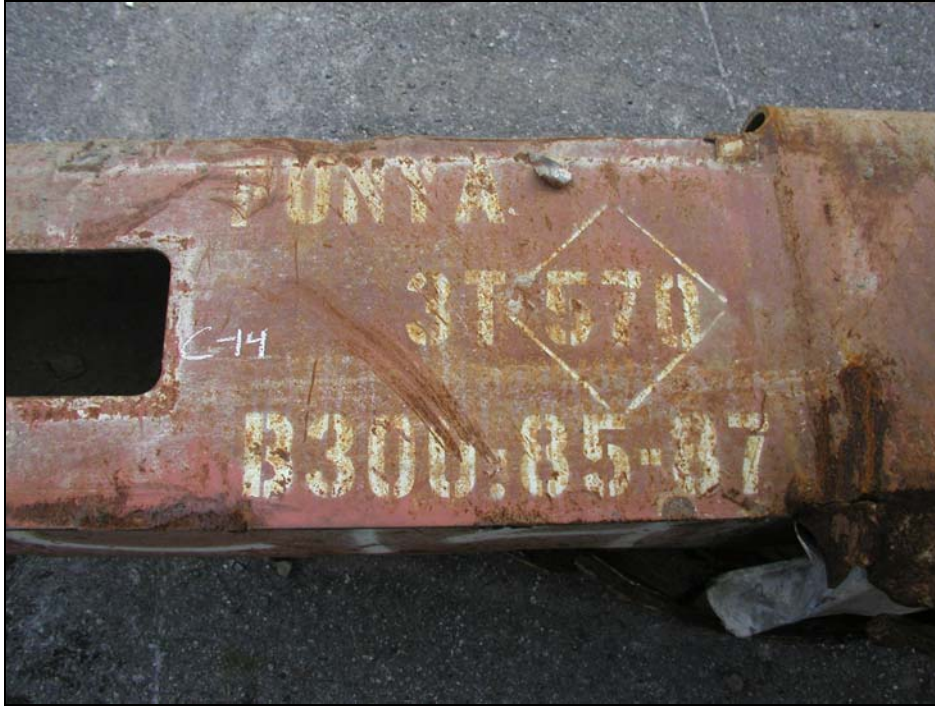
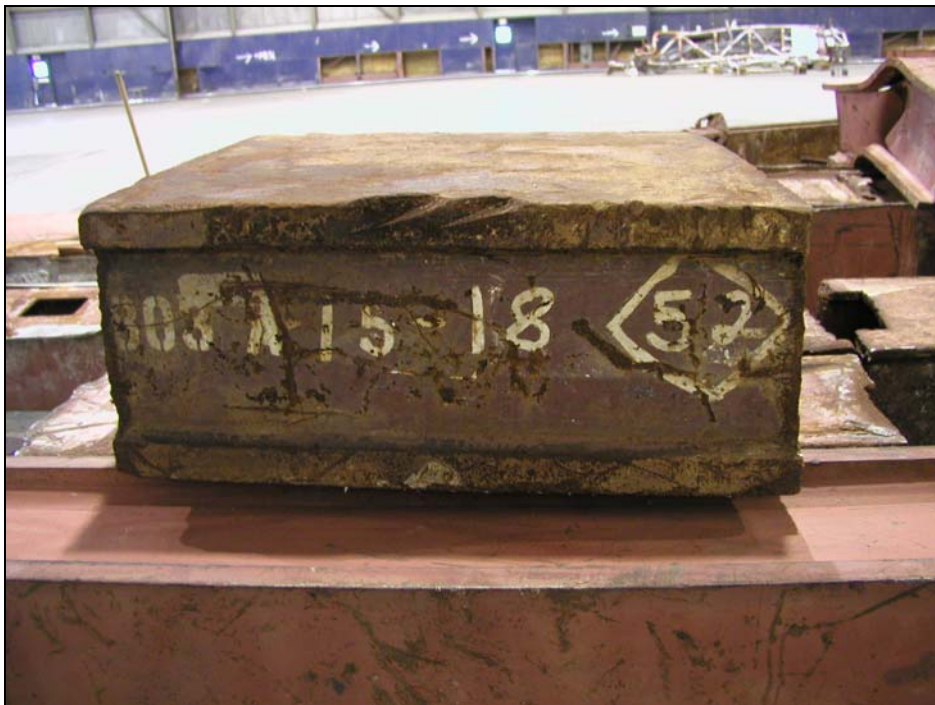
**Figure 3–6. (a) Characteristic stenciling found on the lower portions of the exterior column panels for sample C-14. (b) Characteristic stenciling found on an interior core column for sample B-6152.**

Each of the structural elements was additionally stenciled in white or yellow lettering with similar building information. For the exterior panel sections, the stenciling was located on or near the lower spandrel on the interior face. Figure 3–6 (a) shows a typical stenciling found on a perimeter panel, indicating this piece was in WTC 2, with center column line number 300, spanning floors 85 through 87. For the core columns, both stenciling and handwritten codes have been observed on the recovered pieces. Figure 3–6 (b) shows one of these stencilings from a core column located in WTC 1.

Also seen in Fig. 3–6 (a) are two other indicators, 3T and <570>, found on the exterior panel sections. These markings are the estimated piece tonnage (1 ton equals approximately 907 kg) and the erector's derrick division number, respectively. This information was also stamped on some of the core column pieces (see Fig. 3–4). The erector, Karl Koch Erecting Co., Inc., assigned derrick divisions 47 through 70 for WTC 1 and derrick divisions 547 through 570 for WTC 2.<sup>4</sup> Each division was assigned to a specific area of the building and shared a crane with other nearby derrick divisions. Therefore, a single crane may have lifted pieces from derrick divisions 65, 67, and 69. Figure 3–7 shows the derrick division numbers that hoisted the specific columns for both buildings, according to the derrick numbers found on structural elements with positive identification (also shown in Tables 3–2 and 3–3).

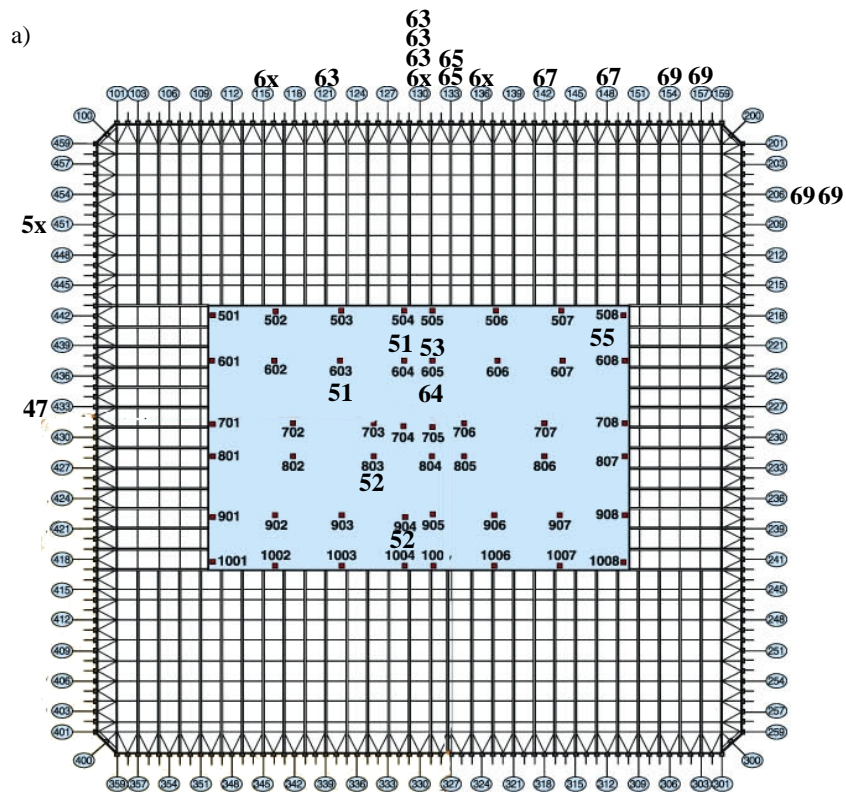
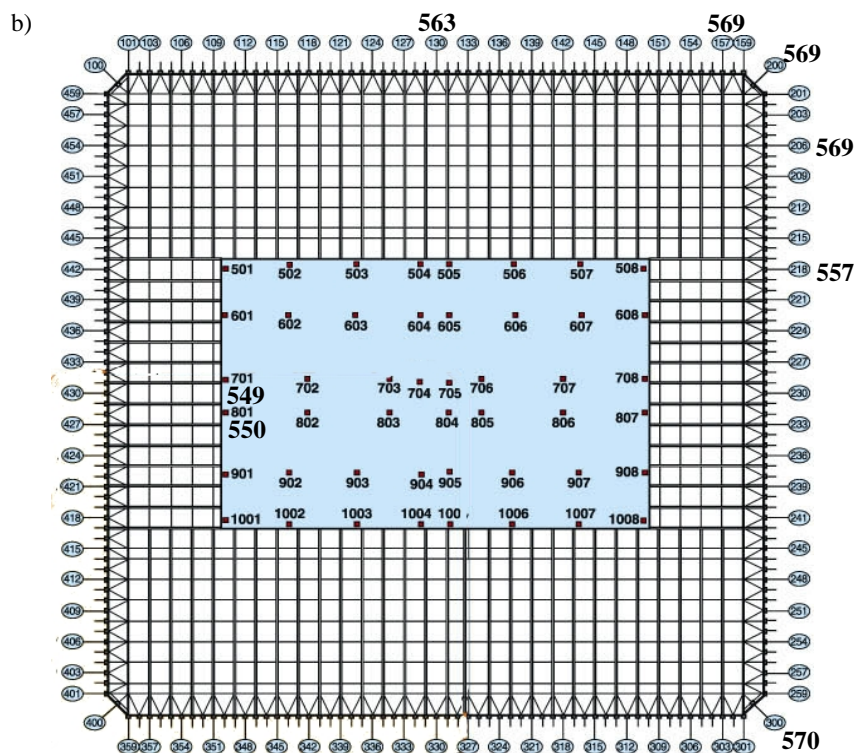
**Figure 3–7. Schematic showing derrick divisions that hoisted the specific columns for (a) WTC 1 and (b) WTC 2. The “x” signifies the information that was not readable.**

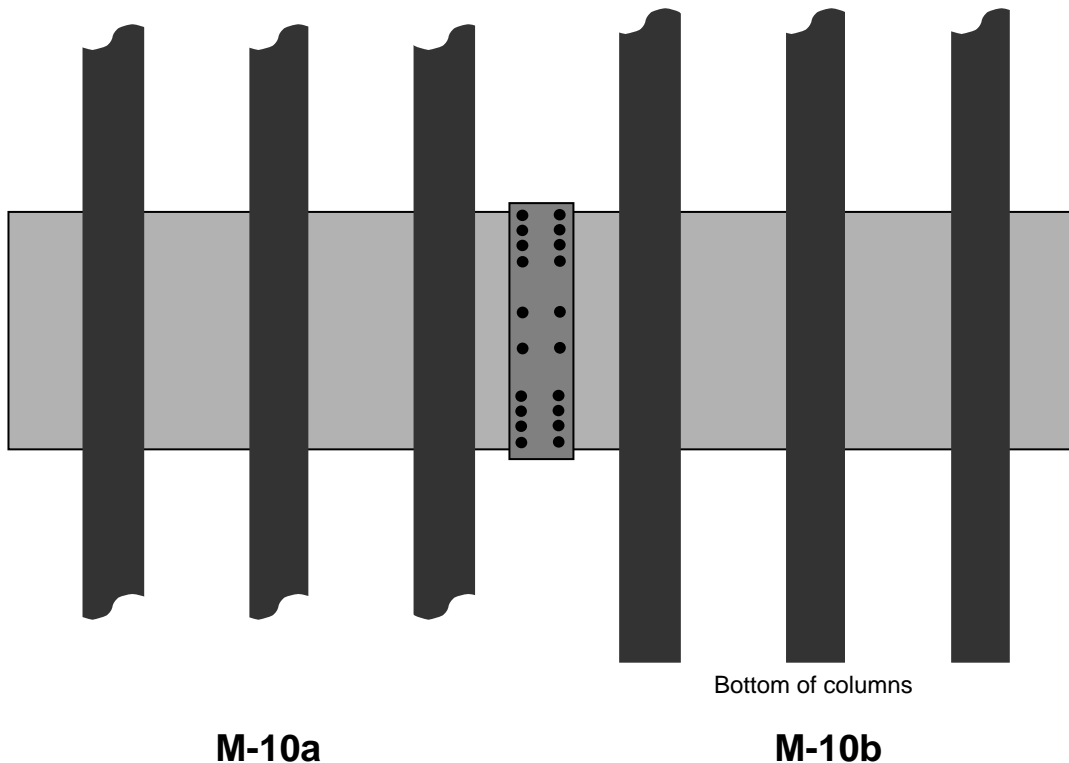
**Figure 3–8. Schematic showing the sample M-10 as two separate exterior column panels, M-10a and M-10b.**

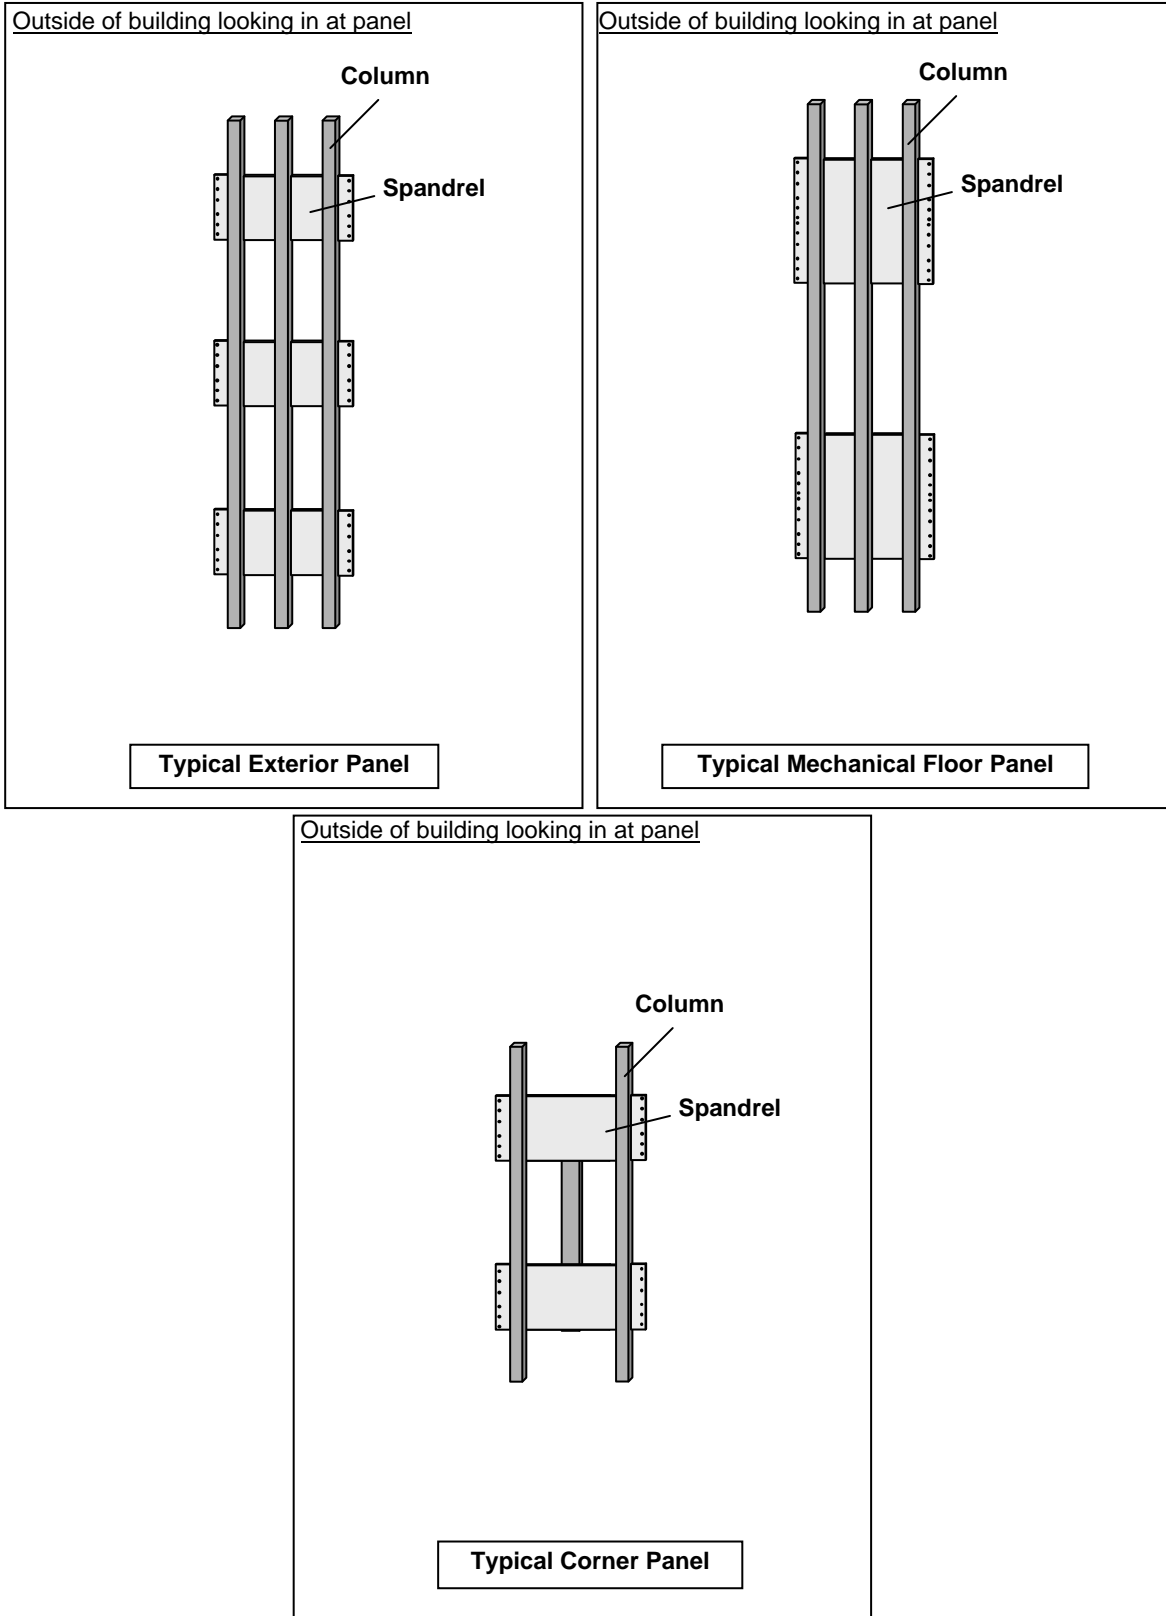
Figure 3–9. Schematics displaying the various types of exterior column panels.

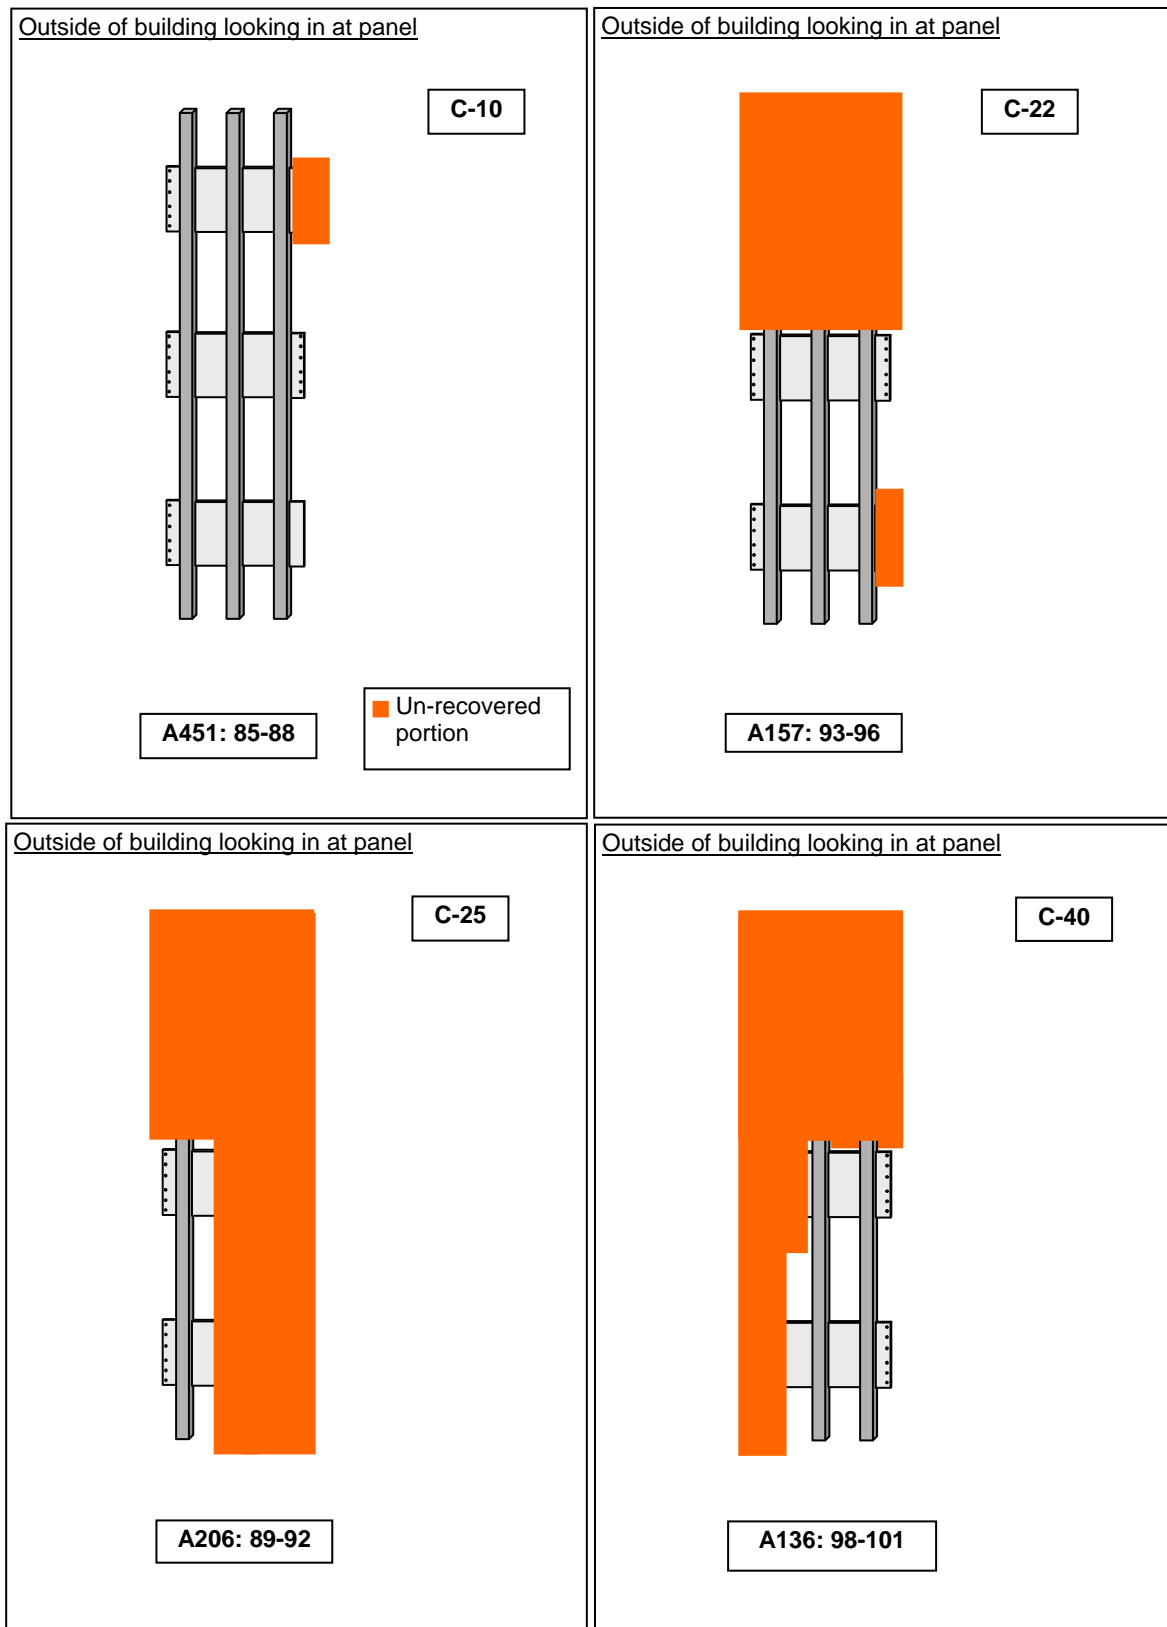
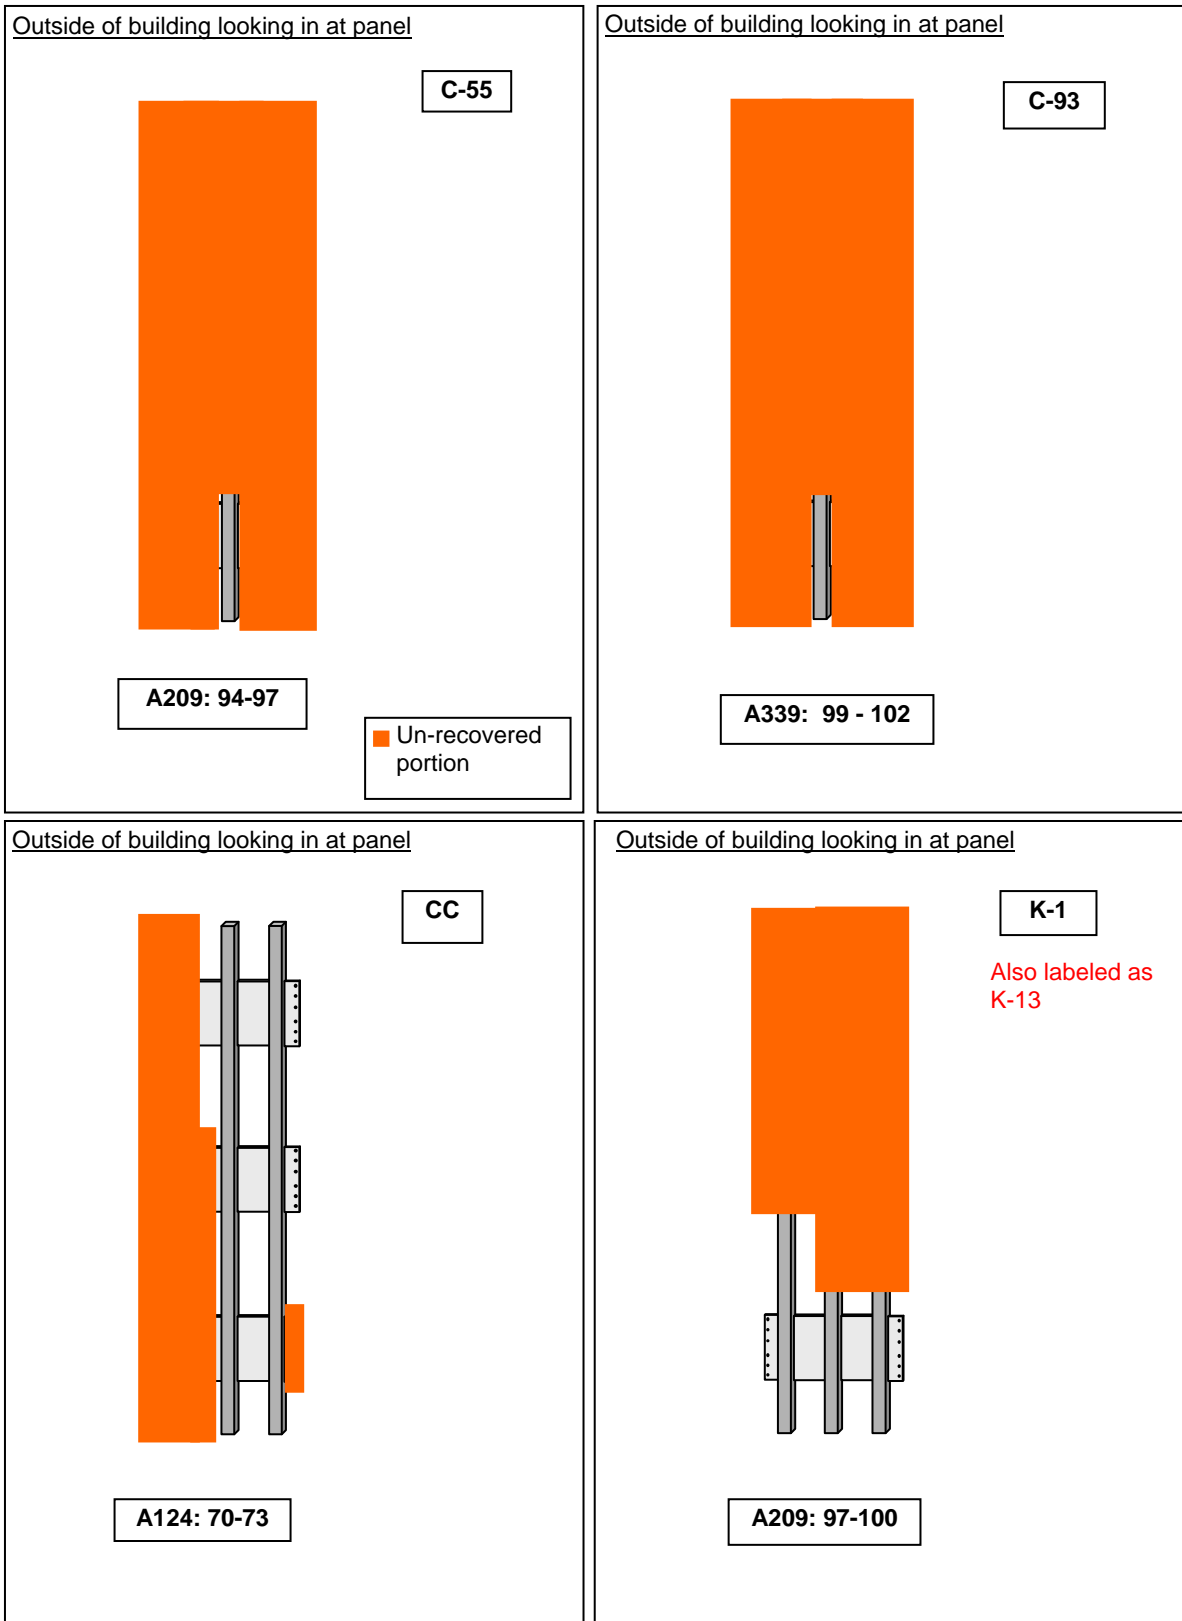
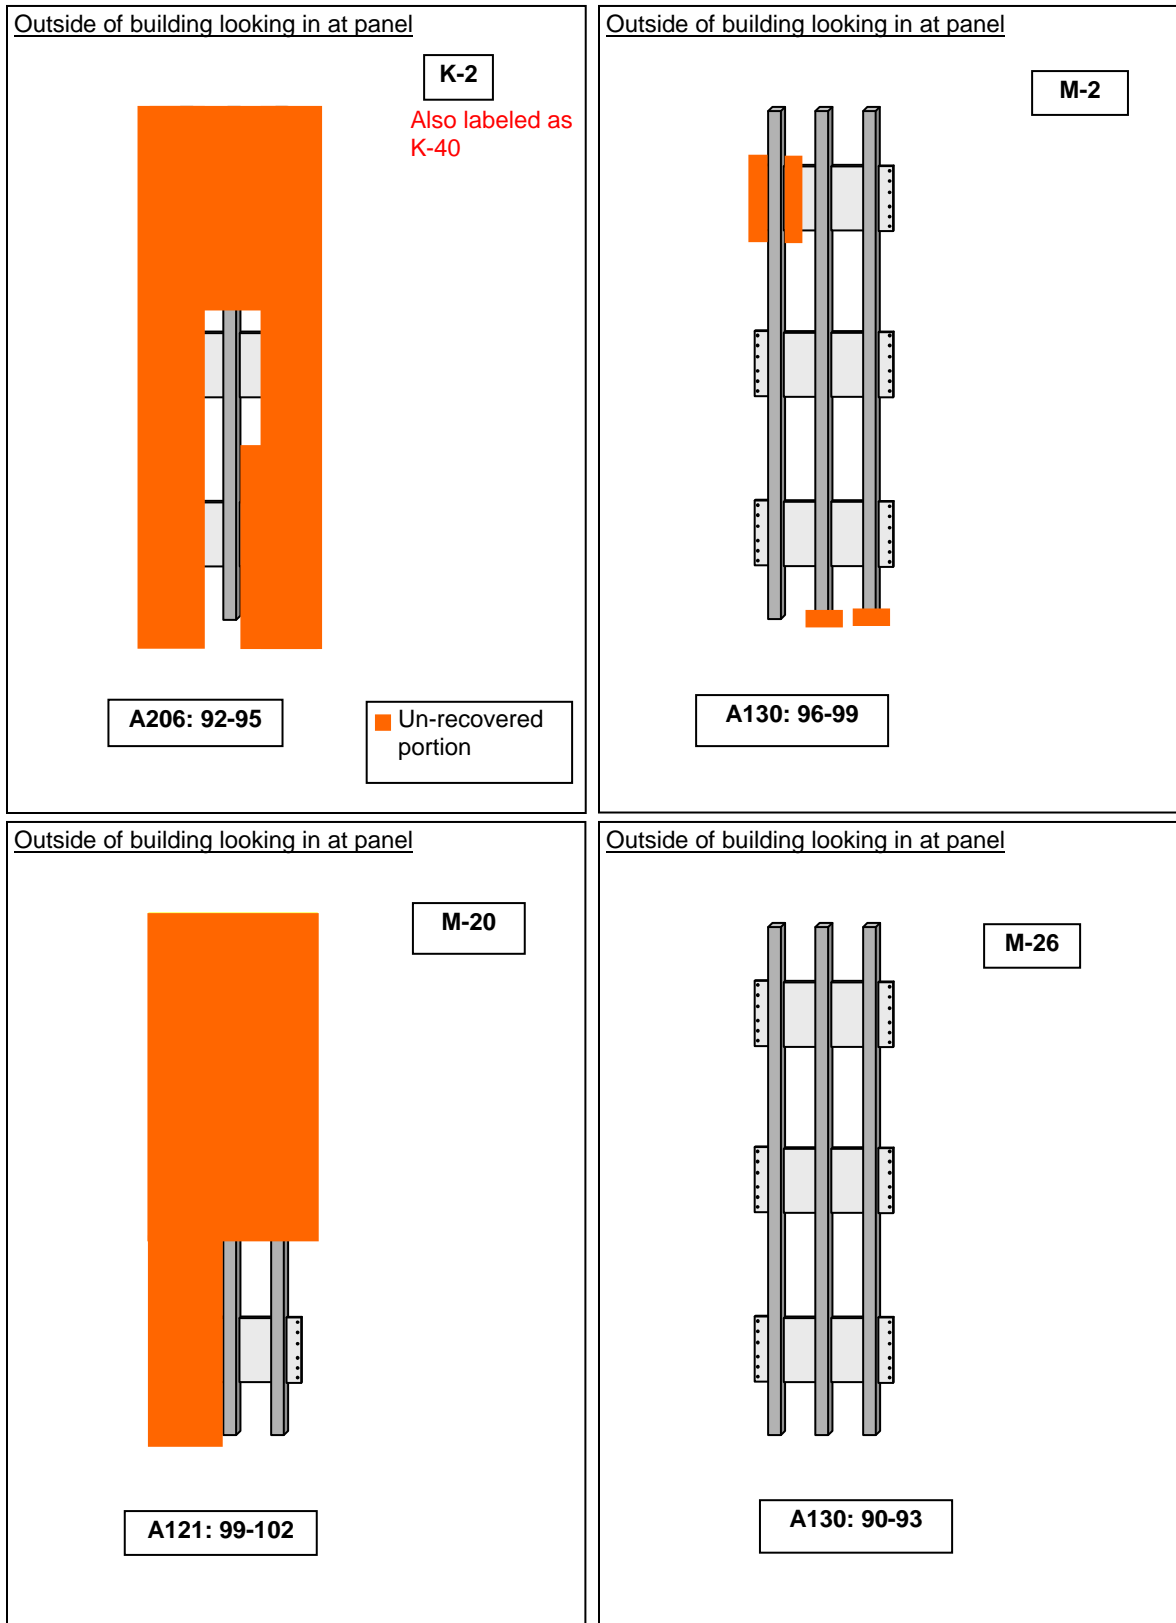
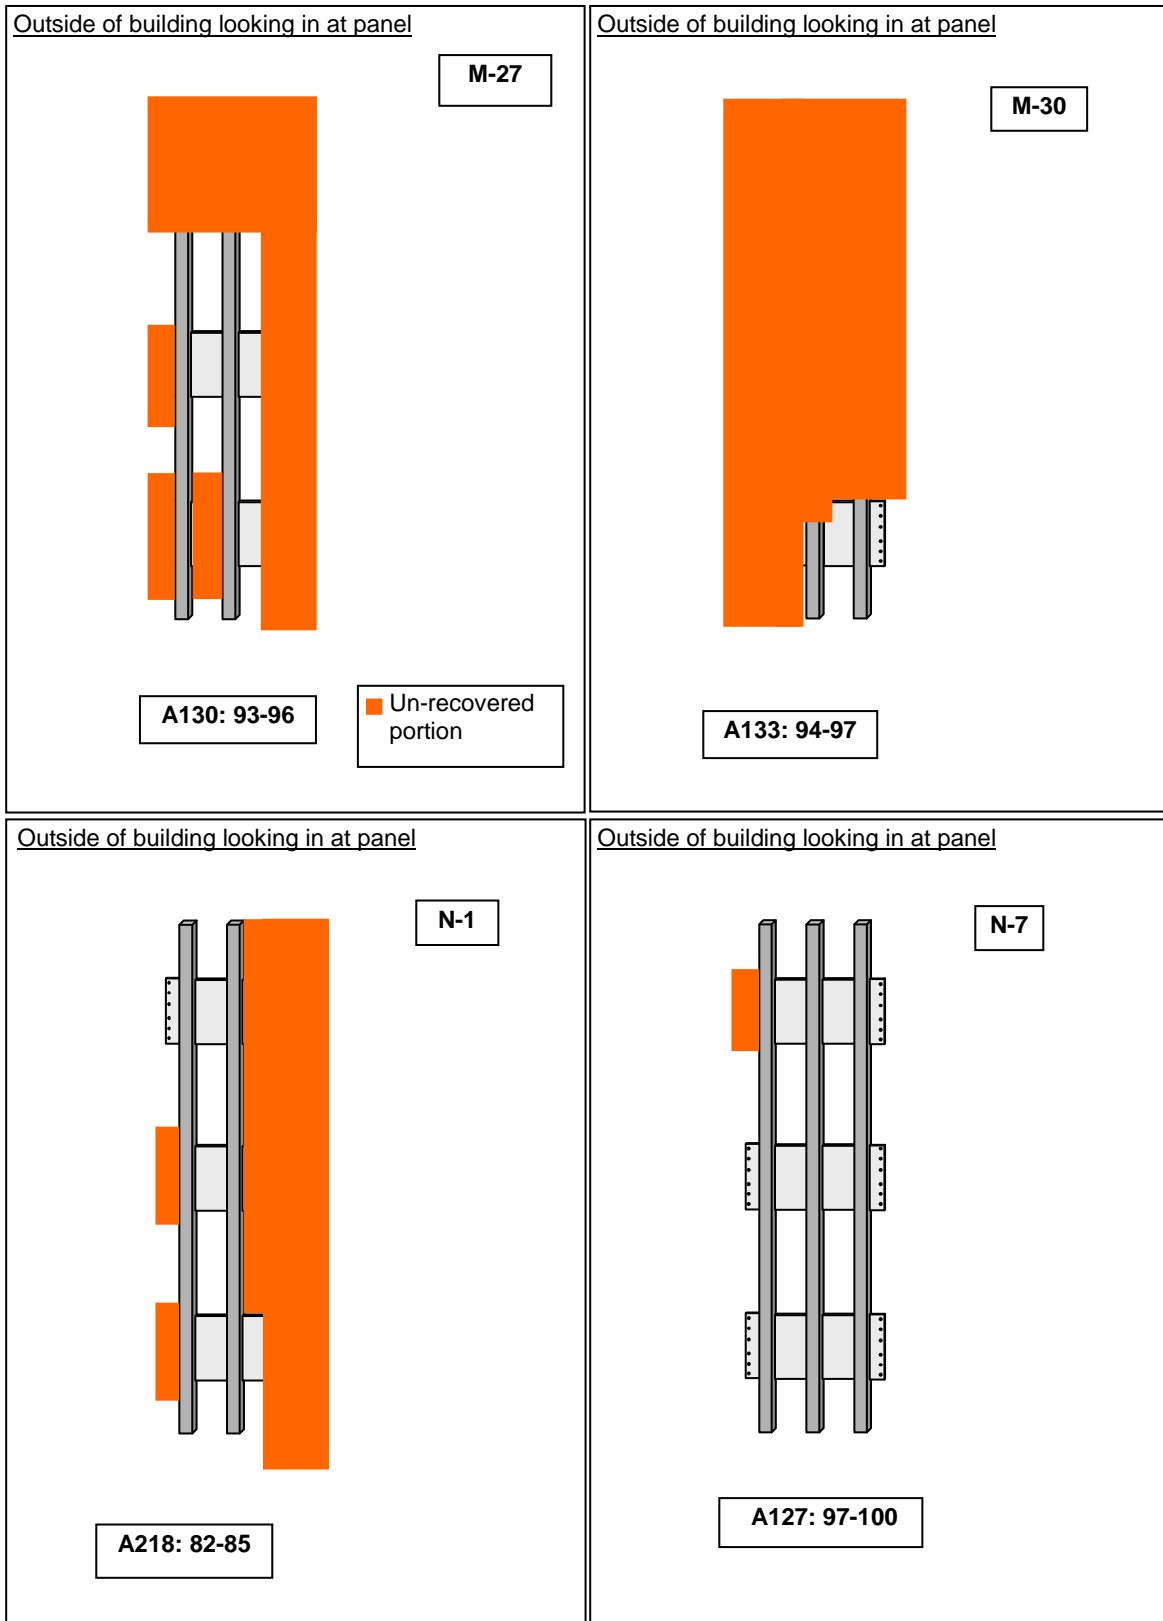
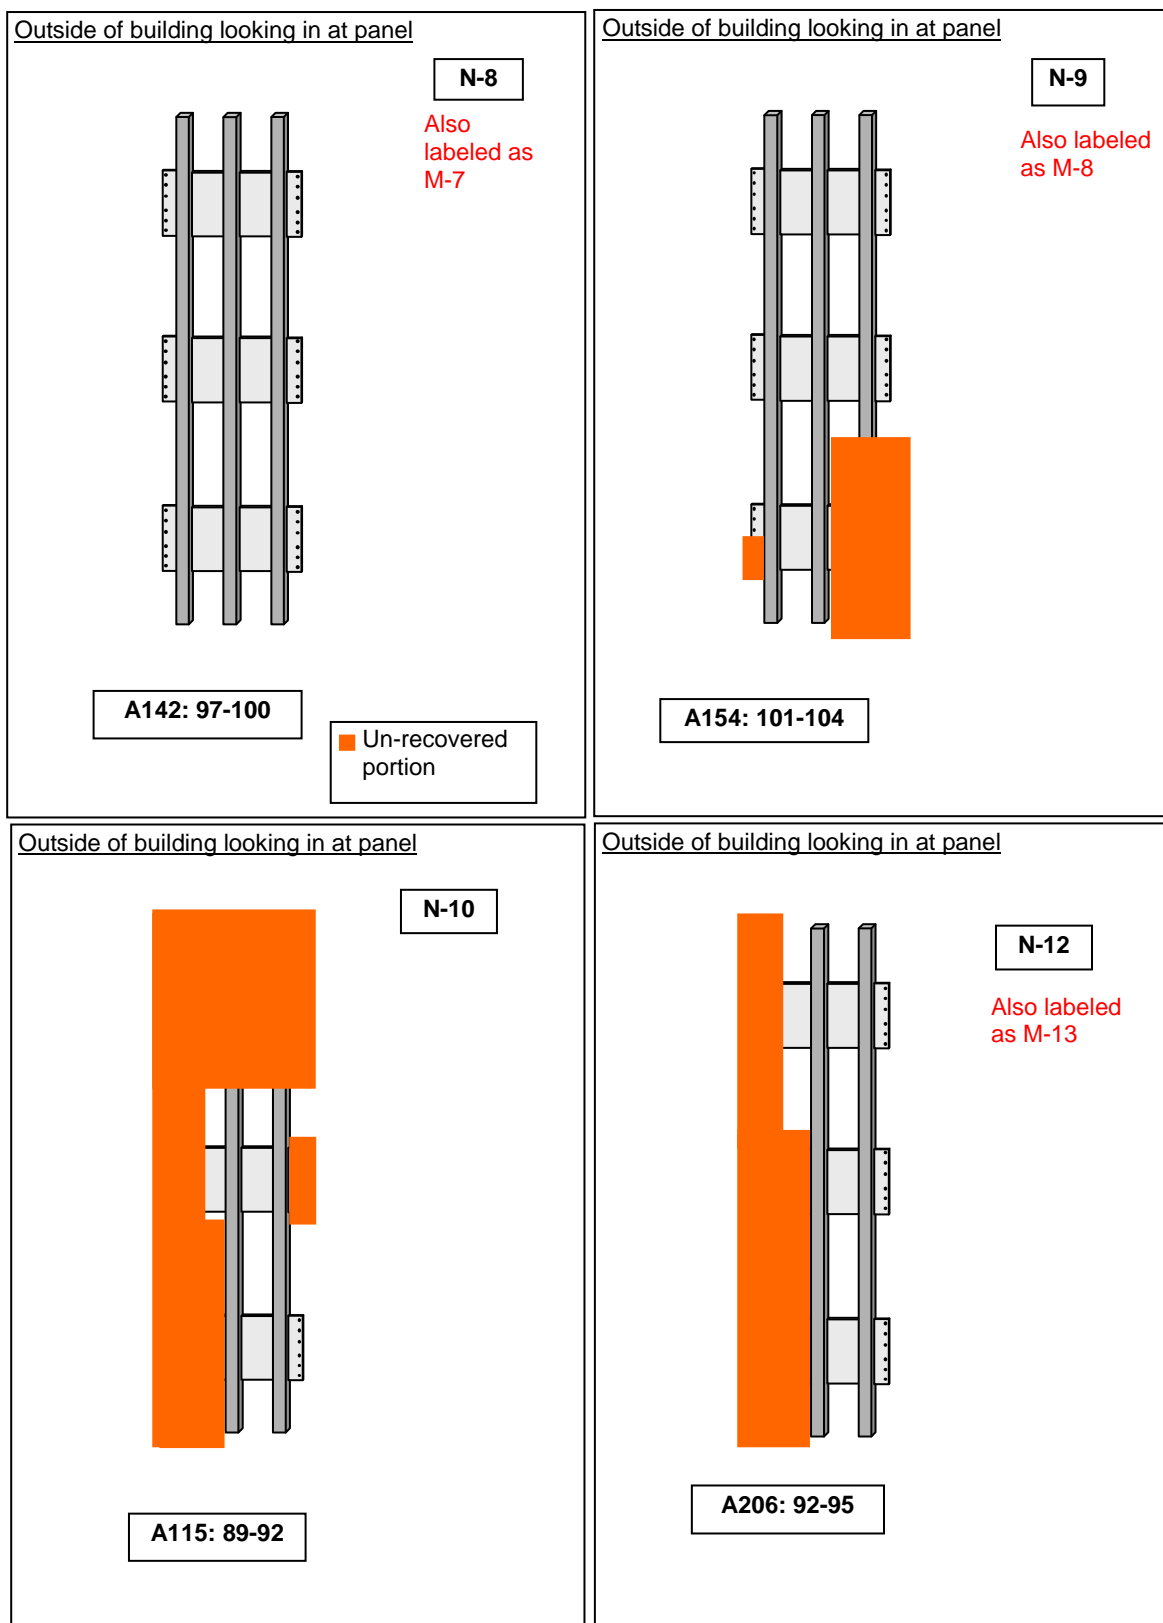
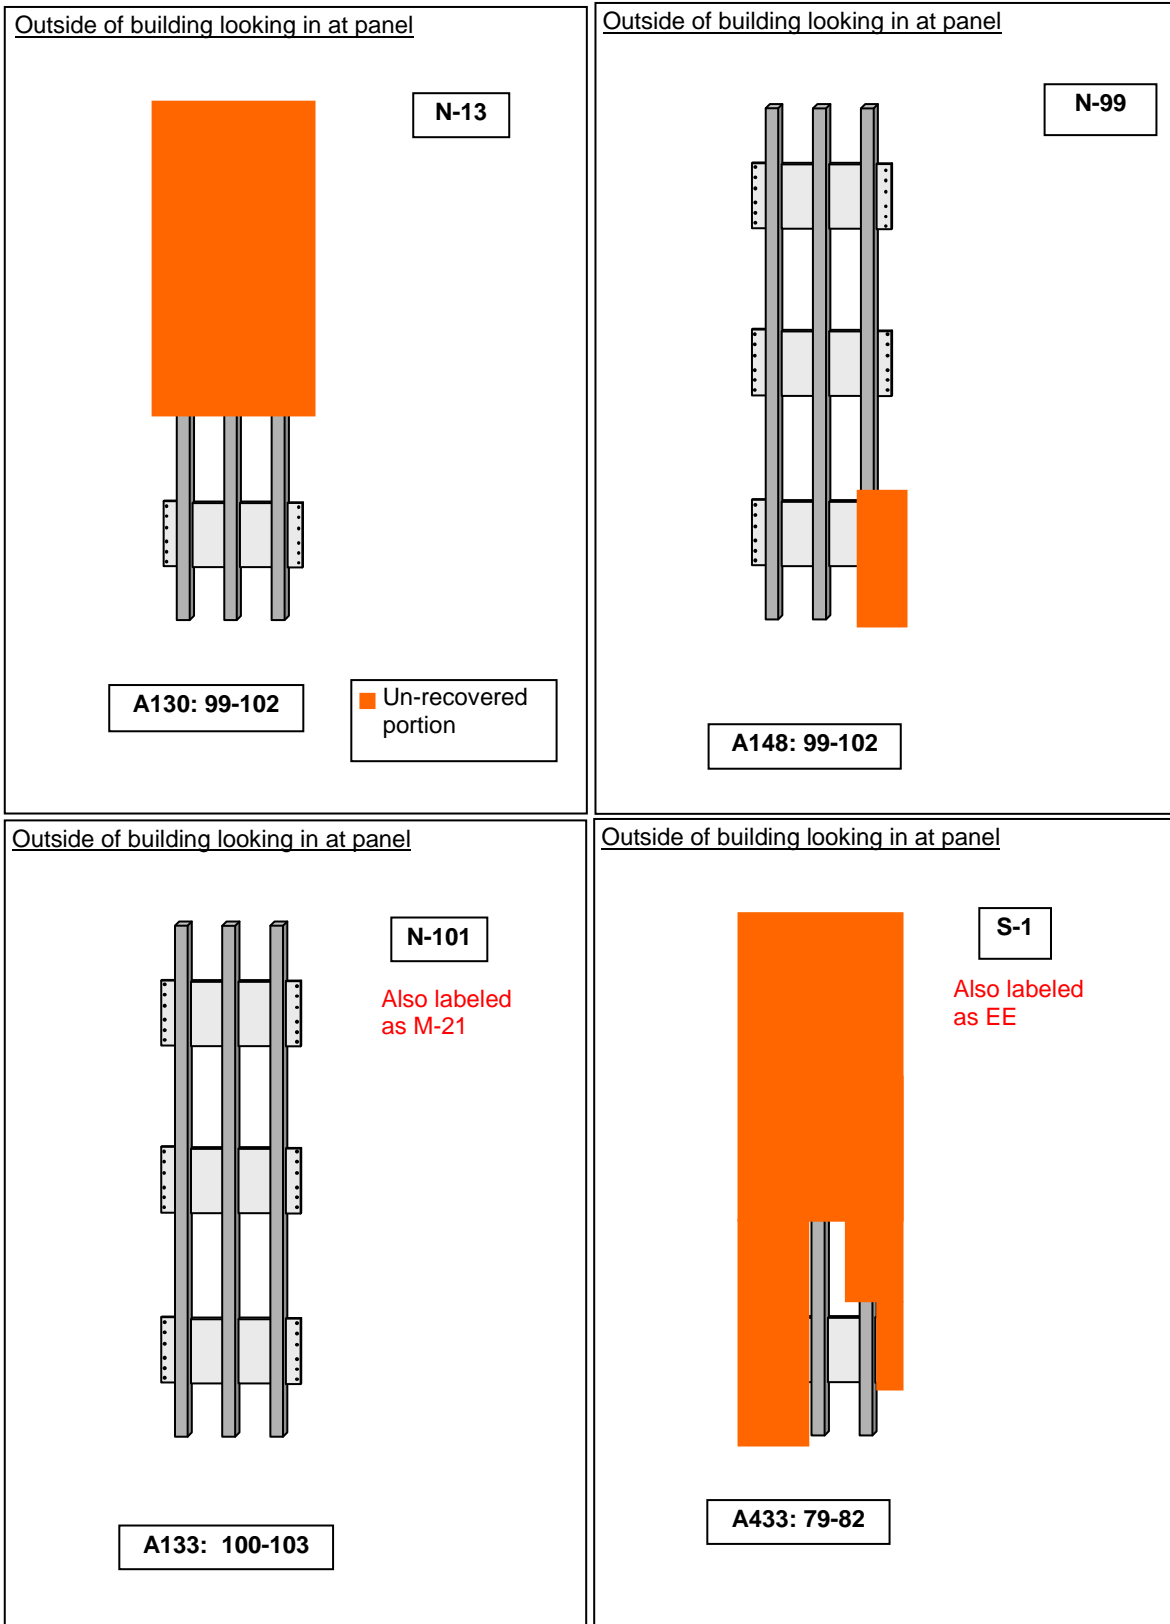
**Figure 3–10. Exterior column panel maps indicating the portion of the specific exterior column panel section recovered from WTC 1.**
