**NIST NCSTAR 1-3B**

**Federal Building and Fire Safety Investigation of the  
World Trade Center Disaster**

# **Steel Inventory and Identification**

Stephen W. Banovic

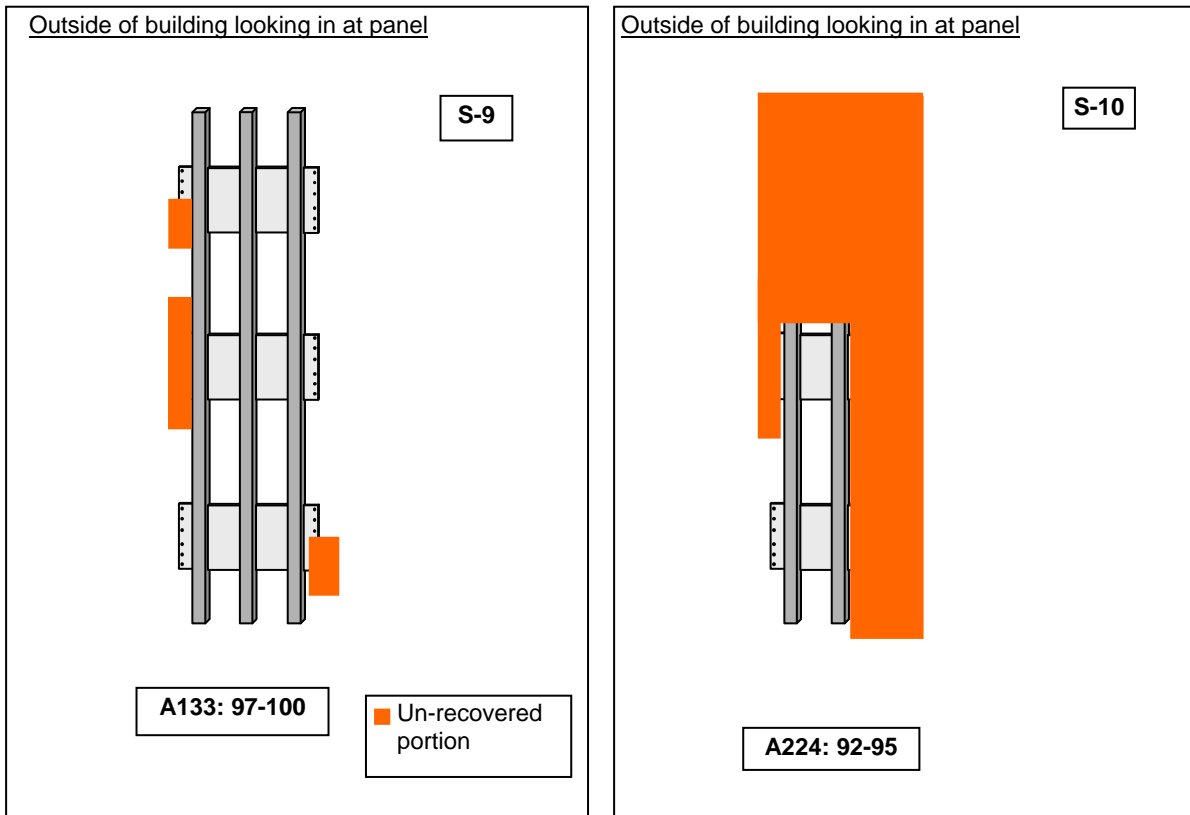
**Figure 3–10. Exterior column panel maps indicating the portion of the specific exterior column panel section recovered from WTC 1 (continued).**

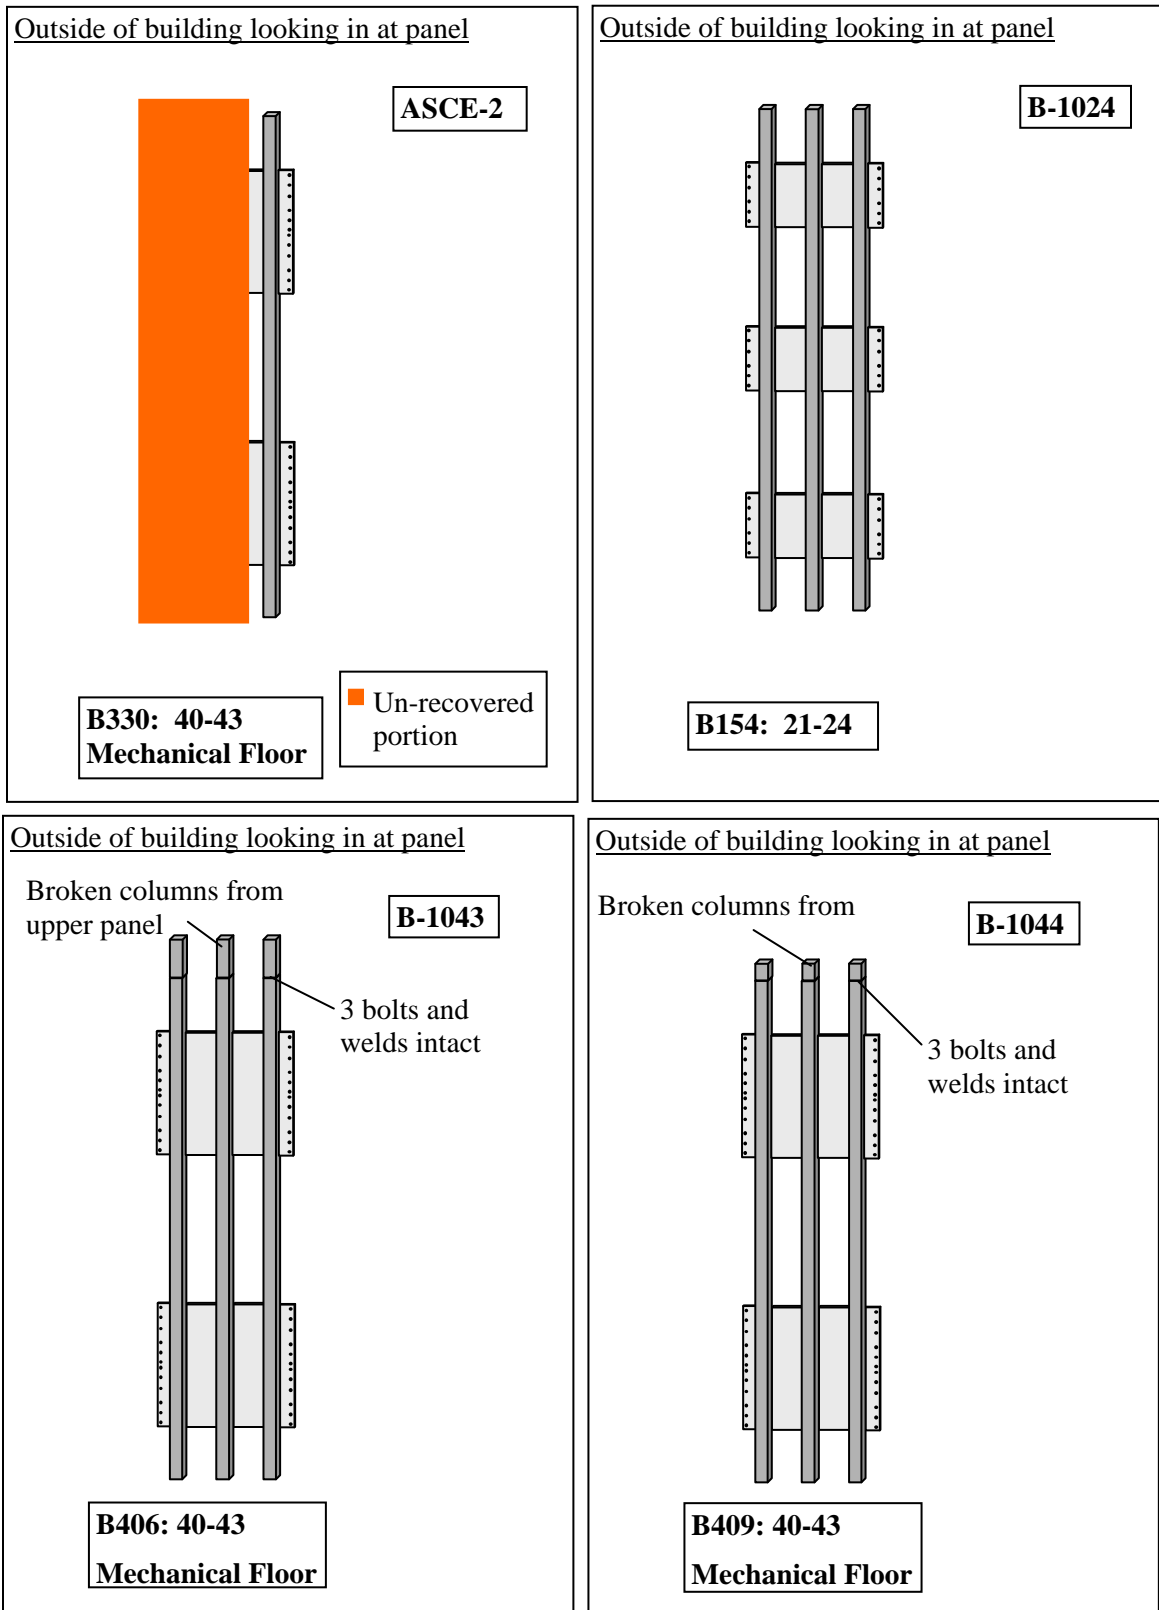
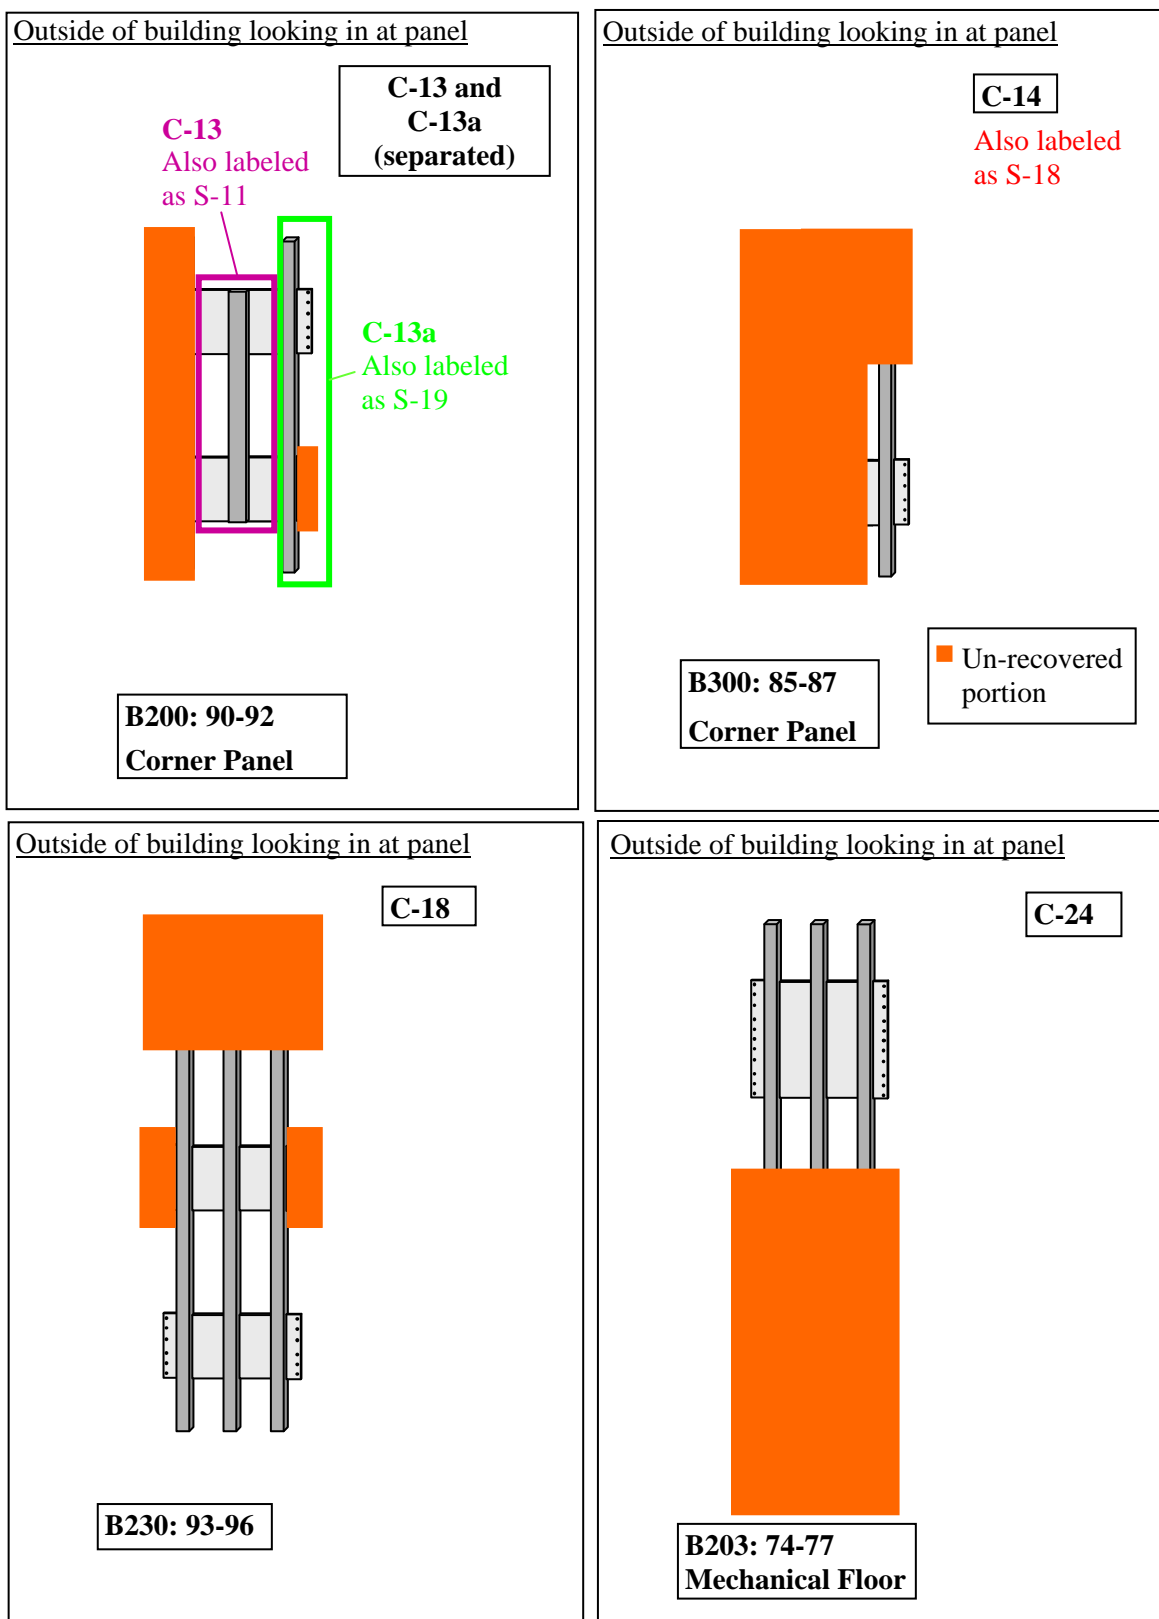
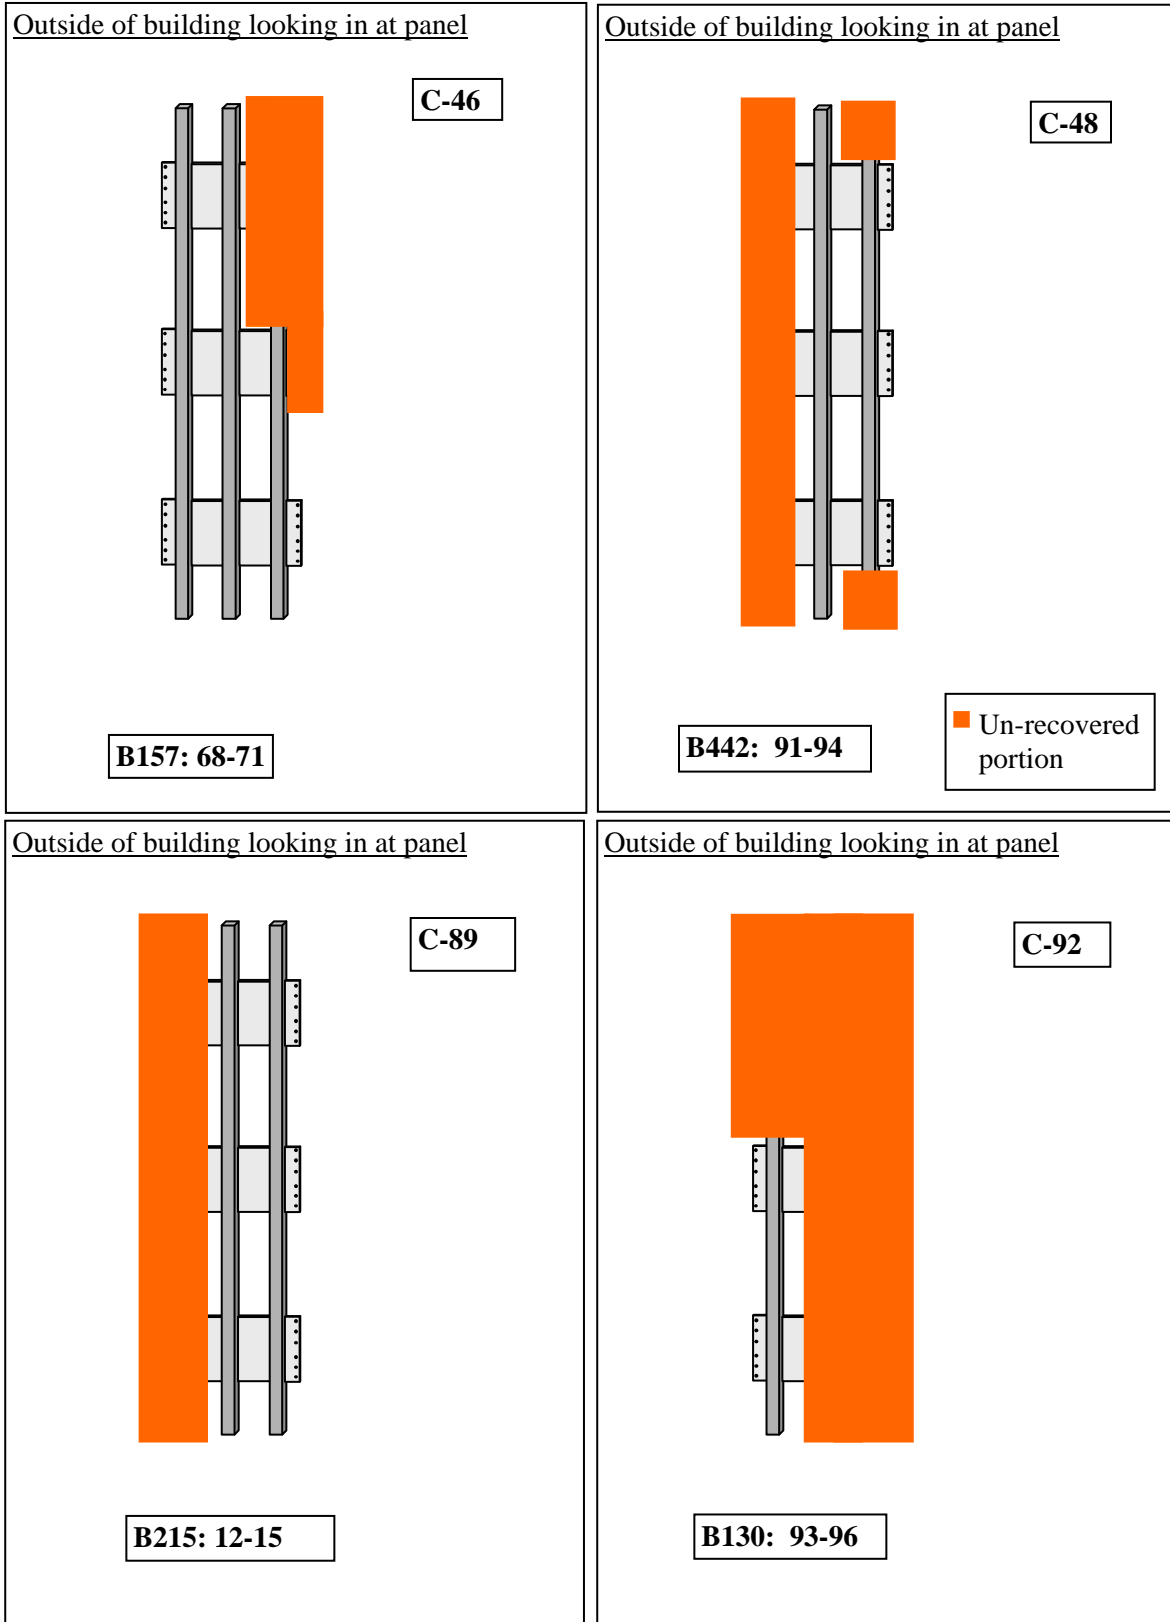
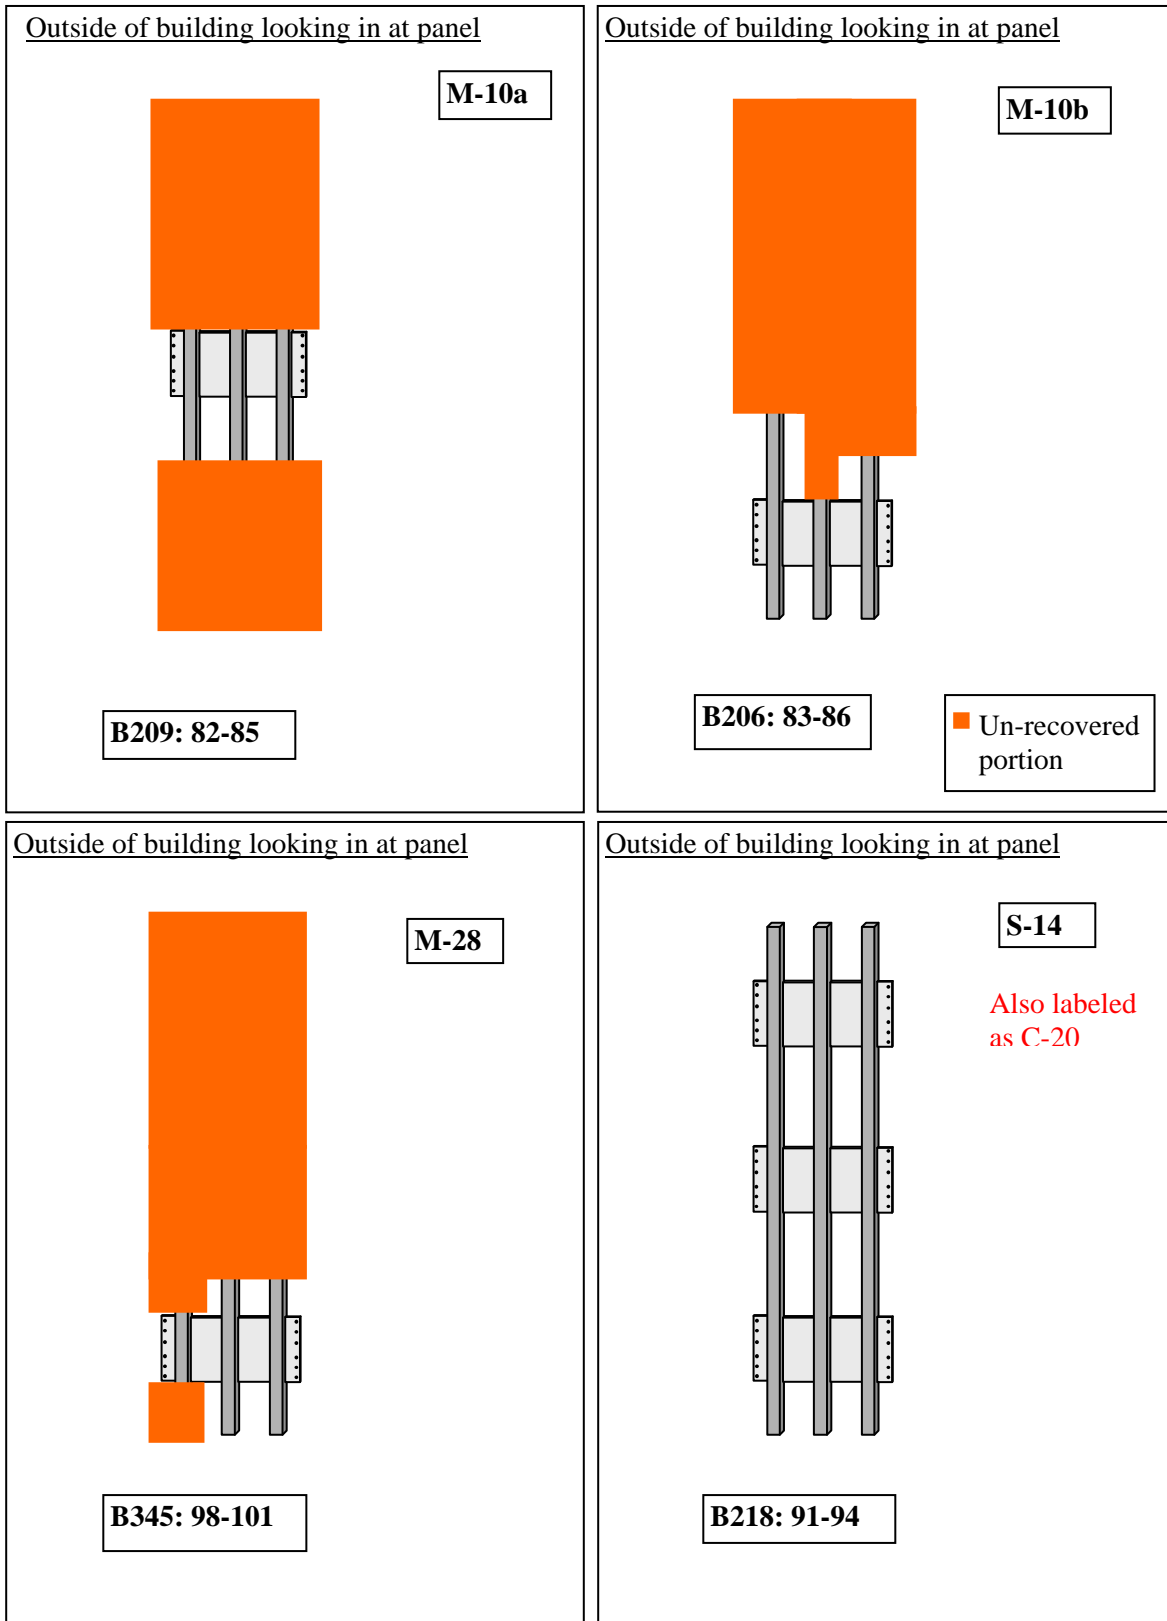
Figure 3-11. Exterior column panel maps indicating the portion of the specific exterior column panel section recovered from WTC 2.

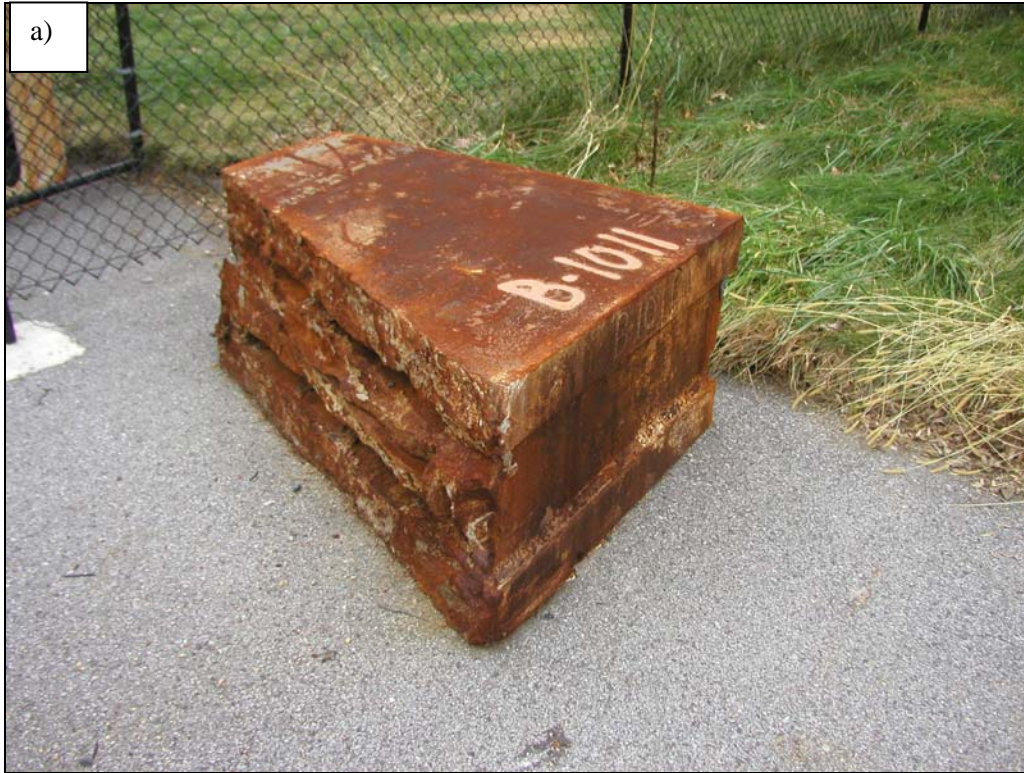
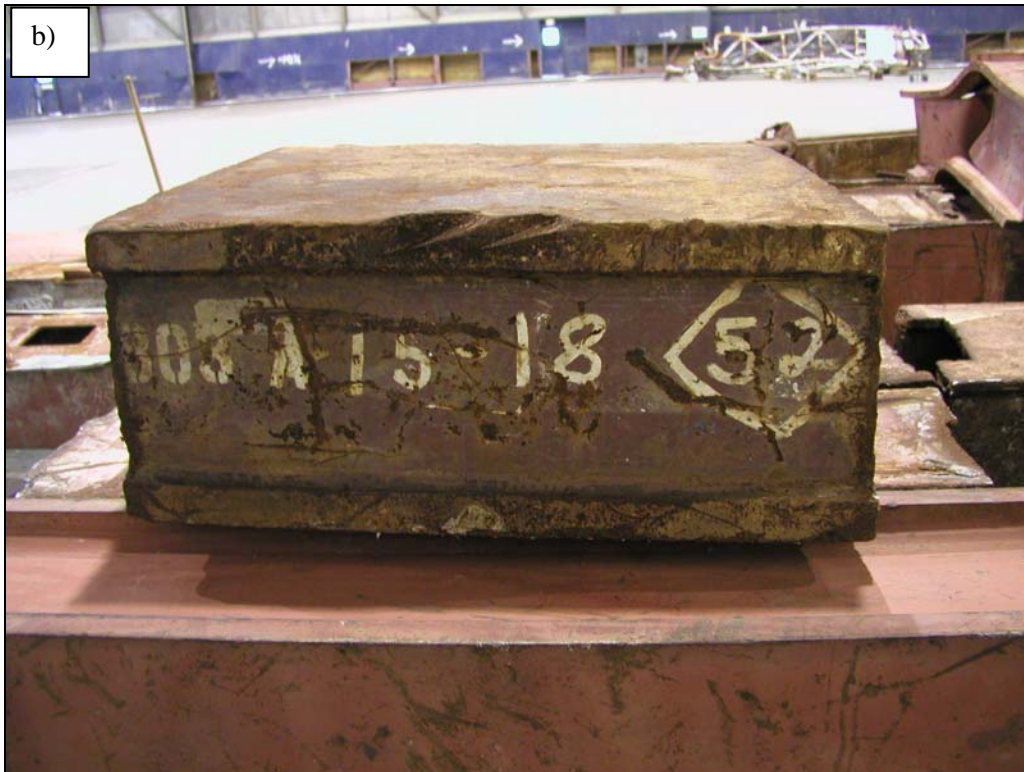
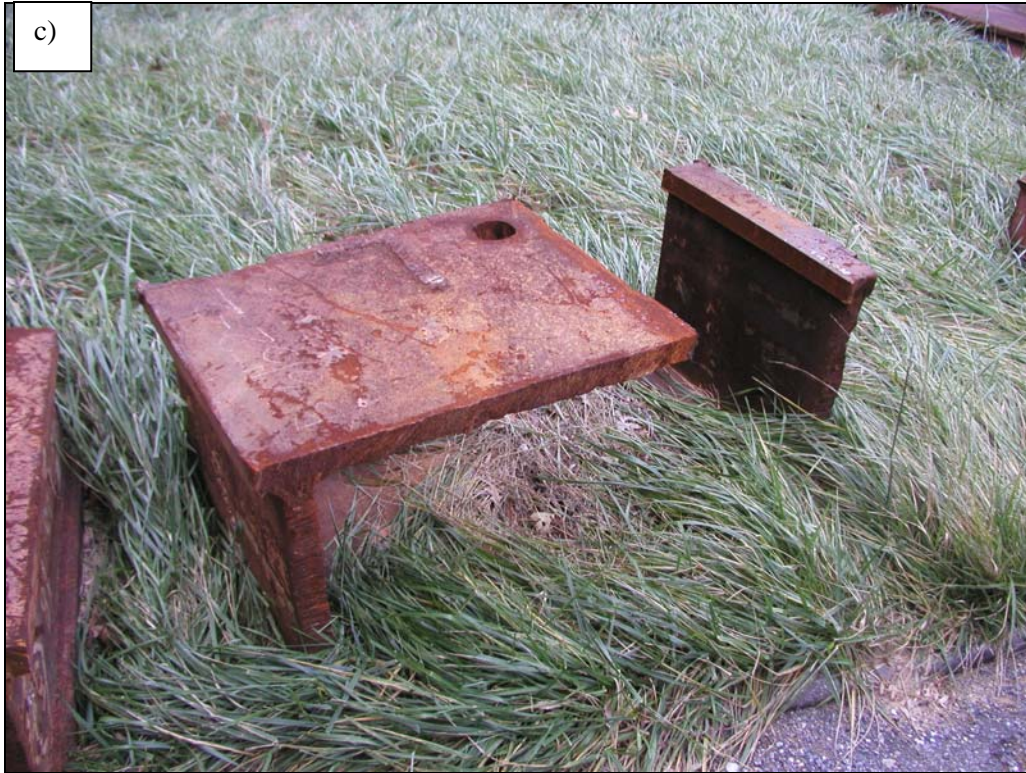
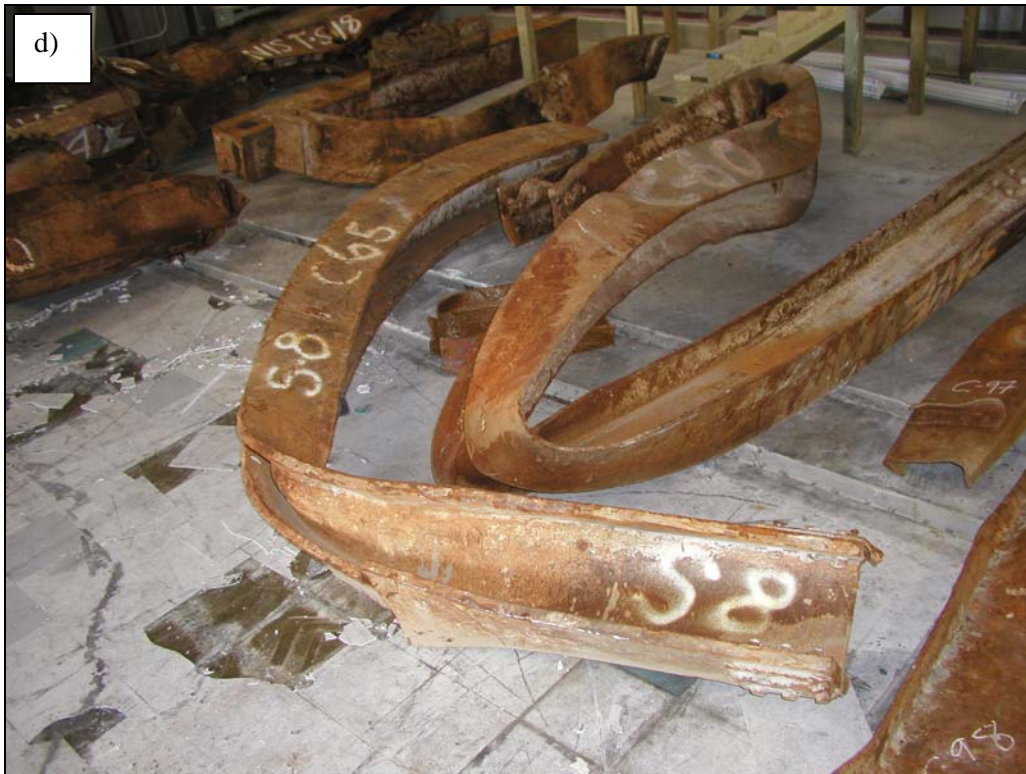
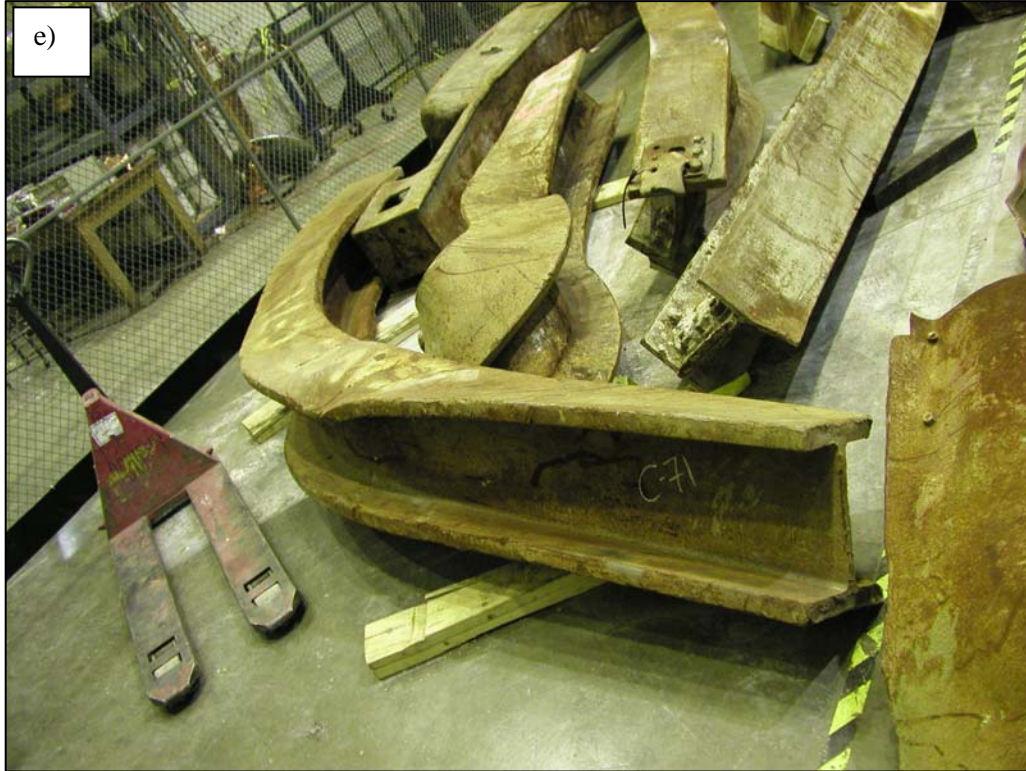
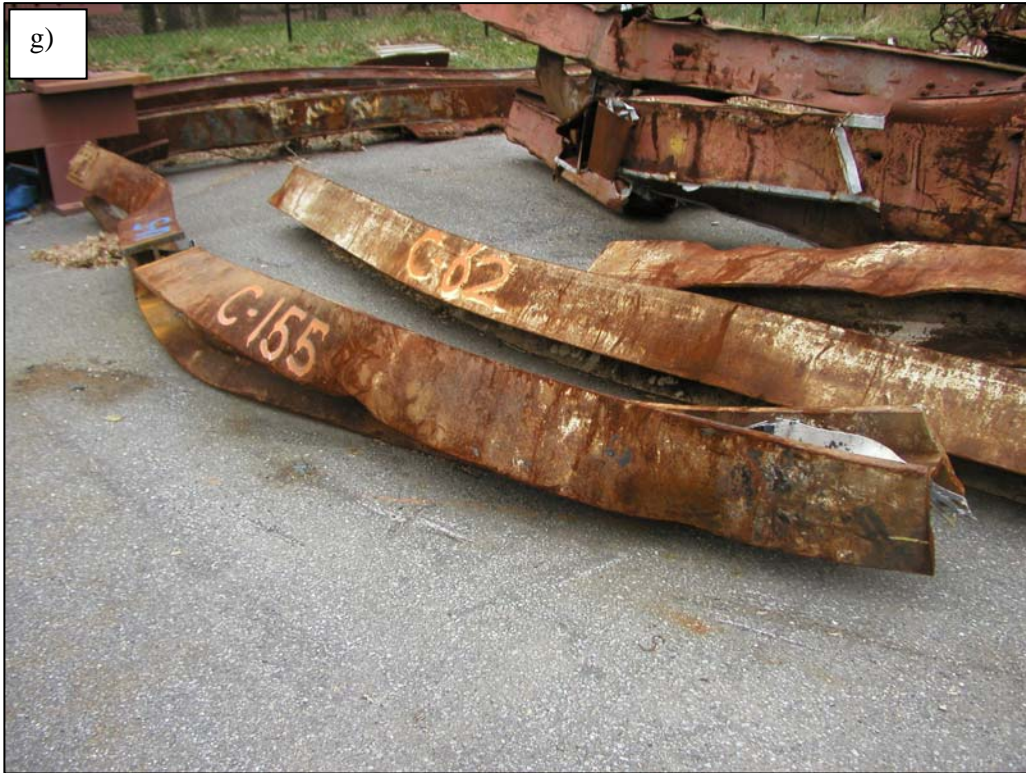
**Figure 3–12. Core columns recovered from WTC 1. a) B-1011 (508A: 51–54), lower 2 ft to 3 ft of built-up box column, b) B-6152-1 (803A: 15–18), lower 3 ft of built-up box column.**

**Figure 3–12. Core columns recovered from WTC 1. c) B-6152-2 (504A: 33–36), lower 2 ft of built-up box column, d) C-65 (904A: 86–89), lower 24 ft of wide flange section (continued).**

**Figure 3–12. Core columns recovered from WTC 1. e) C-71 (904A: 77–80), lower 16 ft of wide flange section, f) C-80 (603A: 92–95), lower 13 ft of wide flange section (continued).**

**Figure 3–12. Core columns recovered from WTC 1. g) C-155 (904A: 83–86), lower 33 ft of wide flange section, and h) HH (605A: 98–101), lower 16 ft of wide flange section (continued).**

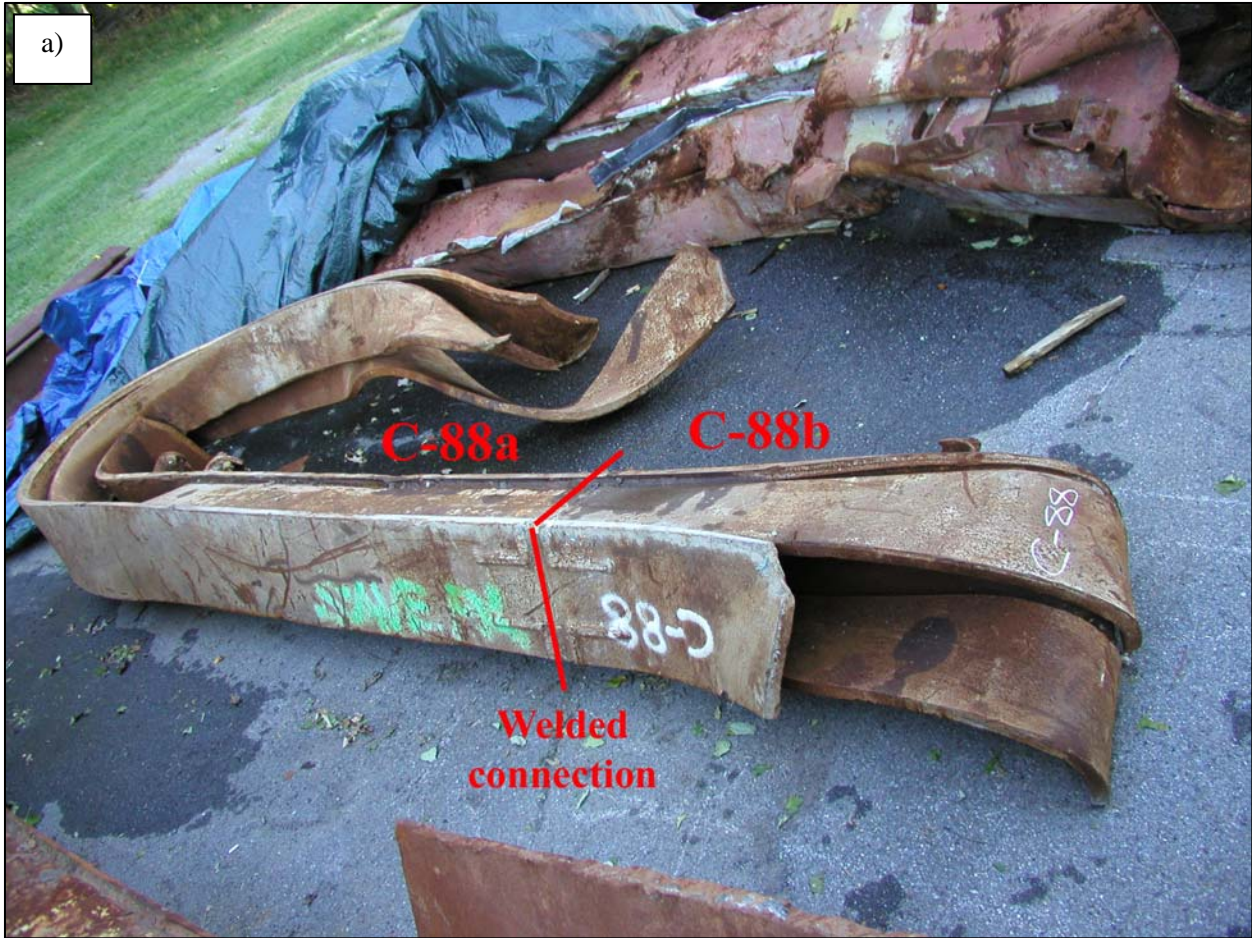
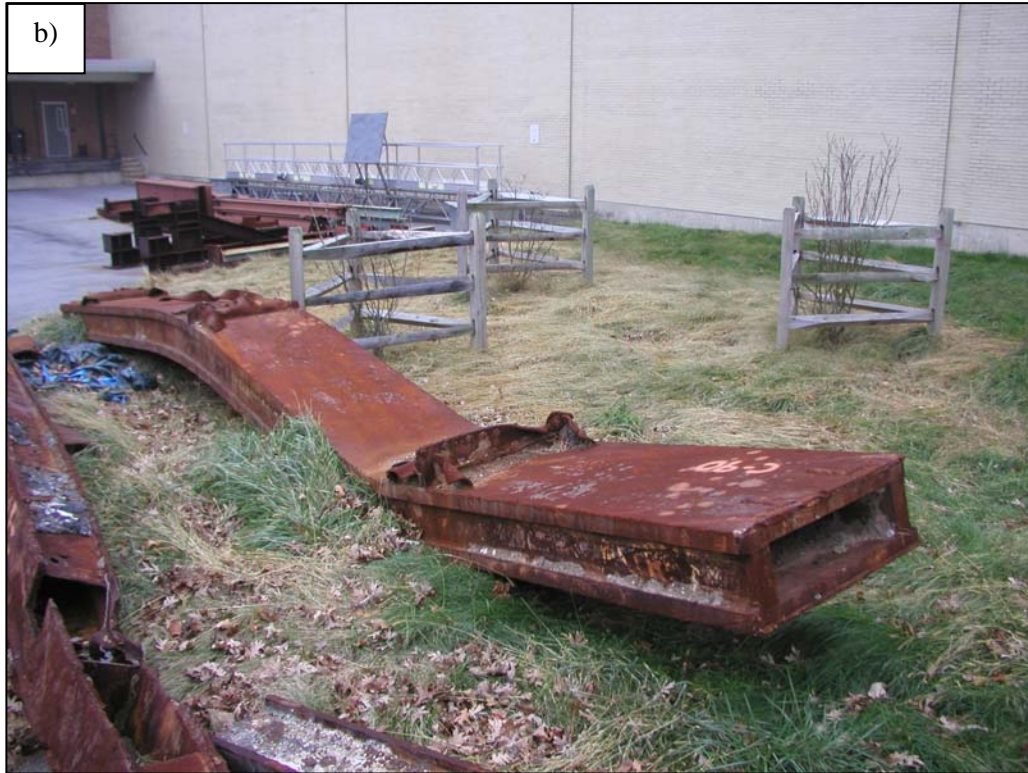
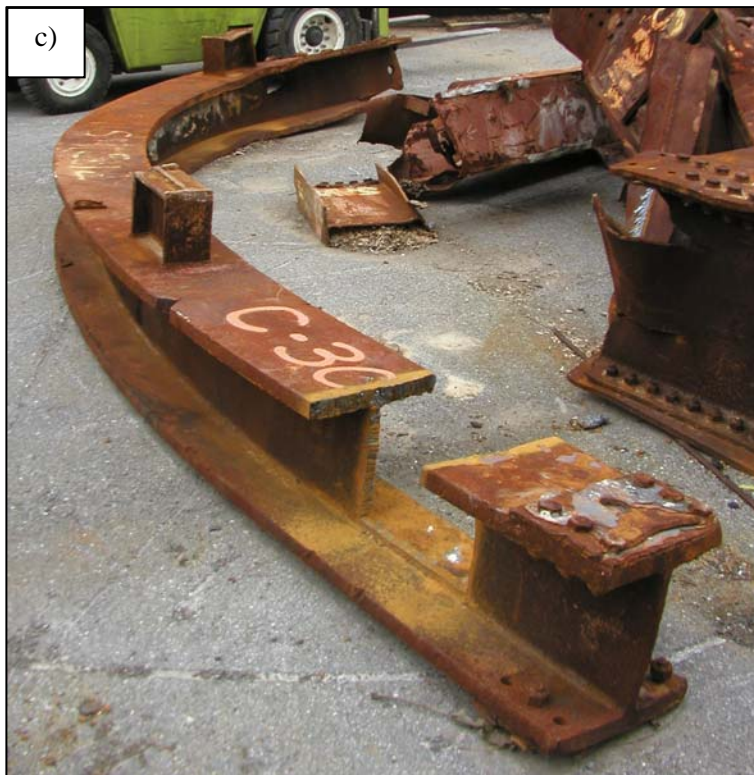
Figure 3–13. Core columns recovered from WTC 2. a) C-88a (801B: 80–83), lower 16 ft of built-up box column and C-88b (801B: 77–80), upper 8 ft of built-up box column.

**Figure 3–13. Core columns recovered from WTC 2. b) C-90 (701B: 12–15), entire length of built-up box column, and c) C-30 (1008B: 104–106) entire length of wide flange section (continued).**

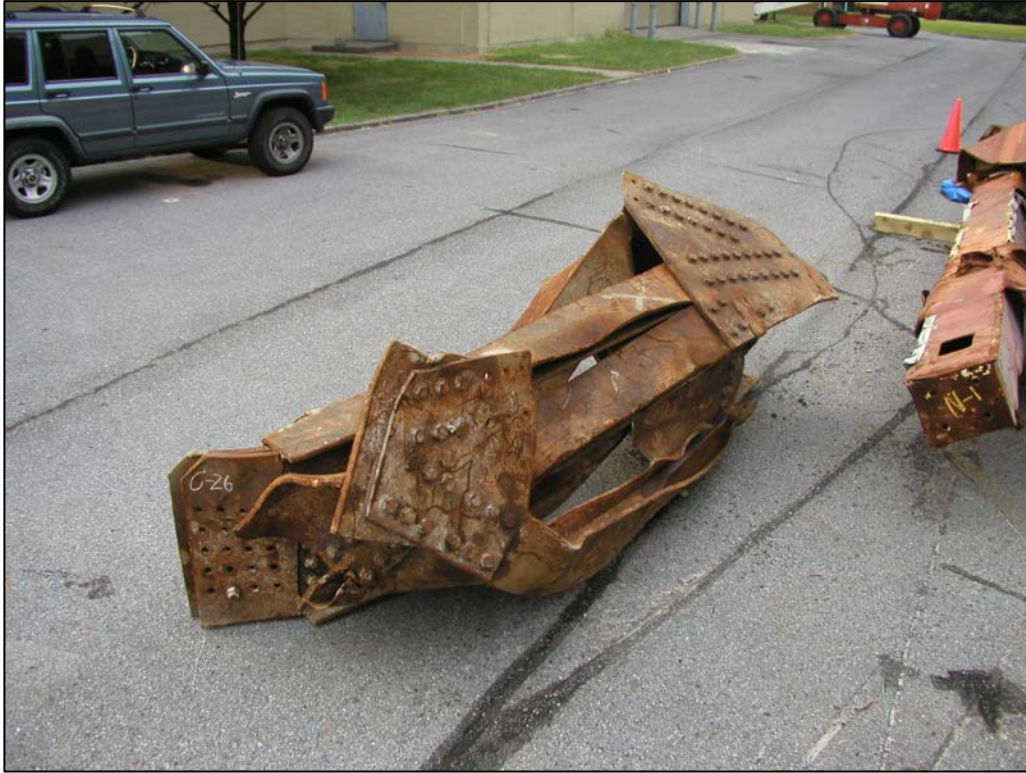
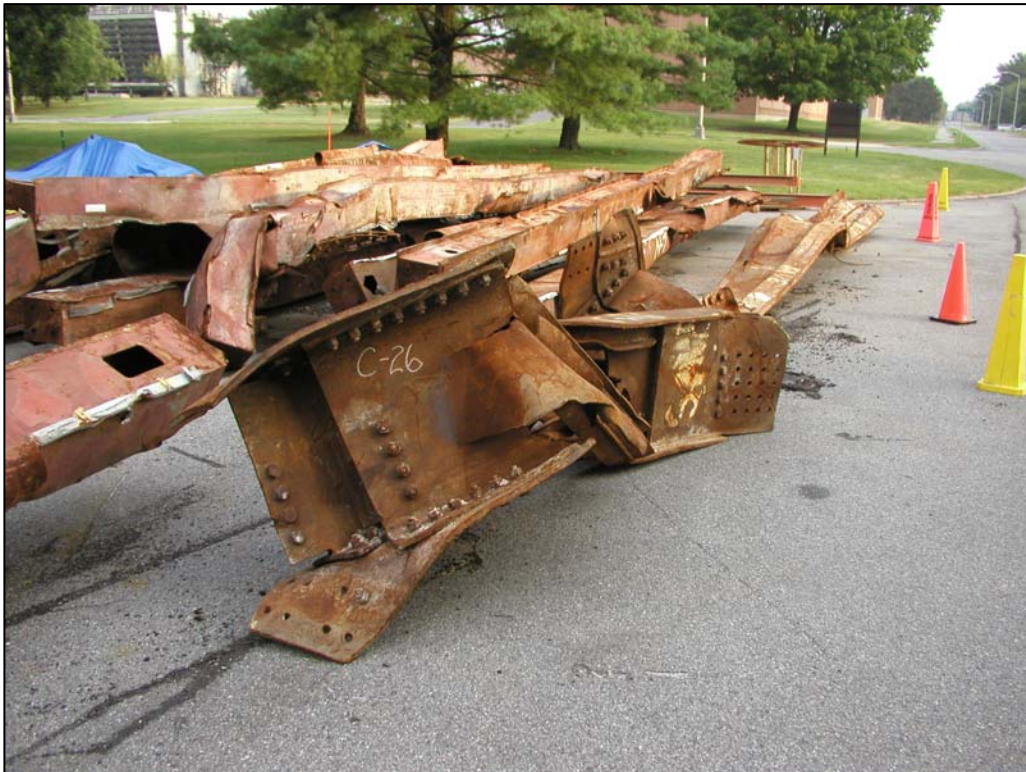
**Figure 3–14. Structural element composed of three wide flange sections bolted together. The component was found to be from the framed floor area outside of the core on the 107th floor of WTC 1 (sample was C-26).**

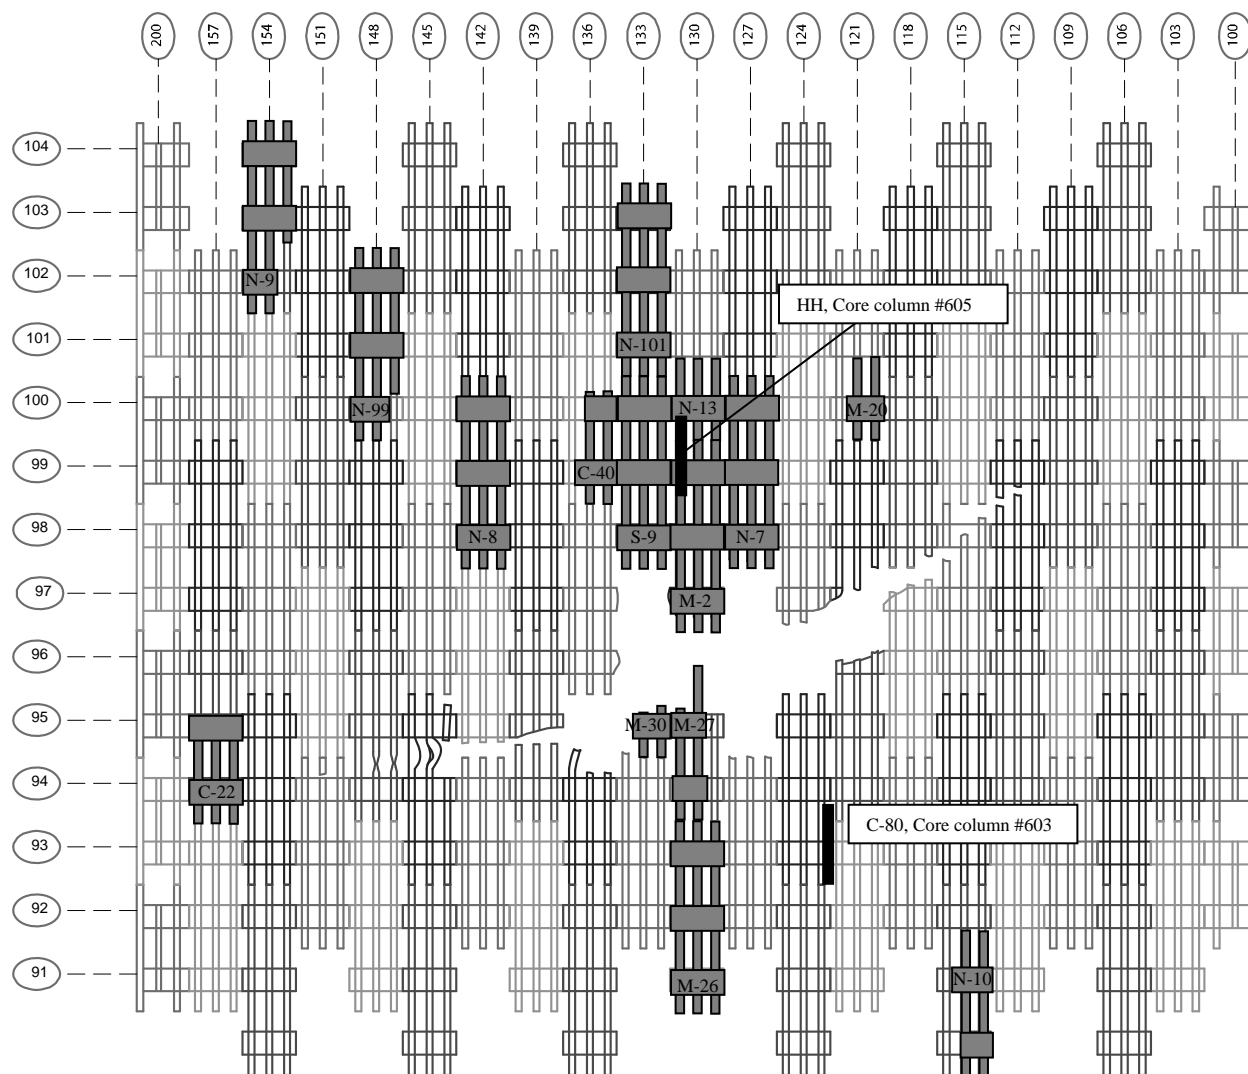
**Figure 4–1. Interpreted column damage, from photographic evidence, to WTC 1, with overlay of samples in NIST’s possession. Samples shown represent recovered portions. Core columns 603 and 605 are in the second row from the north face of WTC 1.**

Interpretation of the photographic evidence revealed that damage to World Trade Center (WTC) 1 due to aircraft impact occurred from floor 94 to floor 99 and was bounded by columns 111 through 152. For WTC 2, the impact area was lower with damage found from floor 77 to floor 85. While the damage appears to be bordered by column lines 411 and 440, columns closer to the southeast corner of the building may also have been affected. However, few images were obtained where smoke is not obscuring this portion of the south face of WTC 2 to complete the analysis. From this information, NIST was able to determine which perimeter panels and core columns could be used to comment on damage and possible failure mechanisms in this area. Figure 4–1 shows the sample overlay of the exterior panels in NIST’s possession in and around the impact zone of WTC 1. Samples C-80 and HH, both core columns, were also identified as residing near the impact zone. The recovered portion of each column is approximately represented in this image. Unfortunately, there were no similar corresponding exterior panels for WTC 2, but two core columns were recovered (Fig. 4–2).

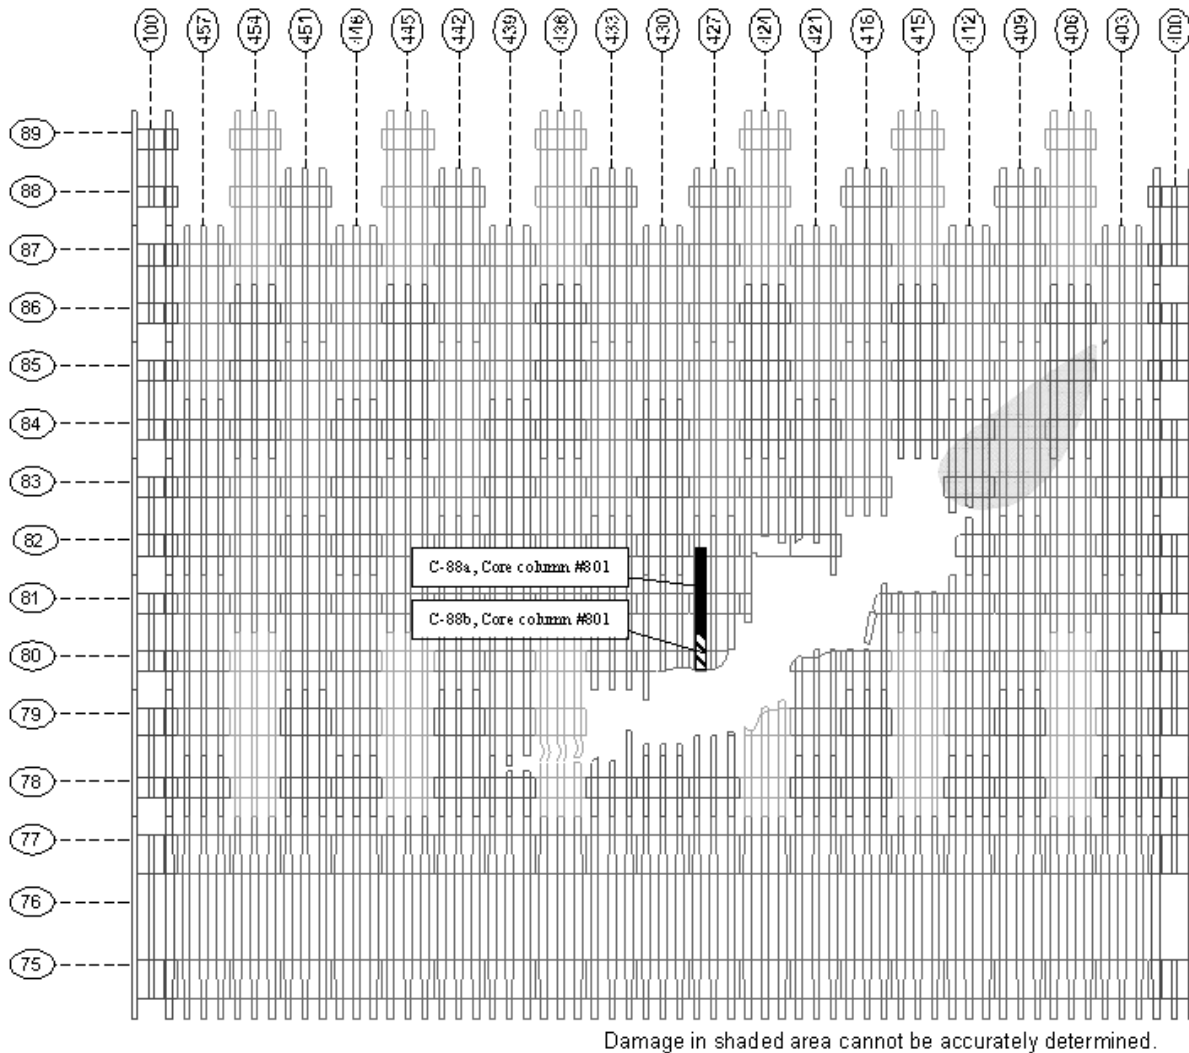
**Note:** Core column 801 is in the closest row to the south face of WTC 2.

**Figure 4–2. Interpreted column damage, from photographic evidence, to WTC 2, with overlay of samples in NIST’s possession.**

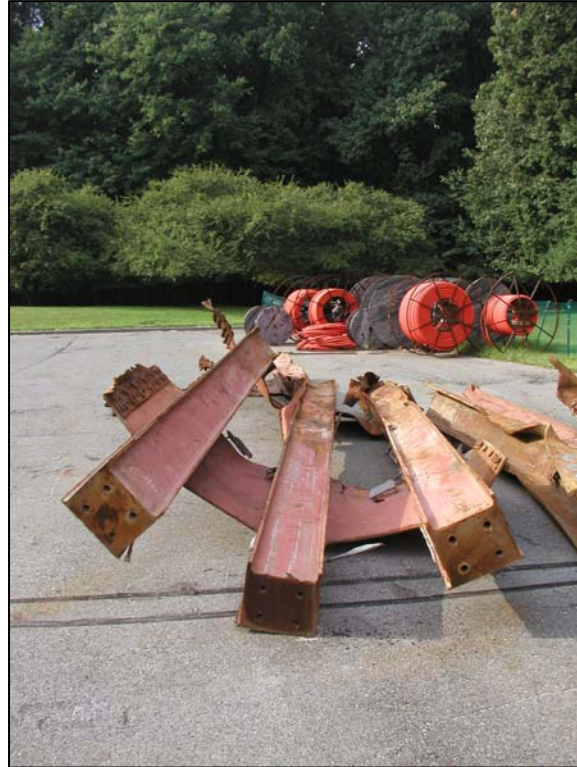
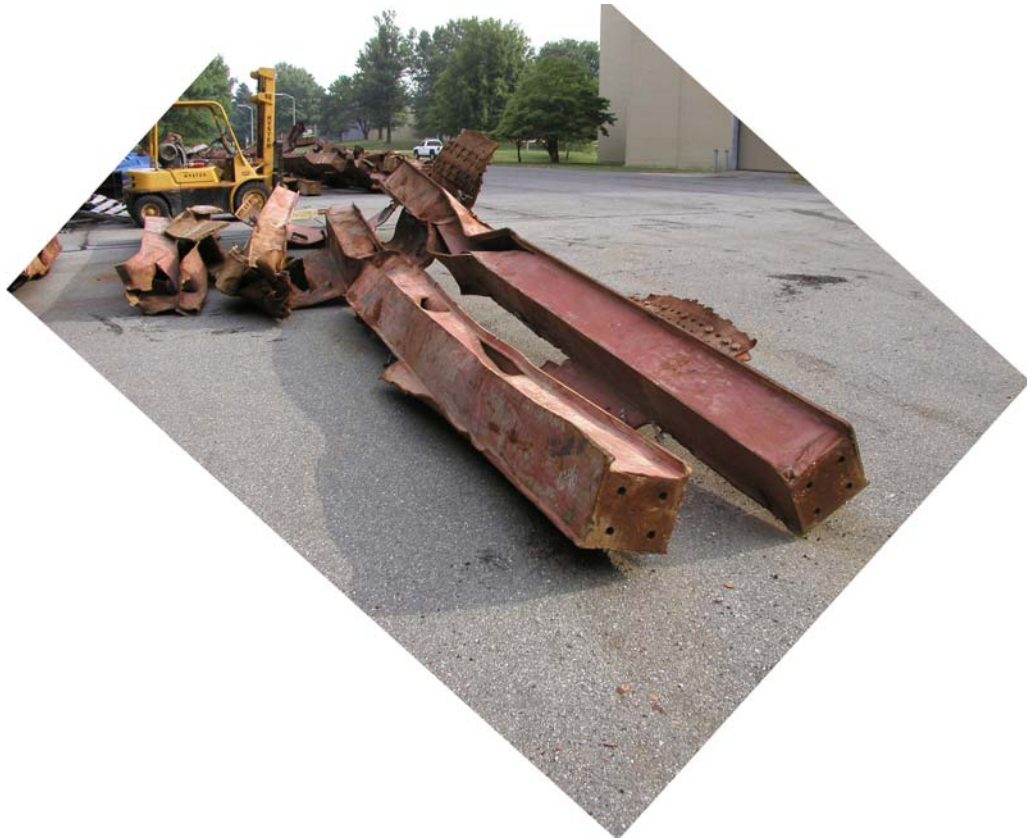
**Figure A–1. Exterior column panel, sample C-46 shown.**
