**NIST NCSTAR 1-3B**

**Federal Building and Fire Safety Investigation of the  
World Trade Center Disaster**

# **Steel Inventory and Identification**

Stephen W. Banovic

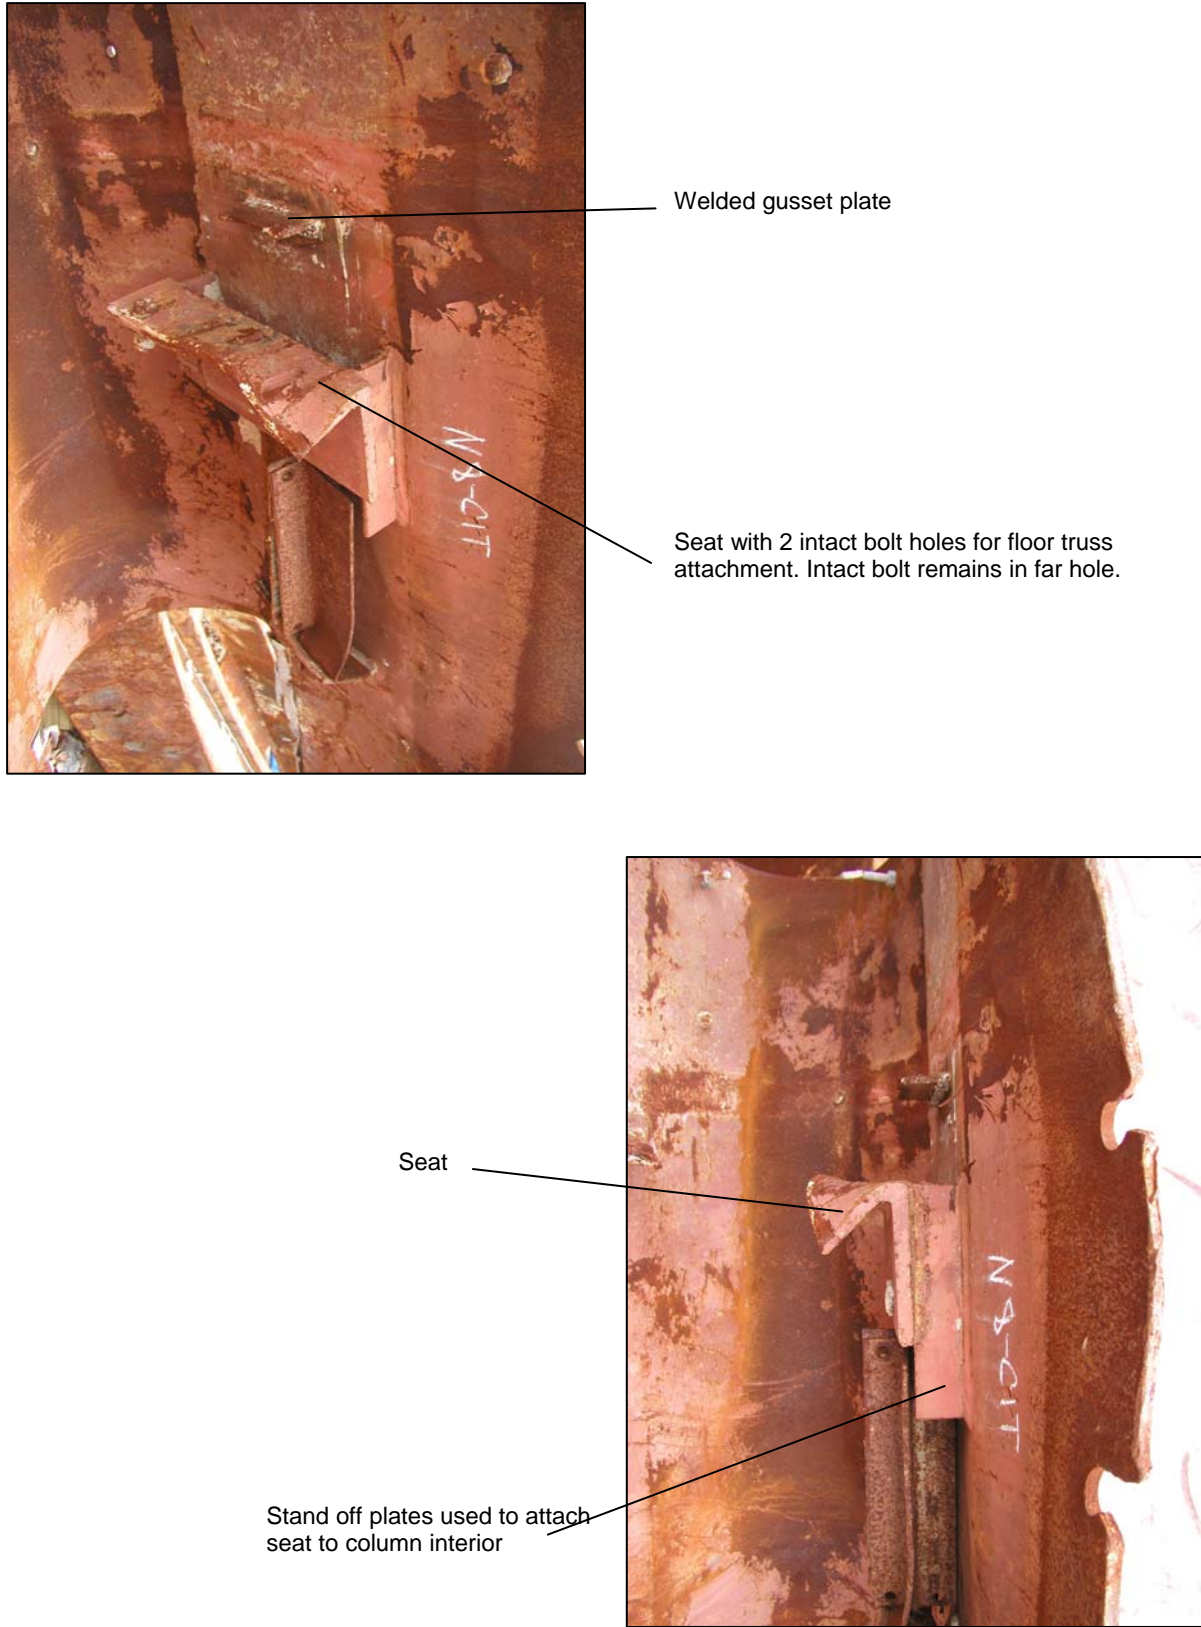
**Figure A-2. Floor truss seats shown from sample N-8.**

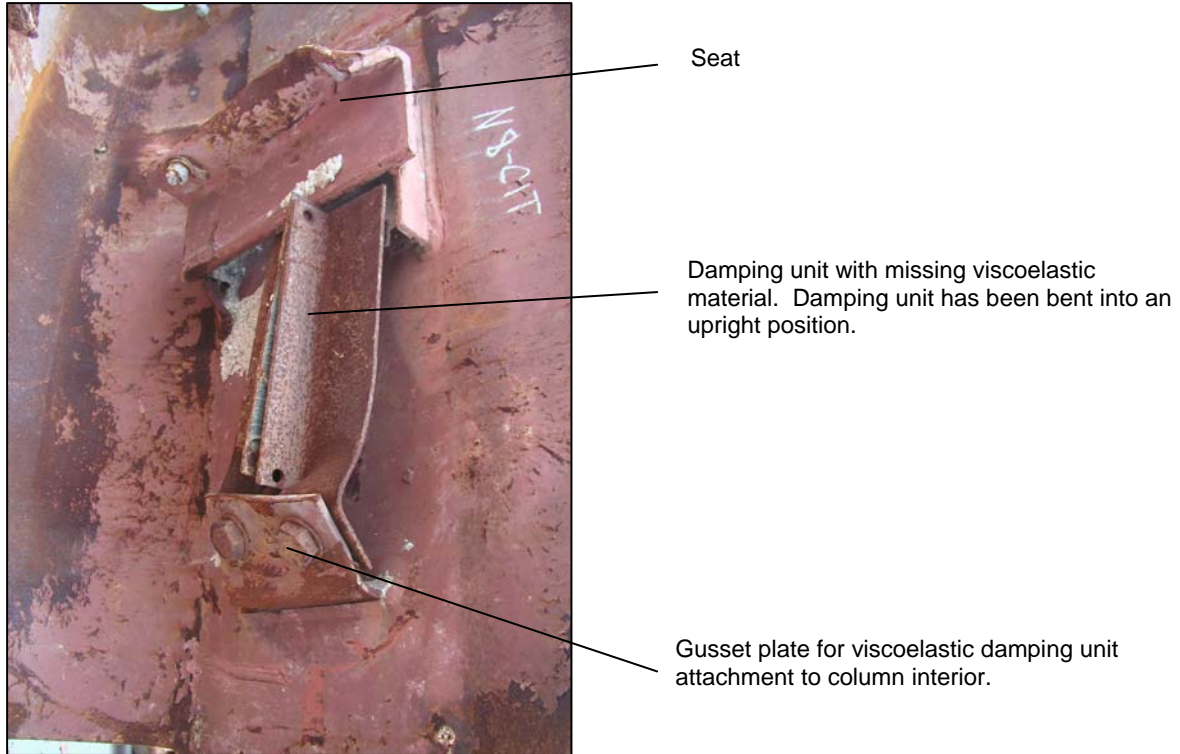
**Figure A-3. Damping Unit shown from sample N-8.**

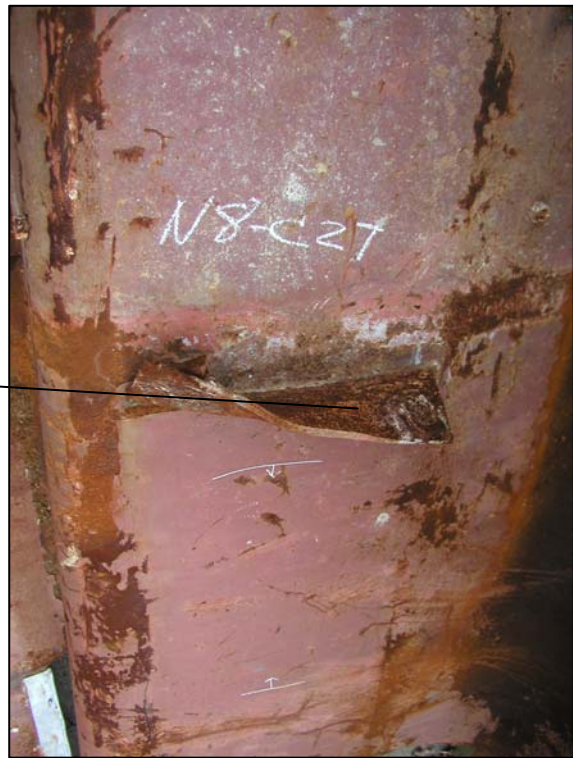
Welded gusset plate used in place of seat on alternate column/spandrel intersections. One method used to attach diagonal bracing strap to exterior wall

**Figure A-4. Gusset plate shown from sample N-8.**

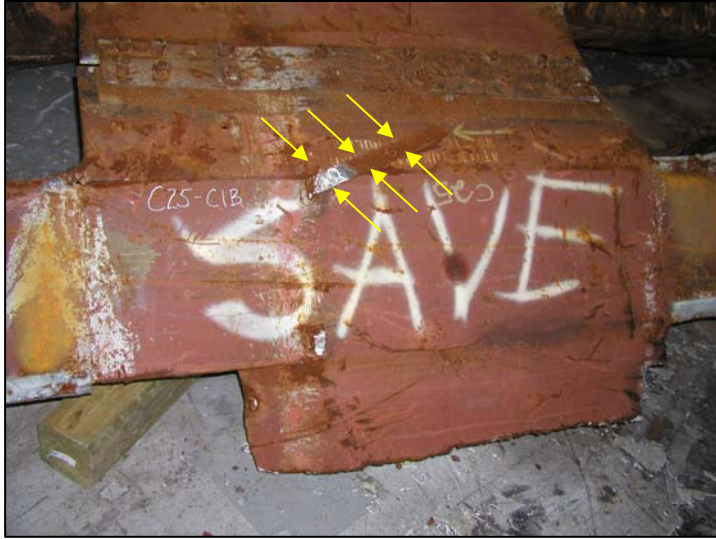
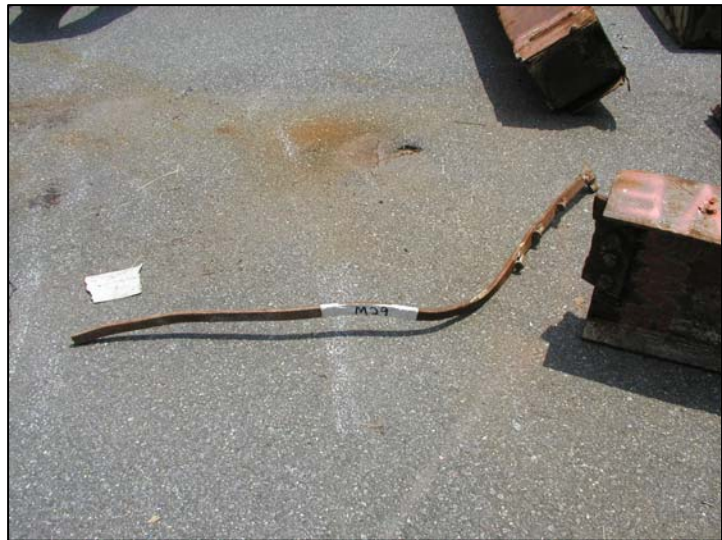
Diagonal bracing strap attached directly to exterior column

**Figure A-5. Diagonal bracing strap shown on sample C-25 (top), and single strap labeled M-29 (bottom).**

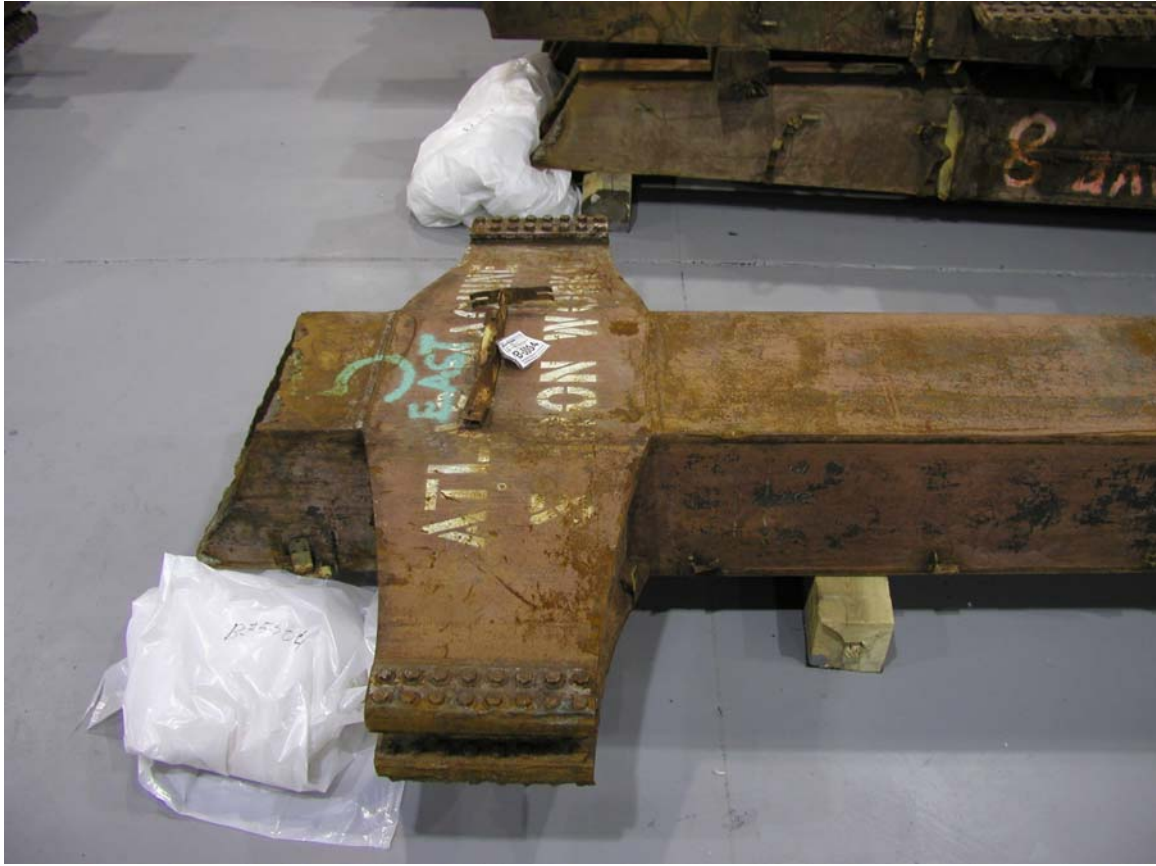
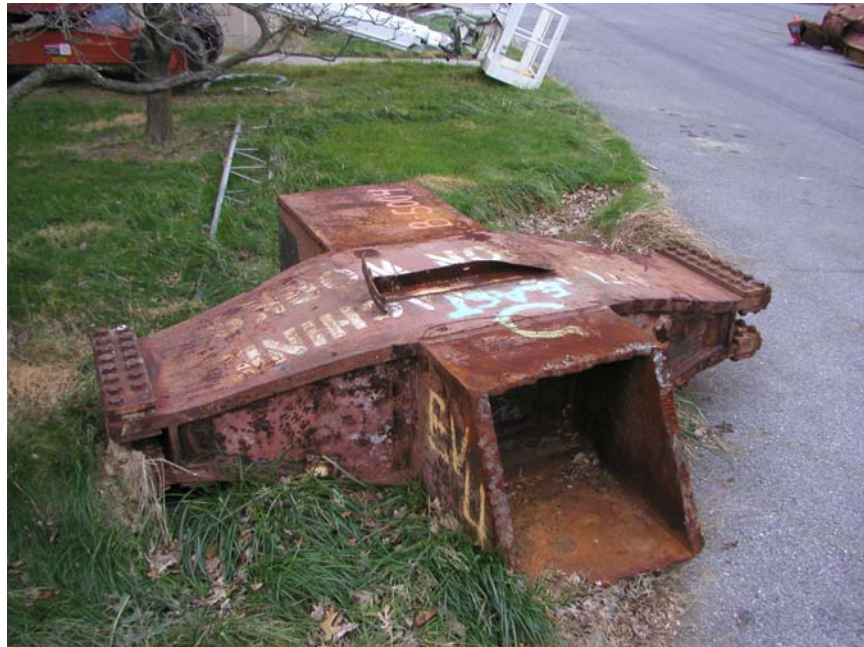
B-5004 at JFK

B-5004 portion cut and moved to NIST campus

**Figure A-6. Bowtie section of exterior wall.**

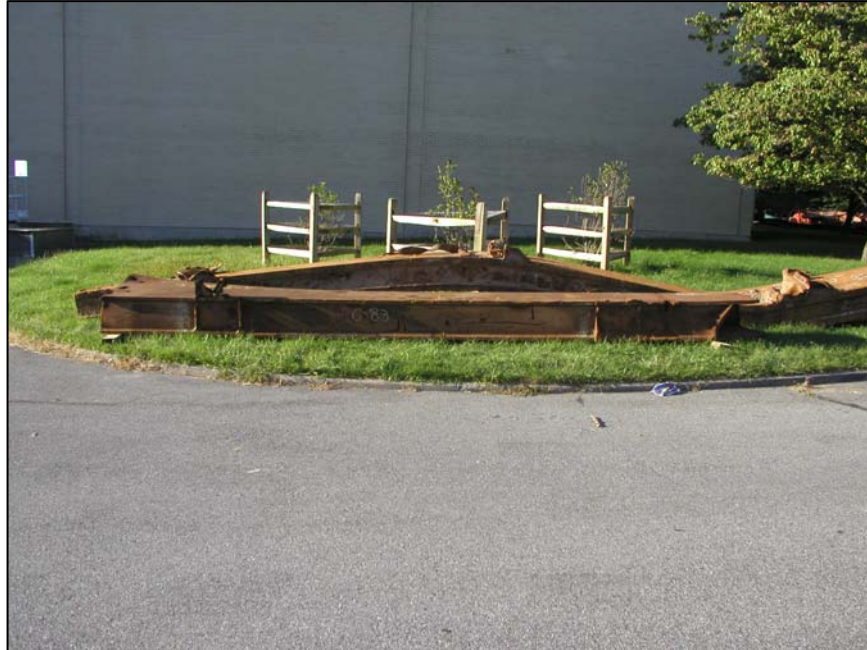
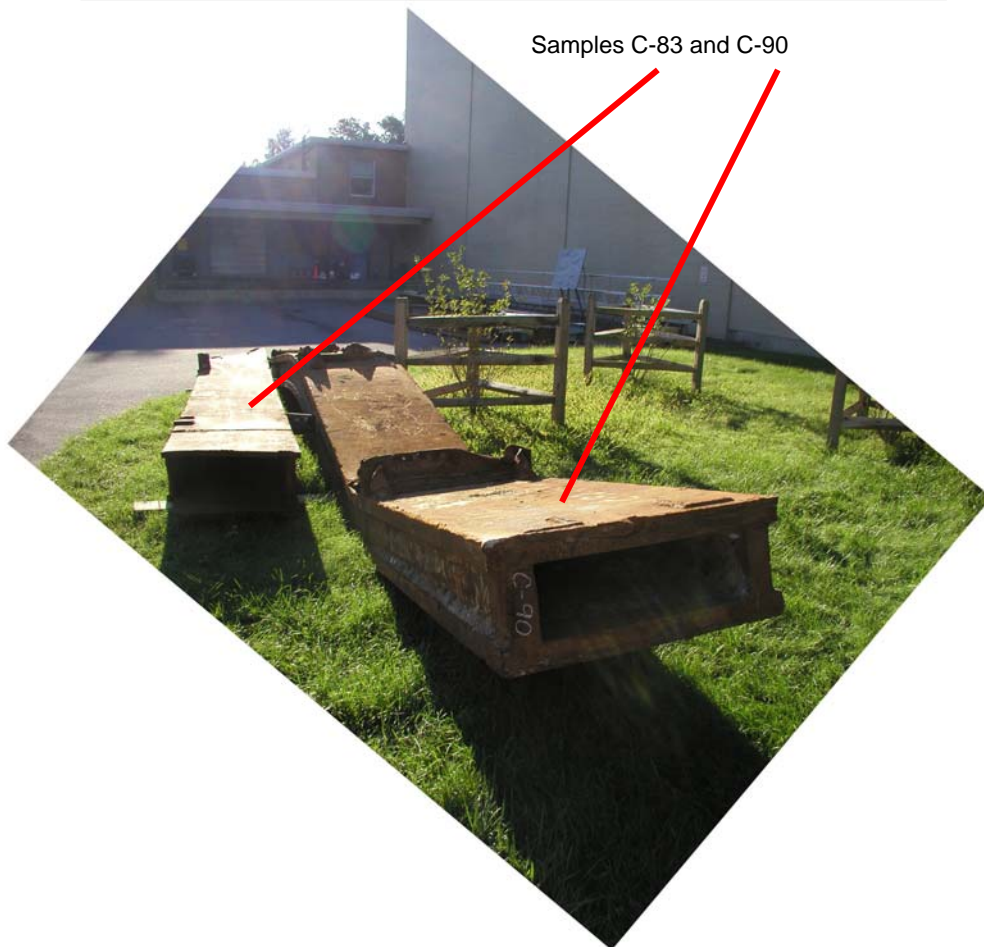
**Figure A-7. Recovered rectangular built up box sections used as core columns.**

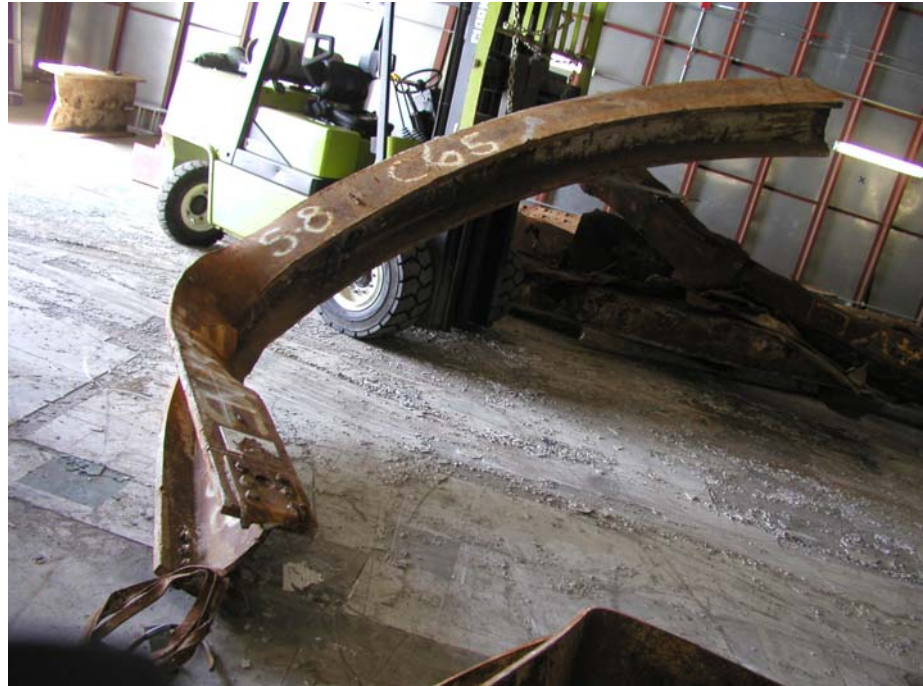
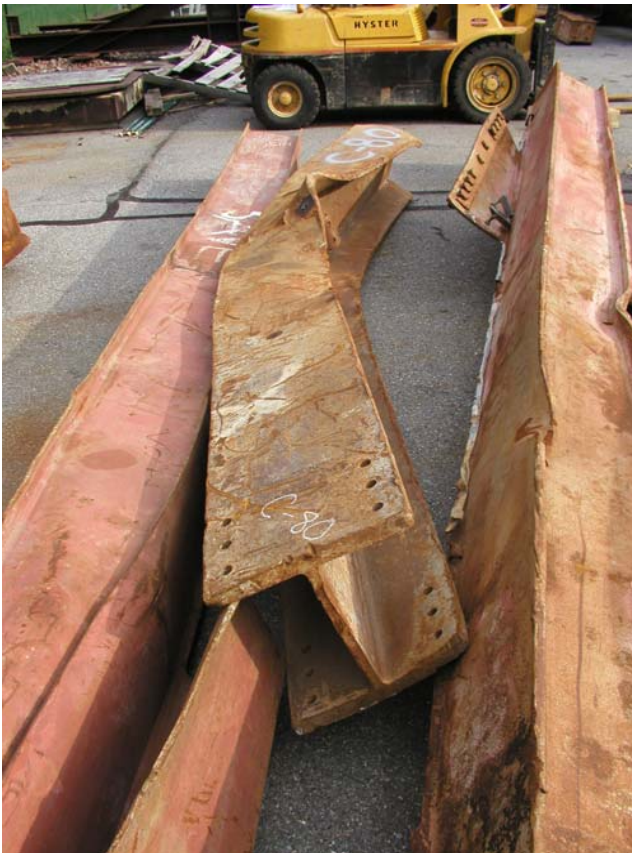
**Figure A–8. Recovered wide flange sections used as core columns.**

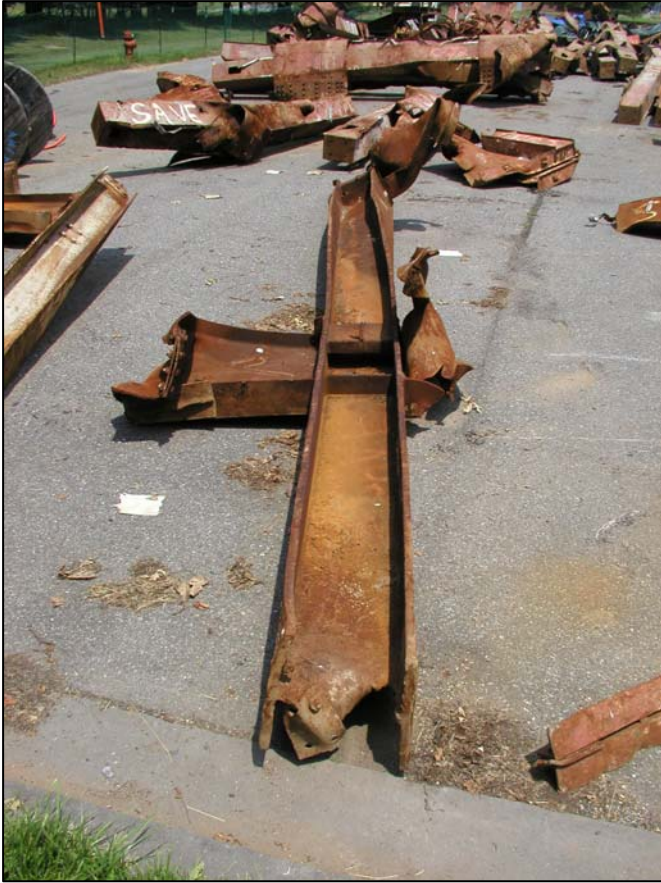
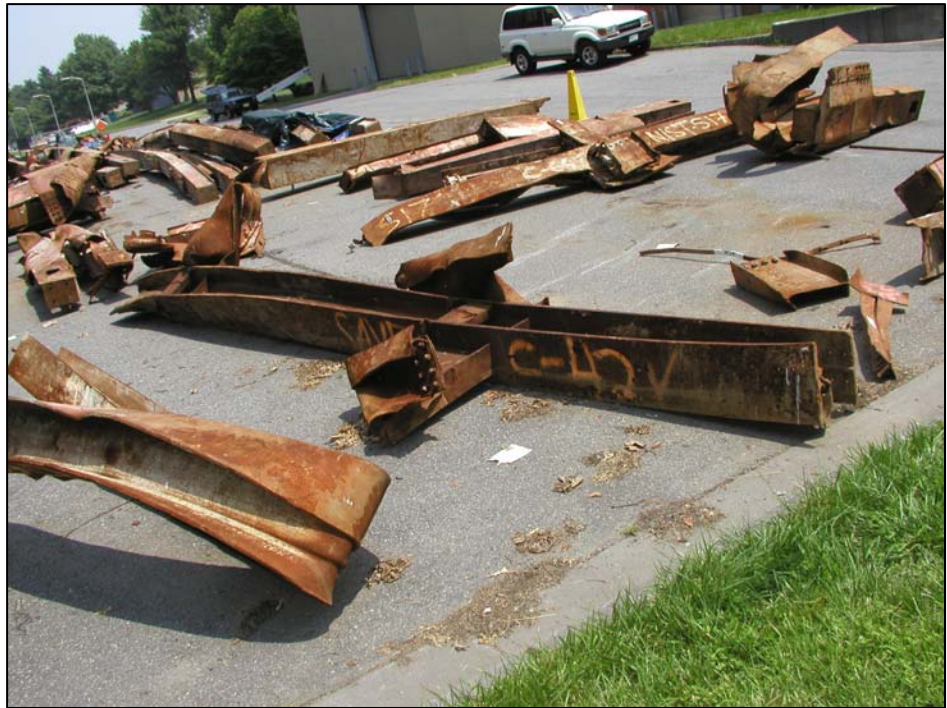
**Figure A–9. Other recovered wide flange sections, shown is sample C-42.**

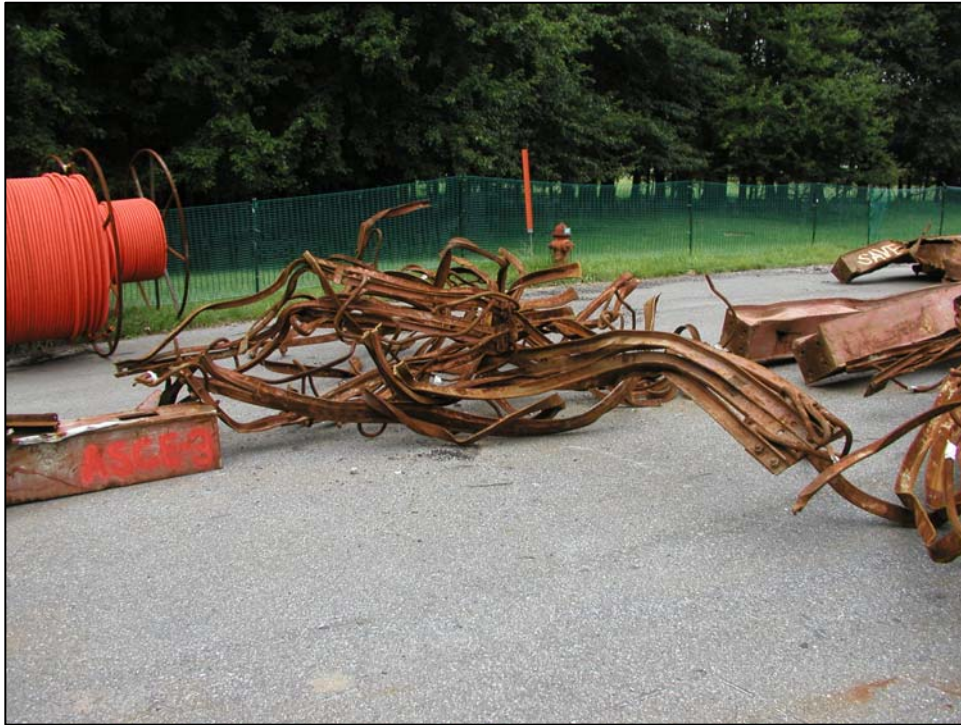
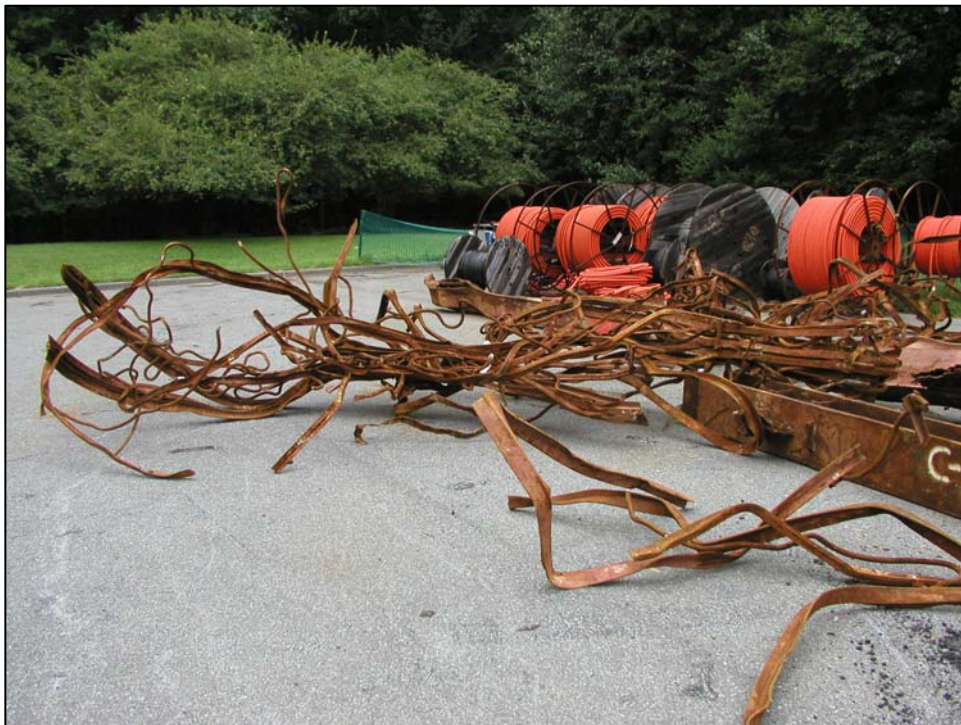
**Figure A–10. Recovered floor truss material; shown are portions of sample C-53.**

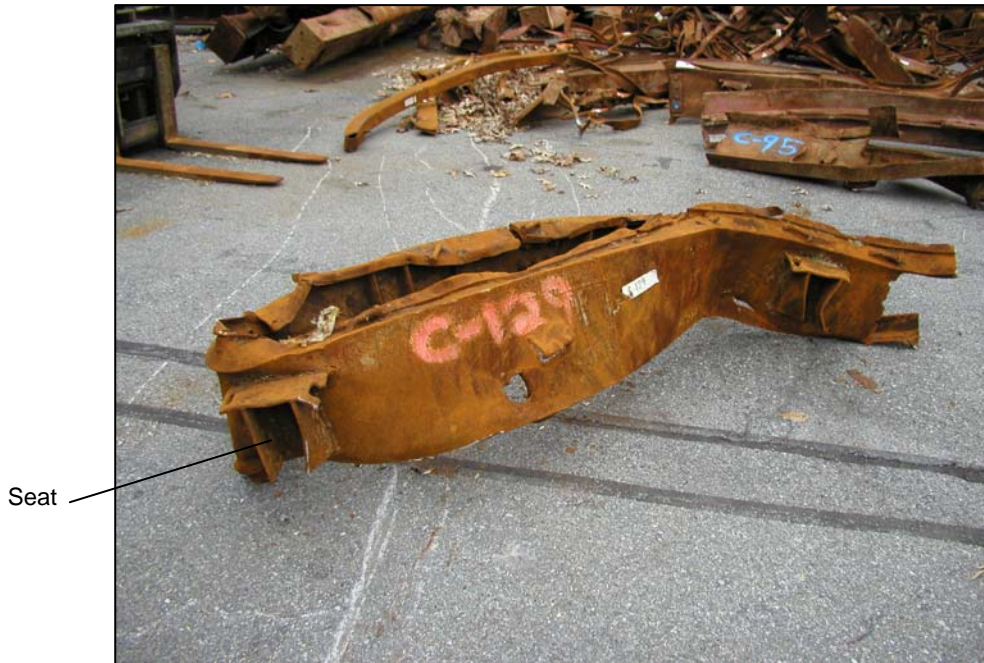
Figure A-11. Recovered inner channel material used to connect floor trusses to core columns; shown is sample C-129.

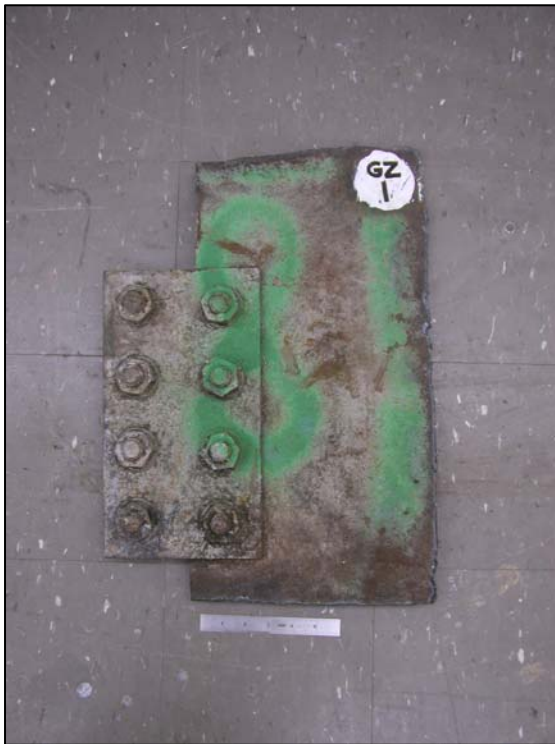
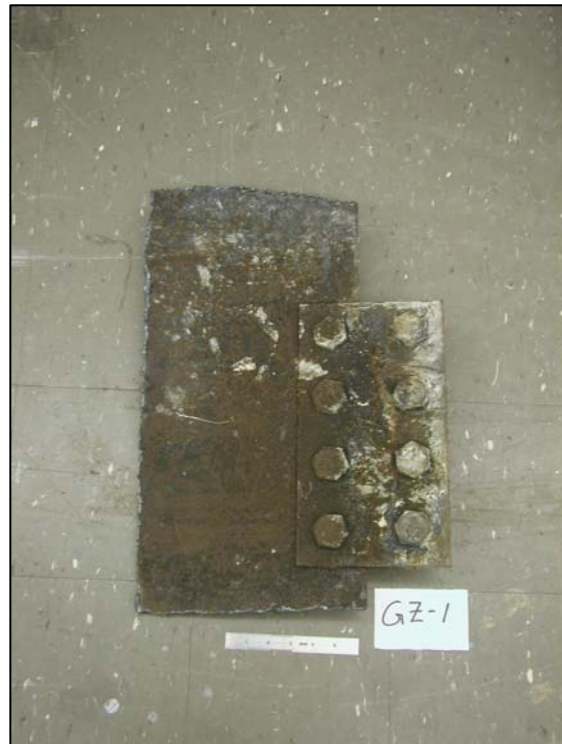
Figure A-12. Coupons removed in the field from WTC 5; shown is sample GZ-1.

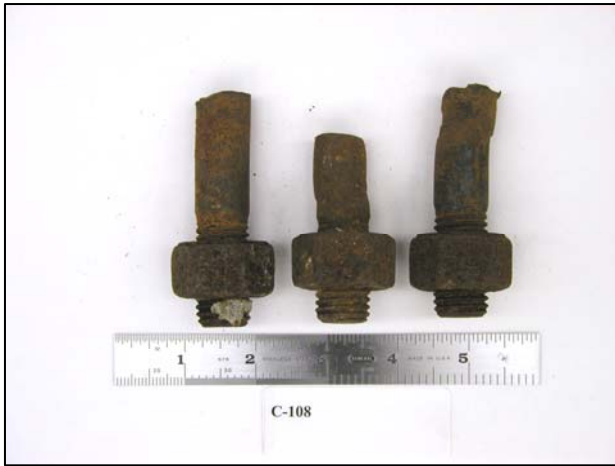
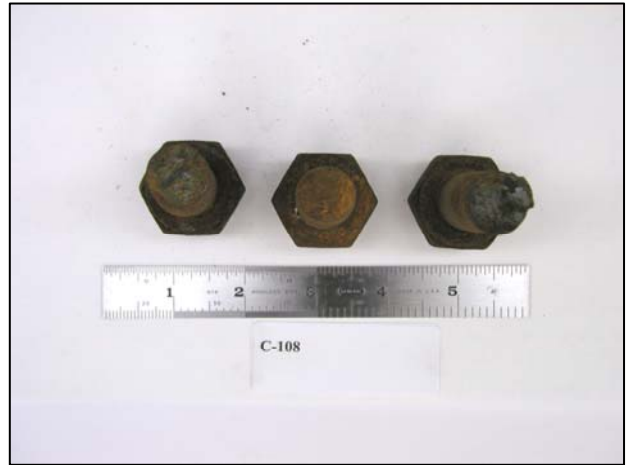
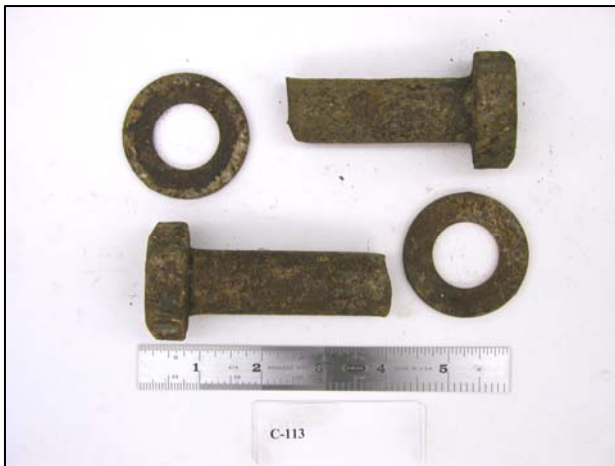
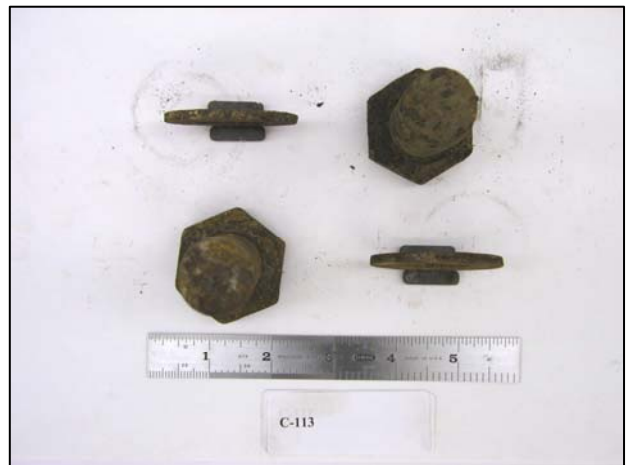
Figure A-13. Examples of recovered bolts from various samples.

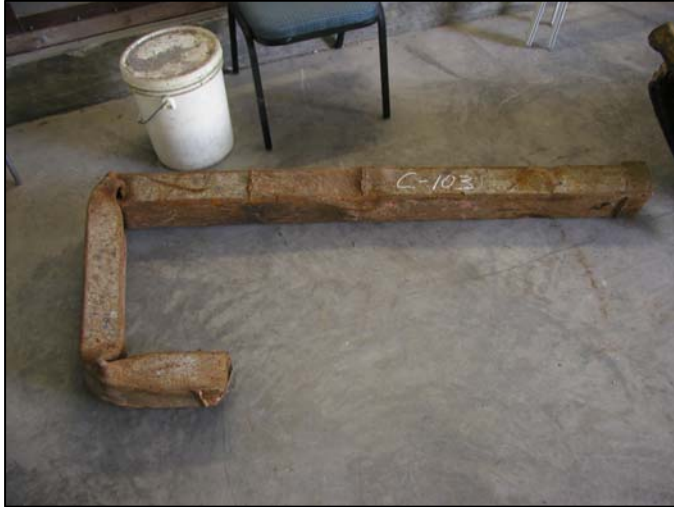
Square tubular piece  
Sample C-103

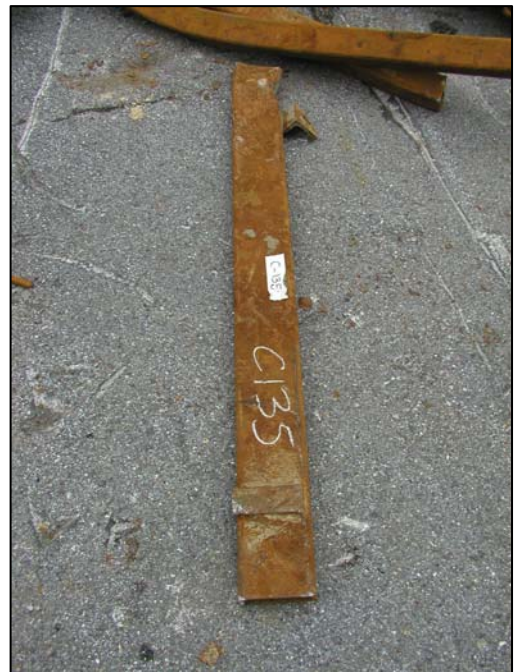
Rectangular tubular piece  
Sample C-135

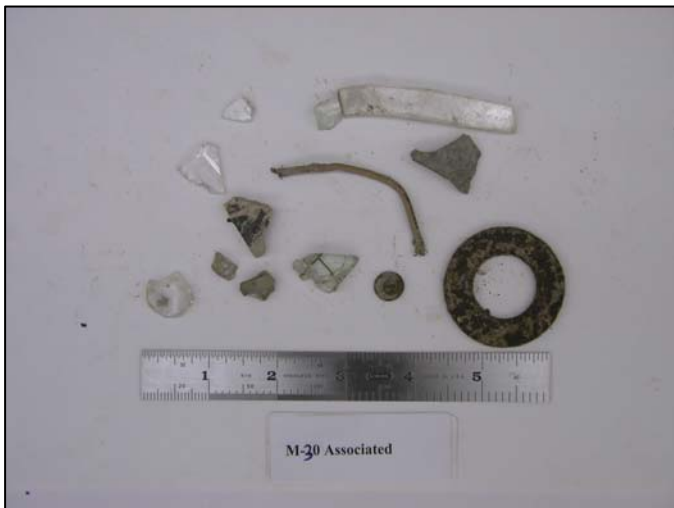
Assorted pieces from within column  
Sample M-30 Associated
