NIST NCSTAR 1-6D

**Federal Building and Fire Safety Investigation of the
World Trade Center Disaster**

Global Structural Analysis of the Response of the World Trade Center Towers to Impact Damage and Fire

Mehdi S. Zarghamee
Yasuo Kitane
Ömer O. Erbay
Simpson Gumpertz & Heger Inc.

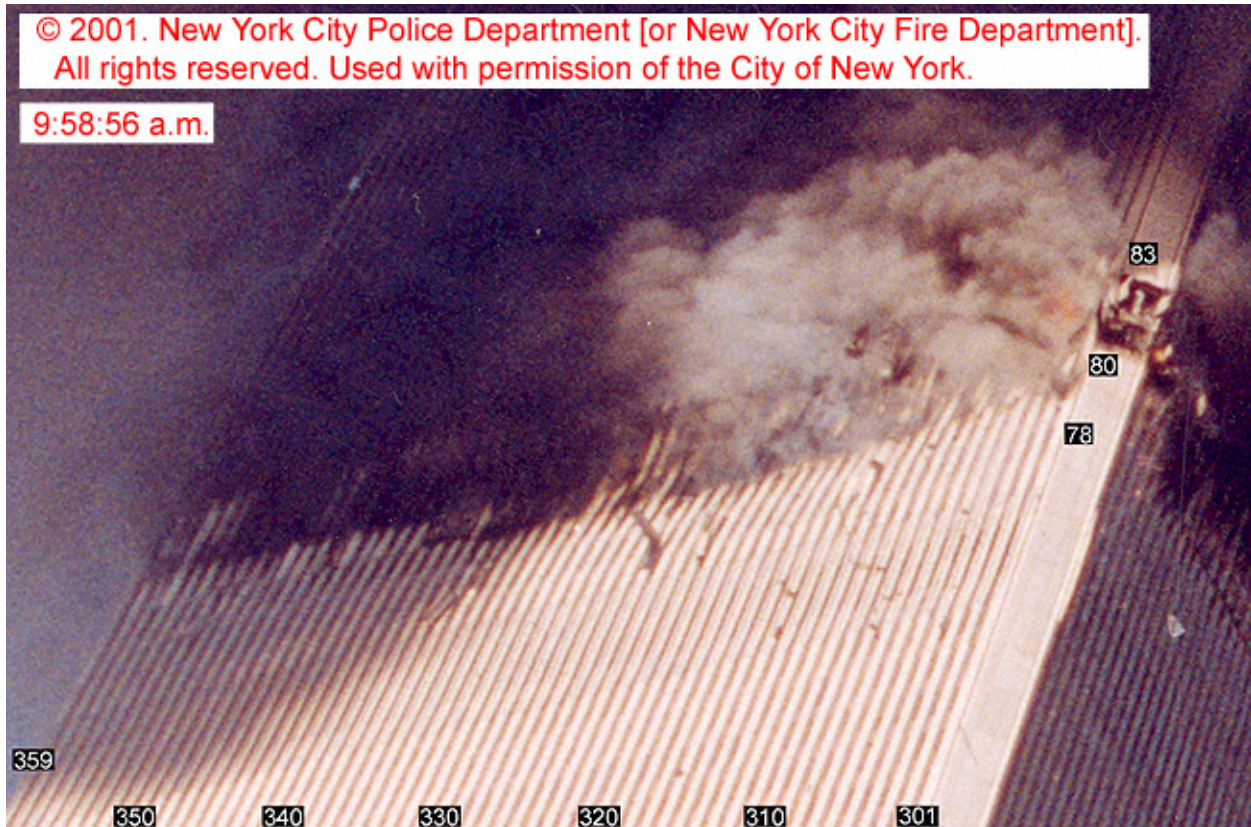
Figure E-14. Inward bowing of exterior columns of the west wall of WTC 2 just before collapse.

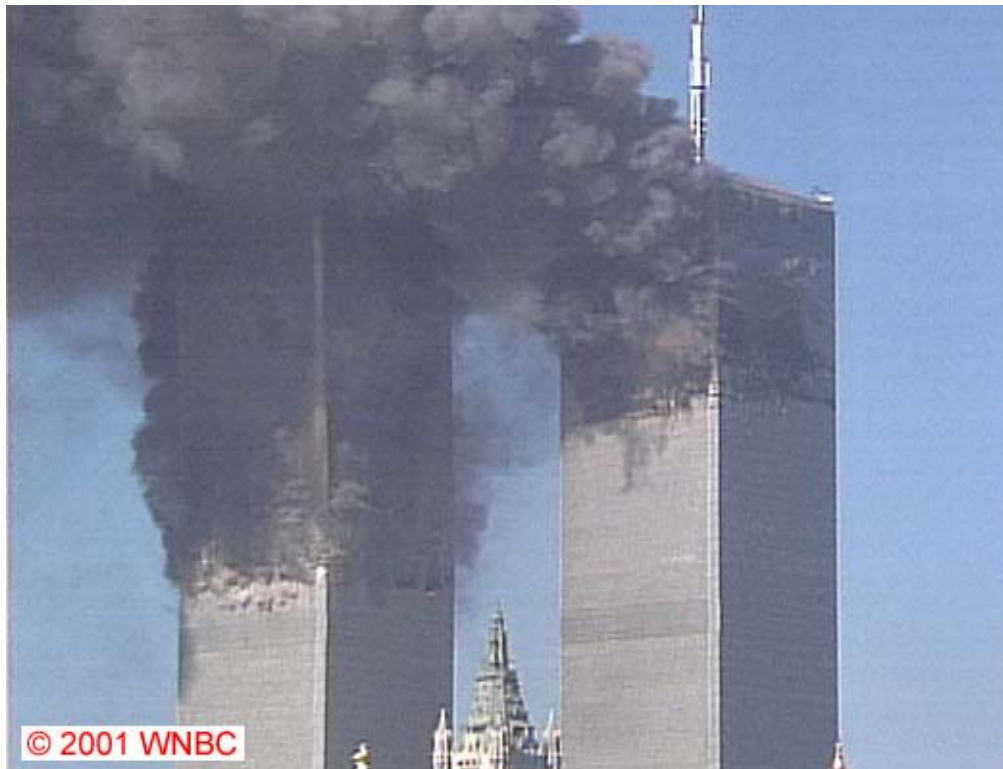
Figure E-16. Initiation of collapse of WTC 2. Note the tilt toward east and south.

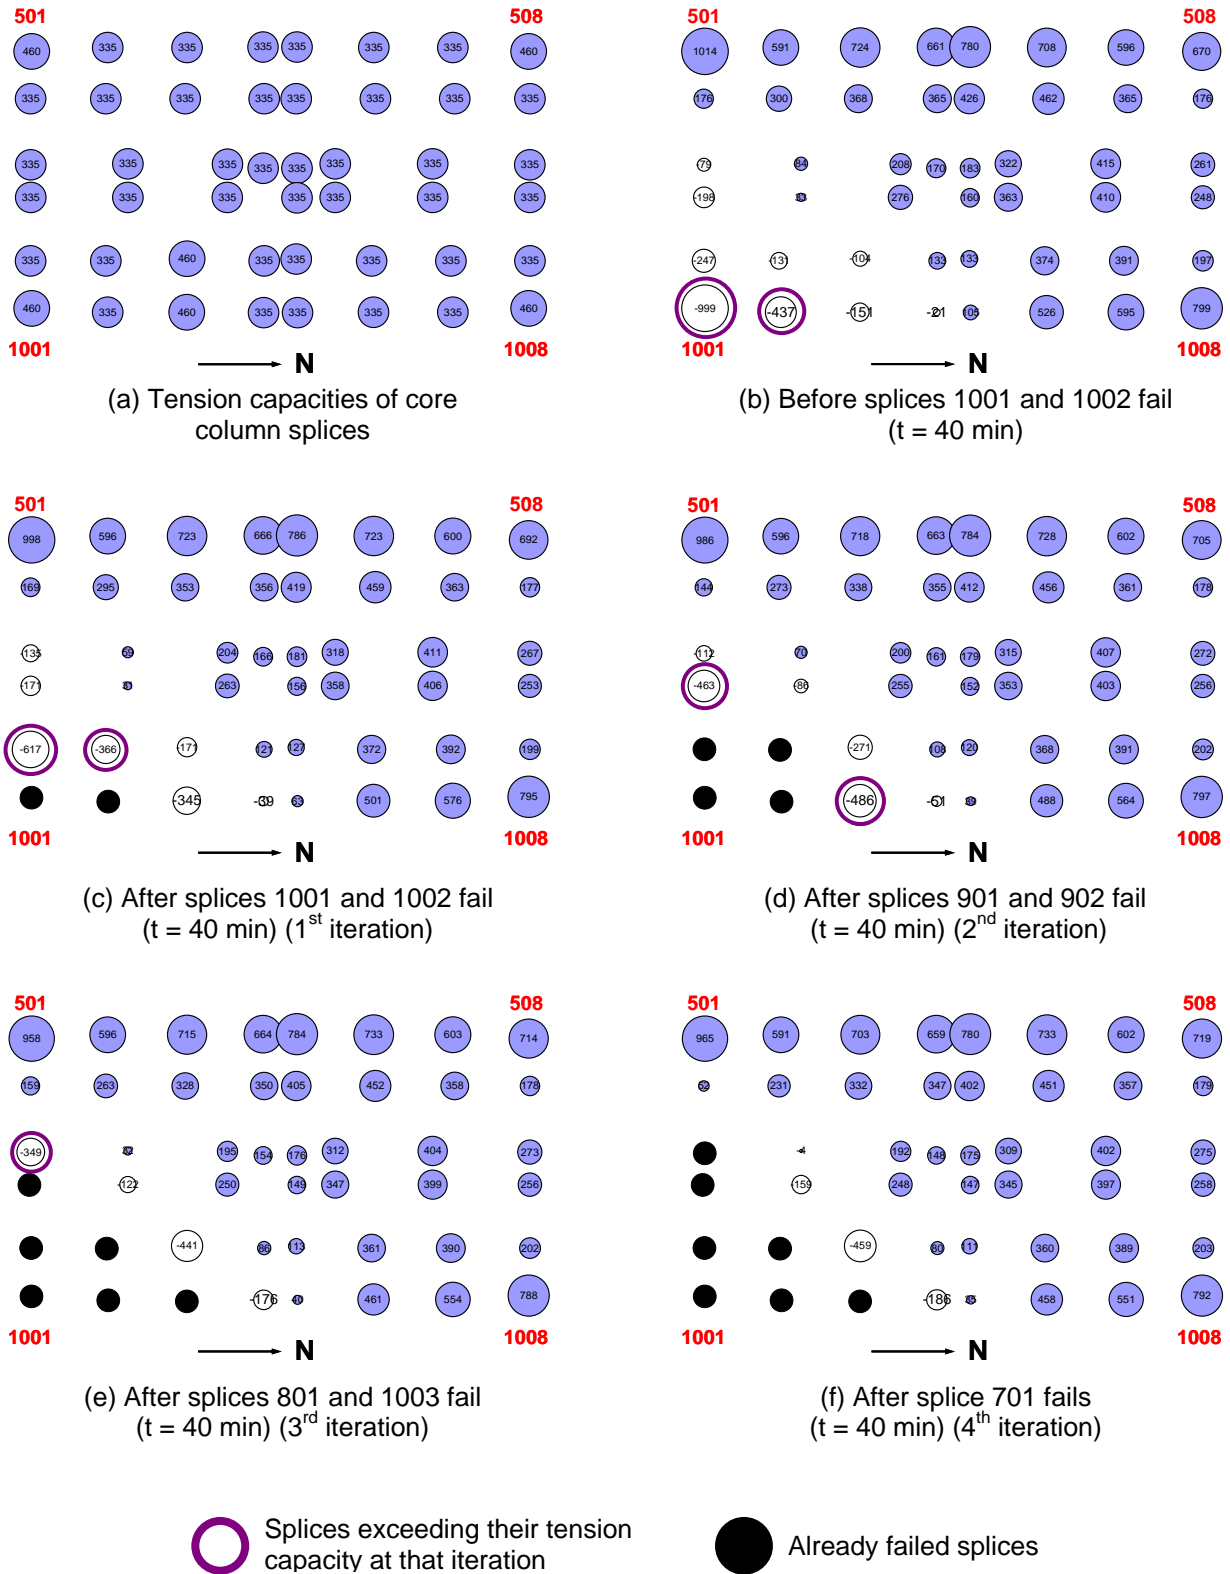
Figure 4–126. Progressive failure of core column splices at Floor 105 of WTC 2 (compression is positive; values are in kip).

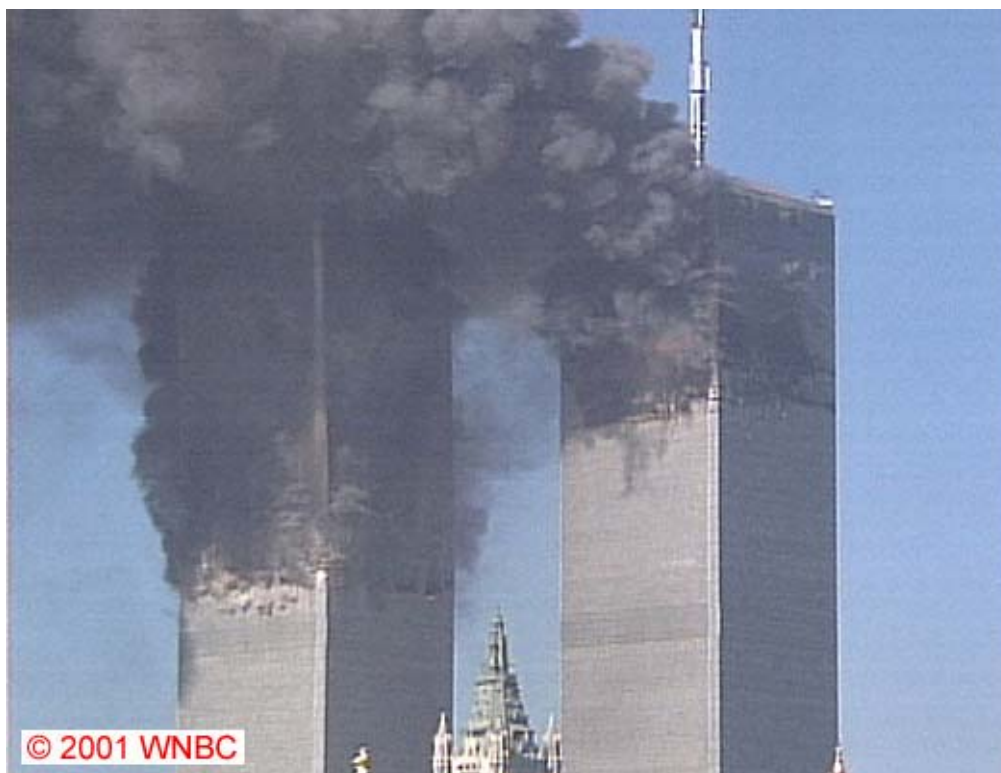
Figure 5–16. Initiation of Collapse of WTC 2. Note the tilt toward east and south.
