### **TECHNICAL SERVICE RESPONSE NO.: UT020**

**Subject:** Analysis of a Foreign Material Found in the Body of a Possible Abductee

**Date:** April 4, 2002

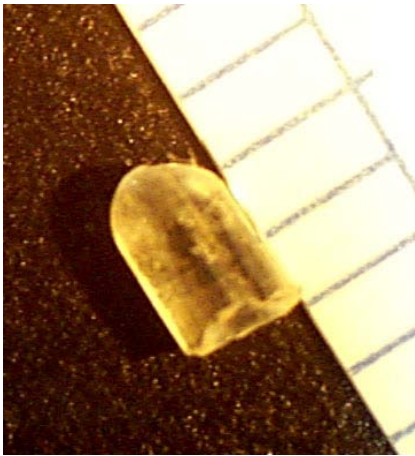
**5. Object and 1/16 inch calibrated ruler.**

The following microphotographs were obtained by this laboratory. Photograph 5 was taken next to a ruler calibrated in 1/16 inch increments. This measurement

shows the object is  $2.5/16$  (0.156 inch) long by  $1.75/16$  (0.109 inch) wide. There is a definite agreement with the other laboratory on the size of the object when the inches are converted to mm, i.e. it converts to 4.0 and 2.8 mm. The sixth photograph is a good overview of the object showing it has a nicked up surface. This indicates the substance is relatively soft. Finally, the seventh photograph was taken of the center after the object was cut in half. The cutting process with a sharp knife also attests to its soft consistency.

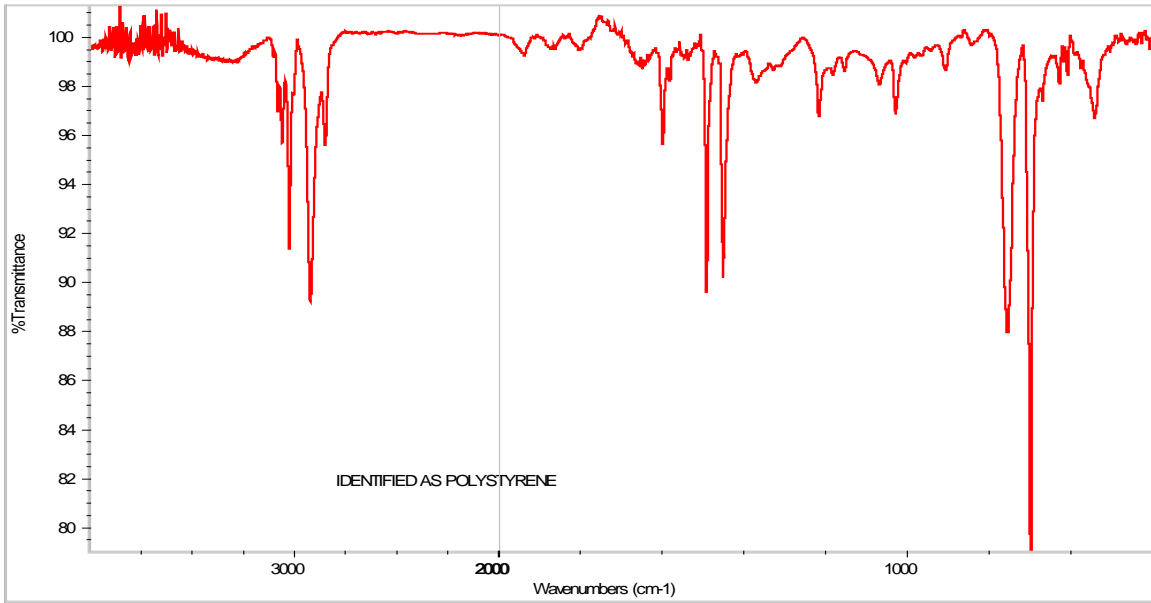
**Infrared Spectrum of "Implant" Exterior**

Infrared analysis positively identifies both the exterior and interior of the “implant” as polystyrene. No other components are detected. This polystyrene identification would explain the above note physical properties such as soft consistency and low mass. Following are spectra taken from the exterior and interior of the object, as well as a reference of polystyrene for comparison. Note the polystyrene reference perfectly matches the “implant” spectra.

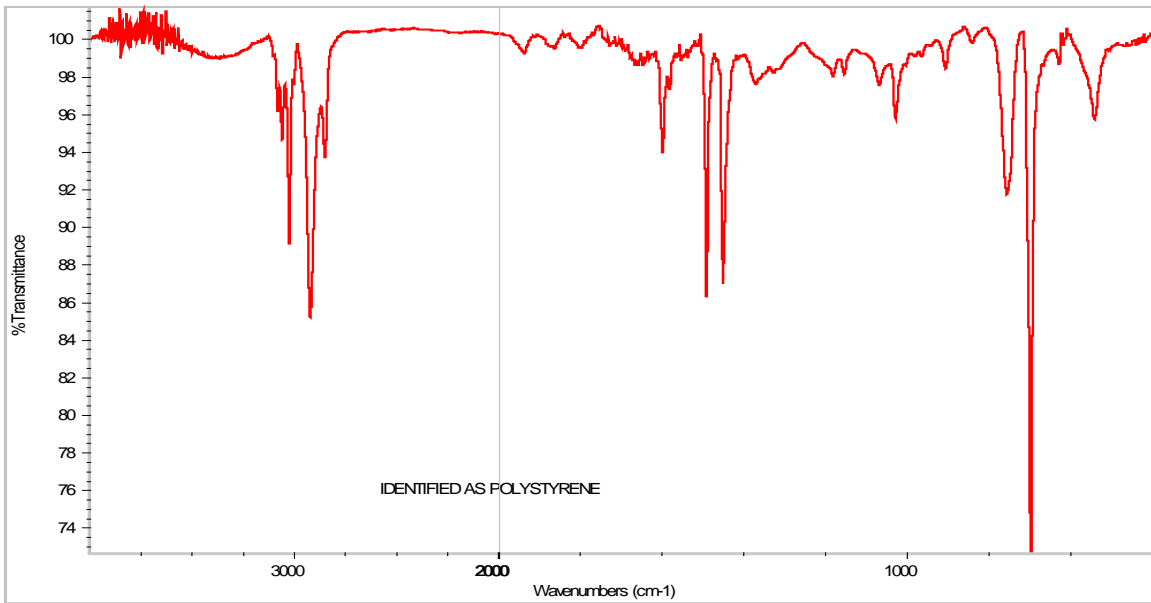
**Infrared Spectrum of "Implant" Interior**

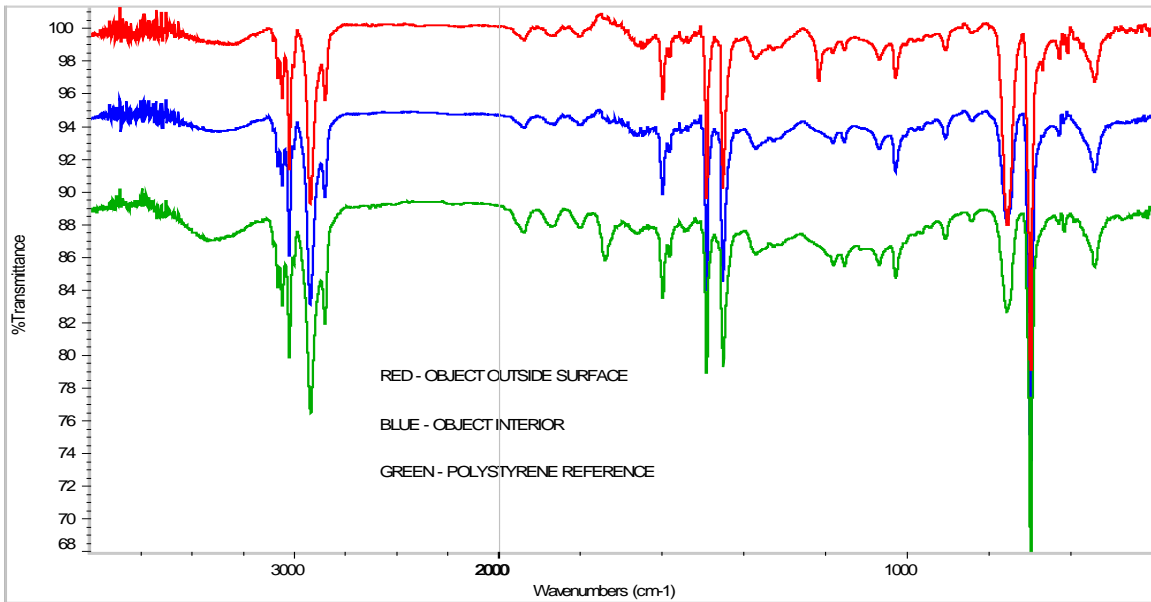
The following shows all of the above spectra on one graph to more clearly display the match.

**Infrared Spectra of: the Object Outside Surface; the Interior; a Reference of Polystyrene**
