Appendix H

WTC 2 EAST FACE COMBINED FIRE AND WINDOW CONDITION AND WINDOW SMOKE CONDITION

WTC 2 SOUTH FACE COMBINED FIRE AND WINDOW CONDITION AND WINDOW SMOKE CONDITION

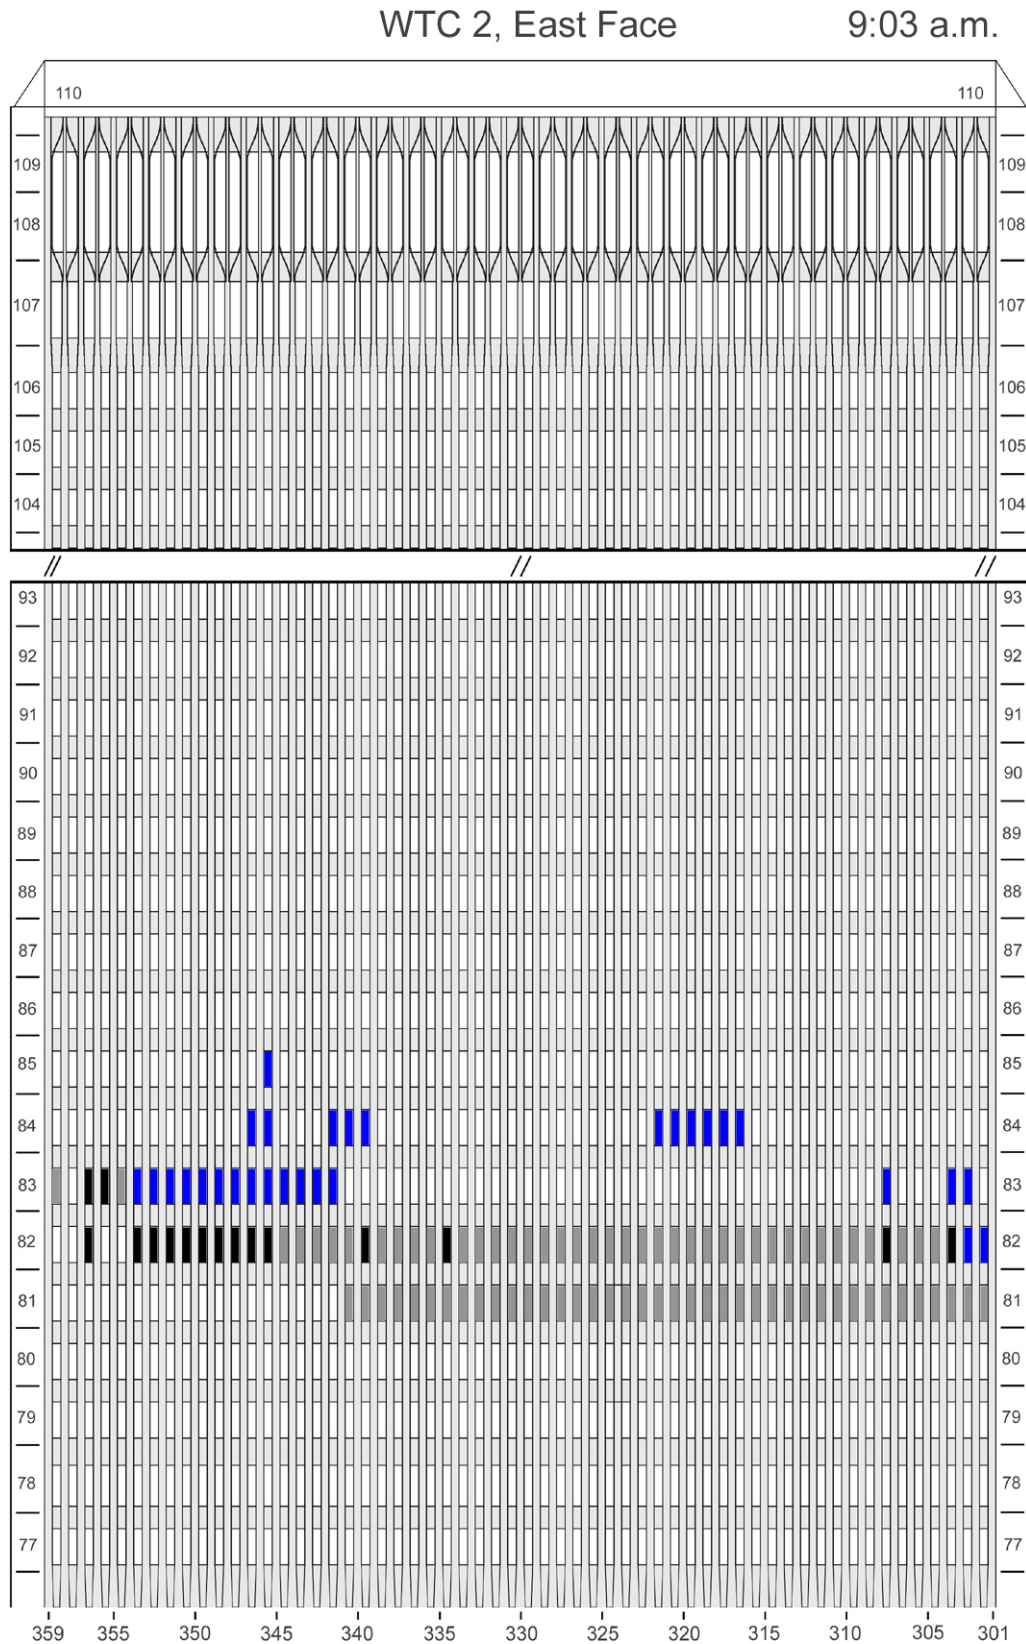
Figure H-2. Diagram of the east face of WTC 2 for floors 77 to 93 and floors 104 to 110 at 9:03 a.m. showing windows where smoke was observed and those hidden from view.
