**Federal Building and Fire Safety Investigation of the
World Trade Center Disaster**

Structural Fire Response and Probable Collapse Sequence of the World Trade Center Towers

John L. Gross
Therese P. McAllister

September 2005

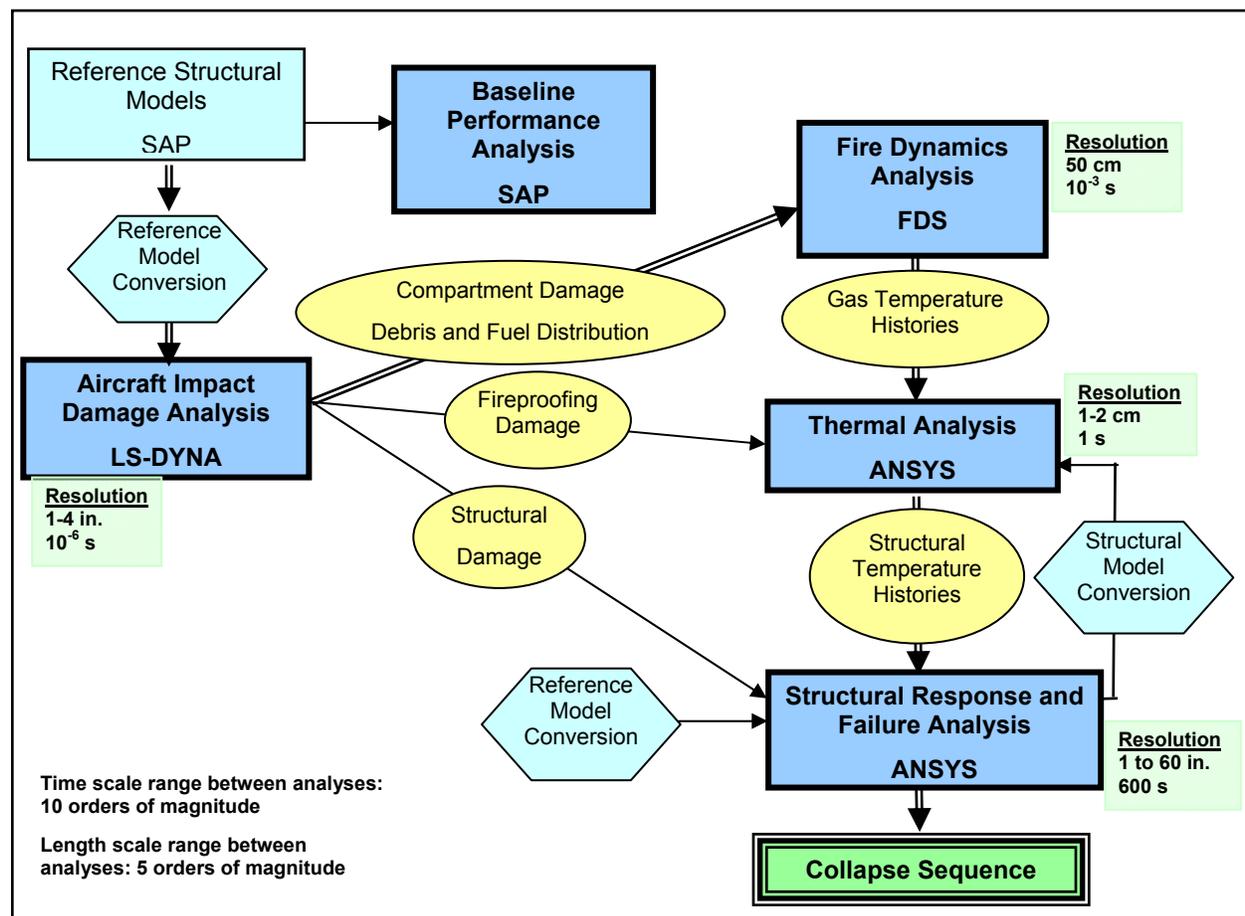
Figure E-1. Critical analysis inter-dependencies.

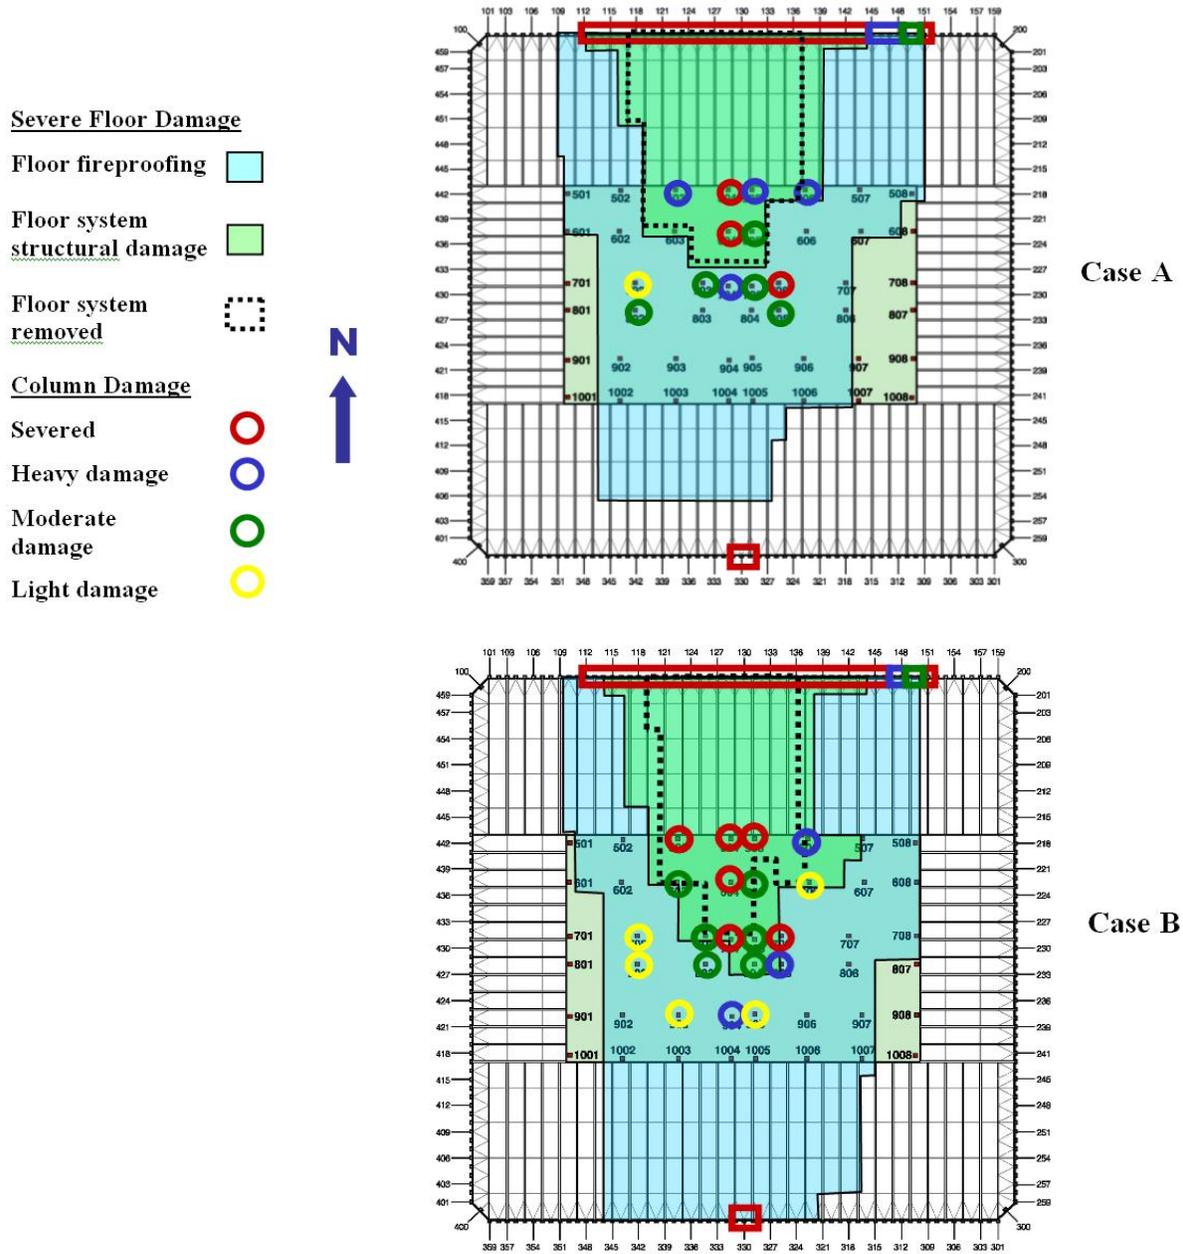
Figure E-3. Plan view of WTC 1 cumulative damage for Floors 93 to 99.

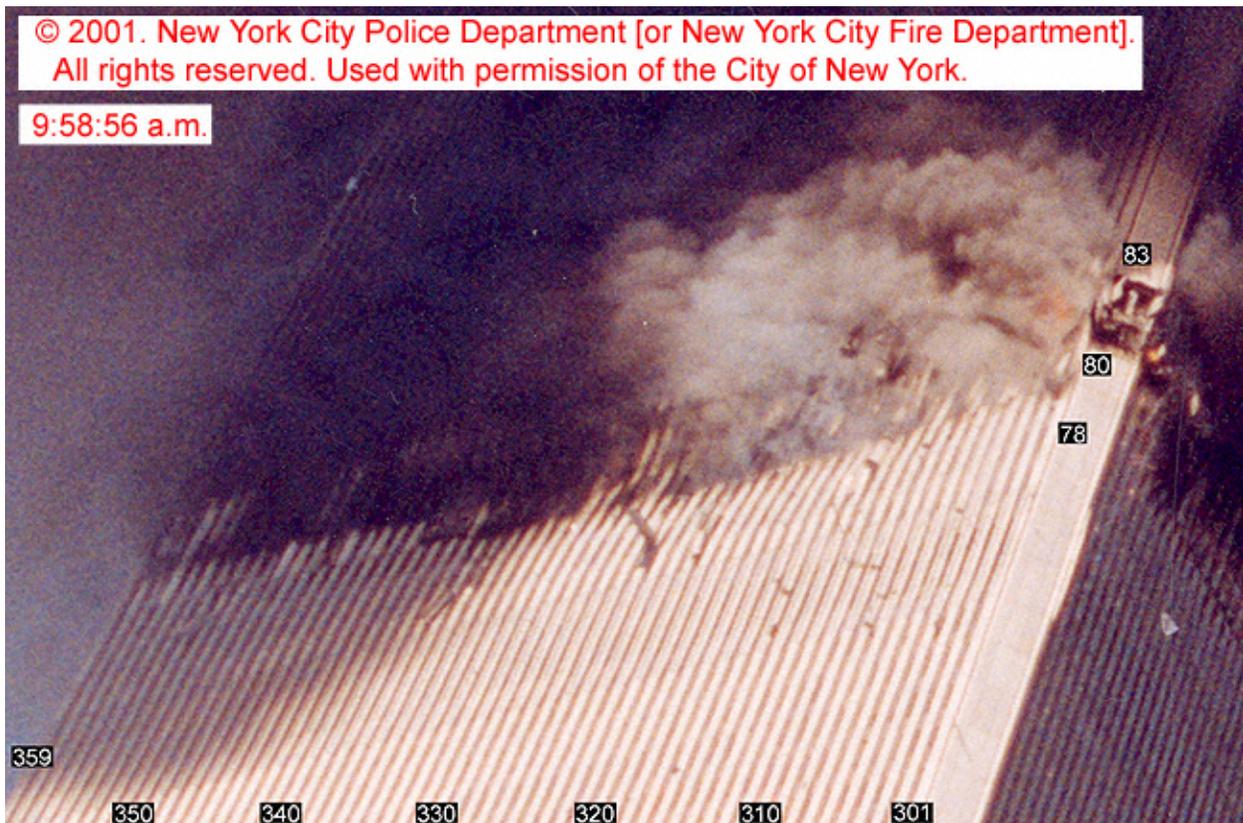
Figure E-7. View of WTC 2 buckling of east wall near northeast corner as collapse initiates from southeast.

- The building section above the impact and fire area tilted to the east and south as the structural collapse initiated as shown in Fig. E-8. There was approximately a 3 to 4 degree tilt to the south and a 7 to 8 degree tilt to the east prior to significant downward movement of the upper building section.

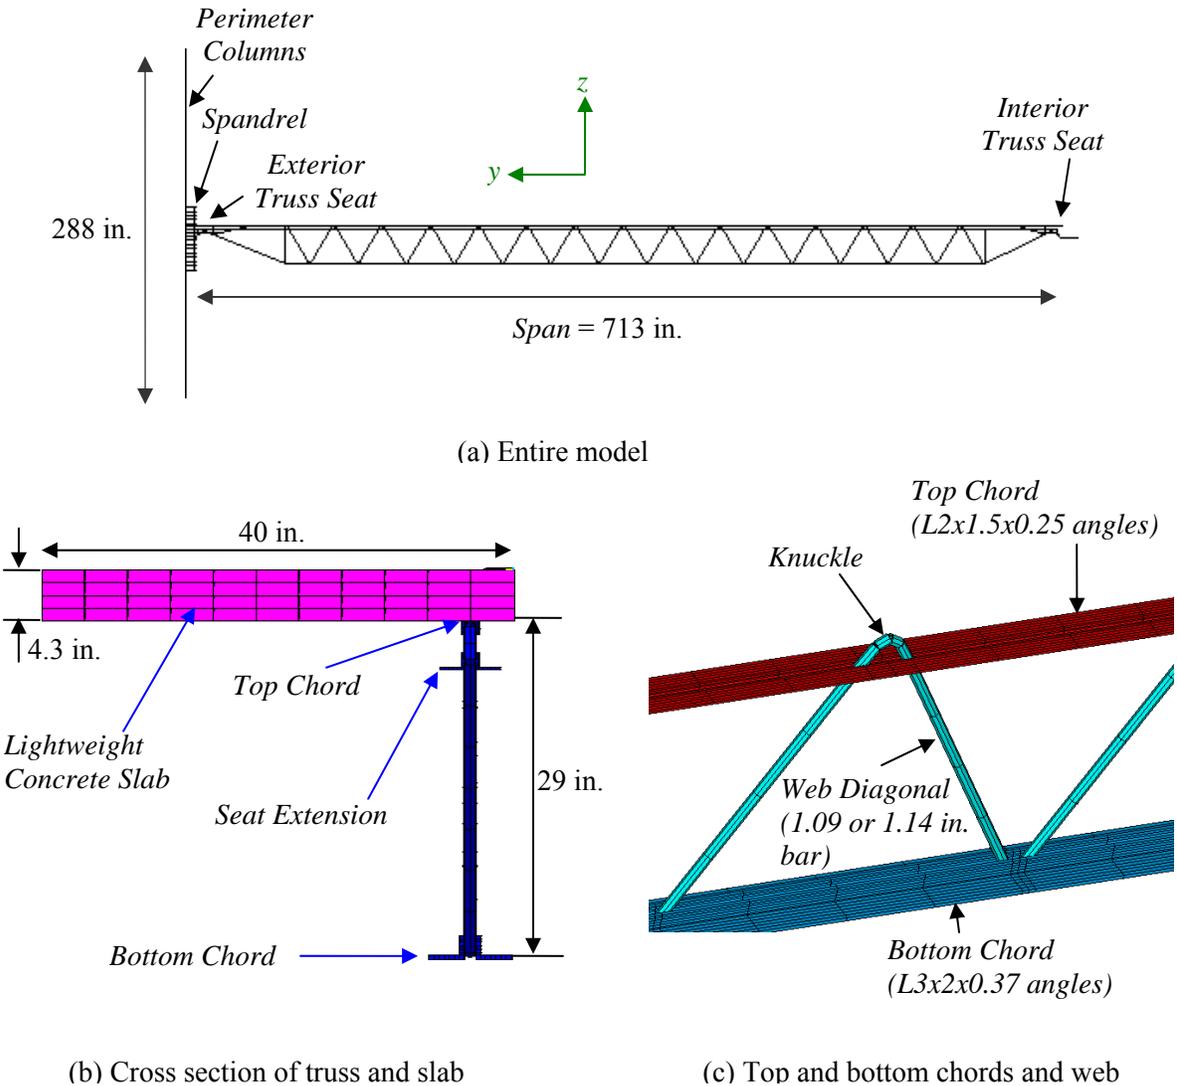
Figure 4–23 illustrates the composite truss and concrete slab model. Symmetry allowed modeling one of the two trusses and one half of the 80 in. composite concrete slab. The model included two perimeter columns, the spandrel, the truss seat, and strap attachments. Each column extended one floor above and one floor below the floor section to account for interaction between the exterior wall and the floor section. Each column was attributed with half of its area and bending properties to account for the symmetry reduction of the floor section. The interior and exterior truss seat connections were also included. The truss was restrained at bridging truss locations to simulate the lateral bracing that would be provided at the bottom chord.

Figure 4-23. Composite truss and concrete slab model.

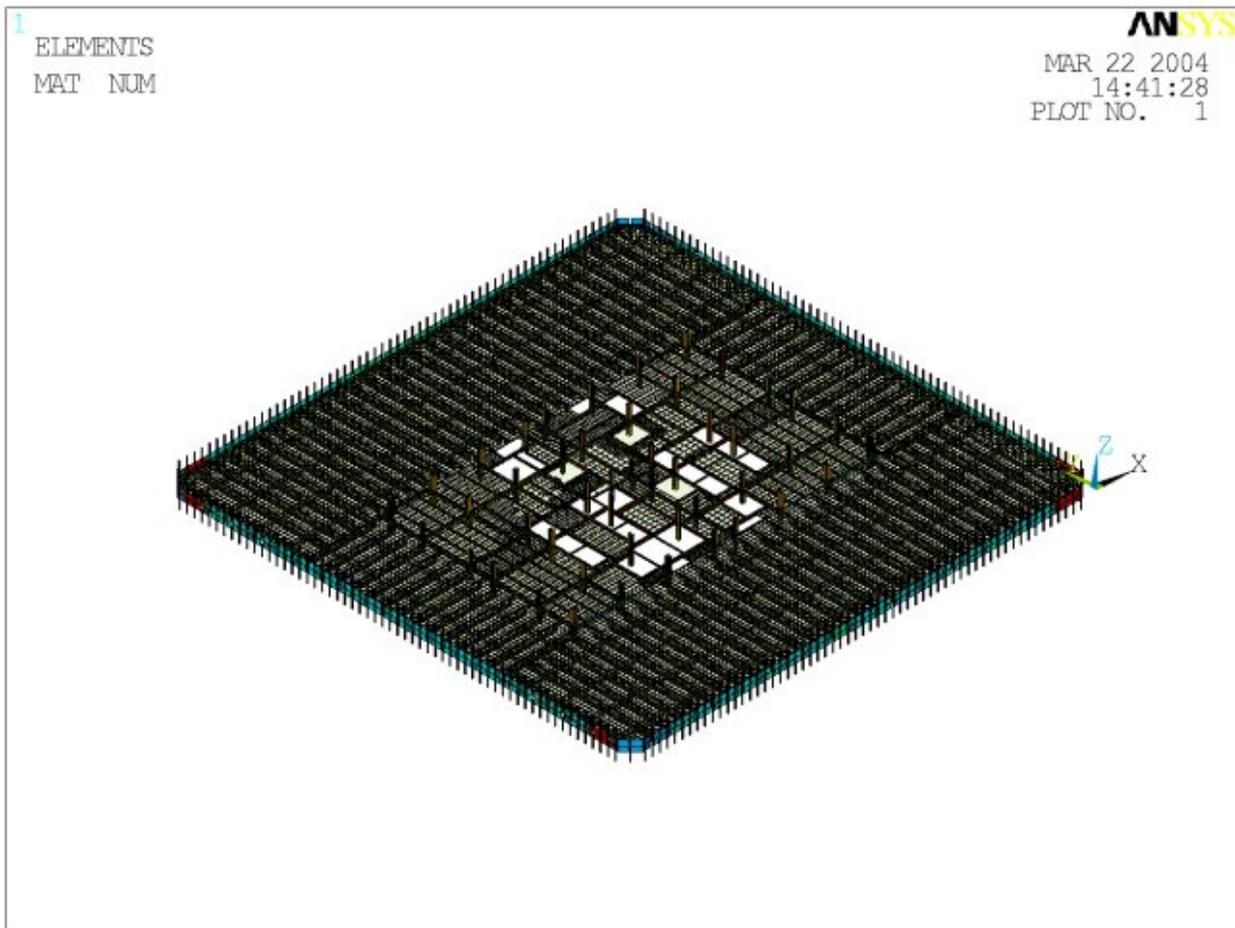
A review of floors in the impact zones of WTC 1 and WTC 2 found that floor 96 in WTC 1 was representative of the floors of interest (see NIST NCSTAR 1-2A), and it was used for the floor analysis. Reference structural models of Floor 96 were developed in SAP2000 for traceability to a verified data set (see NIST NCSTAR 1-2) and translated into ANSYS models (see NIST NCSTAR 1-6C). The ANSYS floor model was used for the structural response analyses. Figure 4–27 shows an overall view of the converted ANSYS model of Floor 96. Figure 4–28 and Fig. 4–29 show a close-up of the truss floor and core framing, respectively.

Figure 4–27. Converted ANSYS model for Floor 96 of WTC 1.

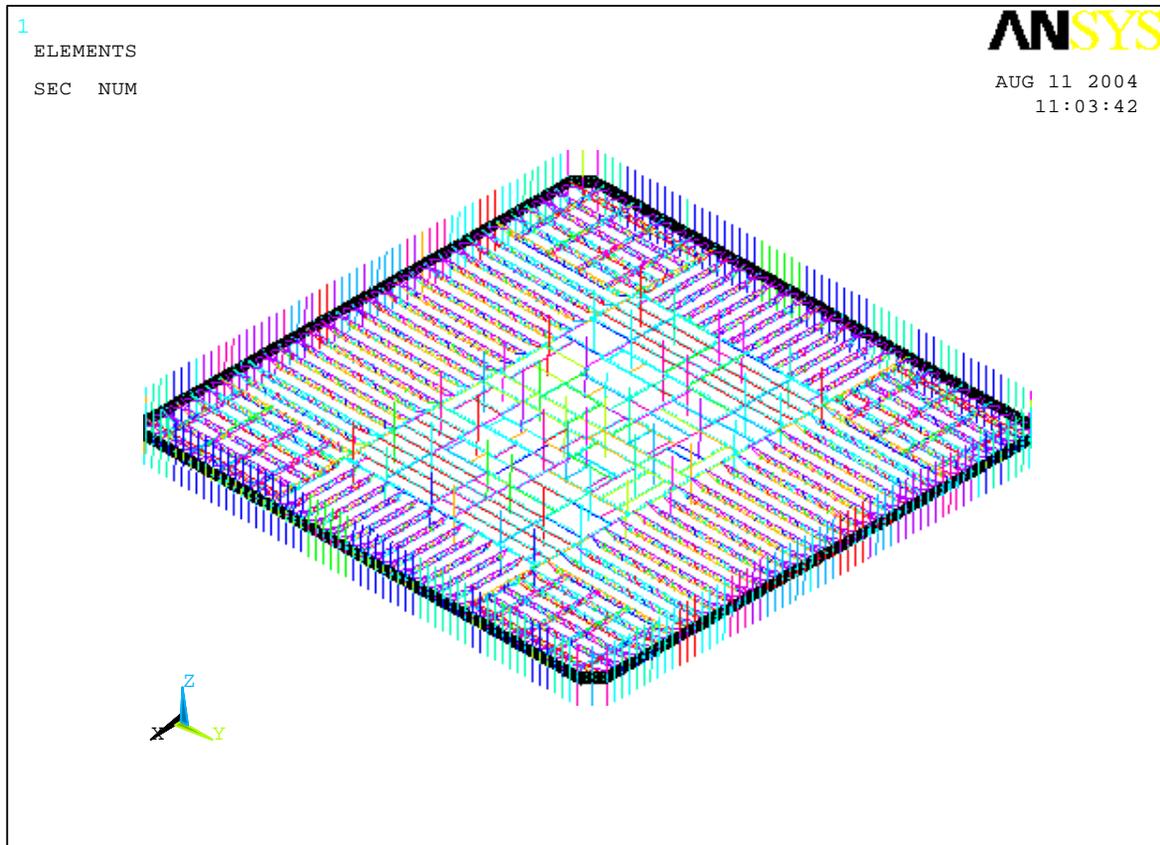
- Exterior and core columns extending from one floor below to one floor above
- Spandrels on the floor of interest
- Concrete floor slab
- Steel floor trusses including primary and bridging trusses
- Strap anchors
- Core beams
- Deck support angles

Figure 4–30. Full floor model before impact damage is included (without concrete floor slab).

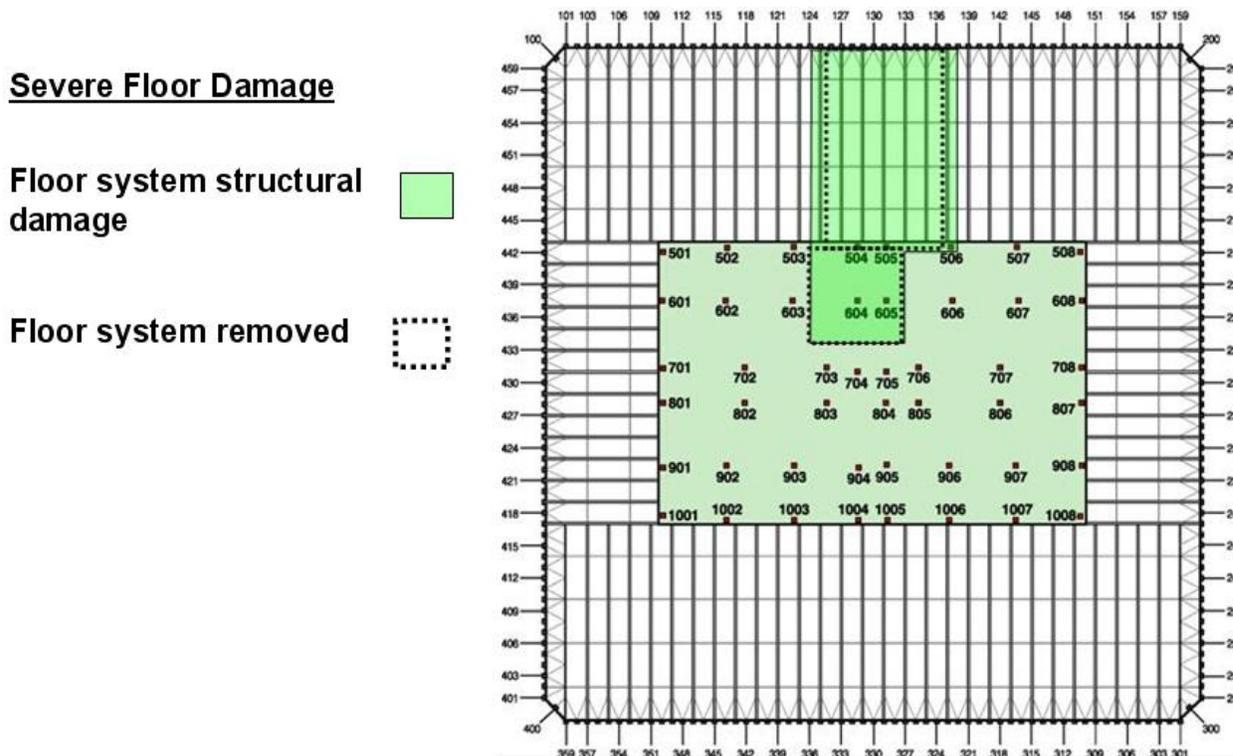
Figure 5–5 shows an example of how the damage in Figure 5–4 was evaluated and summarized for the structural analysis. Areas with severed floor framing and crushed concrete (indicated by red zones) were outlined with a dashed line, indicating where floor areas were to be removed or considered missing. Areas with misaligned framing or loss of composite action with the slab (due to damaged concrete) over more than half the member length were marked with green shading as damaged floor areas. In this example, the dashed outline and green overlay cover nearly the same area, though this is not generally the case for all floors. For analysis purposes, only severe damage was considered; isolated member damage or small areas of concrete damage were ignored as they were considered localized damage. Damage ranges in Figure 5–5 were delineated by boxed areas as there was insufficient data to develop criteria for irregular boundaries.

Figure 5–5. Damage to WTC 1 Floor 95 framing and slab for Case A.

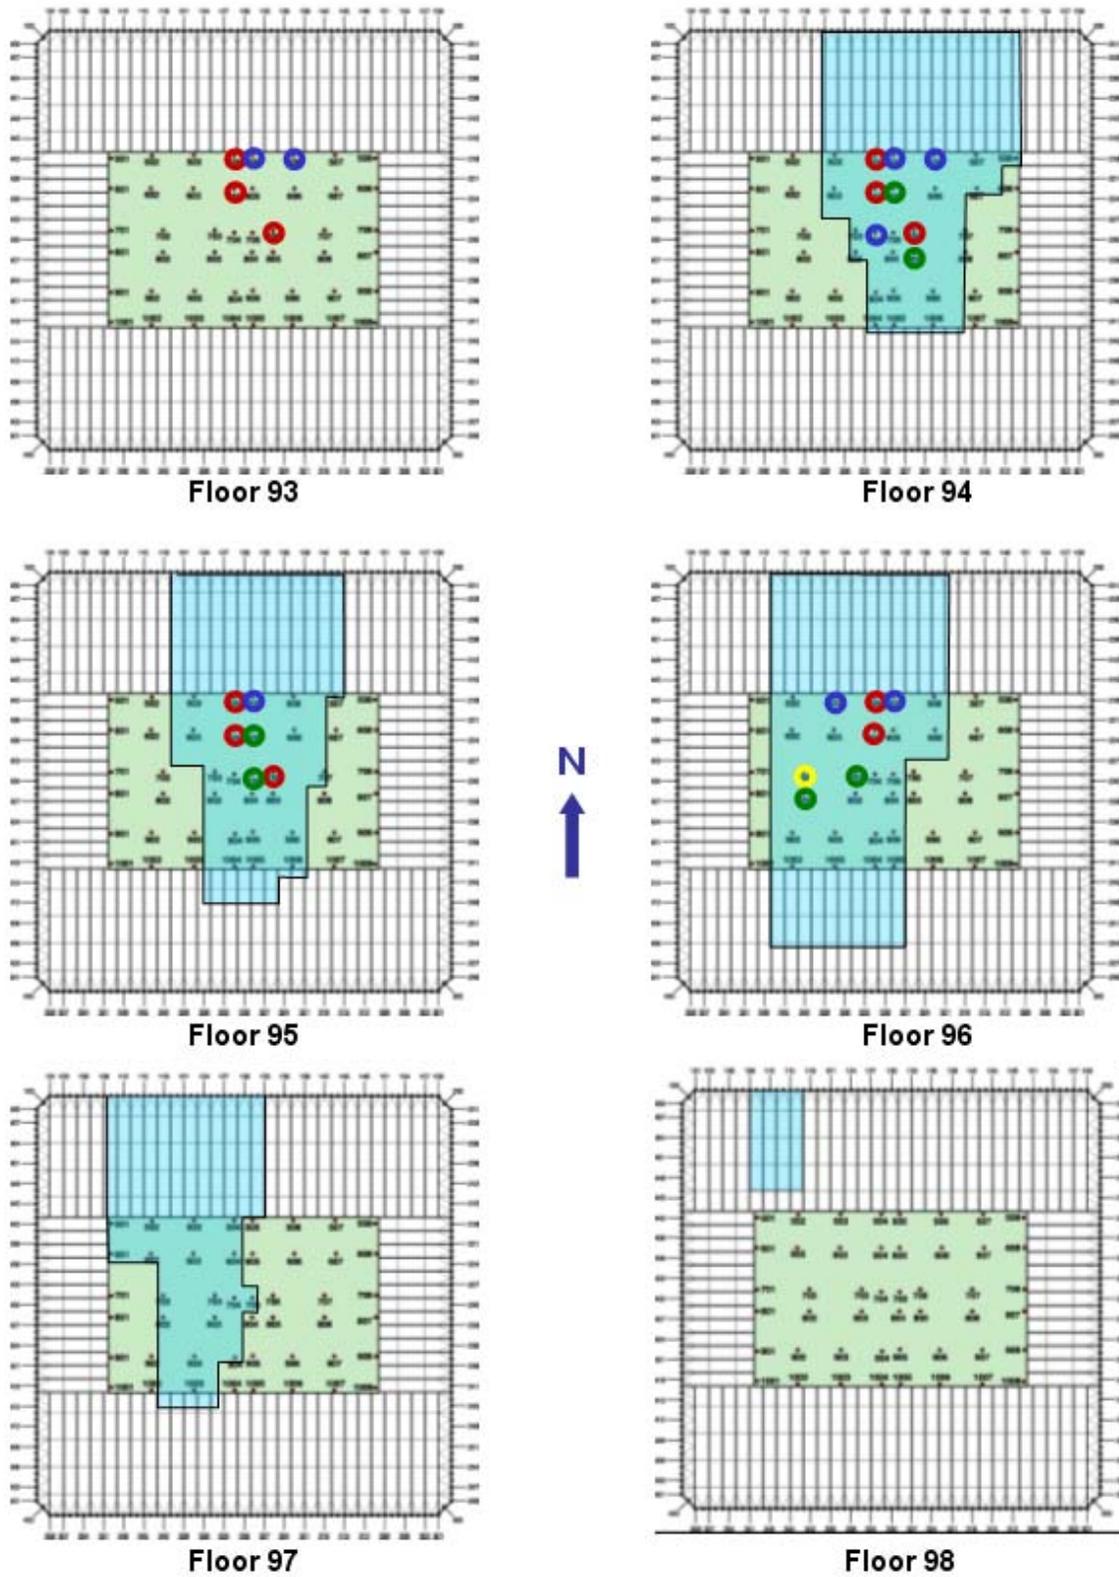
Figure 5-14. Plan view of WTC 1 Case A insulation and column damage to Occupancy Floors 93 to 98.

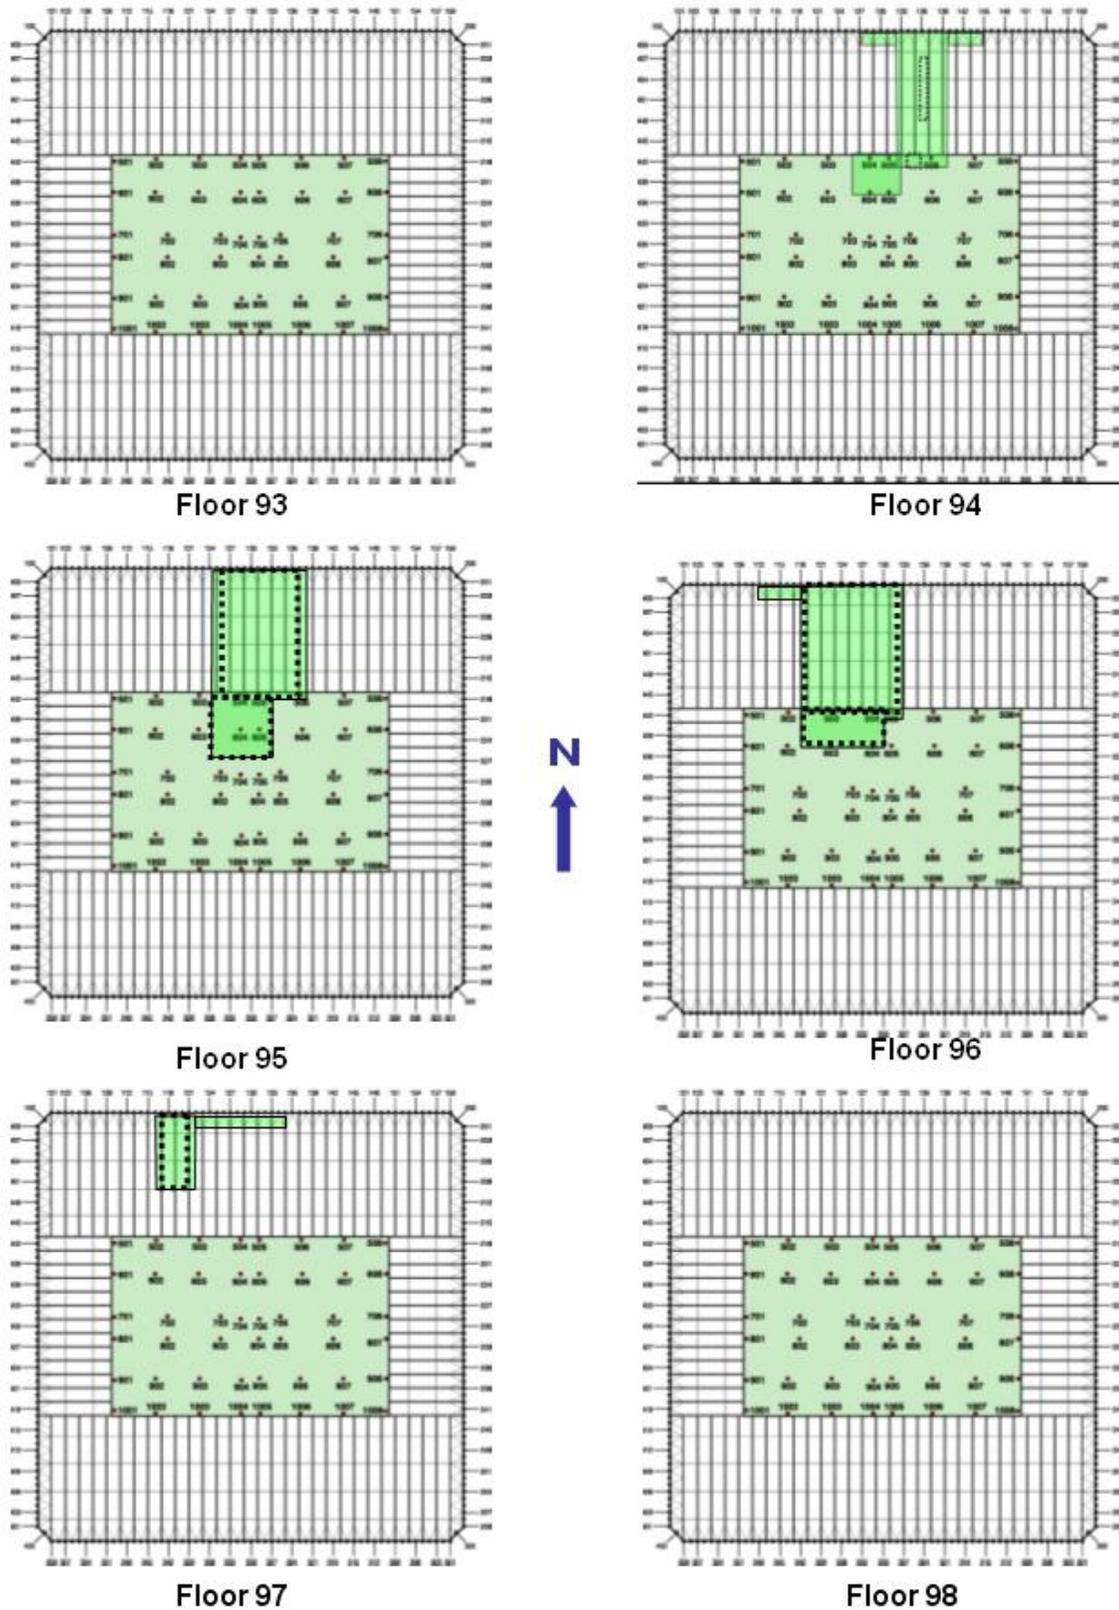
Figure 5–15. Plan view of WTC 1 Case A damage to Structural Floors 93 to 98.

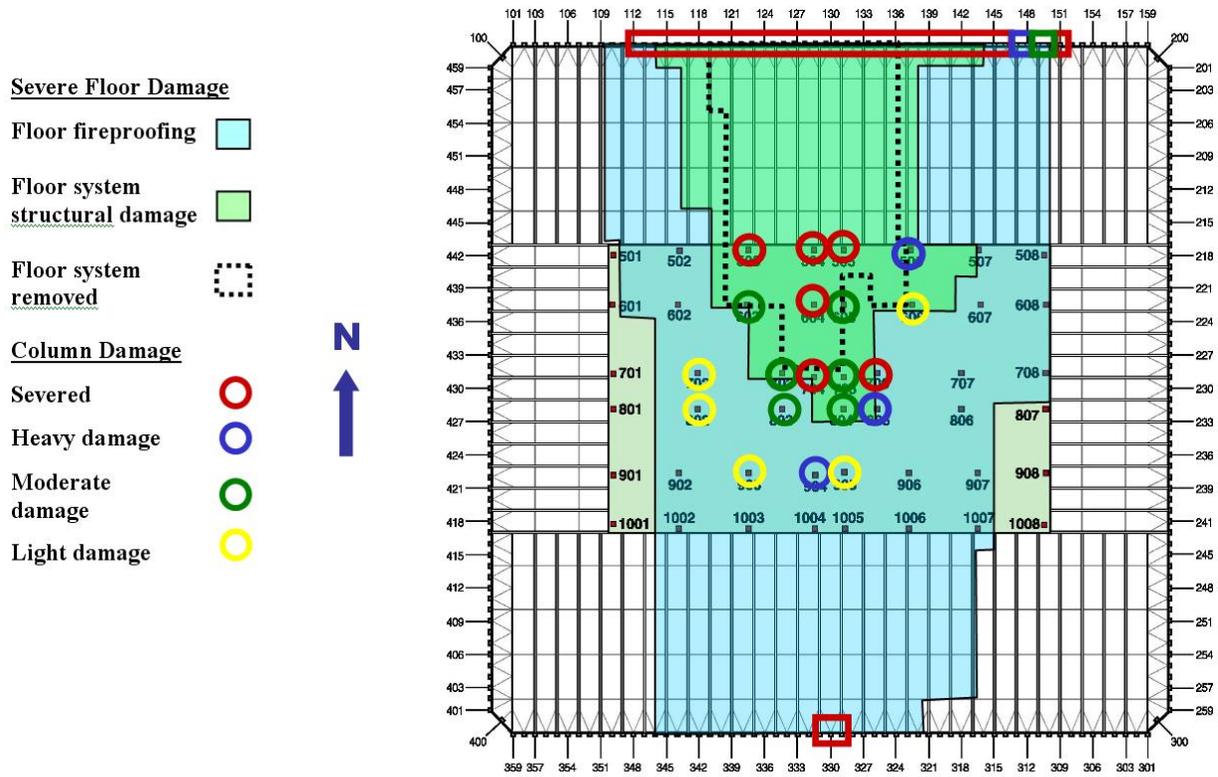
Figure 5–16. Plan view of WTC 1 Case B cumulative damage from Floors 93 to 98.

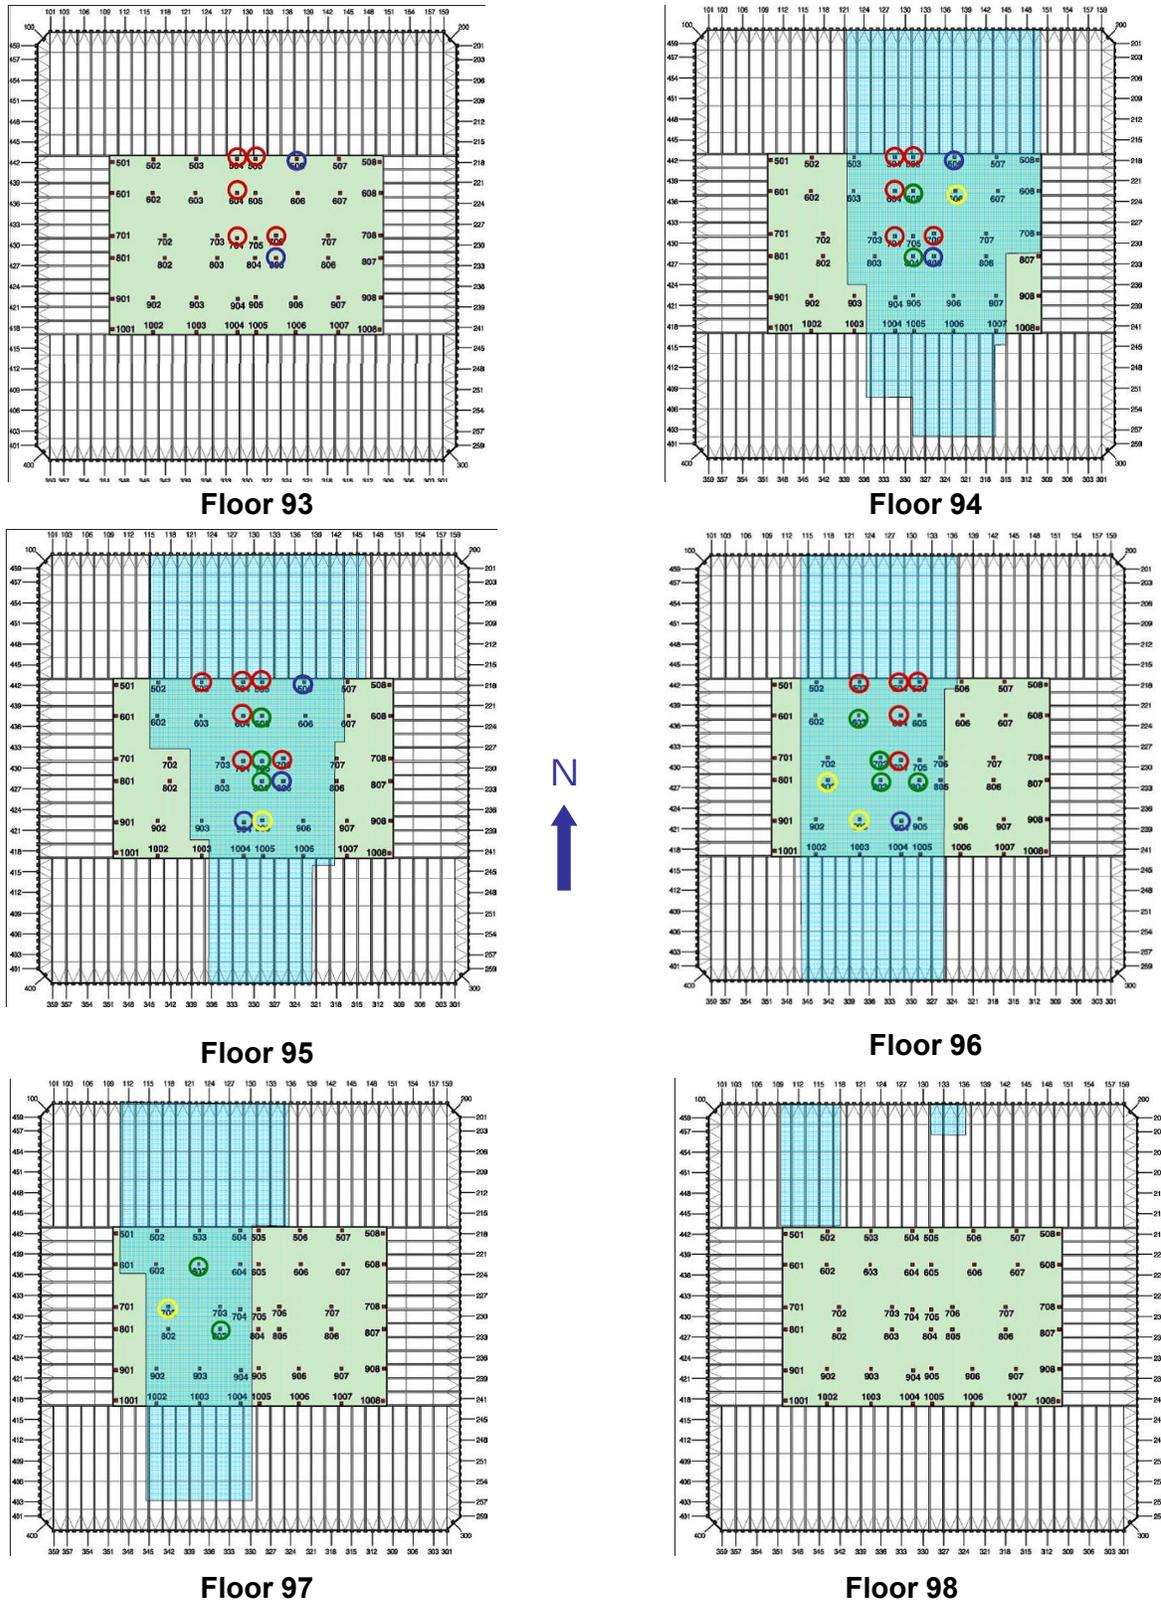
Figure 5–17. Plan view of WTC 1 Case B insulation and column damage to Occupancy Floors 93 to 98.

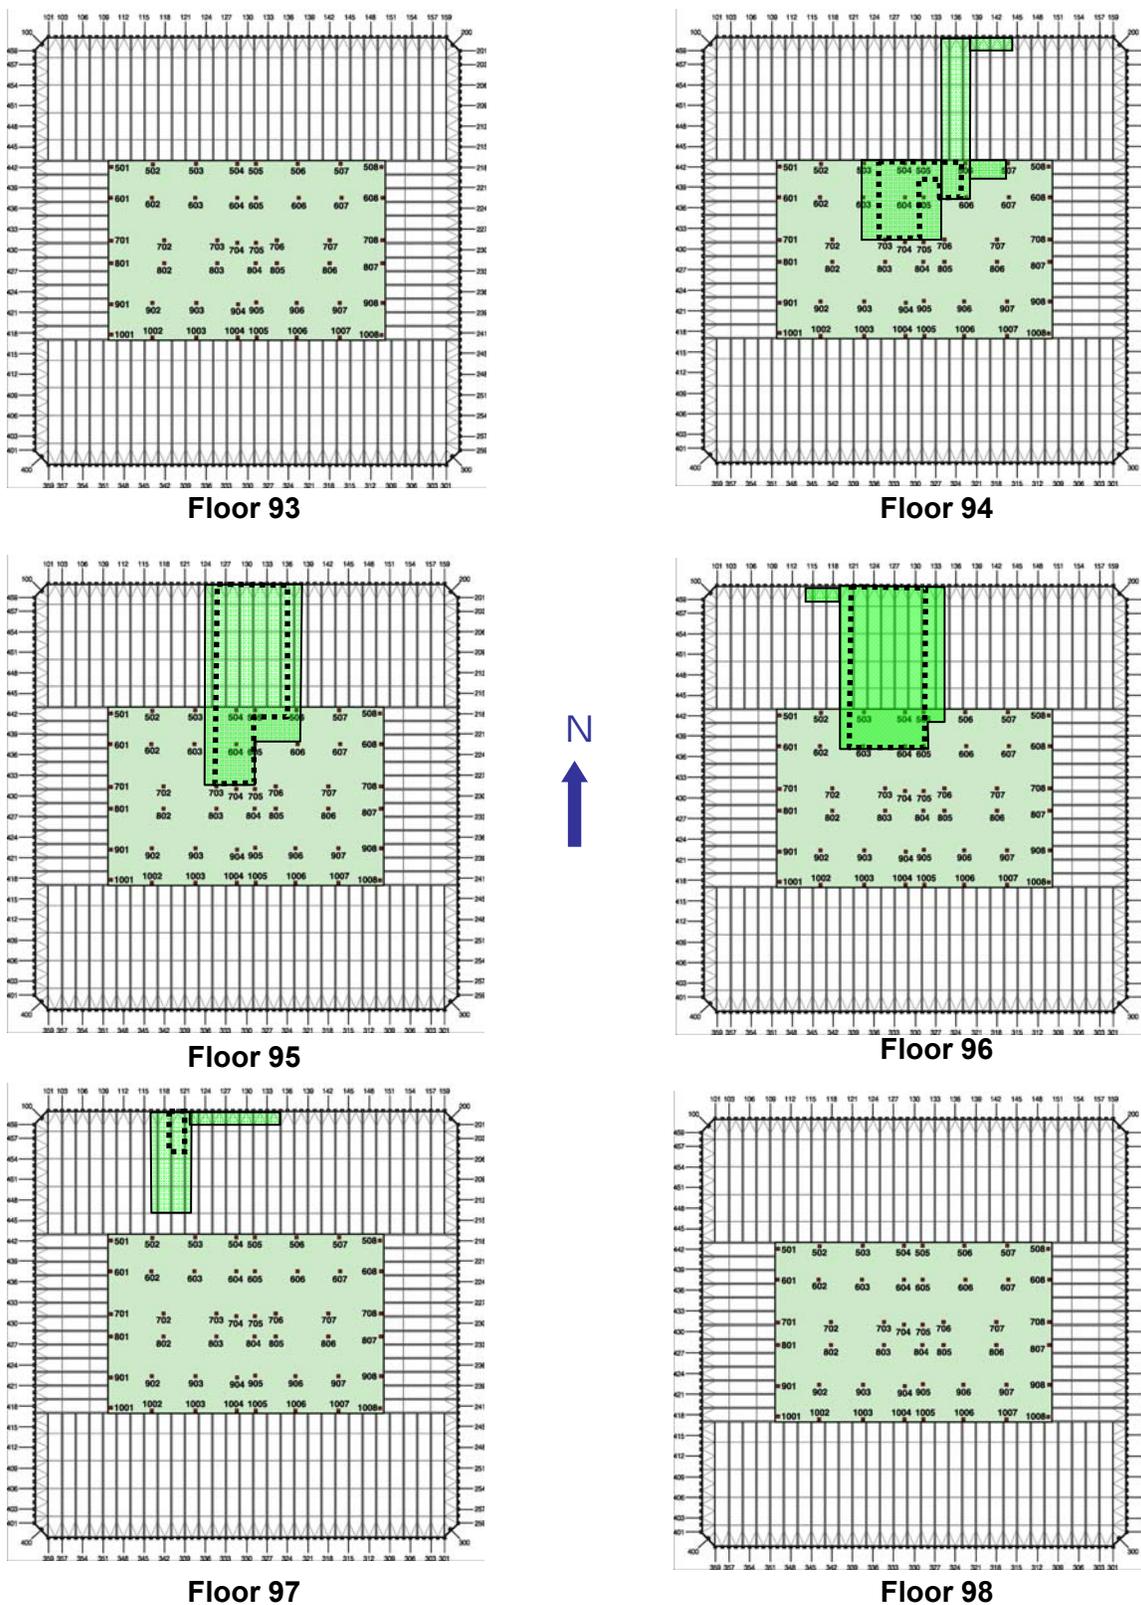
Figure 5–18. Plan view of WTC 1 Case B damage to Structural Floors 93 to 98.

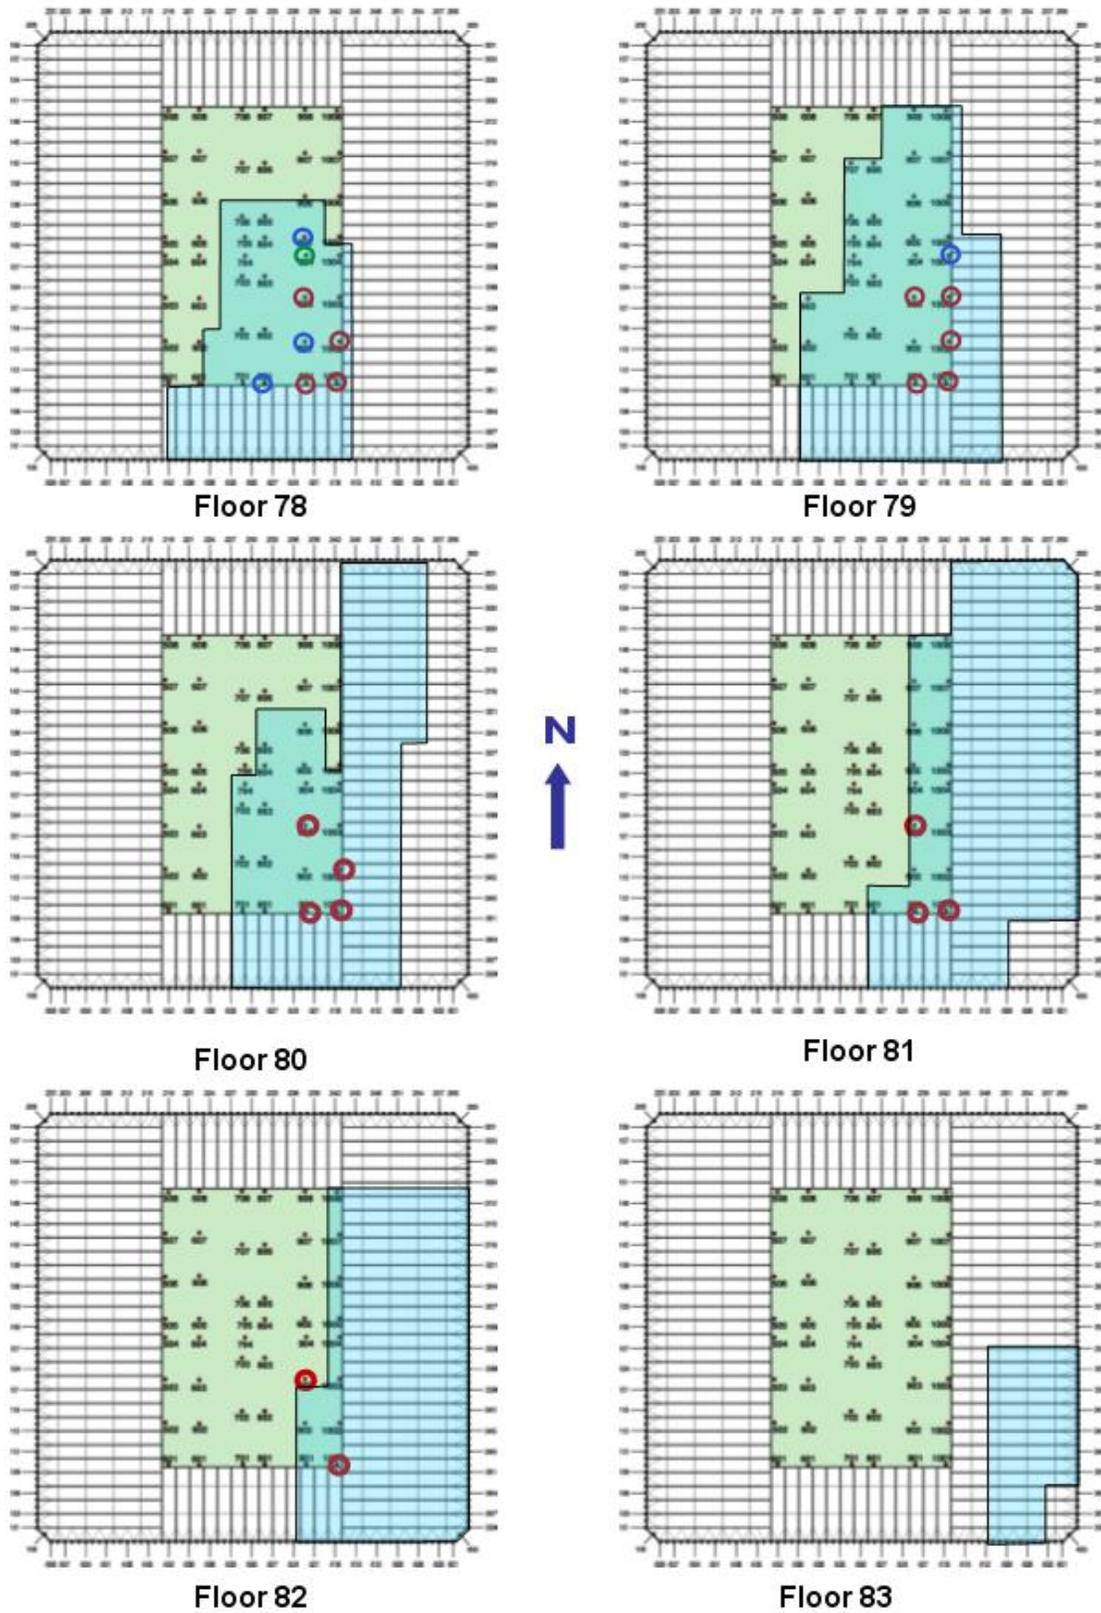
Figure 5–20. Plan view of WTC 2 Case C insulation and column damage to Occupancy Floors 78 to 83.

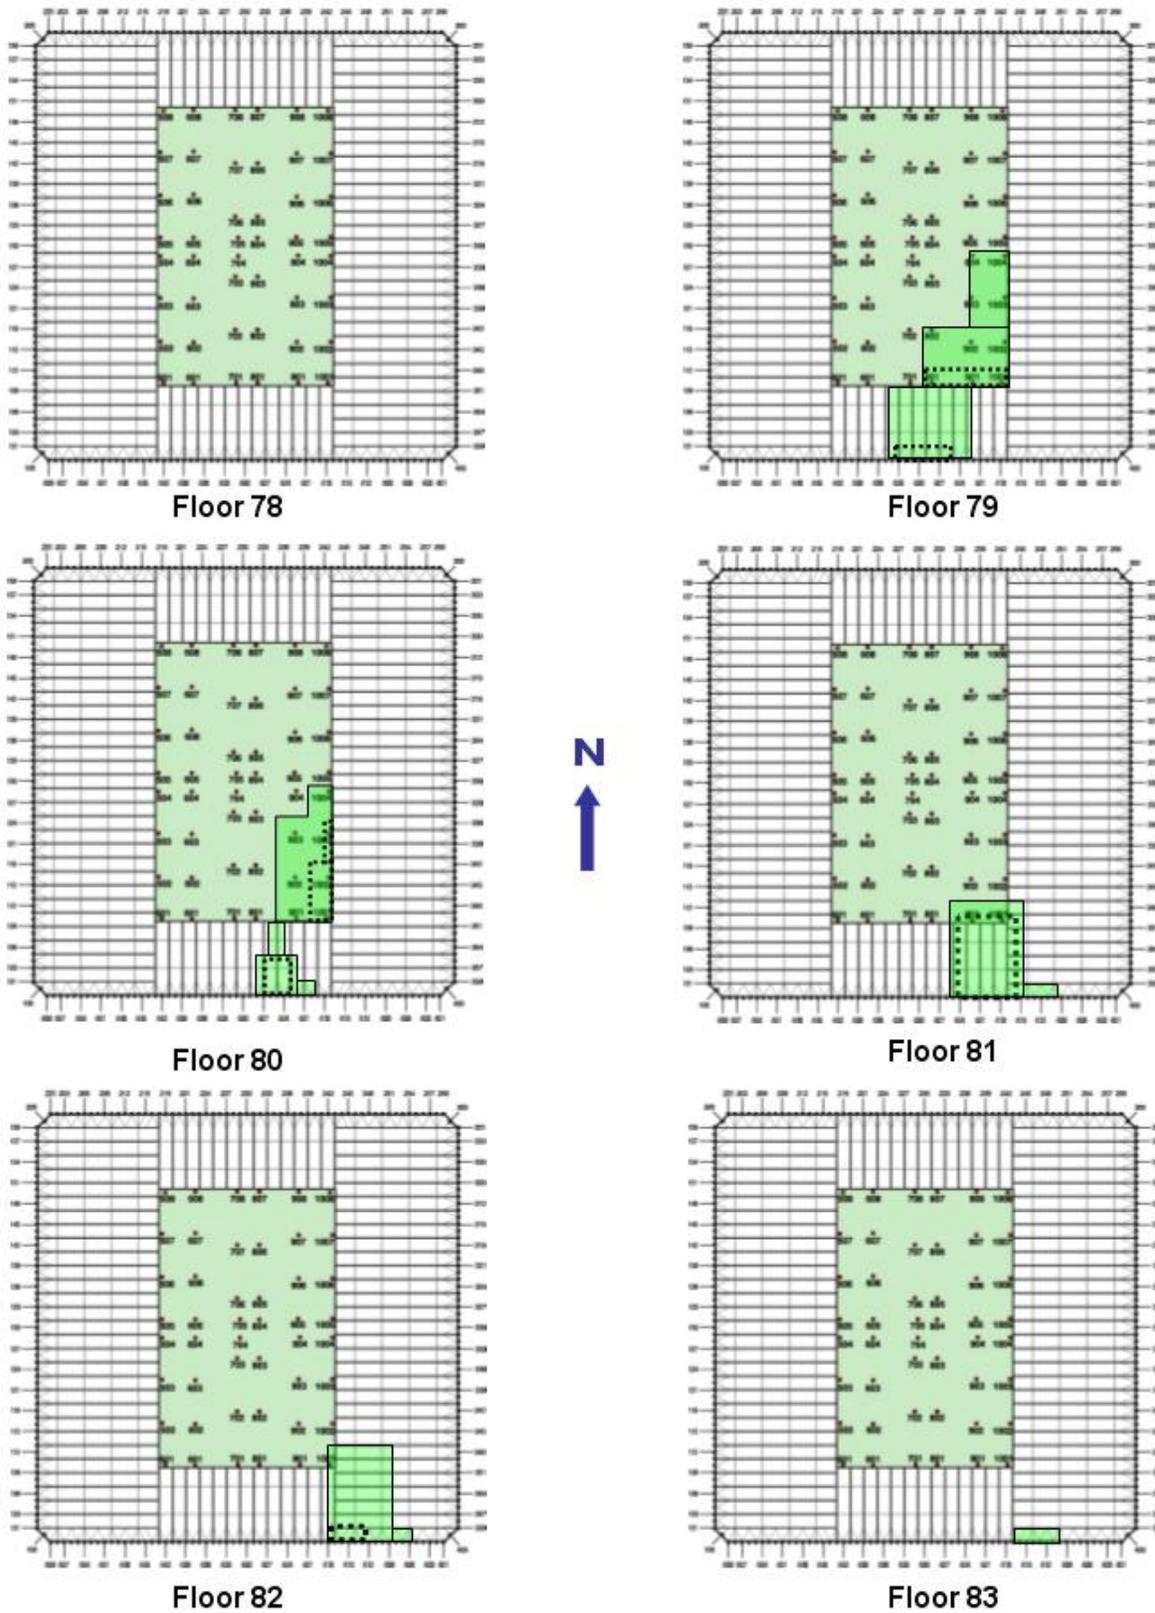
Figure 5–21. Plan view of WTC 2 Case C damage to Structural Floors 78 to 83.

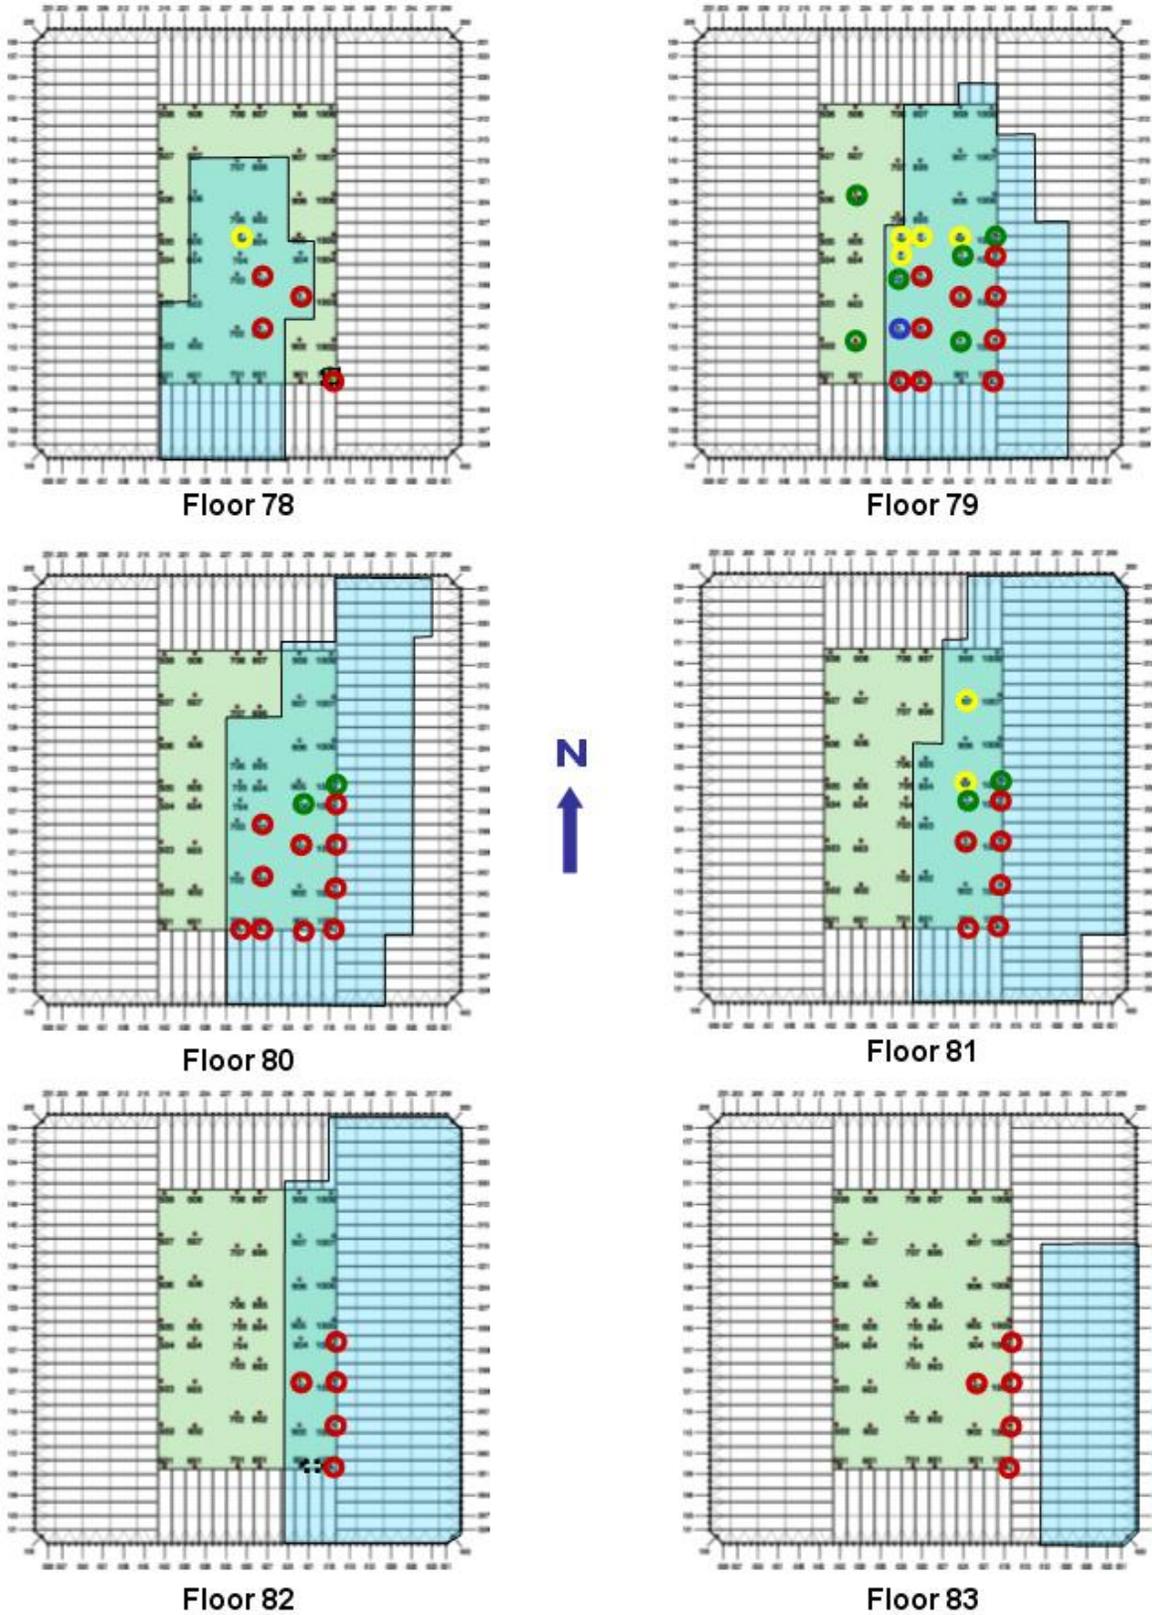
Figure 5–23. Plan view of WTC 2 Case D insulation and column damage to Occupancy Floors 78 to 83.
