**Federal Building and Fire Safety Investigation of the
World Trade Center Disaster**

Structural Fire Response and Probable Collapse Sequence of the World Trade Center Towers

John L. Gross
Therese P. McAllister

September 2005

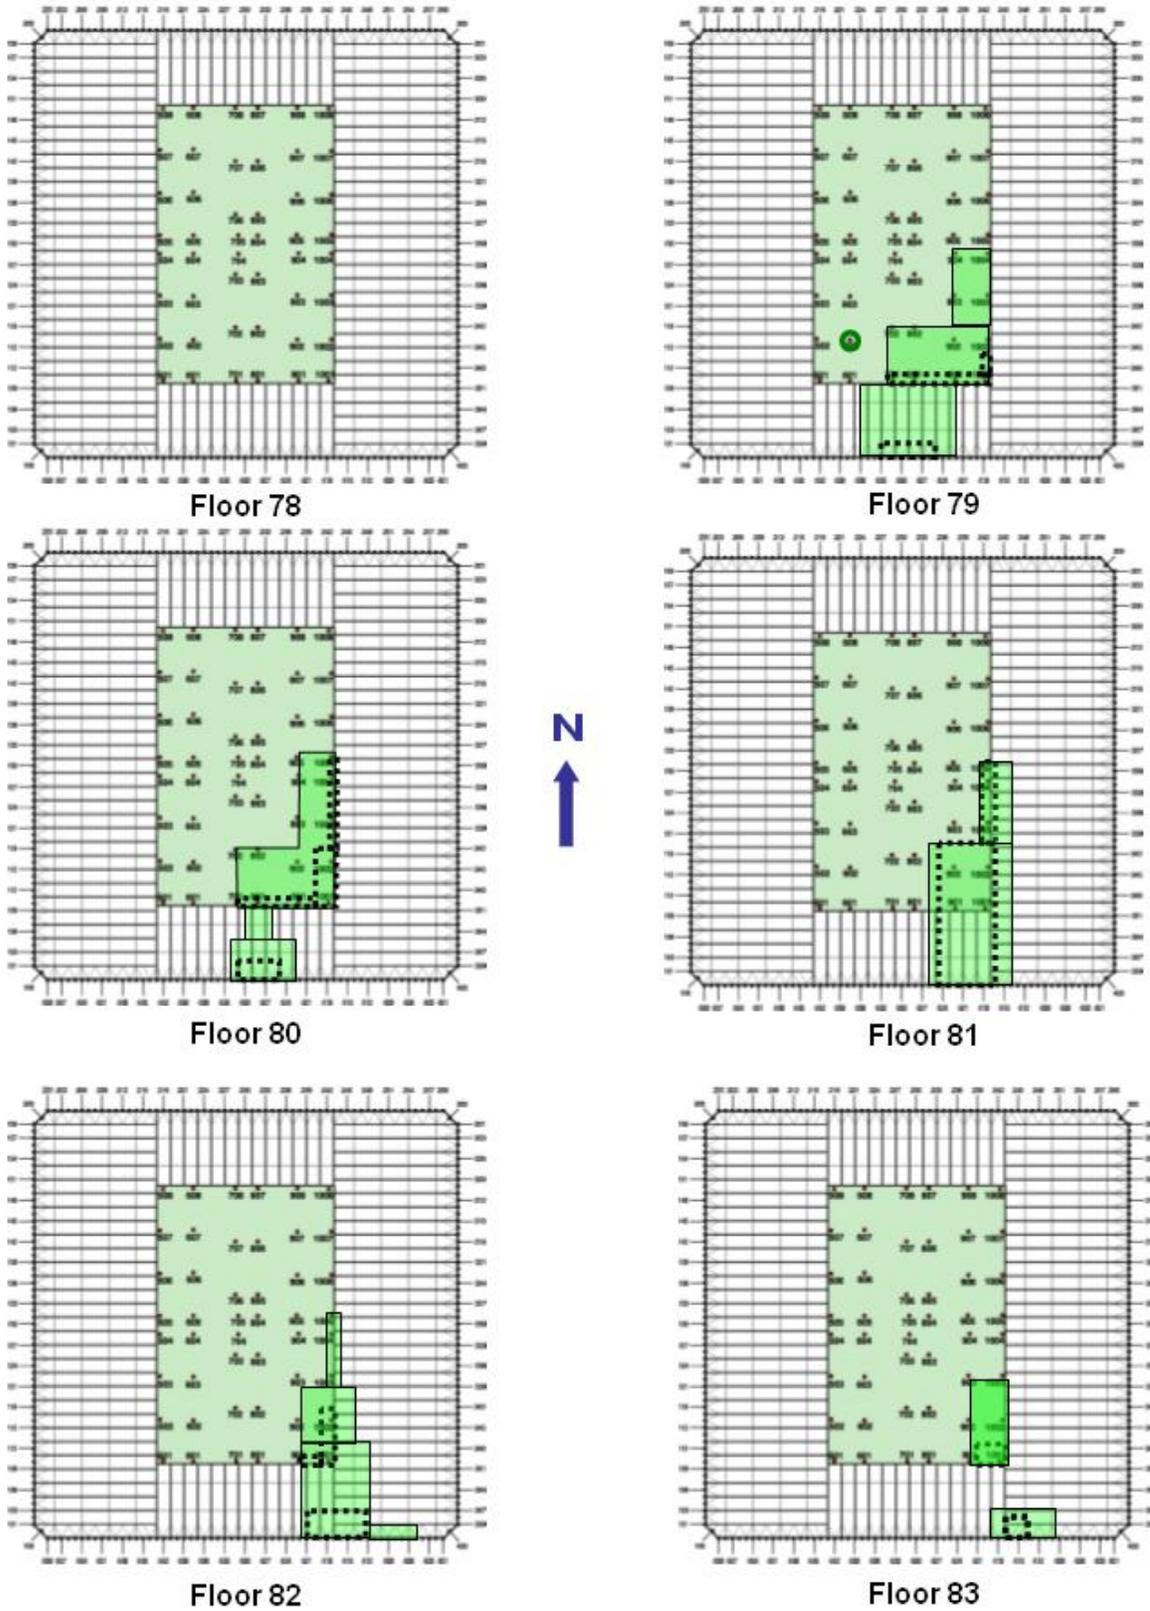
Figure 5–24. Plan view of WTC 2 Case D damage to Structural Floors 78 to 83.

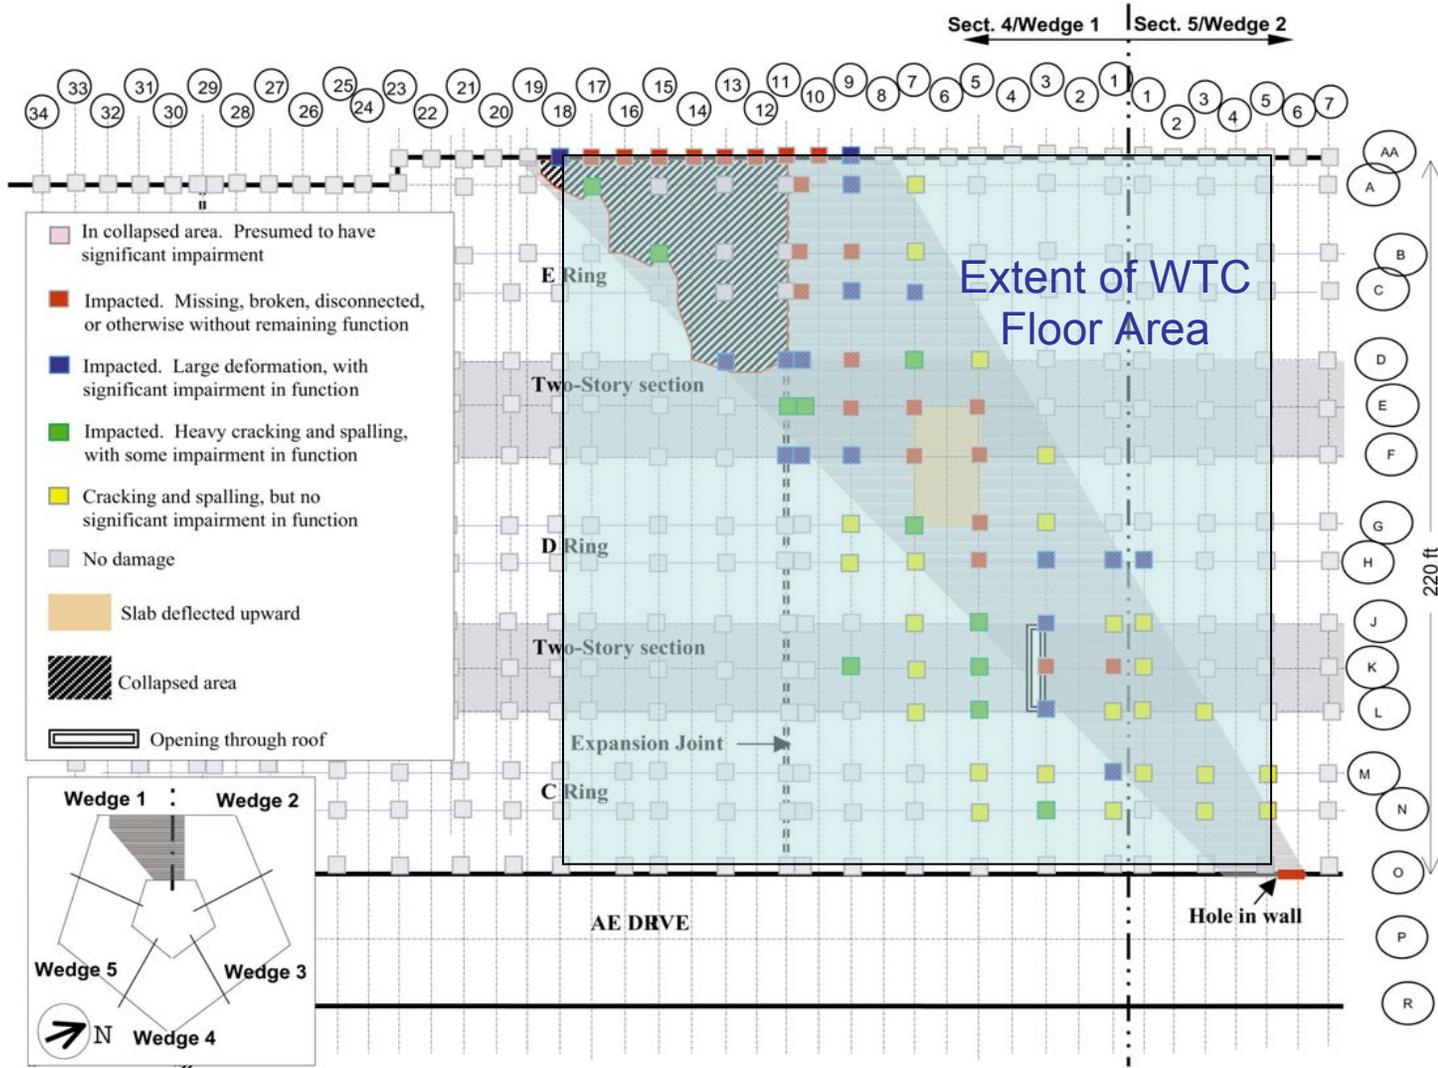
It is the light damage that is of interest relative to insulation damage from aircraft impact. Reinforced concrete columns have a concrete cover of at least one inch, and typically more, over the steel reinforcement. Figures 5–26 and 5–27 show two examples of columns with their concrete cover stripped by the debris field down to the spiral reinforcement over most of the column height. It was assumed that if the debris field could strip away concrete cover then a similar debris field would strip SFRM from steel components.

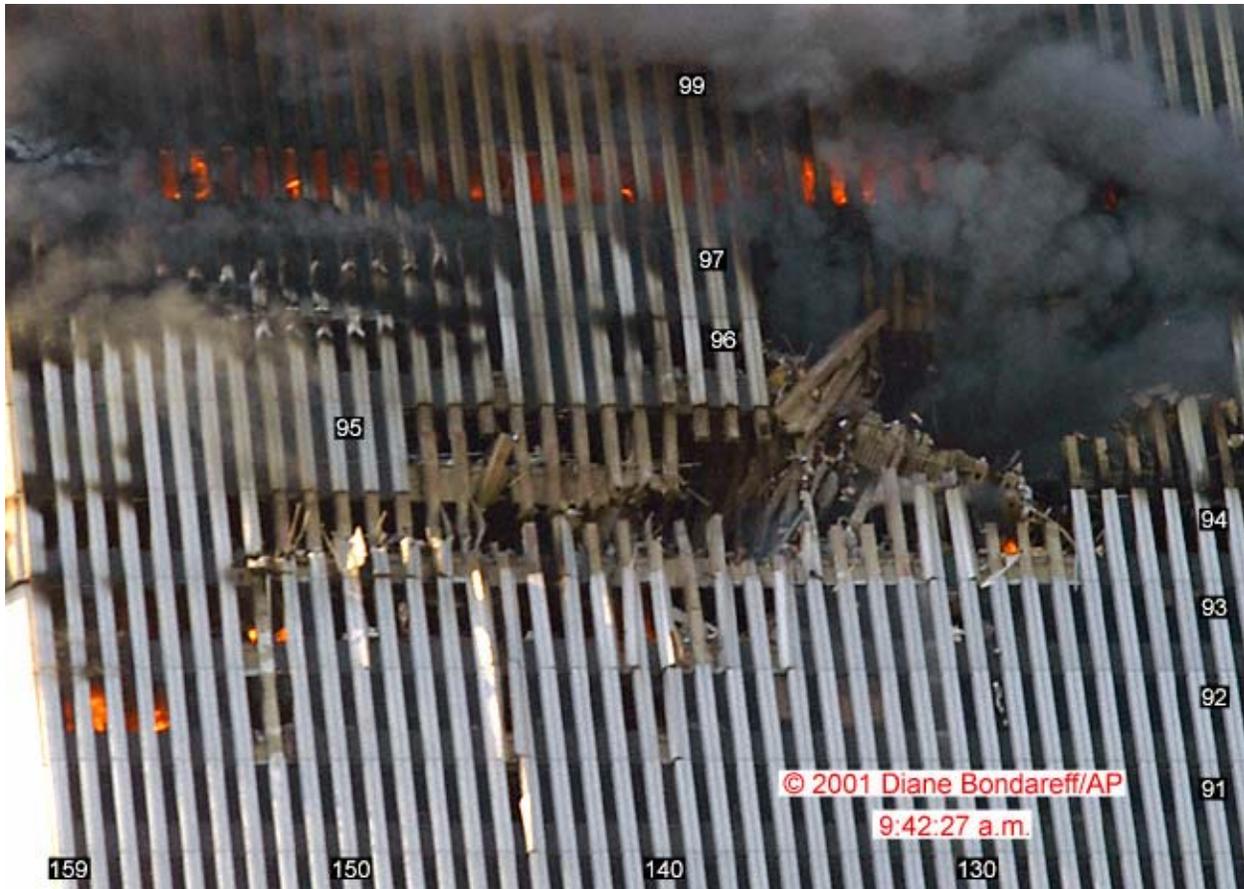
Figure 6–1. Initial aircraft impact damage on WTC 1 north face.

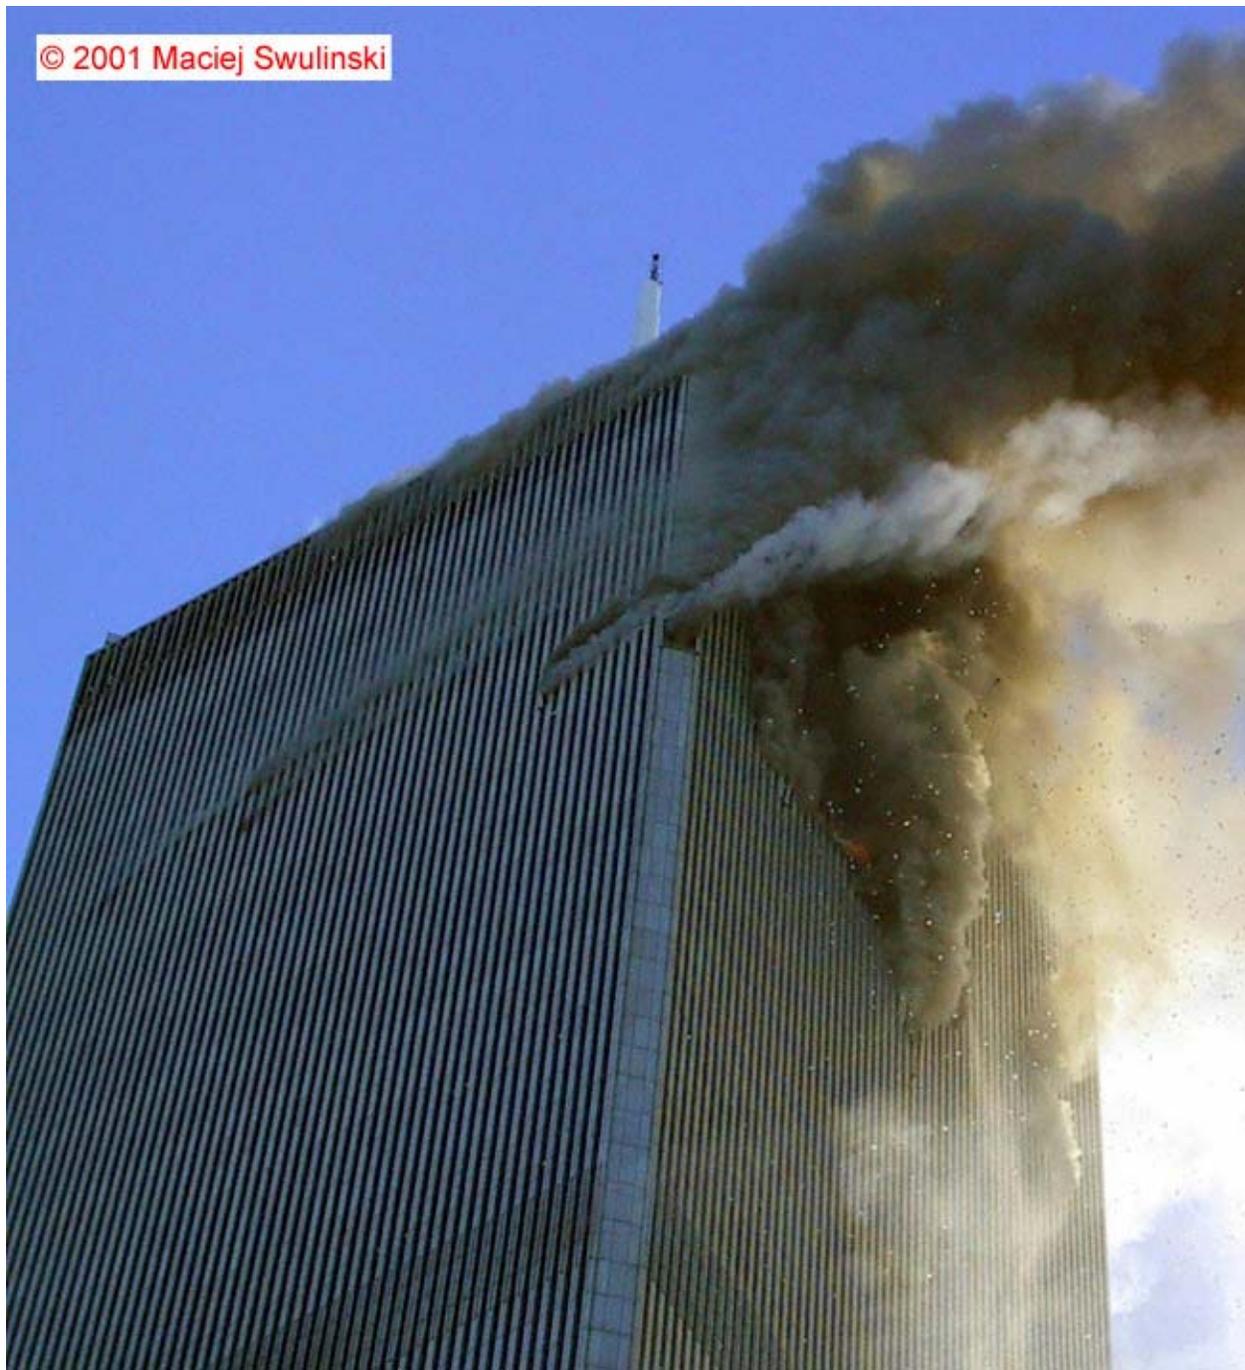
Figure 6–2. Initial aircraft impact damage on WTC 1 west and south faces minutes after impact (exact time of image is unknown).

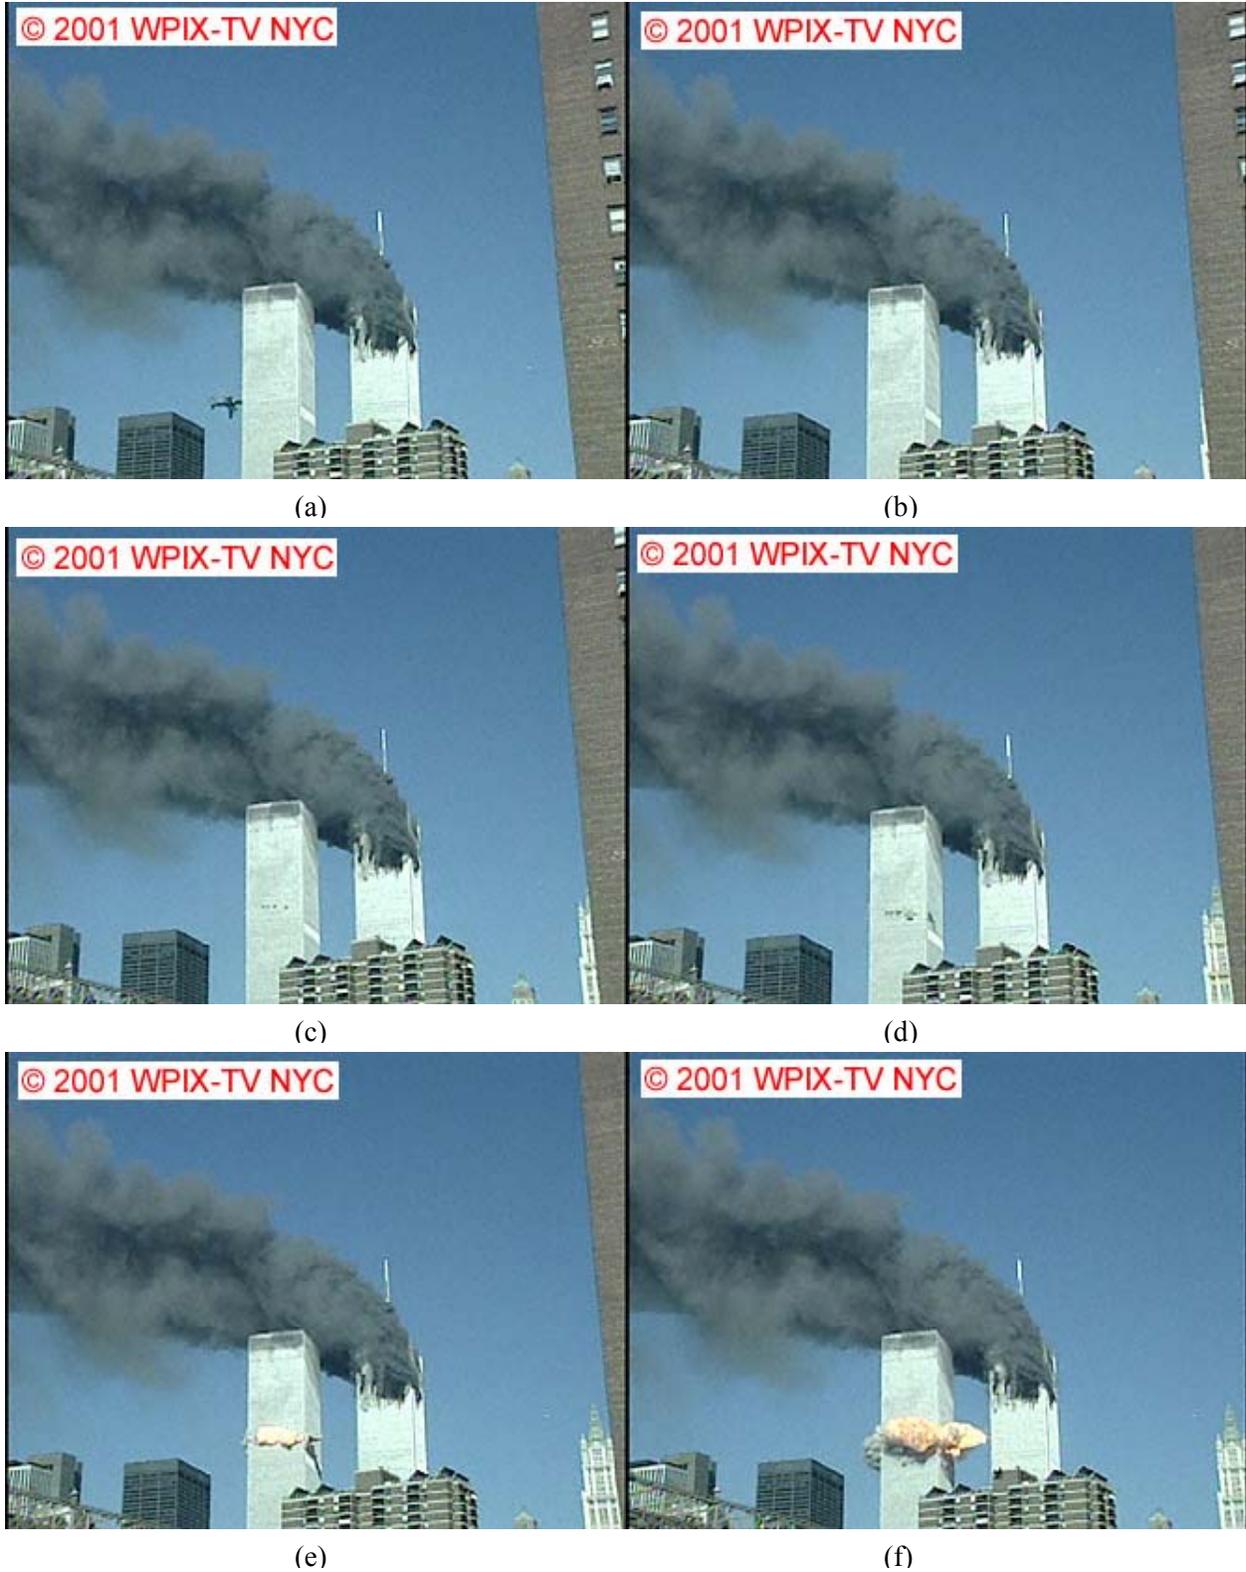
Figure 6–12. Aircraft impact into WTC 2 and fireball, view from the east.

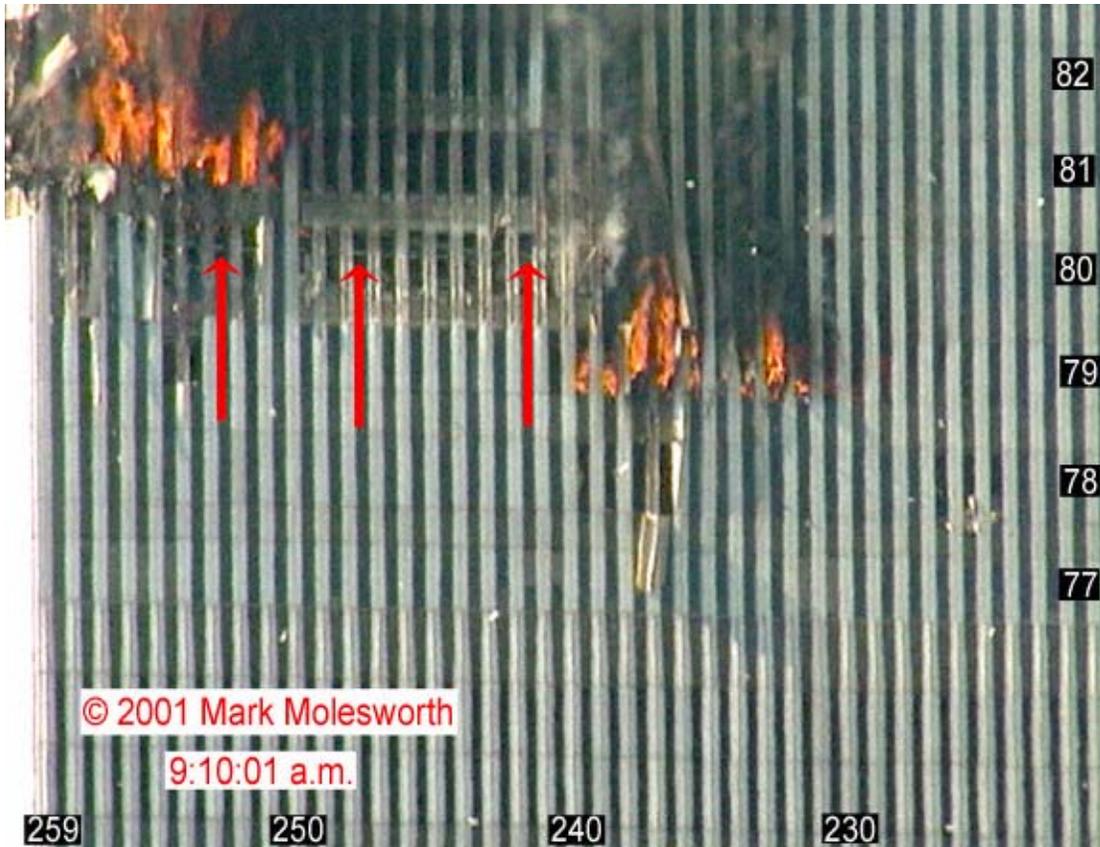
Figure 6–15. Hanging object (noted by arrows) in north windows of Floor 79 appears to be edge of Floor 80.

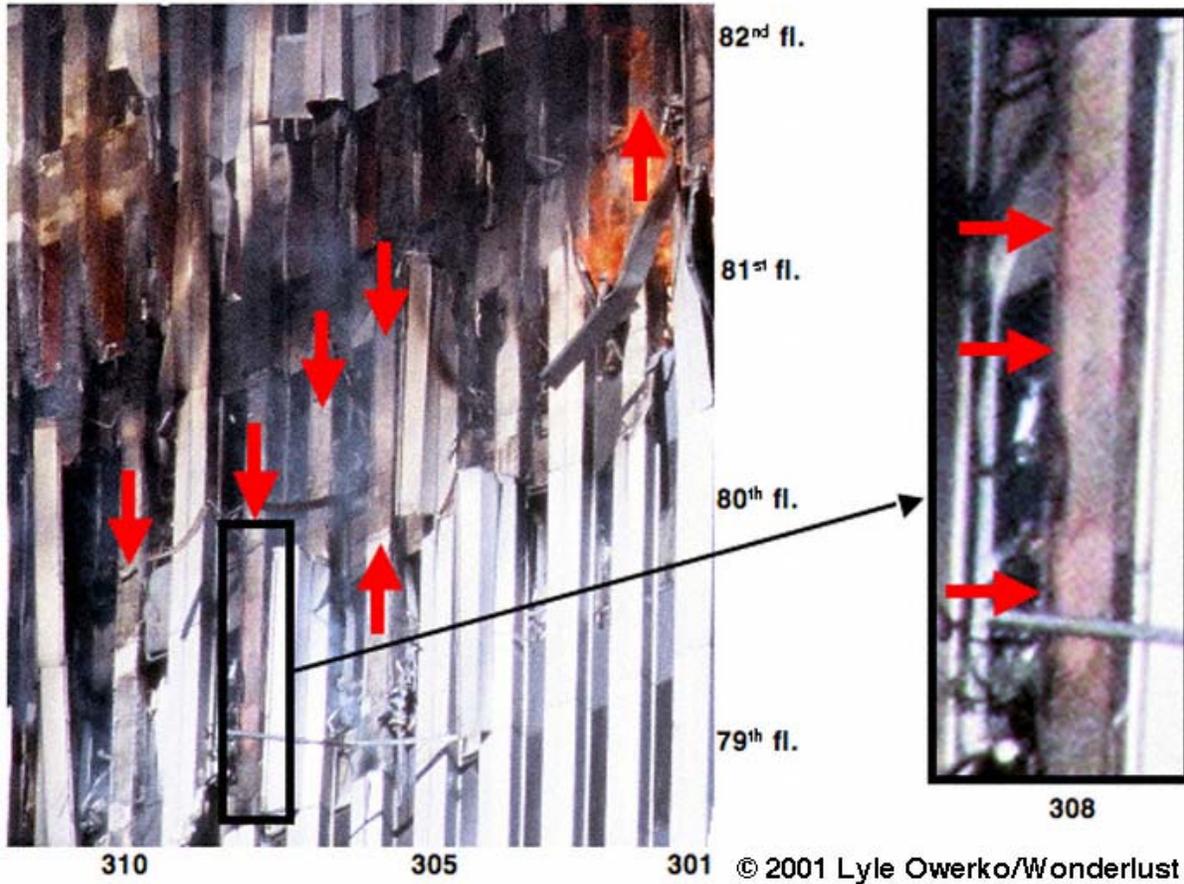
Figure 6–16. Image showing damage to fireproofing on east face of WTC 2 due to internal impact. Red arrows highlight areas where fireproofing has been damaged. The blowup to the right shows a column where red Tnemec primer paint is visible.

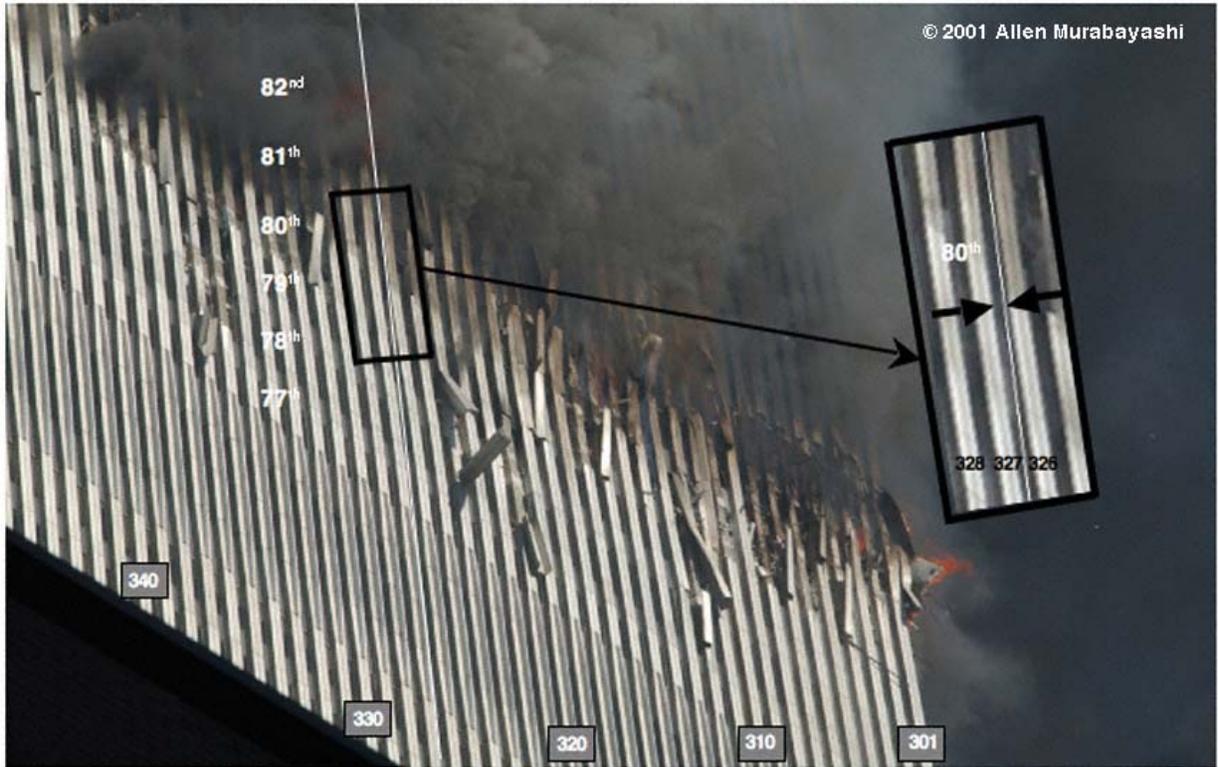
Figure 6–17. WTC 2 exterior columns bowing inward across north side of the east face between Floors 77 and 83 at 9:21 a.m.

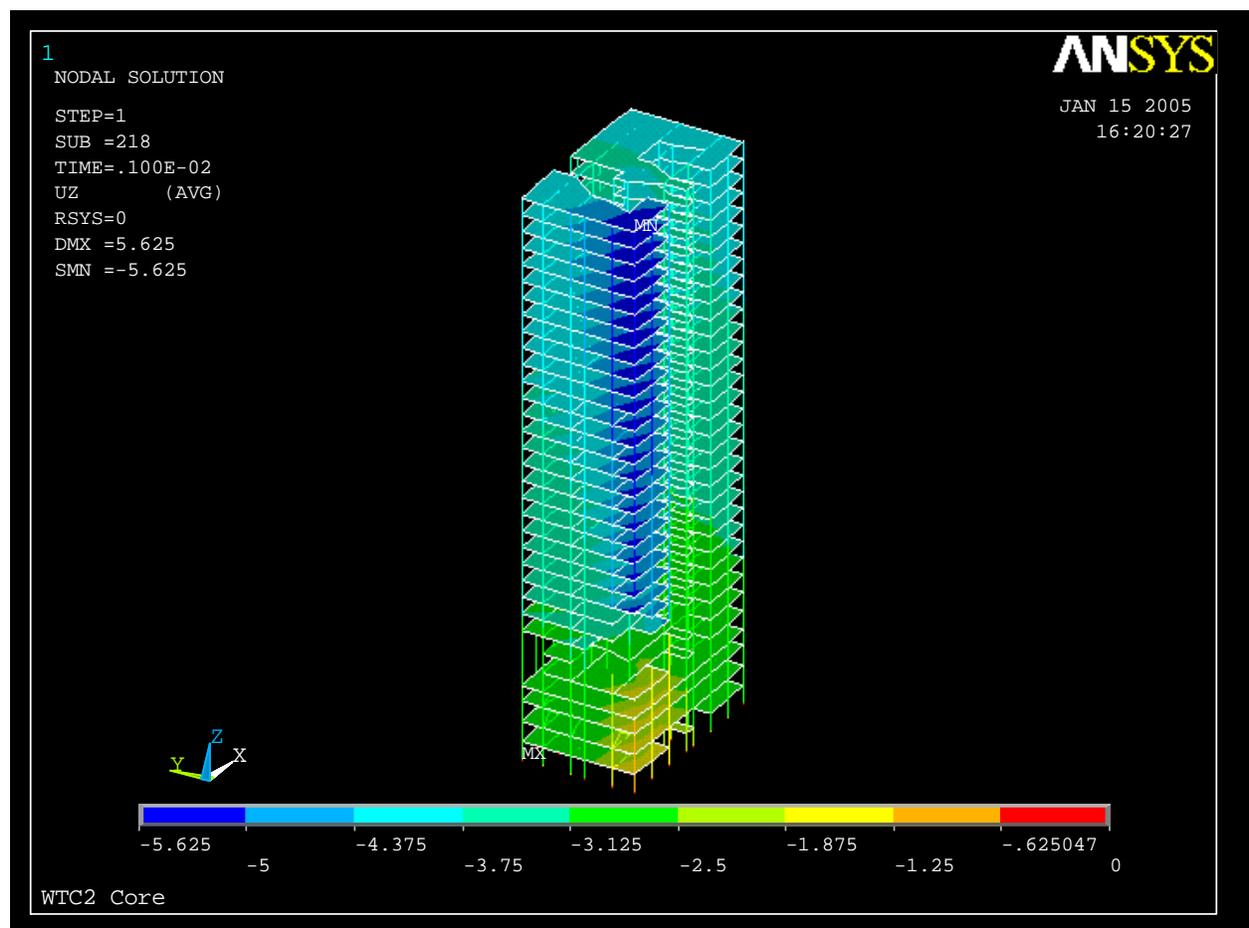
For both Case C and Case D temperatures, the core structure was weakened at the southeast corner and along the east side of the core. The core structural responses to these two temperature conditions illustrate the slight difference in core weakening by the larger deflection in the southeast corner for Case D, which had more column damage. The WTC 2 response for Case C and Case D temperatures was similar, with a 2 in. increase for Case D. When the results of each isolated core model were compared to the observed behavior of WTC 2, both Cases provided a reasonable match.

Figure 7–5. Vertical displacement of the WTC 2 isolated core model with impact damage and gravity loads (south and east faces).

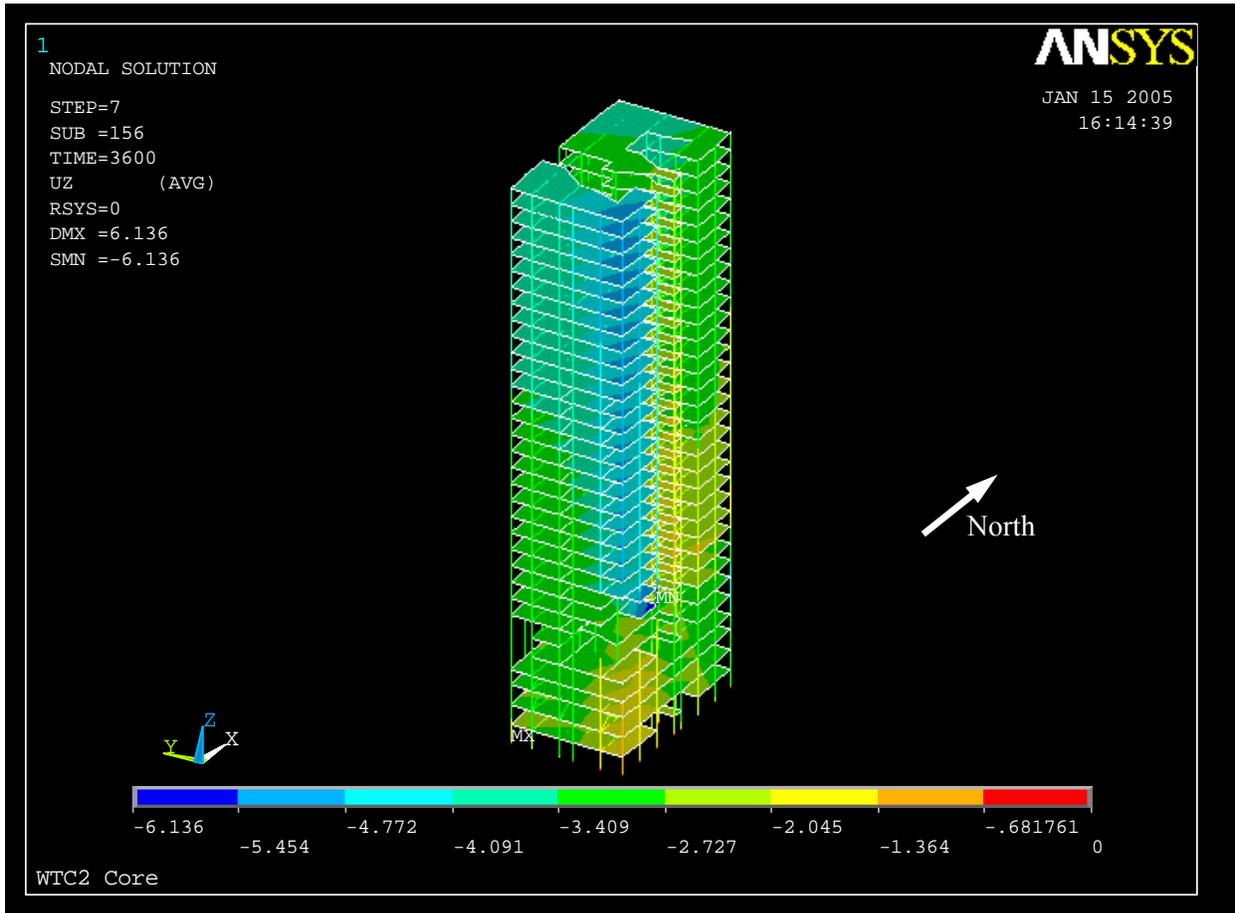
Figure 7–6. Vertical displacement of the WTC 2 core model at 60 min for Case C temperatures (south and east faces).

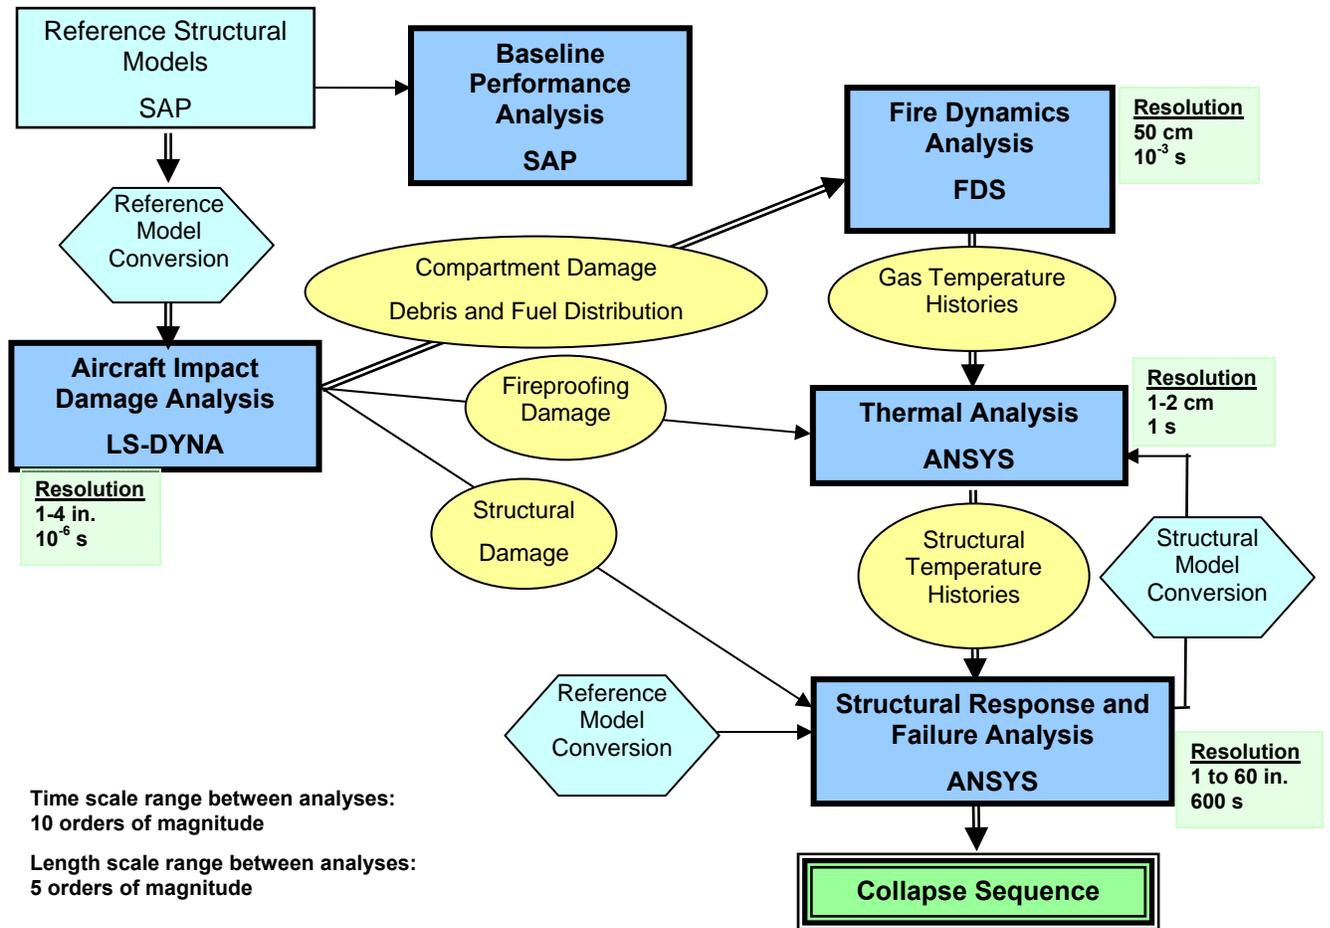
aircraft impact analysis determined damage to the exterior and the interior of the building and included the structural system, insulation, partition walls, and furnishings for each tower. The analysis also provided an estimate of the fuel dispersion in the towers. These results provided initial conditions for the fire dynamics analysis, thermal analysis, and structural analysis. The fire dynamics analysis simulated the growth and spread of fires and produced gas temperature histories for each floor subjected to fire. The fire dynamics model accounted for damage to interior partition walls and floors (which affected ventilation conditions) and the distribution of debris and fuel.

Figure 9–1. Critical analysis inter-dependencies.

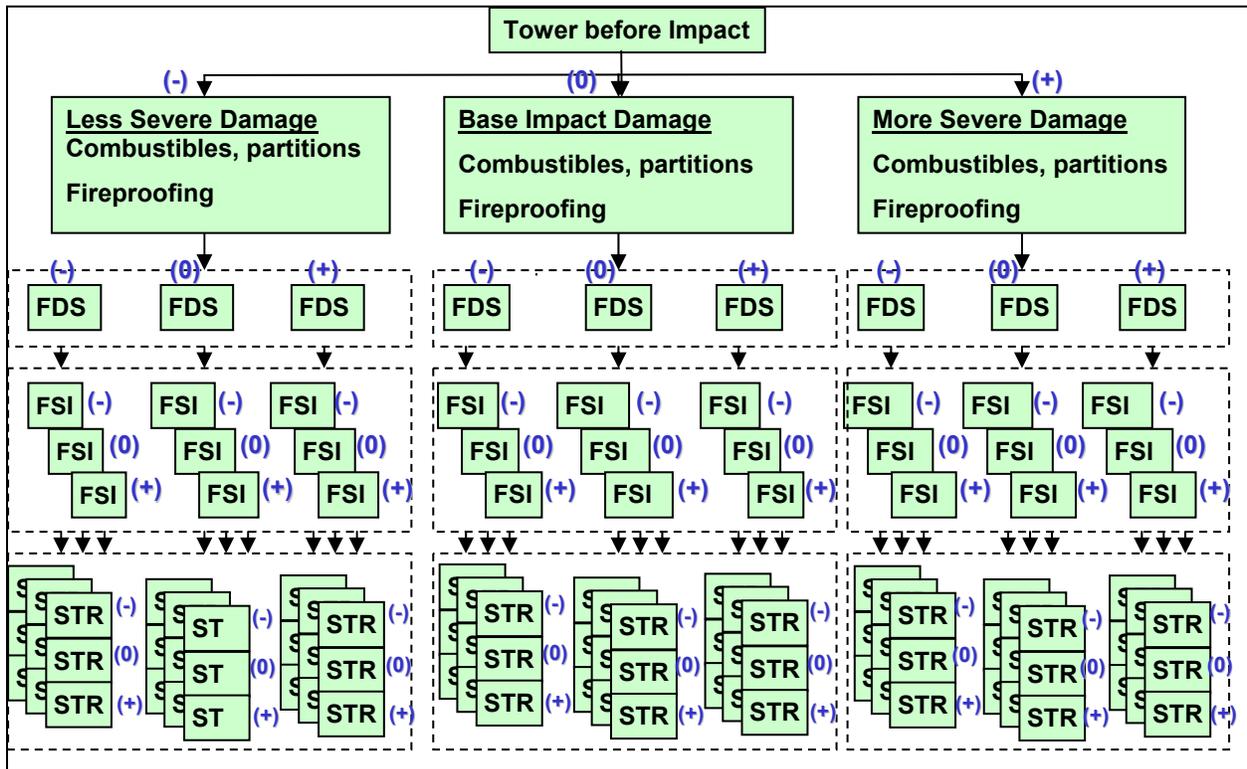
Figure 9–2. Full analysis tree for influential parameter effects.

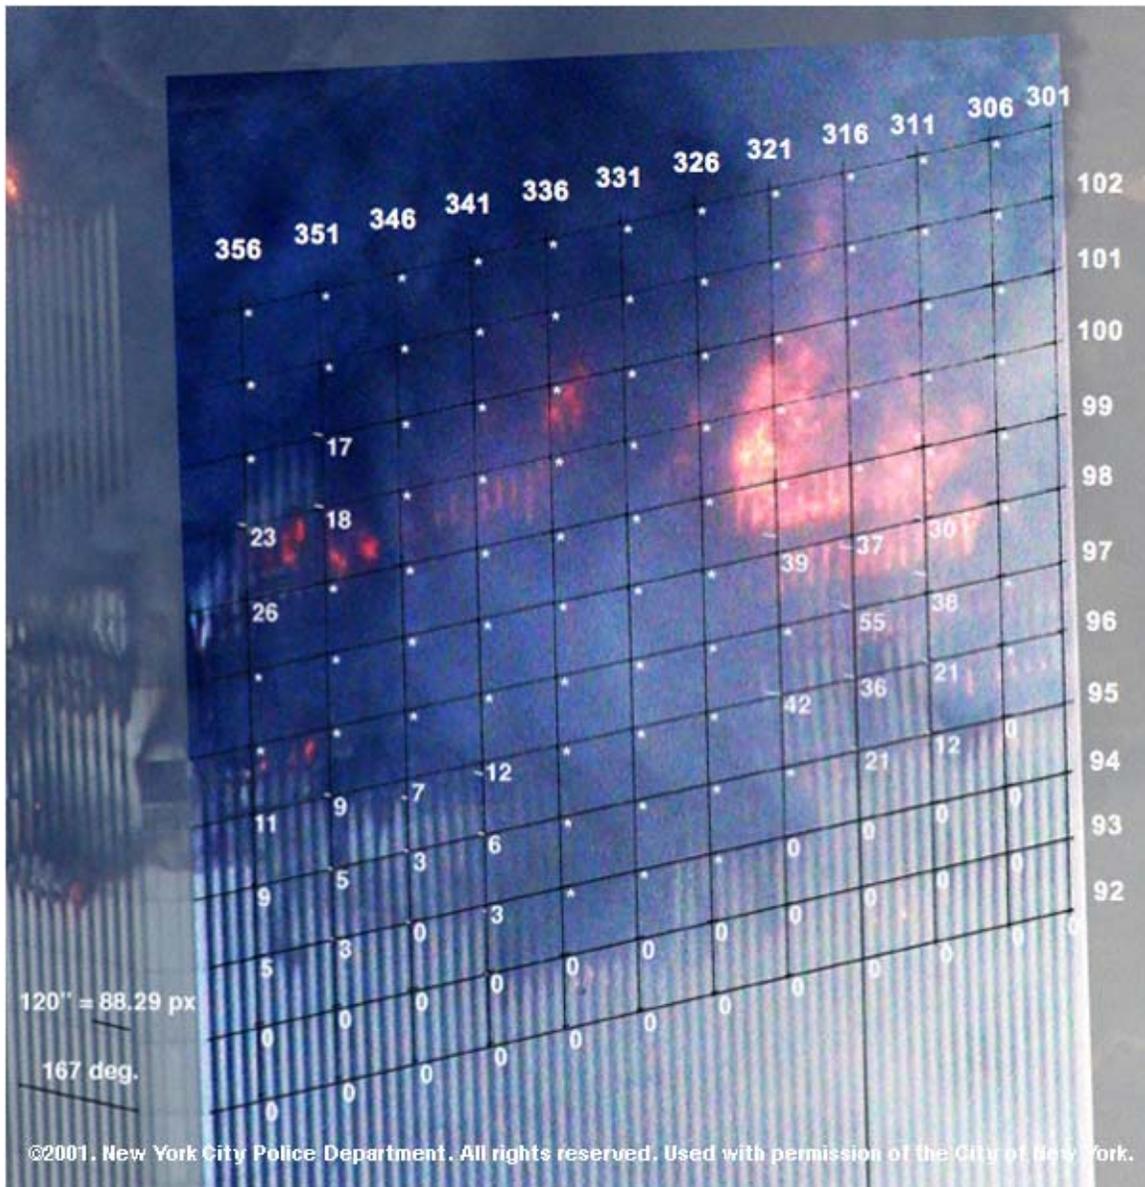
Figure 9–11. Inward bowing of the WTC 1 south wall of WTC 1 at 10:23 a.m.

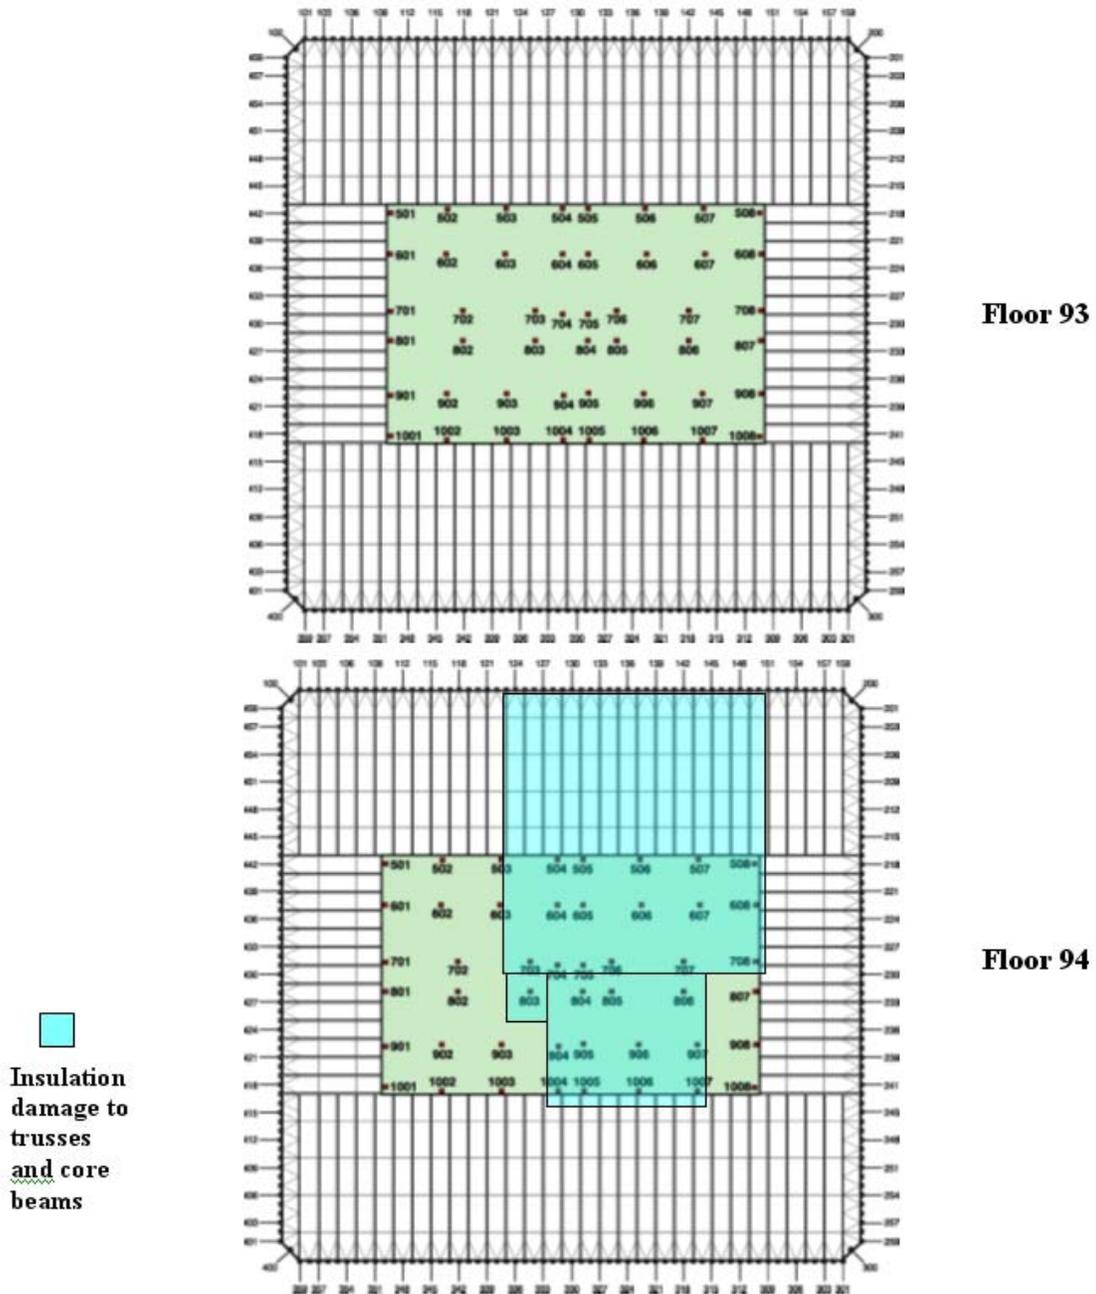
Figure A–1. WTC 1 Case A_i aircraft impact damage to Structural Floor 93 and 94.

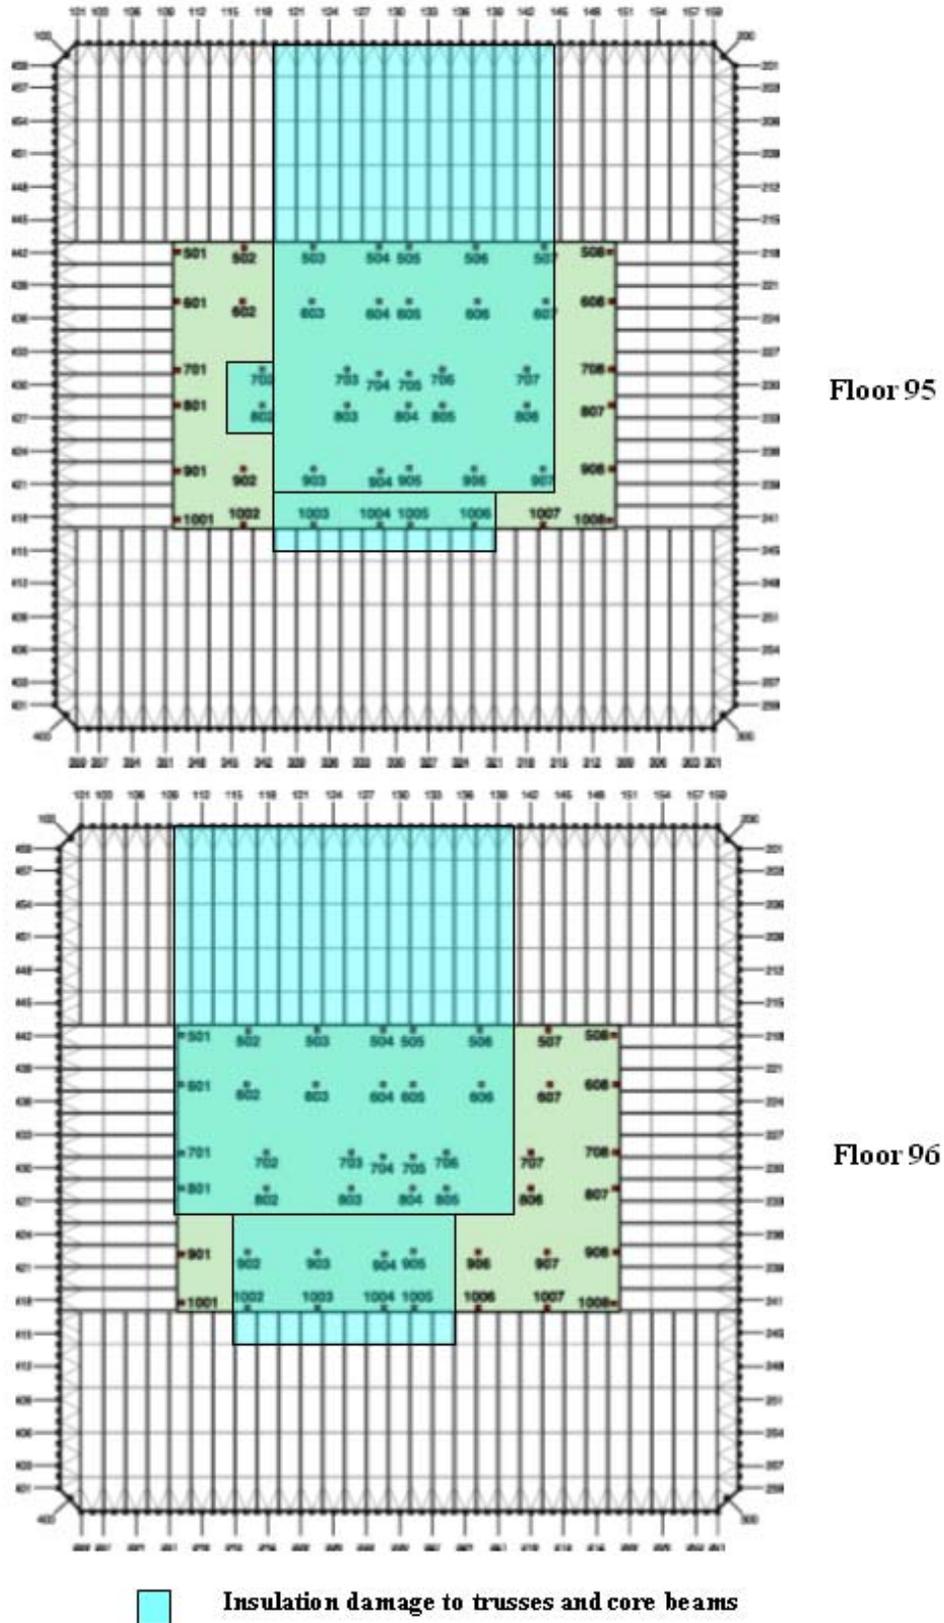
Figure A-2. WTC 1 Case A; aircraft impact damage to Structural Floors 95 and 96.

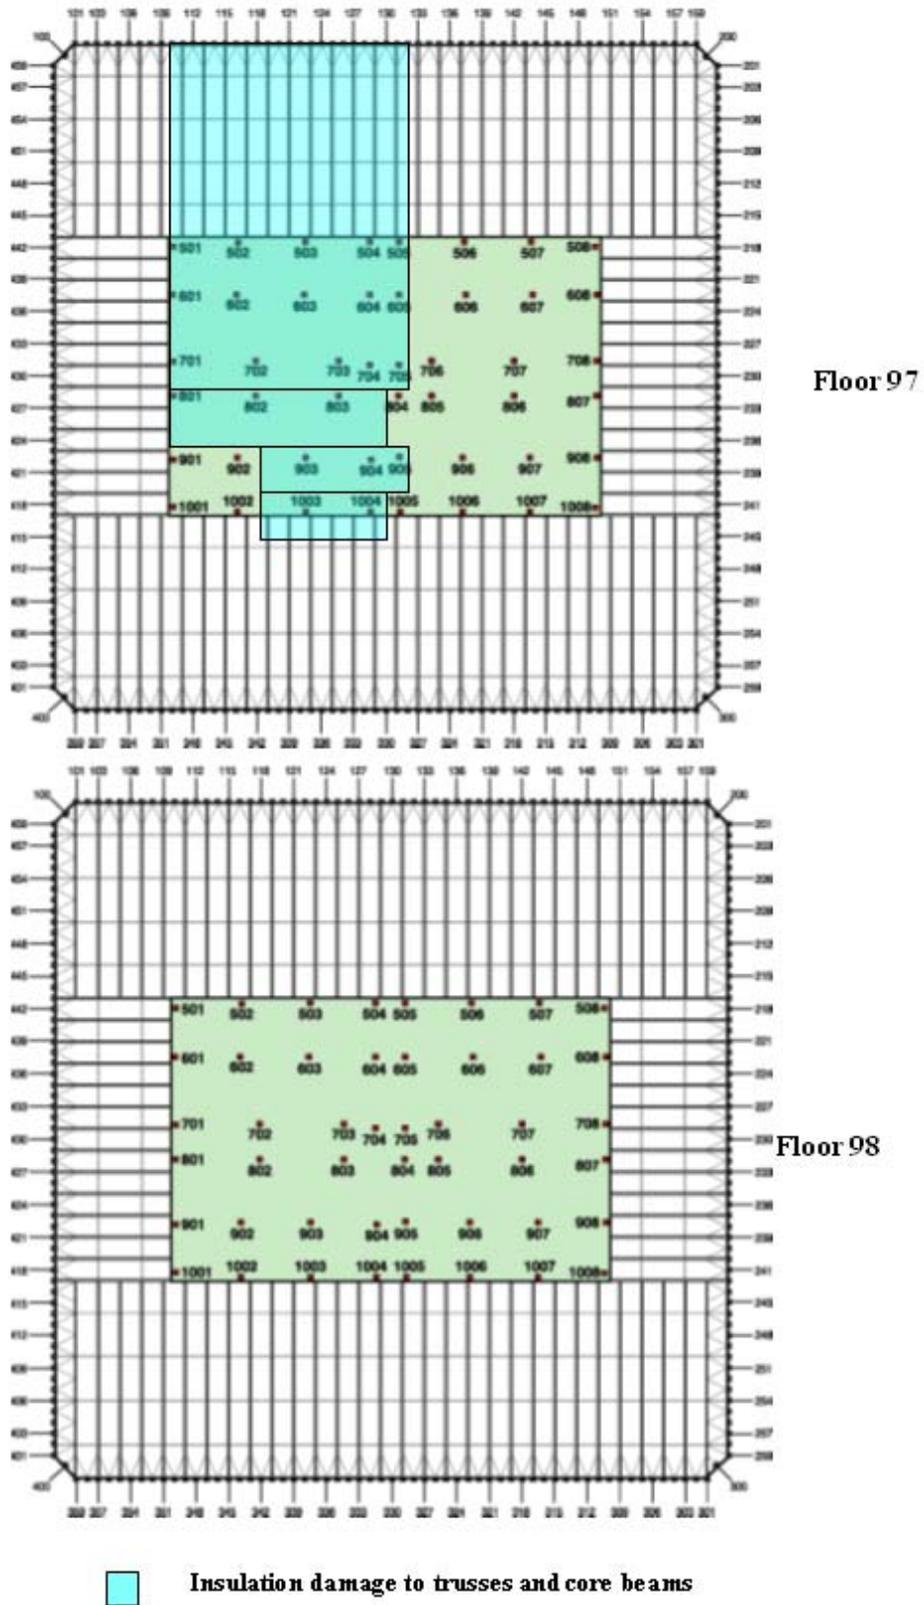
Figure A-3. WTC 1 Case A, aircraft impact damage to Structural Floors 97 and 98.
