**Federal Building and Fire Safety Investigation of the
World Trade Center Disaster**

Structural Fire Response and Probable Collapse Sequence of the World Trade Center Towers

John L. Gross
Therese P. McAllister

September 2005

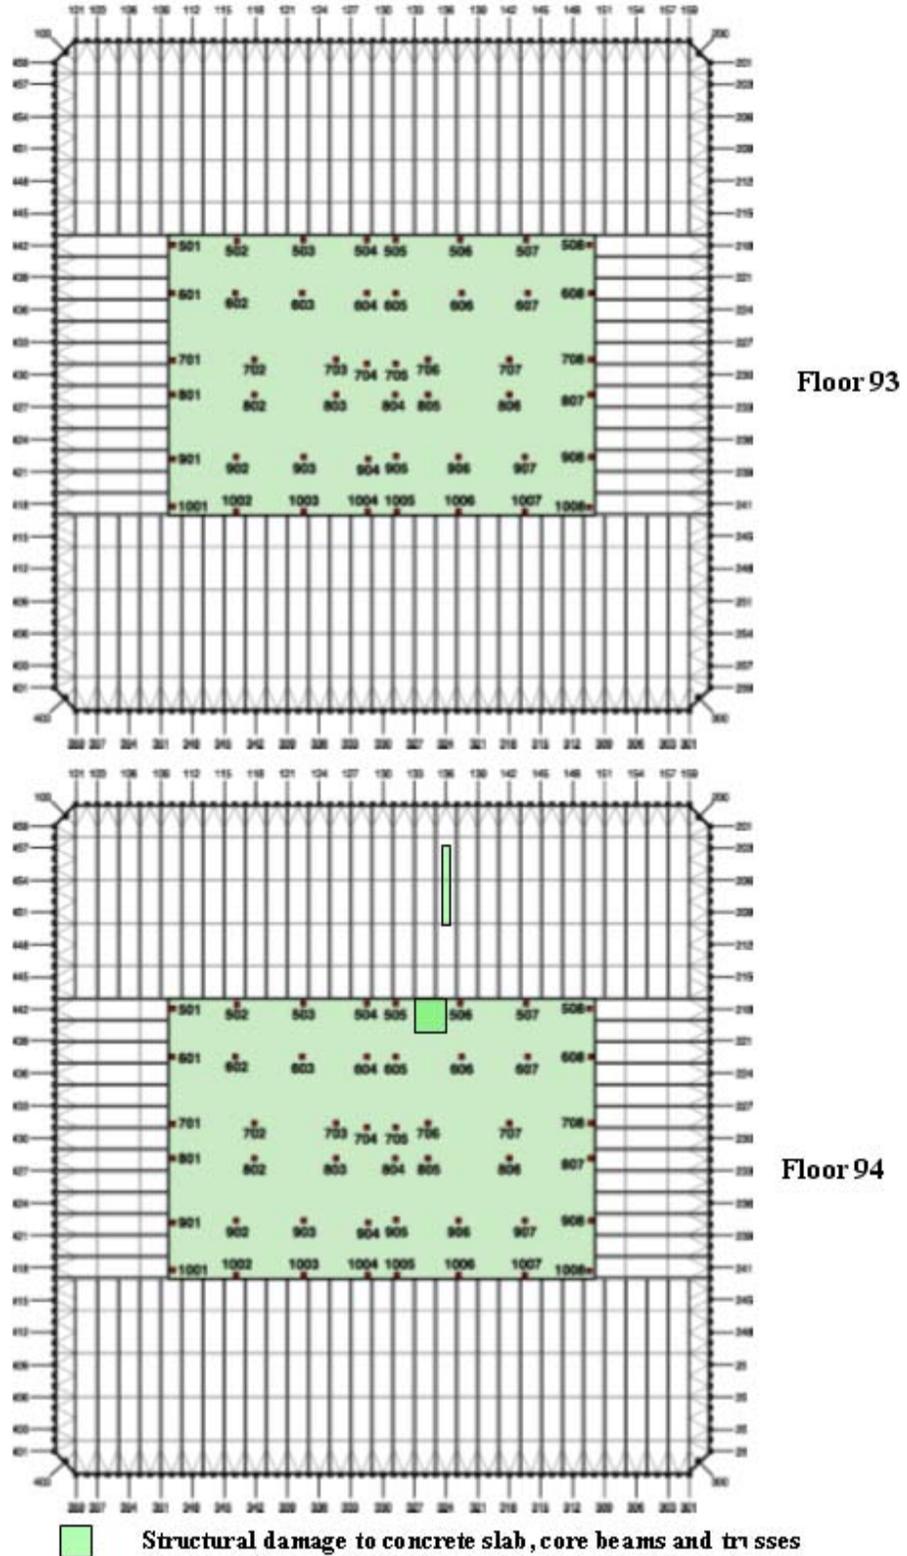
Figure A-4. WTC 1 Case A₁ aircraft impact damage to Structural Floor 93 and 94.

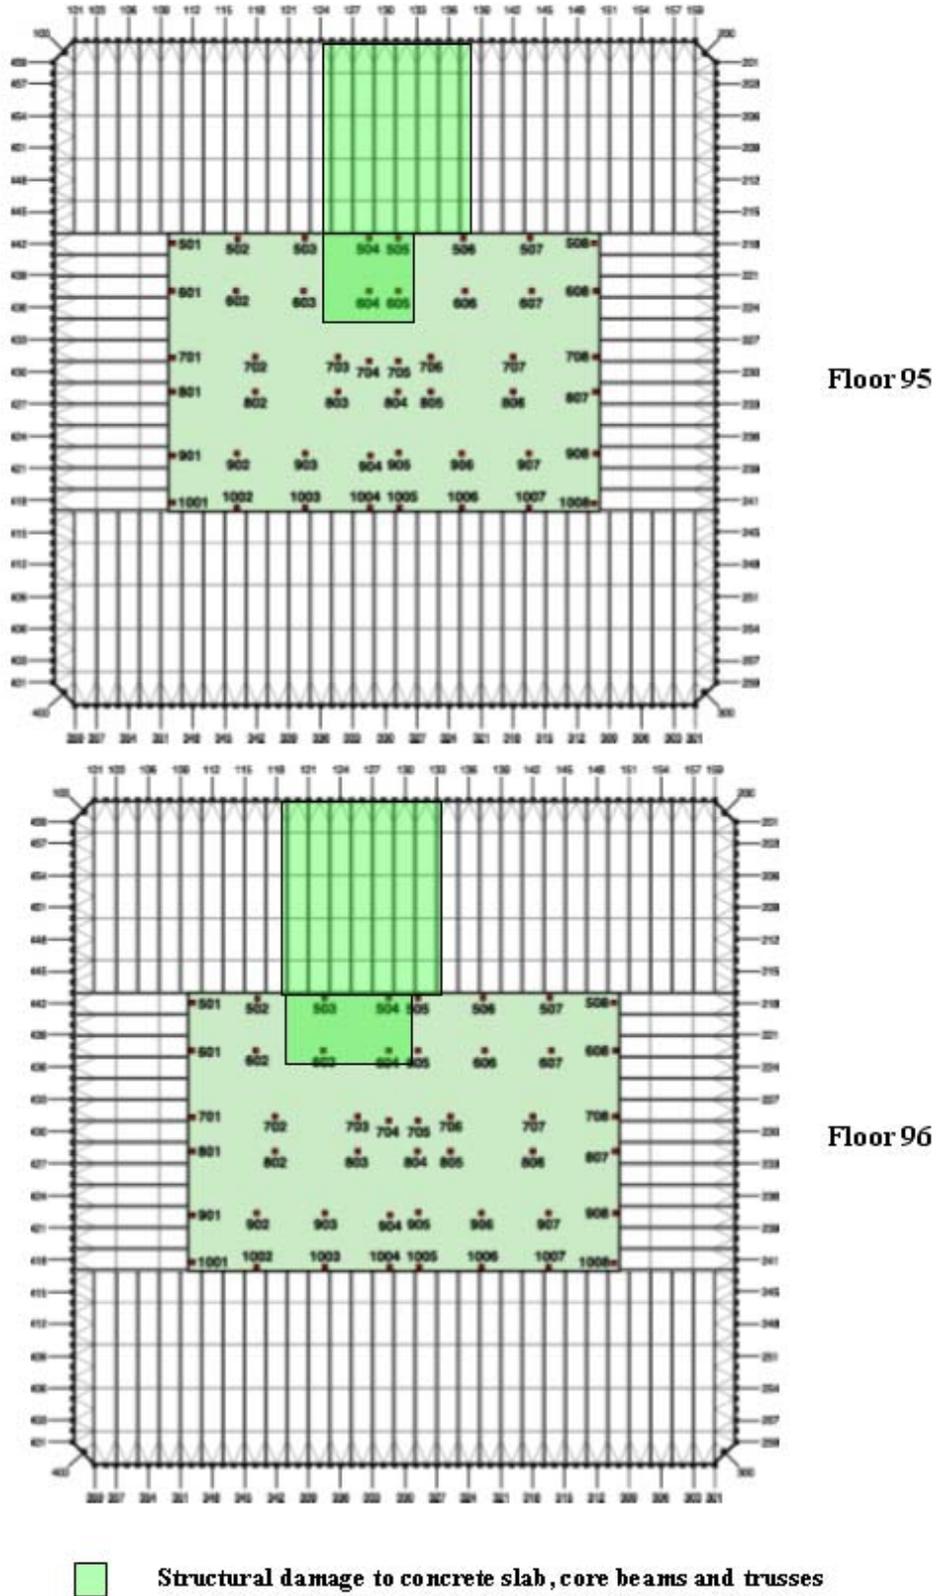
Figure A-5. WTC 1 Case A; aircraft impact damage to Structural Floors 95 and 96.

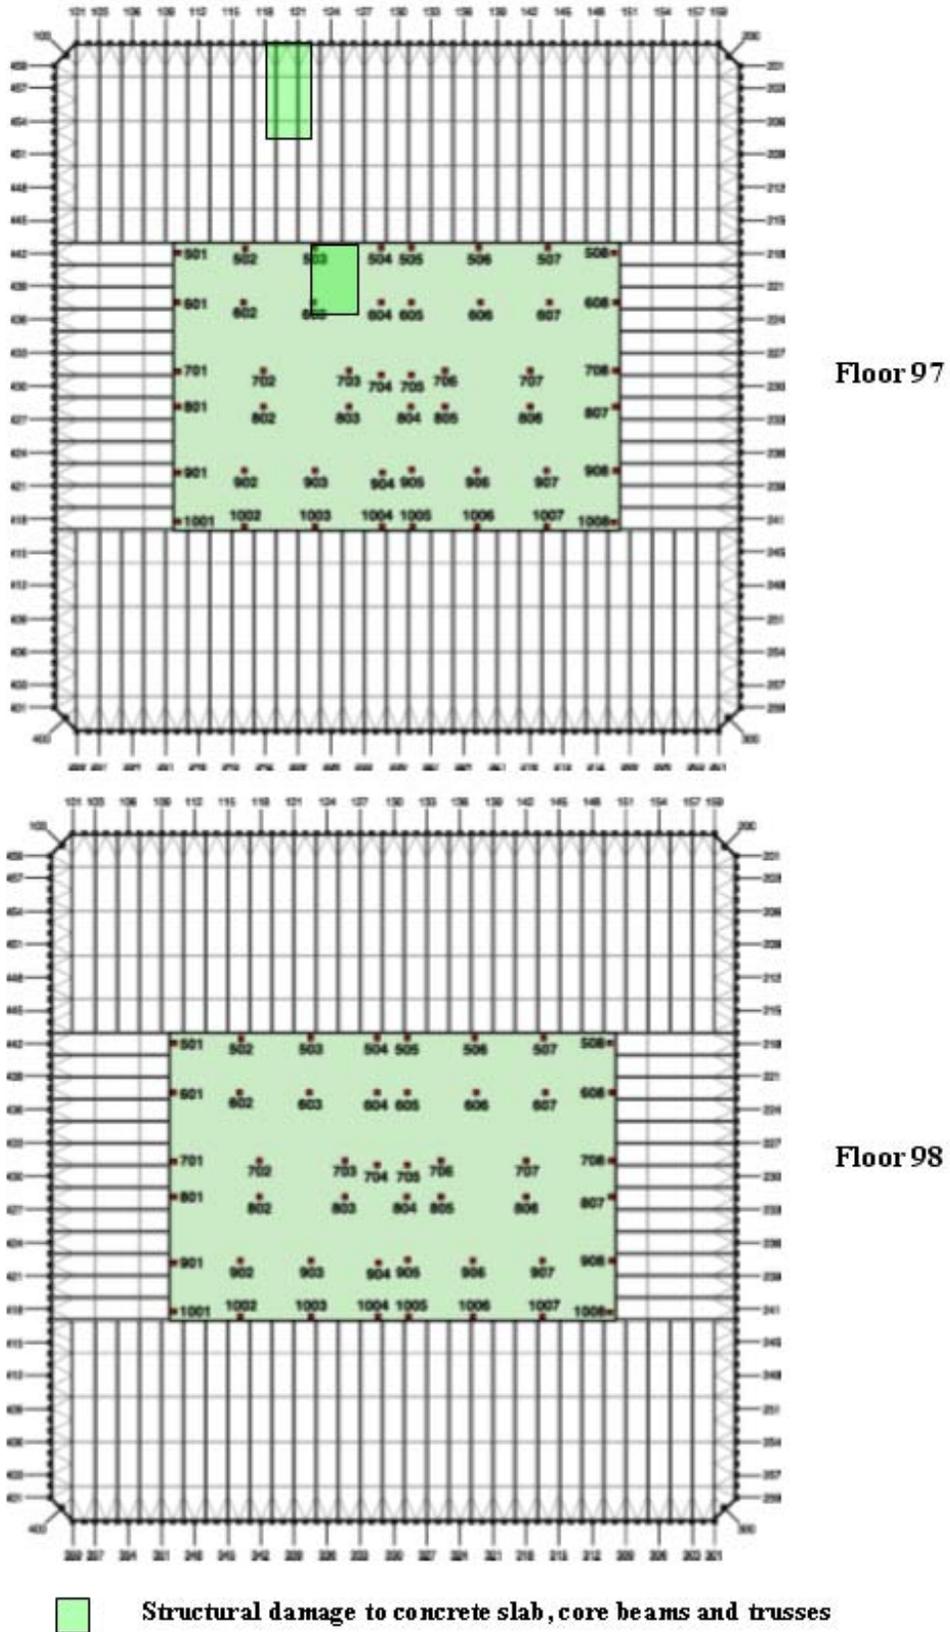
Figure A-6. WTC 1 Case A; aircraft impact damage to Structural Floors 97 and 98.

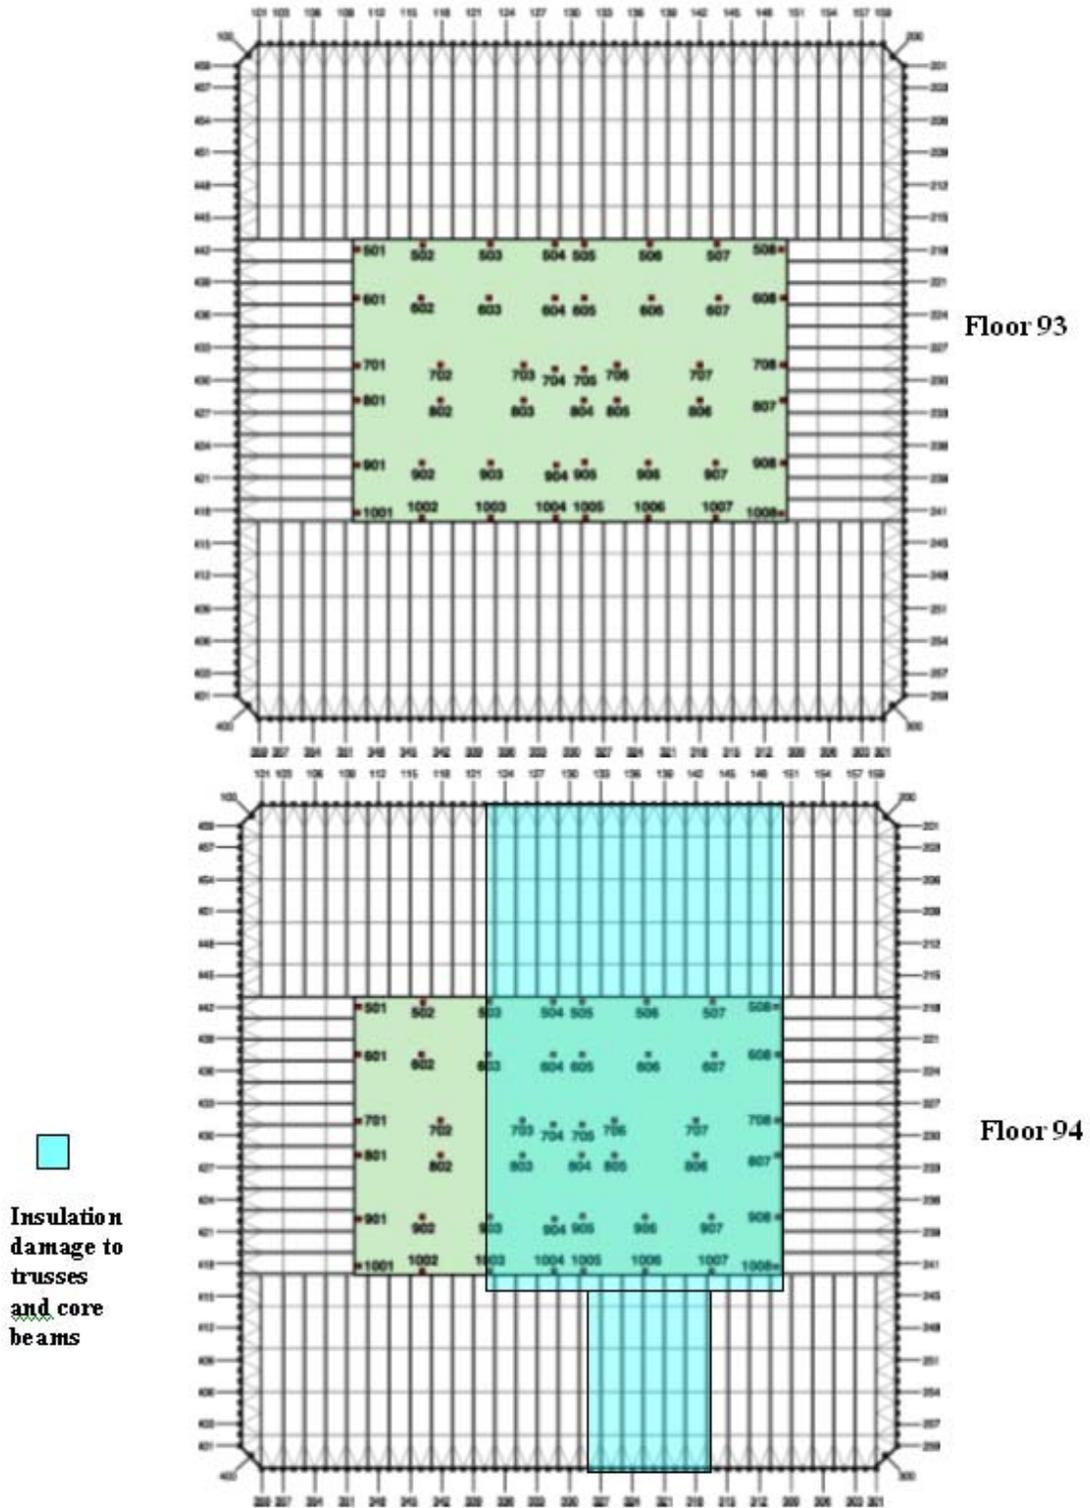
Figure A-7. WTC 1 Case B₁ aircraft impact damage to Structural Floor 93 and 94.

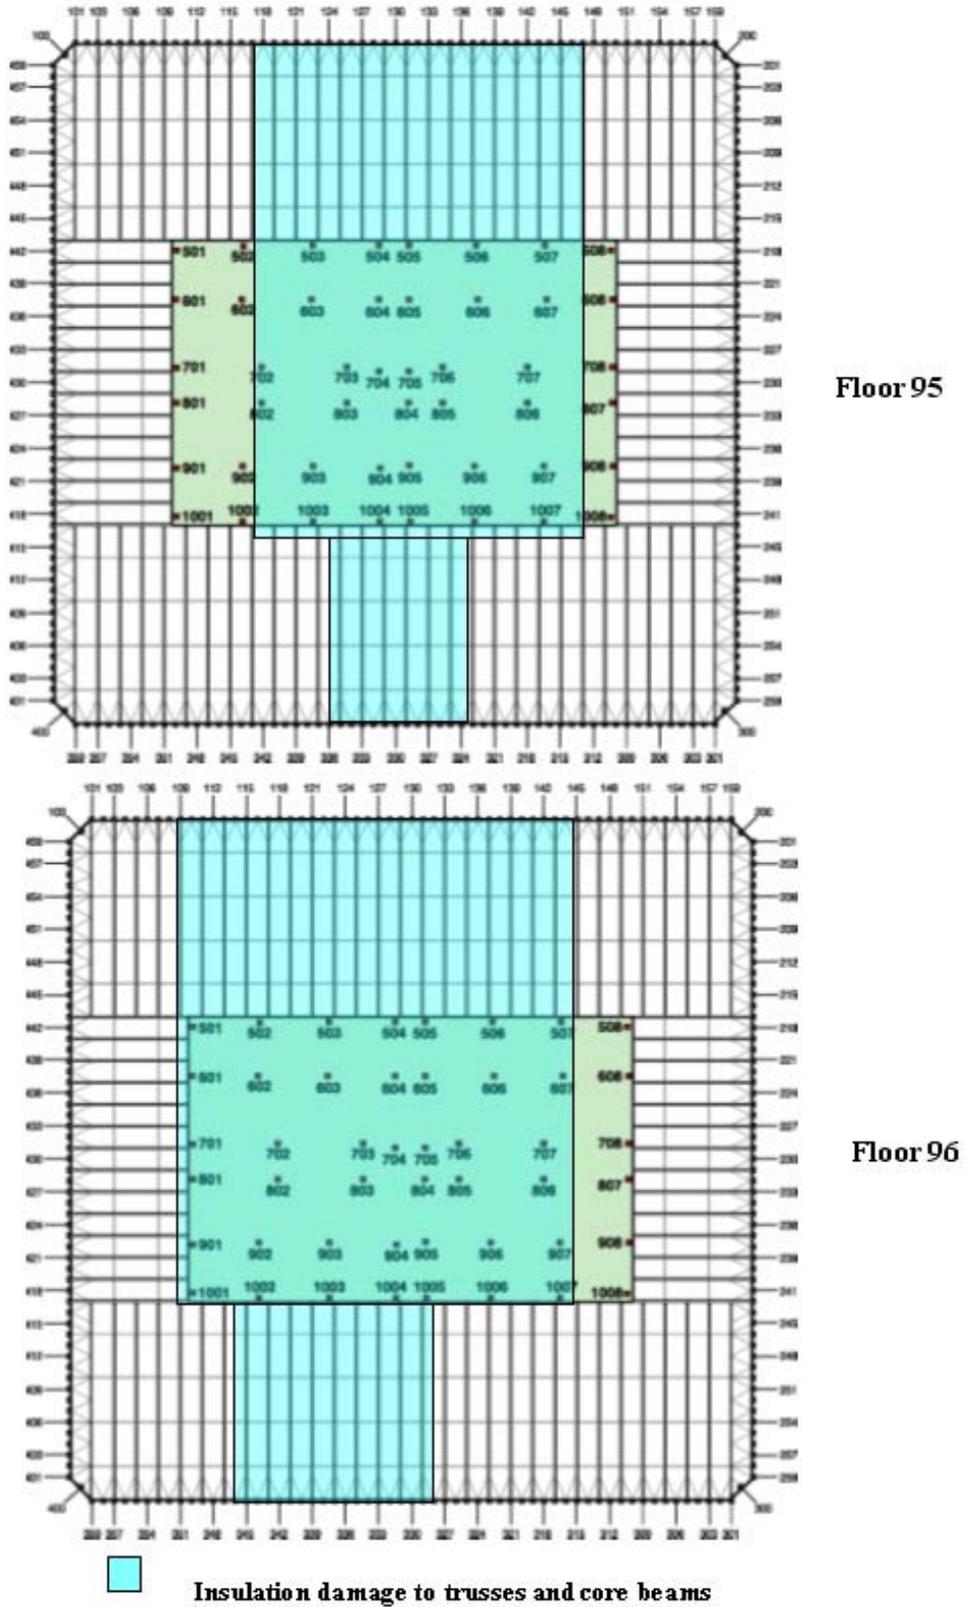
Figure A-8. WTC 1 Case B, aircraft impact damage to Structural Floors 95 and 96.

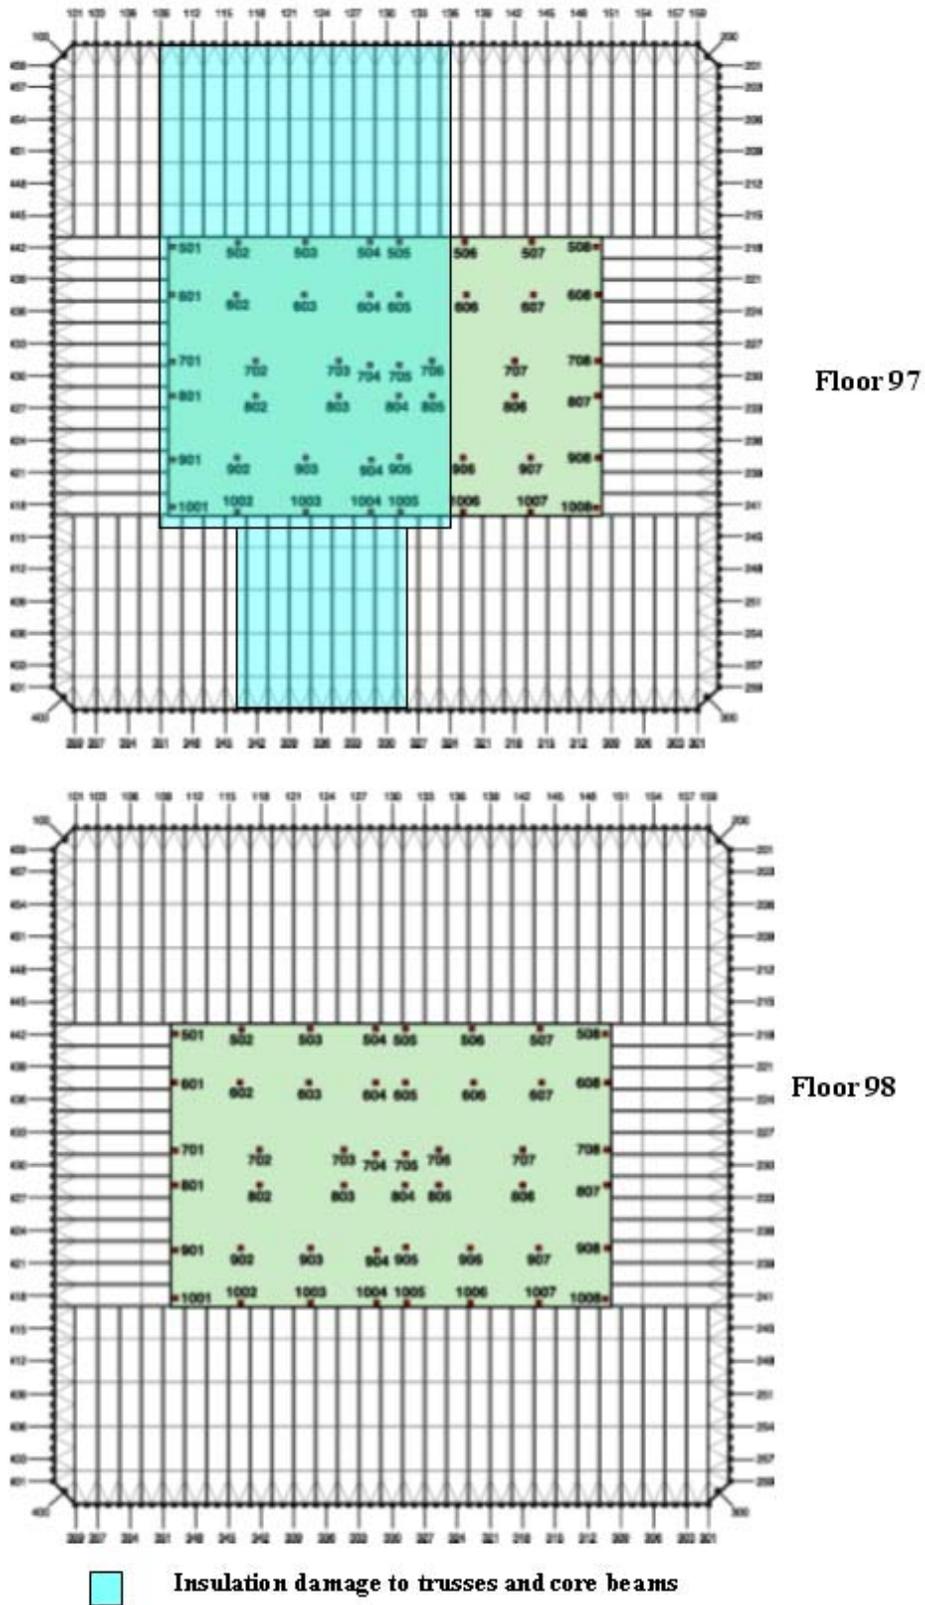
Figure A-9. WTC 1 Case B, aircraft impact damage to Structural Floors 97 and 98.

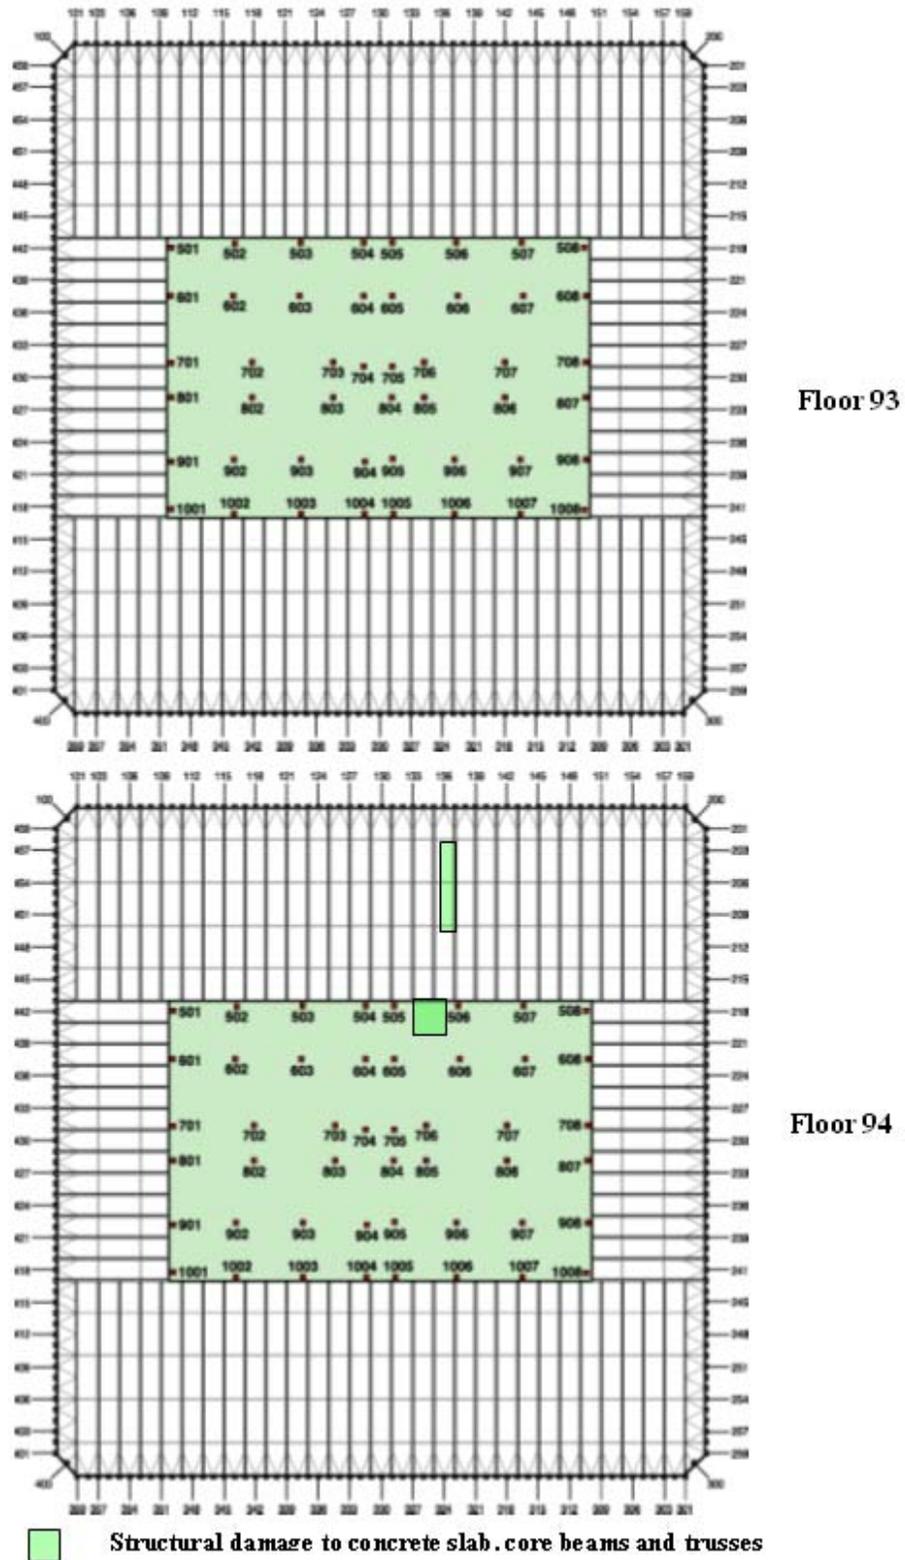
Figure A-10. WTC 1 Case B₁ aircraft impact damage to Structural Floor 93 and 94.

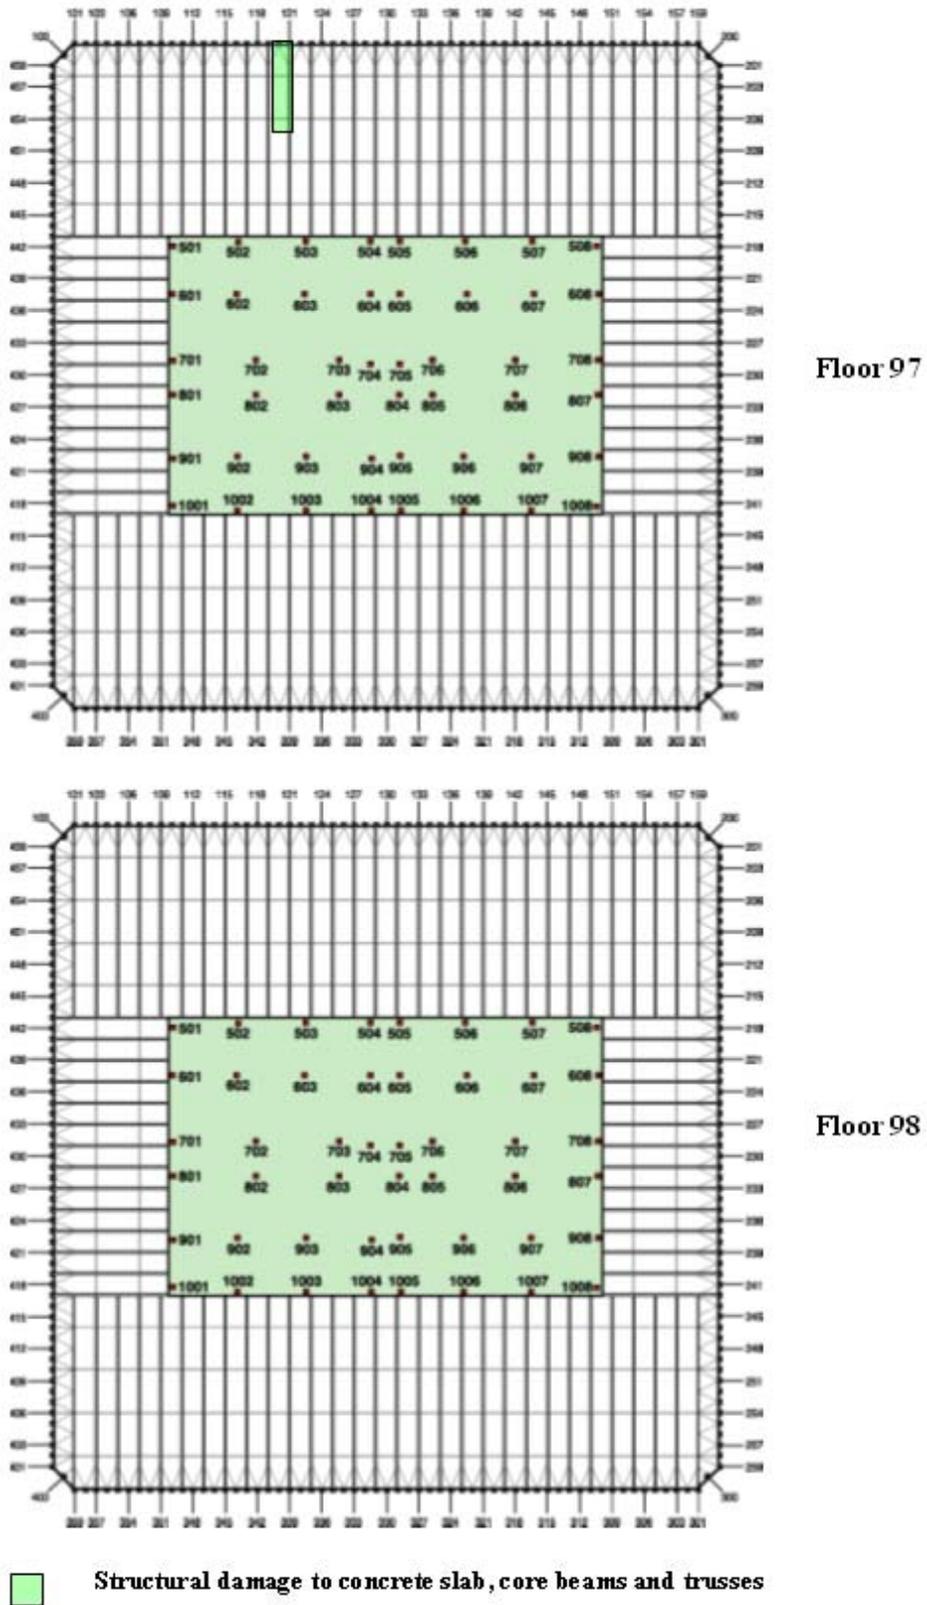
Figure A-12. WTC 1 Case B_i aircraft impact damage to Structural Floors 97 and 98.

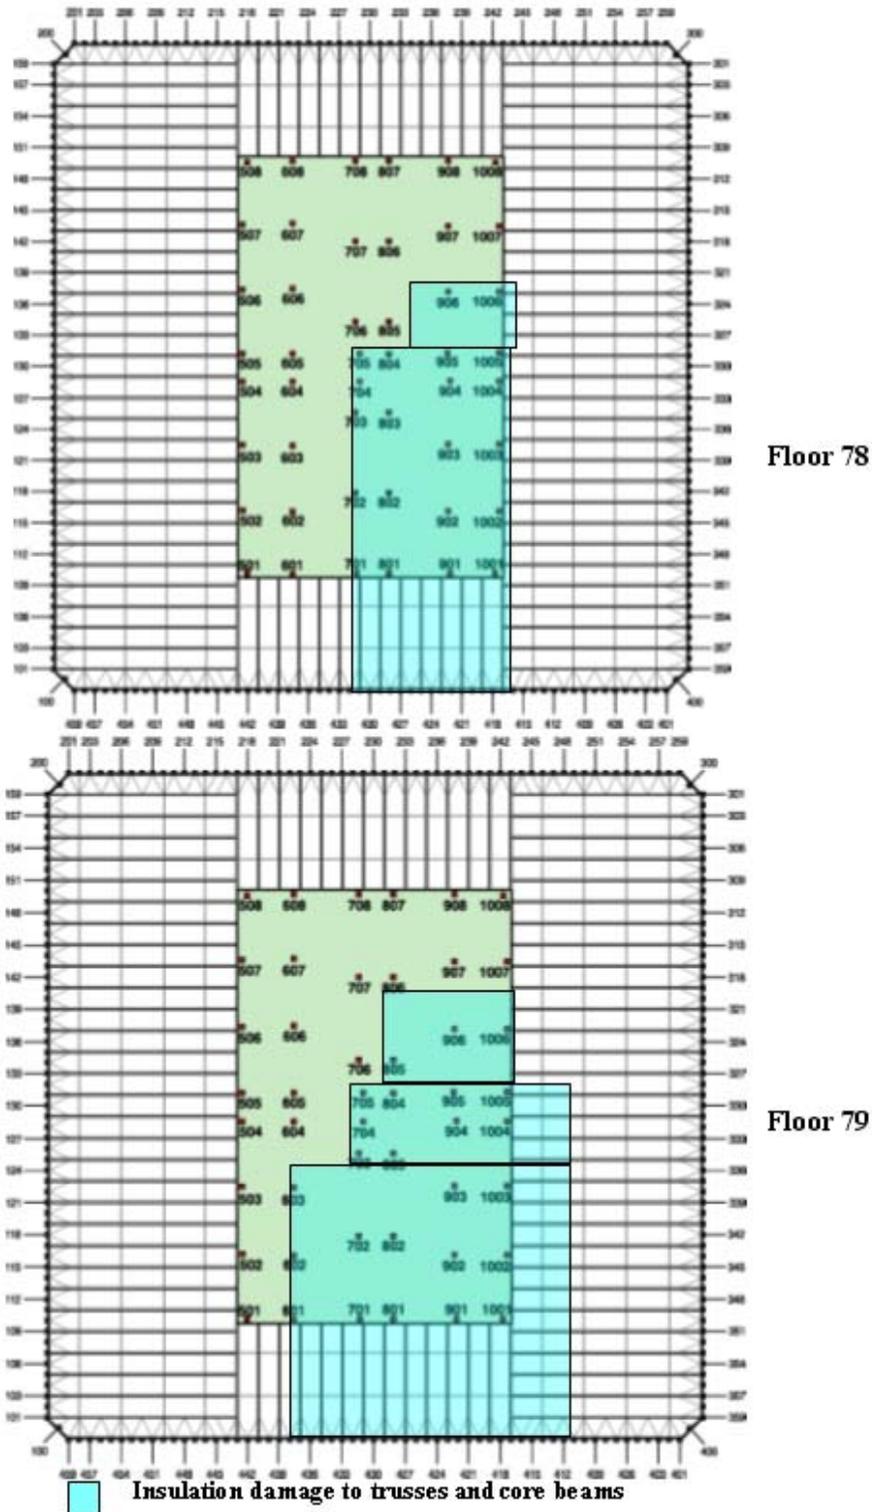
Figure A-13. WTC 2 Case C₁ aircraft impact damage to Structural Floors 78 and 79.

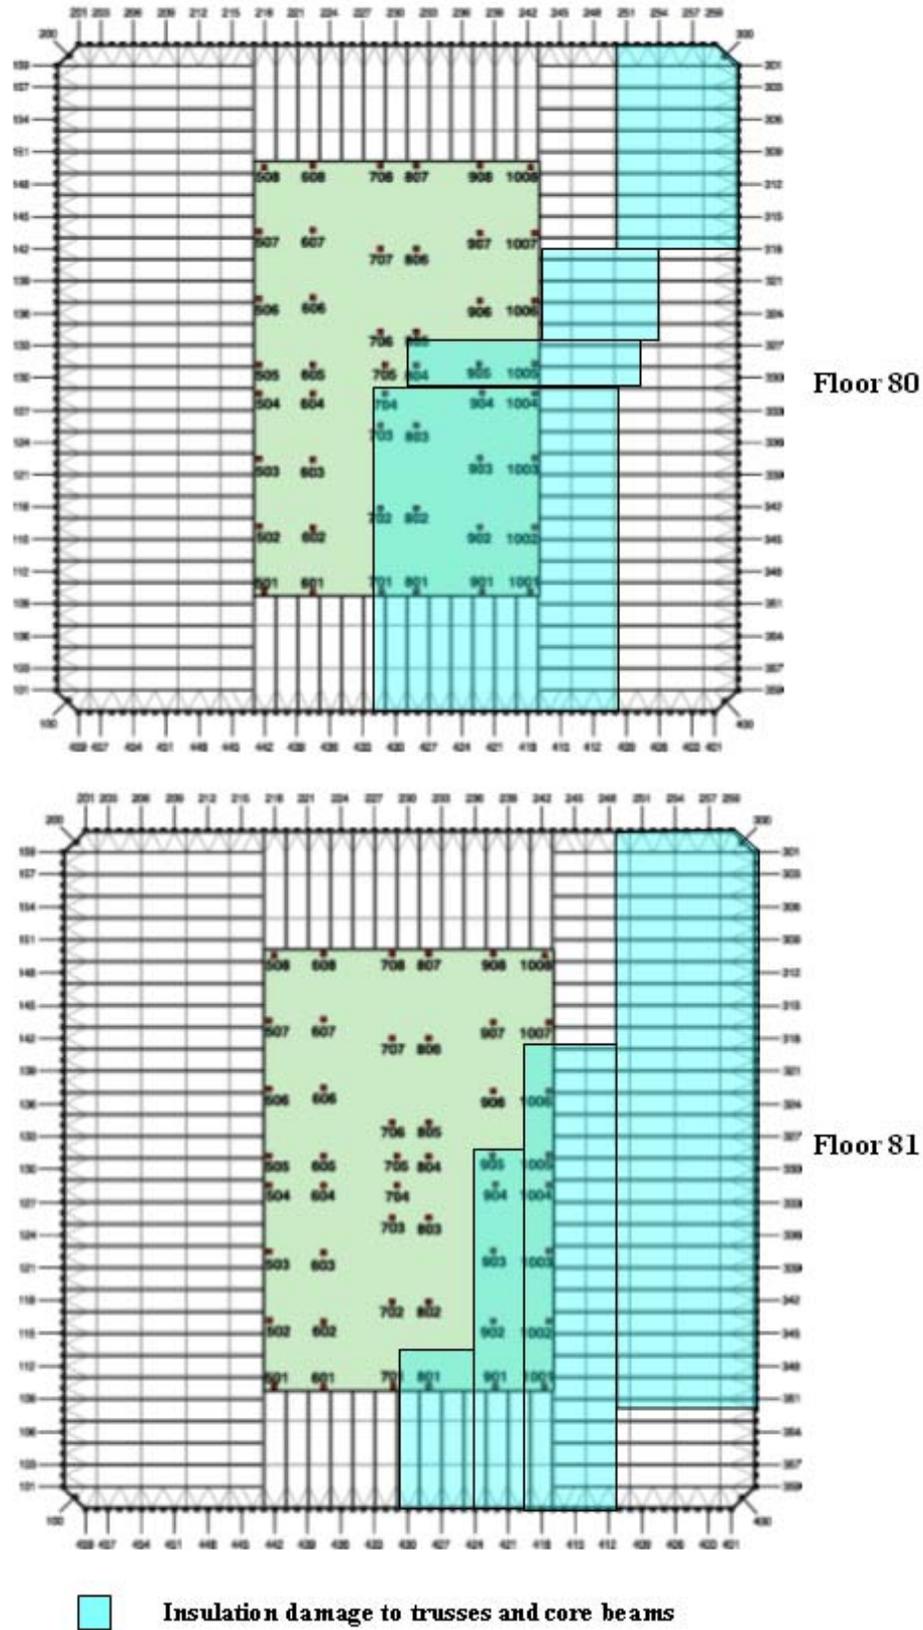
Figure A-14. WTC 2 Case C₁ aircraft impact damage to Structural Floors 80 and 81.

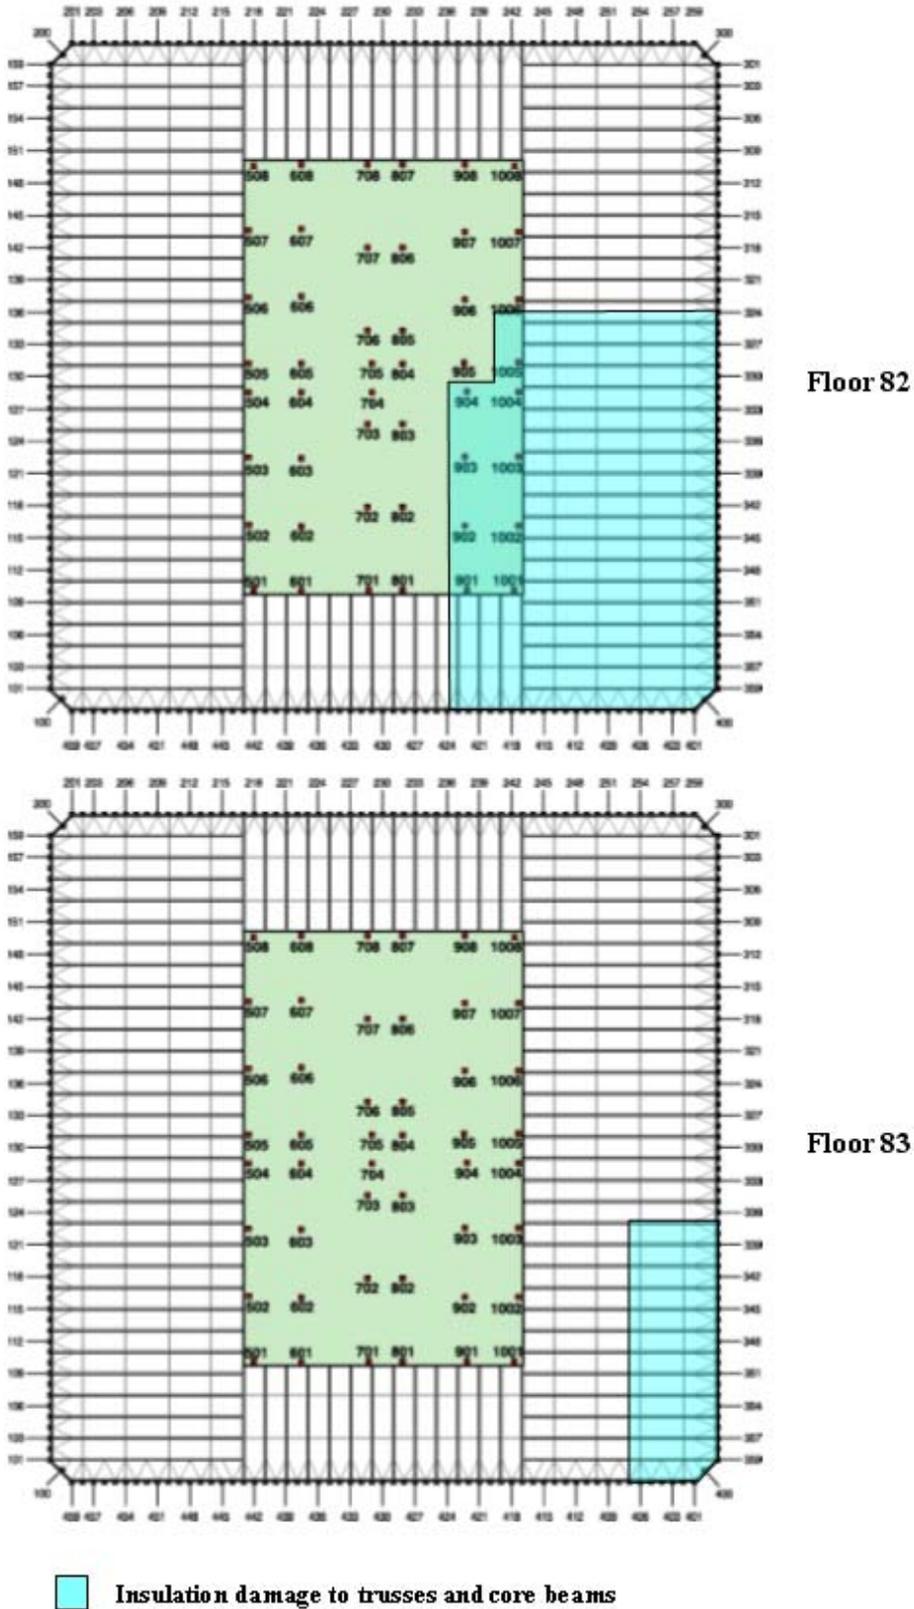
Figure A-15. WTC 2 Case C_i aircraft impact damage to Structural Floors 82 and 83.

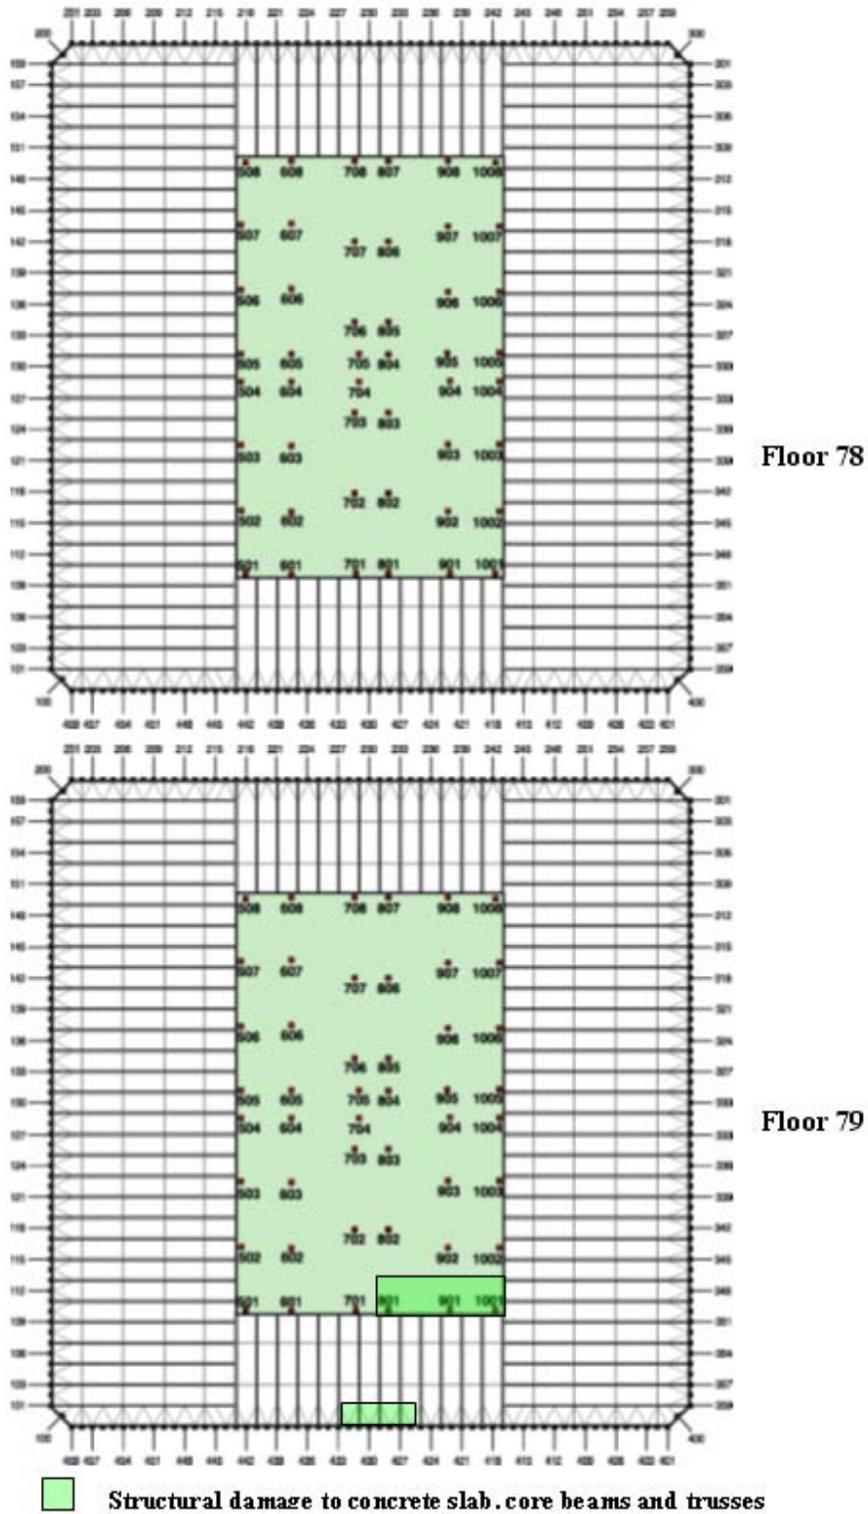
Figure A-16. WTC 2 Case C₁ aircraft impact damage to Structural Floors 78 and 79.

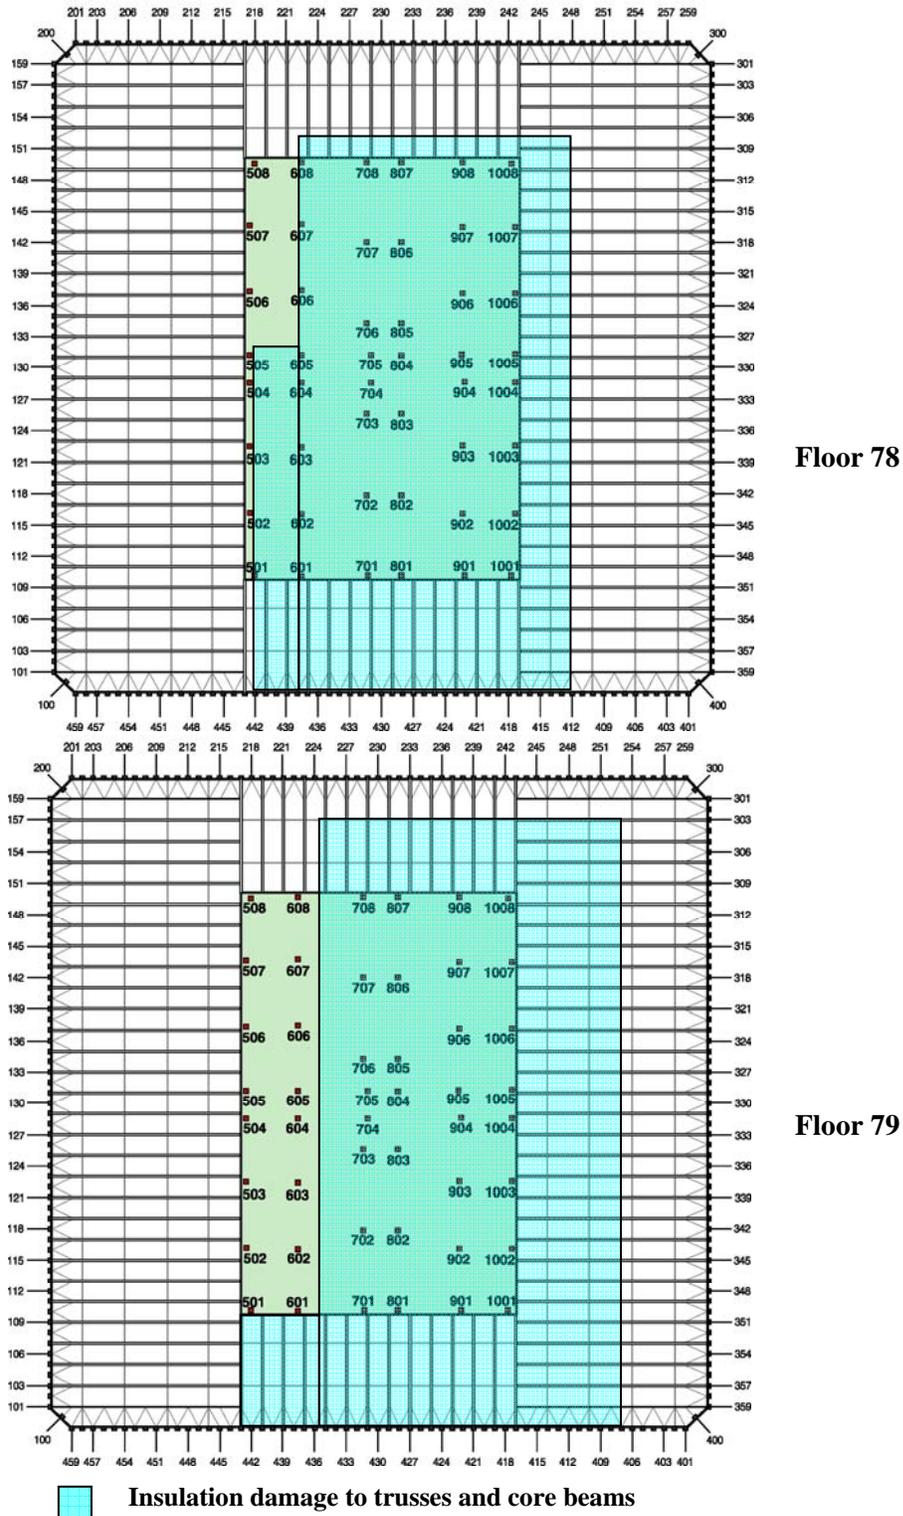
Figure A–19. WTC 2 Case D₁ aircraft impact damage to Structural Floors 78 and 79.

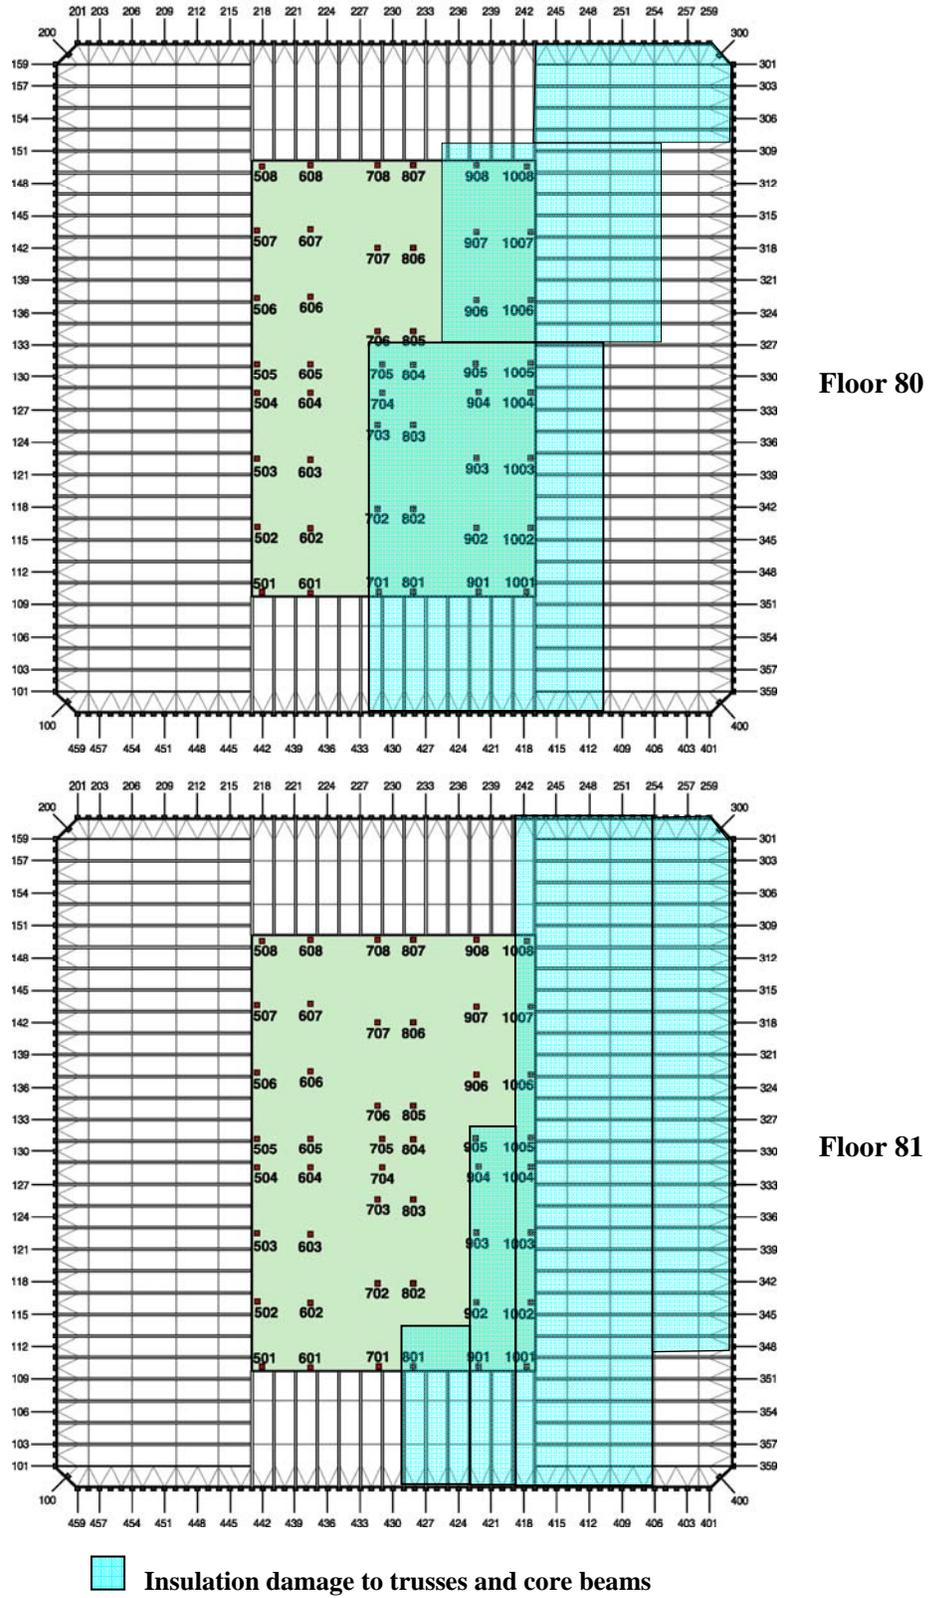
Figure A-20. WTC 2 Case D_i aircraft impact damage to Structural Floors 80 and 81.

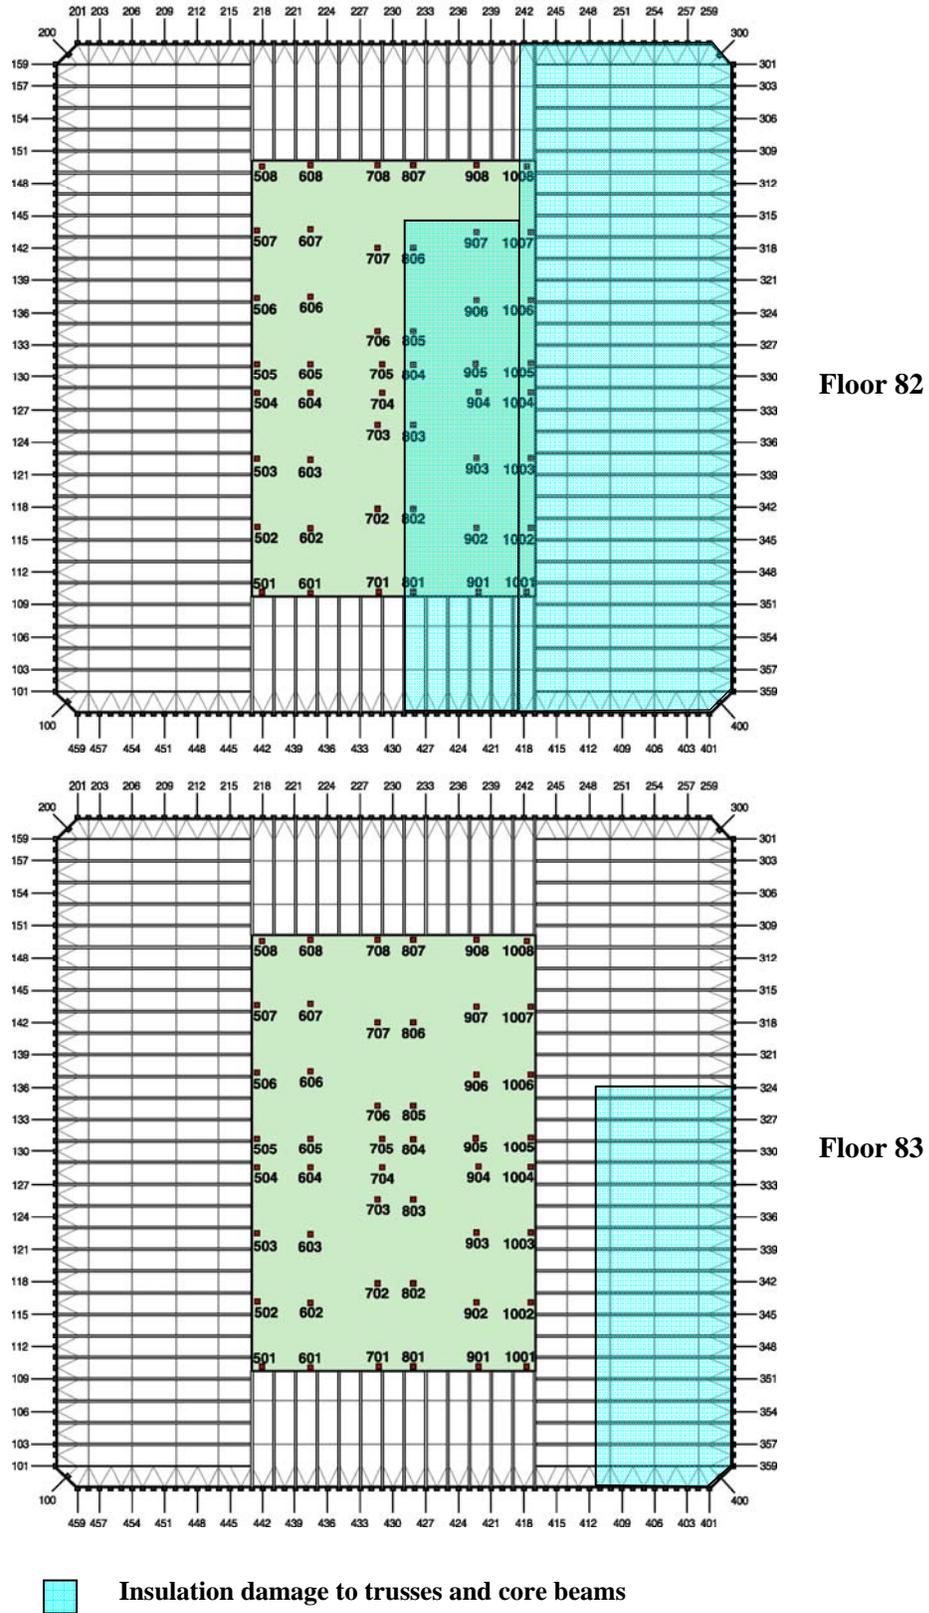
Figure A-21. WTC 2 Case D; aircraft impact damage to Structural Floors 82 and 83.
