**Federal Building and Fire Safety Investigation of the
World Trade Center Disaster**

Structural Fire Response and Probable Collapse Sequence of the World Trade Center Towers

John L. Gross
Therese P. McAllister

September 2005

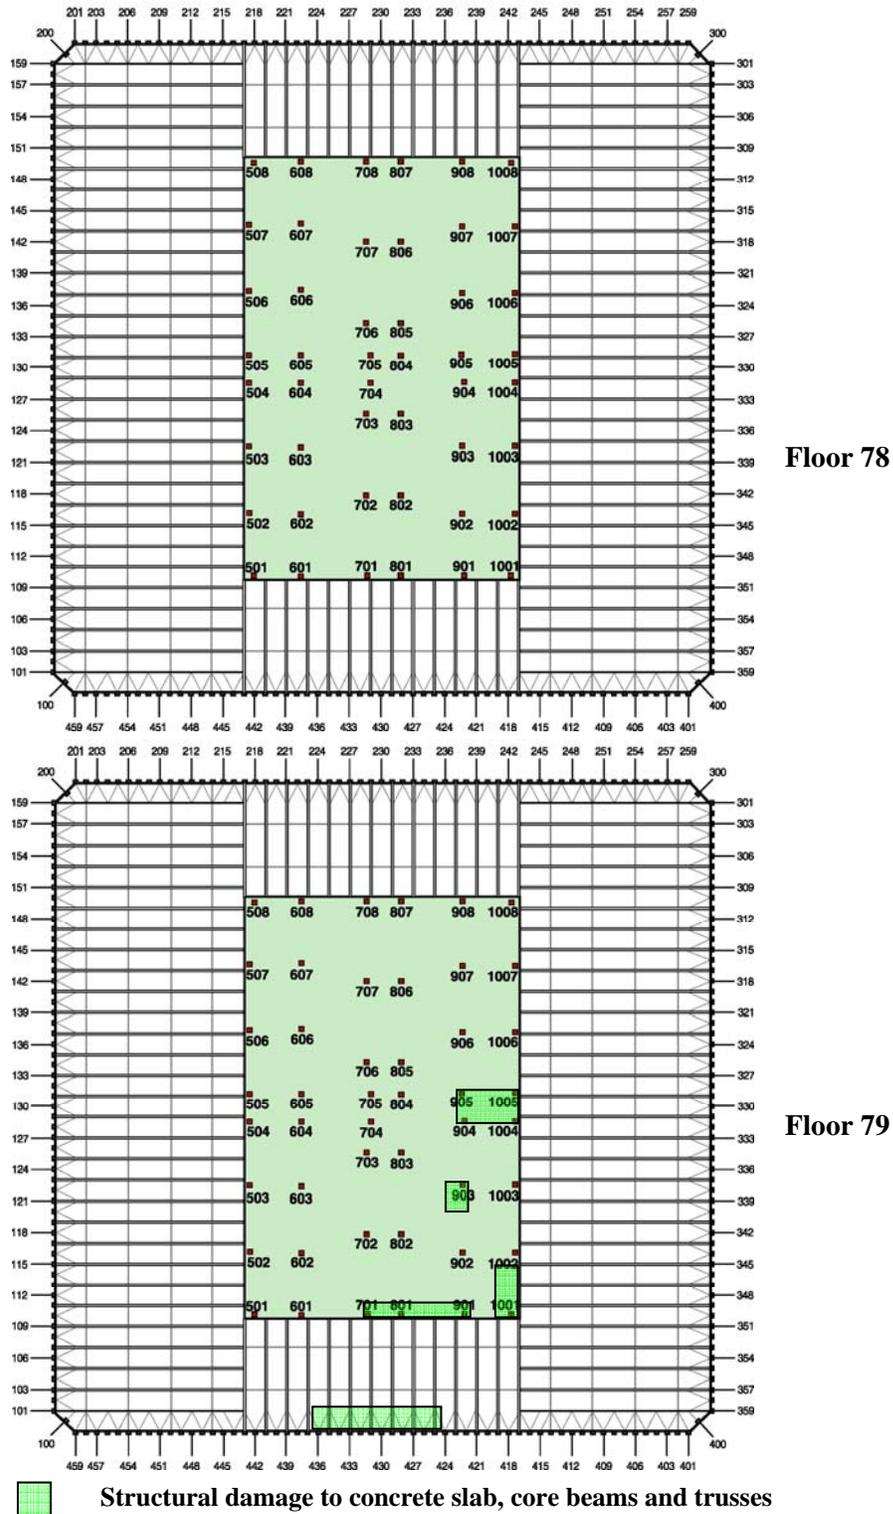
Figure A–22. WTC 2 Case D₁ aircraft impact damage to Structural Floors 78 and 79.

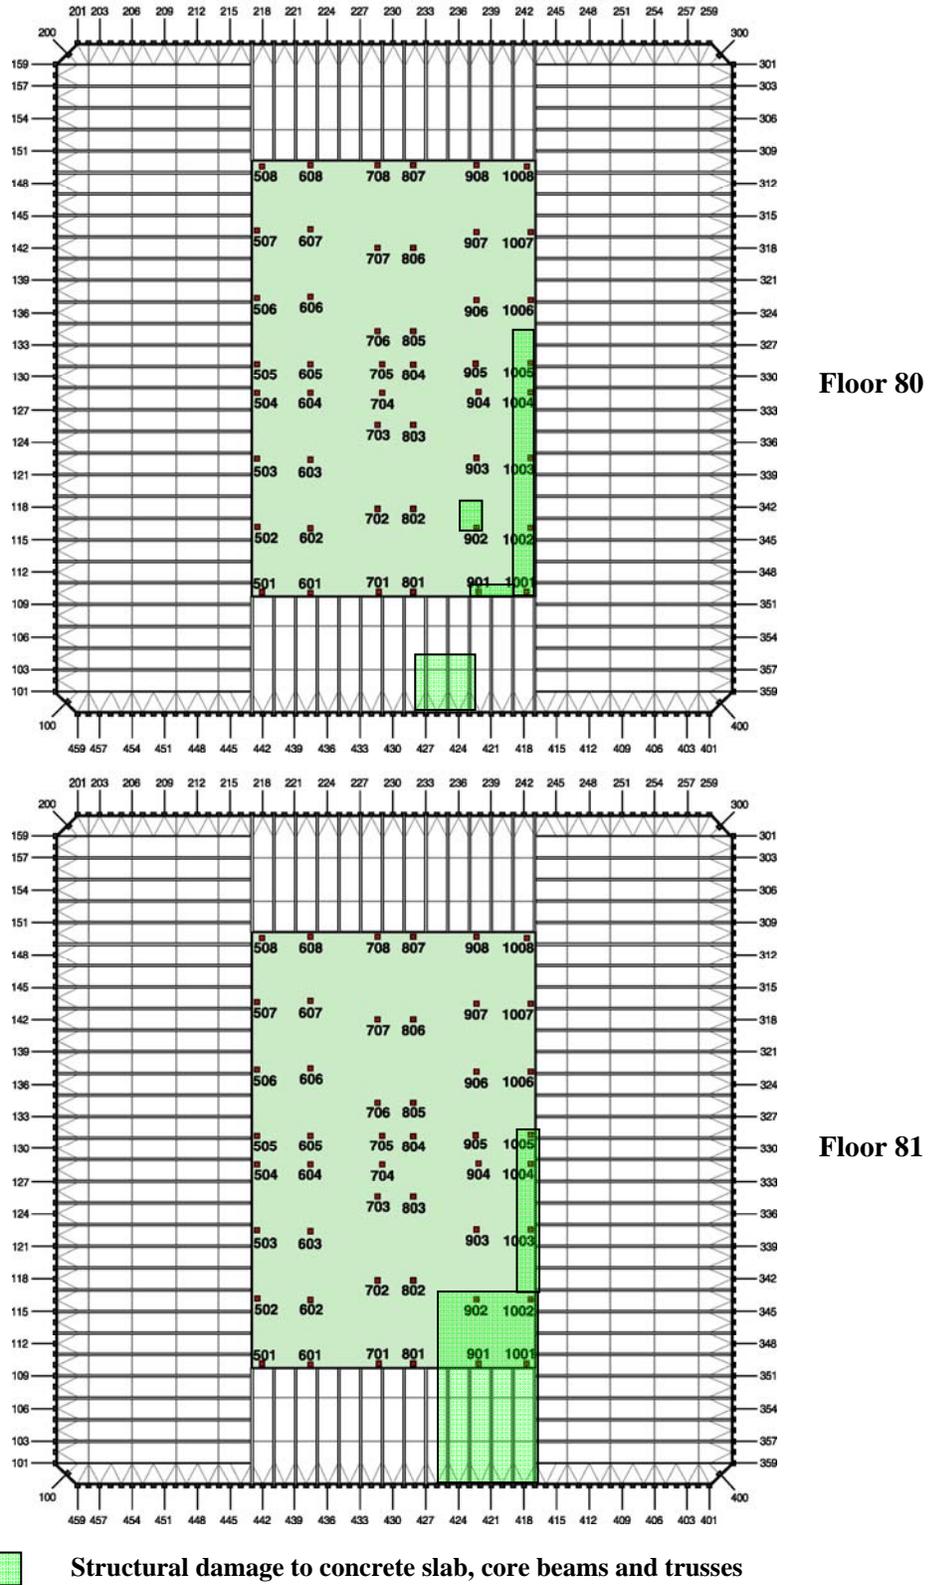
Figure A-23. WTC 2 Case D_i aircraft impact damage to Structural Floors 80 and 81.

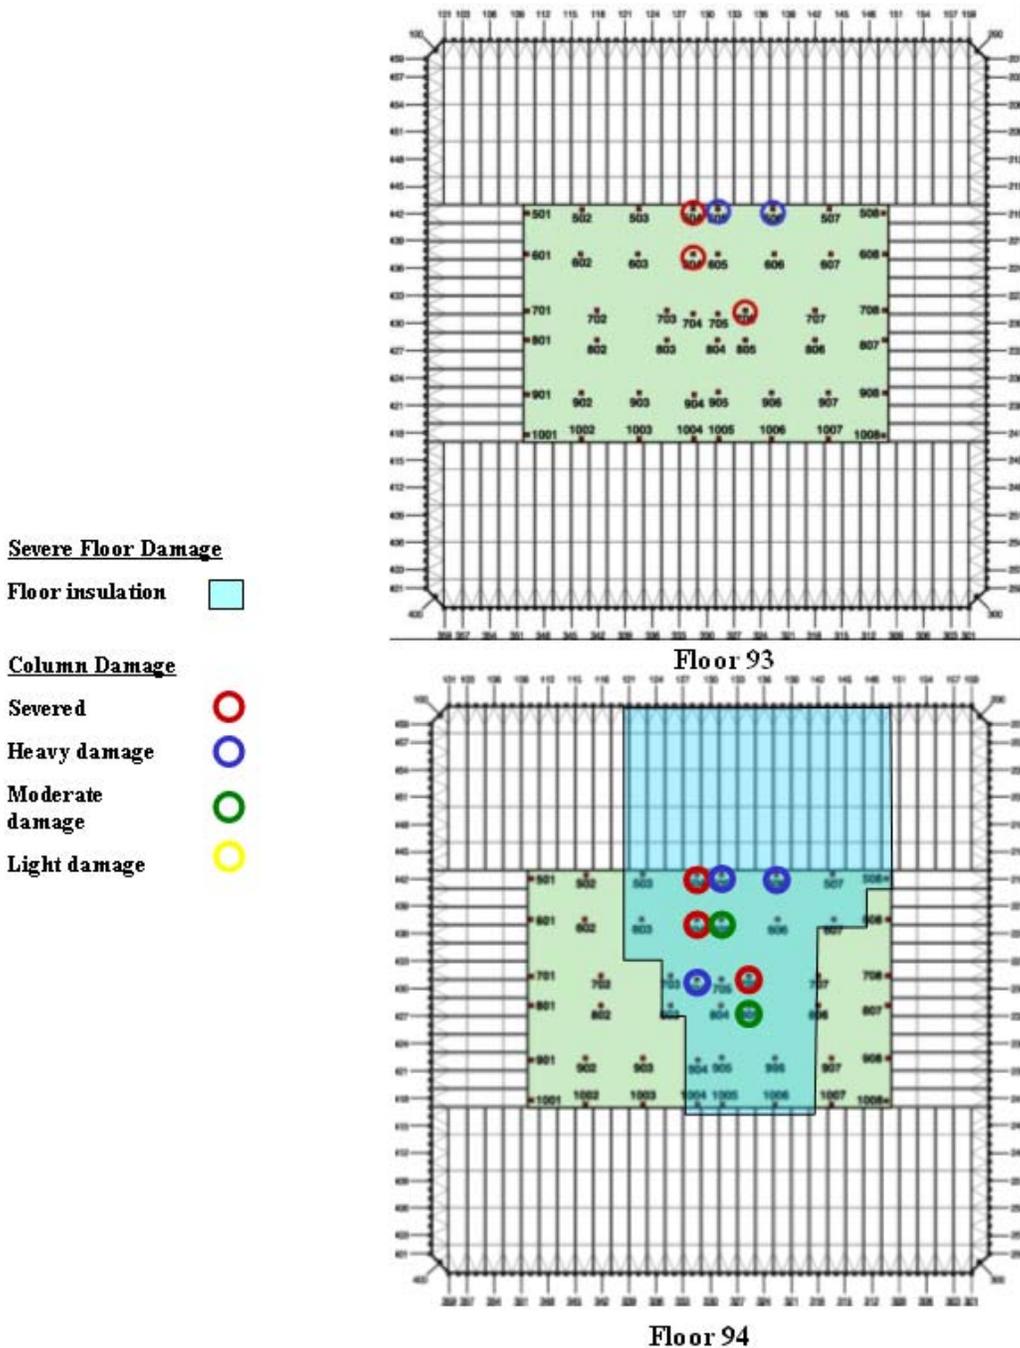
Figure B-1. WTC 1 Case A aircraft impact damage to Occupancy Floors 93 and 94.

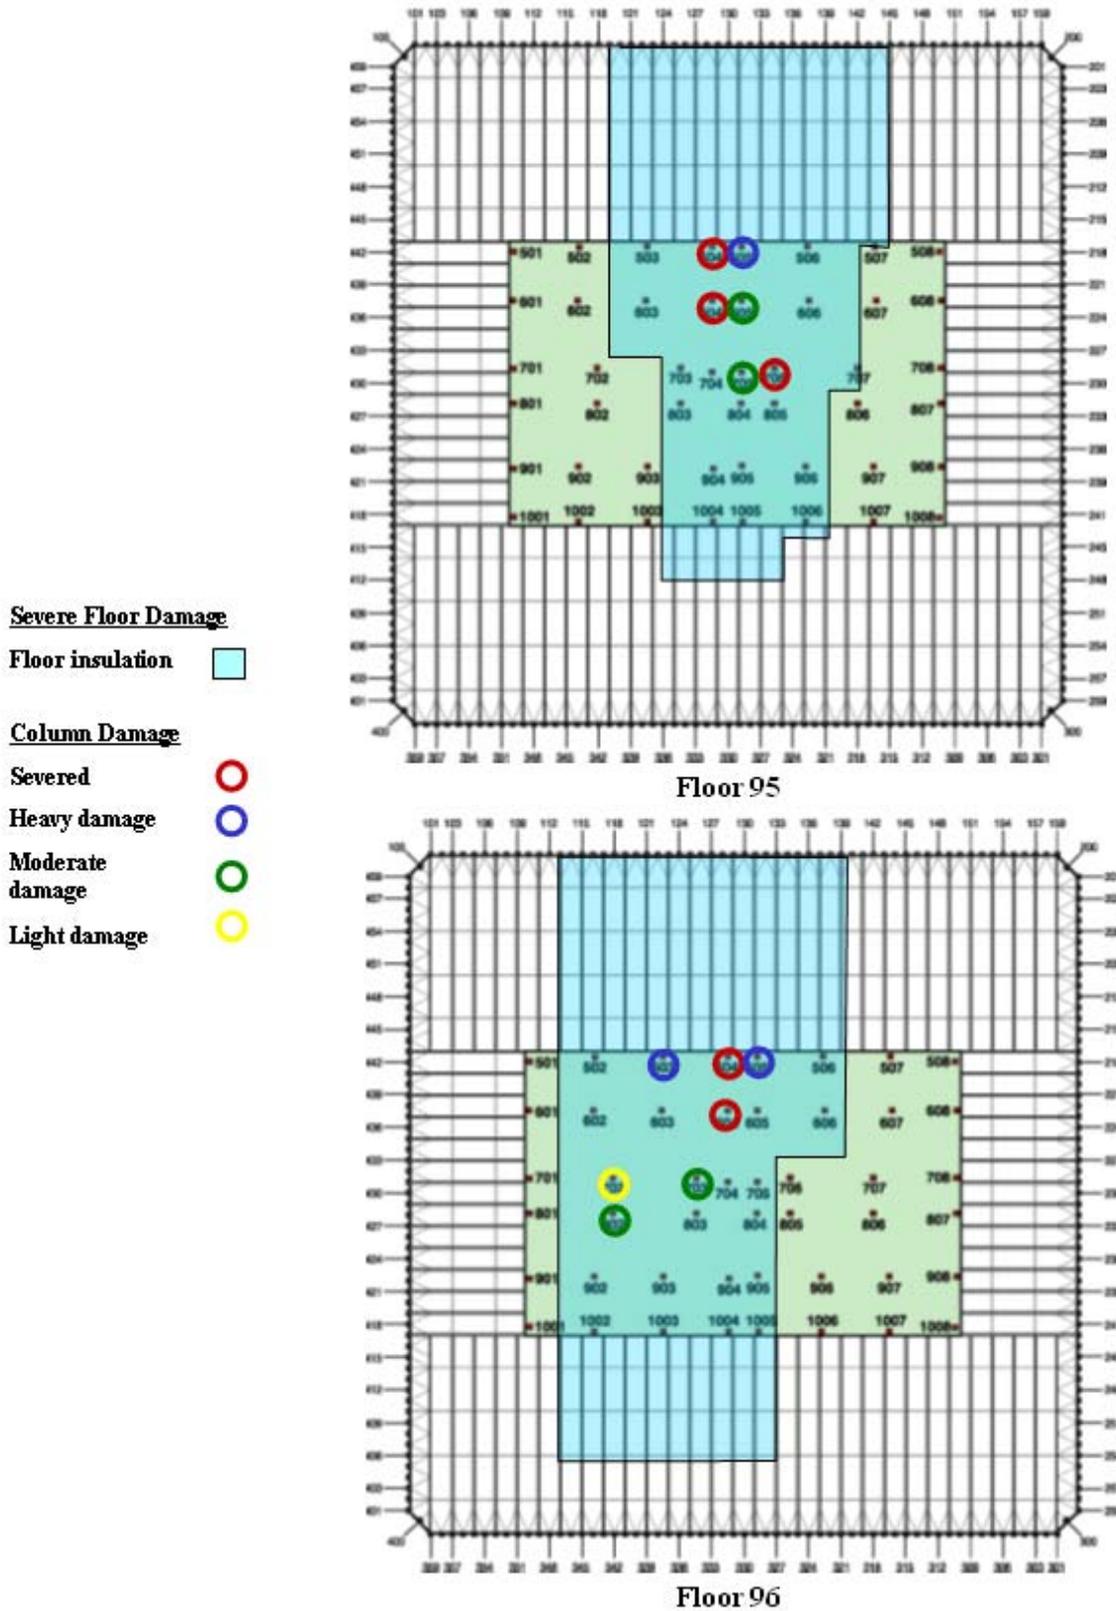
Figure B-2. WTC 1 Case A aircraft impact damage to Occupancy Floors 95 and 96.

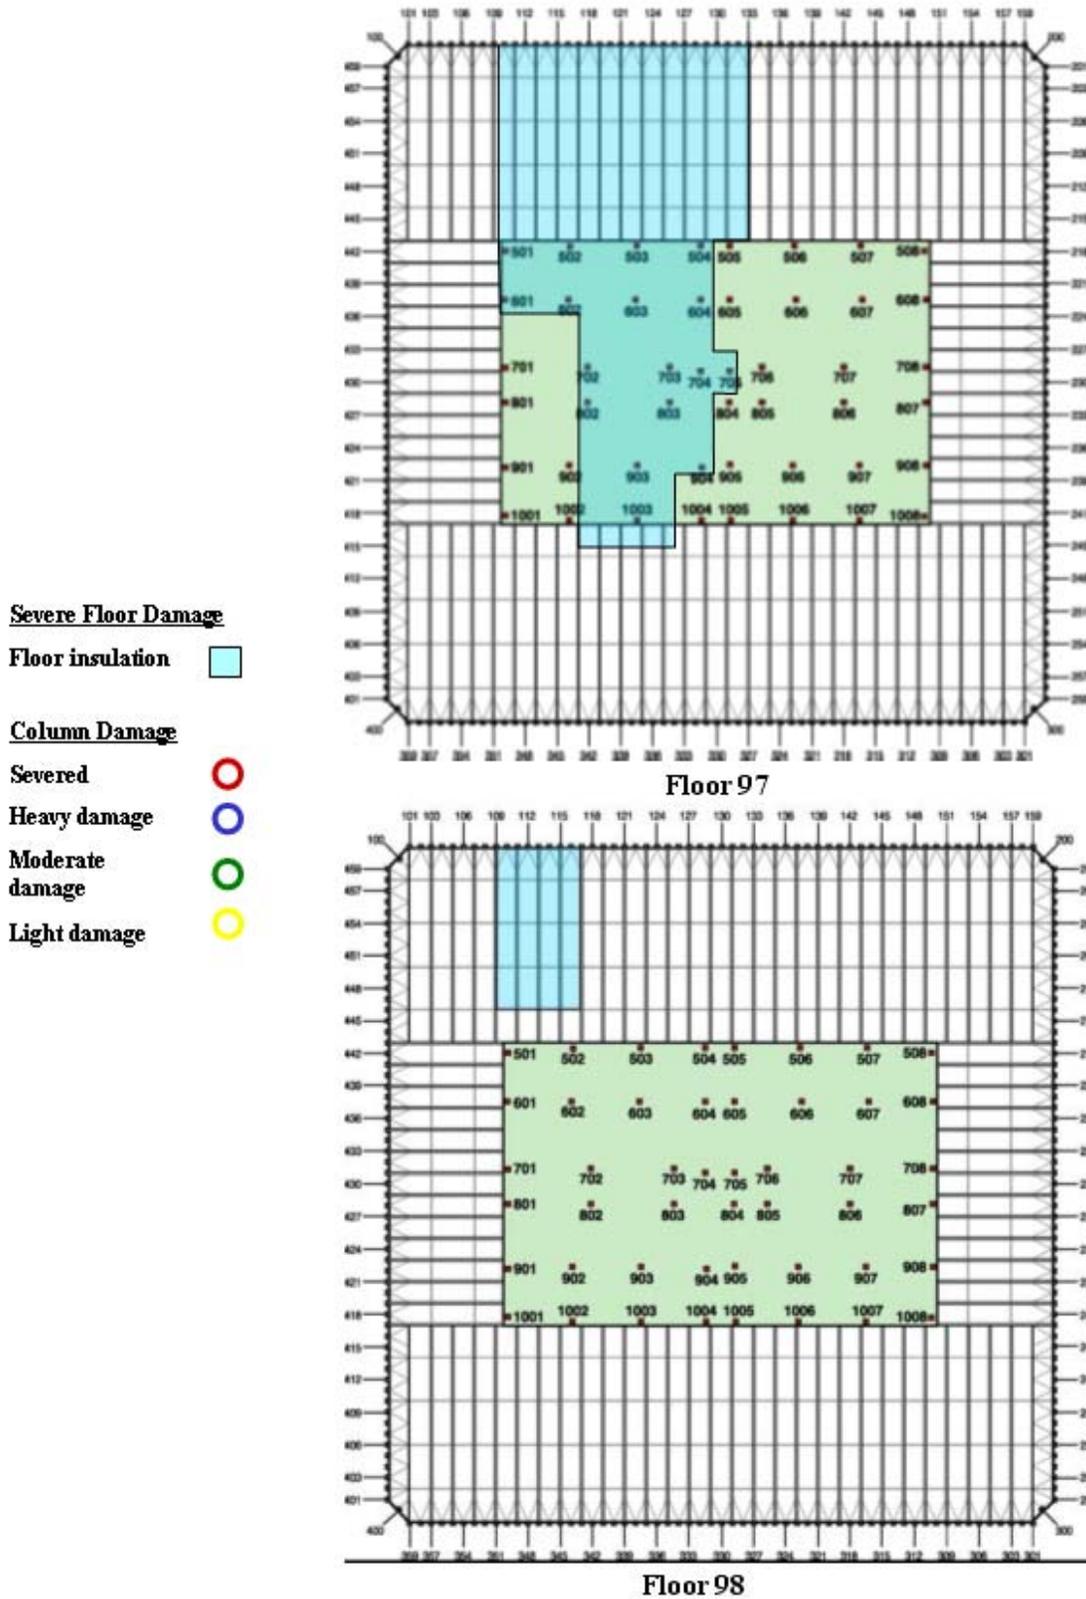
Figure B-3. WTC 1 Case A aircraft impact damage to Occupancy Floors 97 and 98.

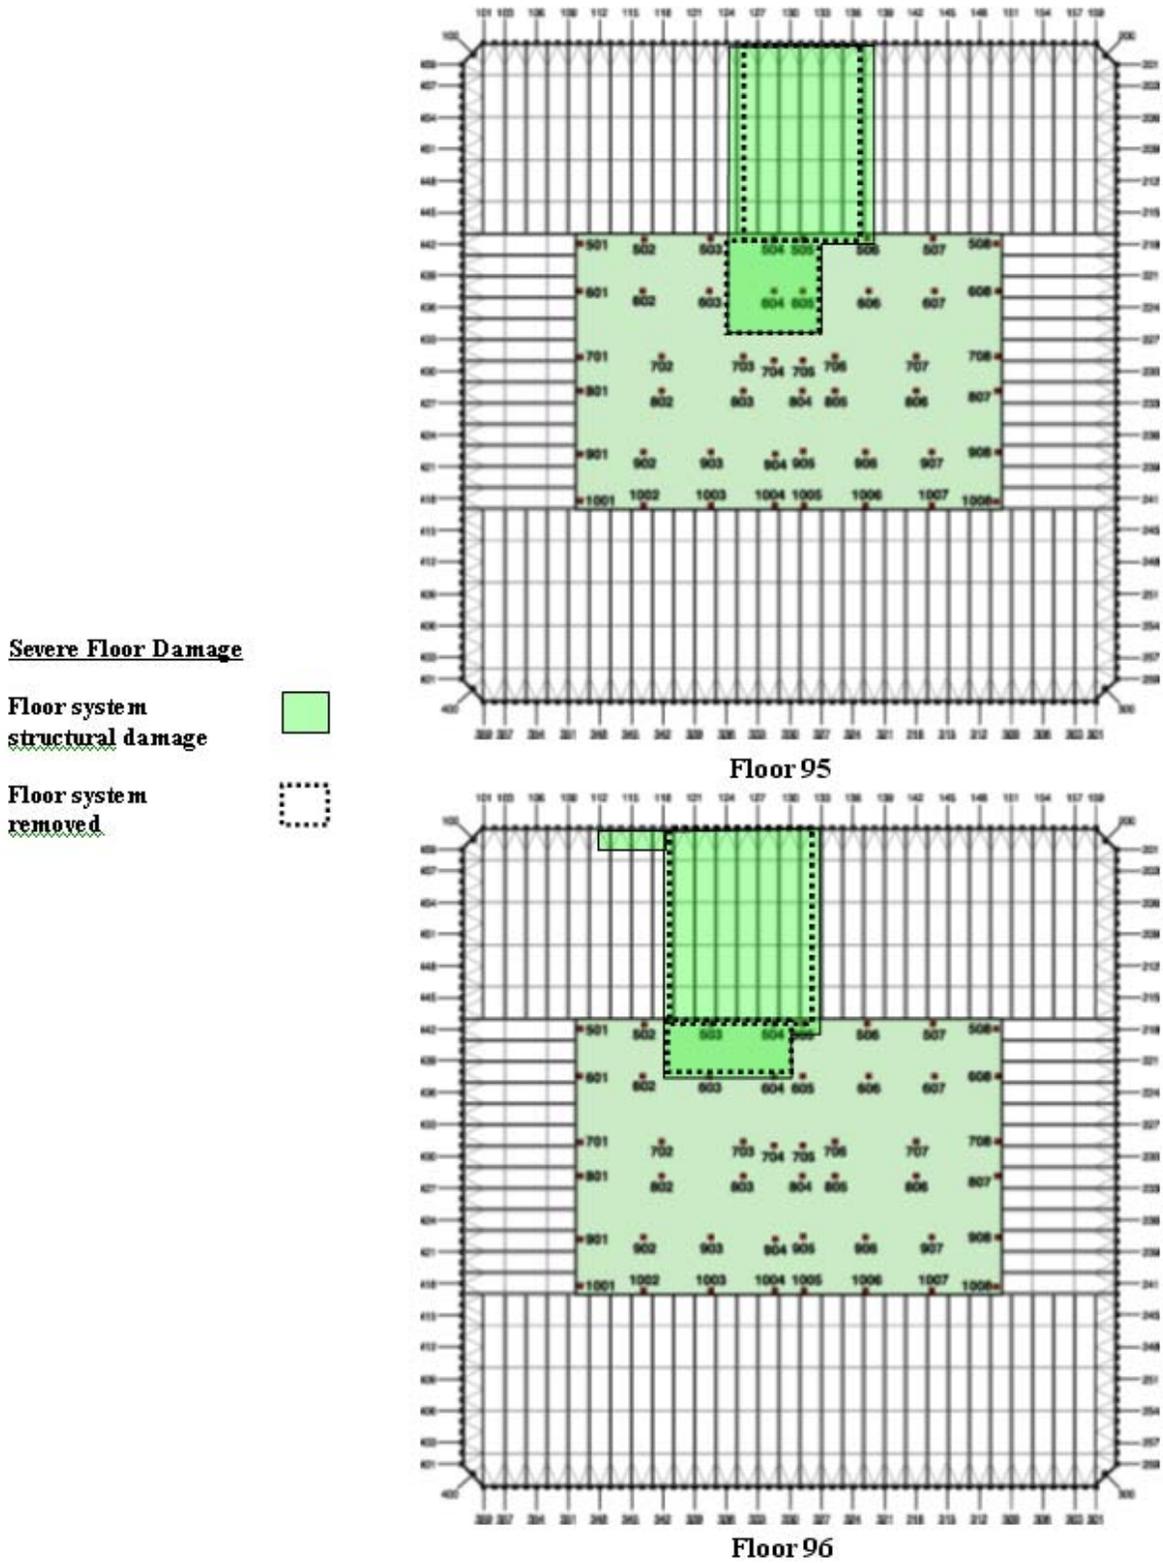
Figure B-5. WTC 1 Case A aircraft impact damage to Structural Floors 95 and 96.

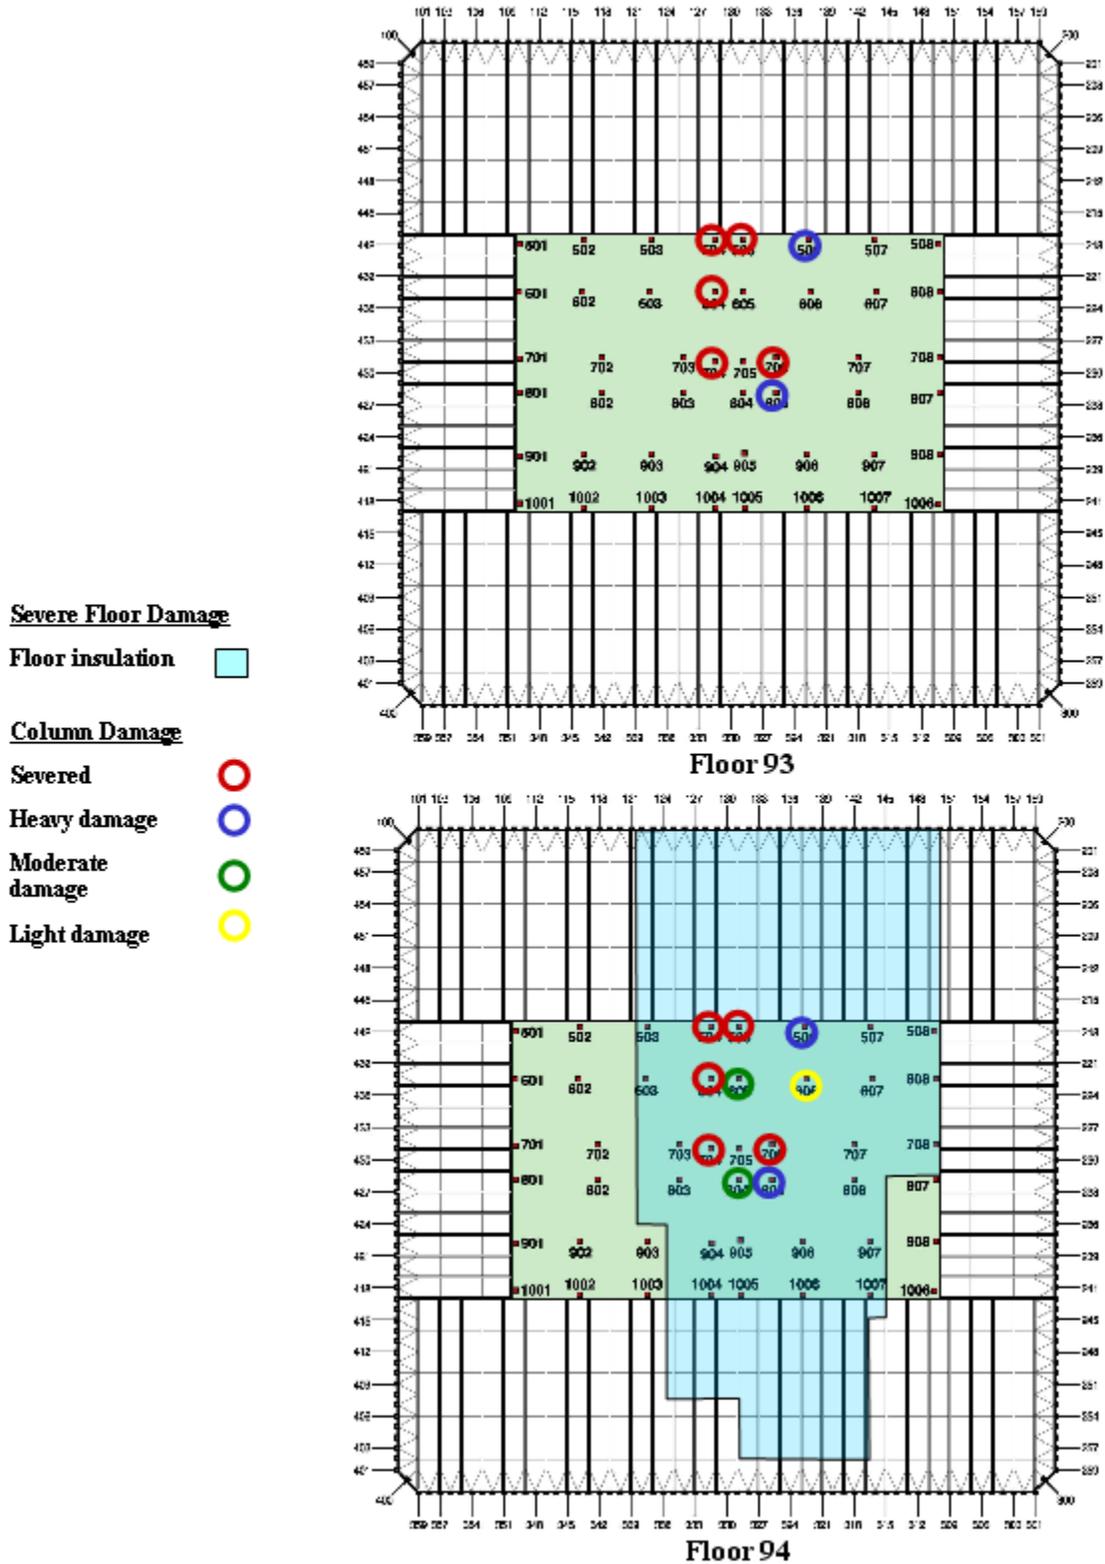
Figure B-7. WTC 1 Case B aircraft impact damage to Occupancy Floors 93 and 94.

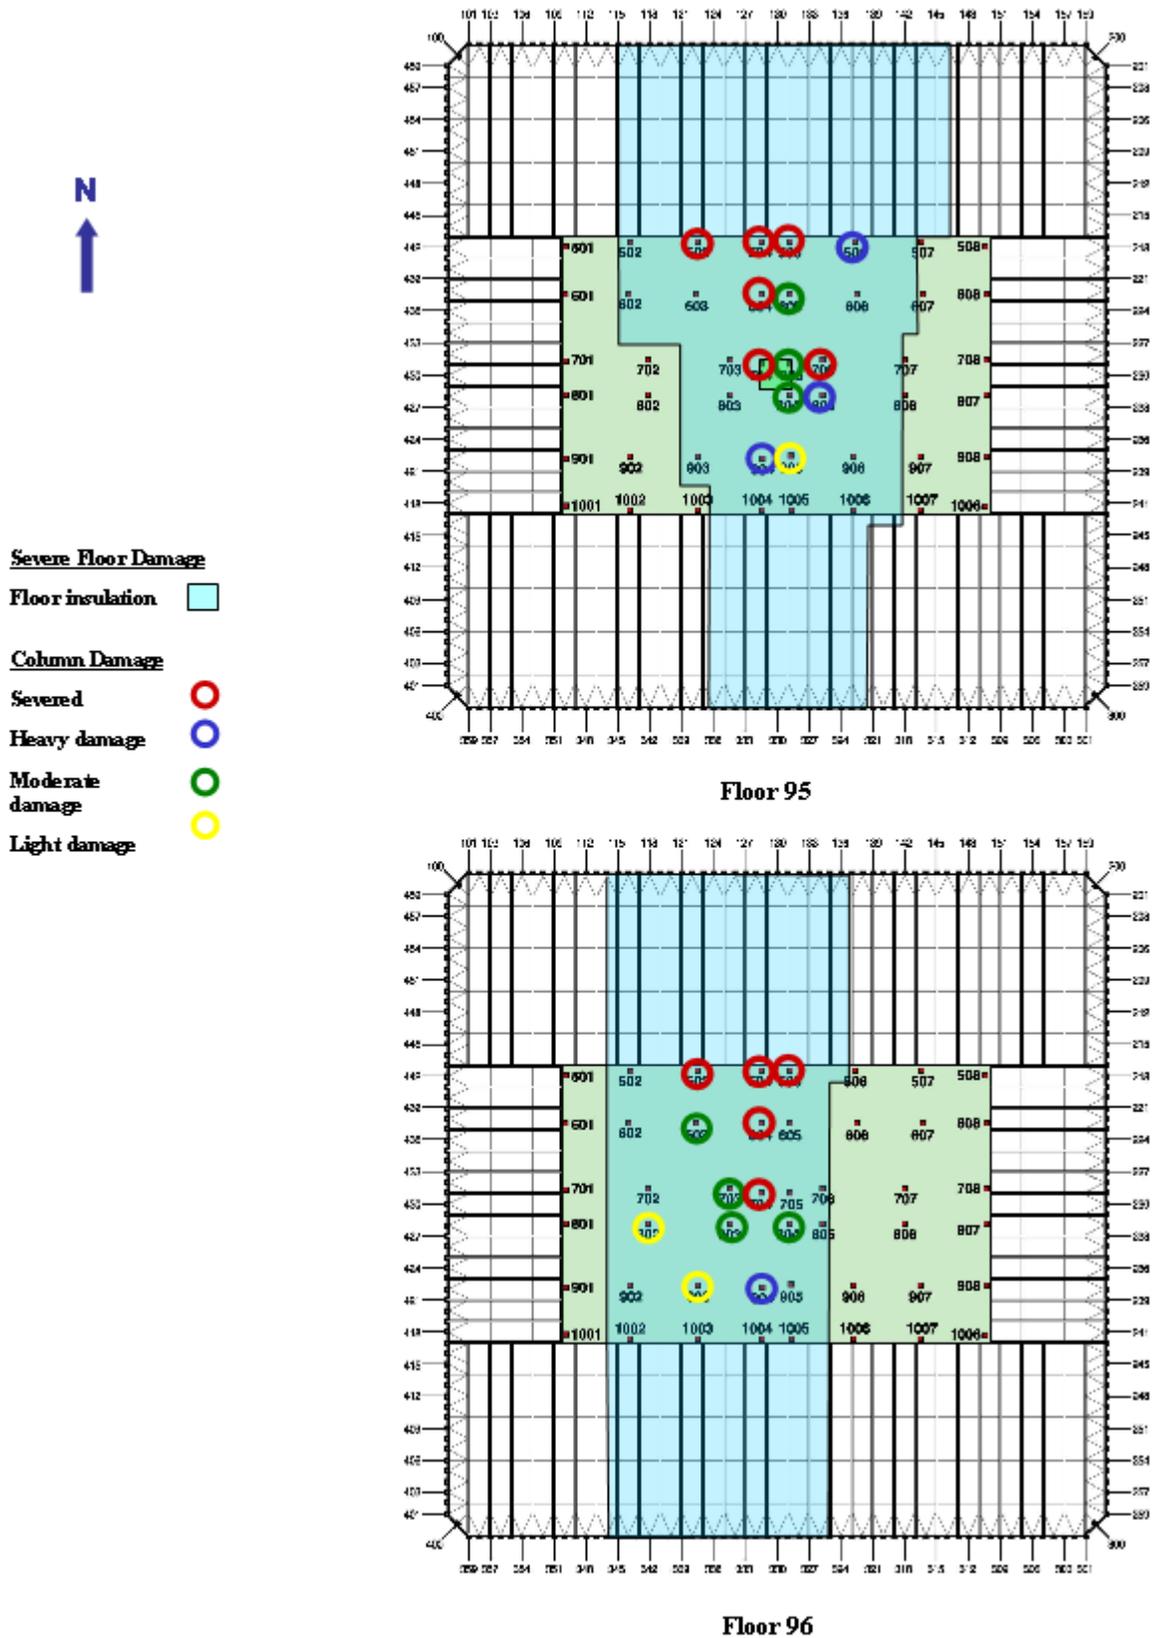
Figure B-8. WTC 1 Case B aircraft impact damage to Occupancy Floors 95 and 96.

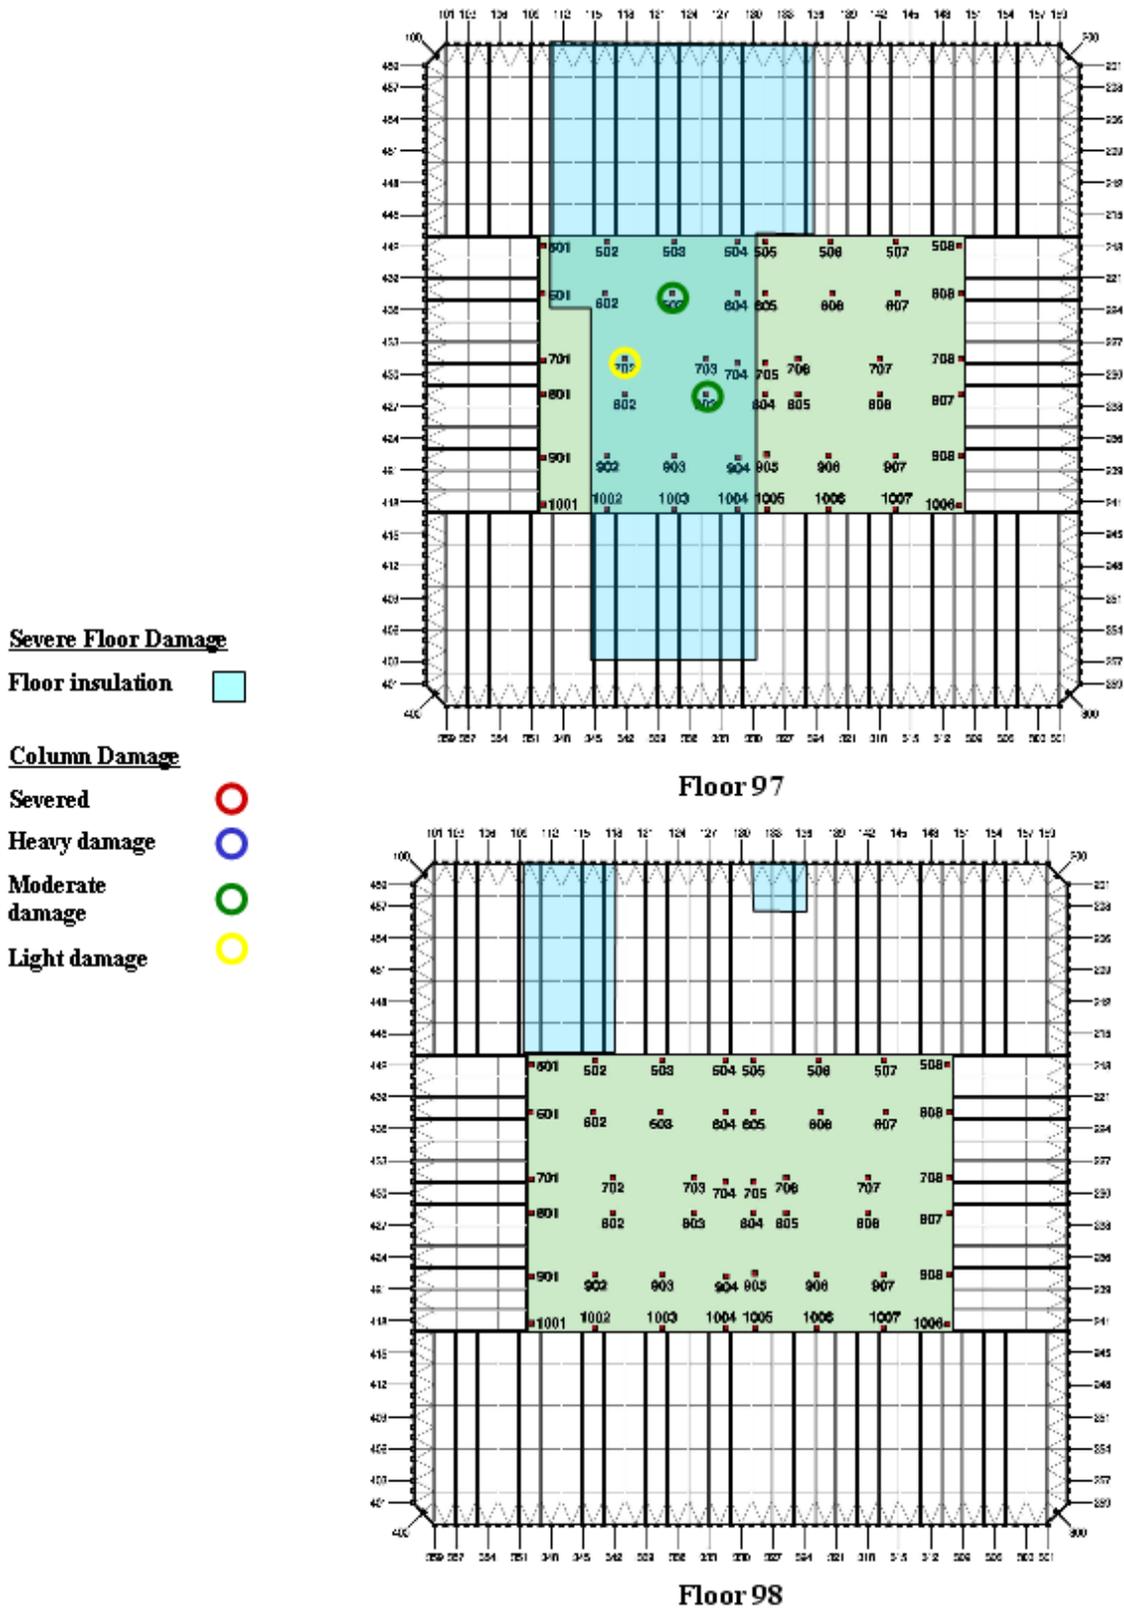
Figure B-9. WTC 1 Case B aircraft impact damage to Occupancy Floors 97 and 98.

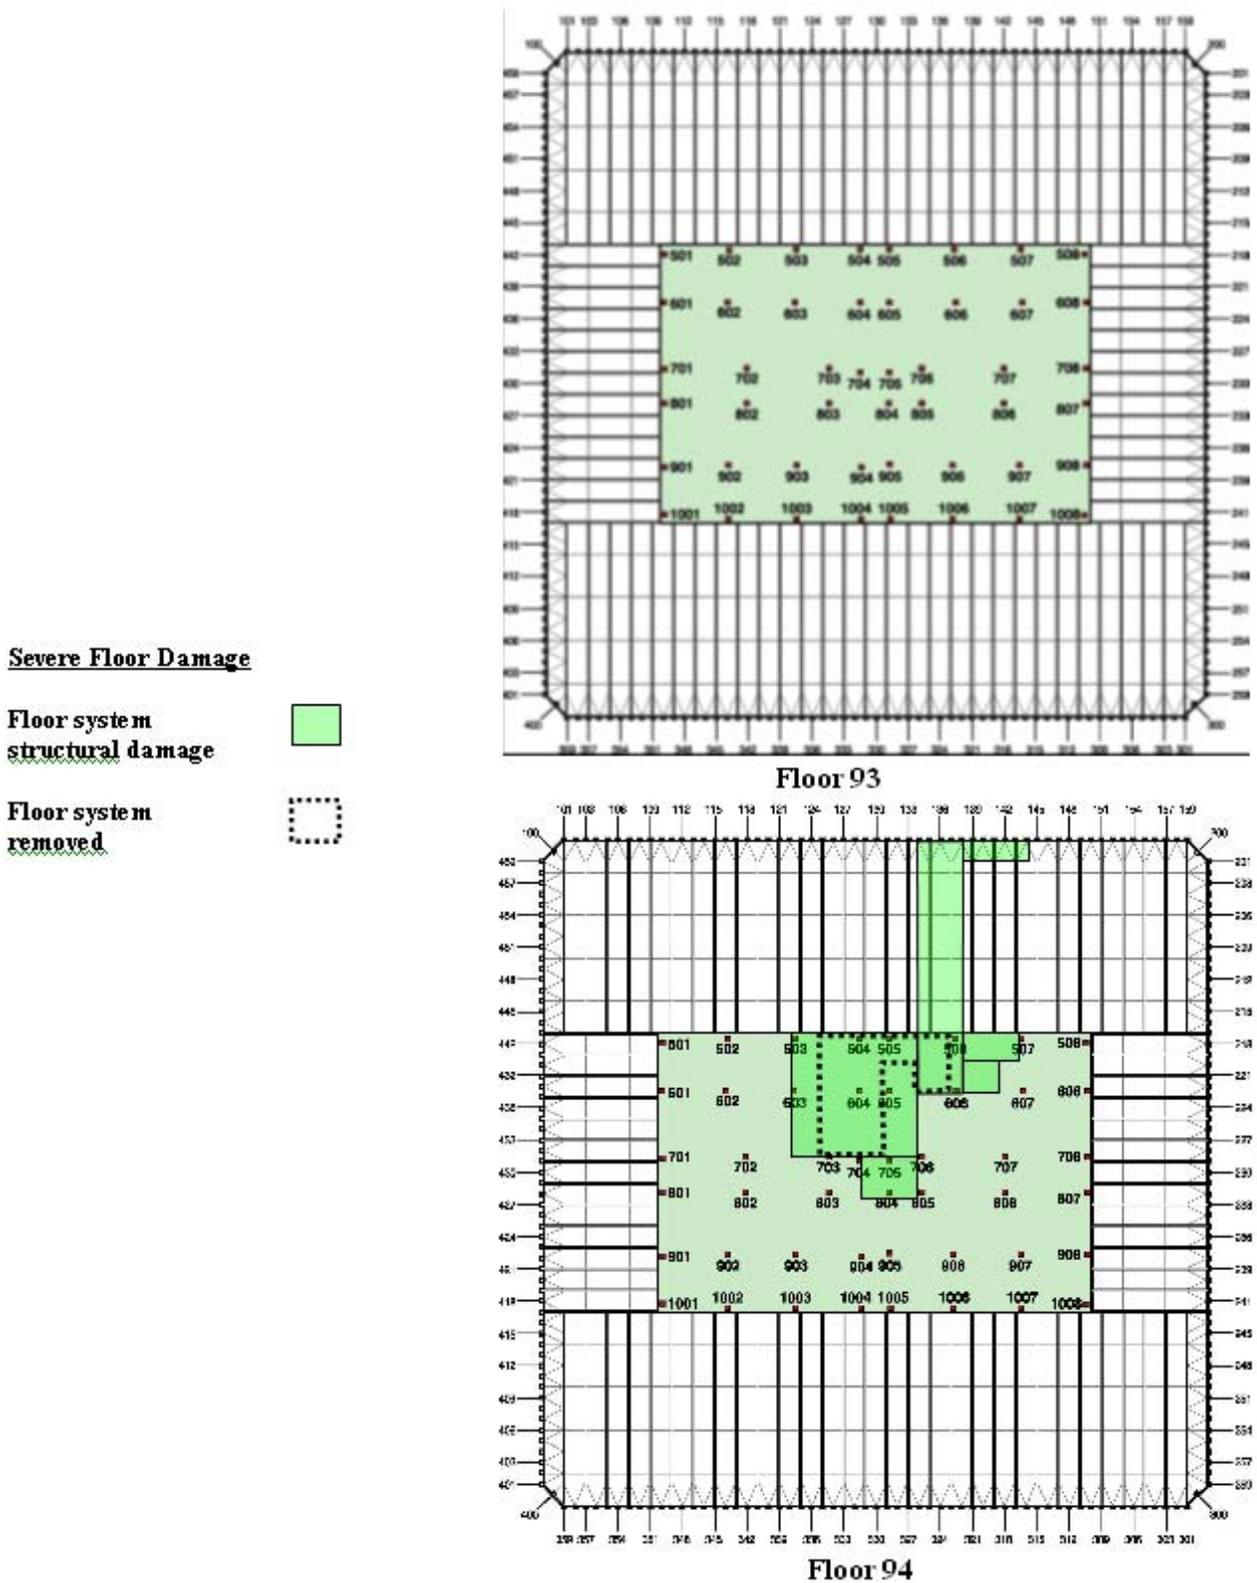
Figure B-10. WTC 1 Case B aircraft impact damage to Structural Floors 93 and 94.

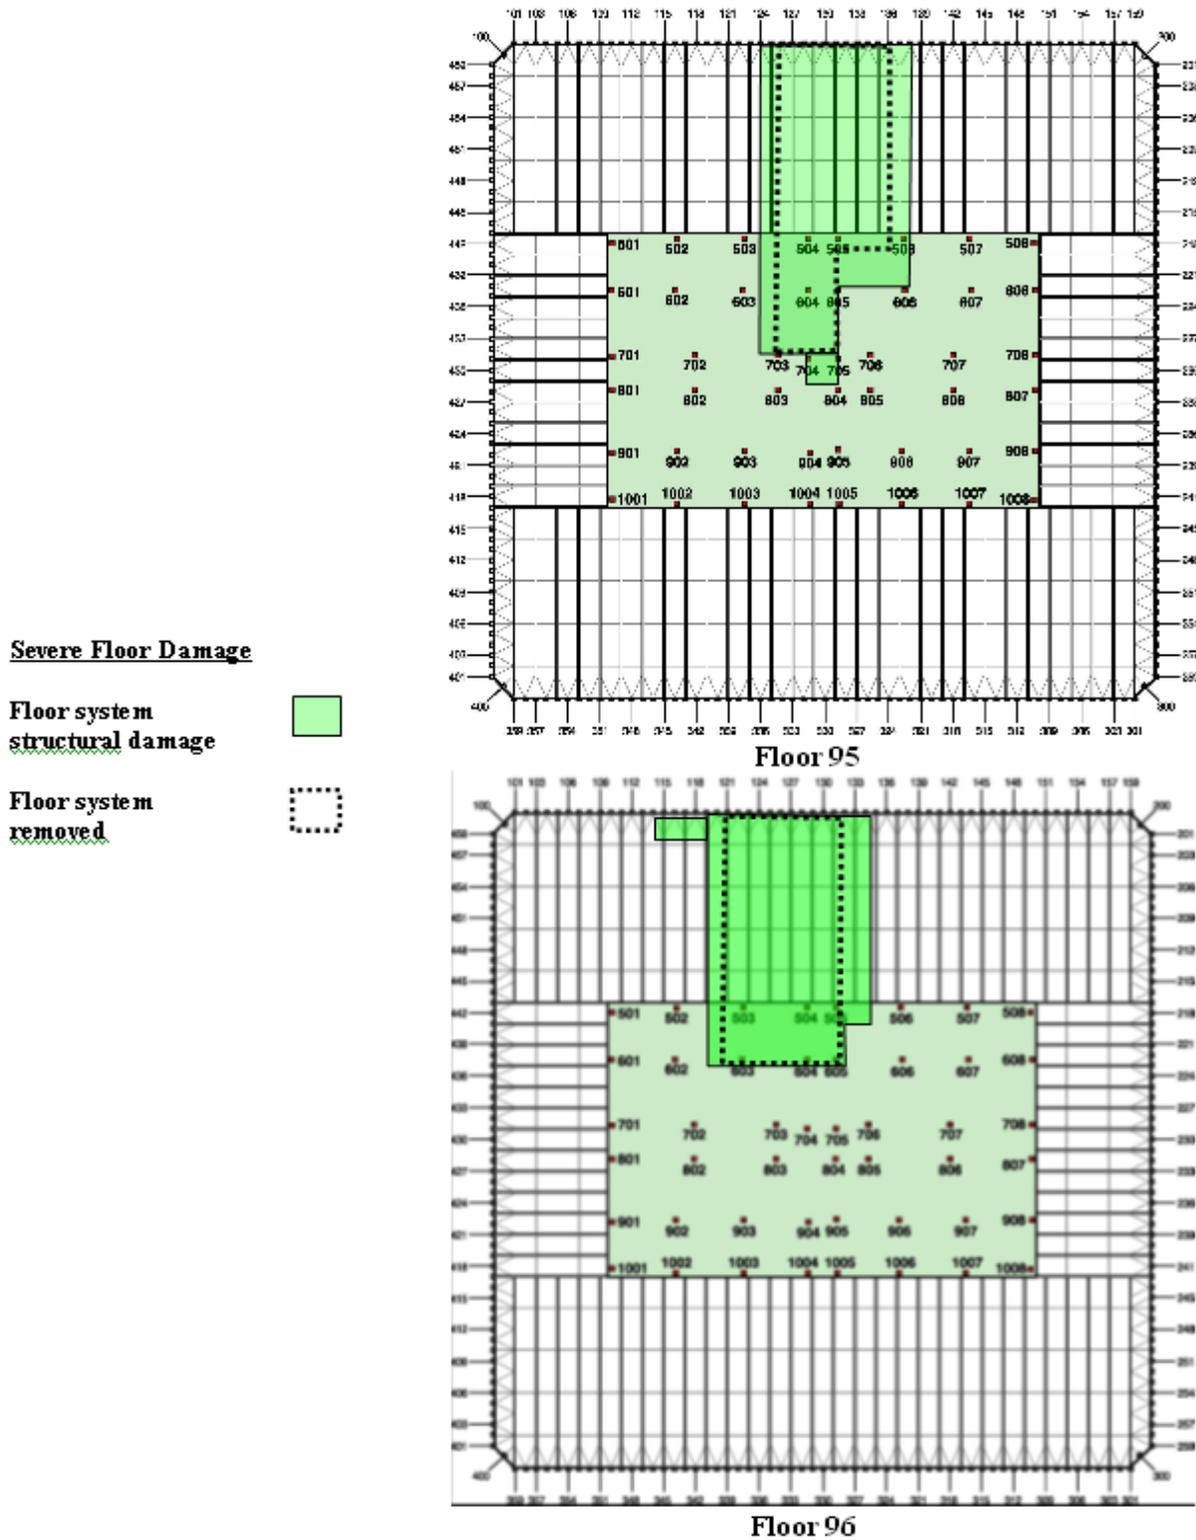
Figure B-11. WTC 1 Case B aircraft impact damage to Structural Floors 95 and 96.

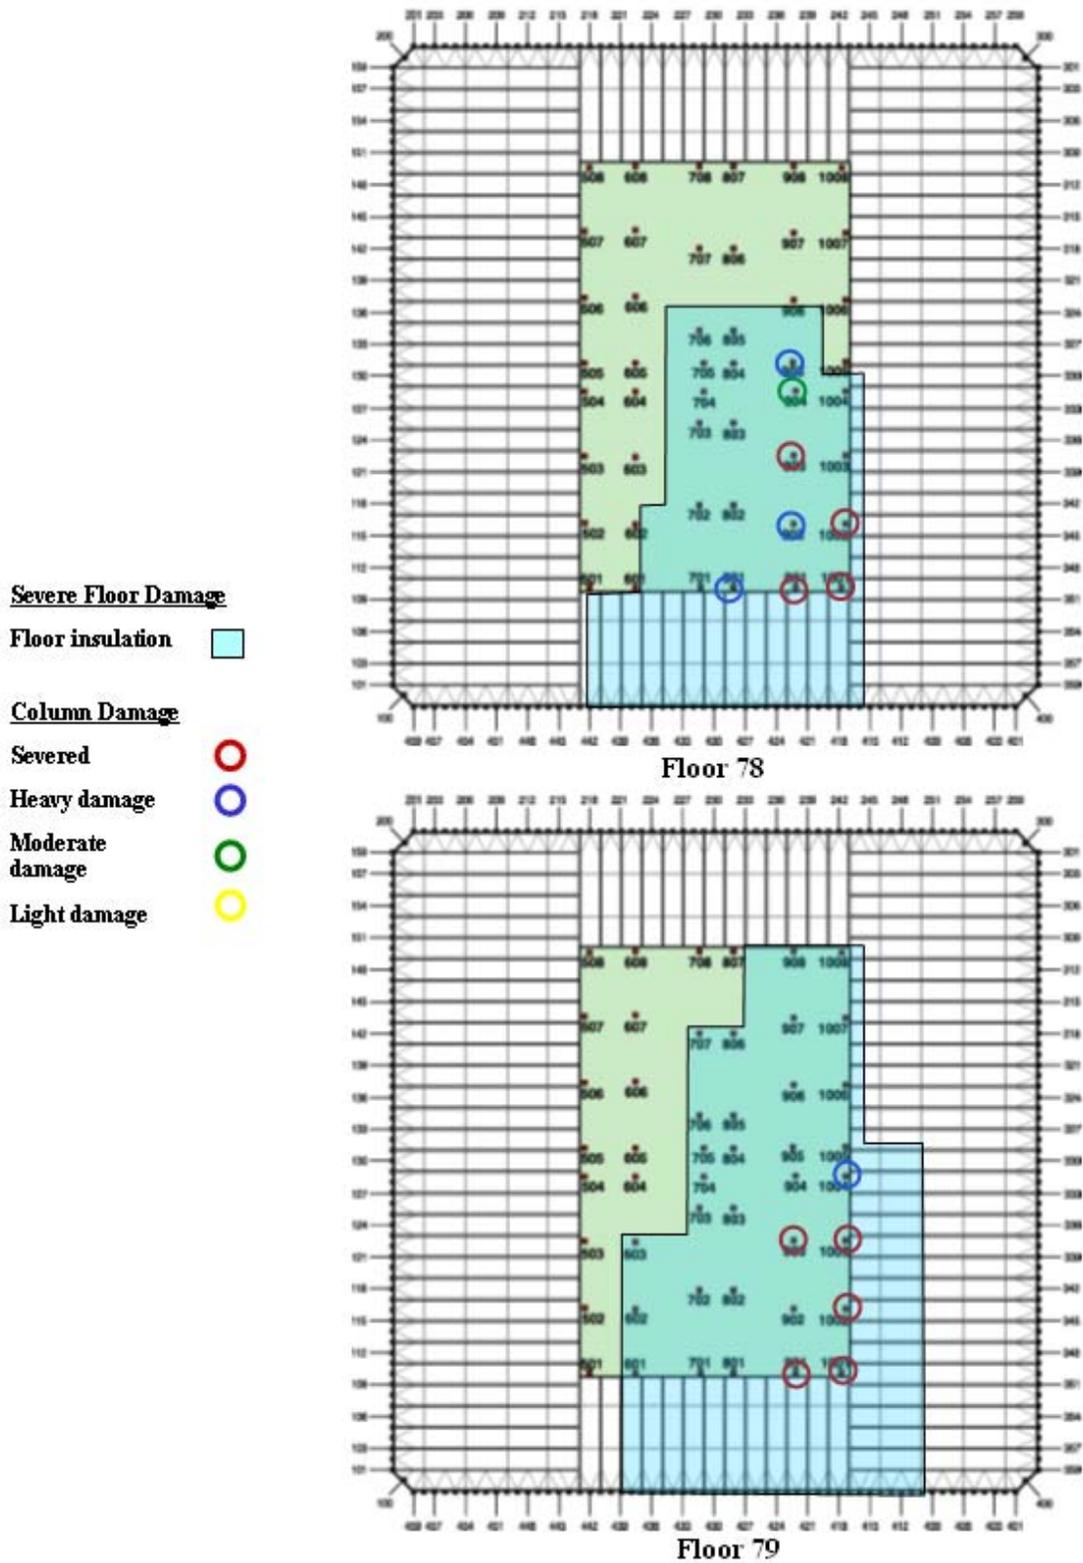
Figure B-13. WTC 2 Case C aircraft impact damage to Occupancy Floors 78 and 79.

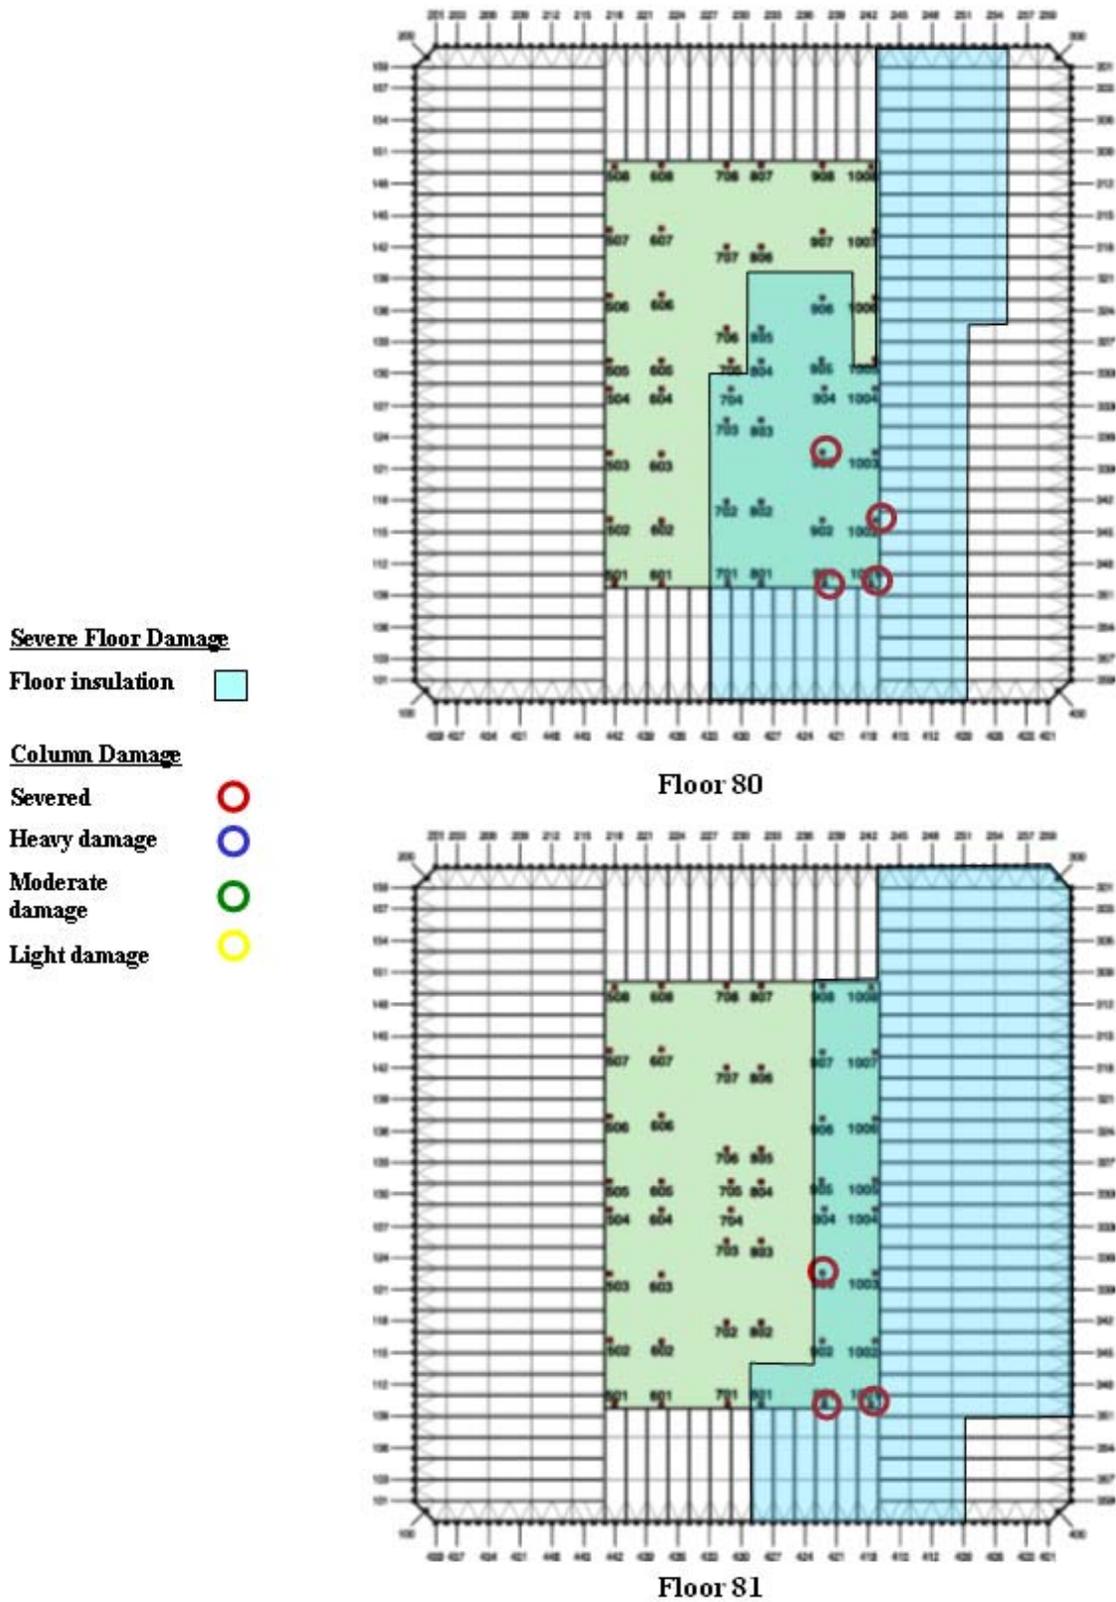
Figure B-14. WTC 2 Case C aircraft impact damage to Occupancy Floors 80 and 81.
