**Federal Building and Fire Safety Investigation of the
World Trade Center Disaster**

Structural Fire Response and Probable Collapse Sequence of the World Trade Center Towers

John L. Gross
Therese P. McAllister

September 2005

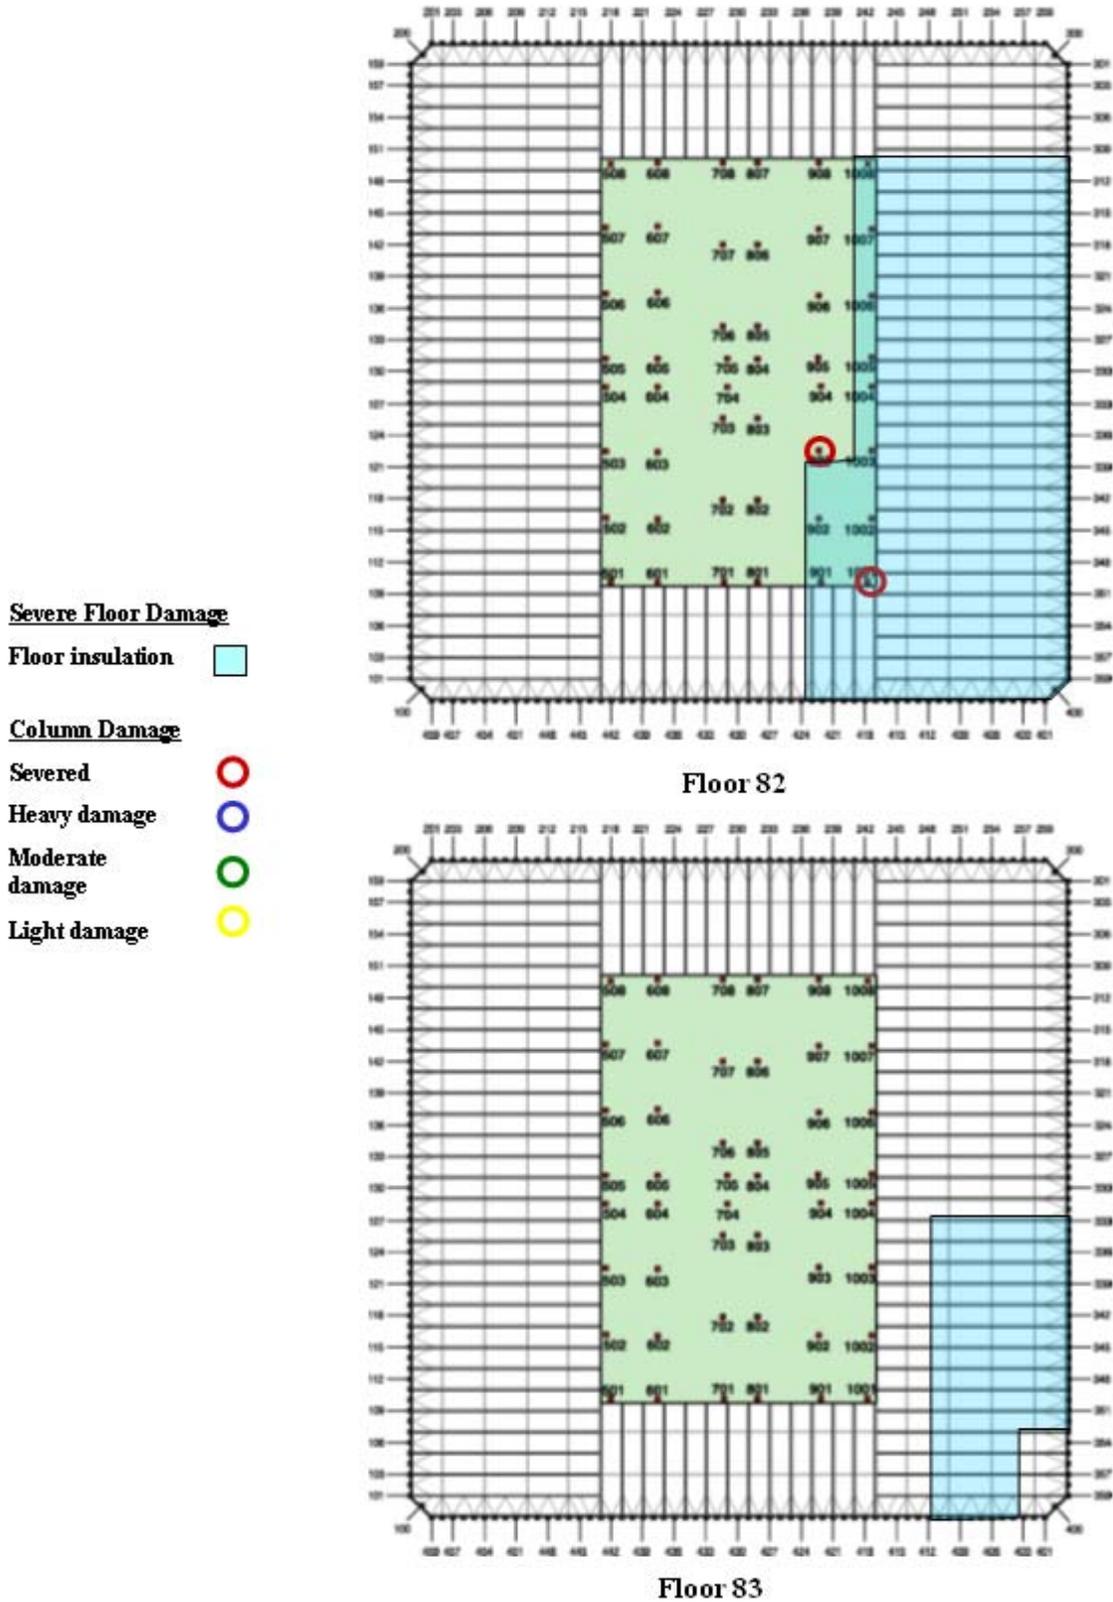
Figure B-15. WTC 2 Case C aircraft impact damage to Occupancy Floors 82 and 83.

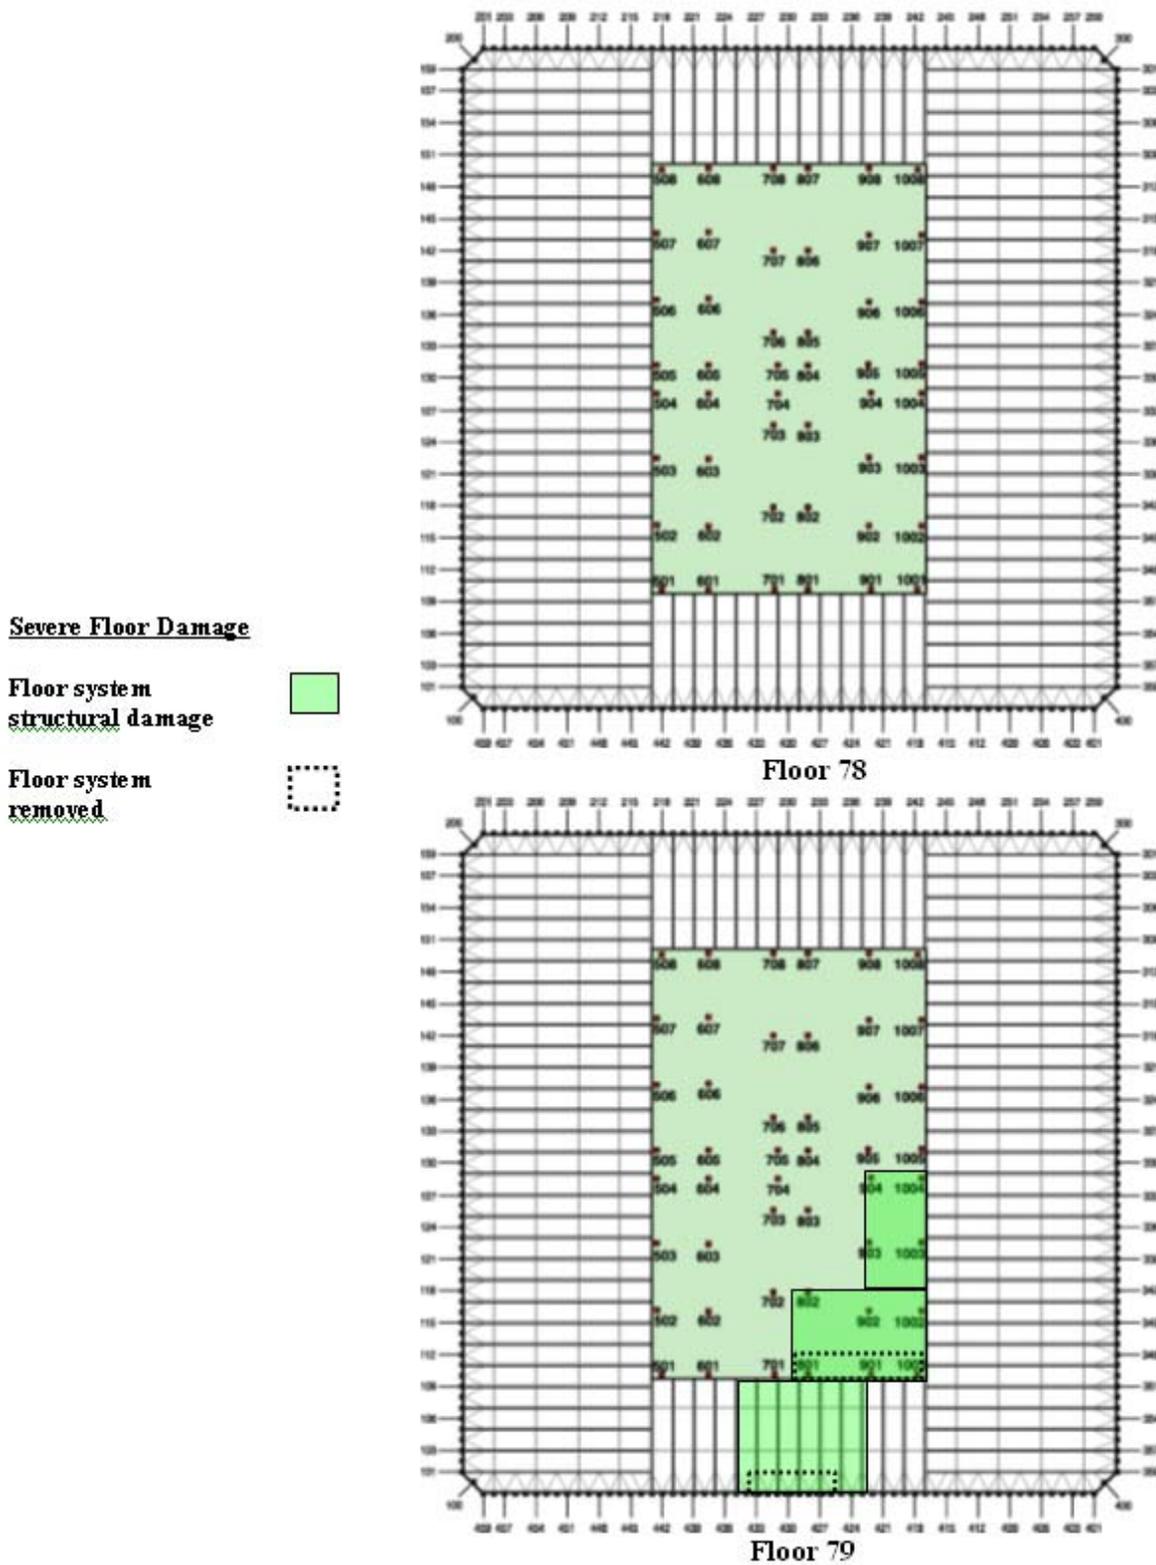
Figure B-16. WTC 2 Case C aircraft impact damage to Structural Floors 78 and 79.

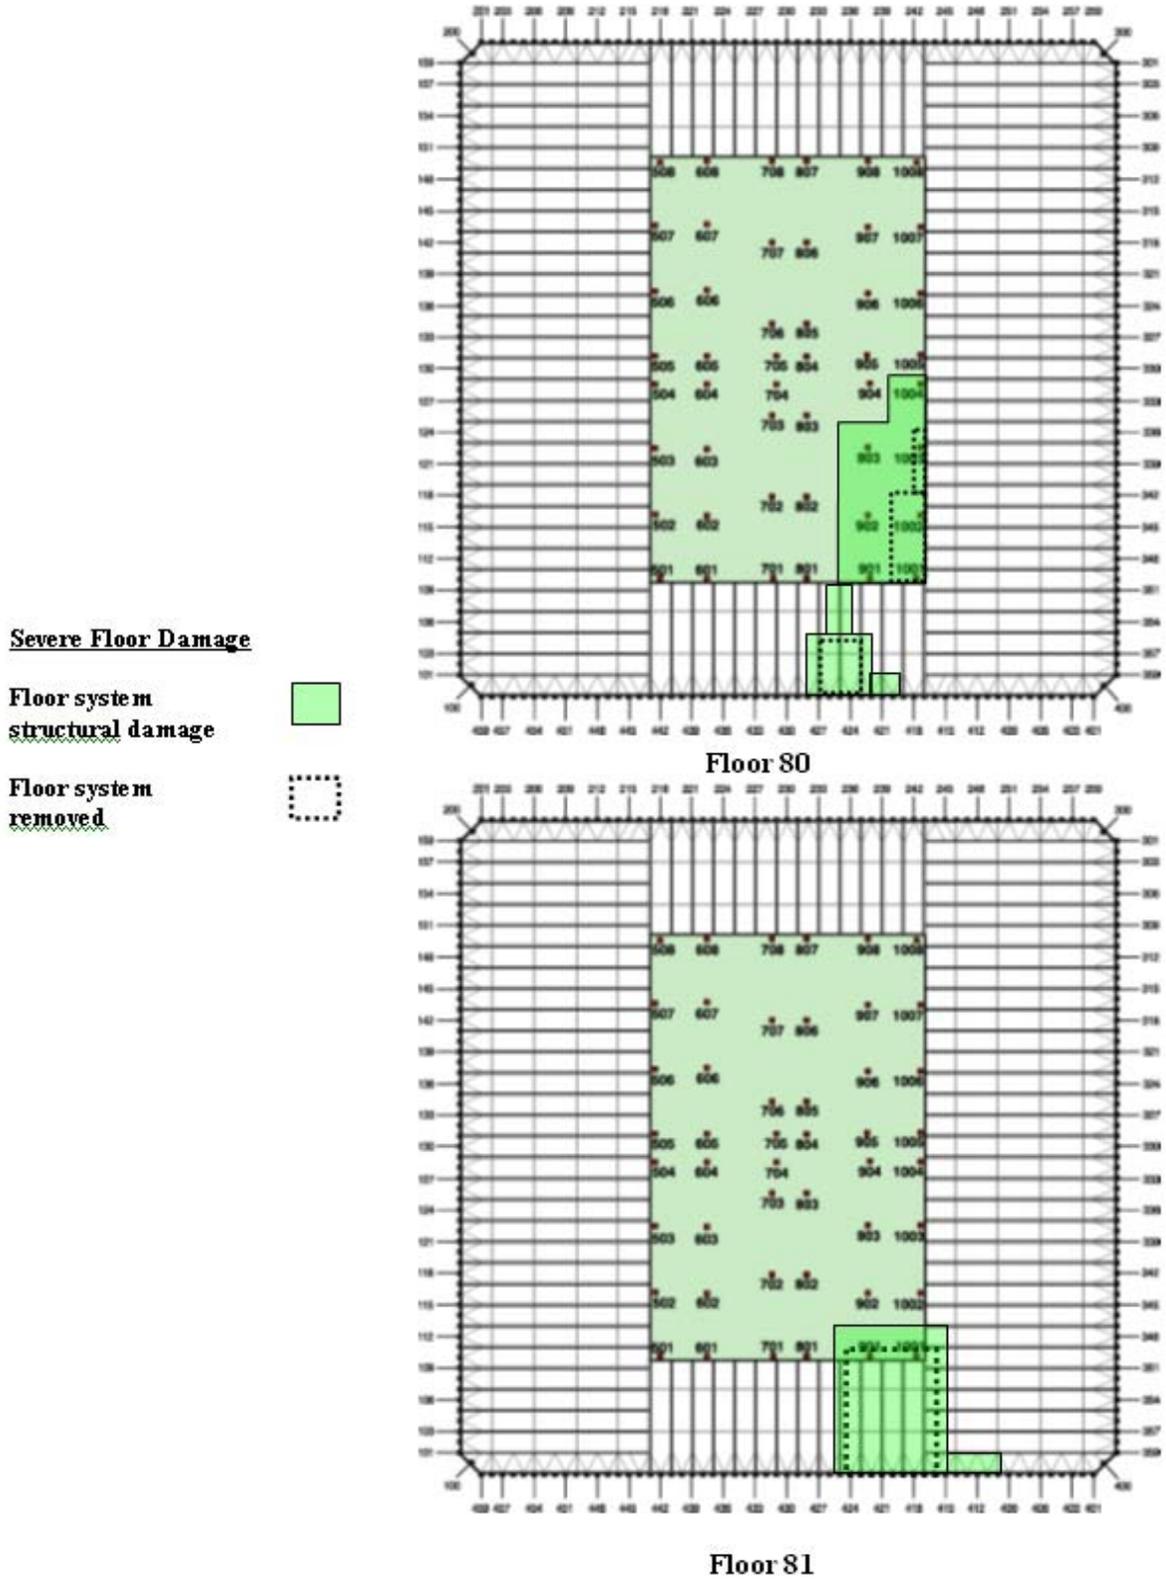
Figure B-17. WTC 2 Case C aircraft impact damage to Structural Floors 80 and 81.

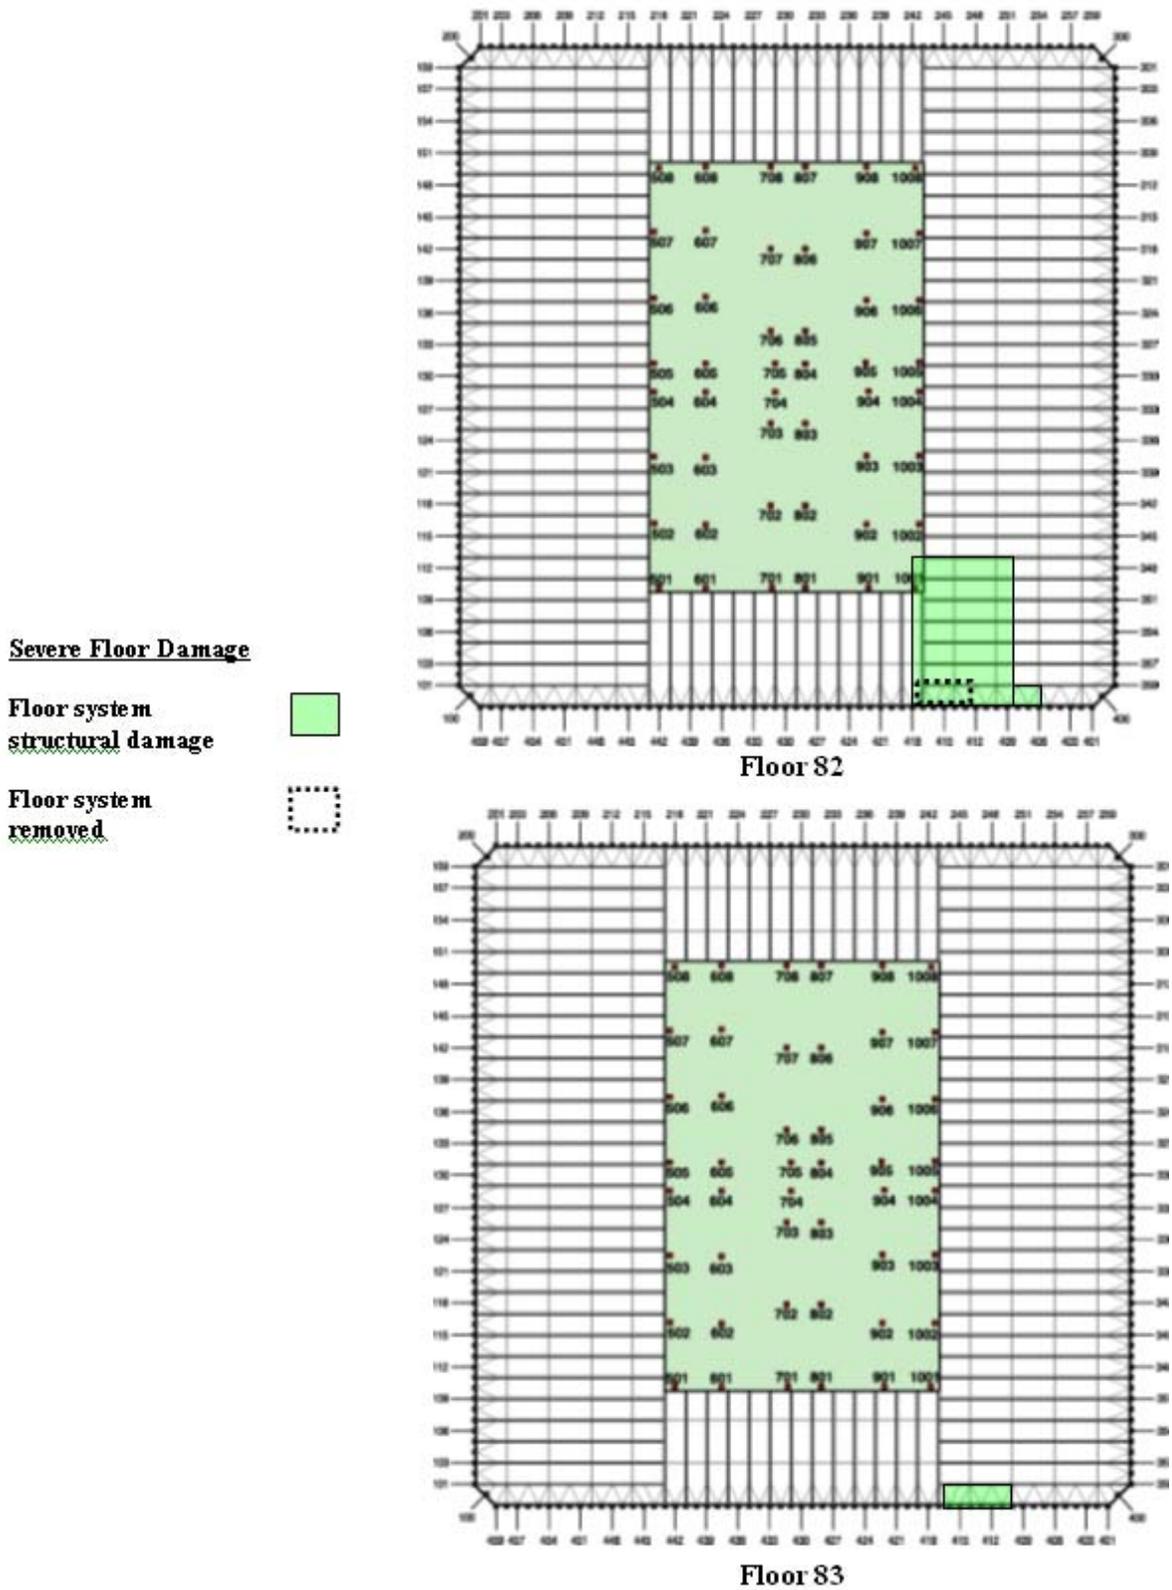
Figure B-18. WTC 2 Case C aircraft impact damage to Structural Floors 82 and 83.

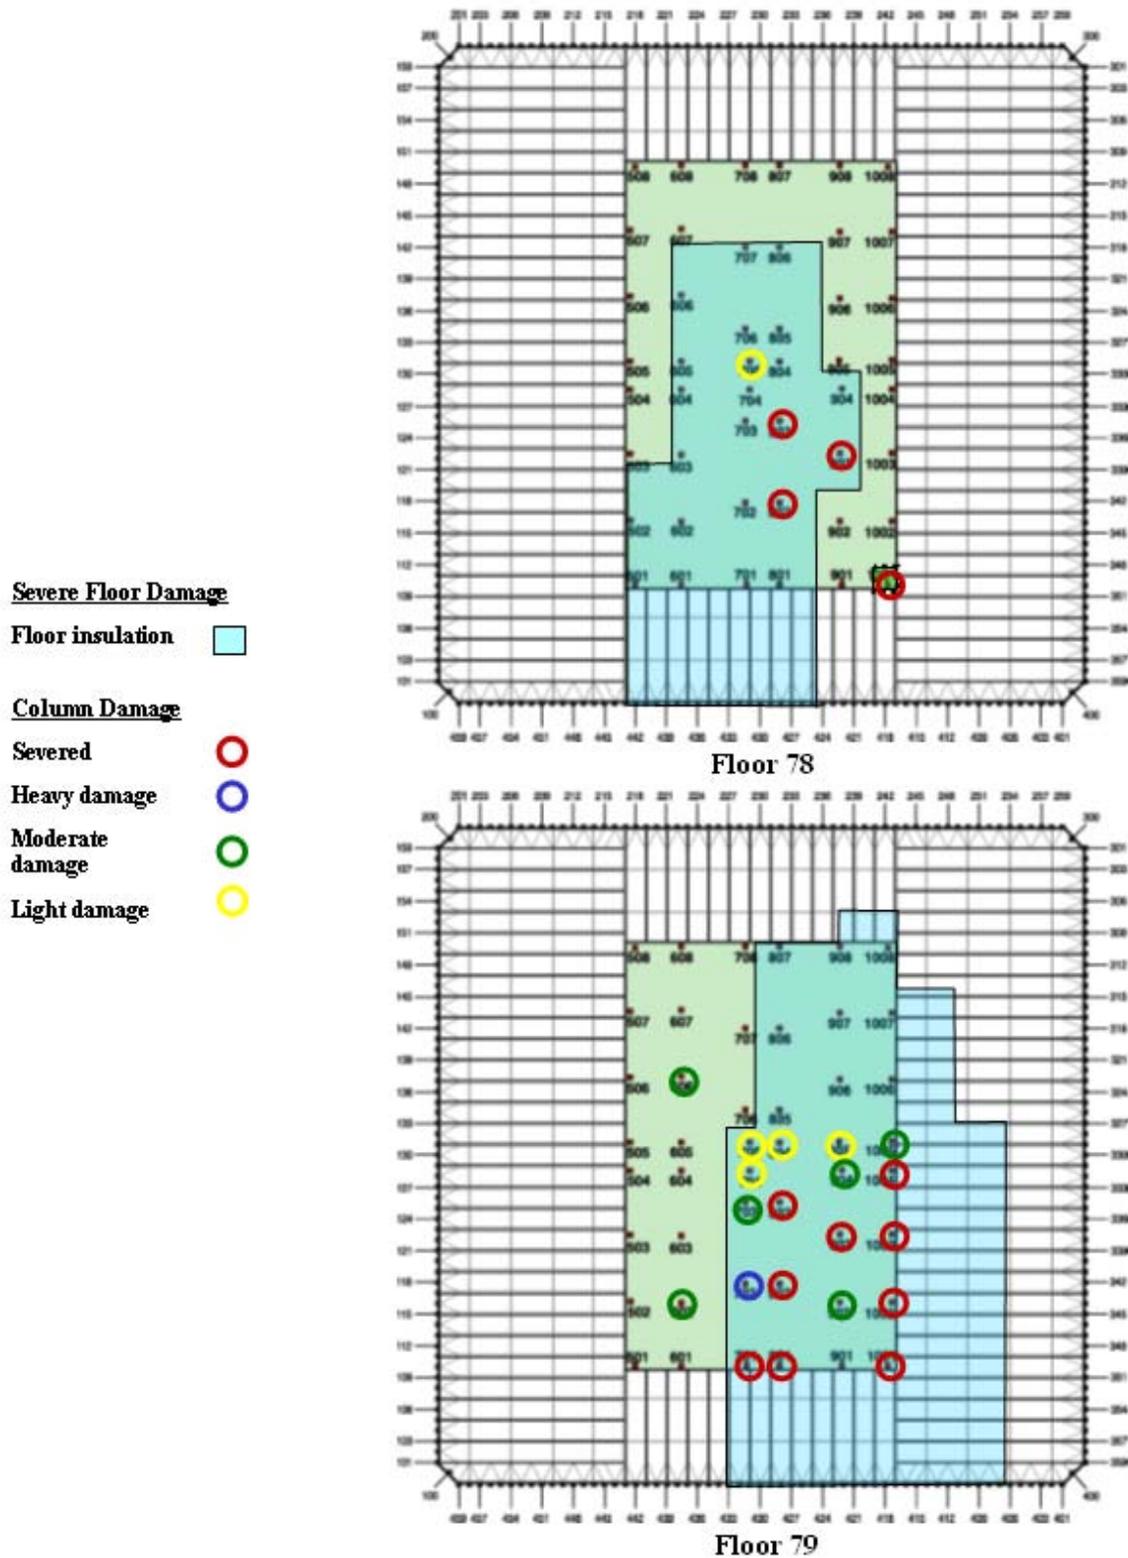
Figure B-19. WTC 2 Case D aircraft impact damage to Occupancy Floors 78 and 79.

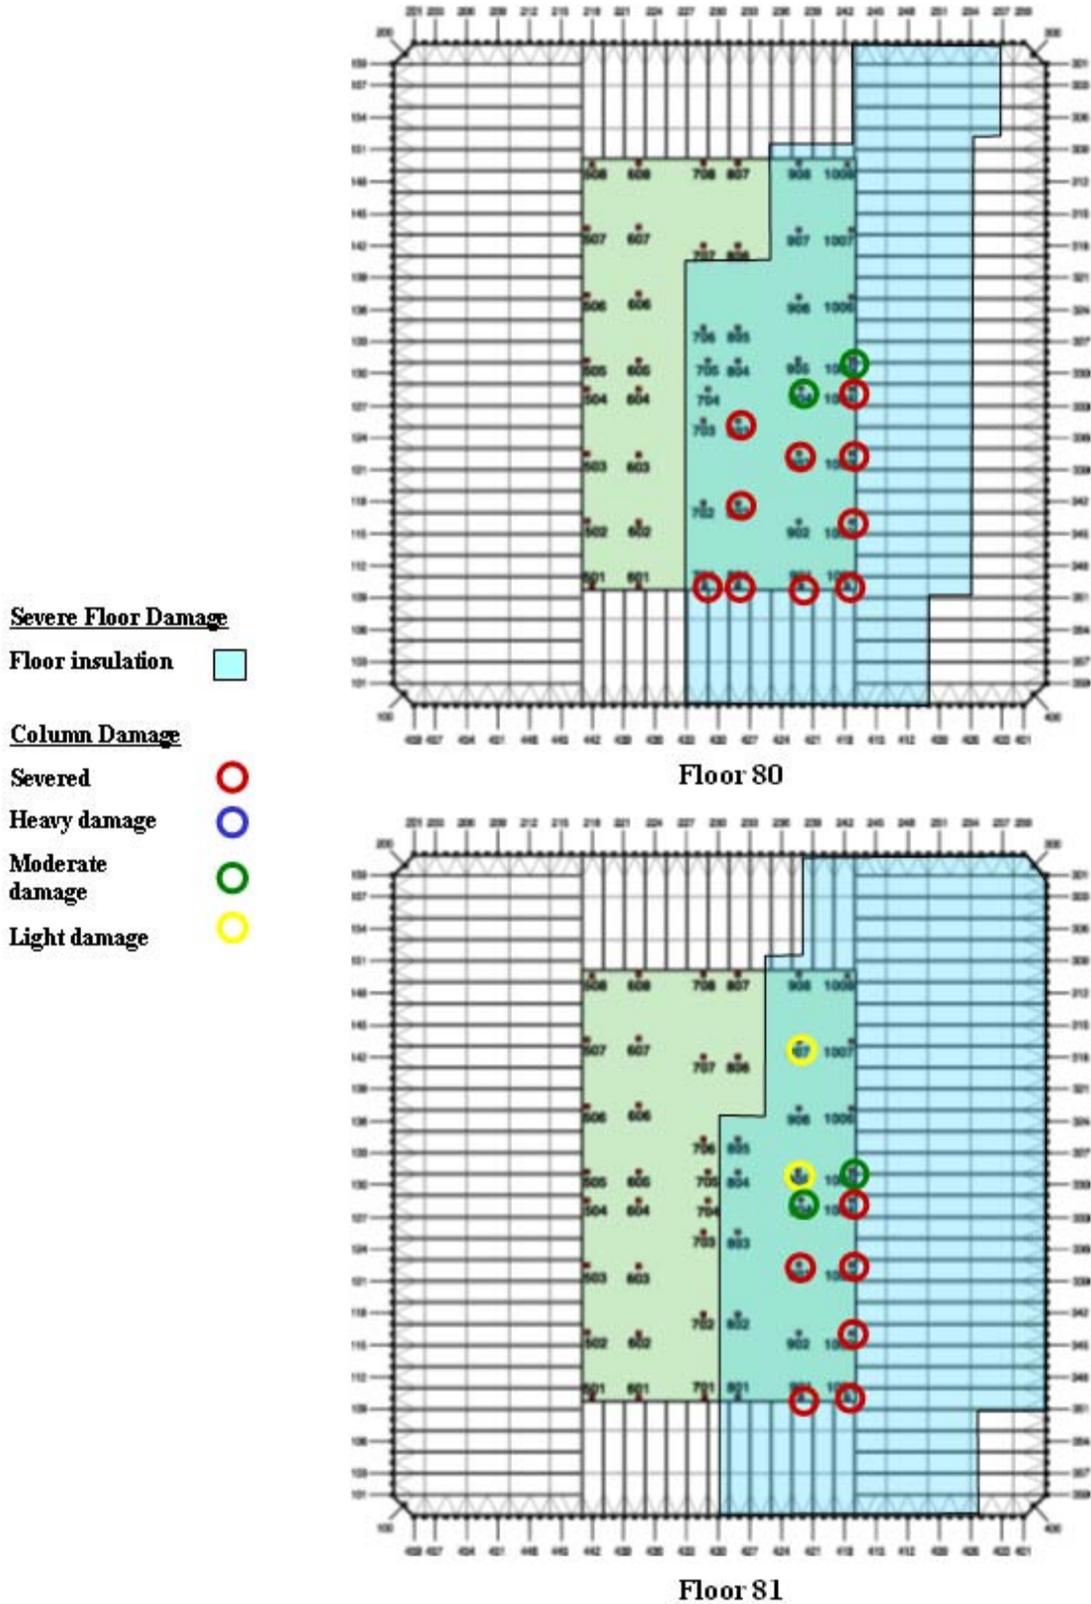
Figure B-20. WTC 2 Case D aircraft impact damage to Occupancy Floors 80 and 81.

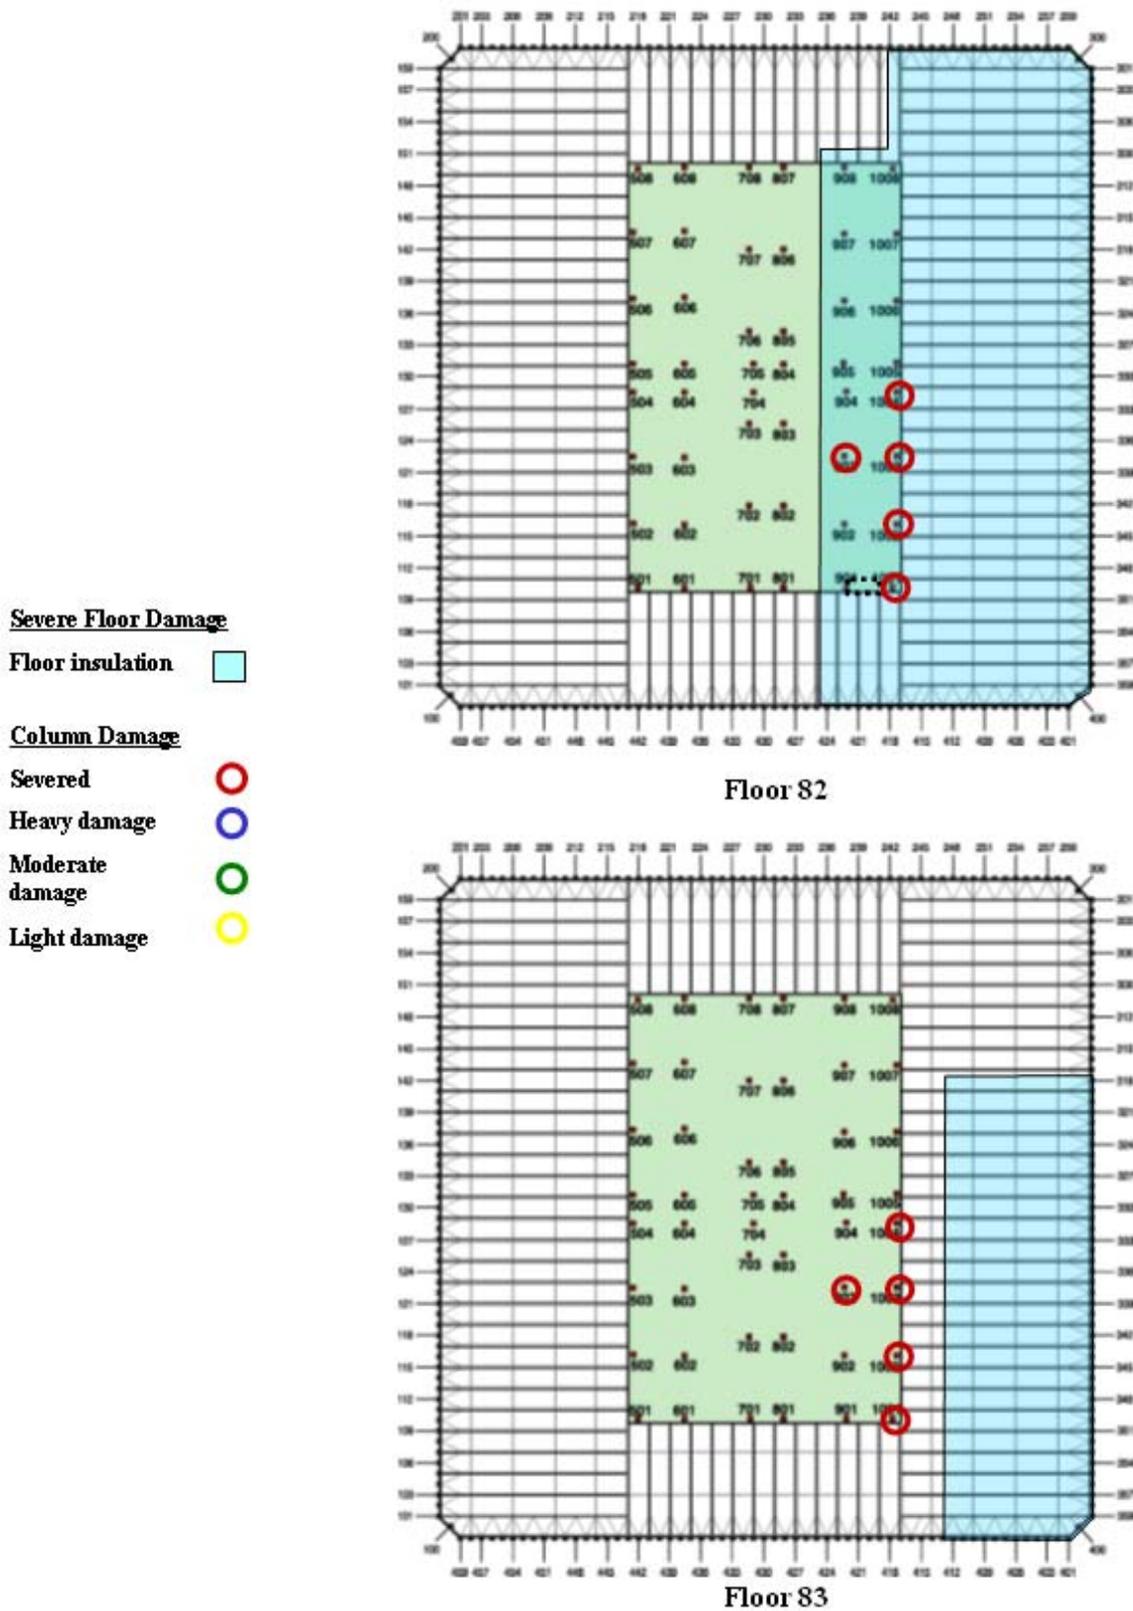
Figure B-21. WTC 2 Case D aircraft impact damage to Occupancy Floors 82 and 83.

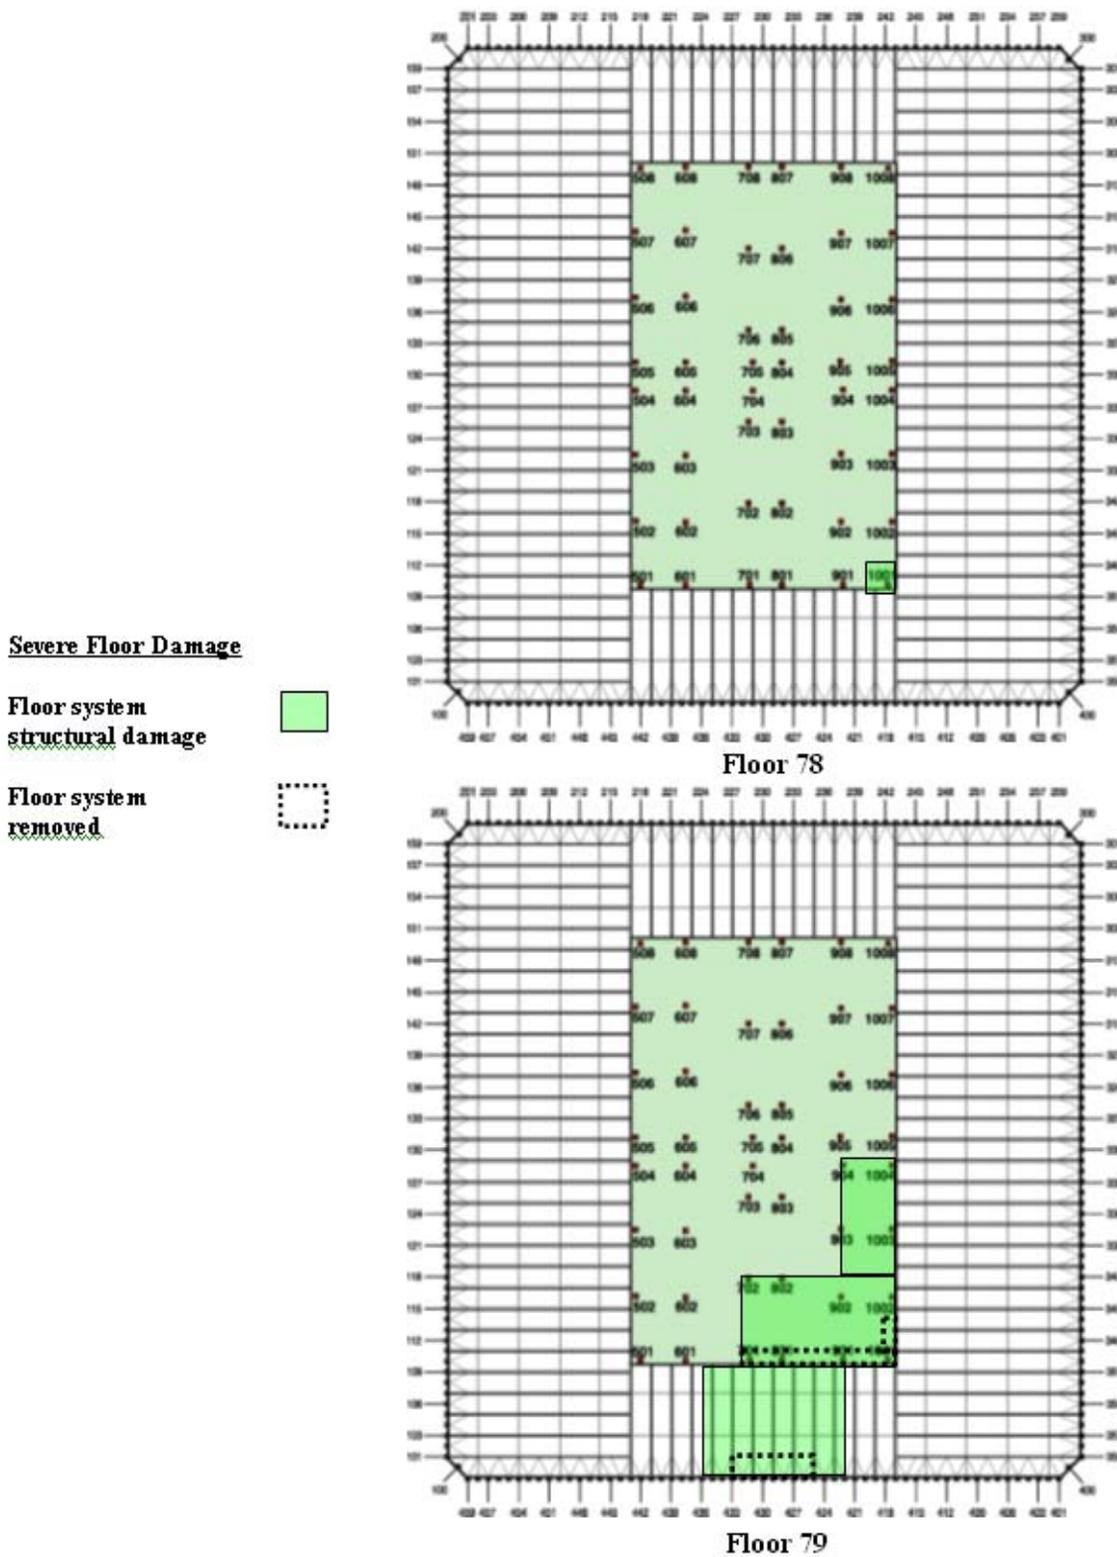
Figure B–22. WTC 2 Case D aircraft impact damage to Structural Floors 78 and 79.

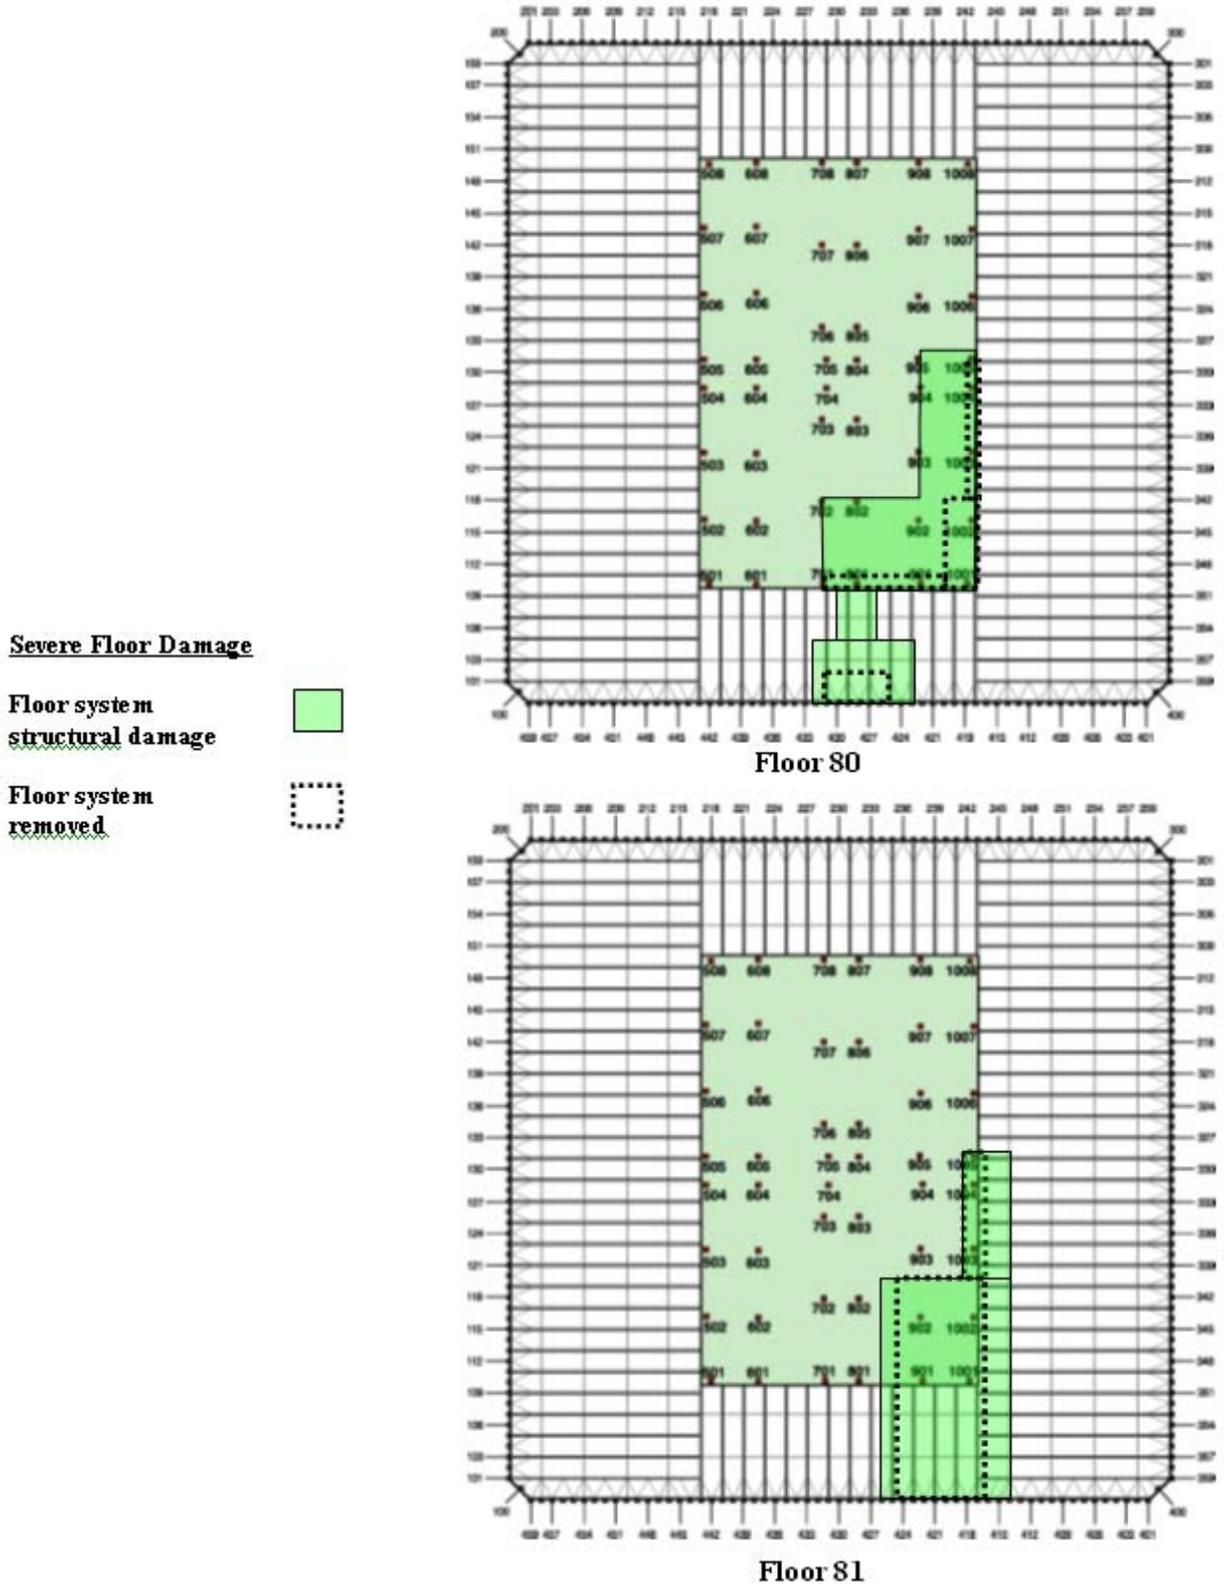
Figure B-23. WTC 2 Case D aircraft impact damage to Structural Floors 80 and 81.

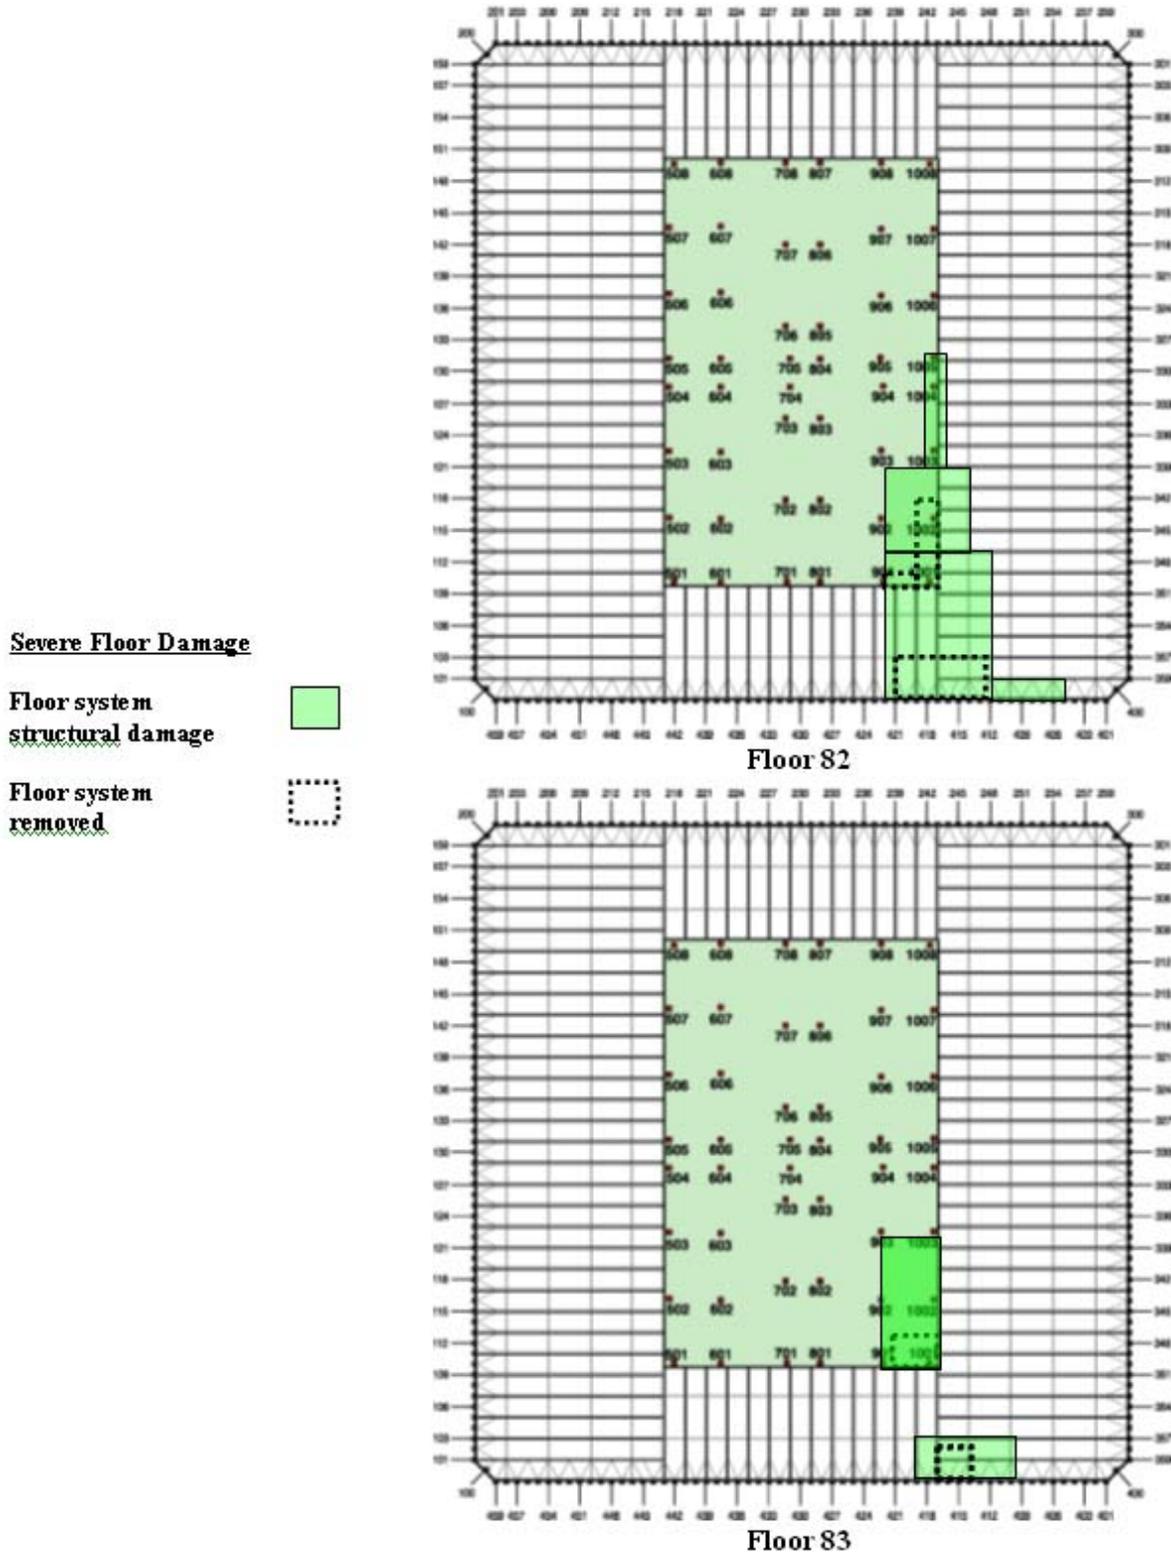
Figure B-24. WTC 2 Case D aircraft impact damage to Structural Floors 82 and 83.
