**JEFFERSON MEMORIAL
NATIONAL MALL & MEMORIAL PARKS
WASHINGTON, DC**

CONTRACT # 1443C2000040800
REPAIR AND CONTROL SETTLEMENT AT JEFFERSON
MEMORIAL SEAWALL, NORTH PLAZA, AND TRANSITION
AREAS
PMIS NO. 128232

SUPPLEMENTAL DOCUMENTS

NATIONAL PARK SERVICE
DENVER SERVICE CENTER
April 2, 2009

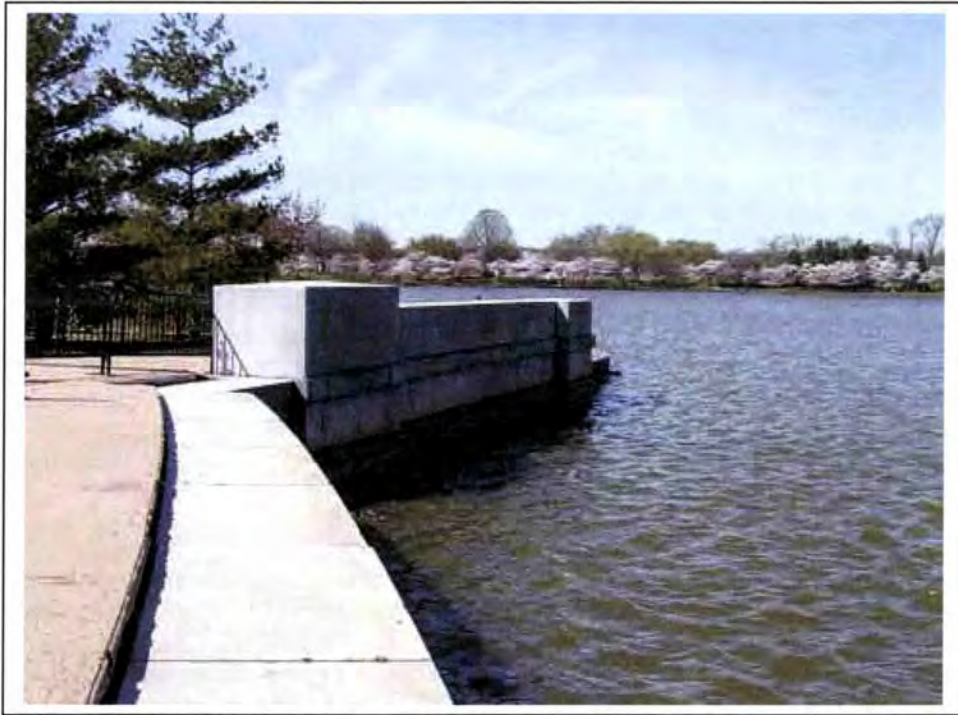
The wall is comprised of 10 wall segments separated by joints. At the joints between wall segments, the capstones of the Ashlar Seawall are displaced with respect to each other, indicating relative movement and/or rotation between the seawall segments. Figures 1 and 2 are photos of the Ashlar Seawall and North Plaza interface.

Figure 1. View Standing on the Ashlar Seawall Looking West (3-29-07)

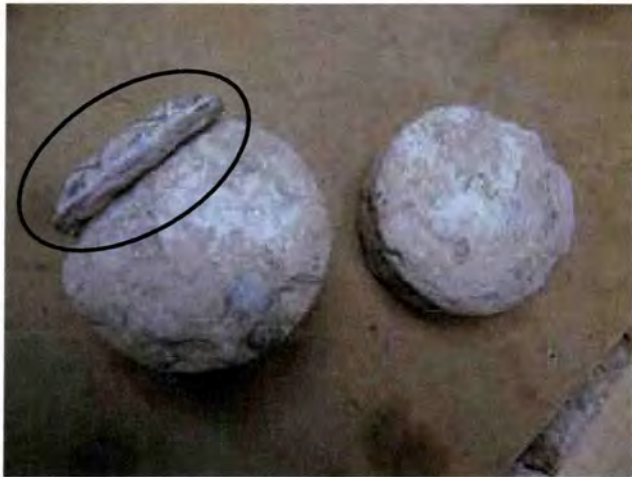
Photo 1: Core 1, Segments 3 and 4 - Cross section of break, showing reinforcing steel (not intact) and evidence of efflorescence (white staining).

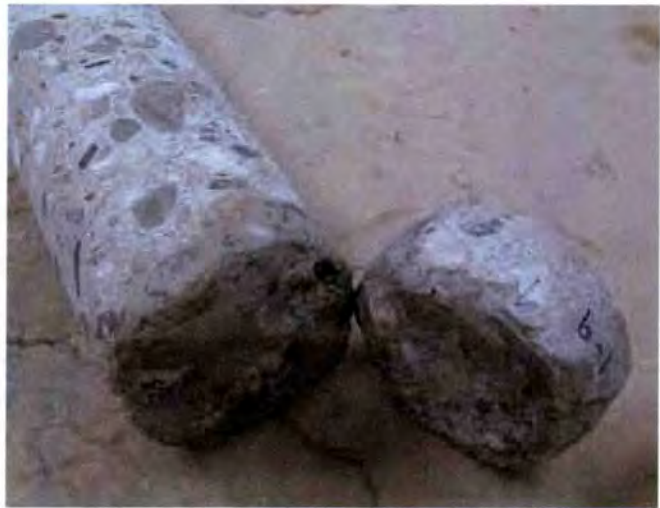
Photo 2: Core 1, Segments 8 and 9 - Cross section of joint.

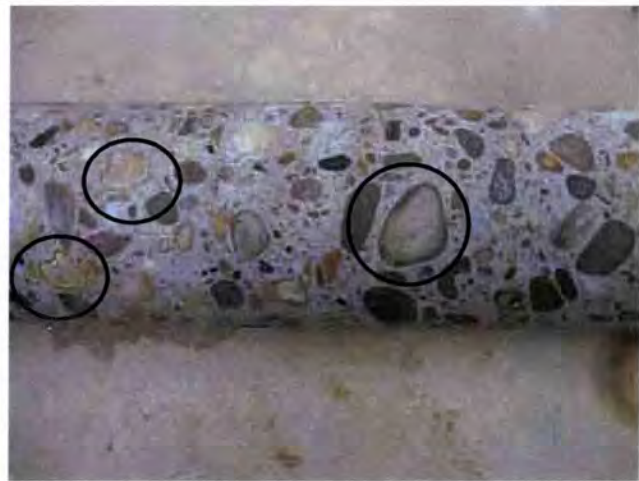
The visual analysis showed that there is a possibility of ASR, which is apparent in dark rings around the aggregate (see Photos 4, 14, and 25). The petrographic analyses confirmed evidence of ASR occurring in the concrete. Silica gel also appears to be forming in the concrete, as noted in Photos 5, 9, 18, and 27. The high compressive strength results of the concrete core breaks and the microscopic magnification of the petrographic analyses indicate that ASR does not currently appear to be a widespread issue in the concrete wall. Low air content and water/cement ratio have likely contributed to limiting the presence of moisture in the concrete. When the ASR gel is exposed to moisture, swelling of the gel occurs, which causes the concrete to develop tension and compressive stresses which in turn cause the concrete to crack. While, at the time of this report, presence of ASR gel in the concrete does not appear to be widespread, the process of installing micropiles (five feet on center) may increase the amount of moisture in the concrete, which may increase the formation of ASR gel in the concrete wall. We recommend that NPS establish a program of periodic concrete coring and petrographic analyses in order to monitor the presence of ASR in the wall if the existing wall is to remain in service.

Photo 4: Core 1, Segment 10 - Dark rings around aggregate show a potential for ASR.

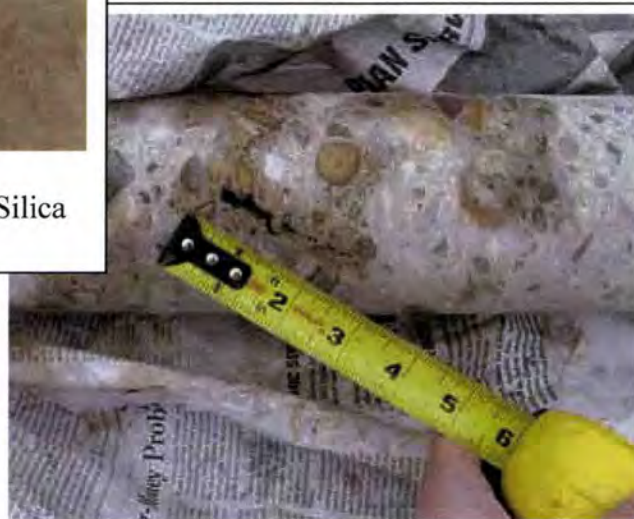
Photo 6: Core 1, Segment 11 - Entrapped air in concrete.

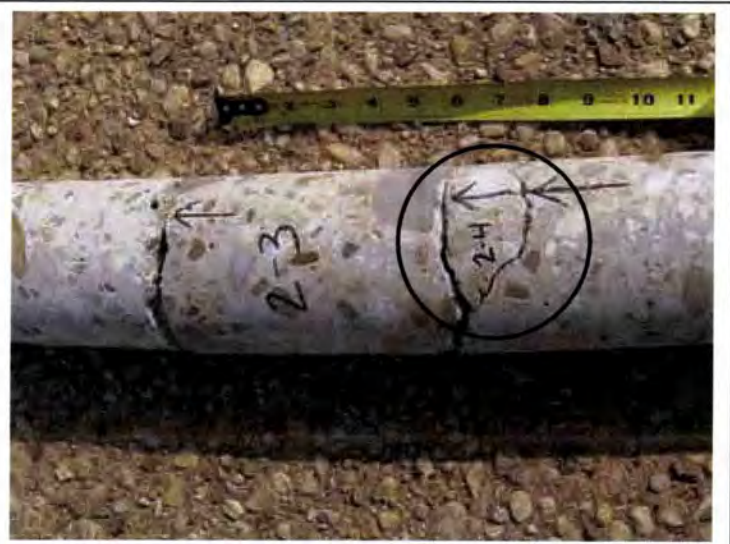
Photo 7: Core 2, Segments 3 and 4 - Chip in Segment 4.

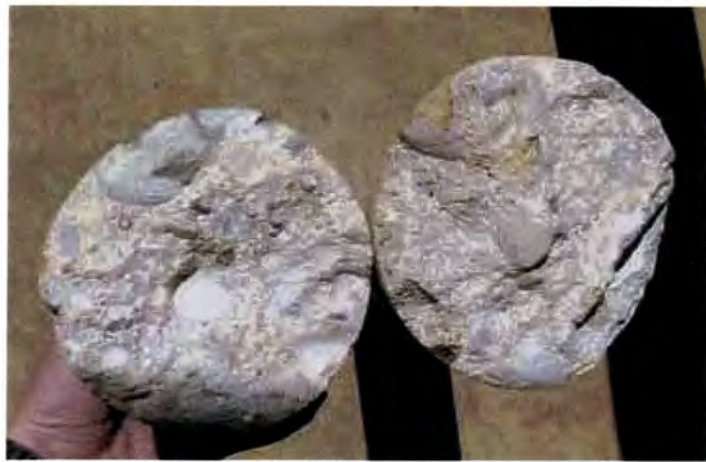
Photo 8: Core 2, Segments 3 and 4 - Evidence of efflorescence (white staining).

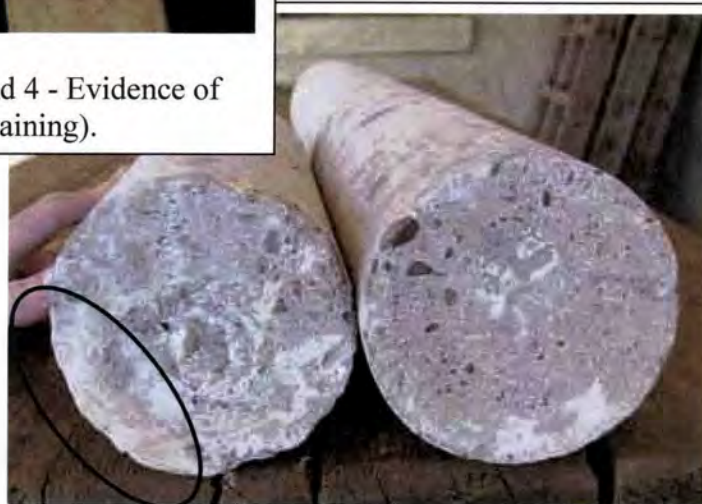
Photo 9: Core 2, Segments 4 and 5 - Smooth finish shows evidence of a joint. Silica gel forming in concrete.

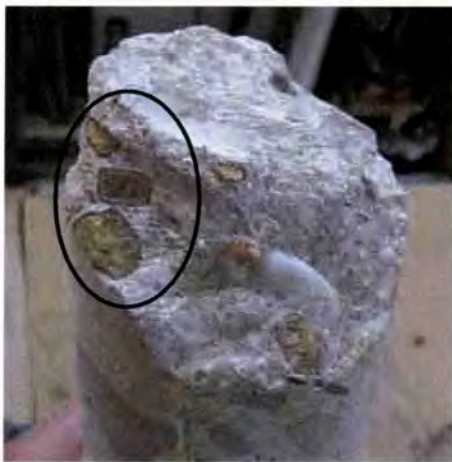
Photo 14: Core 3, Segment 3 - Dark rings around the aggregate show a potential for ASR.

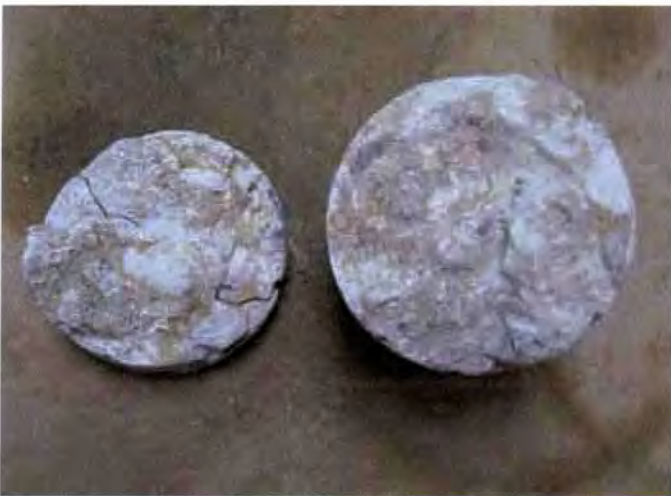
Photo 18: Core 4, Segment 1 - Cracking within Segment 1 shows evidence of efflorescence (white staining).

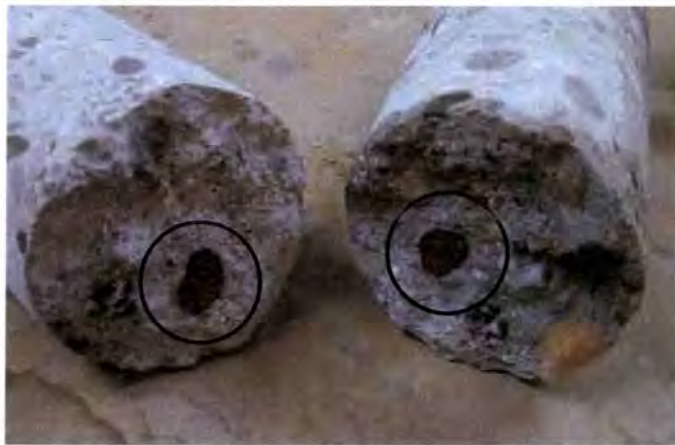
Photo 26: Core 5, Segments 1 and 2 - Cross section of break. Note that the aggregate fractured and that a ring appears around aggregate indicating potential ASR.

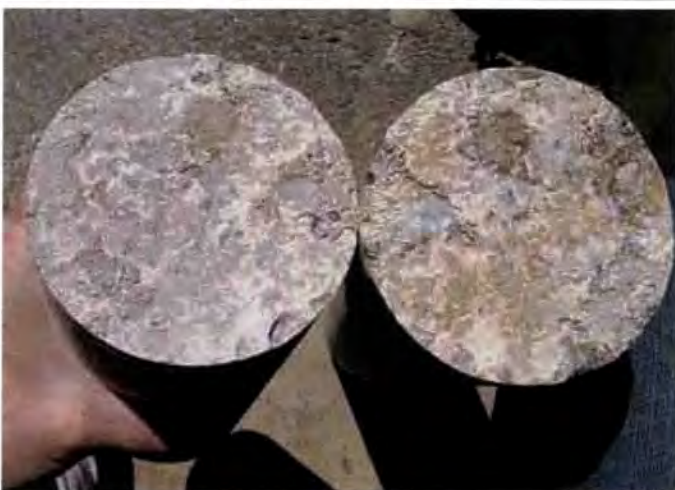
Photo 27: Core 5, Segments 6 and 7 - Cross section of joint shows evidence of efflorescence.

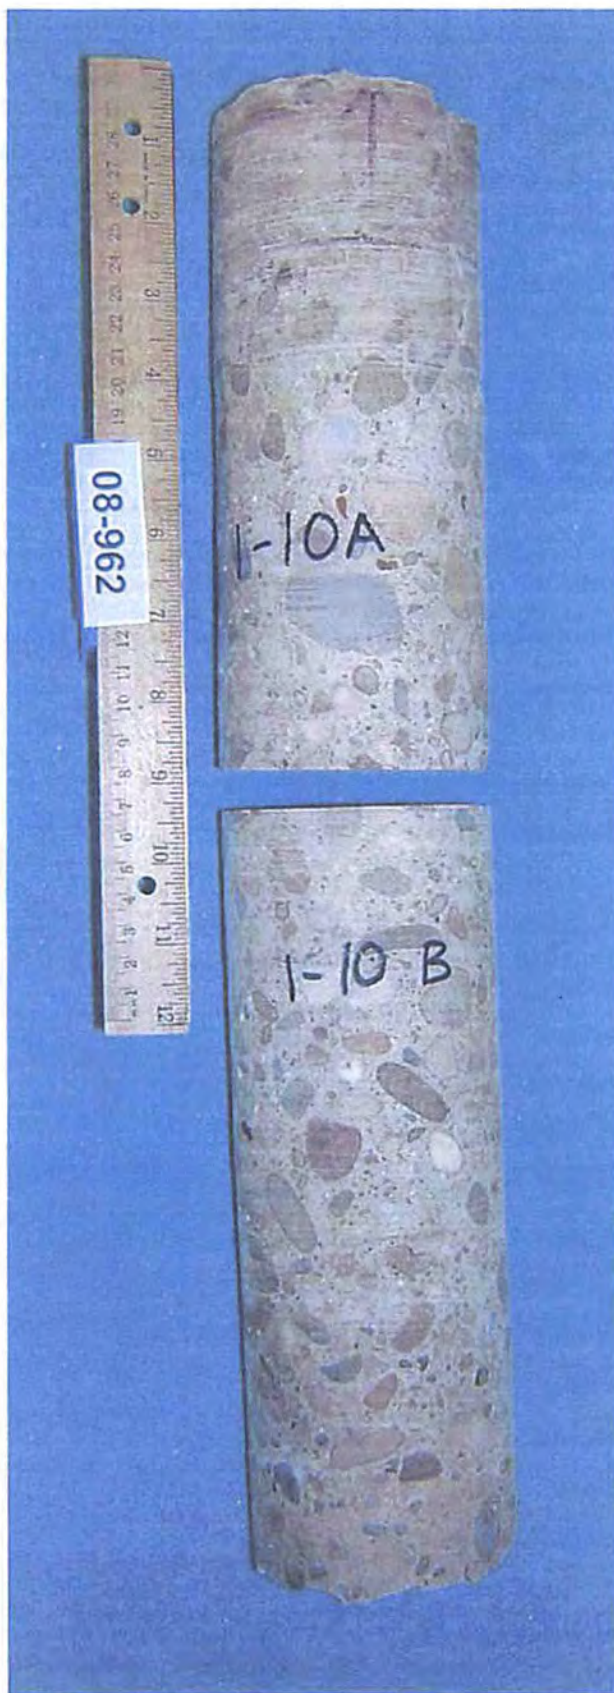
3. Freeze-thaw deterioration is present in Cores 1-10 and 5-1.

Photo 1. Side view of Core 1-10, received in two segments, identified as 1-10A and 1-10B, as received for testing.

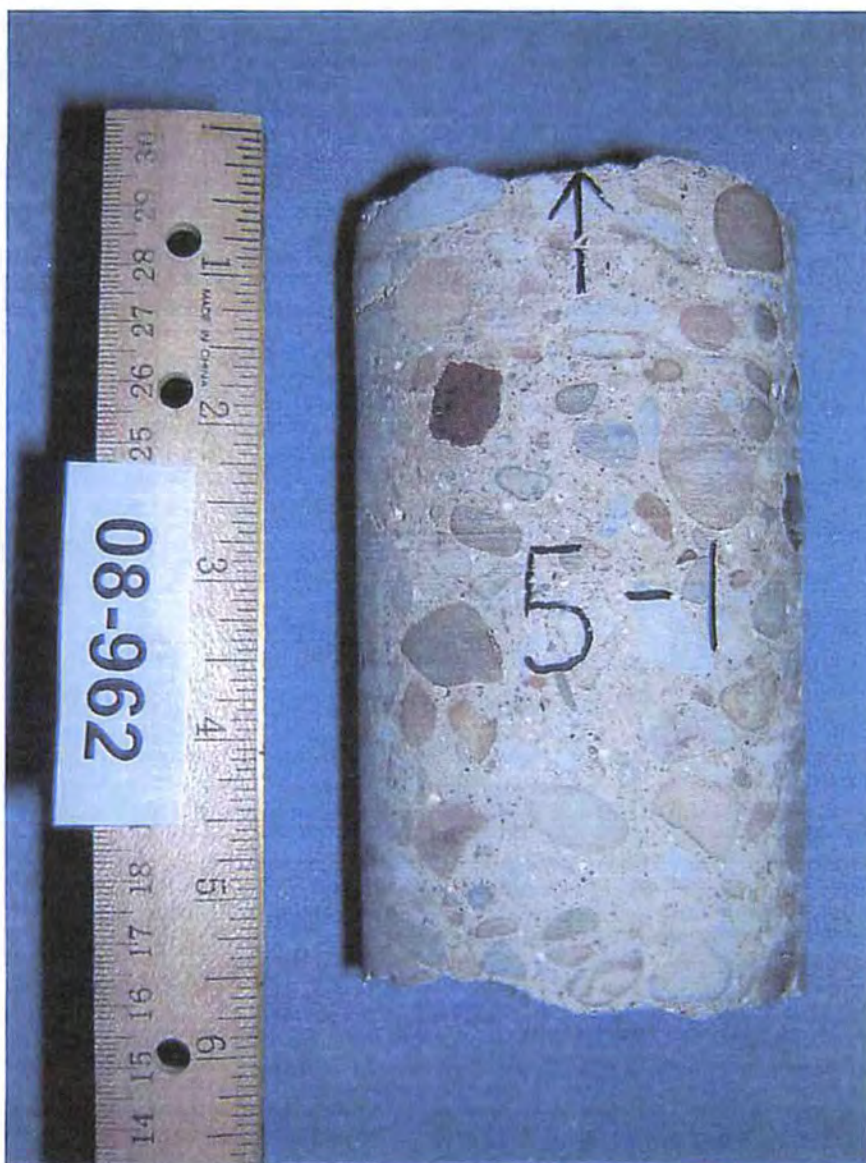
In Core 5-1, freeze-thaw deterioration is present in the top 5-3/4 inches of the core. Several cracks (up to 0.01-inch-wide) are present in the core's top 2-3/4 inches, parallel to the core top surface, commonly passing purposefully through aggregate particles. Several parallel microcracks are present in the core's top 5-3/4 inches, passing around and through aggregate particles.

In Core 5-1 the degree of alkali-silica reaction appears very small. The internally fractured chalcedony particles are present. However, none of the characteristic random microcracks were observed. Also, no deposits of alkali-silica gel were observed.

Photo 3. Side view of Core 5-1, as received for testing.

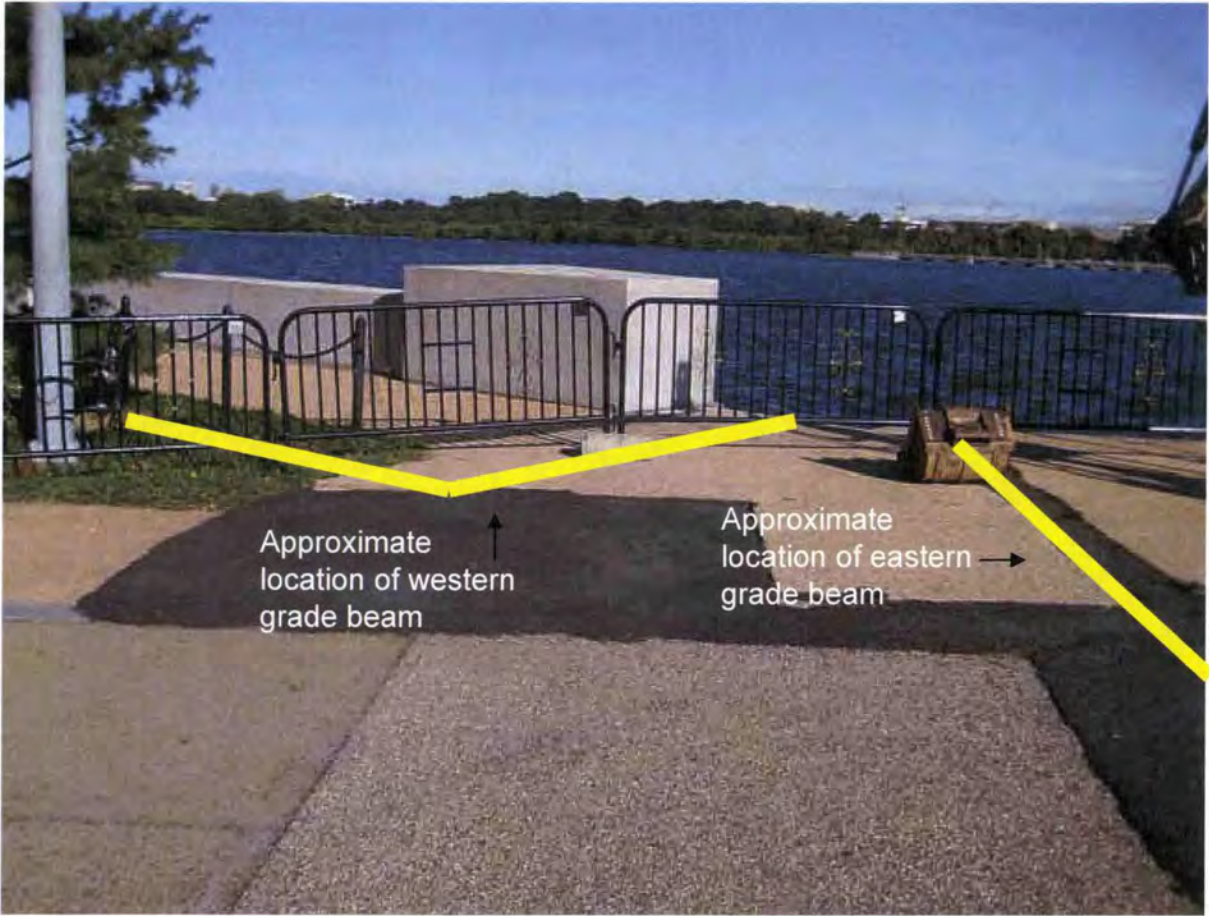
Test Pit #1 was excavated to a depth of about four feet exposing two approximately 3'-2" deep grade beams (See Photo 1 for the grade beam layout). The existing six inches of cold patch asphalt were removed exposing a concrete slab. The six-inch slab contained reinforcing bar on the west side running from the western slab towards the east, but terminating before the slab over the eastern grade beam. Reinforcing bar was also observed in the northeast corner running from the northern slab towards the south, but terminating before the granite pavers (See Photo 2). Soils encountered below the slab were brown silty sand with cobbles, green-gray clay with cobbles and brick fragments, and a six-inch layer of rounded cobbles as shown in Photo 4.

PHOTO 1 – Approximate locations of grade beams

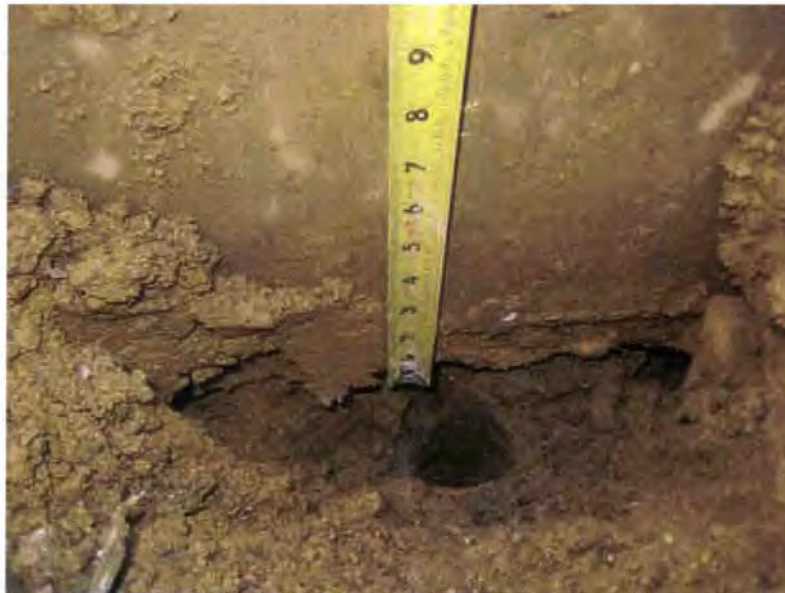
A two to three inch void and loose soils were observed below the grade beam adjacent to the north plaza (See Photos 3 and 5). Ground-Works personnel were able to easily push the handle of a shovel about 14 inches into the loose, moist soil below the grade beam. The concrete plaza slab above the grade beam was about 13-inches thick. The grade beam stuck out 5.5 inches beyond the slab joint as shown in Photos 6 and 7. No bond breaker was observed between the slab and the beam.

PHOTO 3 – Void below eastern grade beam

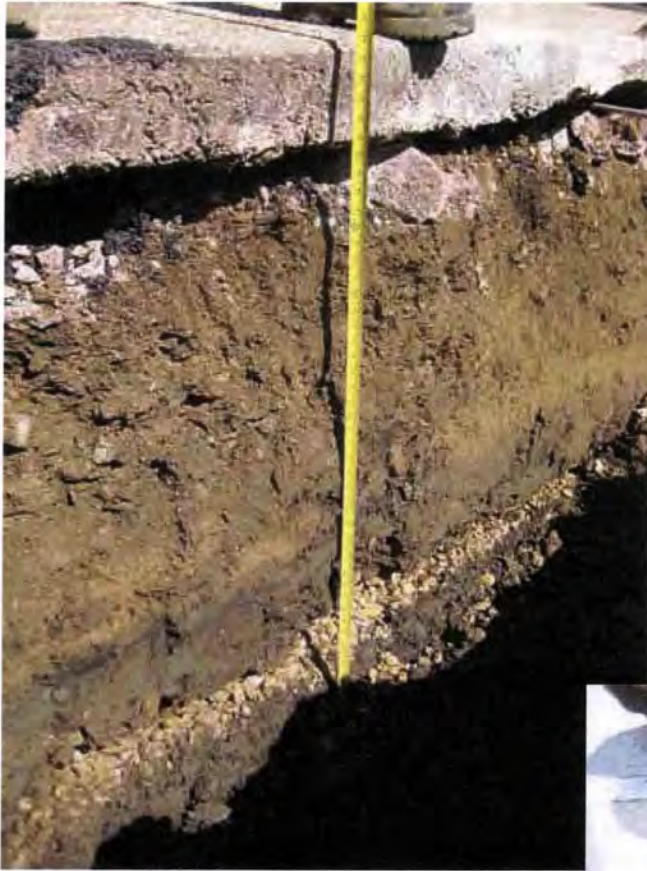
PHOTO 4 – Subgrade material.
Note the 6" layer of rounded
cobble

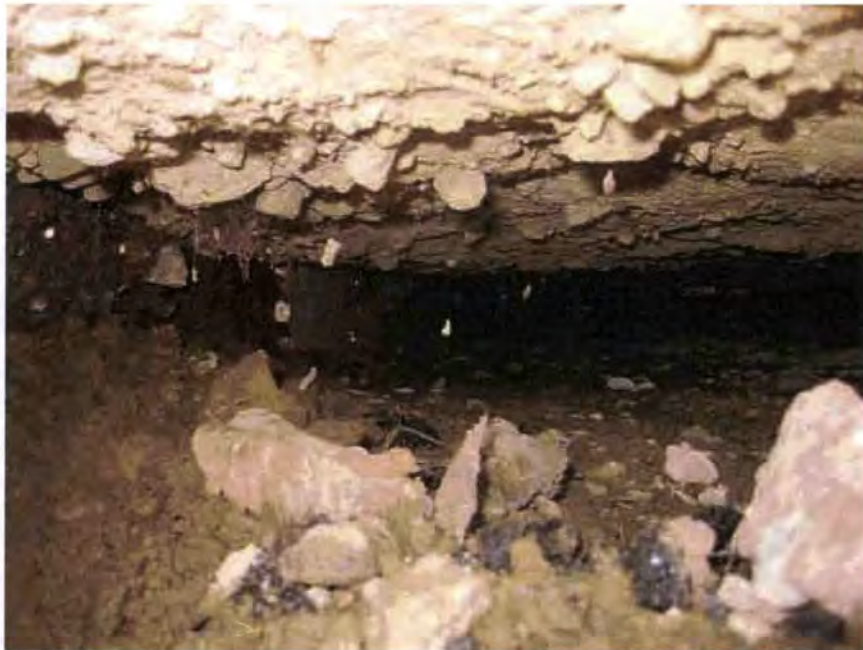
The slab to the north of the excavation had a three to five-inch void observed below it. Daylight was observed through the void from the opening at the seawall (See Photos 8 and 9). The western grade beam ran south from the seawall to the corner of the slab and then ran west along the sidewalk (See Photos 10, 11, and 12).

PHOTO 9 – 3 to 5" void below northern slab

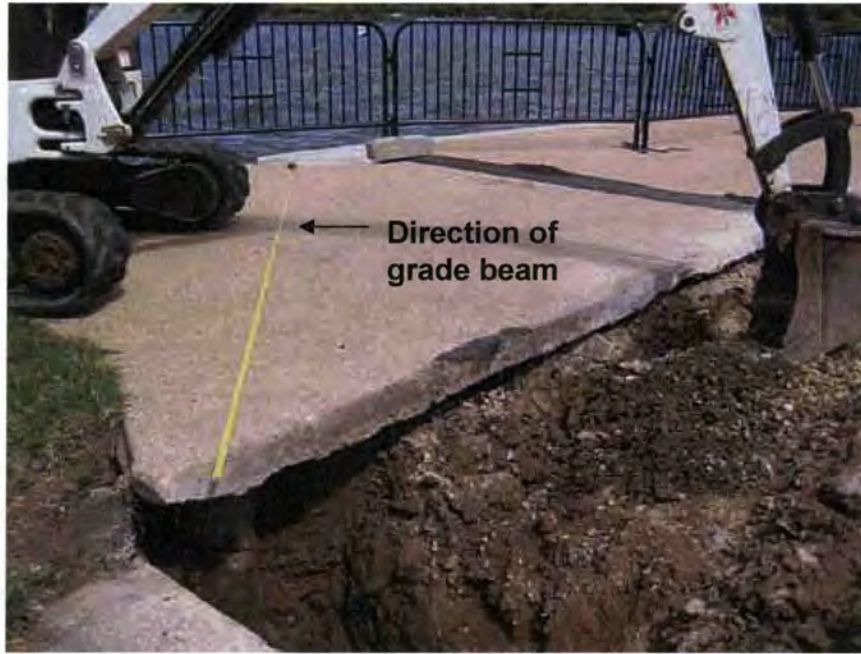
PHOTO 10 – Location of western grade beam

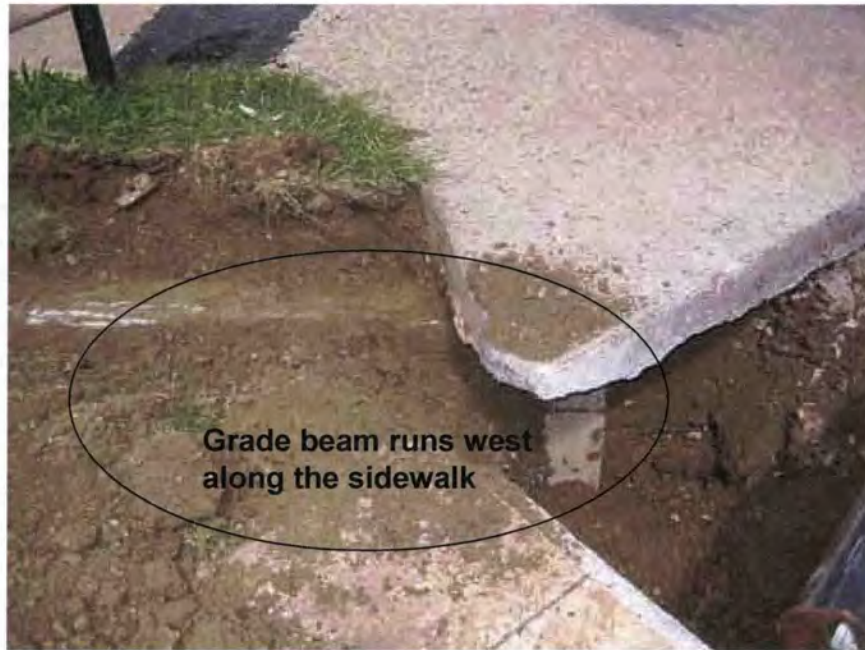
PHOTO 11 – Location of western grade beam

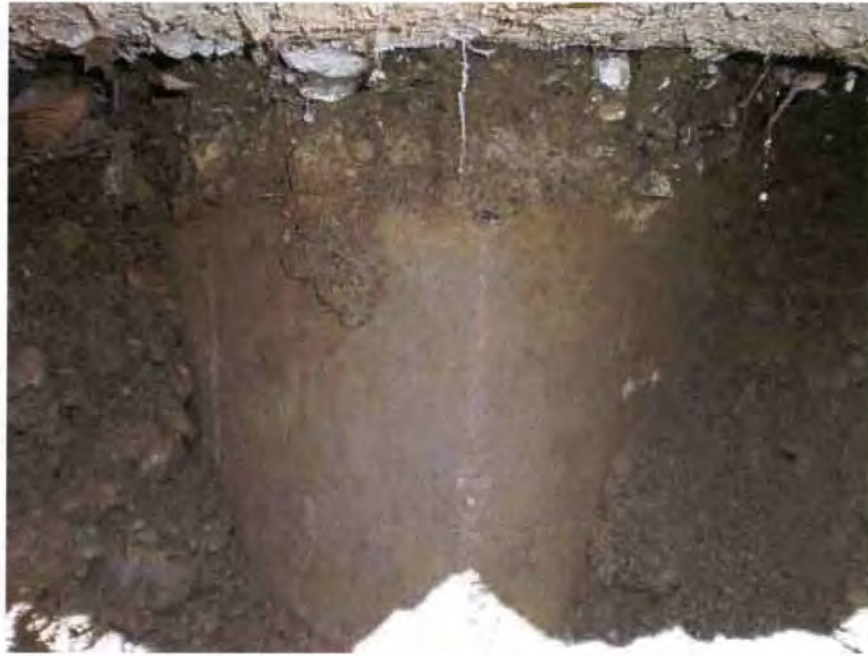
PHOTO 12 – Corner of western grade beam

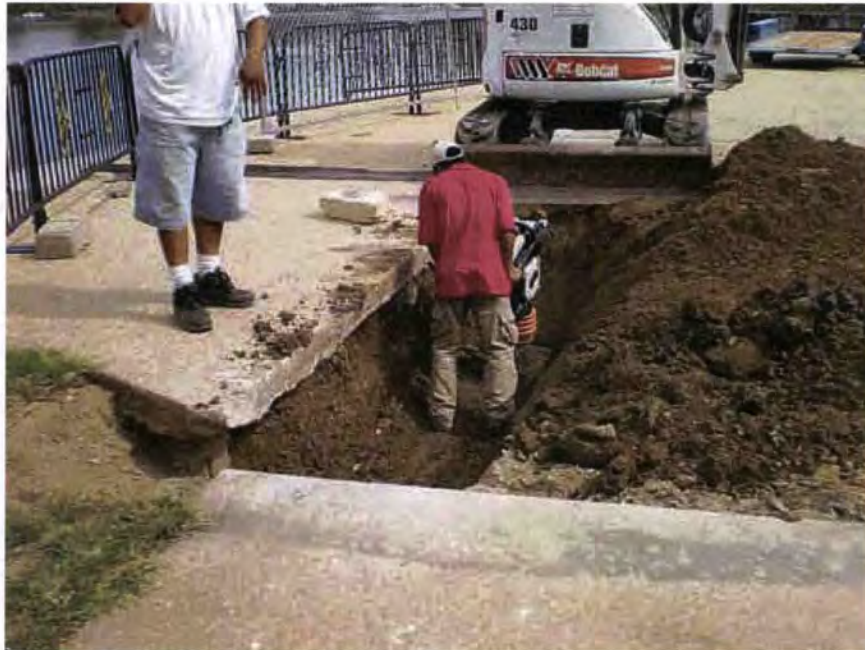
PHOTO 13 – Backfilling and compaction

As shown in Photos 13, 14, and 15, Ground-Works backfilled the excavated area with the excavated material in four lifts, and used a jumping jack to compact the material after each lift. Approximately four inches of #57 stone were then placed and compacted with a vibrating plate compactor. Finally, asphalt was placed on top and compacted with a vibrating plate compactor.

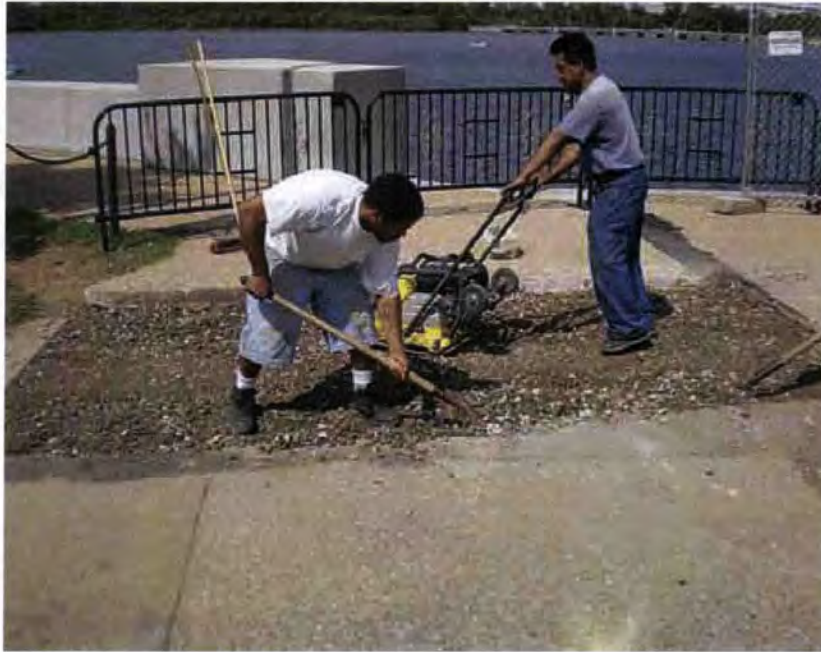
PHOTO 14 – Backfilling and compaction of #57 stone

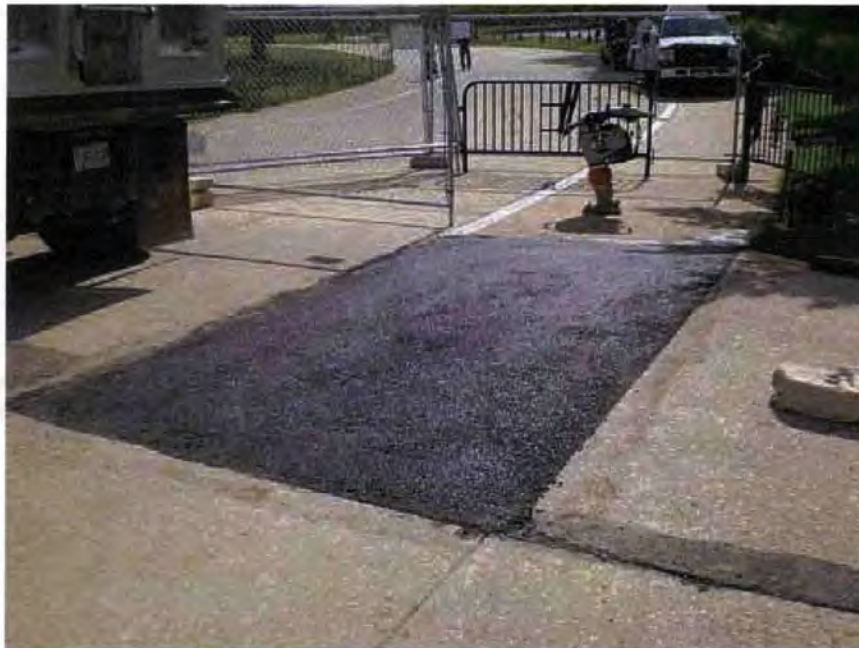
PHOTO 15 – Final asphalt layer

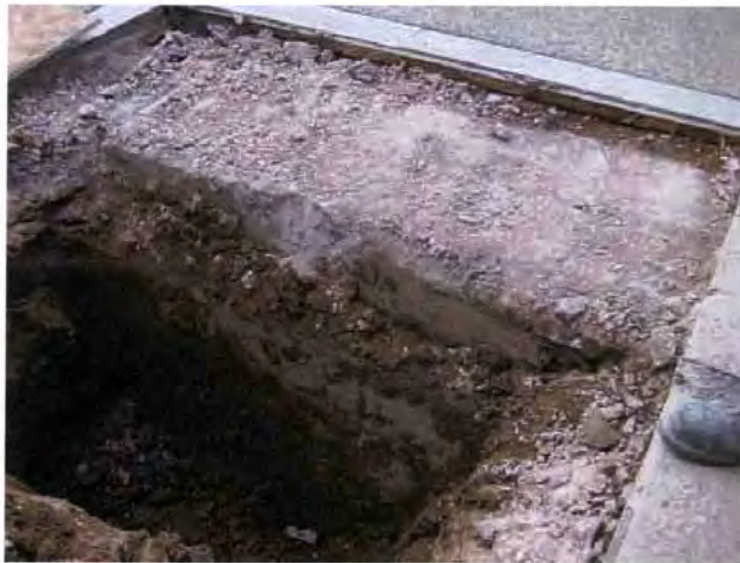
Test Pit #2 was excavated to a depth of about four feet exposing an approximate 3'-2" grade beam as shown in Photo 16. The six-inch concrete slab was removed. The slab contained reinforcing bar running from the northern slab towards the south, but terminating before the granite pavers and running from the eastern slab towards the west, also terminating before the granite pavers (See Photo 17). Soils encountered were brown silty sand with cobbles and green-gray clay with cobbles and brick fragments. The concrete slab above the grade beam was about eight-inches thick, and the beam stuck out about six inches beyond the slab joint as shown in Photos 18 and 19. No bond breaker between the slab and the beam was observed.

PHOTO 16 – Test Pit #2 grade beam

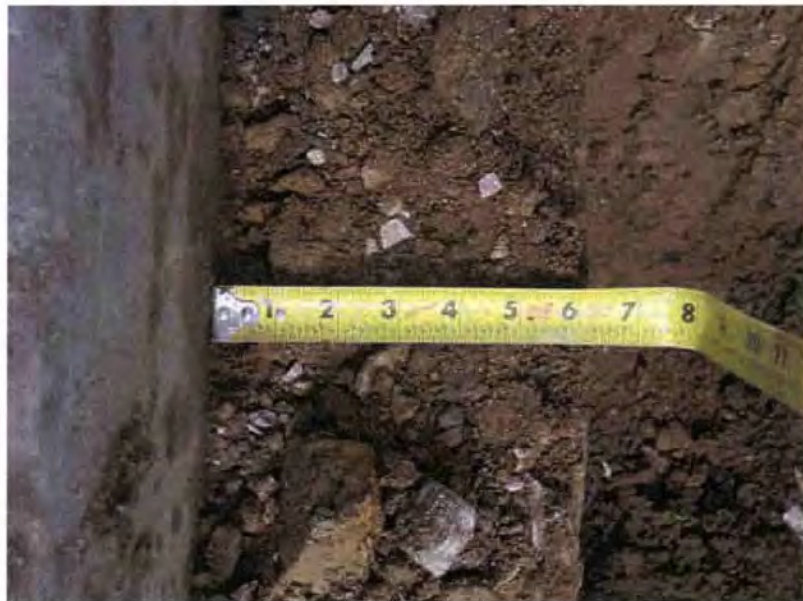
PHOTO 19 – Grade
beam beyond slab joint

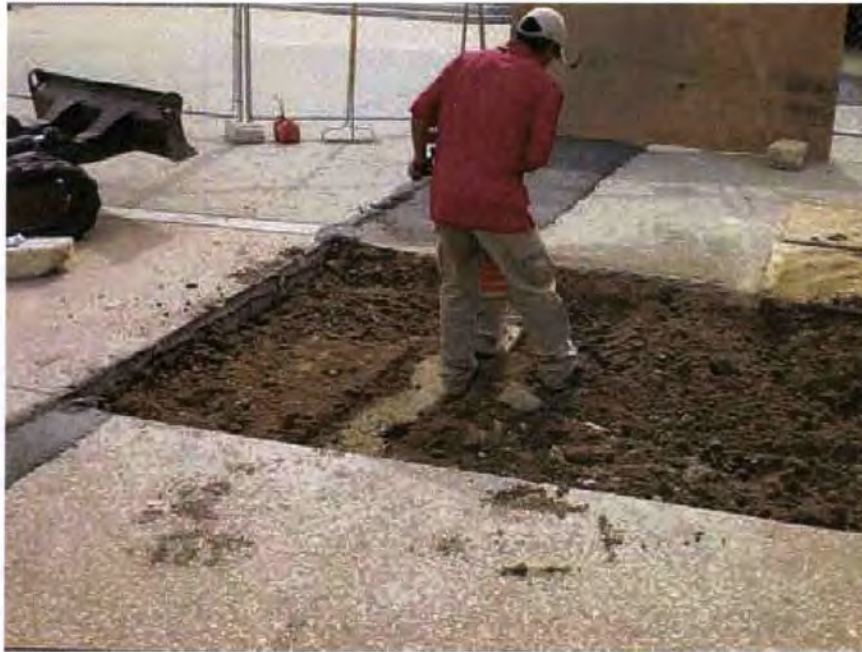
PHOTO 20 – Backfilling and compaction

The contractor then backfilled the area with the excavated material in four lifts and used a jumping jack to compact the material after each lift. Approximately four inches of #57 stone were then placed and compacted with a vibrating plate compactor. Finally, asphalt was placed on top and compacted with a vibrating plate compactor, as shown in Photos 20, 21, and 22.

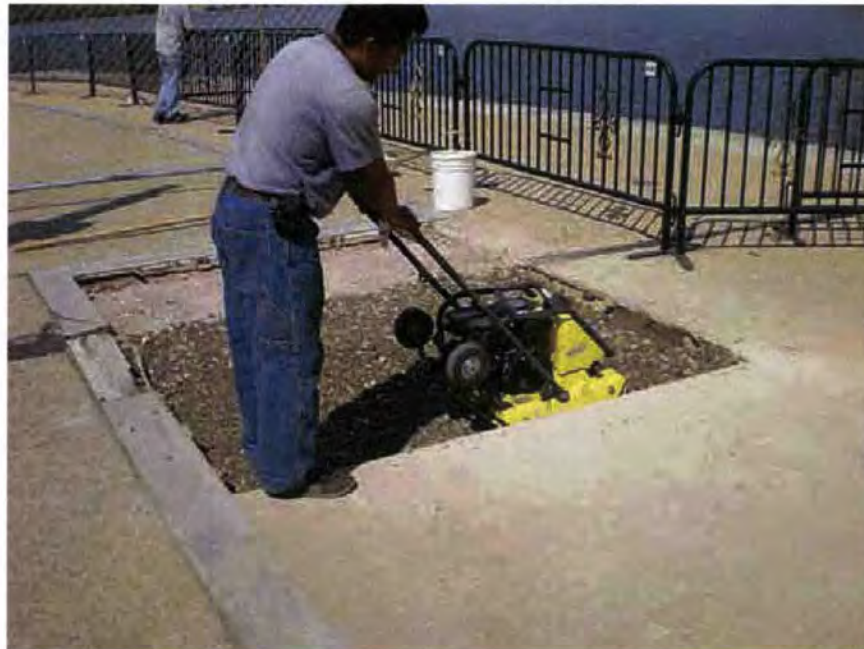
PHOTO 21 – Backfilling and compaction of #57 stone

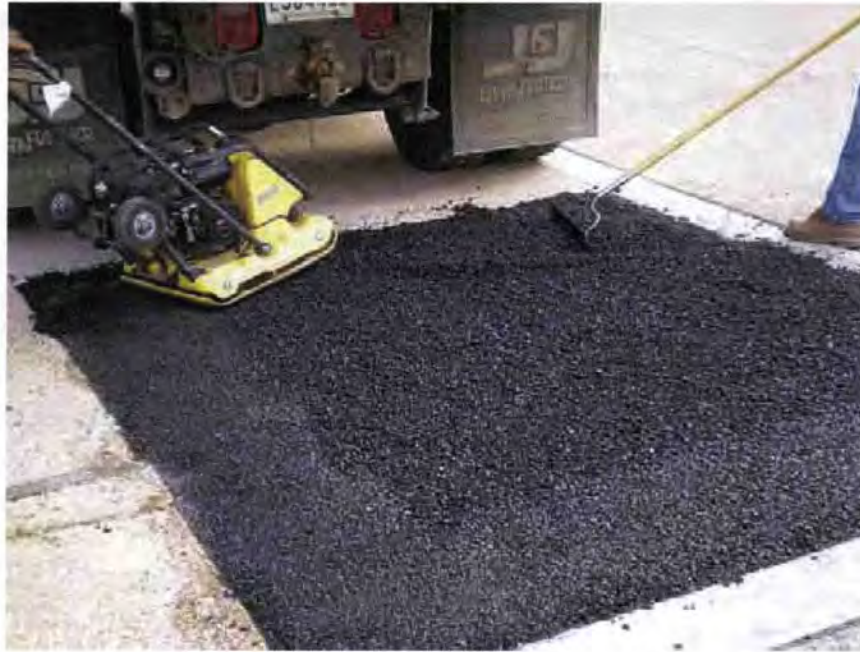
PHOTO 22 – Final asphalt layer

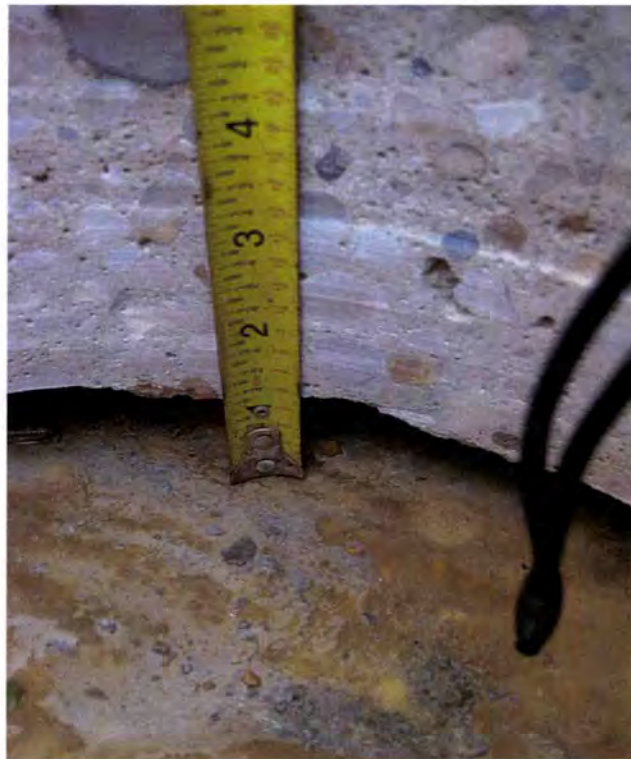
Schnabel personnel cored the concrete slab of the North Plaza in order to advance Boring JMI-05; the core was about 18-inches thick. During observation of the core hole, a void of about one inch was observed beneath the bottom of the North Plaza slab. The void is documented in Boring JMI-05, located in Appendix A.

PHOTO 2: One-inch gap below plaza slab
