## Appendix A

# EXAMPLES OF PERIMETER PANEL FLOOR TRUSS CONNECTORS

The floor trusses were attached to the perimeter panels at the interior intersection of the columns and spandrels by different types of connectors. The following appendix displays photographic examples, taken by National Institute of Standards and Technology (NIST), of these types of connectors as observed on the recovered panels.

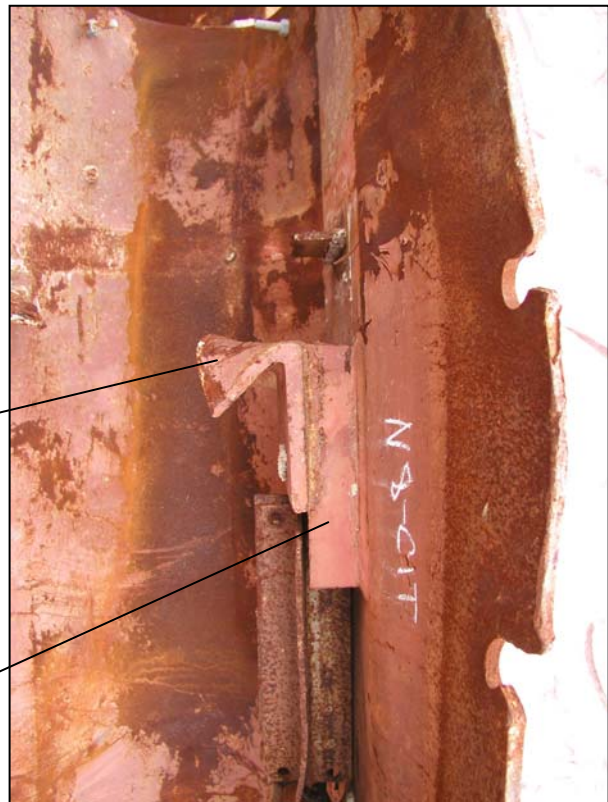
Figure A1a: Type A floor truss connector

**Connection N8-CIT**

Portion of welded gusset plate with backing bar

Seat with 2 intact bolt holes for truss attachment

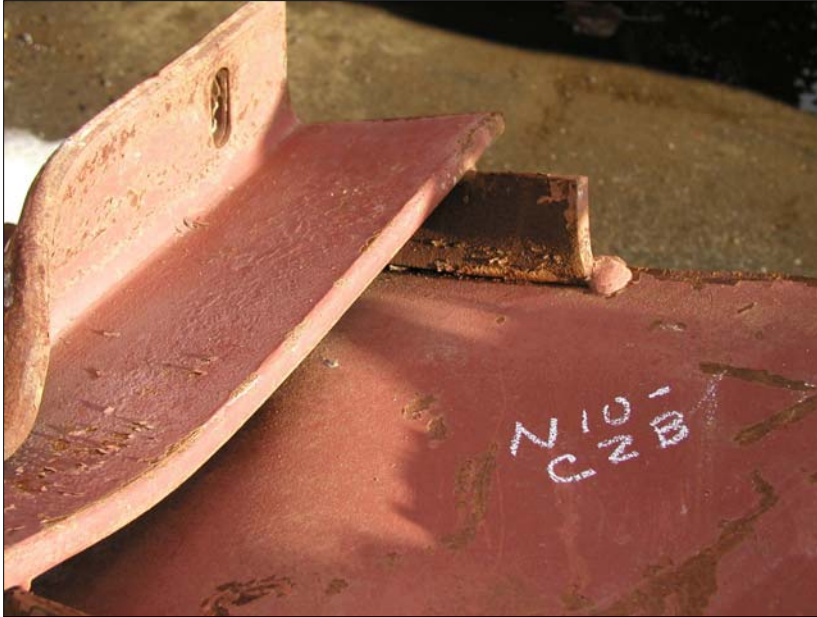
Figure A1c: Type A floor truss connector

**Connection N10-C2B**

Standoff plate welded on only one side

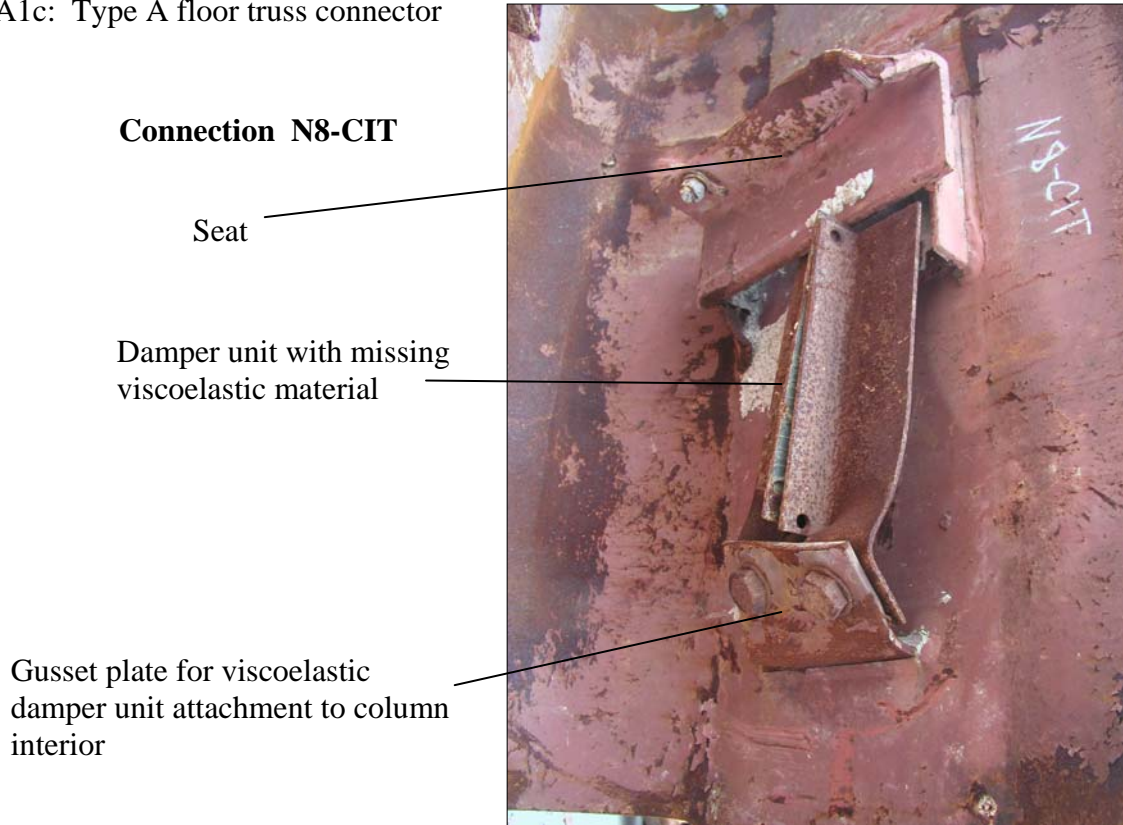
Figure A1d: Type A floor truss connector

**Connection N8-CIT**

Damper unit with missing viscoelastic material

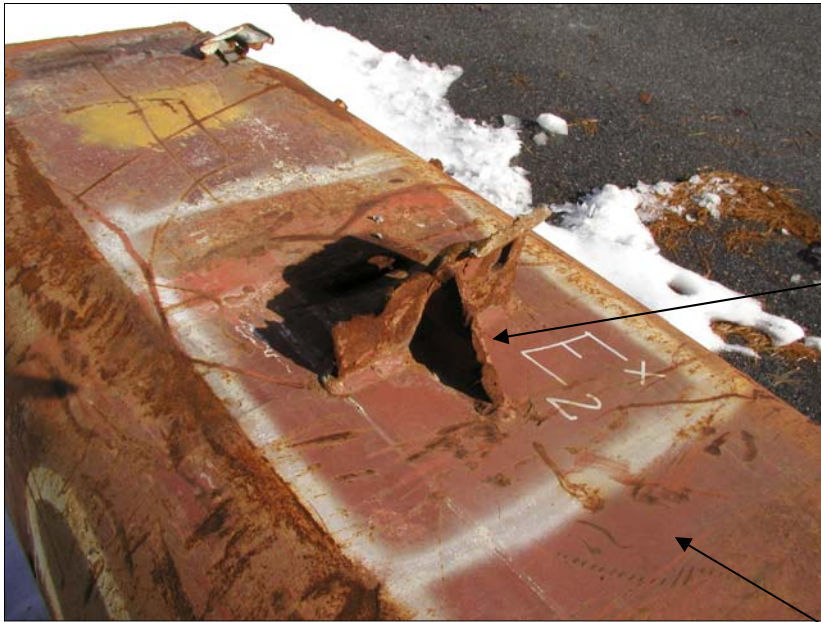
Figure A2a: Type B floor truss connector

Connection C10-CIT

No gusset plate for damper unit

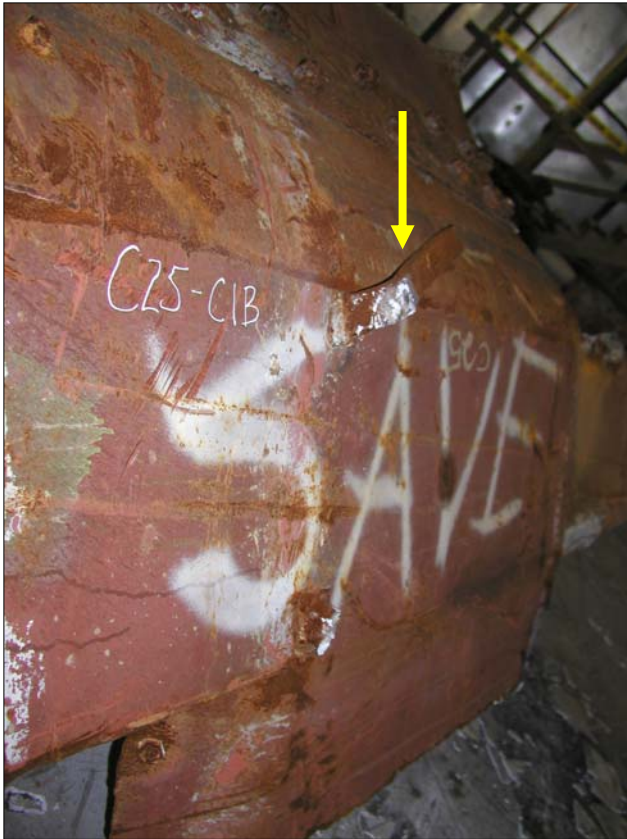
Figure A4a: Type D floor truss connector

**Connection C25-C1B**  
Portion of diagonal bracing straps remain attached to spandrel; welded directly to the spandrel.

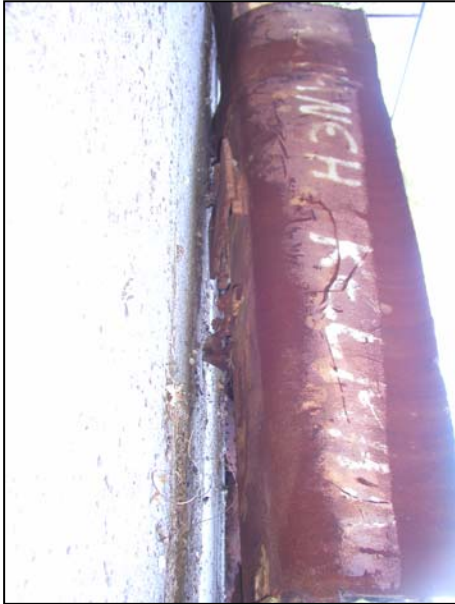
**ASCE2-C3T (WTC 2, Col.329, Fl 43)**

Gusset plate ripped completely out of spandrel;  
Small seat intact, bent downwards, 1 bolt hole  
intact, other ripped out;  
No evidence of gusset plate for damper unit.

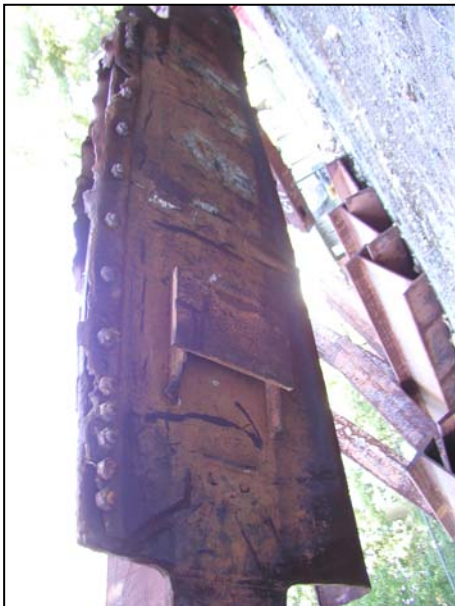
**ASCE2-C3B (WTC 2, Col.329, Fl 41)**

Portion of gusset plate remains;  
Small seat intact, bent downwards, 1 bolt hole  
intact;  
No evidence of gusset plate for damper unit.

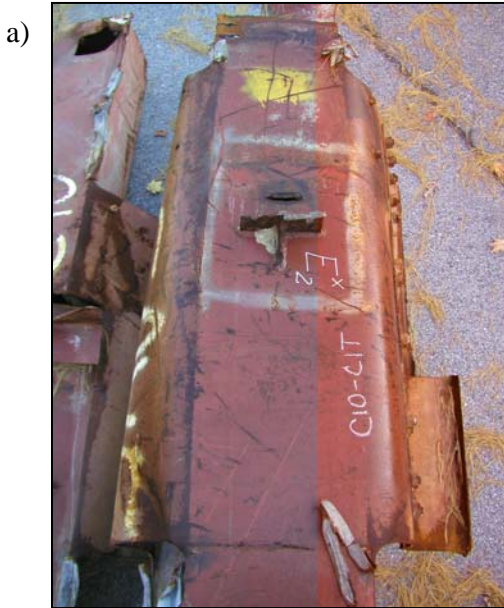
**C10-C1T (WTC 1, Col.452, Fl 88)**

Gusset plate ripped completely out of spandrel;  
Small seat intact, corners bent downwards, 1 bolt  
hole intact other ripped out;  
No evidence of gusset plate for damper unit.

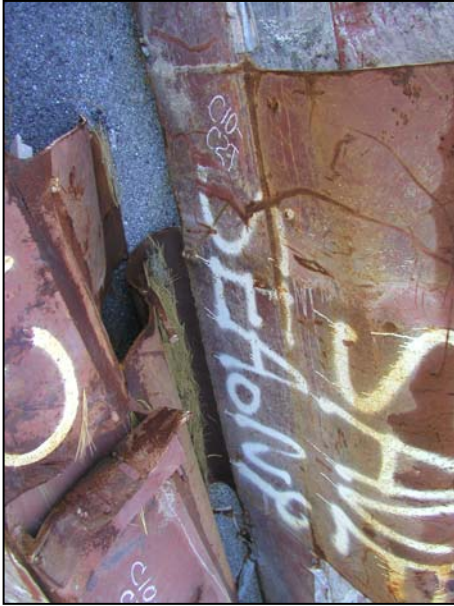
**C10-C2T (WTC 1, Col.451, Fl 88)**

2 1-inch portions of diagonal bracing straps remain.

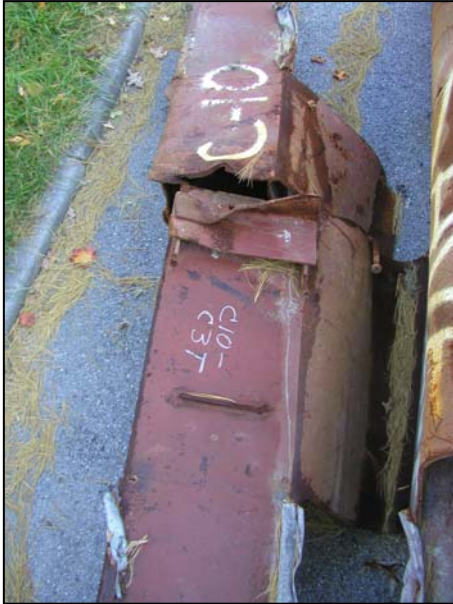
**C10-C3T (WTC 1, Col.450, Fl 88)**

Gusset plate ripped completely out of spandrel, large tear due to internal strengthening plate in the area; Seat intact, bent downwards, both bolt holes intact; Gusset plate for damper unit ripped off at weld.

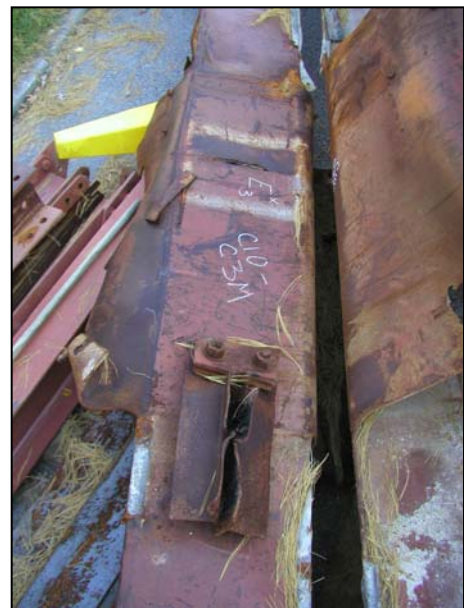
**C10-C3M (WTC 1, Col.450, Fl 87)**

Gusset plate with damper unit intact, bent downwards.

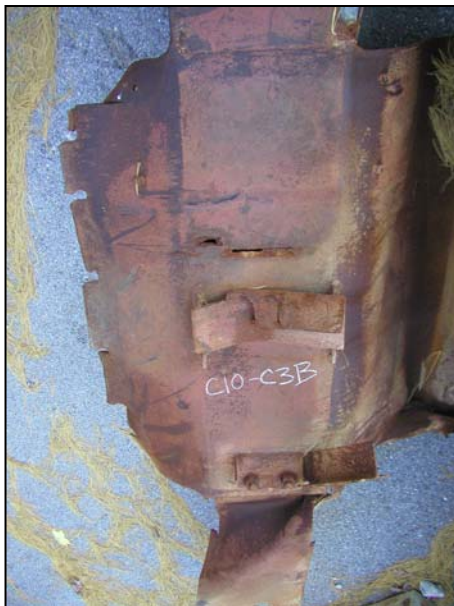
**C10-C3B (WTC 1, Col.450, Fl 86)**

Gusset plate ripped completely out of spandrel; Seat intact, bent towards column and downwards, 1 bolt hole intact, other ripped through; Gusset plate with damper unit intact, bent downwards.

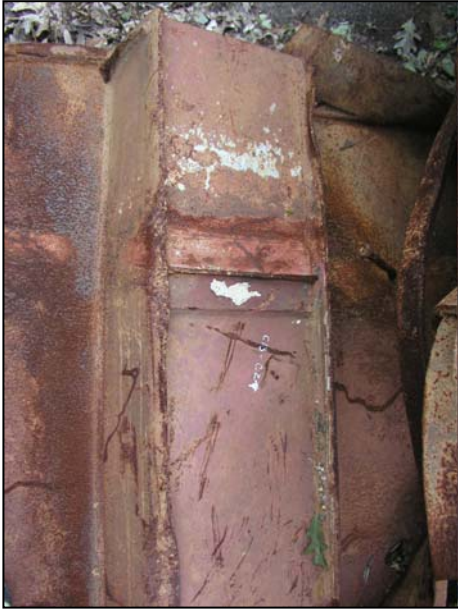
**C13-C2T (WTC 2, Col.200, Fl 92)**

Gusset plate ripped off at weld.

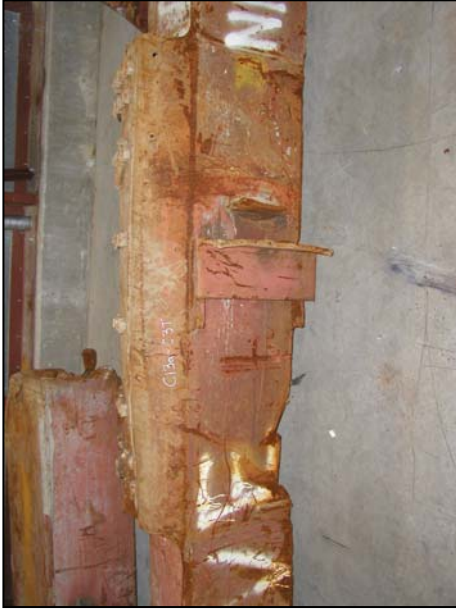
**C13a-C3T (WTC 2, Col.159, Fl 92)**

Gusset plate remains;  
Seat intact with both bolt holes intact;  
Gusset plate for damper unit ripped off at weld.

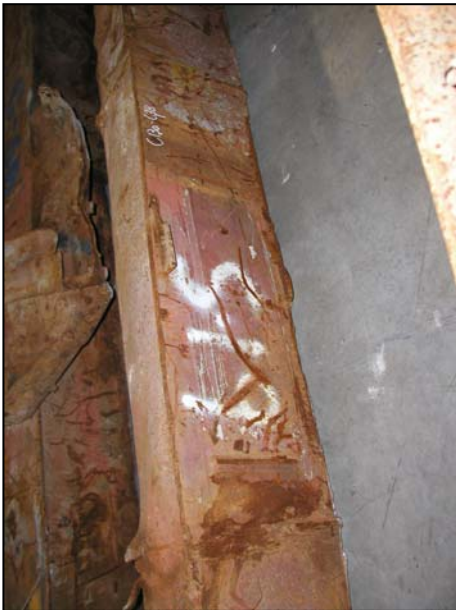
**C13a-C3B (WTC 2, Col.159, Fl 91)**

Gusset plate ripped completely out of spandrel;  
Both standoff plates remain, rest ripped off at welds;  
Gusset plate for damper unit ripped off at weld.

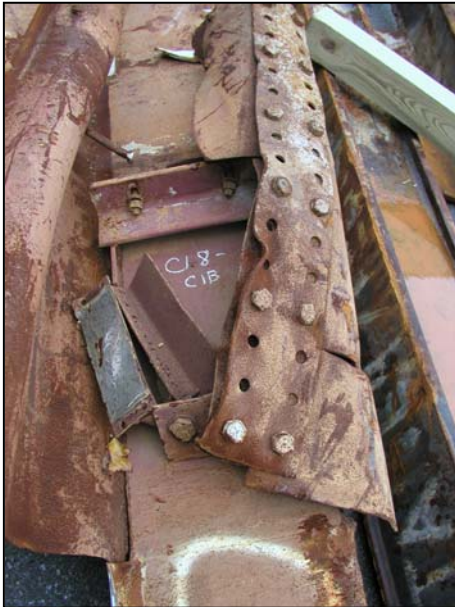
c)

**C18-C1B (WTC 2, Col.231, Fl 94)**  
Type A  
Seat Detail: 1111

Gusset plate intact;  
Seat intact, both bolt holes intact with bolts and nuts; Gusset plate with damper unit intact, bent upwards.

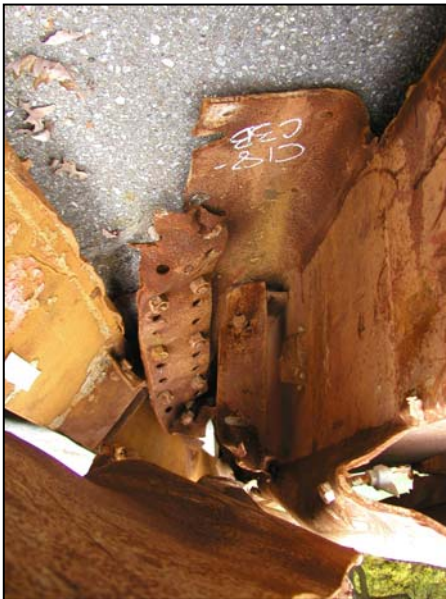
i)

**C18-C3B (WTC 2, Col.229, Fl 94)**  
Type A  
Seat Detail: 1111

Gusset plate intact;  
Seat intact, both bolt holes intact with 1 bolt and nut,  
some damage to corners;  
Gusset plate with damper unit intact, bent downwards.

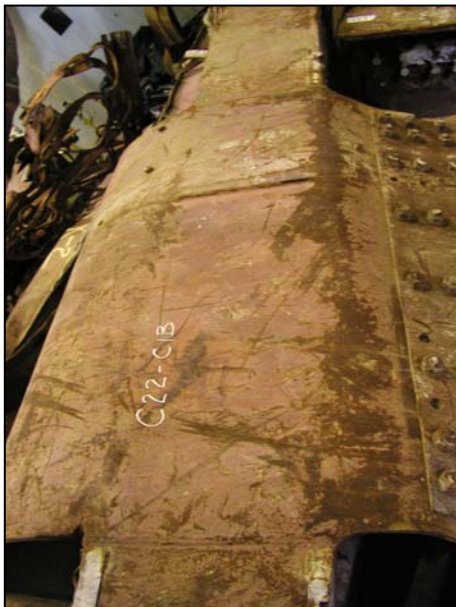
c)

**C22-C1B (WTC 1, Col.158, Fl 94)**  
Type C  
Seat Detail: 5210

Large gusset plate ripped off at weld.

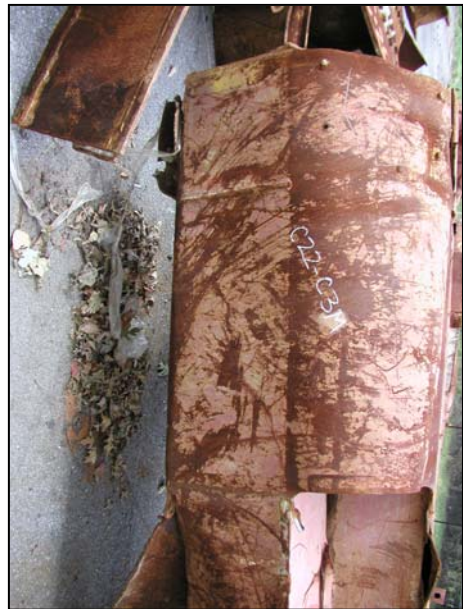
h)

**C22-C3M (WTC 1, Col.156, Fl 95)**  
Type C  
Seat Detail: 5110

Large gusset plate ripped off at weld.

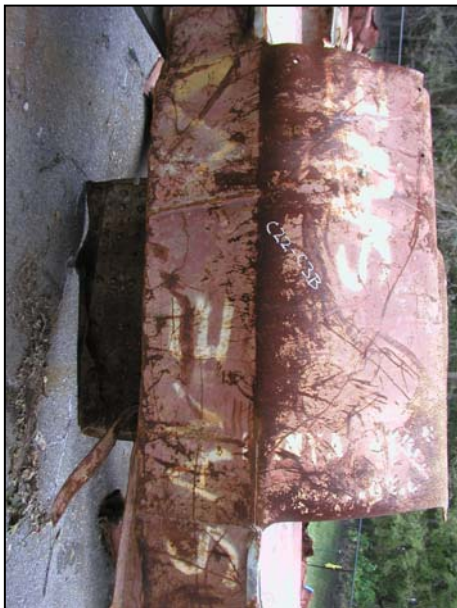
i)

**C22-C3B (WTC 1, Col.156, Fl 94)**  
Type C  
Seat Detail: 5110

Large gusset plate ripped off at weld.

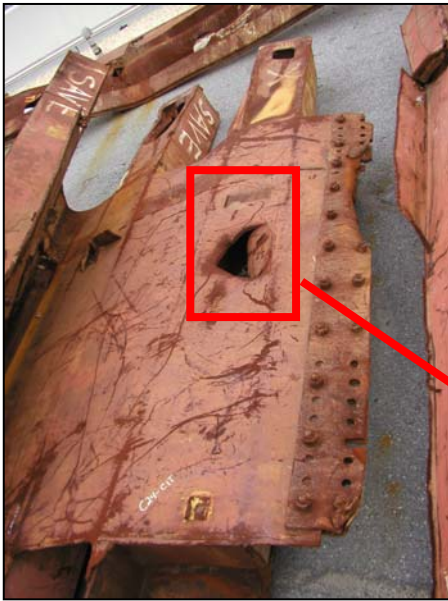
a)

**C24-C1T (WTC 2, Col. 204, F1 77)**

No evidence of gusset plate;  
Seat that was welded directly to column (no shear plates) ripped off at welds;  
No evidence of gusset plate for damper unit.

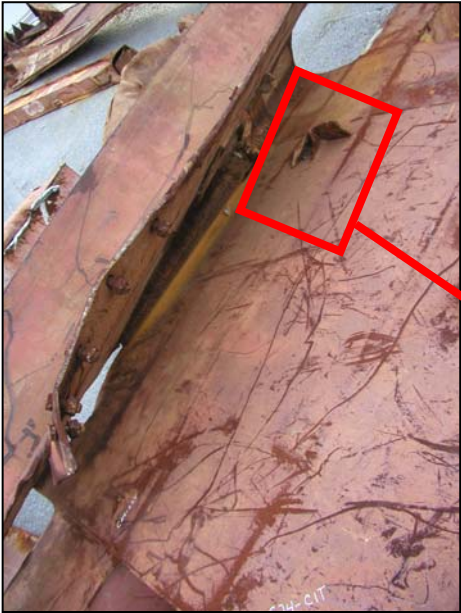
d)

**C24-C2T (WTC 2, Col.203, Fl 77)**

Gusset plate with vertical support, torn and bent down wards.

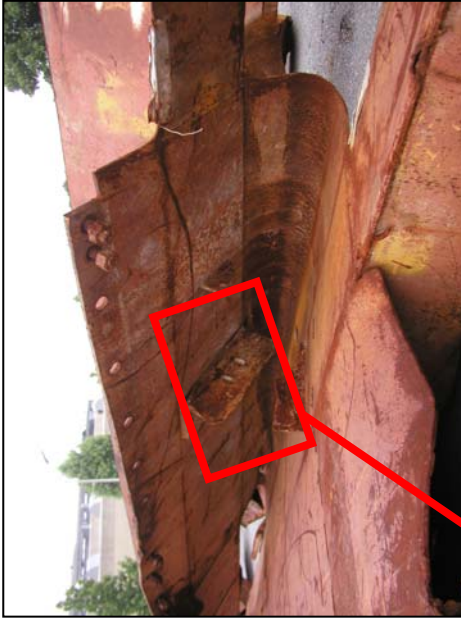
g)

**C24-C3T (WTC 2, Col.202, Fl 77)**

Gusset plate for dampers ripped off at welds.

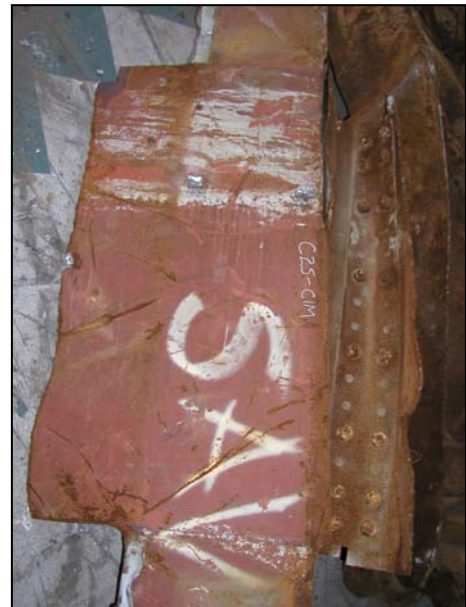
b)

**C25-C1M (WTC 1, Col.207, Fl 91)**

1-in portion of diagonal bracing strap remains, other is ripped off at weld.

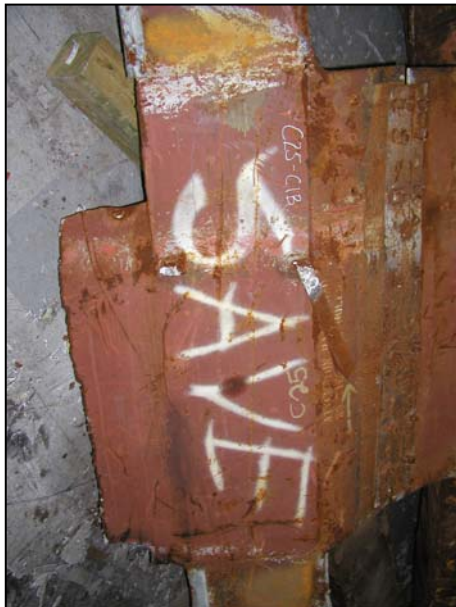
c)

**C25-C1B (WTC 1, Col.207, Fl 90)**

1-ft and 1-in portions of diagonal bracing straps remain.

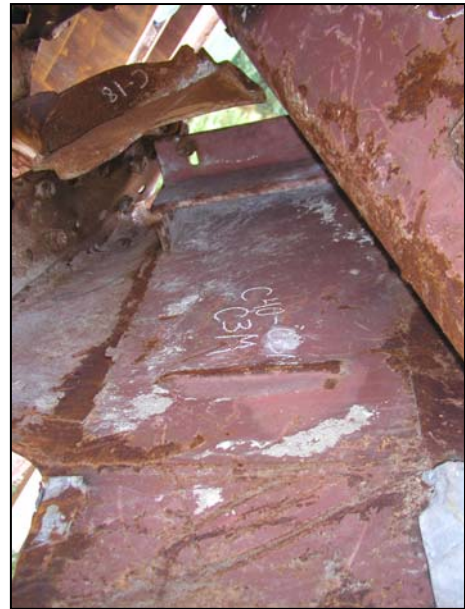
h)

**C40-C3M (WTC 1, Col.135, Fl 100)**  
Type A  
Seat Detail: 1411

Portion of gusset plate intact;  
Seat intact, both bolt holes intact with bolts and nuts remaining;  
Gusset for damper unit ripped off at weld.

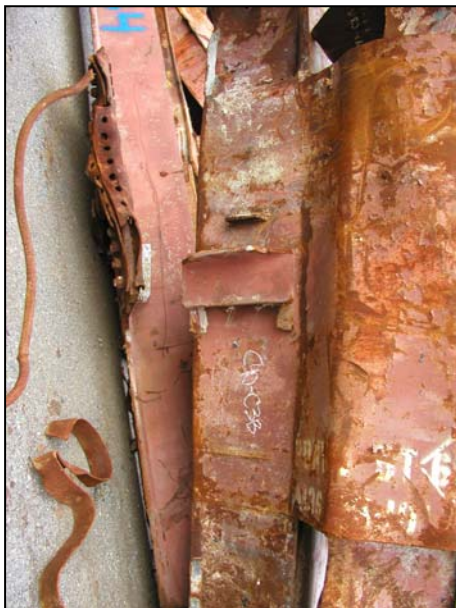
**C40-C3B (WTC 1, Col.135, Fl 99)**  
Type A  
Seat Detail: 1411

Portion of gusset plate intact;  
Seat intact, both bolt holes ripped out;  
Gusset for damper unit ripped out at weld.

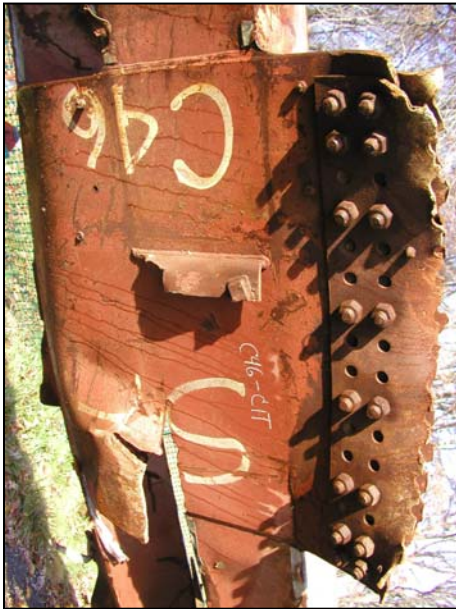
**C46-C1T (WTC 2, Col.158, Fl 71)**

Gusset plate remains, bent downward.

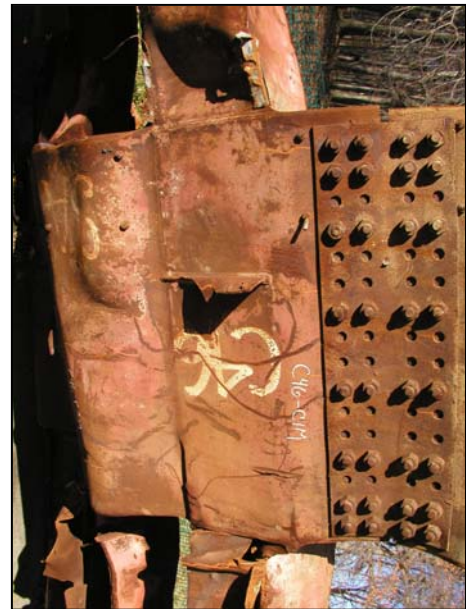
**C46-C1M (WTC 2, Col.158, Fl 70)**

Portion of gusset plate remains, bent downward.

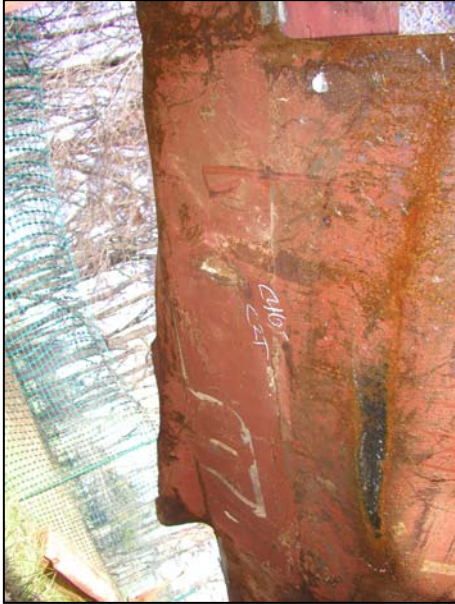
**C46-C2T (WTC 2, Col.157, Fl 71)**

Gusset plate intact;  
Only portions of standoff plates remain;  
Gusset plate for damper unit ripped off at weld.

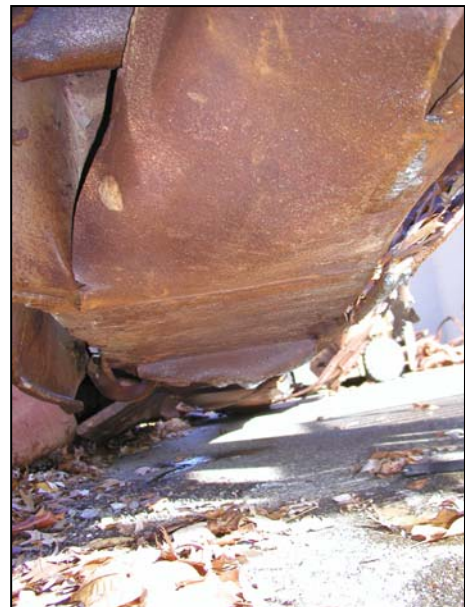
**C46-C3M (WTC 2, Col.156, Fl 70)**  
Type C  
Seat Detail: 5210

Large gusset plate intact, bent downwards, 2 long diagonal bracing straps remain as well.

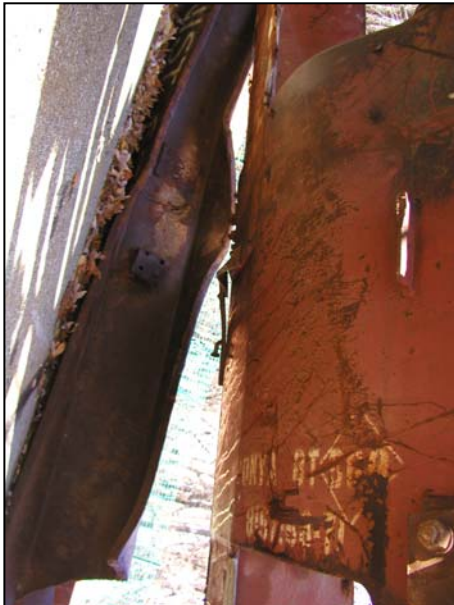
**C46-C3B (WTC 2, Col.156, Fl 69)**  
Type C  
Seat Detail: 5210

Large gusset plate intact, bent downwards, 2 long diagonal bracing straps remain as well.

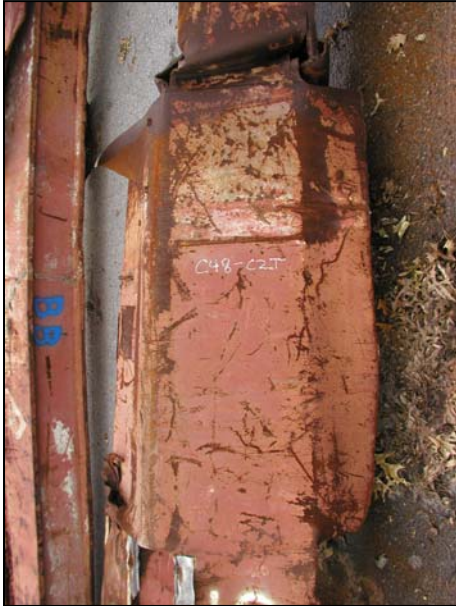
**C48-C2T (WTC 2, Col.442, Fl 94)**

Large gusset plate ripped off at weld.

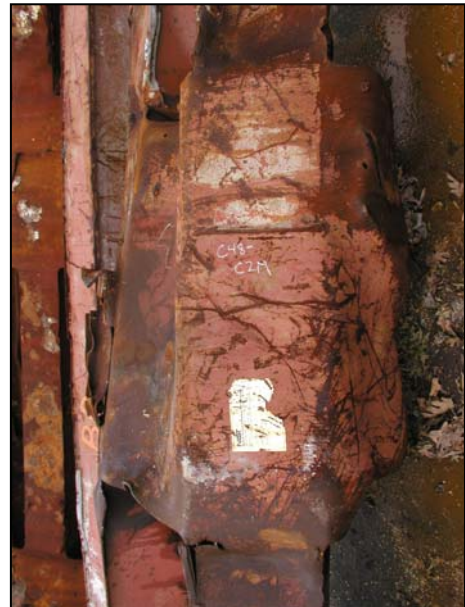
**C48-C2M (WTC 2, Col.442, Fl 93)**

Large gusset plate ripped off at weld.

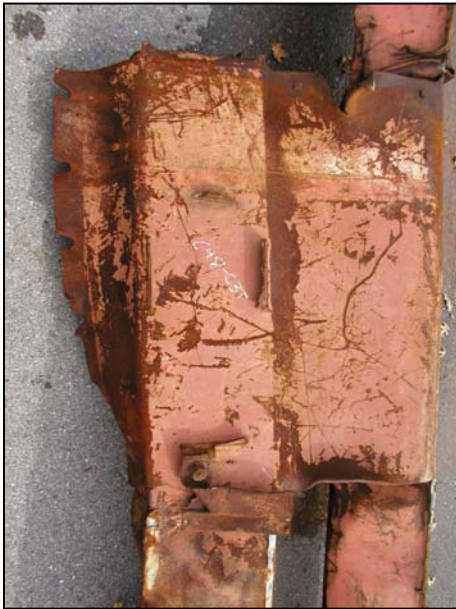
**C48-C3T (WTC 2, Col.441, Fl 94)**

Gusset plate intact;  
1 standoff plate remains, rest ripped off at welds;  
Portion of gusset plate with damper unit intact, bent downwards.

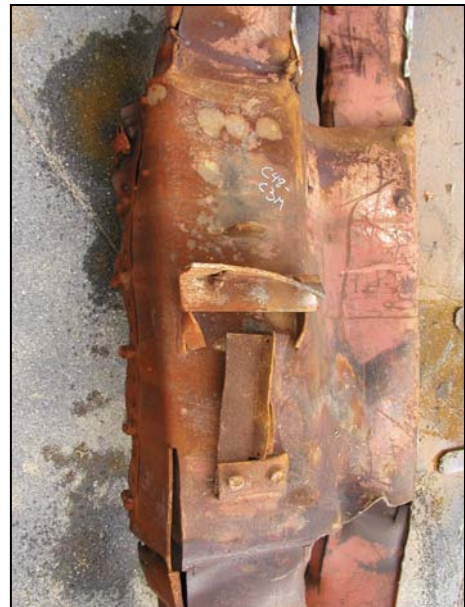
**C48-C3M (WTC 2, Col.441, Fl 93)**

Gusset plate intact;  
Seat intact, bent downwards, both bolt holes intact,  
1 with bolt and nut;  
Gusset plate and damper unit intact, bent upwards.

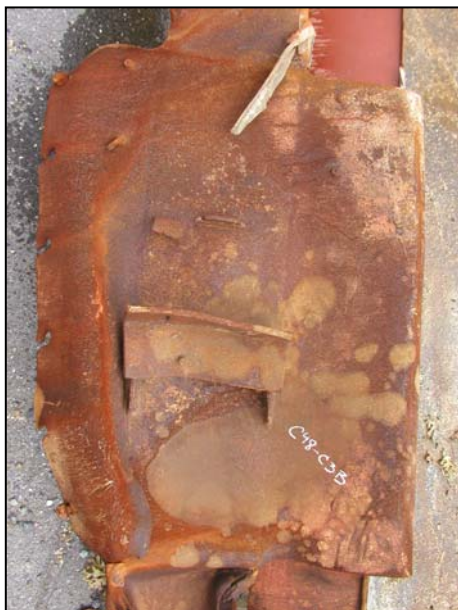
**C48-C3B (WTC 2, Col.441, Fl 92)**

Gusset plate intact;  
Seat intact, bent in towards column, both bolt holes  
intact;  
No evidence of gusset plate for damper unit.

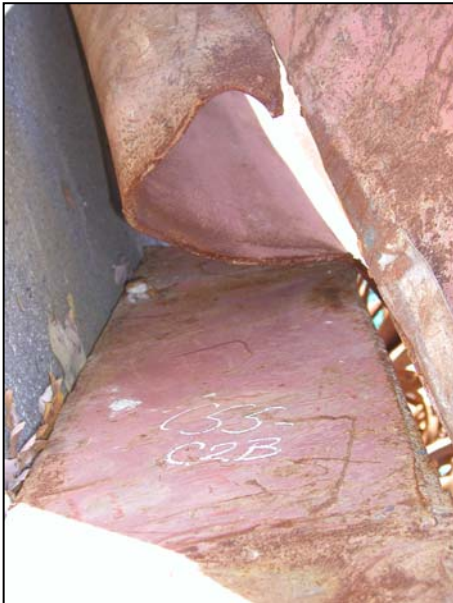
**C55-C2B (WTC 1, Col.209, Fl 95)**  
Type D  
Seat Detail: 5210

One diagonal bracing strap ripped off at weld, other  
Has about 1 in left.

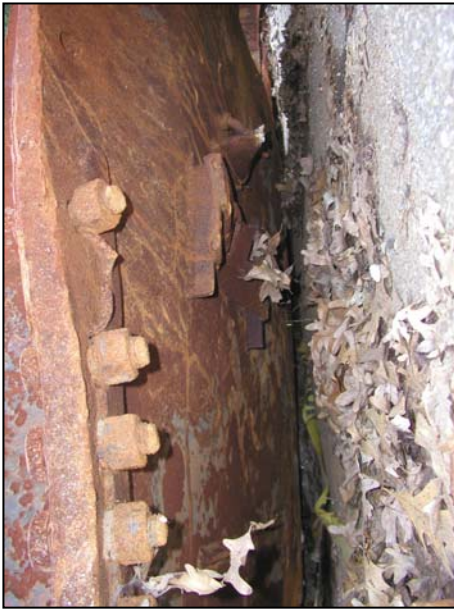
**C89-C3T (WTC 2, Col.214, Fl 15)**

Gusset plate intact with shear bolt, bent up;  
Seat intact, bent down, 1 bolt hole intact, other  
ripped through;  
Gusset plate for damper unit ripped off at weld.

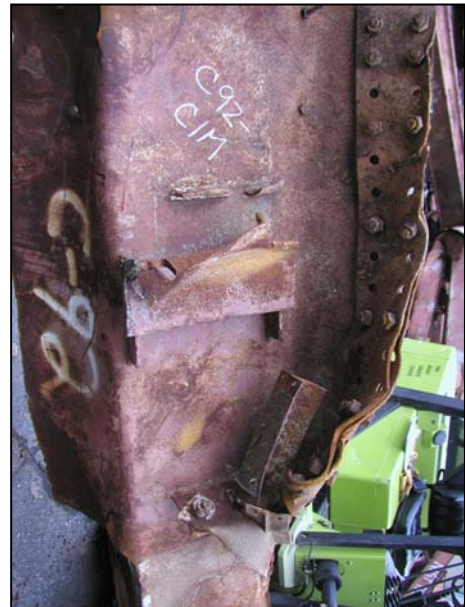
**C92-C1M (WTC 2, Col.131, Fl 95)**

Gusset plate with damper unit intact, half bent up.

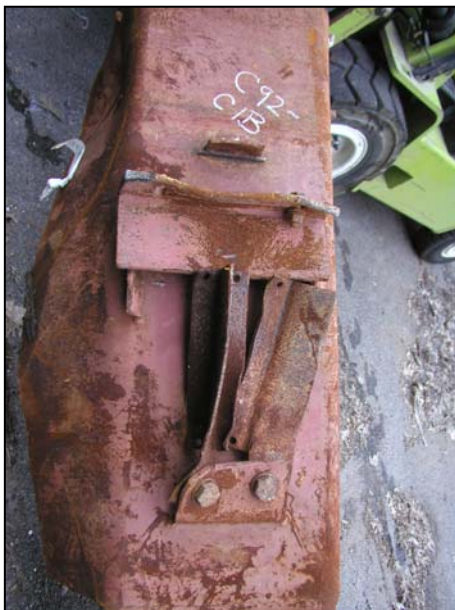
**C92-C1B (WTC 2, Col.131, Fl 94)**

Gusset plate with damper unit intact, bent up.

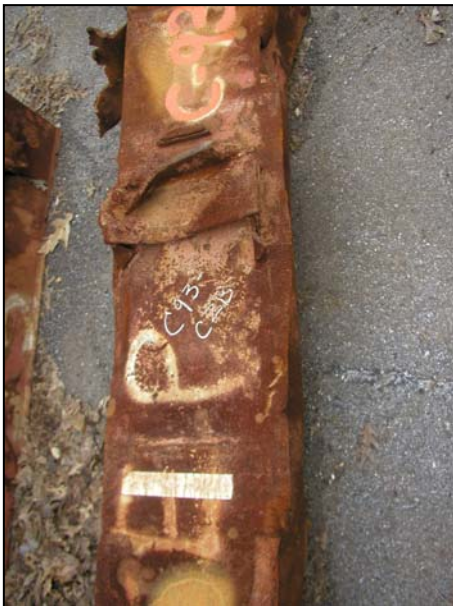
**C93-C2B (WTC 1, Col.339, Fl 98)**  
Type A  
Seat Detail: 1411

Gusset plate ripped off at weld;  
Seat intact, pushed in and bent down, both bolt holes  
ripped through;  
Gusset plate for damper unit ripped off at weld.

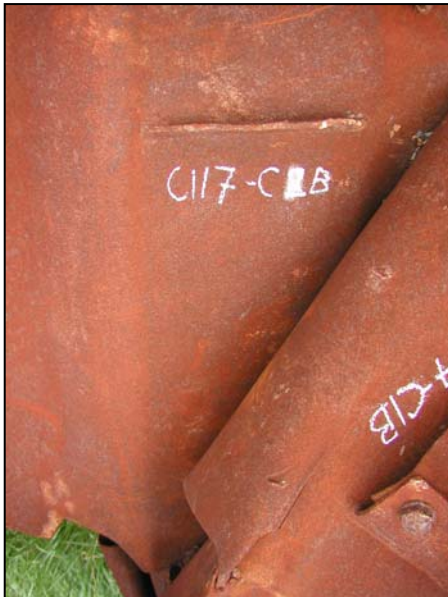
**C117-C2B (Col.unknown, Fl 102)**  
Type C  
Seat Detail:

Portion of gusset plate remains.

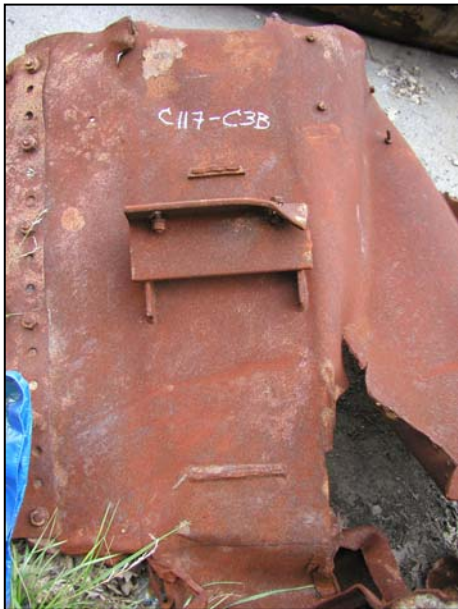
**C117-C3B (Col.unknown, Fl 102)**

Gusset plate ripped off at weld;  
Seat intact, half bent down, both bolt holes intact  
with bolts;  
Gusset plate for damper unit ripped off at weld.

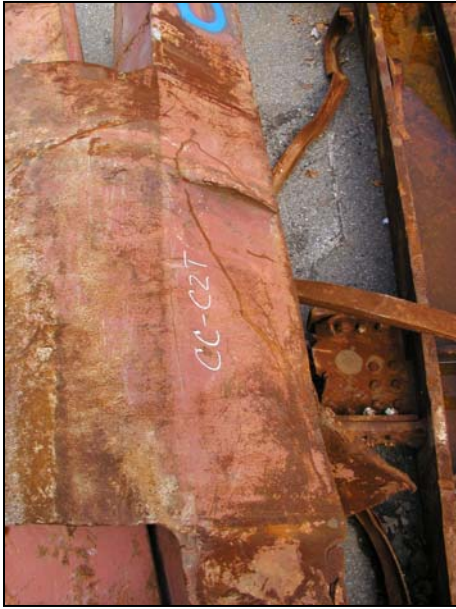
**CC-C2T (WTC 1, Col.124, FI 73)**

Portion of large gusset plate remains.

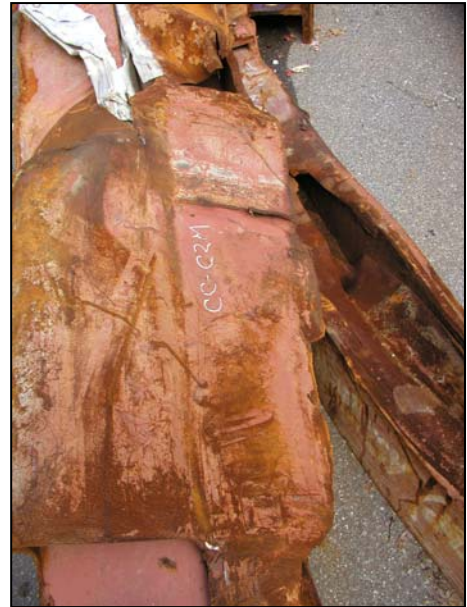
**CC-C2M (WTC 1, Col.124, FI 72)**

Large gusset plate ripped off at weld.

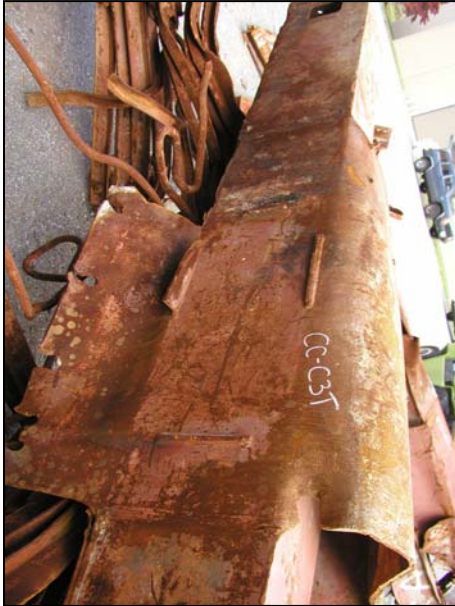
**CC-C3T (WTC 1, Col.123, Fl 73)**

Gusset plate ripped off at weld;  
Only 1 standoff plate remains, rest ripped off at welds;  
Gusset plate for damper unit ripped off at weld.

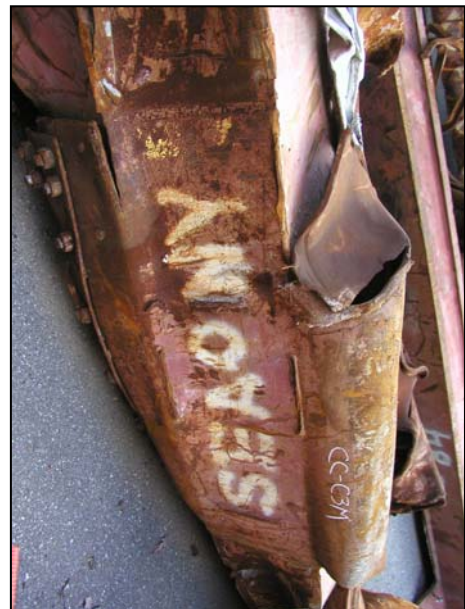
**CC-C3M (WTC 1, Col.123, Fl 72)**

Gusset plate ripped off at weld;  
Standoff plates ripped off at welds;  
Gusset plate for damper unit ripped off at weld.

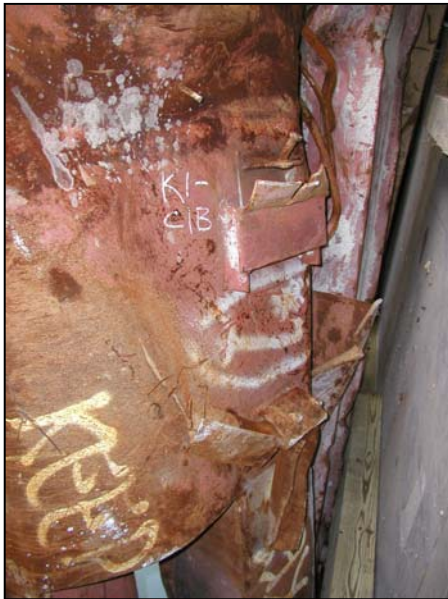
**K1-C1B (WTC 1, Col.210. Fl 98)**  
Type A  
Seat Detail: 1212

Gusset plate with shear bolt intact;  
Seat intact, bent upwards, both bolt holes ripped through;  
Gusset plate with damper unit intact, bent downwards.

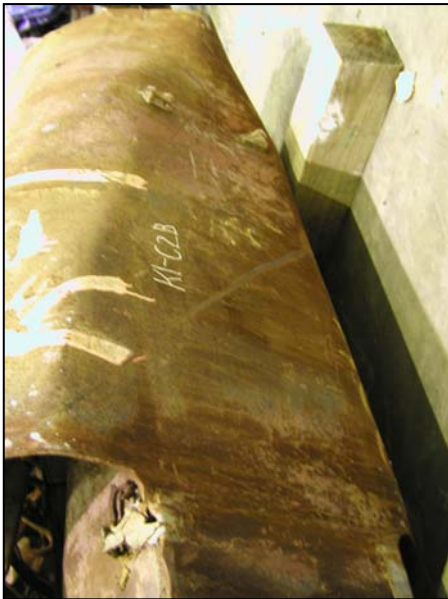
**K1-C2B (WTC 1, Col.209, Fl 98)**  
Type D  
Seat Detail: 5210

Both diagonal bracing straps ripped off at weld.

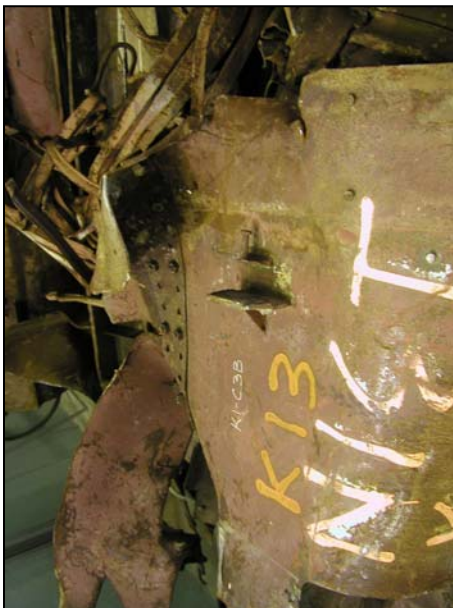
**K1-C3B (WTC 1, Col.208, F1 98)**  
Type B  
Seat Detail: 5010

Gusset plate remains with shear bolt;  
Small seat intact, 1 bolt hole intact, other is  
covered by a welded plate;  
No evidence of gusset plate for damper unit.

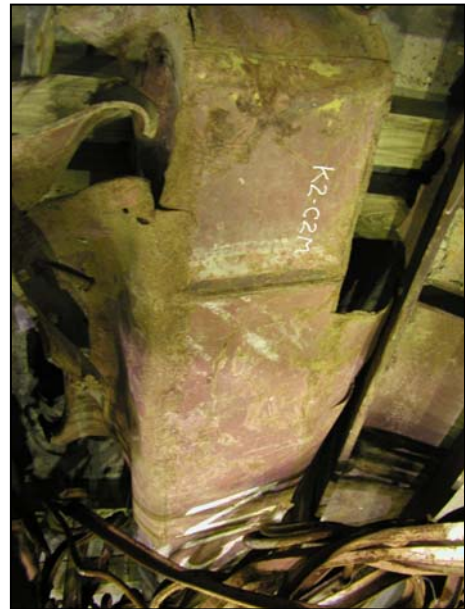
**K2-C2M (WTC 1, Col.236, F1 94)**  
Type C  
Seat Detail: 5110

Gusset plate ripped off at weld.

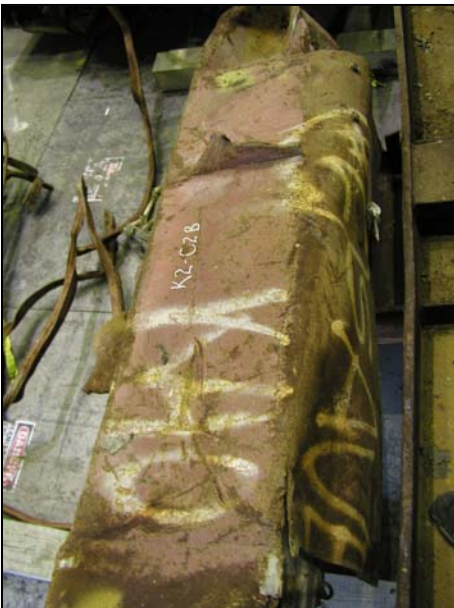
**K2-C2B (WTC 1, Col.236, F1 93)**  
Type C  
Seat Detail: 5110

Portion of gusset plate remains.

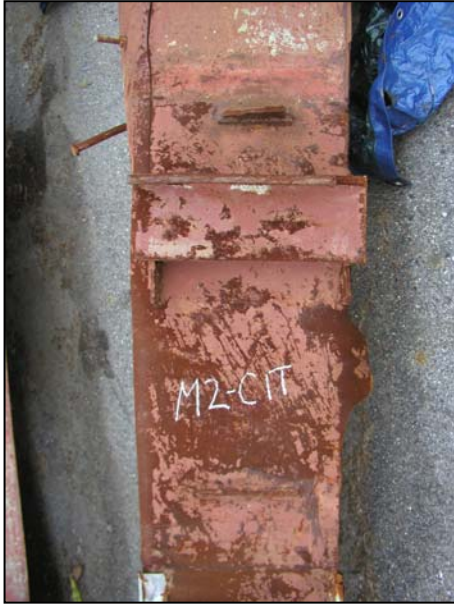
**M2-C1T (WTC 1, Col.131, FI 99)**

Gusset plate remains;  
Seat intact, 1 bolt hole remains intact, other ripped out;  
Gusset plate for damper unit ripped off at weld.

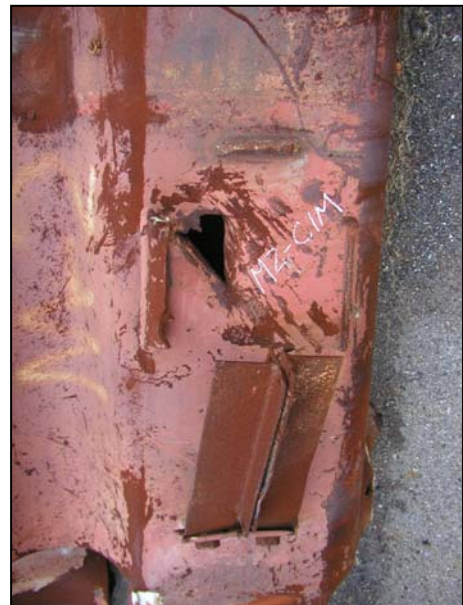
**M2-C1M (WTC 1, Col.131, FI 98)**

Gusset plate intact;  
1 standoff plate remains, seat and other standoff plate ripped off at welds;  
Gusset plate with damper unit intact, bent up.

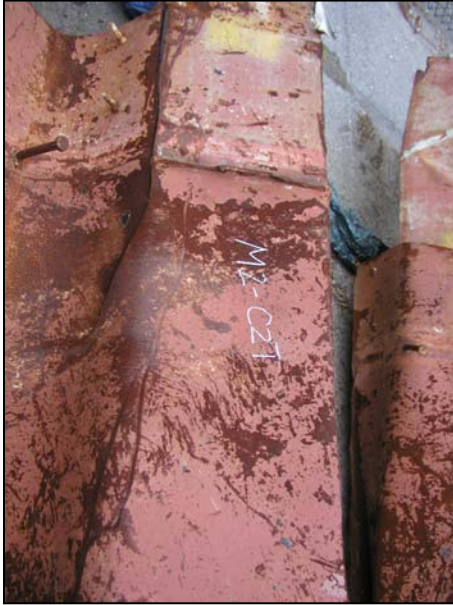
**M2-C2T (WTC 1, Col.130, Fl 99)**  
Type C  
Seat Detail: 5210

Gusset plate ripped off at weld.

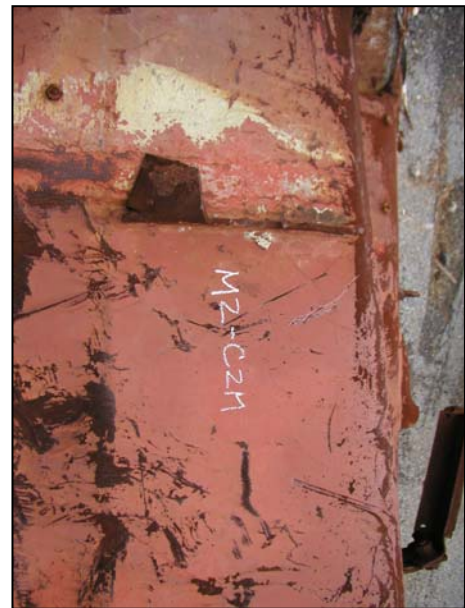
**M2-C2M (WTC 1, Col.130, Fl 98)**  
Type C  
Seat Detail: 5210

Portion of gusset plate remains, bent up.

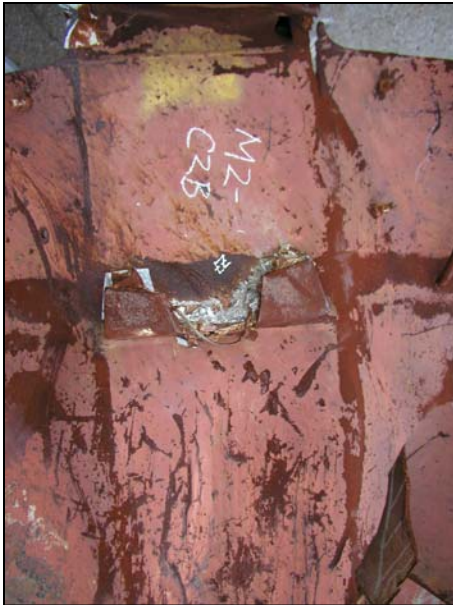
**M2-C2B (WTC 1, Col.130, Fl 97)**  
Type C  
Seat Detail: 5210

Gusset plate remains, bent up.

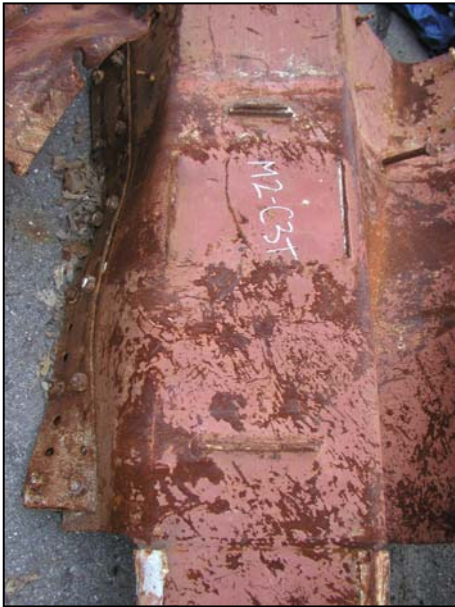
**M2-C3T (WTC 1, Col.129, Fl 99)**

Gusset plate ripped off at weld;  
Standoff plates ripped off at welds;  
Gusset plate for damper unit ripped off at weld.

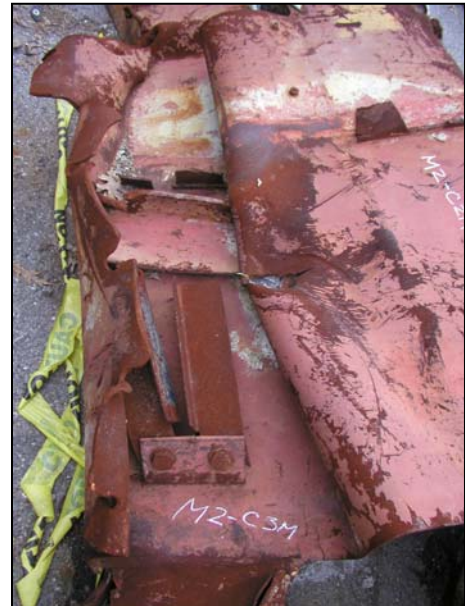
**M2-C3M (WTC 1, Col.129, Fl 98)**

Gusset plate remains;  
Seat intact, bent down, 1 bolt hole remains intact  
with bolt, other ripped out;  
Gusset plate with damper unit intact, bent up.

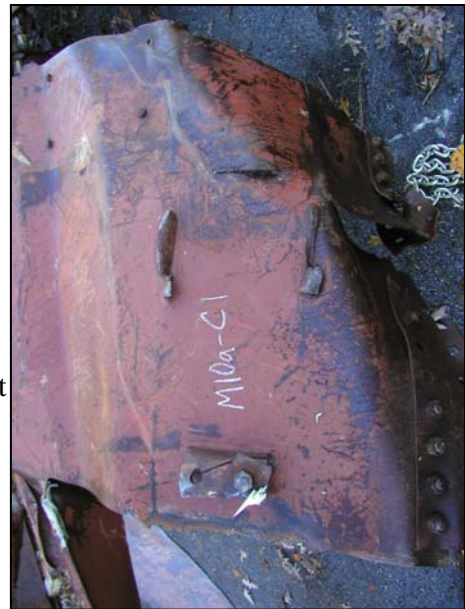
**M10a-C1M (WTC 2, Col.210, Fl 84)**  
Type A  
Seat Detail: 1212

Gusset plate ripped completely out of spandrel;  
Only portions of standoff plates remain;  
Gusset plate with damper unit intact, partially ripped at  
weld, bent downwards, portion of 1 damper remains.

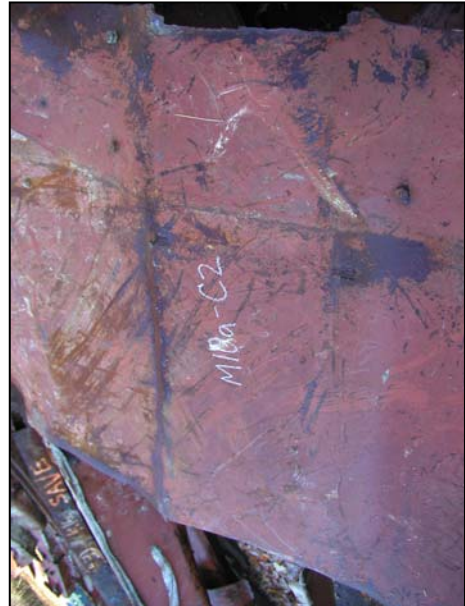
**M10a-C2M (WTC 2, Col.209, Fl 84)**  
Type D  
Seat Detail: 5210

Both diagonal bracing straps ripped off at weld.

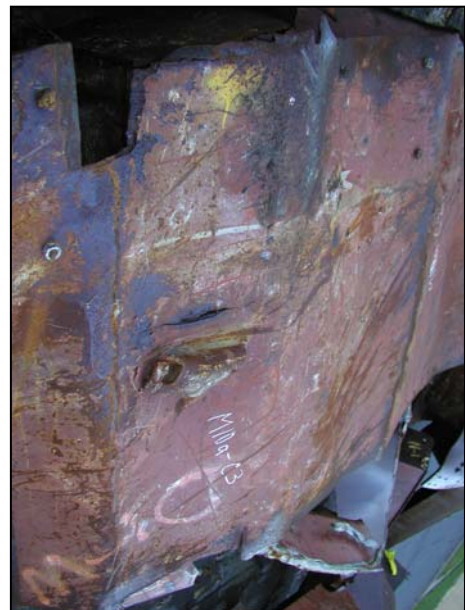
**M10a-C3M (WTC 2, Col.208, Fl 84)**  
Type B  
Seat Detail: 5010

Gusset plate ripped completely out of spandrel;  
Small seat remains, highly deformed, bent  
downwards, 1 bolt hole intact;  
No evidence of gusset plate for damper unit.

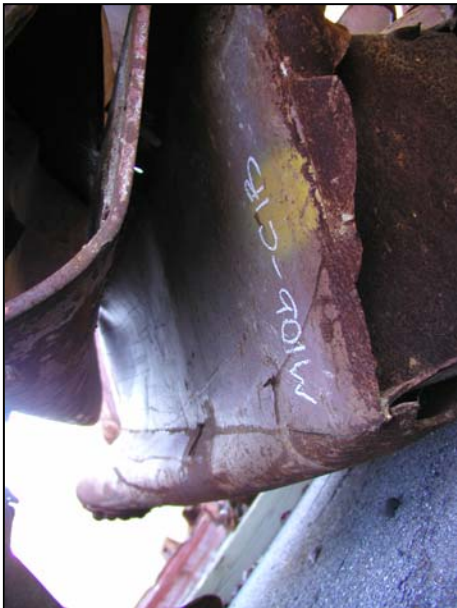
**M10b-C1B (WTC 2, Col.207, Fl 84)**  
Type D  
Seat Detail: 5110

Both diagonal bracing straps ripped off at weld.

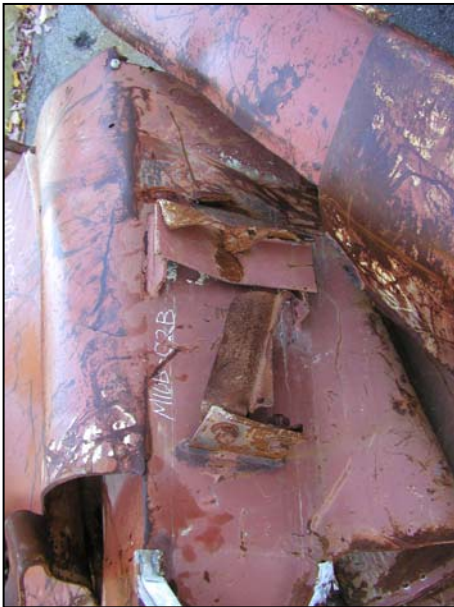
**M10b-C2B (WTC 2, Col.206, Fl 84)**  
Type A  
Seat Detail: 1212

Gusset plate ripped completely out of spandrel;  
Seat intact, bent in towards column and downwards,  
only 1 bolt hole intact, other ripped through;  
Gusset plate with damper unit intact, bent upwards.

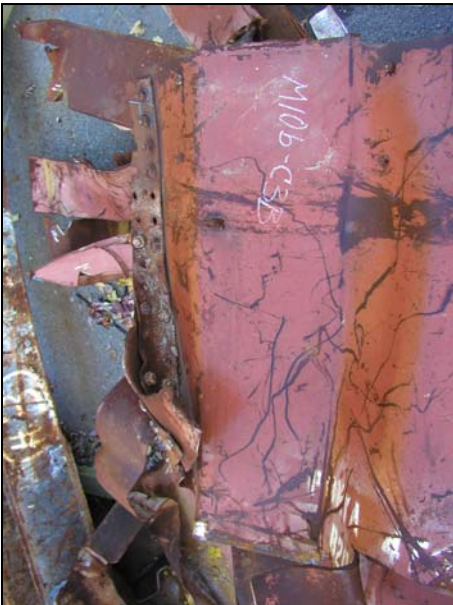
**M10b-C3B (WTC 2, Col.205, Fl 84)**  
Type D  
Seat Detail: 5110

1-in portion of diagonal bracing strap remaining,  
other ripped completely out of spandrel.

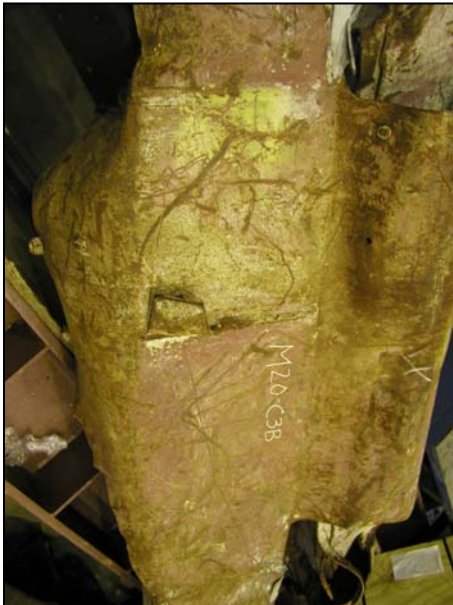
**M20-C3B (WTC 1, Col.120, Fl 100)**  
Type C  
Seat Detail: 5210

Portion of gusset plate remains, bent upward, rest  
ripped off at weld.
