## Appendix A

# EXAMPLES OF PERIMETER PANEL FLOOR TRUSS CONNECTORS

The floor trusses were attached to the perimeter panels at the interior intersection of the columns and spandrels by different types of connectors. The following appendix displays photographic examples, taken by National Institute of Standards and Technology (NIST), of these types of connectors as observed on the recovered panels.

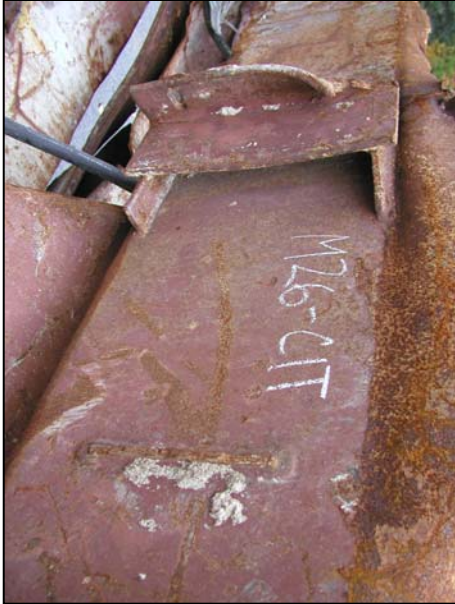
**M26-C1T (WTC 1, Col.131, Fl 93)**

Gusset plate ripped off at weld;  
Seat intact, bent downwards, 1 bolt hole remains intact, other ripped out;  
No evidence of gusset for damper unit.

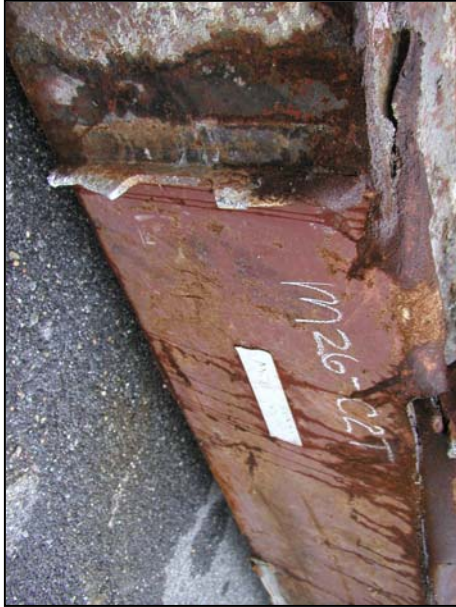
**M26-C2T (WTC 1, Col.130, Fl 93)**

Gusset plate ripped at weld.

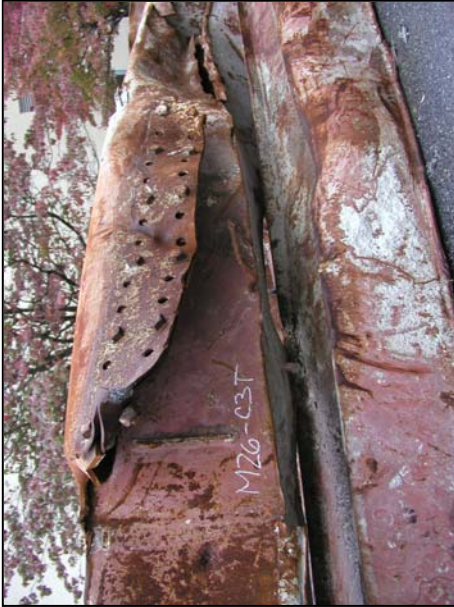
**M26-C3T (WTC 1, Col.129, Fl 93)**

Gusset plate remains;  
Only standoff plates remain, seat ripped off at welds;  
Gusset for damper unit ripped off at weld.

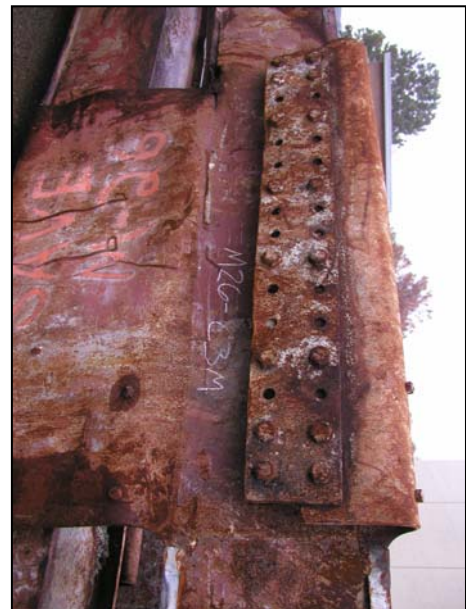
**M26-C3M (WTC 1, Col.129, Fl 92)**

Gusset plate remains;  
Only 1 standoff plate remains, seat and other  
standoff plate ripped off at welds;  
No evidence of gusset plate for damper unit.

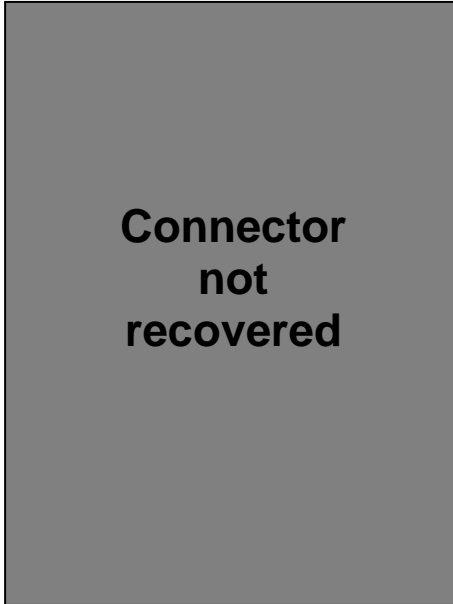
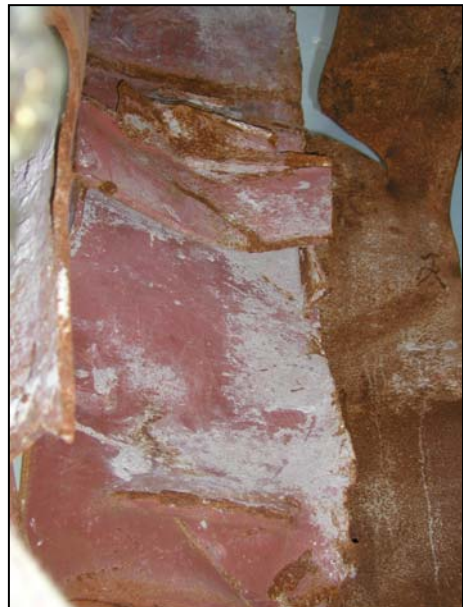
M27-C1M (WTC 1, Col.131, Fl 95)  
Type A  
Seat Detail: 1411

Small portion of gusset plate remains;  
Seat intact but deformed, bent in towards column,  
both bolt holes ripped out;  
Gusset for damper unit ripped off at welds.

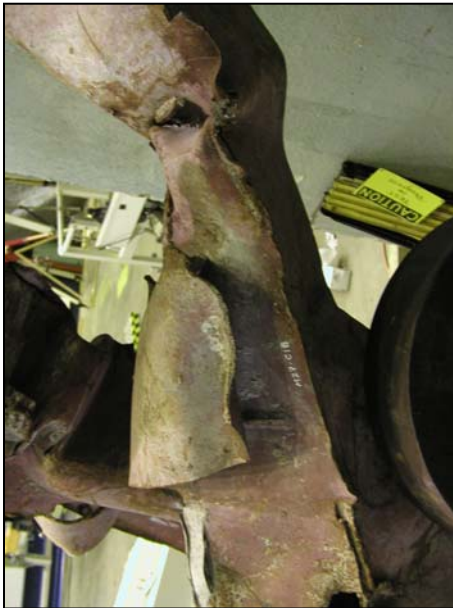
M27-C1B (WTC 1, Col.131, Fl 94)  
Type A  
Seat Detail: 1411

Small portion of gusset plate remains;  
Standoff plates ripped off at welds;  
Gusset plate for damper unit ripped off at weld.

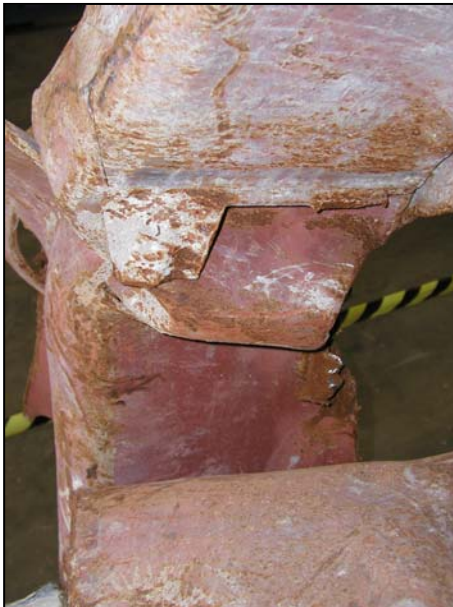
**M27-C2B (WTC 1, Col.130, Fl 94)**  
Type C  
Seat Detail: 5210

Portion of gusset plate remains, bent downwards, with diagonal bracing strap attached.

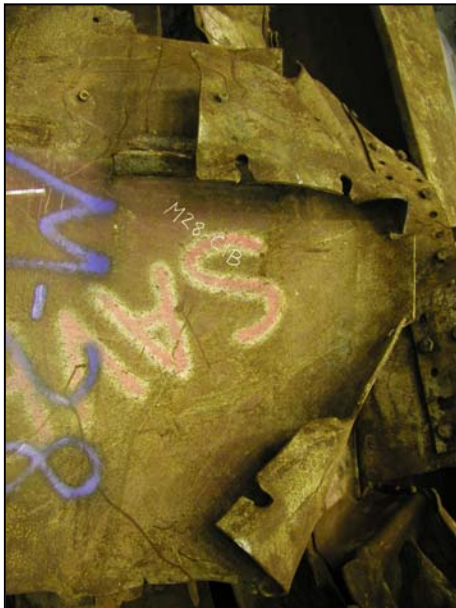
**M28-C1B (WTC 2, Col.346, Fl 99)**  
Type C  
Seat Detail: 5110

Gusset plate intact with portions of diagonal bracing straps attached.

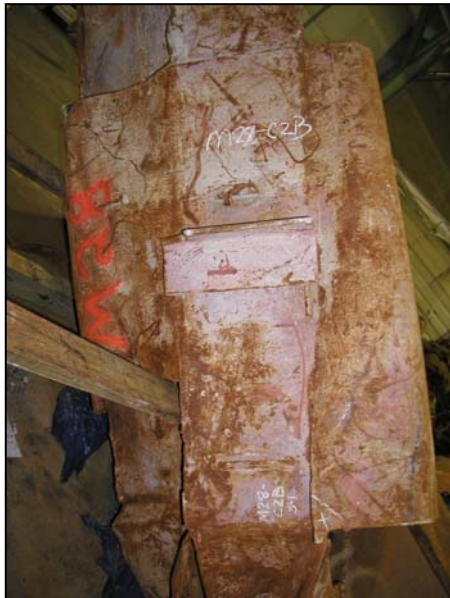
**M28-C2B (WTC 2, Col.345, Fl 99)**  
Type A  
Seat Detail: 1411

Gusset plate remains;  
Seat intact, 1 bolt hole intact, other ripped through;  
Gusset plate for damper unit ripped off at weld.

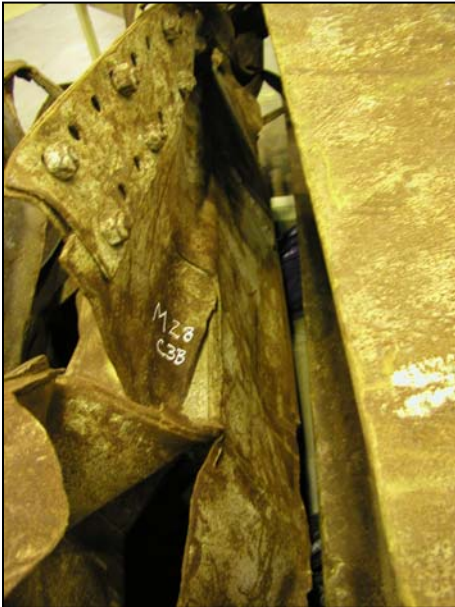
**M28-C3B (WTC 2, Col.344, Fl 99)**  
Type C  
Seat Detail: 5110

Gusset plate ripped off at weld.

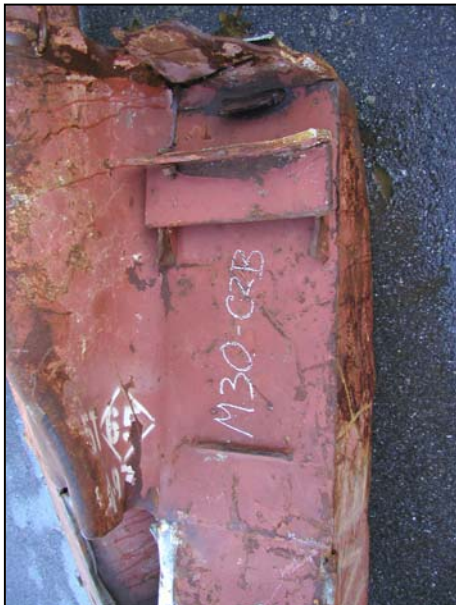
**M30-C2B (WTC 1, Col.133, Fl 95)**  
Type A  
Seat Detail: 1411

Gusset plate remains;  
Seat intact, bent downwards, both bolt holes intact  
with one still having bolt and nut;  
Gusset for damper unit ripped off at weld.

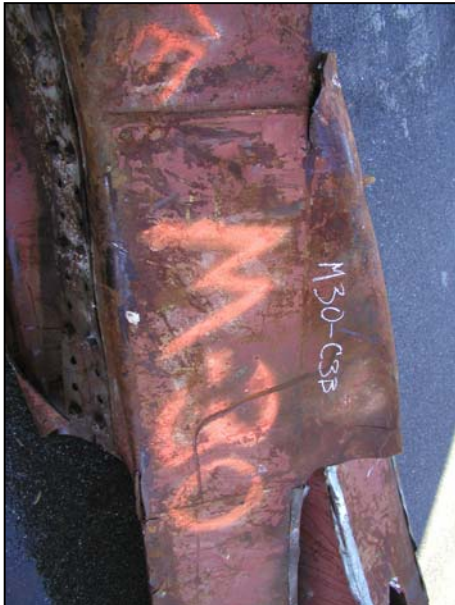
**M30-C3B (WTC 1, Col.132, Fl 95)**  
Type C  
Seat Detail: 5210

Gusset plate ripped off at weld.

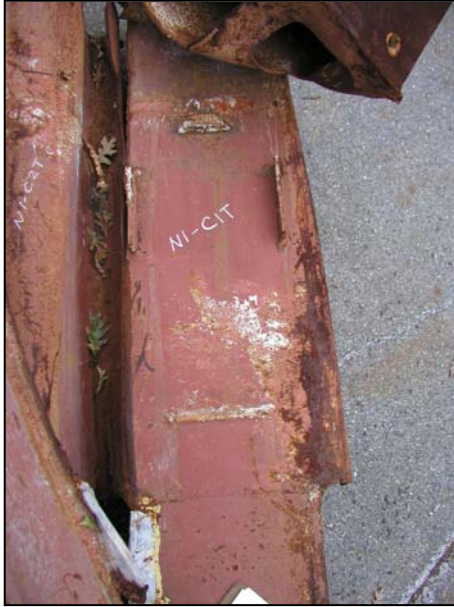
**N1-C1T (WTC 1, Col.219, Fl 85)**

Gusset plate intact;  
Only standoff plates remain;  
Gusset plate for damper unit ripped off at weld.

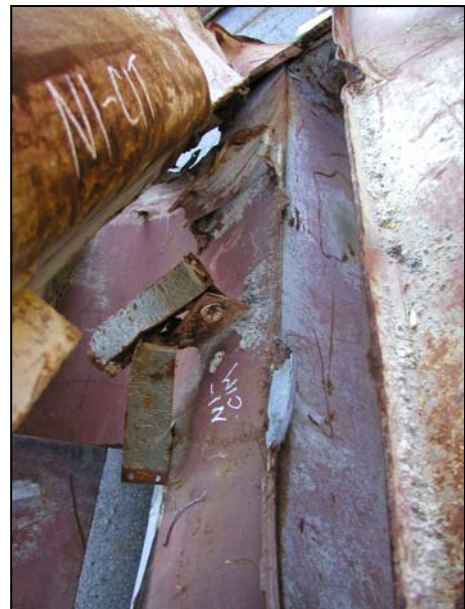
**N1-C1M (WTC 1, Col.219, Fl 84)**

Gusset plate remains;  
Seat intact, bent downwards, both bolt holes intact;  
Gusset plate with damper unit intact, bent downwards.

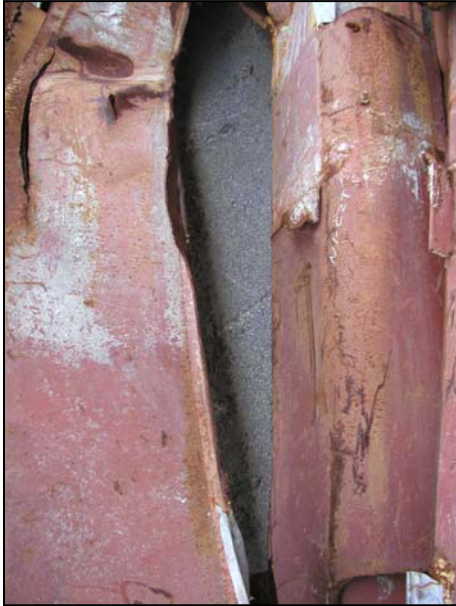
**N1-C2T (WTC 1, Col.218, Fl 85)**

Gusset plate remains, but half ripped away from spandrel at weld.

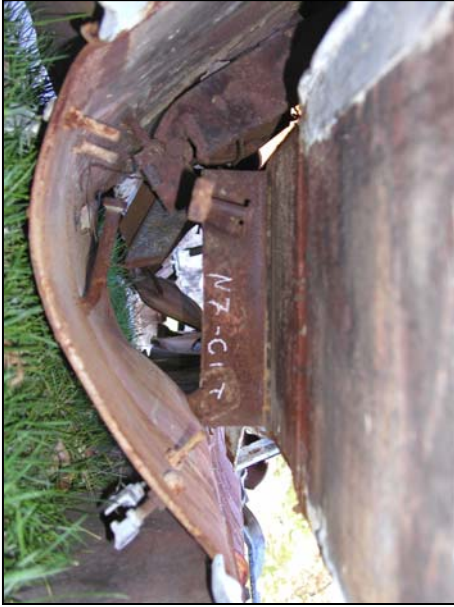
**N7-C1T (WTC 1, Col.128, Fl 100)**

Portion of gusset plate remains, bent downward.

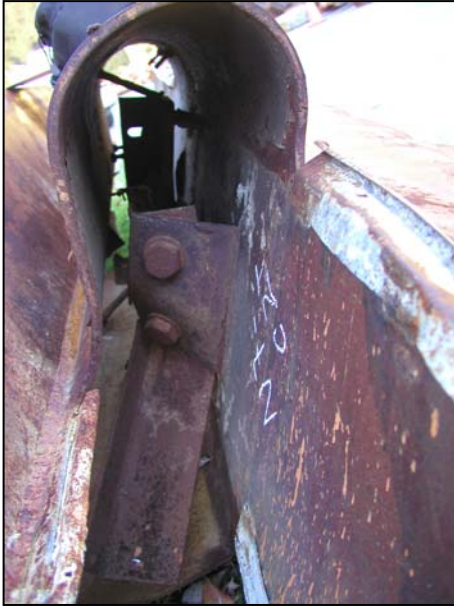
**N7-C2T (WTC 1, Col.127, Fl 100)**

Gusset plate completely ripped out of spandrel;  
Seat intact, partially bent towards column, 1 bolt hole intact, other ripped out, both bolts and nuts remain;  
Gusset plate with damper unit intact, bent upwards, 1 damper bent up, other bent down.

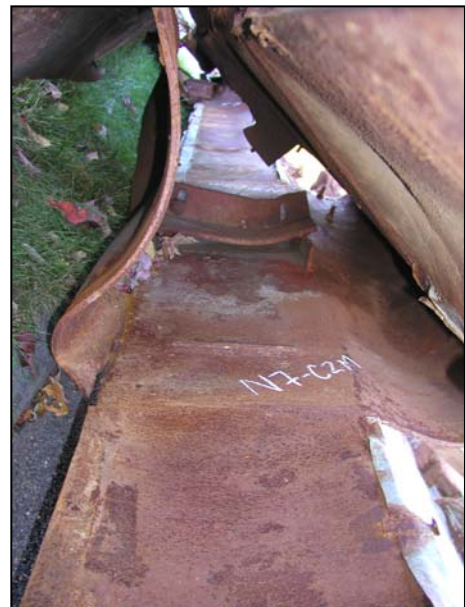
**N7-C2M (WTC 1, Col.127, Fl 99)**

Gusset plate ripped off at weld;  
Seat intact, bent in towards column, both bolt holes intact, 1 with bolt and nut;  
Gusset plate for damper unit ripped off at weld.

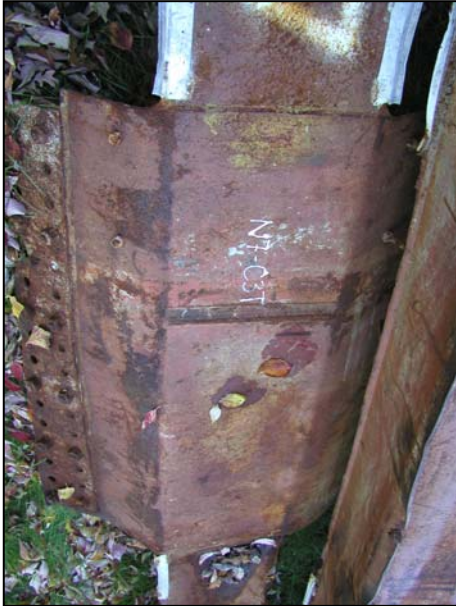
**N7-C3T (WTC 1, Col.126, Fl 100)**

Gusset plate ripped off at welds.

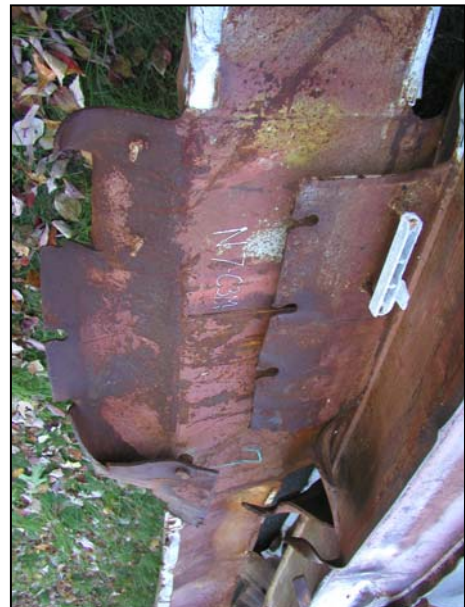
**N7-C3M (WTC 1, Col.126, Fl 99)**

Gusset plate ripped off at welds.

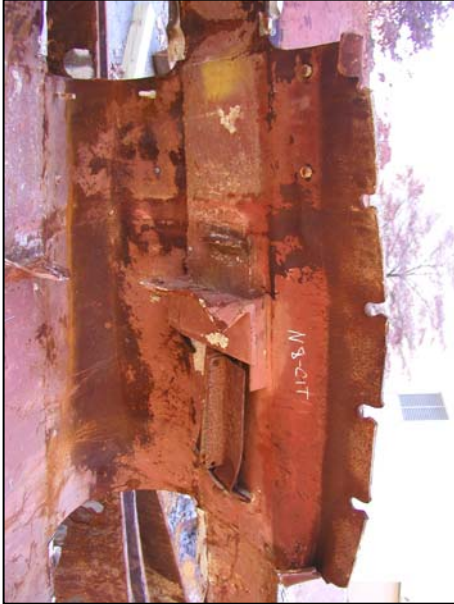
**N8-C1T (WTC 1, Col.143, Fl 100)**

Gusset plate intact;  
Seat intact, partially bent downwards, both bolt holes intact with bolts and nuts;  
Gusset for damper unit ripped off at weld.

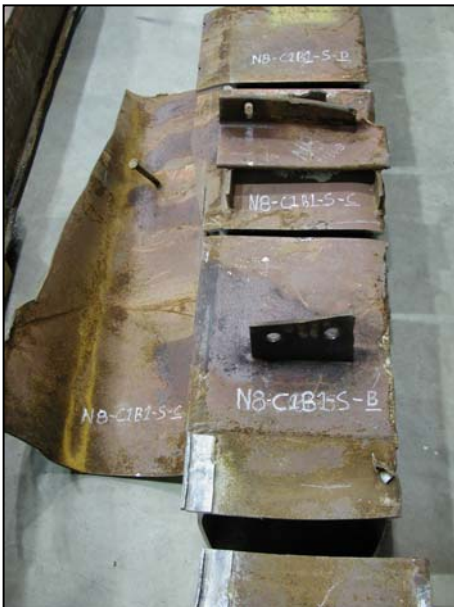
**N8-C1B (WTC 1, Col.143, Fl 98)**

Portion of gusset plate remains;  
Seat intact, partially bent downwards, one bolt hole intact, other ripped out;  
Gusset plate for damper unit intact, bolt holes intact, damper unit missing

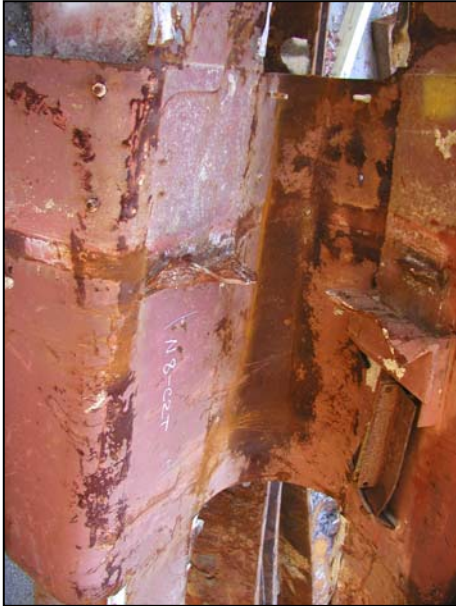
**N8-C2T (WTC 1, Col.142, Fl 100)**

Gusset plate intact with portion of diagonal bracing strap attached, bent downwards.

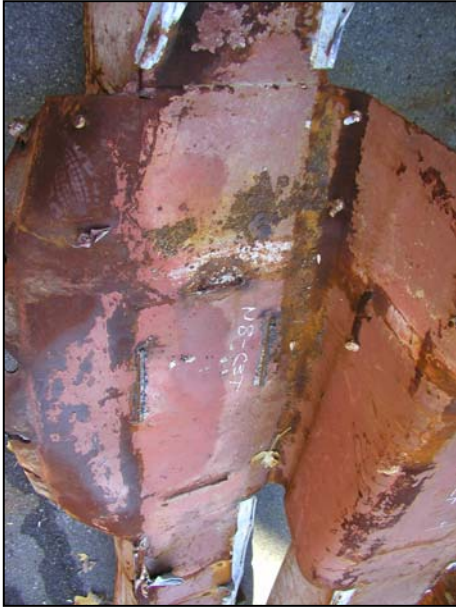
**N8-C3T (WTC 1, Col.141, Fl 100)**

Gusset plate ripped completely out of spandrel;  
Seat intact, 1 bolt hole intact with bolt and nut,  
other ripped out;  
Gusset plate for damper unit ripped out at weld.

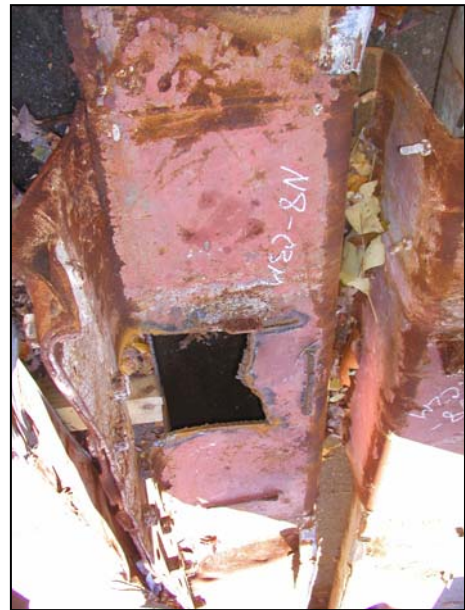
**N8-C3M (WTC 1, Col.141, Fl 99)**

Portion of gusset plate intact;  
Seat intact, both bolt holes intact with bolts and nuts;  
Gusset plate for damper unit ripped off at weld.

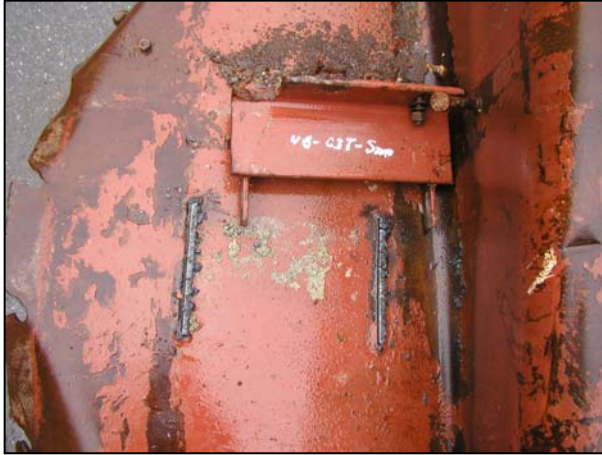
**N8-C3T (WTC 1, Col.141, Fl 100)**

Cut for Boulder on 10/02

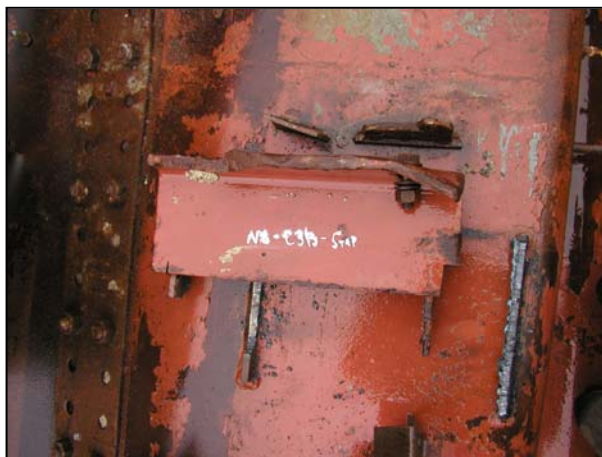
**N8-C3B (WTC 1, Col.141, Fl 98)**

Cut for Boulder on 10/02

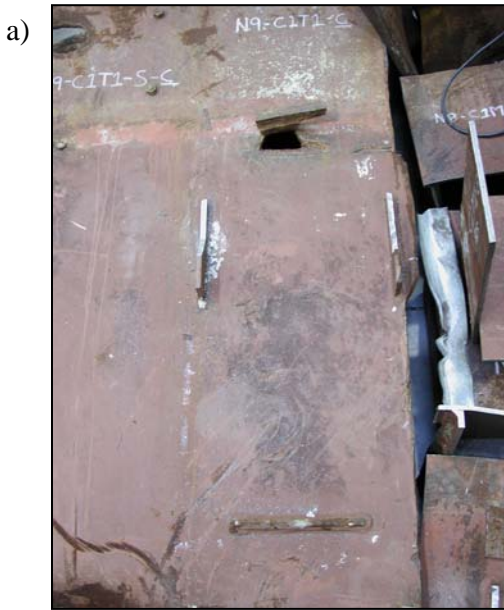
**N9-C1T (WTC 1, Col.155, Fl 104)**

Gusset plate ripped completely out of spandrel;  
Only part of 1 standoff plate remains, rest ripped off at welds;

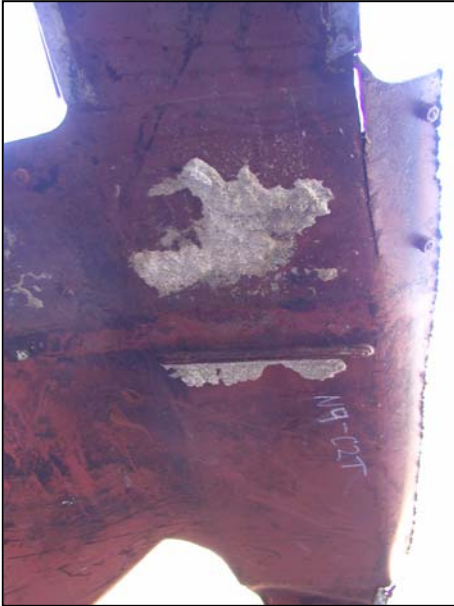
**N9-C2T (WTC 1, Col.154, Fl 104)**

Gusset plate ripped off at weld.

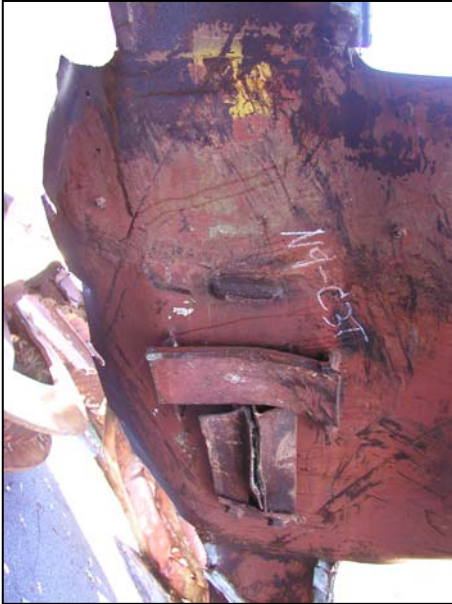
**N9-C3T (WTC 1, Col.153, Fl 104)**

Portion of gusset plate remains;  
Portion of seat is left (vertical part attached to shear plates);  
Gusset with damper unit intact, bent upwards.

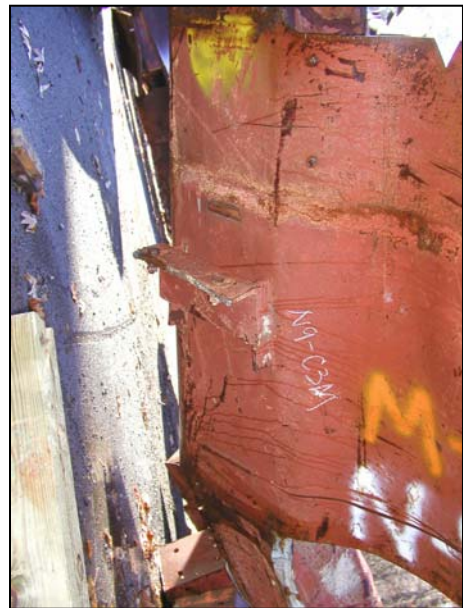
**N9-C3M (WTC 1, Col.153, Fl 103)**

Gusset plate ripped completely out of spandrel;  
Seat intact, both bolt holes intact with bolts and nuts;  
Gusset for damper unit ripped off at weld.

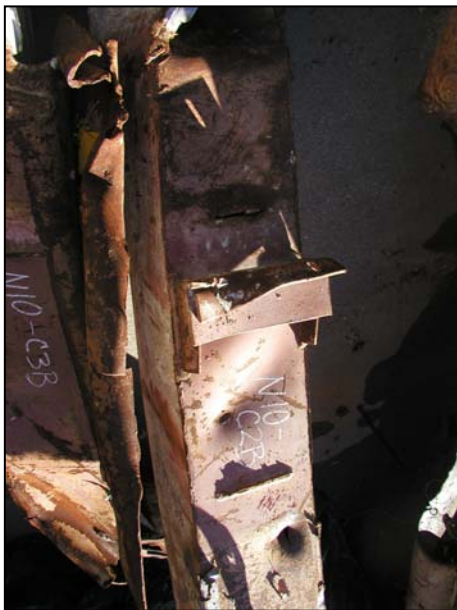
**N10-C2B (WTC 1, Col.115, Fl 90)**  
Type A  
Seat Detail: 1411

Gusset plate ripped completely out of spandrel;  
Seat intact, bent downward, 1 bolt hole remains intact, other ripped out;  
Gusset plate for damper unit ripped off at weld.

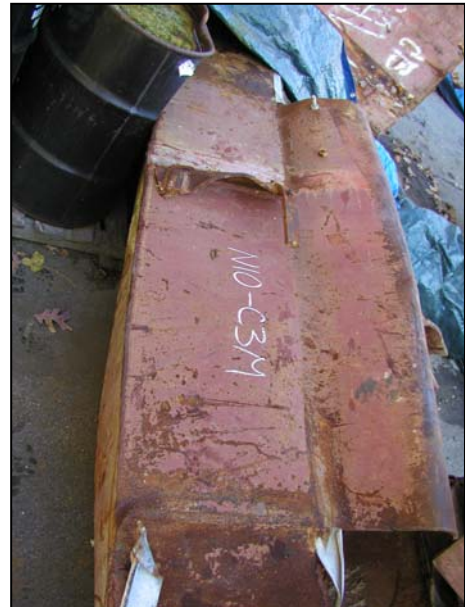
**N10-C3M (WTC 1, Col.114, F1 91)**  
Type C  
Seat Detail: 5110

Gusset plate remains, bent downwards, with portion of diagonal bracing strap still attached.

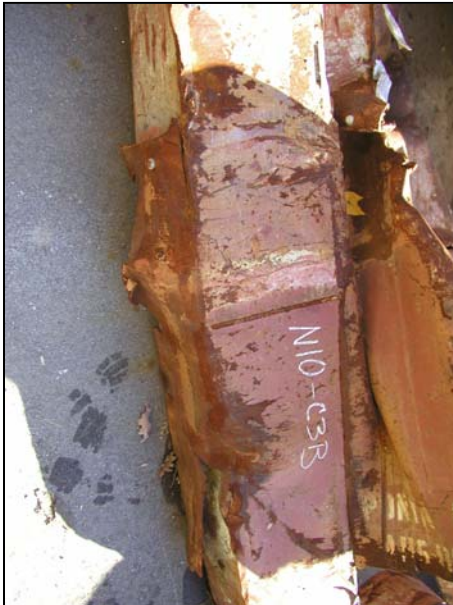
**N10-C3B (WTC 1, Col.114, F1 90)**  
Type C  
Seat Detail: 5110

Gusset plate ripped off at weld.

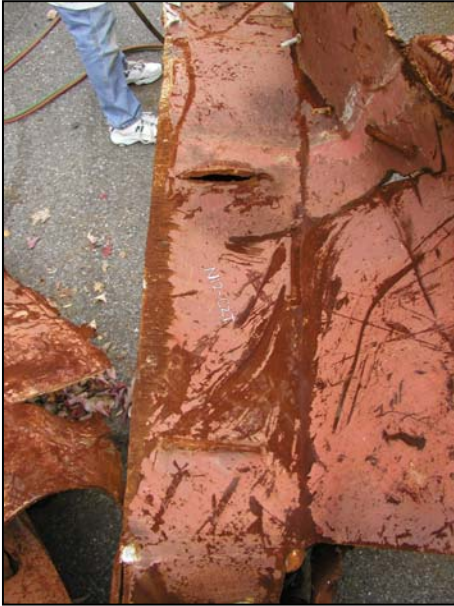
**N12-C2T (WTC 1, Col.206, Fl 95)**

Gusset plate ripped completely out of spandrel;  
Only evidence of 1 standoff plate being welded to  
spandrel, ripped off at weld;  
Gusset for damper unit ripped off at weld.

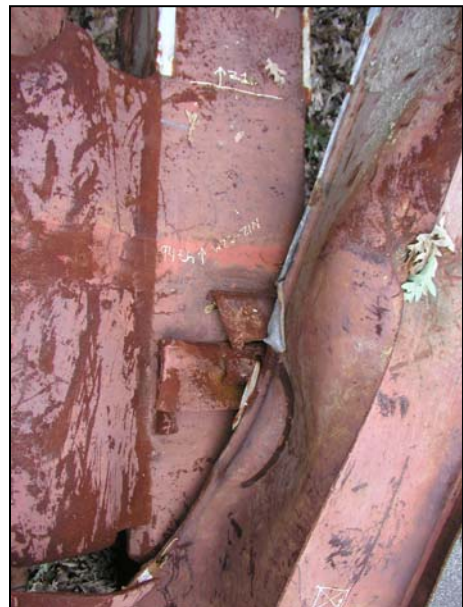
**N12-C2M (WTC 1, Col.206, Fl 94)**

Gusset plate intact, bent downwards;  
Seat intact, bent downwards and in towards  
column, one bolt hole intact, other ripped out;  
Gusset plate for damper unit ripped off at weld.

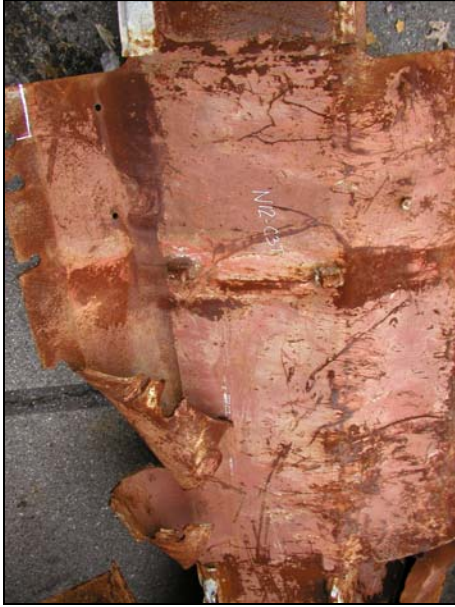
**N12-C3T (WTC 1, Col.205, F1 95)**

2 1-in portions of diagonal bracing straps remaining

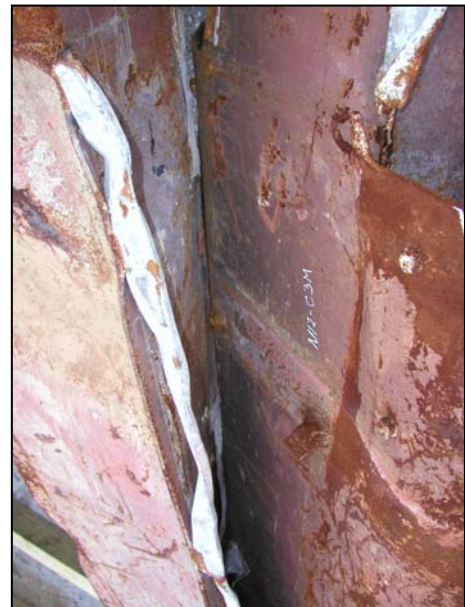
**N12-C3M (WTC 1, Col.205, F1 94)**

2 1-in portion of diagonal bracing straps remaining.

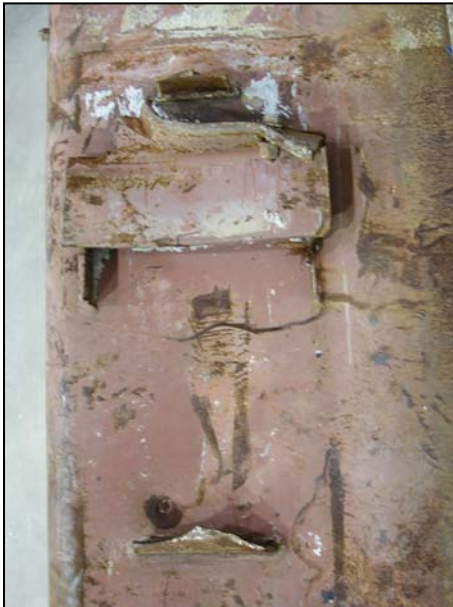
**N13-C1B (WTC 1, Col.131, Fl 100)**  
Type A  
Seat Detail: 1411

Gusset plate remains;  
Seat intact, bent upwards, 1 bolt hole ripped but still has bolt and nut, other completely ripped out;  
Portion of gusset plate remains, bent upwards.

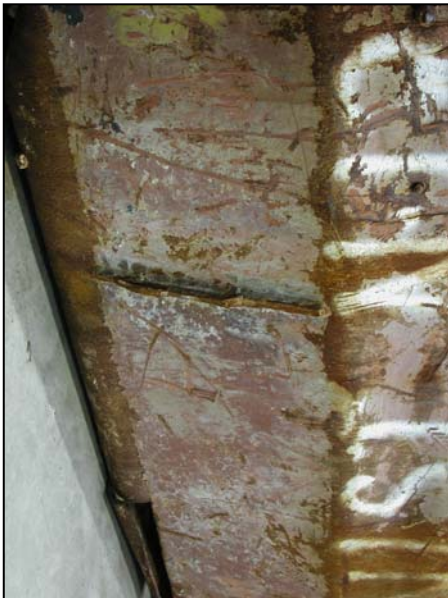
**N13-C2B (WTC 1, Col.130, Fl 100)**  
Type C  
Seat Detail: 5210

Gusset plate ripped off at weld.

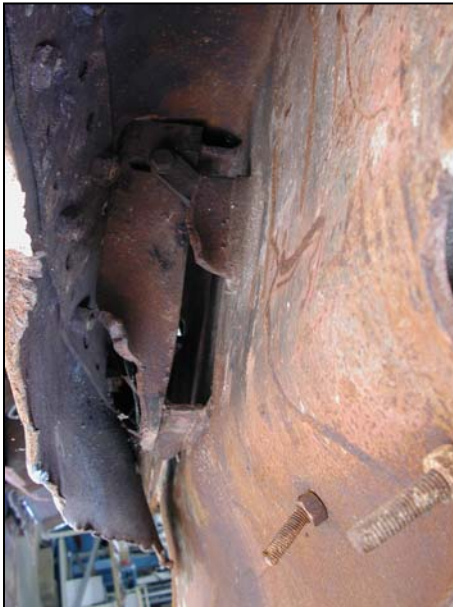
**N13-C3B (WTC 1, Col.129, Fl 100)**  
Type A  
Seat Detail: 1411

Gusset plate remains;  
Seat intact, bent upwards, 1 bolt hole intact  
with bolt and nut, other ripped out;  
Gusset with damper unit intact, bent upwards.

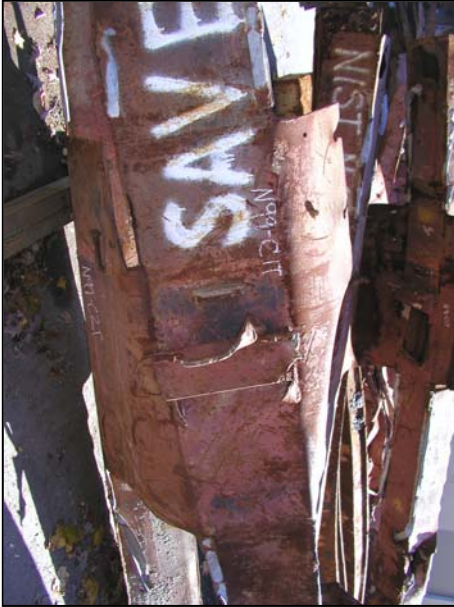
**N99-C1T (WTC 1, Col.149, FI 102)**

Gusset plate intact;  
Seat intact, bent upwards, both bolt holes ripped out;  
Gusset for damper unit ripped off at weld.

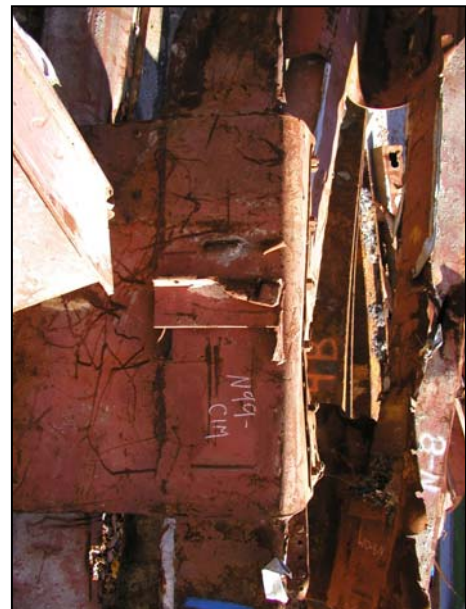
**N99-C1M (WTC 1, Col.149, FI 101)**

Gusset plate ripped off at weld;  
Seat intact, partially bent downwards, 1 bolt hole intact, other ripped through but bolt remains;  
Gusset for damper unit ripped off at weld.

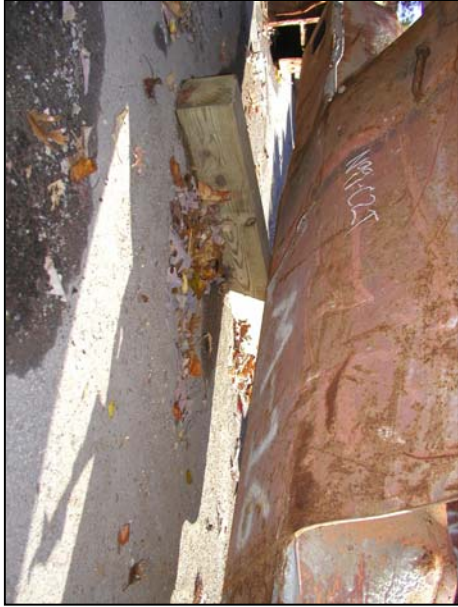
**N99-C2T (WTC 1, Col.148, Fl 102)**

Gusset plate ripped off at weld.

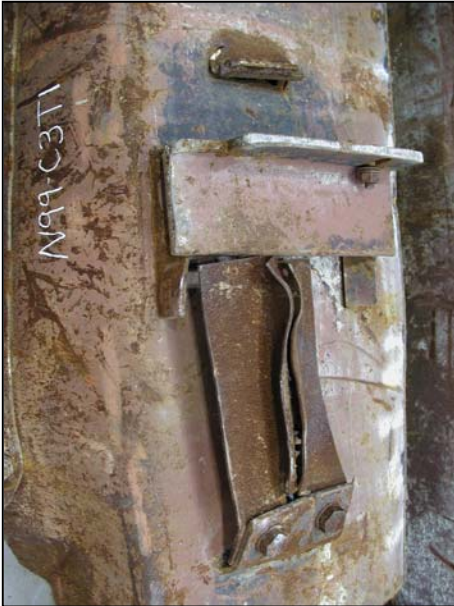
**N99-C3T (WTC 1, Col.147, Fl 102)**  
Type A  
Seat Detail: 1411

Portion of gusset plate remains;  
Seat intact, 1 bolt hole intact with bolt and nut, other ripped out;  
Gusset with damper unit intact, bent upwards.

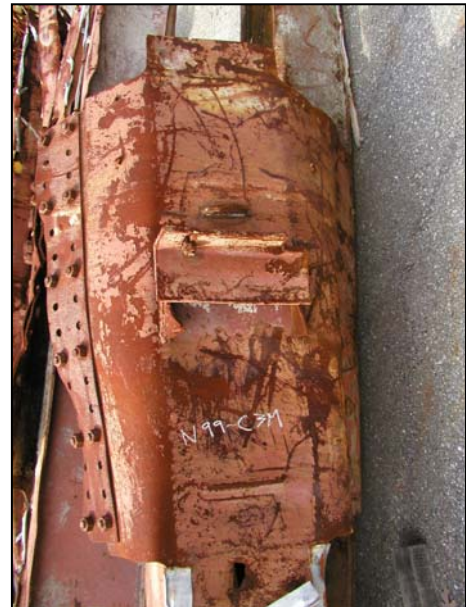
**N99-C3M (WTC 1, Col.147, Fl 101)**  
Type A  
Seat Detail: 1411

Gusset plate intact;  
Seat intact, 1 bolt hole intact with bolt and nut, other ripped out;  
Gusset for damper unit ripped off at weld.

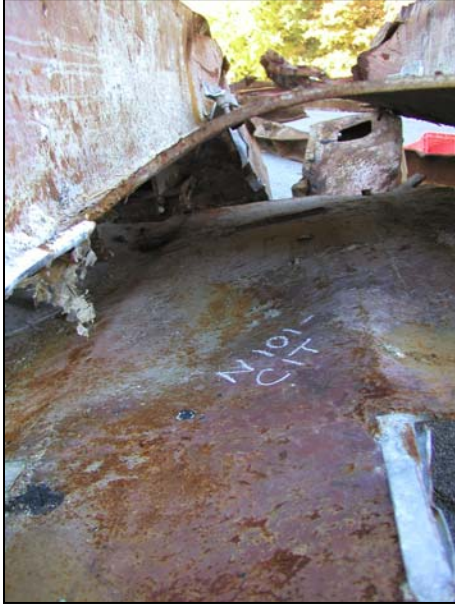
**N101-C1T (WTC 1, Col.134, Fl 103)**

Gusset plate intact with diagonal bracing strap attached, bent upwards.

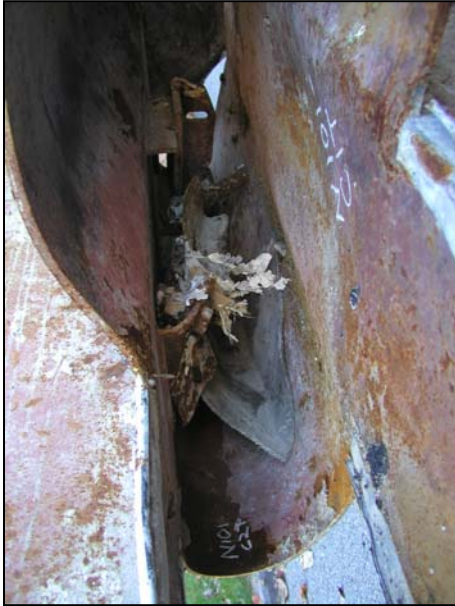
**N101-C2T (WTC 1, Col.133, Fl 103)**

Gusset plate intact, bent upwards;  
Seat intact, both bolt holes intact with bolts and nuts;  
Gusset with damper unit intact, bent upwards.

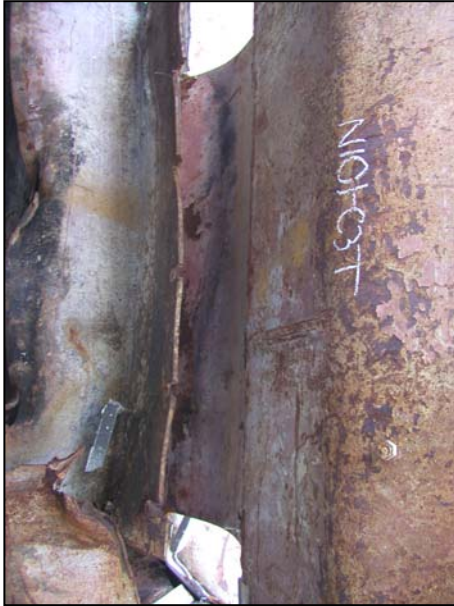
**N101-C3T (WTC 1, Col.132, Fl 103)**  
Type C  
Seat Detail: 5210

Gusset plate ripped out at weld.

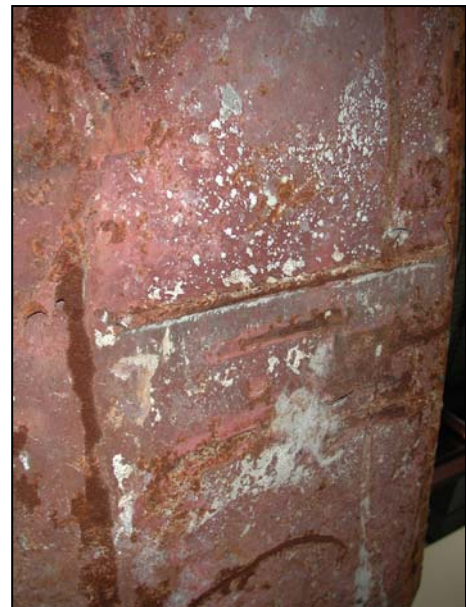
**N101-C3M (WTC 1, Col.132, Fl 102)**  
Type C  
Seat Detail: 5210

Gusset plate ripped out at weld.

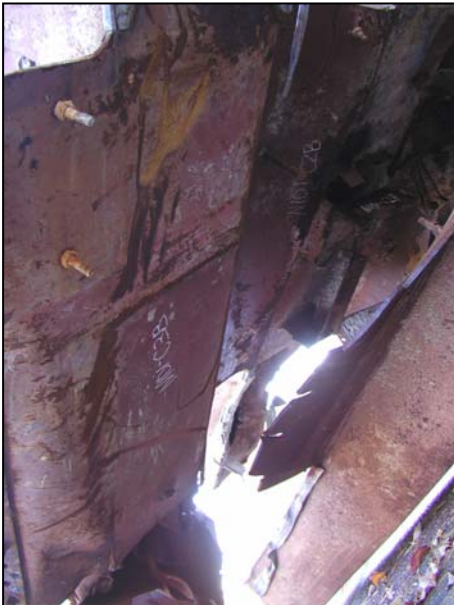
**N101-C3B (WTC 1, Col.132, Fl 101)**  
Type C  
Seat Detail: 5210

Gusset plate ripped out at weld.

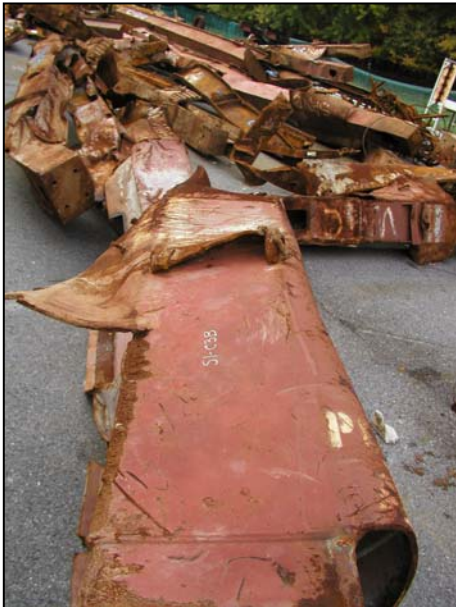
**S1-C3B (WTC 1, Col.432, Fl 80)**  
Type C  
Seat Detail: 5210

Gusset plate intact, bent downwards, with 2  
diagonal bracing straps attached.

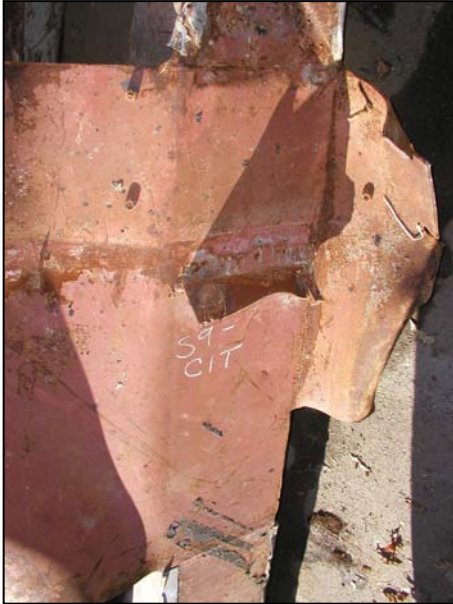
**S9-C1T (WTC 1, Col.134, Fl 100)**

Gusset plate intact, bent downwards, with diagonal bracing strap attached.

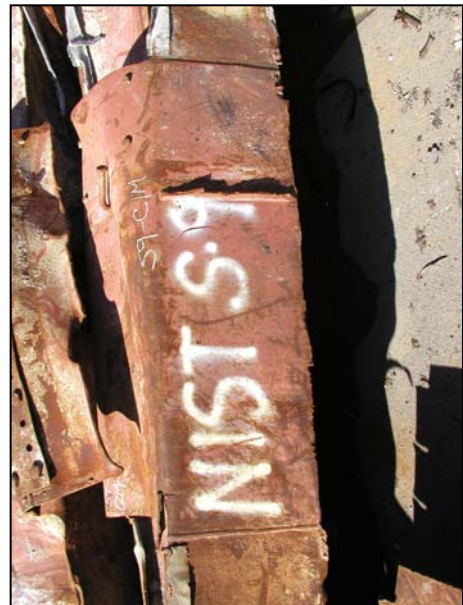
**S9-C1M (WTC 1, Col.134, Fl 99)**

Gusset plate ripped off at weld.

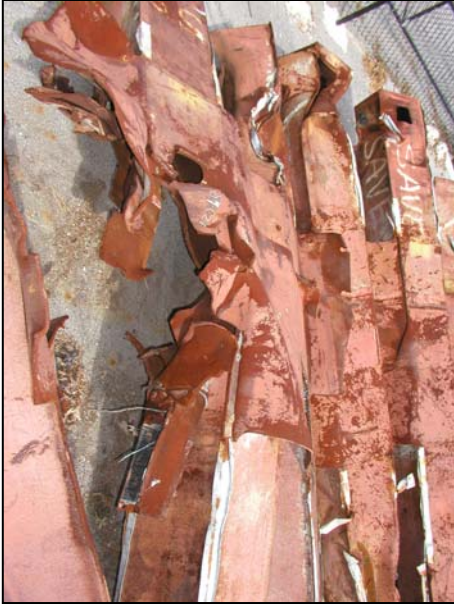
**S9-C2T (WTC 1, Col.133, Fl 100)**

Gusset plate intact;  
Seat intact, bent in towards column, 1 bolt hole intact  
with bolt and nut;  
Gusset plate for damper unit ripped off at weld.

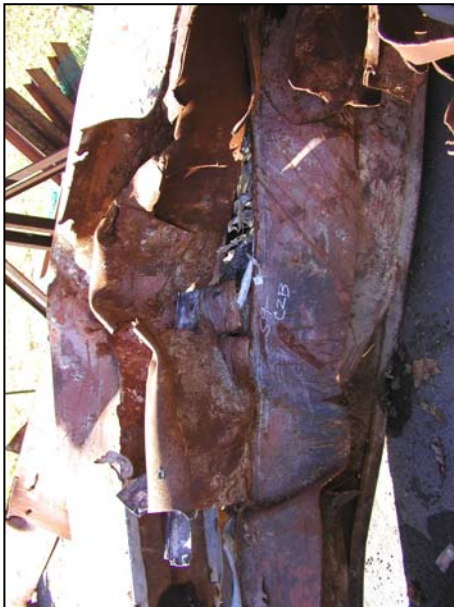
**S9-C2B (WTC 1, Col.133, Fl 98)**

Portion of gusset plate remains;  
Seat intact, has extra stiffener attached, both bolt  
holes intact;  
Gusset with damper unit intact, bent upwards.

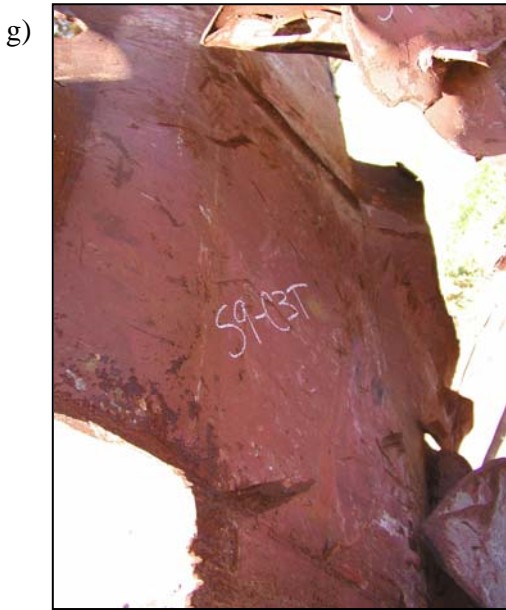
**S9-C3T (WTC 1, Col.132, Fl 100)**  
Type C  
Seat Detail: 5210

Gusset plate ripped out at weld.

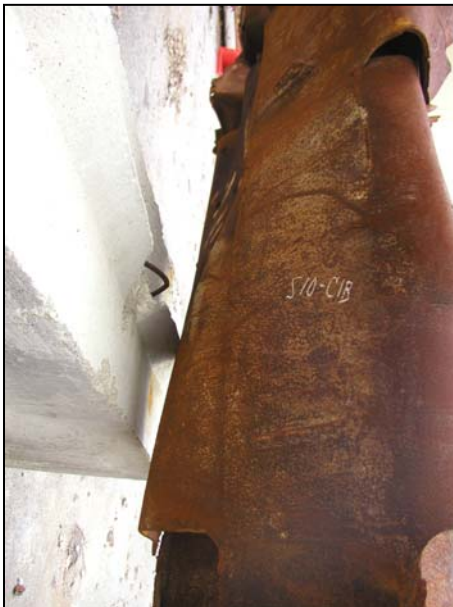
**S10-C1B (WTC 1, Col.225, Fl 93)**  
Type A  
Seat Detail: 1111

Portion of gusset plate remains;  
Standoff plates ripped off at welds;  
Gusset plate for damper unit ripped off at weld.

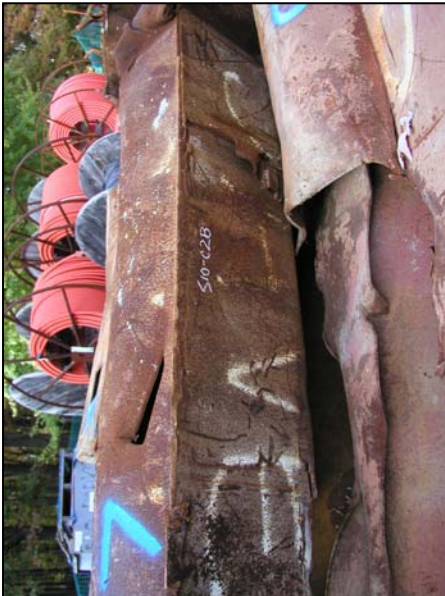
**S10-C2B (WTC 1, Col.224, Fl 93)**  
Type C  
Seat Detail: 5110

Portion of large gusset plate remains, bent downwards.

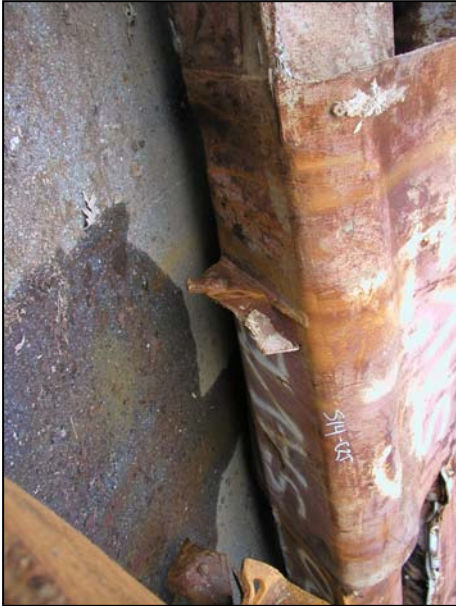
**S14-C2T (WTC 2, Col.218, Fl 94)**

Large gusset plate ripped off at weld.

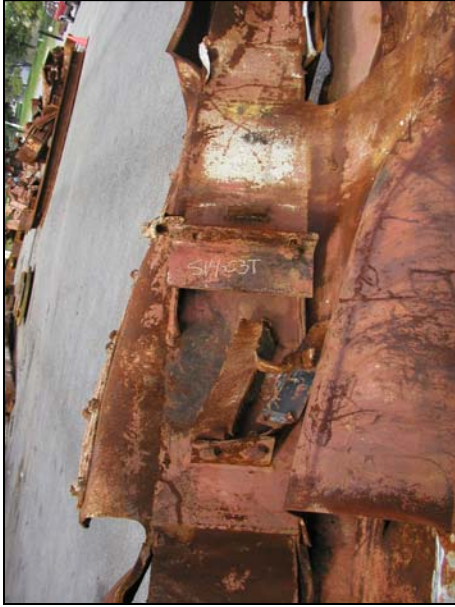
**S14-C3T (WTC 2, Col.217, Fl 94)**  
Type A  
Seat Detail: 1611

Gusset plate intact;  
Seat intact, both bolt holes intact, only one has bolt and nut;  
Gusset plate with damper unit intact, bent upwards.

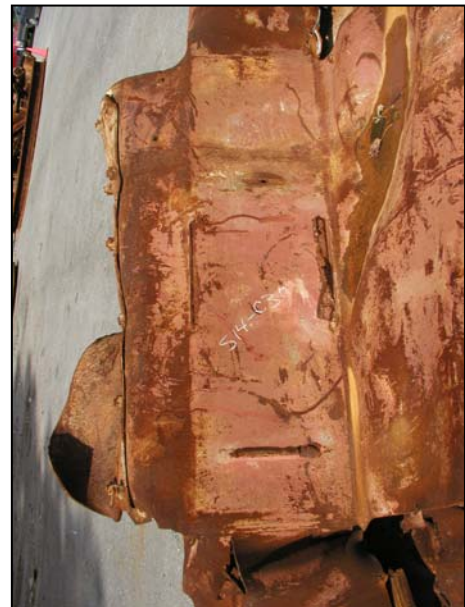
**S14-C3M (WTC 2, Col.217, Fl 93)**  
Type A  
Seat Detail: 1611

Gusset plate ripped out of spandrel;  
Only 1 standoff plate remains, rest ripped off at welds;  
Gusset plate for damper unit ripped off at weld.

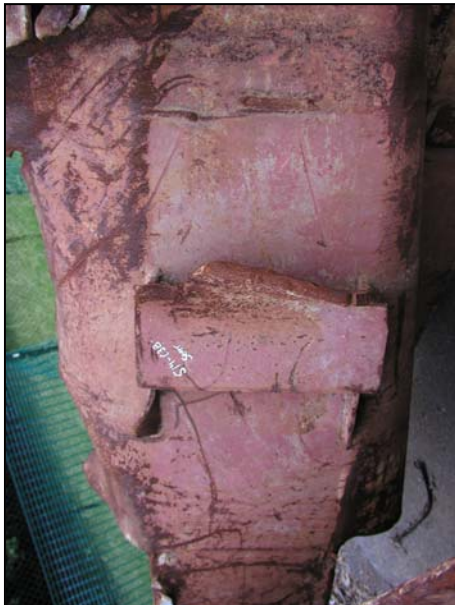
**S14-C3B (WTC 2, Col.217, Fl 92)**  
Type A  
Seat Detail: 2160

Gusset plate ripped off at weld;  
Seat intact, both bolt holes ripped out;  
Gusset plate for damper unit ripped off at weld.

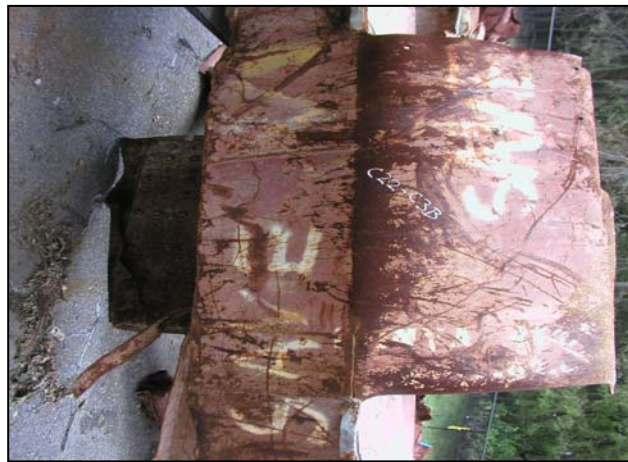
b)

Seat 2: Both holes intact, both have bolts remaining, seat was bent

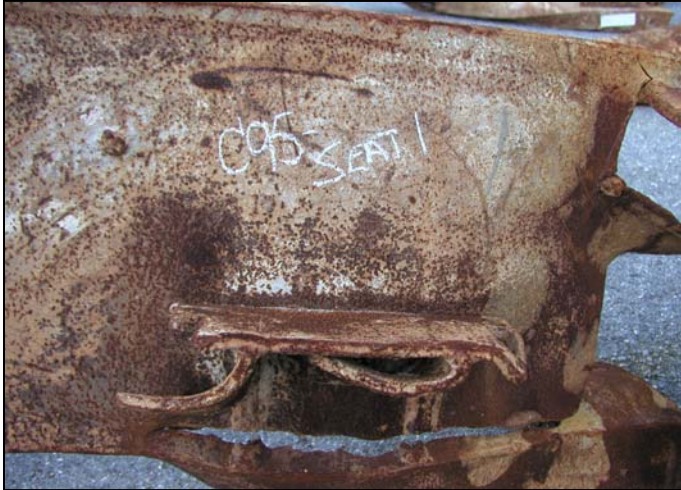
**Figure C-2. Sample C-95, channel with one seat.**

One seat with one hole intact, other ripped out, seat was bent

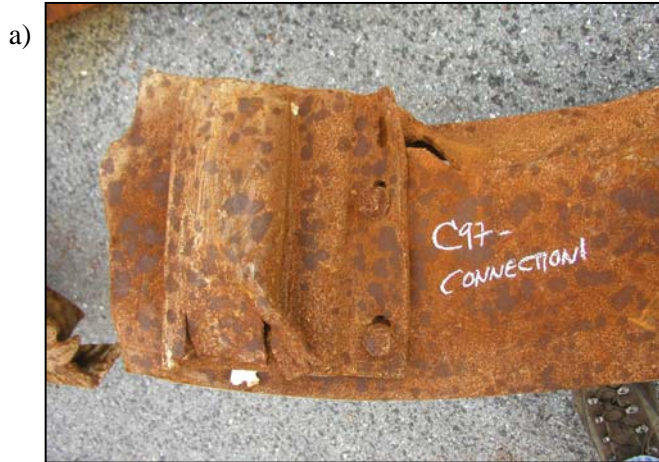
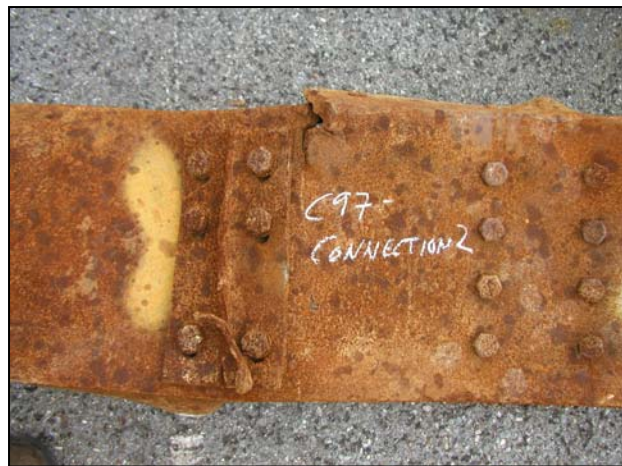
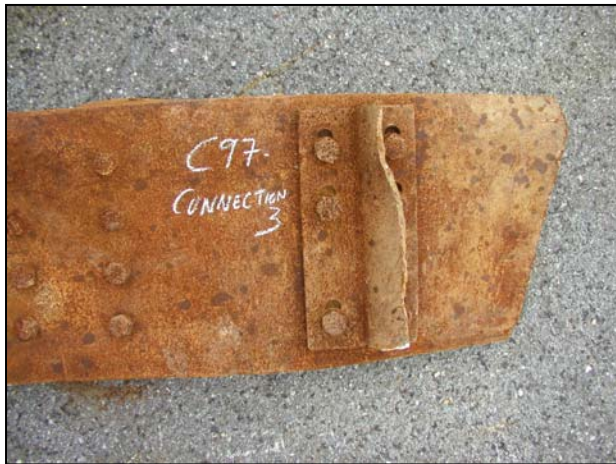
**Figure C-4. Sample C-97, channel with three connectors.**

Connector 1

Connector 2

Connector 3

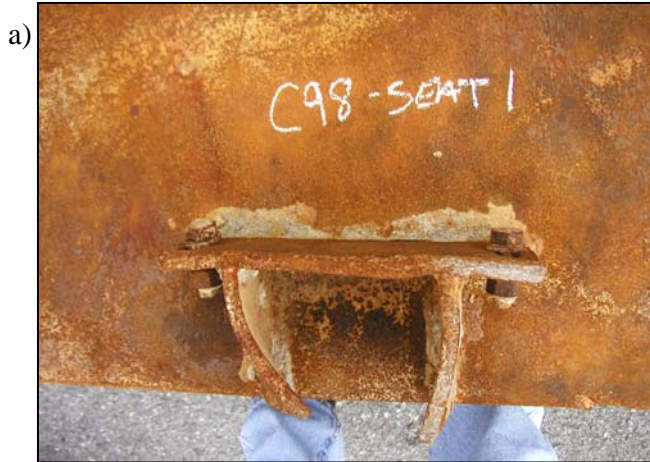
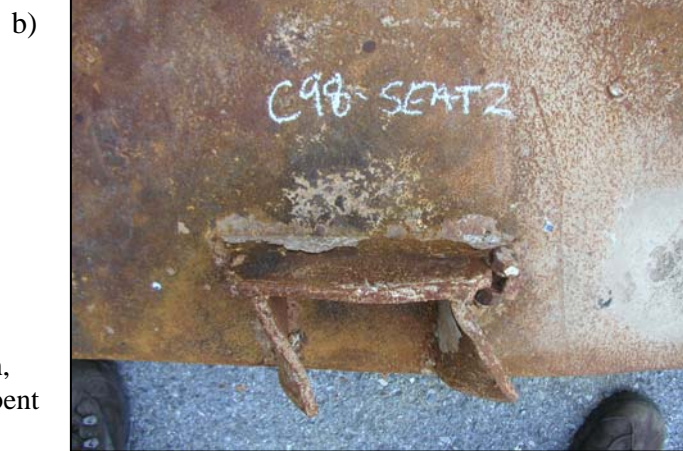
**Figure C-5. Sample C-98, channel with two seats.**

Seat 1: Both holes intact, both have bolts remaining, seat was bent

Seat 2: Both holes ripped through, one has bolt remaining, seat was bent

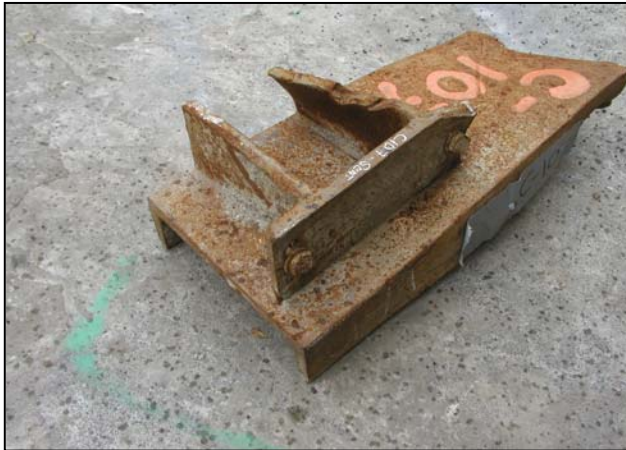
**Figure C-7. Sample C-107, channel with one seat.**

One seat with both holes intact, both holes have bolts remaining
