## Appendix A

# EXAMPLES OF PERIMETER PANEL FLOOR TRUSS CONNECTORS

The floor trusses were attached to the perimeter panels at the interior intersection of the columns and spandrels by different types of connectors. The following appendix displays photographic examples, taken by National Institute of Standards and Technology (NIST), of these types of connectors as observed on the recovered panels.

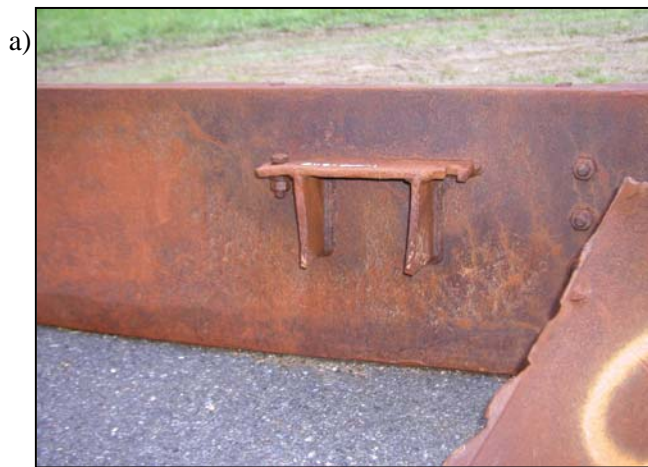
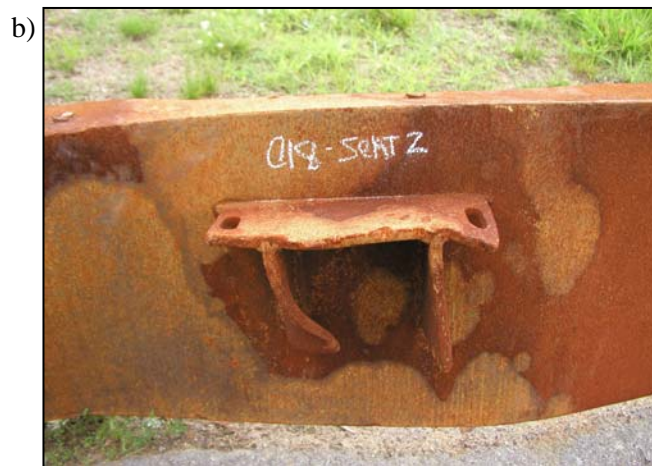
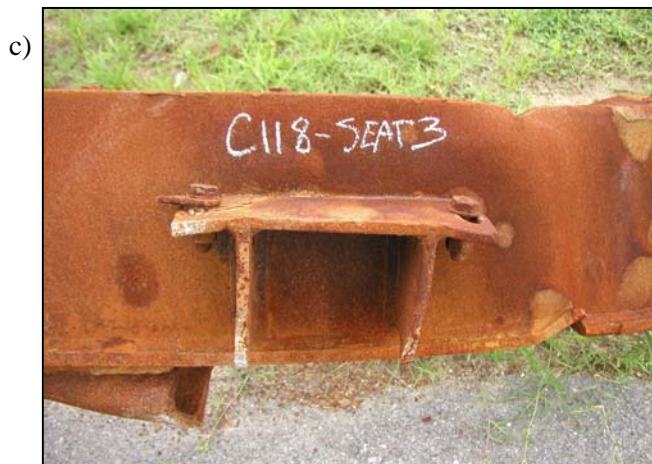
**Figure C-8. Sample C-118, channel with three seats.**

Seat 1: One hole intact with bolt, other ripped out

Seat 2: Both holes intact, seat was slightly bent

Seat 3: Both holes intact with bolts remaining

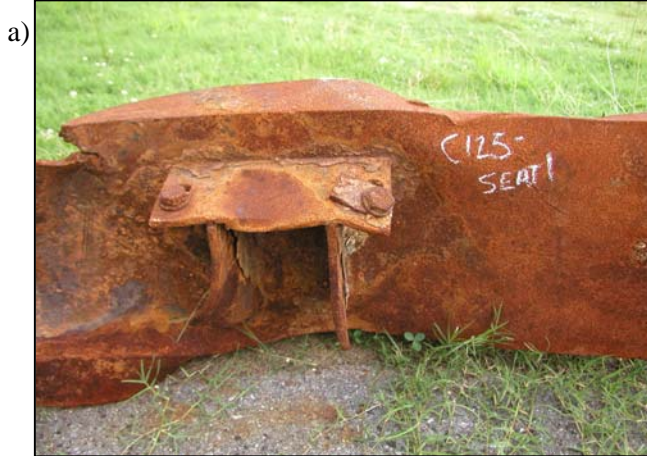
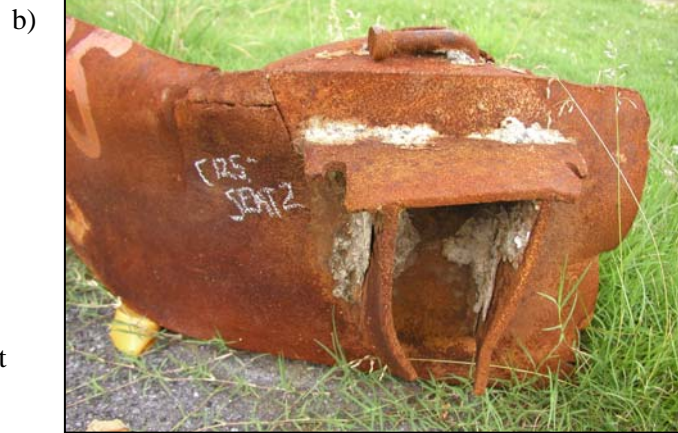
**Figure C-9. Sample C-125, channel with two seats.**

Seat 1: Both holes intact with bolts remaining, one has piece of angle attached, seat was bent

Seat 2: Both holes ripped out, seat was bent

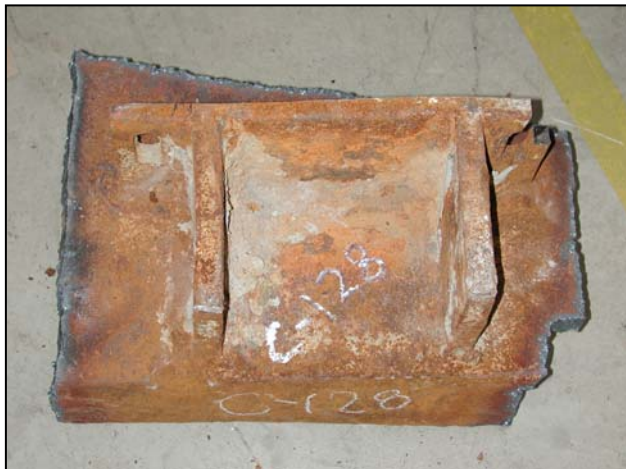
**Figure C-10. Sample C-128, channel with one seat.**

One seat with one hole intact with bolt, other is ripped out

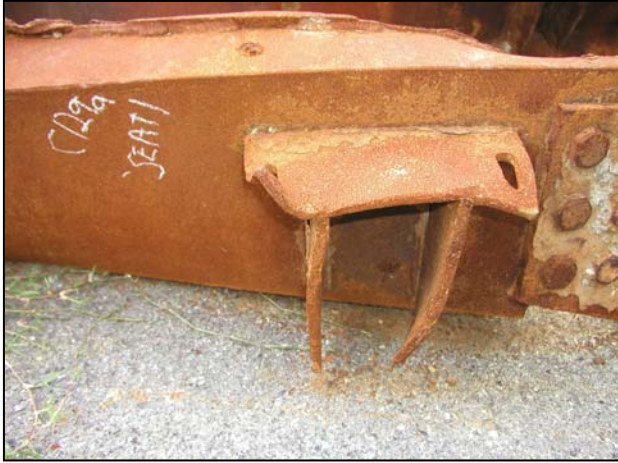
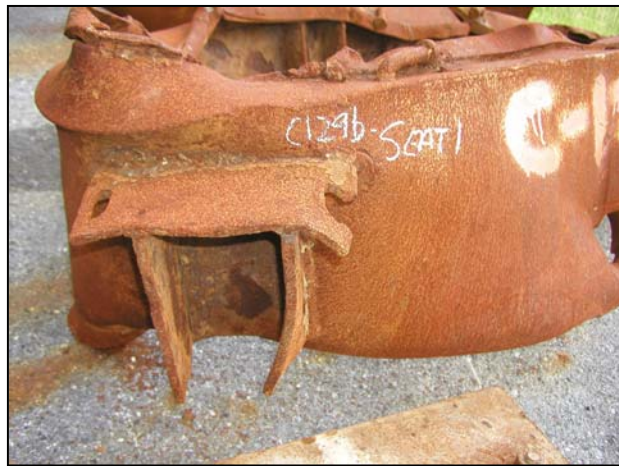
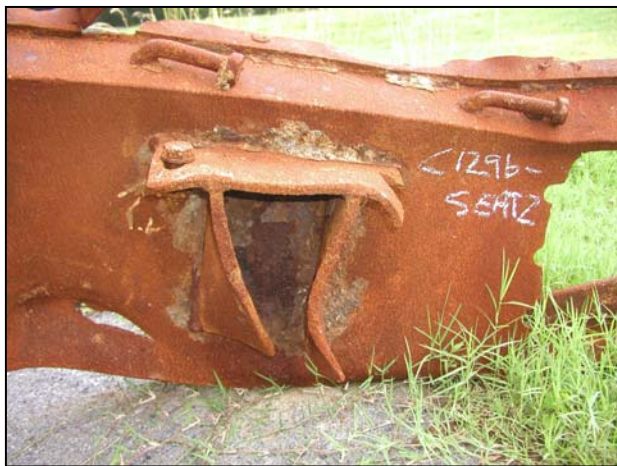
**Figure C-11. Sample C-129, two connected channels with three seats.**

Seat 1a: One hole intact, other ripped out, seat was bent

Seat 1b: One hole intact with bolt, other is ripped out, seat was bent

Seat 2b: Both holes intact, seat was bent

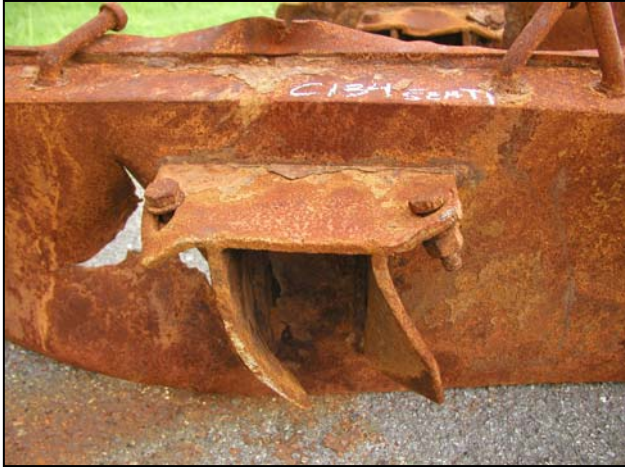
**Figure C-12. Sample C-134, channel with one seat.**

One seat with both holes intact, both holes have bolts remaining, seat was bent

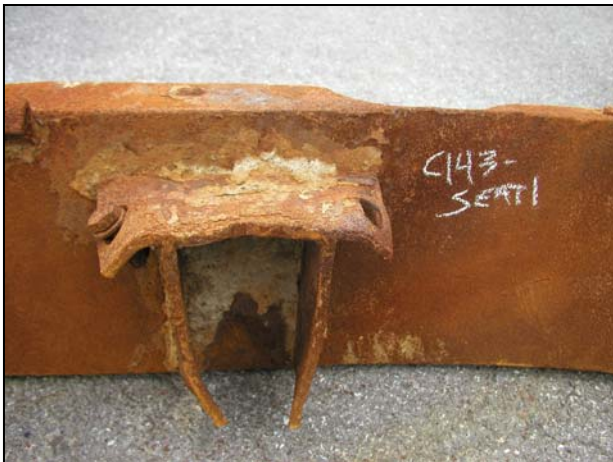
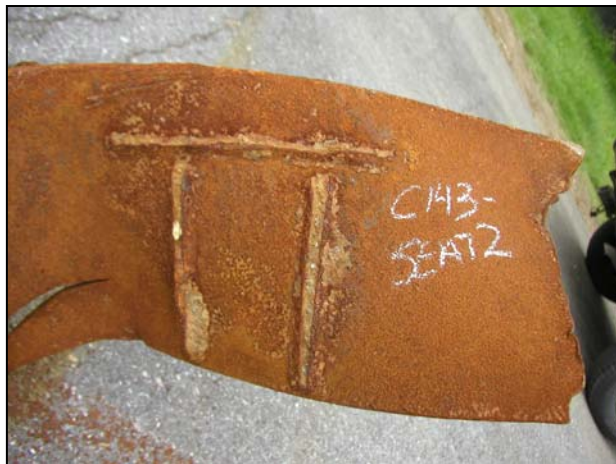
**Figure C-15. Sample C-143, channel with two seats.**

Seat 1: Both holes intact, one has bolt remaining, seat was bent

Seat 2: Ripped off at the weld

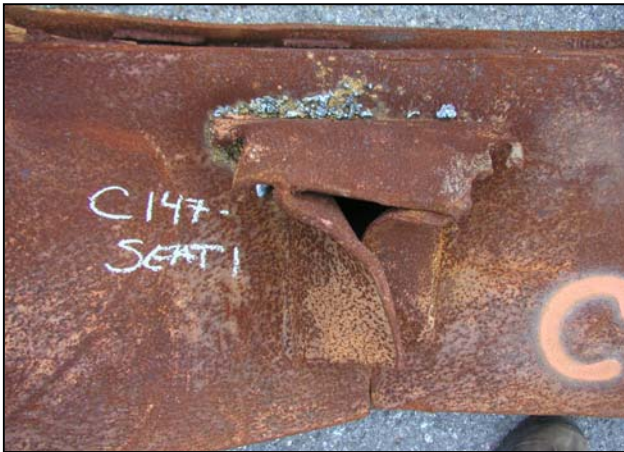
**Figure C-18. Sample C-147, channel with one seat.**

One seat with both holes ripped out, seat was bent

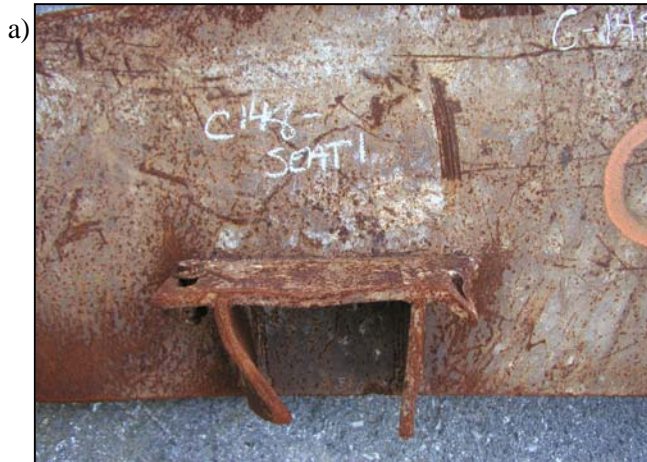
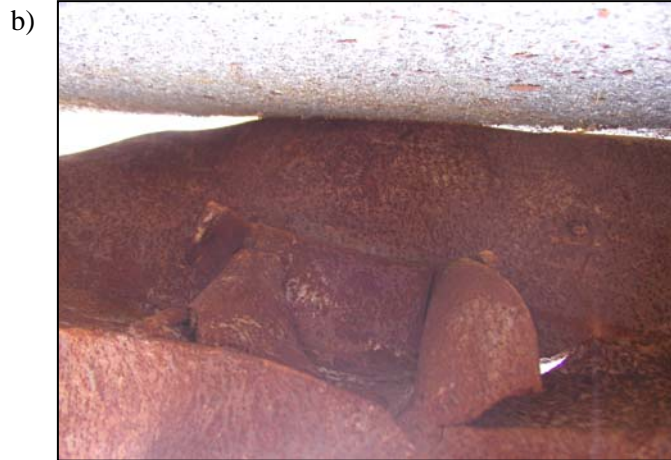
**Figure C-19. Sample C-148, channel with two seats.**

Seat 1: Both holes intact, one has bolt

Seat 2: Both holes ripped out, seat crushed

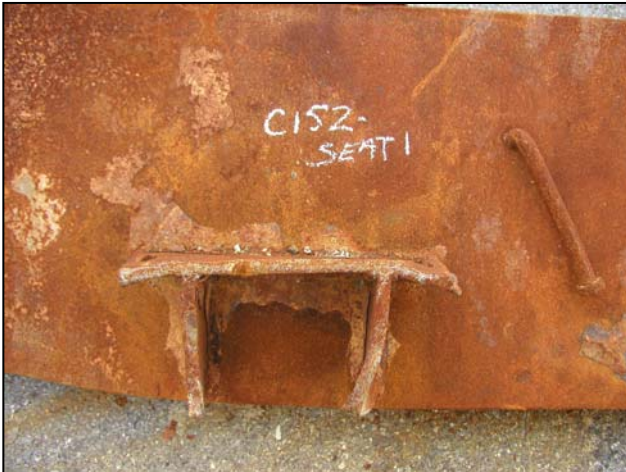
**Figure C-20. Sample C-152, channel with one seat.**

One seat with both holes intact

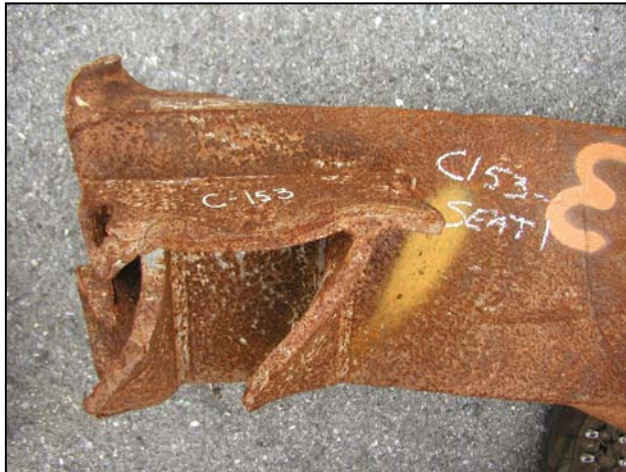
**Figure C-21. Sample C-153, channel with one seat.**

One seat with both holes ripped out, seat was bent

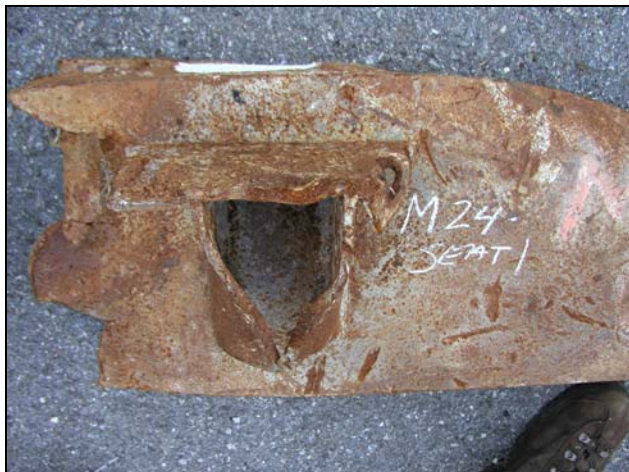
**Figure C-22. Sample M-24, channel with one seat.**

One seat with both holes intact,  
seat was bent

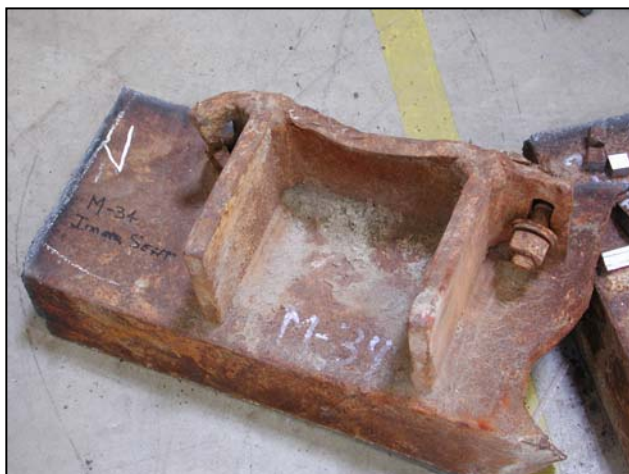
**Figure C-23. Sample M-34, channel with one seat.**

One seat with one hole intact with  
bolt remaining, other was ripped out

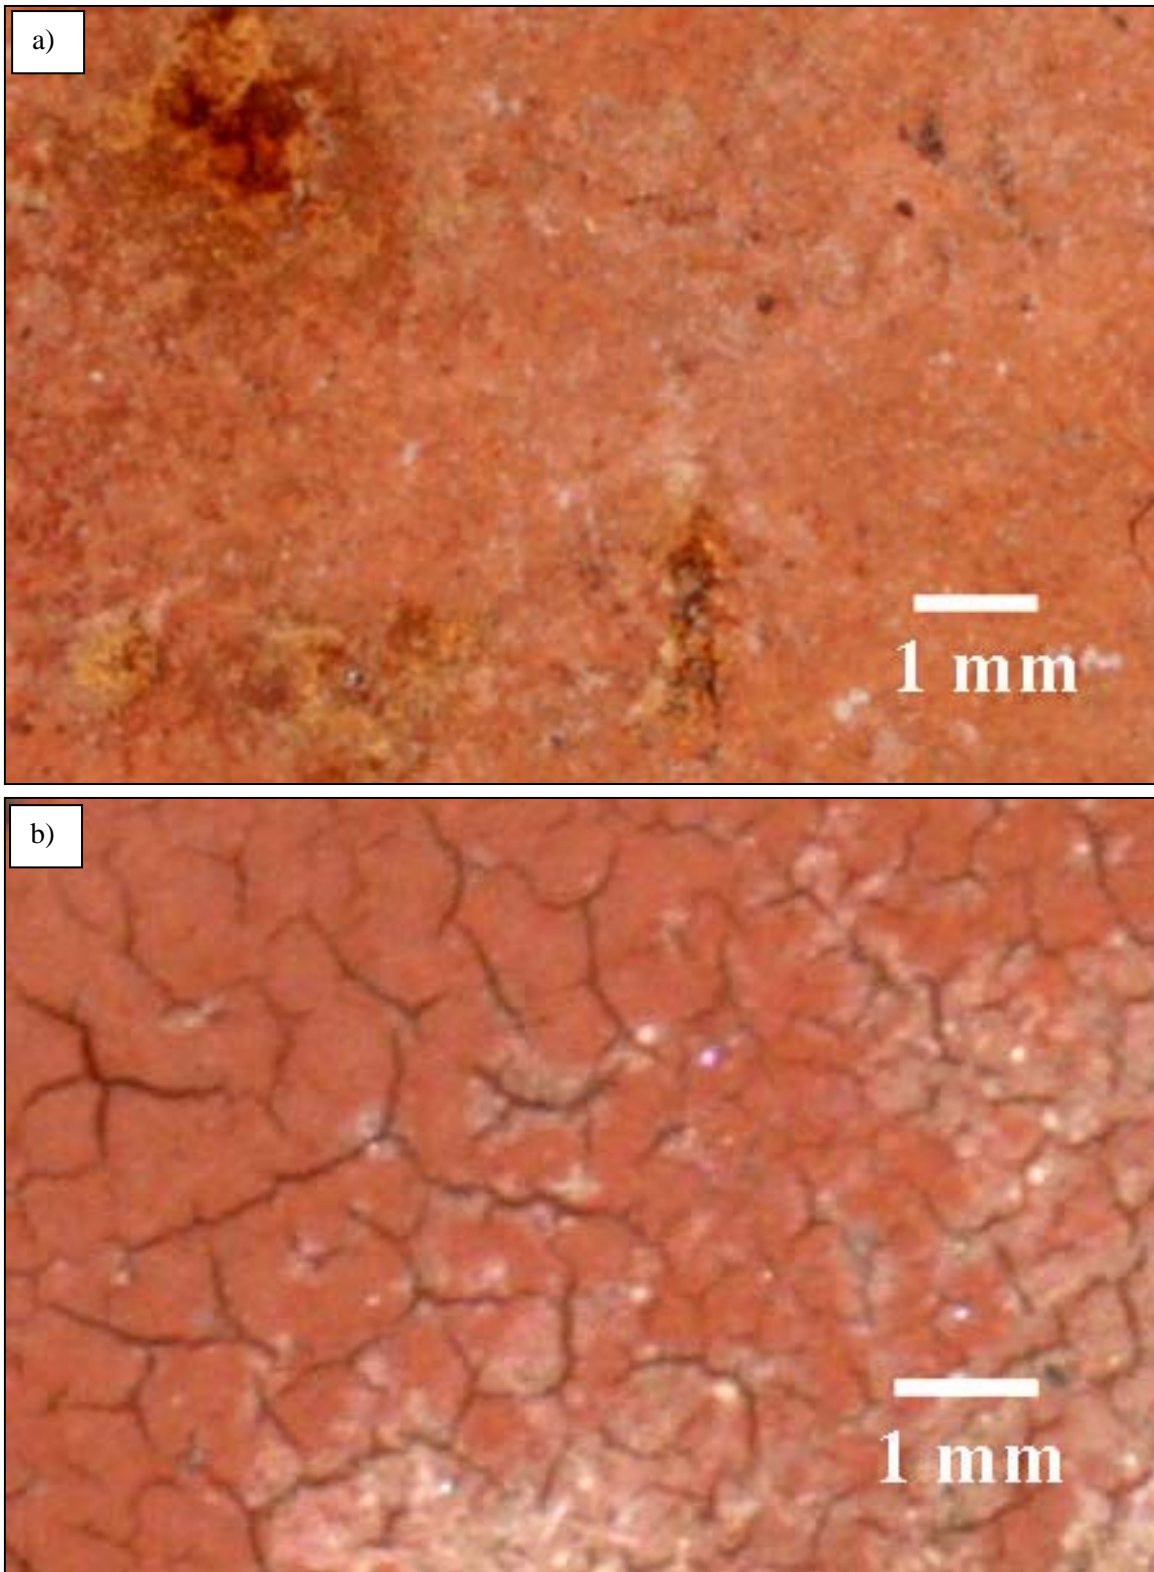
Under the assumption that this was a typical paint with an organic binder, initial burn tests were conducted at relatively low temperatures, looking for the temperature at which the paint will combust. The paint was unaffected at exposure temperatures below approximately 250 °C (Fig. D-1a). Beginning with exposure temperatures of 250 °C, the samples began to exhibit noticeable "mud crack" patterns (Fig. D-1b). These were formed when the paint is put into biaxial tension under the influence of the thermal expansion mismatch between the paint and the base steel. This temperature where the first mud crack patterns appear did not vary between samples by more than 25 °C and was not found to be a function of exposure time beyond this range. Additional burn tests at temperatures up to 650 °C produced mud-crack patterns (Fig. D-1c) that were indistinguishable in size or character from those produced at 250 °C. Figure D-2 shows the time dependence of the mud cracking appearance at 250 °C. These results would indicate that the paint has a characteristic size of the un-cracked islands of the paint that is not subdivided by heating to higher temperatures.

**Figure D-1. Photographic images of the primer paint. a) paint in its original condition and b) mud cracking of paint after exposure at 250 °C for 1 h.**

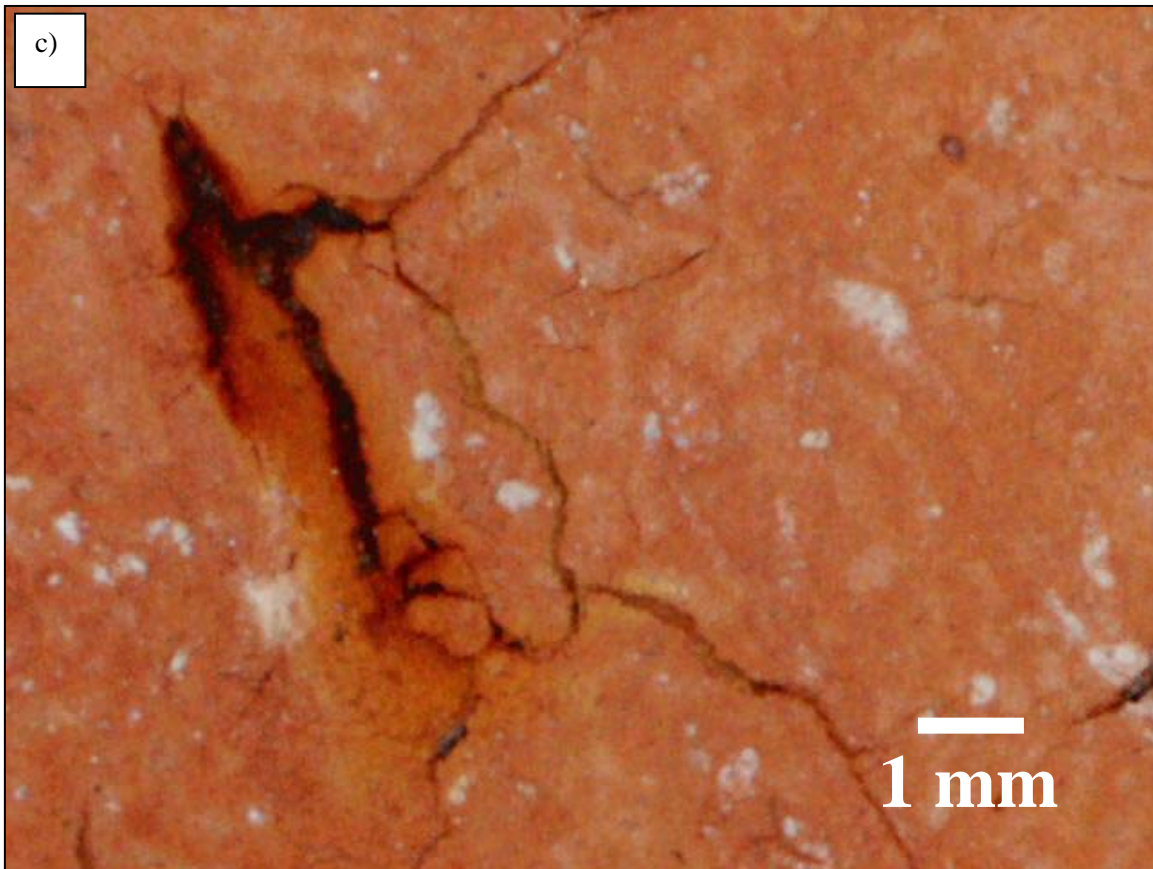
**Figure D-2. Photographic images of the primer paint. c) mud cracking of paint after exposure at 650 °C for 1 h.**

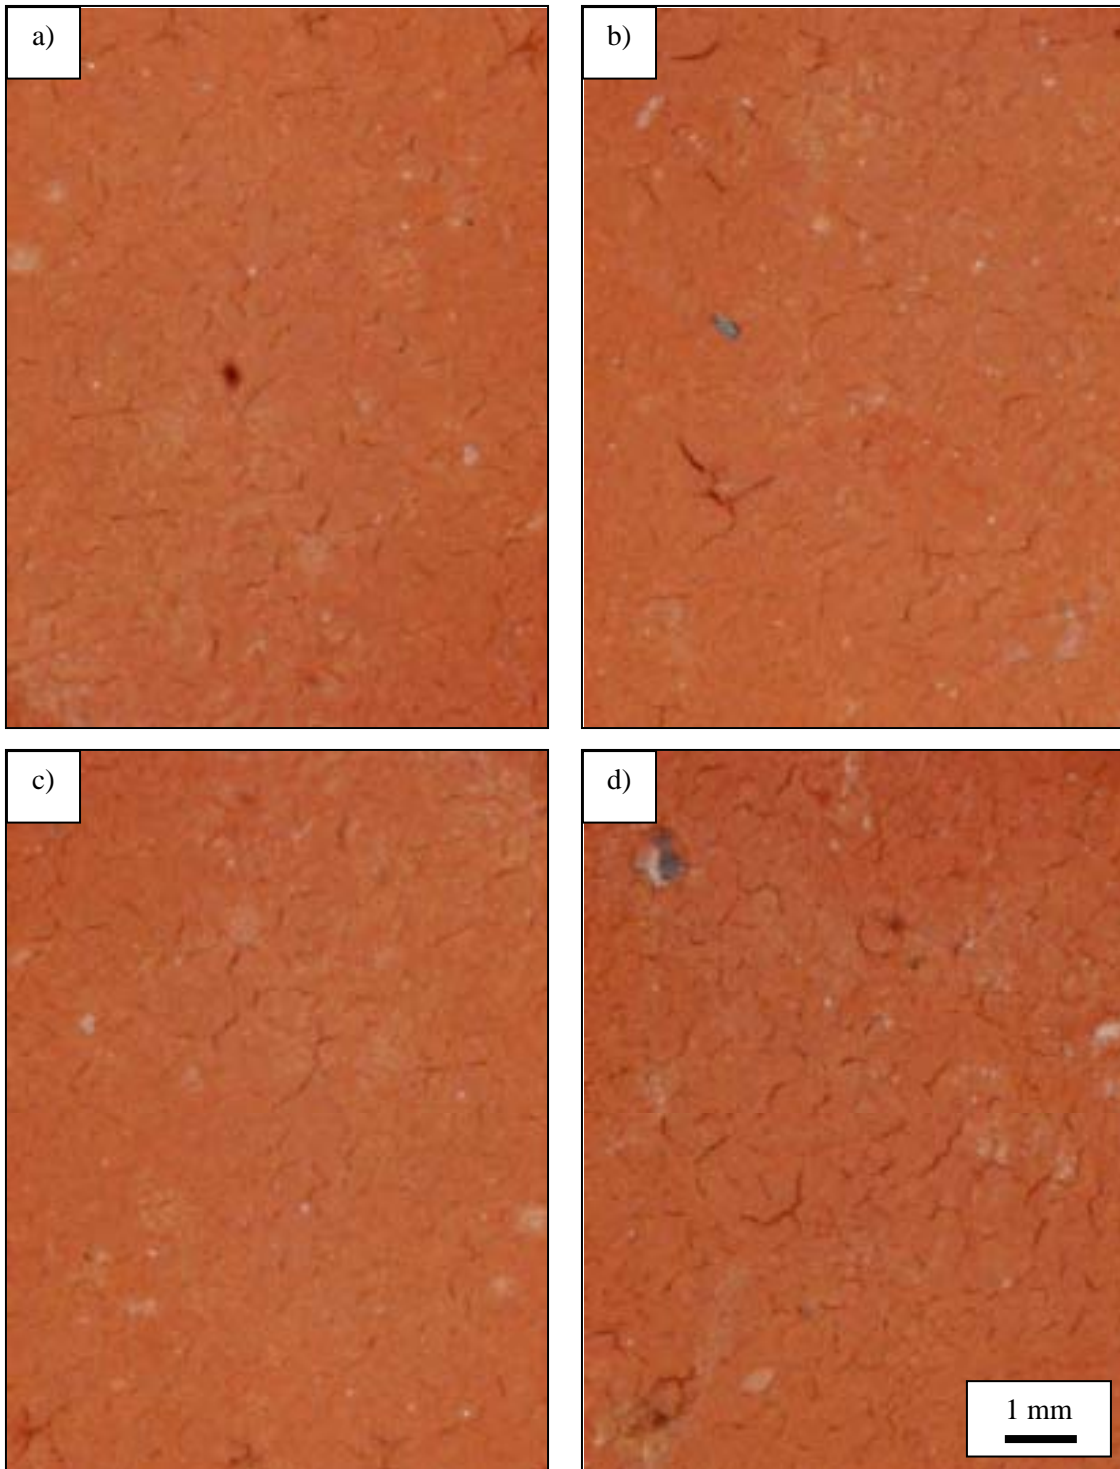
**Figure D–3. Mud cracking appearance as a function of time. Exposure temperature was 250 °C. a) 0.25 h, b) 0.5 h, c) 1 h, and d) 2 h. Note that these images are taken under different magnification and illumination conditions than Figure D–1(b).**

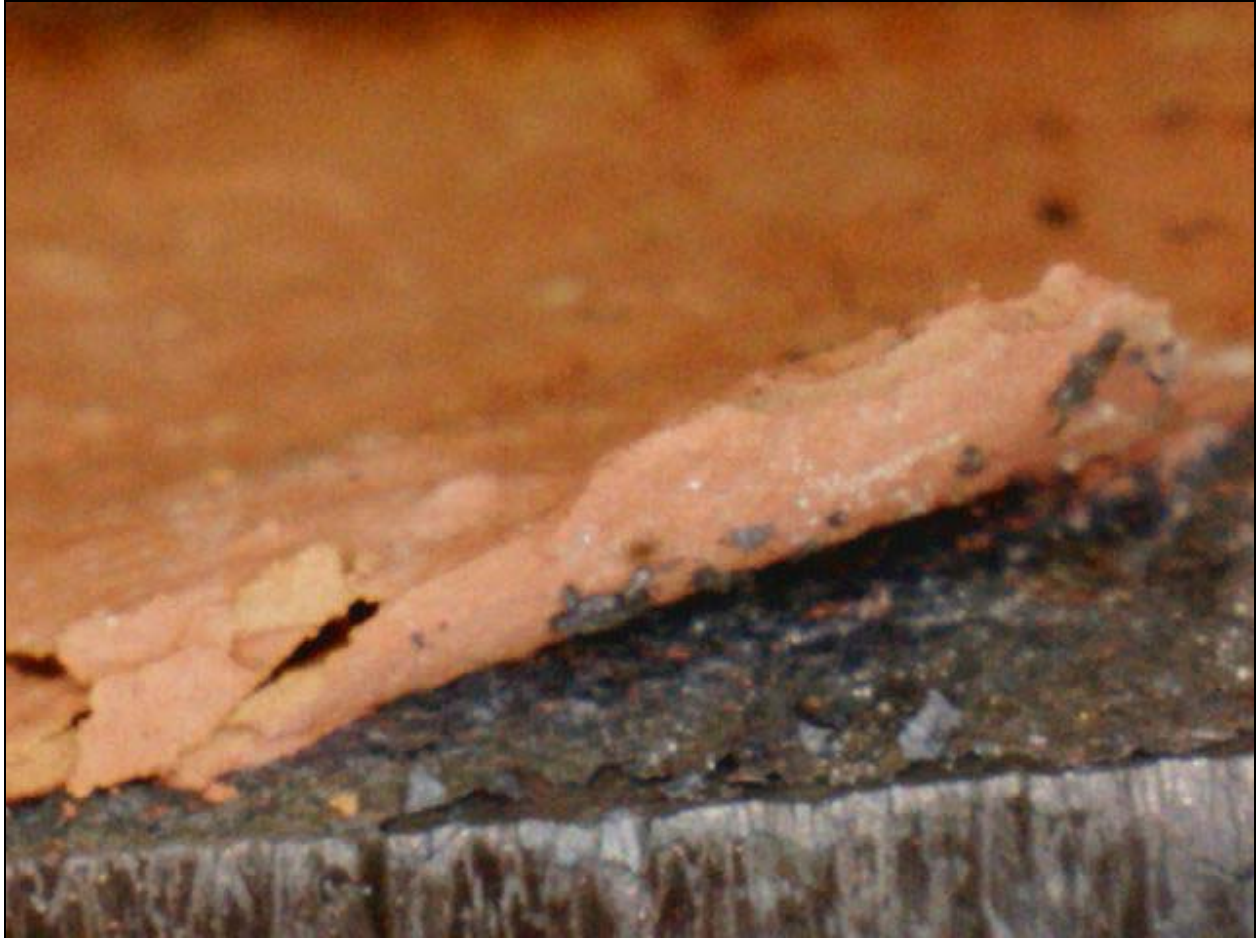
Beyond approximately 650 °C (plus or minus approximately 50 °C for the samples tested), a black scale formed between the steel and the paint, Fig. D-3. This scale layer had very poor adherence to the steel, and the paint was seen to flake off with slight pressure. Above approximately 800 °C, the kinetics of the scale formation were very fast, and after short exposures to this temperature a thick scale formed and spalled off of the steel, carrying away the paint. This left a very dark blue-black colored surface to the steel.

**Figure D-4. Formation of a black scale between paint and steel after exposure greater than 650 °C. Paint readily spalled.**

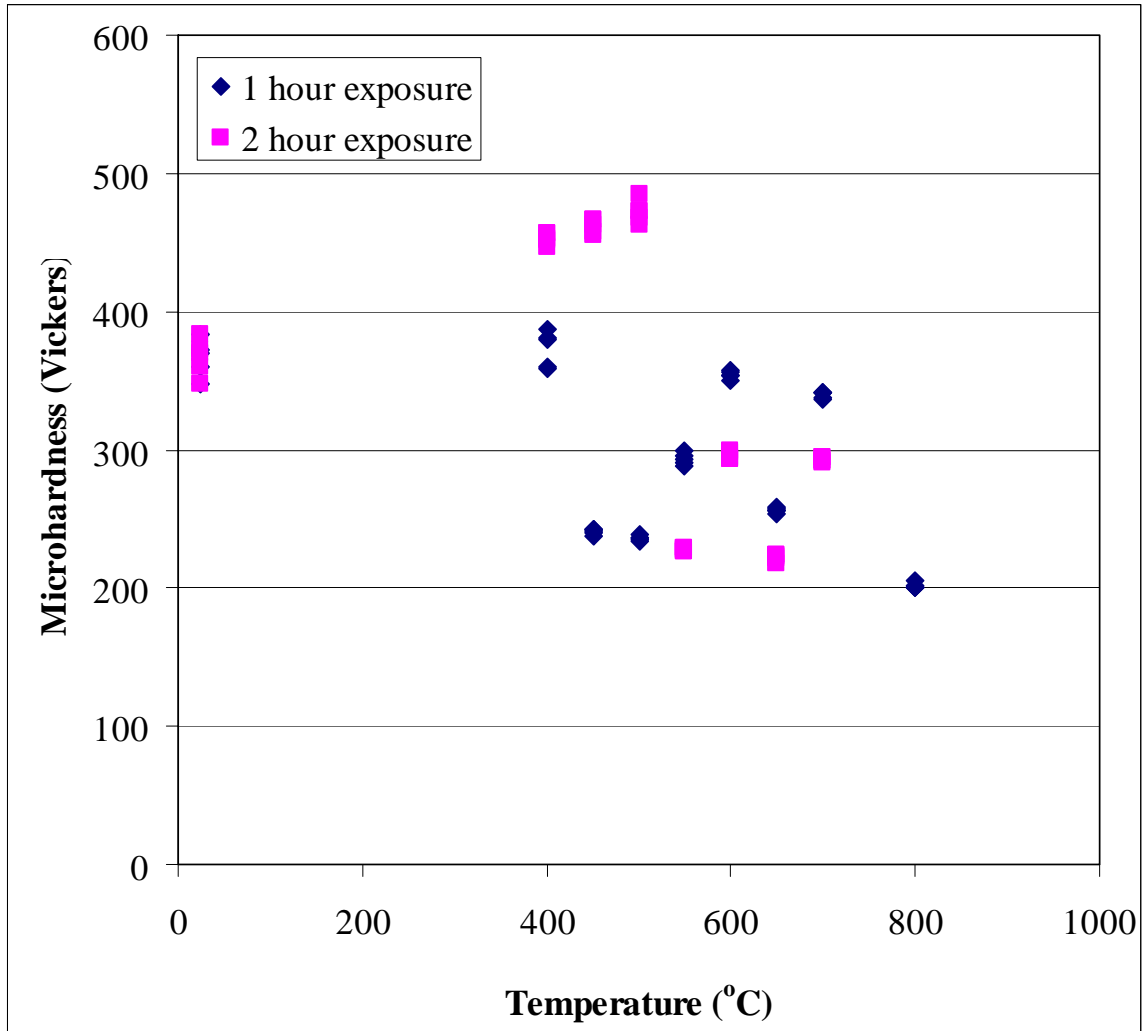
The washers used on the vertical and spandrel bolted connections of the panels of the exterior wall were punched from high strength steel sheet and were subjected to a post-manufacturing anneal to decrease the possibility of warping or cracking. These washers have a high hardness which relies on metastable microstructures and residual stresses that may change with high temperature exposure. The hardness of the washers of the vertical and spandrel panel connections was examined to see if they could give an indication of the maximum temperature of exposure for a given associated component.

Figure D-5. Plot of Vickers microhardness versus exposure temperature for washers recovered from WTC structural steel.

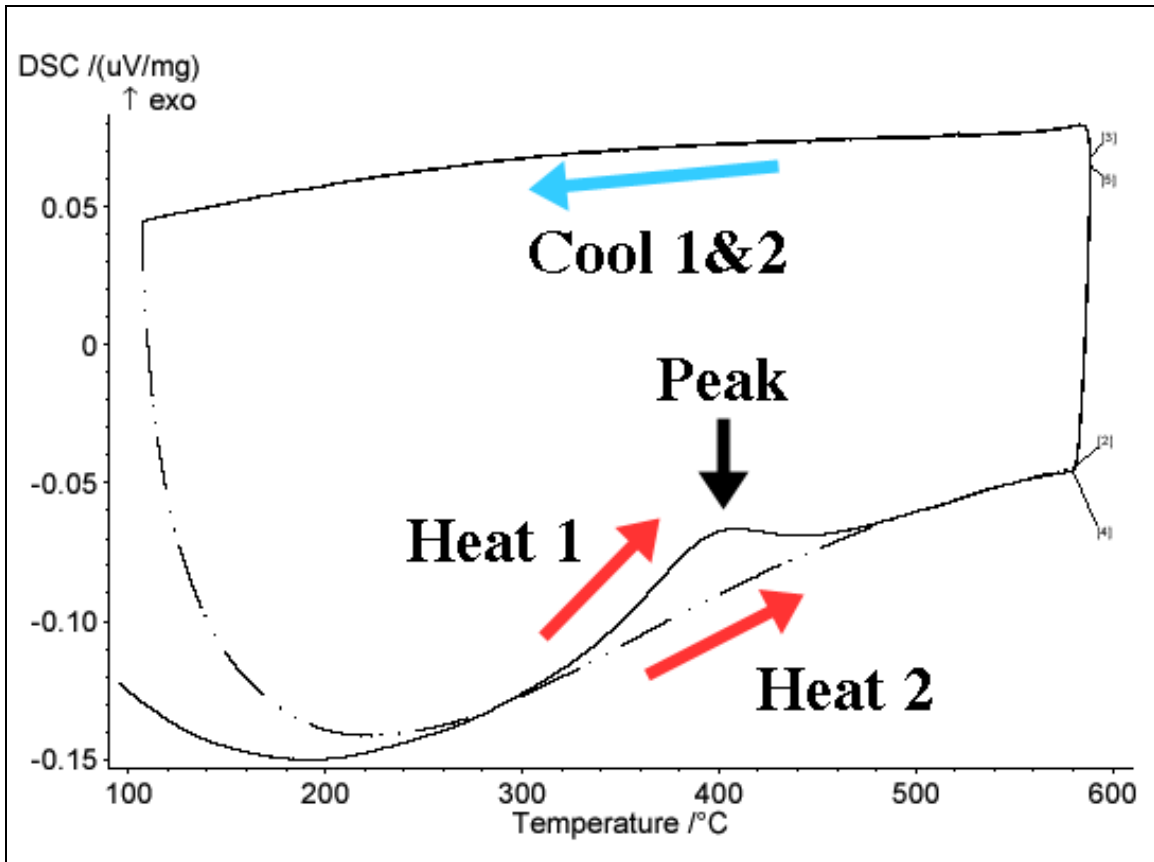
Samples of weld and base metal were cut from pieces retrieved from the WTC. These were subjected to DTA scans over a temperature range of 0 °C to 800 °C. DTA tests were performed on samples from three locations: weld metal, inner web, and flange plate from a sample with  $F_y = 100$  ksi (panel C-10). The initial microstructure of the inner web and flange plate was quenched and tempered. Cylinders, 3 mm diameter and 1 cm long, were cut by Electrical Discharge Machining (EDM). The cylinder from the weld metal was cut with its axis parallel to and centered in the weld zone. Other samples were cut from several locations from the flange and inner web away far from the weld zone. DTA scans were performed in gettered Ar on ~100 mg slices from the EDM cylinders.

Figure D-6. DTA scans of weld metal taken from panel C-10 (A451: 85-88). First scan shows exothermic peak from non-equilibrium structure. Peak is missing in subsequent scan.

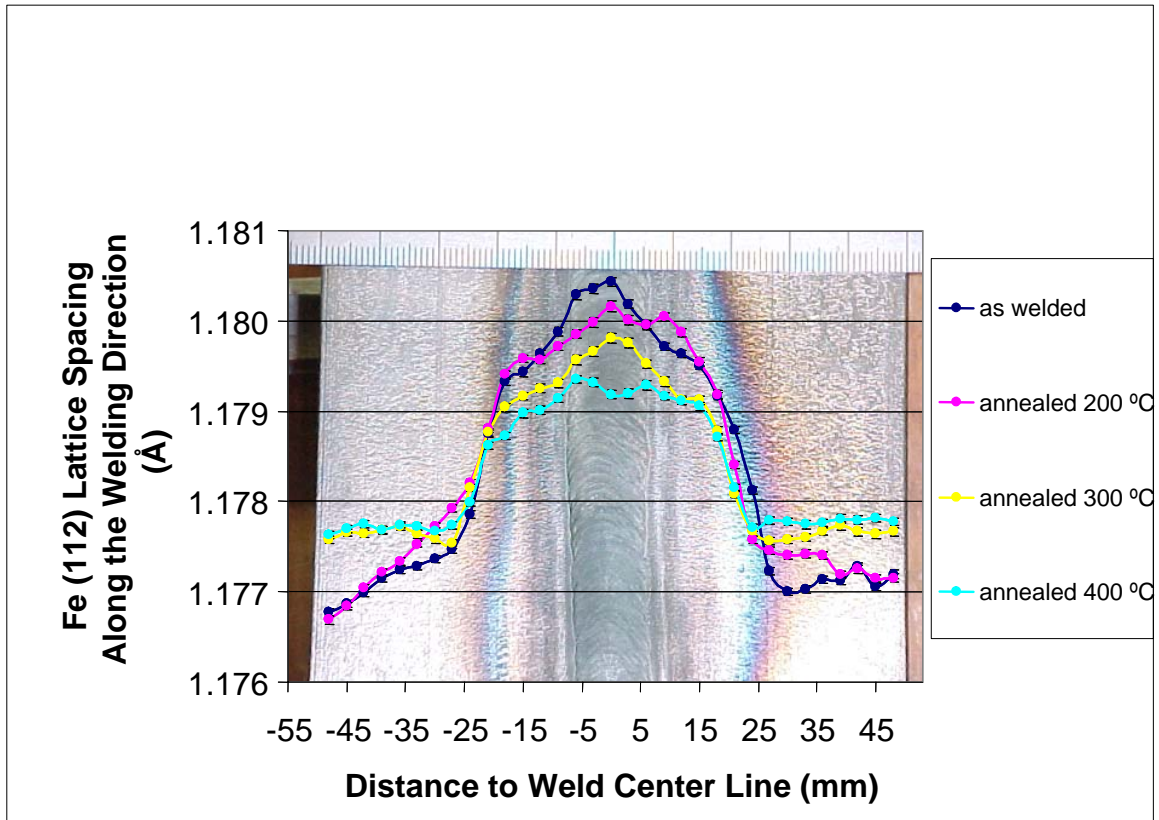
In addition to metastable microstructural phases, residual stresses develop during weld cooling. These form when the yield stress of the cooling metal increases sufficiently to resist deformation against the thermal expansion (contraction) stresses within the weld metal. If the weld metal cools fast enough, the stresses trapped within the structure are large. Annealing at a given temperature will allow the stresses to relax by lowering the flow stress of the metal and allowing plastic flow to occur. Measurement of the residual stresses in welds was surveyed as a possible indicator of the temperature that might have been reached in a fire.

Figure D-7. Residual stress profiles measured in prototype welds on non-WTC steel using neutron diffraction.

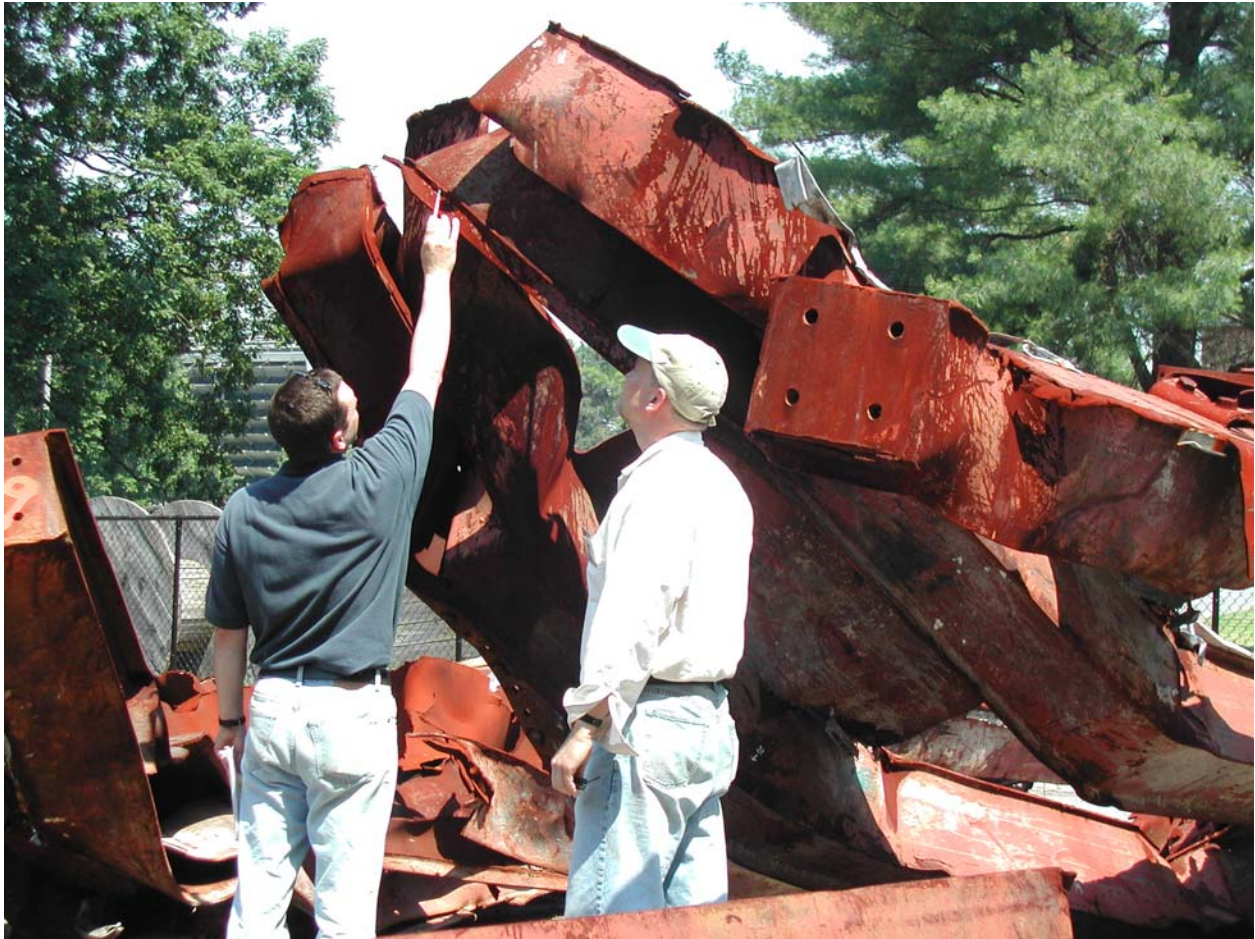
*Figure 4. Contract engineers examine Piece M-2*

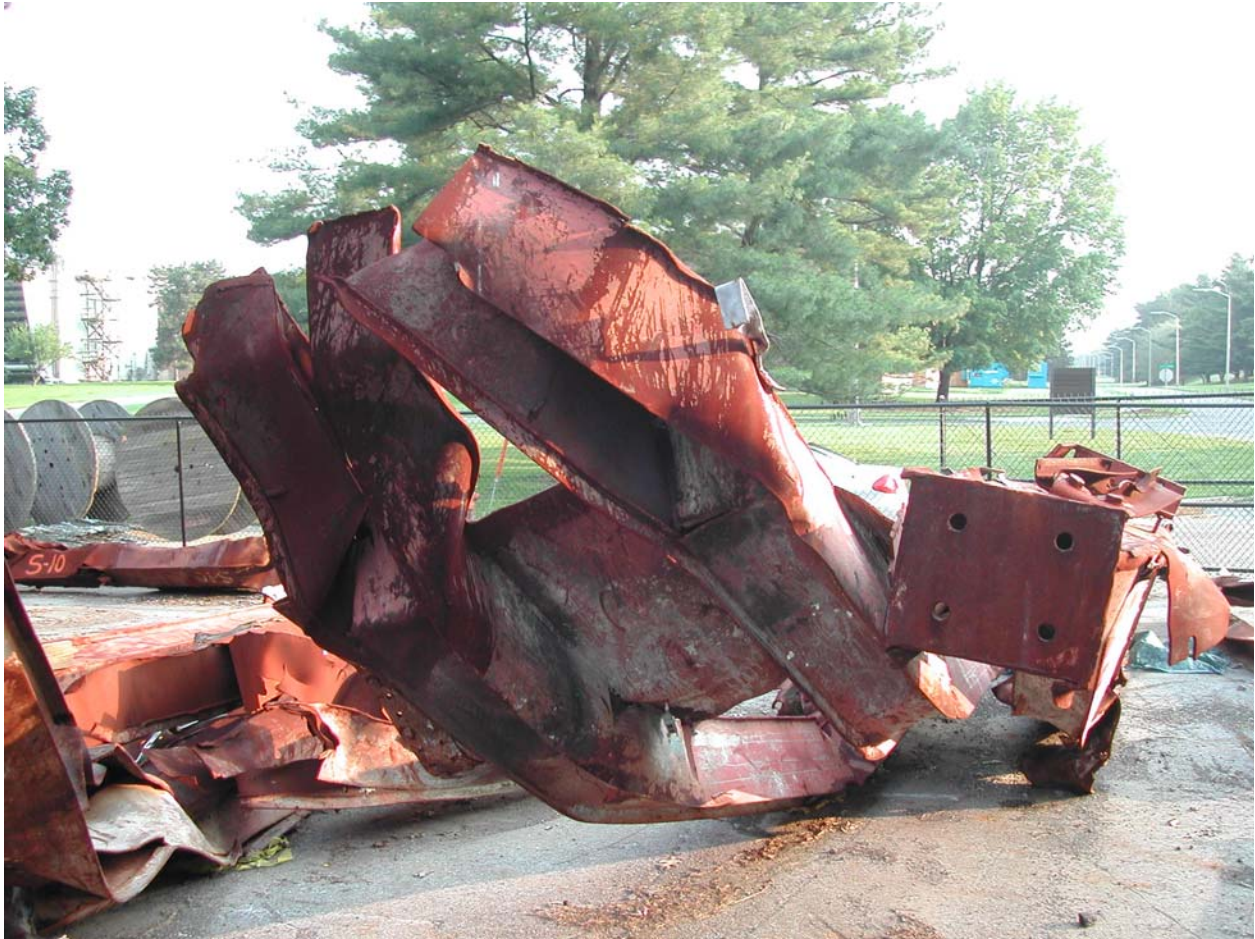
*Figure 12. The extreme ends of the column elements in Piece M-2*

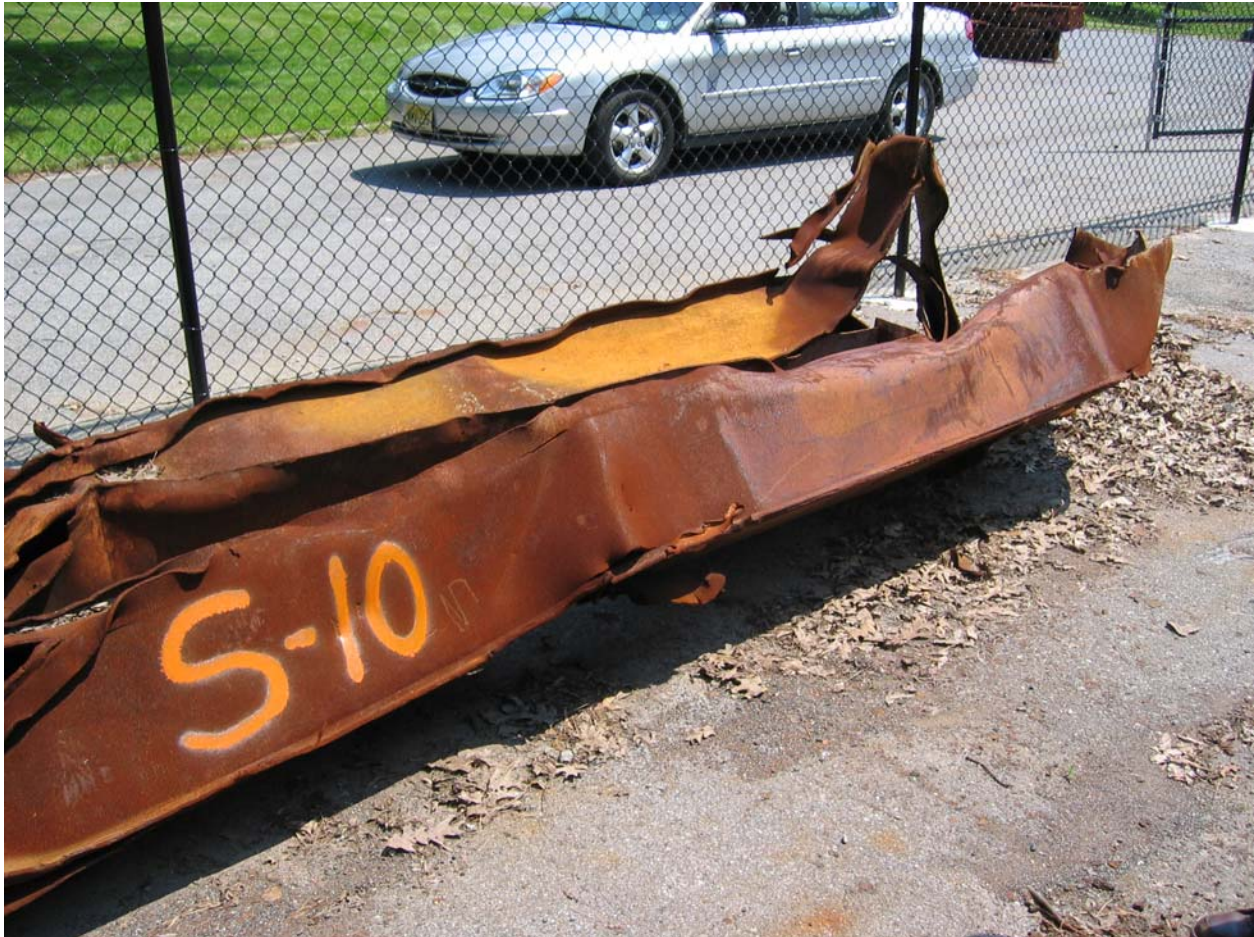
*Figure 15. Pattern of possible fire effects (absence of paint at left; presence of paint at right) observable on the side face of Column 224 of Piece S-10*

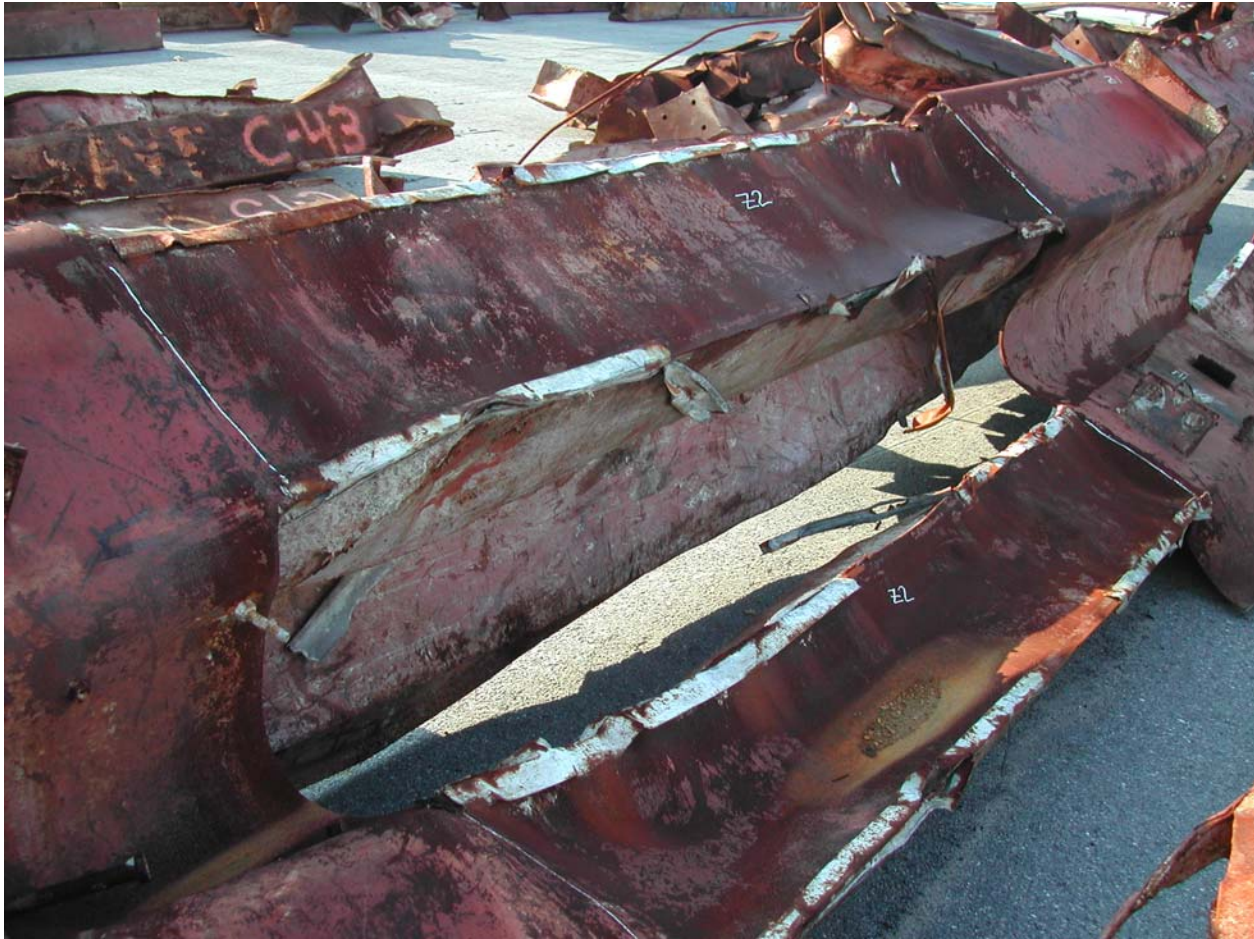
*Figure 16. Pattern of presence and absence of possible fire effects on column elements of Piece M-4. Zones marked Z2 at middle are possible fire-effected areas at window openings. Spandrel plates above and below window openings appear unaffected by fire.*

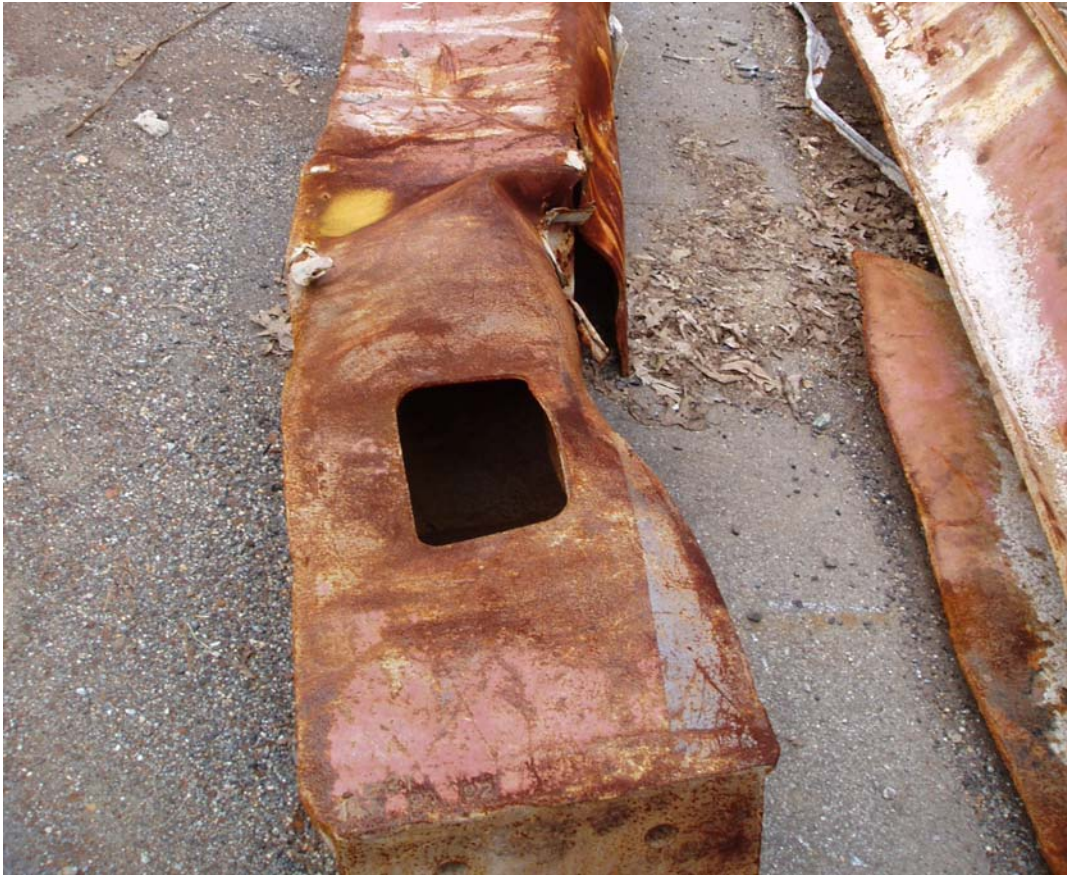
*Figure 17. Possible fire effects on lower end of Piece K-2*
