## Appendix A

# EXAMPLES OF PERIMETER PANEL FLOOR TRUSS CONNECTORS

The floor trusses were attached to the perimeter panels at the interior intersection of the columns and spandrels by different types of connectors. The following appendix displays photographic examples, taken by National Institute of Standards and Technology (NIST), of these types of connectors as observed on the recovered panels.

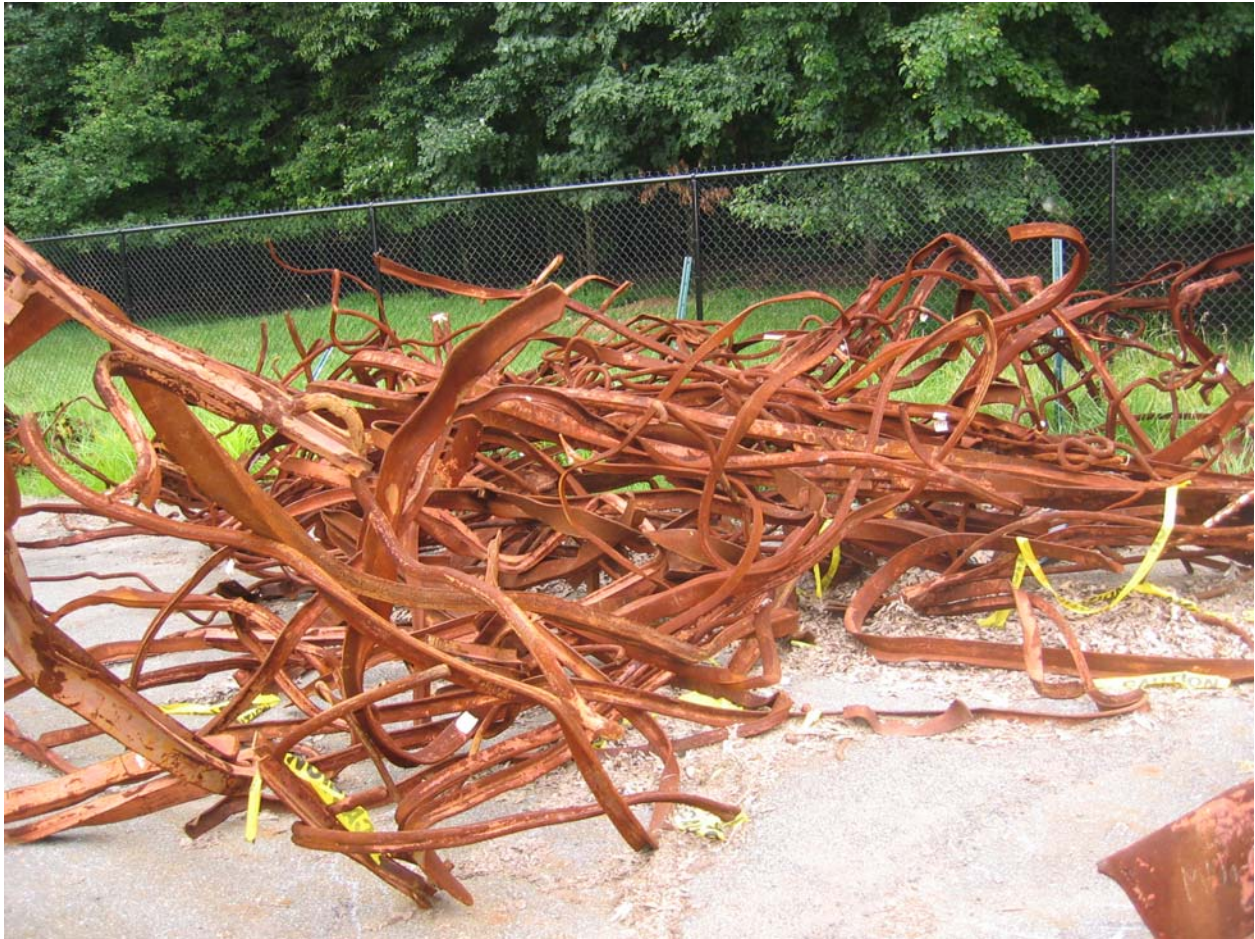
The recovered remnants of floor trusses recovered by NIST are severely distorted and the components from many individual trusses are intermingled into the same debris piles, Figures 18 and 19. It was impossible to determine whether the observed condition of the trusses was due to aircraft impact, fire following aircraft impact and before collapse of the tower, the collapse of a tower, fire in the debris pile following collapse, post-collapse recovery and salvage handling, or any combination of these extreme events. Our detailed observations may be found in Attachment B under Piece C-53.

*Figure 18. General view of a portion of recovered floor truss material*

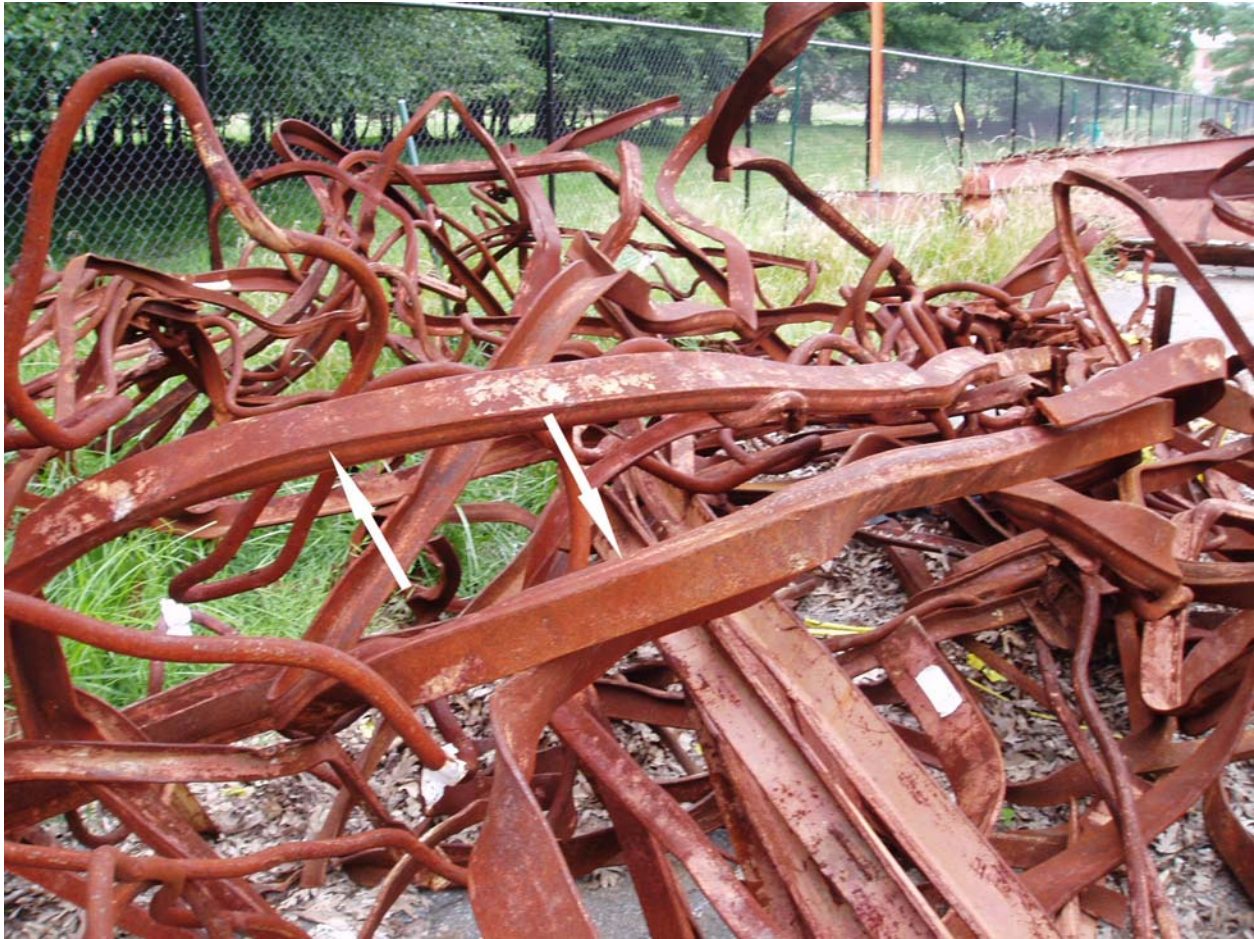
The rolled-steel angle shapes used in making the chords of the floor trusses exhibited a shallow, round rib running longitudinally on the vertical leg of the angle. This rib is visible on truss chords seen in Figure 19. This rib is a proprietary feature of floor trusses manufactured by Laclede Steel. The web-to-chord welds on the recovered truss remnants were observed to have been made by the electric resistance weld process, also typical of Laclede Steel trusses.

*Figure 19. Close view of some recovered floor truss material. Arrows point to truss chords that exhibit longitudinal rib typical of floor trusses manufactured by Laclede Steel*

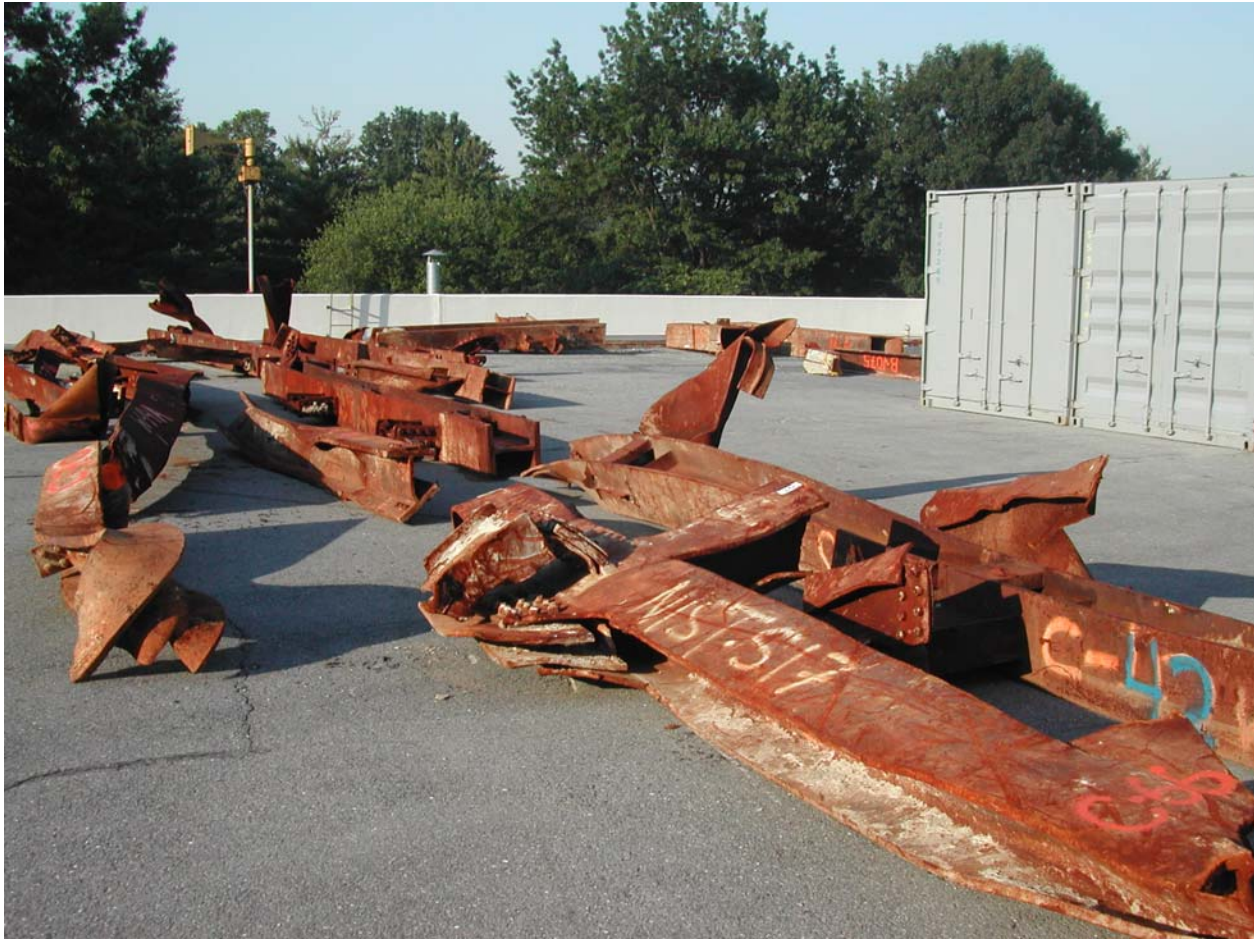
WJE surveyed six pieces believed to have been recovered from structures other than WTC 1 and WTC 2, Figure 20. The pieces surveyed by WJE were prefabricated column-and-beam assemblages, typically comprised of heavy rolled wide-flange columns with pairs of rolled wide-flange beam stubs framing into the strong-axis plane of bending of the column. Typically, two floor levels of floor beam stubs were observed on each piece. In some instances, the pieces had remnants of connections for diagonal elements that also framed into the column tree. Detailed observations and photographs of pieces recovered from structures other than WTC 1 and WTC 2 can be found in Attachment C.

*Figure 20. General view of several pieces believed to have been recovered from structures other than WTC 1 and WTC 2*

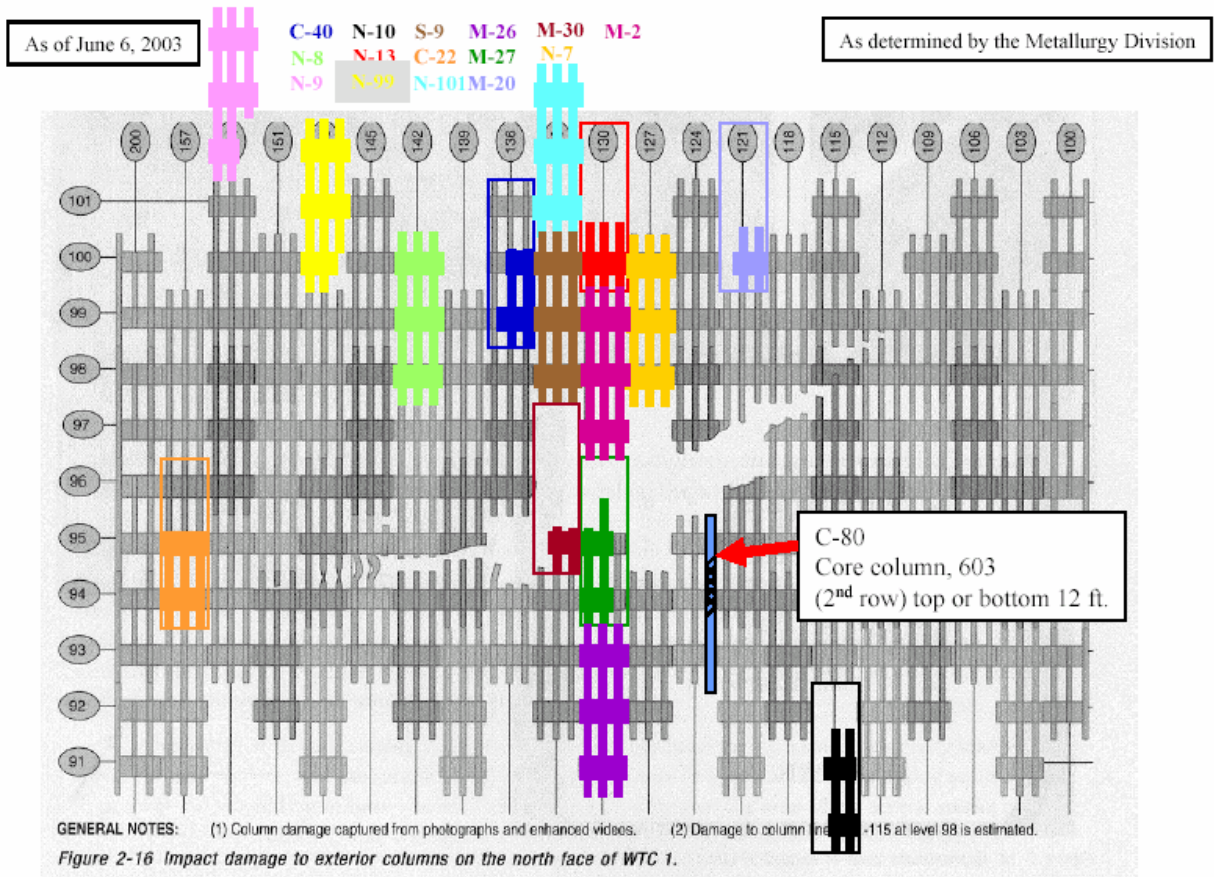
As described previously in Section 3.2, three significant pieces from WTC 1 that were directly impacted by the aircraft were examined: M-2, M-27 and M-30. In the as-built structure, Piece M-27 was located immediately below and connected to Piece M-2, and also immediately adjacent to and connected to Piece M-30. The as-built relationship between these pieces is shown in Figure 21.

Figure 21. Original locations within WTC 1 of Pieces M-2, M-27 and M-30.

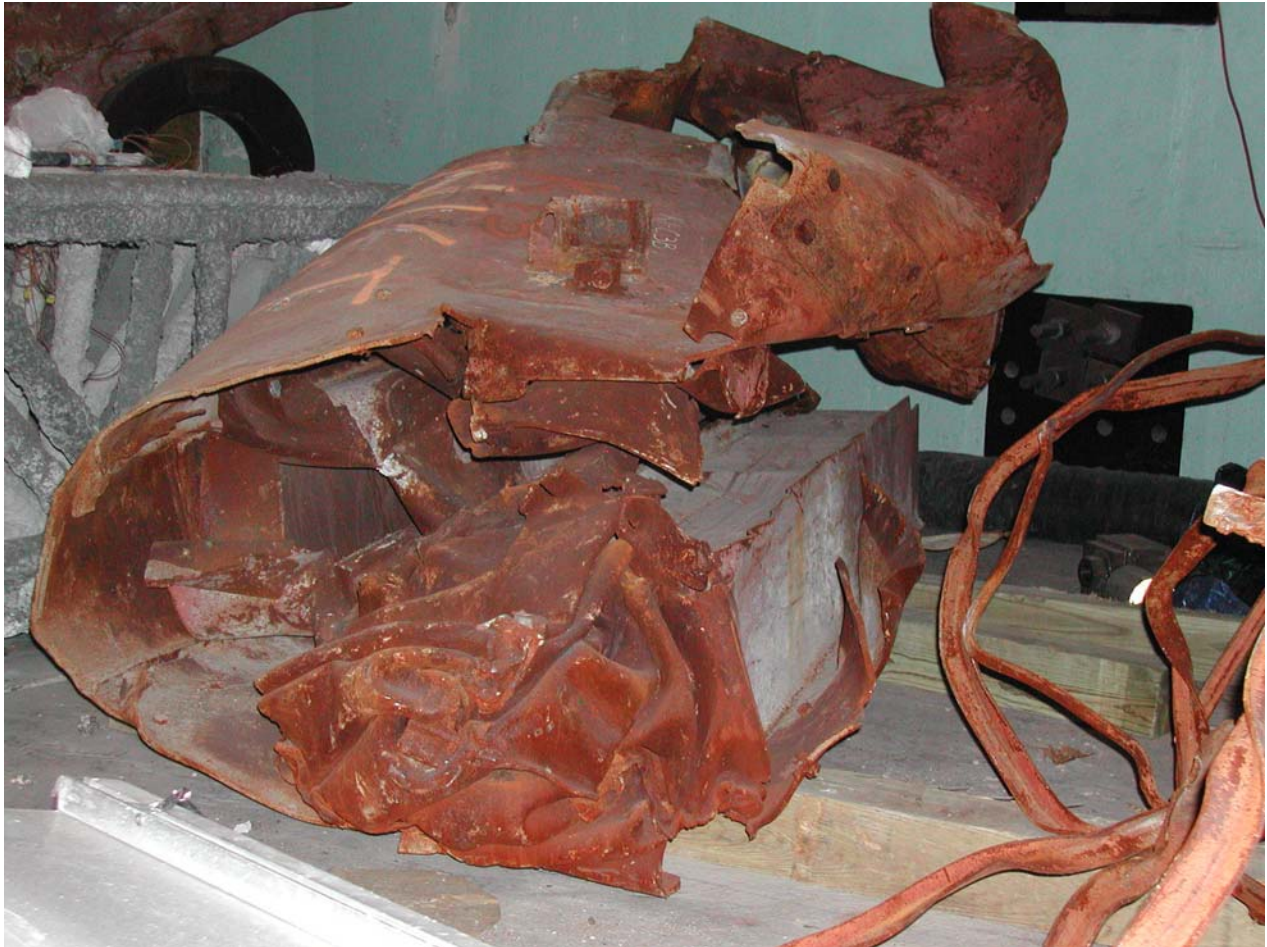
Of note is Piece K-1, shown in Figure 22 and further described in Attachment A. The piece is unique among the recovered steel in that the upper part of one column has probably collapsed in compression in an accordion-like manner. No other similarly-collapsed piece is found among the recovered steel at NIST that was surveyed. The accordion-like collapsed part of this column remains in general concentric axial alignment with the lower portion of the same column, which is relatively undistorted even after salvage and recovery operations. It cannot be readily distinguished whether this failure took place at a high or low rate of loading; whether elevated temperatures contributed to the observed condition; whether or not this failure occurred at about the time of collapse initiation; or if the observed condition is a result of impact as the piece fell to the ground.

*Figure 22. Piece K-1, which has collapsed in compression*

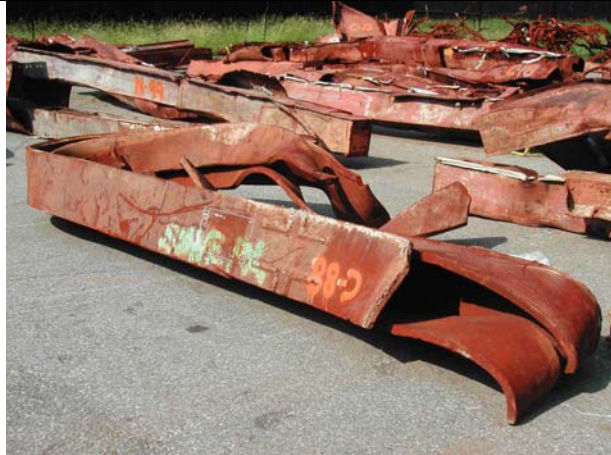
<p>Figure F-A-1a: General view of C-88. The bottom of the column is at lower right in this view. Column splice can be observed between paint marks "SAVE" and "C-88". The side of the column with paint marks faced into a vertical shaft.</p>	<p>Box-shaped core column (Figure A-1). Includes column splice located at floor 80; that portion above the splice is identified as Piece C88a, and that portion below the splice is Piece C88b. (Piece C88c is a large plate fragment cut from the upper end of C88a.) Piece C88b was at a floor level directly impacted by the aircraft.</p> <p>By locating remaining fragments of connections, it was possible to determine the orientation of the piece within the structure. Floor plans showed that one face of the box column faced into an open vertical shaft.</p> <p>At the lower end of the column (Piece C88b), three of the four flange plates exhibit a J-shaped deformed shape (Figures A-1 and A-2). The direction of bend of the hook of the J not consistent with aircraft impact. It is likely, therefore, that the final distorted shapes of these three flanges of the box column were a result of the collapse event. The ends of these three flange plates have been flame cut.</p> <p>The surface condition of these same three flanges at the immediate vicinity of the distortion is rusty (Figures A-1 and A-2), suggesting that the flanges were possibly exposed to fire. The sharpness of the bends in the distorted area, along with the lack of cracking of the steel at the sharp bends, suggests that the steel was at an elevated temperature at the time that the distortion occurred. It is possible that the fire that may have affected these pieces was the fire immediately following the aircraft impact.</p> <p>The fourth flange was severed at a different vertical location and in a different fashion than the other three flanges (Figure A-2). This is the flange that faced into the open vertical shaft. The distorted shape for this flange is consistent with the direction of aircraft travel at the time of impact. This distortion could also have been caused by the collapse of the tower.</p> <p>The fracture surface at the severed end was visually examined close-up. Two areas of interest along the severed end were identified as Z1 and Z2. Area Z1 is a fracture of the steel that appears to have occurred in a non-ductile manner because there is no visible constriction ("neck-down") of the flange plate thickness in the immediate vicinity of the fracture. It is probable that this is a non-ductile fracture that occurred at a high rate of strain as a result of the tower collapse or aircraft impact. Representative fracture surface of Z1 is shown in Figure A-3.</p> <p>Identified area Z2 visually appears to be a flame cut edge. The flame cutting probably occurred sometime during the salvage, shipping and handing of the piece following collapse.</p>

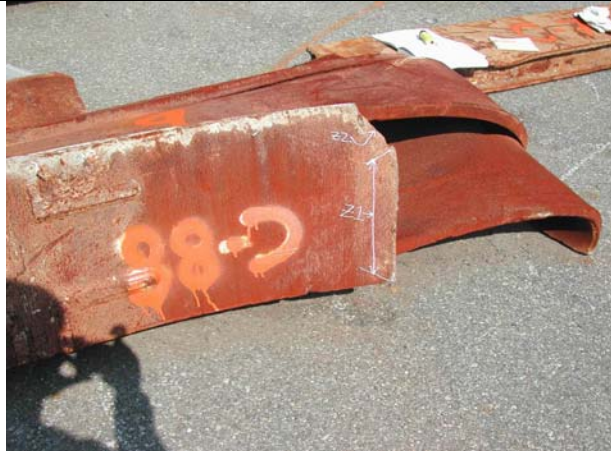
<p>Figure F-A-1b: General view of identified areas Z1 and Z2.</p>

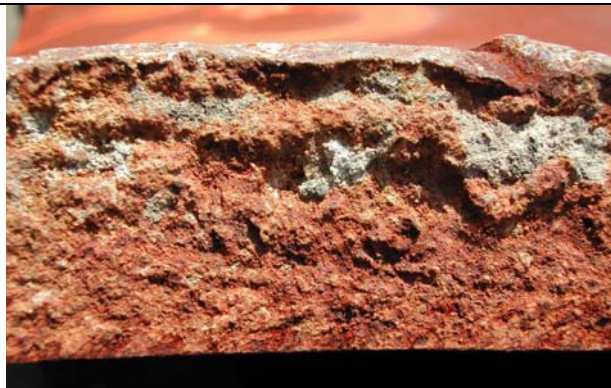
<p>Figure F-A-1c: Close view of fracture surface at area Z1. (The upper horizontal edge of the fracture surface has been damaged due to shipping and handling of the piece.)</p>

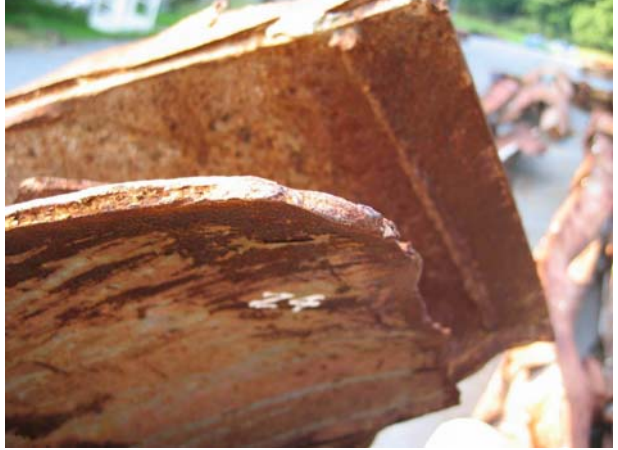
<p><b>Z4:</b> Outside web plate of Column 2 (Figure A-12) is visibly constricted (“necked down”) at vicinity of probable weld to column base plate. Probable cause is high rate of tensile loading due to aircraft impact. Similar effect was noticed on outside web plate of Column 1.</p> <p><b>Z5, Z6:</b> Fracture (Figure A-13) of flange plates at weld to column base plate at Column 2 exhibit a possible longitudinal shear failure instead of the tensile failure observed at Z4. Similar observation can be made for Column 1.</p> <p><b>Z7:</b> Fragments of floor slab concrete (Figure A-14) with fragments of welded wire reinforcement and metal deck have been entrapped by bent-over connection plate element on Column C2. These are probable actual materials from the as-built 97th floor slab.</p>	
Figure F-A-4d: Zone Z4.

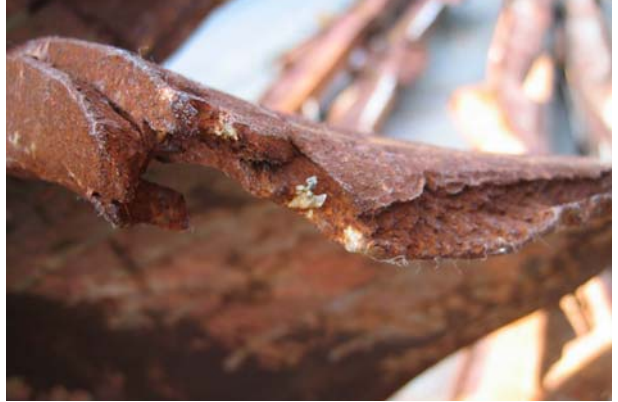
Figure F-A-4e: Representative fracture at Zones Z5 and Z6.

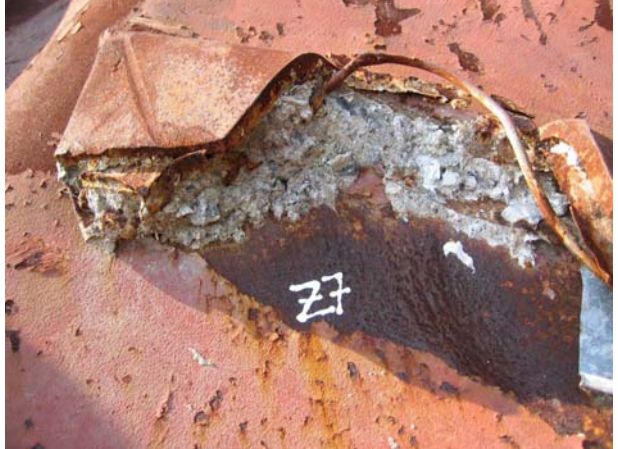
Figure F-A-4f: Entrapped concrete fragments.

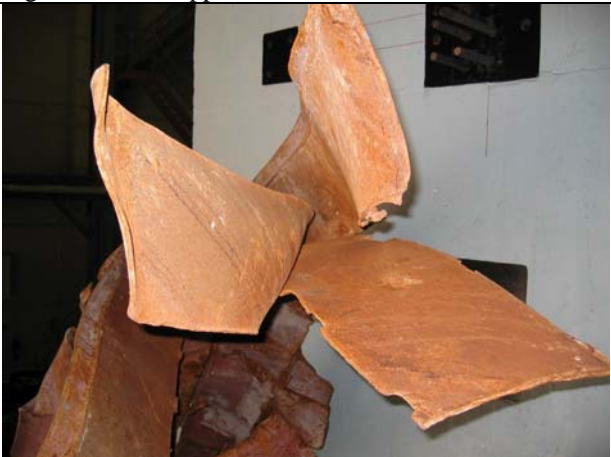
<b>Piece ID Mark:</b> M - 30		<b>By &amp; Date:</b> CP / JH / 31 July 2003	
<b>Bldg:</b> WTC 1		<b>Floors:</b> 94 - 97	
<b>Column:</b> 133		<b>Aircraft impact</b>	
  <p>Figure F-A-6a: General view of Piece M-30.</p>		<p>This piece is from an exterior column panel on WTC 1 that was directly impacted by the aircraft. The recovered piece consists of the lowest approximately three-quarter story of two column elements and a portion of the lowest spandrel element in the panel. Specifically, the recovered piece consists of fragments from Columns 132 and 133, extending from the column splice at mid-height of the 94th floor window to approximately the top edge of the 95th floor spandrel, and the 95th floor spandrel element, extending from the spandrel splice between Columns 131 and 132 to the edge of Column 133 that is towards the location of Column 134.</p>	
  <p>Figure F-A-6b: Close view of severed Column 133 near the top of the 95th floor spandrel. Shown here the inside face of the column, along with the 95th floor joist seat on spandrel.</p>		<p>Column 133 was severed at approximately the 95th floor line, shown in Figures A-20 and A-21. The fractures of the column side faces occur along a line at the edge of an internal column diaphragm stiffener at this location. The side faces probably fractured in longitudinal shear along the edge of the internal stiffener. Remnants of the inside (marked Z1 in Figure A-20) and outside faces of the column extend above the stiffener diaphragm and are bent inward along edges of the stiffener diaphragm. The inside and outside faces probably fractured in tension. It is almost certain that these fractures were caused by the impact of the aircraft and therefore occurred at a high rate of loading.</p>

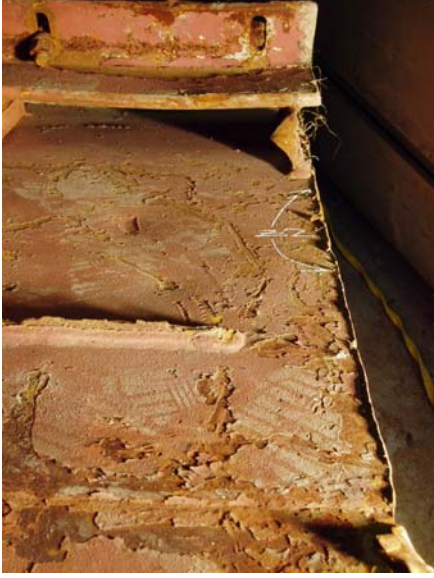
<p data-bbox="201 800 782 888">Figure F-A-6d: View of severed 95th floor spandrel plate at edge of Column 133. Column 134 would have been to the right.</p>	<p data-bbox="824 226 1422 380">The 95th floor spandrel plate has probably fractured in transverse shear along the right edge of Column 133. (This edge is marked Z2 in Figure A-22.) It is very likely that this fracture was caused by the impact of the aircraft and therefore occurred at a high rate of loading.</p>

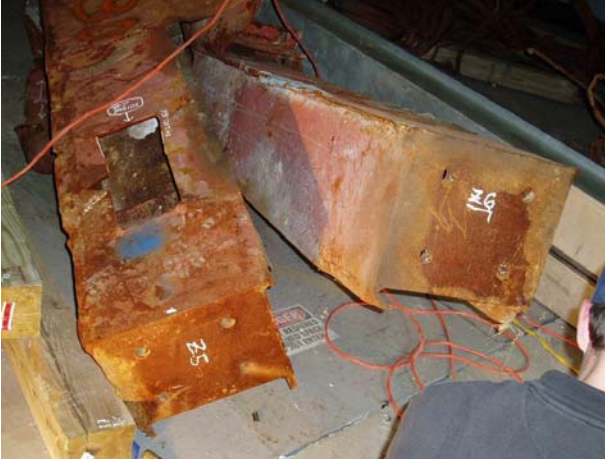
<p>Figure F-A-6h: View of column end plates on Piece M-30. Base of Column 132 is marked Z5 and base of Column 133 is marked Z6.</p>	<p>The bolt holes on the base plates for Columns 132 and 133, marked Z5 and Z6, respectively, show in Figures A-26, A-27 and A-28, were examined for hole elongation that might be related to the failure of the column splice bolts.</p> <p>On the base plate of Column 132, the two bolt holes nearest the outside face of the column exhibited elongation in a direction perpendicular to the outside face. The two bolt holes closest to the interior face exhibited insignificant elongation.</p> <p>On the base plate of Column 133, the direction of elongation of the bolt holes is consistent with the column twisting as the bolts were failing.</p>

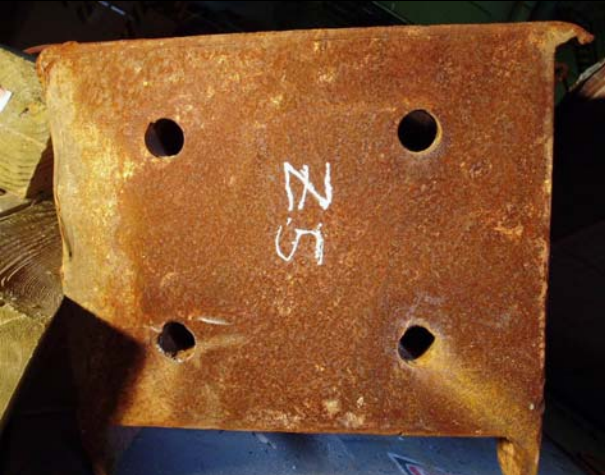
<p>Figure F-A-6i: Base of Column 132. Outside face is down.</p>

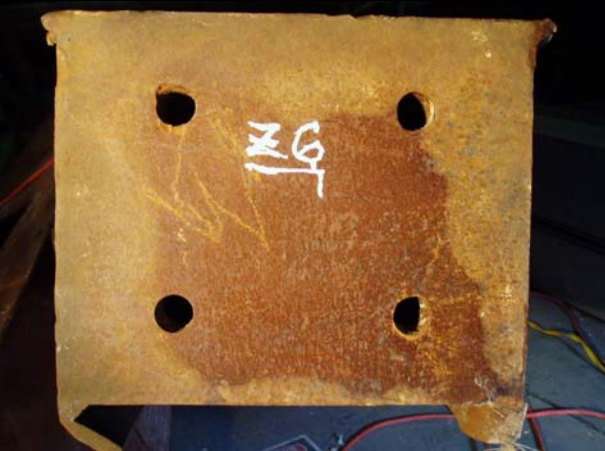
<p>Figure F-A-6j: Base of Column 133. Outside face is down.</p>

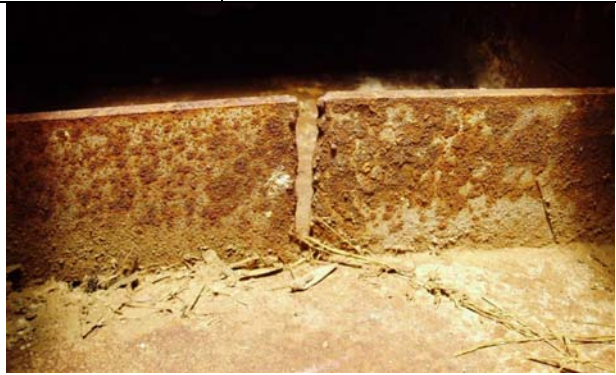
<p>Figure F-A-6k: Separation of rectangular bar found inside access hole at base of Column 132. The inside surface of the outside column face plate is at the bottom of the photo.</p>	<p>A unique separation, Figure A-29, was observed in a small rectangular bar found inside the rectangular access hole at the base of Column 132. The location was marked Z7 on the inside face of the column piece. The rectangular bar is believed to be an aid for fabrication used to support the column outside face plate at the proper position for welding. The bar appears to have ruptured, perhaps in tension, or has been flame cut.. It is not know if this condition is related to the impact of the aircraft into this piece, or is related to original fabrication.</p>

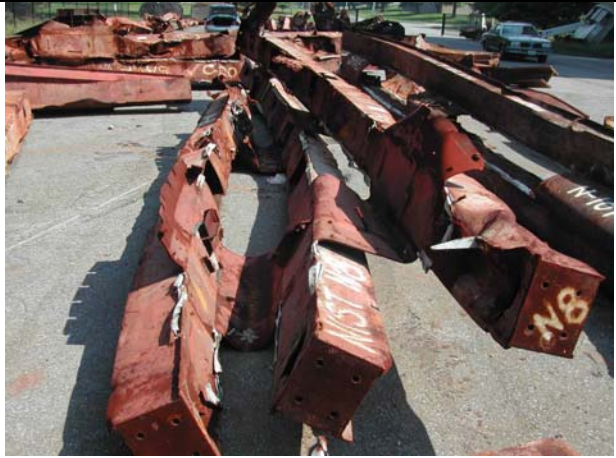
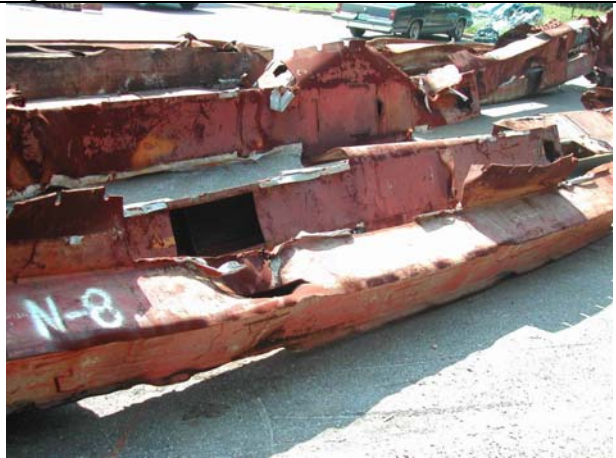
<p>Given location in structure, this exterior column panel was not affected by aircraft impact. Potential effects due to fire following aircraft impact were observed on columns as follows:</p> <p>Window at 97: Little or no fire effect          Spandrel at 98: Little or no fire effect          Window at 98: Some local buckling and some loss of primer paint indicative of possible fire effect          Spandrel 99: Little or no fire effect          Window 99: Some possible fire effect          Spandrel 100: Little or no fire effect          Window 100: Fire effect uncertain</p>
Figure F-A-7a: Piece N-8.

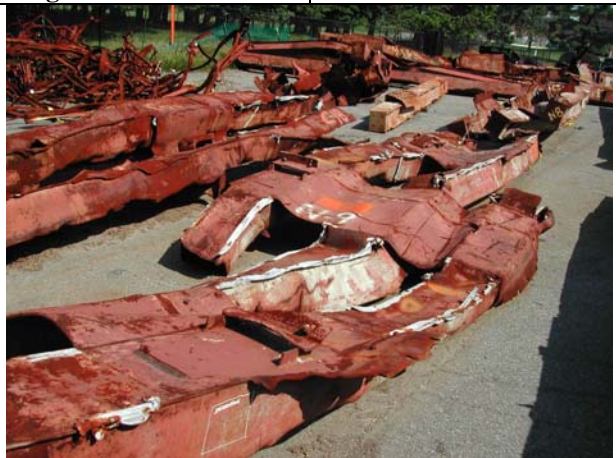
<p>Given original location in building, this exterior column piece has not been affected by direct aircraft impact. Fire effect uncertain: some local buckling on inside faces of columns, along with moderate loss of paint, suggest possible fire effect. However, these visual features are not so pronounced so as to strongly indicate that these are effects due to fire.</p>
Figure F-A-8: Piece N-9.

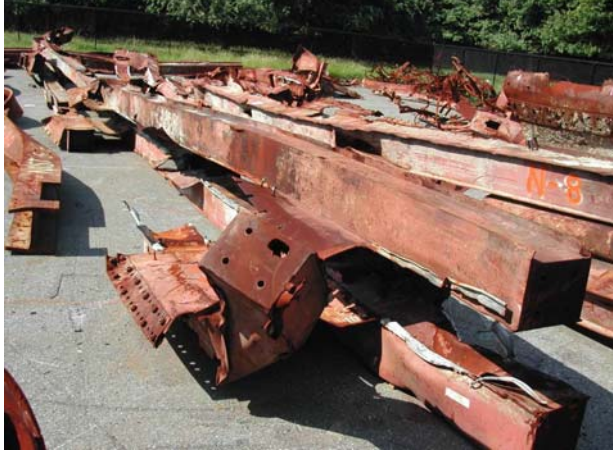
Exterior column panel from face of aircraft impact on WTC 1, but from floor levels that are above the direct impact zone. Consequently, piece is presumably not affected by aircraft impact. Little or no effects of fire were observed on this piece.
Figure F-A-10: Piece N-101.

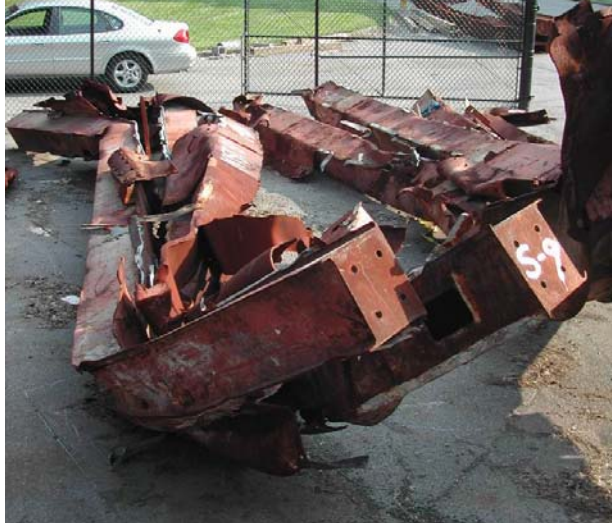
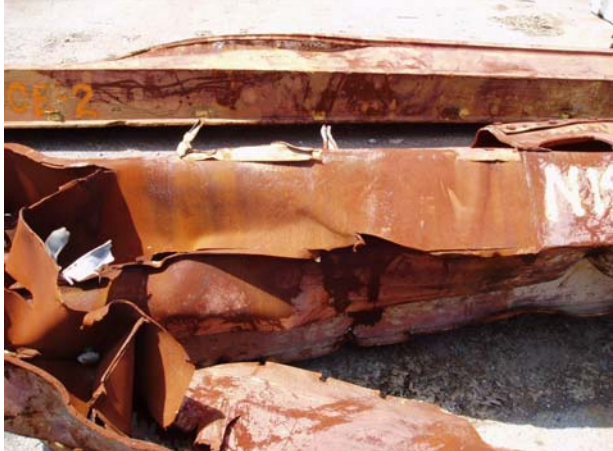
This is an exterior column panel from above the aircraft impact zone of WTC1. Location suggests that this panel was generally intact following aircraft impact. The column splice connections at the bottom of this piece, however, were severed as a result of the aircraft impact. Other than at the 98th floor level, this piece exhibits little indication of fire effects. The fire immediately following the aircraft impact may have affected the faces of the columns adjacent to window openings at the 98th floor, as evidenced by loss of paint and the nature of the distortions in these faces of the column elements (Figure A-38). Apart from these areas, probable cause of observable distress in the remainder of the piece is collapse event, post-collapse events, or both.

Figure F-A-11a: Piece S-9.	
Figure F-A-11b: Column at 98th floor on Piece S-9.

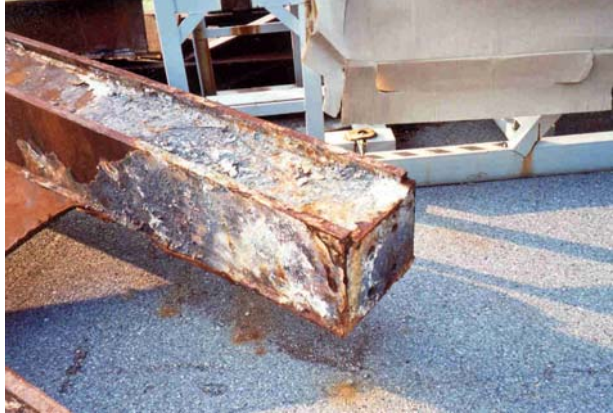
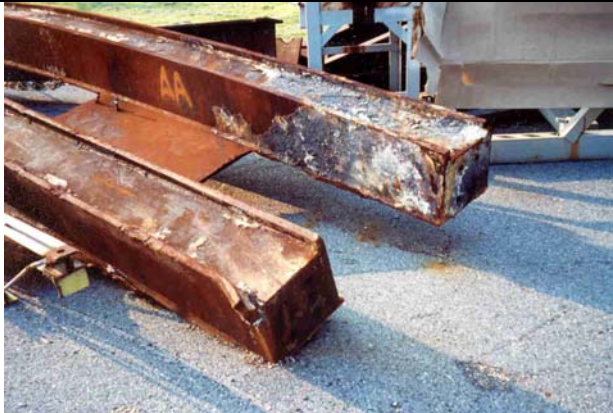
<p>Two exterior box columns from one column panel with fire residue on the end of one column member. Because the residue is on the end plate of one member, it suggests that residue was deposited after the end plate was separated from its matching piece, meaning that residue deposit would have occurred after the collapse.</p>	
<p>Figure F-B-1a: End of one column on Piece AA.</p>

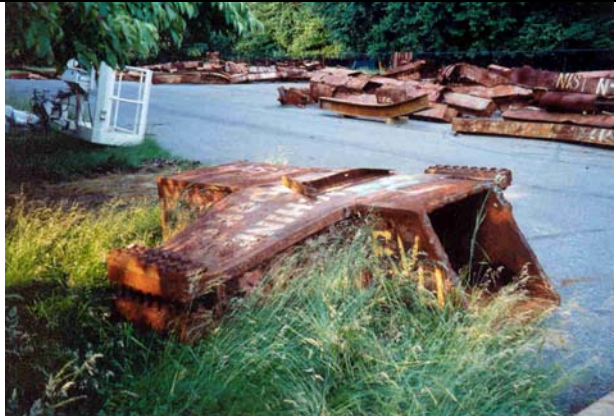
<p>Figure F-B-2a: General view of Piece B5004.</p>	<p>Low level tree haunch with a crack. The nature of the crack suggests that the crack initiated at the weld. Cracks of this nature are known to be a potential problem for welded joints in heavy pieces of fabricated structural steel. The crack probably occurred at the time the piece was fabricated, due to triaxial restraint of weld shrinkage during cooling of the original weld. It is our opinion that the crack was existent at the time of building collapse. The crack may have been extended during erection at the time of original construction.</p> <p>It is very unlikely that the crack was extended or enlarged as a result of aircraft impact or building collapse. It is also very unlikely that the presence of these cracks had any adverse effect on the performance of the building as it may relate to the aircraft impact, fire following aircraft impact, and initiation of progressive collapse. This is because the large compressive forces to gravity loads in the column due would tend to keep these cracks closed, even under loads associated with these extreme events.</p>

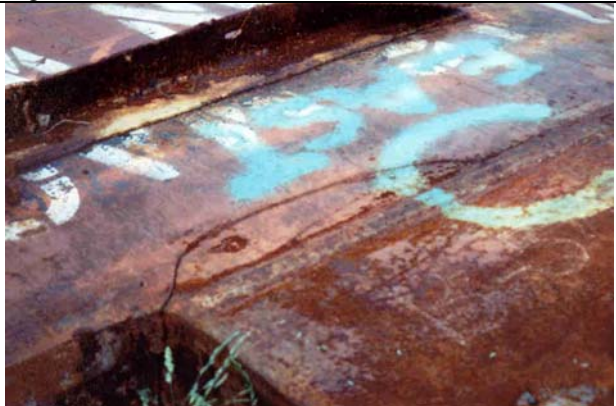
<p>Figure F-B-2b: View of crack observed on Piece B5004.</p>

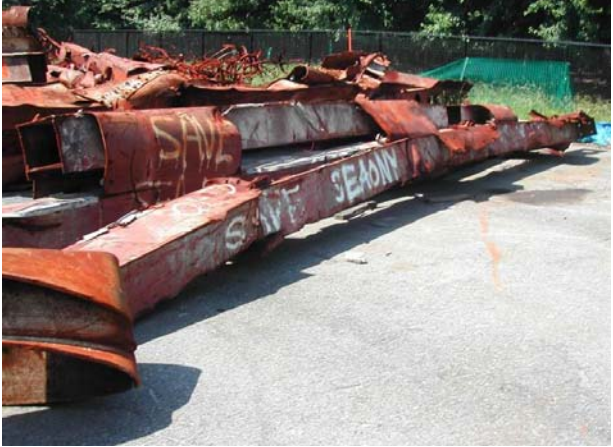
<p>Given the location in the building, this piece was not affected by aircraft impact. Visual indications of fire effect were not readily observed. Observed damage and distortions are probably due to collapse event and subsequent handling.</p>	
<p>Figure F-B-4: Piece C-10.</p>

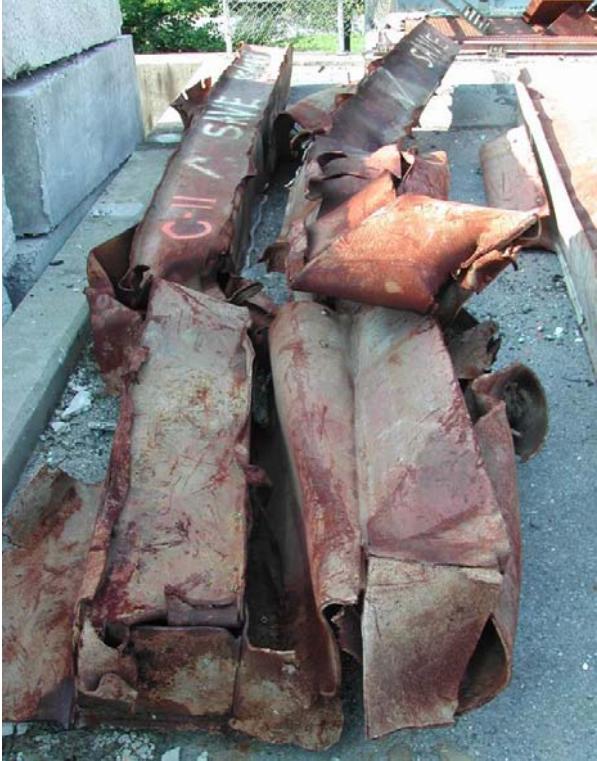
<p>Upper two-thirds of two columns from an exterior column panel. The thickness of the plates is consistent with having been located in the upper portions of one of the buildings. Indications of fire effects are present at the inside faces of the columns at the upper full window locations (between middle and top spandrel elements). Upper spandrel and column elements at the window location above the upper spandrel do not exhibit significant effects of fire.</p>	
<p>Figure F-B-5: Piece C-11.</p>

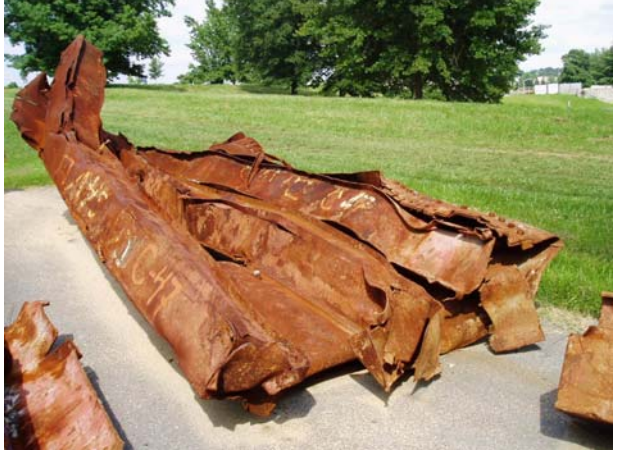
<b>Piece ID Mark:</b> C-47	<b>By &amp; Date:</b> CP / 30 July 2003
<b>Bldg:</b> WTC1 or WTC 2	<b>Floors:</b> unknown
<b>Column:</b> unknown

<p>Partially recovered exterior column panel from WTC 1 or WTC 2. General indications of fire effects widely distributed throughout piece. This observation suggests that the observed effects were a result of fire after collapse.</p>
Figure F-B-6: Piece C-47.

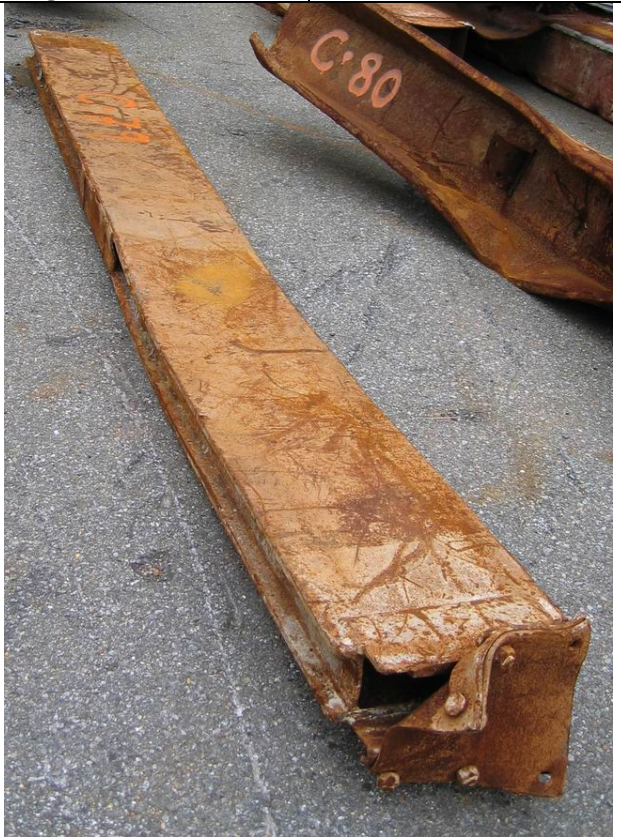
<b>Piece ID Mark:</b> C-79	<b>By &amp; Date:</b> JH / CP / 30 July 2003
<b>Bldg:</b> WTC 1 or WTC 2	<b>Floors:</b> unknown
<b>Column:</b> unknown

<p>Rectangular box beam shape. Connections at ends of the element indicate that this is a horizontally-spanning element. Concrete fragments were observed inside of the box beam. This concrete is well-bonded to the beam and conforms to the interior shape of the beam. This suggests that the concrete is probably from original construction.</p>
Figure F-B-7: Piece C-79.

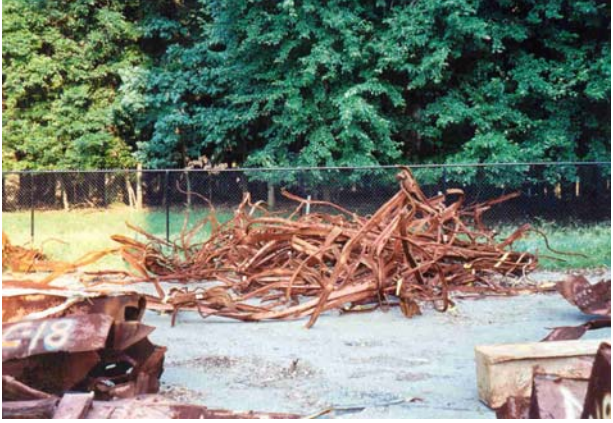
<b>Piece ID Mark:</b> C-53		<b>By &amp; Date:</b> RT / 25 June 2003 CP & JH / 31 July 2003	
<b>Bldg:</b> WTC 1 or WTC 2	<b>Column:</b> not applicable	<b>Floors:</b> unknown

<p>Figure F-B-8a: General view of truss remnants.</p>		<p>Badly tangled remains of Laclede Steel open web steel trusses. The intermingling of the trusses suggests that this occurred during impact, collapse, salvage operations, hauling, storage, or any combination of these events. It is not possible to sort out what damage occurred when.</p> <p>Figures B-11 through B-18 show some of the connection joints within the truss members themselves. The trusses were fabricated with extensions of diagonal web members at the top chord panel points and at end bearing details that develop composite action with the concrete topping slab. As was typical for trusses and joists manufactured by Laclede Steel, the web elements are electric resistance welded to the top and bottom chord angles. Although the angles and web elements are severely distorted in the immediate vicinity of the panel points, the actual welded connections remain intact.</p> <p>Intact welds could be tested. These tests would provide a lower bound to the joist connection capacity. Small lengths of undistorted remnants of the chord angles and web rounds could be tested to provide the equivalent of mill test data.</p>

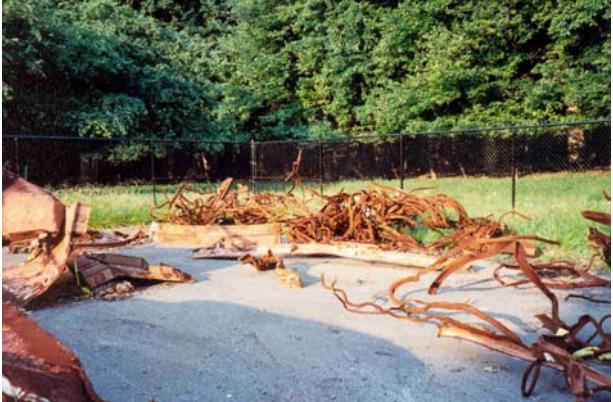
<p>Figure F-B-8b: General view of truss remnants.</p>

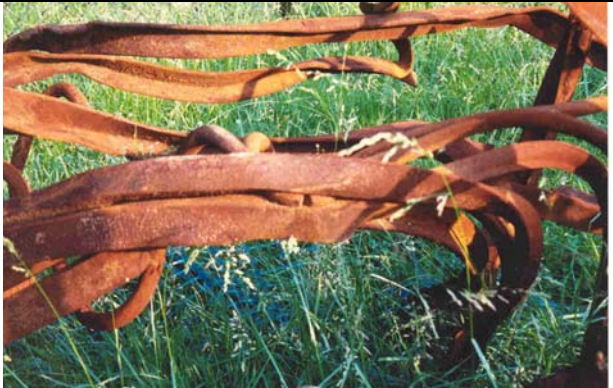
<p>Figure F-B-8c: Connection of truss diagonal to bottom chord.</p>			
		(Figures continue next page)

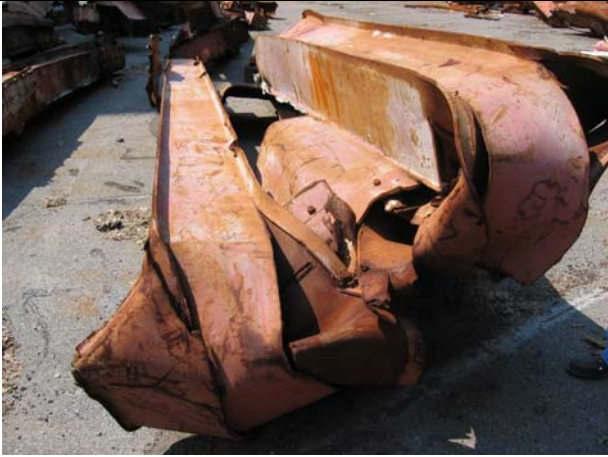
<b>Piece ID Mark:</b> N-1	<b>By &amp; Date:</b> CP / 24 June 2003
<b>Bldg:</b> WTC 1	<b>Floors:</b> 82 - 85
<b>Column:</b> 218

<p>This column is from well below the aircraft impact zone. Panel is bent in half at about mid-length. No indication of fire effect. Given location in building, probable cause of observed damage and distortion is the collapse event and subsequent handling.</p>	
<p>Figure F-B-10: View of piece N-1.</p>

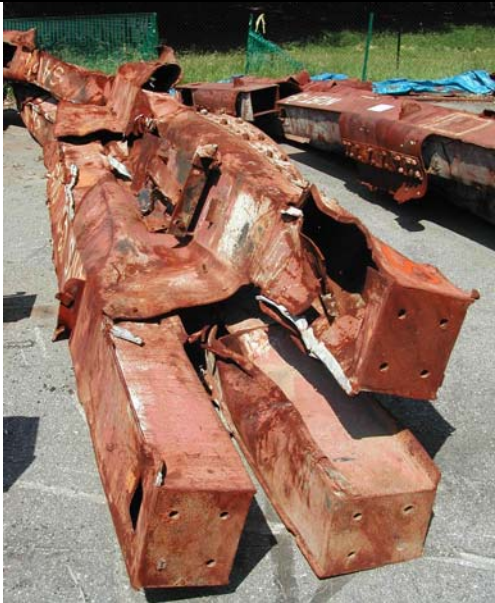
<b>Piece ID Mark:</b> S-14 or C-20	<b>By &amp; Date:</b>
<b>Bldg:</b> WTC 2	<b>Floors:</b> 91 - 94
<b>Column:</b> 218

<p>Full exterior column panel from high floors in WTC 2, well above the aircraft impact zone for WTC 2. Possible fire effects observable at some locations on the piece. Given location of this piece in WTC 2, it is most probable that the observed fire effects are related to post-collapse fire rather than fire immediately after aircraft impact.</p>	
<p>Figure F-B-11: Piece S-14 or C-20.</p>

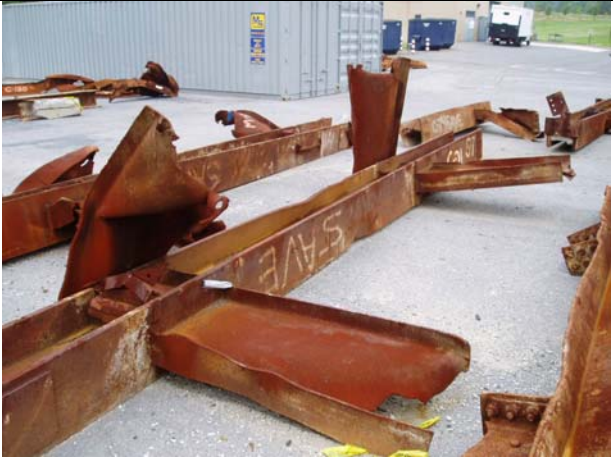
<b>Piece ID Mark:</b> C-31 (also S-7)	<b>By &amp; Date:</b> CP & JH / 31 July 2003
<b>Bldg:</b> unknown	<b>Floors:</b> unknown
<b>Column:</b> unknown	Fire effects

<p>Figure F-C-1a: Piece C-31. Top of piece is at lower left; bottom of piece is at upper right.</p>	<p>Two-story wide flange column piece probably from a structure other than WTC 1 or WTC 2. The column piece itself is generally straight.</p> <p>The beam stubs framing into the flange on one side of the column (i.e., the beams are in the plane of strong axis column bending) are generally undeflected and remain in the plane of strong axis column and beam bending. The fractures at the free ends of these beam stubs suggest that these beam stubs have probably failed in tension generally directed along the longitudinal axis of the beam stub.</p> <p>The beam stubs framing into the opposite flange have been bent out-of-plane, extending in a direction generally perpendicular to the plane of strong axis beam and column bending. Examination of the column piece, including examination of column space at base of column piece, suggest that these beam stubs were bent out-of-plane during collapse. Examination of bolt hole distortions at the connection at the free ends of these beam stubs suggests that these connections also fractured in tension generally directed along the longitudinal axis of the beam stub.</p> <p>The outstand beam stubs appear to be fire effected.</p>

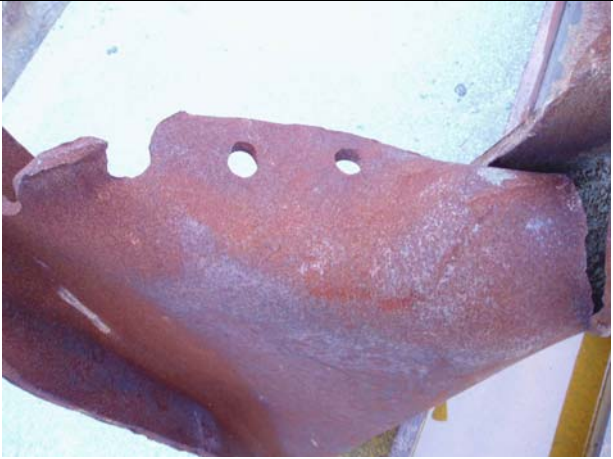
<p>Figure F-C-1c: Piece C-31. Fracture at end of a beam stub that is bent out-of-plane</p>

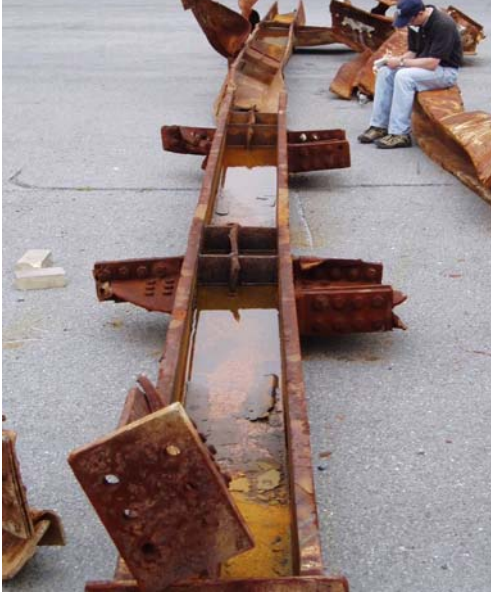
<b>Piece ID Mark:</b> C-85		<b>By &amp; Date:</b> CP & JH / 31 July 2003	
<b>Bldg:</b> unknown	<b>Column:</b> unknown	<b>Floors:</b> unknown

<p>Wide flange shape probably from a structure other than WTC 1 or WTC 2.</p> <p>Remnants of probable diagonal or lateral braces frame into weak axis plane of the column.</p> <p>Remnants of wide-flange beam stubs frame into strong axis side of the column. On one side of the column, the beams appear to have deflected downward and have fractured in net tension through top flange at bolt holes and have torn out through web. Bottom flange connection plate has torn out in tension at weld of connection plate to face of column.</p> <p>The connections on the opposite side of the column require further study. While these beams appear to have fractured in tension, the line of probable fracture passes through the gross section, not the net section through bolt holes in the beam flange. This probable fracture is not consistent with a fracture in direct tension that would be expected to pass through the net tension sectional area.</p> <p>The column base connection plate has fractured in half, probably as the column deflected out-of-plane (weak axis bending plane) during collapse. A fragment of probable floor deck concrete remains in place just above the column base connection plate.</p> <p>Did not visually assess for fire effects.</p>

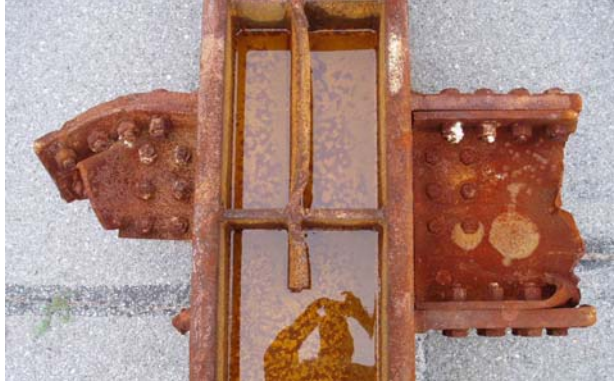
<p>Figure F-C-5a: Overall view of Piece C-85. (Note: Piece C-66 lies beyond Piece C-85 at top of picture.)</p>

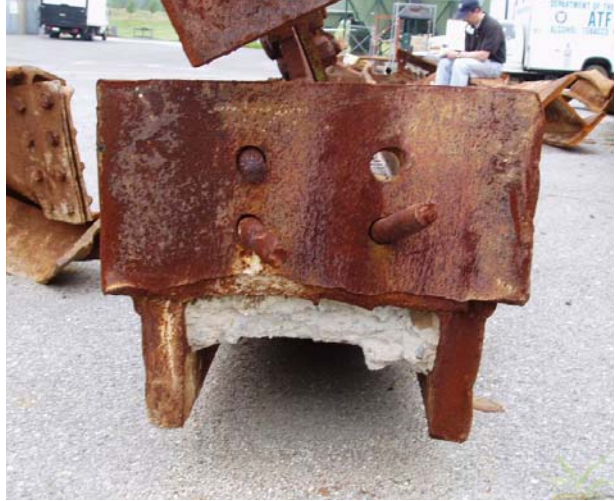
<p>Figure F-C-5b: Piece C-85, connections of beams to column.</p>			
<p>Figure F-C-5c: Piece C-85, column connection plate at base of column</p>

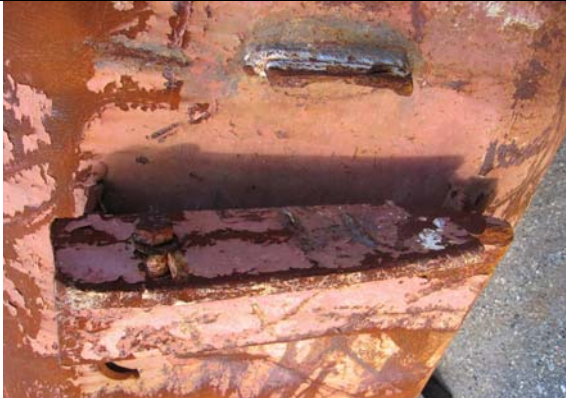
<p><u>Type 1</u>            Seat assembly remains and at least one erection bolt is present in the seat angle            (In Figure D-2a, an erection bolt is present in the hole at the left.)</p>
