## Appendix A

# EXAMPLES OF PERIMETER PANEL FLOOR TRUSS CONNECTORS

The floor trusses were attached to the perimeter panels at the interior intersection of the columns and spandrels by different types of connectors. The following appendix displays photographic examples, taken by National Institute of Standards and Technology (NIST), of these types of connectors as observed on the recovered panels.

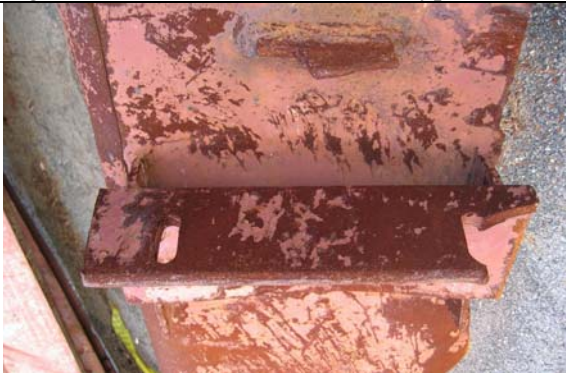
<p><u>Type 2</u>            Seat assembly remains in place and at least one of the bolt holes for the in the seat angle has edge distance tear-out; no bolts are present</p>

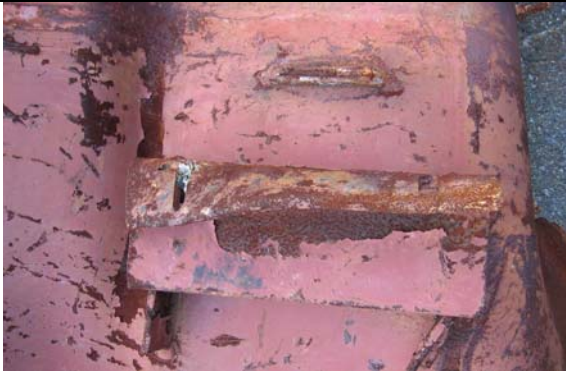
<p><u>Type 3</u>            Seat assembly remains in place with no erection bolts present and no edge distance tear-outs of bolt holes in the seat angle</p>

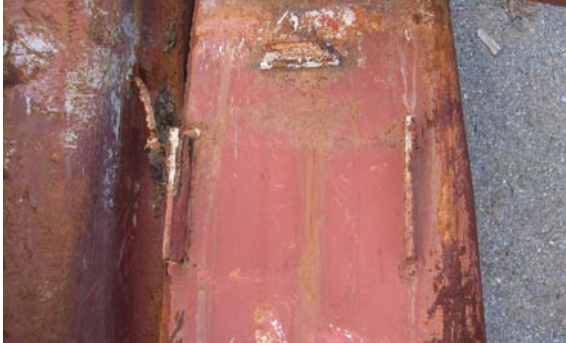
<p><u>Type 4</u>            Seat assembly is missing and appears to have been sheared off where the stand-off plates are welded to the face of the column</p>

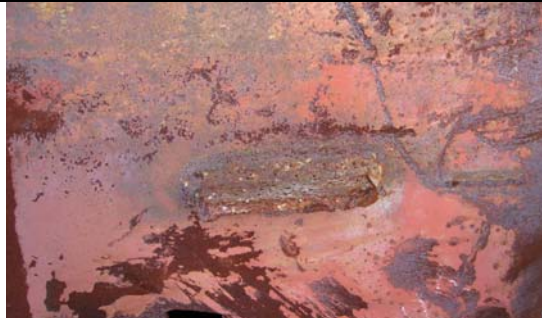
Figure F-D-3a: End gusset failure mode Type 1

<p><u>Type 1</u> Fracture of top plate through gross section away from weld to face of column</p>

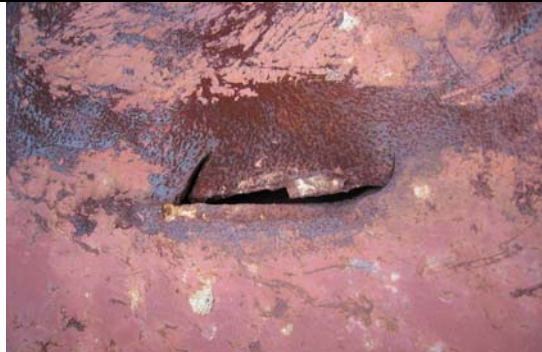
Figure F-D-3b: End gusset failure mode Type 2

<p><u>Type 2</u> Tear-out of top plate and weld from the parent material of the column face</p>

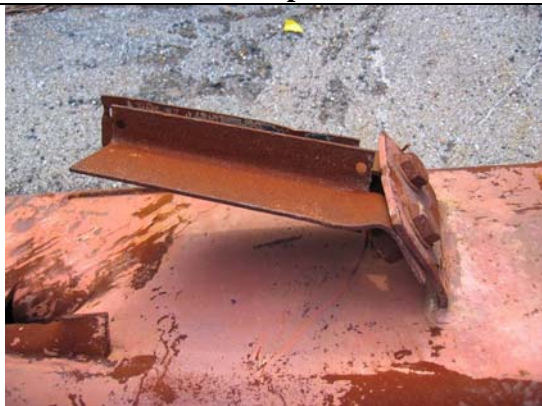
Figure F-D-4a: Damper connection failure Type 1

<p><u>Type 1</u> Remnants of the damper and its connection plate remain attached to column</p>

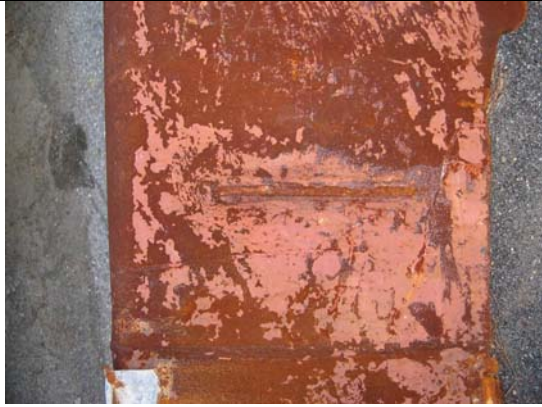
Figure F-D-4b: Damper connection failure Type 2

<p><u>Type 2</u> Damper and its connection plate are missing, typically fracturing at weld of connection plate to face of column</p>
