**NIST NCSTAR 1-5A**

**Federal Building and Fire Safety Investigation of the  
World Trade Center Disaster**

# **Visual Evidence, Damage Estimates, and Timeline Analysis**

September 2005

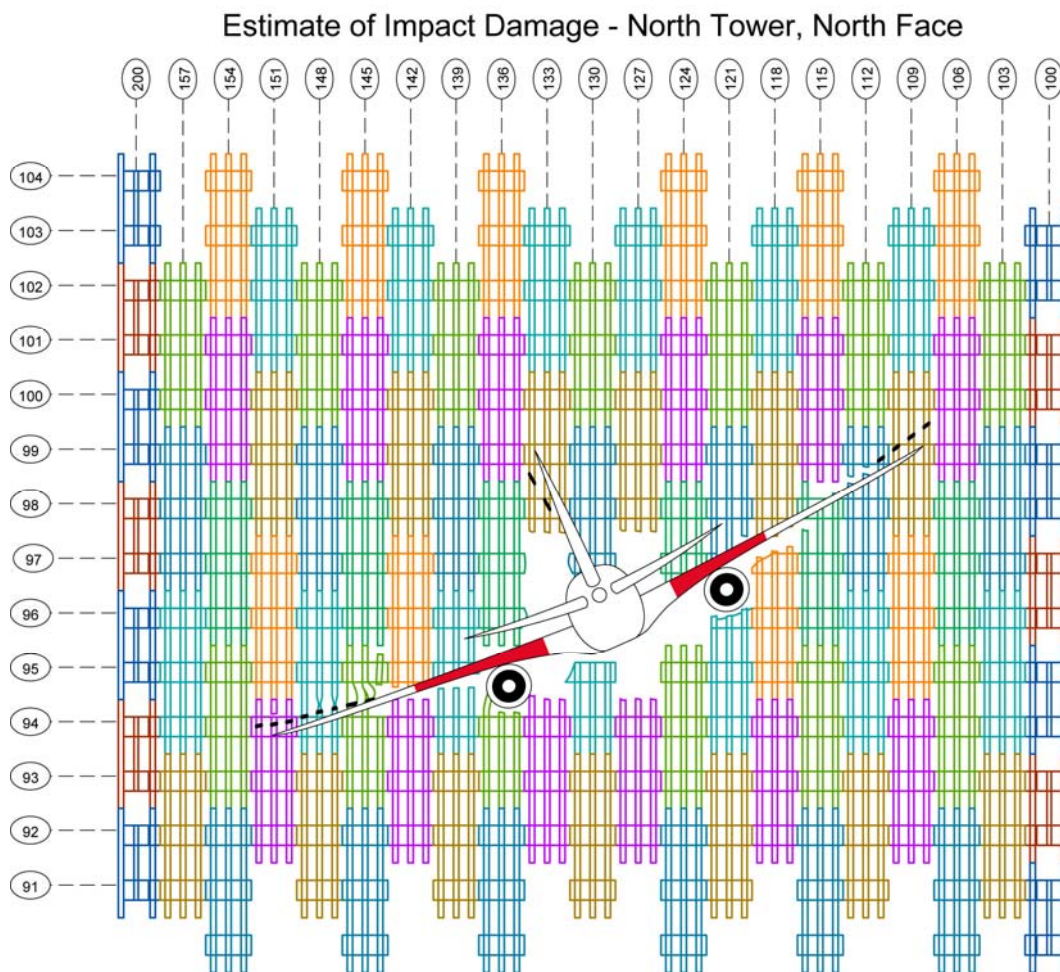
Close-up photographs and videos showing the area of the aircraft impact on the north face were used to generate the damage diagram shown in Figure E-1. Images show that substantial areas of the concrete floor slabs for the 95th through 97th floors were destroyed to an unknown depth within the tower in the immediate vicinity of the aircraft impact area. Locations where the two wing tips and the aircraft’s vertical stabilizer struck the façade are represented by dashed lines in Figure E-1. The locations of the wing marks indicate that the aircraft struck between the 93rd and 99th floors. A properly scaled outline of a Boeing 767-200ER is superimposed on the damage diagram. The position of the aircraft has been adjusted to provide good agreement with the observed damage pattern and the wing and vertical stabilizer marks. The drawing indicates that the nose of the aircraft struck close to the center of the face near columns 129 and 130 at a height that was near the concrete floor slab for the 96th floor.

**Figure E-1. A scaled outline of a Boeing 767-200ER is superimposed on the damage diagram for the north face of WTC 1. The position of the aircraft has been adjusted to best match the damage pattern and marks showing where the wing tips and vertical stabilizer struck. The red areas correspond to the approximate locations of fuel on the aircraft based on an analysis reported elsewhere (NIST NCSTAR 1-2B).**

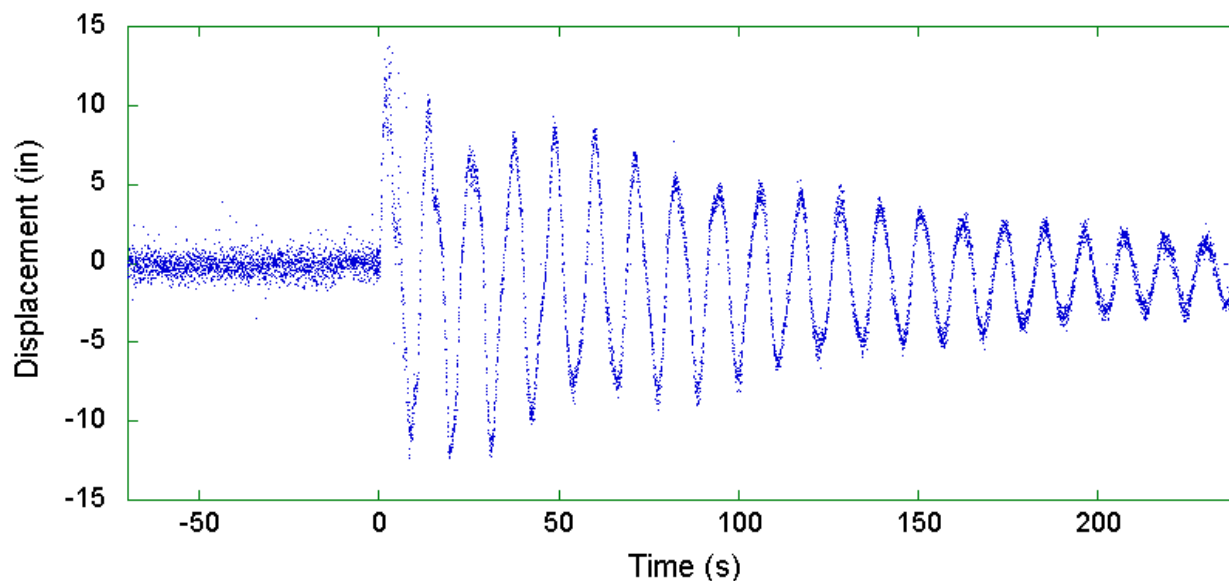
Close examination of this video revealed a perceptible north-south movement of WTC 2 after it was struck by the aircraft. Image analysis of the video allowed the movement of the tower at the 70th floor to be determined as shown in Figure E-2. The maximum deflection was determined to be 12 in.  $\pm$  1 in. at this height, which extrapolates to a value of 22 in.  $\pm$  5 in. at the roofline. The primary period for the motion was 11.4 s  $\pm$  0.1 s, consistent with the fundamental natural mode of the building. Similar measurements using a brief video shot from the north yielded an amplitude near the roof line of 6 in.  $\pm$  1 in. for the east-west direction with a period of 5.3 s  $\pm$  0.1 s. This period and motion are consistent with the first torsional (twisting) mode of the tower.

**Figure E-2. The displacement of the first (left-most) window line on the 70th floor of WTC 2 determined using moiré analysis is shown as a function of time.**

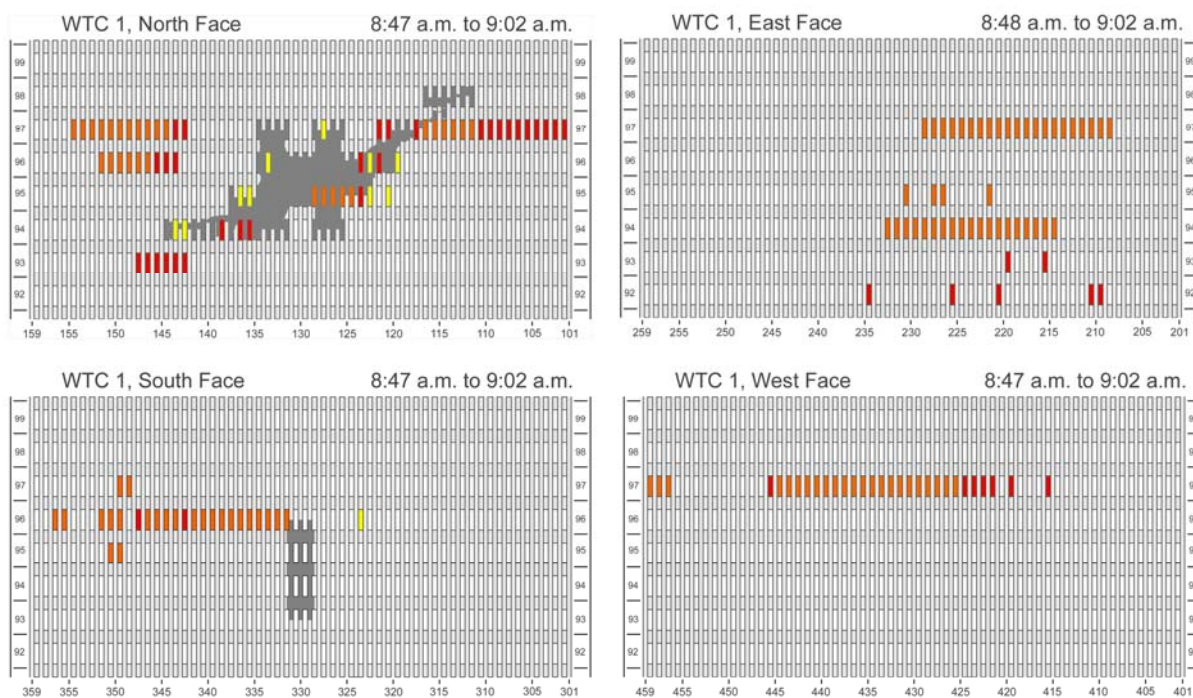
Fire observations for the period are summarized by the façade maps in Figure E-4, which show fire locations integrated over the period. The color coding indicates the highest fire intensity recorded during the period, with yellow representing a spot fire, red a more extensive fire burning inside the tower, and orange a fire with flames extending out of the window.

**Figure E-4. Maps of integrated fire observations between 8:47 a.m. and 9:03 a.m. are shown for the four faces of WTC 1.**

The most extensive fire growth took place on the 97th floor. The apparent rapid development of these fires, particularly on the west face, may be an indication that the fire growth and spread was accelerated by the presence of initially unburned aviation fuel that may have been dispersed over this floor during the aircraft impact.

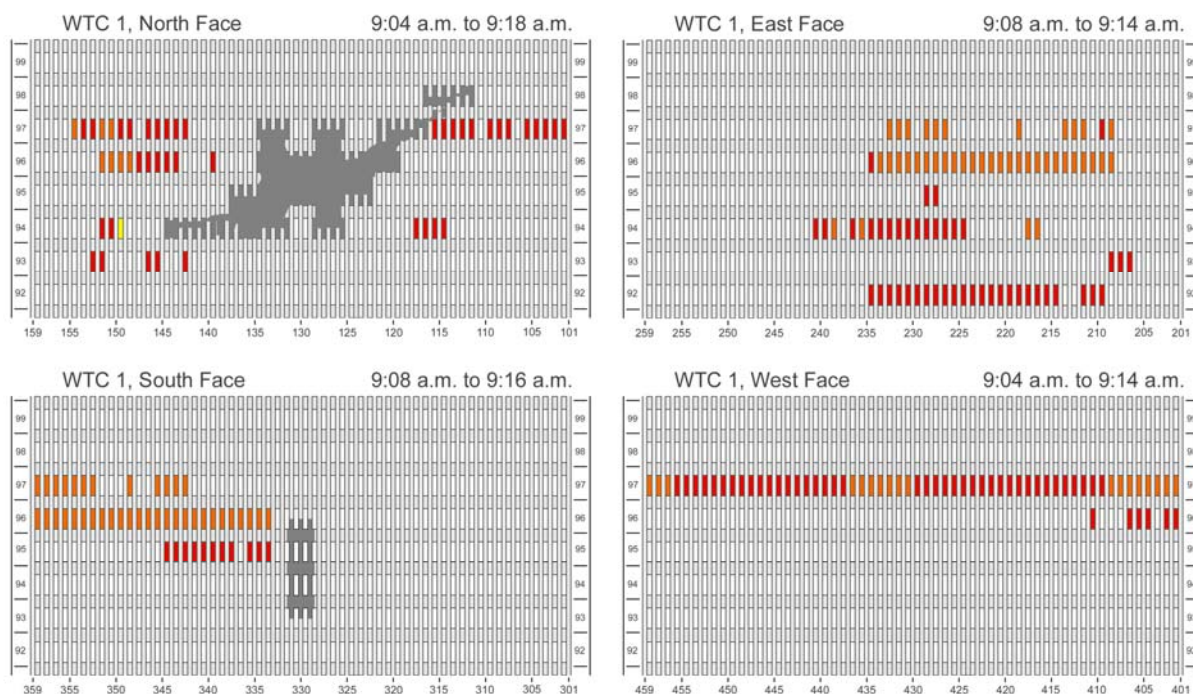
Figure E-5 shows integrated fire maps for the four faces of WTC 1 covering the period. Comparison with Figure E-4 reveals the changes in fire distributions between the two time periods. The most prominent feature in Figure E-5 is the extent of the fires on the 97th floor, with flames visible in a nearly continuous band running clockwise from just west of the center of the south face, along the western and northern faces, and reaching just past the center of the east face. Another feature which stands out is the general lack of visible fire in the southwest quadrant of the tower.

**Figure E-5. Maps of integrated fire observations between 9:03 a.m. and 9:18 a.m. are shown for the four faces of WTC 1.**

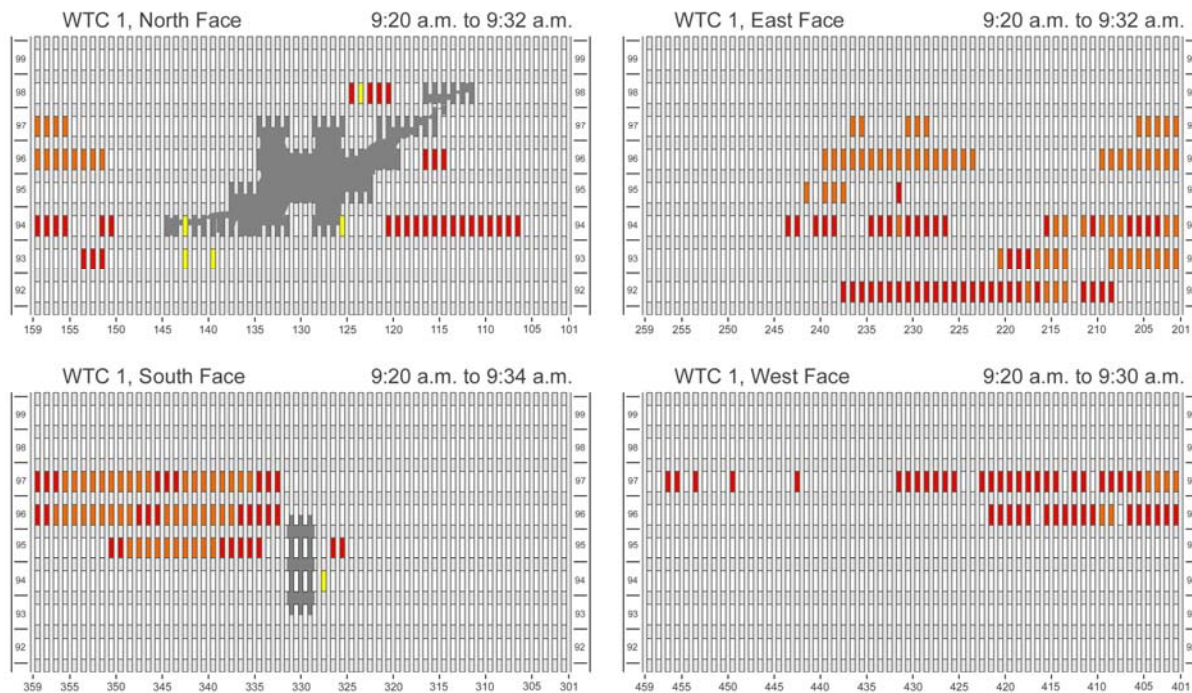
Integrated façade maps for the fires observed during the period are shown in Figure E-6. In general, fire spread during this period was reduced compared to the first two periods. While intensely burning fires with extended flames developed in northeast corner rooms on several floors, most of the new fire growth involved less intense flames that did not extend from windows. Such fires included those on the west side of the 94th floor and the central section of the 98th floor on the north face and the south side of the 96th floor on the west face.

**Figure E-6. Maps of integrated fire observations between 9:19 a.m. and 9:35 a.m. are shown for the four faces of WTC 1.**

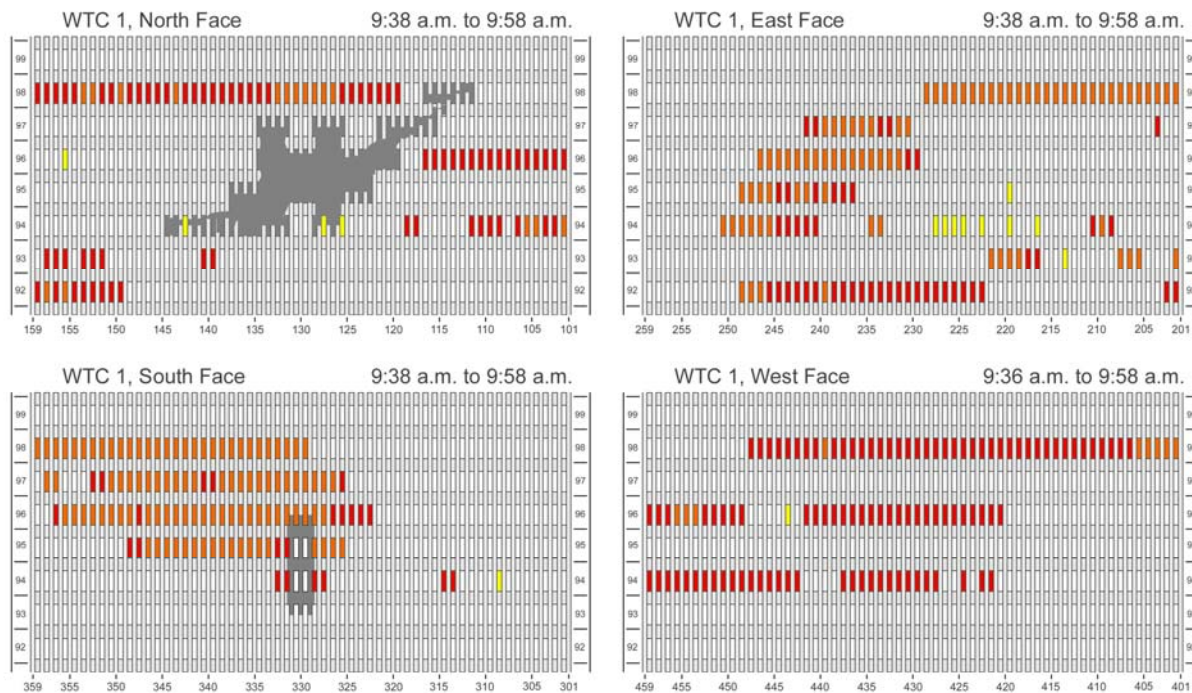
**Figure E-7. Maps of integrated fire observations between 9:36 a.m. and 9:59 a.m. are shown for the four faces of WTC 1.**

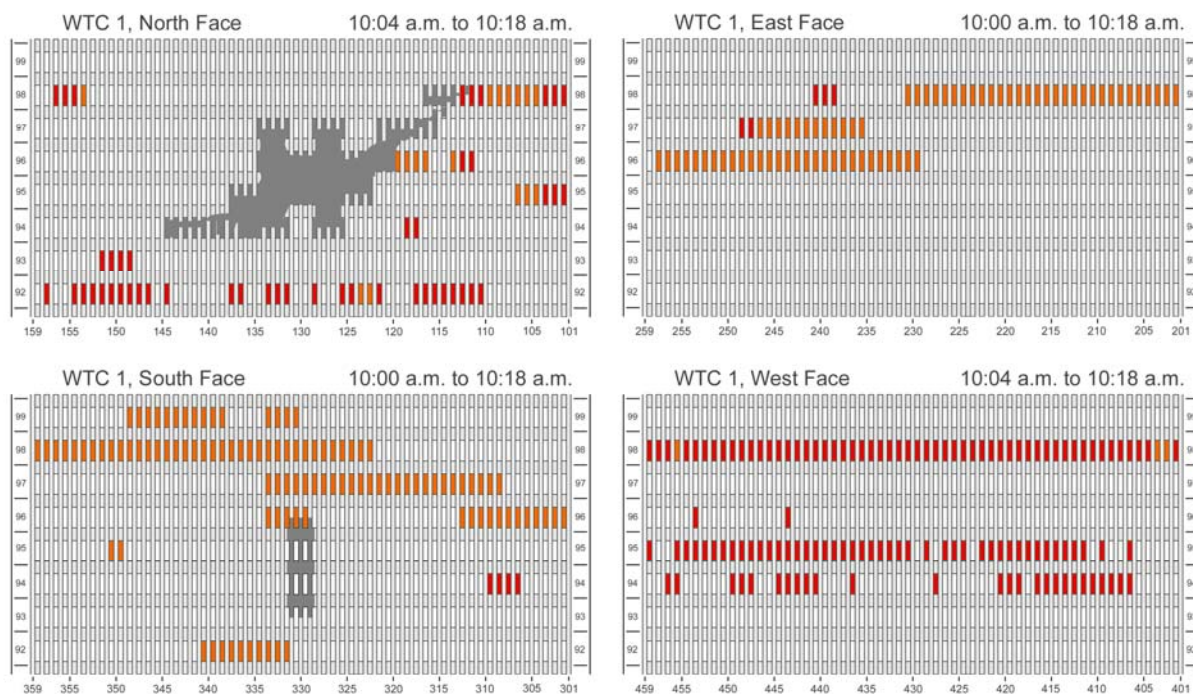
Integrated fire maps of the four faces for the period are included in Figure E-8. These maps likely underestimate the actual extent of the fires due to the limited visibility on the east and south faces. The extensive fires on the 98th floor are a dominant feature. Keep in mind that the much of the fire on the north side of this floor had already died down. The intense fires that developed rapidly along the periphery of the southeast quadrant also stand out. The broad extent of the low intensity fires on the west

sides of the 94th and 95th floors is also evident. Note that the intense fire that grew on the south side of the west face of the 104th floor is not displayed in the façade map.

**Figure E–8. Maps of integrated fire observations between 10:00 a.m. and 10:18 a.m. are shown for the four faces of WTC 1.**

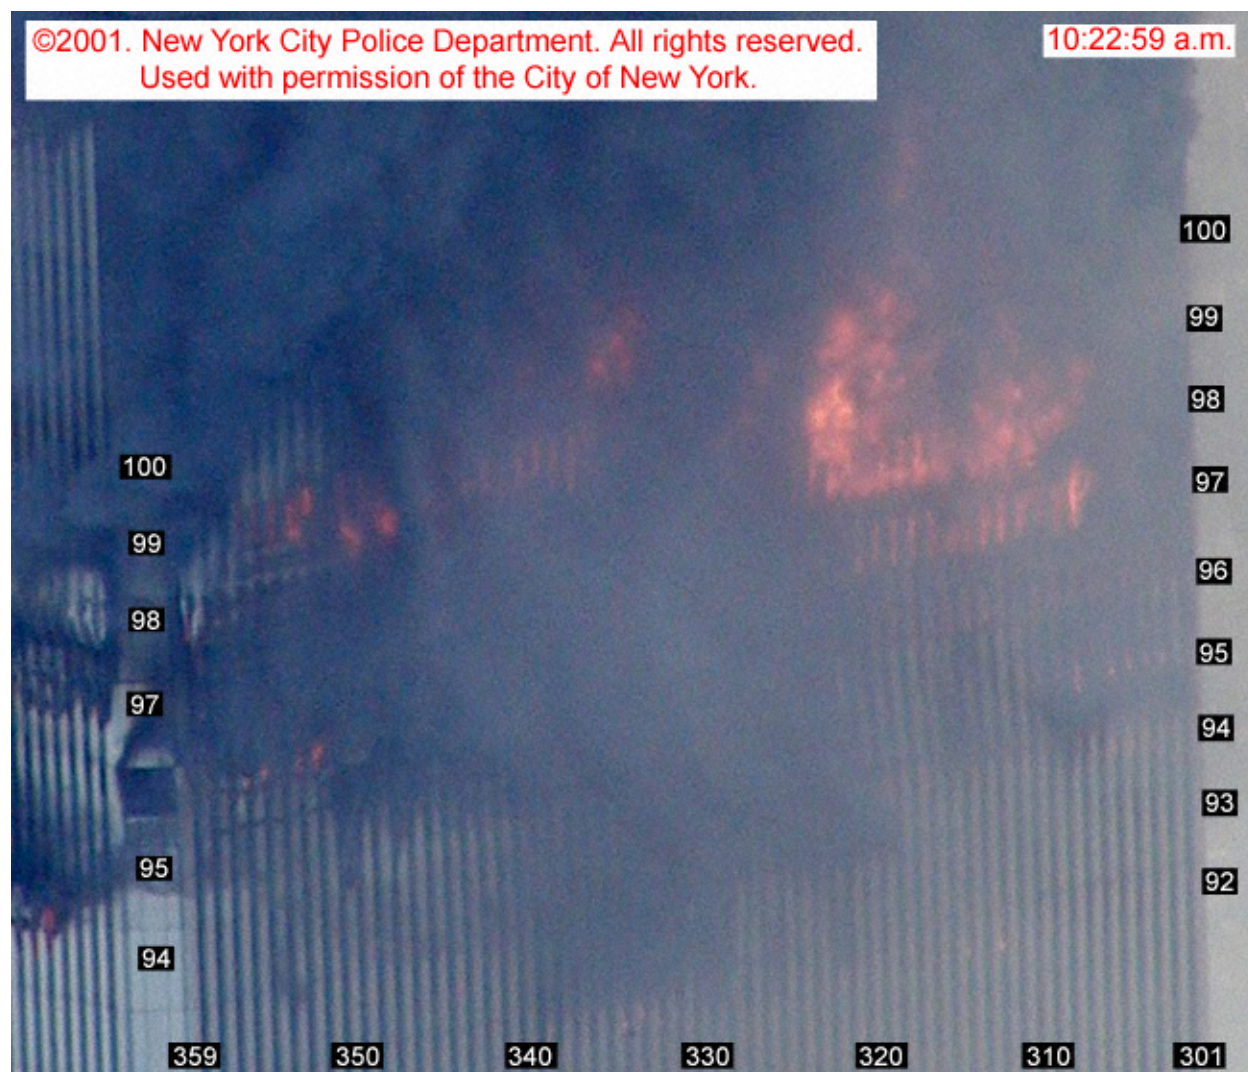
Views of the south face of WTC 1 were also limited for this time period, but several photographs taken from a helicopter flying relatively close to the tower provided a good indication of conditions on this face roughly half way through the period. Figure E-9 shows a cropped view of one of these photographs shot from the southwest at 10:22:59 a.m. Fires are visible on the east side of the face on the 92nd through 98th floors. A long distance video showed that the particularly intense fire on the 98th floor moved into the area around 10:19 a.m. Closer inspection reveals that many of the columns on the south face in the vicinity of 95th floor to the 98th floors were bowed inward at this time. Somewhat smaller flames are visible on the west side of the face on the 92nd, 96th, 98th, 99th, and 100th floors. Around 10:25 a.m. heavy smoke and fire appeared from windows in a room located in the southwest corner of the 94th floor. Long distance videos show that during the period leading up to the tower collapse the line of fire on the 98th floor continued to burn vigorously. The fire on the 99th floor appeared to intensify and move toward the east, eventually reaching a location more than half way between the center of the face and the east edge. When WTC 1 began to collapse, a large amount of flame was pushed from openings on the south face, with flames appearing to come from three separate locations. The first was from the vicinity of the intense fire burning on the east sides of the 98th and 99th floors, the second was from the fire burning on the western edge of the 94th floor, and the third came from around the center of the face near the 94th floor.

**Figure E–9.** This photograph showing the south face of WTC 1 is a cropped version of a photograph shot from a helicopter at 10:22:59 a.m. It has been enhanced by adjusting the intensity levels, and column and floor numbers have been added.

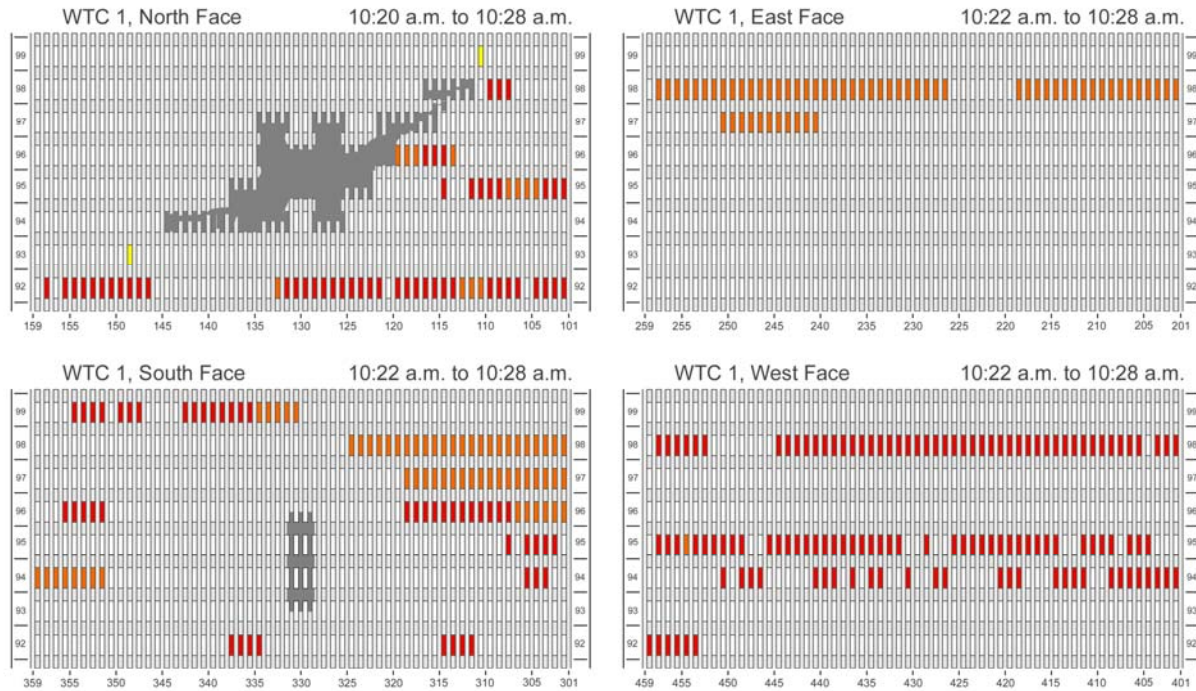
The integrated fire data for the period are shown in Figure E–10. A notable feature is the widespread presence of intense fire in the southeast quadrant of the tower following a long period when the area seemed to be isolated from fires burning elsewhere.

**Figure E–10. Maps of integrated fire observations between 10:20 a.m. and 10:28 a.m. are shown for the four faces of WTC 1.**

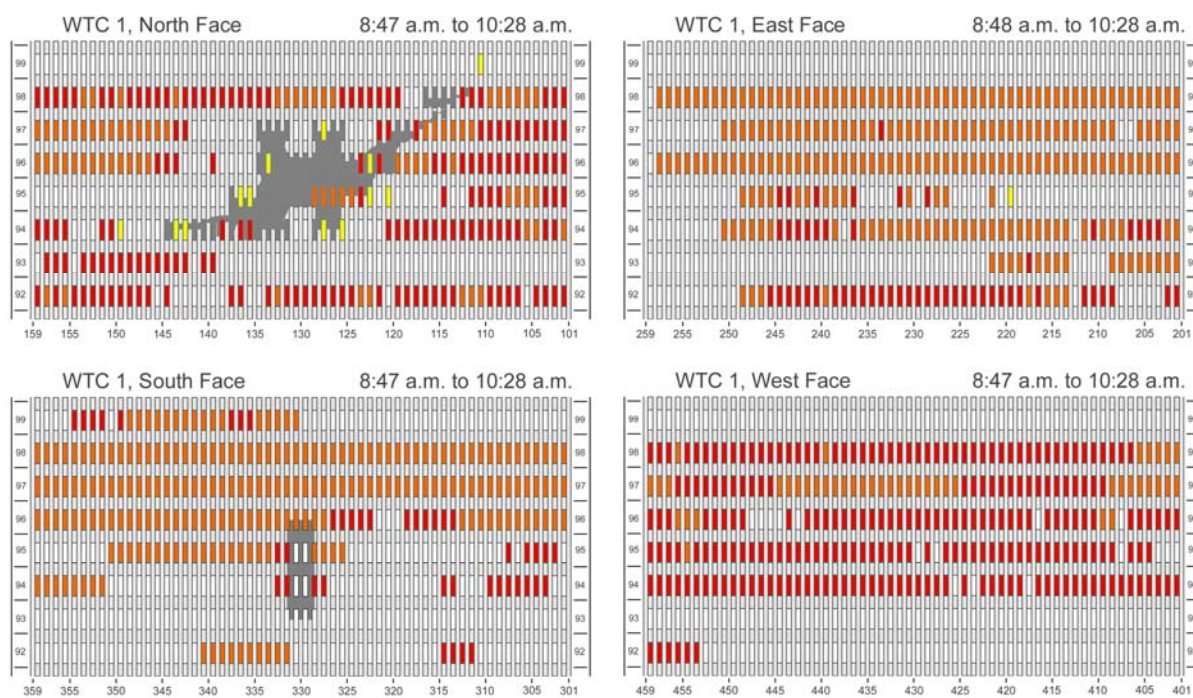
An interesting aspect of the fire behavior in WTC 1 was the variation in burning behavior observed on the different faces. Fires at most locations on the west and north faces of the towers burned without flame extension or release of large amounts of smoke from nearby windows. In many cases the fires appeared to burn as relatively low intensity distributed flames. The preponderance of red in the north and west face maps in Figure E-11 reflects this type of burning. In contrast, the fires burning on the east and south faces

most often generated external flames and heavy smoke flows at nearby windows as indicated by the extensive areas of orange on the façade fire maps. Various explanations for the different burning behaviors were considered. The most plausible is the effect of the prevailing wind. On September 11, the wind was striking WTC 1 from the northwest and then flowing down the north and west faces. This wind created positive pressures at the windows on these faces that tended to resist gas flows out of the tower. On the east and south faces the effect of the wind was the opposite, creating low pressure areas at the windows that tended to draw gases out of the building. The net effect of these pressure forces was a tendency for gases to flow internally on a floor, if a pathway was available, from the west and north faces to the east and south faces.

**Figure E-11. Maps of integrated fire observations between 8:47 a.m. and 10:28 a.m. are shown for the four faces of WTC 1.**

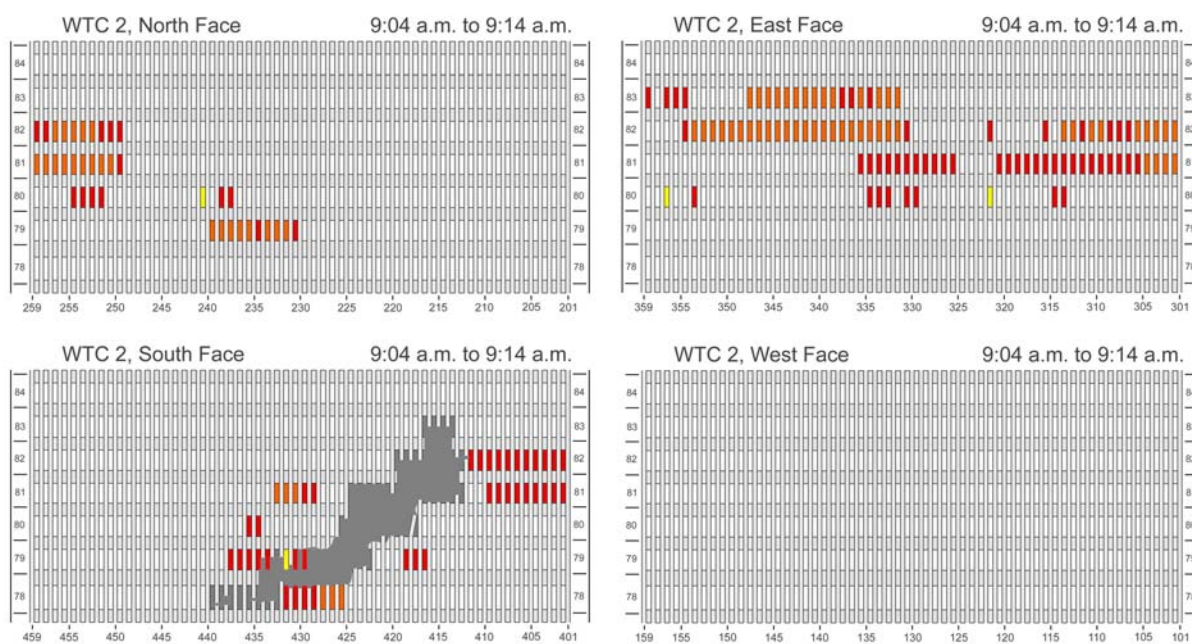
The fire data sheets for the period were integrated as a means for summarizing the fire distributions. The results are shown in Figure E-12. From these maps it is clear that the major visible fires were burning on the east and north faces of the tower. The most intense fires were on the 81st through 83rd floors, i.e., the upper portion of the floors impacted by the aircraft.

**Figure E–12. Maps of integrated fire observations between 9:04 a.m. and 9:14 a.m. are shown for the four faces of WTC 2.**

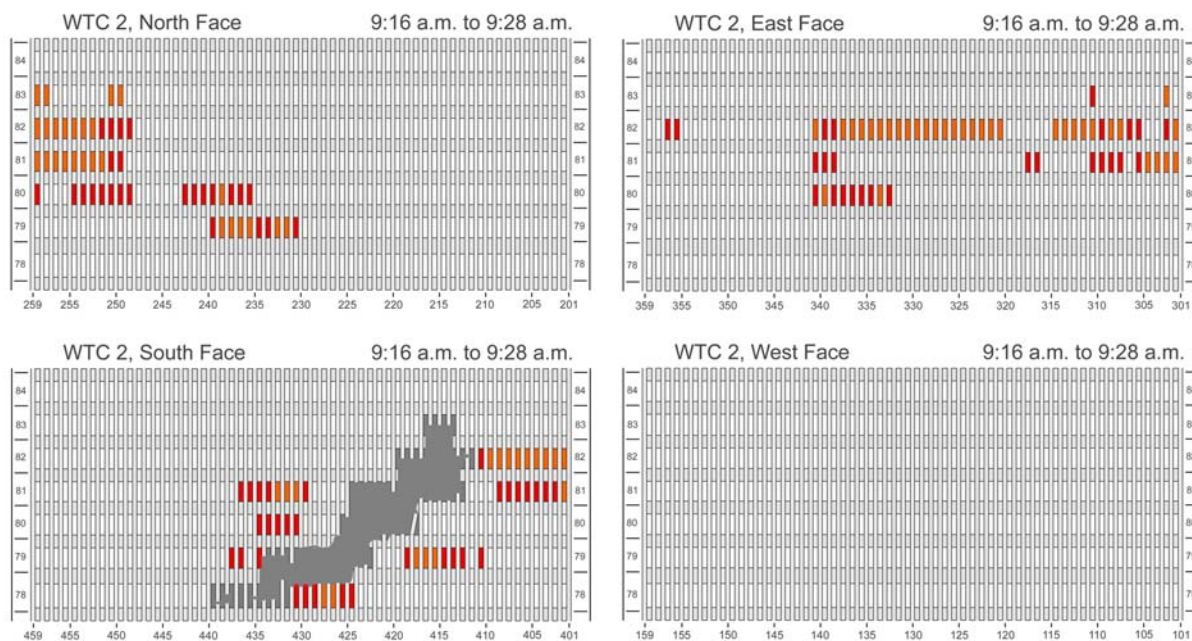
Maps of integrated fire intensities over the period for the four faces are shown in Figure E-13. Comparison with Figure E-12 confirms that minimal fire spread was taking place during the period. The fire distributions on the east face for the two periods appear quite different due to the rapid changes in the fires observed near the beginning of the first period and the continued northward spread of the fire on the 81st floor, which initially developed on the south side of the face, while going through a cycle of growth, intense burning, and decay. As during the initial time period, the largest fires were in the northeast corners of the tower on the 81st and 82nd floors and near the center of the north face on the 79th and 80th floors. These fires had been burning since the aircraft impact and were slowly dying down.

**Figure E-13. Maps of integrated fire observations between 9:15 a.m. and 9:29 a.m. are shown for the four faces of WTC 2.**

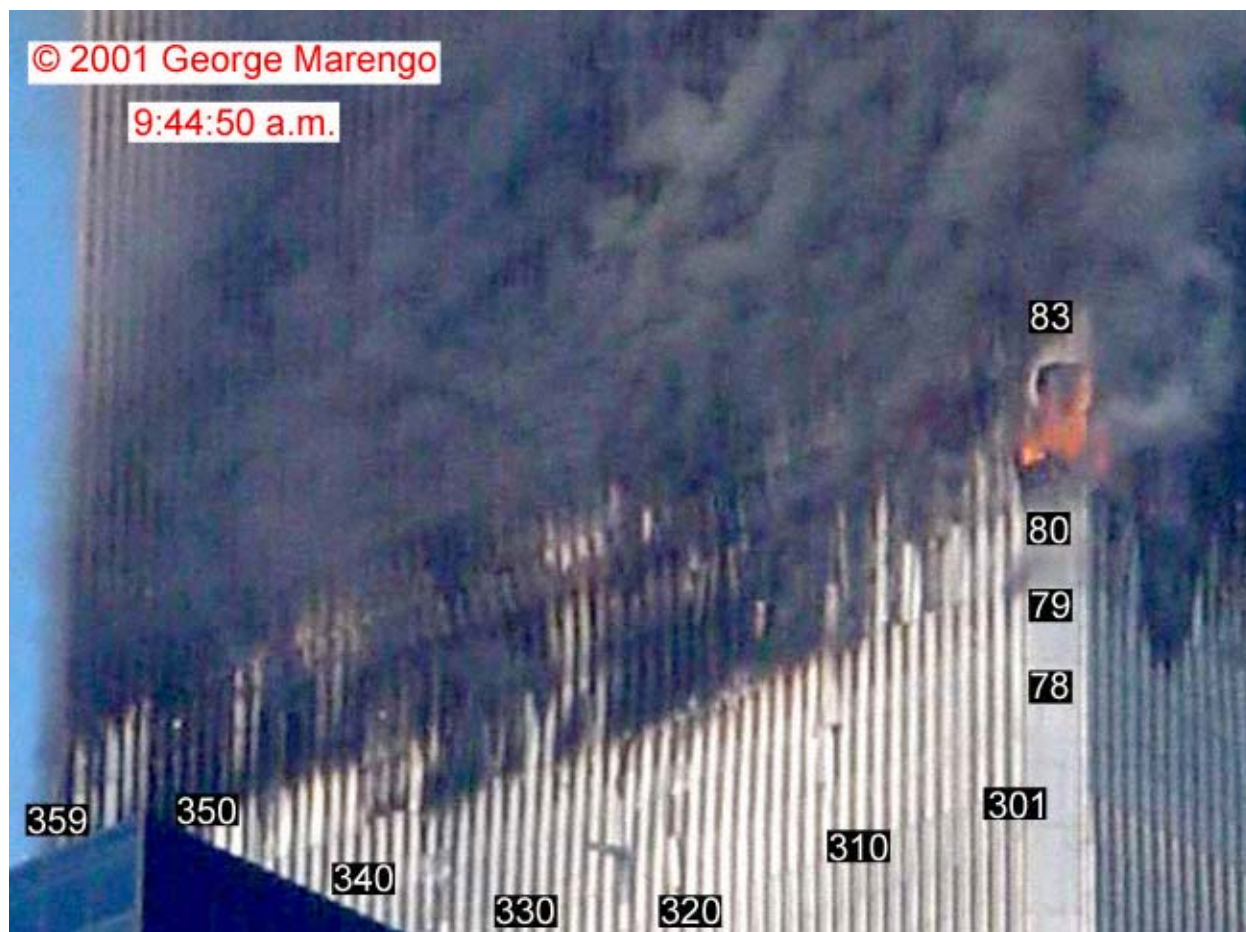
images and was still present at the end of the period. Around this time, three people either tried to climb down or fell from a window on the south side of the 79th floor, providing a possible indication that conditions were rapidly deteriorating on this floor. The unusual short-lived smoke puffs from windows on the face described earlier continued, apparently randomly, throughout the period. Some of these puffs released sufficient smoke to briefly obscure the face. In some instances smoke was also pushed simultaneously from windows on the north and south faces. Another type of transient behavior was first observed starting around 9:35:45 a.m. Heavy smoke began flowing out of numerous windows over the face and was particularly heavy near the centers of the 79th and 80th floors. Unlike observed during the short-lived smoke puffs, intense flames were also visible coming from many of these windows and, instead of lasting only a few seconds, the heavy smoke and flames were present for just over a minute before they abated as quickly, seemingly, as they appeared. This roughly one minute widespread release of heavy smoke and flames represents a distinct type of behavior from the short smoke puffs and more typical burning behaviors seen up to this time. This unusual event was not unique. Two similar releases of smoke and fire, each lasting roughly one minute, were observed, with one starting just before 9:40 a.m. and the other after 9:41 a.m. A photograph taken around 9:38 a.m. showed that the hanging object (possibly the 83rd floor slab) visible earlier through open windows on the 82nd floor of the east face had once again dropped further down and that some intermediate portions had disappeared from view. The windows where the object first appeared below the 83rd-floor spandrel had moved further toward the edges of the tower on both the north and south ends. Figure E-14 shows a photograph of the east face taken just before 9:45 a.m. during a period when there was very little smoke flow from the face. Closer inspection reveals that the columns near the center of the face on the 80th and 81st floors are bowed inward. Similar bowing was identified in other images of the face starting as early as 9:22 a.m.

**Figure E–14.** This cropped photograph was shot from the northeast and shows the east face of WTC 2 at 9:44:50 a.m. The original intensity levels have been adjusted, and column and floor numbers have been added.

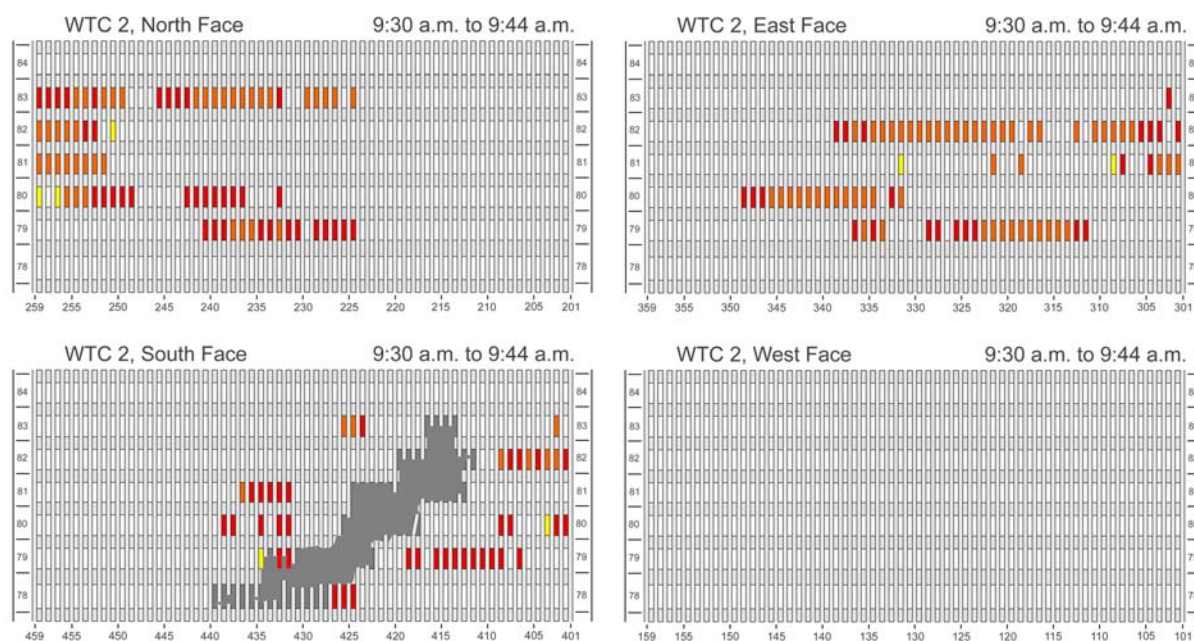
Figure E-15 shows integrated fire maps for the period. The new areas of fire that appeared on the 79th and 83rd floors of the north face are evident. Extensive new areas of fire were also present on the 79th and 80th floors of the east face. It should be remembered that a fraction of the observed fire indicated on the maps for these floors was associated with the three roughly one-minute-duration periods during which heavy smoke flows and fires were present.

**Figure E-15. Maps of integrated fire observations between 9:30 a.m. and 9:45 a.m. are shown for the four faces of WTC 2.**

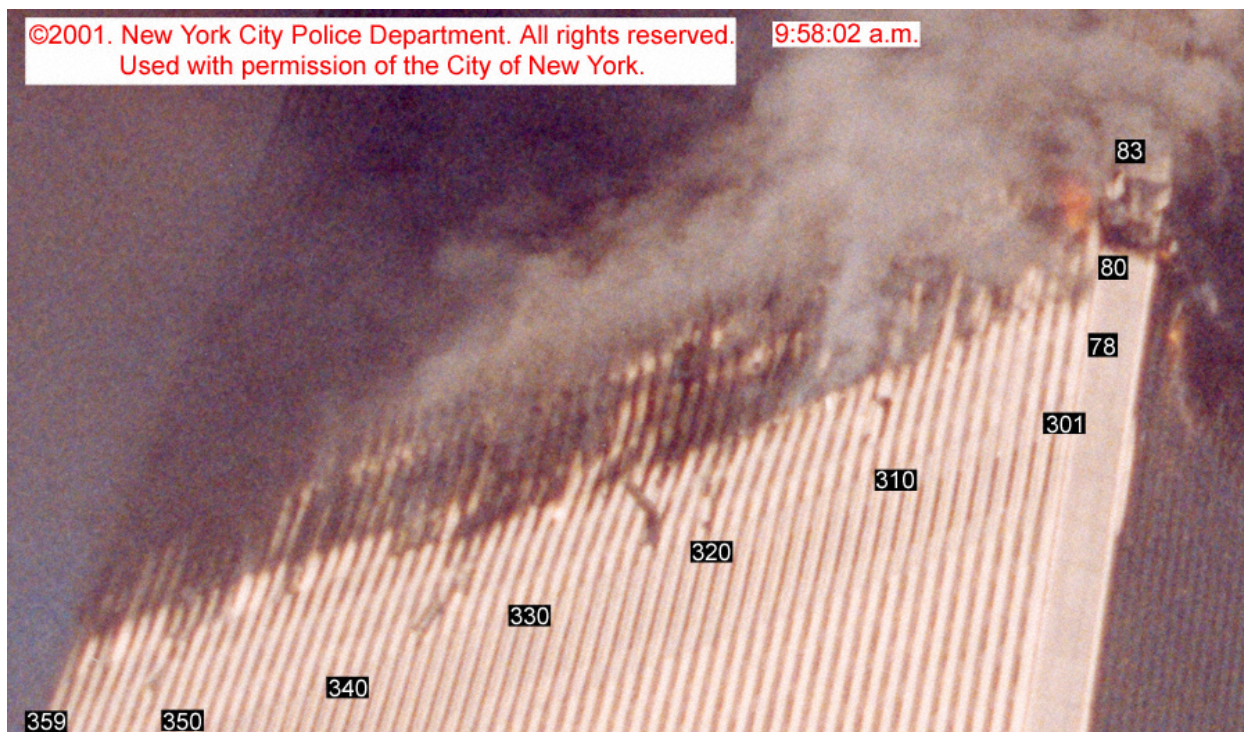
through windows on the 82nd floor changed again, with the northernmost window where the object could first be seen located slightly to the north. A prominent feature on the east face during the period was the inward bowing of the outer wall. This can be seen clearly over the 79th to 82nd floors in Figure E-16, which was taken less than a minute before the collapse started. During the 20 s prior to the collapse, a large number of pieces of debris fell from the northern sides of the 80th and 81st floors. The falling debris coincided with a heavy flow of molten metal from the north face. When WTC 2 collapsed, very little flame was expelled from the east face windows. Based on observations elsewhere on the two towers, regions of intense burning would have been expected to generate short-lived jets of flames. Their absence suggests that large fires were not burning near the east face at the time of collapse.

**Figure E-16. This cropped image shows the east face of WTC 2 at 9:58:02 a.m. The intensity levels have been adjusted, and column and floor numbers have been added.**

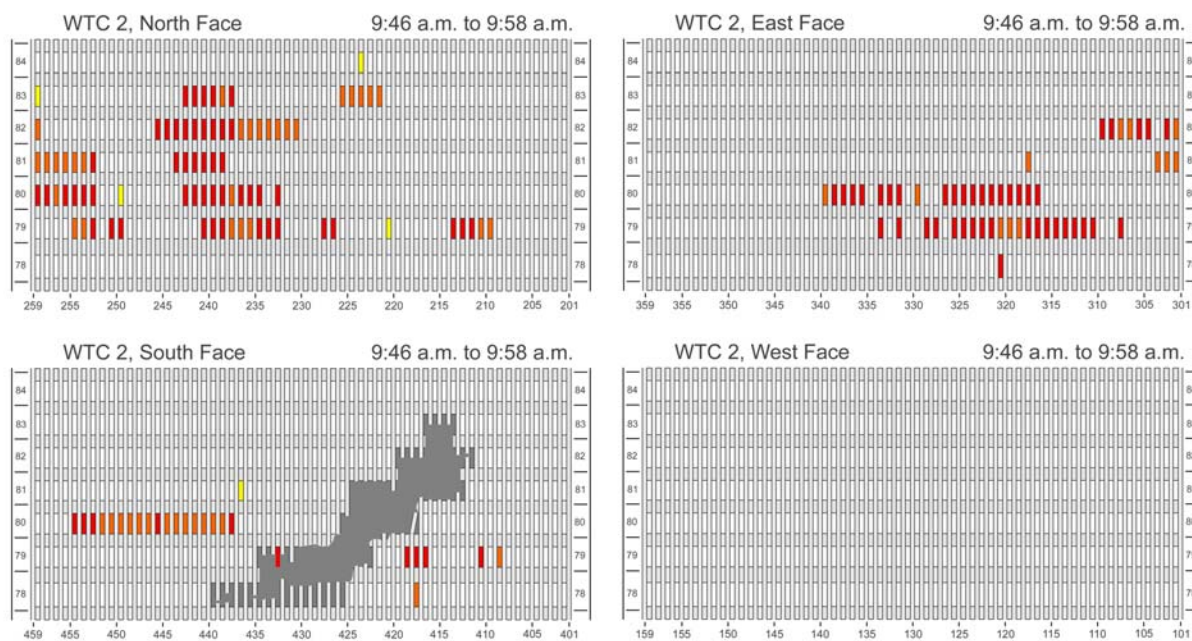
Façade maps of integrated fire intensities for the period are shown in Figure E-17. Many of the fires present during earlier periods were either no longer visible or were dying down during the final interval prior to the tower collapse. Some fire spread to the west had taken place on several floors on the north face. Areas with substantial fires included those on the north sides of the east face on the 79th and 80th floors (recall that the observed fires are combinations of sustained fires and short-lived flame releases) and the intense fire that grew on the west side of the south face on the 80th floor.

**Figure E-17. Maps of integrated fire observations between 9:45 a.m. and 9:59 a.m. are shown for the four faces of WTC 2.**

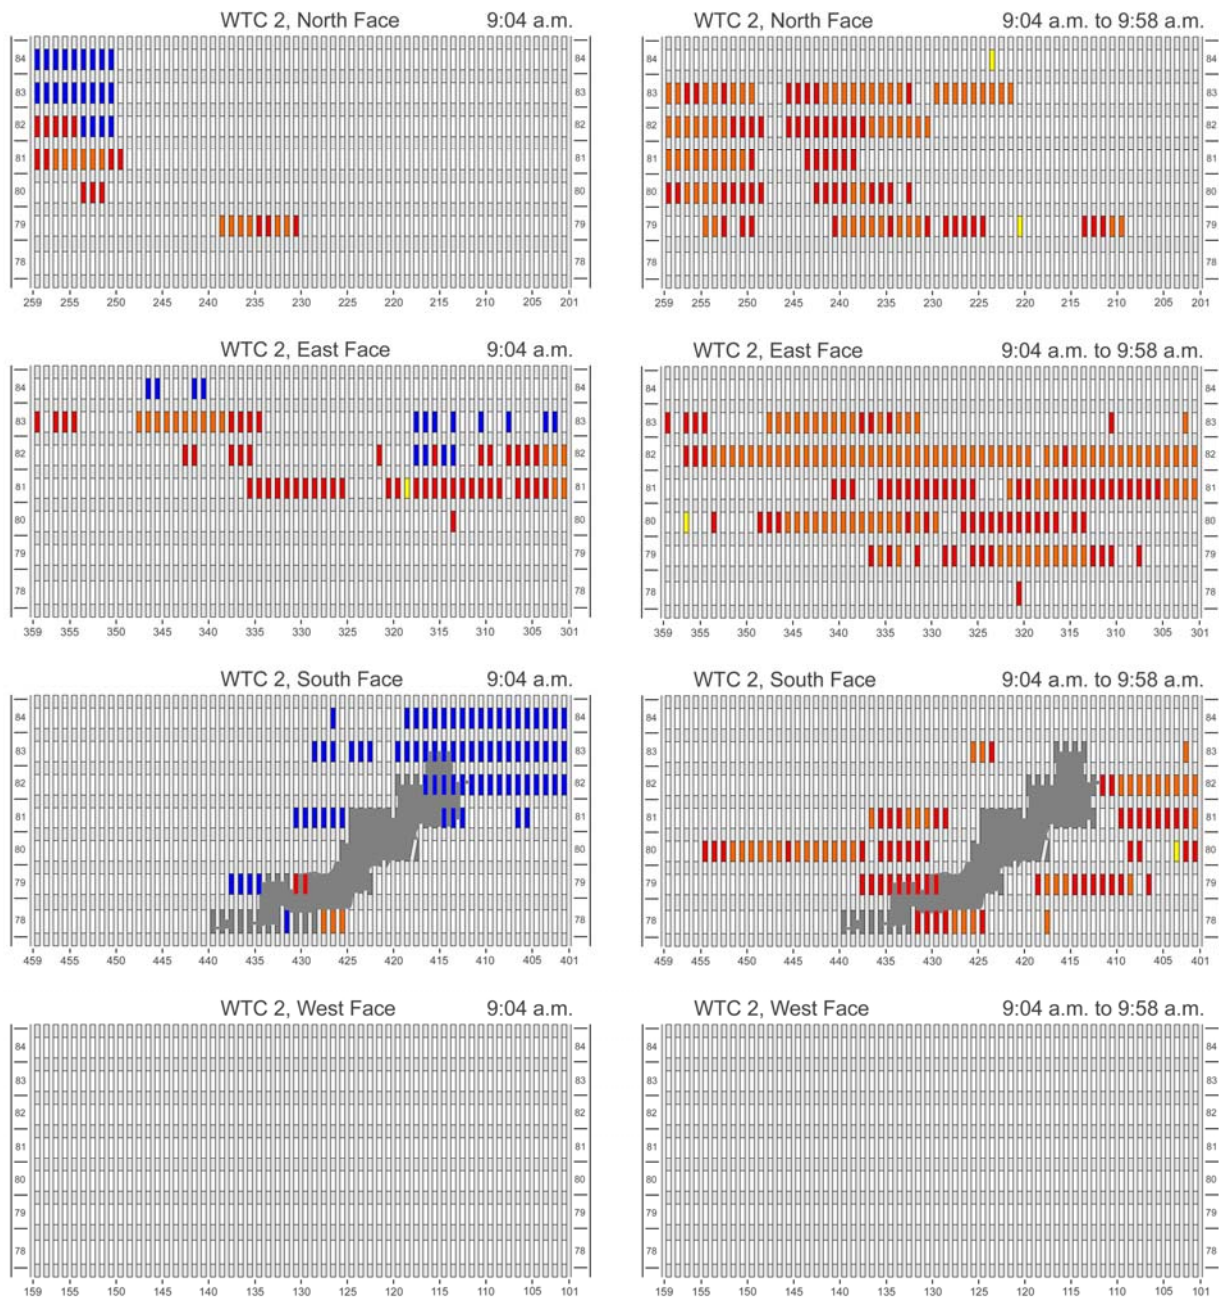
Compared to WTC 1, there was less observed fire spread in WTC 2, even when the difference in available time (102 min for WTC 1 and 56 min for WTC 2) is taken into account. Figure E-18 compares WTC 2 integrated façade maps of fire observations for the entire 56 min period with fire distributions present shortly after the aircraft impact. Primary areas of fire growth and spread include the east side of the 83rd floor and locations to the west of the cold spot on several additional floors of the north face, much of the 81st floor and extensive areas toward the centers of the 79th and 80th floors on the east face, and areas on either side of the aircraft impact cavity on the south face, particularly to the west side of the 80th floor and to the east on the 81st and 82nd floors. The absence of visible fire indicates that substantial fires did not reach the west face of the tower during the available time.

**Figure E-18. Maps of observed fire distributions on the four faces of WTC 2 shortly after the aircraft impact (near 9:04 a.m.) are compared with the corresponding integrated fire observations for the entire period between 9:03 a.m. and 9:59 a.m. Blue represents windows where observations were not possible.**

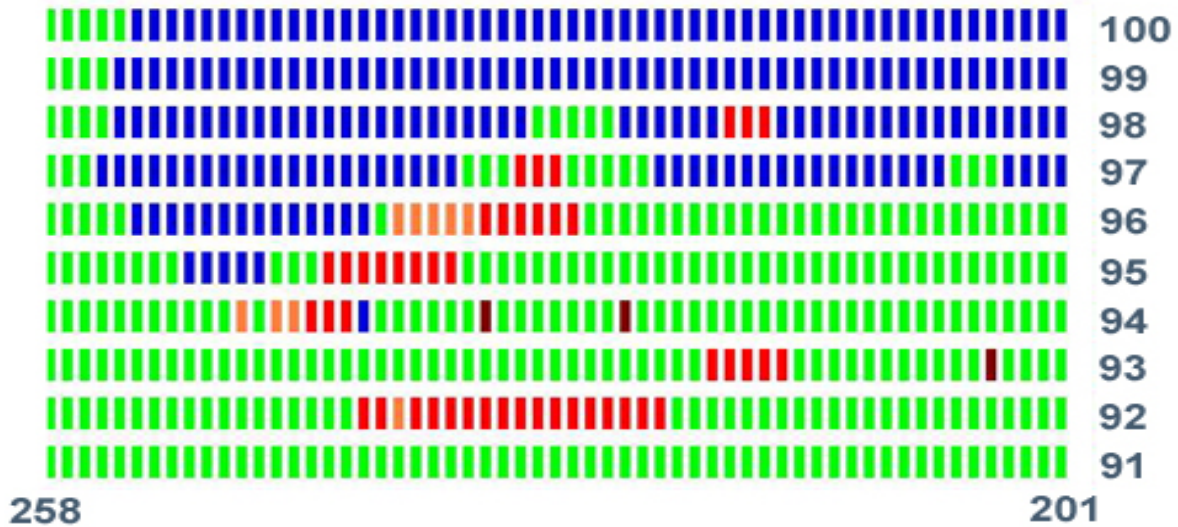
Figure 5-3. A representation of fires for floors 91 to 100 on the east face of WTC 1 around 9:42 a.m. is shown. Results are taken from the Excel spreadsheet shown in Figure 5-2.

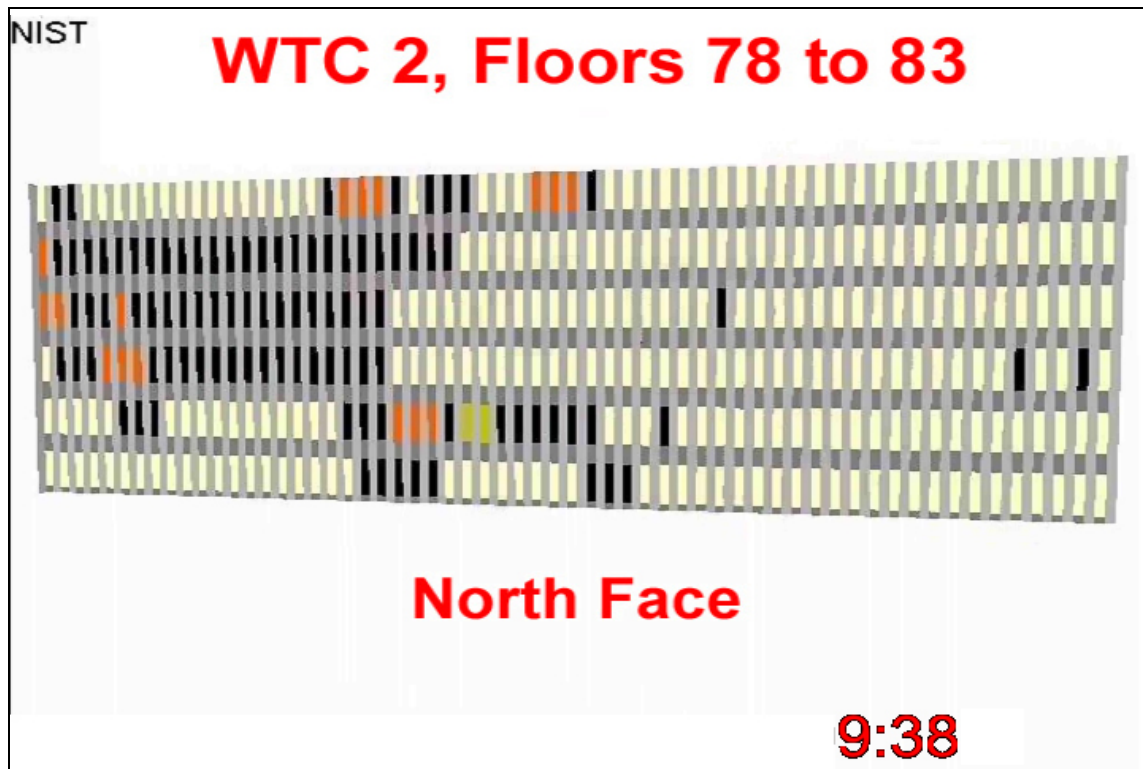
Figure 5-4. A single frame from a time-dependent visualization generated by Smokeview is reproduced. The animation is a three-dimensional representation of the condition of windows and fires on WTC 2 from the time of the aircraft impact at 9:02:59 a.m. until the tower collapsed at 9:58:59 a.m. The color assignments are: grey – window in place, black – missing window, orange – external flaming, yellow – fire inside, and green – spot fire.
