**NIST NCSTAR 1-5A**

**Federal Building and Fire Safety Investigation of the  
World Trade Center Disaster**

# **Visual Evidence, Damage Estimates, and Timeline Analysis**

September 2005

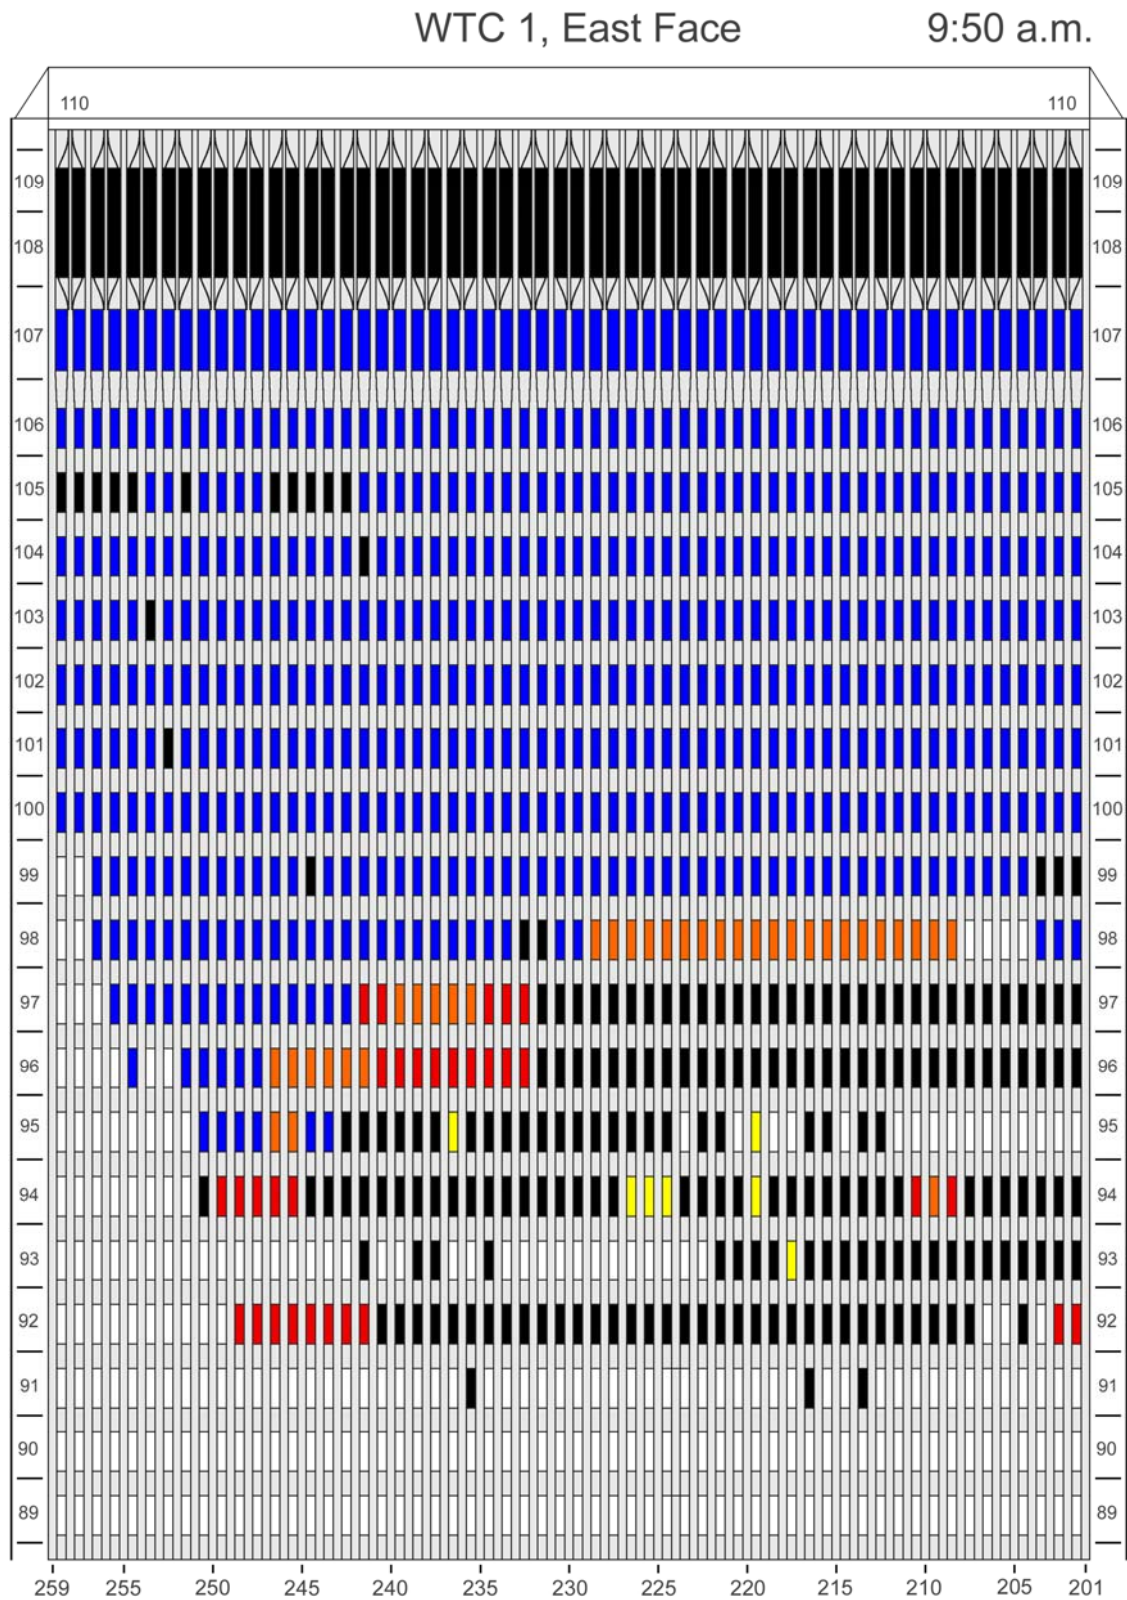
**Figure 5-6.** An example of a façade drawing combining data for window condition and fires is shown. The data is for the east face of WTC 1 around 9:50 a.m.

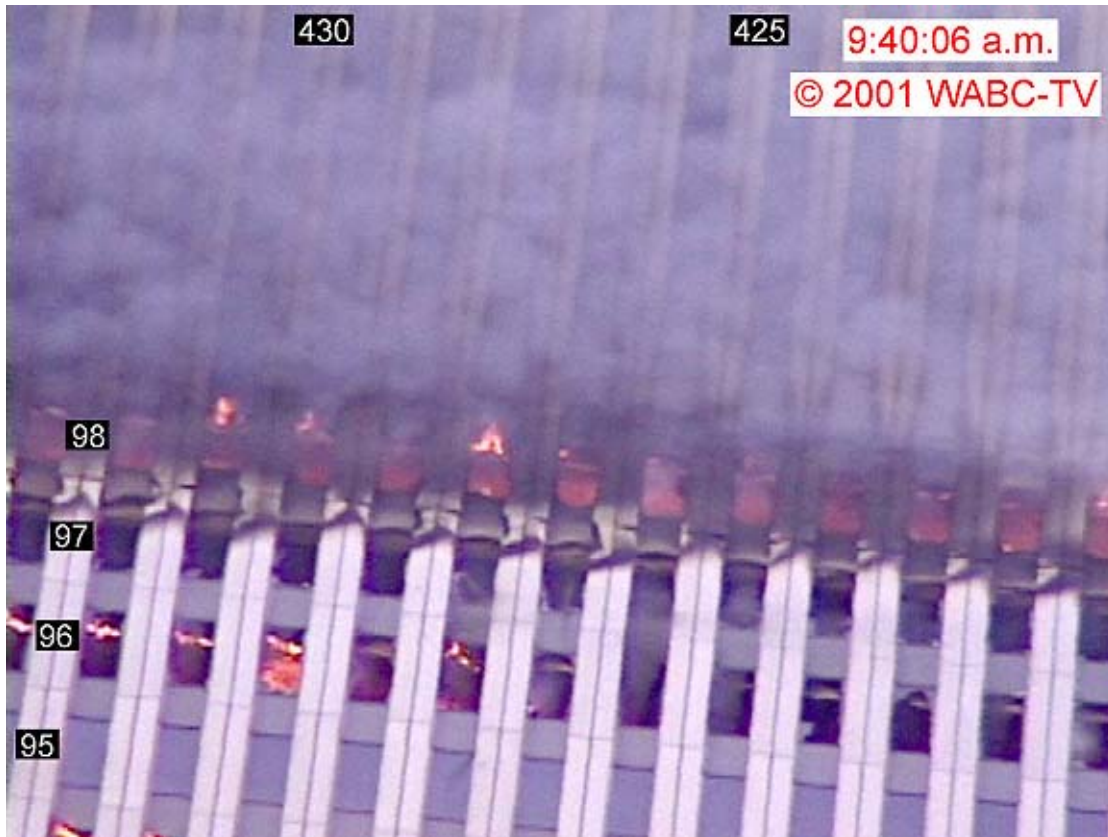
**Figure 5-9.** This close up view of the west face of WTC 1 was captured from a video recorded at 9:40:06 a.m. It has been enhanced by adjusting the intensity levels. Column and floors numbers have been added.

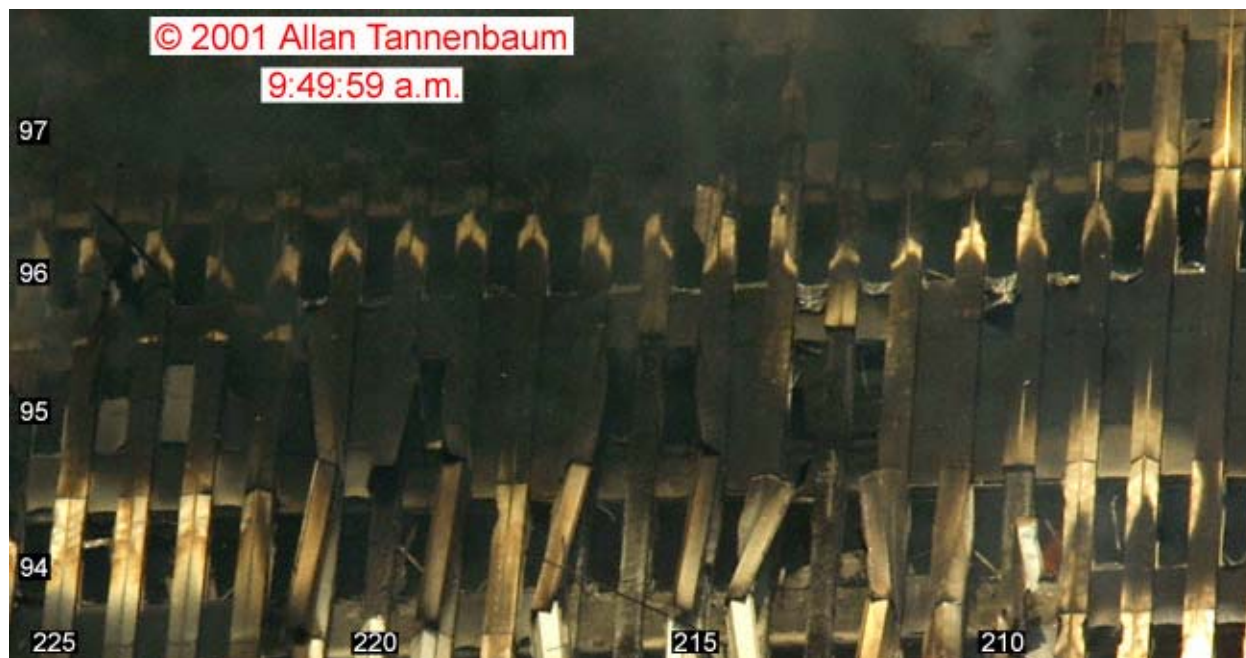
exiting a window. This flow pattern resulted in the formation of distinct patterns on the columns near the base of the burning flow that were easily identified. The marks resulted from deposited soot on the underside of the flames. Due to their shapes, this type of column pattern will be referred to as a “caret.” Figure 5–10 show examples of carets observed on the 96th floor of the east face of WTC 1. Variations in the heights of the patterns are evident from window to window. The location of a caret on a column cover provides an indication for the distance between the top of the window and the lower region of the burning gases leaving the window. This, in turn, reflects the depth of the layer of rich combustion gases behind the window. Typically, a deeper layer corresponds to a local region of higher combustion gas formation and temperature and generally indicates a location of more intense burning.

**Figure 5-10. This cropped photograph shows a portion of the east face of WTC 1 at 9:49:59 a.m. The image has been rotated and enhanced by adjusting the intensity levels. A number of carets are visible near the tops of windows on the 96th floor. These carets were created during periods of external flaming from adjacent open windows. Column and floor numbers have been added.**

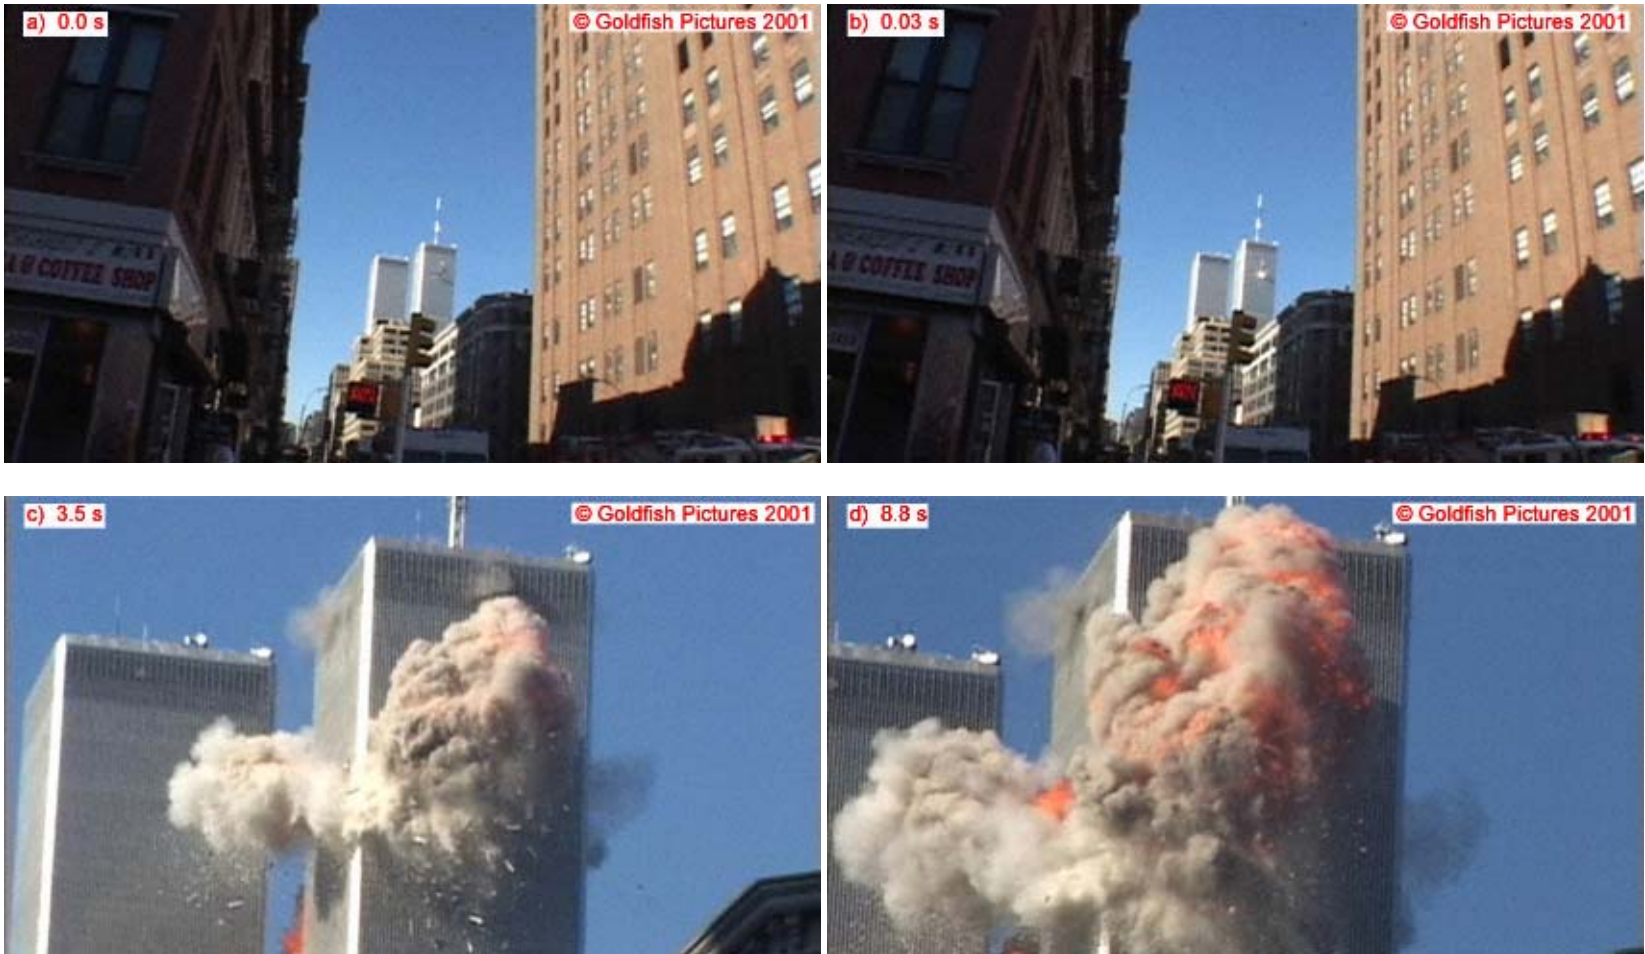
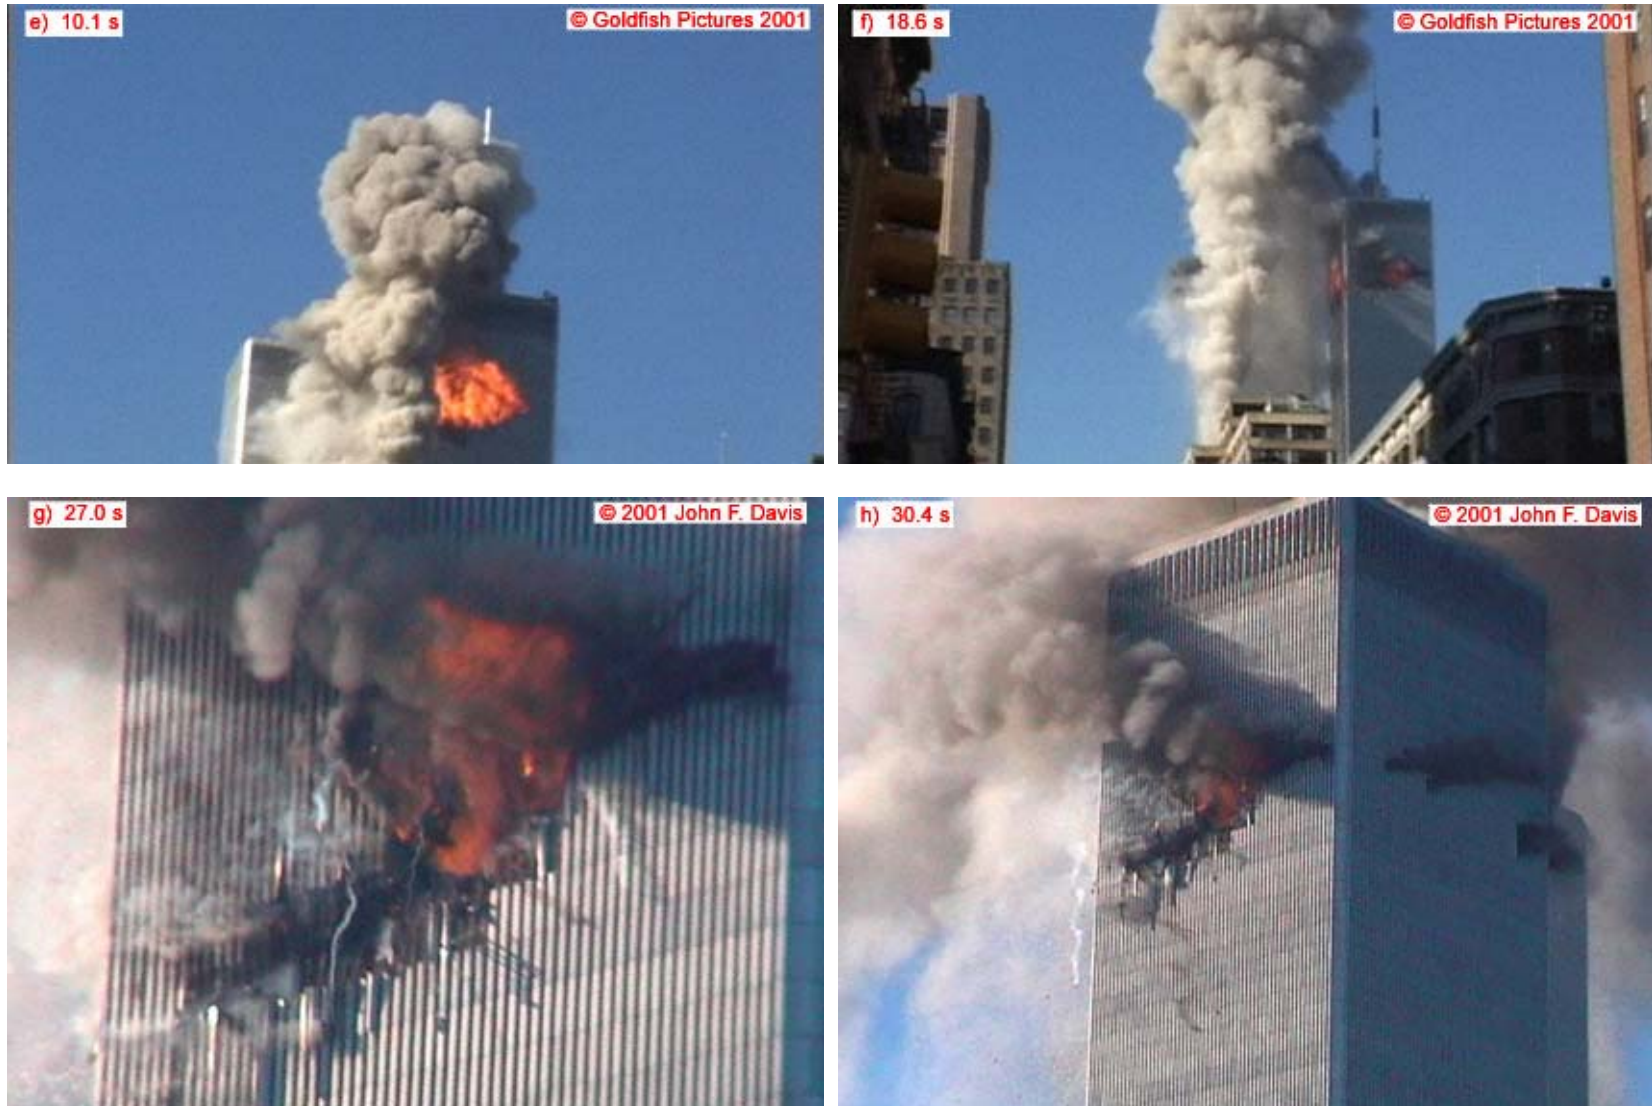
Roughly 5 s later (frame d), the dust clouds on the north and east faces have grown substantially. The north-face dust cloud is considerably larger, and extensive flames can now be seen throughout the cloud, interspersed with the white dust. A large amount of debris can be seen falling below the aircraft impact location. The prevailing wind has begun to blow the external fireball and falling debris across the north face toward the east. Flames on the east face seem to be present only near the building, suggesting that much less aviation fuel has been expelled on this face. A small region of fire is still visible extending beyond the southern edge of the east face, i.e., apparently coming from the south face of the tower.

At 10.07 s following the aircraft impact (frame e), the fireball that formed on the north face appears to have dissipated, leaving a “thermal” that is continuing to rise. For this report, the word “thermal” is used to identify a mushroom-shaped buoyant plume generated by the rapid release of a large amount of heat. The dust cloud created by debris falling from this face has developed a tube-like appearance and has been blown to the east edge of the tower. A bright region of flame is present across much of the region where the aircraft entered. The dust cloud on the east face has continued to expand, and no flames are now evident within this cloud.

Figure 6-1. A series of frames from videos shows American Airlines Flight 11 striking WTC 1 and the immediate aftermath. Times relative to the aircraft impact time are shown in the upper left-hand corner.

The next frame, (f), was recorded roughly 8.5 s later. At this time the dust-filled cloud sinking below the impact area and the rising thermal created on the north face have been blown further by the wind and are now more than a building width to the east of the northeast corner of the tower. The tube-like cloud of debris extends downward many stories and has developed the appearance of a concentrated vortex. The wind has also blown the debris away from the east face, and this face can now be observed. Substantial fires are now evident on the north and east faces in areas where the dust plumes were initially observed. Even though frame (f) is more zoomed out than frame (e), it is evident that the fire on the north face is much smaller than it was just 8.5 s earlier, suggesting that fires due to the aviation fuel released by the aircraft impact are already beginning to burn out. A thermal can be seen rising behind WTC 1, which provides additional evidence that the south face was damaged by debris passing through the tower.

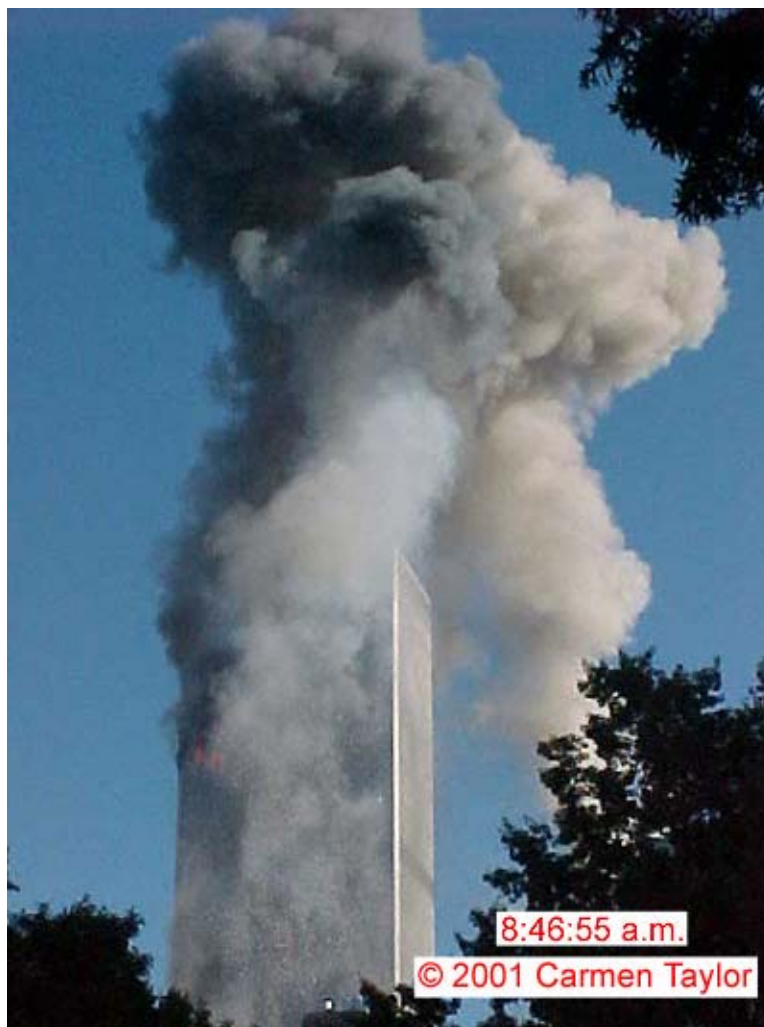
The photograph shows both WTC 1 and WTC 2, with the south face of WTC 1 partially hidden by WTC 2, which is in the foreground. An area of intense fire is apparent on the western side of the south face of WTC 1. This fire is in the vicinity of the 96th floor. An area of falling debris can be seen moving in front of the south face of WTC 2. This debris fell from the south face of WTC 1 and was blown to this location by the prevailing wind. Above the debris cloud a small thermal can be seen rising above the tower. This thermal must have resulted from a fireball that formed on the south face of WTC 2 following the aircraft impact. The occurrence of this fireball is consistent with the area of fire on the south face described above. The formation of a fireball on the south face indicates that a significant amount of aviation fuel from the aircraft passed all the way through the tower and burned on the other side.

**Figure 6-2. View of the WTC towers shot at 8:46:55 a.m. from the southeast shortly after American Airlines Flight 11 struck WTC 1. A dust-filled vortex is visible on the right side. A second area of falling debris can be seen passing on the south side of WTC 2. Significant fires are present on the west side of the south face of WTC 1, which can be seen to the left and behind WTC 2.**

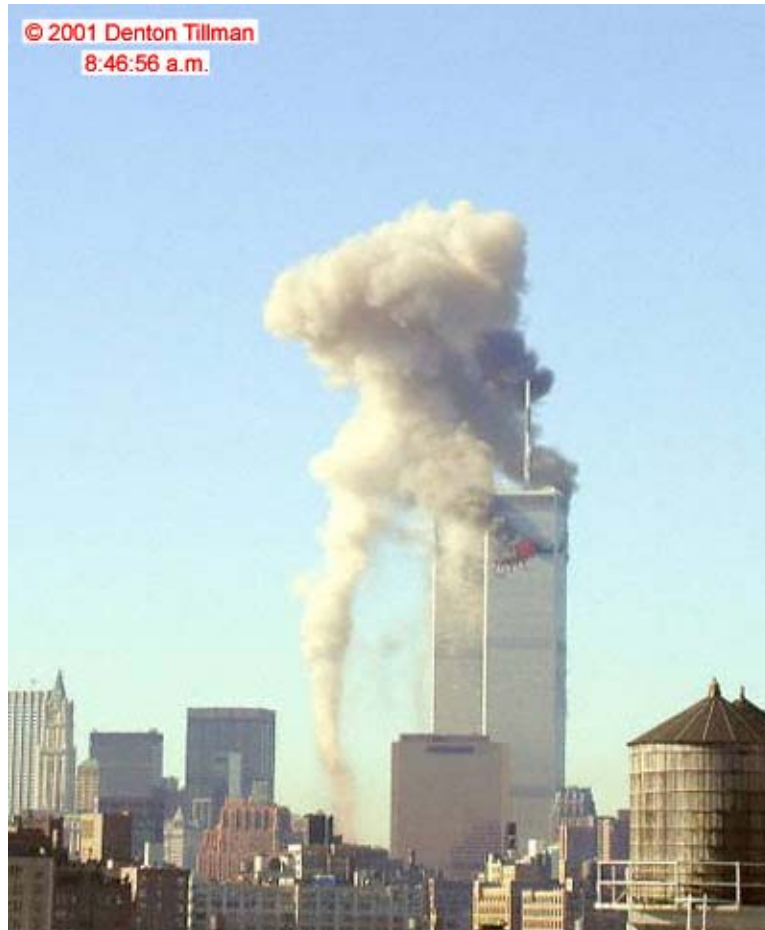
The presence of significant burning on the south face of WTC 1 is also indicated by the photograph shown in Figure 6–3 that was taken 26 s (i.e., 8:46:56 a.m.) after the aircraft impact on the tower. The thermal formed by the fireball on the rear side can be seen behind the large thermal formed by the fireball on the north face. A large amount of smoke is rising from behind the tower, consistent with the heavy fire seen on the south face in Figure 6–2. This photograph also provides an excellent view of the vortex generated on the north face of WTC 1 by the aircraft impact. The vortex is large, extending all the way down to near the ground. It has been transported a large distance by the prevailing wind. Even at this distance, the large fire burning inside the impact cavity in the tower is evident. This is consistent with Figure 6–1 (g), which was recorded at nearly the same time.

**Figure 6-3.** A cropped photograph taken from the north shows the WTC towers at 8:46:56 a.m., i.e., 26 s after the aircraft impact on WTC 1. Colors have been adjusted.

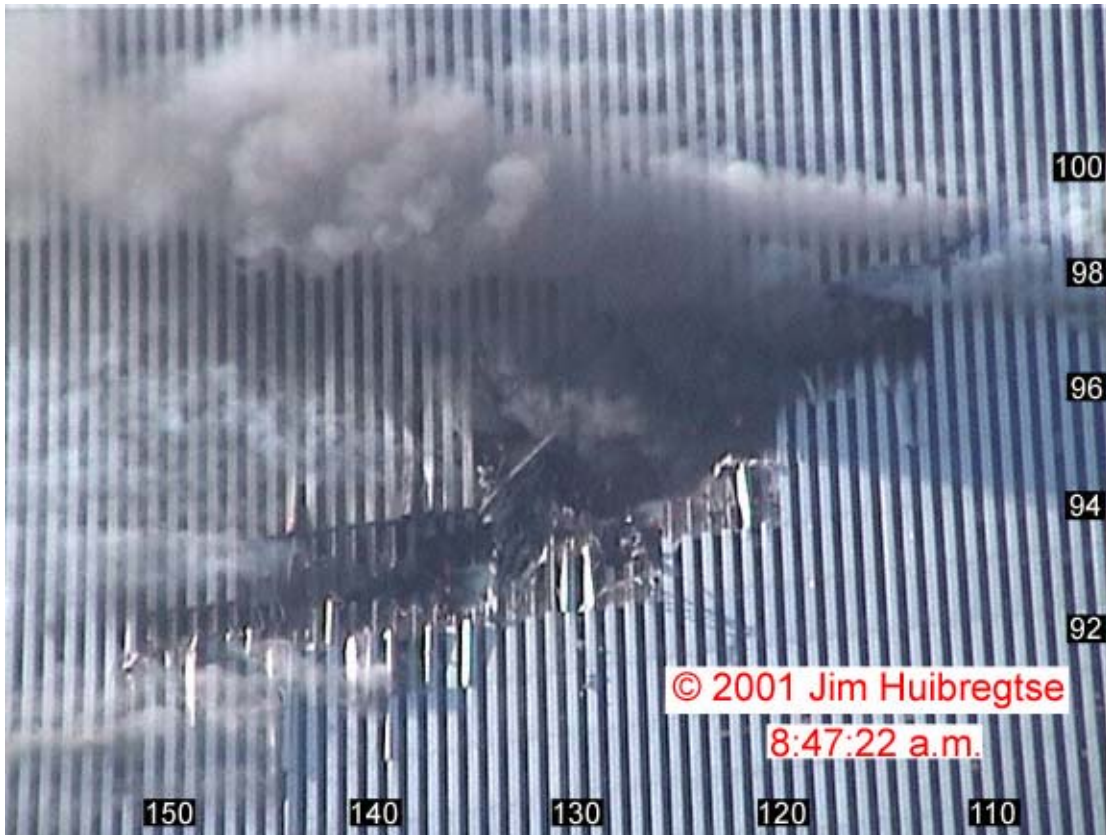
By inspection of Figure 6–4 and similar images, it was observed that the wing tips and the top of the vertical stabilizer at the tail of the aircraft damaged the aluminum column covers on the steel façade without cutting through the steel below or completely removing the covers. Using these images, it was possible to map out locations on columns where the wingtips and the vertical stabilizer struck the tower. These locations were then transferred to the representation of the damaged steel façade shown in Figure 6–6 and are represented by dashed lines, with wings to the right and left and the vertical stabilizer in the center. The good agreement between the damage pattern and the wing-tip locations is evident. It was reported in the FEMA report (McAllister 2002) and widely in the media that American Airlines Flight 11 struck floors 94 to 98 of WTC 1. The dotted horizontal lines on the left side of Figure 6–6 indicate the locations of concrete floor slabs. It can be seen that while the tip of the left wing of the aircraft struck very close to the base of the 94th floor, the wing end marked column 153 at the very top of the 93rd floor. It is evident from the Figure that the right wing actually struck well up on the 99th floor on column 109. The impacted floors therefore range from the 93rd floor to the 99th floor.

Figure 6-4. This image of the north face of WTC 2 is a frame taken from a video recorded at 8:47:22 a.m. Column and floor numbers have been added.

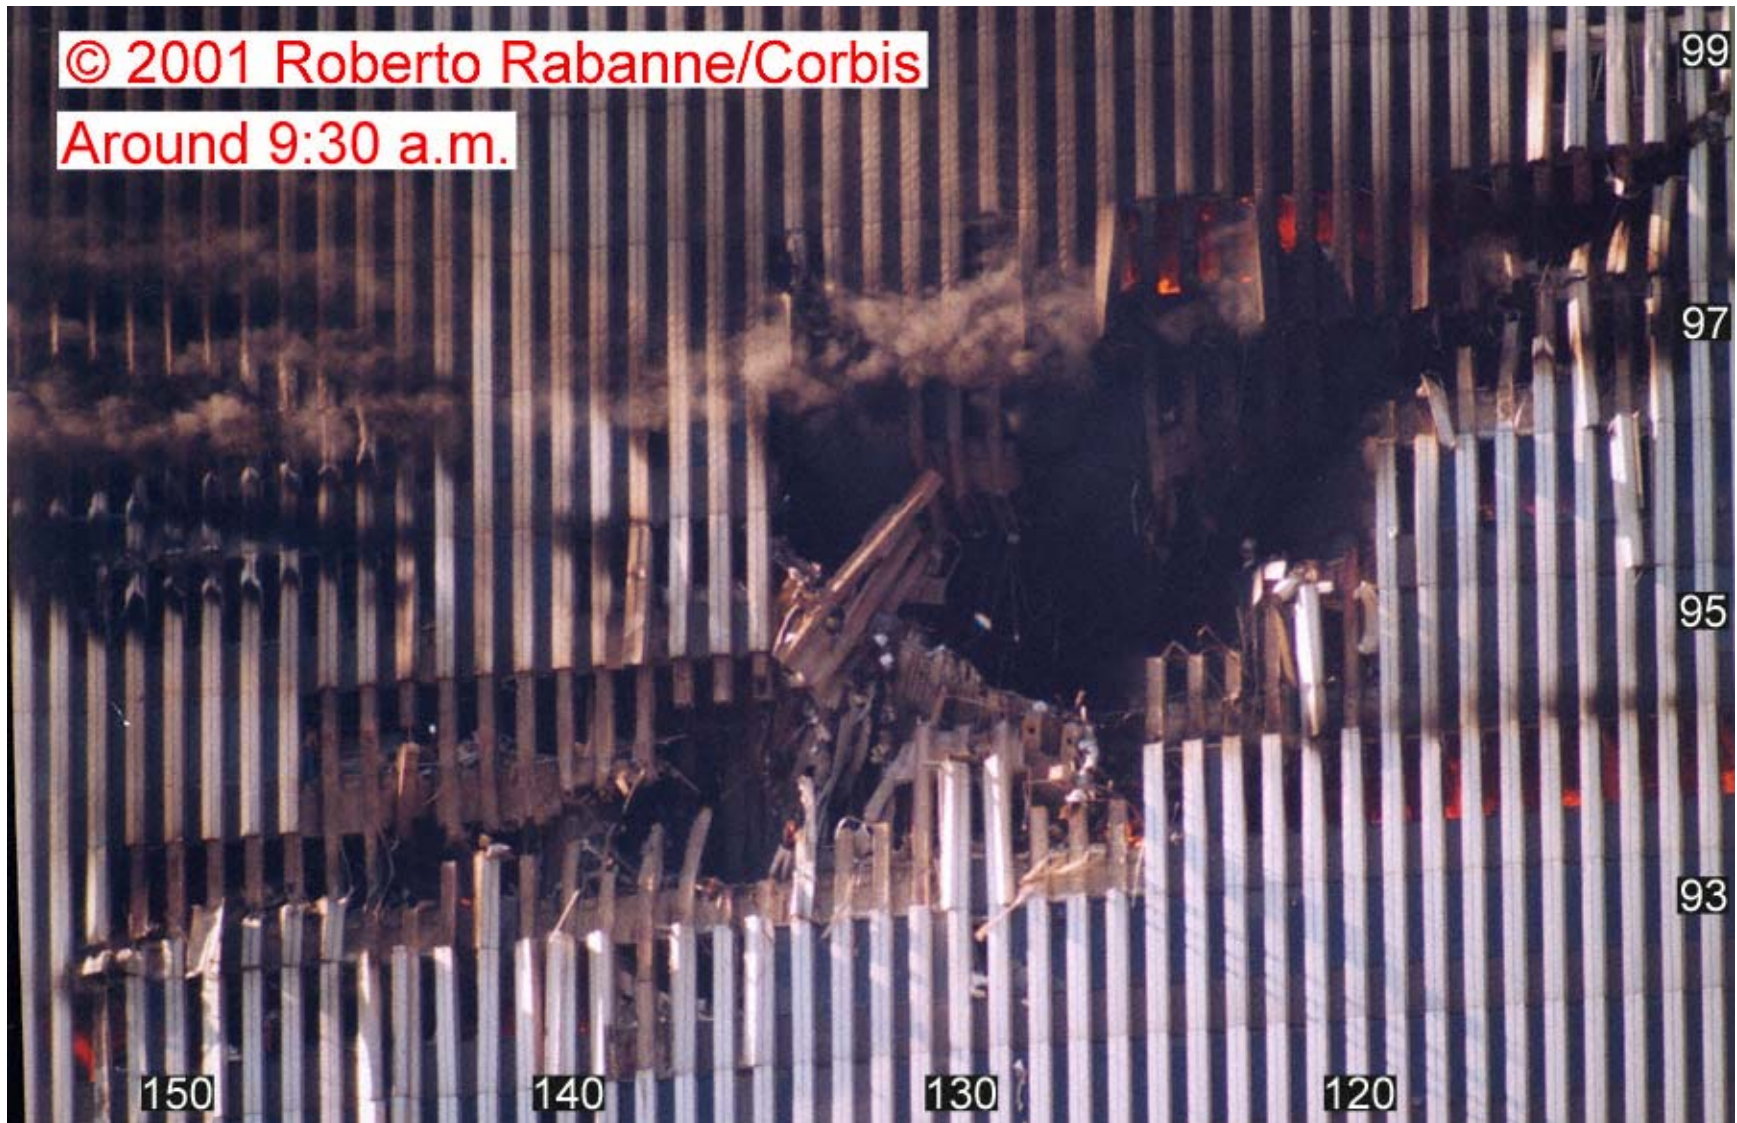
Figure 6-5. A close-up image of the north face of WTC 1 recorded around 9:30 a.m. shows the area of WTC 1 where the aircraft impacted. Column and floor numbers have been added.

From Figure 6-5 and Figure 6-6 it can be seen that the passage of the aircraft through the north face façade broke out two complete steel panel sections (columns 126 to 128 and columns 132 to 134 extending from the middle of the 94th floor to the middle of the 97th floor) as well as portions of several other panel sections. Most likely these were pushed into the building, since there is no visual evidence that they landed on the ground. The end of one of these panel sections can be seen sticking out of the building at the bottom of the opening in the figures.

It is evident from Figure 6–4 and Figure 6–5 that substantial areas of the concrete floor slabs for the 95th through 97th floors were destroyed in the immediate vicinity of the aircraft impact location. There is a large open area in the impact region in which no floor slabs are visible. A substantial section of collapsed floor slab is apparent in the enlarged portion of Figure 6–5 shown in Figure 6–8. One of the trusses (indicated by an arrow) that supported the floor slab and the corrugated sheet metal on which the concrete was poured are visible. The floor slab section appears to have collapsed from above and is at least 17 ft wide. No visual material has been identified that allows the depth into the building of the floor removal and damage to be determined (it is apparently too dark to see inside), but it clearly extends many feet.

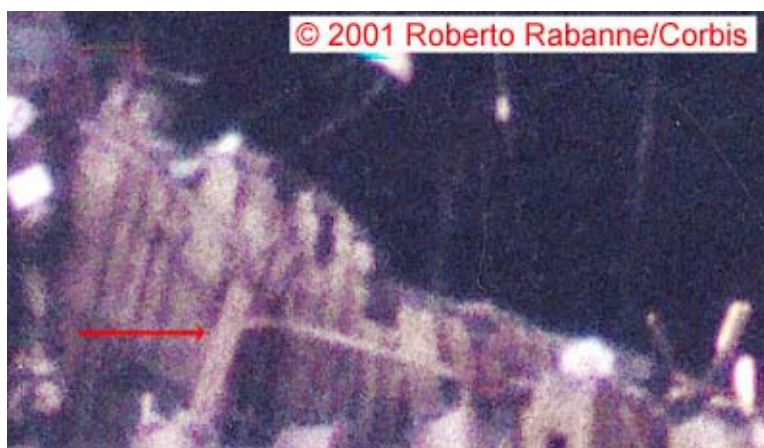
**Figure 6-8. An enlarged and enhanced portion of Figure 6–5 shows a portion of one of WTC 1’s floor slabs that has collapsed into the opening created by the aircraft impact. The corrugated steel on the bottom of the floor slab and a portion of one of the support trusses (indicated by an arrow) can be seen.**

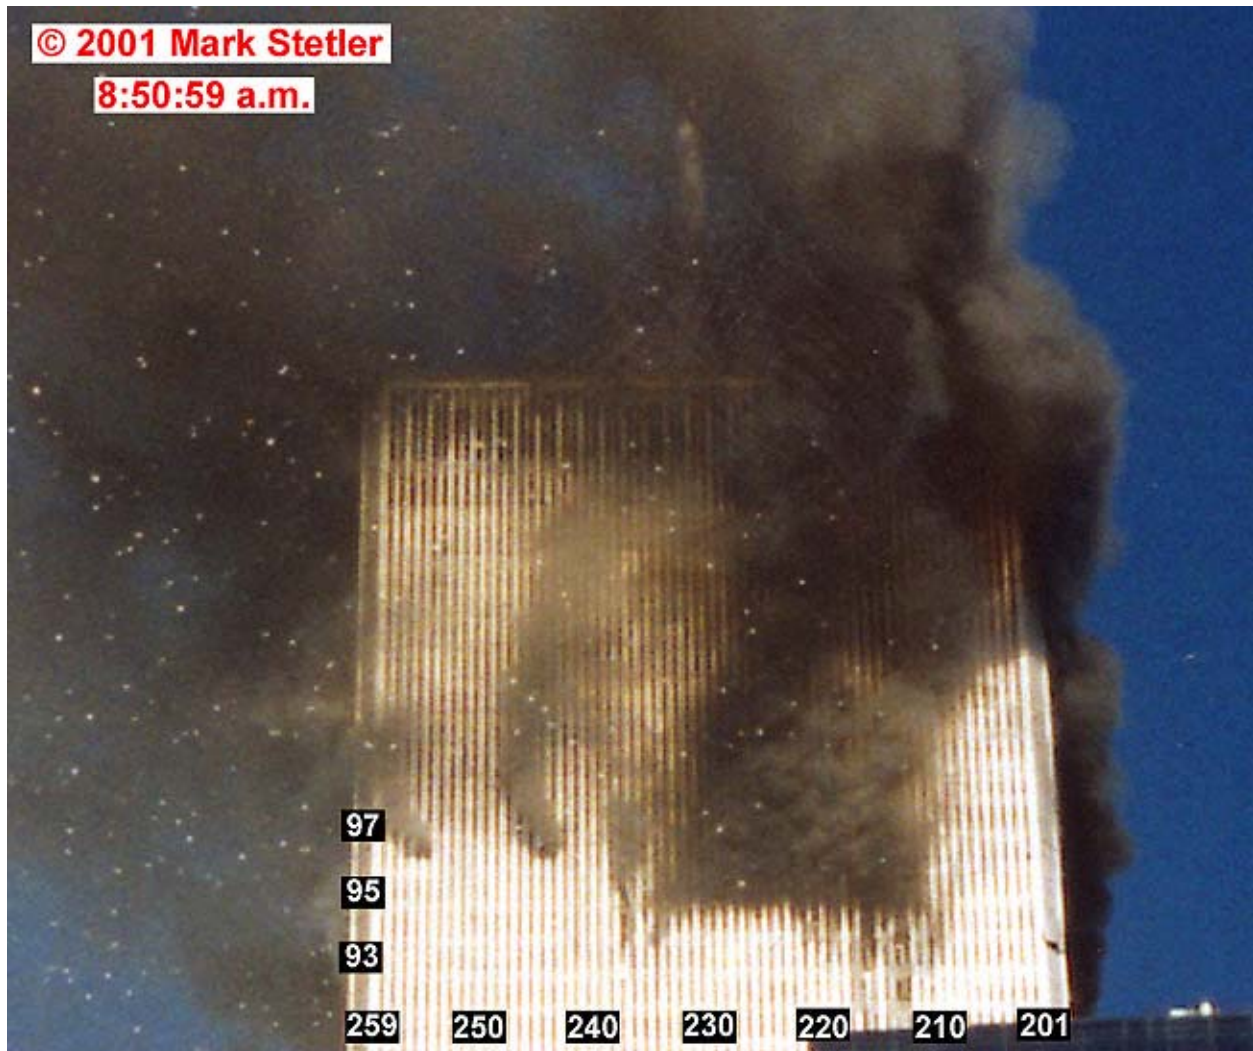
Figure 6–10 shows a photograph of the east face of WTC 1 taken roughly four and a half minutes after the aircraft impact. It looks similar to more distant videos that were recorded very shortly after the event, suggesting that the appearance of this face has not changed significantly since the aircraft impact. Figure 6–11, which also looks similar, was taken just over a minute later and provides a closer view. Numbers indicating floors and columns have been added to both figures for reference.

**Figure 6-10. Photograph showing the east face of WTC 1 recorded at 8:50:59 a.m. Column and floor numbers have been added.**

On the north face (Figure 6-19 and Figure 6-4), fires were only observed within the cavity created by the aircraft impact during this early period. On the east face (Figure 6-19 and Figure 6-10) a region of flame, with some extension out of windows, was present on the 94th floor, covering about ten windows centered near window 94-225. Recall that much of the aviation fuel from the aircraft's port tank was likely released on this floor and that a fireball was observed emanating from this area. Heavy smoke coming from the 94th floor hid much of the area immediately above this fire, while only a few isolated windows on lower floors were emitting smoke (see Figure 6-10). The aircraft impact and resulting overpressure due to the associated fires caused significant window breakage on the west side of the south face. Shortly after the impact, fires were observed extending from windows 96-336 to 96-339 on the 96th floor. As can be seen in the building map included in Figure 6-19 and the image in Figure 6-12, smoke from this floor and from isolated regions lower down obscured much of the west side of the south face above the 96th floor. The heavy smoke coming from the 93rd floor at the center of the face hides the location where a panel section is thought likely to have been dislodged by aircraft debris passing through the building (see Section 6.4.3). The area is hidden in all images of the south face in the visual database. During this early period no flames were seen on the west face, and smoke issuing from broken windows was relatively light (see Figure 6-12).

During the first few minutes following the aircraft impact, similar extensive fire growth or spread was not evident on the east face. The location and intensity of the fires was little changed between 8:48 a.m. and 8:52 a.m. Figure 6-10 in Chapter 6 shows the appearance of this face around 8:51 a.m. In contrast, the original area of external flaming present on the 96th floor of the south face doubled in size between 8:47 a.m. and 8:52 a.m., and new regions of flame appeared to the west on both the 95th and 96th floors.

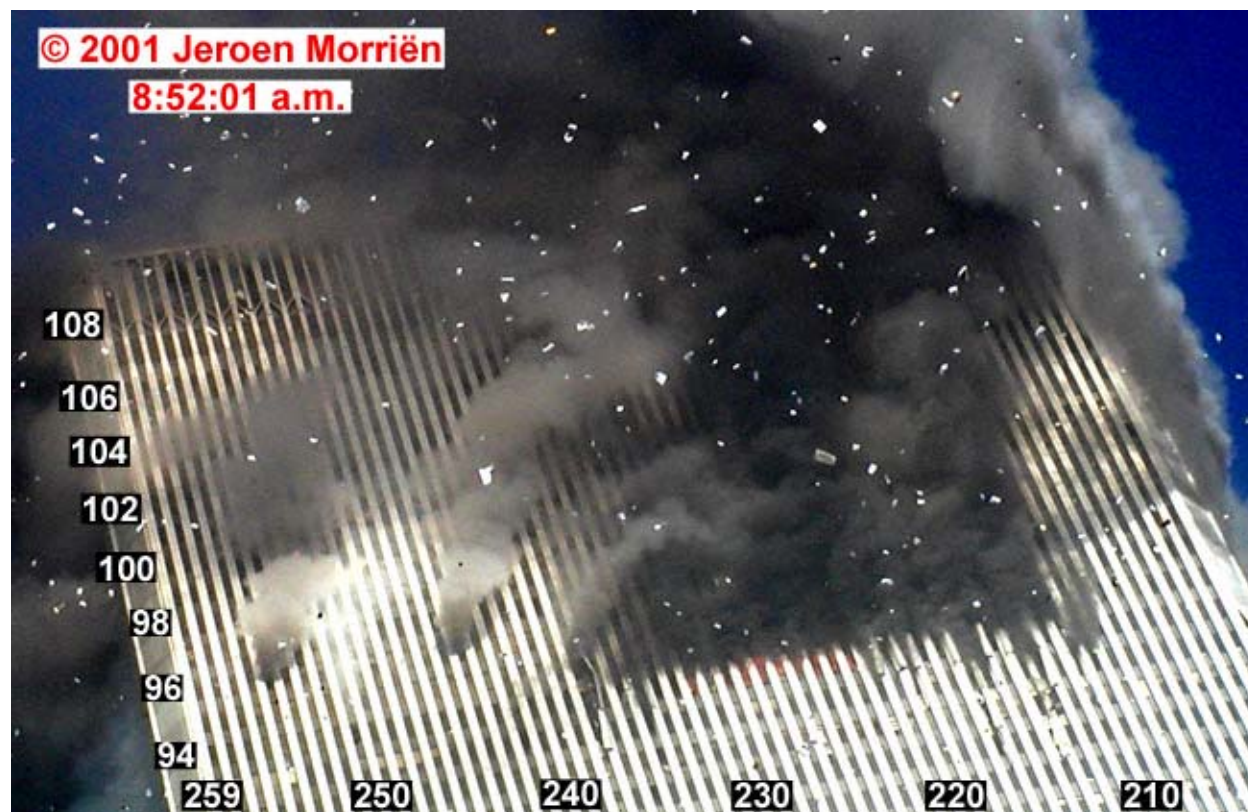
The most prominent feature in Figure 6–11 is a long line of smoke on the 94th floor extending from roughly window 94-210 to window 94-237, or a distance of nearly 90 feet. Clearly, all of the glass in the windows over this length has been broken out. Closer inspection shows that several of the aluminum covers on these columns have been partially dislodged as well. Most are near the right edge of the region, but the cover for column 94-237 has been nearly removed. Two covers, for columns 94-213 and 94-216, are missing completely. The aluminum cover on the northeast corner for this floor has also been partially

displaced. This proved to be an easily recognized marker for the floor. Isolated windows at 94-241 and 94-250 are also missing.

**Figure 6-11. Photograph of the east face of WTC 1 taken at 8:52:01 a.m. The photograph has been enhanced and cropped. Floor numbers are indicated along the left edge of the building and column numbers along the bottom of the photo.**

Some damage and missing window glass are present on lower floors that were not directly impacted by the aircraft. Window glass has been broken out and some column covers have been displaced or removed completely on the 93rd floor from columns 93-209 to 93-216 as well as columns 93-219 and 93-220. The glass for window 93-237 is missing, and the aluminum cover for column 93-237 has been displaced. Damage is also apparent on the 92nd floor, where windows 92-212 and 92-213 have been broken out. A chair is stuck in window 92-212, and the aluminum cover on column 92-212 has been removed. Covers on columns 92-216 and 92-217 have been displaced, and the window glass between these two columns is missing. On the 91st floor, the covers on columns 91-213, 91-214, and 91-216 have been displaced, and windows 91-213 and 91-216 are open. There is no apparent damage lower than the 91st floor.

Portions of the east face above the 94th floor are hidden by the smoke rising from this floor. Only minimal damage is seen on these higher floors, including a displaced column cover and missing window glass at window 95-237 and two broken windows on the 96th floor at windows 96-243 and 96-254. All window glass and column covers to the north of column 209 appear to be undisturbed.

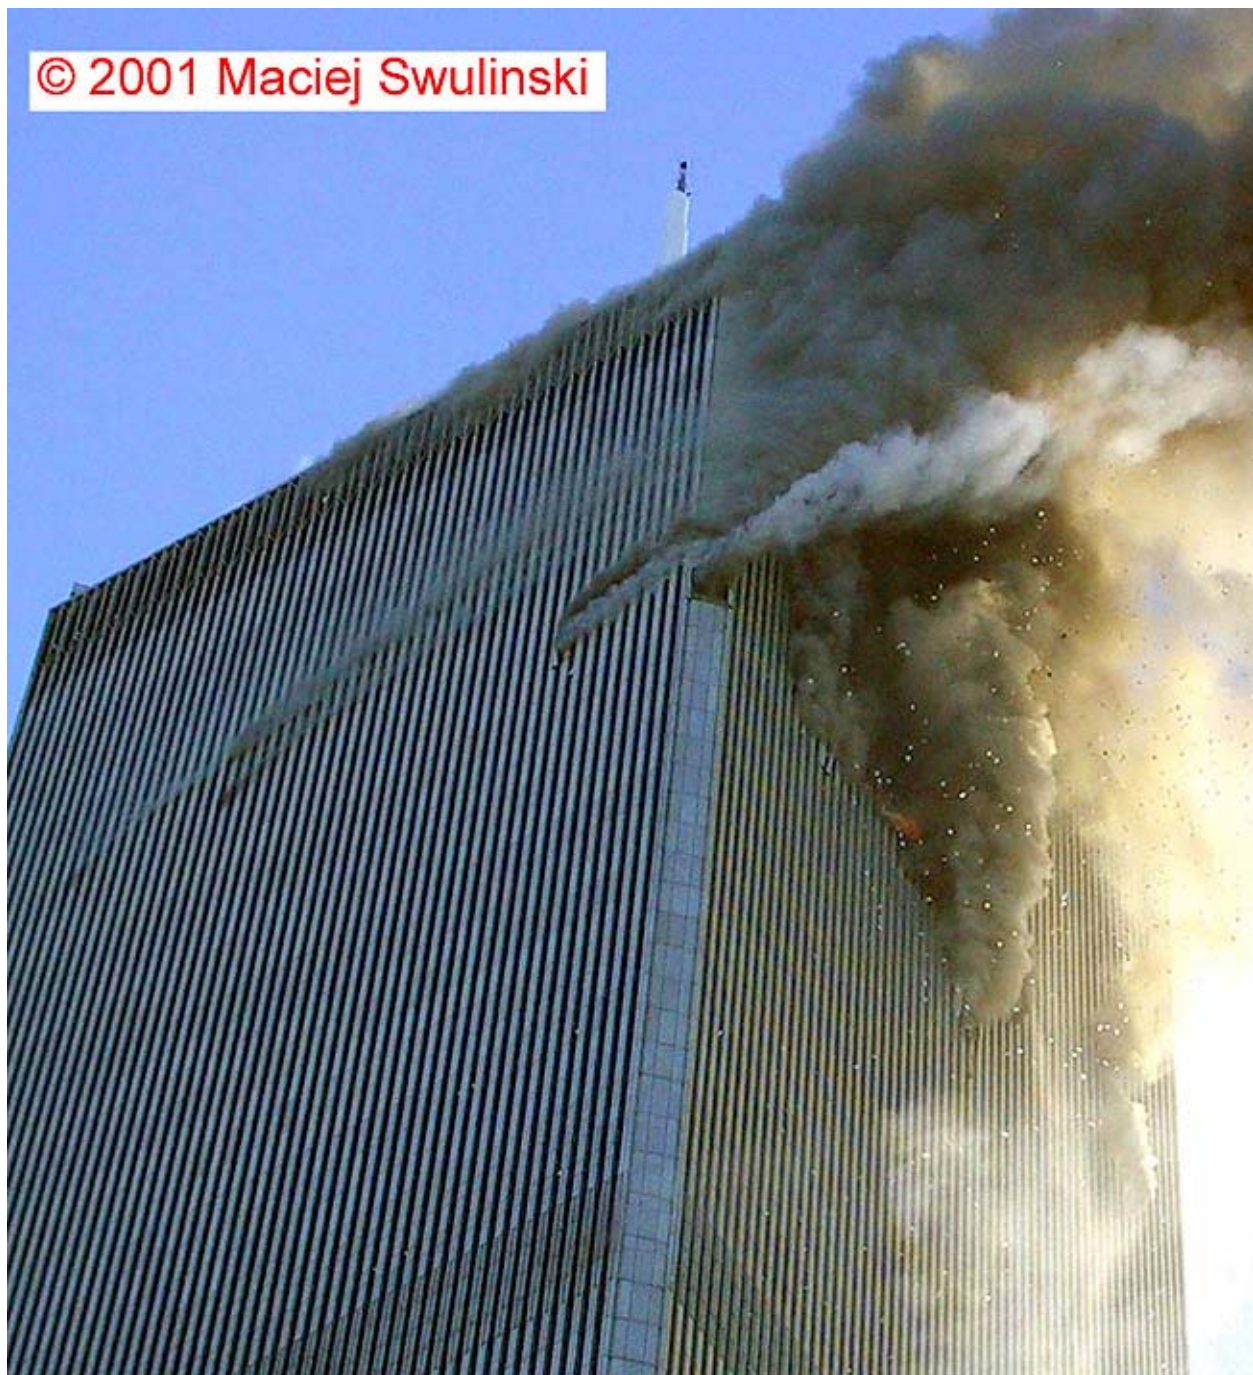
In contrast to the relatively large number of windows missing on the east and south faces of the tower, the number of windows initially opened on the west face was considerably less. This can be seen in Figure 6–12, which shows the west face shortly after the aircraft impact. The façade maps for window condition on the west face shown in Figure 6–9 is based on a number of photographs and videos and indicates that nine windows were broken open on this face by the aircraft impact and fireballs. The only obvious damage to the aluminum facing occurred on columns 410 and 411 at the 96th and 97th floors. The covers for column 410 were removed on both floors, while those on column 411 were partially dislodged.

**Figure 6-12. A cropped photograph shows the west and south faces of WTC 1 shortly after the aircraft impact. The image has been enhanced by adjusting the intensity levels. The exact time of the image is unknown, but the appearance suggests that it was taken within two minutes of the aircraft impact.**

Several windows were opened on the 101st floor on the east side of the south face (presumably by people), and smoke was flowing from these locations (see Figure 6-12). Images suggest that additional windows may have been open higher up on the east side, but the quality of the images and the amount of smoke coming from other locations did not allow this to be confirmed.

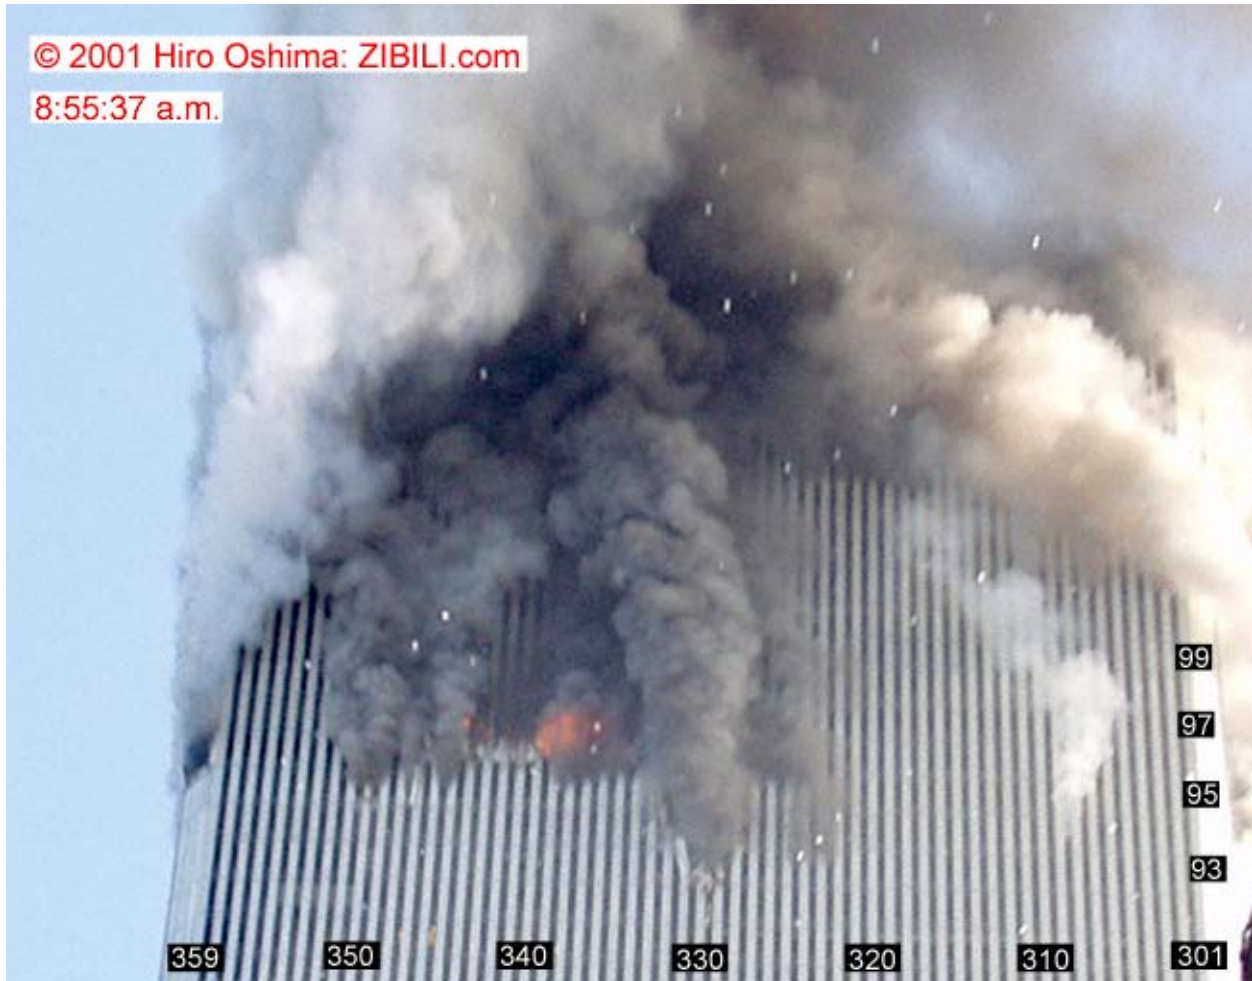
A prominent feature in both photographs is the missing aluminum cover on the southwest corner of WTC 1 at the 96th floor. Heavy smoke is flowing from this opening. This missing cover is easily recognized and provides a quick reference for identifying the tower, face, and floors in visual material. In addition to the missing corner, some of the aluminum column covers on the face have been displaced. Using the corner marker as a guide, it is apparent that most of the smoke seen issuing from broken windows on the south face is coming from the 95th and 96th floors on the western side. Only a single window (94-308) to the east of column 322 appears to be broken open. There is an area of heavy smoke at the center of the face coming from lower down on the 93rd floor. Comparison of a number of photos and videos taken during the event showed that the smoke released from this point remained heavy until the tower collapsed. It was never possible to get a clear view of the damage in the immediate vicinity. As discussed further in Section 6.4.3, it is believed that the damage in this area was the result of the removal of a complete three story steel panel section from the face.

**Figure 6-13.** This enhanced and cropped photograph shows the south face of WTC 1 at 8:55:37 a.m. Column and floor numbers have been added.
