**NIST NCSTAR 1-5A**

**Federal Building and Fire Safety Investigation of the  
World Trade Center Disaster**

# **Visual Evidence, Damage Estimates, and Timeline Analysis**

September 2005

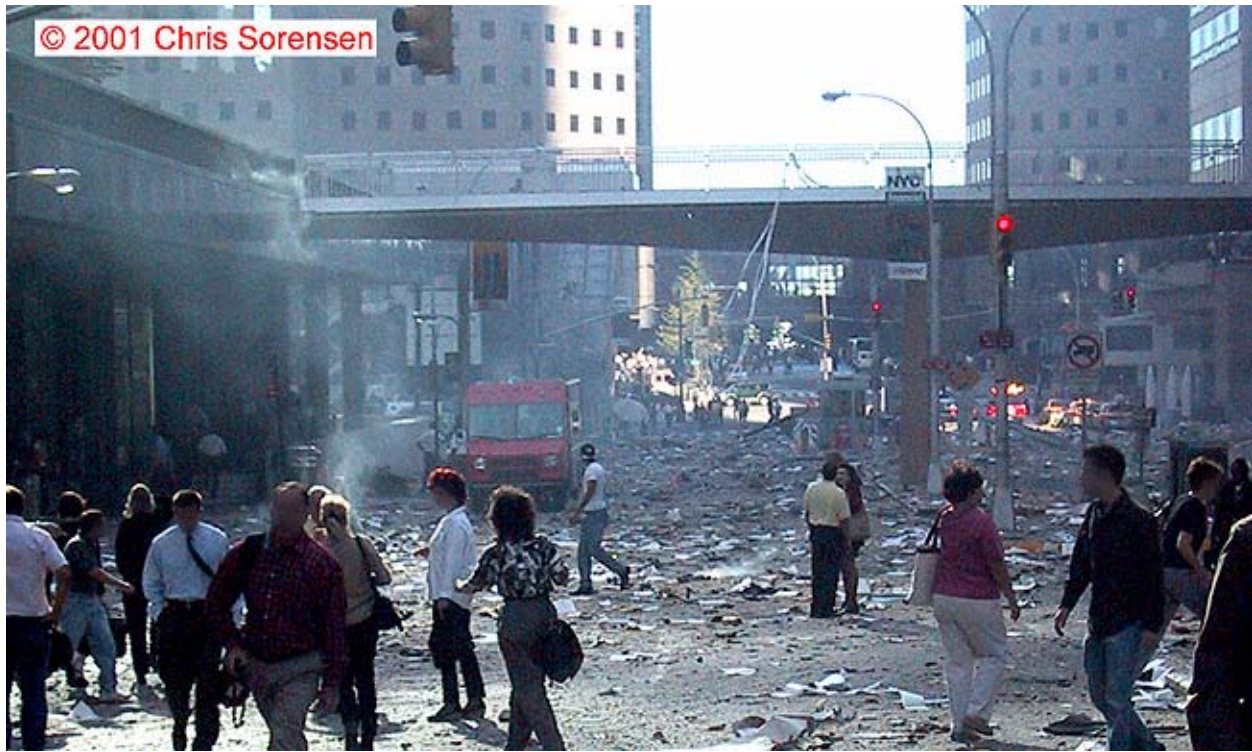
Figure 6–15 shows another view of the streets around the WTC shortly after the aircraft struck WTC 1. This shot was taken from the corner of Liberty Street and Church Street looking west down Liberty Street. It was taken before WTC 2 was struck, so the debris has come from WTC 1. The bridge across Liberty Street connected the southwest corner of WTC 4 to the Bankers Trust Building. The building visible on the right side beyond WTC 4 is WTC 3 (Marriott Hotel), which was located on the corner of West Street. A deep layer of debris is seen strewn across much of the visible length of Liberty Street. Most of this debris is lying to the south of WTC 2. The only possible way for it to have reached this location is by being blown by the prevailing wind from the south face of WTC 1. It is likely that it was dropped from the dust cloud seen to the south of WTC 2 in Figure 6–2. This image, along with several others, shows that, in addition to a lot of paper, the debris in the street consisted of a number of aluminum column covers and what appeared to be small chunks of concrete. The amount and nature of the debris

indicates that the aircraft impact and fireballs must have caused significant damage close to and on the south face of WTC 1. There were also a number of small fires burning on Liberty Street immediately following the aircraft impact (not visible in Figure 6–15).

**Figure 6-15. This photograph was taken from the corner of Liberty Street and Church Street looking west down Liberty Street after WTC 1 was struck by American Airlines Flight 11 but before WTC 2 was hit by United Airlines Flight 175. Some faces are blurred.**

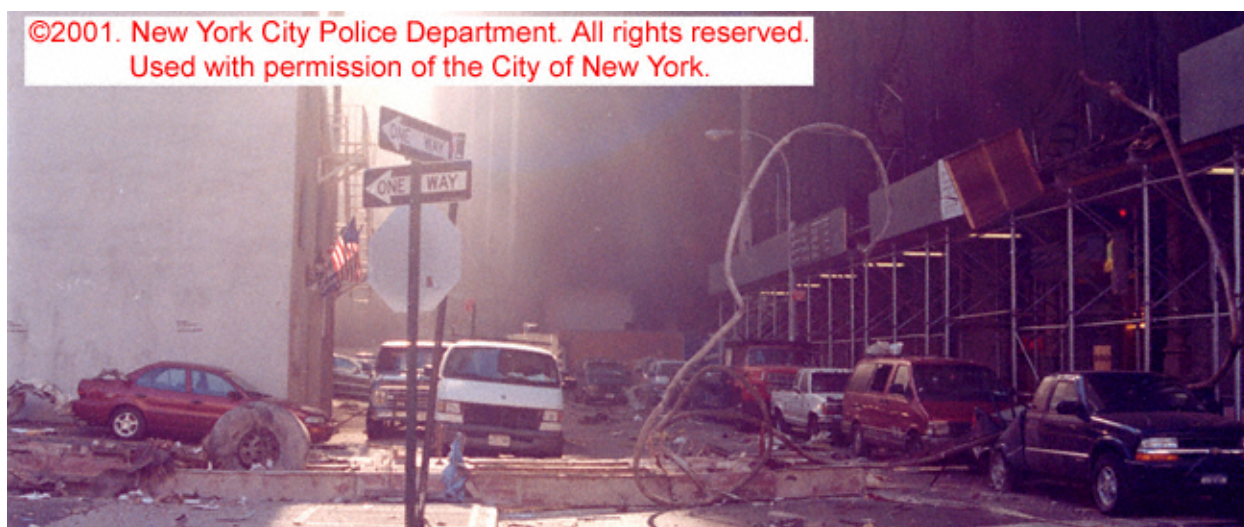
A curious aspect of Figure 6–16 is the large pipe that can be seen twisted about and rising above the panel section. A different view of the pipe is available in Figure 6–17, where it can be seen that it extends from well above the panel section across the pickup truck to the right and then up into the air. The force of the collision of the pipe with the pickup has crushed the cargo bay. The pipe section length is considerably longer than the panel section, which is 36 ft. The pipe diameter has been estimated as 1.5 in., based on its size relative to the panel section.

**Figure 6-17. This cropped and enhanced photograph shows another view of the three-story steel panel section included in Figure 6–16. A long pipe section attached to the steel rises above both the panel section and the pickup truck to the right. The building on the left is Saint Nicholas Greek Orthodox Church, and the building on the right is 90 West Street.**

Review of building plans and consultation with The Port Authority of New York and New Jersey staff and consultants have provided a plausible explanation for the source of this pipe. Cooling at the perimeter of the towers was accomplished by means of cold-water induction units located along the outer wall at the base of the windows. These units were fed cooled water by a series of vertical risers (pipes) that extended either up or down from the mechanical equipment rooms. Water was returned by parallel risers. The pipe in the figures seems to be attached to the bottom of the steel panel section on the center column, i.e., column 130 at the 93rd floor. Induction units on the 92nd floor and higher were connected to the mechanical equipment room on the 106th floor. Building plans indicate that supply and return risers were located just to the inside of column 130. The supply riser was 1.5 in. pipe and the return riser was 2 in. pipe. The appearance and location of the pipe in the figures indicate that it is mostly likely part of a supply riser that fed the induction coolers at this location.

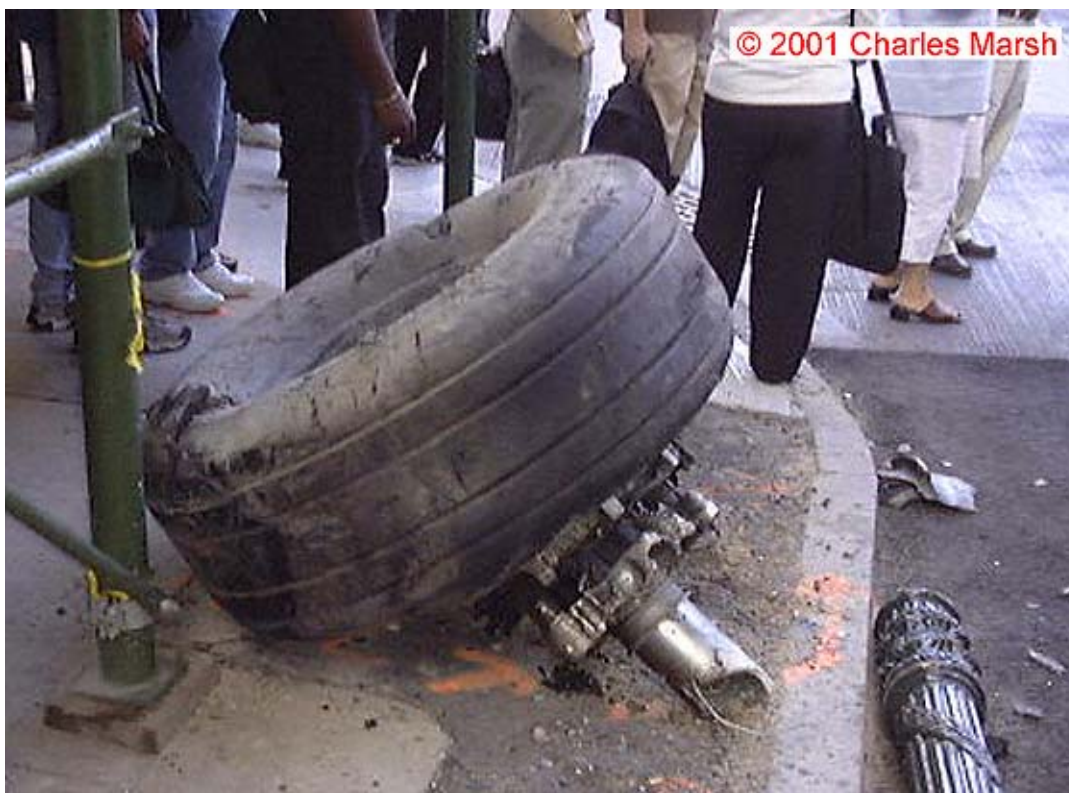
A second wheel from a landing gear, shown in Figure 6–18, was found much further south at the corner of Rector Street and West Street. This is a distance of roughly 1,385 ft from the base of the south face of WTC 1. The presence of a braking system indicates that this wheel also came from one of the two main landing gears.

**Figure 6-18. The photograph shows a wheel from the aircraft that struck WTC 1 lying at the southeast corner of the intersection of Rector and West Streets.**

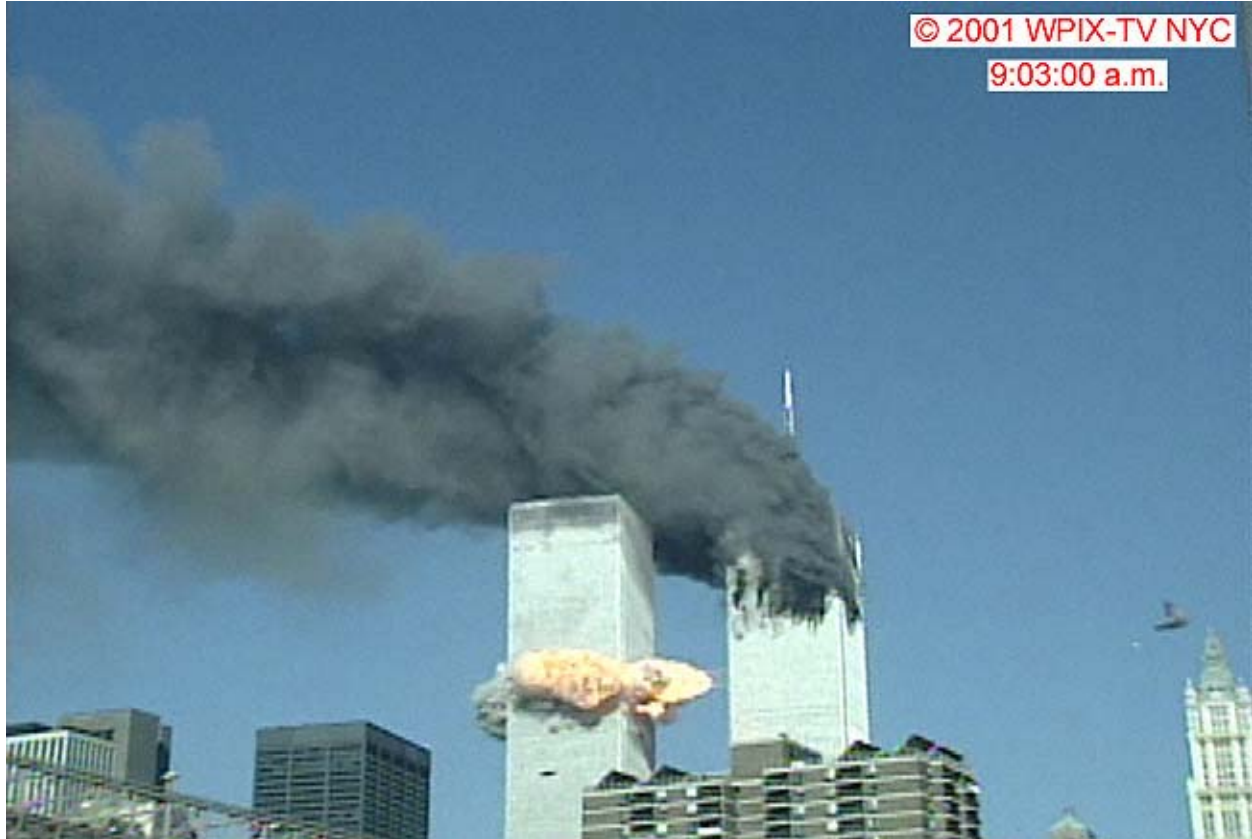
Close inspection of Figure 7-1 shows that there are three distinct fireballs present on the north face. Videos shot from the north indicate that the largest of these grew from the area of fire that originally

appeared on the 80th, 81st, and 82nd floors in the vicinity of windows 239 to 249 (see Table 7–1). The second, somewhat smaller, of the fireballs is at roughly the same height and emanates from near the northeast corner. The third fireball is the smallest and is located below the other two. Northern views show that this fireball was formed from fire exiting from windows 79-233 to 79-240 on the 79th floor (see Table 7–1).

**Figure 7-1. The nascent fireballs and dust clouds formed on WTC 2 1.2 s after the aircraft impact on the tower are shown. The image is a frame from a video.**

A large cloud of dust is evident in Figure 7–1 on the south face that does not appear to be burning despite the fact that ignition was observed on this face (see Table 7–1). It appears as if there was much less fuel in the material that was expelled from this face than observed on the east and north faces. Other regions of dust can be seen below the fireball on the east face and in the vicinity of the mechanical equipment room on the 75th and 76th floors on the east and north faces.

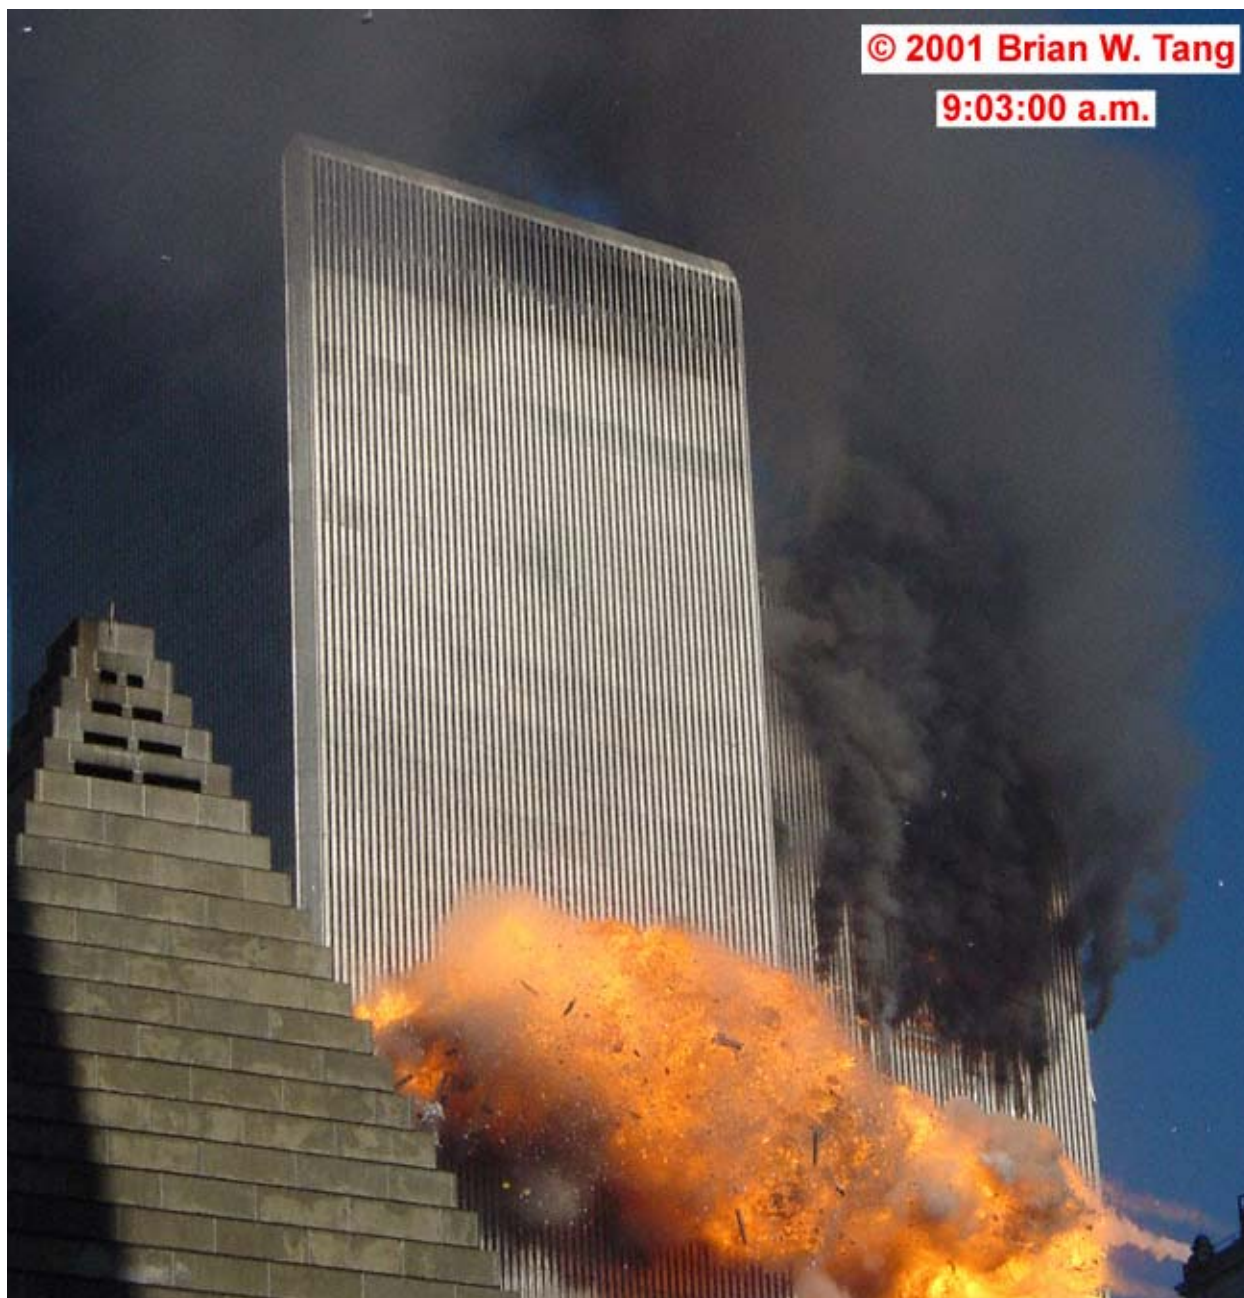
**Figure 7-2. This cropped photograph shows the fireball formed on the east face of WTC 2 following the aircraft impact that took place 1.1 s earlier. The east face of WTC 1 is visible in the background**

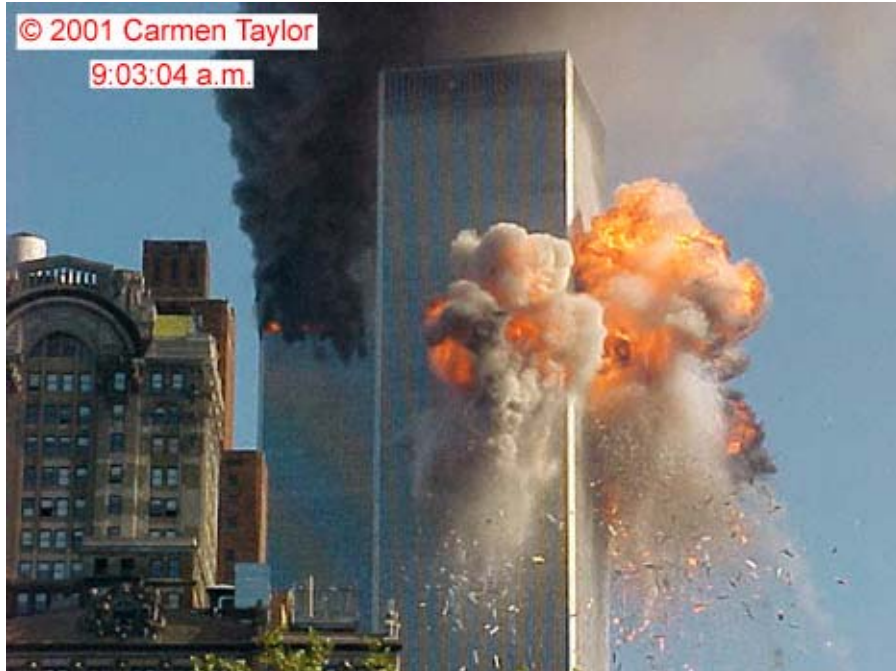
As the fireballs continued to burn, buoyancy forces due to the heated gases began to dominate, and the fireballs were carried upward. Figure 7-3 shows the fireballs on the south and east faces of WTC 2 observed 4.3 s after the aircraft impact. Their appearances are very much changed from those in Figure 7-1 and Figure 7-2. Burning is now observed at heights well above where the aircraft impacted, and both fireballs have become more spherical in shape. Large amounts of dust and larger debris are seen falling downward below the fireballs. The fireball on the east face is considerably larger than that on the south.

**Figure 7-3. An image of WTC 2 recorded from the southeast is shown. The photograph was taken 4.3 s after the aircraft impact on the tower. The south face of WTC 1 can be seen burning in the background.**

Burning on the south face seems to be concentrated more on the west side, with little flame evident in the dust cloud toward the east.

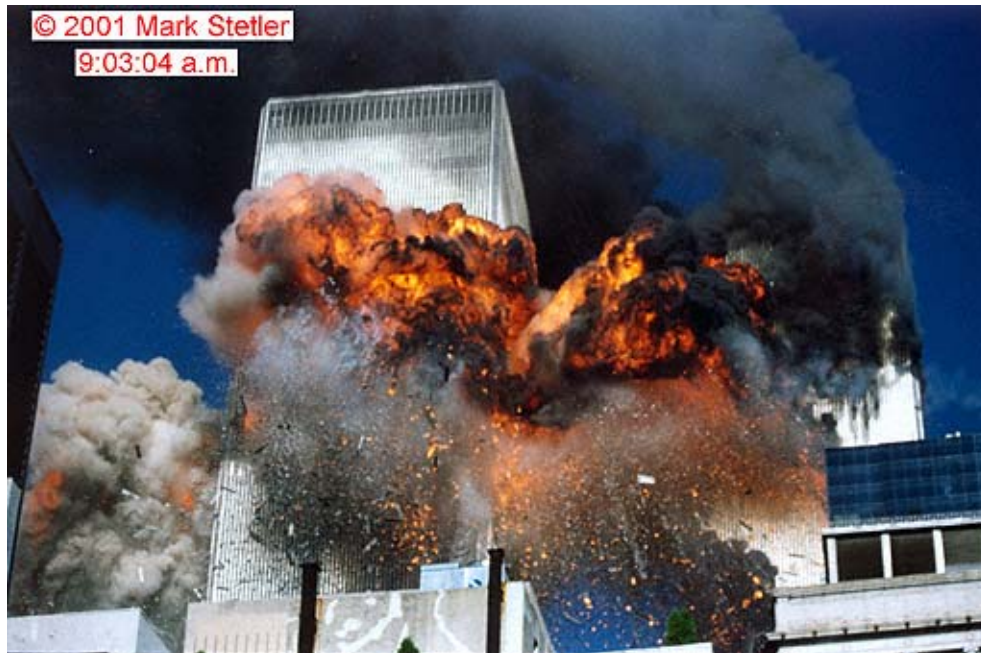
Figure 7-4 shows a photograph of the fireballs taken from just north of due east 4.6 s after the aircraft impact. The features of the fireballs are similar to those already described. The large extent of the fireball on the north face is apparent by noting that the width of each tower is 209 ft. The large amount of dust and larger debris (some flaming) generated by the collision and fireballs can be seen falling below the fireballs. Some isolated regions of fire are evident in the dust cloud on the south face.

**Figure 7-4.** An image of the fireball on WTC 2 recorded from just north of due east is shown. The photograph was taken 4.6 s after the aircraft impact on the tower.

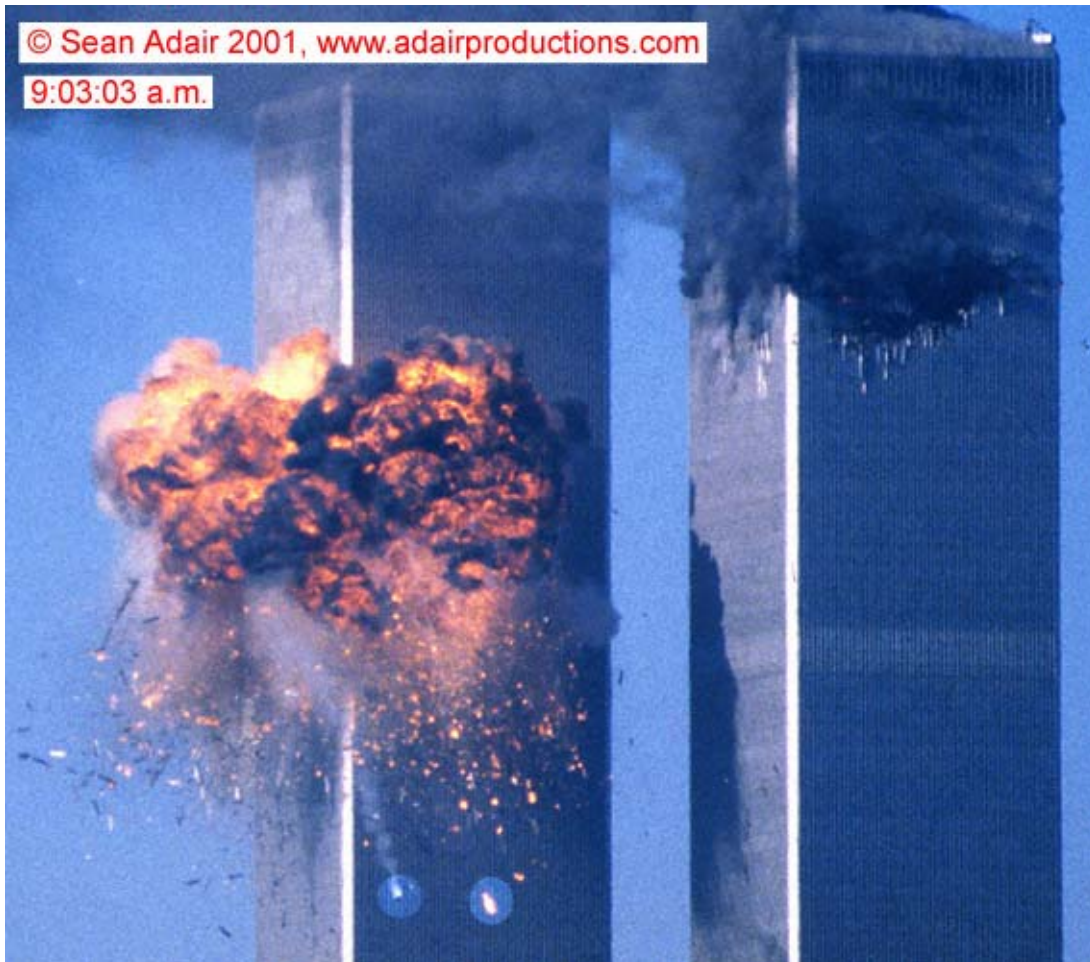
**Figure 7-5. An image of the towers recorded from the north northeast is shown. The photograph was taken 4.3 s after the aircraft impact on WTC 2. Highlighted areas show two large pieces of aircraft debris that passed through the building and landed in the vicinity of the Church and Murray Streets intersection.**

Videos and photographs indicate that several pieces of the aircraft passed all the way through WTC 2 and exited at high speeds from the north side. Most of these were relatively small, but at least two were of substantial size. These two objects are highlighted in Figure 7-5. Both large pieces left smoke trails that formed parabolas as they fell to the ground. The object on the right was burning, and videos show that the flames suddenly grew dramatically and formed a long tail after the debris had passed by WTC 1. The object on the left, i.e., to the east, was spiraling as indicated by the smoke trail it left behind.

It is likely that the two large aircraft pieces visible in Figure 7-5 are the part of an engine and the landing gear subsequently identified. If correct, this means the two large aircraft pieces highlighted in Figure 7-5 landed at the corner of Church Street and Murray Street and 45 Park Place. The resting locations of the debris indicate the spiraling object was the engine (a plausible conclusion based on the shape of the component in Figure 7-34), and the flaming component was the landing gear.

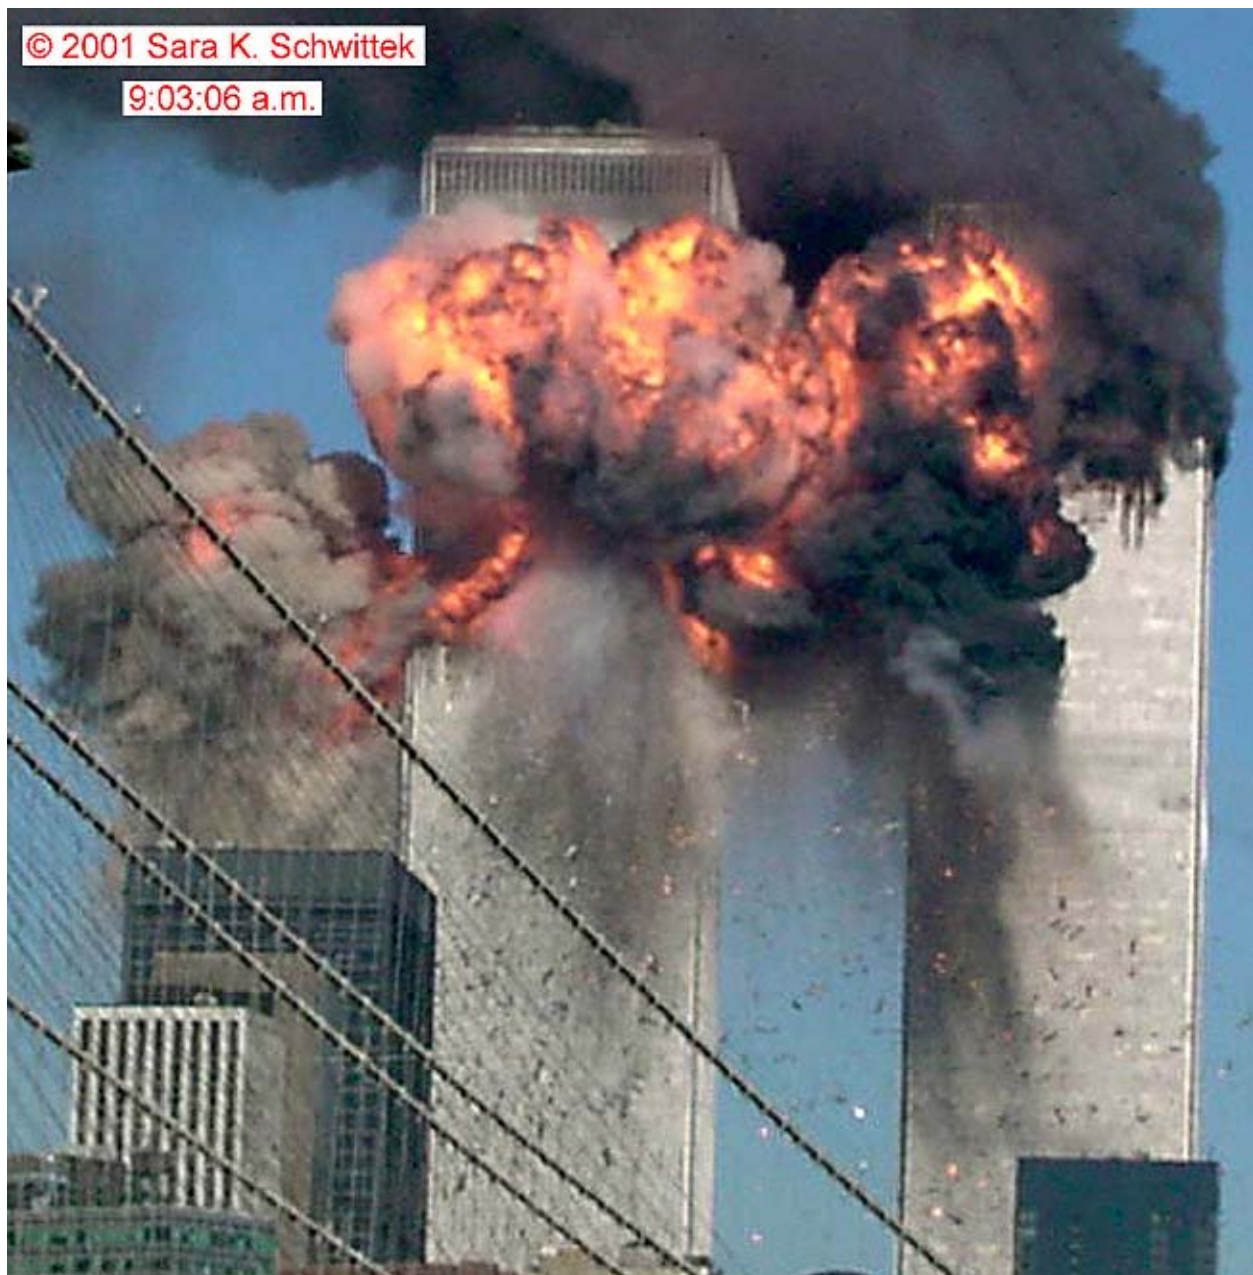
**Figure 7-6.** This cropped image of the towers recorded 6.5 s after the aircraft impact on WTC 2 was shot from the east on the opposite side of the East River in Brooklyn.

A variety of photographs and videos indicate that, during the 5 s to 10 s period following the aircraft impact, intense flames extended from windows on the south face, east face, and north face of the tower. Examples of these flames can be seen in Figure 7-6 to Figure 7-8. The most intense flames were located on the south face and east face near the southeast corner of the 82nd floor, on the east face near the northeast corner, and on the north face near the northeast corner on the 81st floor. These flames increased in intensity after the formation of the fireball, with the largest flames observed roughly 8 s after impact.

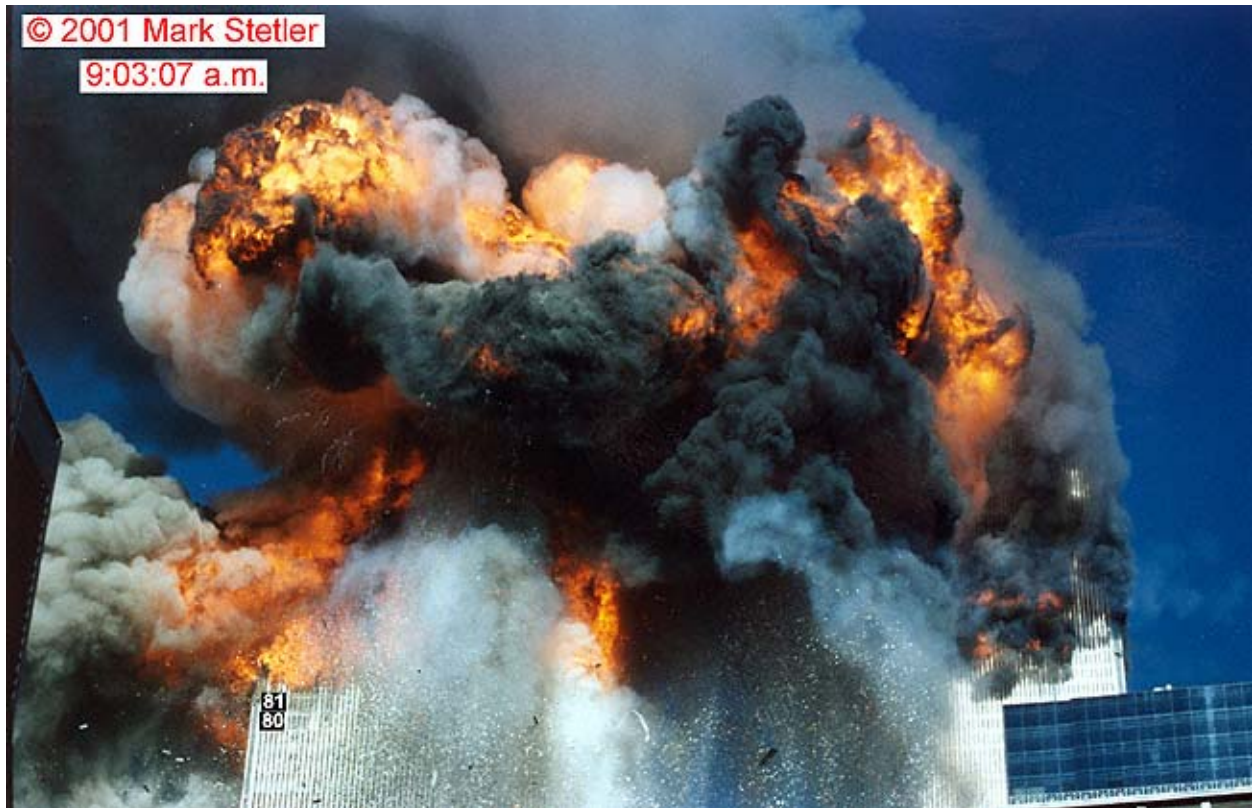
Figure 7-7 is an image recorded 7.9 s following the aircraft impact from the same perspective as Figure 7-4. The large fireball formed by the rapid expulsion of aviation fuel from the tower immediately following the aircraft impact has continued to rise and has begun to separate from the release point. Intense flaming is still seen in the vicinity of the building where the aircraft impact occurred. Even though significant façade damage is evident on the south side of the east face over three floors (80th, 81st, and 82nd), flames are emanating primarily from the 82nd floor windows. It is possible that flaming from higher windows is also occurring, but is hidden. Similar flaming is evident on the south and north faces.

Dark regions are beginning to show over large areas of the fireballs, particularly at lower locations. These dark regions are due to heavy smoke. As time passes the dark surface areas grow larger, while areas of orange flames become relatively smaller.

**Figure 7-7. An image of WTC 2 recorded from just north of due east is shown. The photograph was taken 7.9 s after the aircraft impact on the tower. The locations of the 80th and 81st floors are identified**

Large amounts of debris and dust are falling from the central region of the east face. Some of this debris is higher than the aircraft impact floors. This indicates that a portion of the debris that was expelled from the building was initially carried upward by the fireball. Since the debris is heavier than air, it eventually loses its upward momentum and drops from the bottom of the fireball.

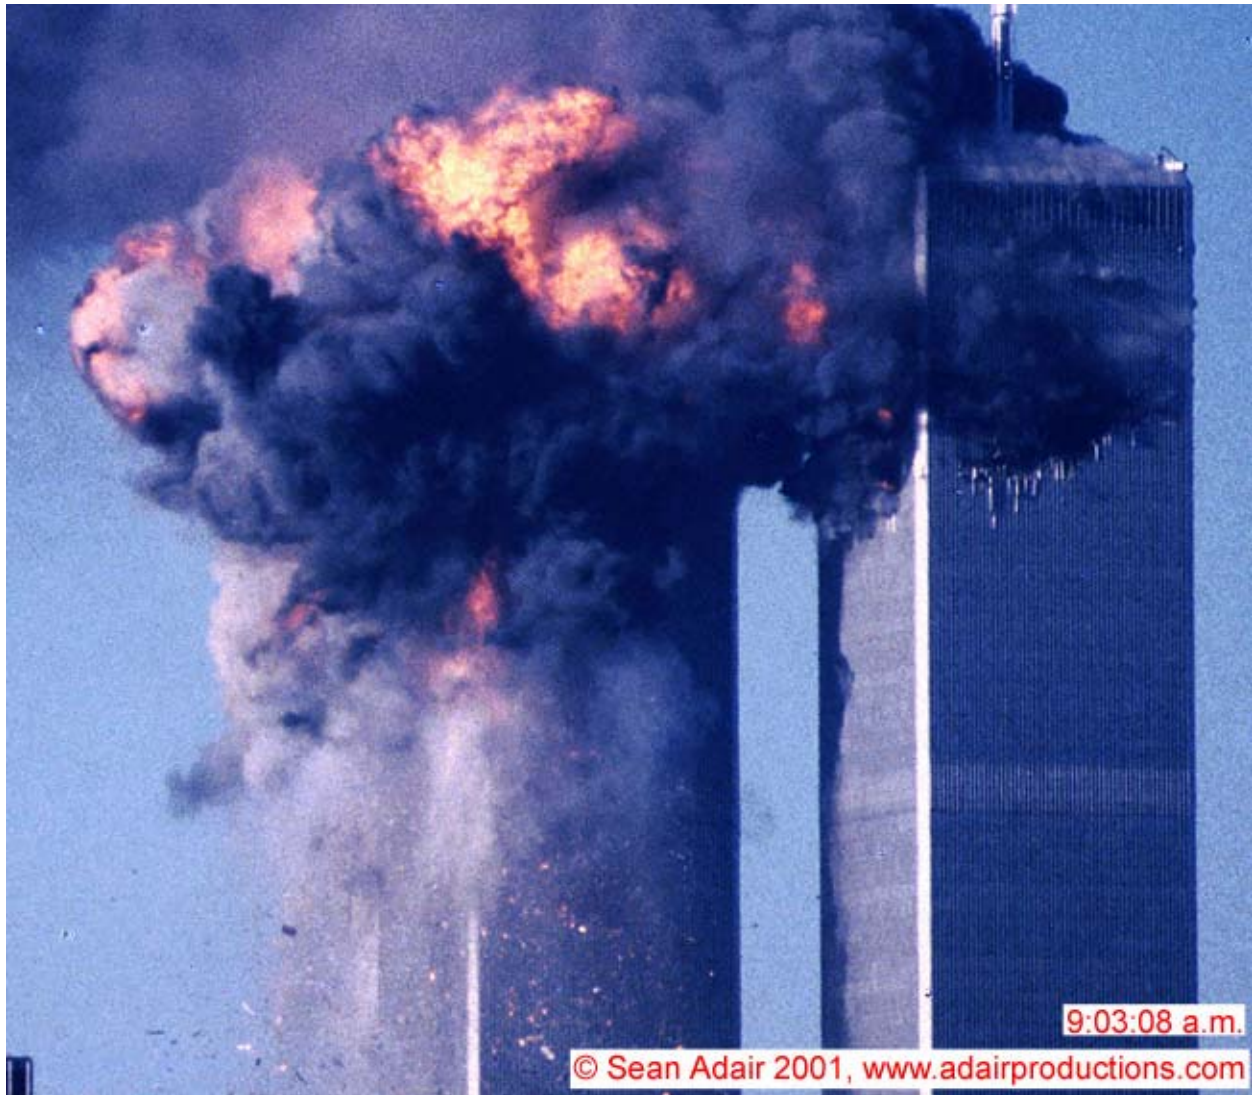
Figure 7-8 shows a northern view of the fireball taken 8.7 s after the aircraft impact. The perspective is the same as in Figure 7-5. The appearance of the fireball is consistent with that described for Figure 7-7, but the amount of visible flame in the fireball appears to be significantly reduced, indicating that it is beginning to burn out. There appears to be a large amount of debris falling on the northeast corner of the tower and considerably less from regions of the north face more toward the center. The falling debris on the northeast corner is evident in Figure 7-7 as well. Similar to the east face photographs shown in Figure 7-6 and Figure 7-7, which were taken at roughly the same time, significant flaming from the tower is evident below the fireball in the vicinity of the aircraft impact location.

**Figure 7-8. An image of the towers recorded from the north northeast is shown. The photograph was taken 8.7 s after the aircraft struck WTC 2.**

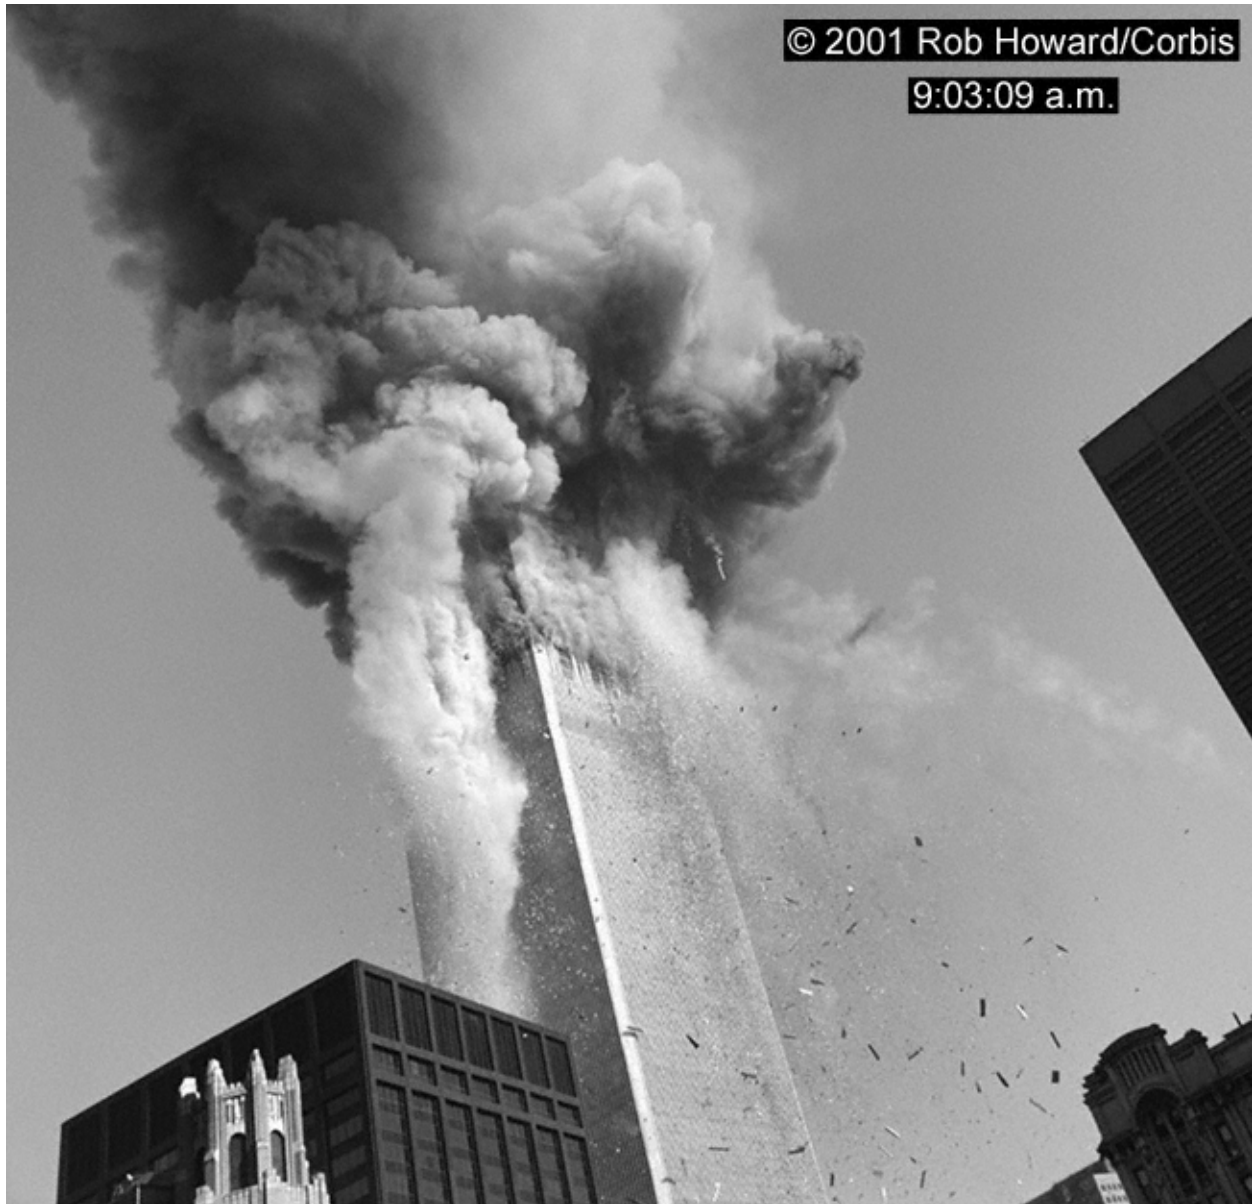
Figure 7-9, taken 10 s after the second aircraft struck WTC 2, shows the debris and dust clouds on the south and east faces of WTC 2. The cloud on the south face is much larger than that on the east face. This is consistent with the conclusion that more debris was expelled from the south face than from either the east face or north face. The observation of a smaller, shorter-lived fireball on the south face suggests that less fuel was consumed by this fireball than those on the east face and north face.

**Figure 7-9. This cropped black and white photograph was recorded from the southeast of WTC 2 10 s after the second aircraft impact.**

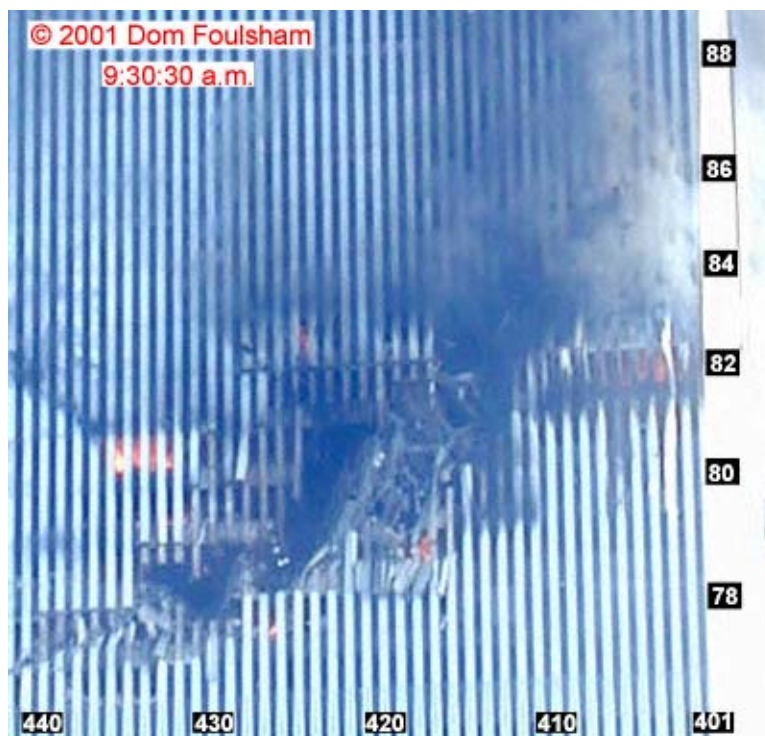
**Figure 7-22.** This cropped photograph shows the damage to the south face of WTC 2 caused by the aircraft impact. The image was enhanced by adjusting the intensity levels. Column and floor number have been added.

Inspection of Figure 7-22, Figure 7-23, and Figure 7-24 shows that portions of the aluminum cladding that formed the curtain wall for the building were partially or completely removed at locations close to where the aircraft impact occurred. This includes areas on the 80th floor extending from column 80-426 to column 80-431, on the 81st floor extending from column 81-425 to column 81-430, and on the 82nd floor extending from column 82-420 to column 82-426. In Figure 7-24 it can be seen that the aluminum cladding covering the southeast corner on the 82nd floor was pushed outward during the event. It is likely that this occurred as a result of the overpressure within the building generated by burning of aviation fuel released from the tanks of the aircraft. This damage provided a convenient marker for identifying the 82nd floor.

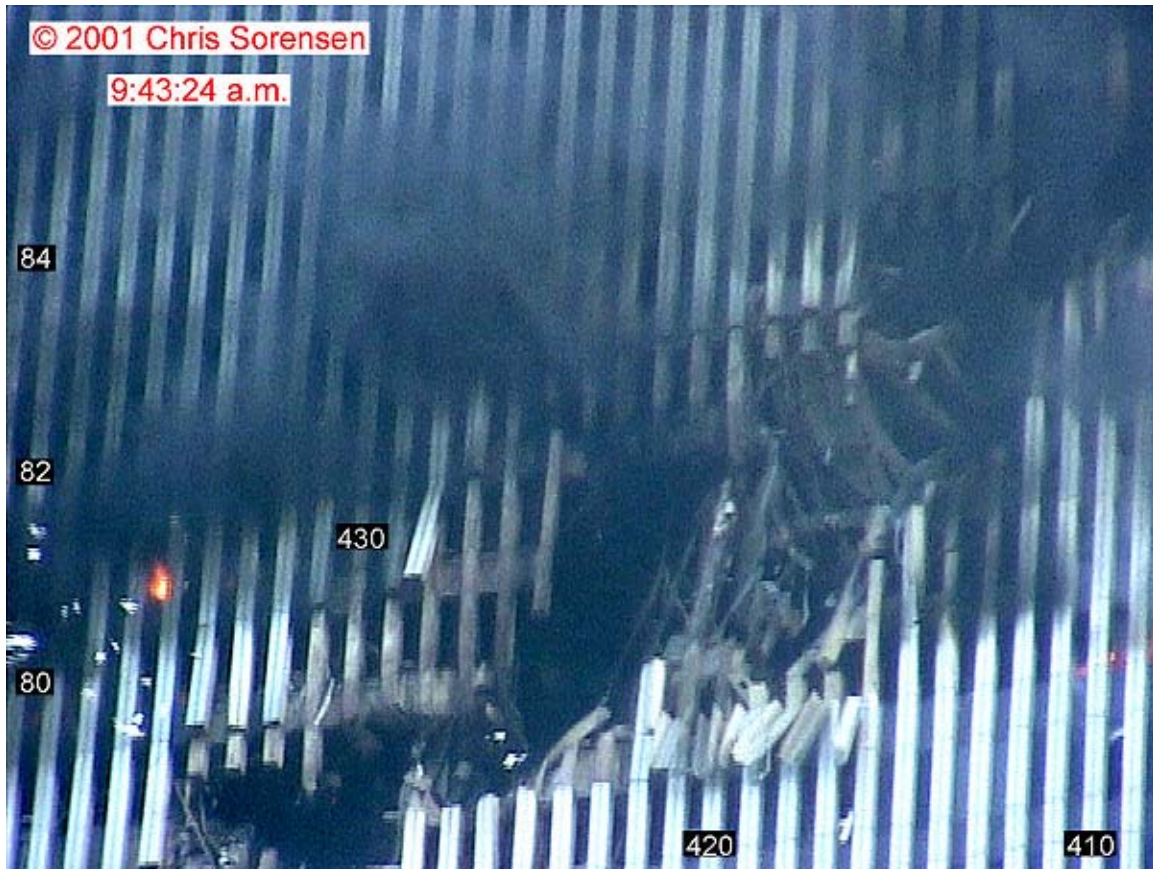
**Figure 7-23. A frame captured from a video recording of the aircraft impact location on the south face of WTC 2 is shown. The image has been enhanced by adjusting the intensity levels. Column numbers and floor numbers have been added.**

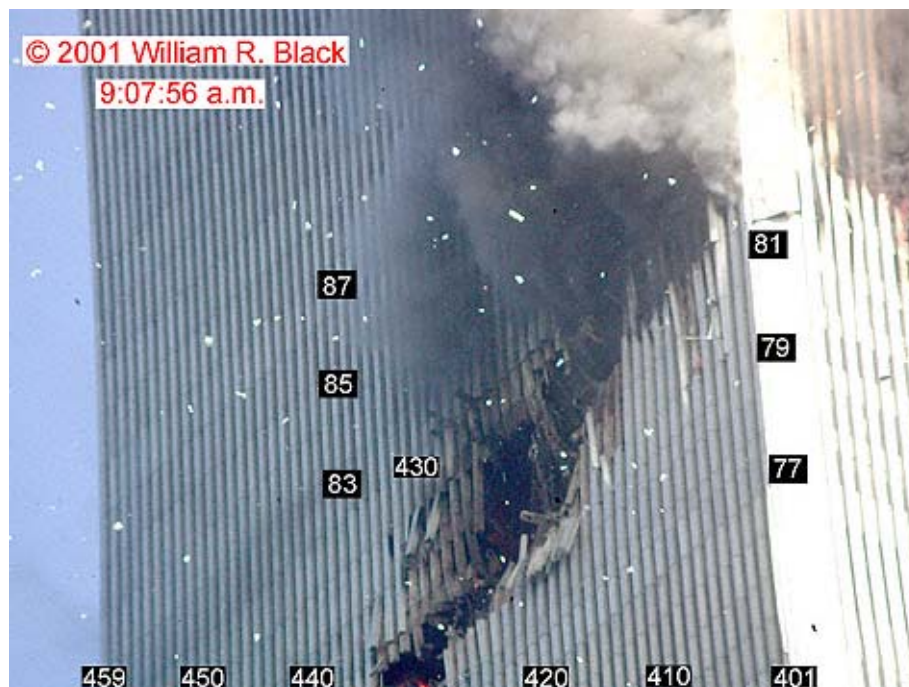
**Figure 7-24.** This cropped photograph shows the damage to the south face of WTC 2 caused by the aircraft impact. The original image has been enhanced by adjusting the intensity levels. Column and floor numbers have been added.

Close inspection of the photographs and videos reveals a great deal of debris piled on the right-hand side of the opening created by the aircraft impact. This debris, along with the depth of the opening, indicates that floor slabs in this area were partially collapsed by the collision. There is insufficient information to determine the exact areas over which the floor slab collapses occurred or the depth of the collapses inside the building. Visual evidence to be discussed in Section 7.4.3 suggests that at least some of the concrete in the floor slabs was pulverized during the collision.

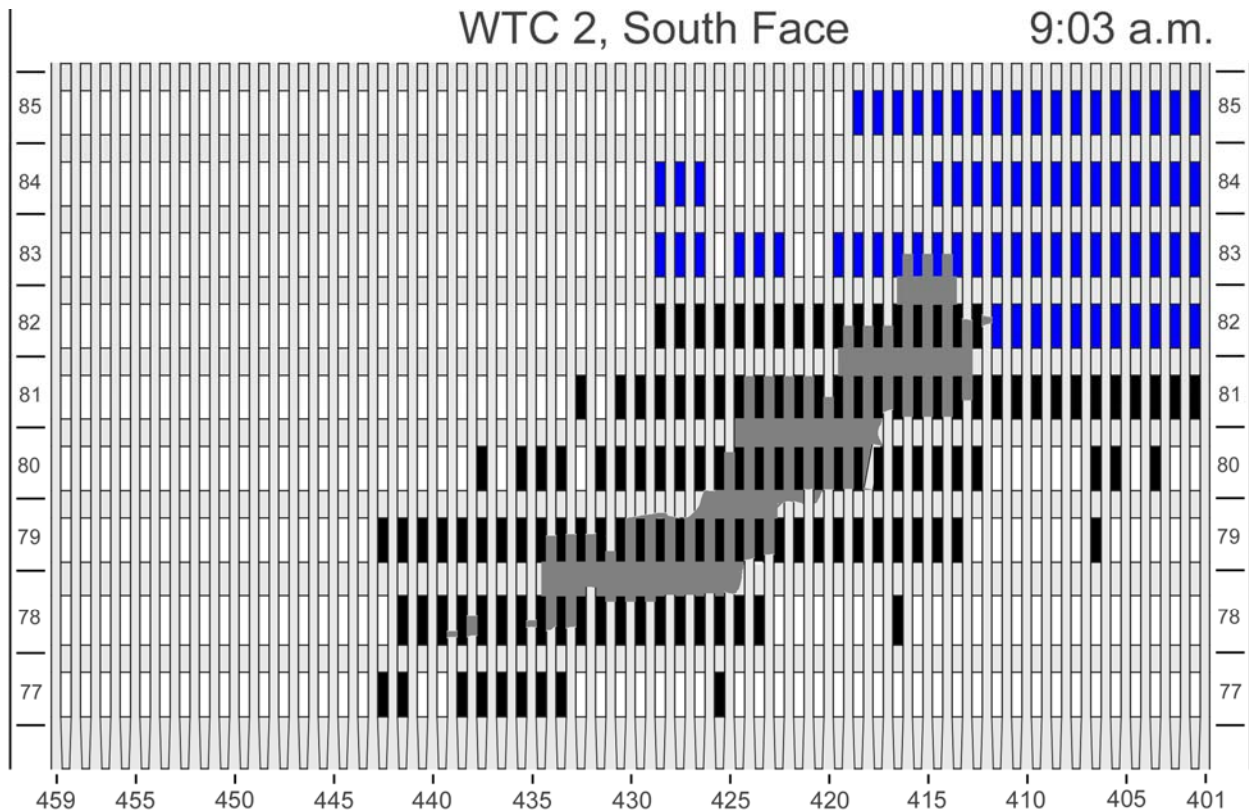
In general, the glass in windows near the aircraft impact location was broken out, while those windows further away tended to remain intact, although some windows were blown open by the overpressure generated by the initial fireball formation within the building. Figure 7-27 is a color-coded representation showing the condition of the windows on the south face in the area immediately following the aircraft impact. Note that a portion of the face was hidden by smoke at this time.

**Figure 7-27.** A schematic of observed window conditions on the south face of WTC 2 immediately following the aircraft impact is shown. Window and floor numbers are indicated. The colors represent ■ - window broken open, □ - glass in place, and ■ - not visible.

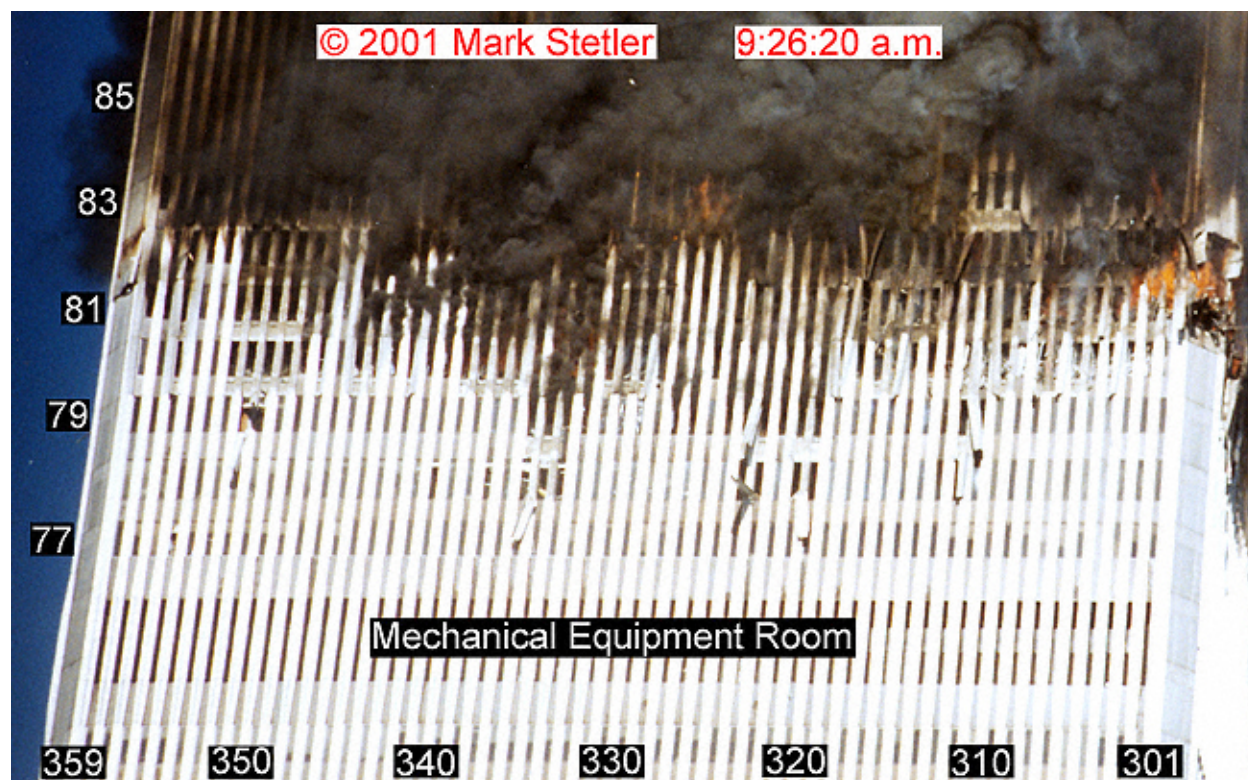
Substantial areas of the aluminum curtain wall have been removed over multiple floors. These areas appear dark due to the color of the underlying column and spandrel steel and fireproofing. In other areas the aluminum column and spandrel covers were disturbed, but remained in place. Video evidence and the wide extent of the damage indicate that much of this damage was due to the overpressures generated within the building by the sudden ignition of atomized aviation fuel and that these overpressures were sufficient to “blow off” numerous sections of the curtain wall. The potential magnitude of the overpressure generated within the tower was discussed in Section 6.5.

**Figure 7-28. A cropped photograph shows the east face of WTC 2 at 9:26:20 a.m. The image has been rotated, and column and floor numbers have been added.**

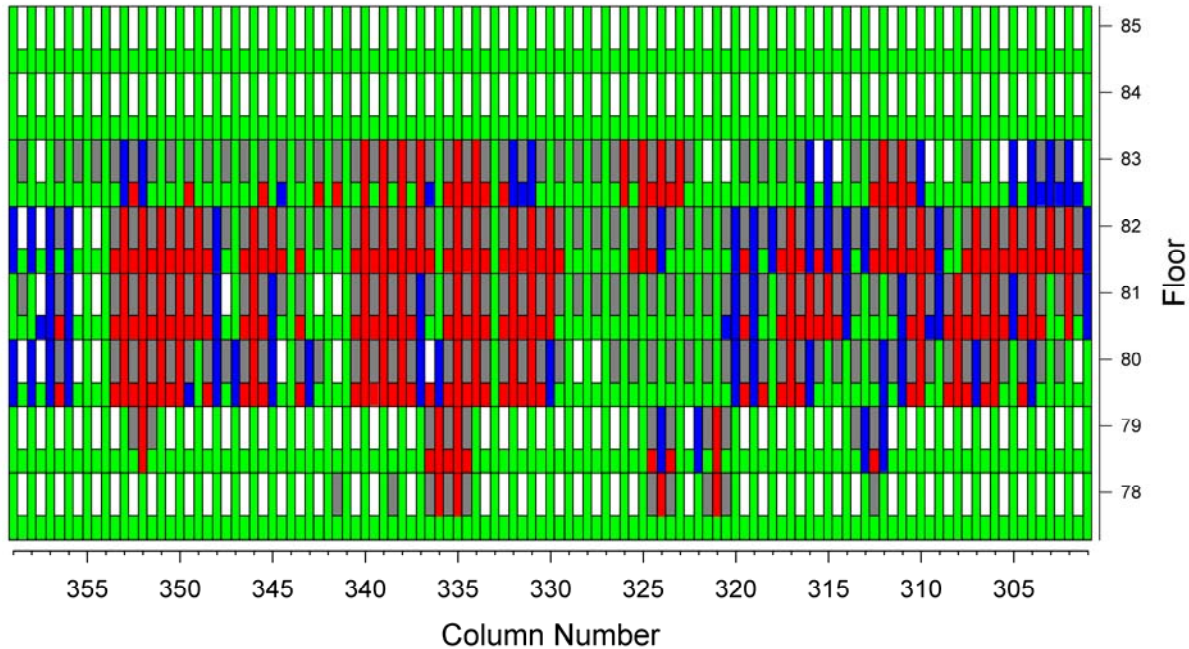
Figure 7–28, along with numerous other photographs and videos, was used as the basis for a detailed assessment of the initial damage to the curtain wall on the east face. Figure 7–29 shows the results. The information displayed includes details about the condition of the aluminum facing and whether or not window glass is missing or is still in place. It is apparent that the largest areas of damage were concentrated on the 80th, 81st, and 82nd floors. Based on Figure 7–26, these correspond to the two floors struck by the body of the aircraft (80th and 81st floors) and the floor where the majority of fuel from the starboard fuel tank was dumped (82nd floor). Interestingly, much less damage is apparent on the 79th floor, which is the floor where most of the fuel from the aircraft’s port tank should have been released.

**Figure 7-29. A color-coded map of the damage to the east face of WTC 2 as a result of the aircraft impact and fireball is shown. Details concerning damage to the aluminum curtain wall (■ - undisturbed, ■ - disturbed but still in place, and ■ - aluminum facing missing) and windows (■ - glass missing and □ - glass in place) are combined.**
